SNARE HYDRO SYSTEM

2006 Comprehensive Dam Safety Review

FINAL

Kohn Crippen Berger

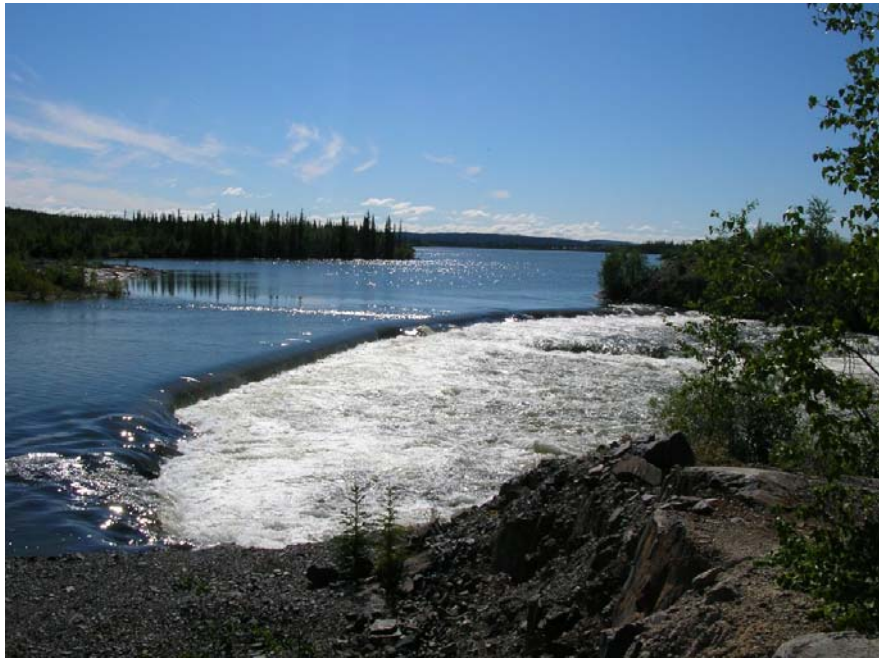
Photo 59 Snare Forks Spillway - flow over the concrete spillway is smooth with no irregularity in the flow pattern, $Q = 85 \text{ m}^3/\text{s}$.

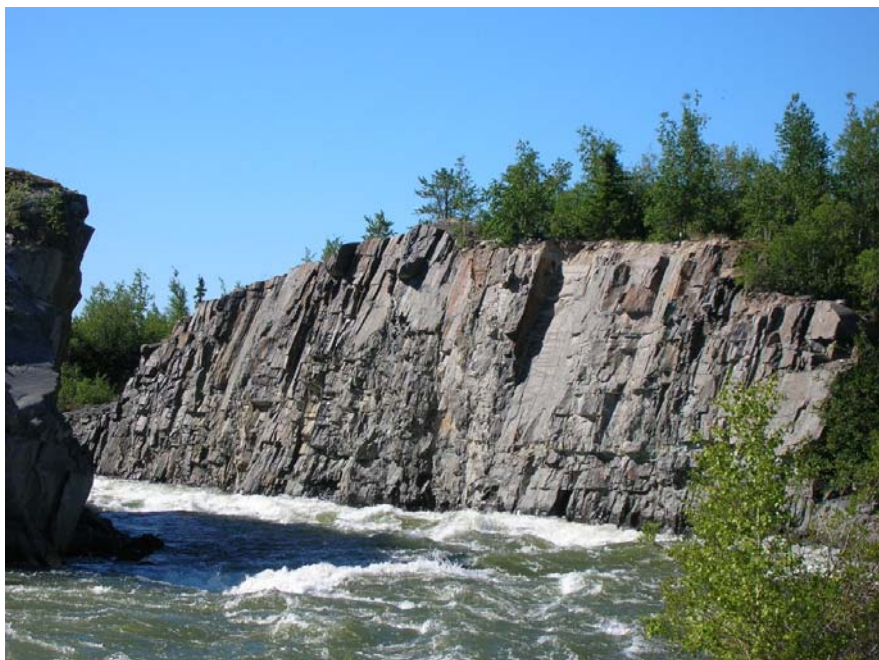
Photo 60 Snare Forks Spillway - excavated channel downstream of the spillway control structure is in good condition.

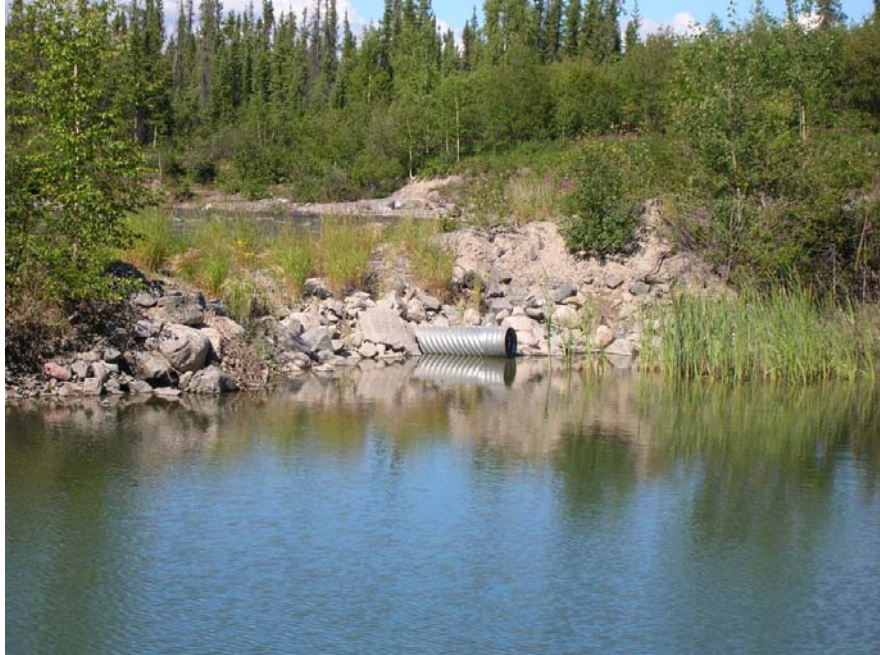
Photo 61 Snare Forks Dam - culvert installed through the cofferdam. Invert slightly below pond level.

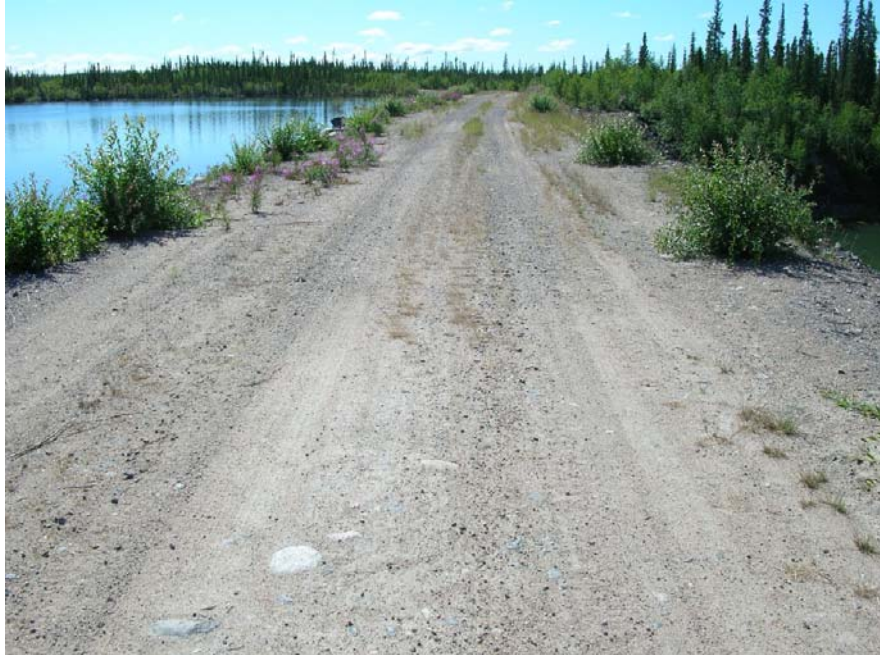
Photo 63 Snare Forks Dam – crest planar with no signs of settlement, cracks or erosion.

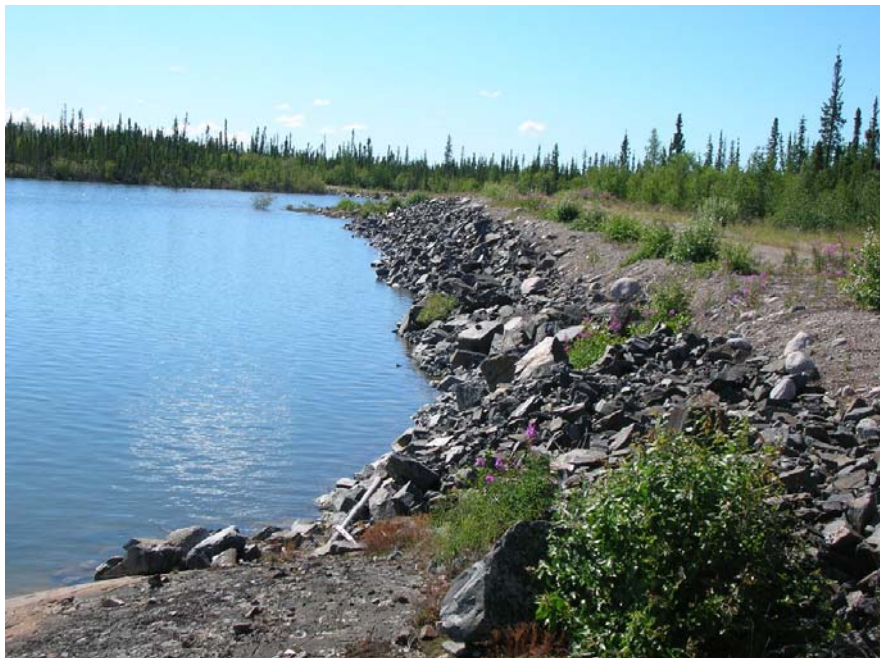
Photo 64 Snare Forks Dam - upstream slope typically shows no signs of settled areas or instability with no erosion or beaching of the riprap evident.

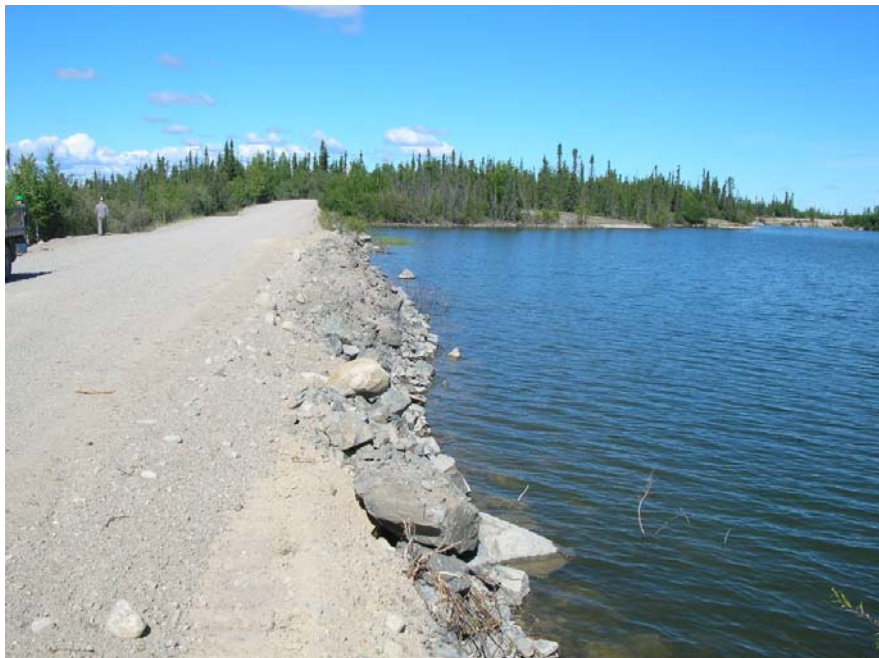
Photo 68 Freeboard Dyke 2 – crest exhibits no longitudinal cracking but recently placed sand fill may mask actual condition.

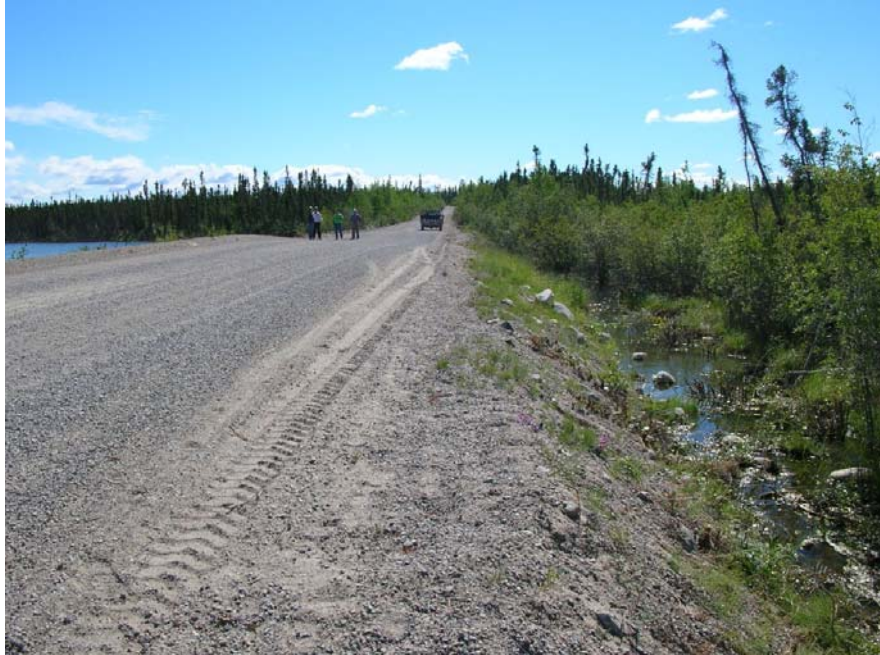
Photo 69 Freeboard Dyke 2 - downstream shoulder of the dyke cross section appears lower than at the centerline.

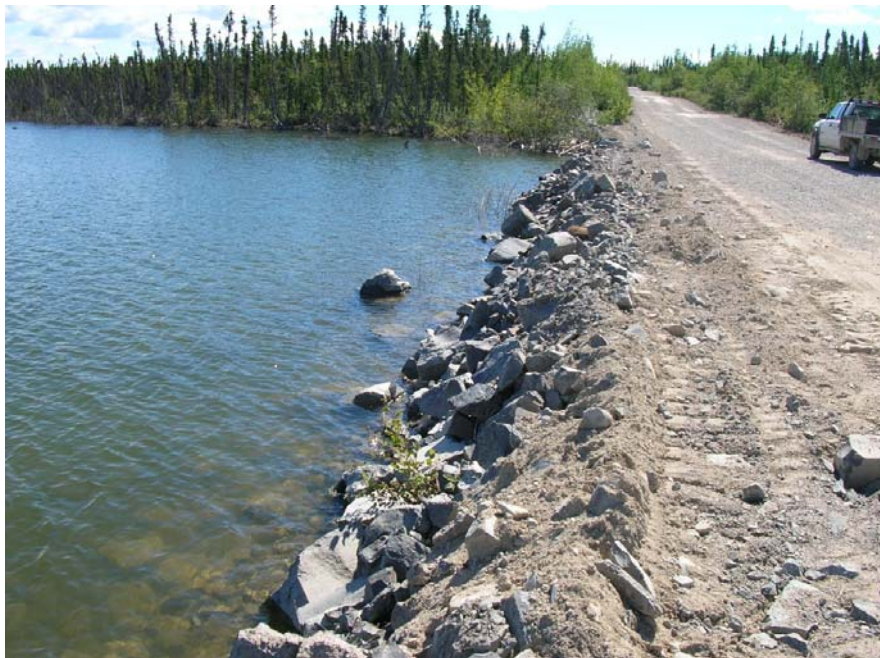
Photo 70 Freeboard Dyke 2 – riprap on upstream face is in acceptable condition.

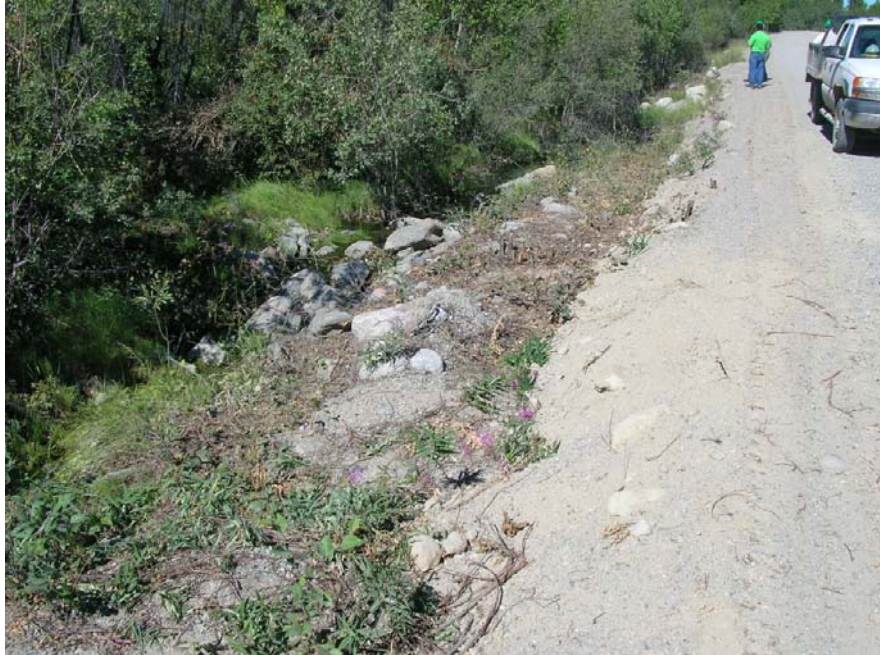
Photo 71 Freeboard Dyke 2 - ponded water along the downstream toe originates from foundation seepage at the left abutment.

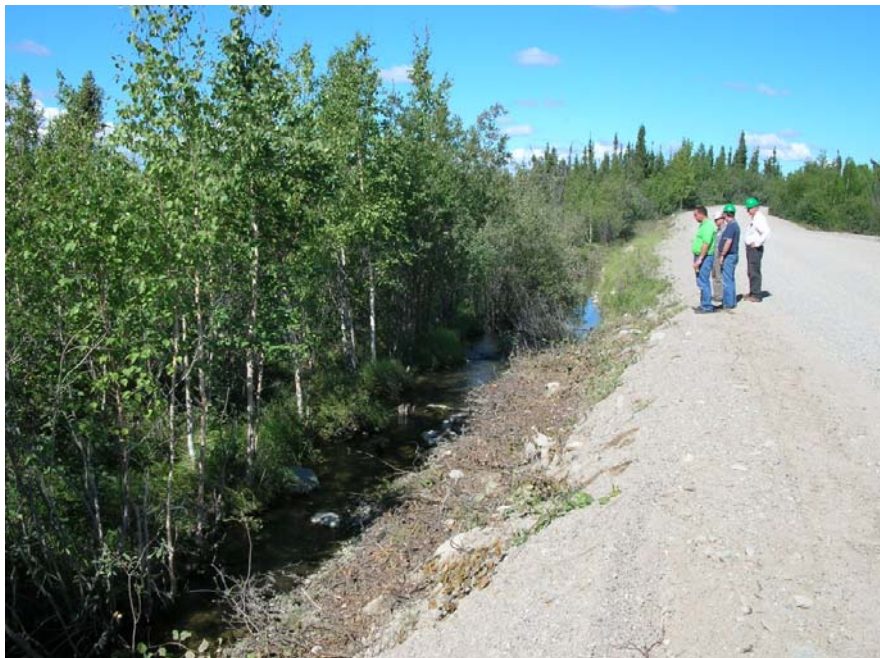
Photo 72 Freeboard Dyke 2 –seepage from foundation flows down the toe of the downstream slope, collecting in the low point.

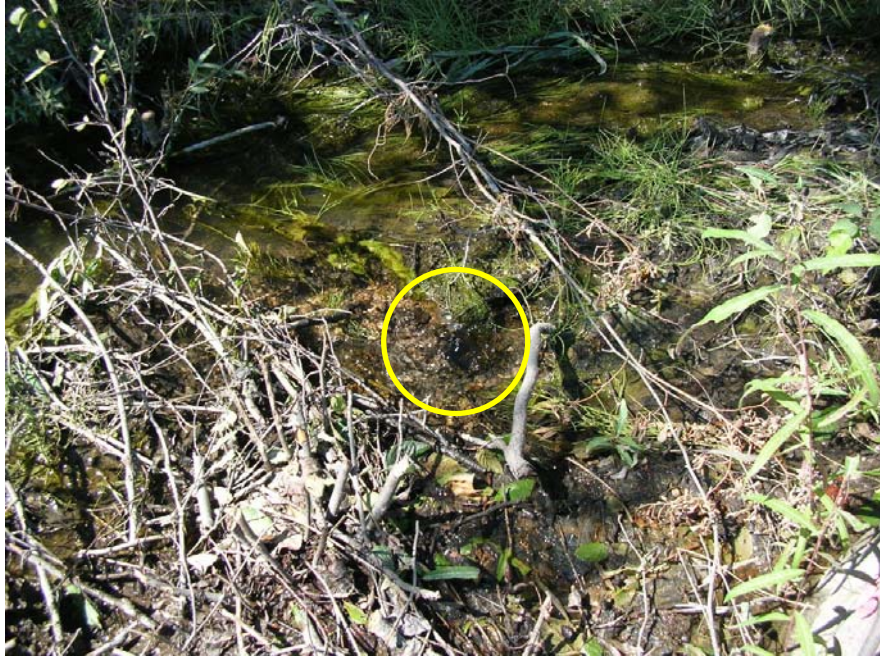
Photo 73 Freeboard Dyke 2 – small boil (5 cm max) discharging clear water beneath the ponded water within approximately 2 m of the toe of the dyke. .

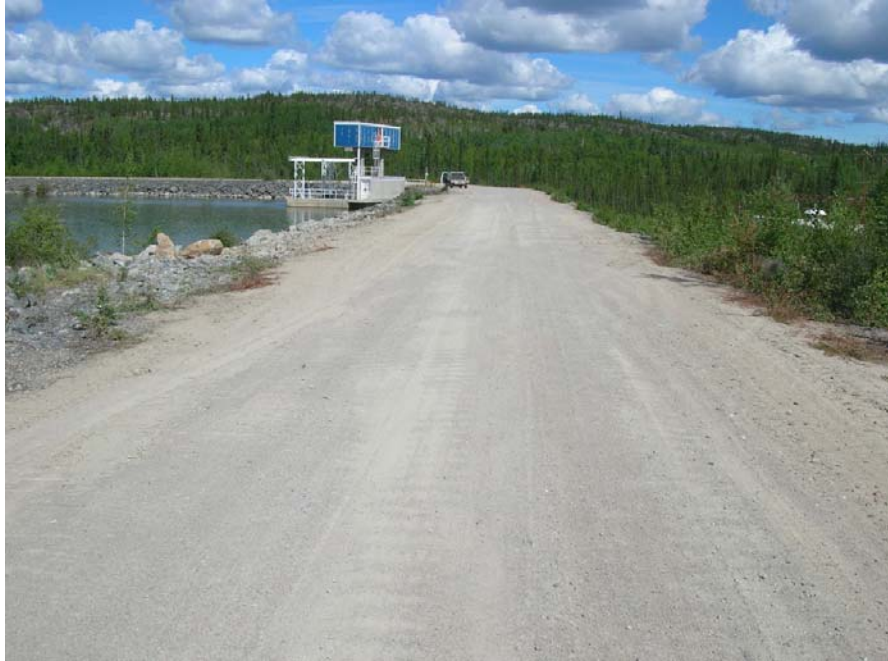
Photo 77 Strutt Lake Dam - crest is planar, with no visible settlement, cracks or erosion.

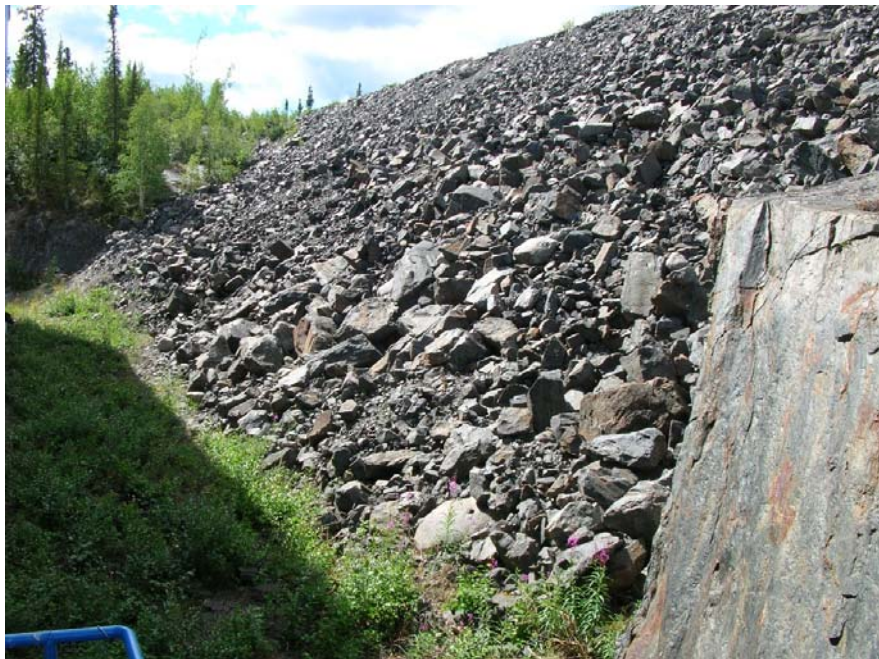
Photo 78 Strutt Lake Dam - downstream shell of the dam is planar with no settled areas, erosion gulleys or evidence of abutment seepage.

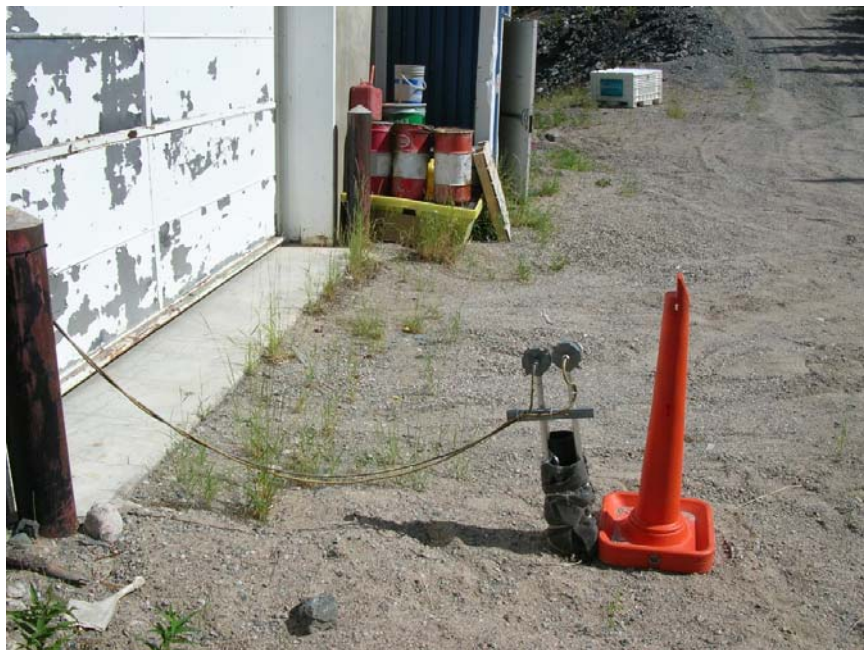
Photo 80 Snare Forks Powerhouse - heat traced perforated PVC pipe installed along the SW side of the powerhouse to address the minor seepage observed from the rockfill downstream.

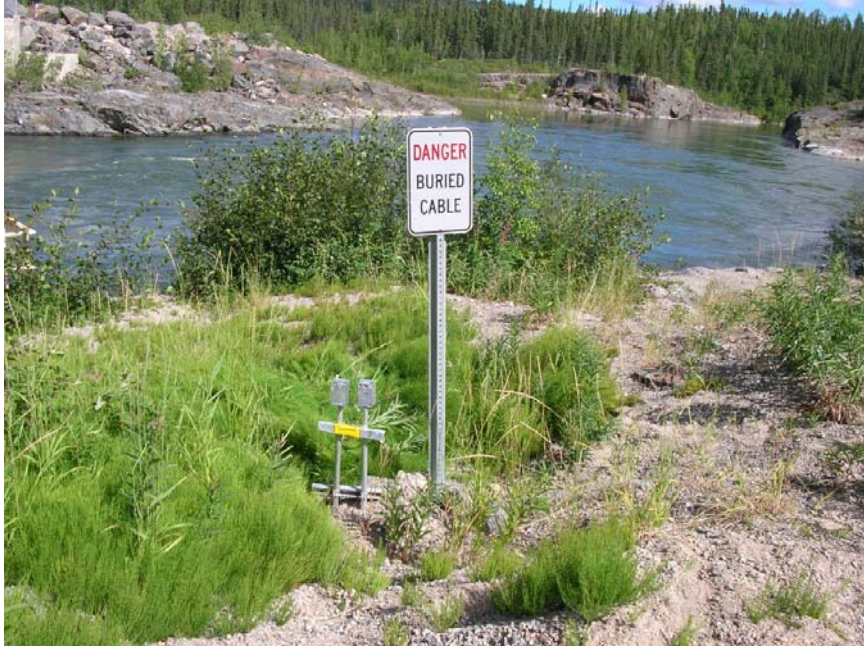
Photo 81 Snare Forks Powerhouse - some dampness along the SW side of the powerhouse evident, but there is no longer observable seepage.

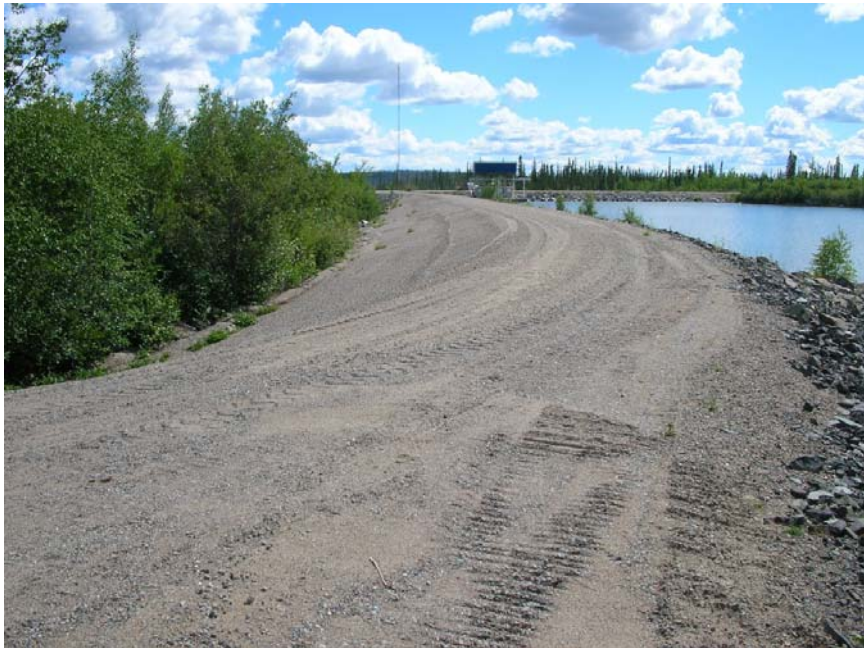
Photo 82 North Dyke – crest recently topped-up at the time of inspection and appeared to be in satisfactory condition. The crest is planar with no cracks, settled areas or erosion.

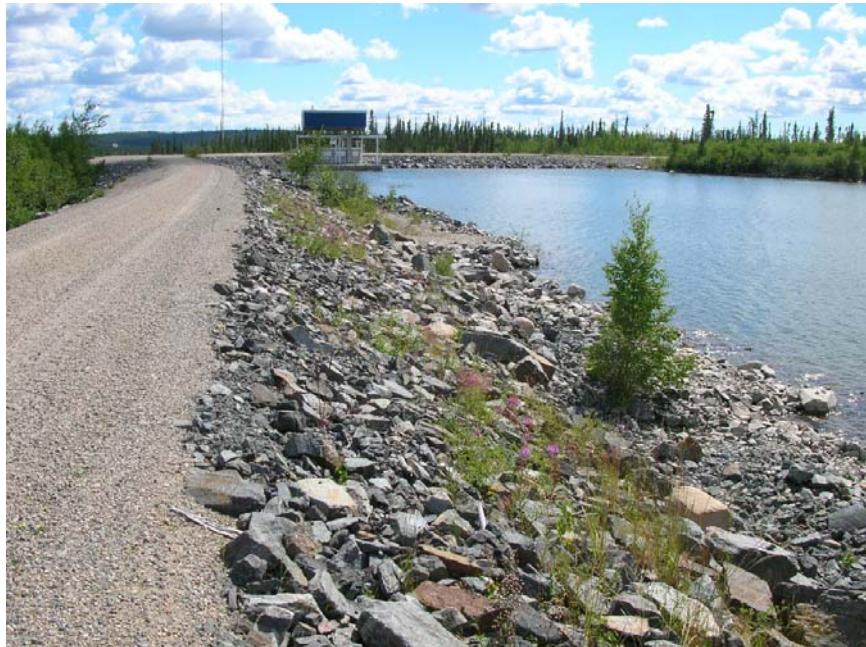
Photo 83 North Dyke - riprap on the upstream face is satisfactory. .
