Report: Contact Lake Mine Remedial Action Plan with Project Update

RE: Contact Lake Mine Remedial Action Plan – Project Update

CONTACT LAKE MINE REMEDIAL ACTION PLAN

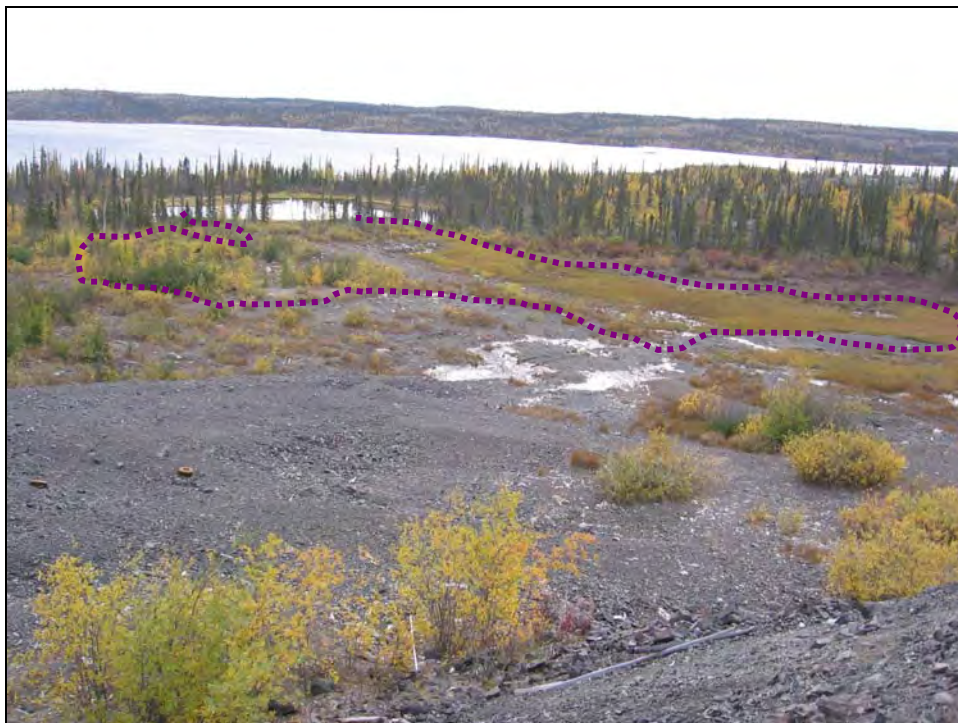
FIGURE 3.6-12
CONTACT LAKE SURFACE TAILINGS

From document reviews, 1969 estimates of tailings (see Figure 3.6-12) on site were in the order of 5,000 tons. This estimate was refined to 2,264 tons in 1973 by Bill Knudsen (Knudson 1973) of Echo Bay Mines. Subsequently, records indicate that 2,085 tons of tailings were removed by winter road to Echo Bay's Port Radium mill in 1975. The residual surface tailings remnants (less than 200 tons, 2264 less 2085) are thinly spread across the flat area below the waste rock pile that is bounded on each side by rock outcrops. The remaining surface tailings have likely been subject to sheet erosion over time with eroded materials migrating down gradient to a natural pond that acts as a natural sump. This pond is a natural stable structure that is bounded by rock outcrops on all sides.

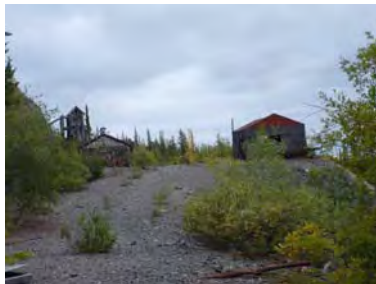
- Safety Hazard
- Visual attraction to site
- Some chemical hazards (lead paint, DDT, asbestos)

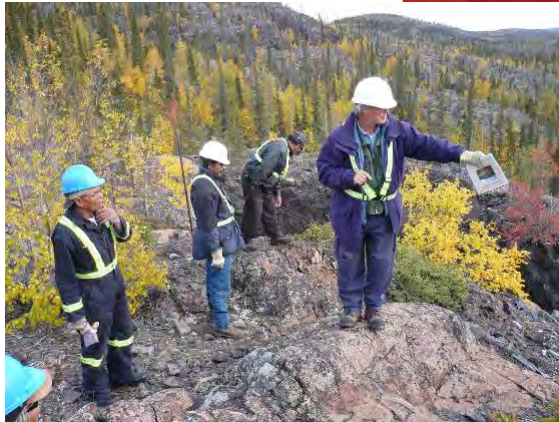
- Large opening
- Falling hazard

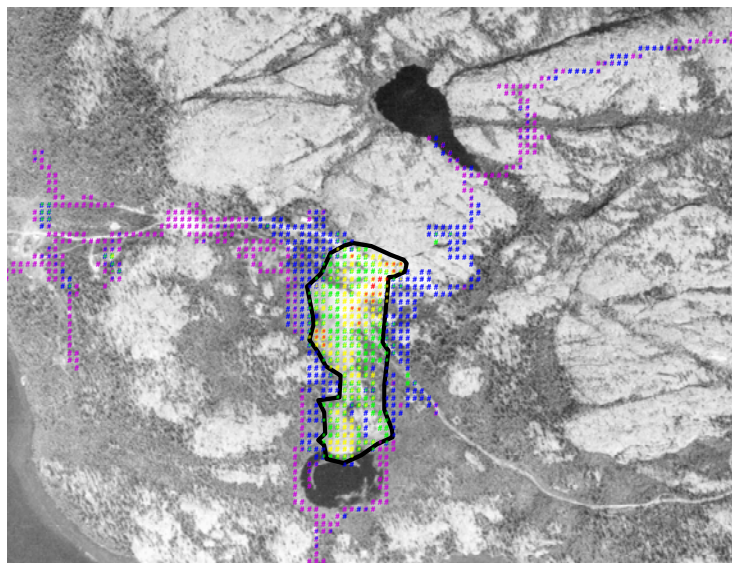
- Main Pile (26,000 m³ over 1.6 hectares)
- Slopes appear to be stable
- Limited leaching of metals (e.g. arsenic)
- Waste Rock (non-acid generating)
- The waste rock has elevated levels of gamma radiation – 200 m² averaged over 250 uR/h

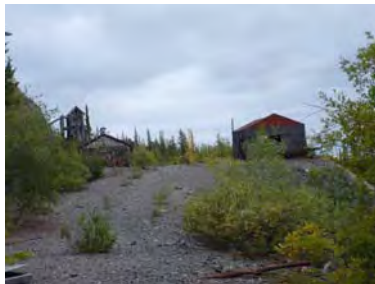
- Safety Hazard
- Visual attraction to site
- Some chemical hazards (lead paint, DDT, asbestos)

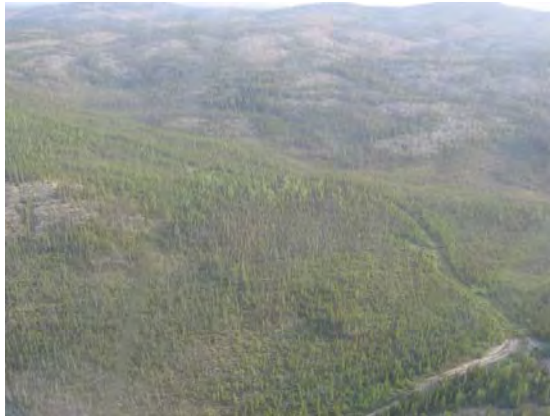
- Overgrown
- Minimal environmental impact

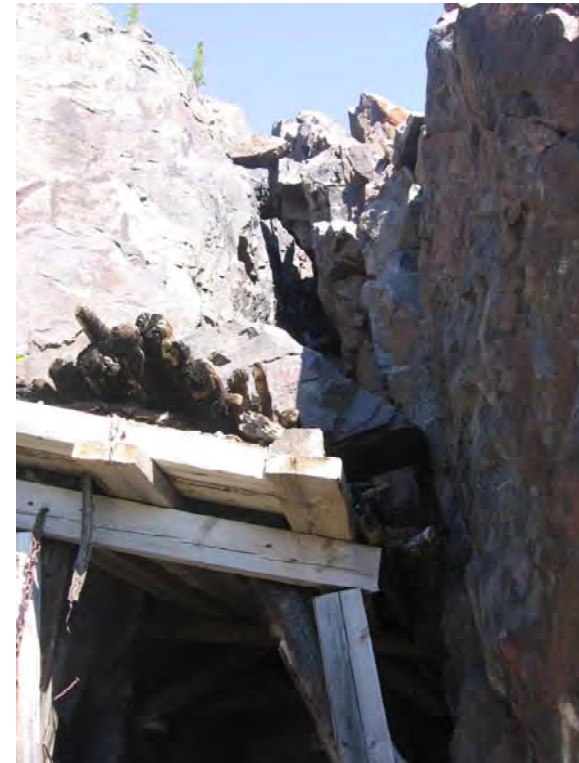
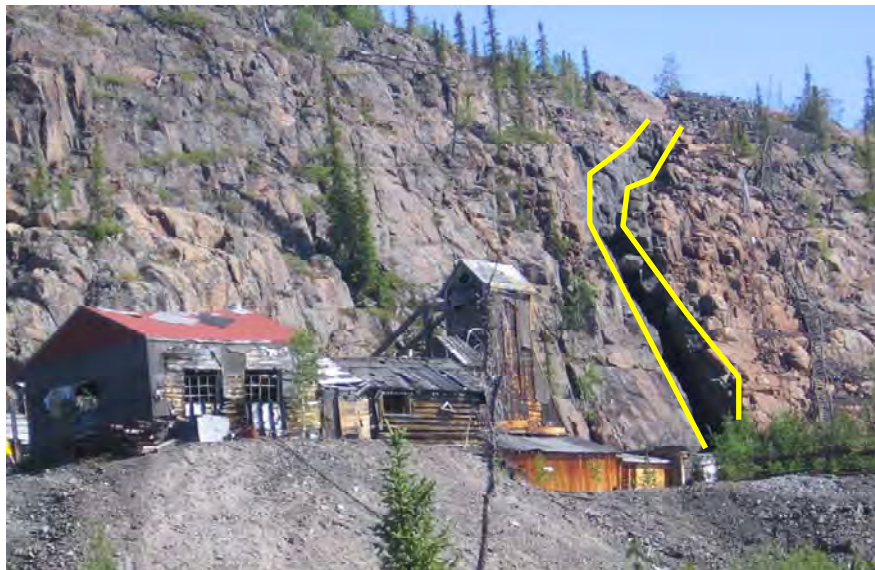
Stoping in the 111 and 112 Stope Areas

Stoping above the access adit.
Once timber support fails the will be limited further failure.

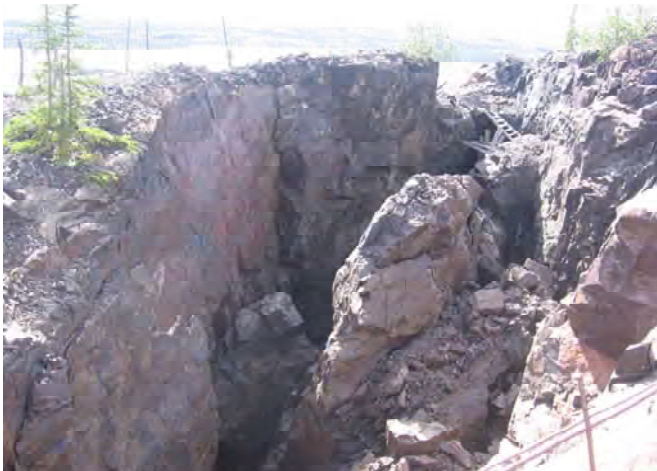
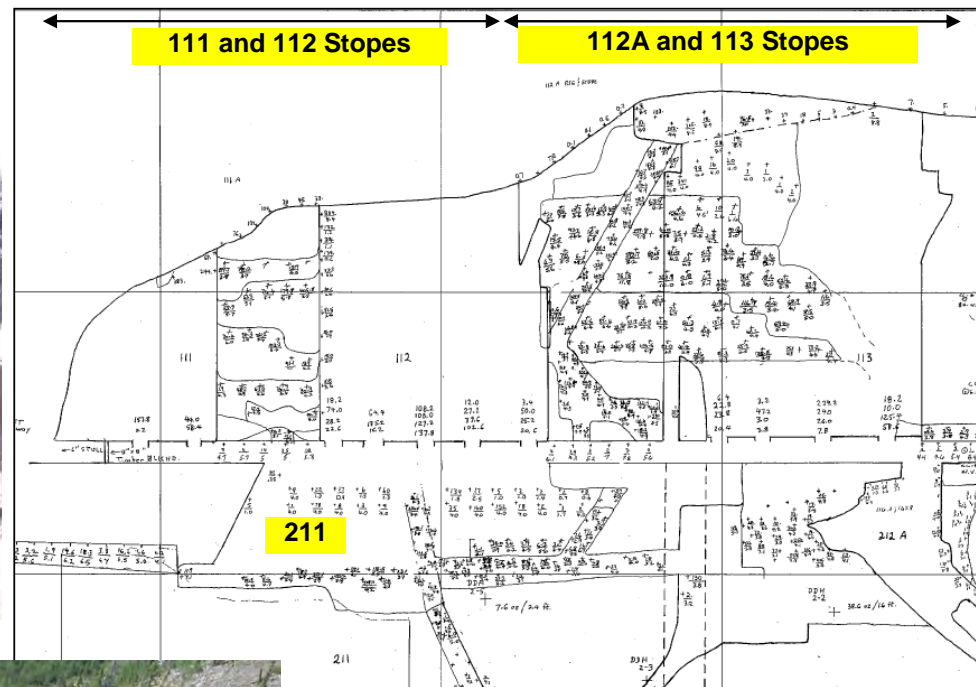
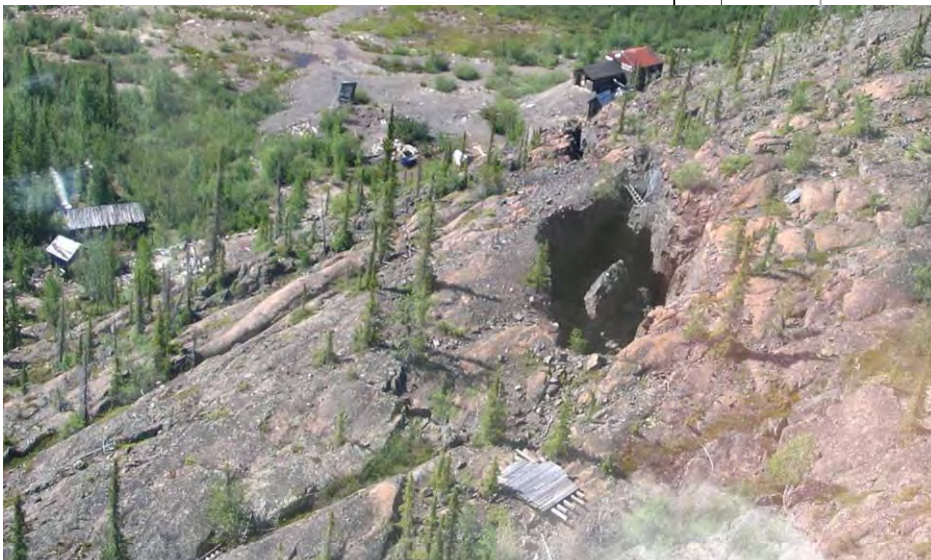
Stoping in the 112A and 113 Stope Areas

Stoping in the 112A and 113 was undertaken over substantially wider stopeing width than the 111 Stope Area. Larger stopes have led to a greater degree of break-back.

This is not expected to get much dramatically larger due to verticality and that the failed sidewall material is potentially stabilizing the stope
