| File Number | S17X-004 |
| Type of Operation | AIRSTRIP |
| Location | Monitoring Wells |

ENVIRONMENTAL INSPECTION REPORT

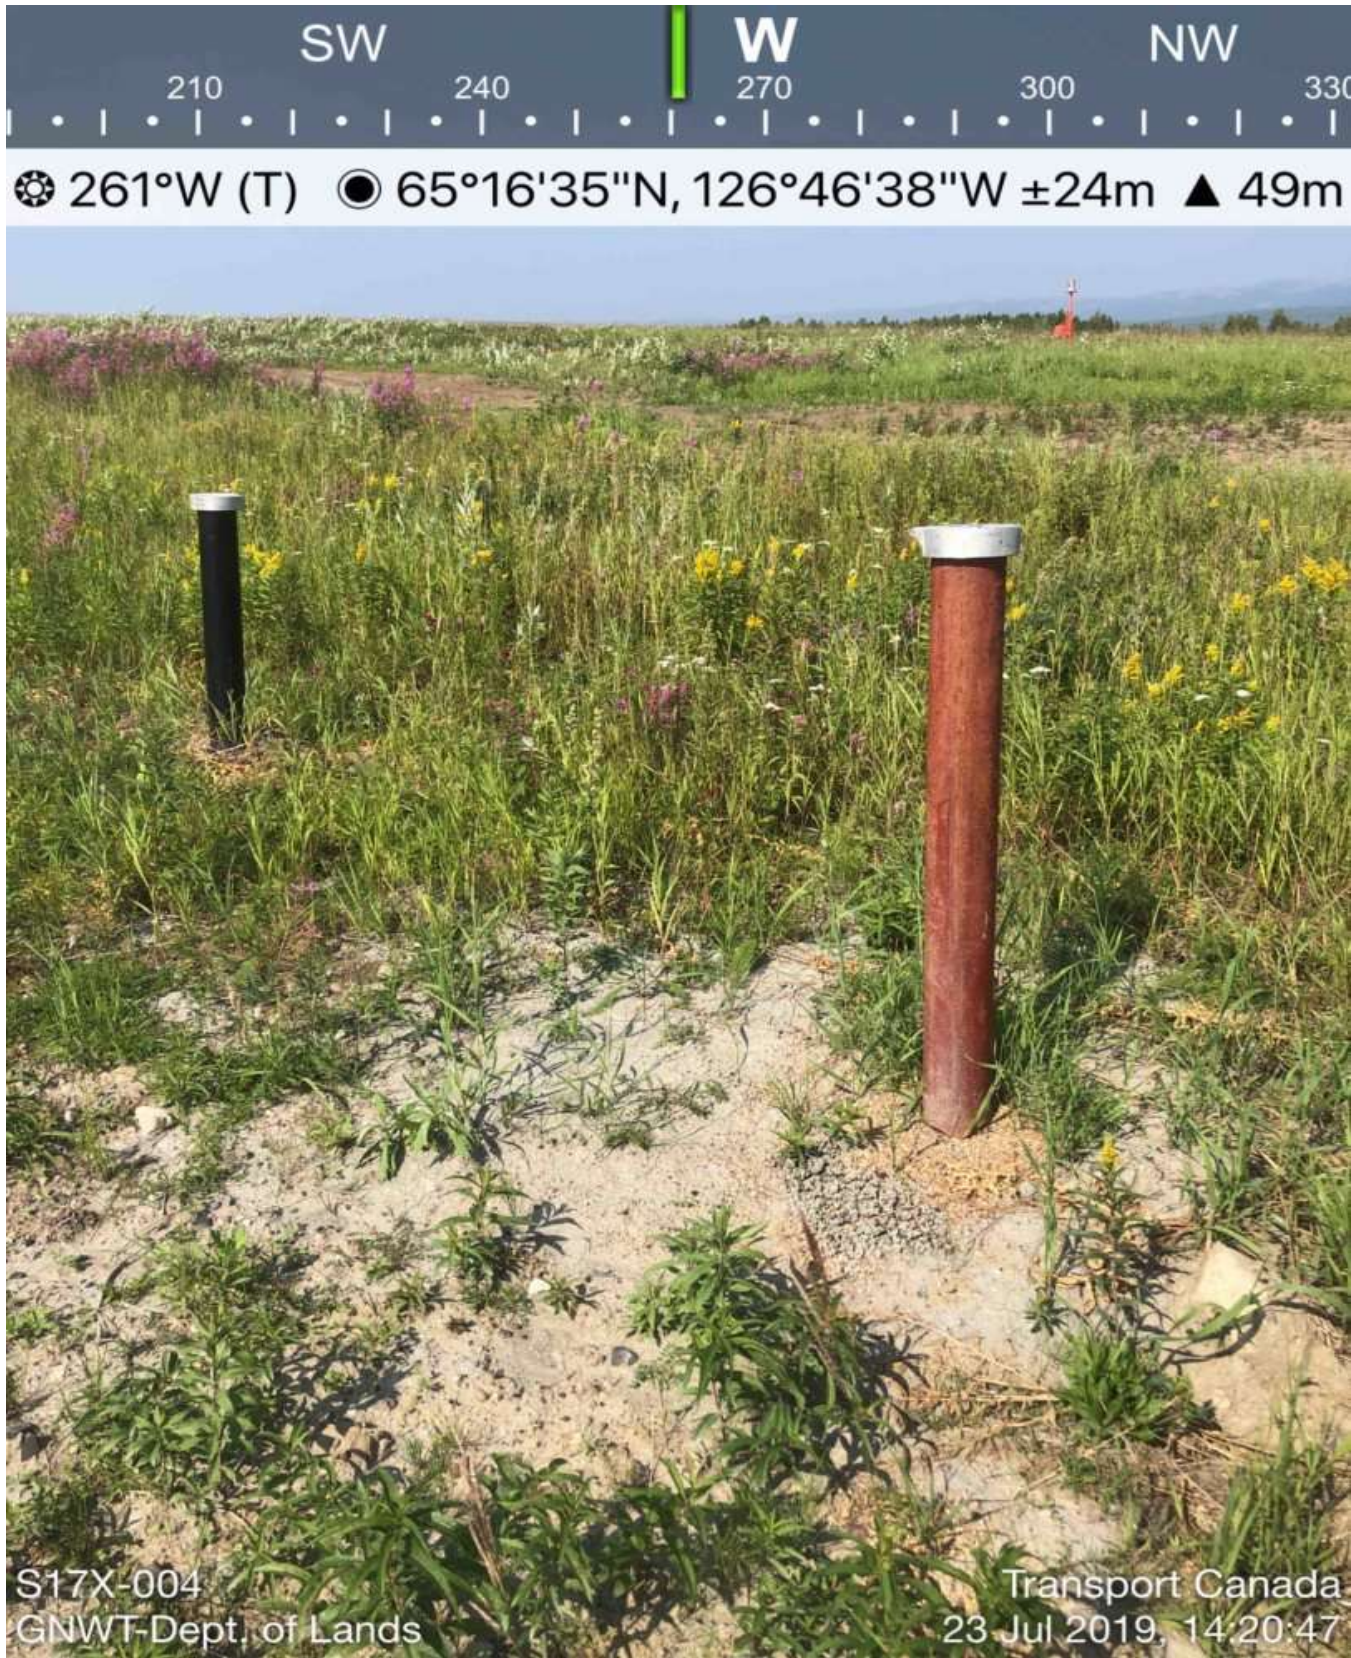
Figure 1

MW-01 (Black) and old monitoring well (Red).

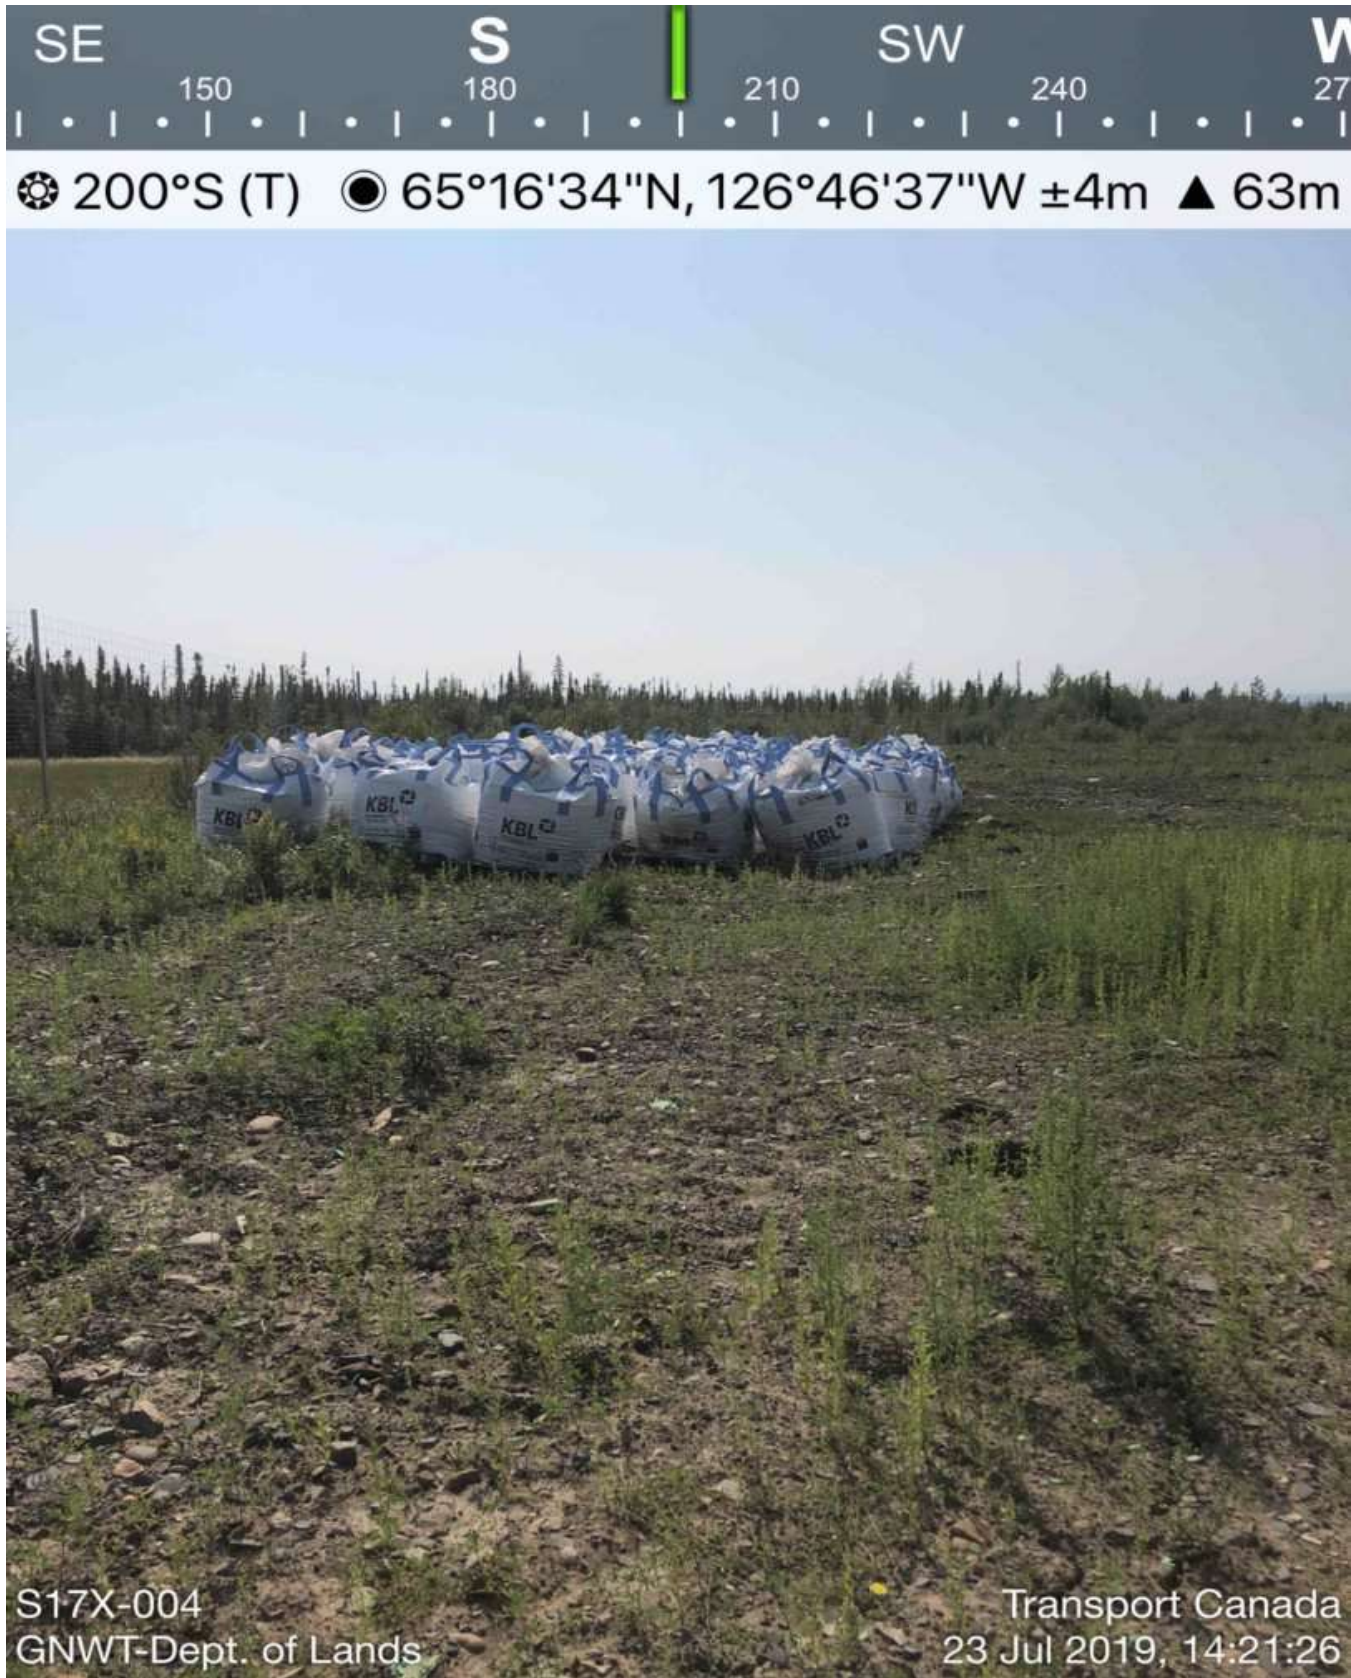
BluMetric was on site the week of August 6th, and has confirmed that the bagged soil that was remaining on site was NOT impacted soil. All bags were identified as non-impacted soil through cross-referencing of the numbers printed on the bags and BluMetrics analysis logs from last season. As well, all impacted bags were clearly marked as such for easy identification by the disposal contractor. It was then confirmed that there were 48 bags of non-impacted soil remaining onsite. These bags have since been emptied and spread on site per this season's work plan.

Inspectors were pleased with the condition of the site. It was kept tidy, and contaminated soil was stored in 48 full lined heli-sacks and 1 partially full heli-sack. Inspectors are curious as to when contaminated soils extracted will be moved to the licenced KBL Environmental Soil Disposal Facility in Yellowknife. The Closure and Reclamation plan submitted in September 2018 stated: “material will be excavated, placed in soil bags, stored on pallets off-site and hauled via winter road for disposal...”(5.4 Investigation of Underlying Soils, page 9). The material is still stored on-site.

Figure 2
Contaminated soil in lined heli-sacks (48).

Please inform Inspectors when (Dates) these materials will be removed and shipped to the appropriate facilities.

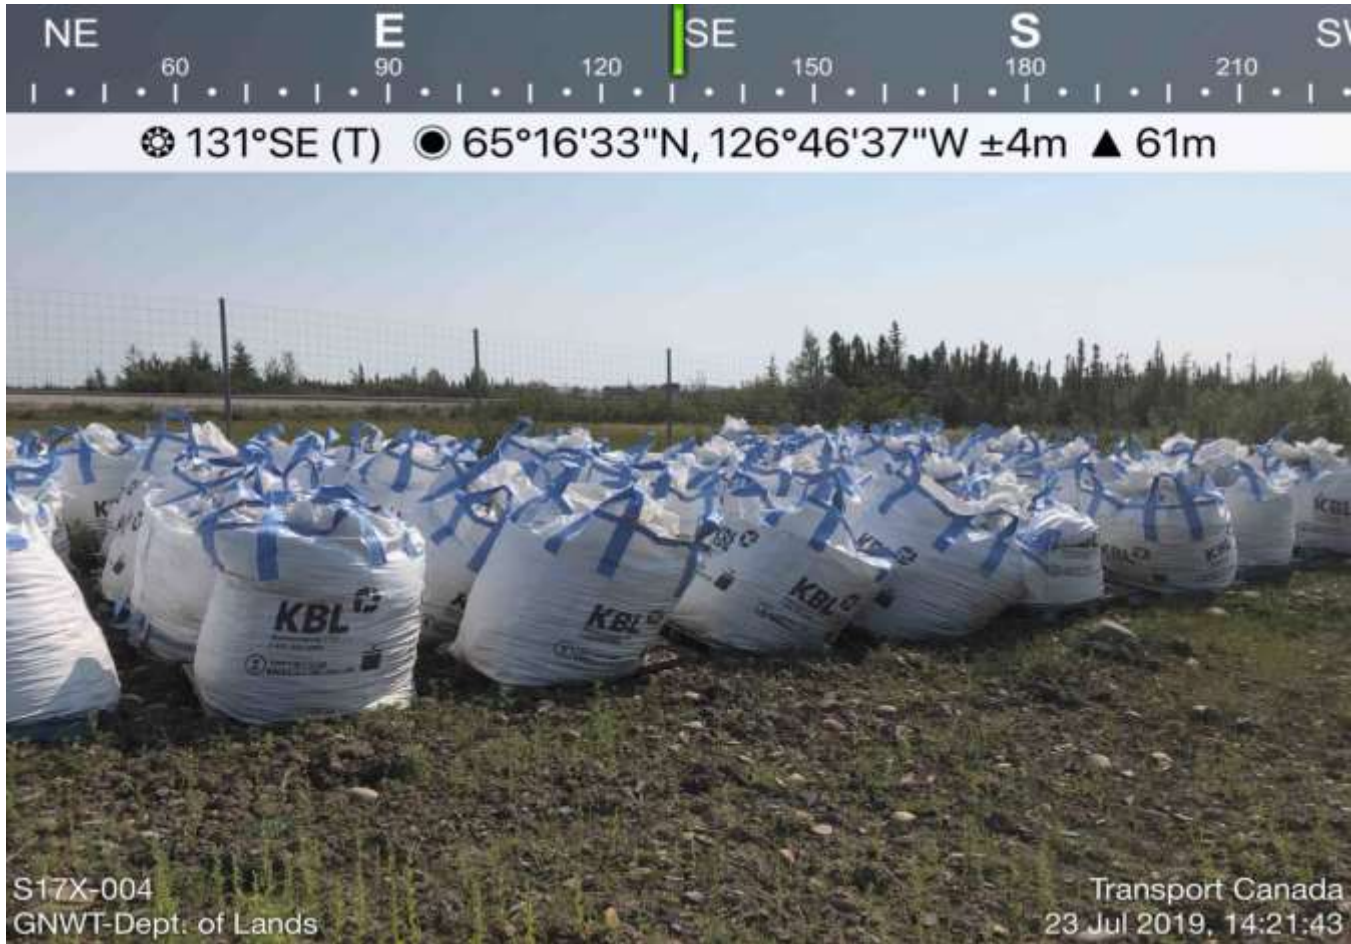
Figure 3
Contaminated soil in lined heli-sacks (48 full).

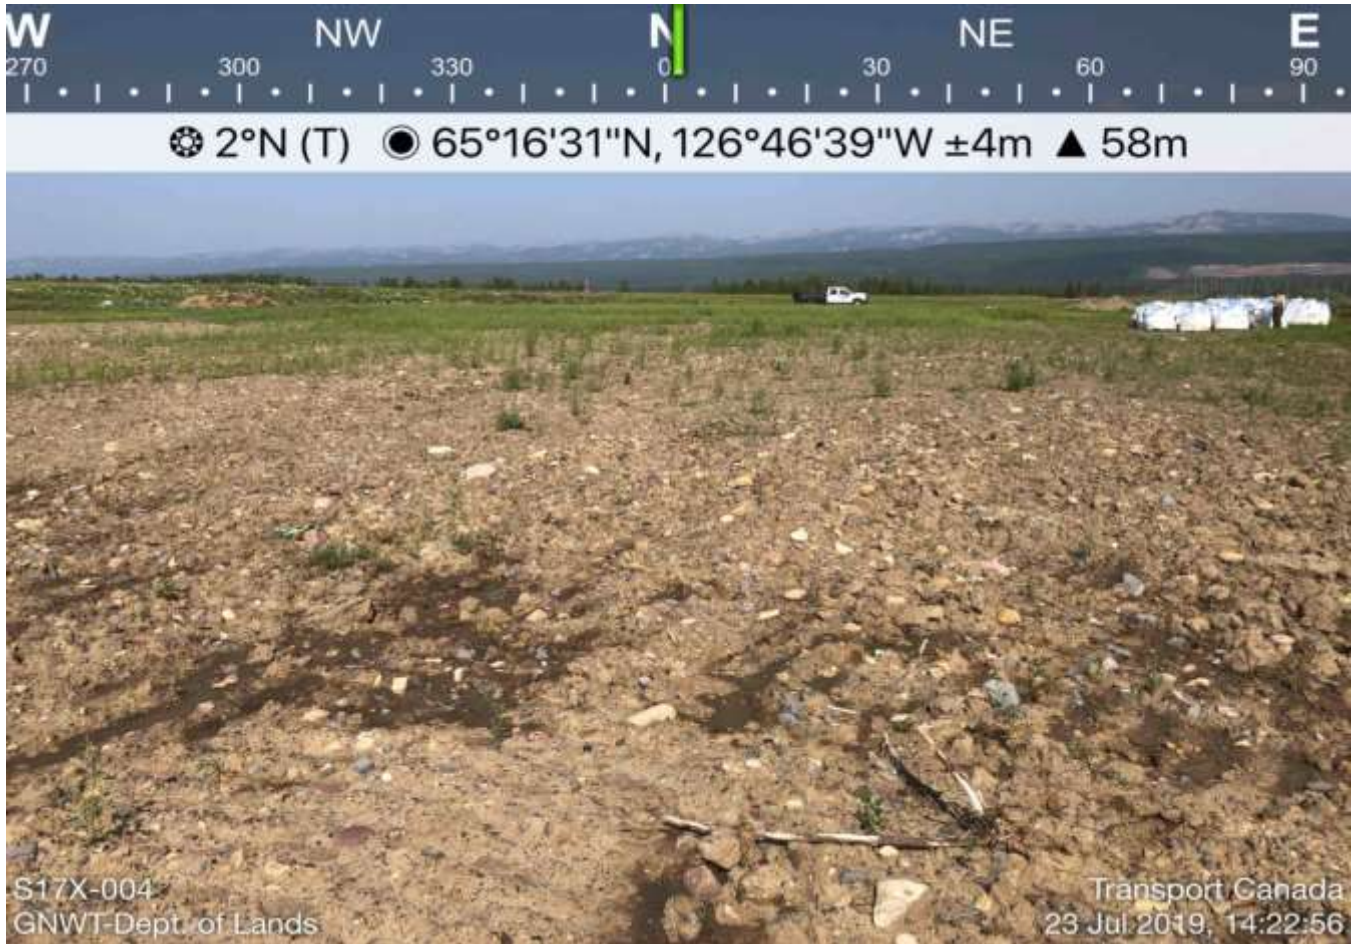
Figure 6

LTU approx. 100m x 50m.

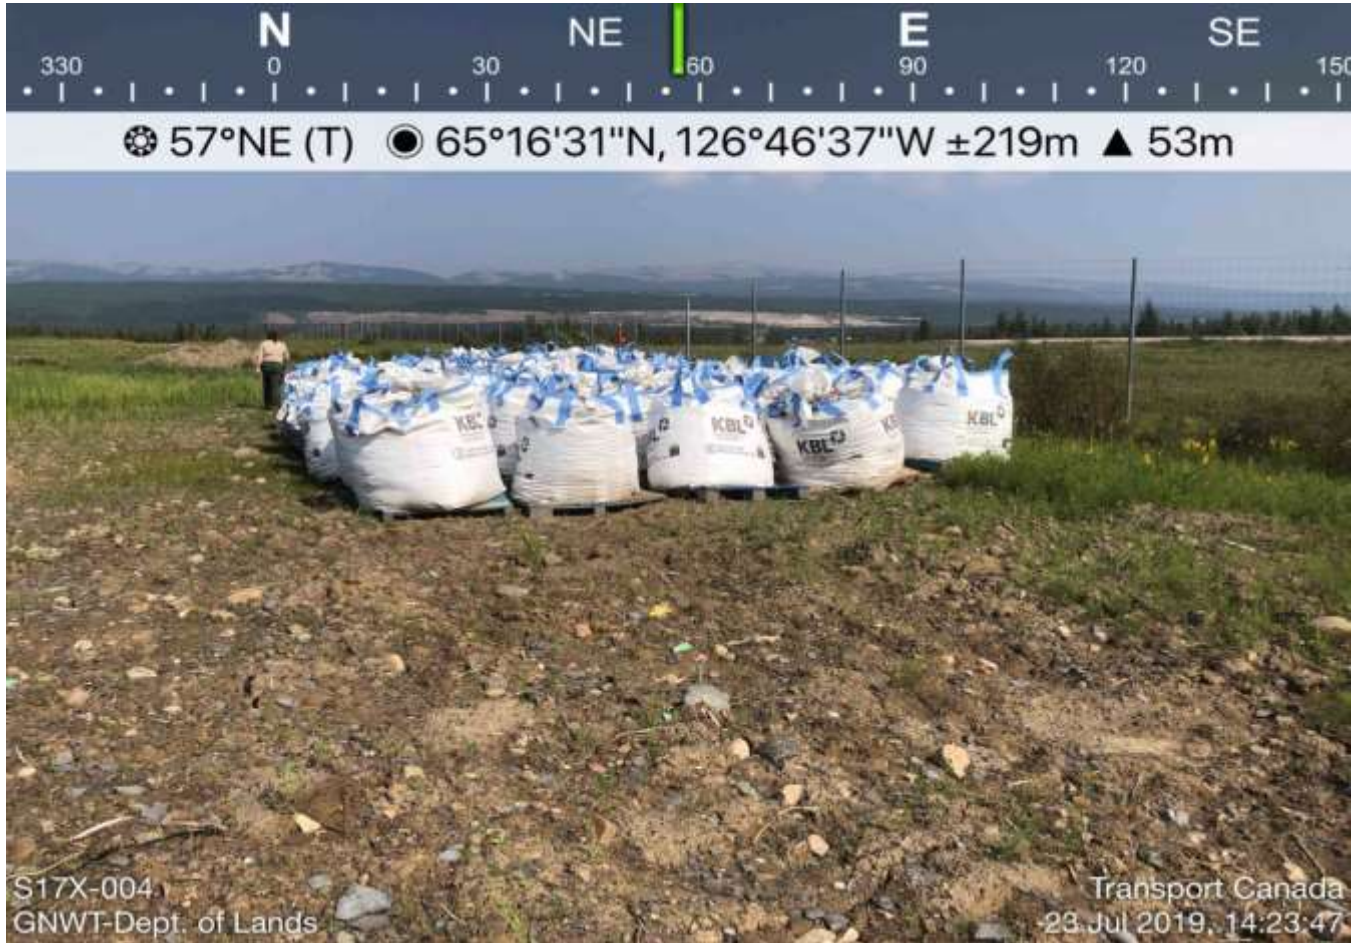
Figure 7

Contaminated soil in lined heli-sacks (48).

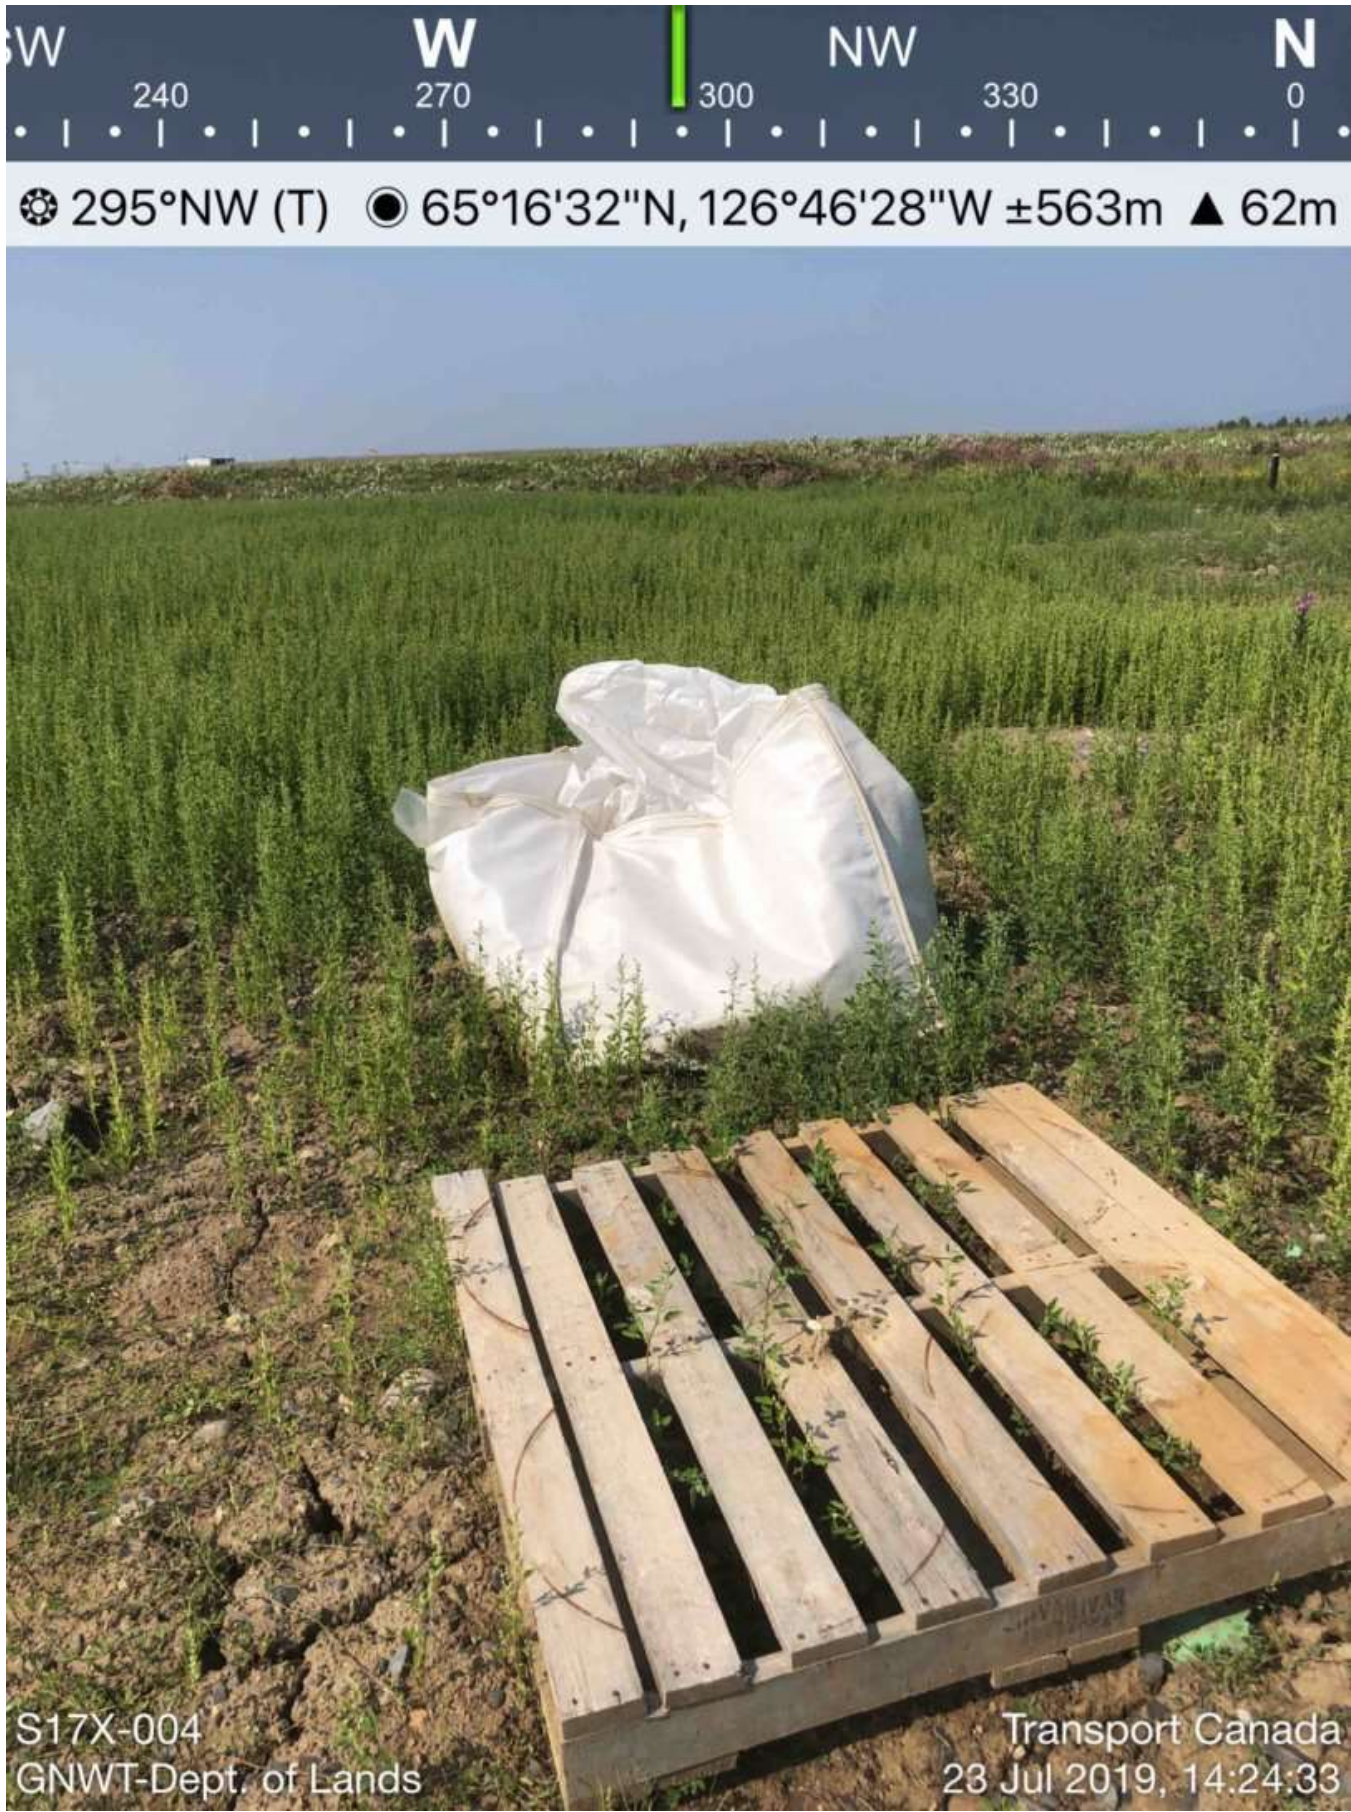
Figure 8

One partial full, lined heli-sack.
