# Memo

To:	MGM Energy	From:	James Hymers, Project Manager K'alo-Stantec Ltd.
	2800, 421 - 7 Avenue SW Calgary, AB T2P 4K9		Tulita, NT, Canada X0E 0T0
File:	123514551	Date:	January 22, 2024

#### Reference: 2023 Environmental Site Monitoring Report: Maunoir C-34 Wellsite Area

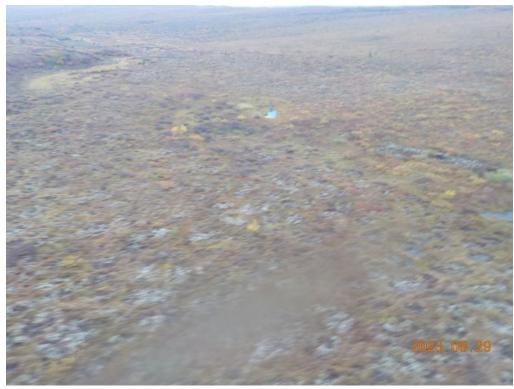
# Photo B.1 C-34 Wellsite Area: Overview

Note: Overview of the Wellsite Area and surrounding area (facing northeast) showing overall terrain and vegetation conditions (August 29, 2023).

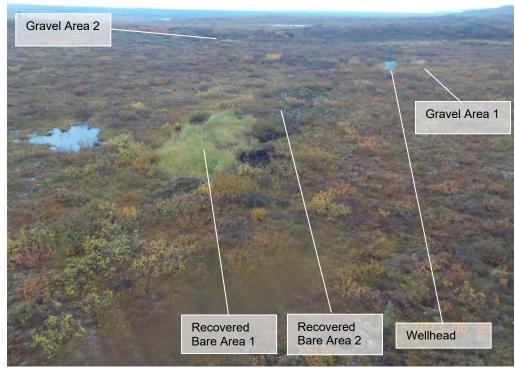
## Photo B.2 C-34 Wellsite Area: Overview

Note: Overview (facing north) showing locations of Wellhead, Recovered Bare Areas 1 and 2, and Gravel Areas 1 and 2 (August 29, 2023).

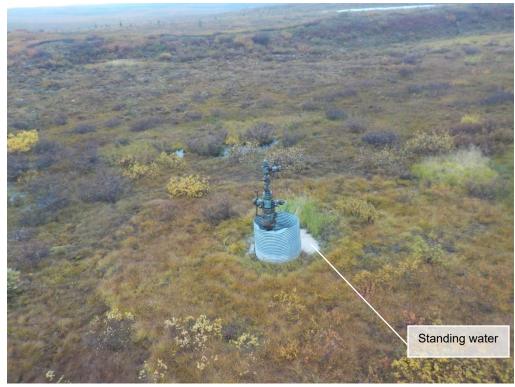
# Photo B.3 C-34 Wellsite Area: On-Site Materials

Parameters	Monitoring Observations and Results	Soil and Water Analytical Results (if exceedances)	Future Recommended Work
On-Site Materials	<ul> <li>A wellhead, sign, and protective culvert were present at the Site during the site visit (Attachment B: Photo B.3).</li> <li>No other surface structures, materials, or waste were observed within the remainder of the Site during the site visit.</li> </ul>	<ul> <li>Not applicable for this parameter.</li> </ul>	• No further work related to on-site materials recommended until the wellhead is cut, capped, and abandoned.
Terrain	<ul> <li>No terrain stability concerns observed at the Site during the site visit. Terrain conditions were observed to be stable.</li> </ul>	Not applicable for this parameter.	Continue visual monitoring for potential signs of stress and/or ground movement during a future site visit.
Standing Water	<ul> <li>No further standing water sampling was recommended as per the 2017 report<sup>4</sup>.</li> <li>No standing water was sampled during the 2023 site visit.</li> <li>Standing water was observed around the wellhead at the time of the site visit.</li> </ul>	Water samples were not collected from the wellhead area during the 2023 site visit.	<ul> <li>No sampling of standing water recommended, unless visible evidence<sup>5</sup> triggers sample collection during a future site visit.</li> <li>Monitor the standing water around the wellhead and sample for petroleum hydrocarbons (PHC) if a sheen and/or odour are present.</li> </ul>

Note: View (facing northwest) toward the on-site materials showing the wellhead and protective culvert (August 29, 2023).

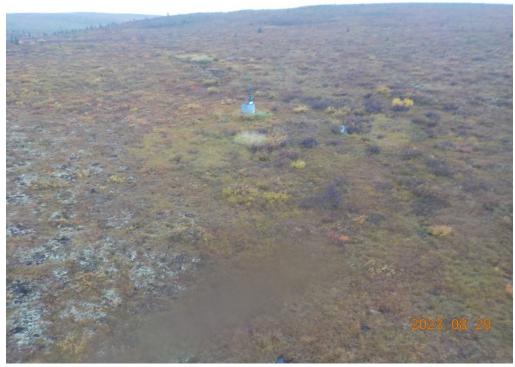
## Photo B.4 C-34 Wellsite Area: Vegetation Cover

Vegetation	<ul> <li>Site has naturally revegetated in the Wellsite Area around the wellhead location (Attachment B: Photo B.4).</li> </ul>	Not applicable for this parameter.	• Reconnaissance level vegetation monitoring only, particularly at Recovered Bare 1, Recovered Bare Area 2, Gravel Area 1, and Gravel Area 2

Note: View of ground and vegetation conditions in the Wellsite Area looking southwest. Wellsite Area revegetated with naturally established trees, shrubs and forbs. Vegetation cover met the permit requirements (i.e., >70% cover and healthy condition) (August 29, 2023).

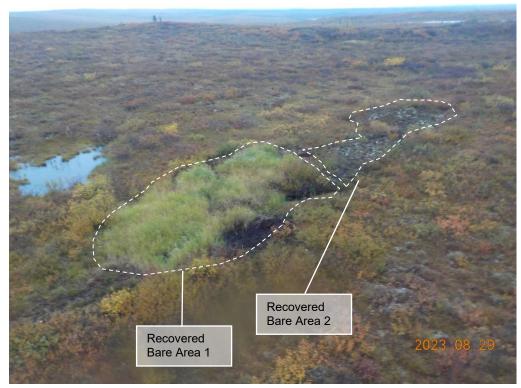
Photo B.5 C-34 Wellsite Area: Vegetation Cover - Recovered Bare Area 1 and Recovered Bare Area 2

• Native vegetation cover and health on the Site met the land use permit requirements (i.e., >70% vegetation cover and in healthy condition).			
	Recovered Bare 1 and Recovered Bare Area 2 (Attachment A: Figure A.3; Attachment B: Photo B.5).		No reclamation treatments on Wellhead Bare Area recommended until the well is cut.	
	<ul> <li>Recovered Bare 1 and Recovered Bare Area 2 had vegetation cover and vegetation health that met the land use permit requirements (i.e., &gt;70% vegetation cover and in healthy condition) based on aerial observations.</li> </ul>		capped, and abandoned.

Note: View of ground and vegetation conditions at Recovered Bare Area 1 and Recovered Bare Area 2 looking north. Areas were unchanged in dimensions and shape since 2015 monitoring. At the time of the 2023 site visit, vegetation cover met the permit requirements (i.e., >70% cover and healthy condition) (August 29, 2023).

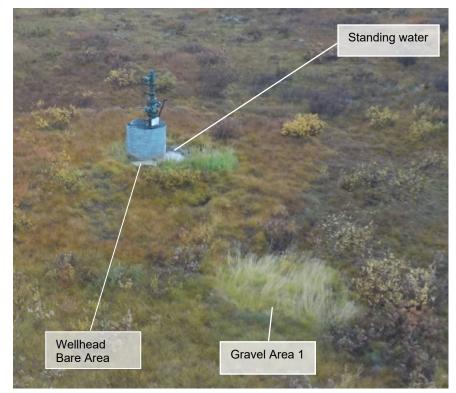
#### Photo B.6 C-34 Wellsite Area: Vegetation Cover – Wellhead Bare Area and Gravel Area 1

Parameters	Monitoring Observations and Results	Soil and Water Analytical Results (if exceedances)	Future Recommended Work
Vegetation (cont'd)	<ul> <li><i>Gravel Area 1 and Gravel Area 2</i> (Attachment A: Figure A.3; Attachment B: Photo B.6 and Photo B.7)</li> <li>Gravel Area 1 and Gravel Area 2 underwent reclamation treatments in 2017. Both areas have significantly increased vegetation cover since 2017. Vegetation met the permit requirements (i.e., &gt;70% vegetation cover and in healthy condition) at the time of the 2023 site visit based on aerial observations.</li> <li>Vegetation cover was approximately 80% to 85% at Gravel Area 1 and 75% to 80% at Gravel Area 2.</li> <li><i>Wellhead Bare Area</i> (Attachment A: Figure A.3; Attachment B: Photo B.3 and Photo B.6):</li> <li>Area underwent reclamation treatments in 2017; however, vegetation has only established on a small portion of the area. Overall vegetation cover was approximately 25% to 30%, all consisting of grasses.</li> <li>Grass cover was present on the north and south sides. Standing water was also present on the north side.</li> <li>Vegetation appeared to be meeting land use permit requirements for health, but not for cover (i.e., not greater than 70% cover) based on aerial observations.</li> <li>No invasive plants/weeds were observed within the Site during the 2023 site visit.</li> </ul>	Not applicable for this parameter.	<ul> <li>Reconnaissance level monitoring for invasive plants whenever a site visit is carried out, particularly at Wellhead Bare Area, Recovered Bare 1, Recovered Bare Area 2, Gravel Area1, and Gravel Area 2.</li> <li>Carry out invasive plant/weed control treatments if infestations reach a density that prohibits vegetation establishment and growth, including pulling plants, storing in garbage bags, and disposing off-site at an approved facility.</li> <li>At the Wellhead Bare Area, recommend backfilling and grading low spots with local material sourced around the wellhead to prevent water from accumulating.</li> </ul>

Note: View of Wellhead Bare Area and Gravel Area 1 facing southwest. Both areas underwent reclamation treatments in 2017 (organic mulch pellet application, ground tilling, application of native grass seed and fertilizer). In 2023, vegetation cover was approximately 25% to 30% in the Wellhead Bare Area and 80% to 85% in Gravel Area 1 and appeared healthy. Vegetation cover in Gravel Area 1 met the permit requirements (i.e., >70% cover and healthy condition); however, cover in the Wellhead Bare Area met the land use permit requirements for health, but not for cover (i.e., did not have greater than 70% cover) (August 29, 2023).

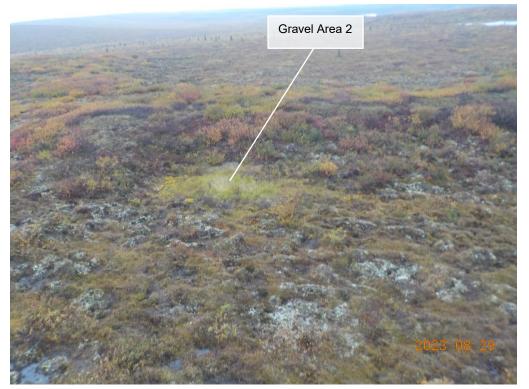
#### Photo B.7 C-34 Wellsite Area: Vegetation Cover - Gravel Area 2

Note: View facing northwest toward Gravel Area 2, which underwent reclamation treatments in 2017 (organic mulch pellet application, ground tilling, application of native grass seed and fertilizer). At the time of the 2023 site visit, vegetation cover was approximately 75% to 80%, appeared healthy and met the permit requirements (i.e., >70% cover and healthy condition) (August 29, 2023).

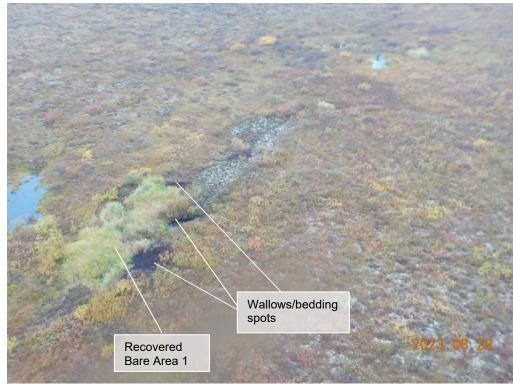
Photo B.8 C-34 Wellsite Area: Wildlife Signs - Recovered Bare Area 1- wallows/bedding spots

Wildlife Signs	<ul> <li>Three wallows or bedding spots were observed at the north and south ends of Recovered Bare Area 1. The wallows/bedding spots were in dry, soft, peaty material. It is suspected these spots were created by muskox (<i>Ovibos moschatus</i>) (Attachment B: Photo B.8 and Photo B.9).</li> <li>The wallows did not appear larger than last year. Being in peat material, these wallows seemed more like bedding areas rather than areas where the animals lick the material for salts.</li> <li>No other wildlife signs of use were observed within the Site during the 2023 site visit.</li> </ul>	• Not applicable for this parameter.	<ul> <li>Recommend reclamation treatments at the wallows/bedding spots in Recovered Bare Area 1. Treatments should include raking/recontouring of wallows, application of native vegetation seed mix and fertilizer, and installation of grid deterrent structures.</li> <li>Continue monitoring for wildlife use whenever at the Site.</li> </ul>

Note: View facing northwest looking at wallows/bedding spots presumed to be created by muskox located at the north and south ends of the Recovered Bare Area 1 (August 29, 2023).

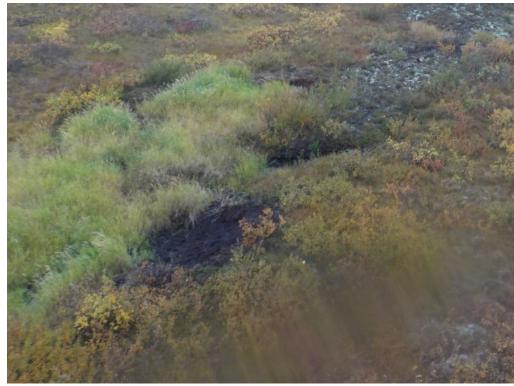
Photo B.9 C-34 Wellsite Area: Wildlife Signs - Recovered Bare Area 1 - wallows/bedding spots

Note: View of wallows/bedding spots (facing northwest) presumed to be created by muskox located at the north and south ends of the Recovered Bare Area 1 (August 29, 2023).
