File Number	S20L3-003
Type of Operation	CLASS B- MUNICIPAL
Location	Mackenzie River -Reservoir

WATER USE INSPECTION REPORT

LICENCE #:	S20L3-003	EXPIRY DATE:	February 02, 2031
LICENCEE:	Charter Community of K’asho Got’ine (Fort Good Hope)	PREVIOUS INSPECTION:	September 15, 2022
COMPANY REP:	Irvin Eng (SAO)	INSPECTION DATE:	October 10, 2024

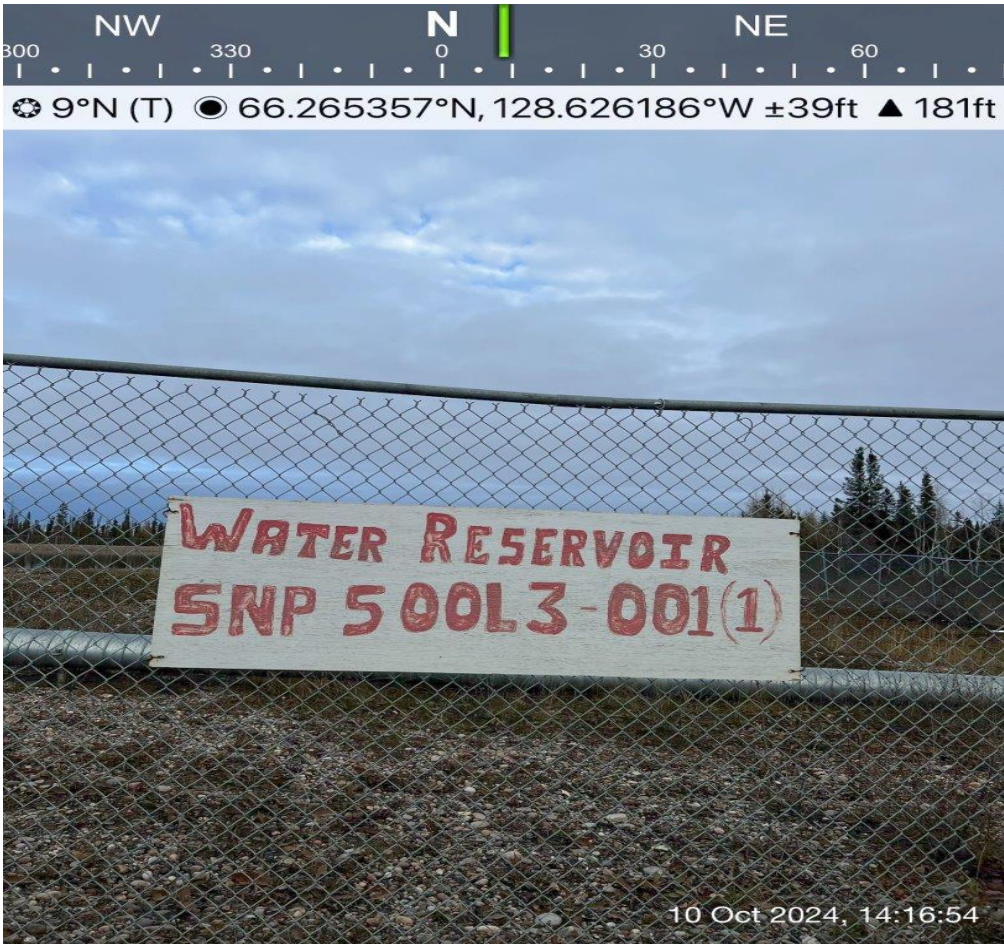
Figure 1

Signage posted on the fence at the reservoir needs to be updated with the correct Water Licence number: S20L3-003.

Water Reservoir in need of new sign with updated Water Licence number S20L3-003

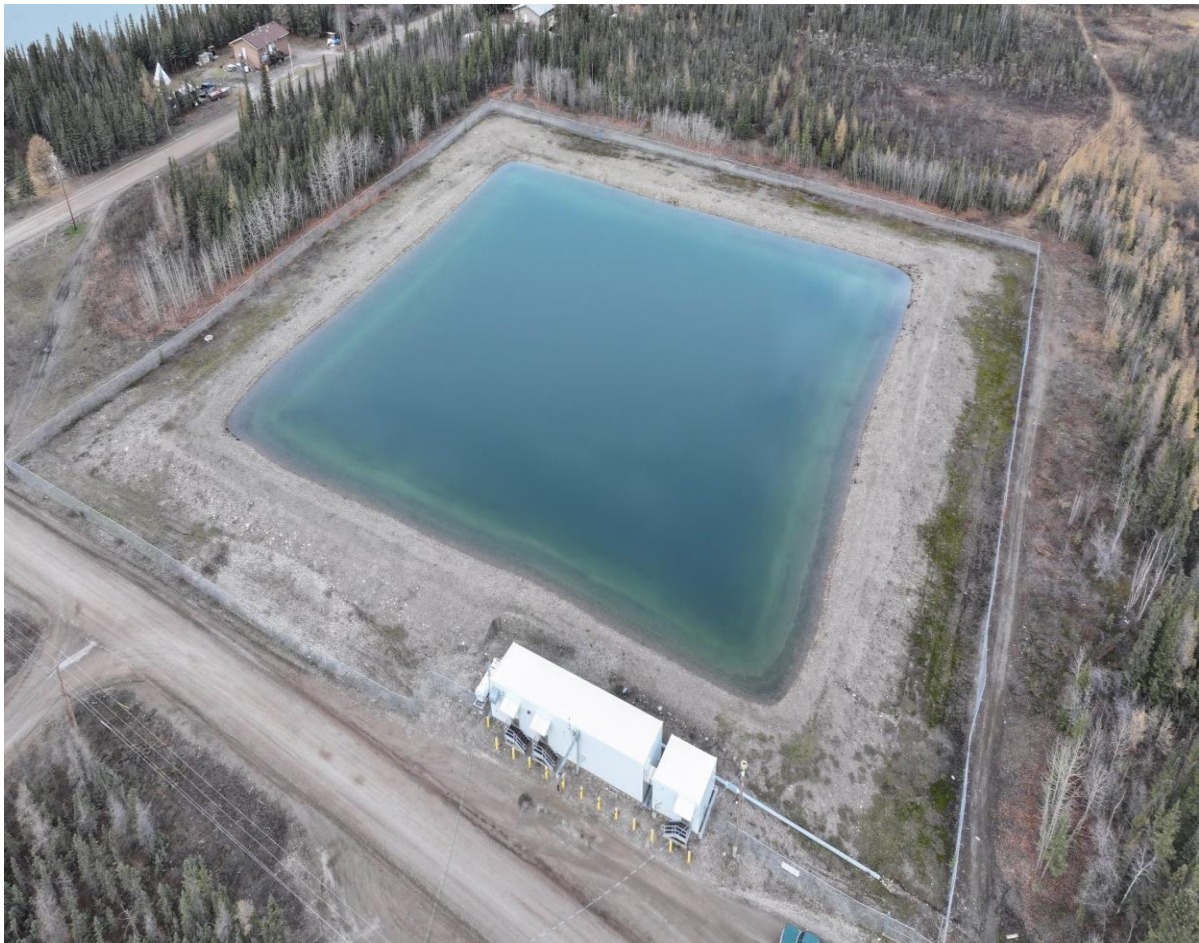
Figure 2

Unlike the other communities in the Sahtu region, Fort Good Hope has a Water Reservoir located in town. The Reservoir has been inspected and seems to be in good standing. In June 2024 a fire threatened the community and residents were evacuated. The fire was very close to the reservoir area so concerns were that there could be debris, or ash in the water.

Aerial view of water reservoir and water treatment plant

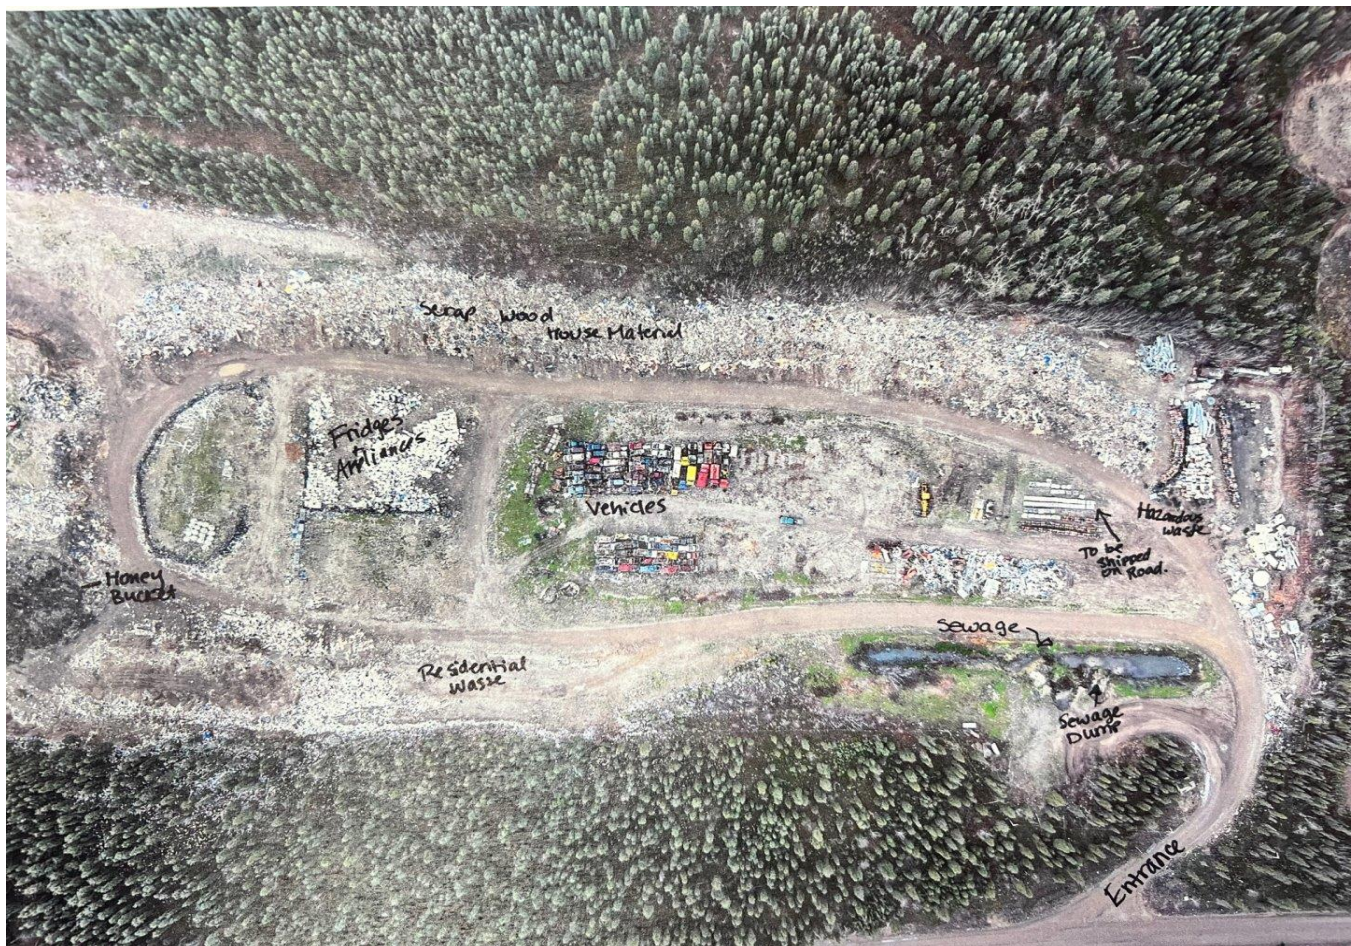
The Solid Waste Facility is at full capacity. The Residential waste area requires more space to be buried and covered. It is recommended that the Municipality works to expand, or build a new facility in the near future. The Sewage lagoon, which is located in the Solid Waste Facility, also requires maintenance and upgrades to be compliant with licence conditions.

Figure 3
Aerial view of Solid Waste facility and Sewage Disposal facility

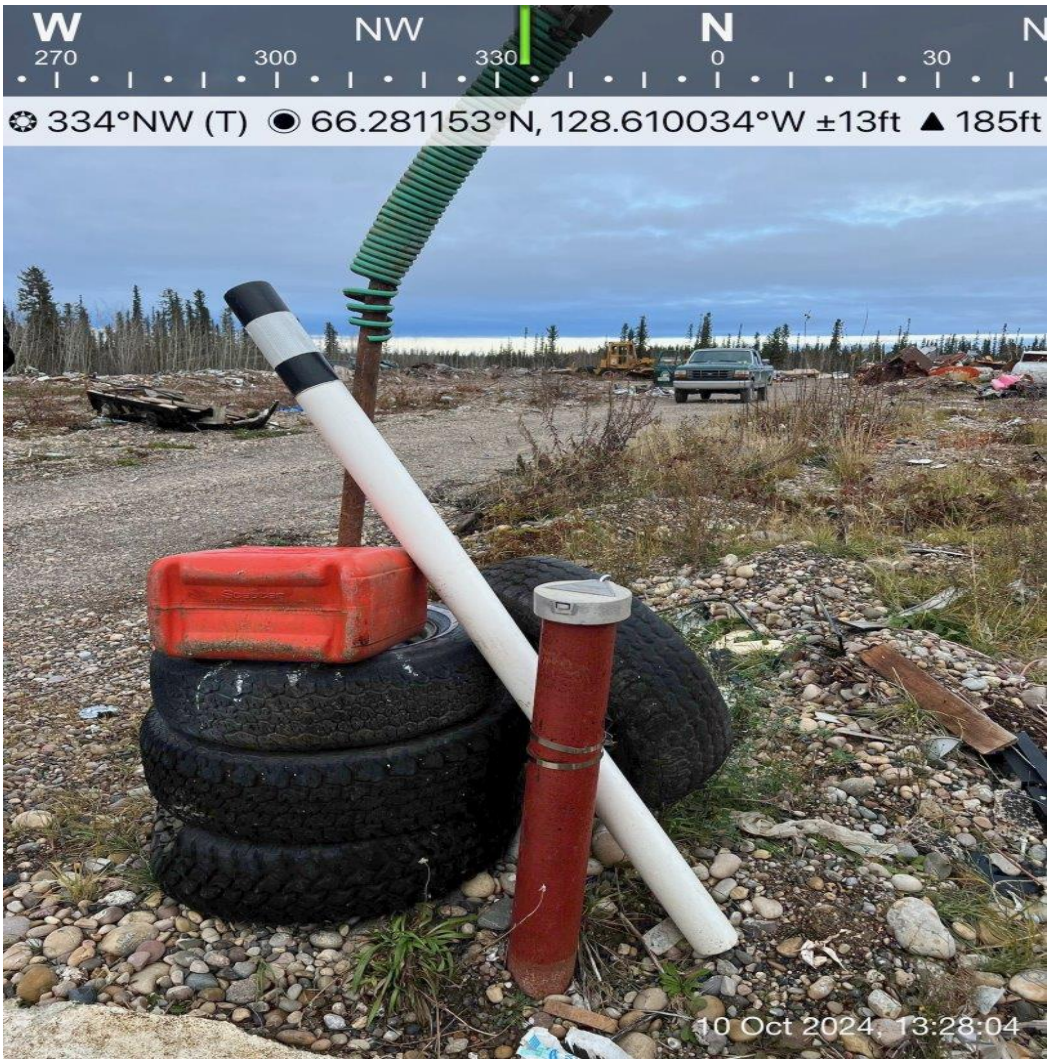
- MW18-03(2015-03) – see photo Figure 6
- MW18-04 (2015-04) –See photo Figure 4
- MW18-06 (2015-06)
- MW18-14 (2015-6)

Figure 4
Groundwater monitoring well SNP MW18-04

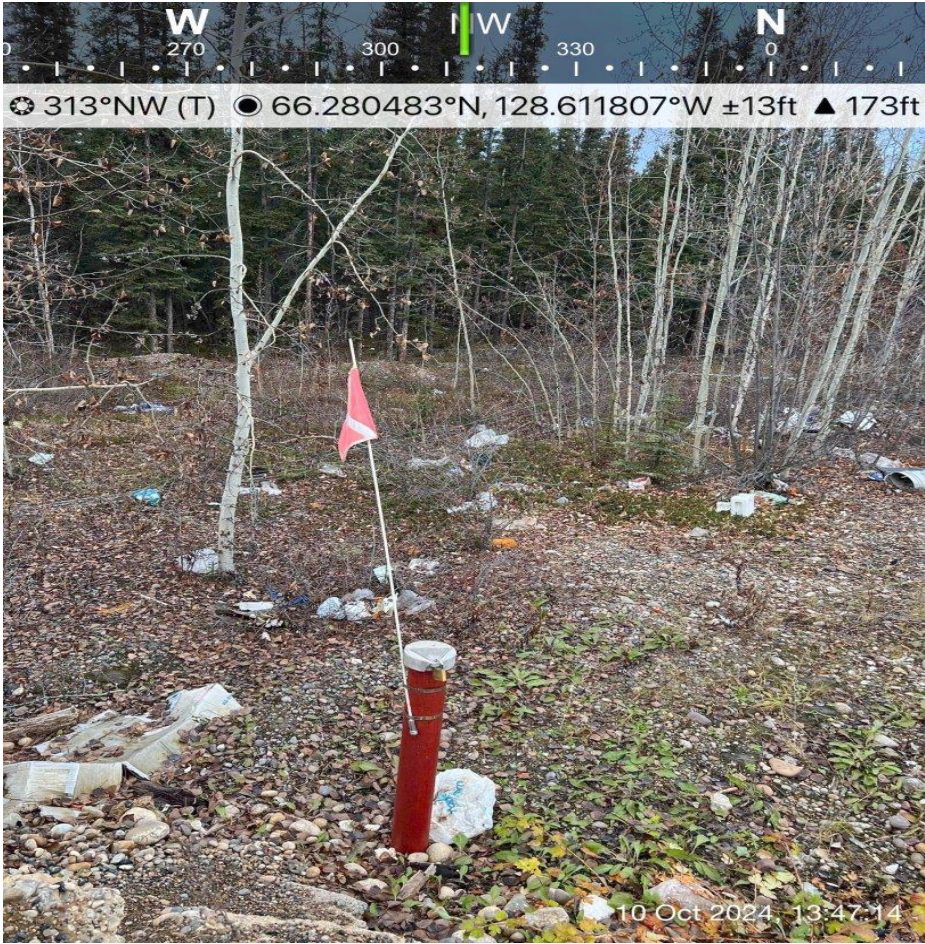
Figure 5
SNP Solid waste facility

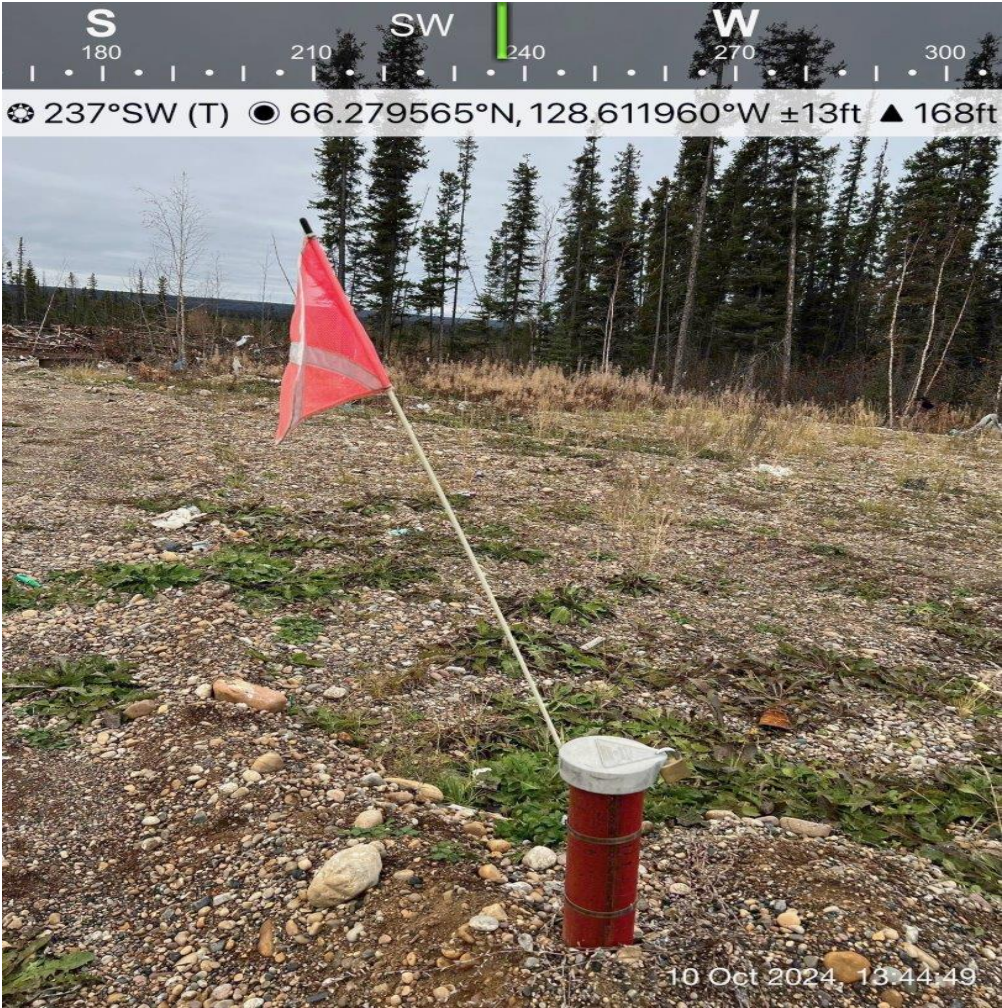
Figure 6
SNP Solid waste facility

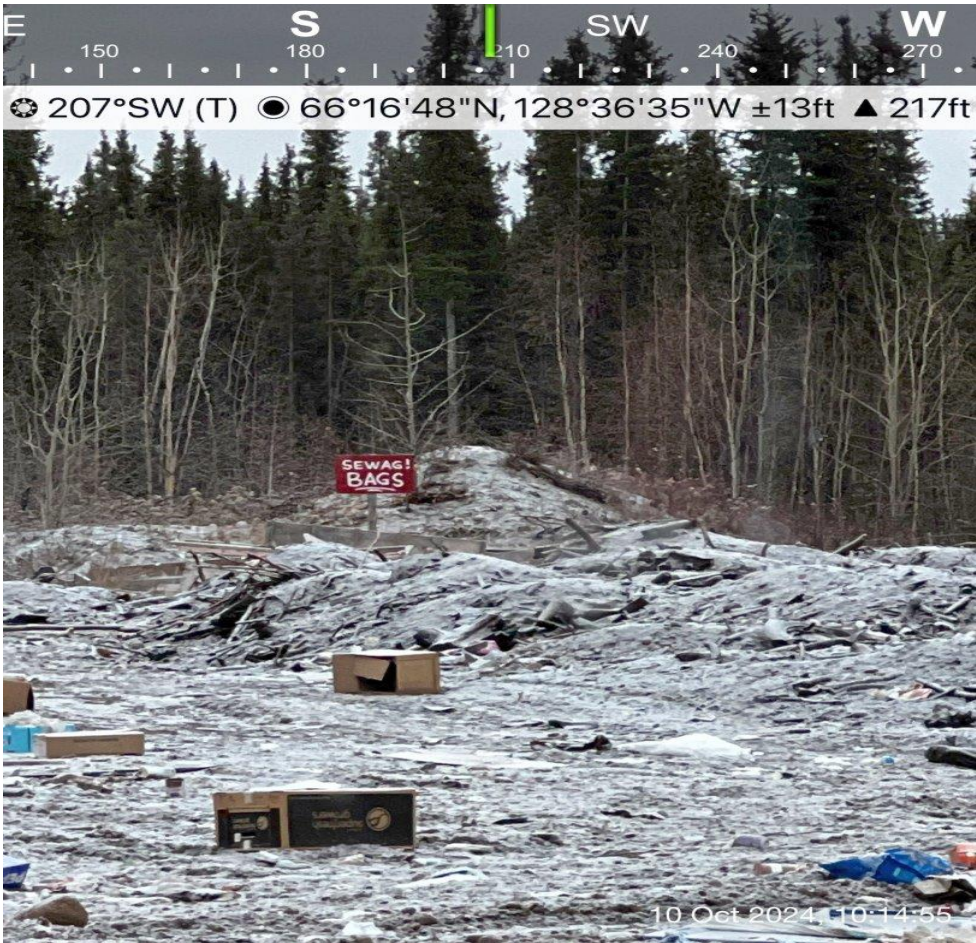
Figure 7
SNP station located behind the sewage bags (honey bags)

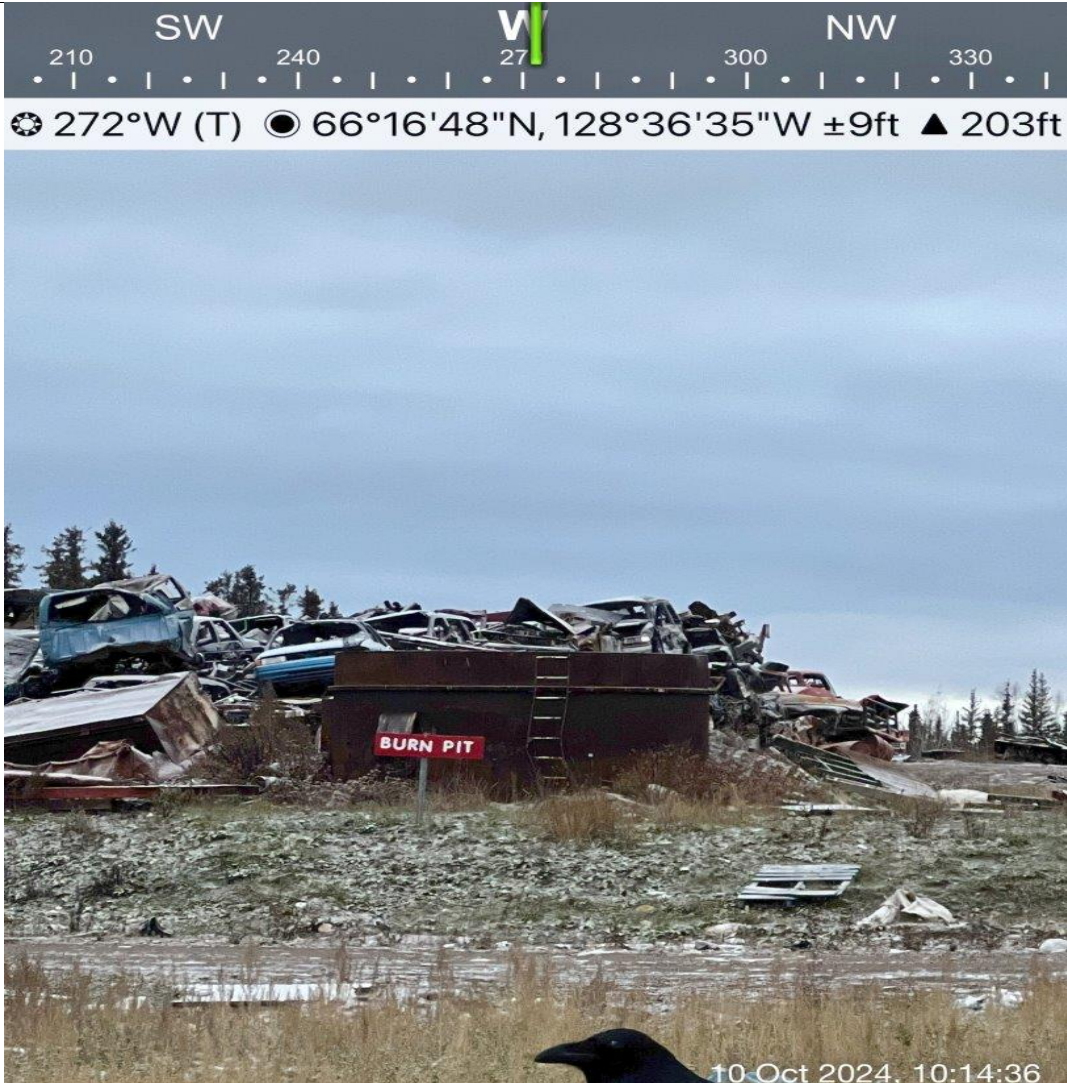
Disposal Method		Open dump					
Open Dump	Yes	Landfill	No	Burn & Landfill	No	Underground	No
Offsite Removal	No	Other	A burn pit was noticed in the area, please see Figure #8				
Owner / Operator	Charter Community of K’asho Got’ine

Figure 8
Burn pit at Solid Waste Facility

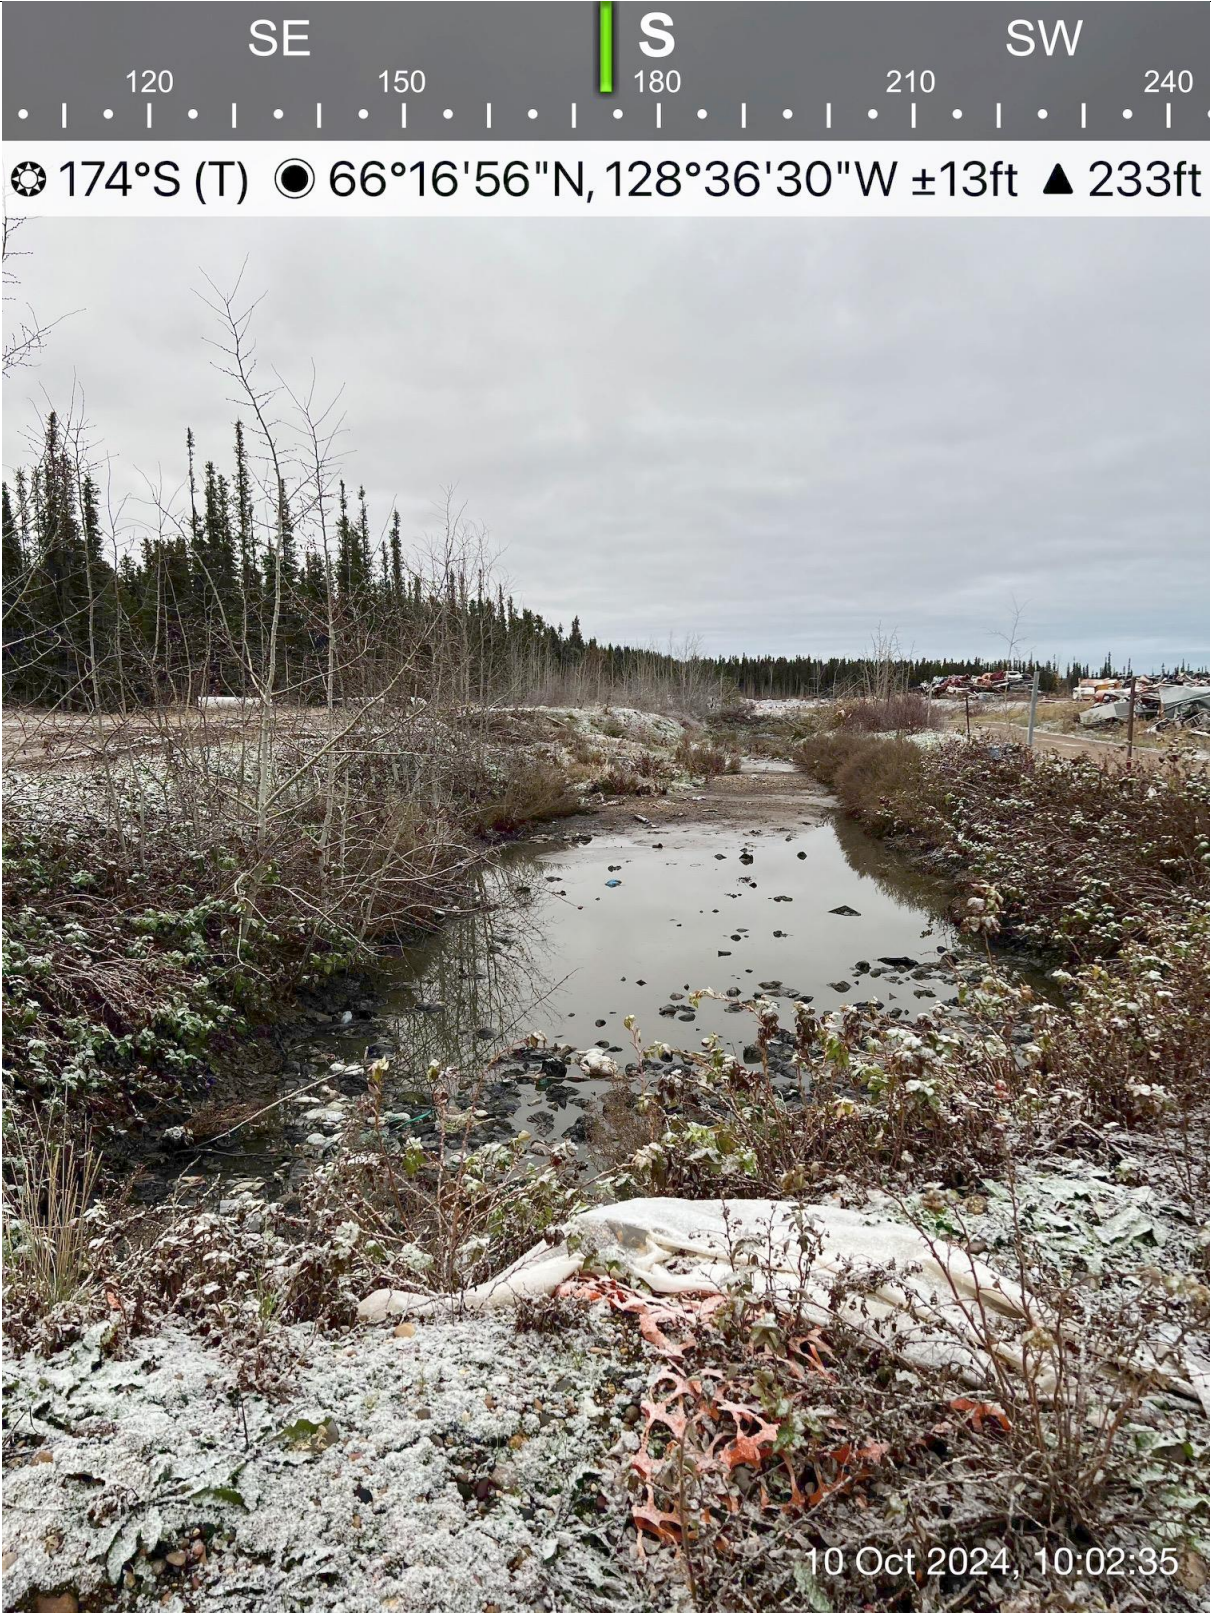
The Sewage Lagoon has not been updated to meet current Water Licence Conditions. This area is in need of an upgraded solution to release sewage waste. Please refer to the pictures below.

This area is not an ideal sewage disposal location as, the area is located in the Solid Waste Facility and is easy accessed by the public. The disposal area is not fenced and poses a risk to landfill users and wildlife. Wildlife are attracted to the site due to poorly managed waste streams. Please take steps to secure the sewage disposal area and work to reduce wildlife attractants at the Solid Waste facility.

Figure 9
Sewage dumping area at Solid Waste Facility
