File Number	S20P-003
Type of Operation	PIPELINES (existing)
Location	Camp, Pipeline ROW KP 158

ENVIRONMENTAL INSPECTION REPORT

Permittee:	Enbridge Pipelines	Permit Expiry Date:	September 17, 2025
Land Use Permit No.	S20P-003	Previous Inspection:	May 07, 2021
Quarrying Permit No.	N/A	Inspection Date:	February 10, 2022
Contractor:	N/A	Subcontractor:	N/A
Location(s) Inspected:	Camp, Pipeline ROW KP 158		
Current Stage of Operation:	Remediation		
Program Modifications Approved:	None

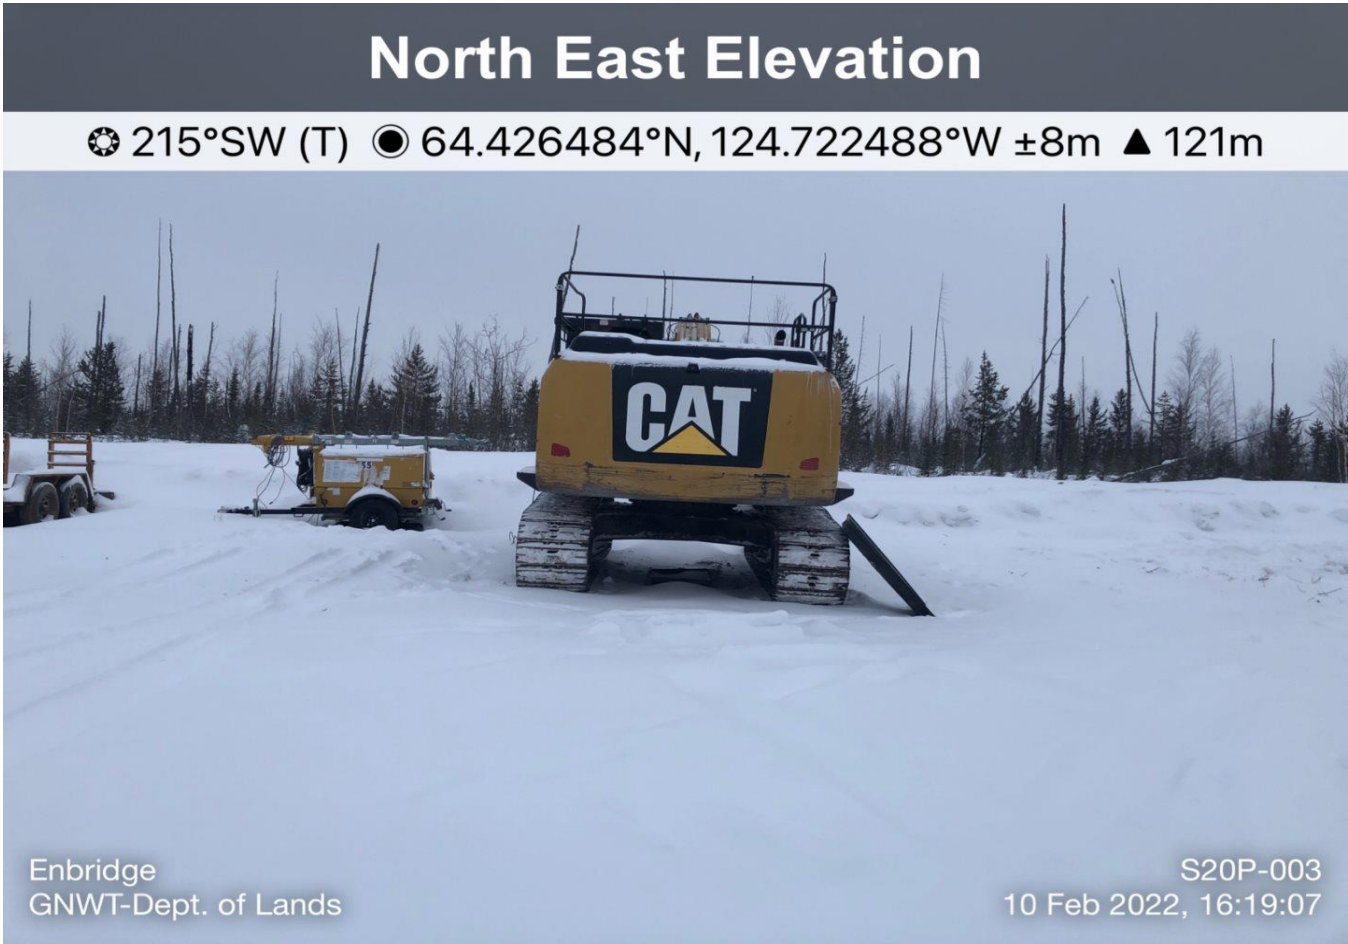
Figure 1

Excavator on site

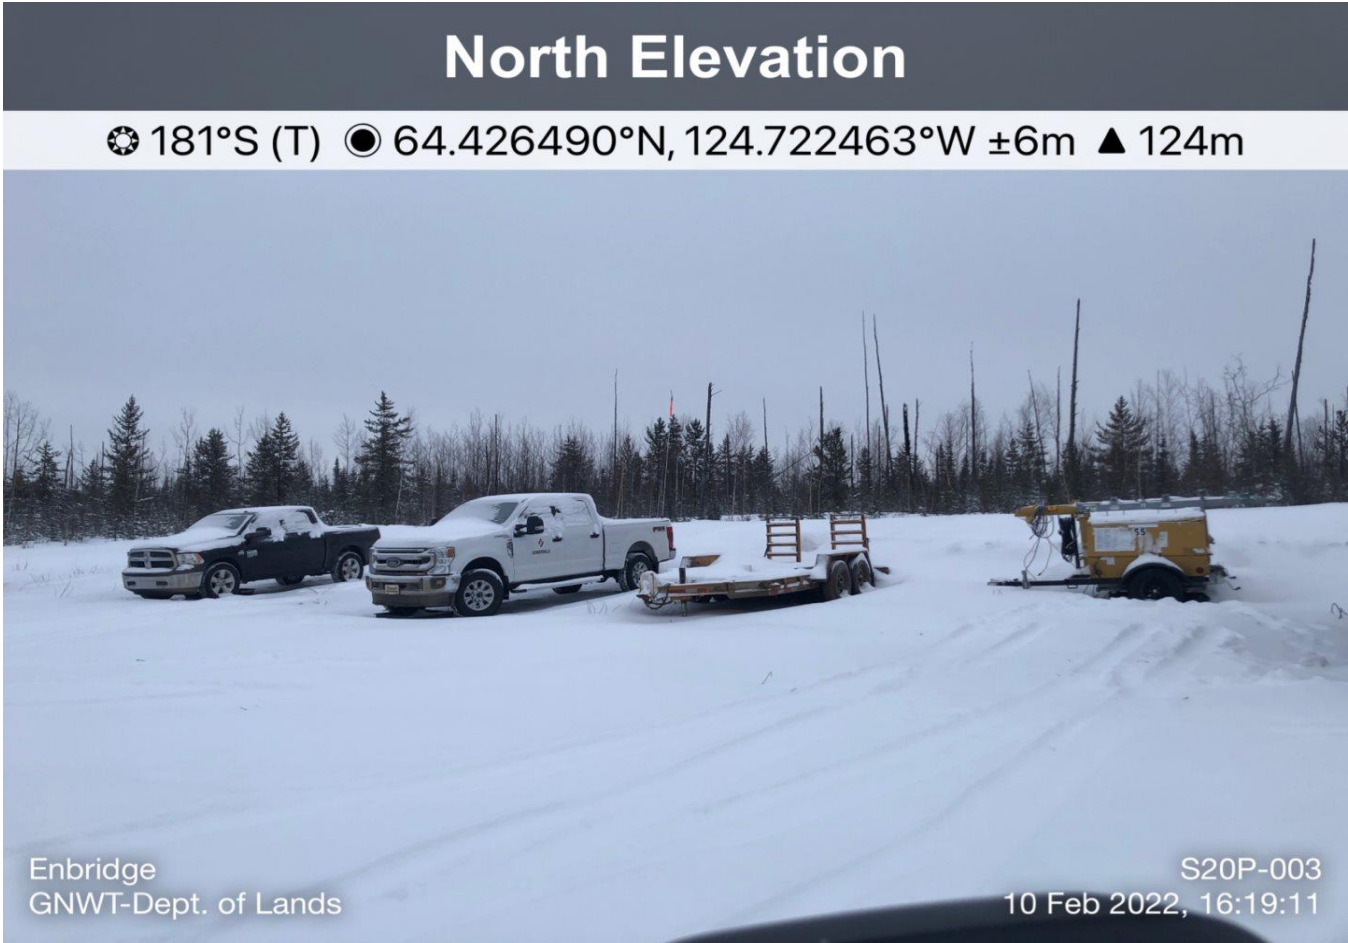
Figure 2

Trailer, mobile light tower, and two pickups

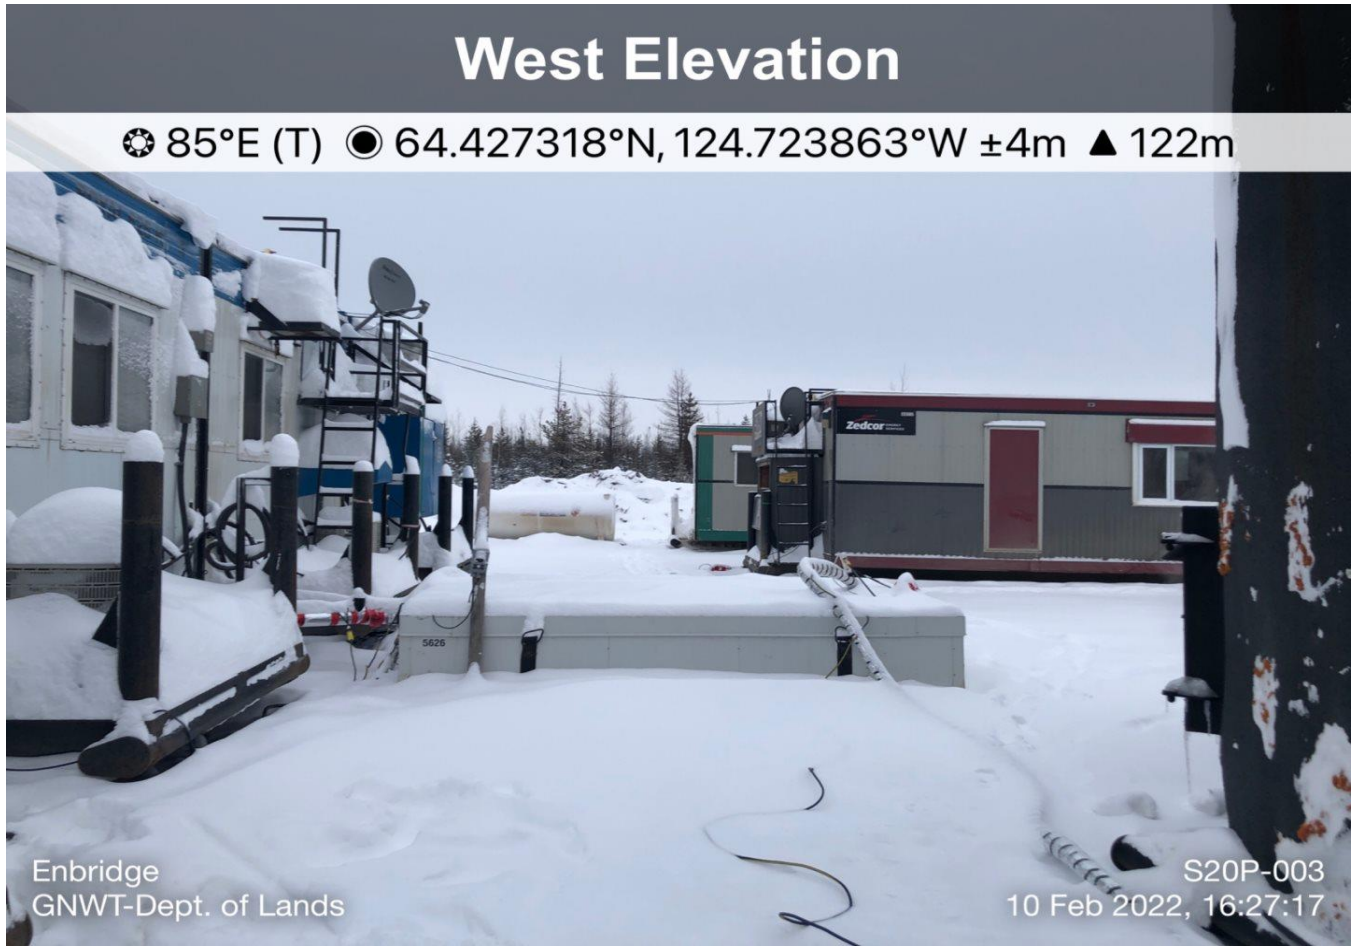
Figure 3
Center of the camp

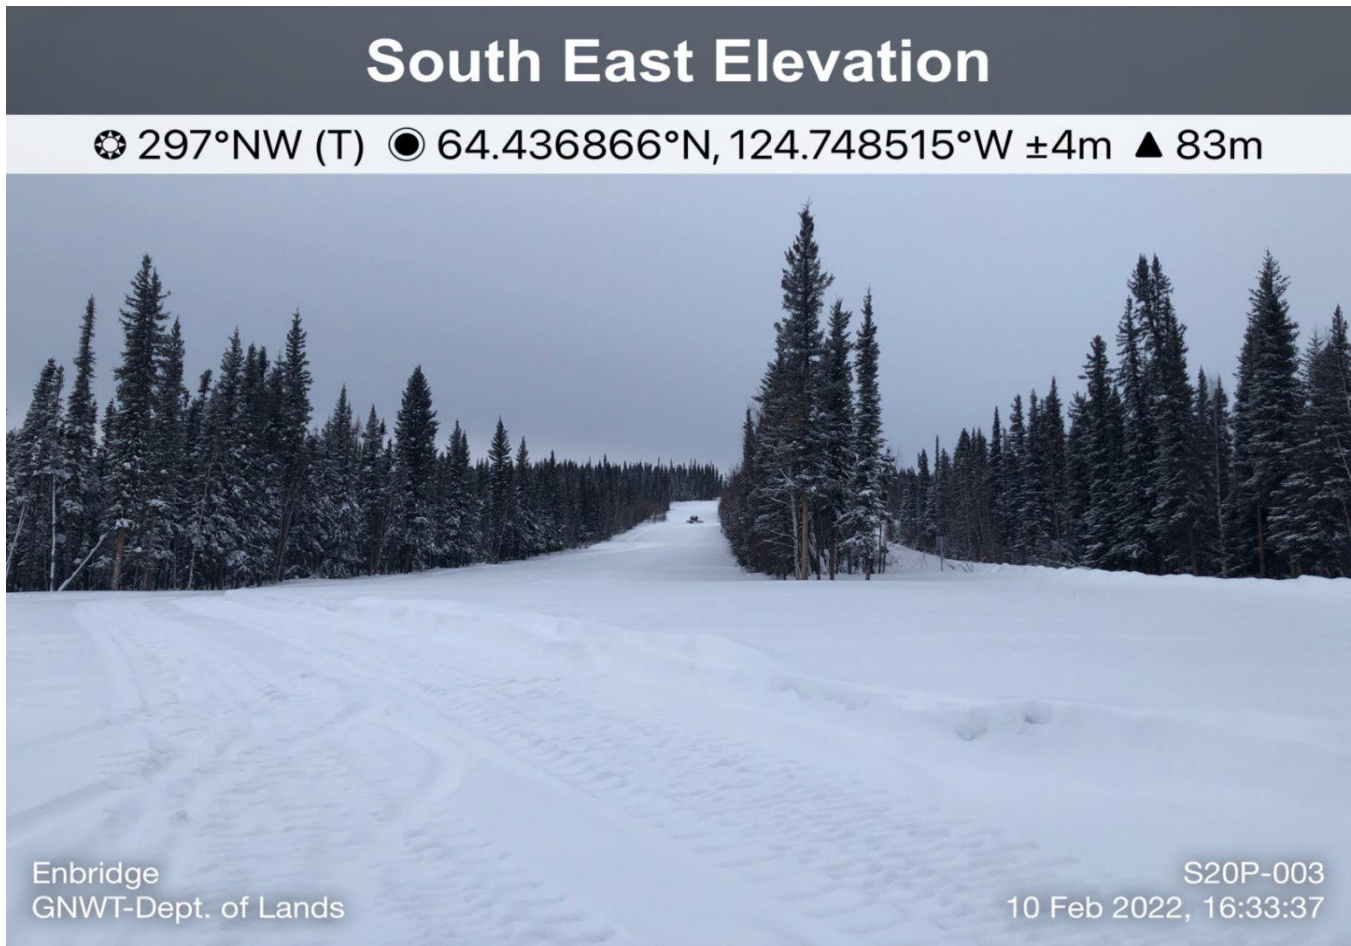
During the inspection, a snowcat on the pipeline ROW at KP 158, Prepping the site for remediation work. There were no concerns at this time.

Figure 4
Pipeline ROW KP 158 with Snowcat

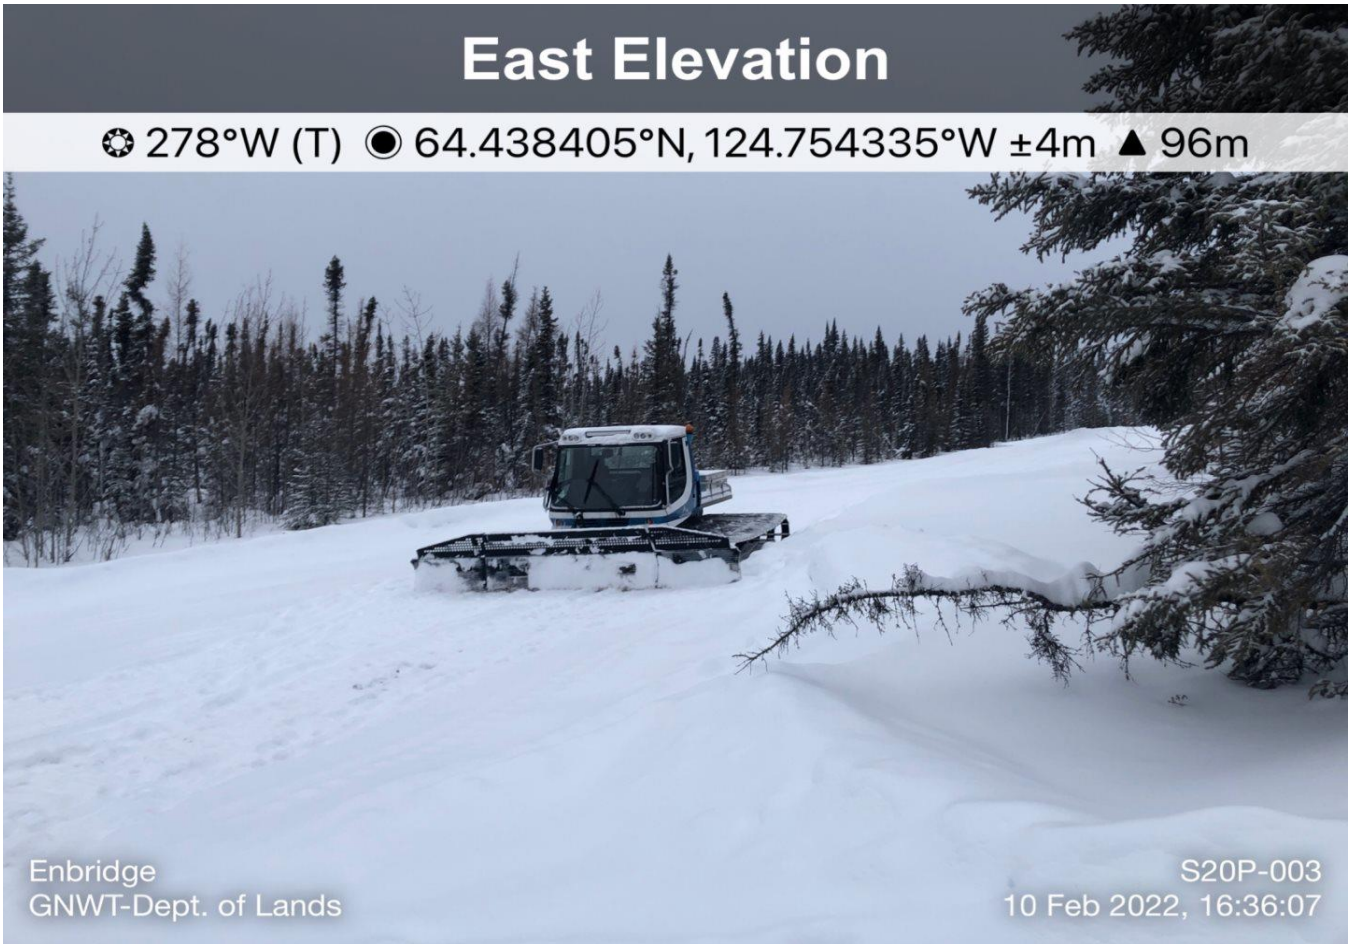
Figure 5
Snowcat on ROW

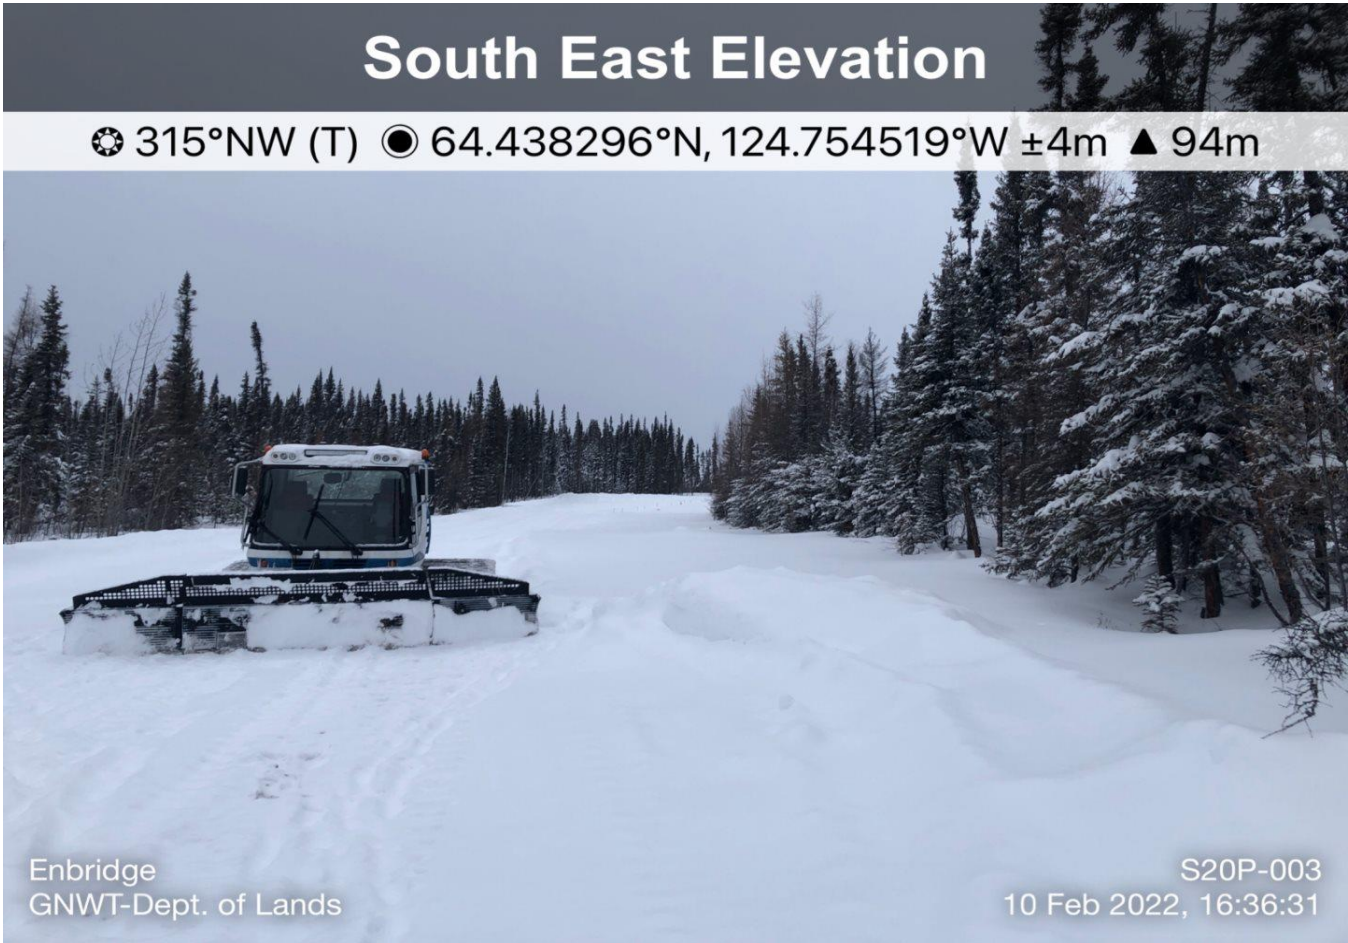
Figure 6
Snowcat on ROW

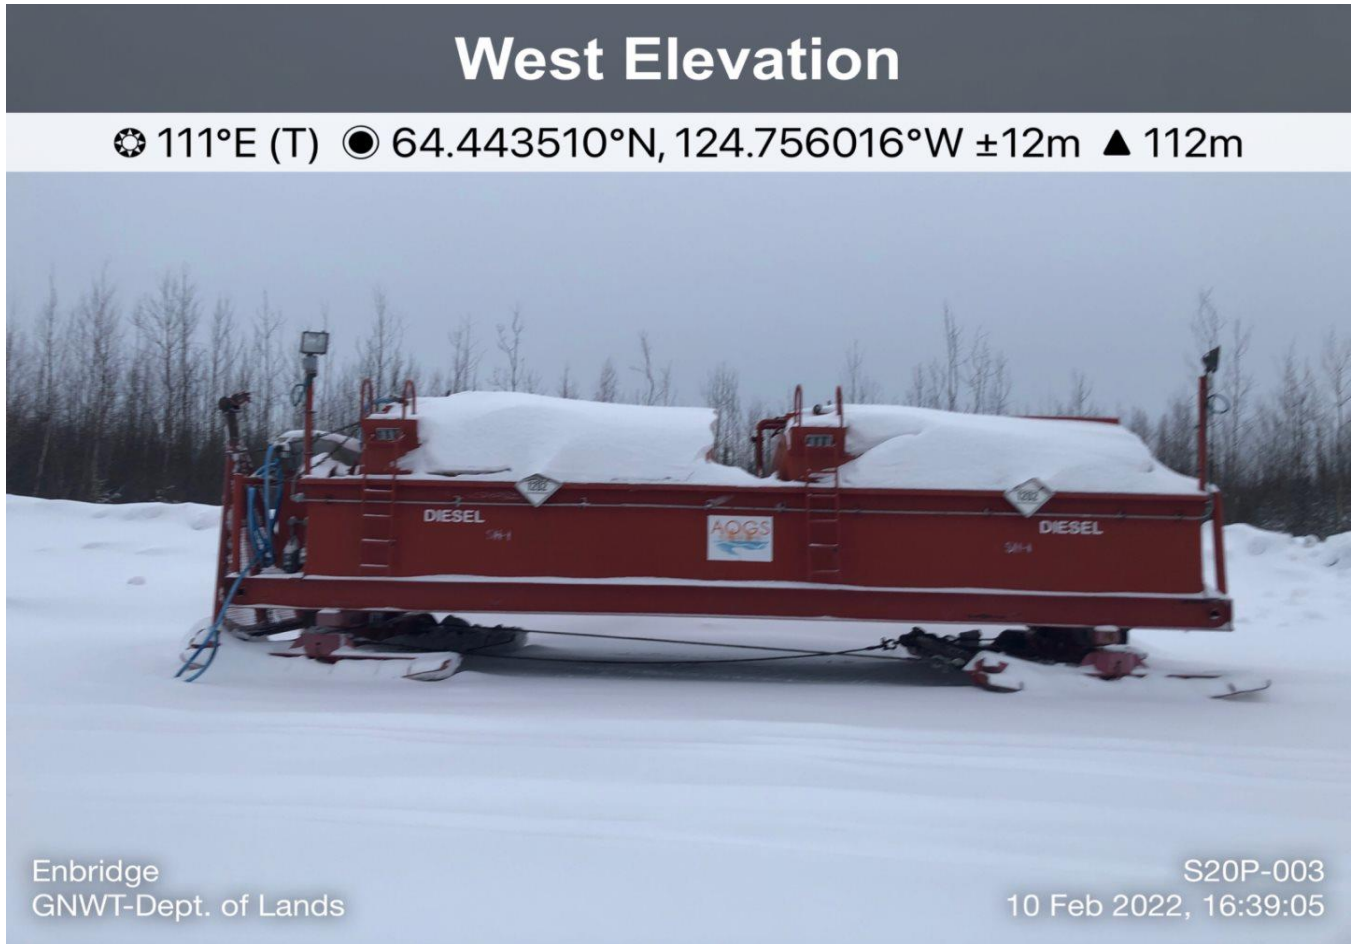
Figure 7
Portable refueling sleigh

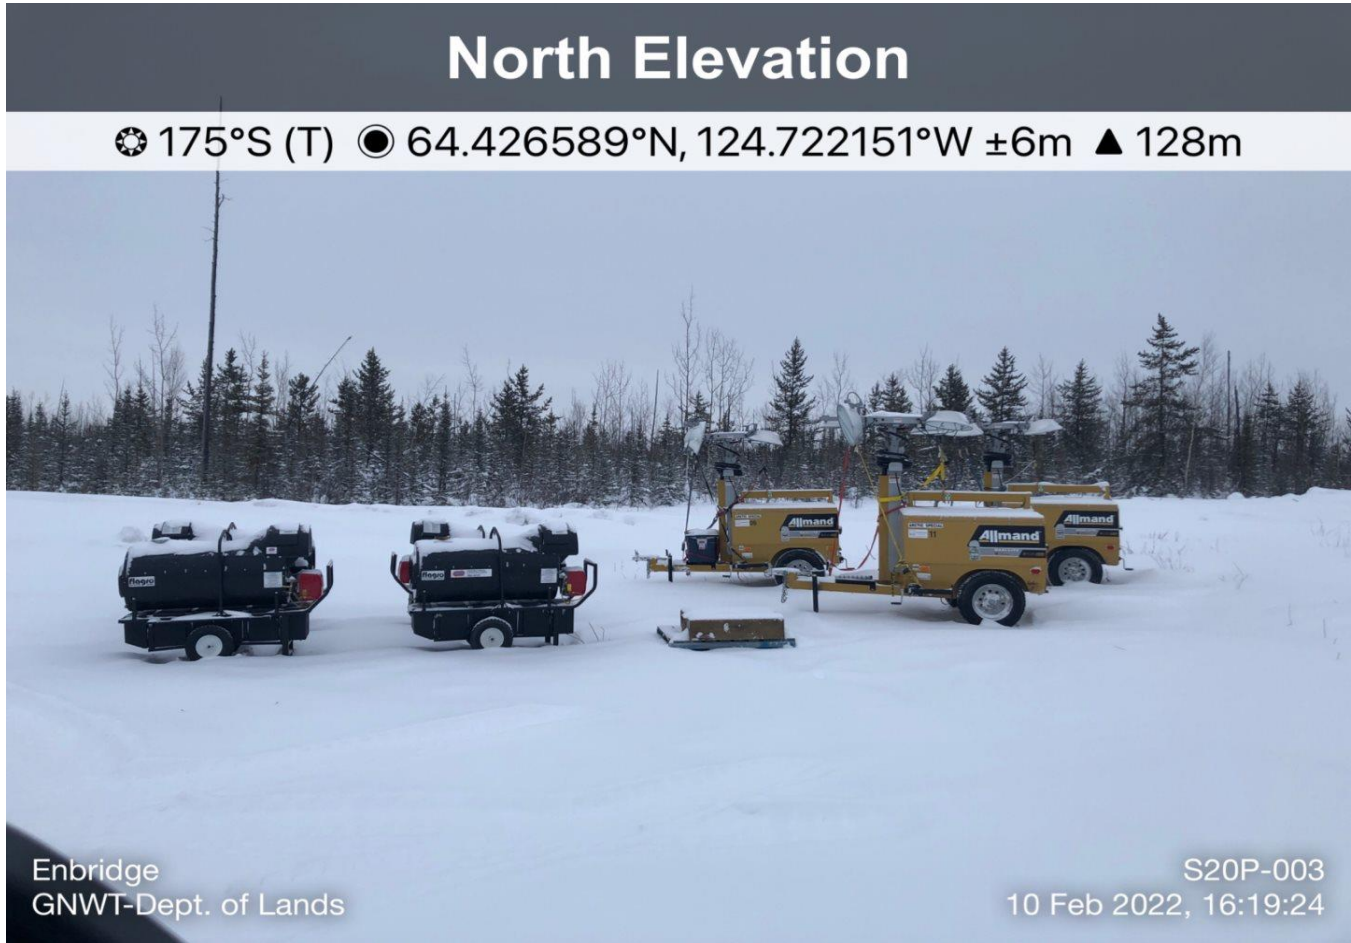
Figure 8
Mobile light towers and forced air heaters

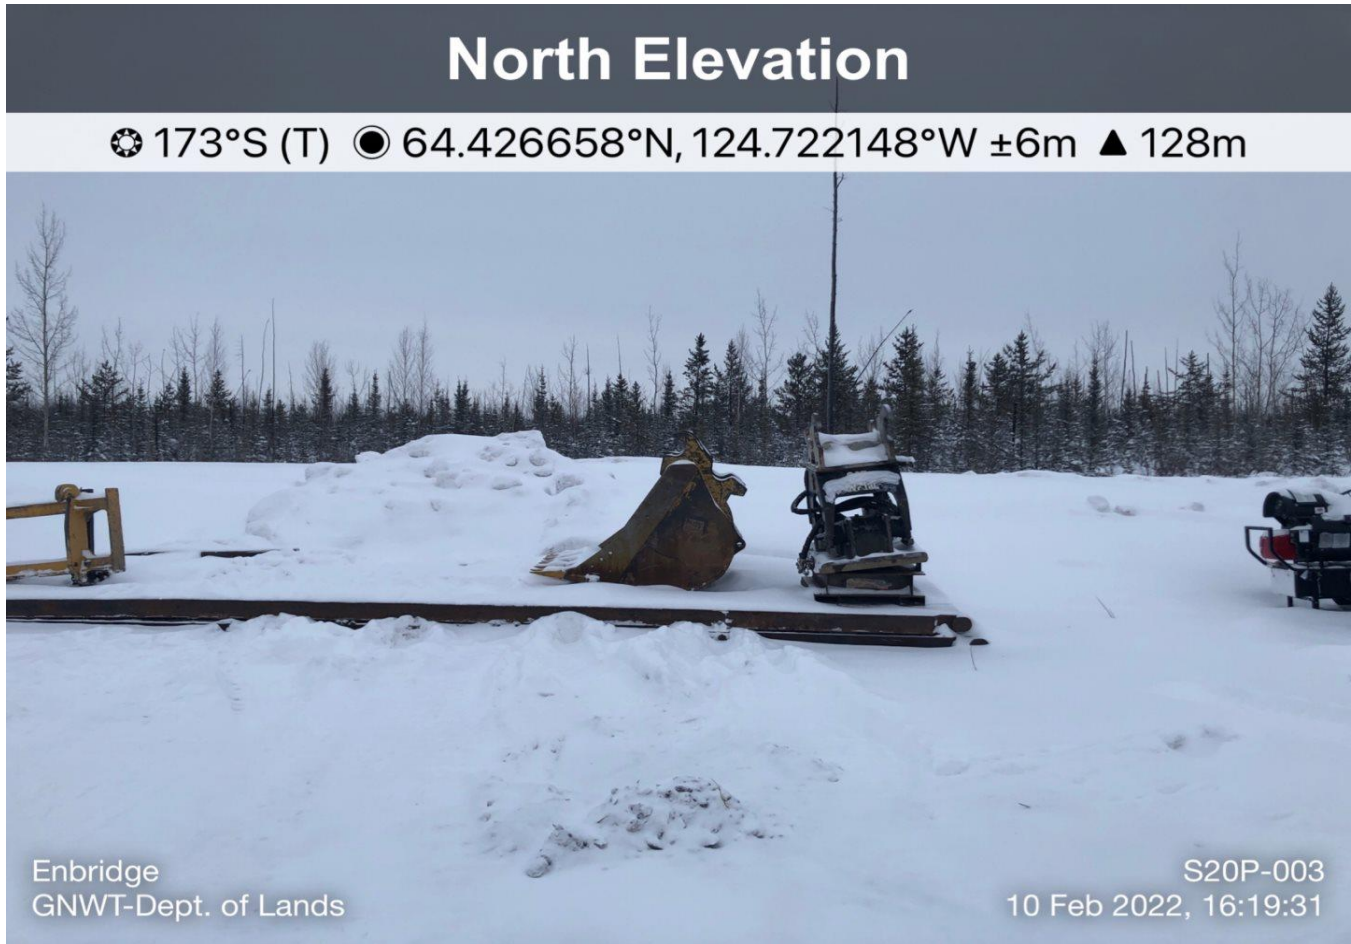
Figure 9

Heavy equipment attachments on a rig mat

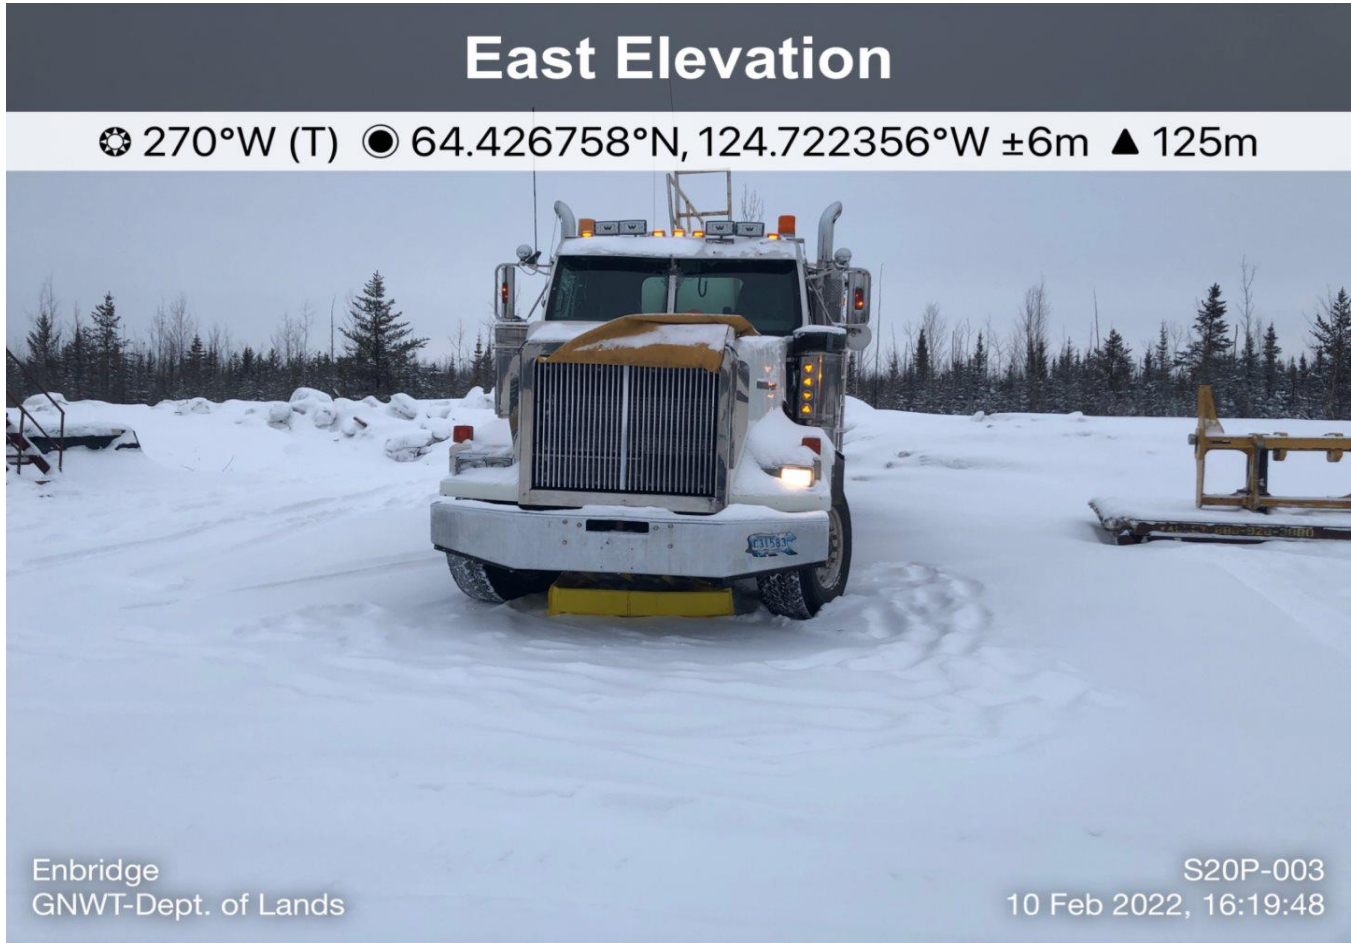
Figure 10

Transport truck with drip tray

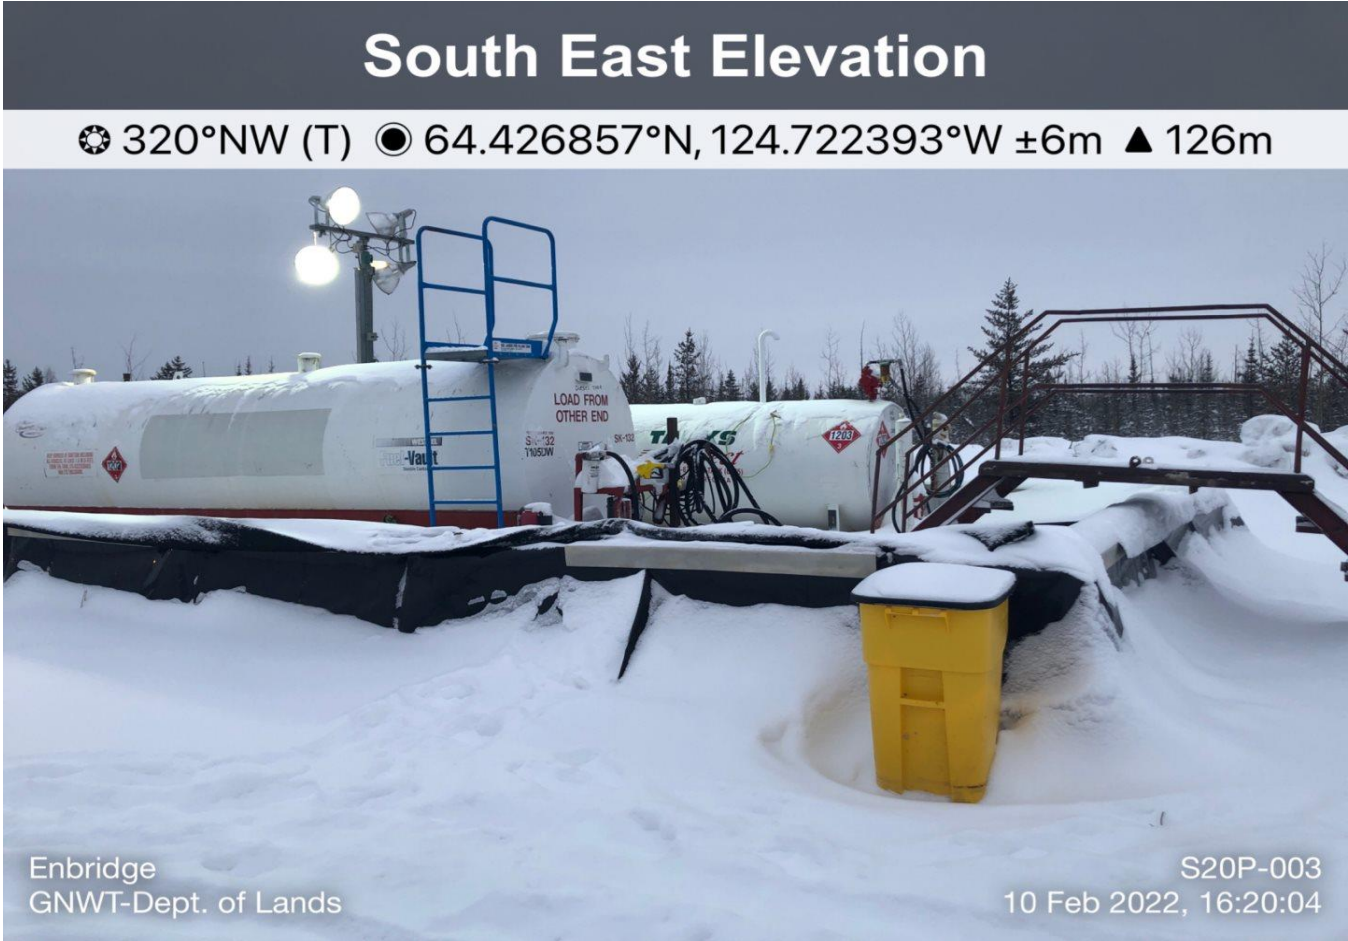
Figure 11

tanks and a fuel storage shed, as seen in figures 11, 13, 17, 18, and 22. Currently, Inspector has no concerns regarding these tanks. In addition, there were numerous pickups and heavy machinery on-site supporting drip trays. Again, Inspector has no concerns at this time.

Two bermed fuel tanks on site

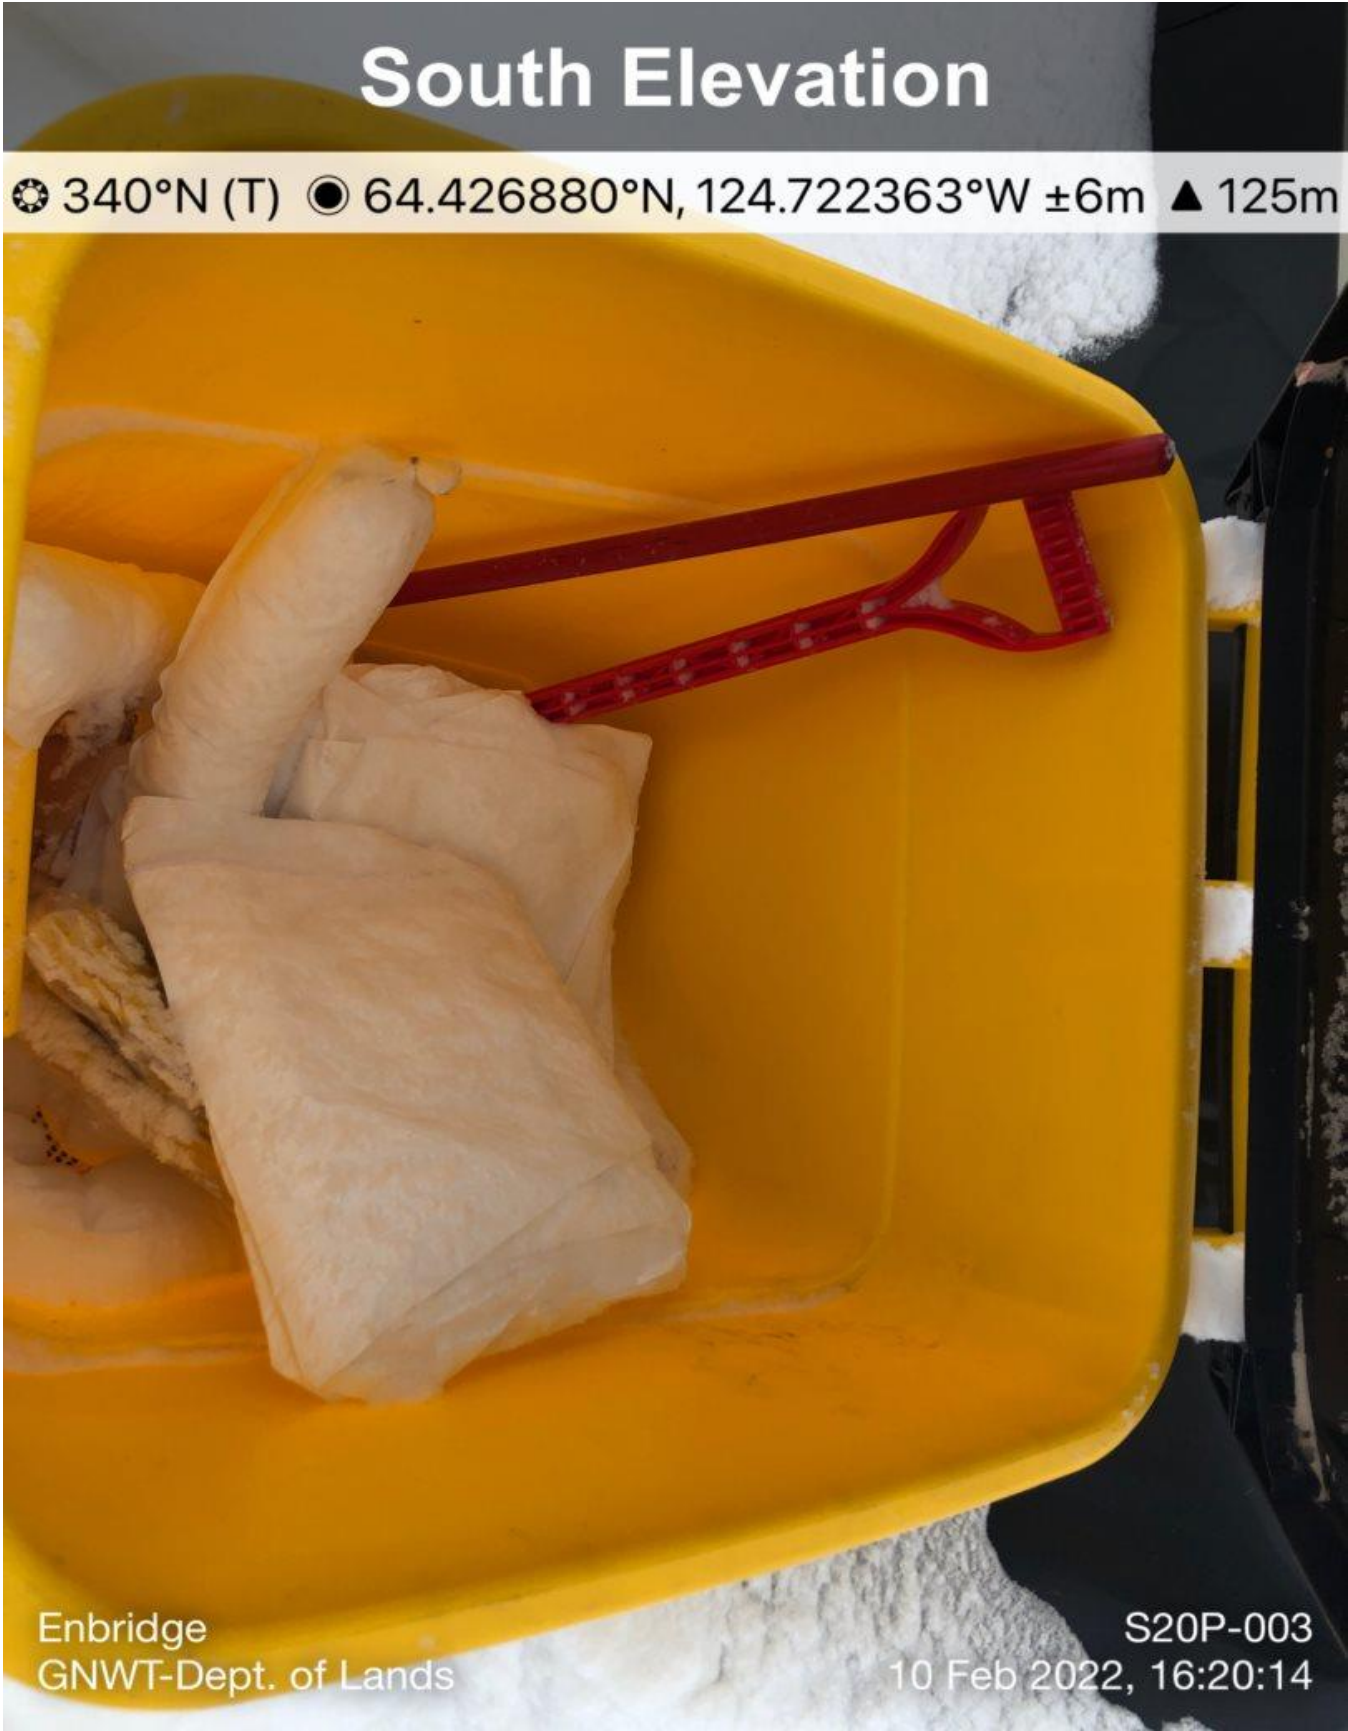
Figure 12
Spill kit on site

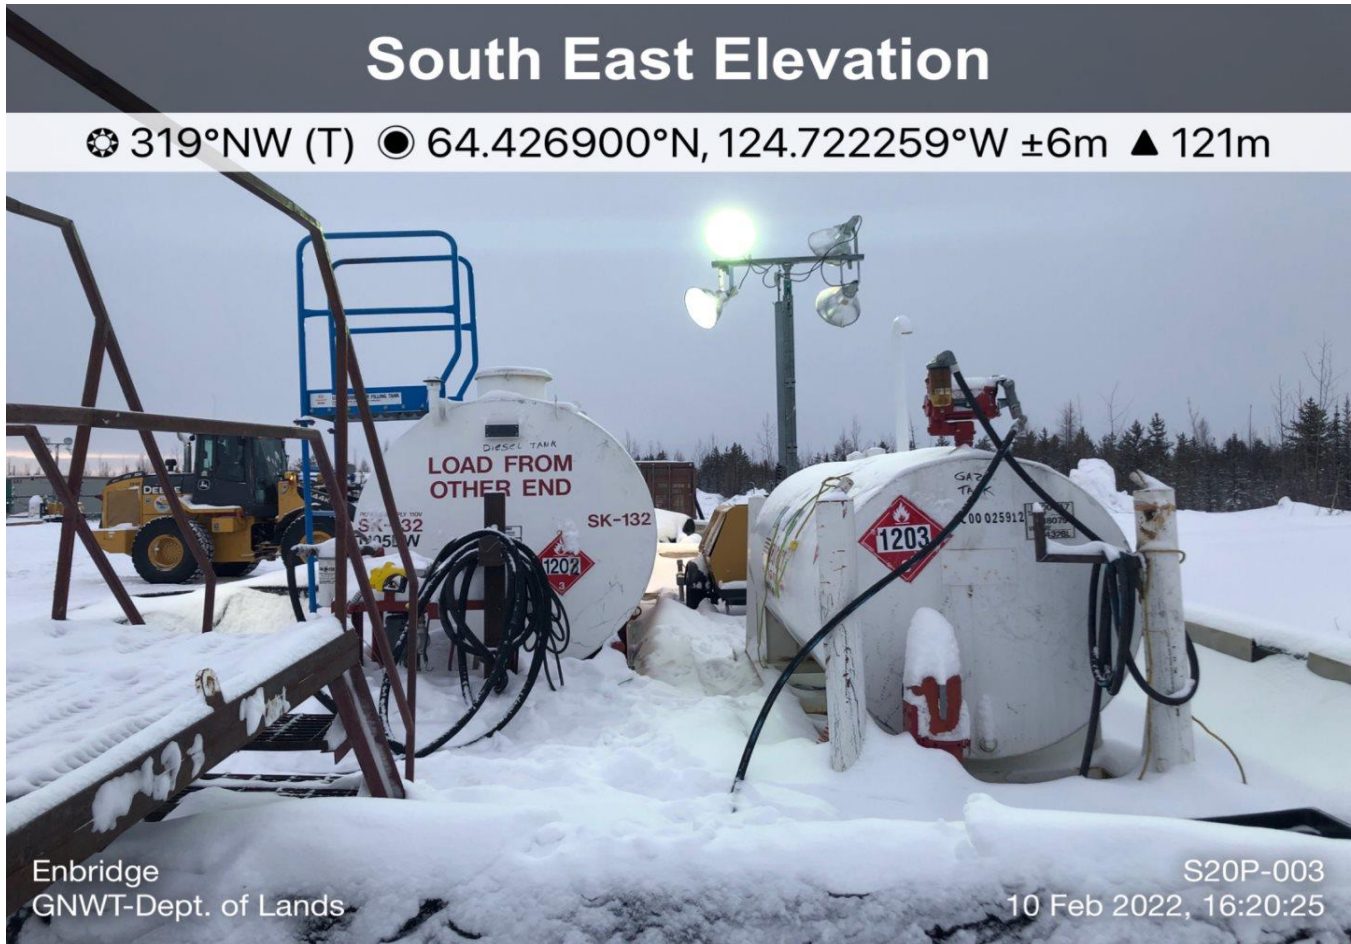
Figure 13
Bermed diesel tank and gas tank located at the camp

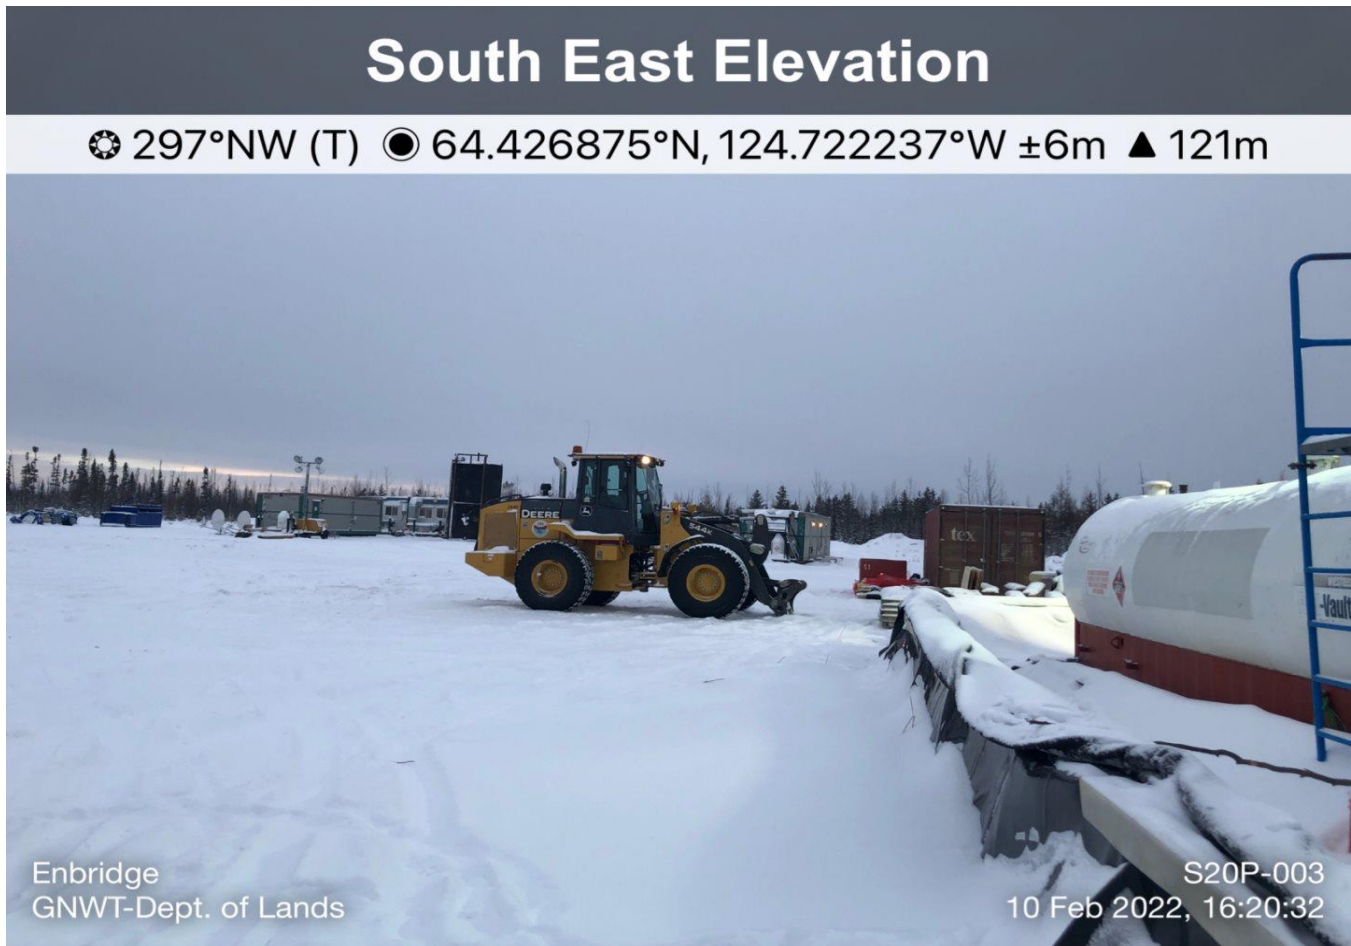
Figure 14
Front end loader

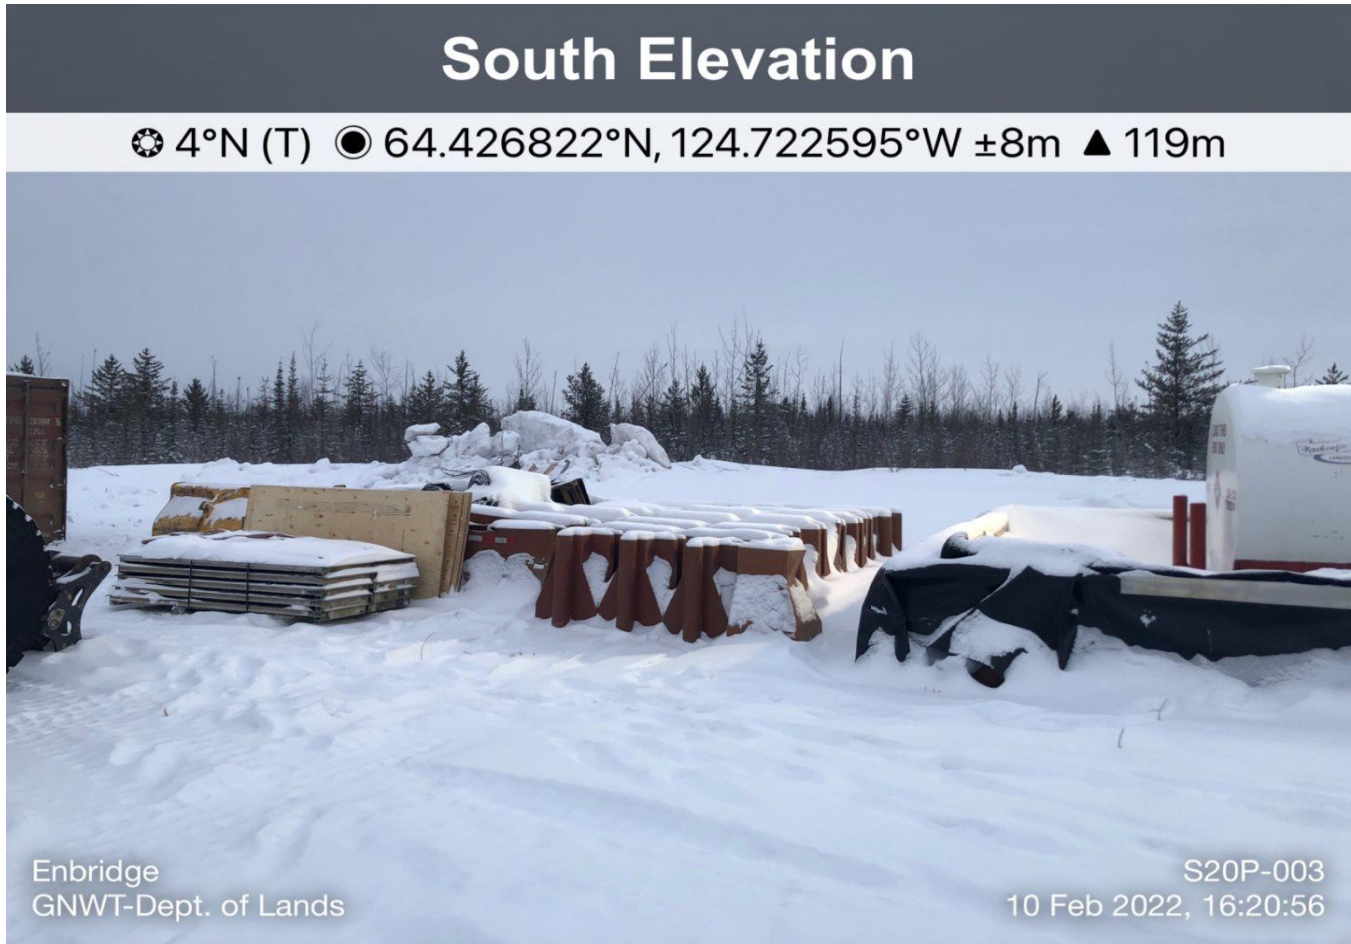
Figure 15
Material for the project

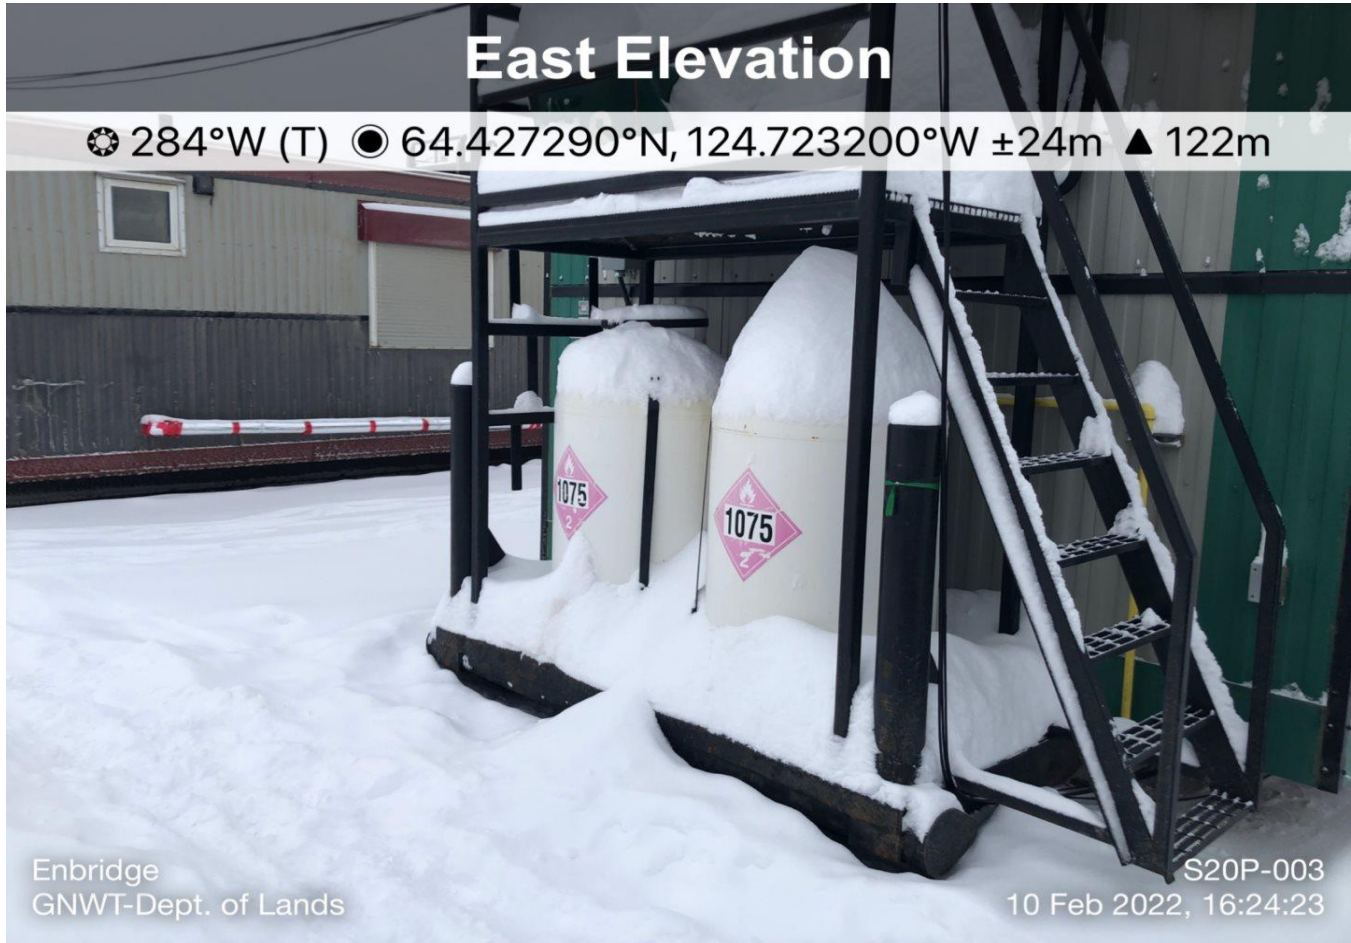
Figure 16
Propane tanks for camp operations

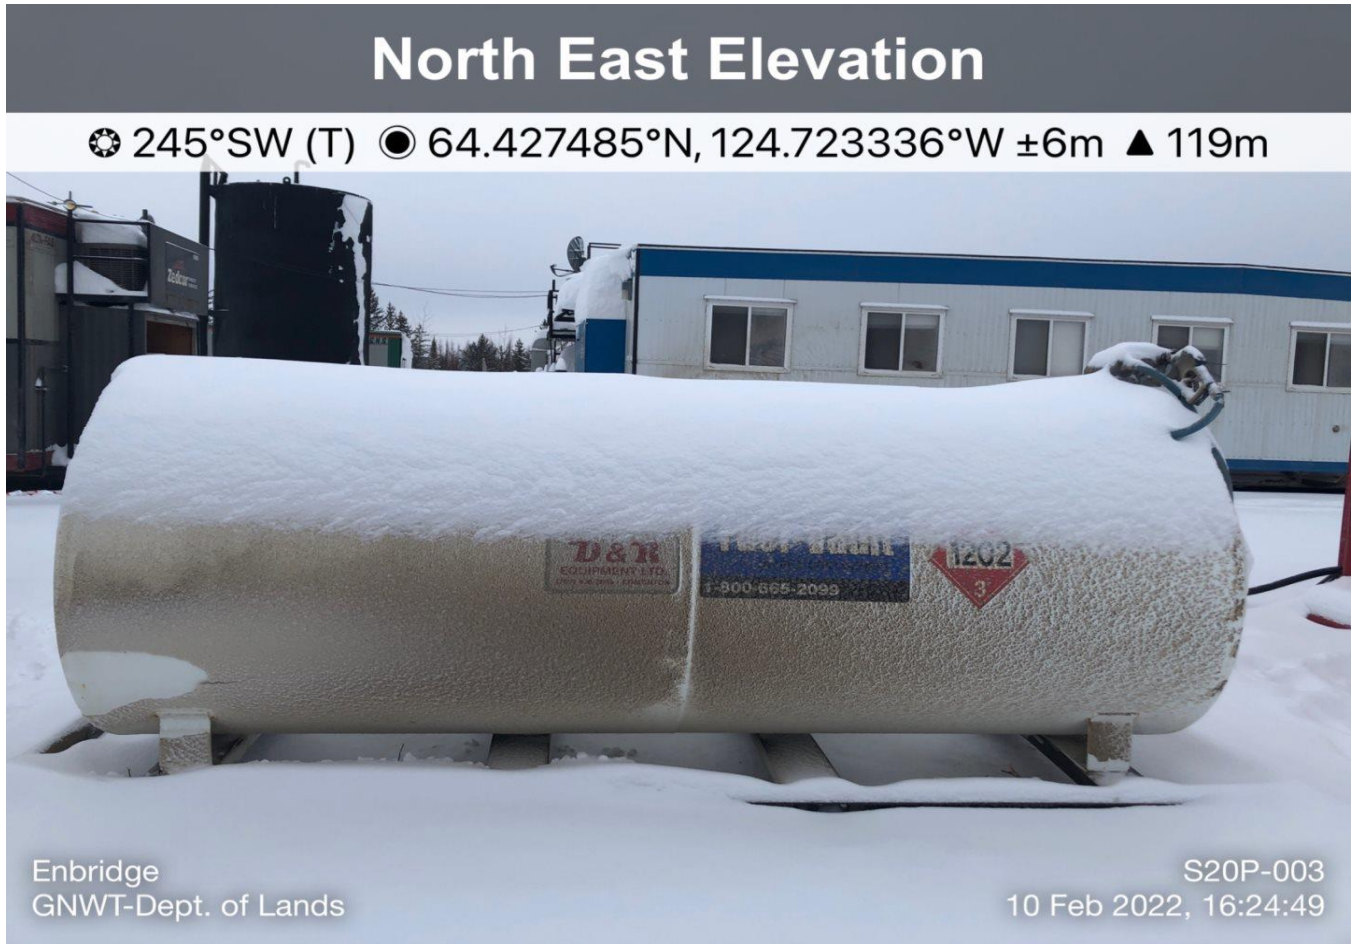
Figure 17

Fuel tank next to the camp
