File Number	S20P-003
Type of Operation	PIPELINES (existing)
Location	Camp, Pipeline ROW KP 158

ENVIRONMENTAL INSPECTION REPORT

Permittee:	Enbridge Pipelines	Permit Expiry Date:	September 17, 2025
Land Use Permit No.	S20P-003	Previous Inspection:	May 07, 2021
Quarrying Permit No.	N/A	Inspection Date:	February 10, 2022
Contractor:	N/A	Subcontractor:	N/A
Location(s) Inspected:	Camp, Pipeline ROW KP 158		
Current Stage of Operation:	Remediation		
Program Modifications Approved:	None

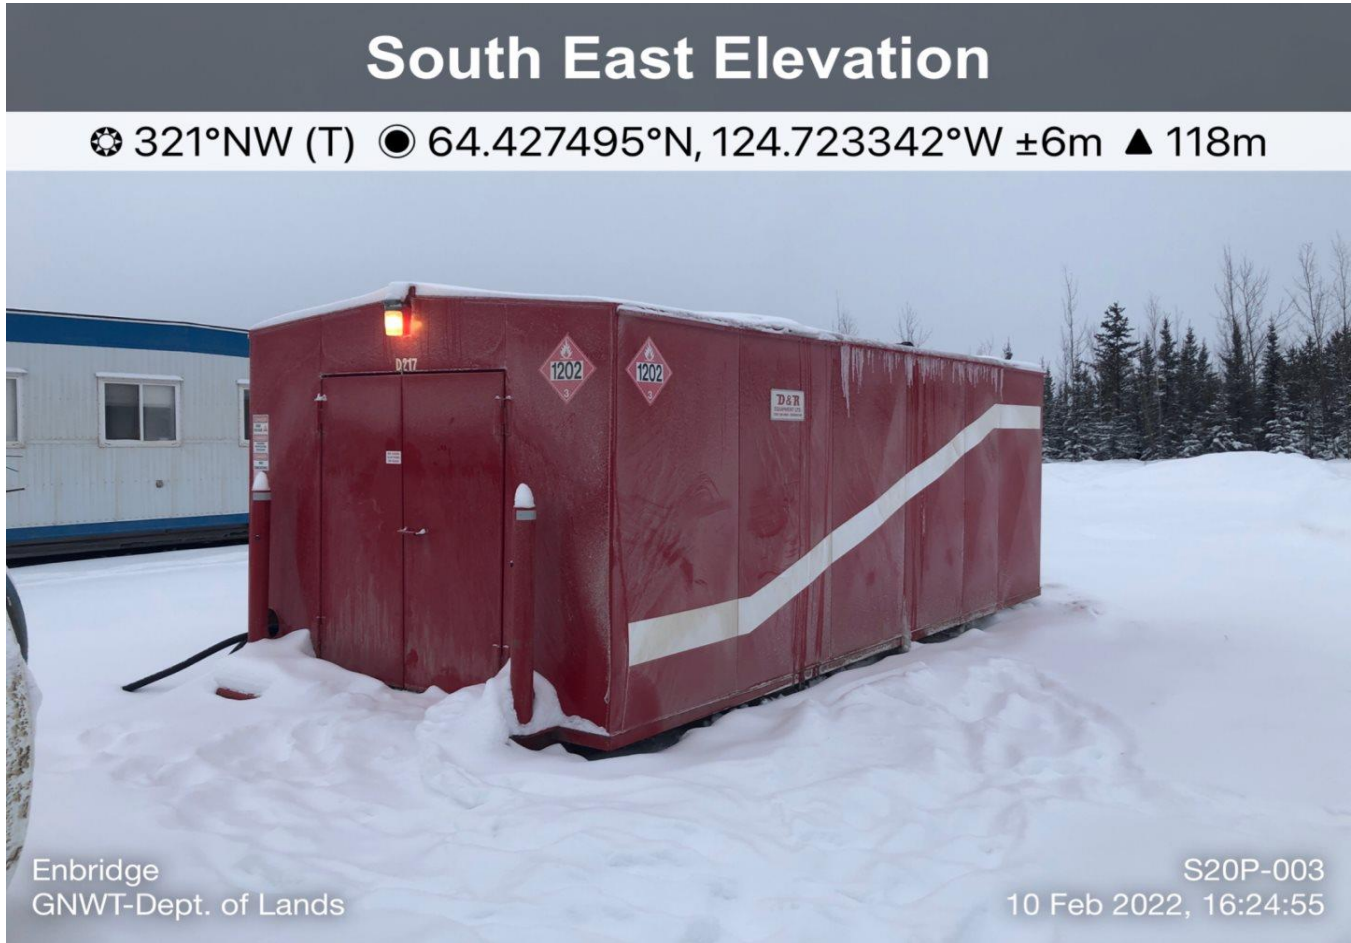
Figure 18

tanks and a fuel storage shed, as seen in figures 11, 13, 17, 18, and 22. Currently, Inspector has no concerns regarding these tanks. In addition, there were numerous pickups and heavy machinery on-site supporting drip trays. Again, Inspector has no concerns at this time.

Fuel storage shed behind the camp

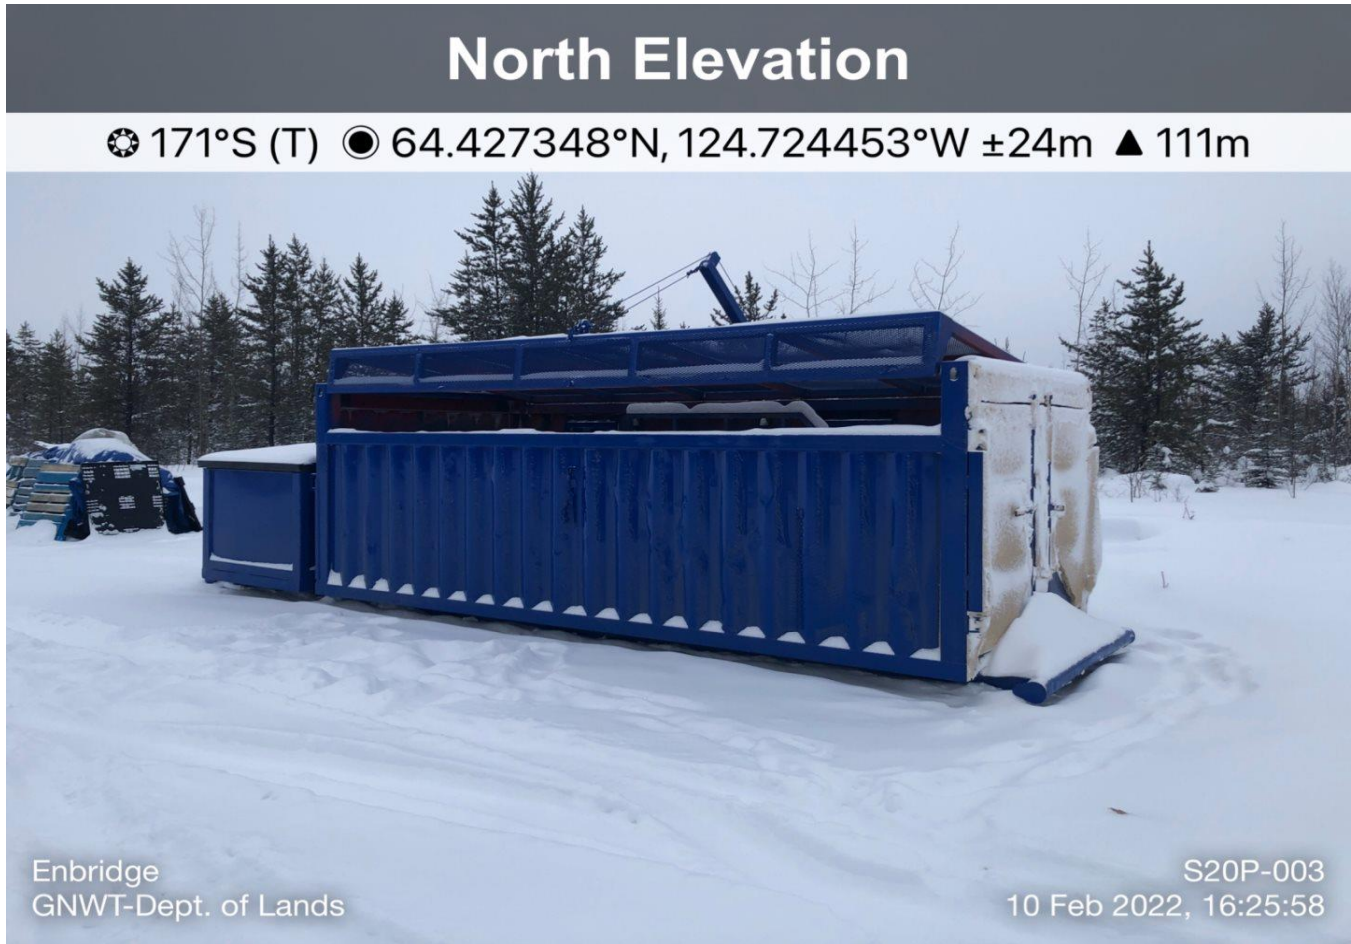
The campsite was very neat and tidy. Figure 19 illustrates using a wildlife-proof waste disposal container for domestic waste generated by camp operations. Inspector has no concerns at this time.

Figure 19
Garbage disposal bin

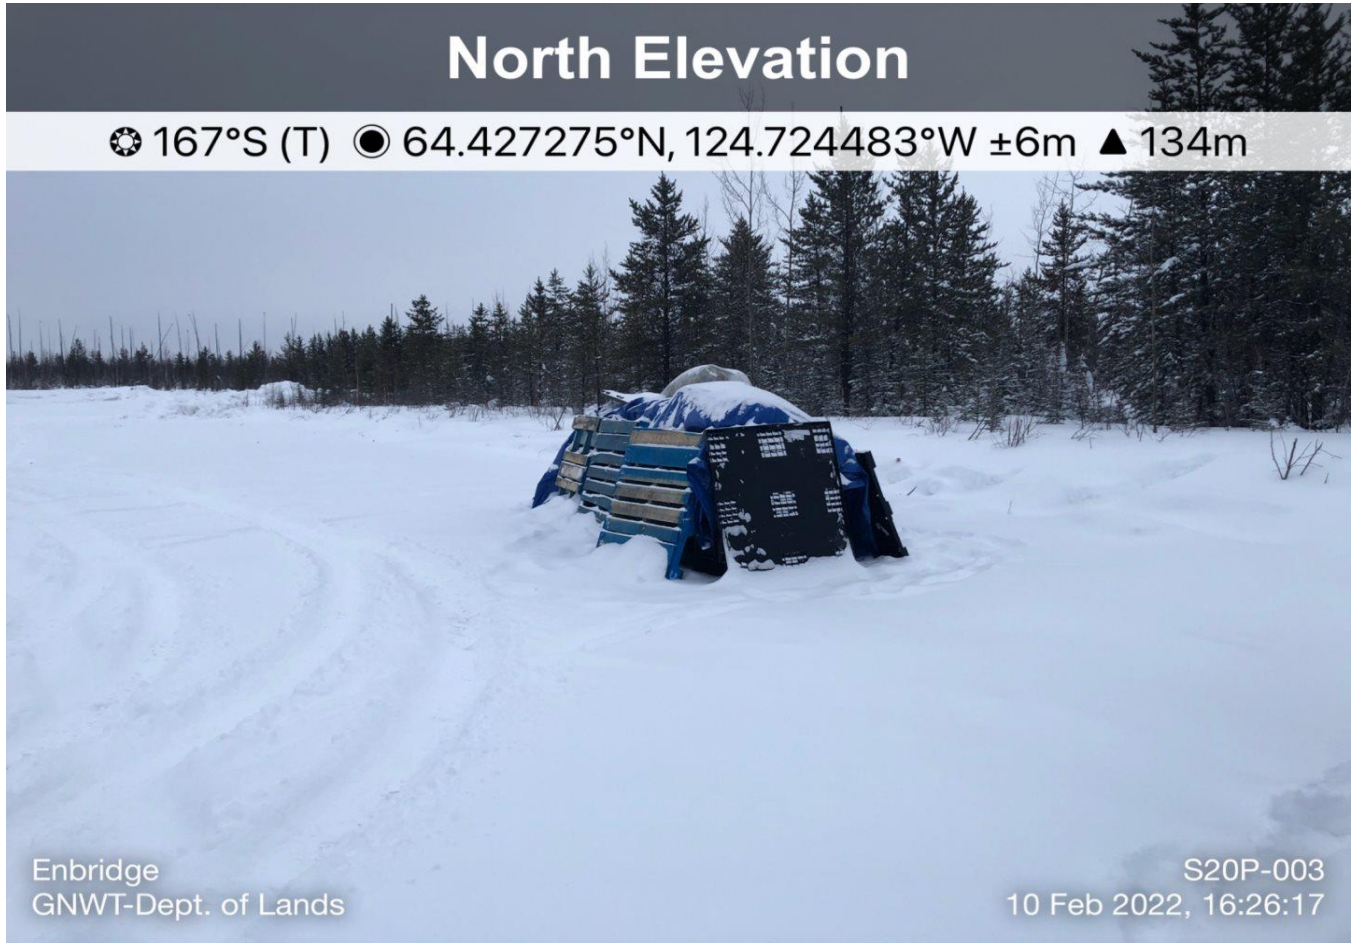
Figure 20
A tarp over some materials with pallets

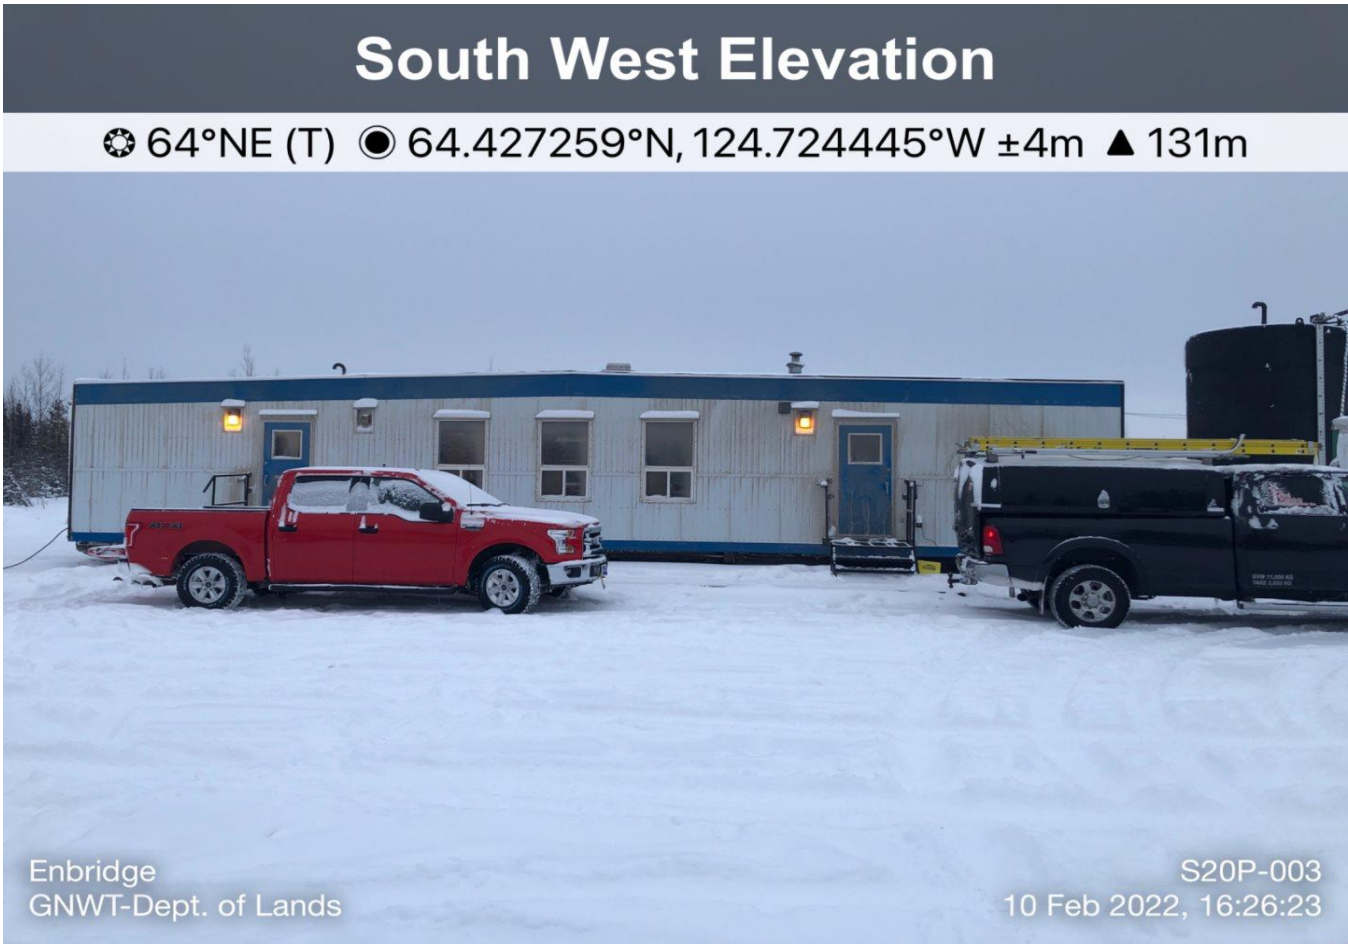
Figure 21
Camp with some pickups

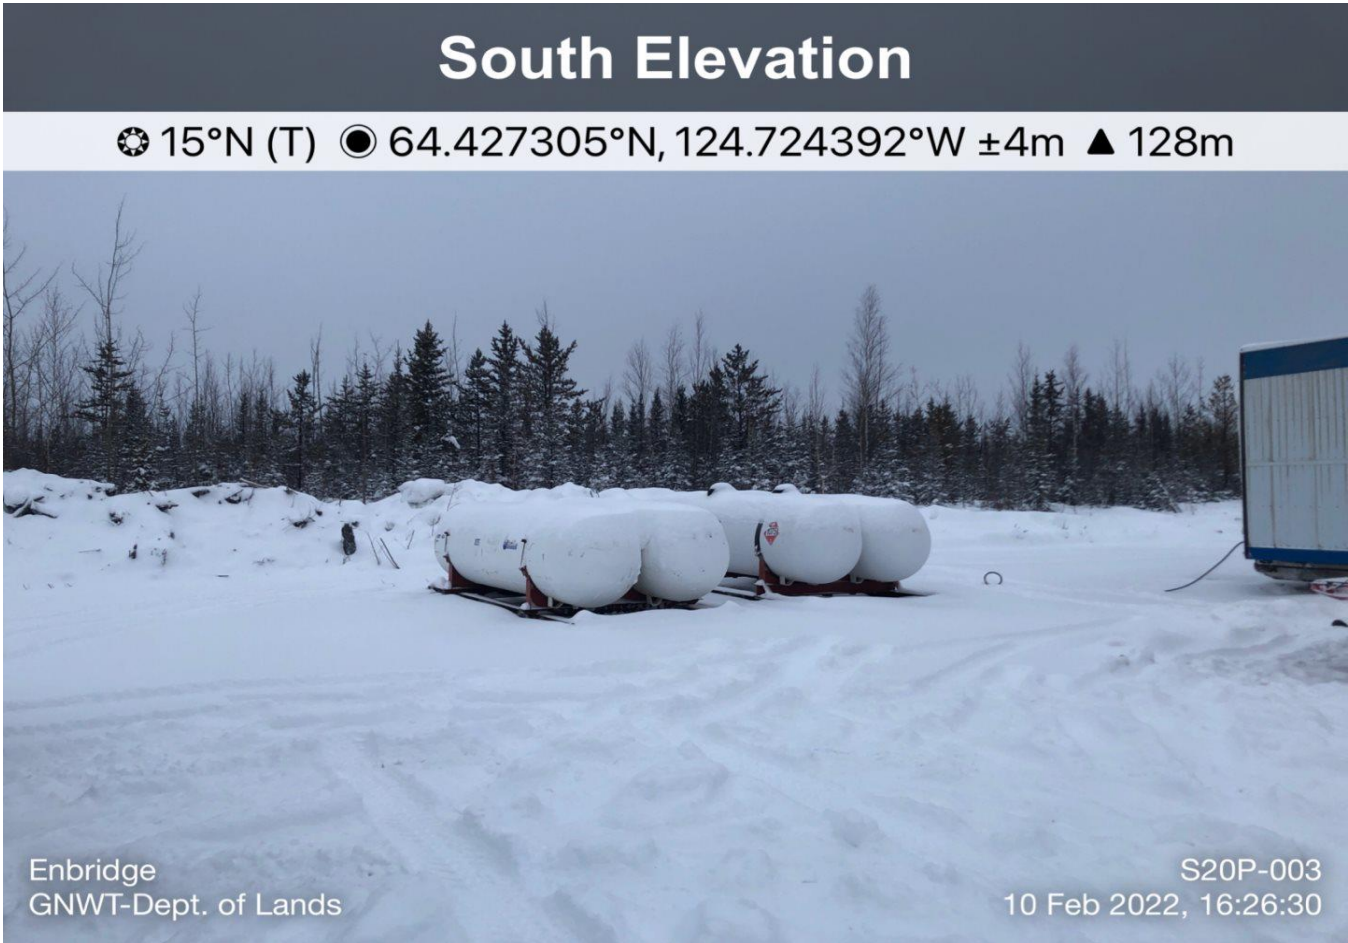
Figure 22
Smaller fuel tanks behind the camp

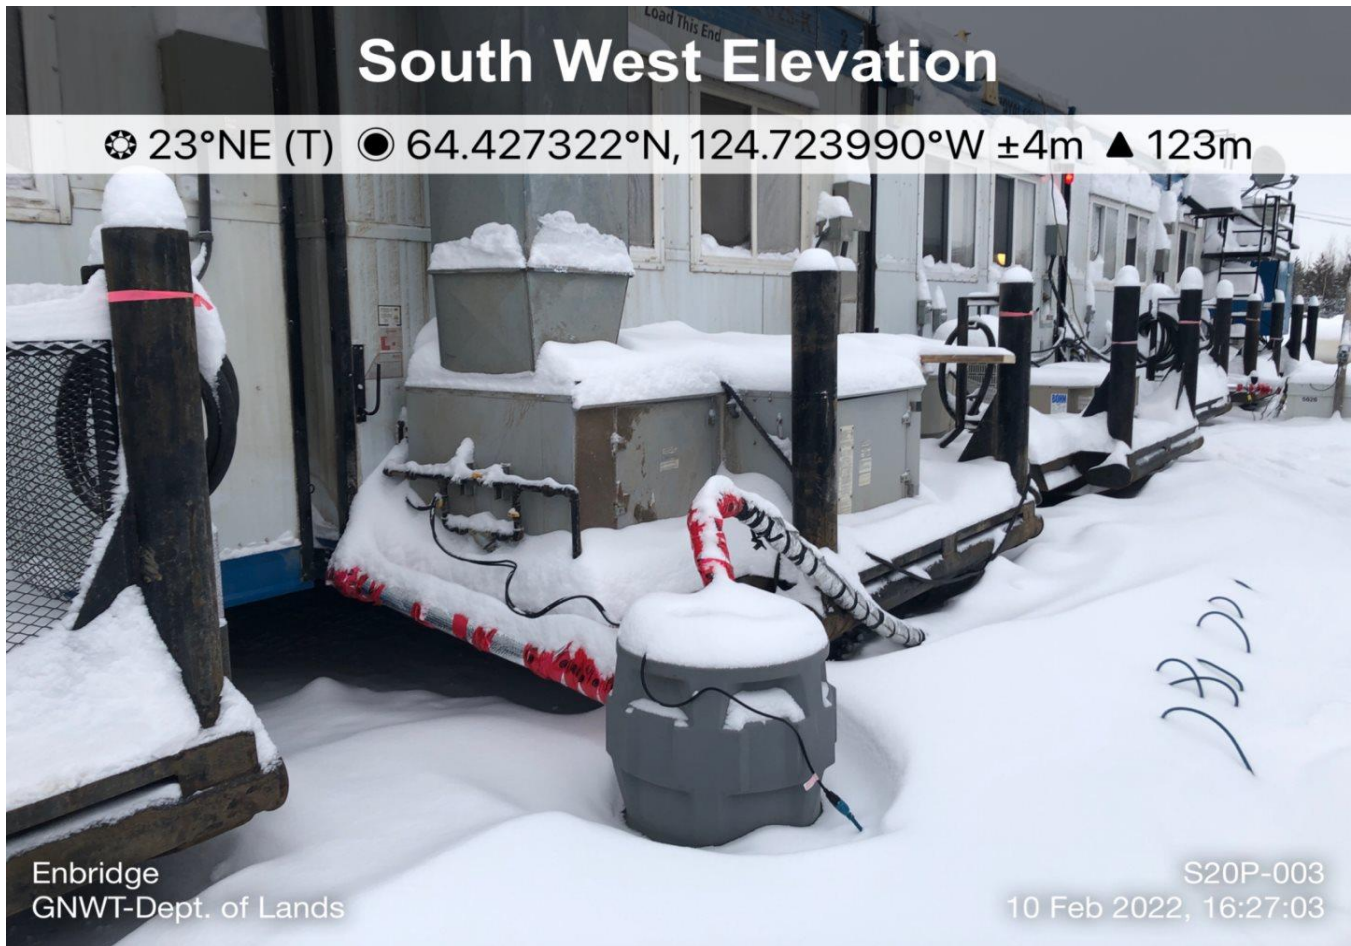
Figure 23
View from behind the camp

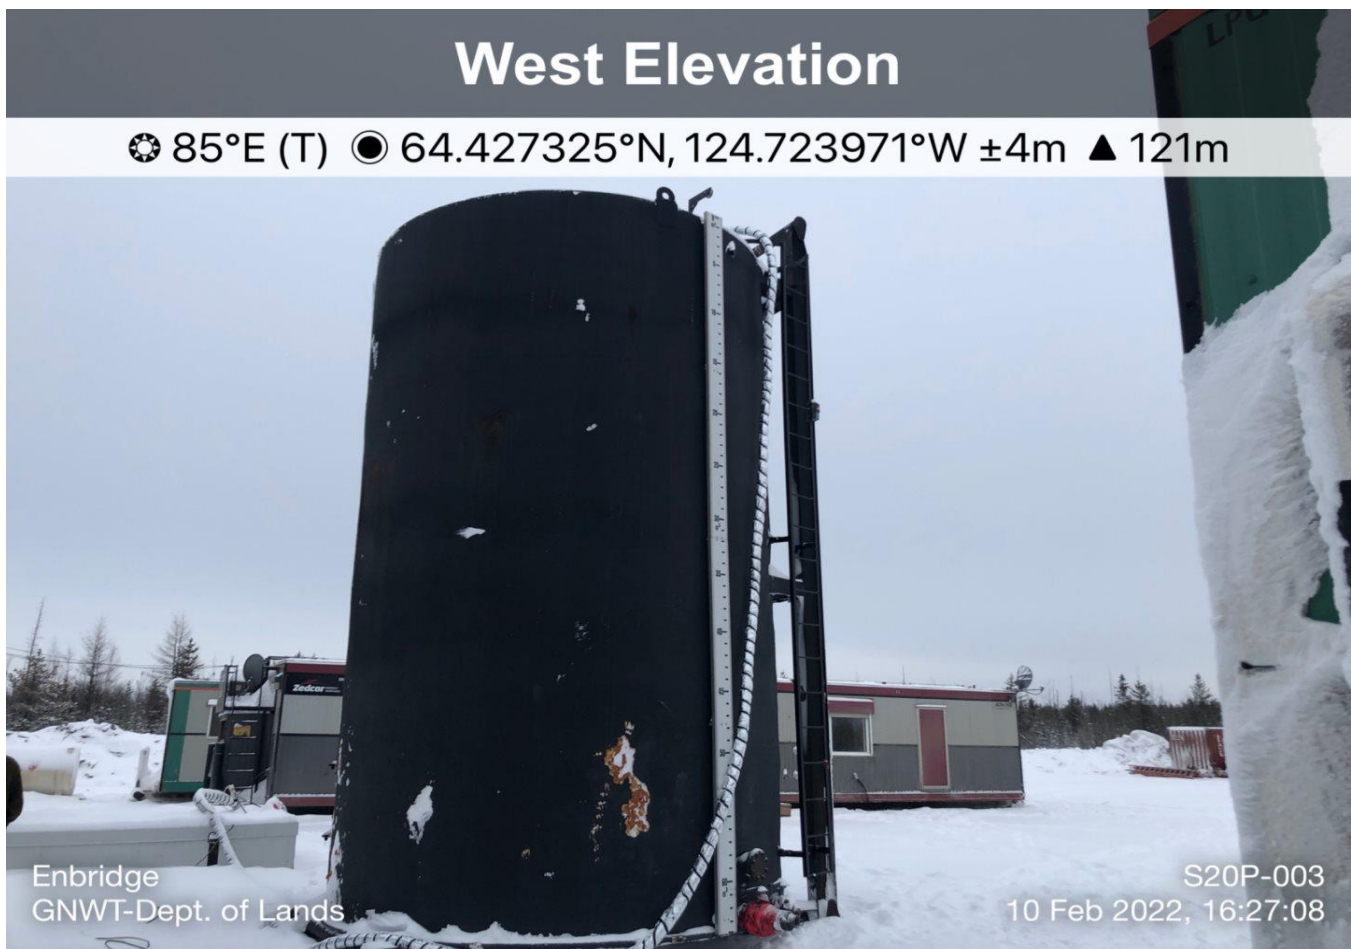
Figure 24
Black and grey water storage tank
