File Number	S20P-003
Type of Operation	PIPELINES (existing)
Location	Camp

ENVIRONMENTAL INSPECTION REPORT

Permittee:	Enbridge Pipelines	Permit Expiry Date:	September 17, 2025
Land Use Permit No.	S20P-003	Previous Inspection:	February 22, 2023
Quarrying Permit No.	N/A	Inspection Date:	March 21, 2023
Contractor:	N/A	Subcontractor:	
Location(s) Inspected:	Camp		
Current Stage of Operation:	Remediation		
Program Modifications Approved:	None

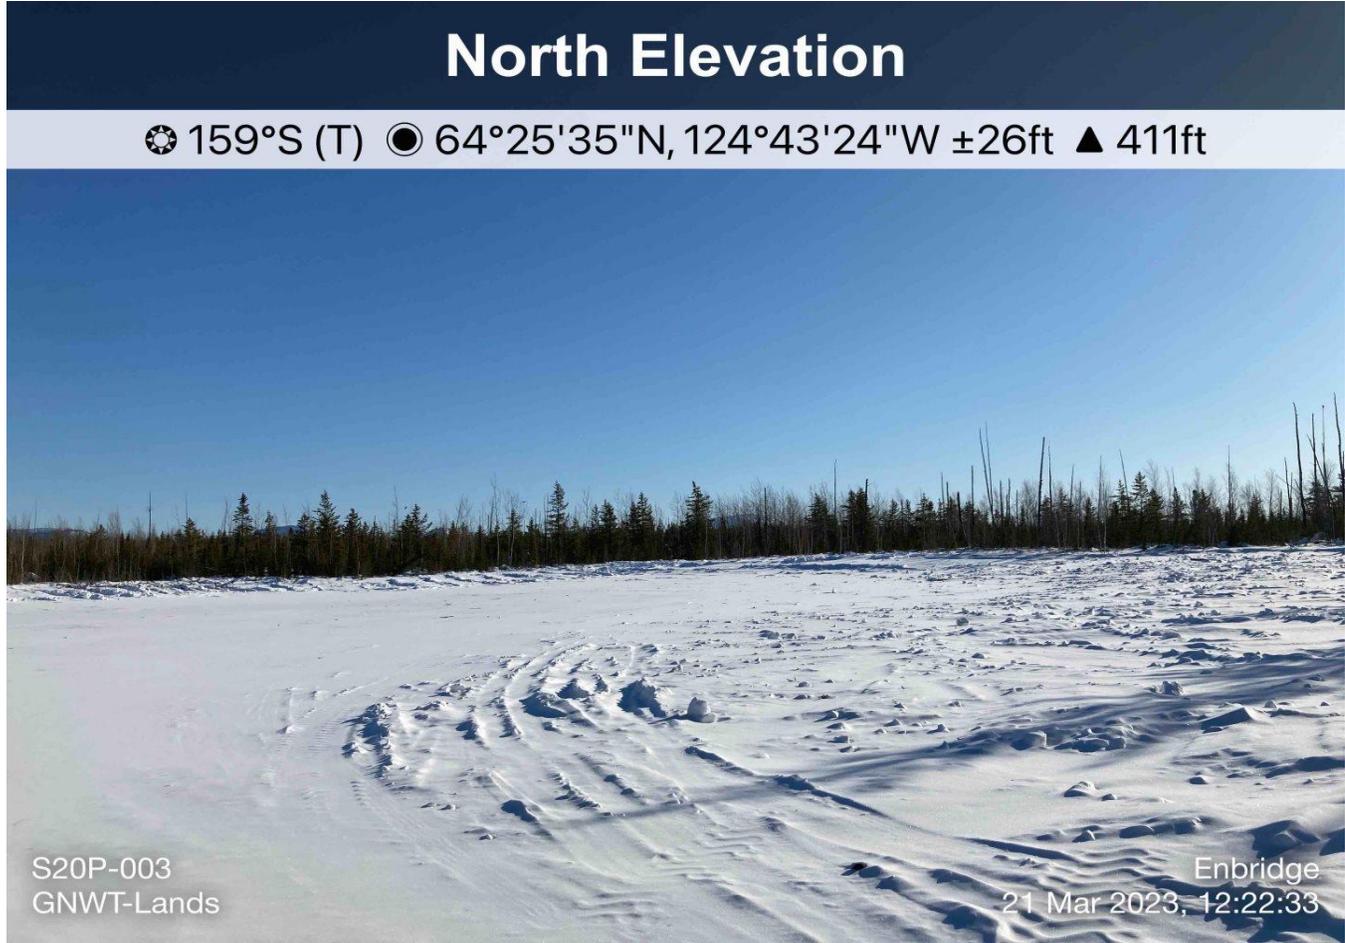
Figure 1

The timeline for this work occurred within the time frame identified during the last inspection and all material and equipment was removed from the site (Figure 1-7). As evident from the images throughout the report, there was no hazardous waste or garbage left at the camp site. While the site was primarily snow covered, there were some dark patches throughout the camp. These dark areas are not indicative of spills, they are areas where the soil below the snow has been exposed (3-7). Access to this site has been blocked by berms of snow to discourage unauthorized access (Figure 8).

Location previously used for fleet storage prior to camp shut down

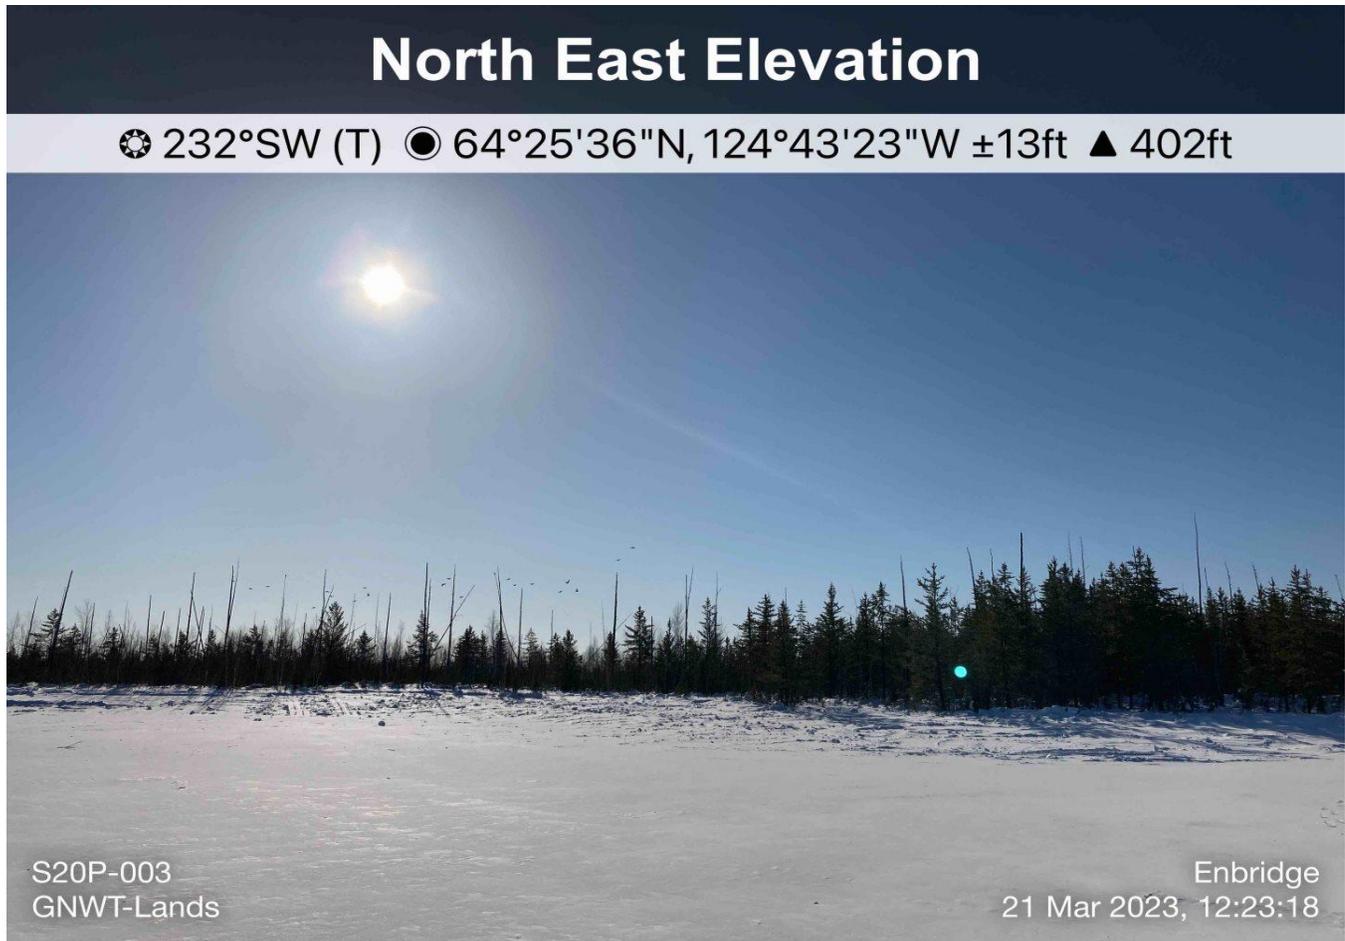
Figure 2

General area where improperly stored material was noted in previous inspection

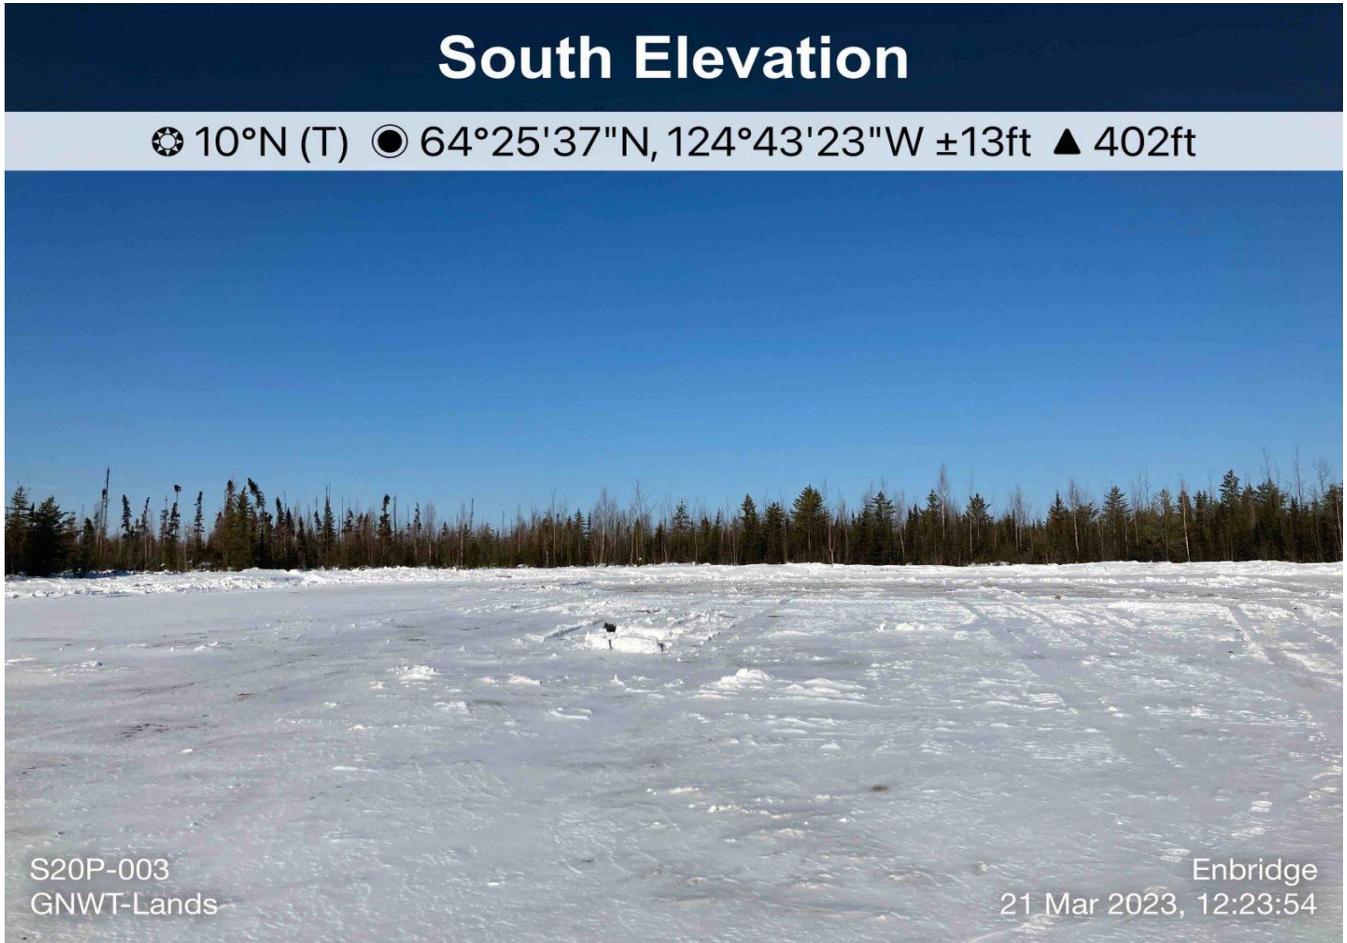
Figure 3

Location of light duty vehicle parking area and camp facilities prior to shut down.

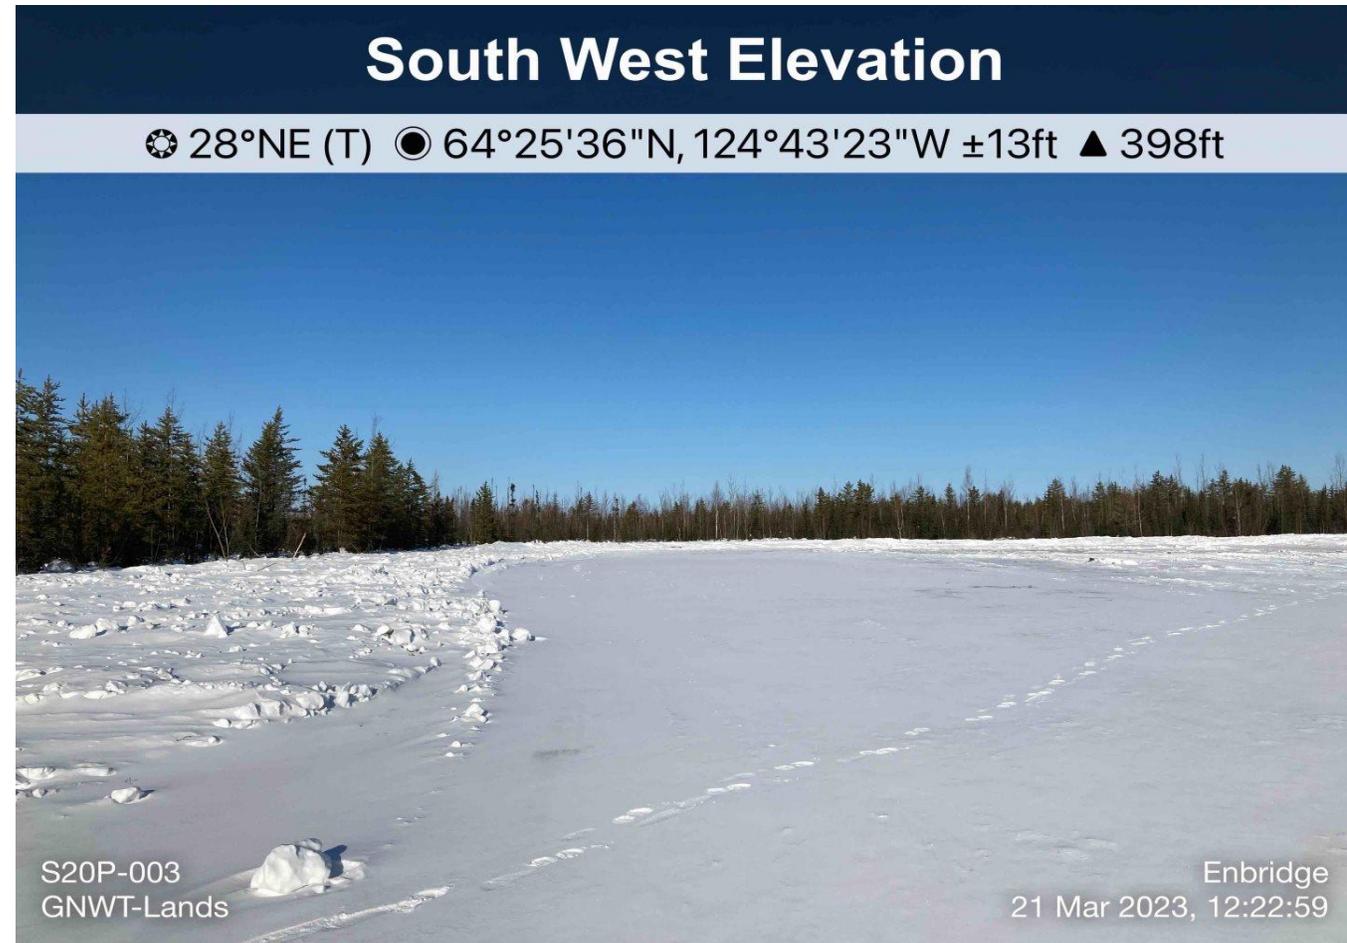
Figure 4

Area with waste bins prior to camp shut down.

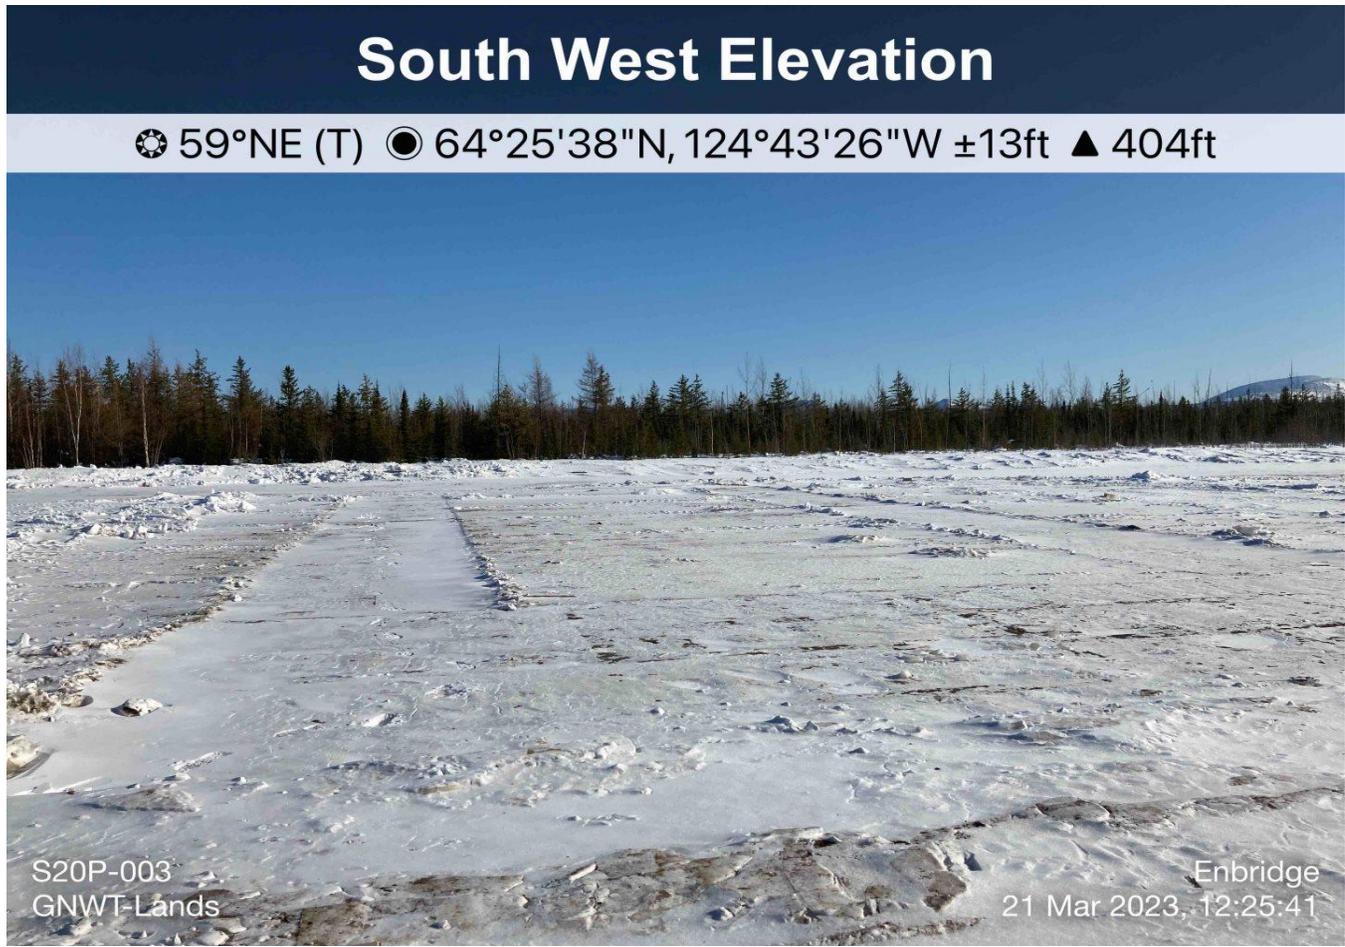
Figure 5

Camp facility area after camp shut down.

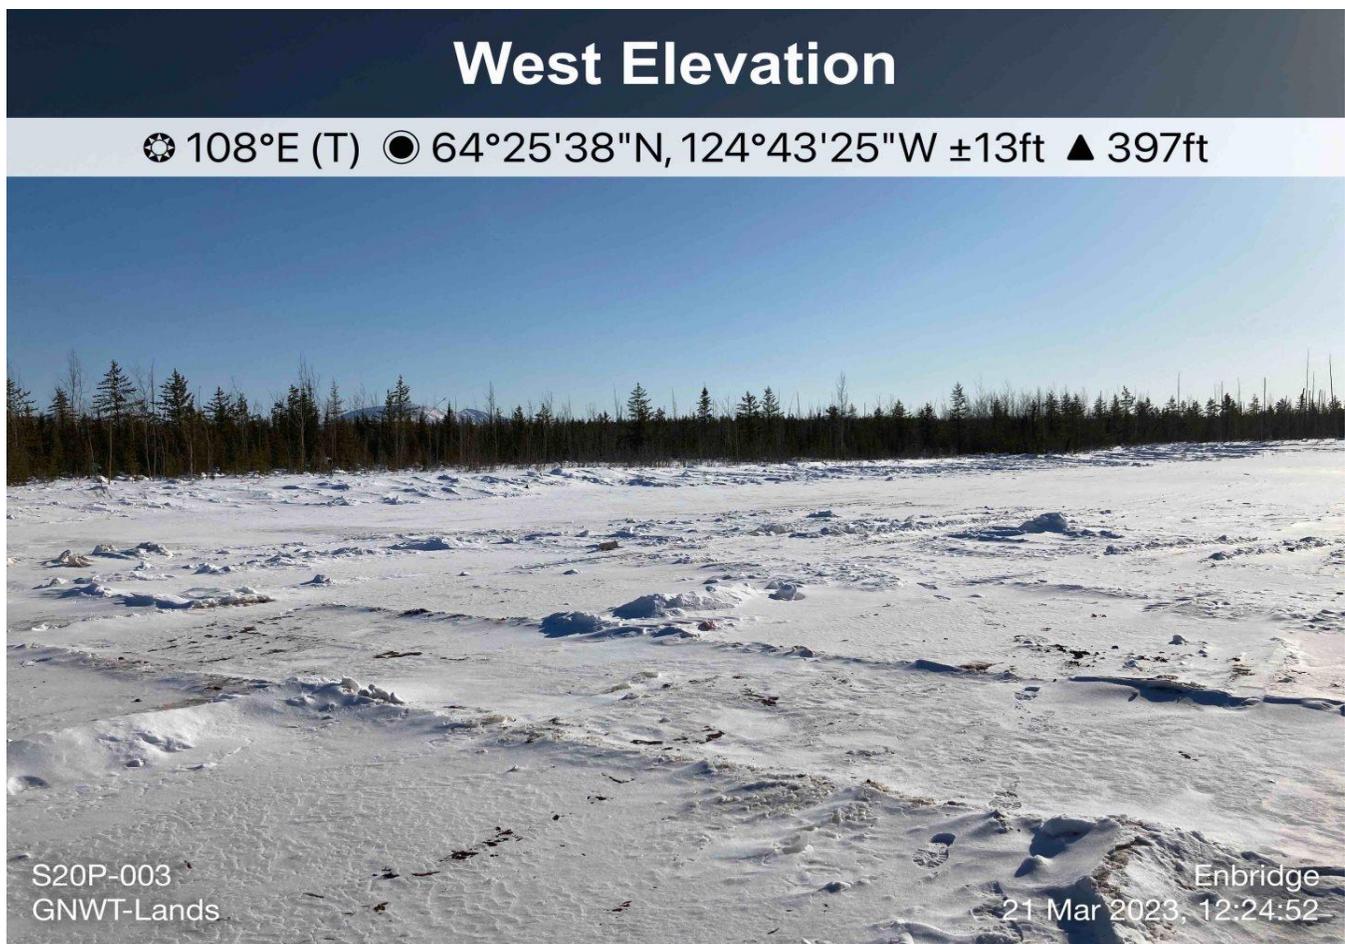
Figure 6

Alternative angle of camp facility area after final site clean up.

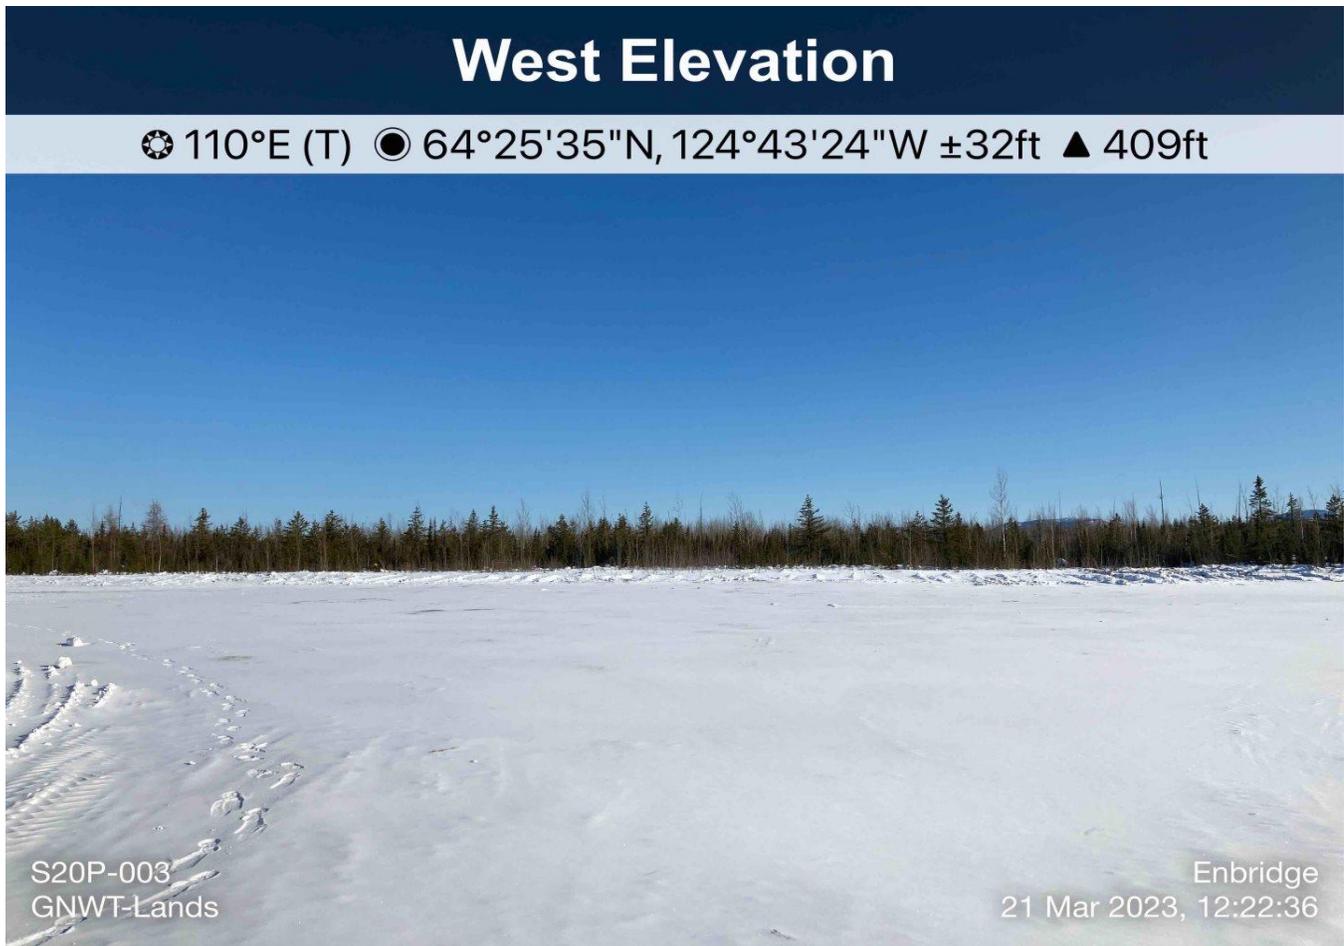
Figure 7

Site conditions after camp shut down

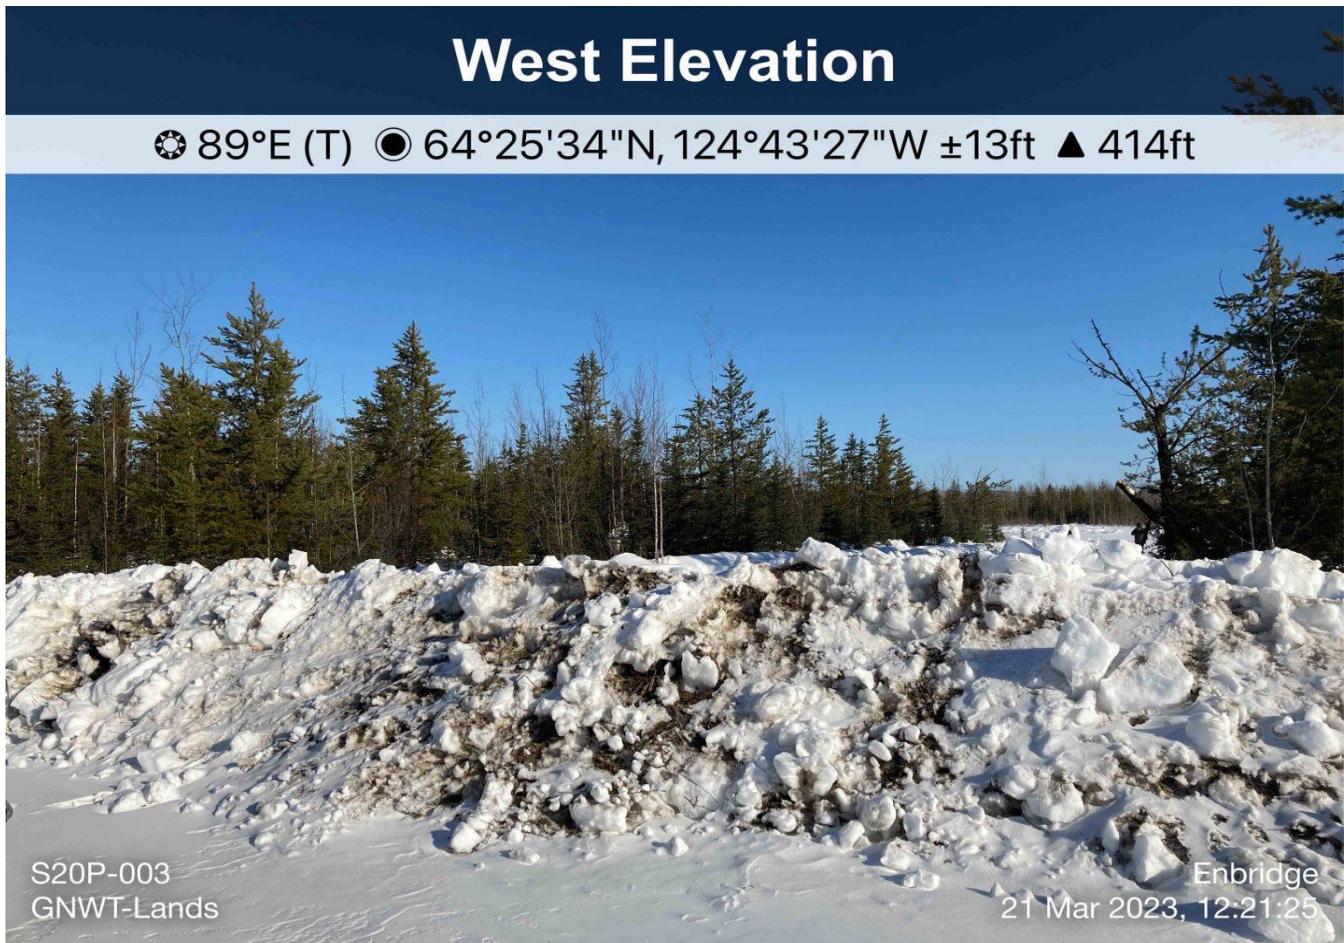
Figure 8

Snow berm created at camp access point.
