To: MGM Energy  
2800, 421-7 Avenue SW  
Calgary, AB T2P 4K9  
File: 123513469

From: Sarah Zembiak, Project Manager  
Kālo Stantec Ltd.  
Tulita, NT, Canada X0E 0T0  
Date: December 1, 2020

**Reference: 2020 Environmental Site Monitoring Report: East Mackay I-78 Wellsite Area and Staging Area**

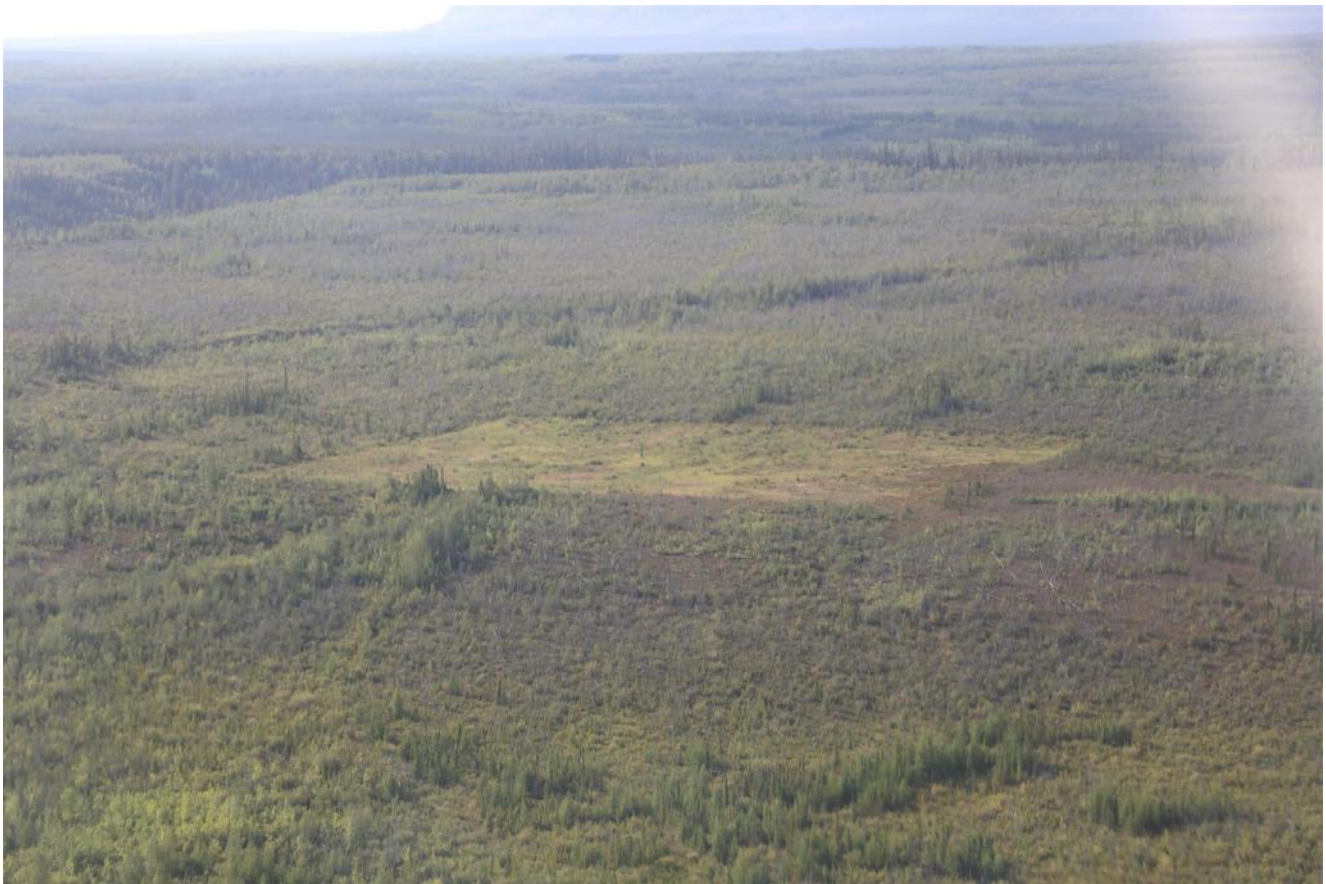
### **Photo B.1      I-78 Wellsite Area: Overview**

**NOTE:** Overview of the Wellsite Area and surrounding area showing overall terrain and vegetation conditions (August 20, 2020).

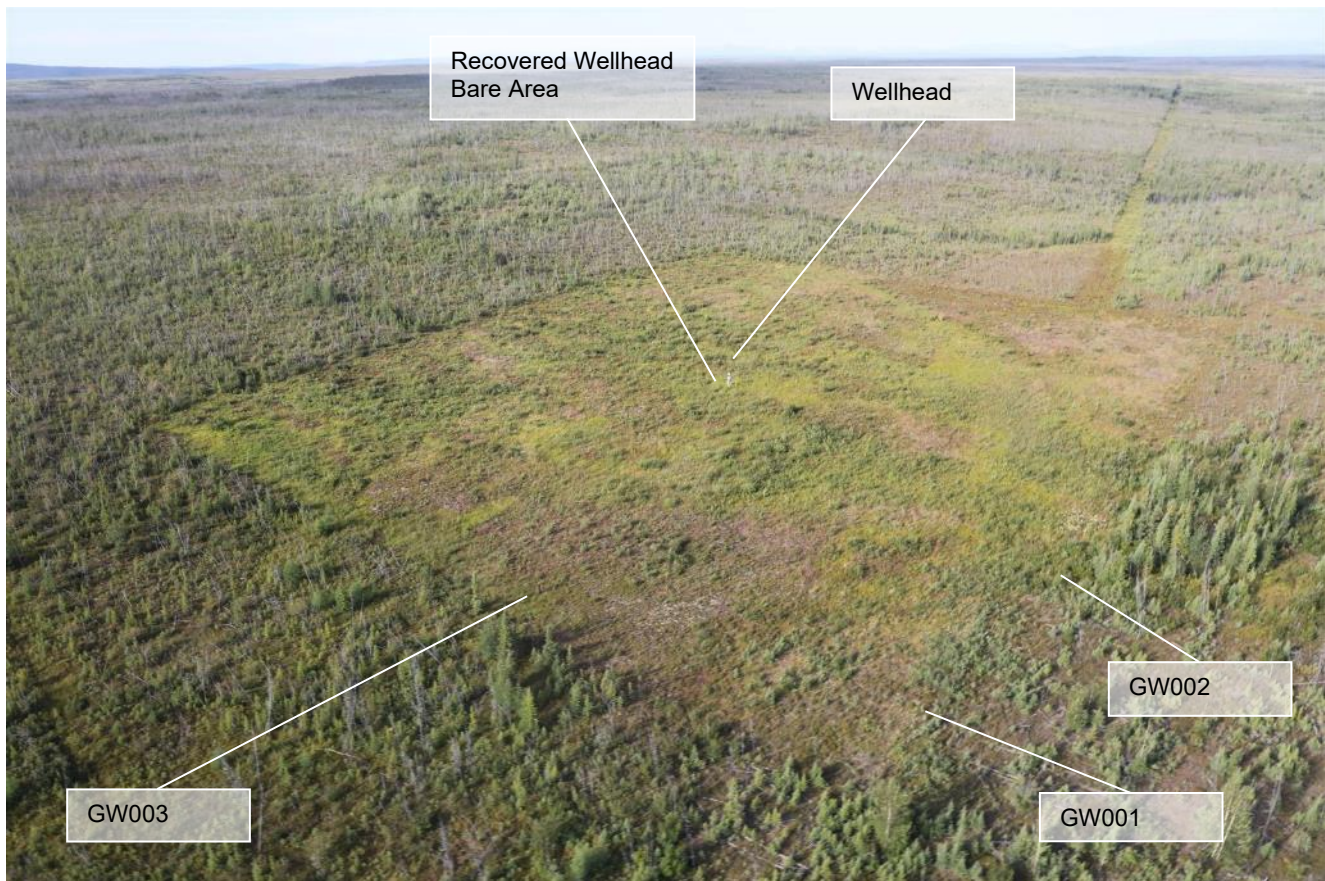
**Photo B.2 I-78 Wellsite Area: Overview**

NOTE: Overview showing the Wellsite Area and locations of the Wellhead, Recovered Wellhead Bare Area, and Groundwater Monitoring Wells (GW001, GW002, GW003) (August 20, 2020).

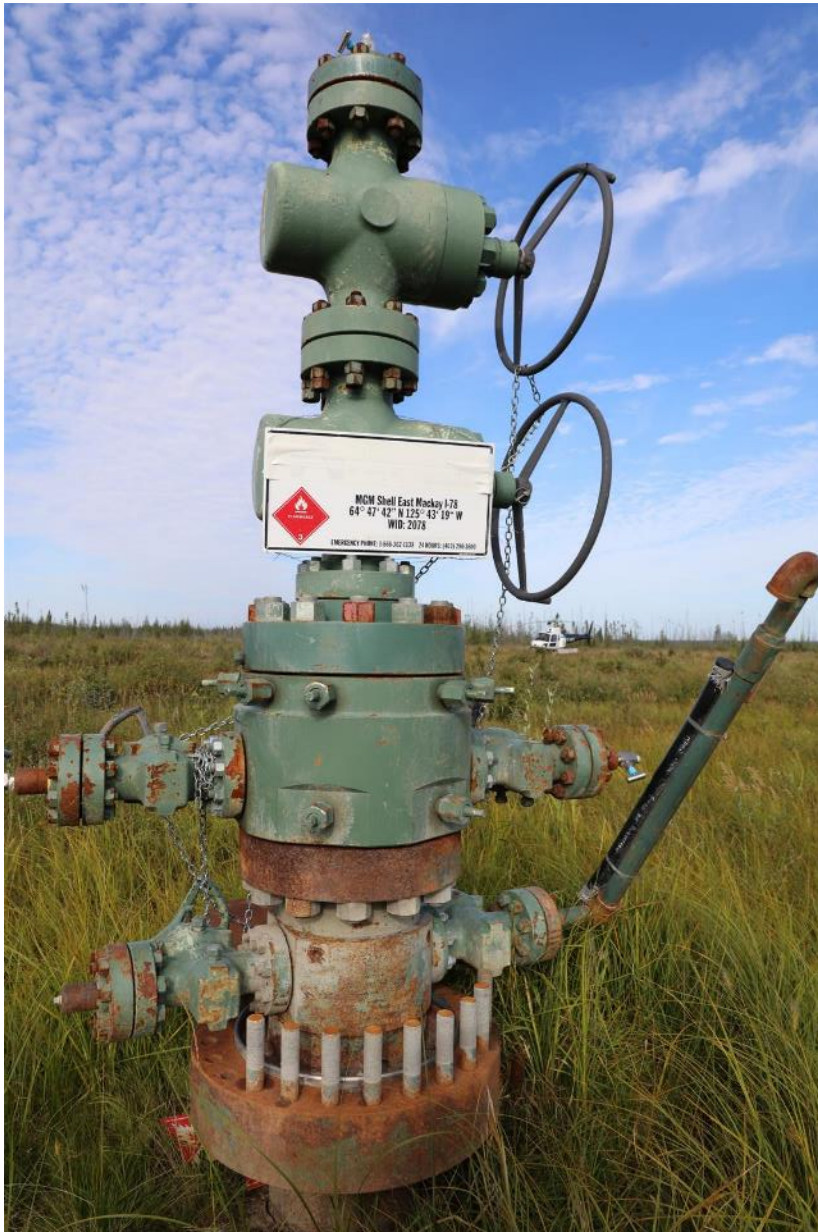
**Photo B.3** I-78 Wellsite Area: On-Site Materials

NOTE: On-site materials showing wellhead and sign (August 20, 2020).

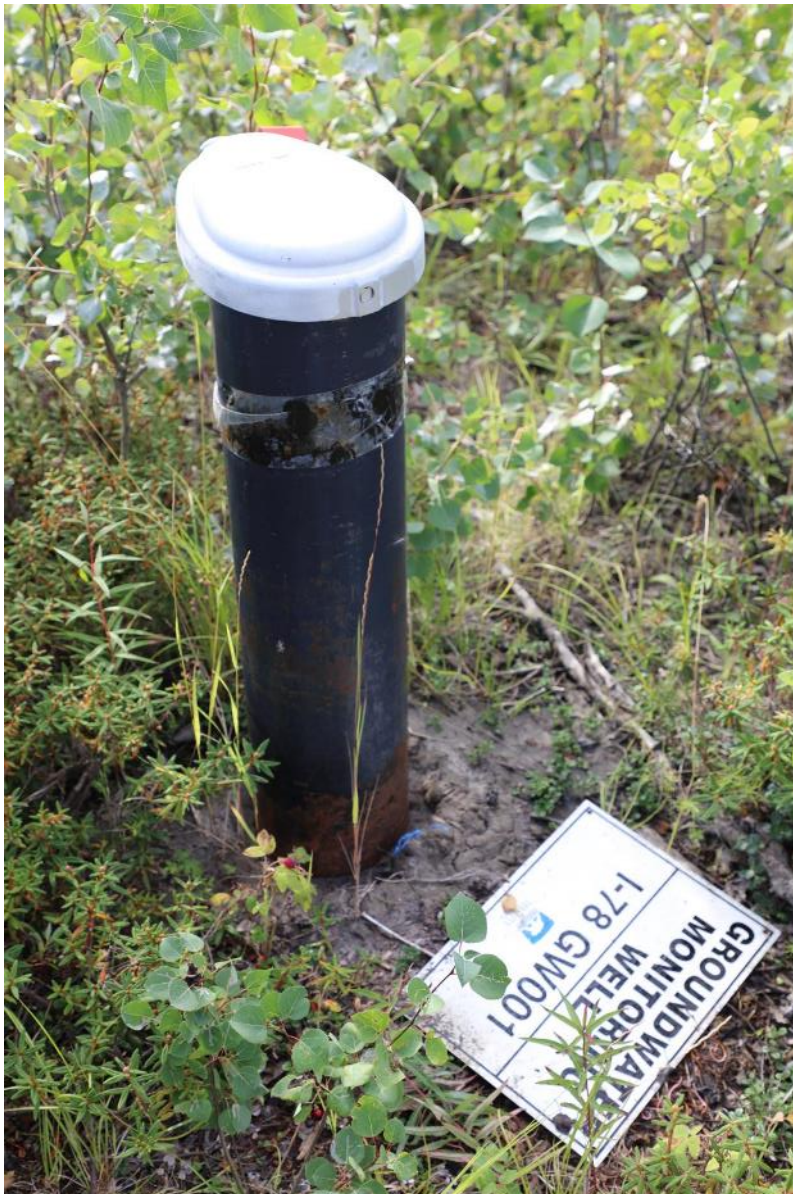
**Photo B.4** I-78 Wellsite Area: On-Site Materials

NOTE: Condition of Groundwater Monitoring Well I-78 GW001 in Wellsite Area (August 20, 2020).

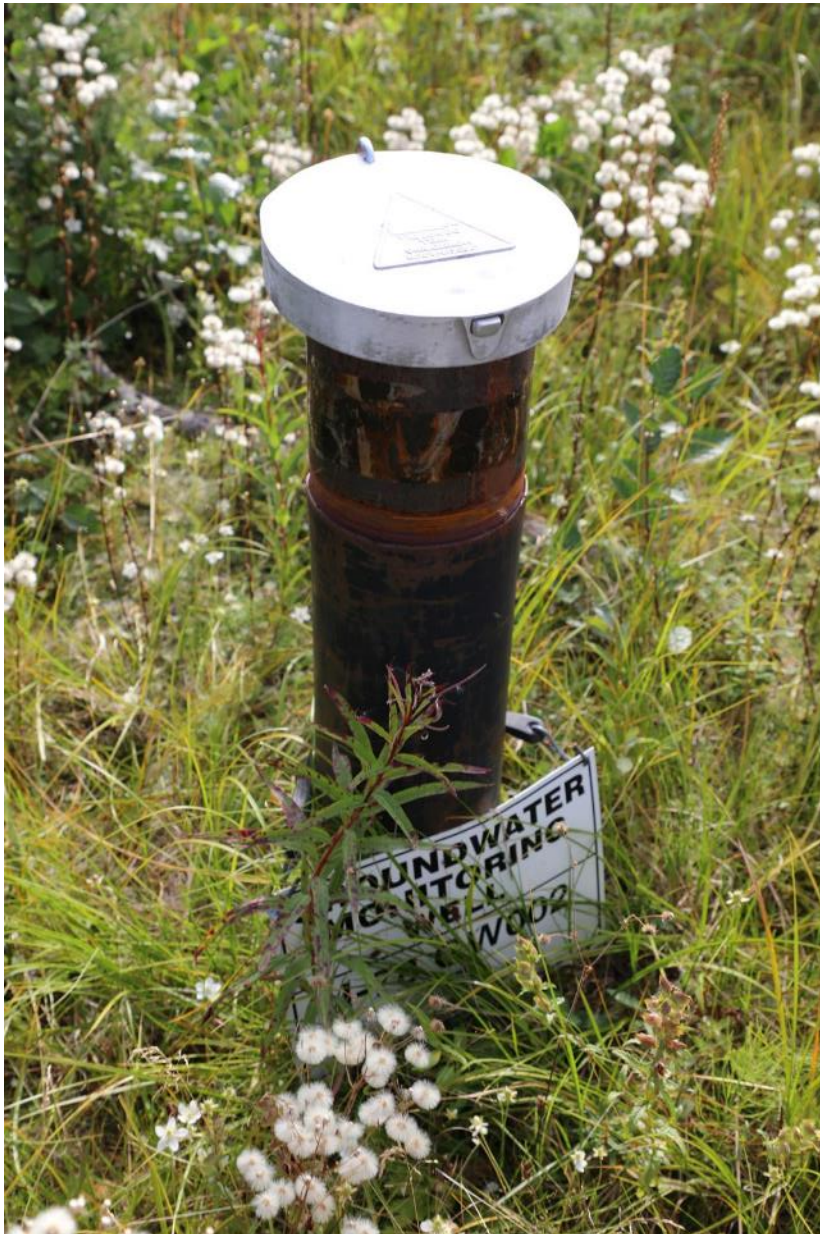
**Photo B.5** I-78 Wellsite Area: On-Site Materials

**NOTE:** Condition of Groundwater Monitoring Well I-78 GW002 in Wellsite Area (August 20, 2020).

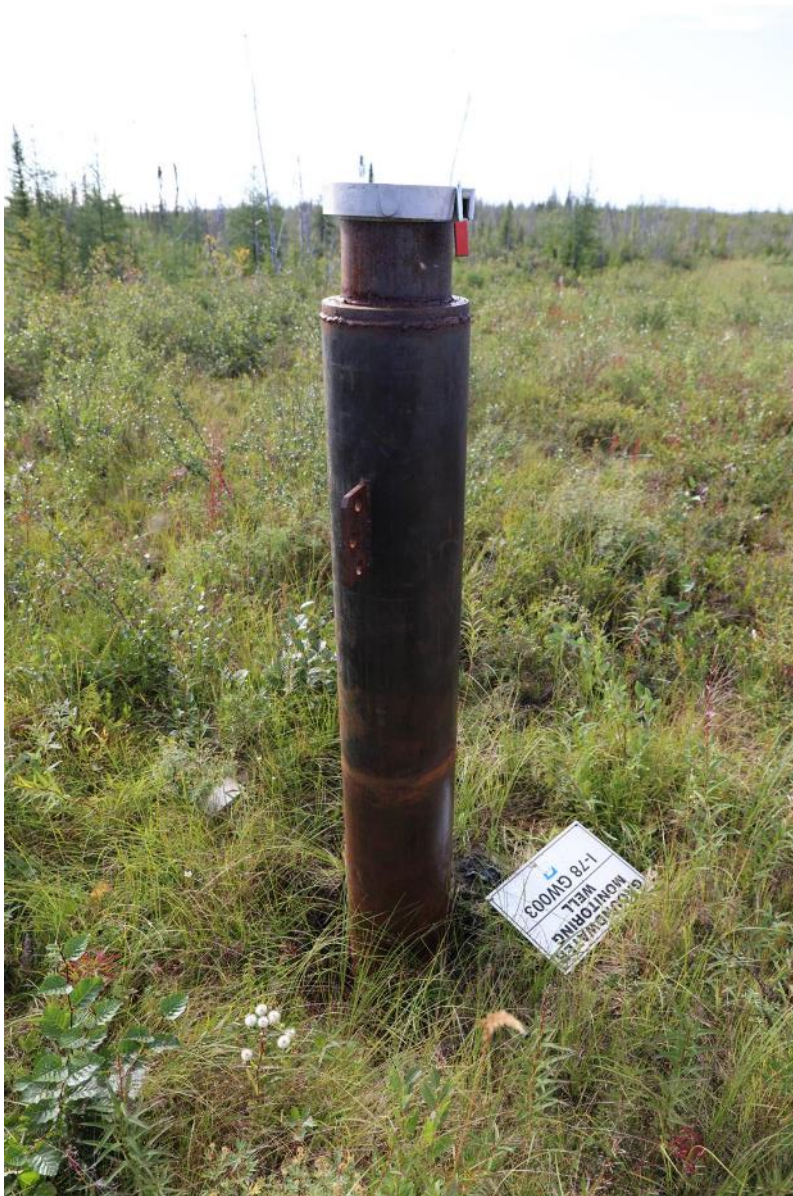
**Photo B.6** I-78 Wellsite Area: On-Site Materials

NOTE: Condition of Groundwater Monitoring Well I-78 GW003 in Wellsite Area (August 20, 2020).

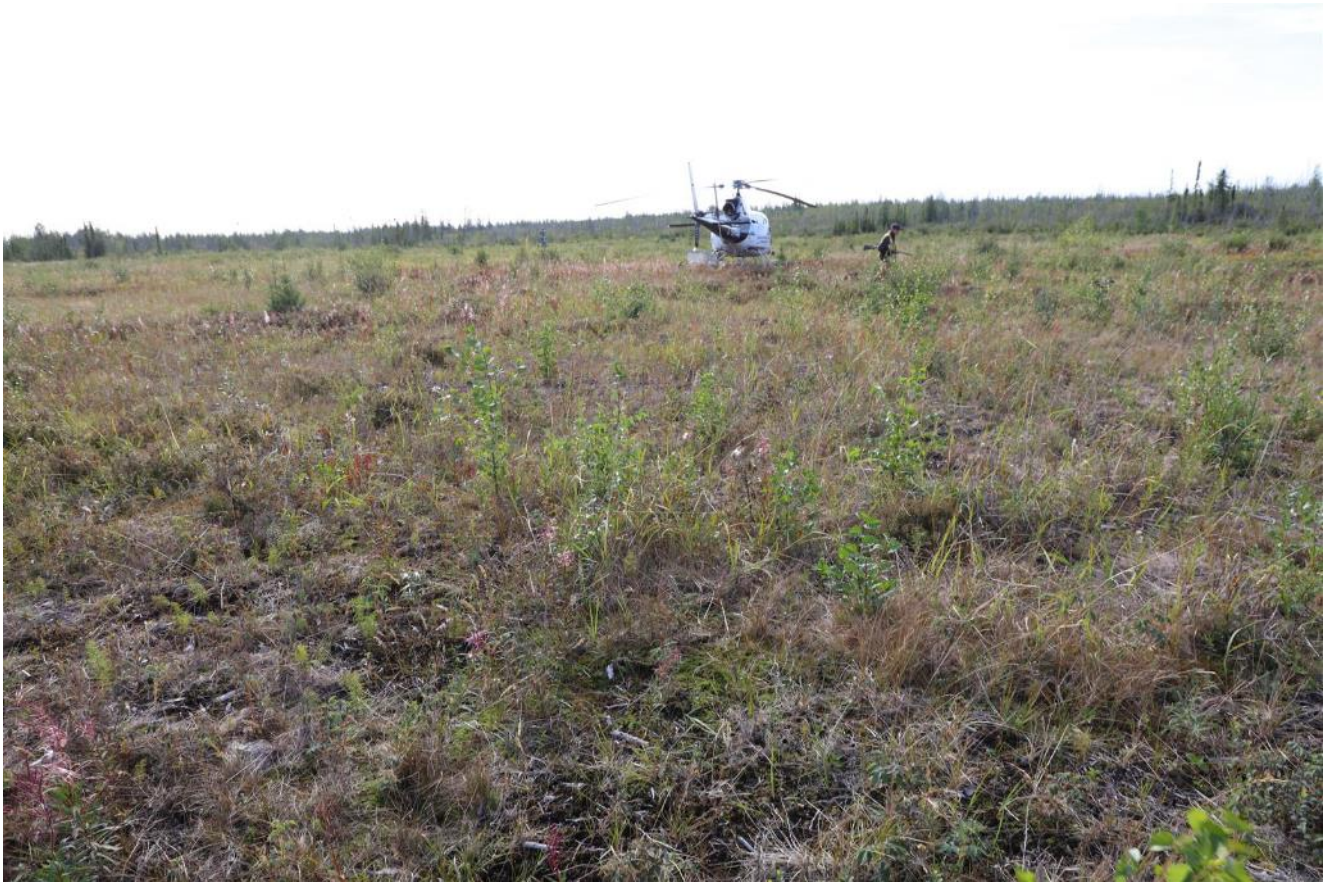
**Photo B.7** I-78 Wellsite Area

**NOTE:** View of ground and vegetation conditions in the Wellsite Area looking southeast. Wellsite Area was undisturbed and has revegetated with naturally established native trees, shrubs, and forbs. Vegetation cover, was meeting permit requirements (>70% cover, healthy conditions) (August 20, 2020).

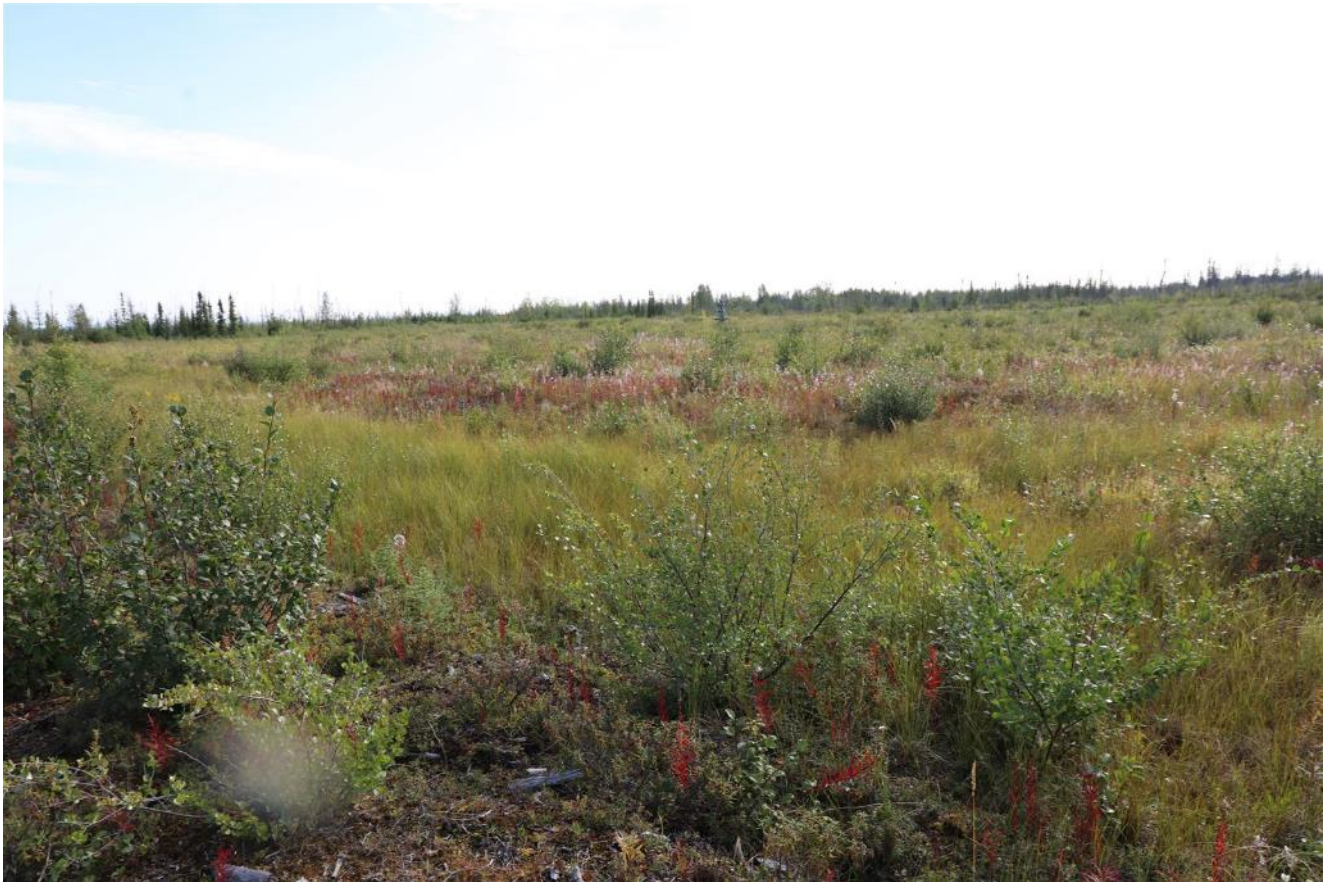
**Photo B.8** I-78 Wellsite Area

**NOTE:** View of ground and vegetation conditions in the Wellsite Area looking northeast. Wellsite Area was undisturbed and has revegetated with naturally established native trees, shrubs, and forbs. Vegetation cover was meeting permit requirements (>70% cover, healthy conditions) (August 20, 2020).

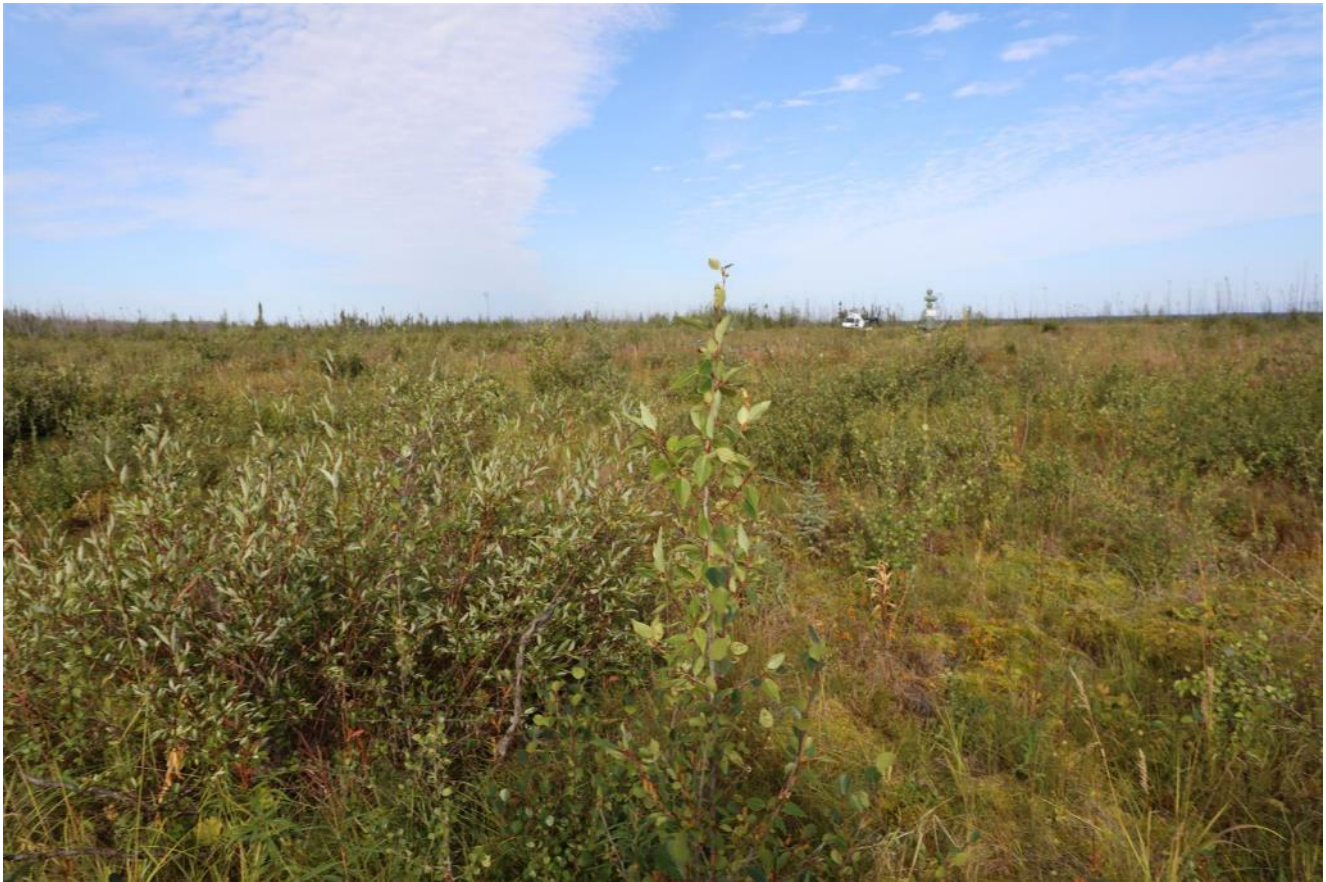
**Photo B.9** I-78 Wellsite Area

**NOTE:** View of ground and vegetation conditions in the Wellsite Area looking northwest. Wellsite Area was undisturbed and has revegetated with naturally established native trees, shrubs, and forbs. Vegetation cover was meeting permit requirements (>70% cover, healthy conditions) (August 20, 2020).

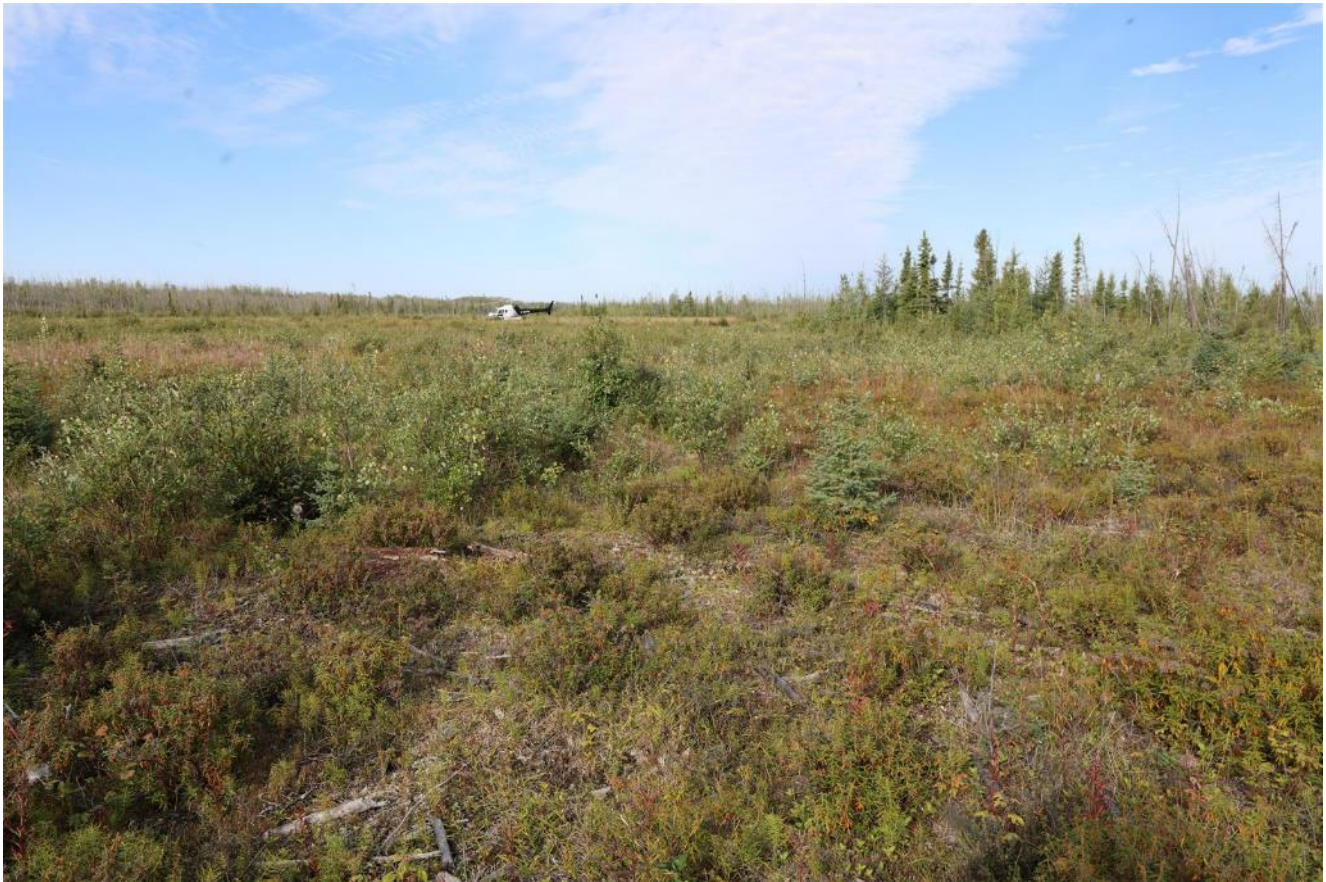
**Photo B.10** I-78 Wellsite Area

**NOTE:** View of ground and vegetation conditions in the Wellsite Area looking south. Wellsite Area was undisturbed and has revegetated with naturally established native trees, shrubs, and forbs. Vegetation cover was meeting permit requirements (>70% cover, healthy conditions) (August 20, 2020).

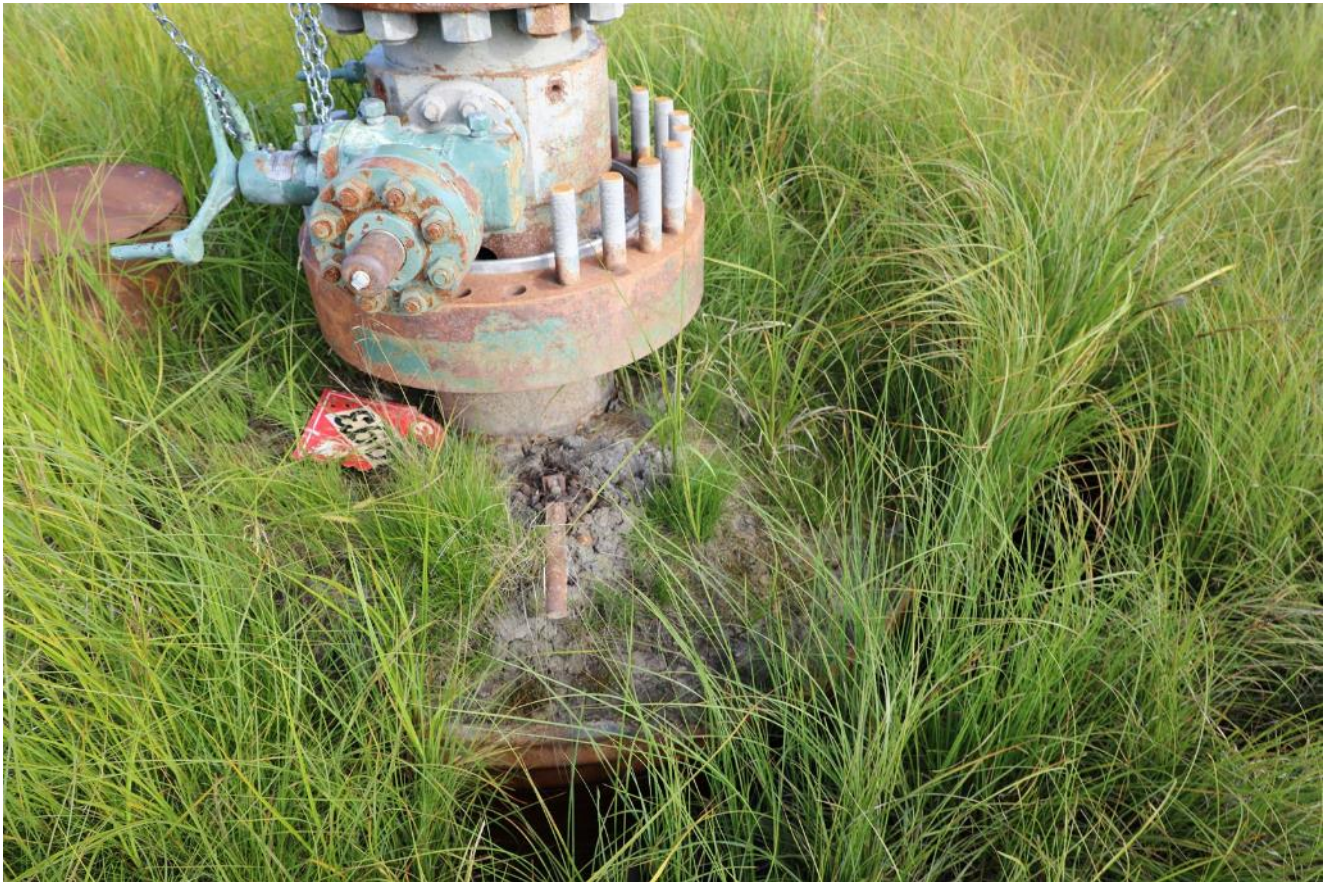
**Photo B.11** I-78 Wellsite Area: Recovered Wellhead Bare Area

**NOTE:** The ground immediately around the wellhead is the Recovered Bare Area. Vegetation cover was meeting permit requirements (>70% cover, healthy condition) (August 20, 2020). Standing water was observed in the vegetated area immediately adjacent to the Wellhead casing.

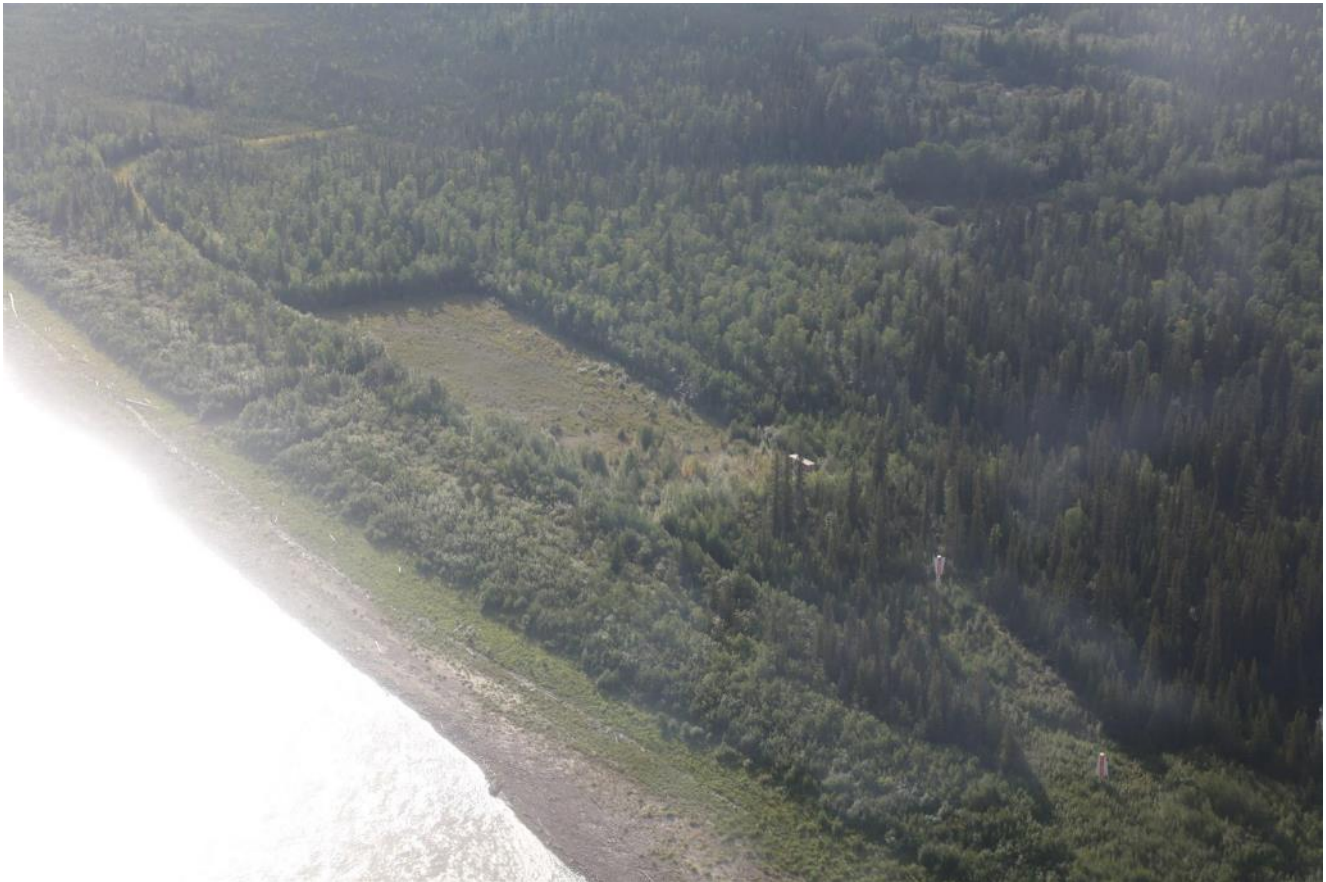
**Photo B.12 I-78 Staging Area: Overview**

**NOTE:** Overview of the Staging Area and surrounding area showing overall terrain, water, and vegetation conditions (August 20, 2020).

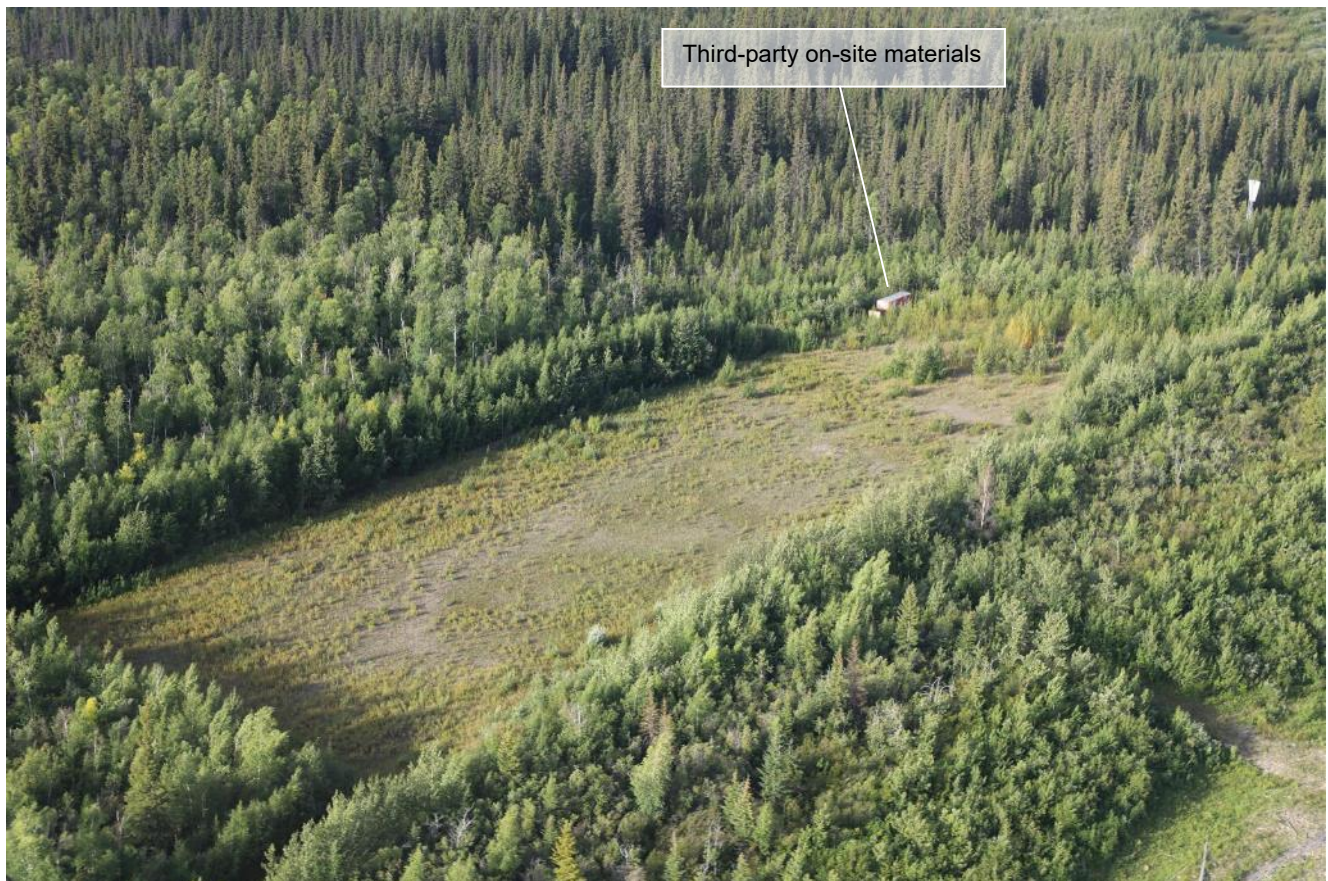
**Photo B.13 I-78 Staging Area: Overview**

**NOTE:** Overview showing the overall ground and vegetation conditions and location of the third-party on-site materials (August 20, 2020).

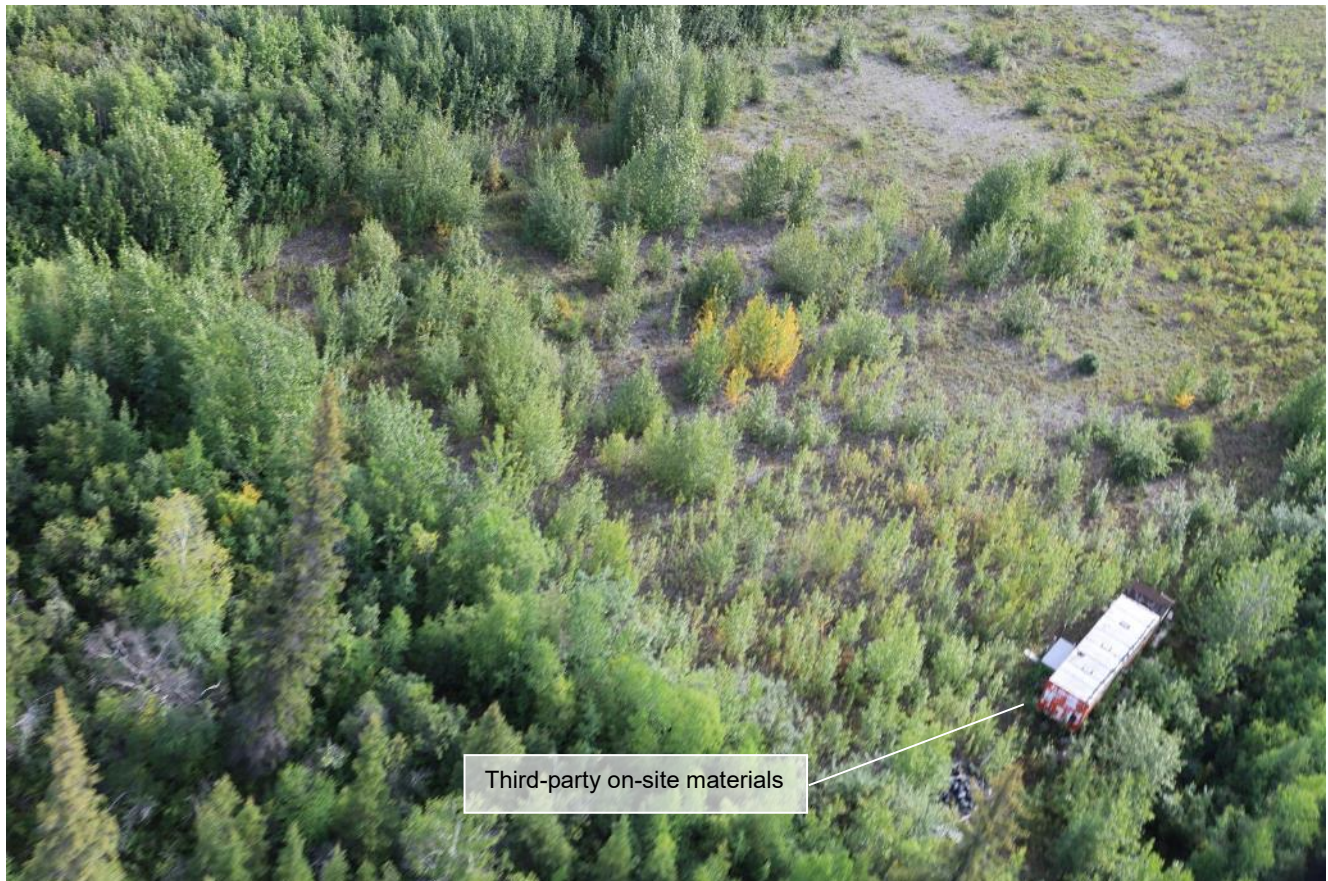
**Photo B.14** I-78 Staging Area: On-Site Materials

**NOTE:** Aerial overview of the Staging Area showing third-party trailer, outbuildings, and debris located in the southwest corner of the Staging Area.

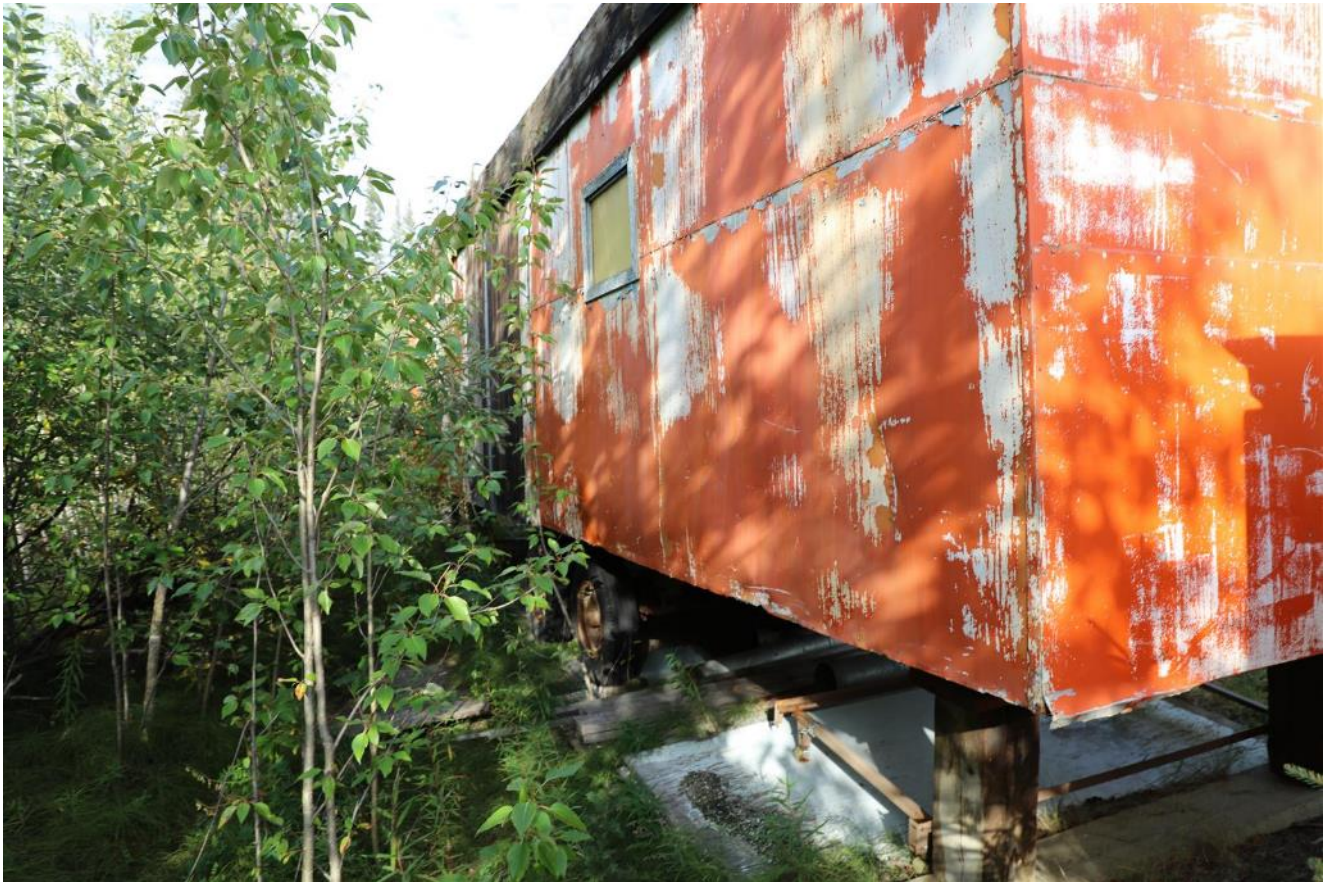
**Photo B.15** I-78 Staging Area: On-Site Materials

NOTE: Third-party trailer and outbuilding located in the southwest corner of the Staging Area.

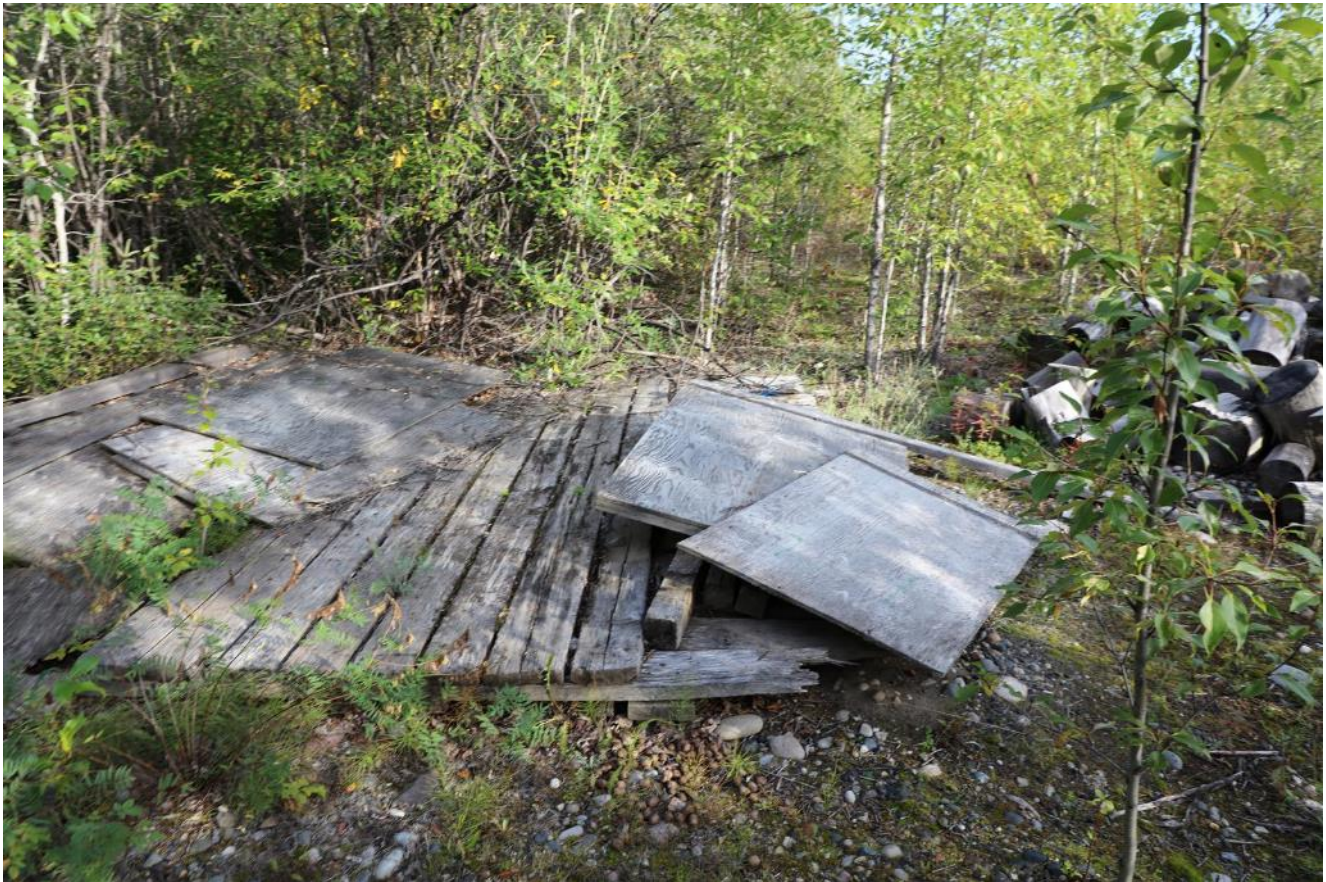
**Photo B.16** I-78 Staging Area: On-Site Materials

NOTE: Third-party debris located in the southwest corner of the Staging Area.

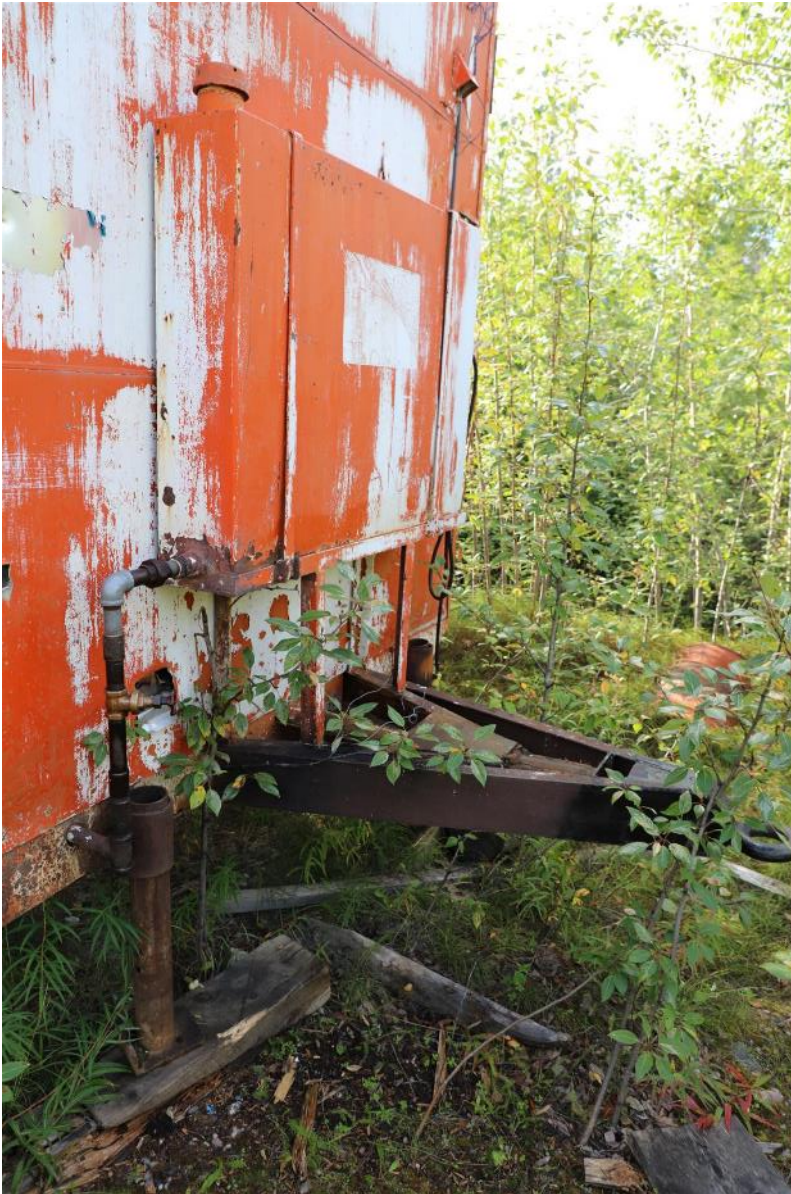
**Photo B.17** I-78 Staging Area: On-Site Materials

**NOTE:** Observed fuel oil/kerosene tank with slight leak on trailer located in the southwest corner of the Staging Area.

Parameters	Qualitative Monitoring Observations and Results	Recommendations for 2021
Soils	<p><b>Wellsite Area:</b></p> <ul style="list-style-type: none"> <li>Soil samples were not collected during the site visit.</li> <li>No evidence of soil contaminants such as sheen, surface staining, or surface crusts were observed at the Wellsite Area.</li> </ul> <p><b>Staging Area:</b></p> <ul style="list-style-type: none"> <li>No soil samples were collected during the site visit.</li> <li>Surface staining (oily residue) on the ground below the kerosene/fuel tank found slightly leaking. The fuel tank is associated with the third-party trailer located in the southwest corner of the site.</li> </ul>	<p><b>Wellsite Area:</b></p> <ul style="list-style-type: none"> <li>Soil sample collection in 2021 at the wellhead area for PHCs, metals and extractable barium to laterally delineate previously reported exceedances.</li> <li>Remediation recommended when the wellhead is cut, capped and abandoned.</li> </ul> <p><b>Staging Area:</b></p> <ul style="list-style-type: none"> <li>Soil sampling for PHCs to confirm and delineate the surface staining associated with the fuel tank recommended once leak is fixed.</li> </ul>

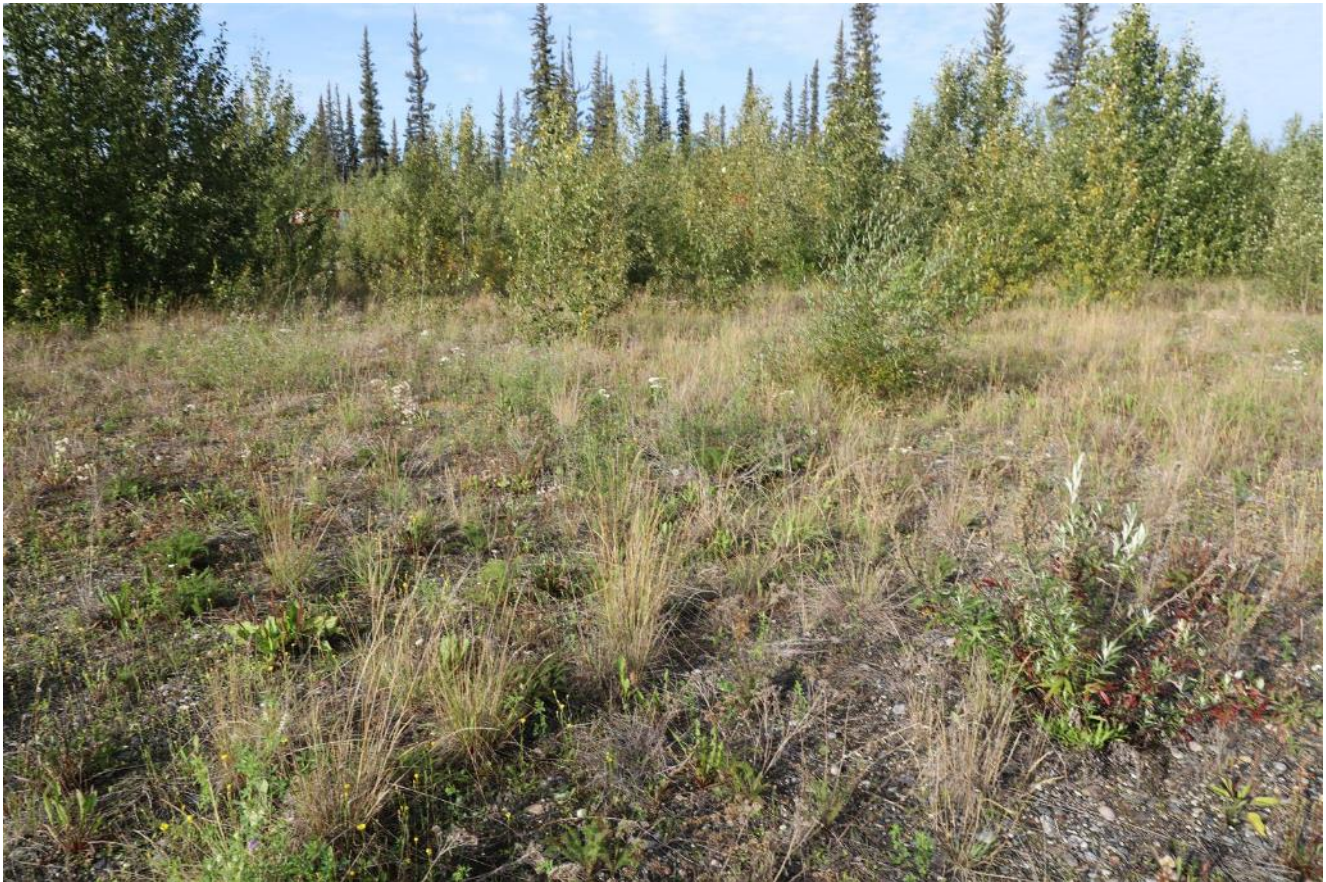
**Photo B.18** I-78 Staging Area

**NOTE:** View of ground and vegetation conditions in the west end of the Staging Area looking west. West end of Staging Area has naturally revegetated with native trees, shrubs and forbs. Vegetation cover in the west end was meeting permit requirements (>70% cover, healthy conditions) (August 20, 2020).

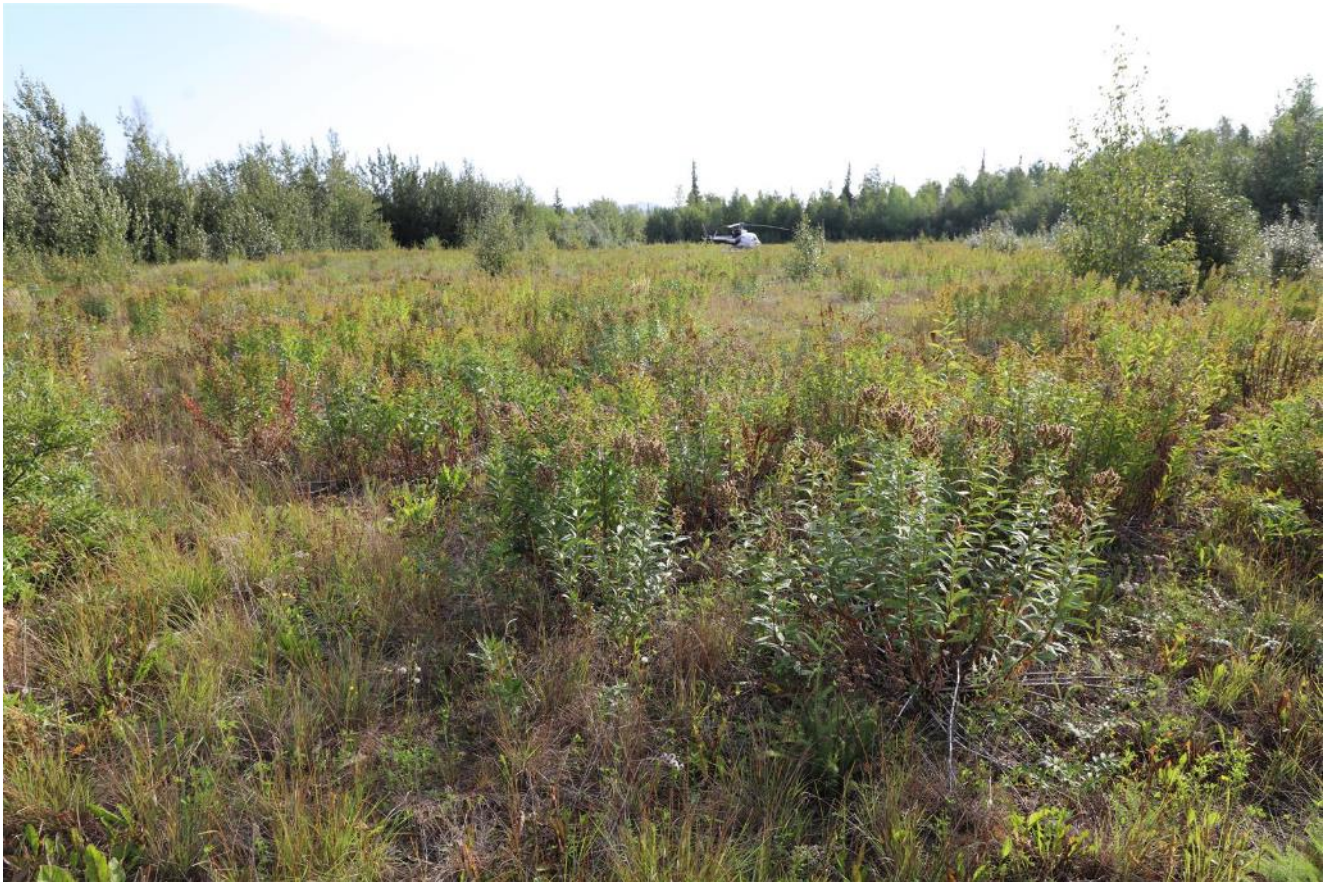
**Photo B.19** I-78 Staging Area

**NOTE:** View of ground and vegetation conditions in the east portion of the Staging Area looking east. East portion has revegetated with seeded agronomic legumes and grasses and naturally established native trees, shrubs, and forbs. Vegetation cover in the east portion was approximately 55% to 70% cover and appeared healthy (August 20, 2020).
