To: MGM Energy  
2800, 421-7 Avenue SW  
Calgary, AB T2P 4K9  
File: 123513469

From: Sarah Zembiak, Project Manager  
Kālo Stantec Ltd.  
Tulita, NT, Canada X0E 0T0  
Date: December 1, 2020

**Reference: 2020 Environmental Site Monitoring Report: East Mackay I-78 Wellsite Area and Staging Area**

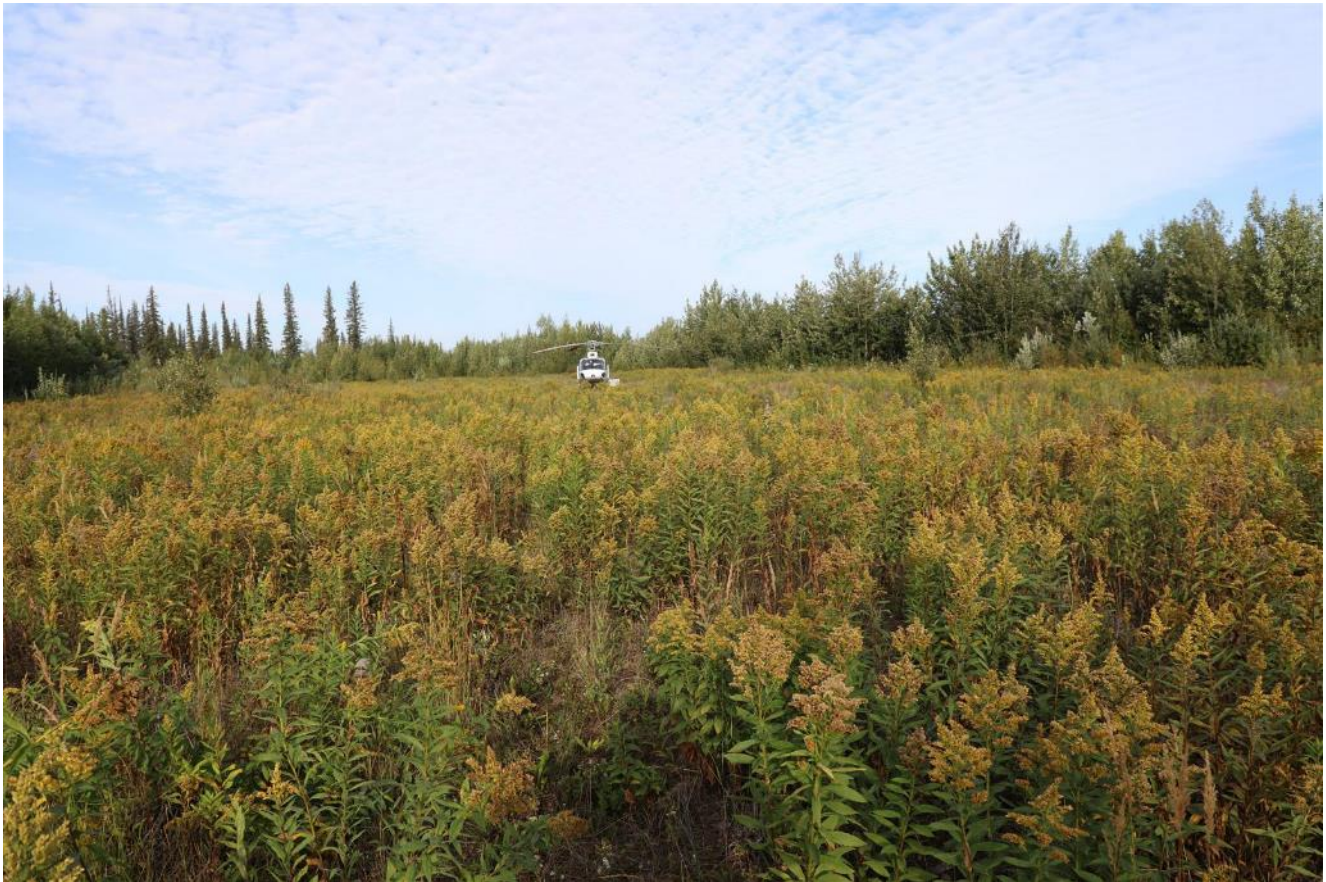
**Photo B.20 I-78 Staging Area**

**NOTE:** View of ground and vegetation conditions in the east portion of the Staging Area looking west. East portion has revegetated with seeded agronomic legumes and grasses and naturally established native trees, shrubs, and forbs. Vegetation cover in the east portion was approximately 55% to 70% cover and appeared healthy (August 20, 2020).
