**To:** MGM Energy2800, 421 - 7 Avenue SW
Calgary, AB T2P 4K9**File:** 123514551**From:** James Hymers, Project Manager
K'alo-Stantec Ltd.

Date: January 22, 2024

Reference: 2023 Environmental Site Monitoring Report: East Mackay I-78 Wellsite Area and Staging Area

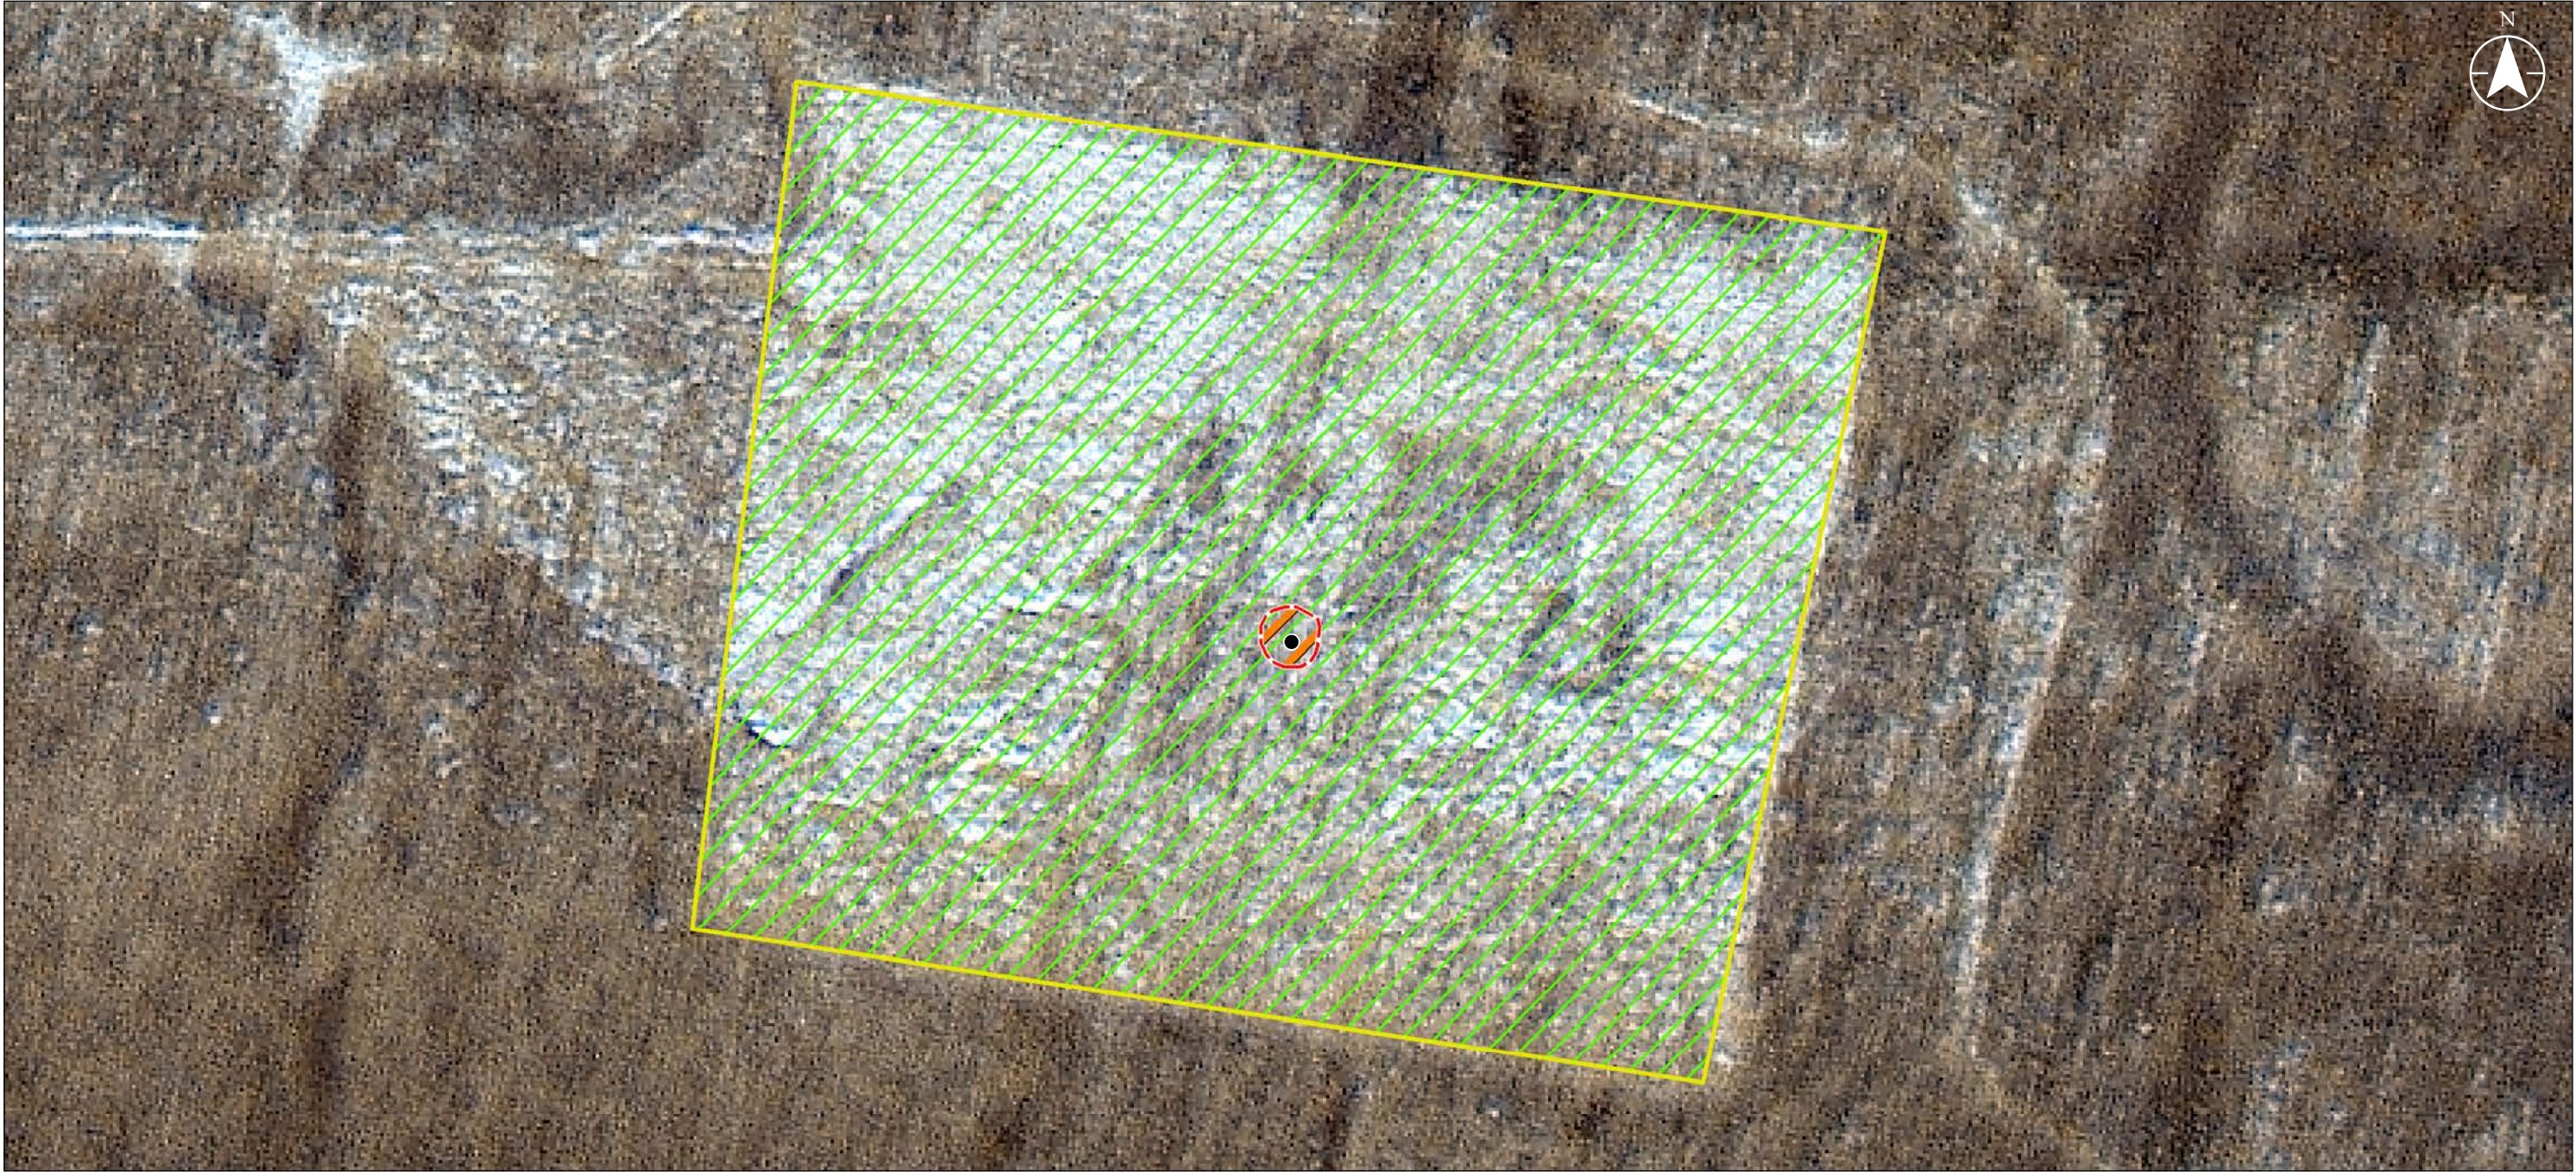
Figure No.
A.3

*Wildfire was actively burning in the Wellsite Area at the time of the 2023 site visit. Approximately 50 percent of the area was completely burned/damaged.

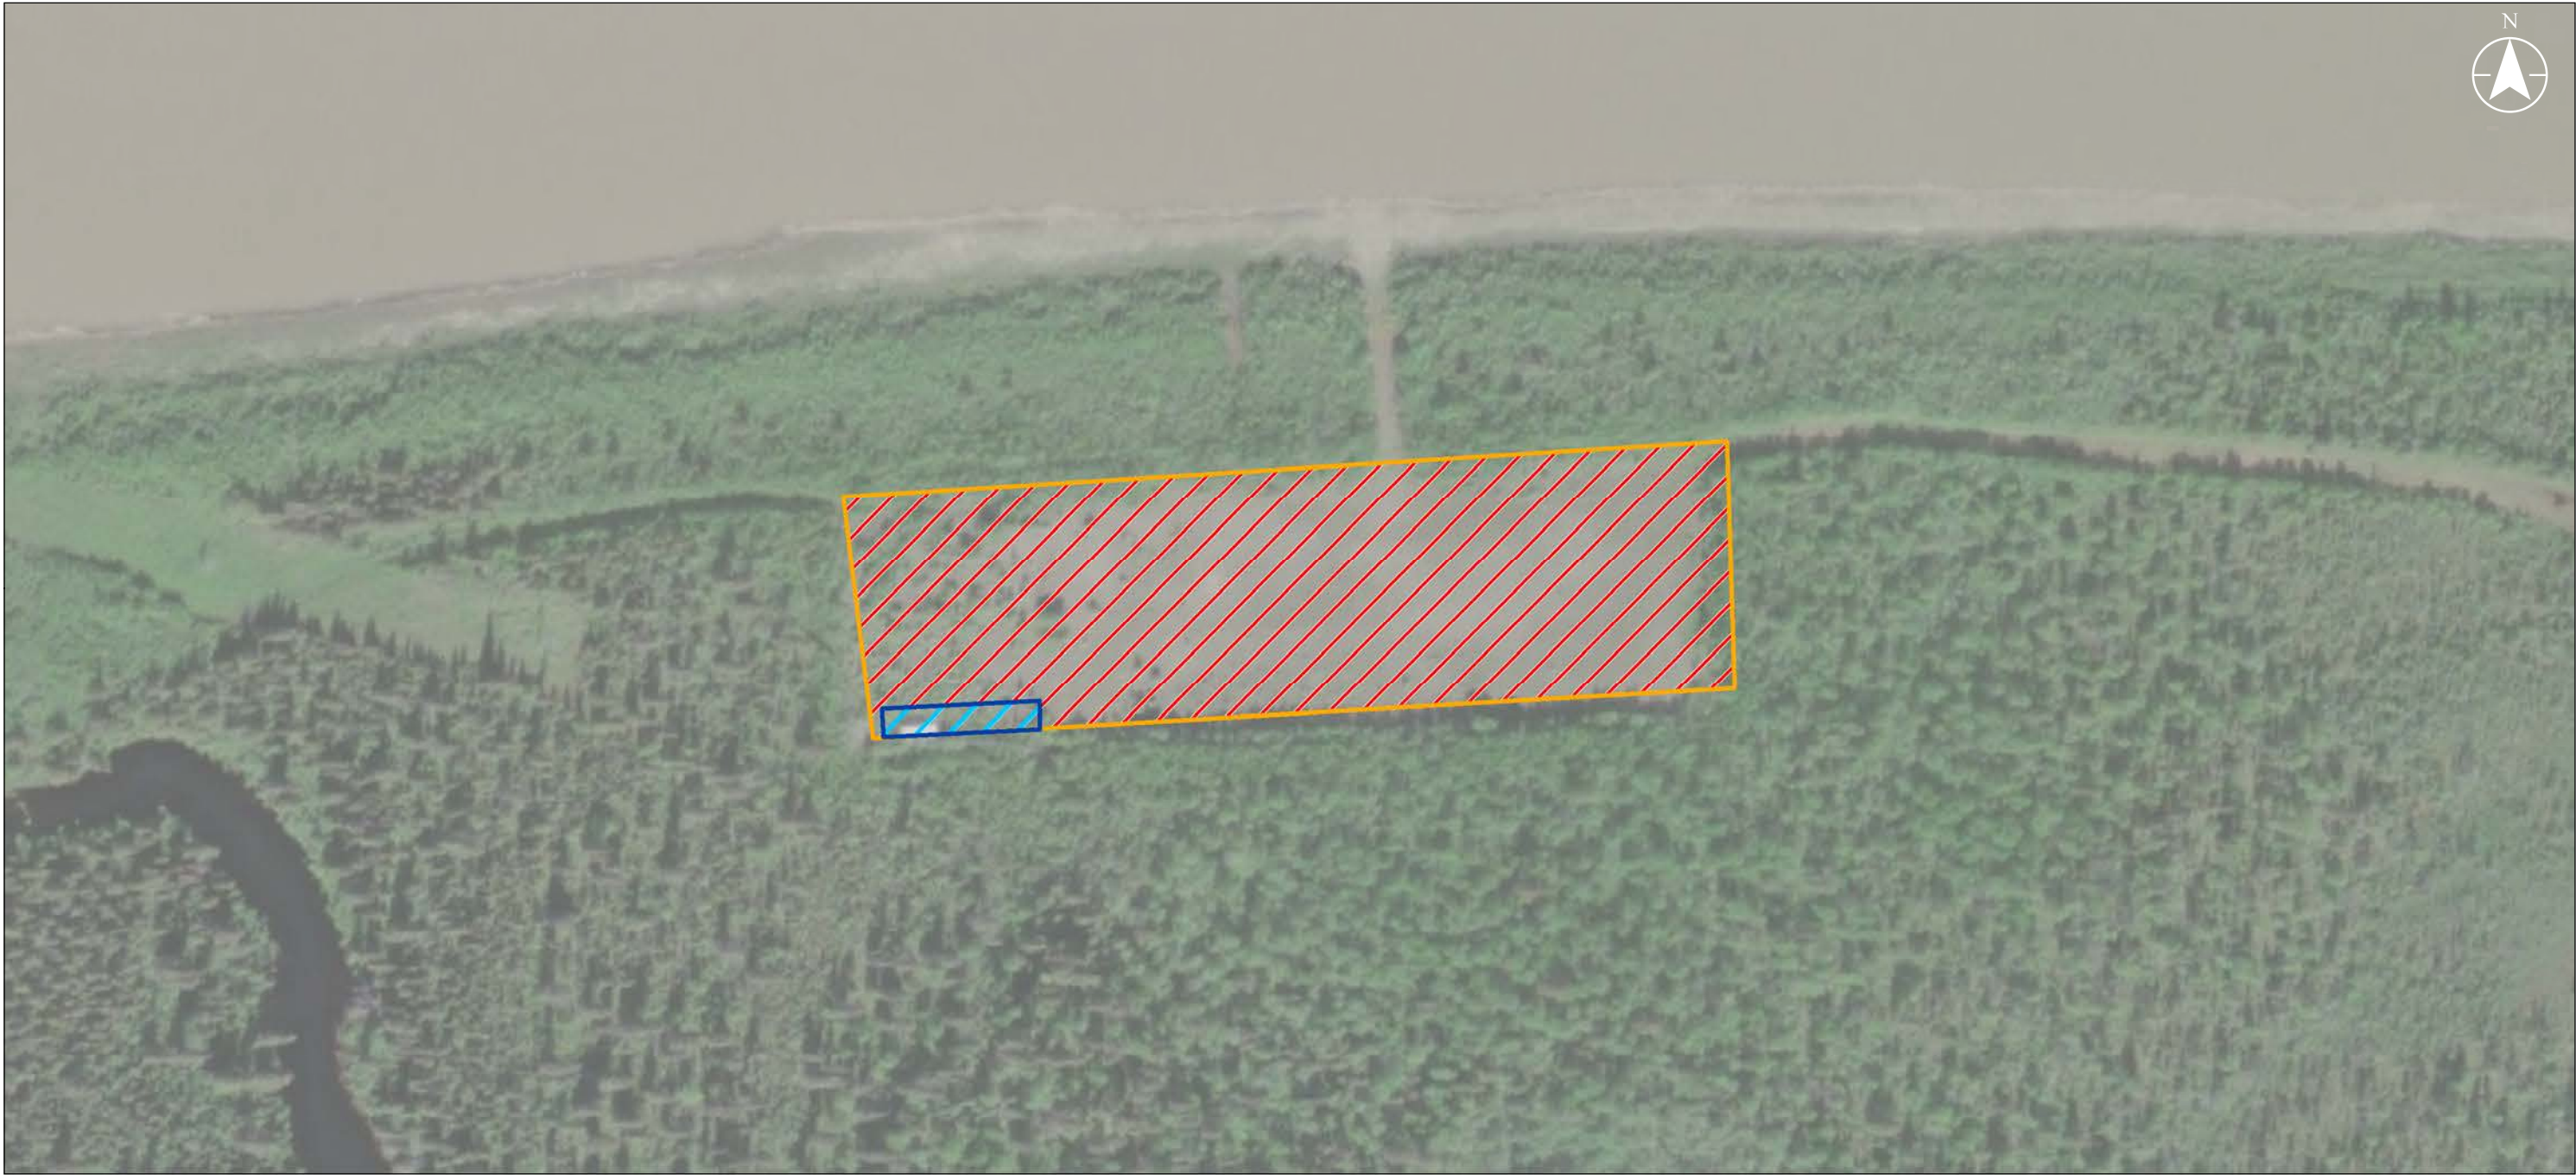
Figure No.
A.4

Area containing third-party construction trailer, outbuildings and debris
-

Further Treatment Required - Defer reclamation treatments. Monitoring only
-

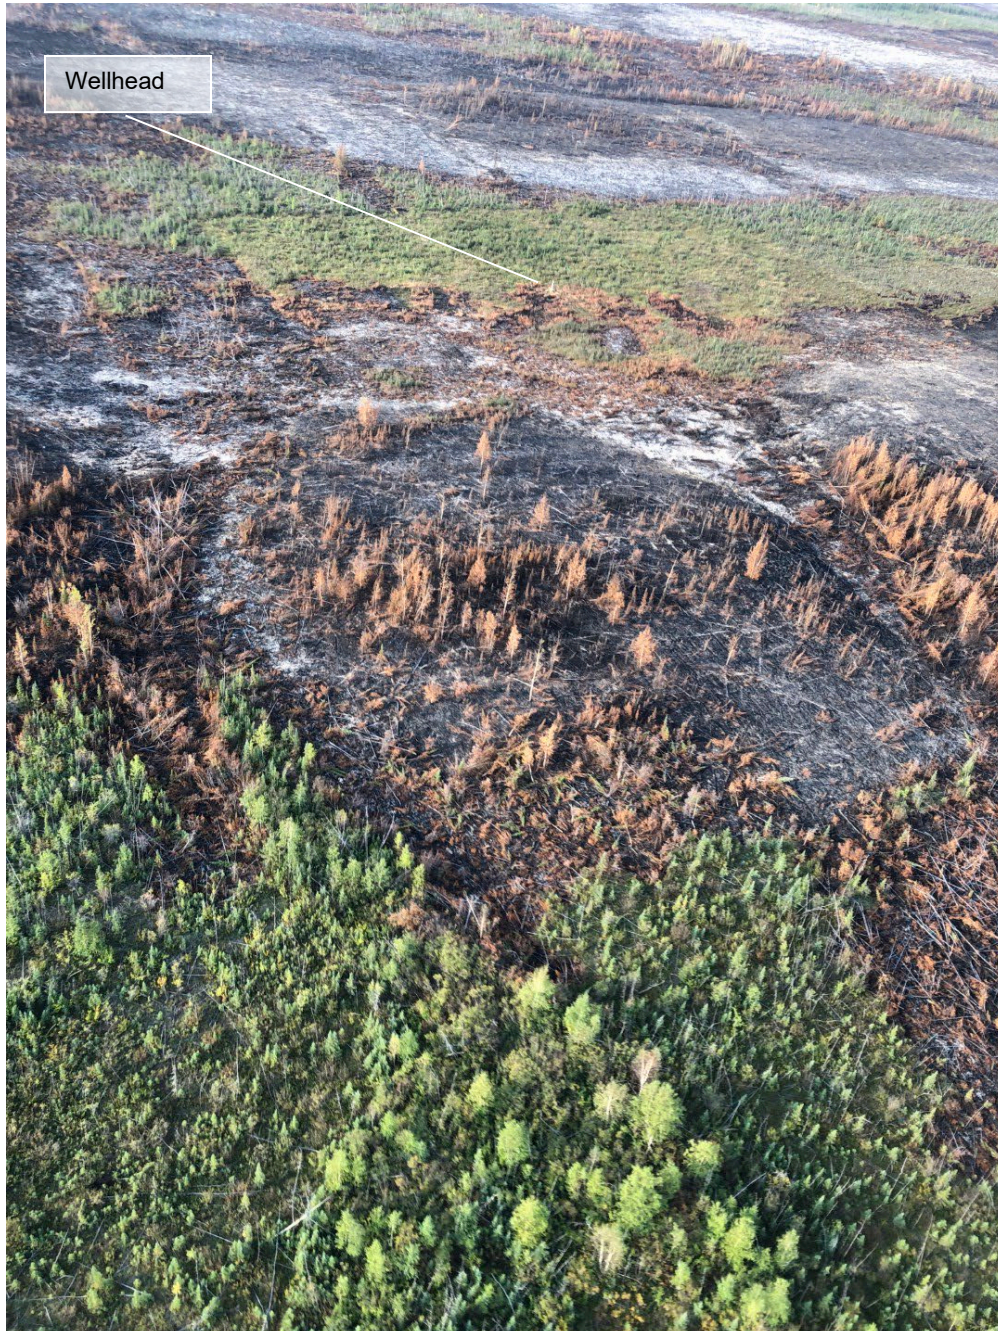
Photo B.1 I-78 Wellsite Area: Overview

^b At the time of the 2023 site visit, a wildfire was actively burning in the Wellsite Area. Vegetation in approximately 50% of the area was burned/damaged (Attachment B: Photo B.1). The remaining vegetation cover appeared to be in good condition.

Note: Overview of the Wellsite Area and surrounding area (facing north) showing overall terrain and vegetation conditions (August 30, 2023). A wildfire was actively smoldering at the time of 2023 site visit. Note extent of burned vegetation cover in the Wellsite Area.

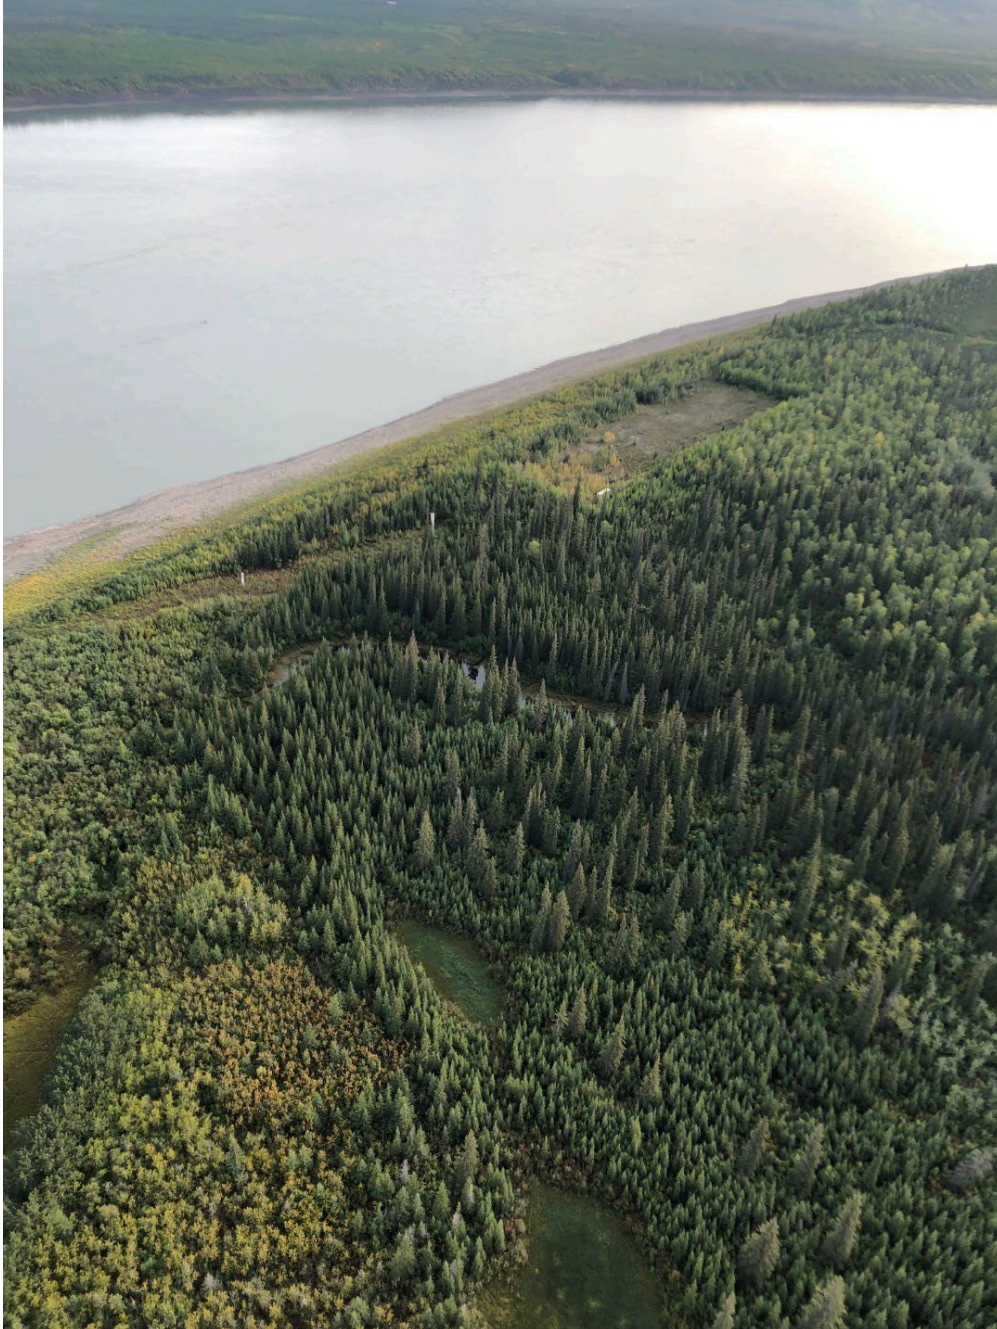
Photo B.2 I-78 Staging Area: Overview

Note: Overview of the Staging Area and surrounding area (facing northeast) showing overall terrain, water, and vegetation conditions (August 30, 2023).

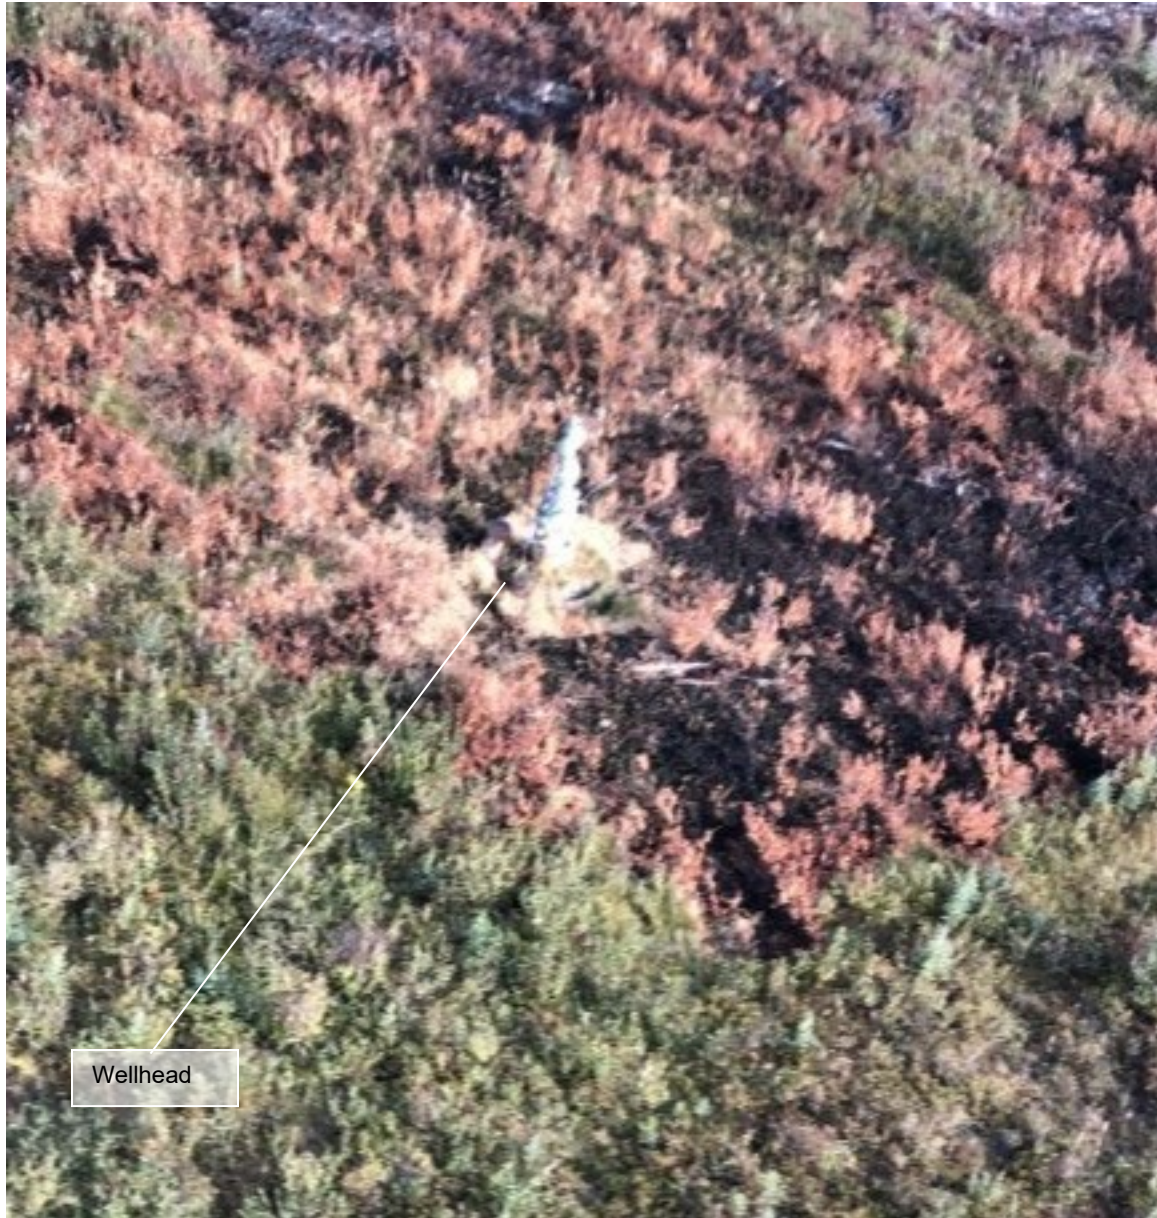
Photo B.3 I-78 Wellsite Area: On-Site Materials

^a A wellhead was still present on the Site. It appeared to be in acceptable condition, as per permit requirements, at the time of the site visit.

Note: Aerial view of on-site materials (facing north) showing the wellhead (August 30, 2023). Note the wildfire had burned vegetation immediately adjacent to the wellhead approximately 1 to 2 m away from the wellhead.

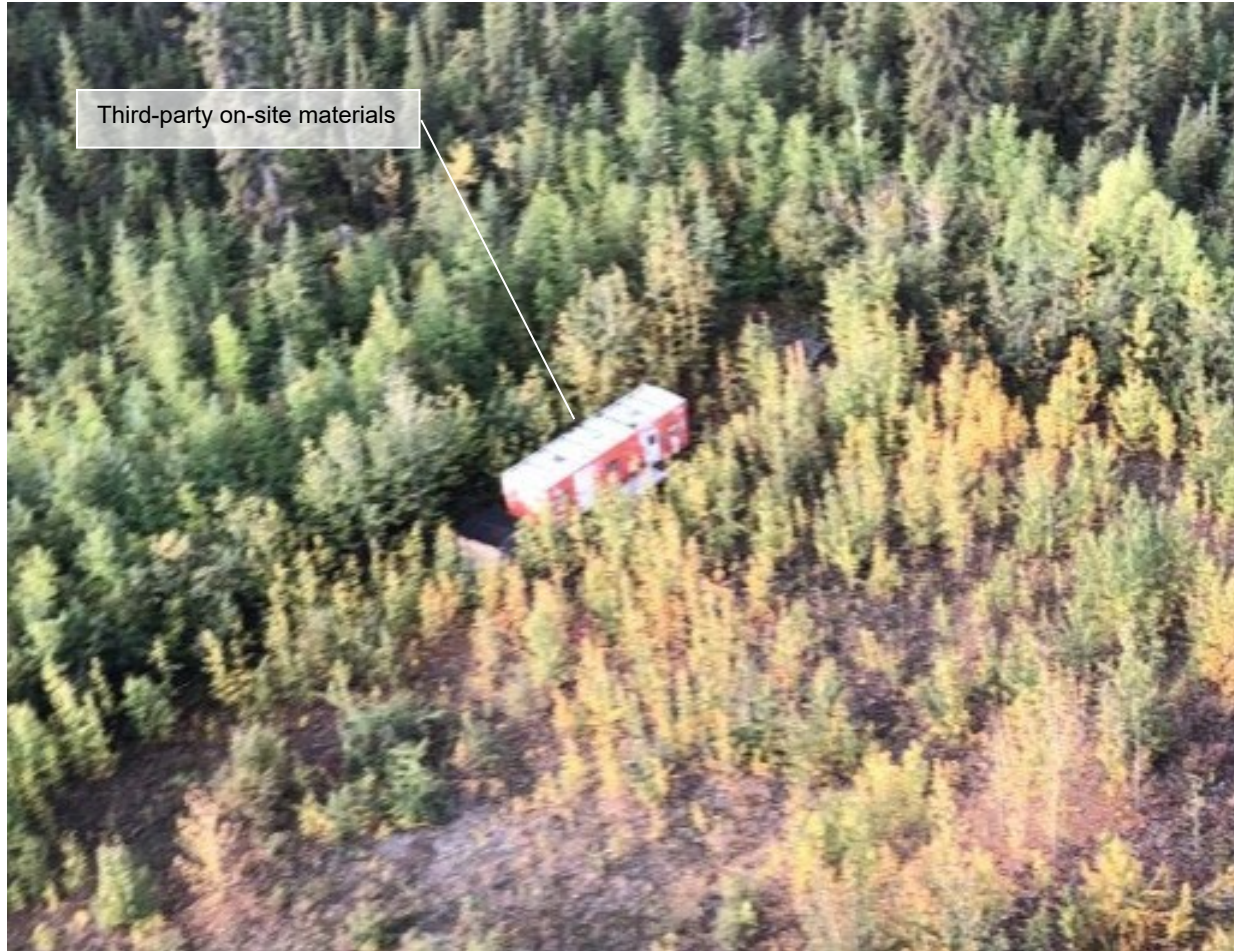
Photo B.4 I-78 Staging Area: Third-Party On-Site Materials

Note: Overview facing southwest at the Staging Area showing third-party trailer, outbuildings, and debris located in the southwest corner of the Staging Area (August 30, 2023).

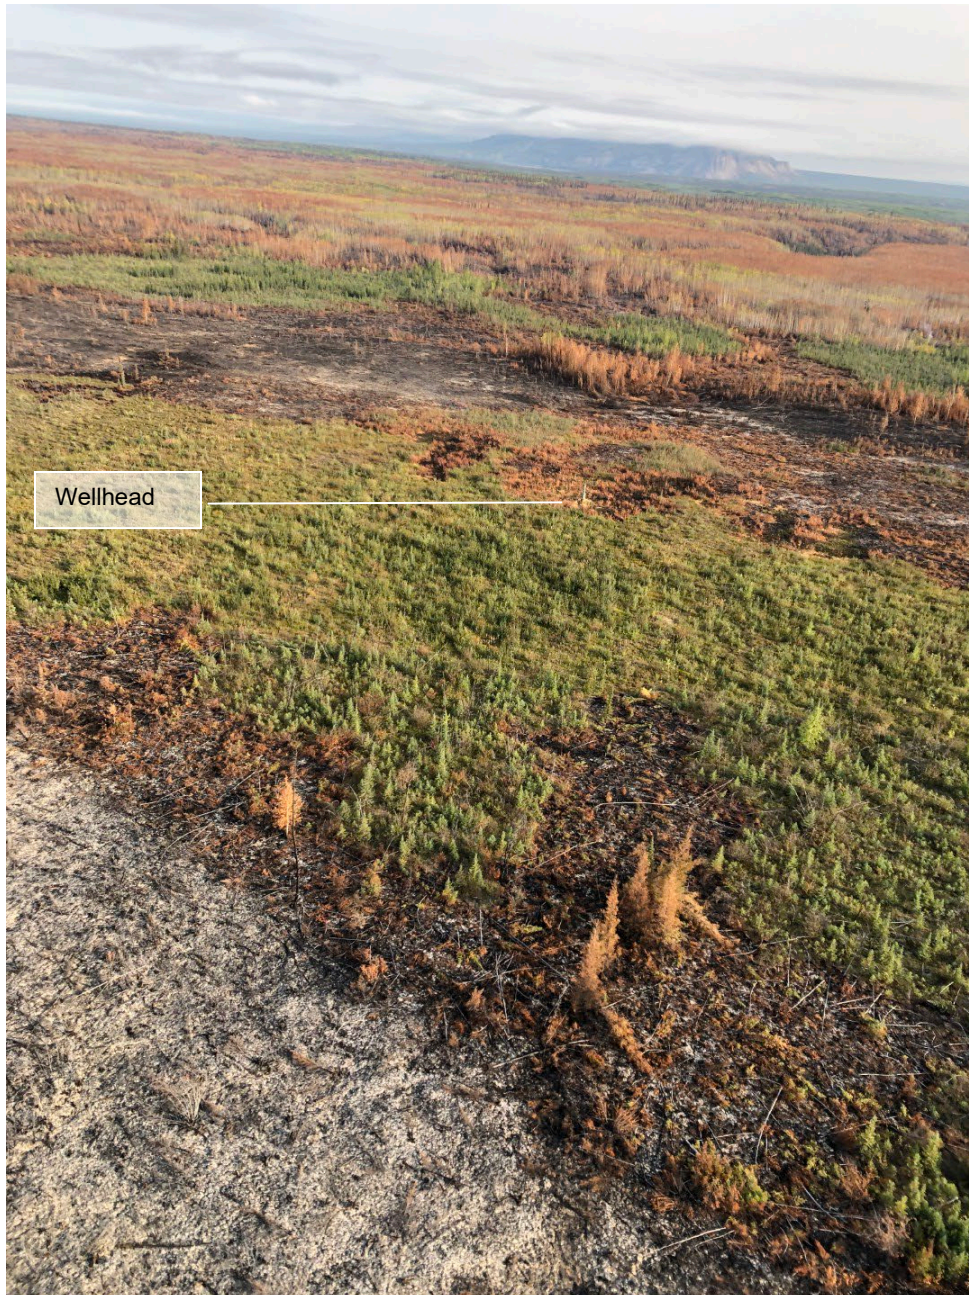
Photo B.5 I-78 Wellsite Area: Vegetation Cover

Parameters	Qualitative Monitoring Observations and Results	Soil and Water Analytical Results (if exceedances)	Future Recommended Work
Vegetation	<p>Wellsite Area (Attachment A: Figure A.3; Attachment B: Photo B.5 and Photo B.6):</p> <ul style="list-style-type: none"> The Wellsite Area had revegetated with naturally established trees, shrubs, and forbs. At the time of the site visit, a wildfire was actively burning in the Wellsite Area. The vegetation in approximately 50% of the area was completely burned/damaged. The vegetation in the remaining unburned sections appeared in healthy condition and had approximately 95% cover. Overall, vegetation cover was not meeting permit requirements (i.e., did not meet >70% cover and healthy condition) due to the wildfire burning a large portion of the pre-existing vegetation cover. Prior to the wildfire occurring, the Wellsite Area had revegetated very well, and had 95% cover of naturally established trees, shrubs, and forbs in healthy condition. No invasive plants/weeds were observed within the Site during the site visit. 	<ul style="list-style-type: none"> Not applicable for this parameter. 	<p>Wellsite Area:</p> <ul style="list-style-type: none"> No reclamation treatments recommended until the wellhead is cut, capped, and abandoned. Reconnaissance level vegetation monitoring only at the Site to assess growth and establishment of vegetation.

Note: Aerial view facing northwest of the ground and vegetation conditions in the Wellsite Area. Wellsite Area had previously revegetated with naturally established trees, shrubs, and forbs. At the time of the site visit, a wildfire was actively burning in the Wellsite Area. The vegetation in approximately 50% of the area was completely burned/damaged. The vegetation cover in the remaining unburned sections appeared to be in healthy condition and had approximately 95% cover. Overall, vegetation cover was not meeting the permit requirements (i.e., did not meet >70% cover and healthy condition) due to the wildfire (August 30, 2023).

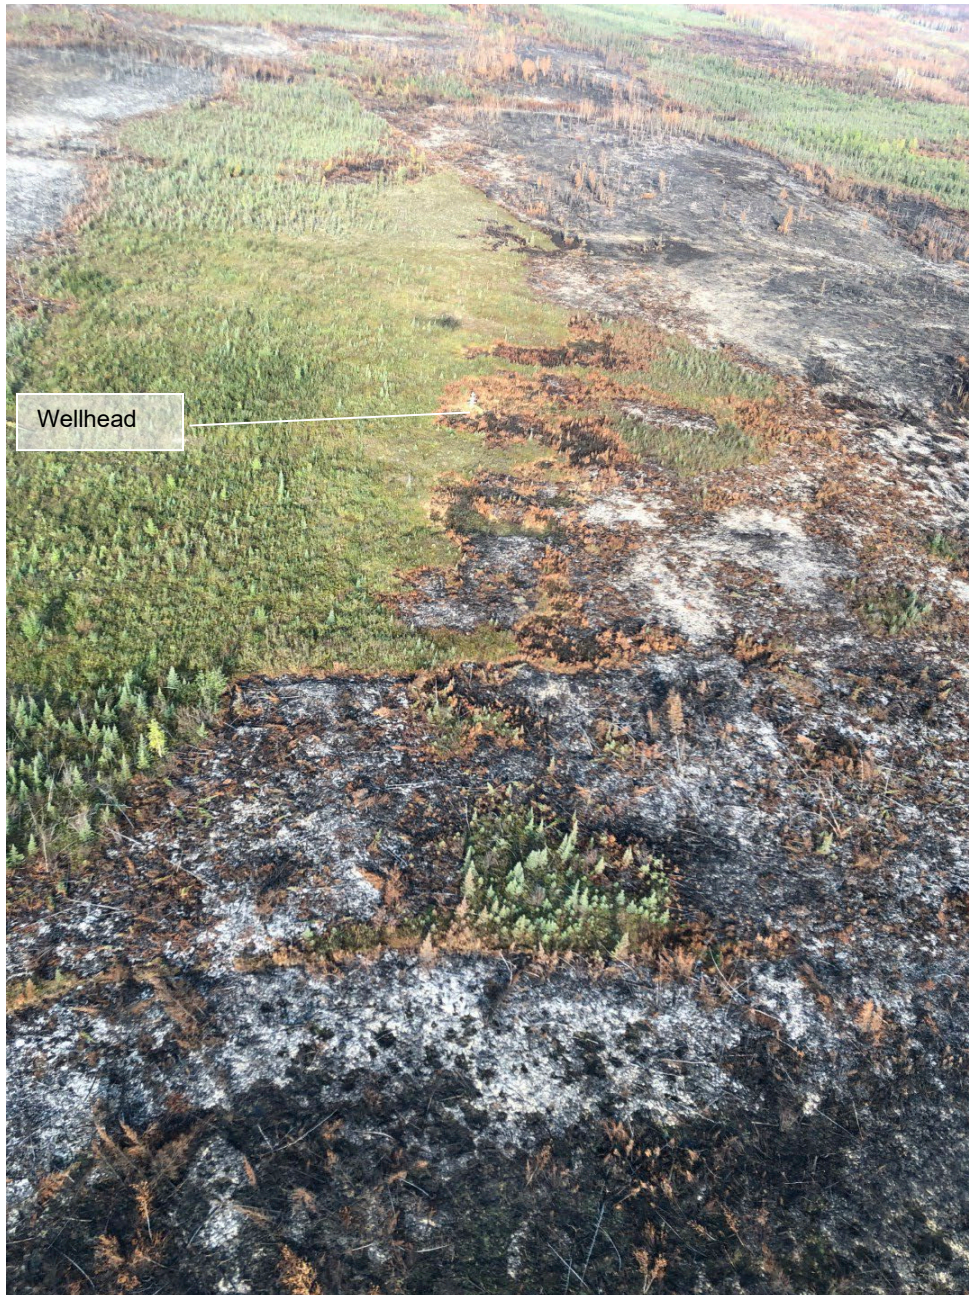
Photo B.6 I-78 Wellsite Area: Vegetation Cover

Note: Aerial view facing southeast of the ground and vegetation conditions in the Wellsite Area. The Wellsite Area had previously revegetated with naturally established trees, shrubs, and forbs. At the time of the site visit, a wildfire was actively burning in the Wellsite Area. The vegetation in approximately 50% of the area was completely burned/damaged. The vegetation cover in the remaining unburned sections appeared to be in healthy condition and had approximately 95% cover. Overall, vegetation cover was not meeting permit requirements (i.e., did not meet >70% cover and healthy condition) due to the wildfire (August 30, 2023).

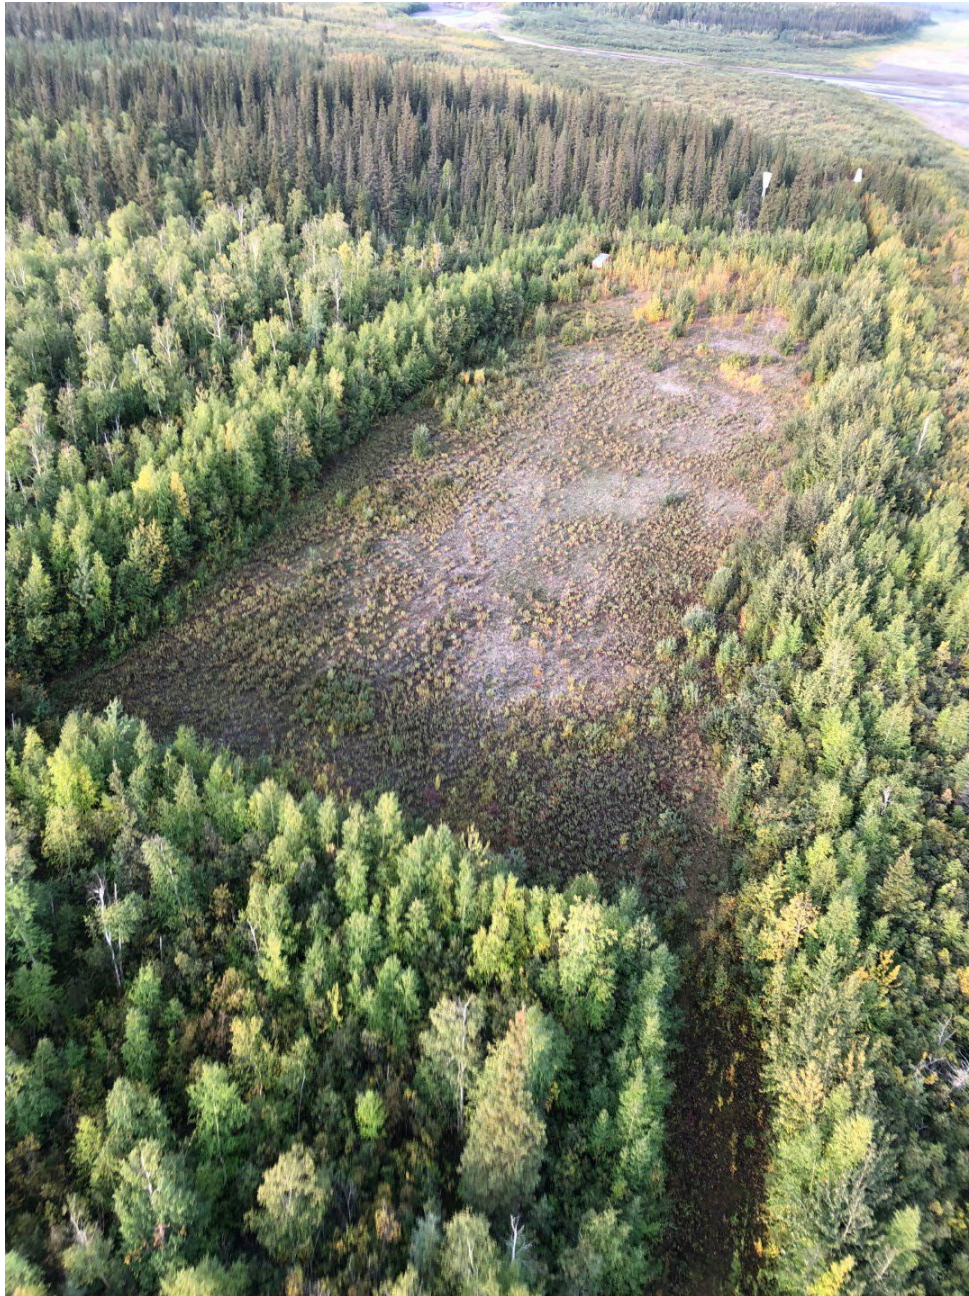
Photo B.7 I-78 Staging Area: Vegetation Cover

Parameters	Qualitative Monitoring Observations and Results	Soil and Water Analytical Results (if exceedances)	Future Recommended Work
Vegetation (cont'd)	<p>Staging Area (Attachment A: Figure A.4; Attachment B: Photo B.7):</p> <ul style="list-style-type: none"> West end of Staging Area was naturally revegetated with trees, shrubs, and forbs (Attachment B: Photo B.8). Vegetation cover met the permit requirements (i.e., >70% cover and healthy condition). Central and east sections had revegetated with seeded agronomic grasses and legumes and naturally established trees, shrubs, and forbs (Attachment B: Photo B.9). <ul style="list-style-type: none"> Vegetation cover in the central and east portion of the Staging Area had approximately 65% to 70% cover. Vegetation appeared healthy and no health issues were observed. Overall, vegetation cover in the central and east sections met the land use permit conditions for vegetation health but did not meet the permit requirements for vegetation cover (i.e., had <70% cover). No invasive plants/weeds were observed within the Staging Area during the site visit. 	<ul style="list-style-type: none"> Not applicable for this parameter. 	<p>Staging Area:</p> <ul style="list-style-type: none"> No reclamation treatments recommended at this time. Defer reclamation treatments until the third-party use of the Staging Area and responsibility for site reclamation is resolved with the GNWT regulators. Monitor for invasive plants in previously identified infestation locations⁷. <ul style="list-style-type: none"> Carry out invasive plant/weed control treatments if infestations reach a density that prohibits vegetation establishment and growth, including pulling plants, storing in garbage bags, and disposing off-site at an approved facility.

Note: View of vegetation conditions in the Staging Area (facing west). The west section of the Staging Area was naturally revegetated with trees, shrubs and forbs; central and east sections had revegetated with seeded agronomic legumes and grasses and naturally established trees, shrubs, and forbs (August 30, 2023). The vegetation cover in the west section met the permit requirements (i.e., >70% cover and healthy condition). The vegetation cover in the central and east sections met the land use permit conditions for vegetation health but not for vegetation cover (i.e., had <70% cover).

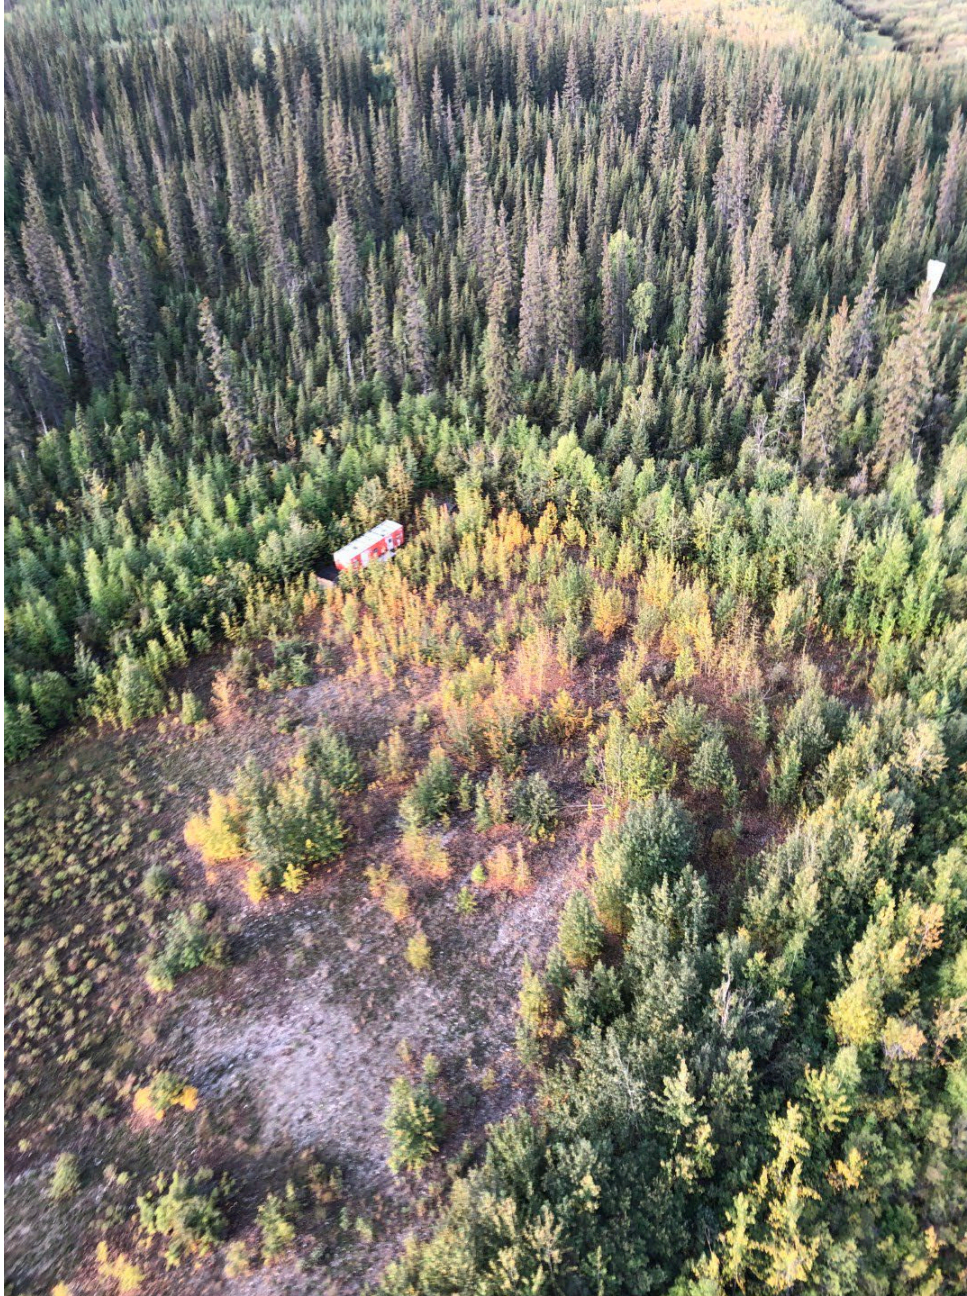
Photo B.8 I-78 Staging Area: Vegetation Cover

Note: View of ground and vegetation conditions in the west end of the Staging Area looking southwest. This portion of the Staging Area was naturally revegetated with trees, shrubs and forbs. The vegetation cover in the west end was meeting the permit requirements (i.e., >70% cover and healthy condition) (August 30, 2023).

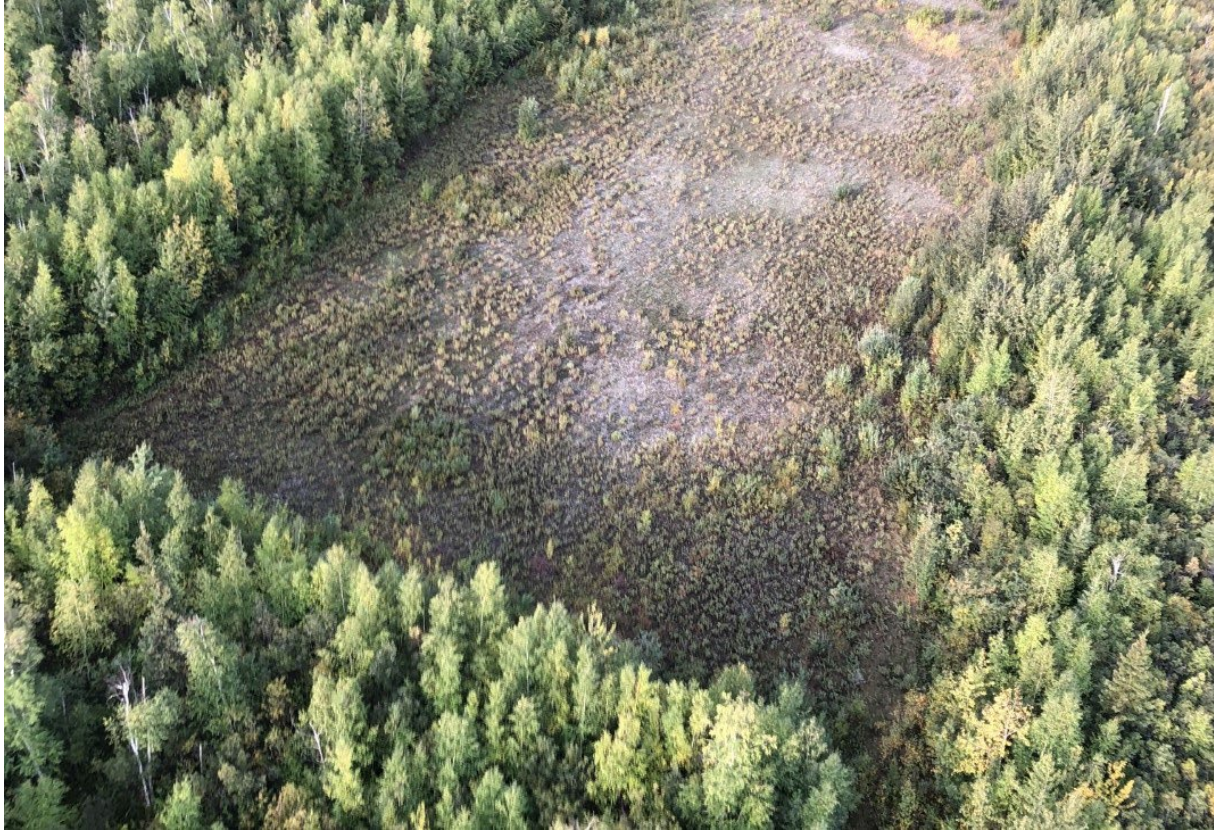
Photo B.9 I-78 Staging Area: Vegetation Cover

Note: View of ground and vegetation conditions in the central and east sections of the Staging Area looking southwest. These sections were revegetated with seeded agronomic legumes and grasses and naturally established trees, shrubs, and forbs. The vegetation cover in the east portion had approximately 65% to 70% cover and appeared healthy, but was not meeting the permit requirements for cover (i.e., had <70% cover) (August 30, 2023).
