**Report: Contact Lake Mine Remedial Action Plan with
Project Update**

CONTACT LAKE MINE REMEDIAL ACTION PLAN

March 2008

FINAL

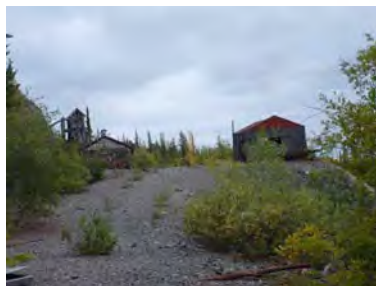
- Safety Hazard
- Visual attraction to site
- Some chemical hazards (lead paint, DDT, asbestos)

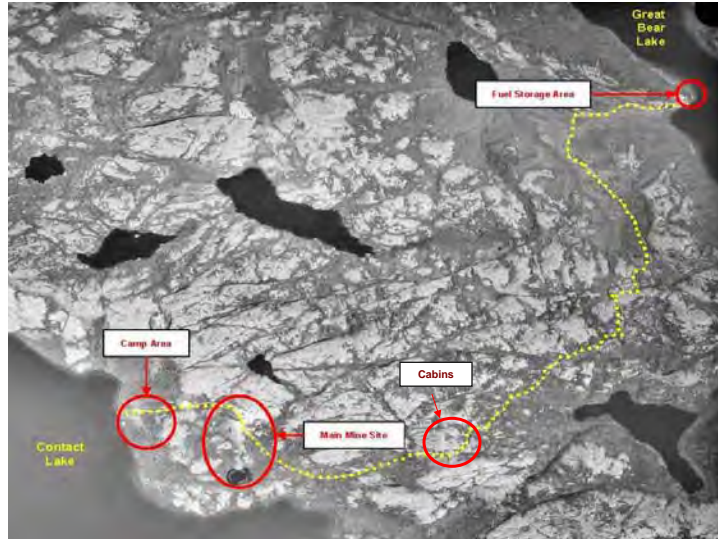
Roads – Existing Conditions

- Road connects mine and camp with fuel storage depot
- Roads are overgrown in many areas

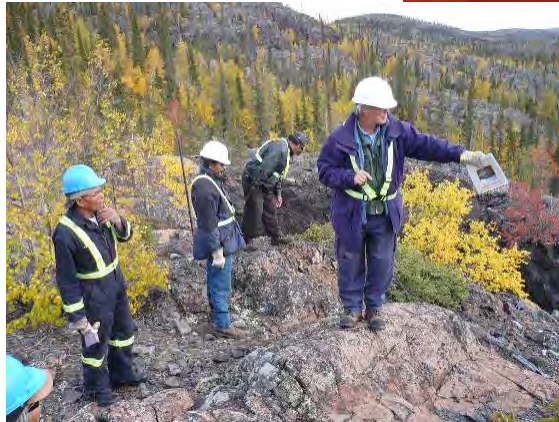
- Large opening
- Falling hazard

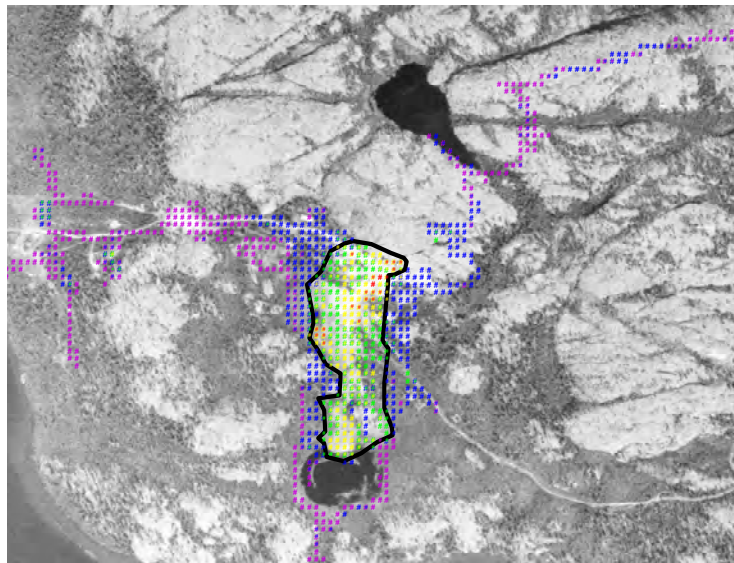
- Main Pile (26,000 m³ over 1.6 hectares)
- Slopes appear to be stable
- Limited leaching of metals (e.g. arsenic)
- Waste Rock (non-acid generating)
- The waste rock has elevated levels of gamma radiation – 200 m² averaged over 250 uR/h

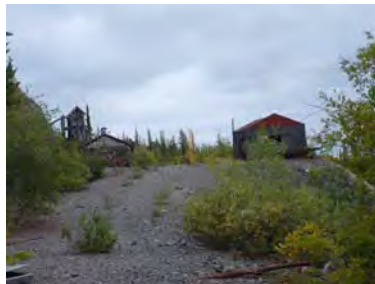
- Safety Hazard
- Visual attraction to site
- Some chemical hazards (lead paint, DDT, asbestos)

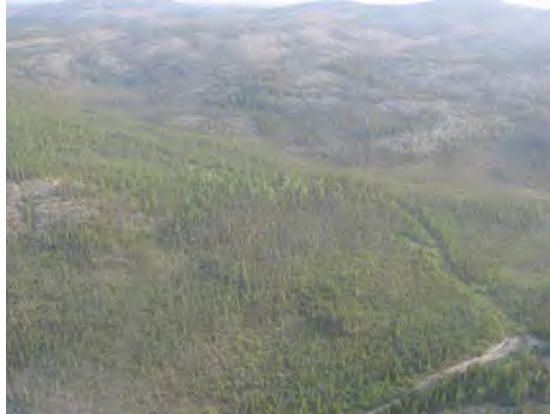
- Overgrown
- Minimal environmental impact

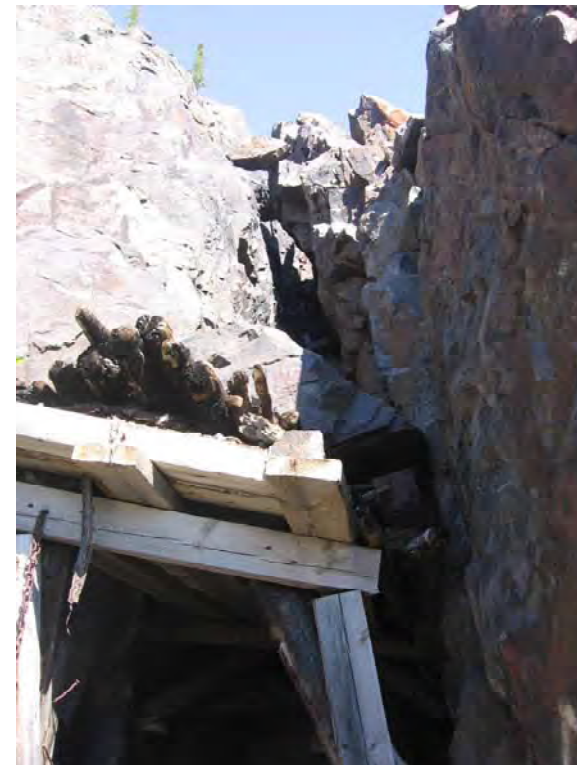
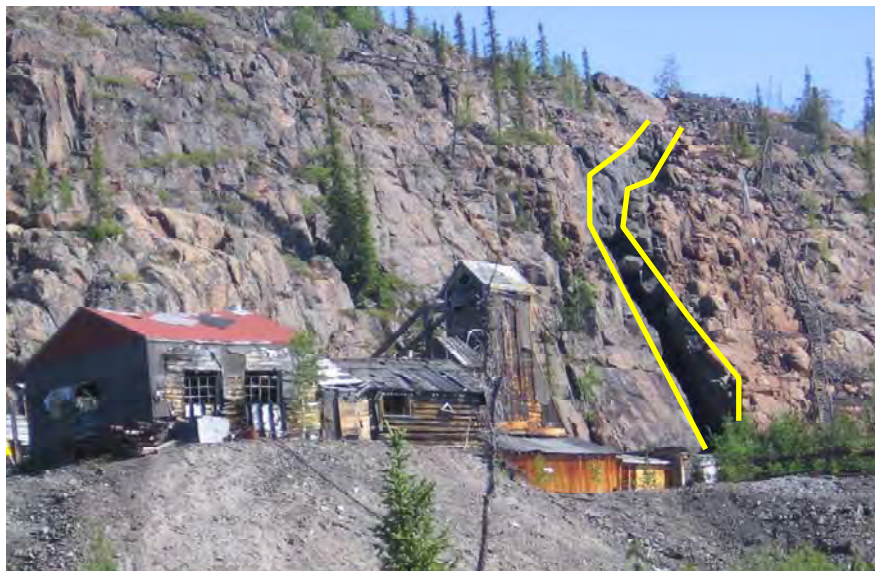
Stopeing in the 111 and 112 Stope Areas

Stopeing above the access adit.
Once timber support fails the will be limited further failure.

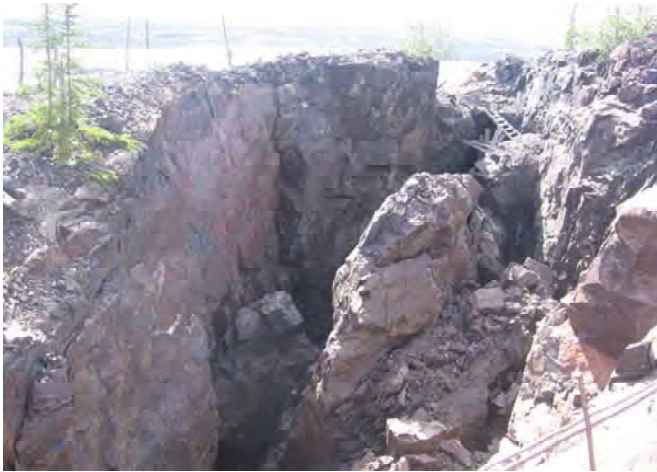
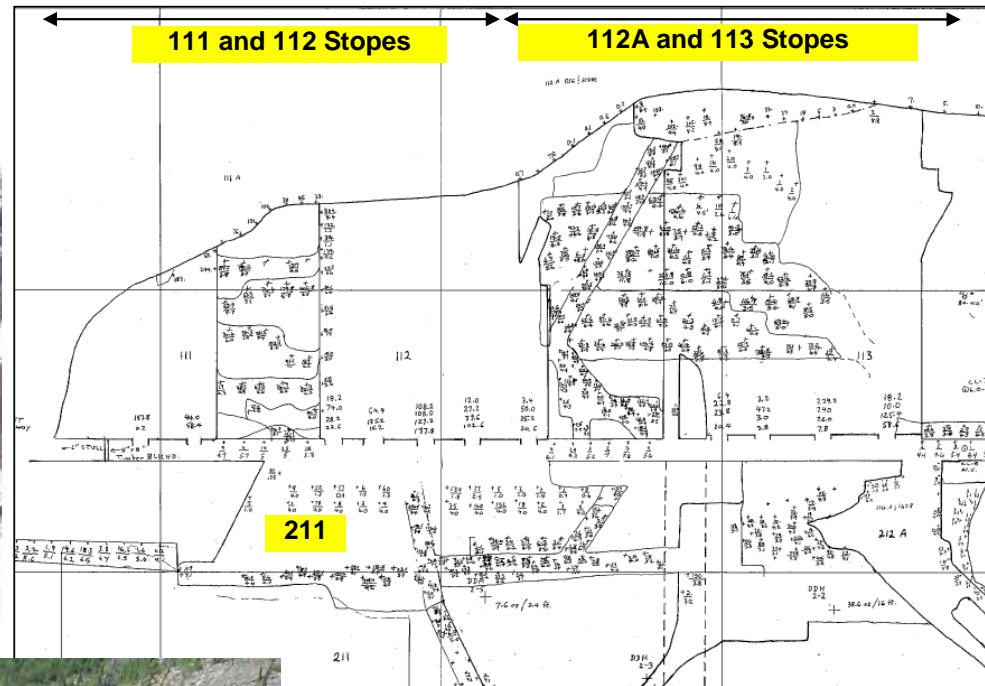
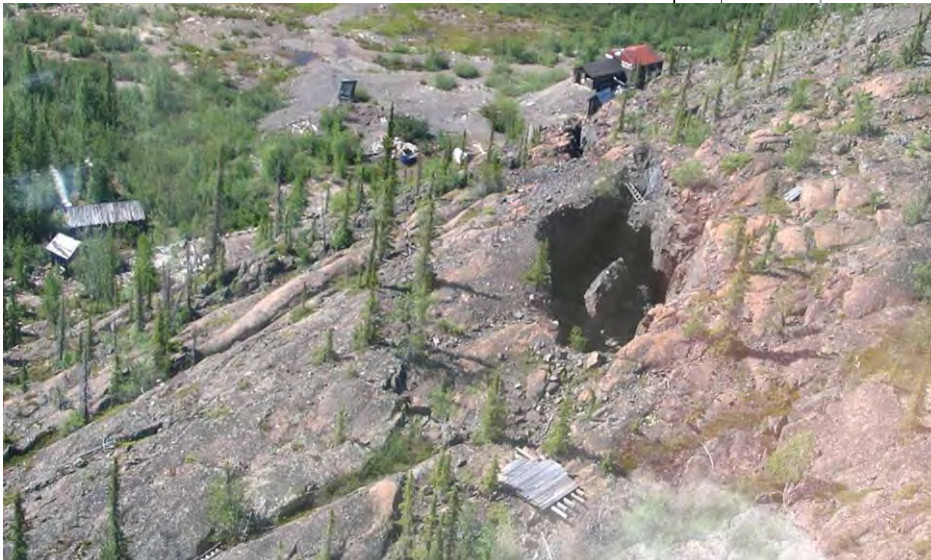
Stoping in the 112A and 113 Stope Areas

Stoping in the 112A and 113 was undertaken over substantially wider stopeing width than the 111 Stope Area. Larger stopes have led to a greater degree of break-back.

This is not expected to get much dramatically larger due to verticality and that the failed sidewall material is potentially stabilizing the stope

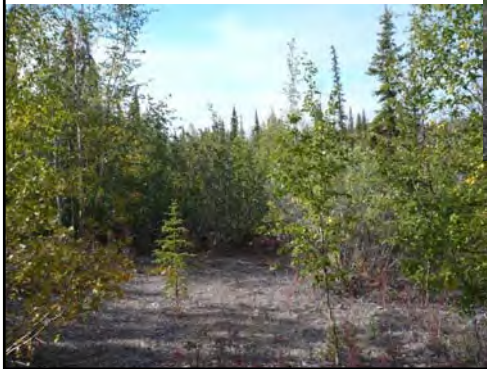
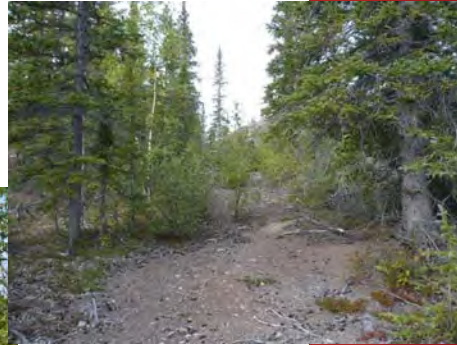
- Road connects former airstrip and El Bonanza and Bonanza Mines
- Roads are overgrown in many areas

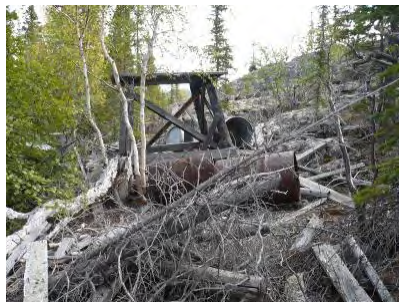
- Some elevated metals and hydrocarbons associated with dump areas
- Could be uptake of contaminants by wildlife and plants
- Physical hazard – could be injury to people and animals

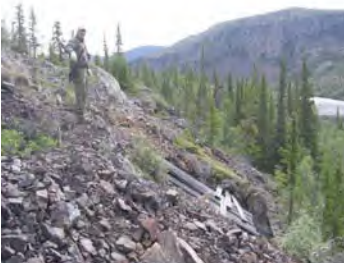
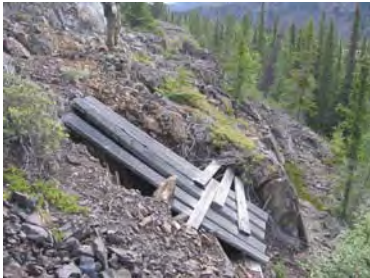
- Falling hazard
- Access is limited

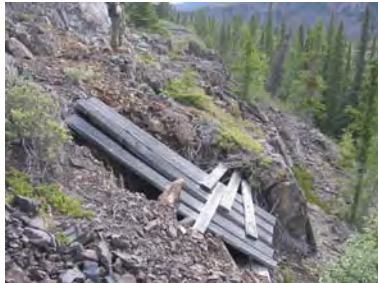
- Falling hazards

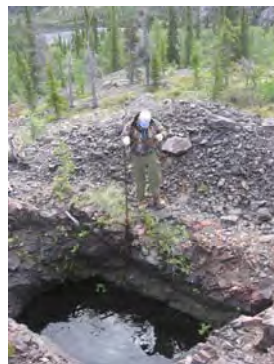
- Falling Hazards
- Elevated aluminum and zinc in water in one pit (#3)
