<b>File Number</b>	<b>S99A-015</b>
<b>Type of Operation</b>	<b>OIL AND GAS DRILLING - WELLSITE</b>
<b>Location</b>	Sump

## ENVIRONMENTAL INSPECTION REPORT

<b>Permittee:</b>	EnCana Corporation	<b>Permit Expiry Date:</b>	December 15, 2004
<b>Land Use Permit No.</b>	S99A-015	<b>Previous Inspection:</b>	July 09, 2019
<b>Quarrying Permit No.</b>	N/A	<b>Inspection Date:</b>	June 06, 2022
<b>Contractor:</b>	N/A	<b>Subcontractor:</b>	N/A
<b>Location(s) Inspected:</b>	Sump		
<b>Current Stage of Operation:</b>	Remediation		
<b>Program Modifications Approved:</b>	None

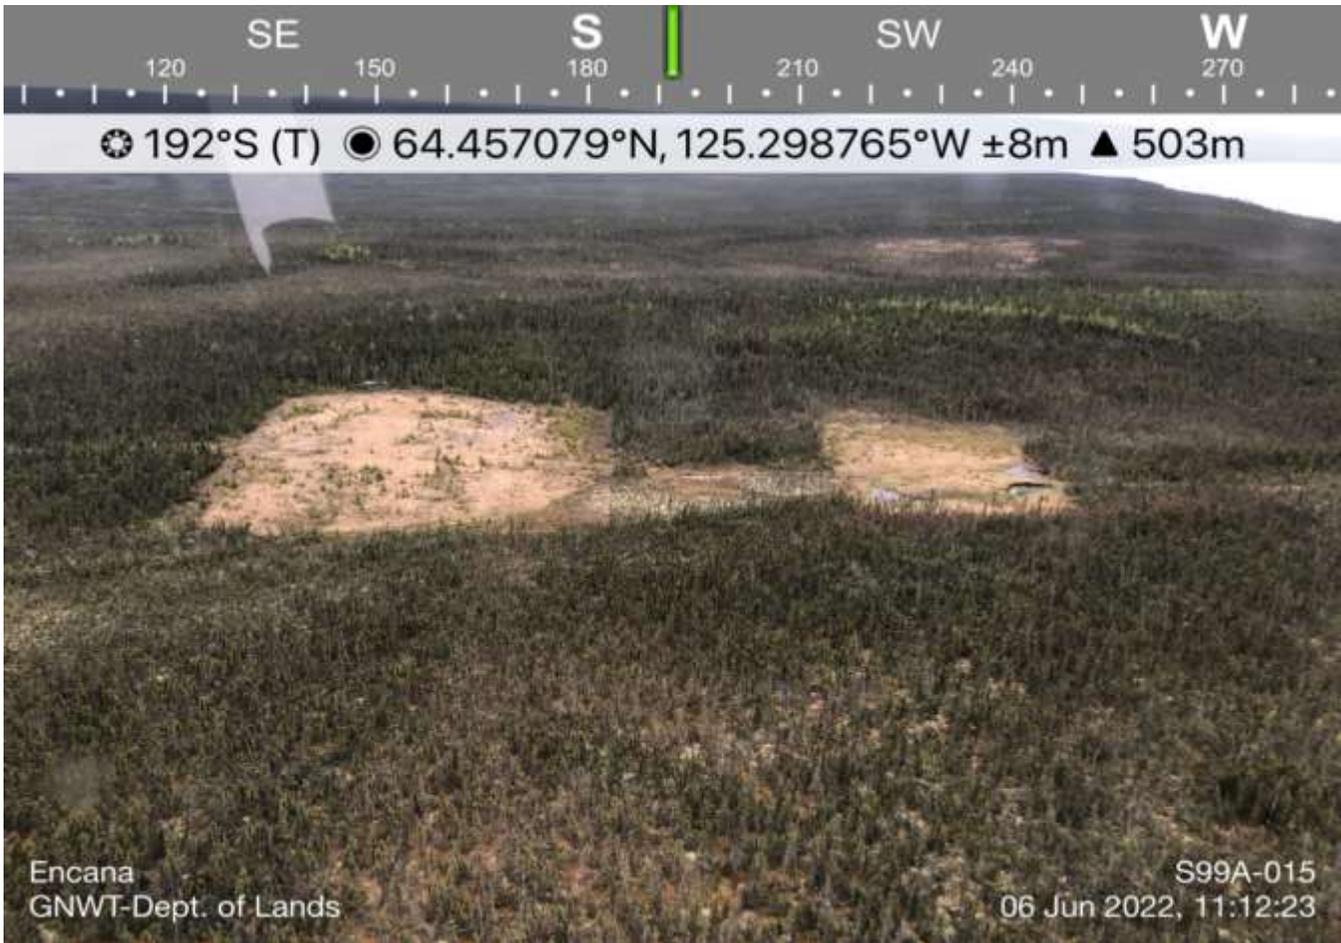
**Figure 1**

Aerial of wellsite G-18 and remote sump

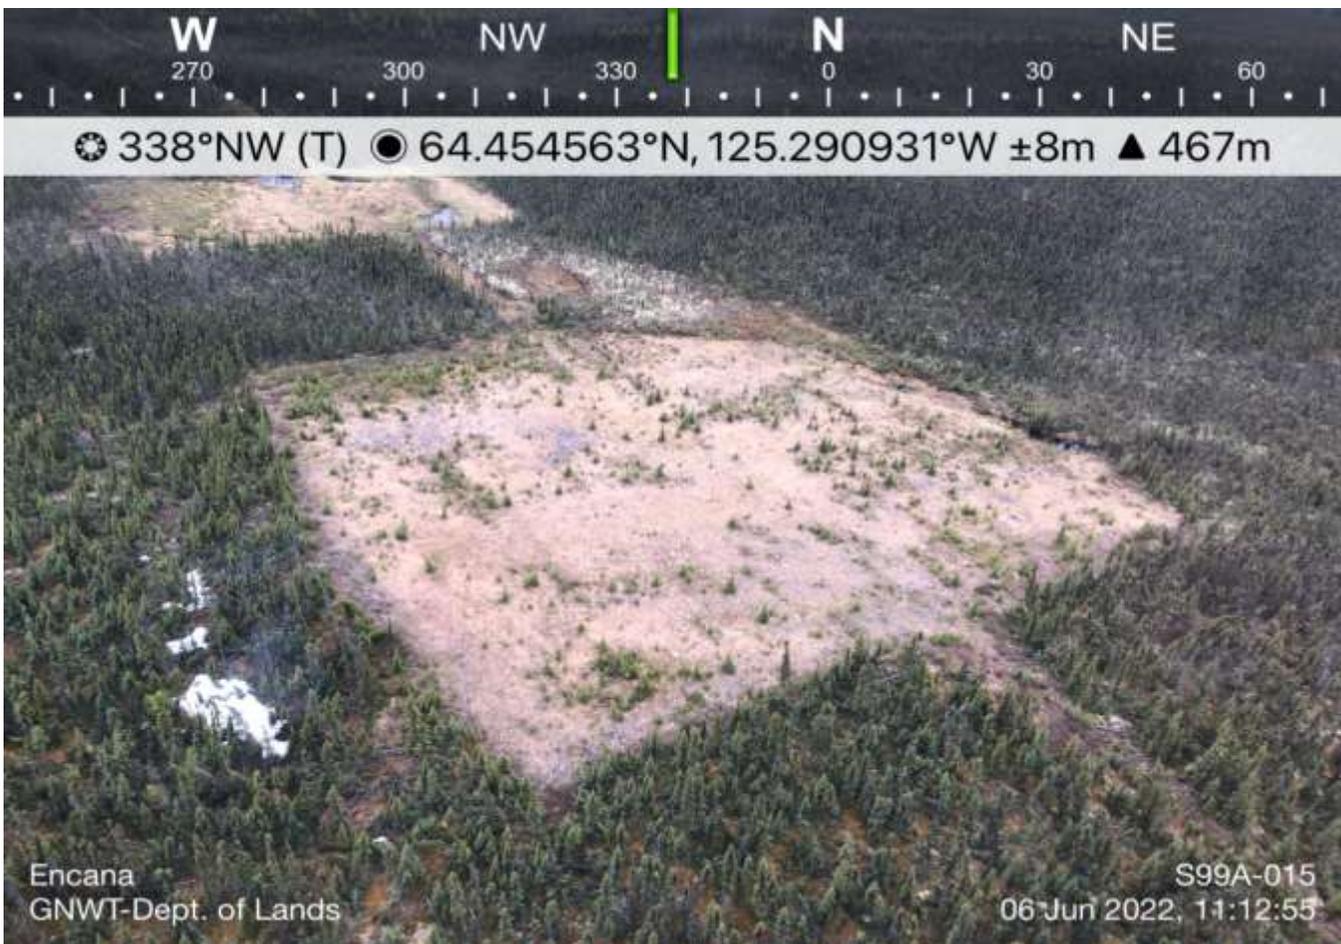
**Figure 2**

Aerial of wellsite G-18

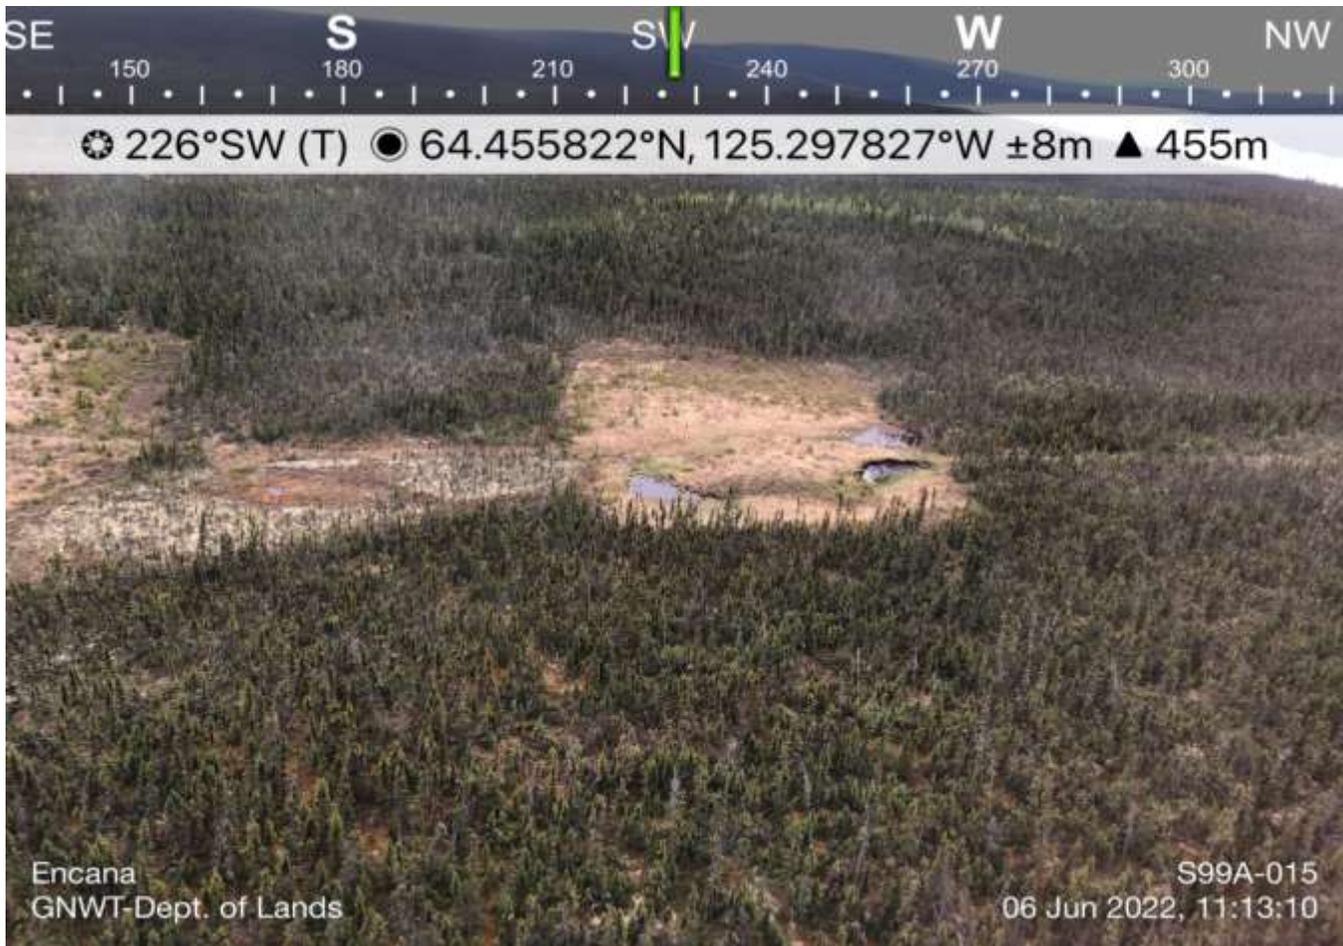
**Figure 3**

Aerial of the remote sump

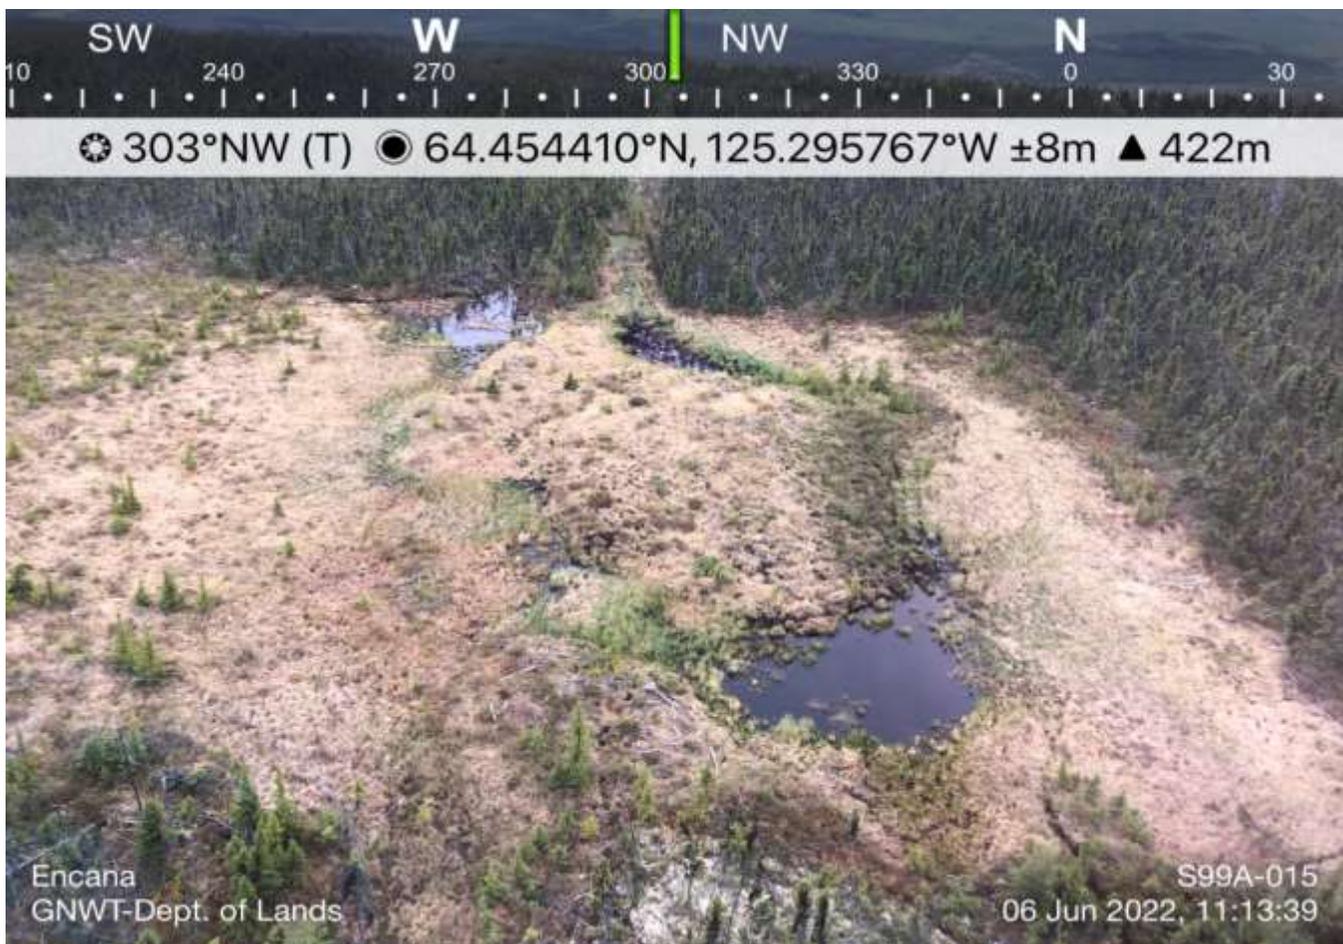
**Figure 4**

Remote sump

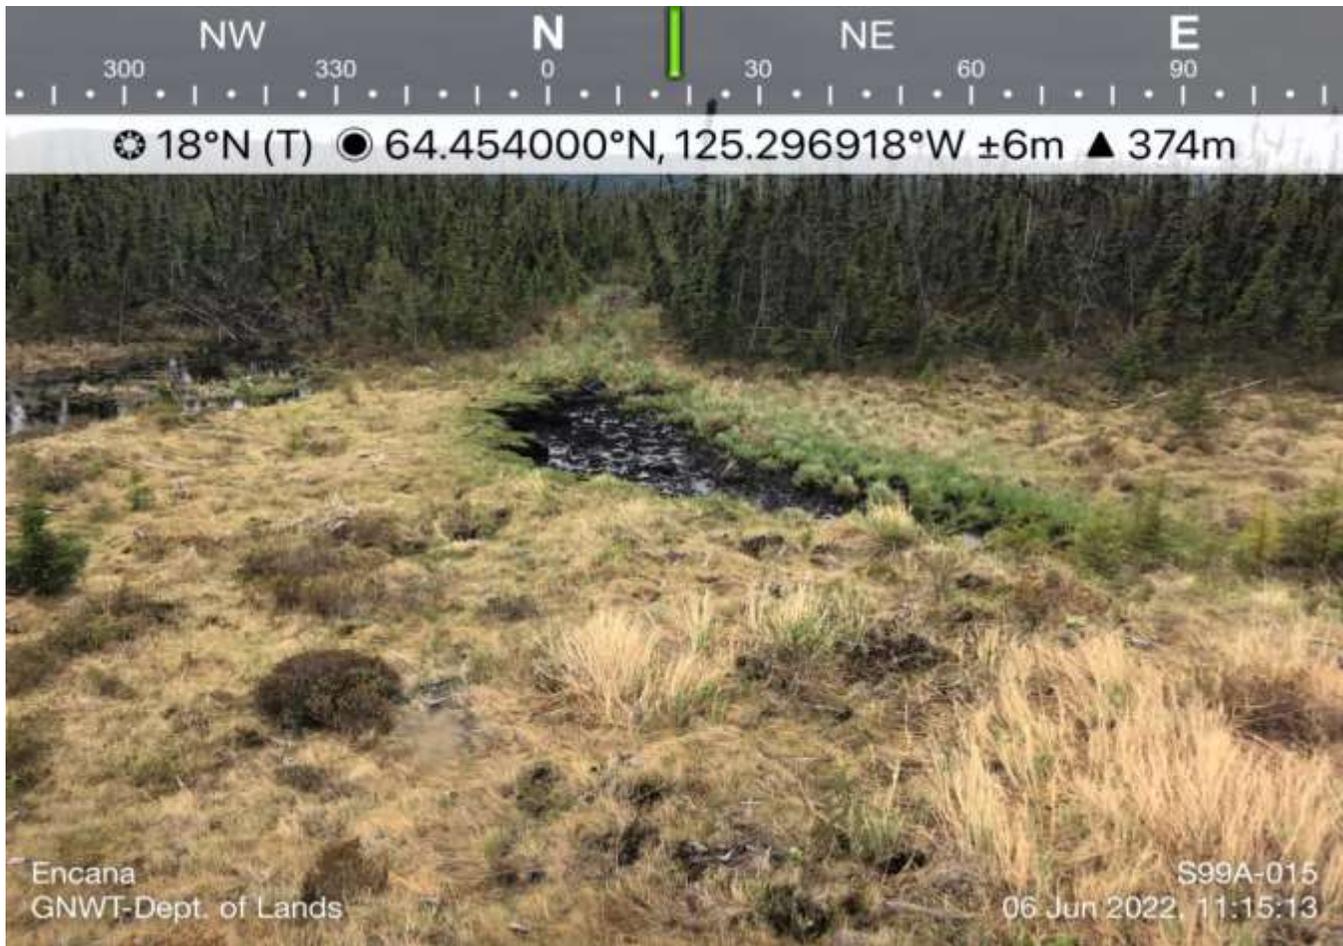
**Figure 5**

It has been confirmed the area exceeds CCME guidelines (Letter and sample results sent October 9, 2019) for SAR and requires remediation to remedy this issue. Due to the high salt content, Ungulates continue to wallow and create more erosion issues around the sump.

Wallowing pit

Please submit a detailed plan to the Department of Lands, Sahtu Region, highlighting the methodology and timeline on how EnCana Corporation plans to remediate this site. This plan should be received by the Lands no later than **December 31, 2022**.

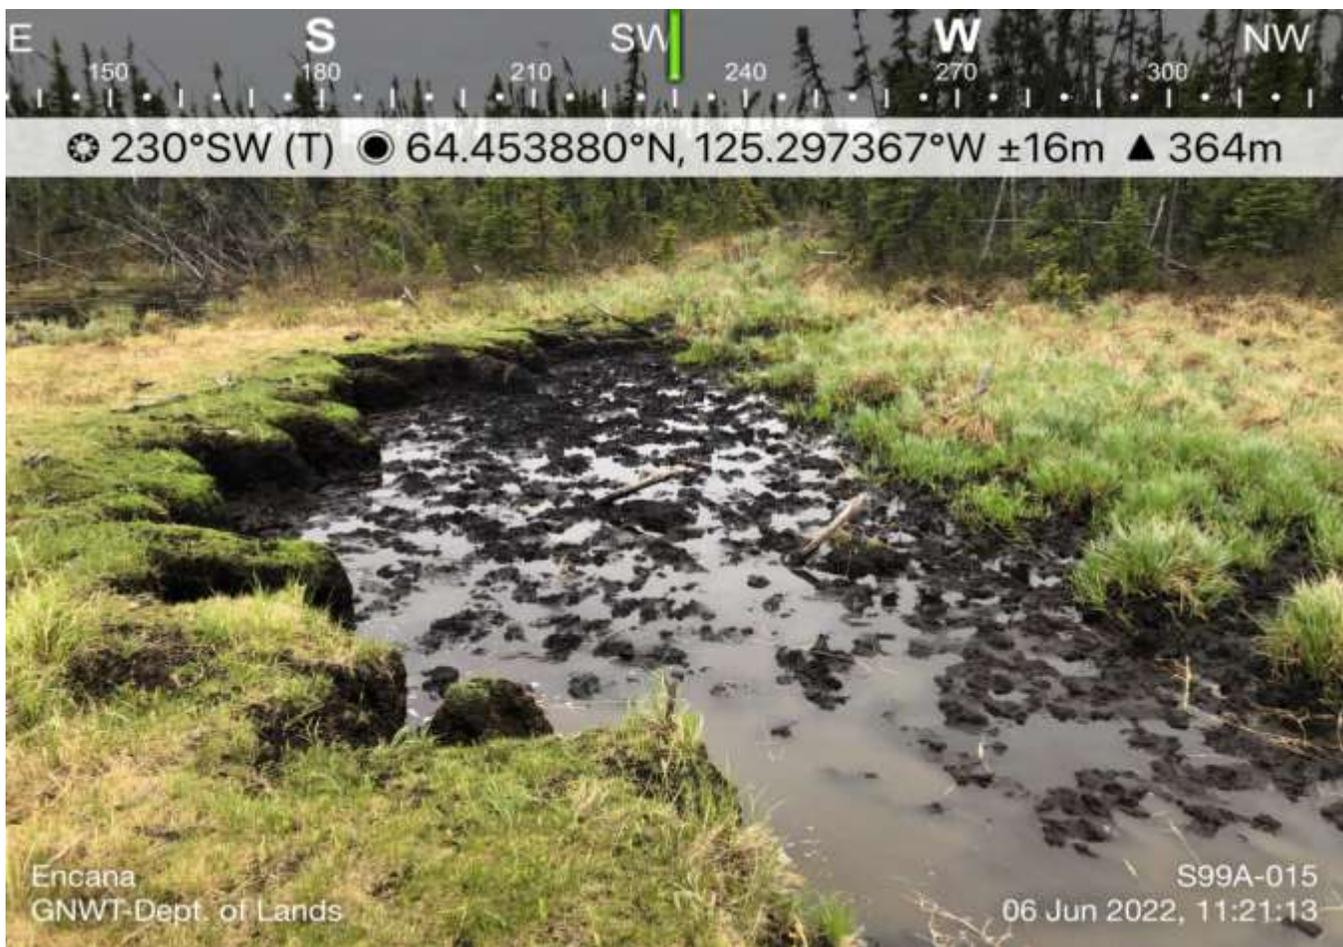
**Figure 6**

Wallowing pit

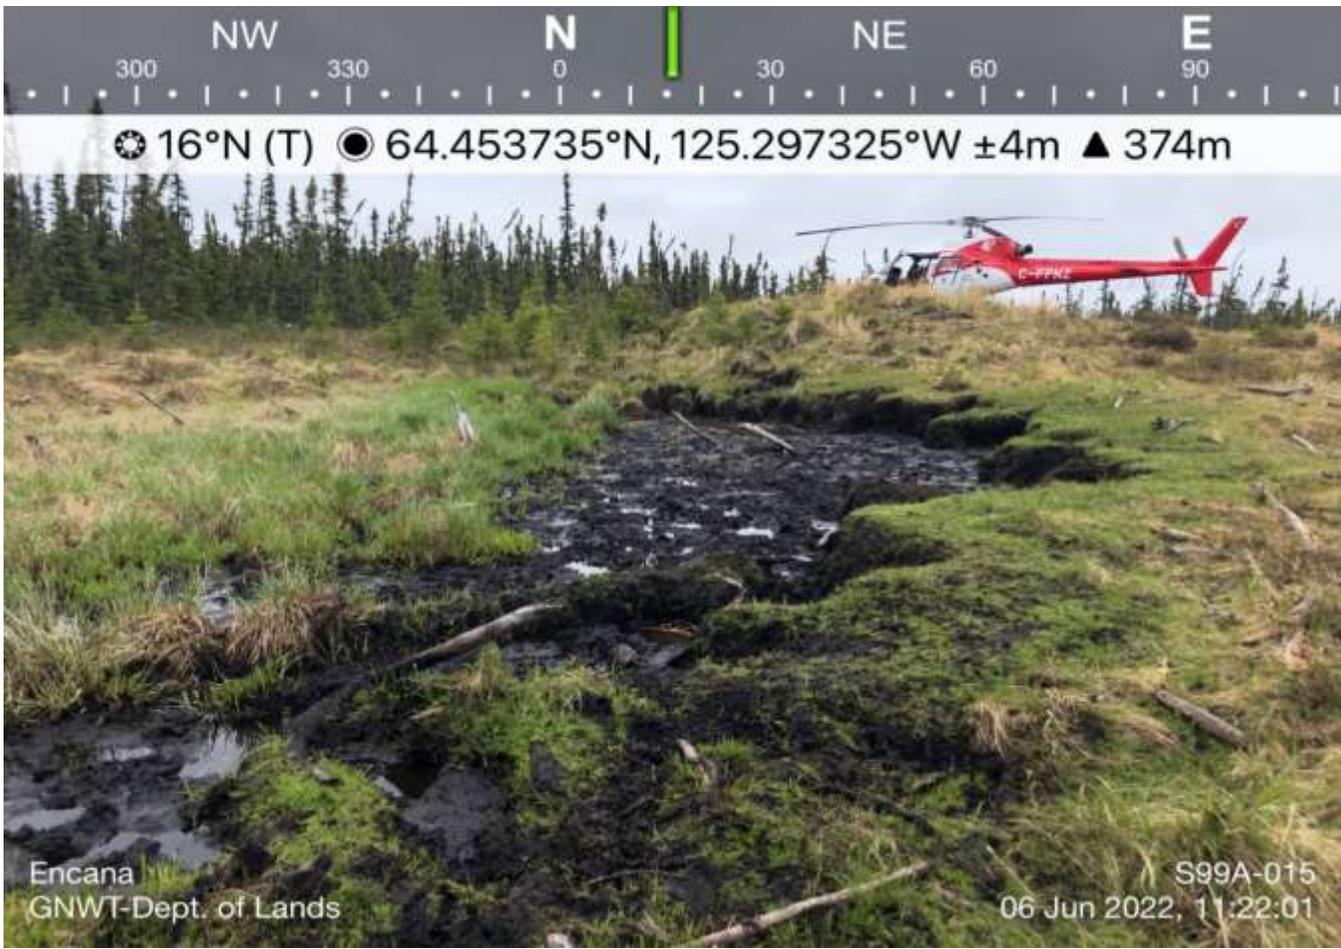
**Figure 7**

Wallowing pit

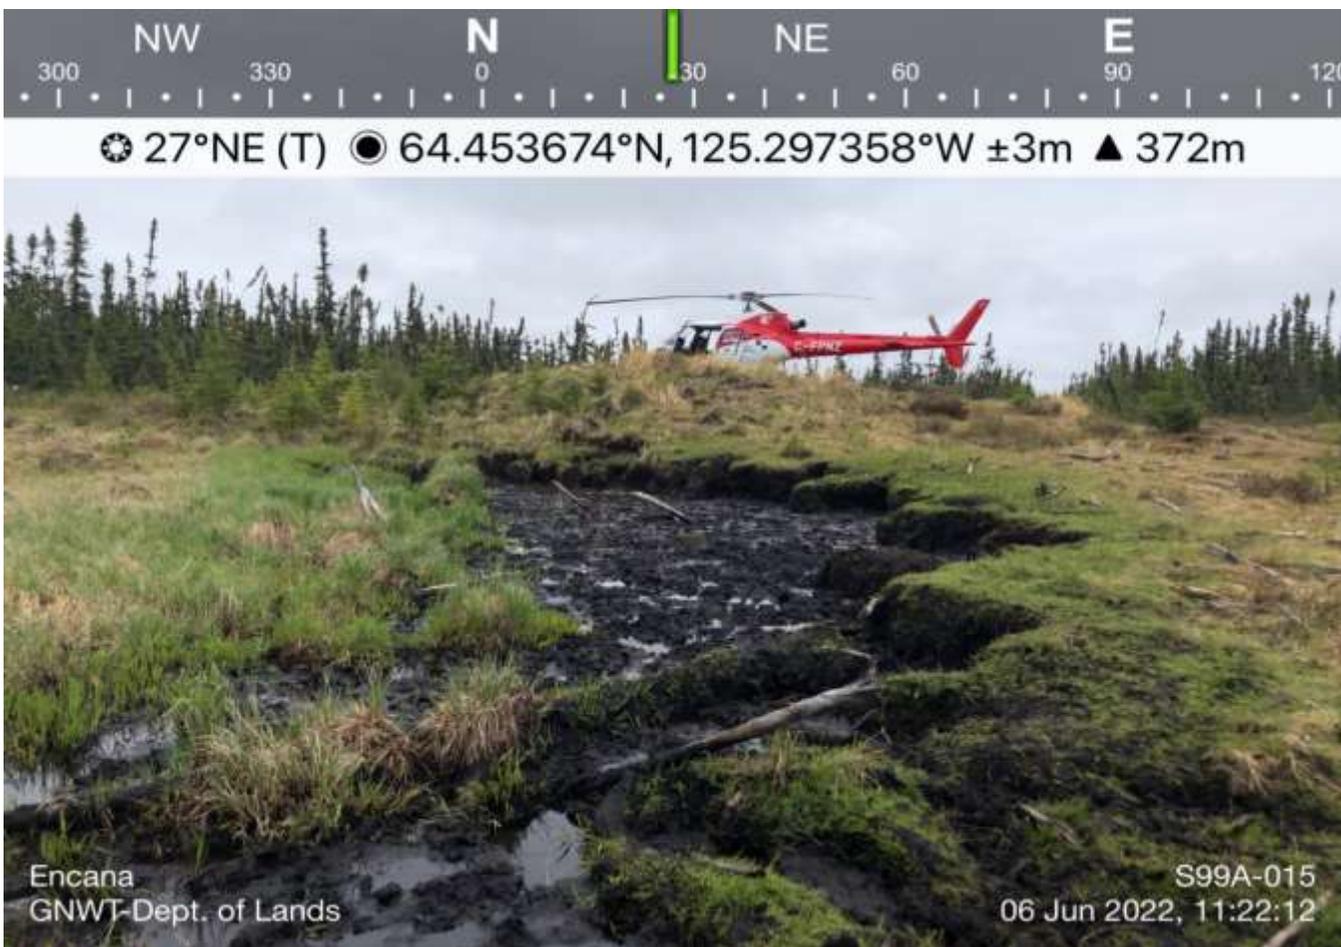
**Figure 8**

Wallowing pit

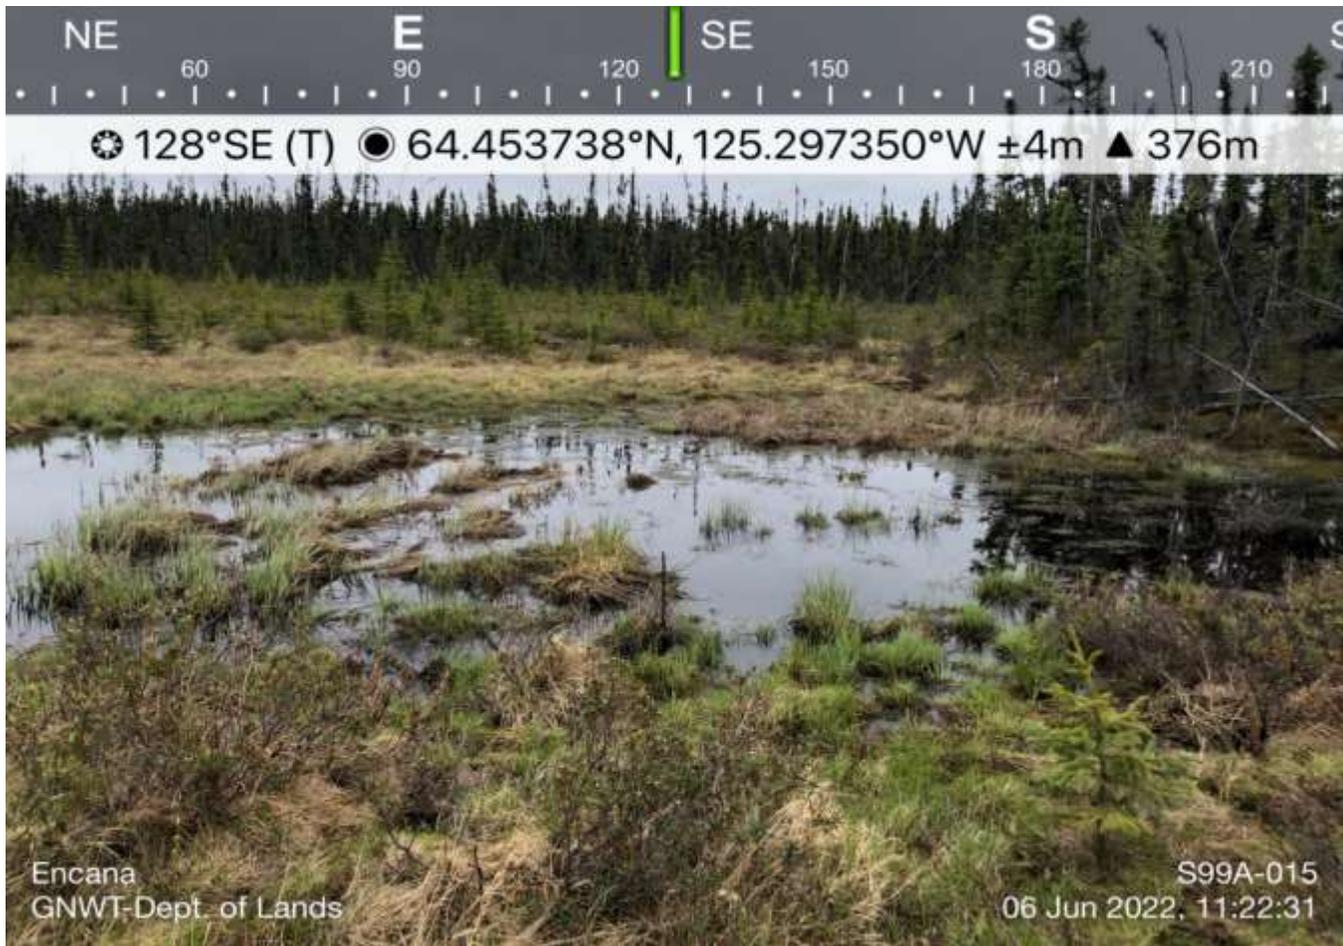
**Figure 9**

Pooling water

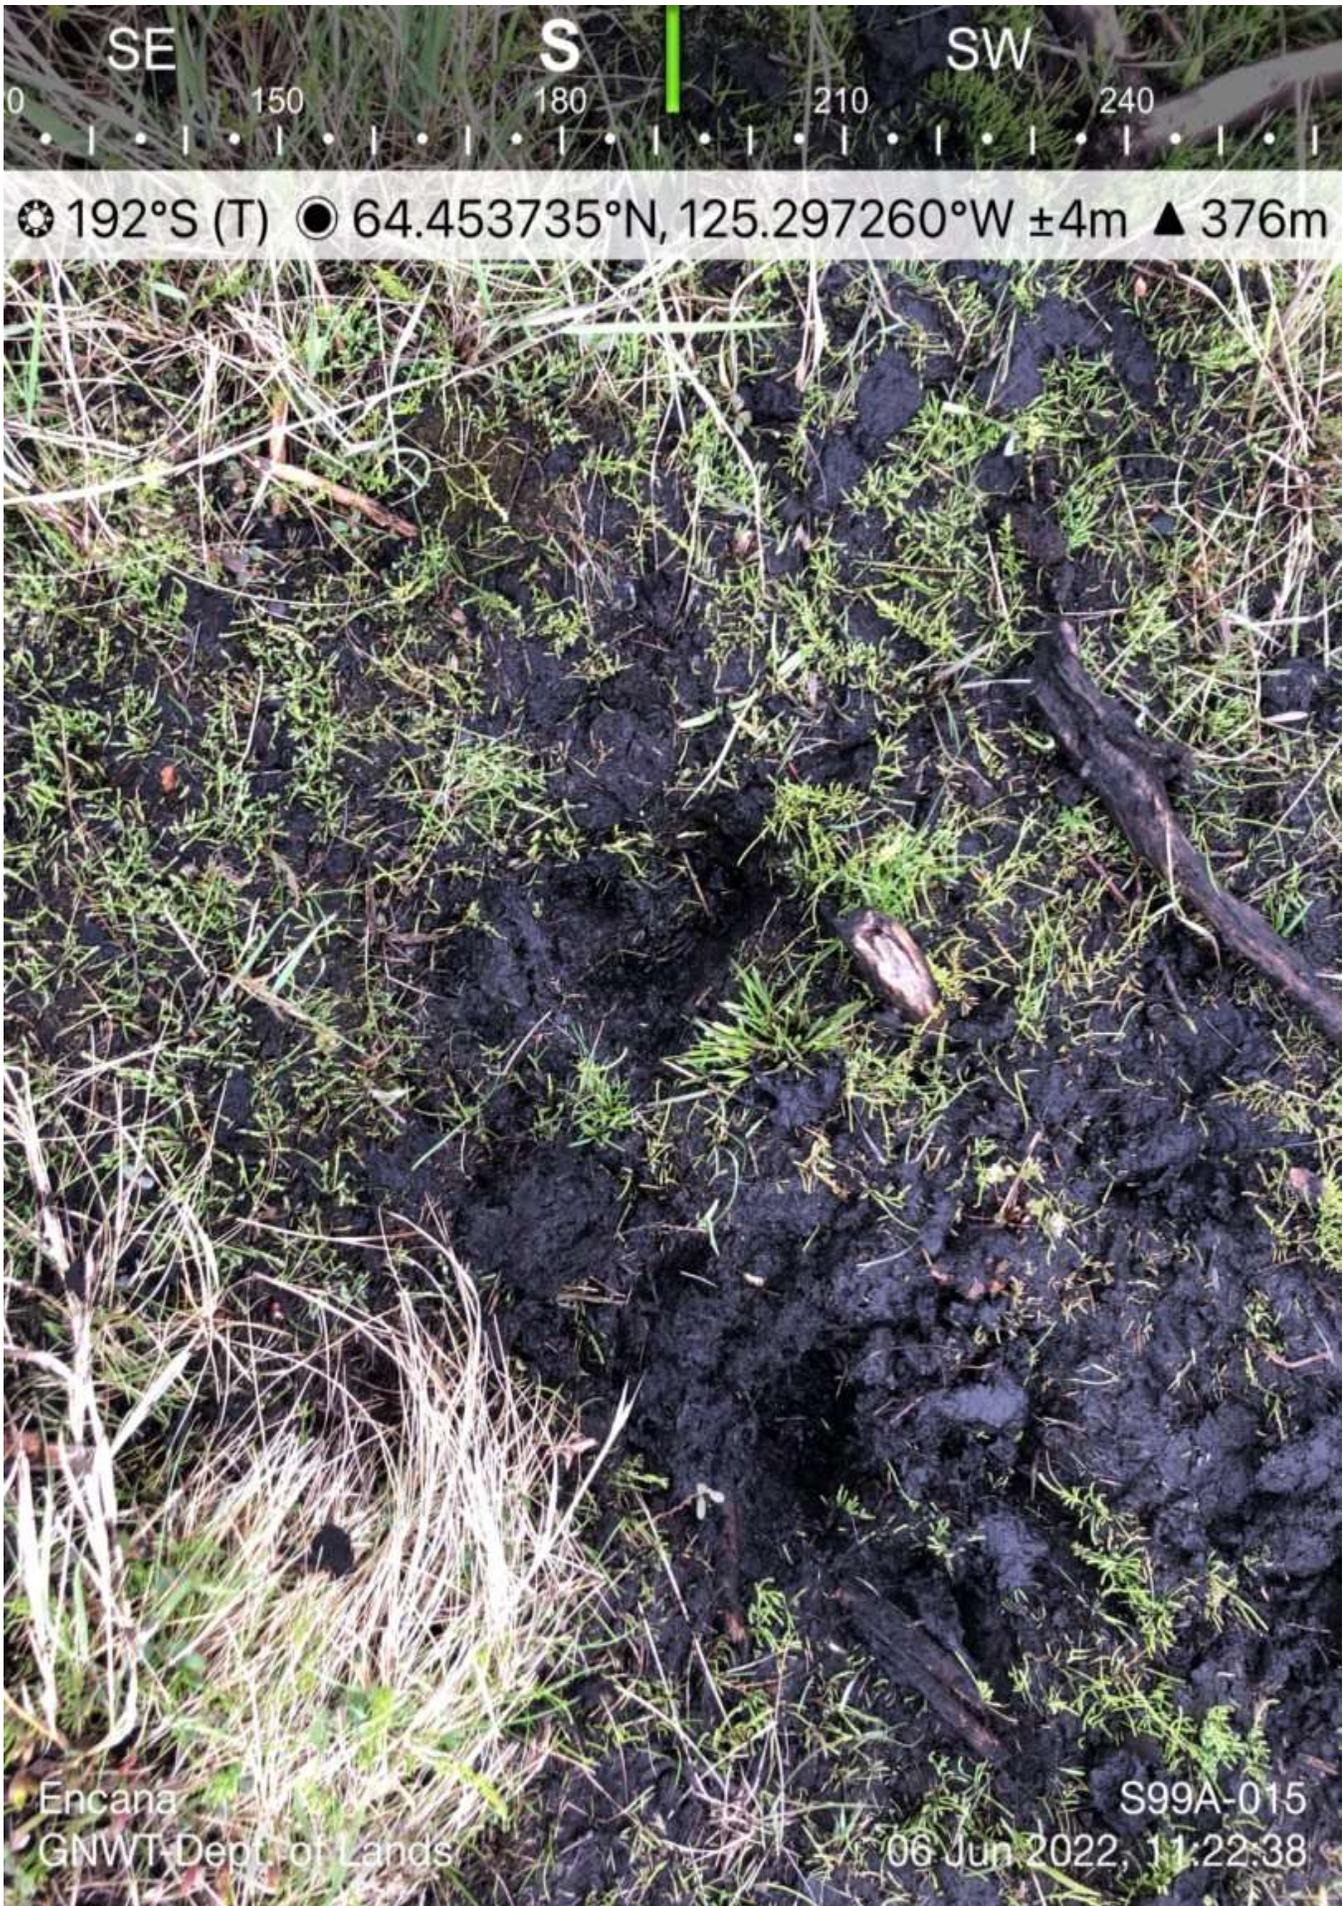
**Figure 10**

Ungulate tracks

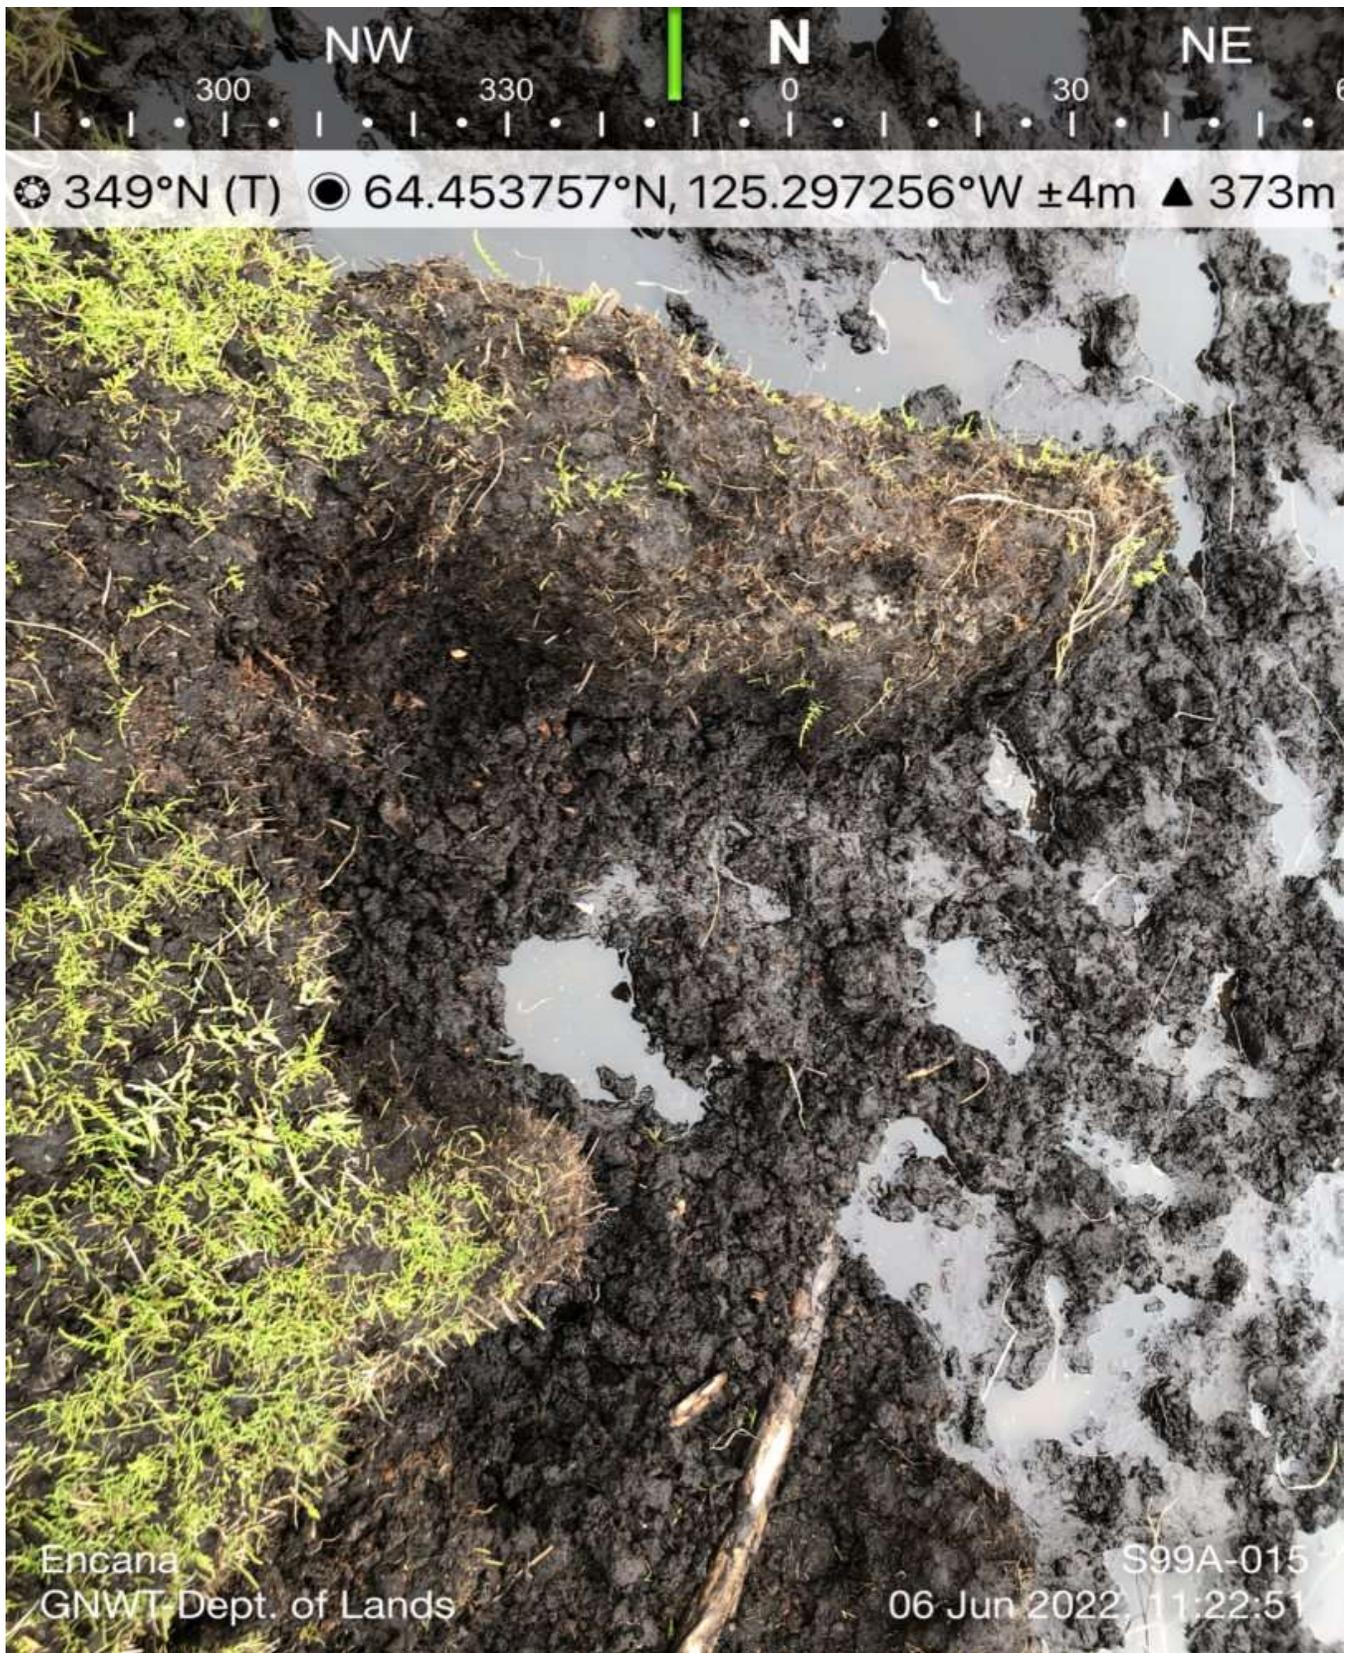
**Figure 11**

Ungulates causing erosion

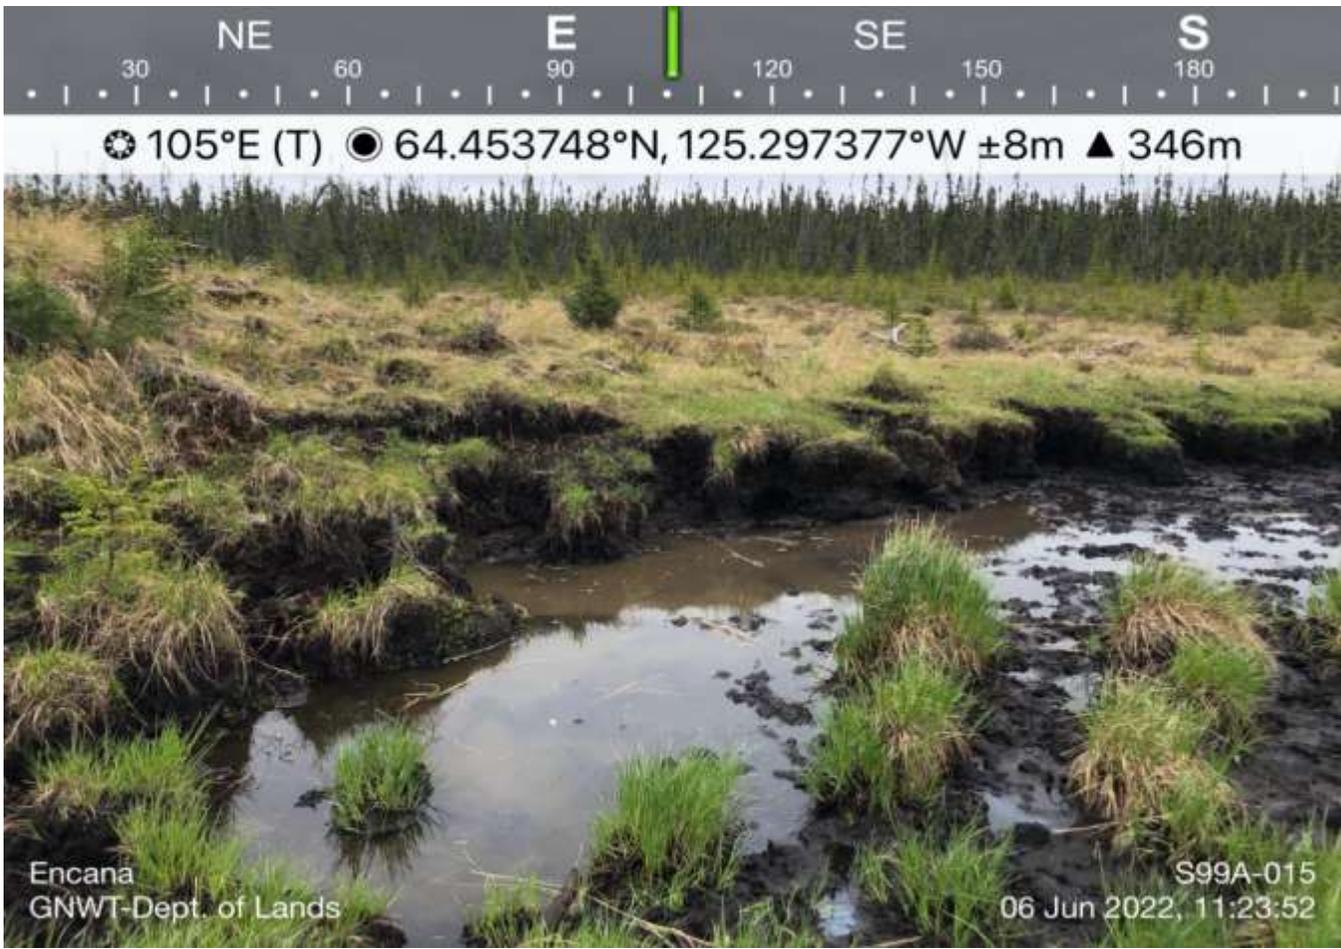
**Figure 12**

Wallowing pit

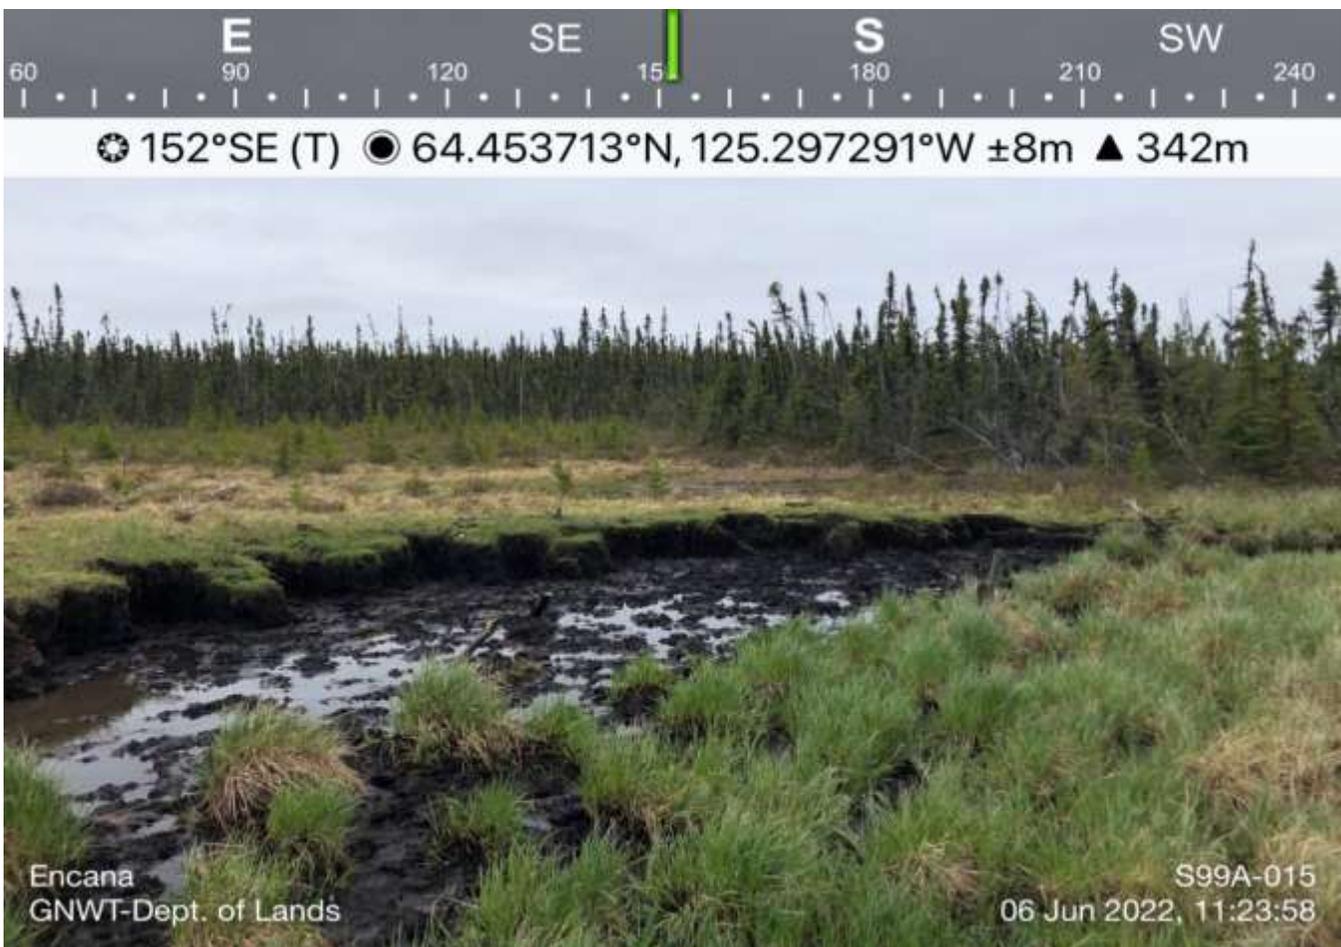
**Figure 13**

Wallowing pit

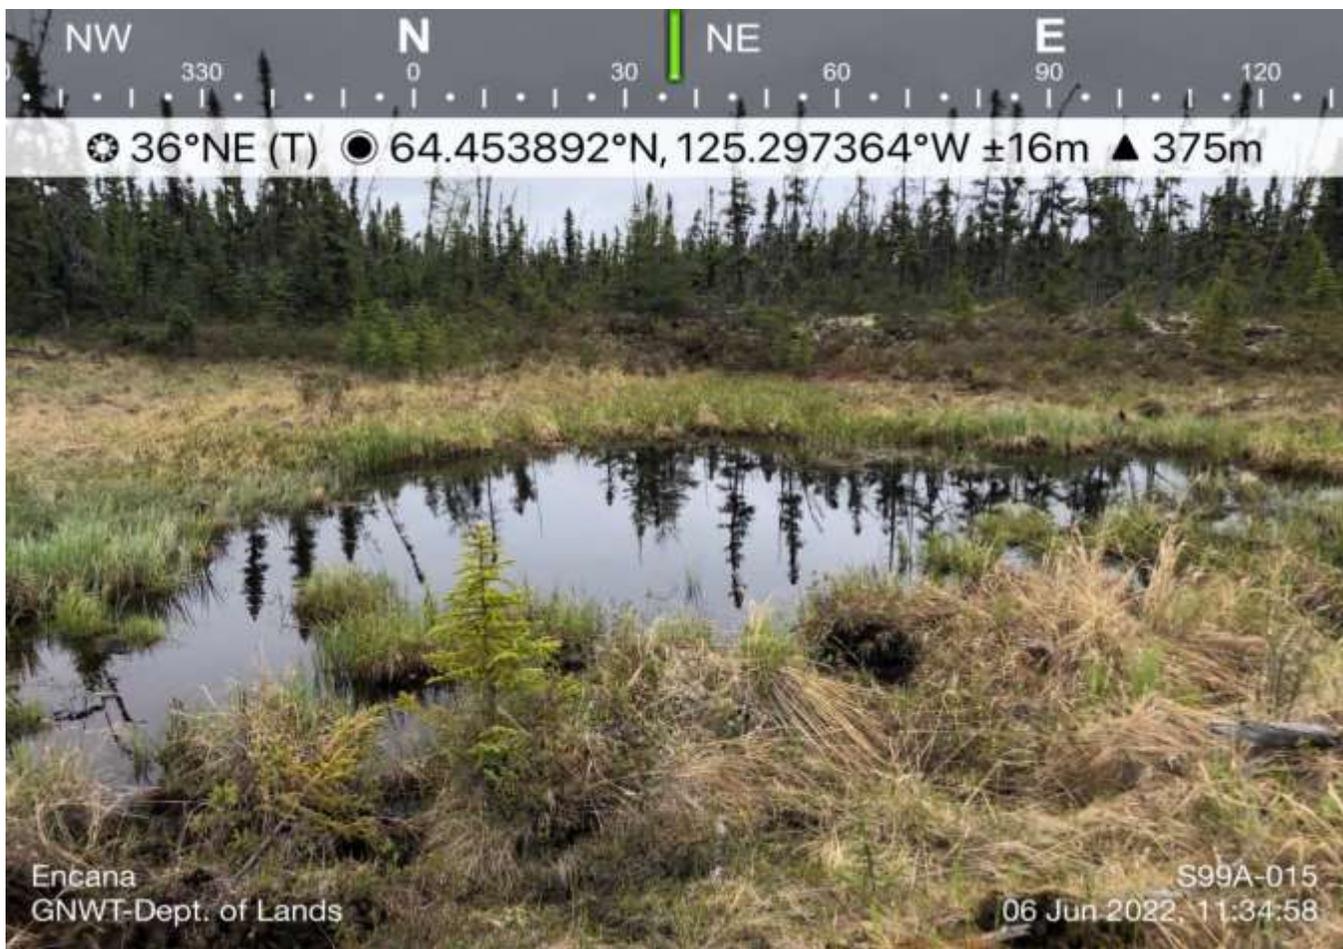
**Figure 14**

Pooling water

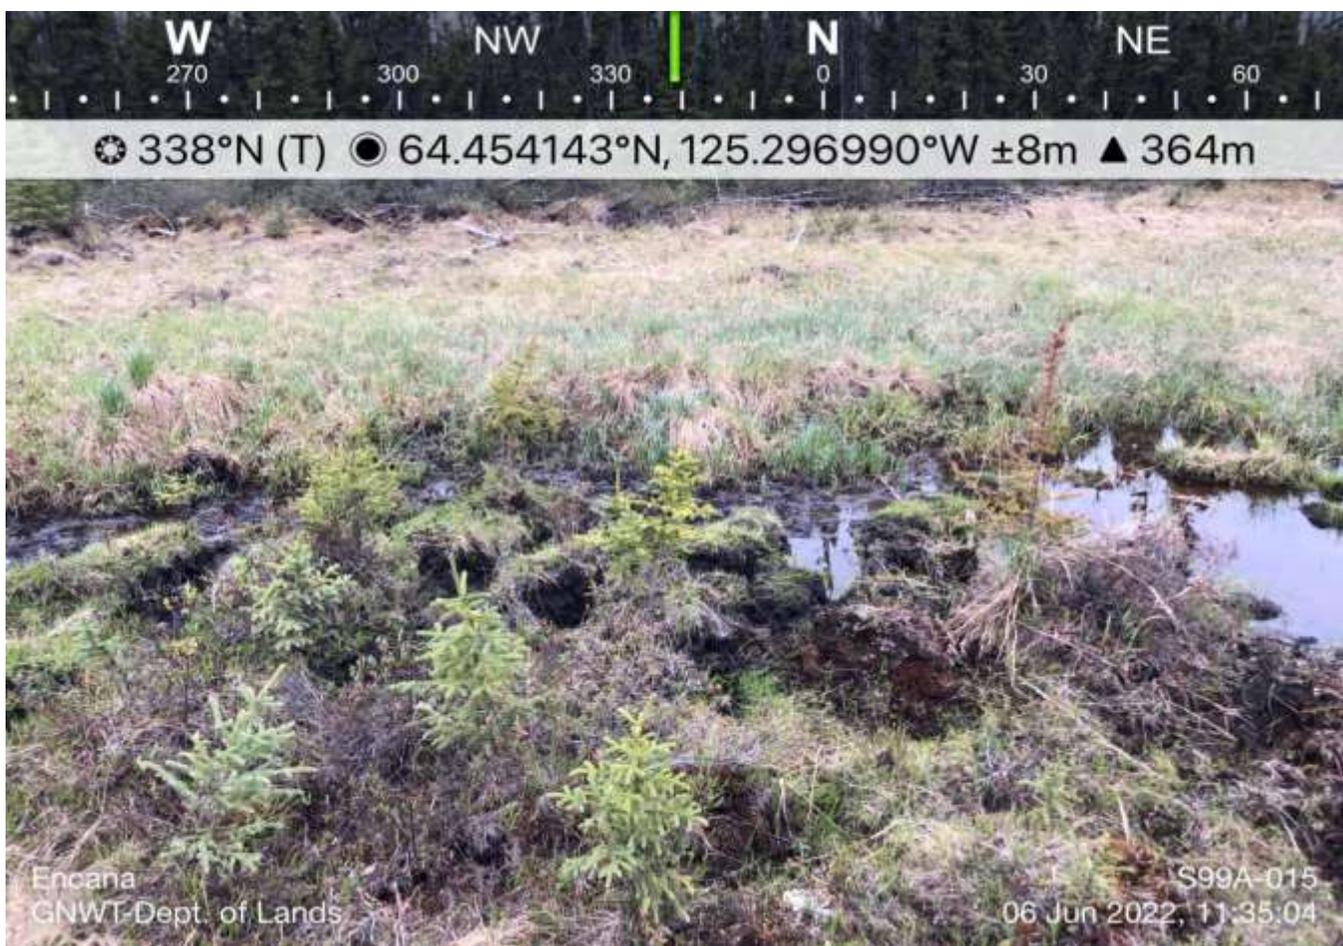
**Figure 15**

Wallowing pit

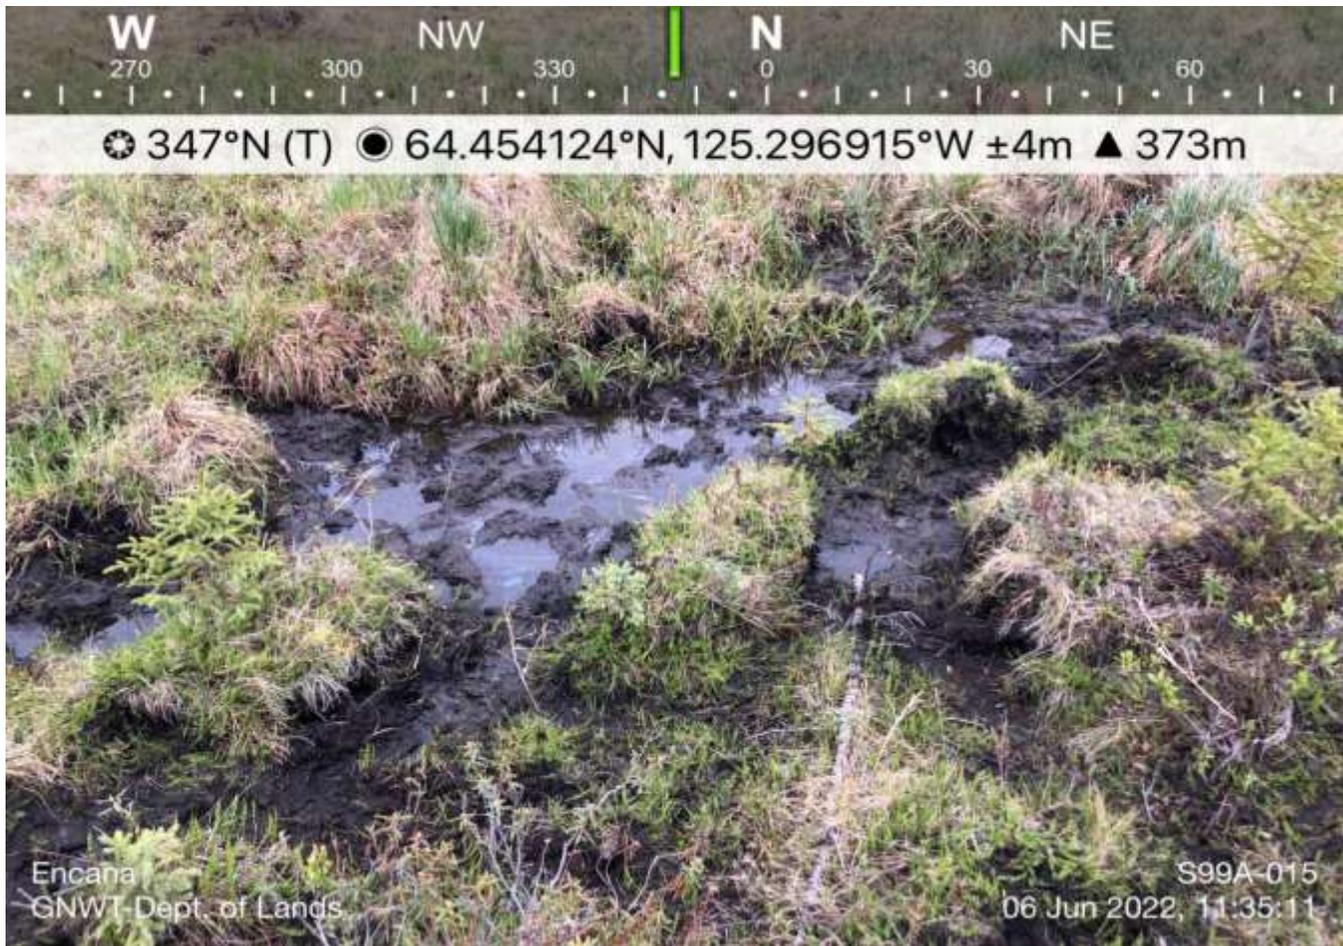
**Figure 16**

Wallowing pit
