<b>File Number</b>	<b>S99A-015</b>
<b>Type of Operation</b>	<b>OIL AND GAS DRILLING - WELLSITE</b>
<b>Location</b>	Sump

## ENVIRONMENTAL INSPECTION REPORT

<b>Permittee:</b>	EnCana Corporation	<b>Permit Expiry Date:</b>	December 15, 2004
<b>Land Use Permit No.</b>	S99A-015	<b>Previous Inspection:</b>	July 09, 2019
<b>Quarrying Permit No.</b>	N/A	<b>Inspection Date:</b>	June 06, 2022
<b>Contractor:</b>	N/A	<b>Subcontractor:</b>	N/A
<b>Location(s) Inspected:</b>	Sump		
<b>Current Stage of Operation:</b>	Remediation		
<b>Program Modifications Approved:</b>	None

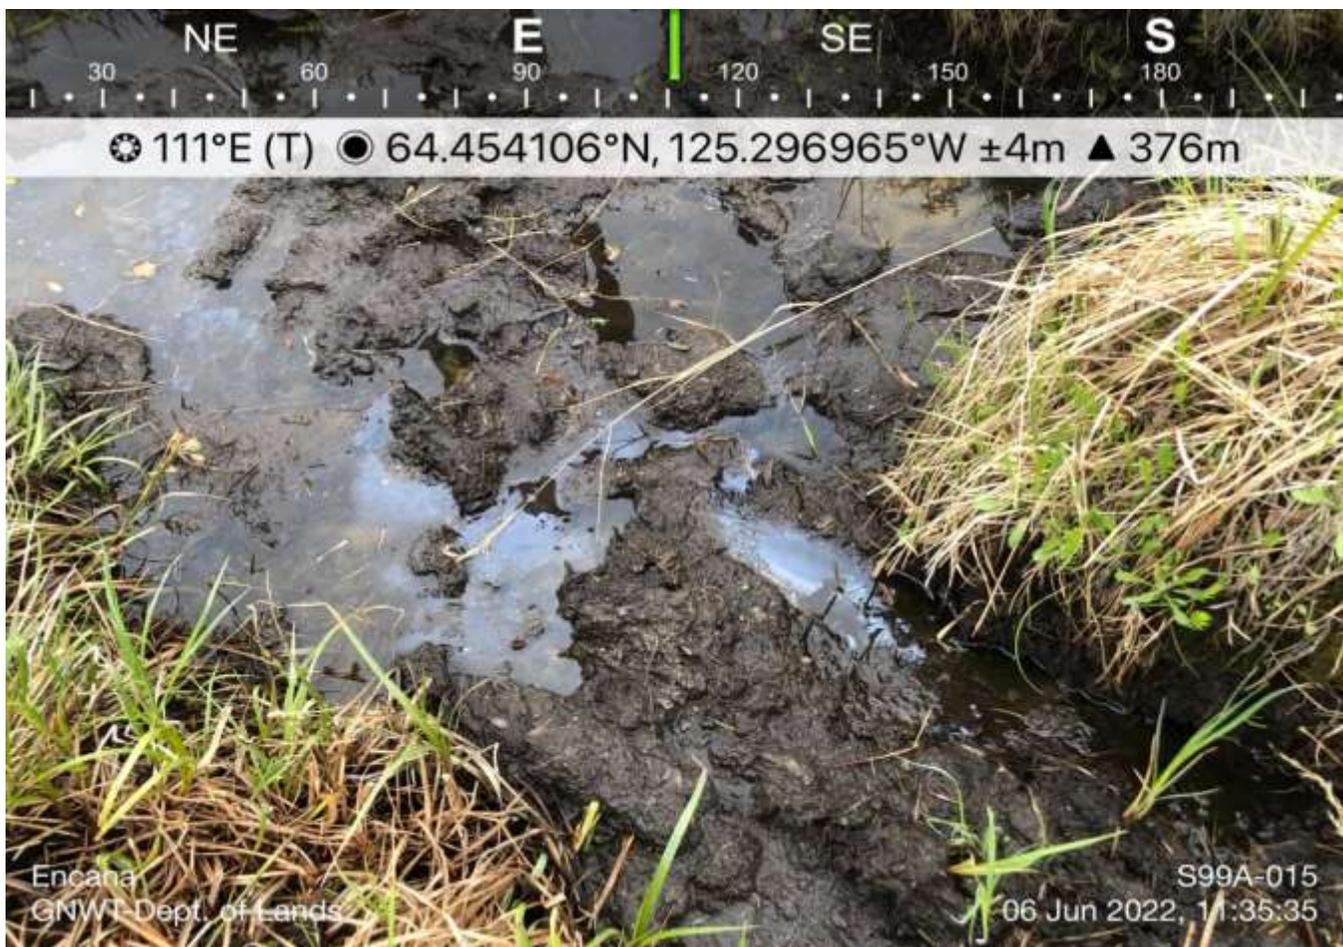
**Figure 17**

Sheen was found on top of the water in the wallowing pit

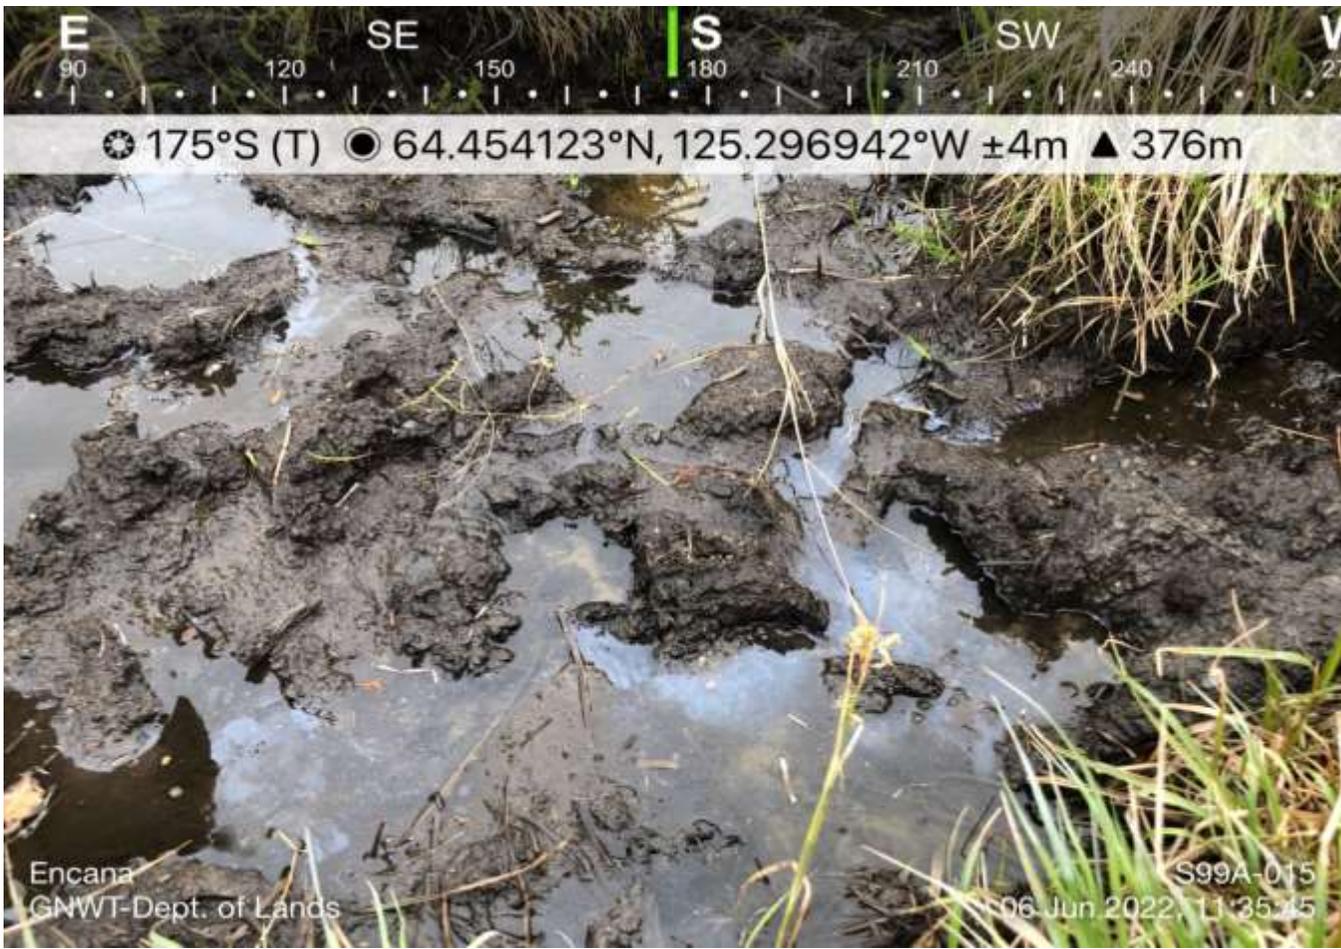
**Figure 18**

Sheen was found on top of the water in the wallowing pit

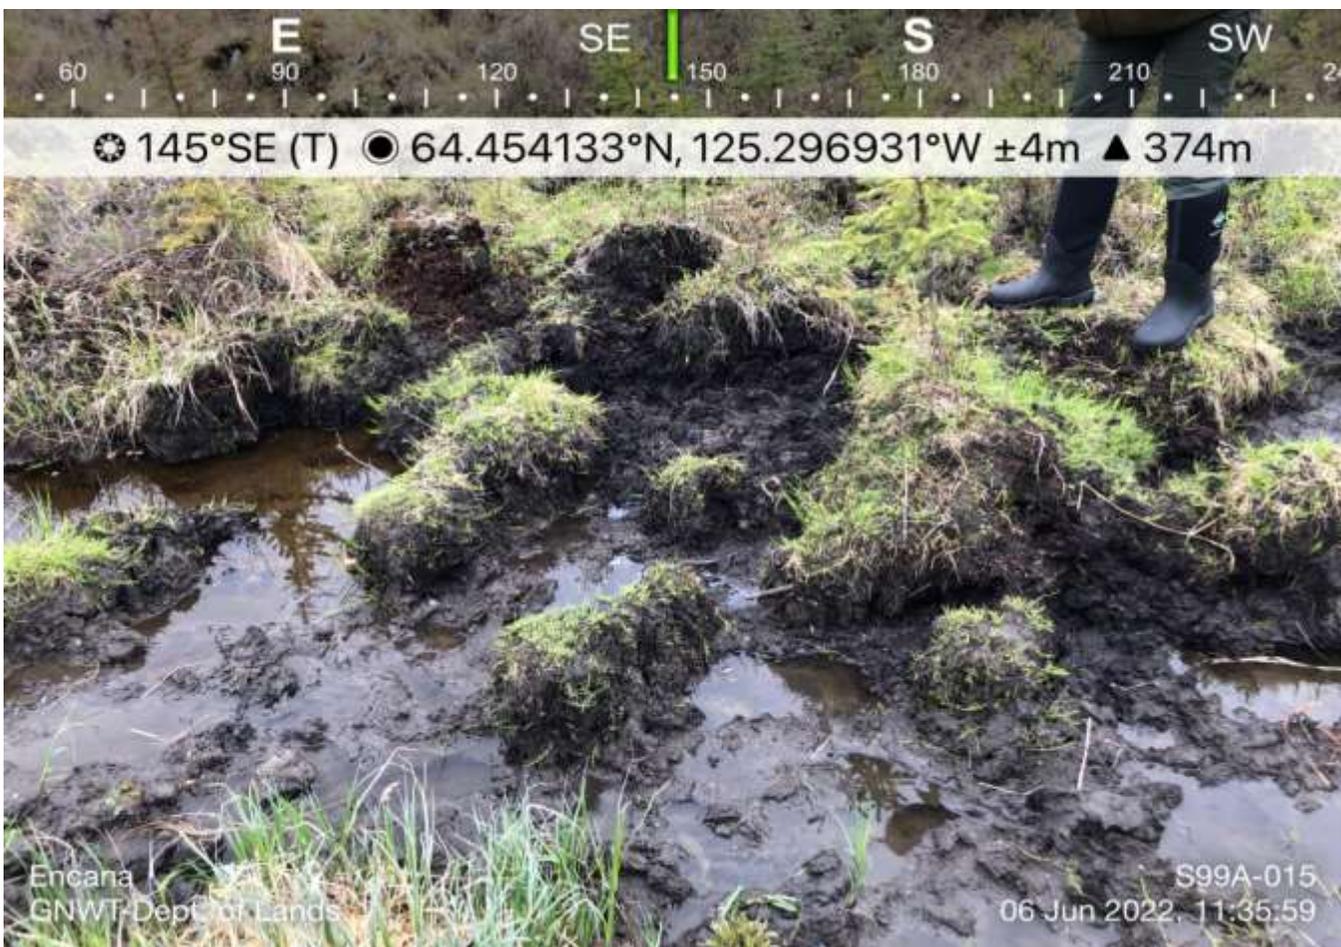
**Figure 19**

It has been confirmed the area exceeds CCME guidelines (Letter and sample results sent October 9, 2019) for SAR and requires remediation to remedy this issue. Due to the high salt content, Ungulates continue to wallow and create more erosion issues around the sump.

Wallowing pit

Please submit a detailed plan to the Department of Lands, Sahtu Region, highlighting the methodology and timeline on how EnCana Corporation plans to remediate this site. This plan should be received by the Lands no later than **December 31, 2022**.
