Subject: 2022 Annual Dam Safety Review – A418 Dike

2022 Dam Safety Review

A418 Dike Diavik Diamond Mine, Northwest Territories, Canada

NOVEMBER 9, 2022
ISSUED FOR USE
FILE: 704-ENG.EARC03226-03

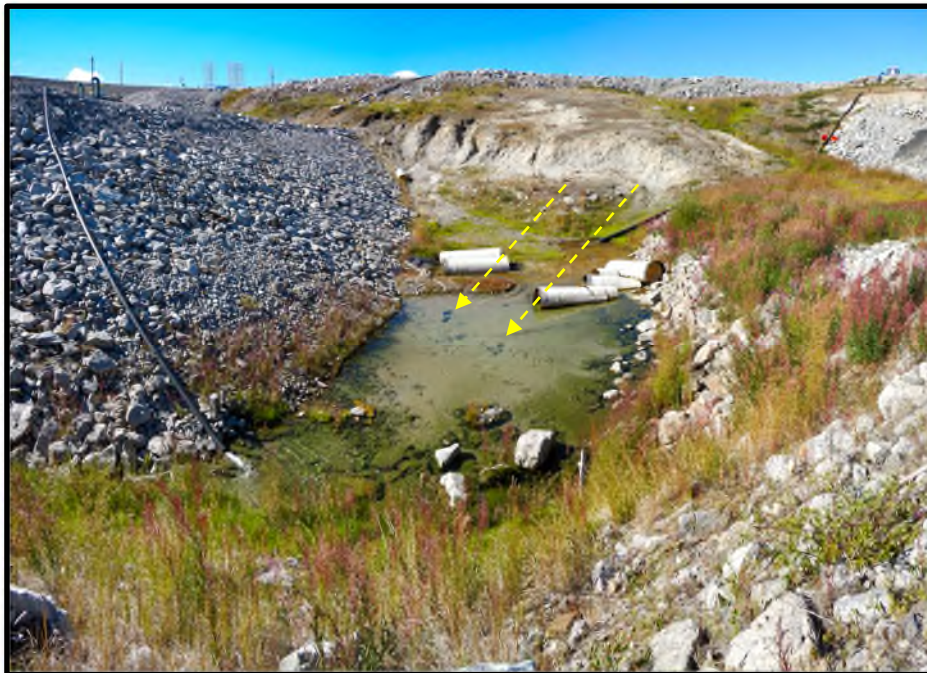
Photo D14: DPS-6 intake pond showing small sinkholes observed at the base of the pond.

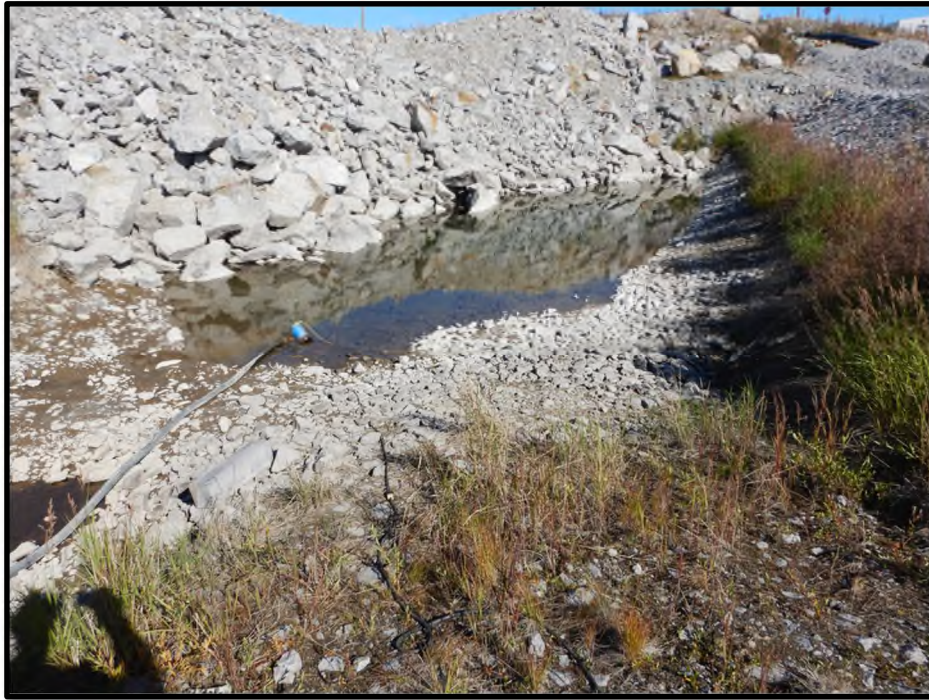
Photo D21: Downstream pool of collected water near Station 0+070, looking north.

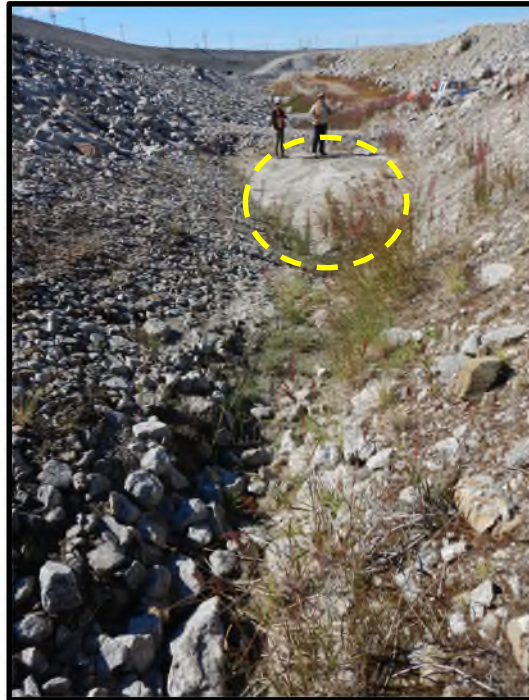
Photo D23: Downstream toe ditch near Station 0+450 showing sediment accumulation upstream of check dam.

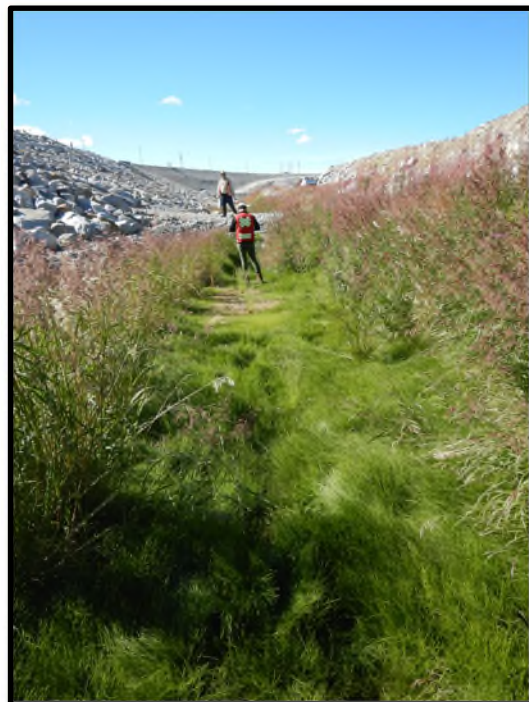
Photo D24: Downstream toe ditch near Station 0+550 showing abundant vegetation.

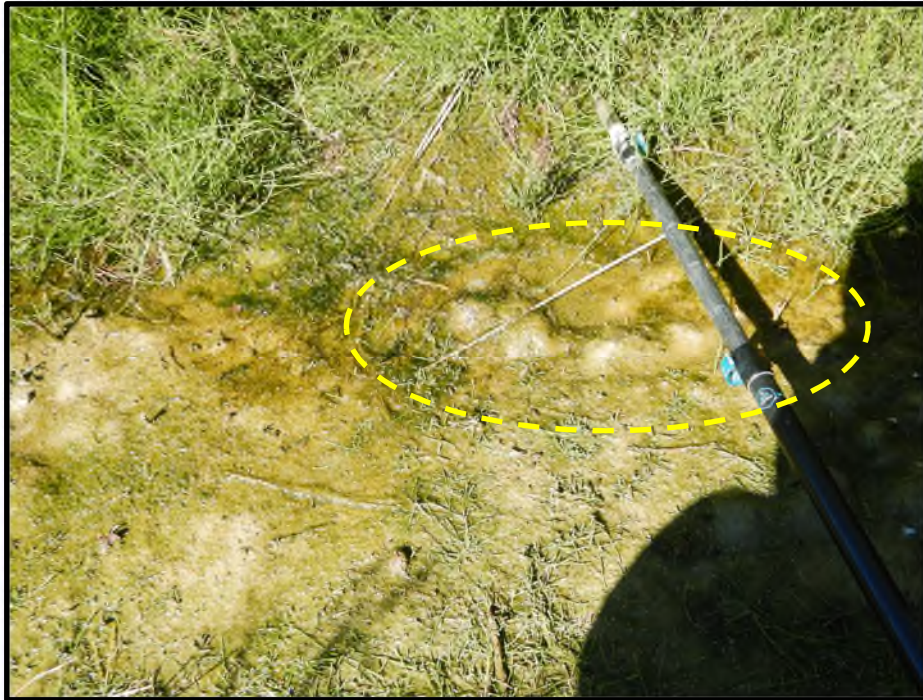
Photo D25: Downstream toe ditch near Station 0+550 showing blisters of air and water found in the ditch sediments.

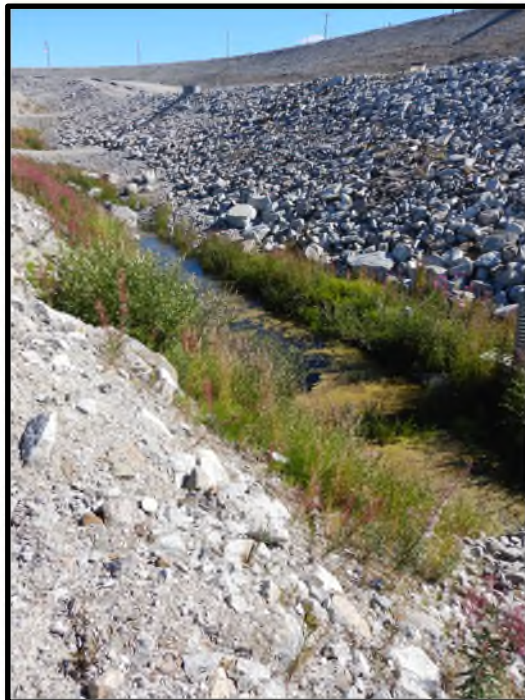
Photo D26: Downstream toe ditch near Station 0+650 showing ponded water along the base of the ditch.

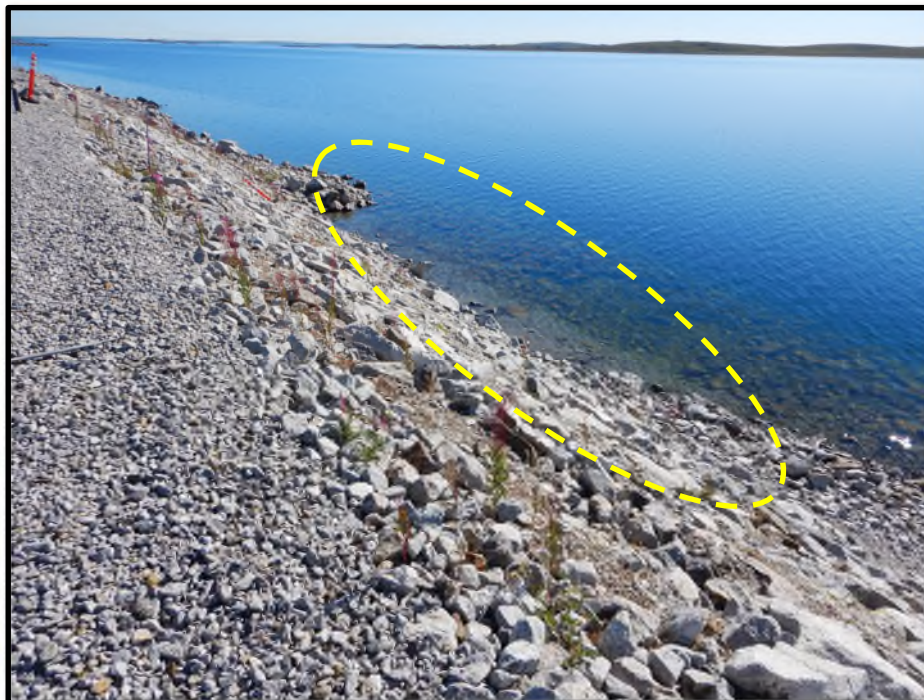
- A site inspection of the A418 Dike observed that the structure was generally in good condition and consistent with those described in the 2021 Annual Inspection and Performance Evaluation; however, two areas of erosion protection along the upstream slope of the dike were observed to have deficiencies and are recommended to be assessed;

Photo D42: Gap in erosion protection along the upstream slope near Station 0+750.

A418 Dike – New DSR Recommendations					
A418 Dike	<u>Erosion Protection between Stations 0+530 to 0+600 and Stations 0+700 to 0+750</u>	2022 DSR	3	2023	Will discuss with Engineer of Record to determine priority of item and add to

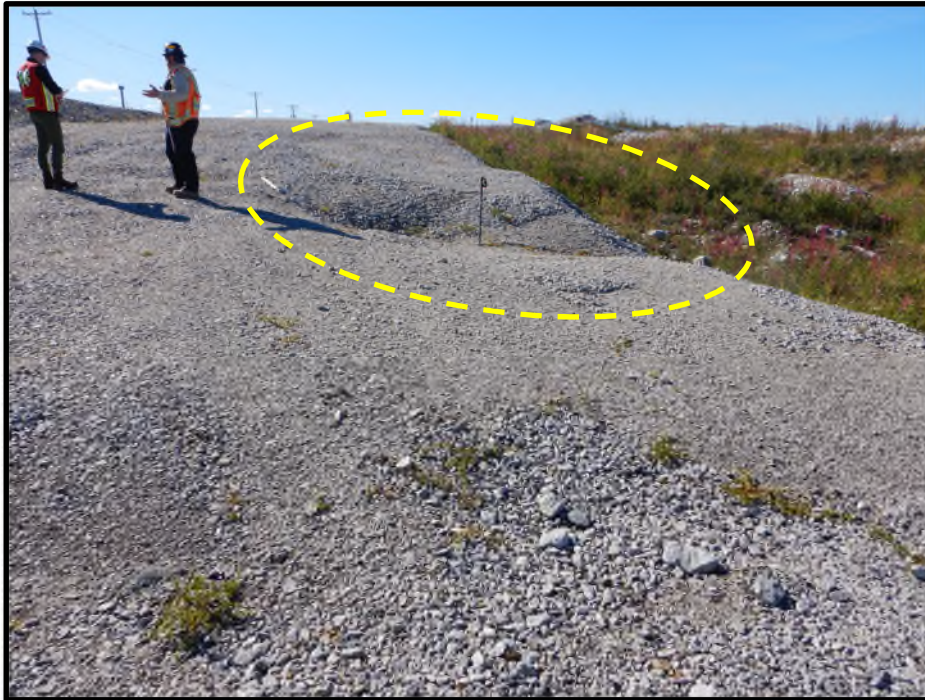
Photo D43: Thaw settlement of upstream thermal berm near Station 0+100.

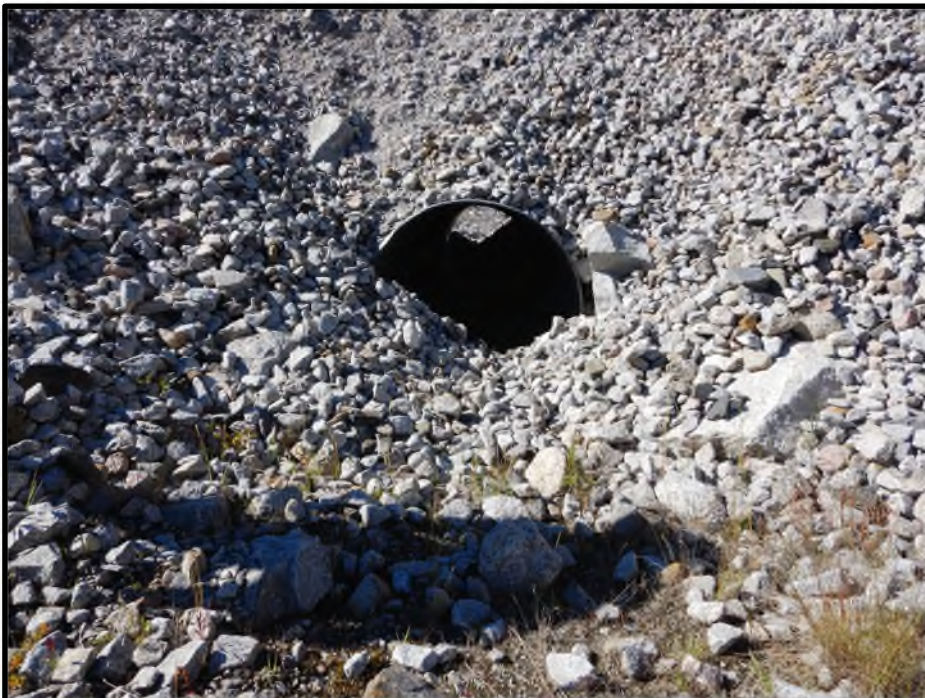
Photo D44: Partially blocked culvert along downstream water collection ditch near Station 0+800.

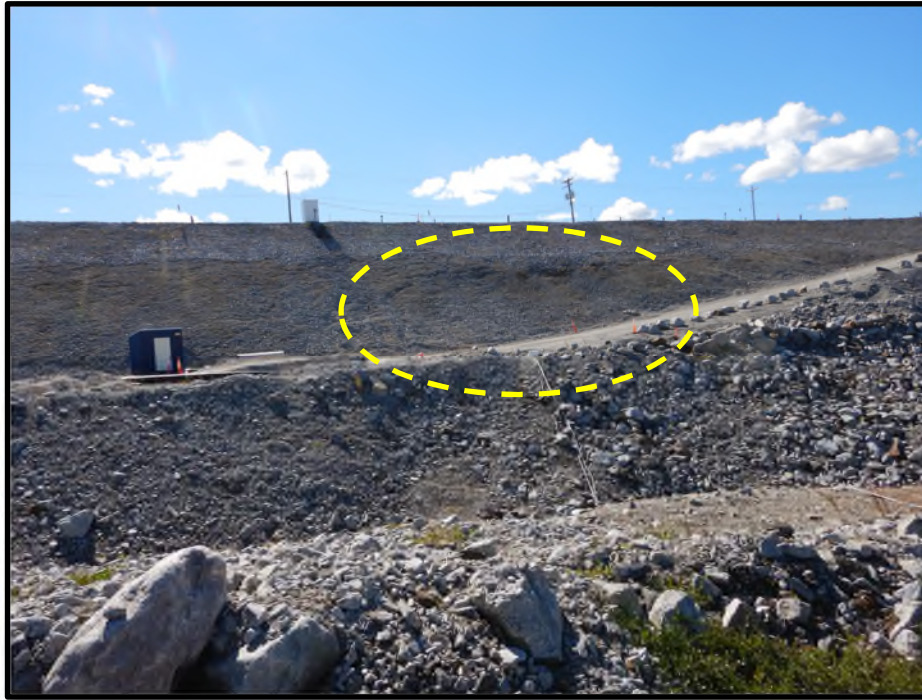
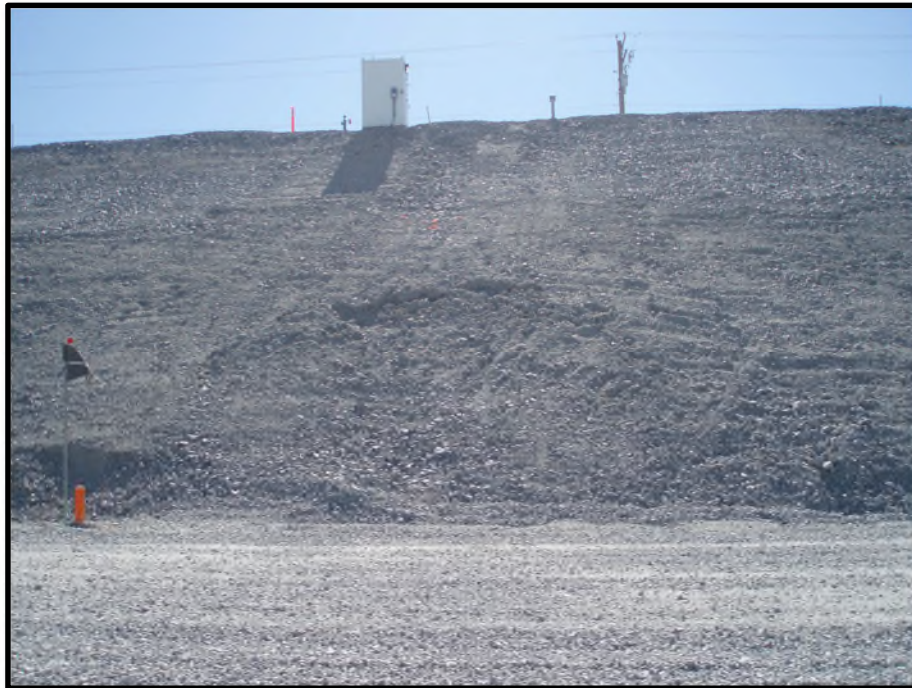
Photo D45: Downstream slope undulation observed near Station 0+900 (photo taken by Tetra Tech in 2022).

Photo D46: Same downstream slope undulation shown in Photo D45 (photo provided by DDMI from 2007).

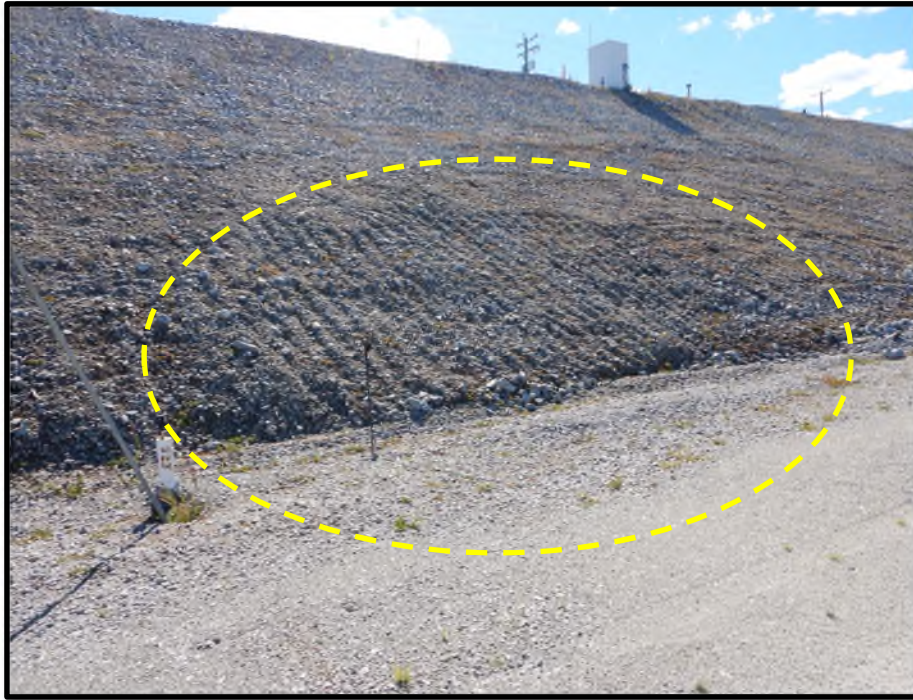
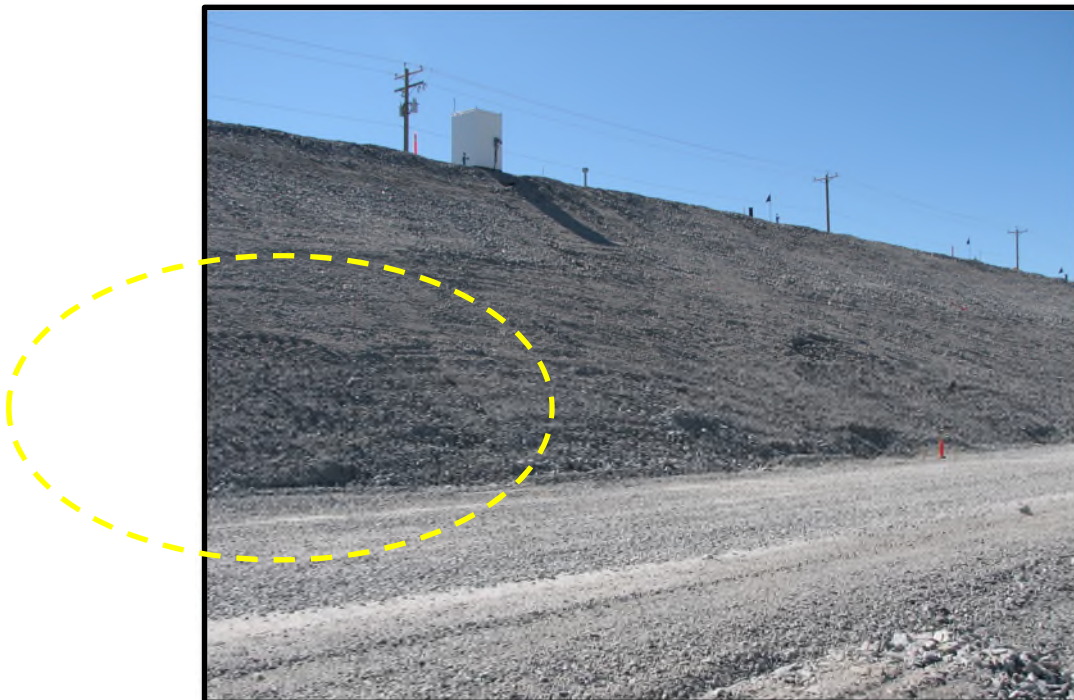
Photo D47: Downstream slope regrading observed near Station 0+575 (photo taken by Tetra Tech in 2022).

Photo D48: Same downstream slope regrading shown in Photo D47 (photo provided by DDMI from 2007).
