Our reference: DDMI Incident number 129935911_61366

Your reference: GNWT Spill 2024475

Subject: Follow-up to GNWT Spill report 2024475

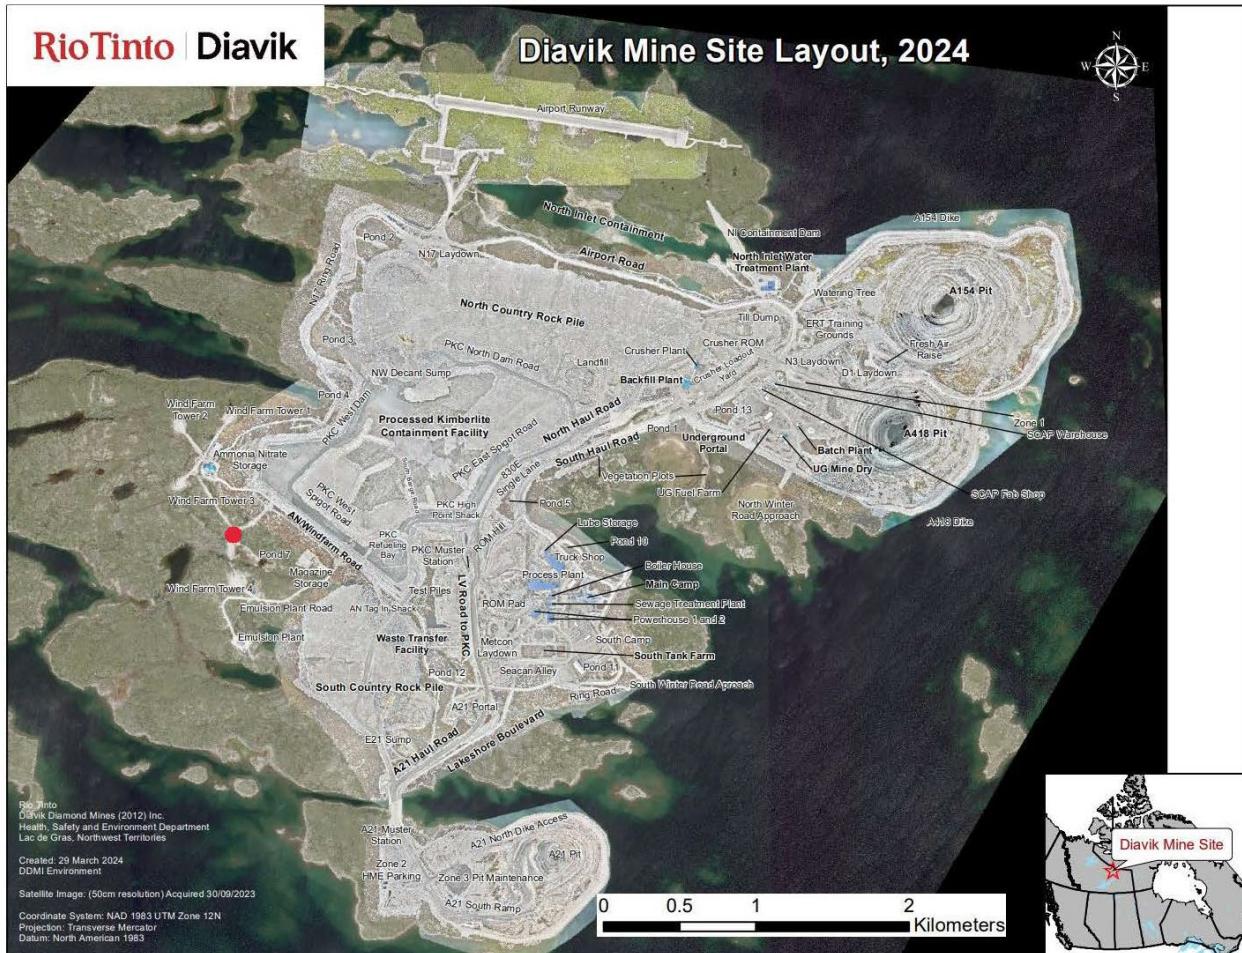
- On 19 December 2024, approximately 1688 L of diesel was spilled when a fuel truck tipped onto its side at the inside toe of the Pond 7 dam (Figure 1, Figure 2), causing diesel to spill out through the top air vent (Figure 3).

- The incident location is approximately 120 m from the Pond 7 breach location. There is no evidence of migration through the residual dam or to the breach location.

Figure 1: Spill 2024475 Location indicated by the red dot.

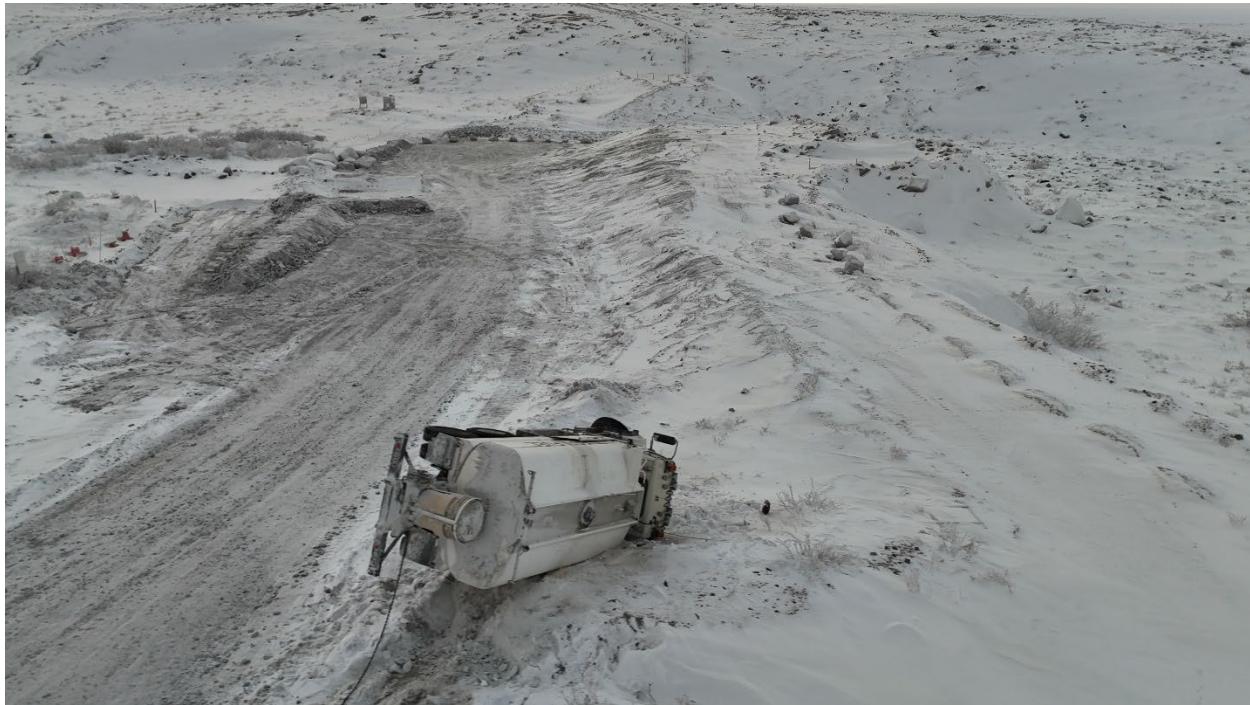
Figure 2: Aerial image of truck tipped onto its side at inside toe of residual Pond 7 dam.

- Excavation continues in the impacted area and completion will be verified by soil sampling efforts and by the GNWT-ECC Inspector.
- DDMI's internal investigation determined that the road in question was generally only used for seasonal dewatering prior to area closure activities, and was not designed with sufficient criteria (berms, sightlines, and signage) to be navigated by heavy equipment in winter conditions. A sitewide audit of roads and intersections for design and signage risks is underway to prevent recurrence as area uses continue to change with progressive closure activities.
- Enhanced spill reporting and response training has been developed and will be rolled out to all site leadership.
- Downstream monitoring will be conducted during freshet to the satisfaction of the GNWT-ECC Inspector.

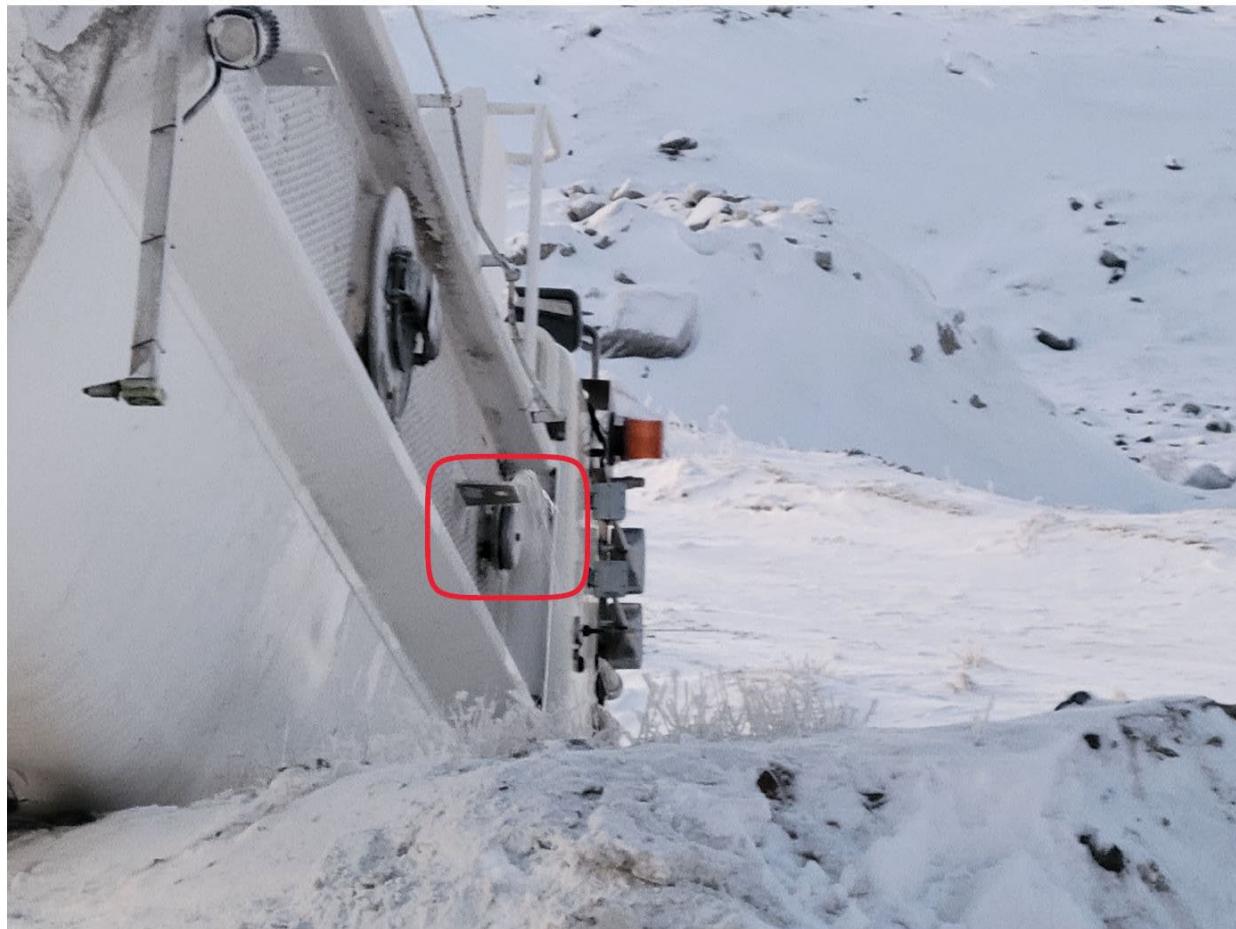
Figure 3: Flow of diesel from top air vent of overturned truck.

- After ensuring the safety of the involved person and stabilizing the tipped vehicle, measures were taken to minimize the volume of spilled diesel by catching it in buckets until the air vent could be sealed.

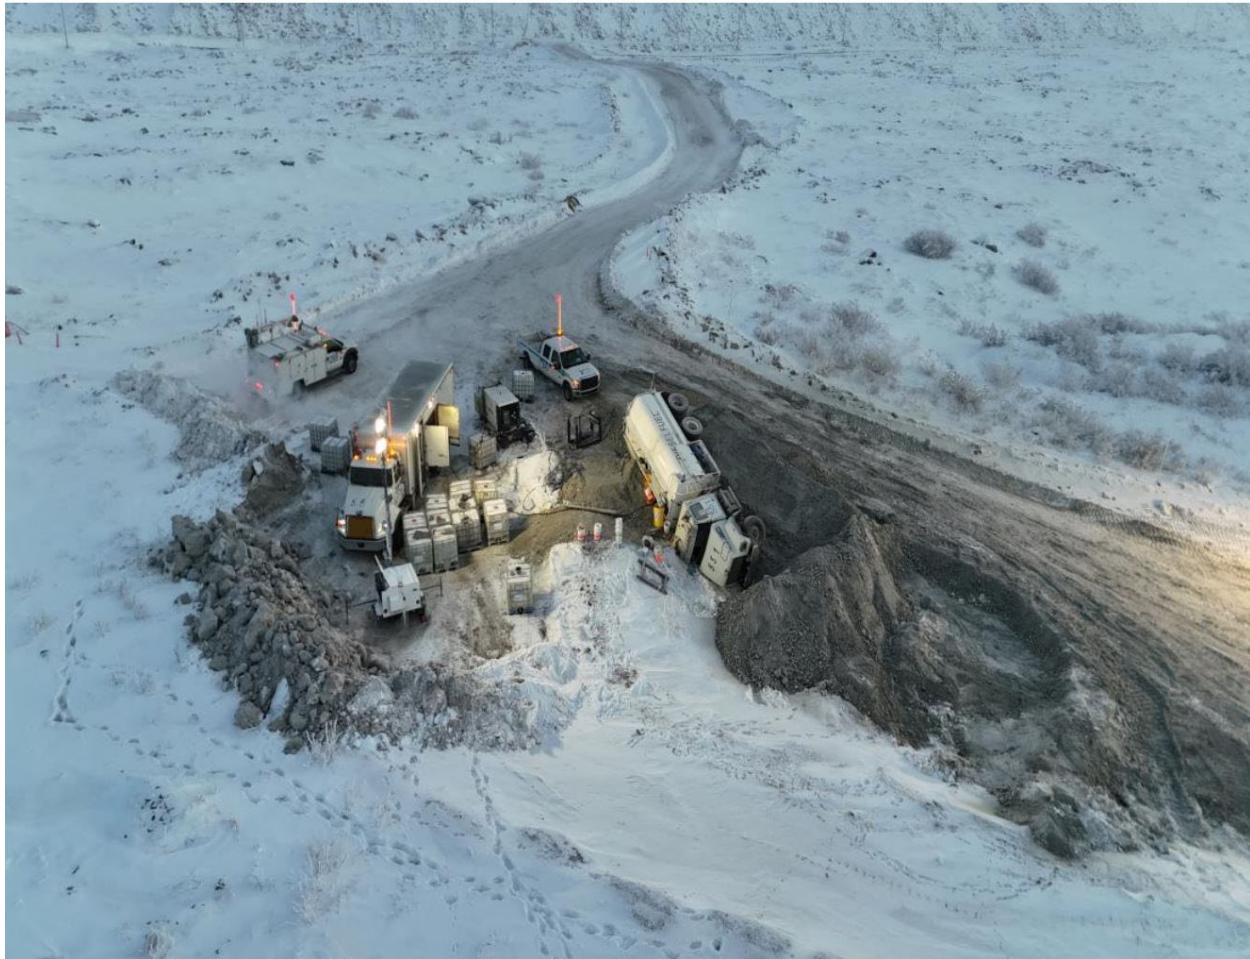
Figure 4: Aerial image of fuel pump-off operations and decanted totes of fuel.

- Remaining fuel was pumped out of the truck (Figure 4) prior to the truck being righted and removed for safety purposes.
- Once the truck was removed, excavation commenced in the spill area and is anticipated to be completed by the end of January. Further efforts will be focused on the area during freshet to monitor for, and prevent further migration to the satisfaction of the GNWT-ECC inspector (Figure 5).

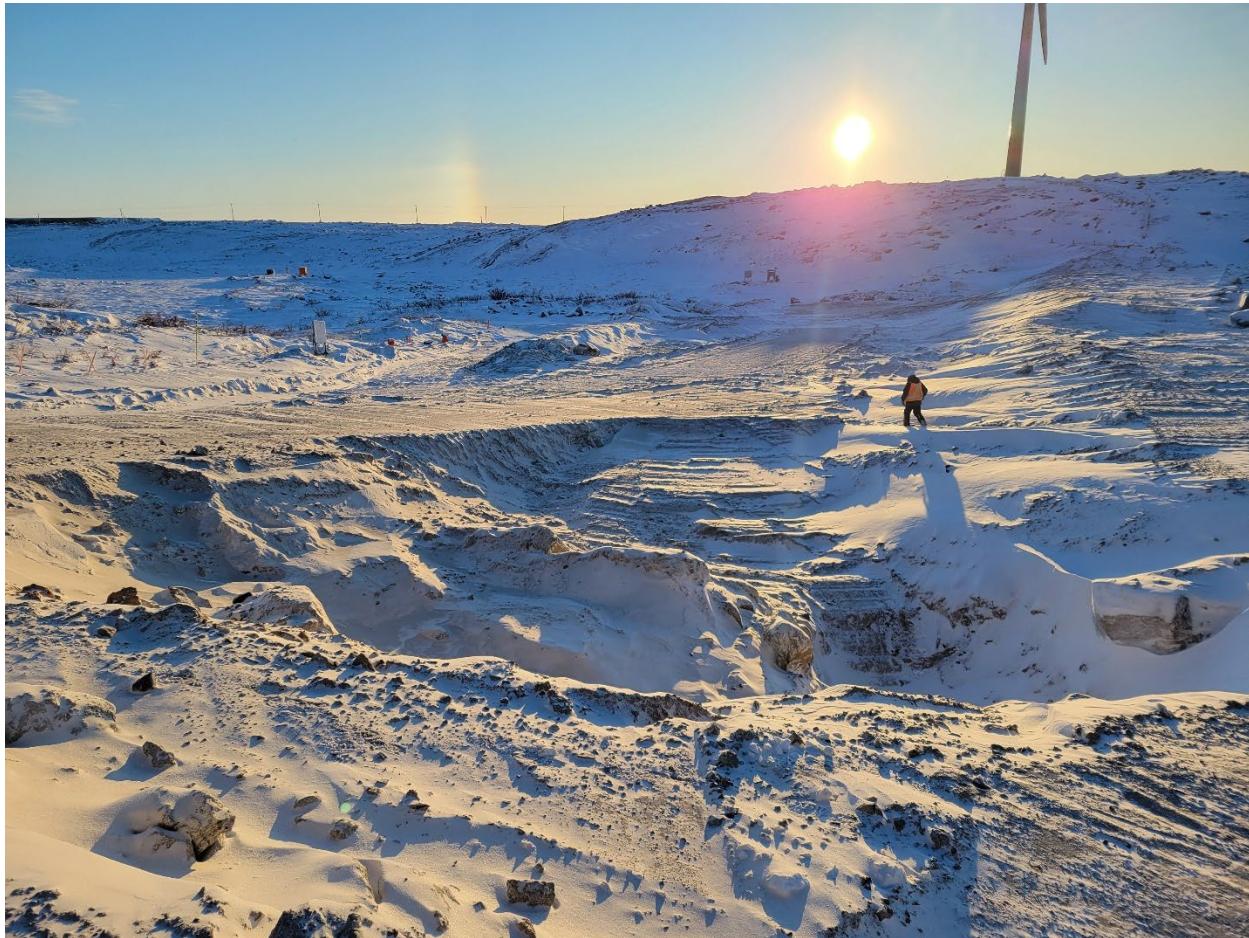
Figure 5: Spill area excavation as of 16 January 2025.

- DDMI notified the GNWT-ECC Inspector and reported the spill to the GNWT spill reporting line.
- The truck was stabilized to allow for better control of the spillage, and remaining fuel in the truck was pumped out to allow the truck to be safely righted and removed.
- Once the truck was removed, excavation commenced in the impacted area. 616 m³ of contaminated material has been removed to date – 257 m³ of large grain material to the North Country Rock Pile (NCRP) Type 3 storage area, 109 m³ of fine grain material to the Land farm, and 250 m³ of mixed-size material awaiting sorting.
