CIRNAC-CARD Rayrock Remediation Project

**RE: Land Use Permit W2020X005, Water License W2020L8-0003 – Rayrock Remediation Project**

INSPECTION DATE – March 12, 2025

**ENVIRONMENTAL INSPECTION REPORT (W2020X0005 & W2020L8-0003)**

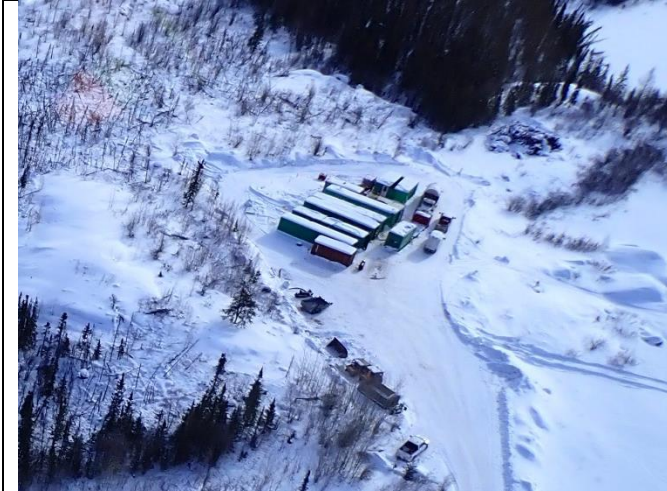
During the winter season, the main camp at Rayrock is not operational; instead, a small winterized camp is utilized to accommodate the winter road crew (Photo #1). The wastewater management system at the winter camp differs from that of the summer camp, with greywater being disposed of in a sump and blackwater being collected in drums for offsite removal. The camp wastewater treatment building is being transported out via the winter road (Photo #2), and a larger unit will be brought in to address challenges associated with meeting the wastewater discharge EQC requirements for the 2025 summer construction season. The inspectors visited the wastewater containment structure located behind the main camp, which currently contains two portable bladder tanks—one almost full and the other partially filled (Photo #3). Snow cover impeded the ability to fully assess the condition of the bladder tanks that have overwintered at the site or the condition of the liner of the wastewater containment structure as tears were observed during the October 2024 inspection.

**Photo #1: Overview of the small winterized trailer camp set-up at Rayrock.**

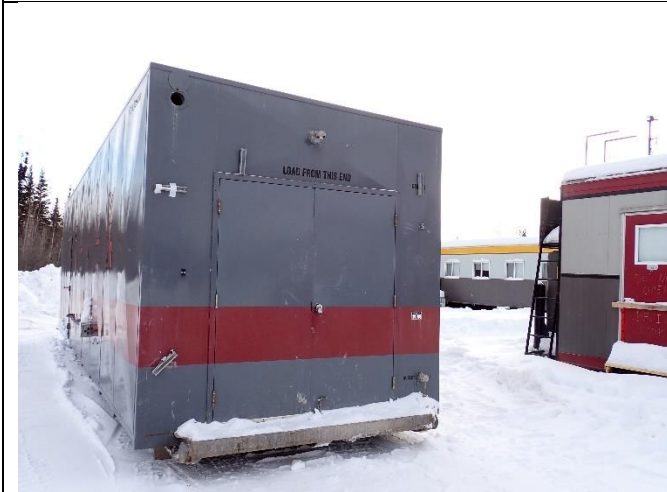
**Photo #2: The old wastewater treatment plant that was in operation during the 2024 construction season. This unit will be replaced in 2025 with a larger unit.**

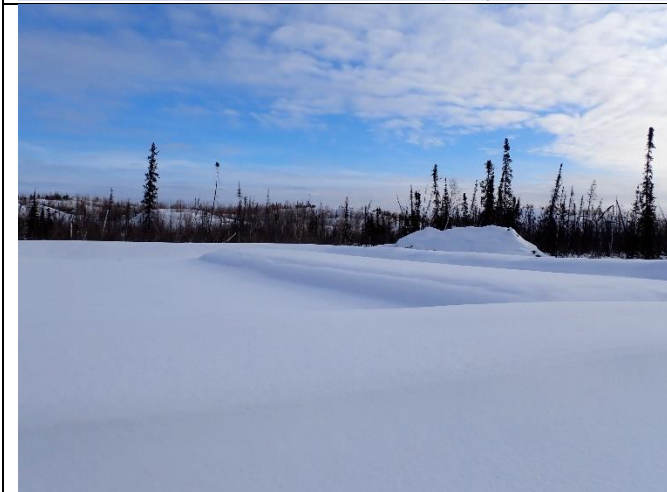
**Photo #3: Snow covered wastewater containment structure.**

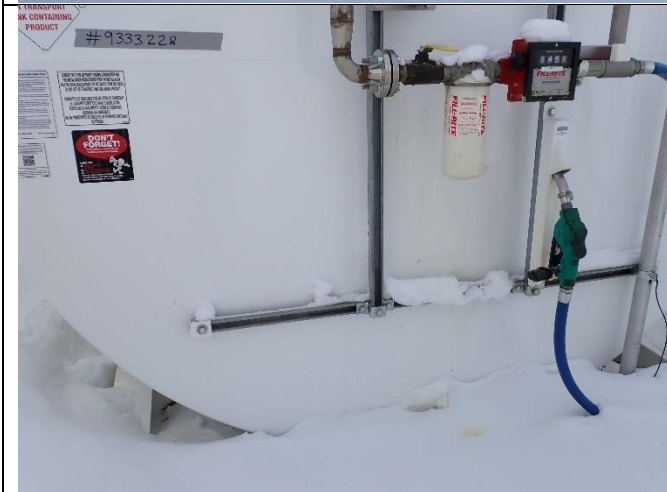
The inspectors also examined the large bulk fuel storage tanks on site. No significant issues were identified, although minor fluid leakage was observed beneath one of the tanks and was flagged for attention by on-site personnel (Photo #4). Contaminated snow, attributed to exhaust fumes from the light tower, was observed near the fuel tanks (Photo #5) that requires collection and proper disposal. Minor ground rutting was also observed in this area, which will require remediation.

**Photo #4: Contaminated snow from dripping liquid at the fuel tanks.**

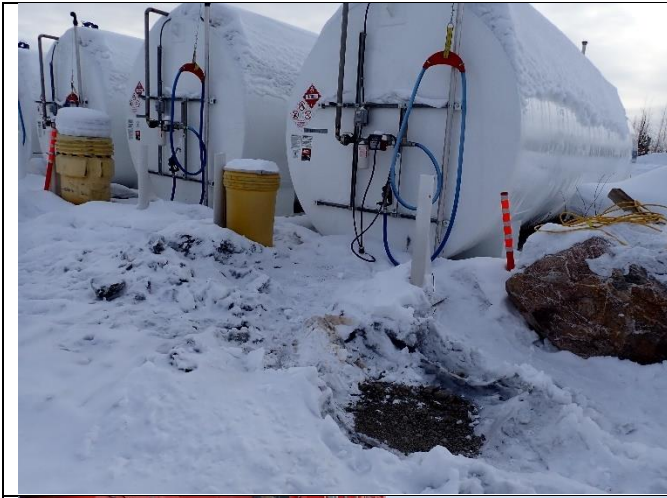
**Photo #5: Contaminated snow and minor ground rutting located near the fuel tanks at site resulting from the exhaust from the light tower.**

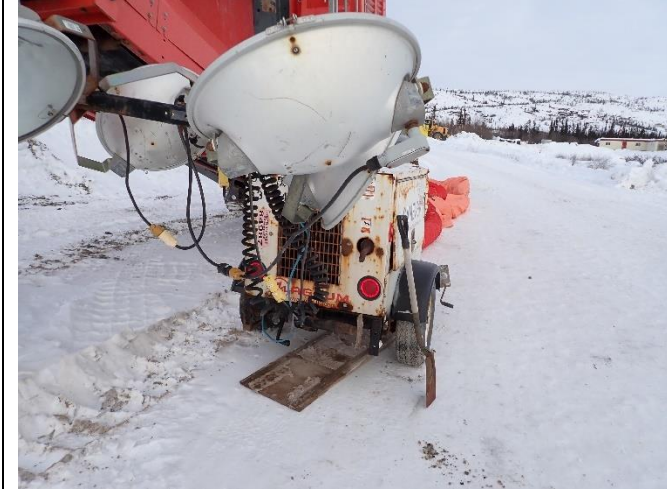
While machinery and equipment on site were equipped with drip trays, the absorbent pads appeared worn and ineffective, and many require replacement (Photo #6). The majority of fuel drums and waste products on-site remain within secondary containment, however the proponent is advised to ensure that snow is removed from the containment and properly disposed of prior to spring melt. Efforts to verify and maintain the structural integrity of secondary containment, including walls and corners, is required. A few tears were noted in the corners of the berms on site (Photo #7).

**Photo #6: A drip tray that should be refreshed.**

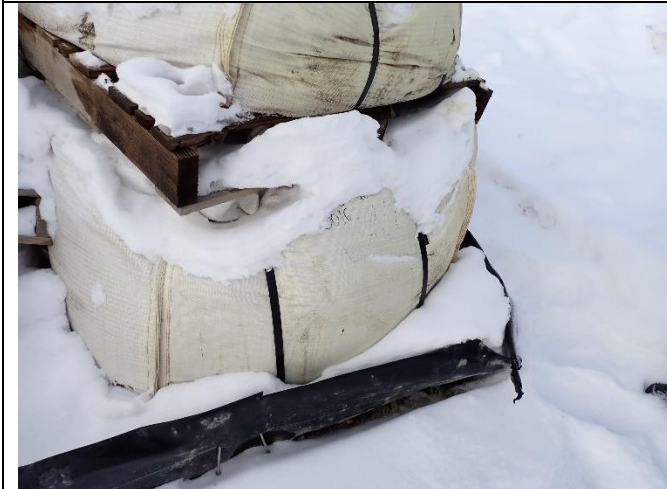
**Photo #7: Tear in the side wall of a berm holding waste on site. All secondary containment should be inspected to ensure they function effectively prior to spring melt.**

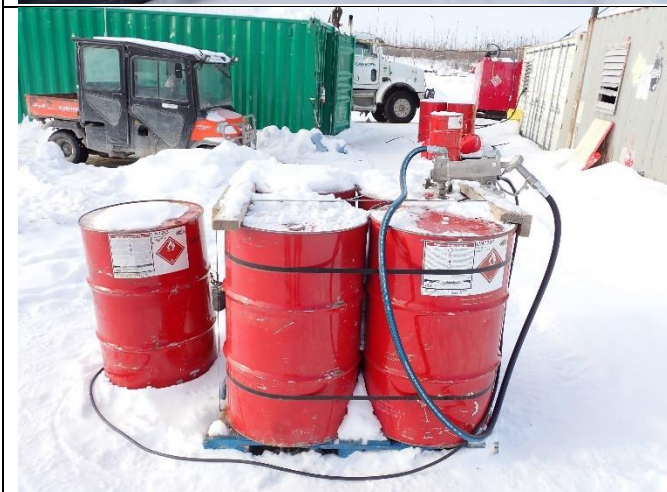
**Photo #8: Fuel drums near the camp facilities not stored in proper secondary containment.**

Several fuel drums located adjacent to the winter camp were found to be outside secondary containment (Photo #8) and must be relocated into secondary containment. A large battery providing power for a fuel pump was observed on the ground, it is recommended that it be elevated off the ground and appropriately stored when not in use.

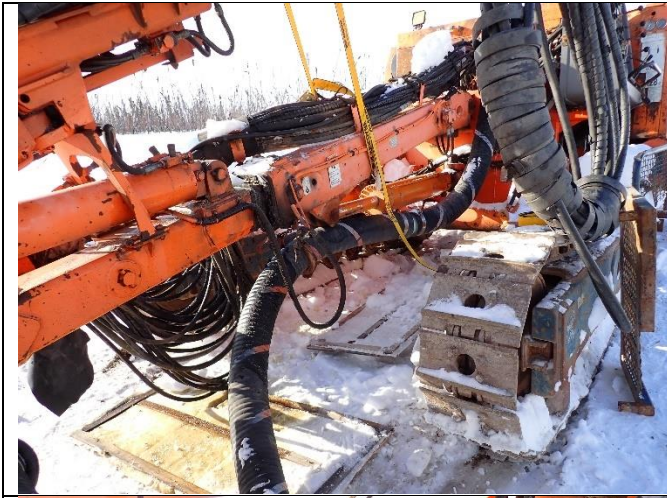
**Photo #9: A saturated drip tray under drilling machinery that needs to be replaced.**

During the inspection, a drill was noted to have a fluid leak, with the drip tray beneath the machine saturated (Photos #9 and #10). A pail containing oily water was also discovered behind the drill and must be disposed of in accordance with environmental protocols (Photo #11). The equipment should be examined and maintained as necessary, the drip tray replaced, and any contaminated snow appropriately disposed of.

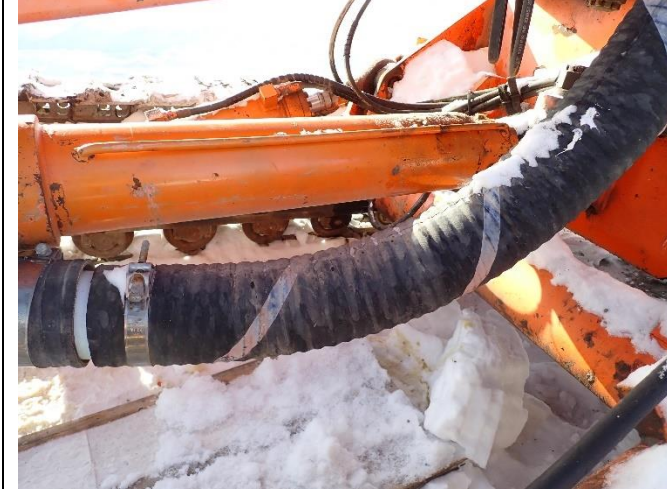
**Photo #10: Additional liquid from drilling equipment that has contaminated surrounding snow and must be addressed.**

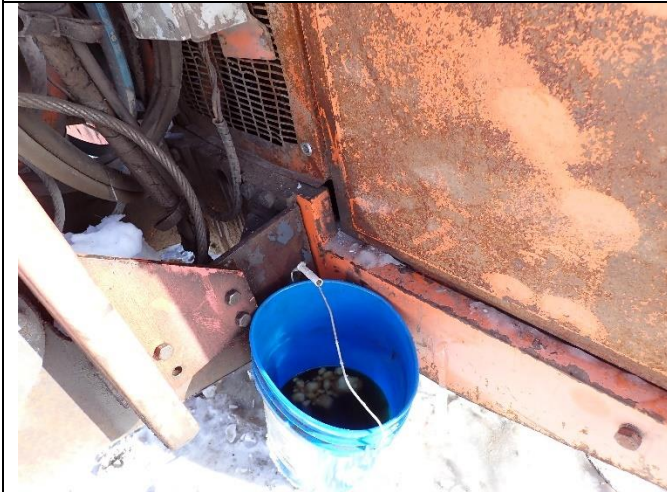
**Photo #11: Oily water stored behind the drill that will need to be appropriately disposed of.**

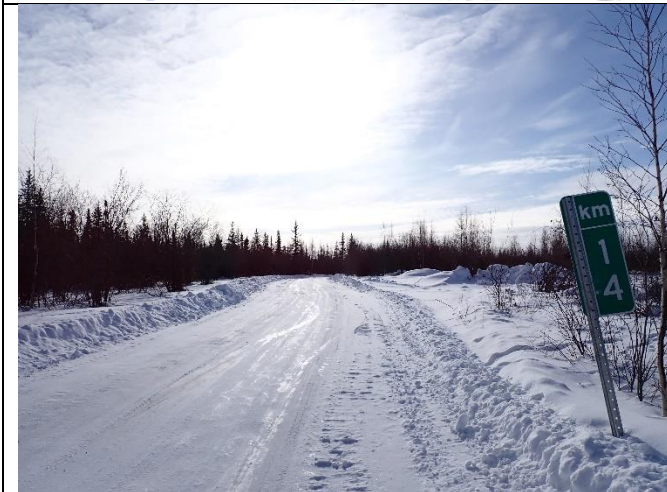
The inspectors flew over the progress made on the winter road construction and observed no concerns with the road's condition. Brush clearance was completed as required, and the road appeared well-maintained (Photo #12). The winter road between Rayrock and Sunmain was found to be in good condition (Photo #13). The inspectors were satisfied with the winter road's operation.

**Photo #12: The entrance to the Rayrock Winter Road at the edge of the camp.**

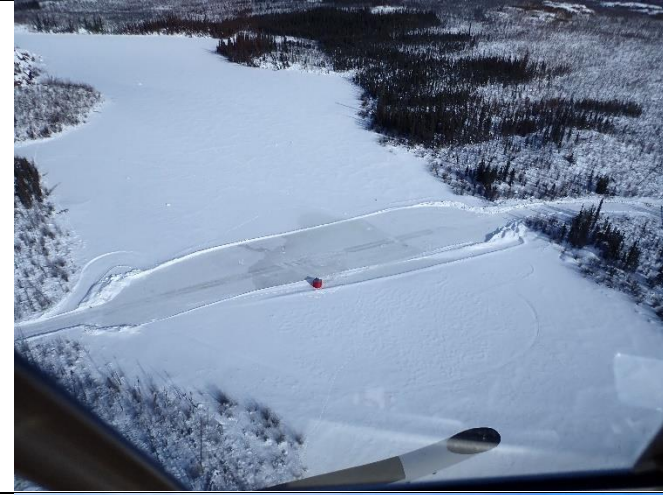
**Photo #13: One section of the winter road at a lake crossing. An emergency shelter is present on the side of the road.**

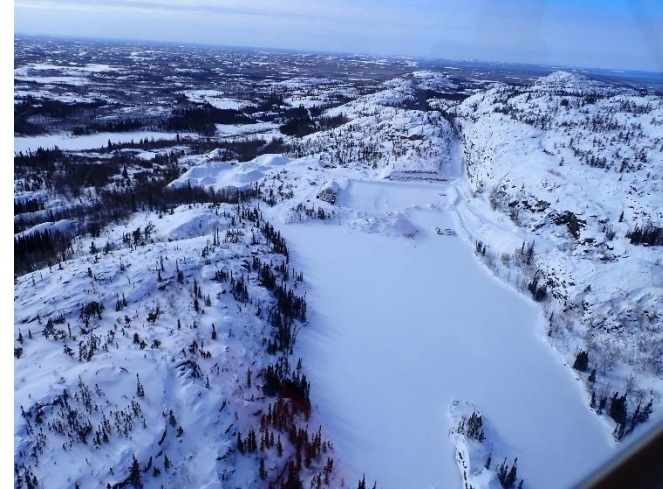
An aerial flyover of the full project site, including the confined disposal facility (CDF), confirmed that minimal winter operations have occurred in other areas of the site to date (Photo #14). Notification of an upcoming drill program near Mill Cove and the CDF had been received by inspectors on March 11, 2025.

**Photo #14: Overview of Mill Lake, the CDF, and the Mill Lake water treatment facility.**

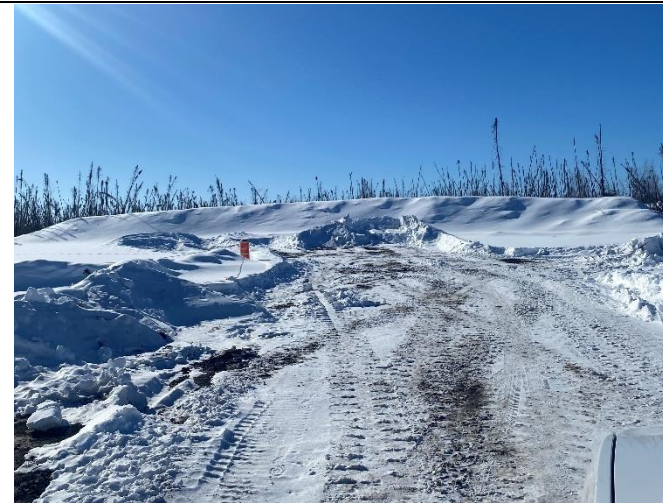
**Photo #15: Drill removed from site. Photo provided by Sanexen.**

leak has been removed from the site via the winter road as it will not be required for the upcoming season, and the oily residue was disposed of (Photo #15). Drip trays around the site were replaced (Photo #16), and snow staining from the exhaust of the light tower has been identified and is being collected as the equipment is moved. Fuel previously found outside secondary containment has been relocated into secondary containment (Photo #17).

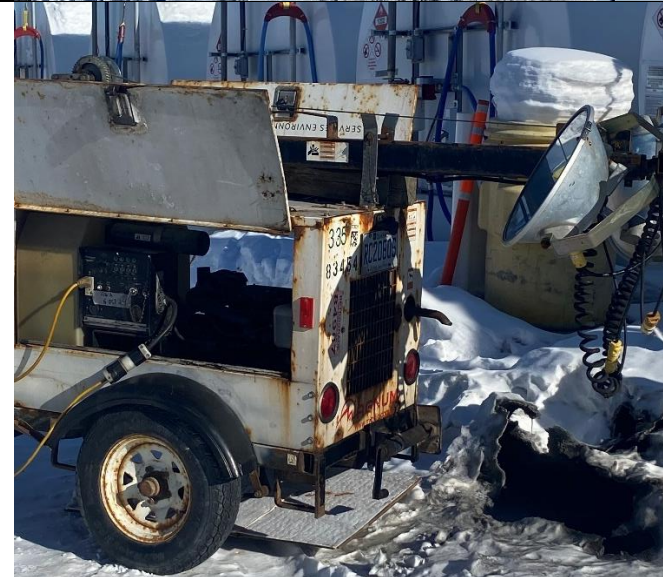
**Photo #16: Replaced drip-tray under machinery. Snow staining from light tower exhaust still requires collection and appropriate disposal. Photo provided by Sanexen.**

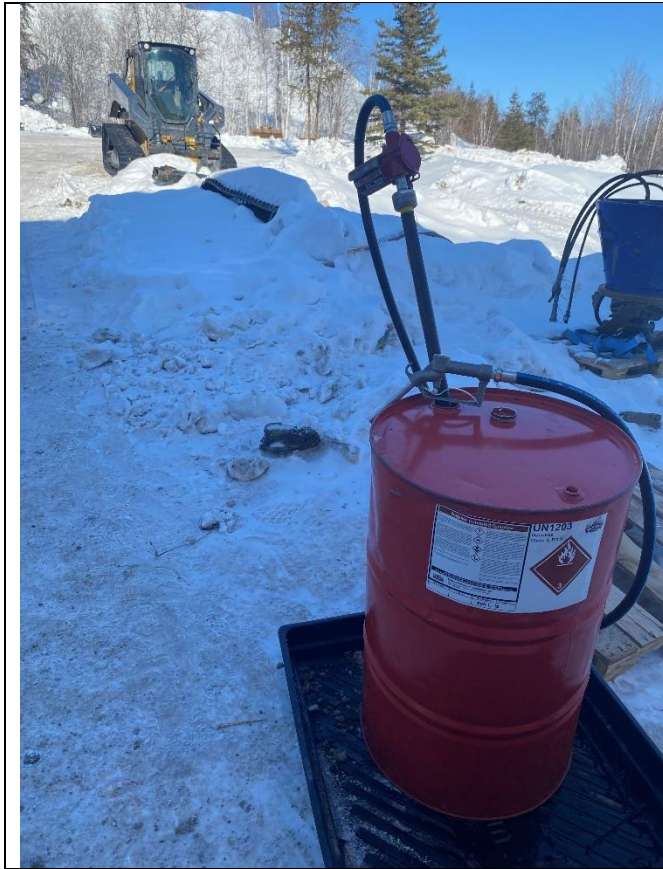
**Photo #17: Fuel drum moved in to secondary containment. Photo provided by Sanexen.**
