CIRNAC-CARD Rayrock Remediation Project

**RE: Land Use Permit W2020X005, Water License W2020L8-0003 – Rayrock Remediation Project**

INSPECTION DATE – May 26, 2025

ENVIRONMENTAL INSPECTION REPORT (W2020X0005 & W2020L8-0003)

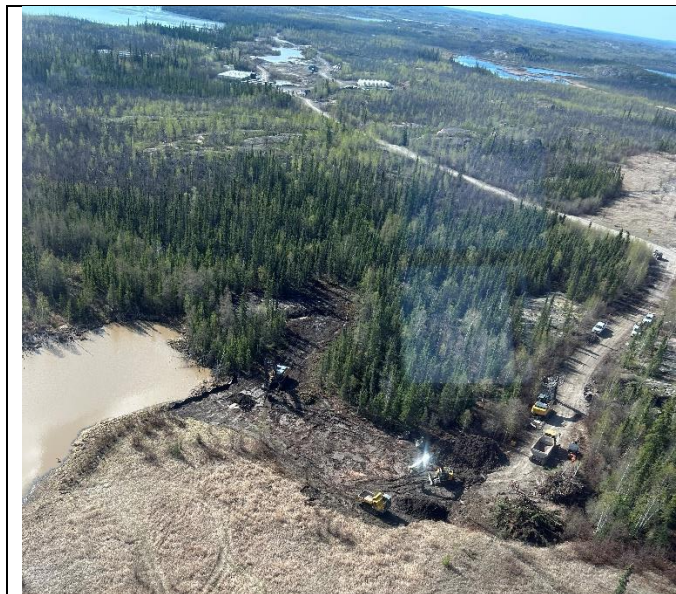
Rayrock camp was in operation during the inspection, with work concentrated on adding cover material to areas of previously capped tailings. While doing this work, some areas of uncapped tailings that were not remediated to standard during previous remediation work were discovered. Vegetation clearing and radiation sweeps were occurring in an area adjacent Beta Lake during the inspection (Photo #1, Photo #2). The Inspector reminded on-site staff that nest sweeps for breeding birds are to be conducted in any areas of additional vegetation removal required for the tailings cover work to minimize disturbance to wildlife per permit condition 26(1)(q) 87.

**Photo #1: Overview of work being completed to add cover to a small tailings area.**

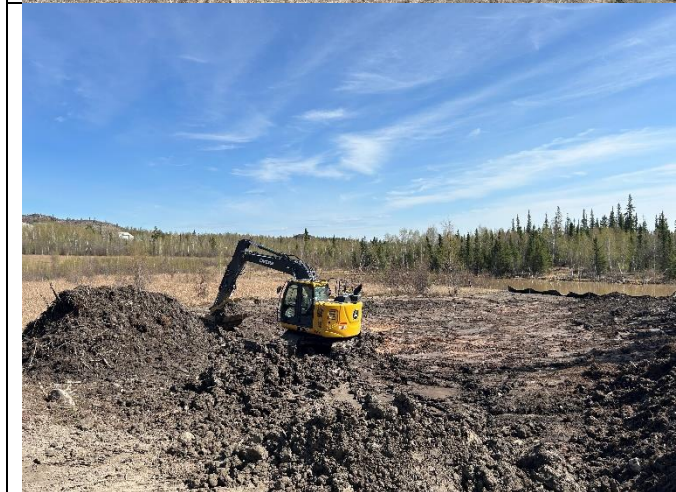
**Photo #2: A tailings cover area being prepared for remediation capping near Beta Lake.**

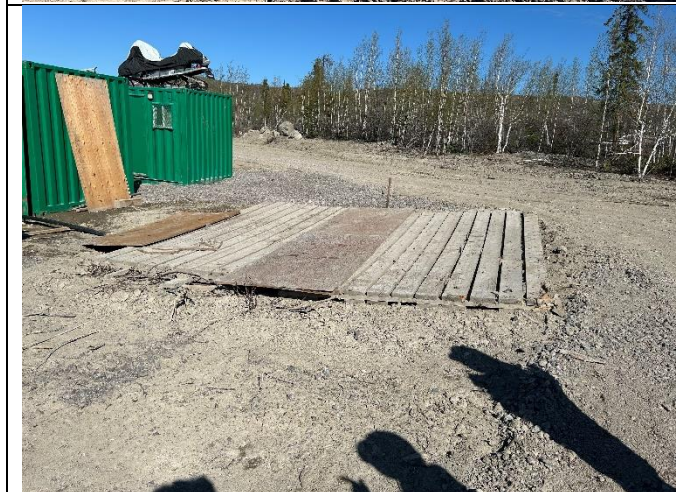
The camp accommodations have moved back to the summer trailer setup, with the winter camp trailers moved via winter road network to Sunmain to support a small satellite crew. Boards were placed over the grey water sumps used during the winter camp period to mark them and prevent wildlife interaction (Photo #3).

**Photo #3: Grey water sump from the winter camp with boards covering it to prevent wildlife interaction.**

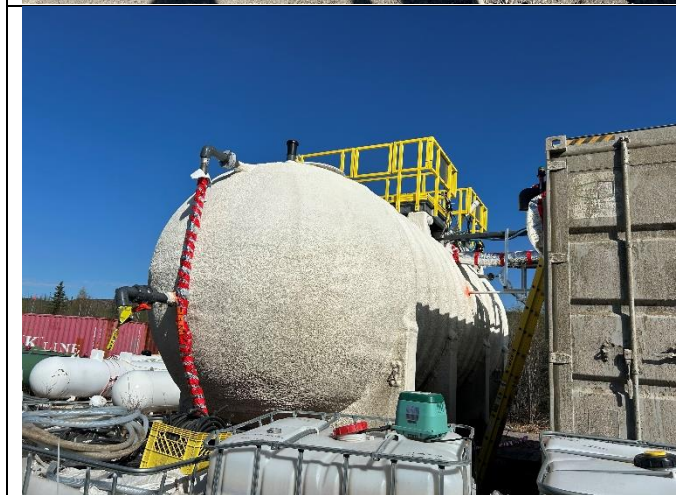
Camp wastewater operations were active and effectively treating water during the inspection. A new camp wastewater treatment system was brought to site during the winter road season. Compliant, treated water was being directed to the drainage field (Photo #4, Photo #5). The wastewater containment structure contains free water from snow melt, as well as the two bladder tanks which remain intact (Photo #6). The bladder tanks contain non-compliant wastewater from last season that will be gradually treated to meet license criteria for camp wastewater, and drained throughout the summer season (Photo #7). New tears were observed in the liner of the secondary containment structure that require repair, along with the tears noted in the fall prior to camp shut down. The Inspectors would like a plan and schedule for addressing these tears as per the Secondary Containment Structure Construction, Maintenance and Decommissioning Plan. Bear activity on site has been high this spring, with a curious bear interested in one of the pumps related to the wastewater treatment facility. To prevent pump roughhousing, the cover on one of the pump systems had been temporarily removed (Photo #8).

**Photo #4: Part of the new camp wastewater treatment plant.**

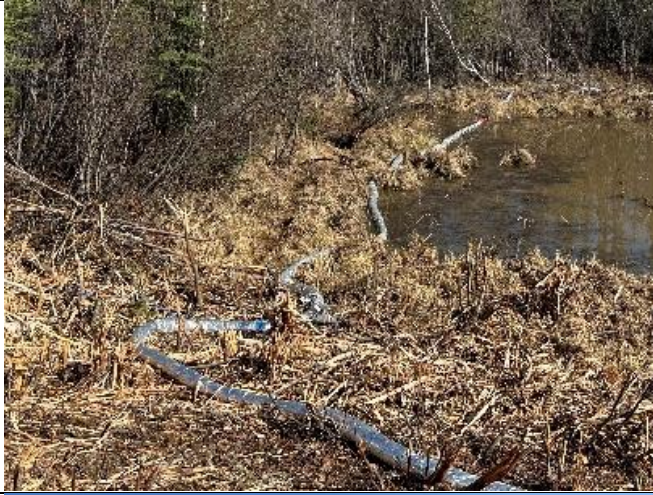
**Photo #5: Portion of the camp wastewater discharge line that continues into the trees to a discharge field.**

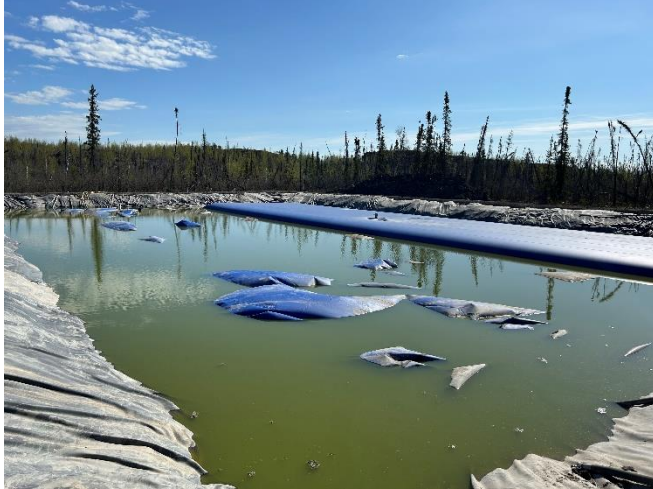
**Photo #6: Overview of the wastewater containment structure, holding free water and two blue bladder tanks.**

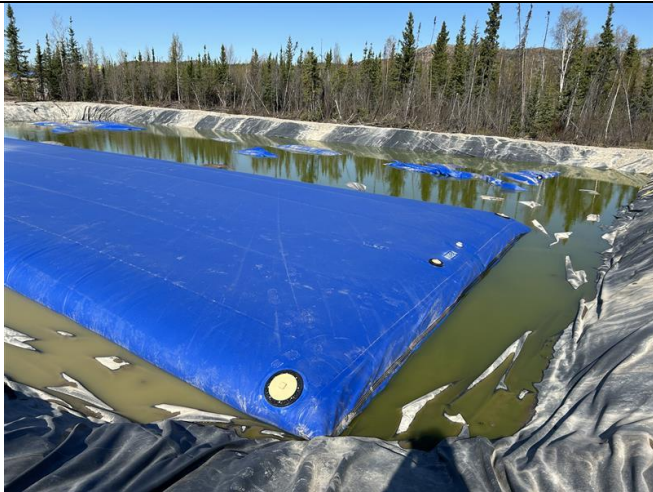
**Photo #7: One of the blue bladder tanks on site within the wastewater containment structure. Water will need to be treated before being discharge this summer.**

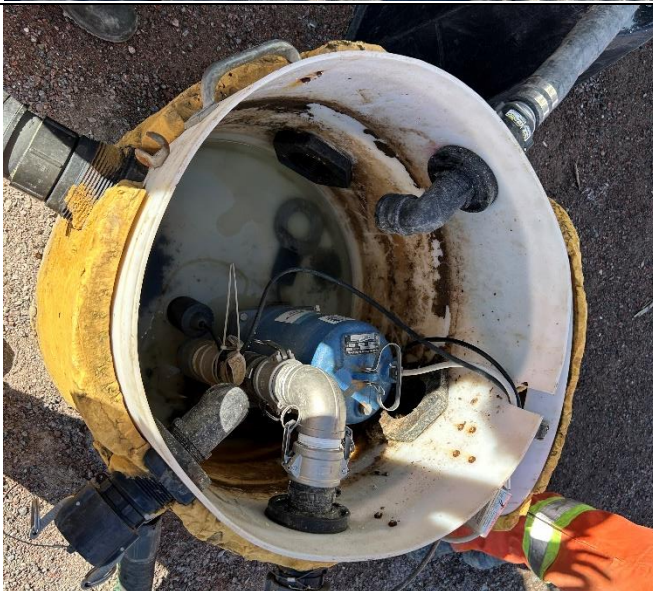
**Photo #8: Water pump associated with the camp wastewater treatment plant. A curious bear has been removing the cover.**

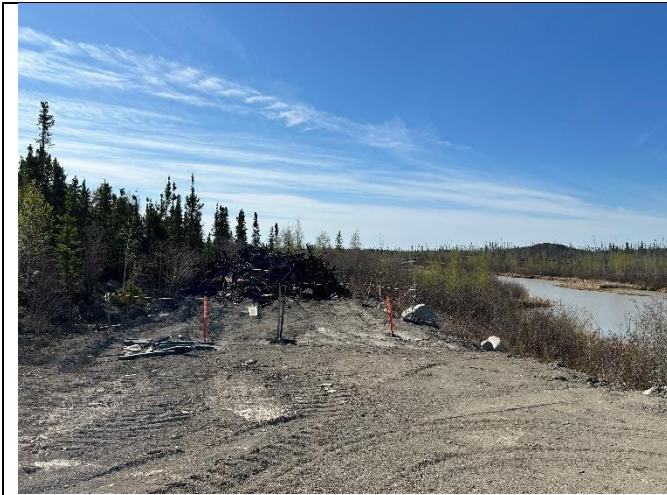
**Photo #9: Metal waste continues to be stored on-site.**

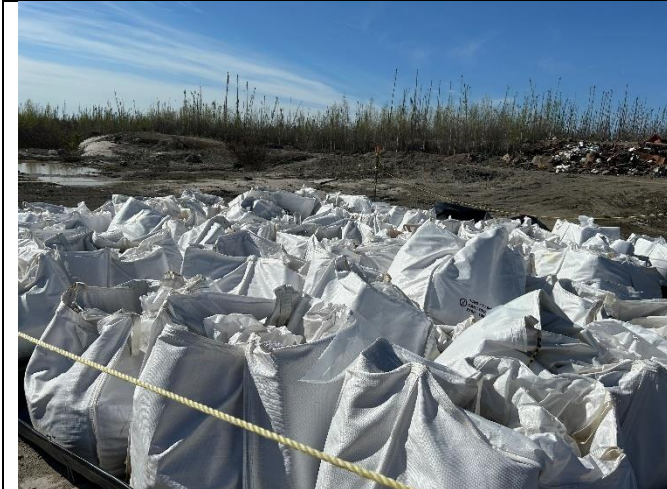
**Photo #10: Mega-bags containing waste materials that will eventually be removed from site after remediation.**

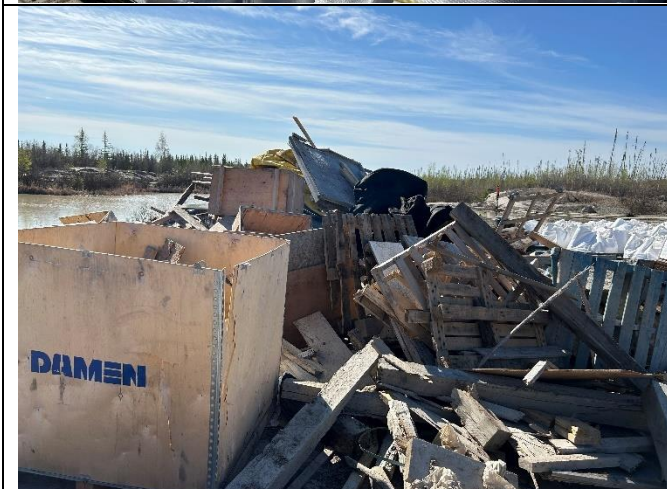
**Photo #11: Consolidated wood debris. Some non-wood material was observed in the pile (tarp) that requires removal and appropriate handling.**

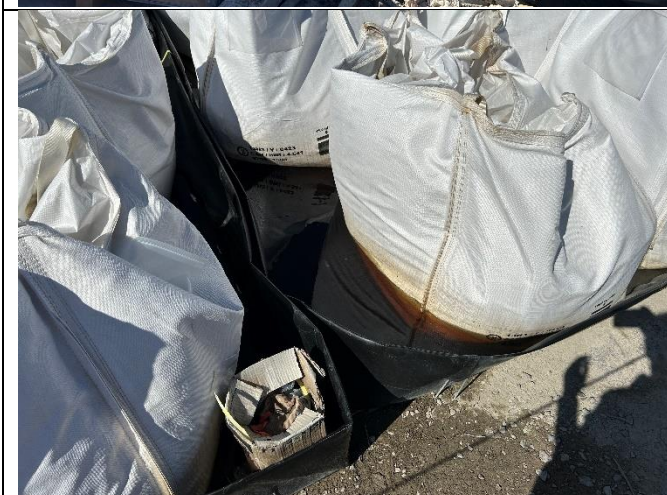
Assorted waste remain on site and was sorted, and compiled together. Metal (Photo #9), waste stored in white megabags (Photo #10), and wood products (Photo #11) were assimilated together, and when appropriate, contained in secondary containment (Photo #12). Secondary containment berms containing waste and fuel had melt water in them and should be pumped out to continue to function effectively as secondary containment measures (Photo #13). There was a noticeable fuel odor coming from one berm; as such, the water will require appropriate disposal and the stored materials inspected for potential leaks. Some minor tears were also observed that require repair.

**Photo #12: Water in a secondary containment berm containing the megabag waste bags. This water will need to be drained and appropriately disposed to ensure the secondary containment can effectively function.**

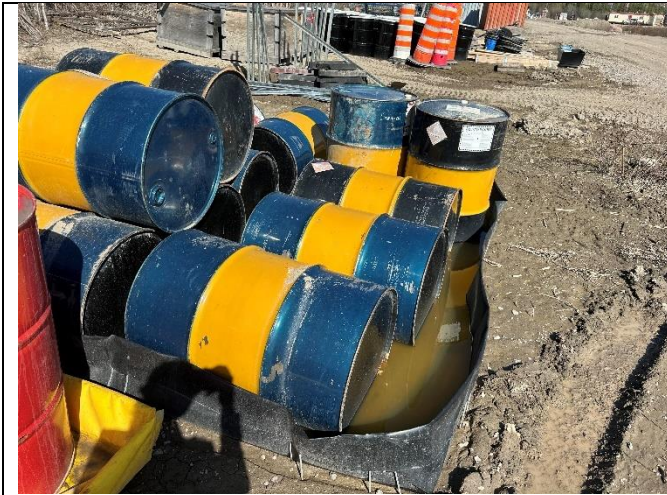
**Photo #13:** Water in the secondary containment berms needs to be drained and appropriately disposed of for the berms to effectively function as secondary containment.

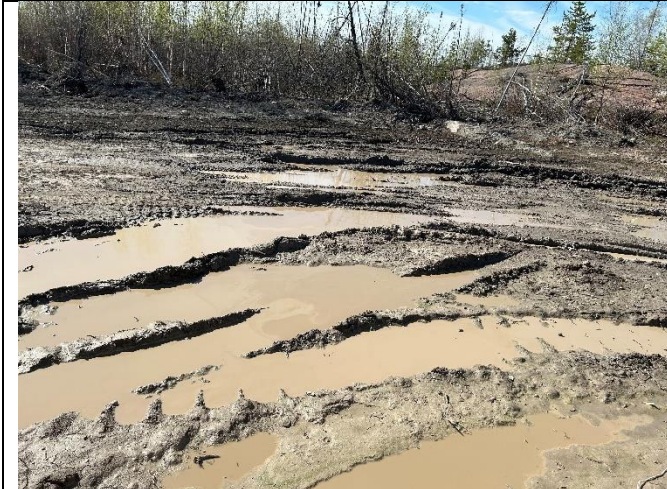
Minor ground rutting was observed and coincided with wet, low-lying areas where water accumulated (Photo #14). Extra care should be taken to drive slowly and avoid if possible.

**Photo #14:** Minor rutting and standing water at a low-lying spot at camp.

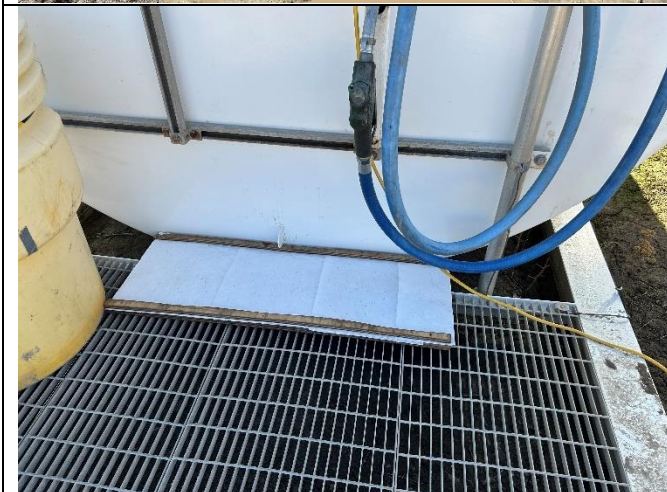
Fuel and refueling points were well managed, with effective drip trays placed under valves and nozzles (Photo #15). The machinery shop on site continues to be well organized and clean. Oils and greases were stored in secondary containment and a recycling bag for empty canisters noted (Photo #16).

**Photo #15:** A fresh drip-pad placed under the active fuel tank on site.

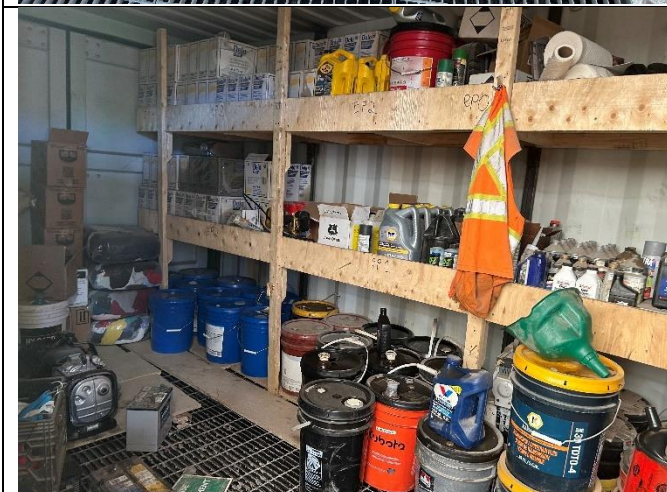
**Photo #16:** A well organized and clean mechanic shop.

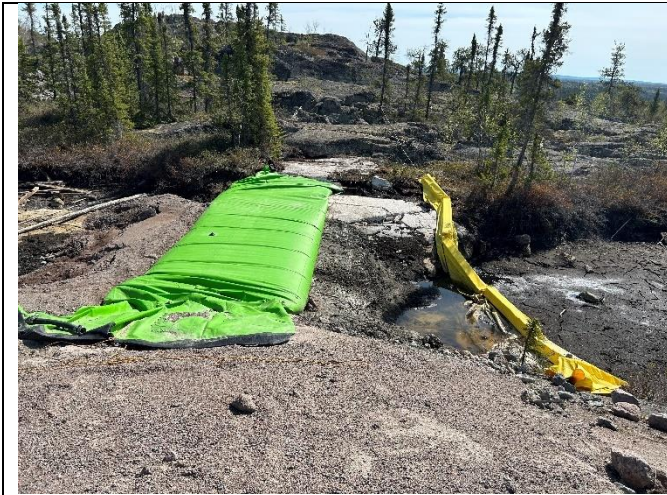
The inspectors visited the confined disposal facility (CDF) construction site, where additional work will be completed this summer on dredging and treating water from Mill Lake, and further construction of the CDF structure. Water levels in Mill Lake remain low, making the use of the filled aqua-dam on site redundant (Photo #17). Silt fence were observed in place in many areas to reduce sediment and erosion during spring melt and precipitation events. A water truck was in use to manage dust on roadways. Minor corrective measures were requested to the silt fence at the site of the water withdrawal point on

**Photo #17: Aqua-dam and silt curtains adjacent to Mill Lake. Water levels are low, and these are not currently needed to hold back water from draining into Sherman Lake.**

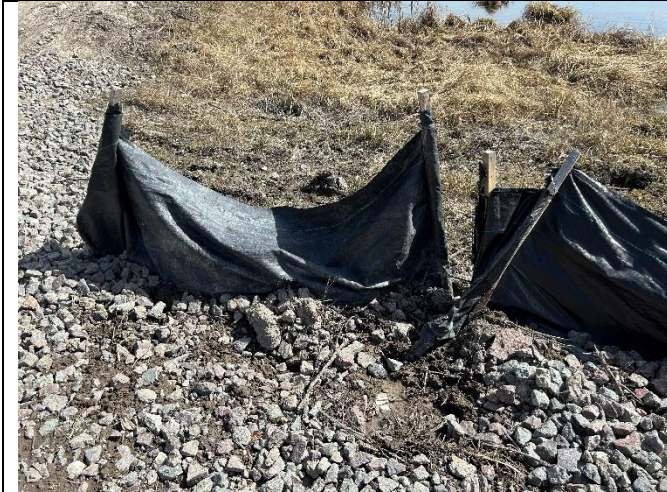
**Photo #18: A silt fence near the water withdrawal point that requires repositioning.**

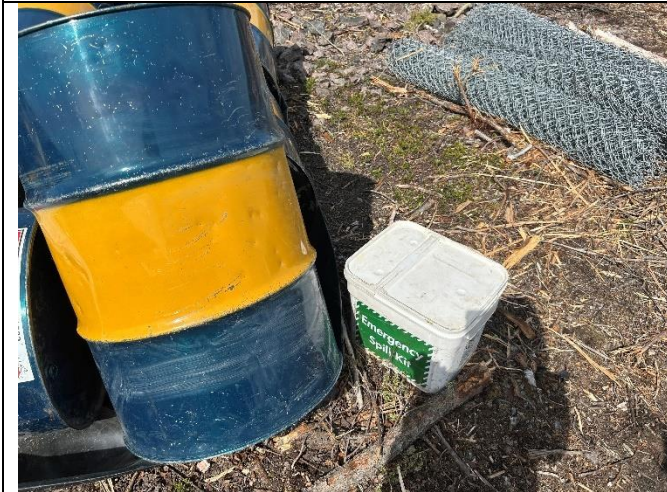
The Inspectors also visited Sunmain camp. Fuel on site was stored within a berm; however, the spill kit associated with the fuel cache was insufficiently small to effectively manage a spill and should be replaced or supplemented with a larger one (Photo #19). Machinery around site had drip trays effectively placed (Photo #20). Buildings at Sunmain were secure apart from one room (#3), where the door was open. Inspectors placed rocks outside of the door to keep it closed, but this should be secured at the earliest opportunity to prevent wildlife from entering camp facilities (Photo #21).

**Photo #19: Sunmain fuel cache and a small spill kit which is not sufficient for the size of the fuel cache.**

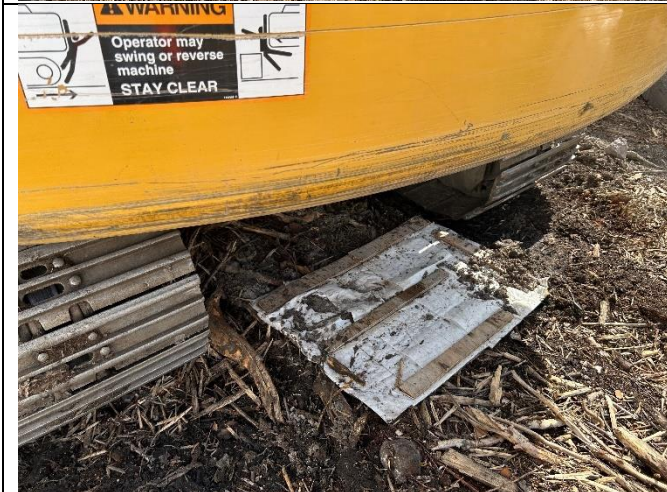
**Photo #20: A drip tray appropriately placed under heavy machinery at Sunmain.**

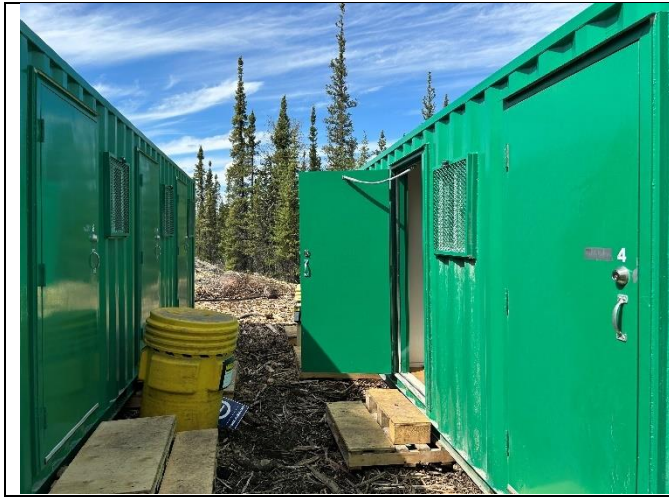
**Photo #21: Cabin #3's door before being closed at Sunmain.**
