**RE: Land Use Permit W2021C0009 – Nighthawk Gold Corp – Indin Lake Gold Project – Colomac Camp – Inspection – CIRNAC Federal Lands**

**INSPECTION DATE – March 25, 2025**

**ENVIRONMENTAL INSPECTION REPORT (W2021C0009)**

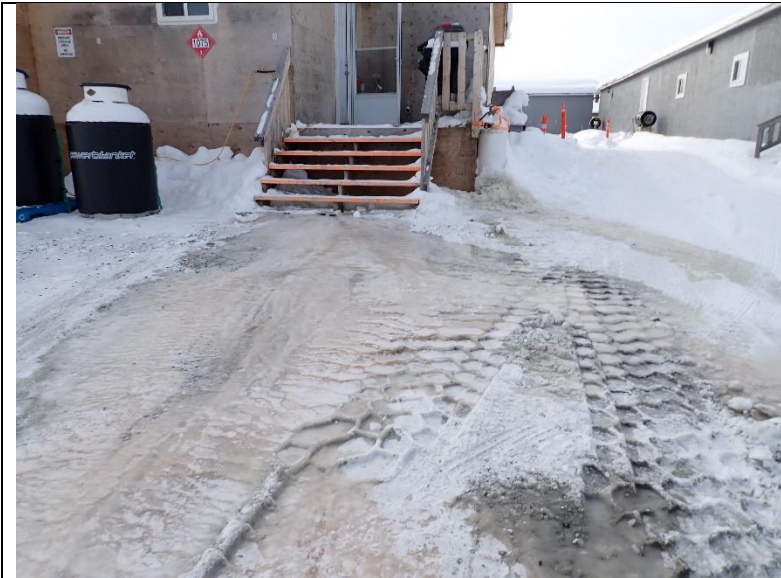
It was observed that the flow line that would typically direct kitchen greywater to the sump had frozen and was damaged, resulting in greywater release and subsequent icing in the area behind the kitchen (Photo #1). This piping system will be repaired in the summer to redirect water to the appropriate sump.

**Photo #1: Overview of the back of the kitchen building, where a frozen and damaged pipe has resulted in grey water discharge and subsequent icing.**

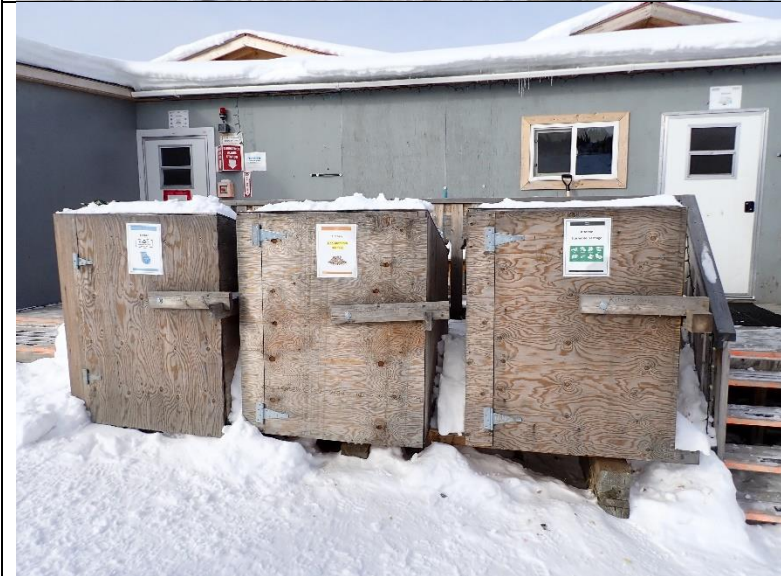
Waste streams at the camp were well-managed during the inspection, with different kitchen waste streams being sorted and securely contained (Photo #2).

**Photo #2: Waste on site is sorted and organized into different waste streams.**

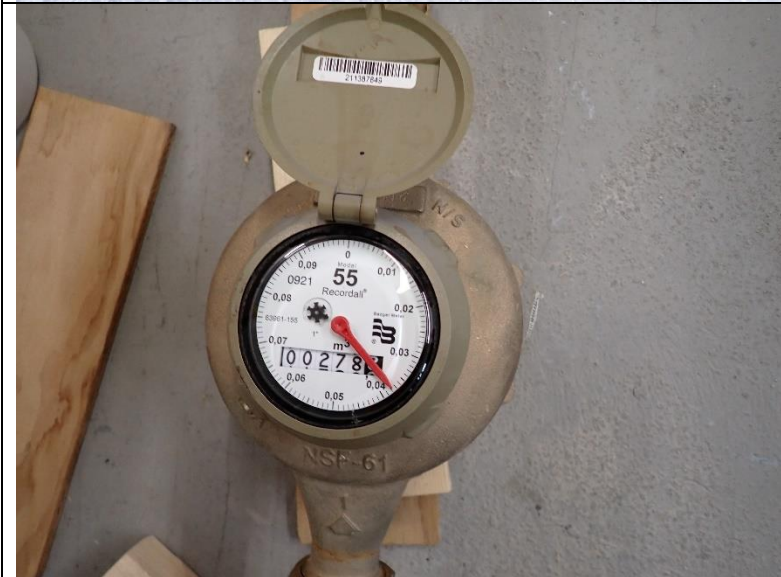
Water use for the camp continued to be monitored as per W2021L2-0005 water licence requirements. The water gauge at the water storage tanks tracks the water utilized by camp operations (Photo #3).

**Photo #3: Camp water continues to be tracked and volumes monitored throughout the winter road season.**

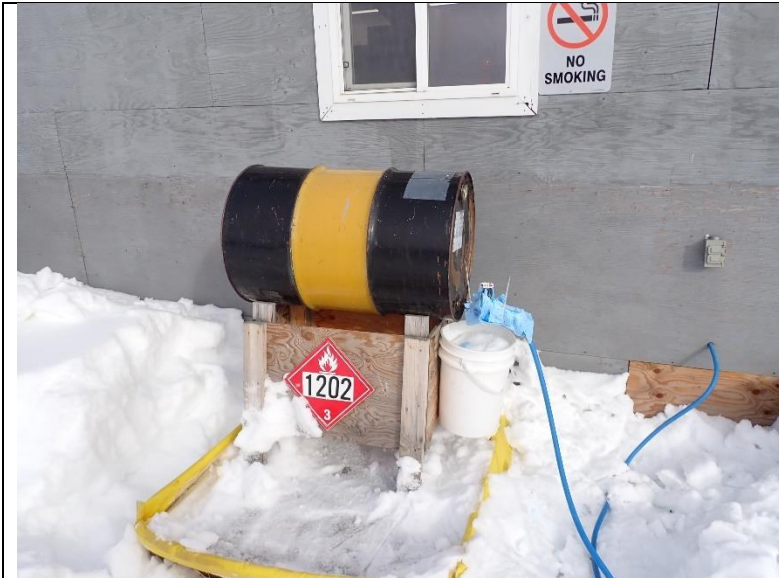
**Photo #4: Fuel is stored elevated from the ground, with appropriate secondary containment and cleared of snow on a regular basis.**

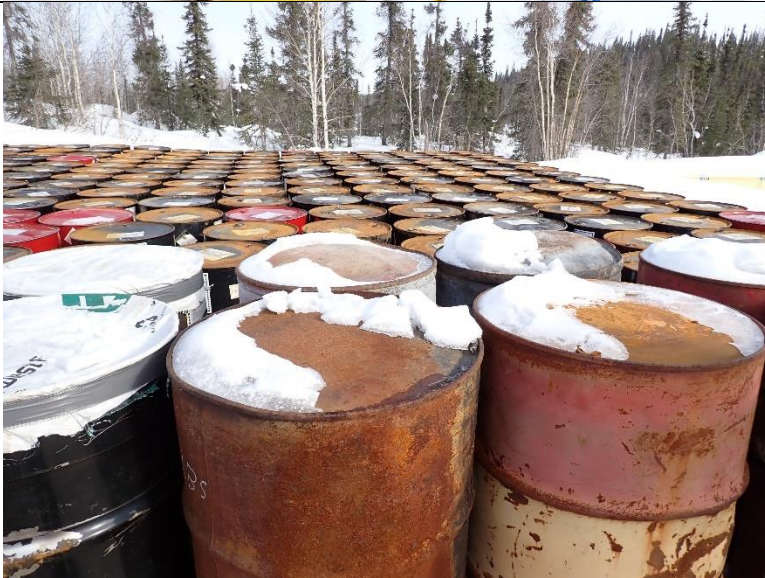
**Photo #5: Empty fuel drums that are slated to be removed from site. All drums were stored within adequate secondary containment.**

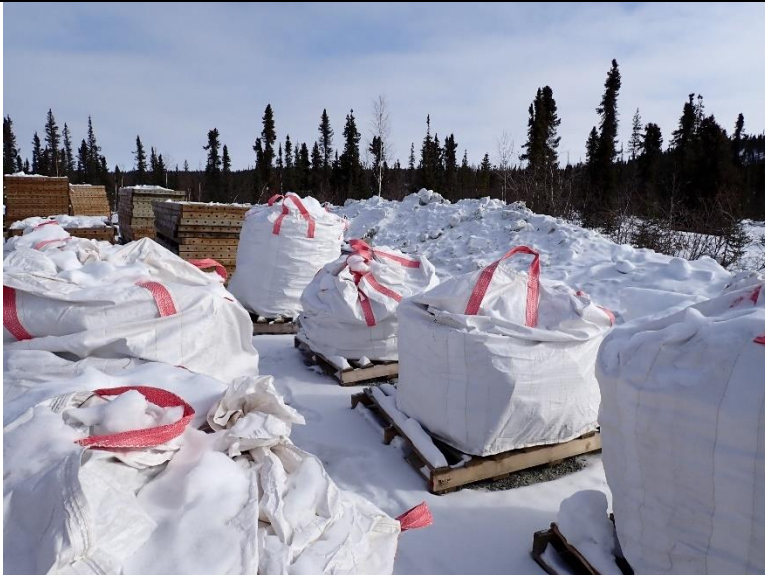
**Photo #6: Waste material staged at the end of the airstrip in preparation for backhaul on the winter road and appropriate disposal. All materials were securely packaged, labelled, and weighted.**

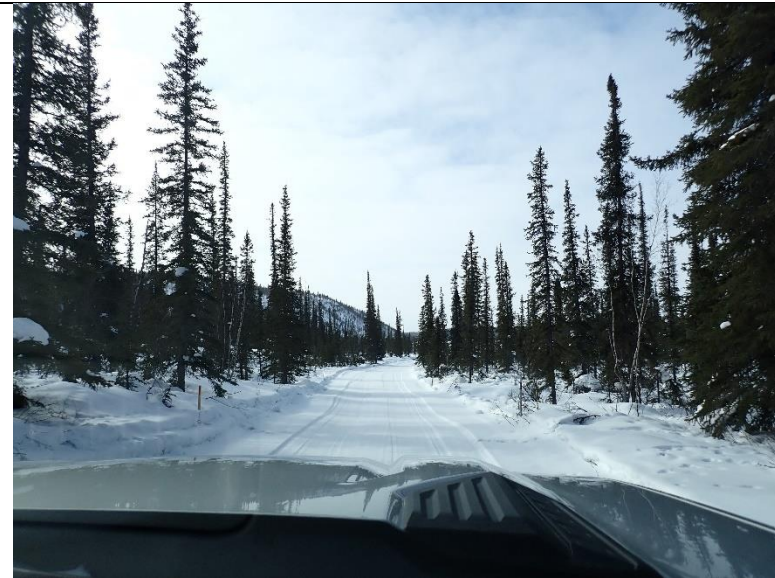
The inspectors were driven over the federal portion of the winter road, that connects the Colomac Camp to the Wekweètì Winter Road. Conditions on the portage sections (Photo #7) and on lake ice (Photo #8) were appropriately cleared and in good shape.

**Photo #7: Driving the winter road from camp on a portage section.**

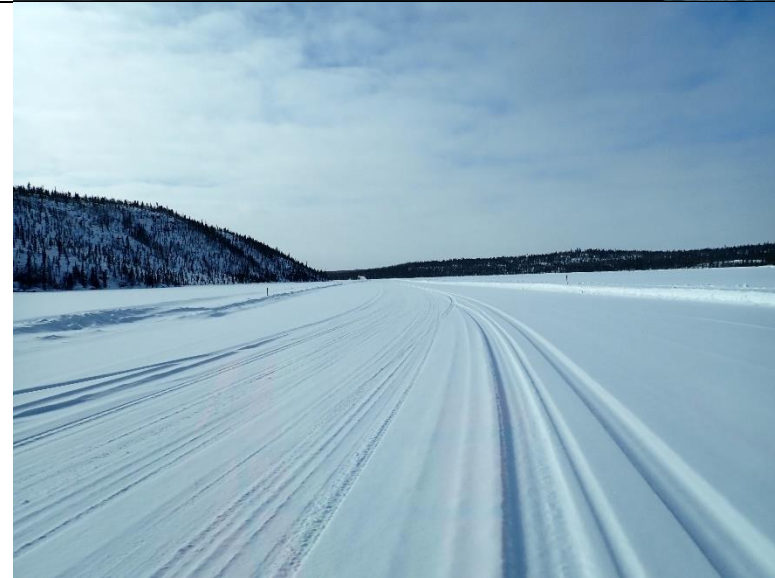
**Photo #8: Open lake ice-road section of the winter road.**
