**Re:    Land Use Permit W2021C0009  
Mineral Exploration  
Colomac and Damoti Lake Area, NT**

ENVIRONMENTAL INSPECTION REPORT

Location(s) Inspected:	Completed drill sites on Territorial Land from the Summer 2023 Exploration Program.
------------------------	---

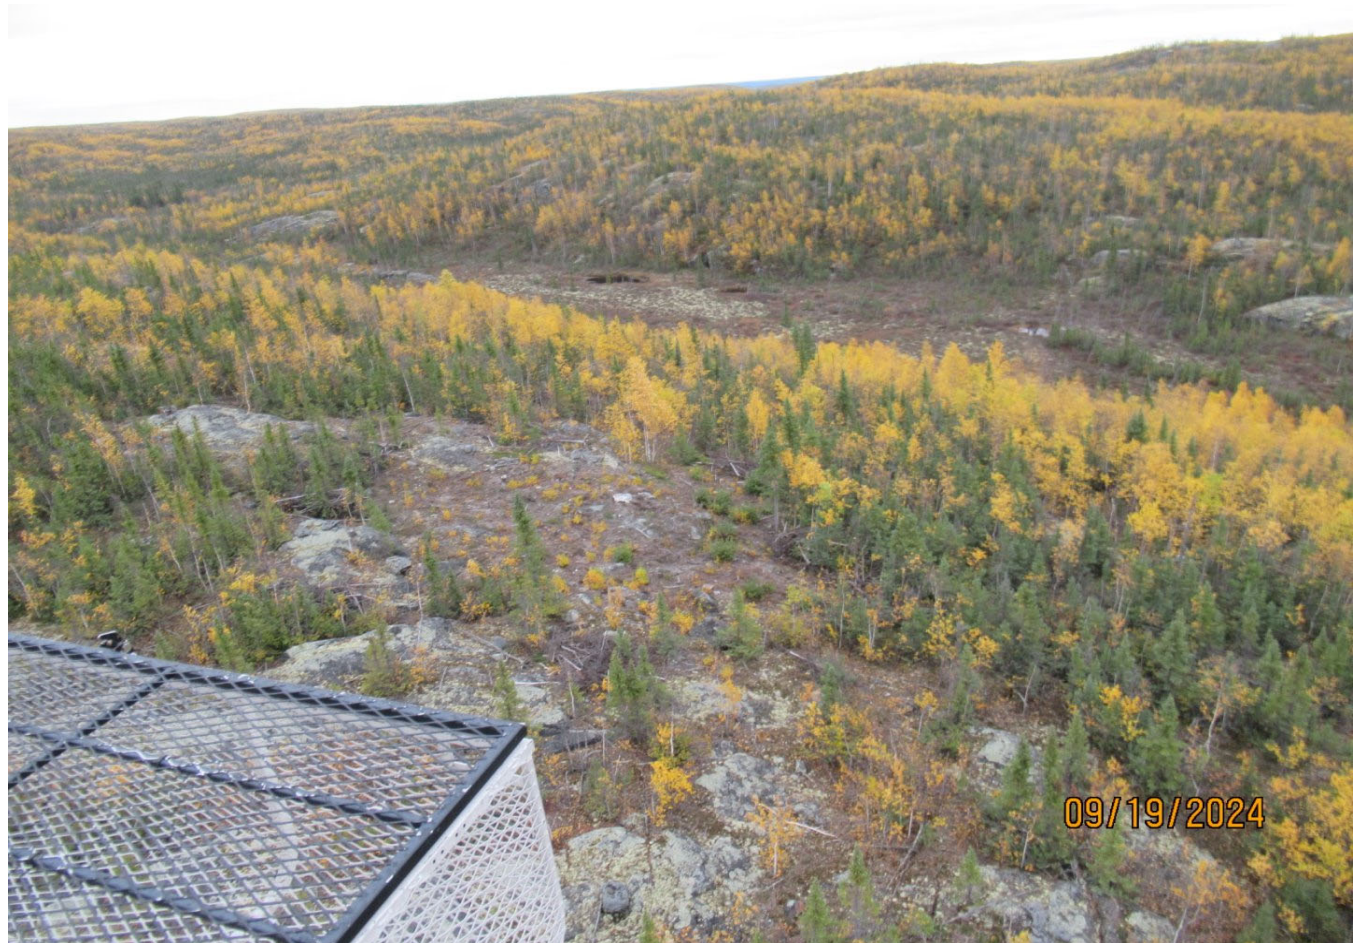
Figure 1  
Completed drill site from the Summer of 2023.

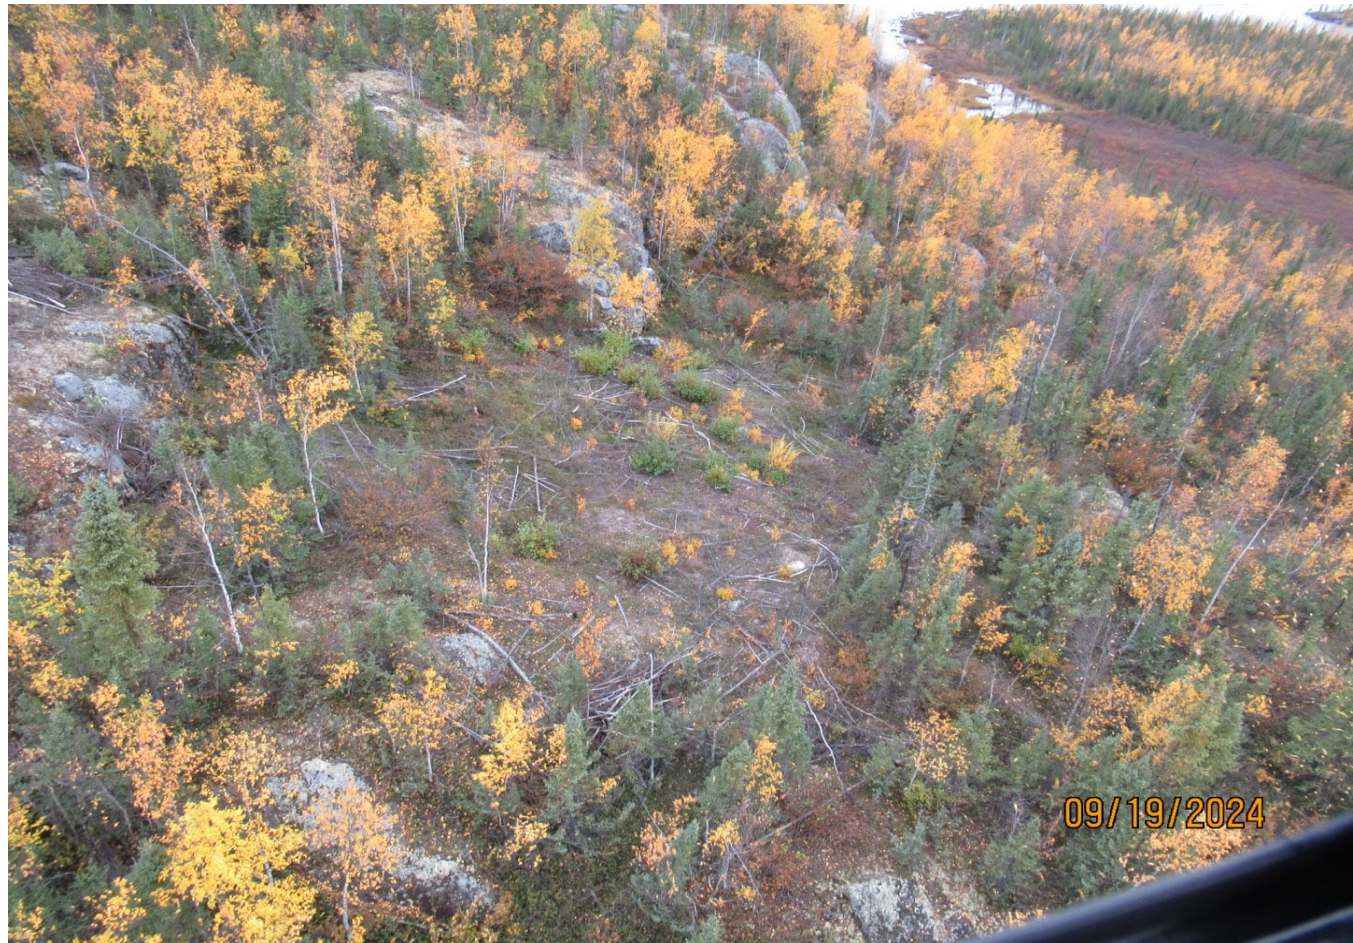
Figure 2  
Another example of a completed drill site.

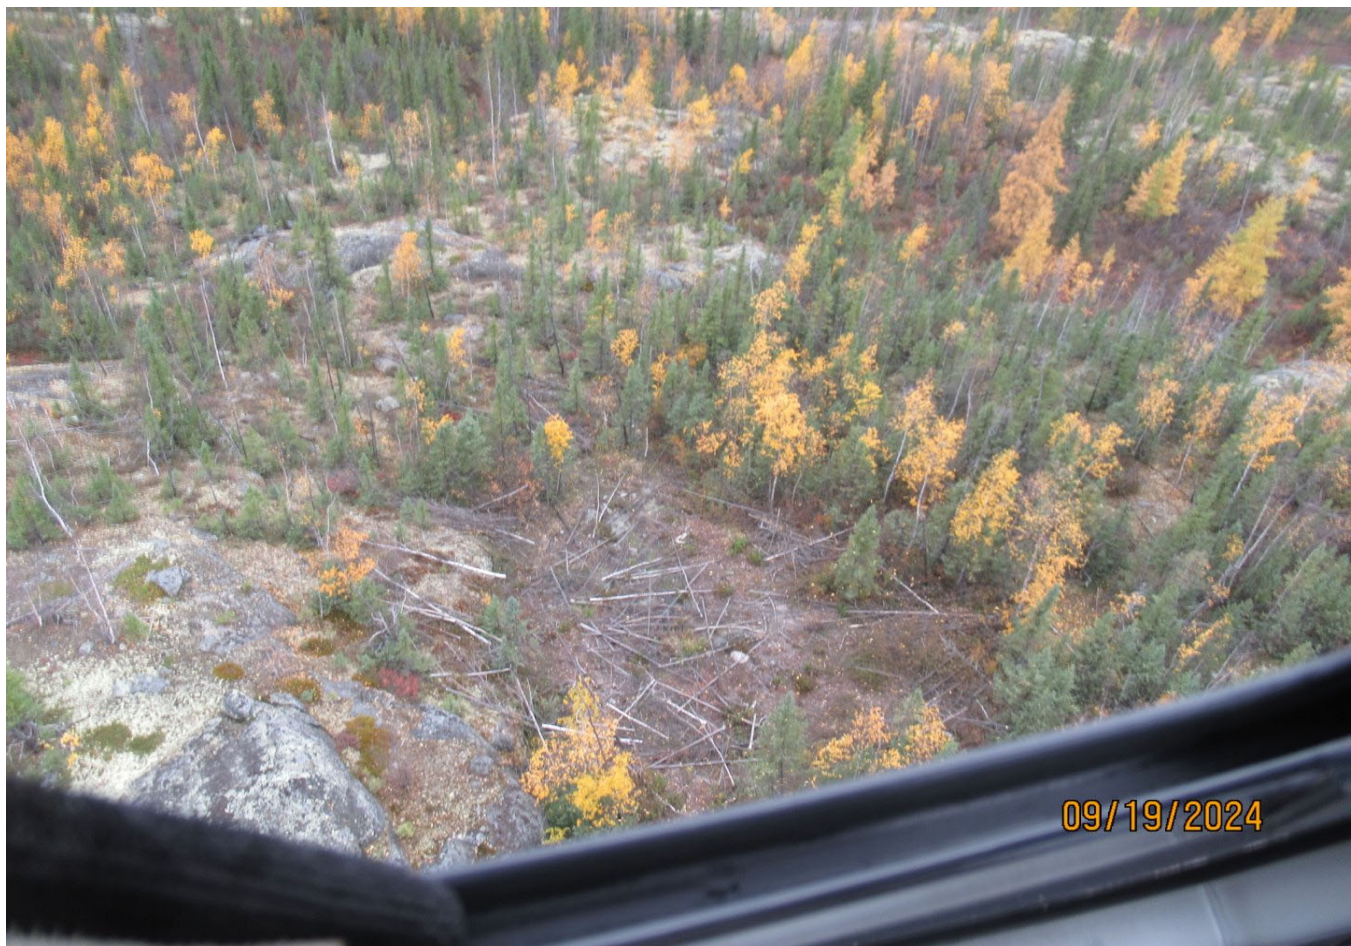
- Trees & brush were pulled back over the completed drill sites and spread to ensure all parts of the trees lie flat on the ground surface (Condition #79).

**Figure 3**  
**Trees have been pulled back over completed drill sites so they lie flat on the ground surface.**

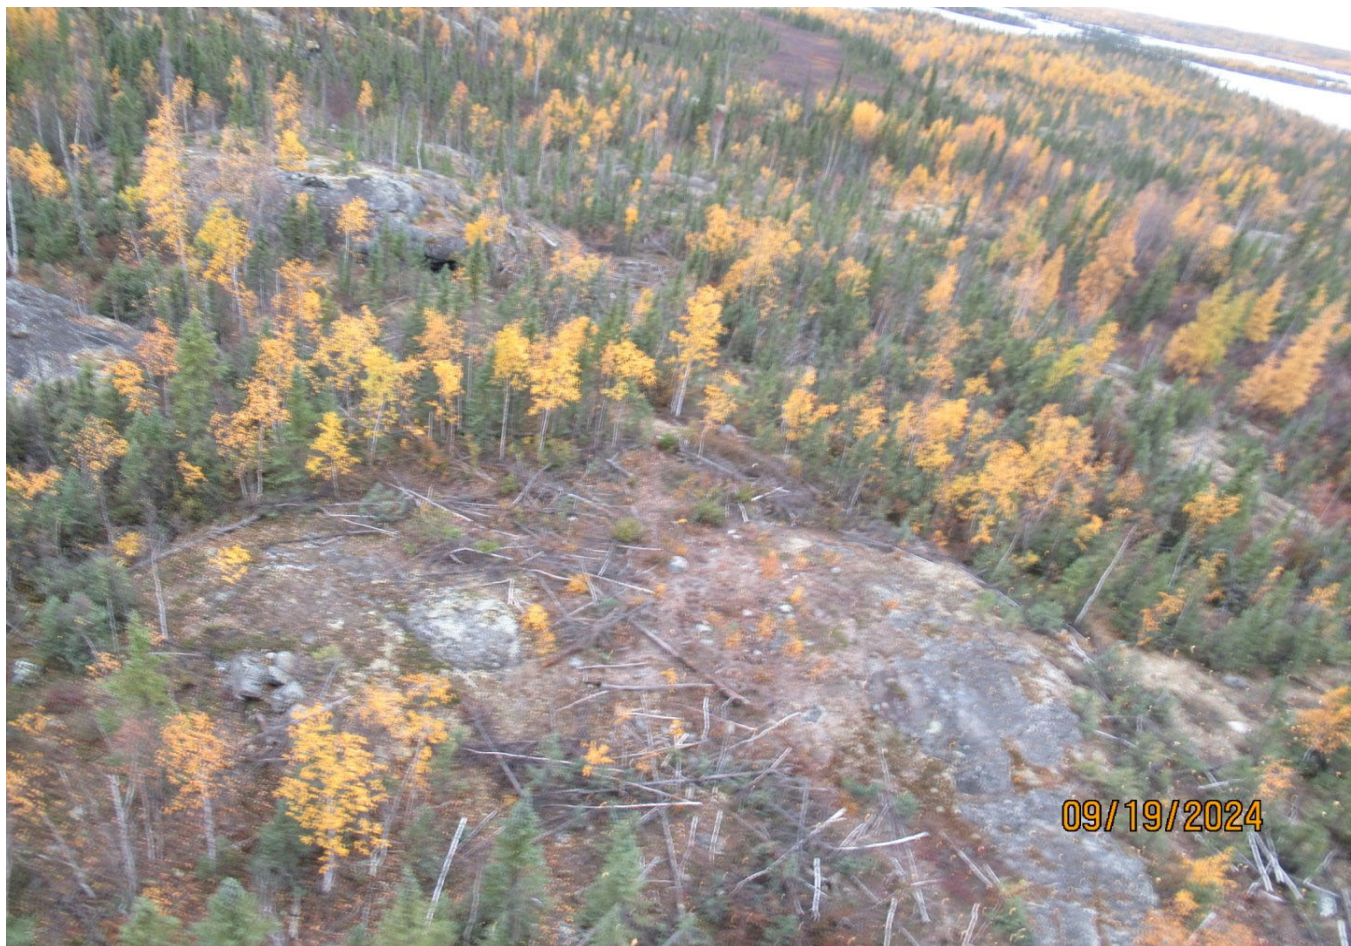
**Figure 4**  
**Another example of a completed drill site from the Summer of 2023.**

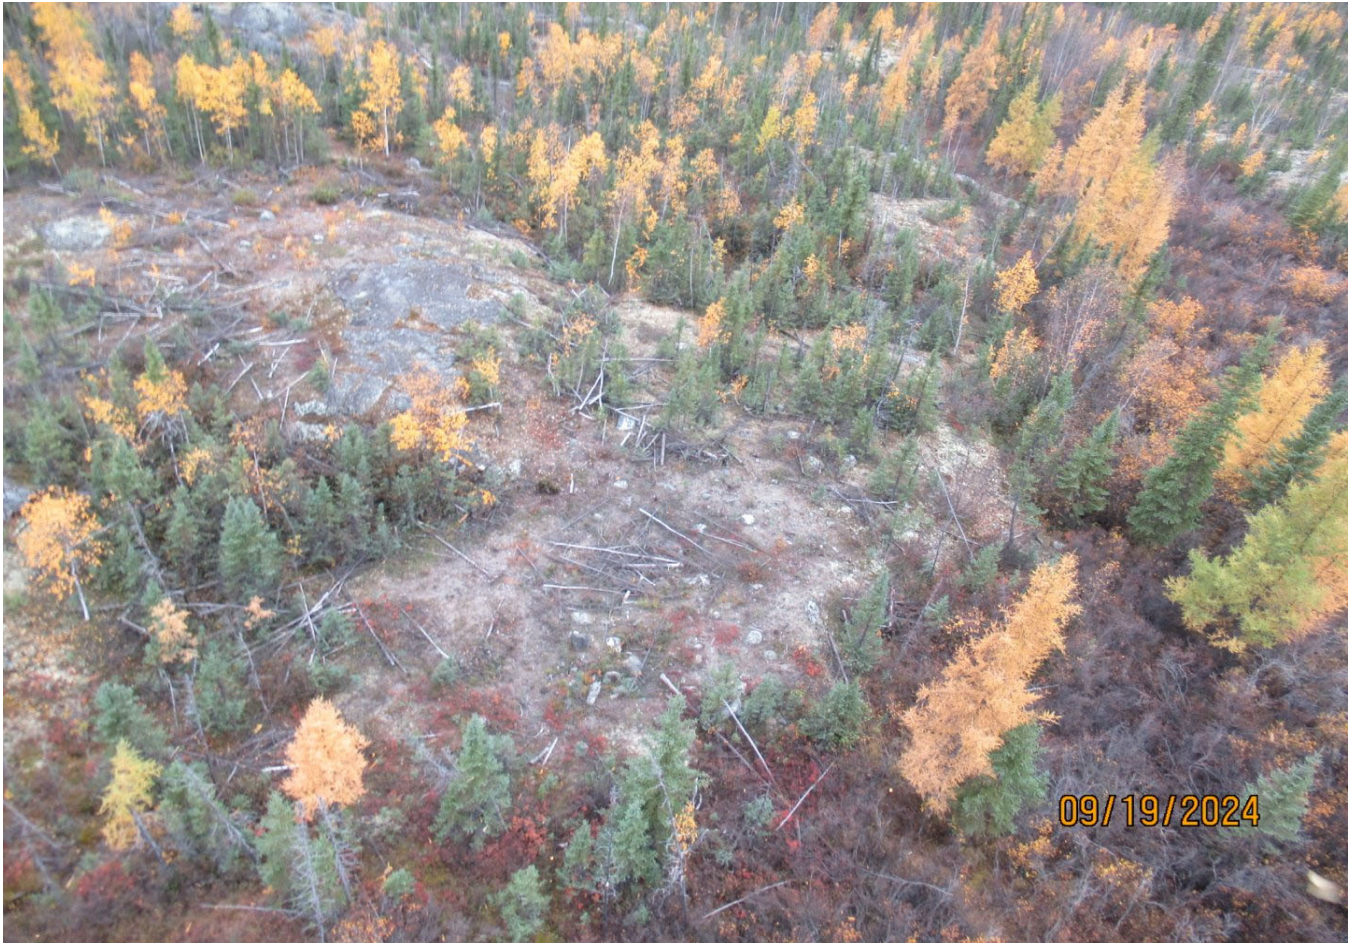
- Drill casings were capped and the majority of the casing was relatively flush with the ground surface or no greater than 12" high (Condition #21).
- No obstructions to natural drainage was observed at any of the completed drill sites (Condition #27).

Figure 5  
Casing has been left in place at completed sites and capped.

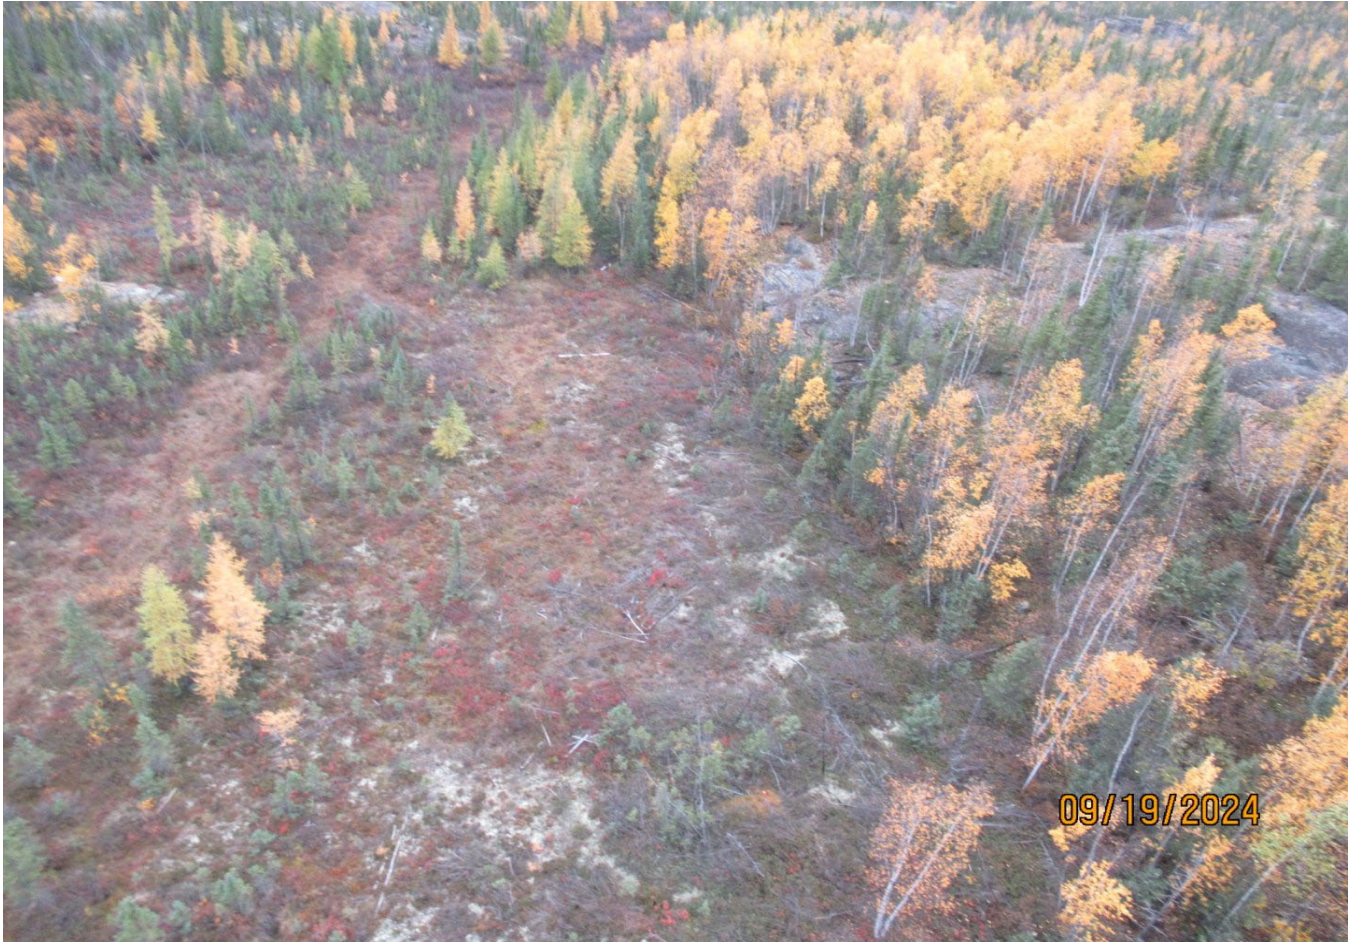
Figure 6  
Another example of a completed drill site.

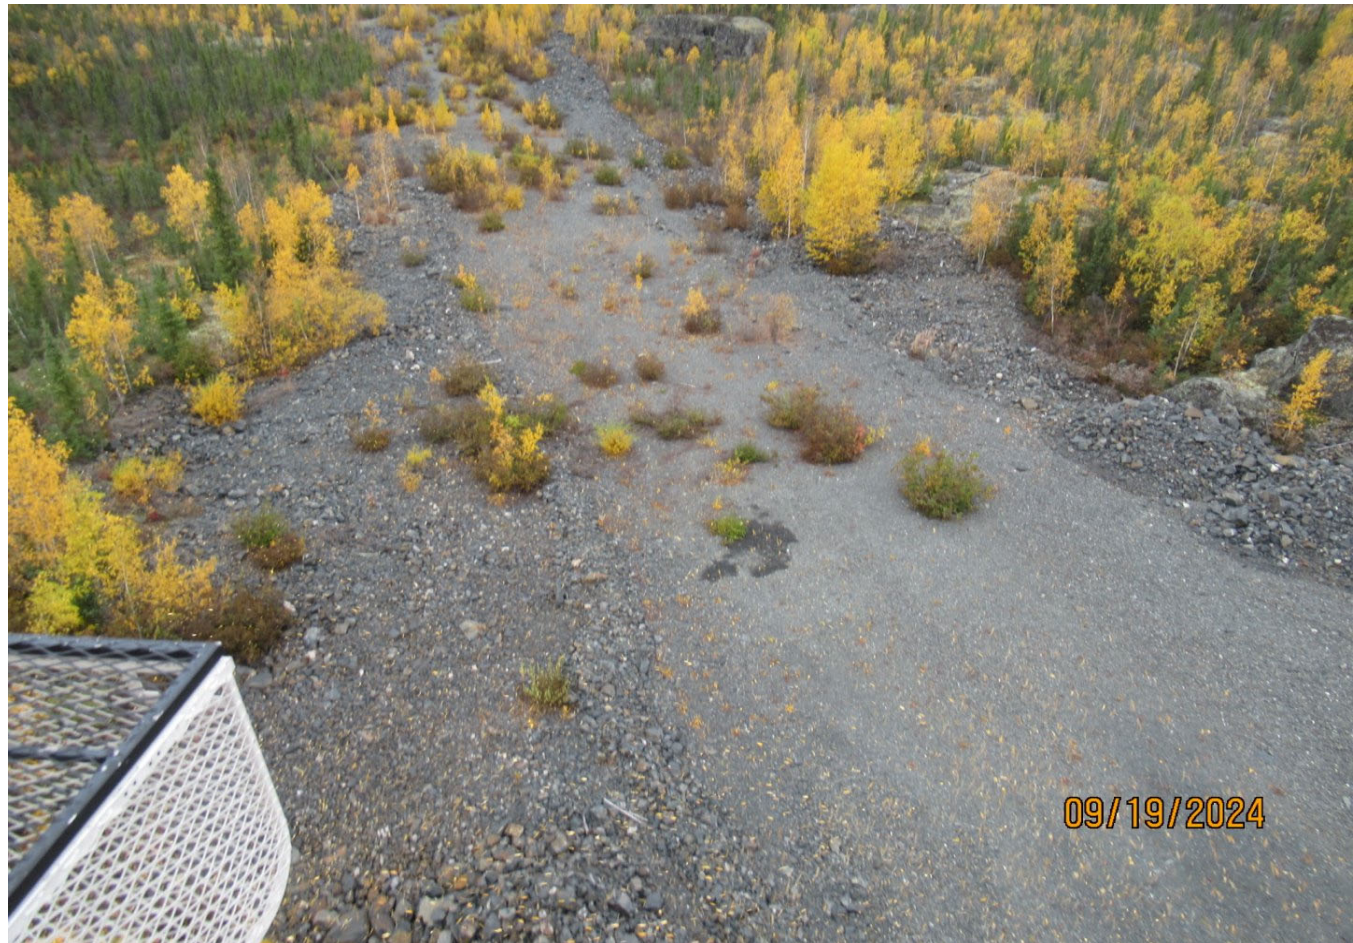
Figure 7

The only concern noted during the inspection was with a minor amount of cleanup required at completed drill sites CM-P37 & CM-P38. There appears to be impacted soils at the collar of these drill sites (Figure 7 & 8) and next time personnel are on site, a thorough cleanup must be completed with proper disposal of soils. The Permittee must also provide before & after photographs of the cleanup to the Inspector.

Completed drill site CM-P38. Impacted soils require cleanup for proper offsite disposal.

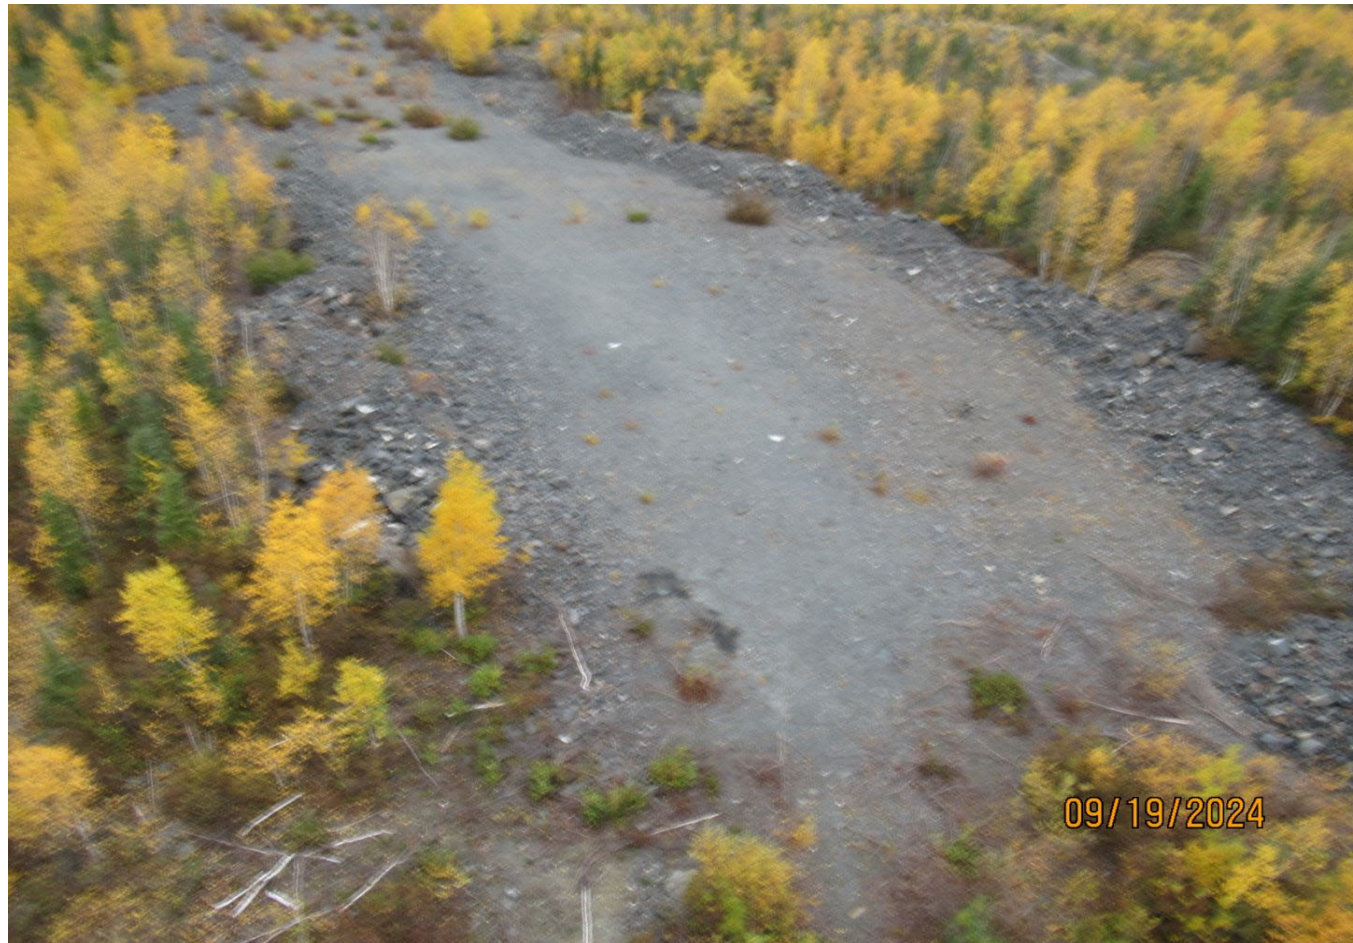
Figure 8

Completed drill site CM-P37 with a minor amount of cleanup required.
