**GNWT ECC - North Slave Region**

**Re: October-November 2024 Water Licence Inspection**

On January 13-14<sup>th</sup> 2025, a Water Licence Inspection was conducted at the Ekati Diamond Mine by Jamie Steele, Manager Diamond Resource Management.

**INDUSTRIAL WATER USE INSPECTION REPORT**

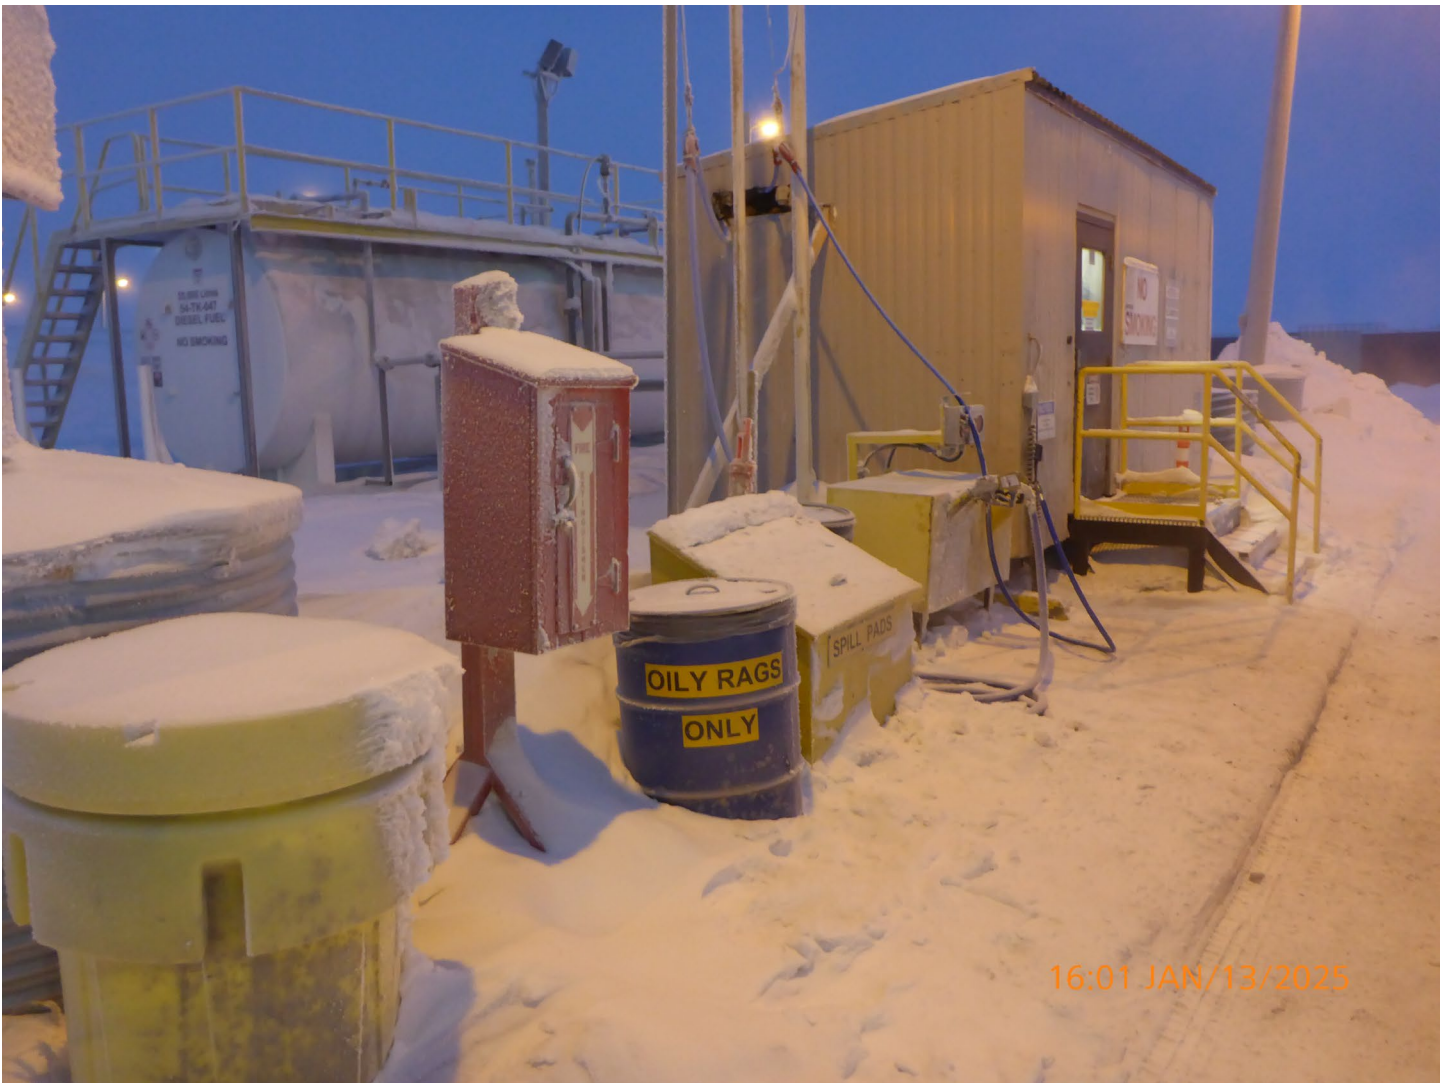
**Photo 1 – Main Camp Refuelling – The Main Camp refuelling area was clean and well maintained with no indication of any hydrocarbon leaks or spills.**

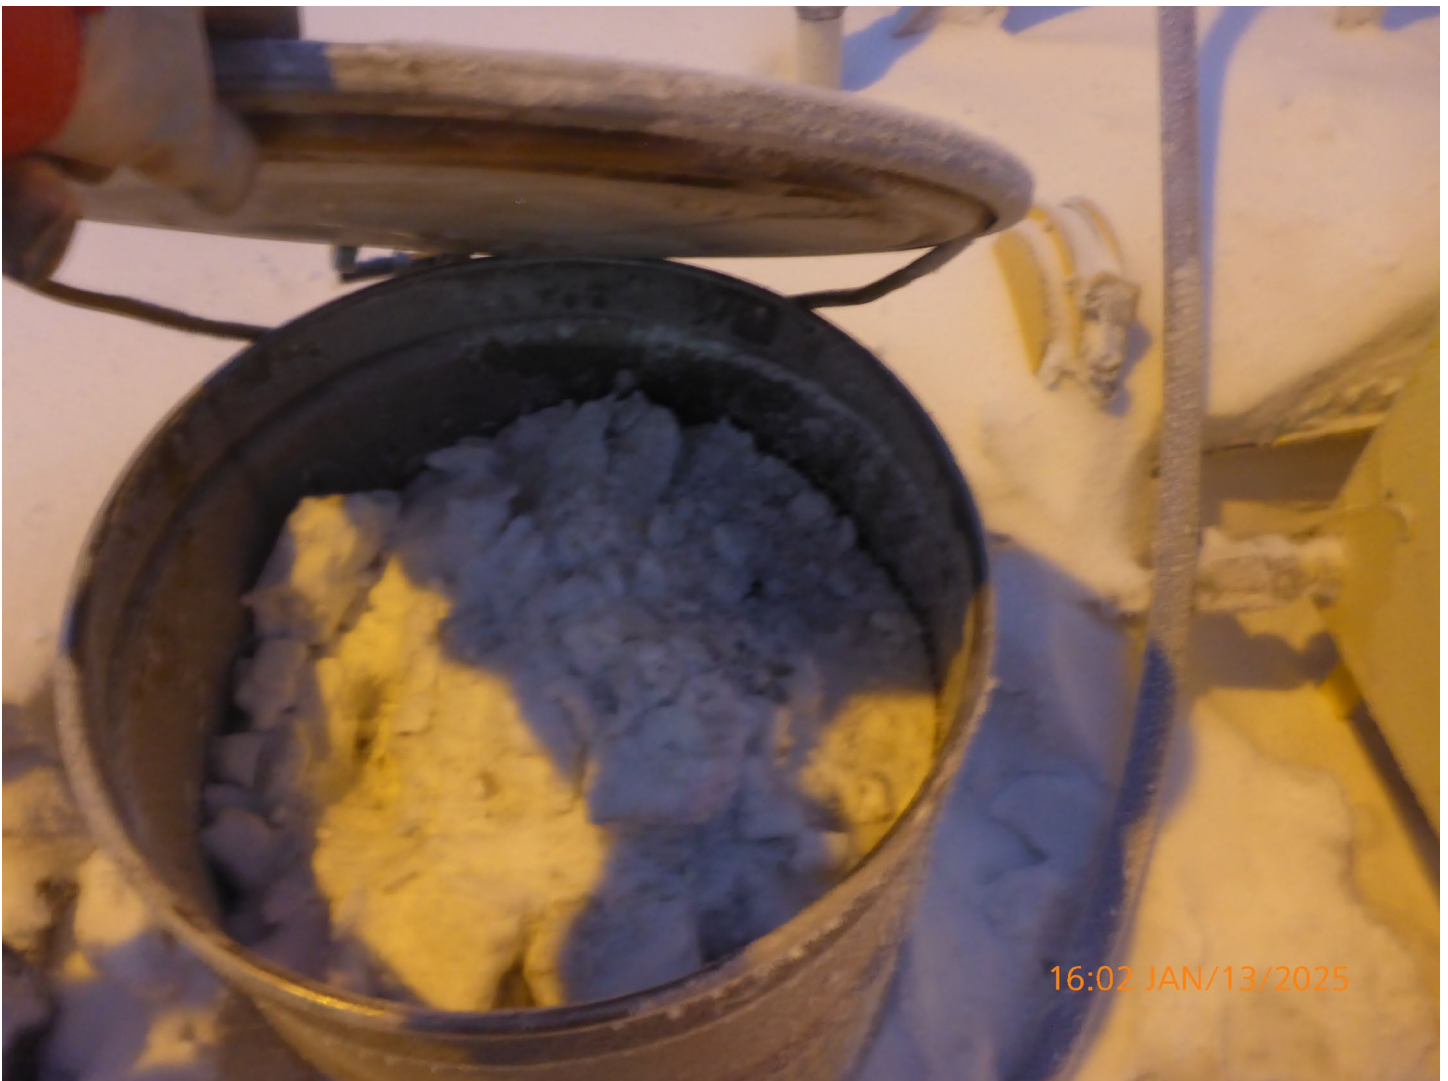
The Main Camp refuelling area was clean and well maintained with no indication of any hydrocarbon leaks or spills. Spill response equipment was fully stocked and easily accessible. The waste container for contaminated snow was getting full and will need to be emptied (Photos 1 and 2). The bulk fuel transfer area to the main tank farm was clean and well maintained. Spill response equipment was snowed in and not easily accessible. The spill response equipment needs to be dug out to allow for easy access prior to the winter road fuel transfer (Photo 3).

**Photo 2 – Main Camp Refuelling – The waste container for contaminated snow was getting full and will need to be emptied to ensure capacity to clean up small spills.**

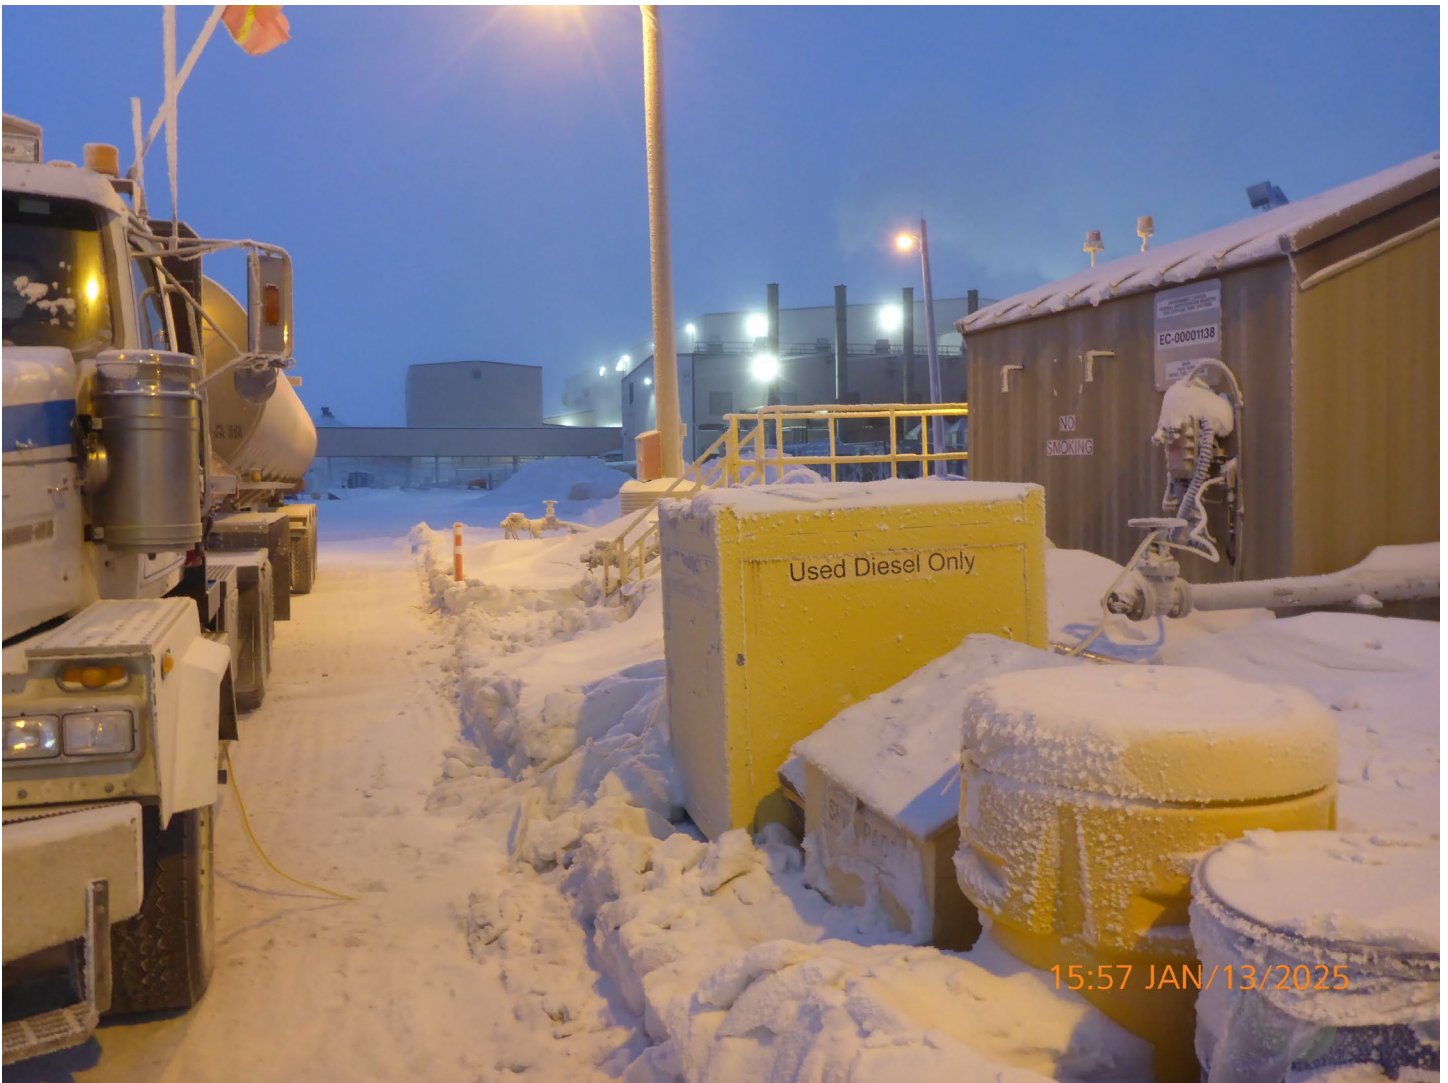
**Photo 3 – Main Tank Farm Transfer Area – Spill response equipment was snowed in and not easily accessible. The spill response equipment needs to be dug out to allow for easy access.**

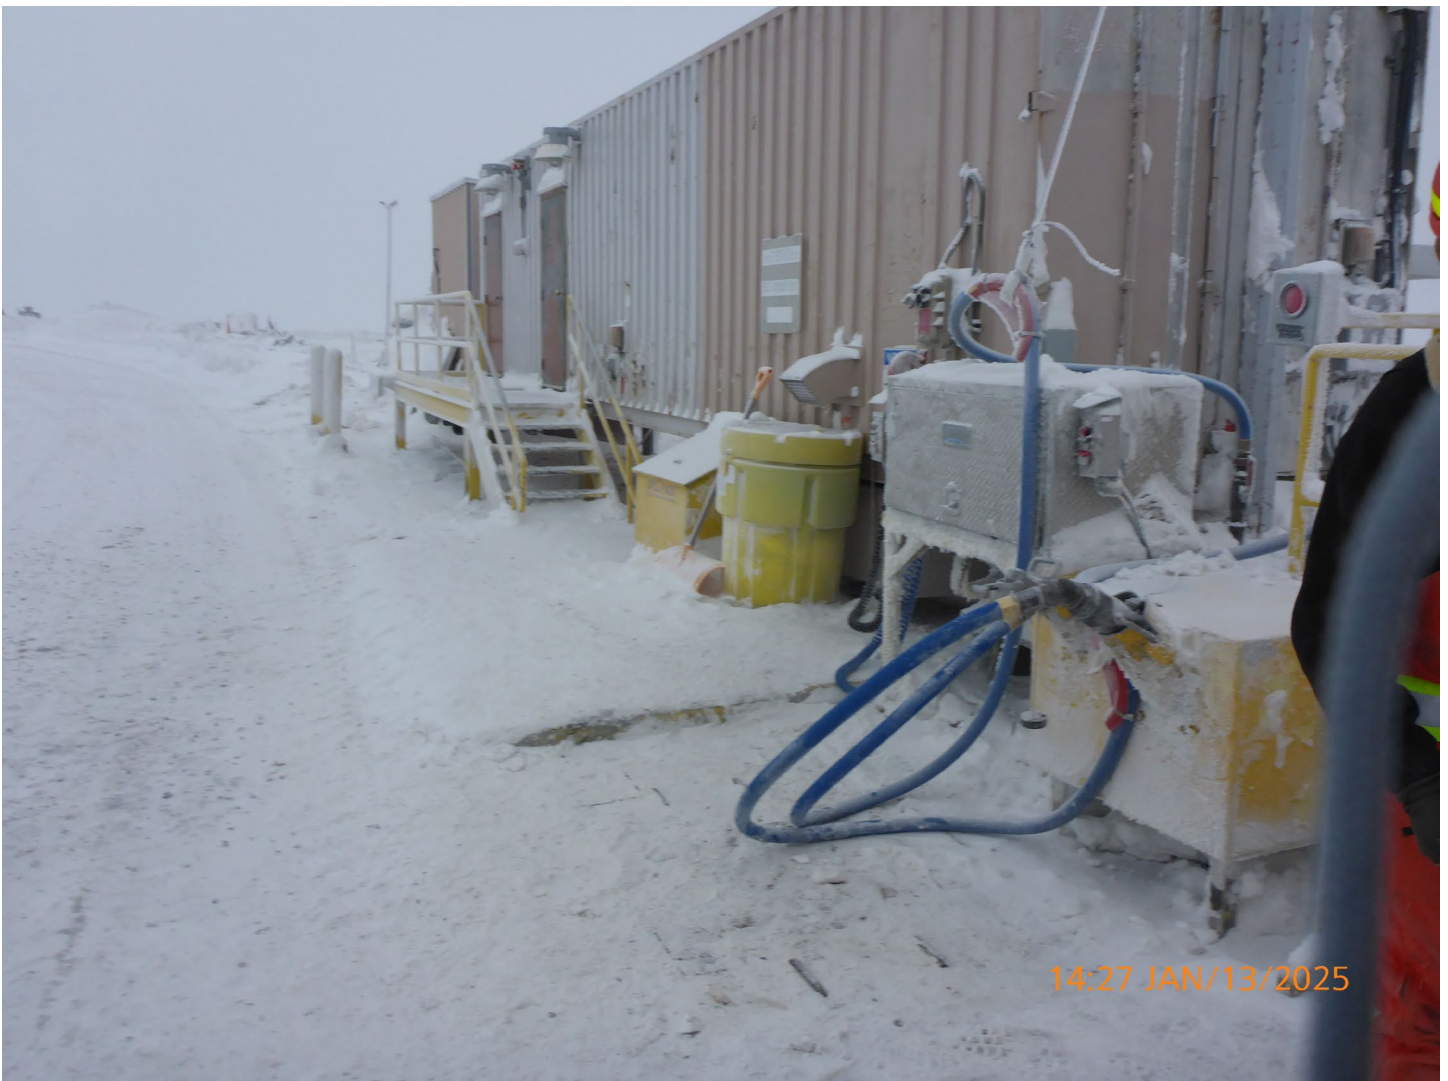
**Photo 4 – Koala Refuelling – The Koala Refuelling Station was clean and well organized with no indication of any leaks or spills.**

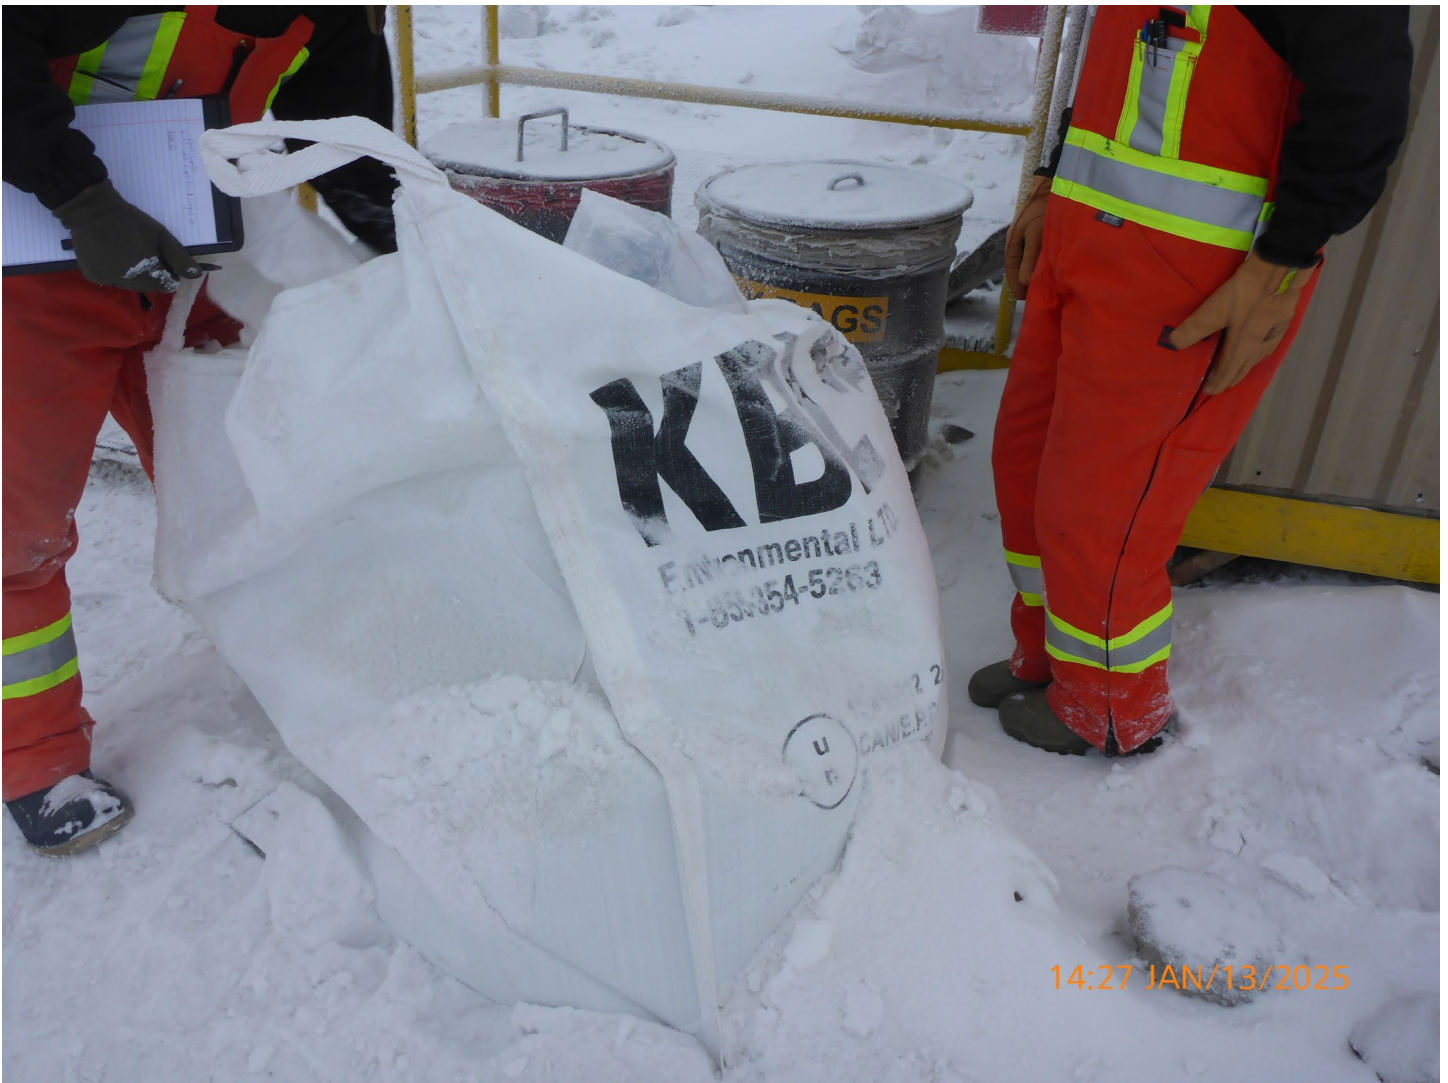
The Koala Refuelling Station was clean and well organized with no indication of any leaks or spills. Spill response equipment is fully stocked and easily accessible. Waste containers were being maintained however there was an unlabelled KBL megabag with some unknown waste inside. Waste containers require labels as per the approved Waste Management Plan. This bag will need to be labelled and disposed of appropriately (Photos 4 and 5).

**Photo 5 – Koala Refuelling – An unlabelled megabag contains unknown waste. The waste will need to be identified and disposed of as per the approved Waste Management Plan.**

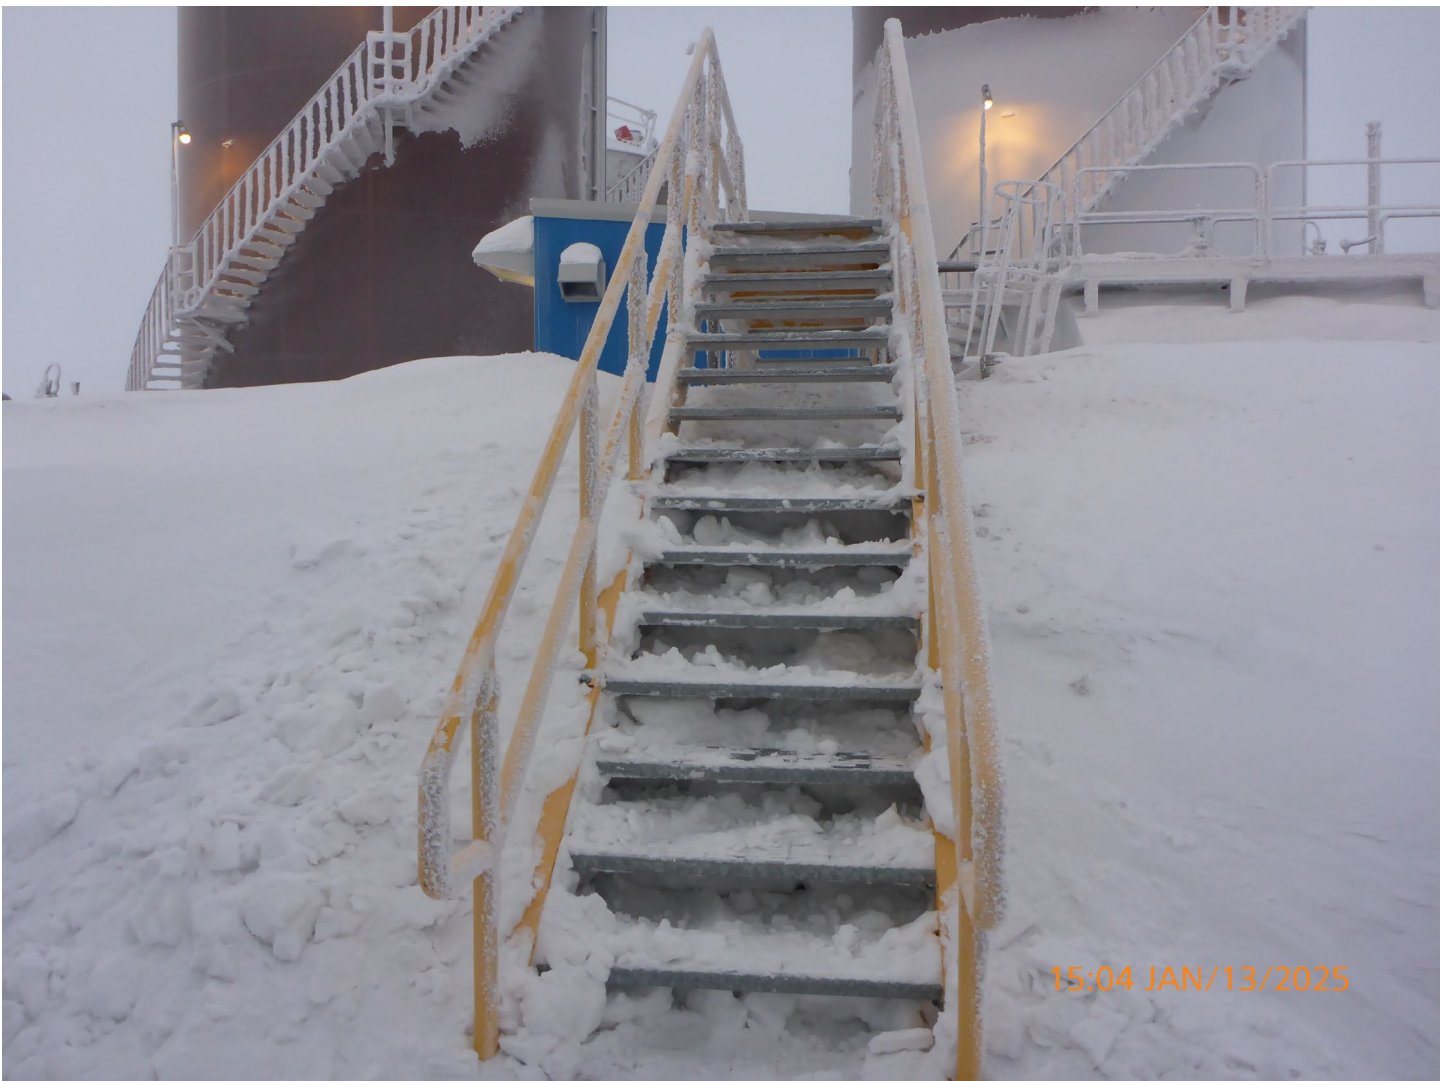
**Photo 6 – Sable Tank Farm – Access to the Tank Farm is being maintained to facilitate regular inspections.**

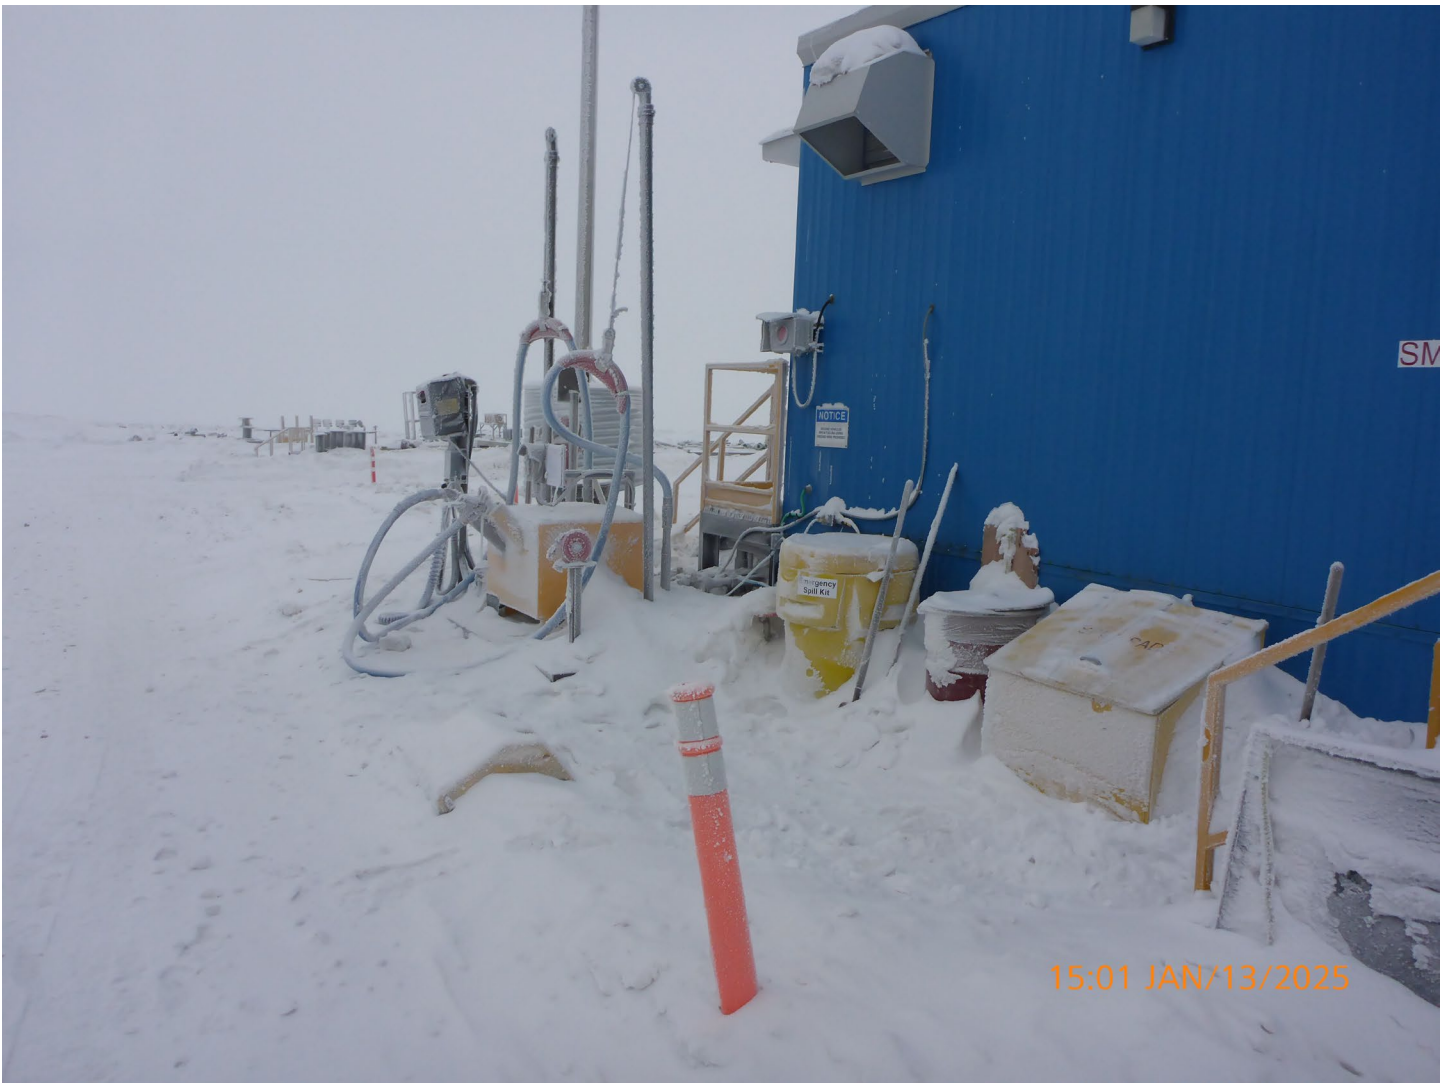
**Photo 7 – Sable Refuelling – The Sable refuelling area was clean and well maintained with no indication of any hydrocarbon leaks or spills. Spill response equipment was fully stocked and easily accessible.**

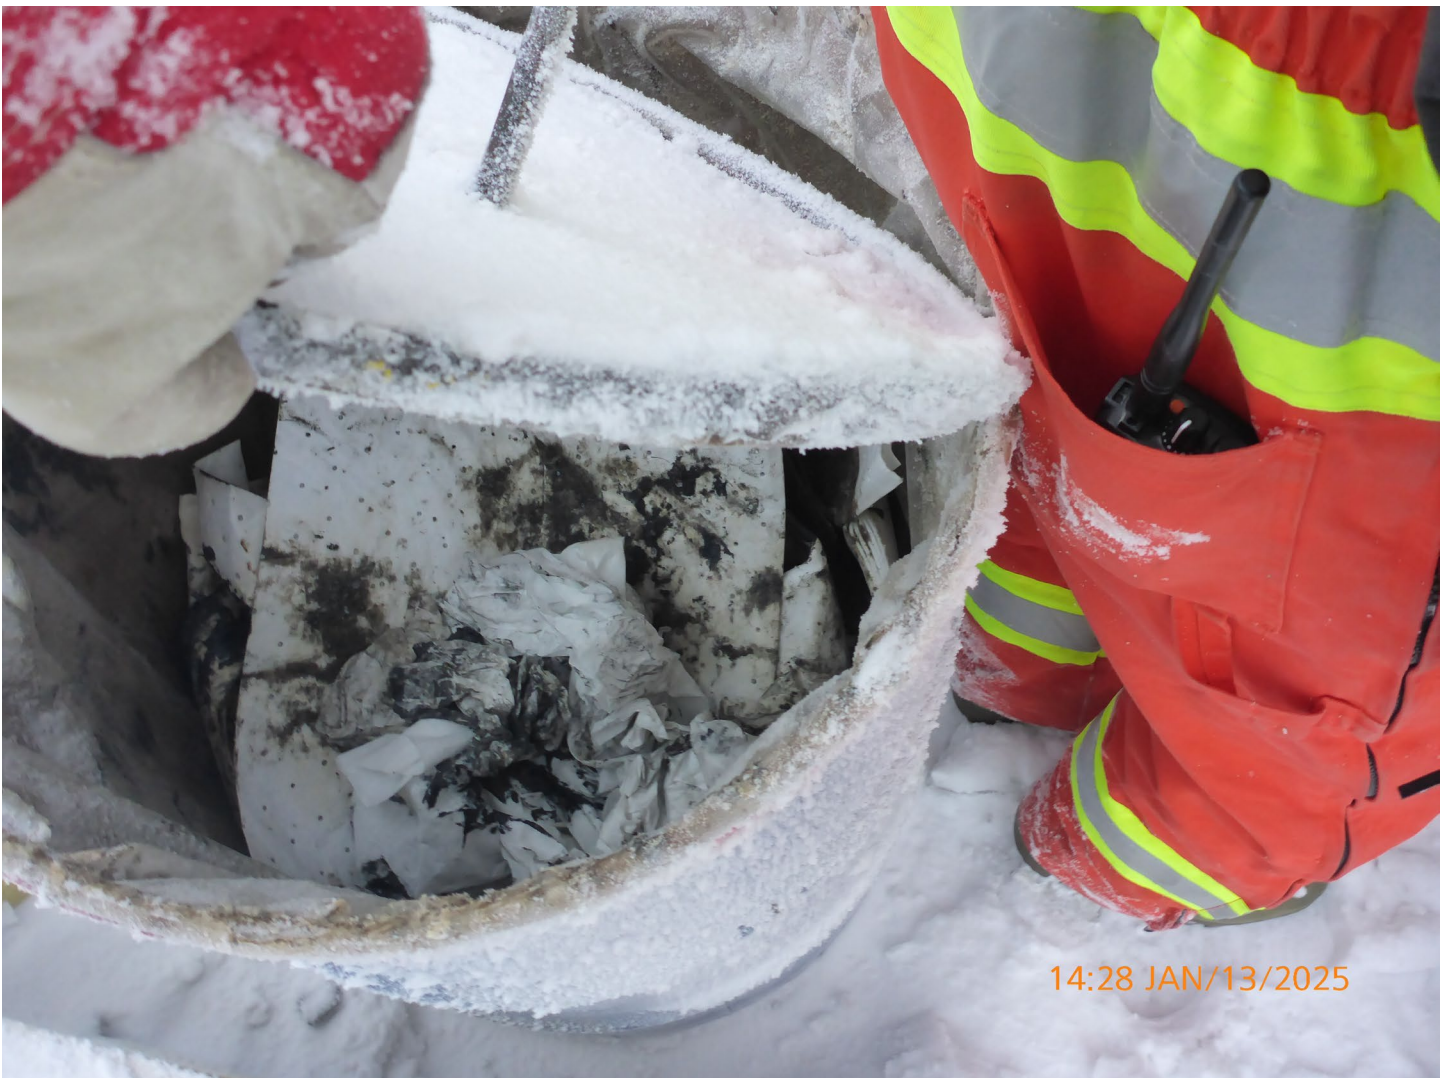
**Photo 8 – Sable Refuelling – Labelled waste containers are being used. The oily rags drum is starting to get full and will need to be emptied.**

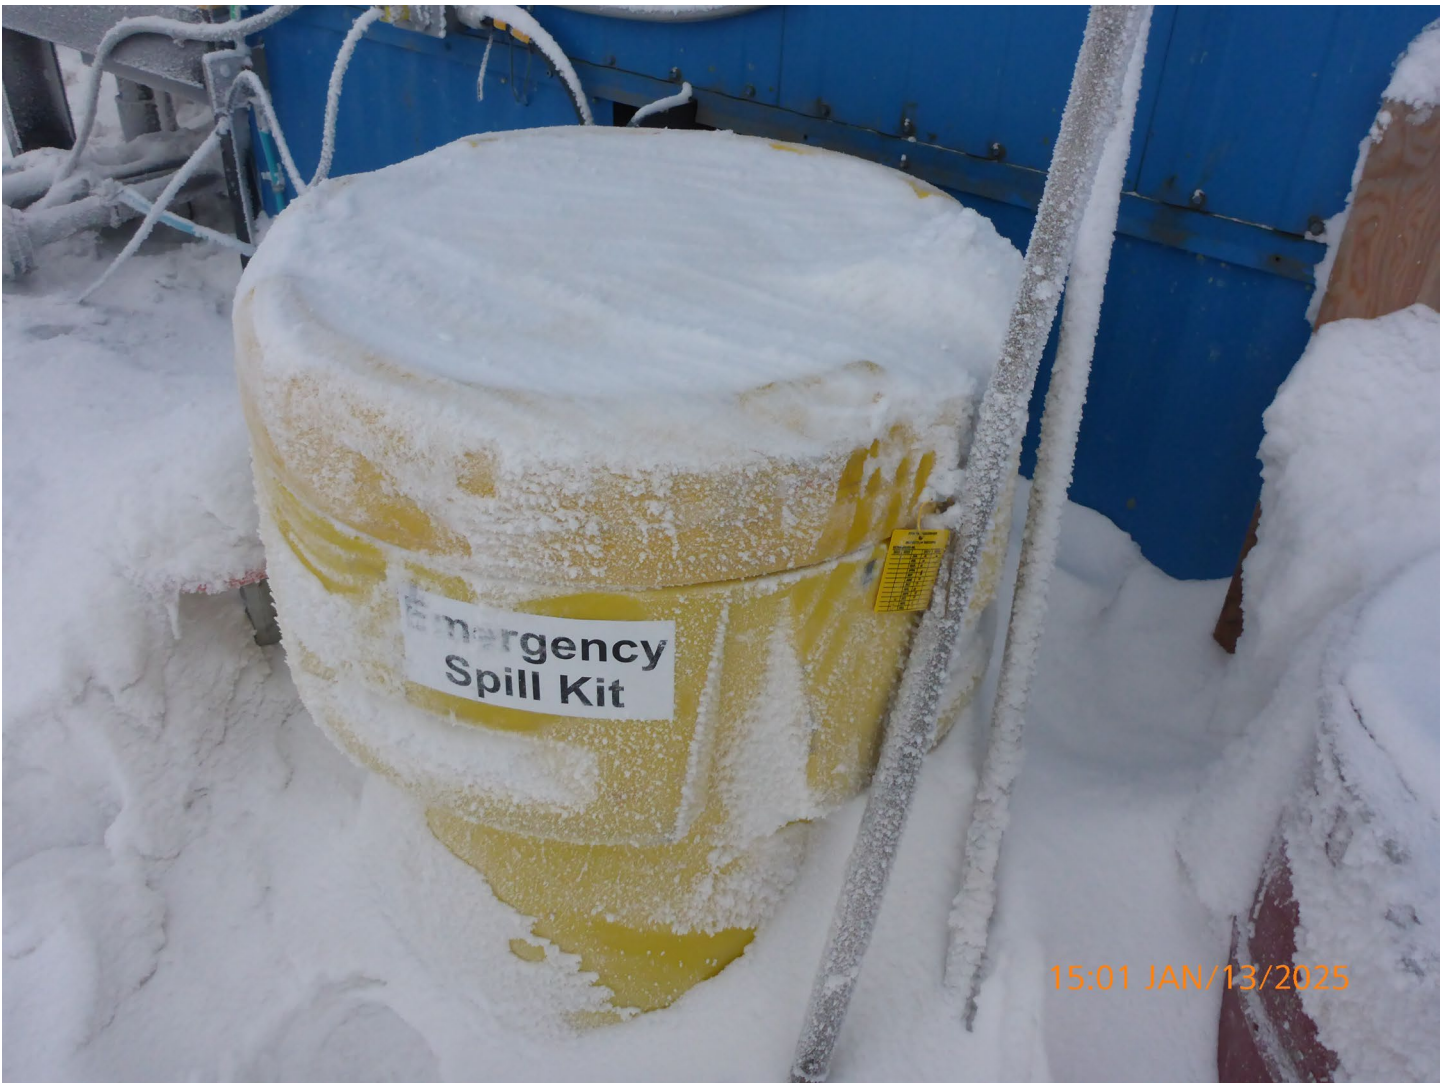
**Photo 9 – Sable Refuelling – The spill kit was fully stocked, but buried in snow. The spill kit needs to be dug out to ensure easy access for spill response.**

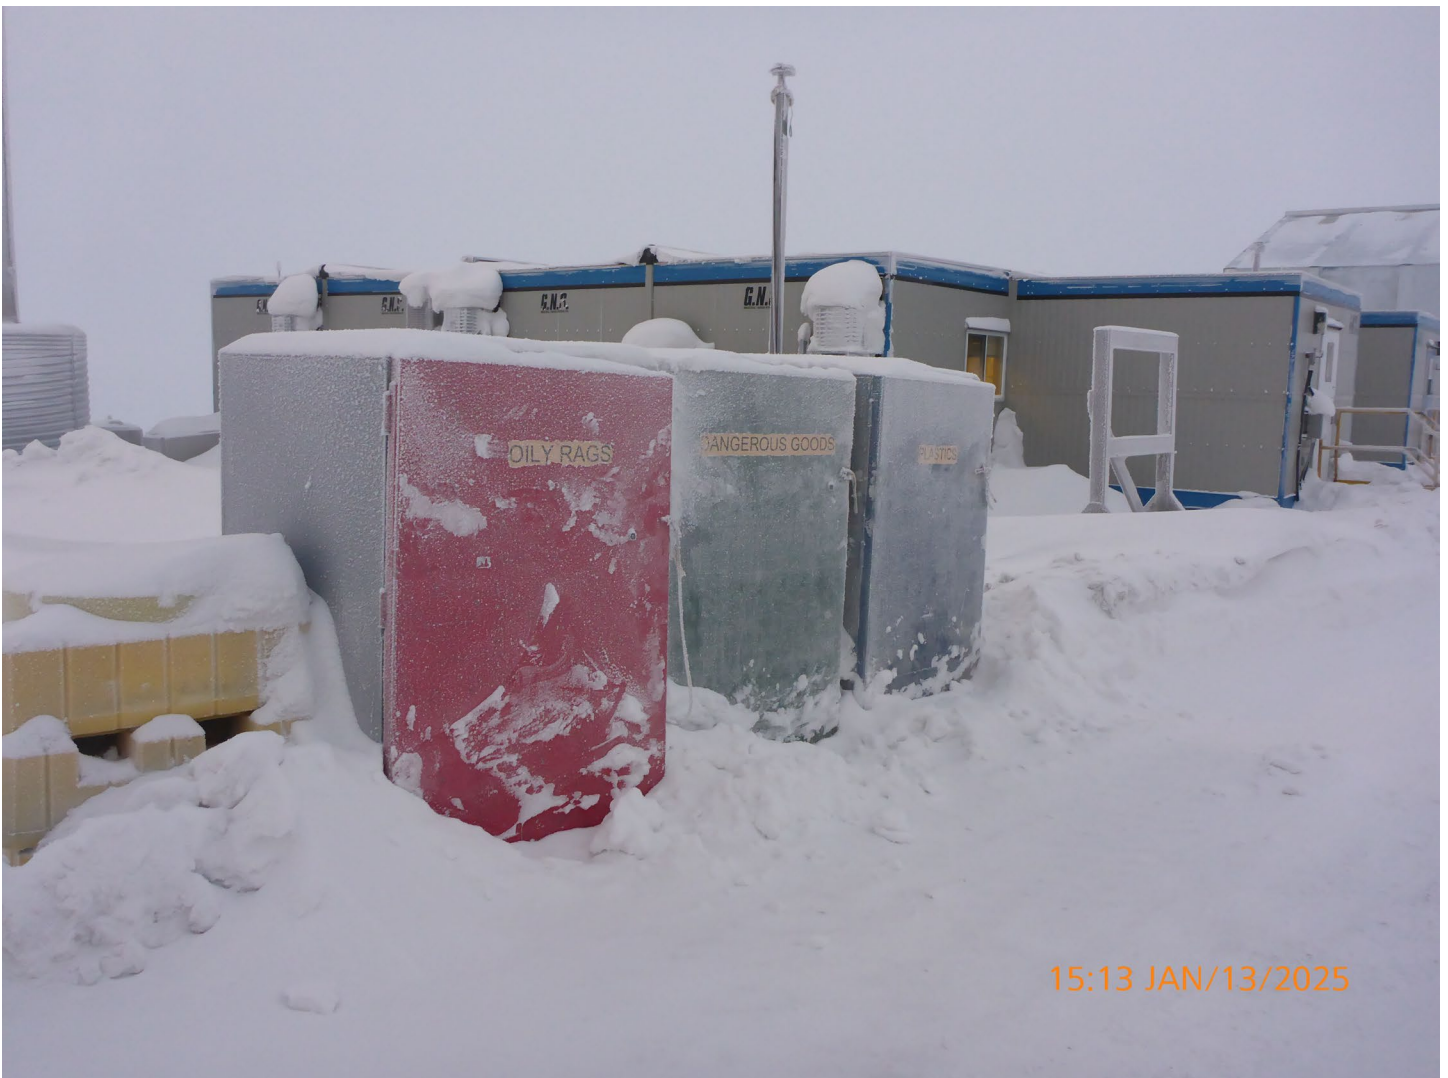
Waste at the Sable Development is segregated into labelled bins. The waste bins were starting to get blown in with snow and will need to be dug out to allow for convenient waste drop off. There was no indication of any misdirected waste (Photos 10 through 12).

**Photo 10 – Sable Waste Management – Waste bins are starting to get blown in with snow. The bins should be shovelled out to help facilitate waste dropoff and pickup.**

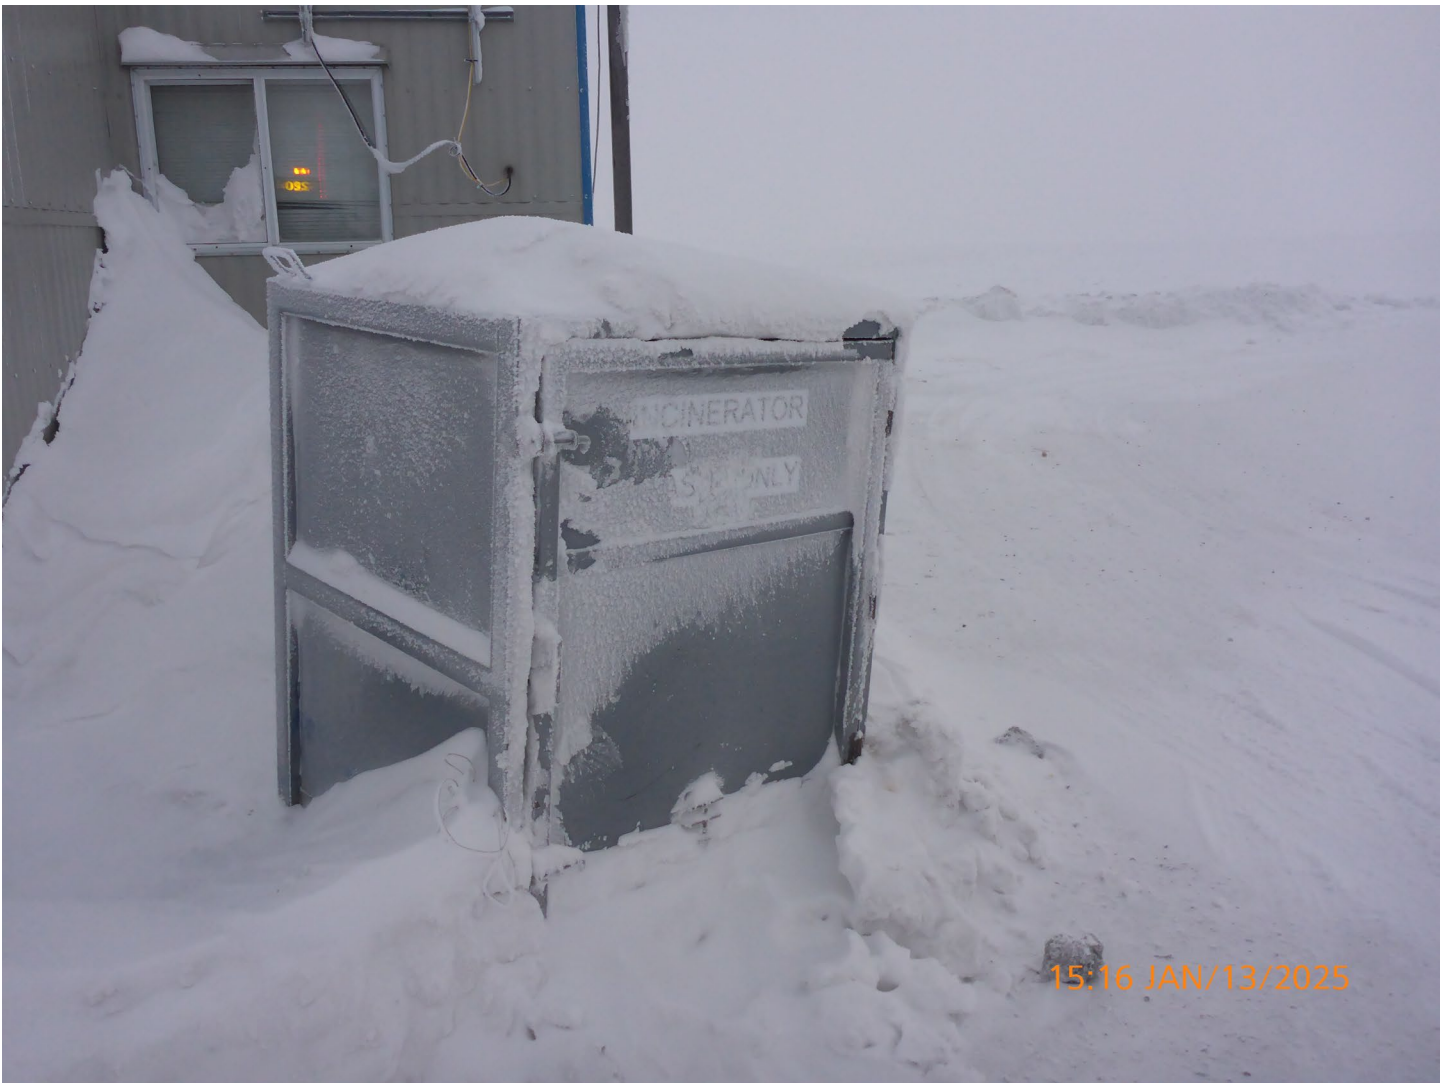
**Photo 11 – Sable Waste Management – The incinerator waste bin is blown in with snow.**

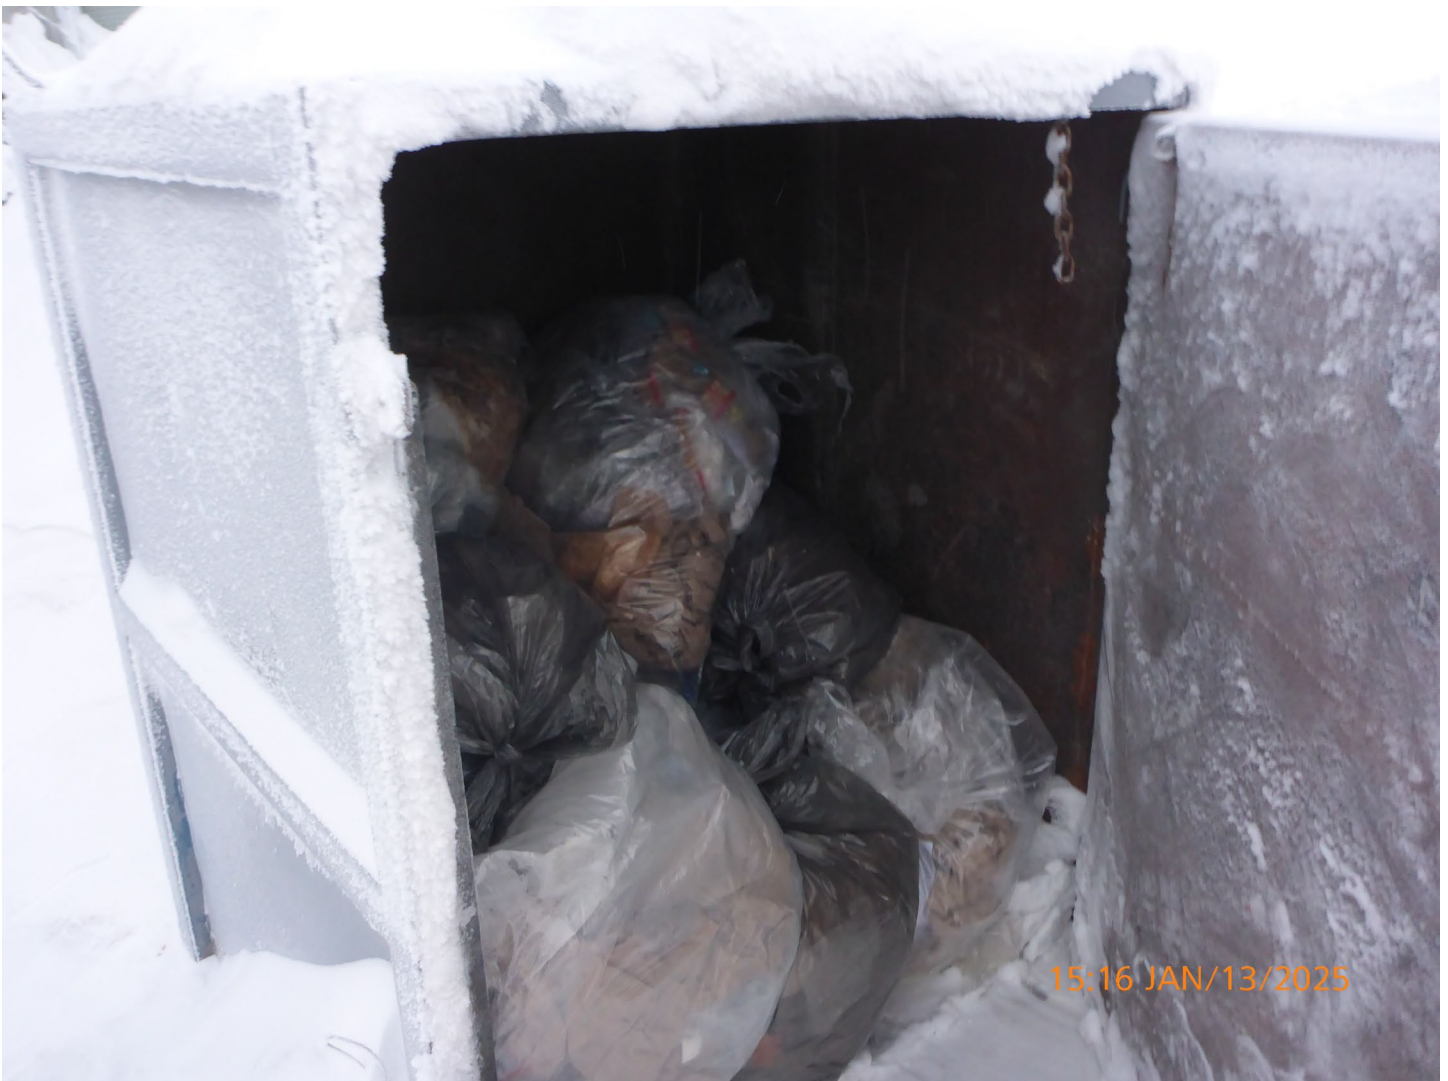
**Photo 12 – Sable Waste Management – The incinerator waste bin is starting to get full and needs to be emptied before becoming an animal attractant.**

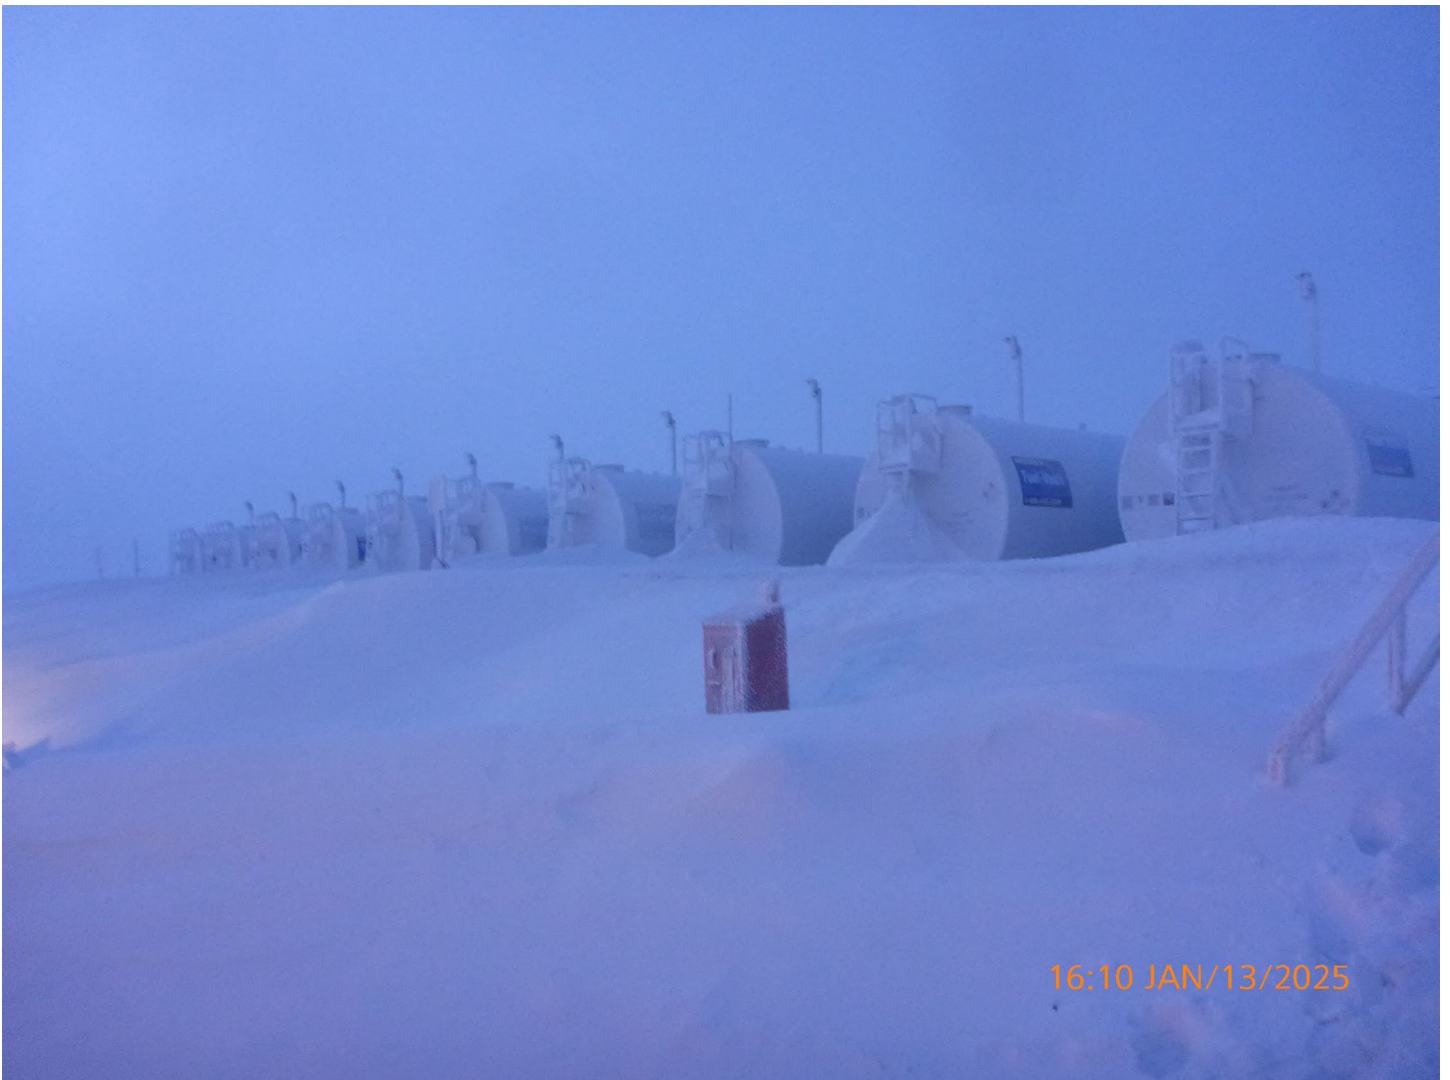
**Photo 13 – Aviation Fuel Storage – Aviation fuel is stored in a 1 million litre tank farm located by the Drill Core Logging Facility. Jet A aviation fuel is transported on the winter road. The tank farm is located within a lined containment berm.**

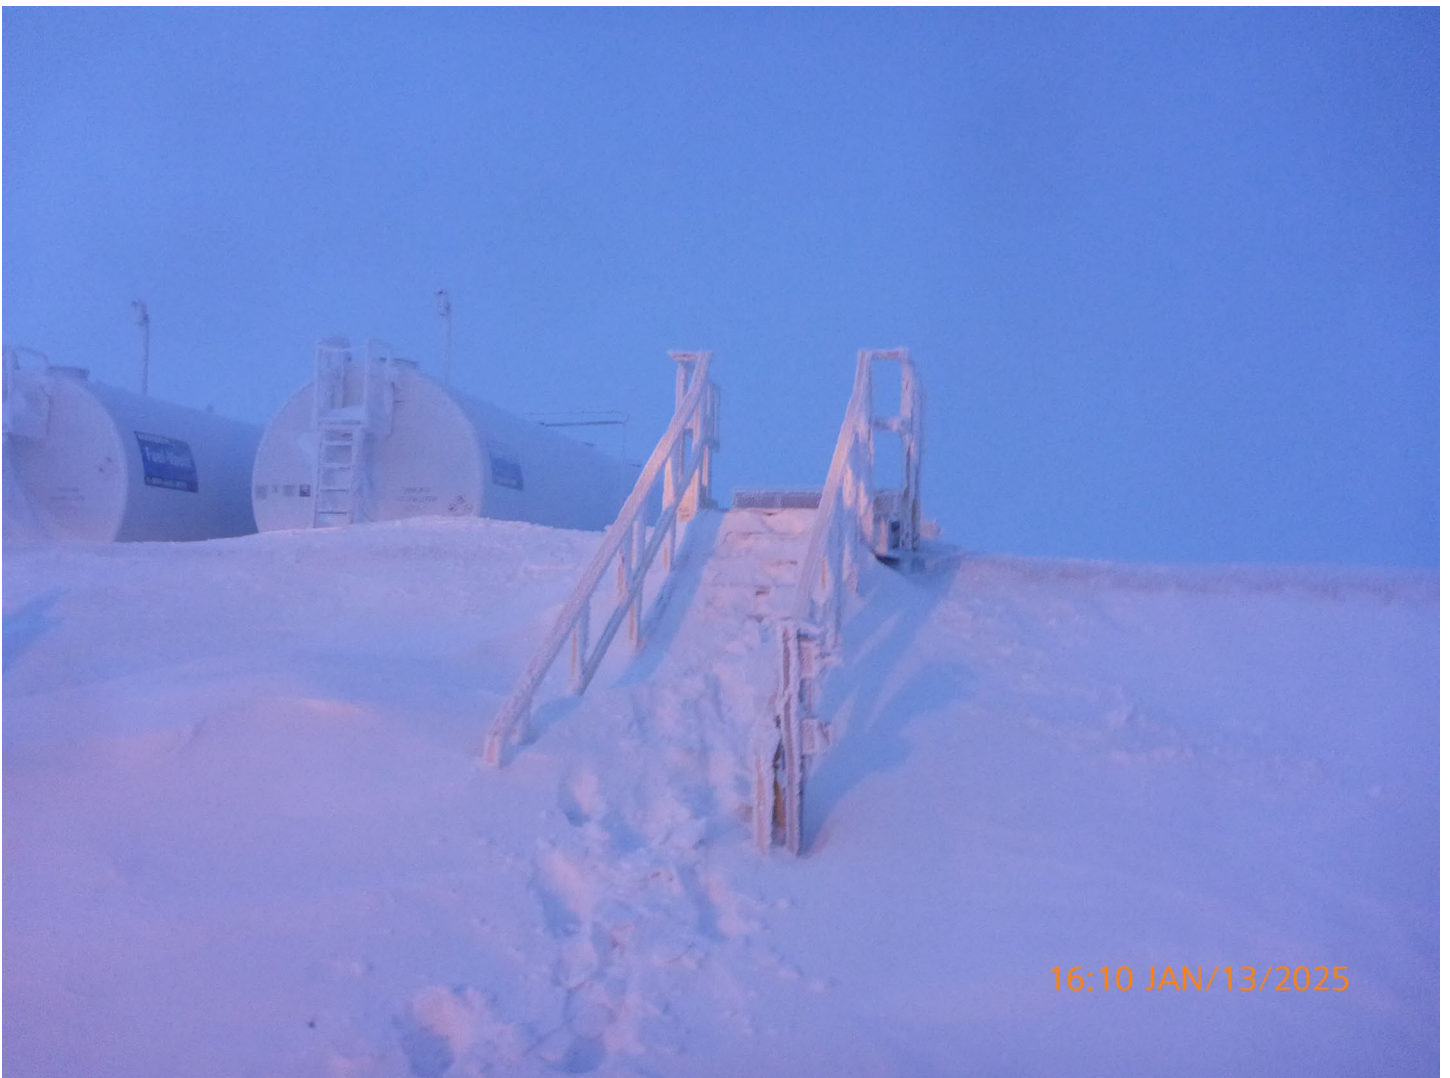
Jet A aviation fuel is brought to site on the winter road and stored in a lined 1 million litre tank farm located adjacent to the core logging facility. The tank farm is being inspected, however snow is beginning to build up on the access stairway. The Inspector recommends that access to the tank farm be maintained to help facilitate inspections (Photos 13 and 14).

**Photo 14 – Aviation Fuel Storage – The tank farm appears to be inspected regularly. The Inspector recommends that access to the tank farm be maintained to facilitate regular inspections.**
