**GNWT ECC - North Slave Region**

**Re: October-November 2024 Water Licence Inspection**

On January 13-14<sup>th</sup> 2025, a Water Licence Inspection was conducted at the Ekati Diamond Mine by Jamie Steele, Manager Diamond Resource Management.

**INDUSTRIAL WATER USE INSPECTION REPORT**

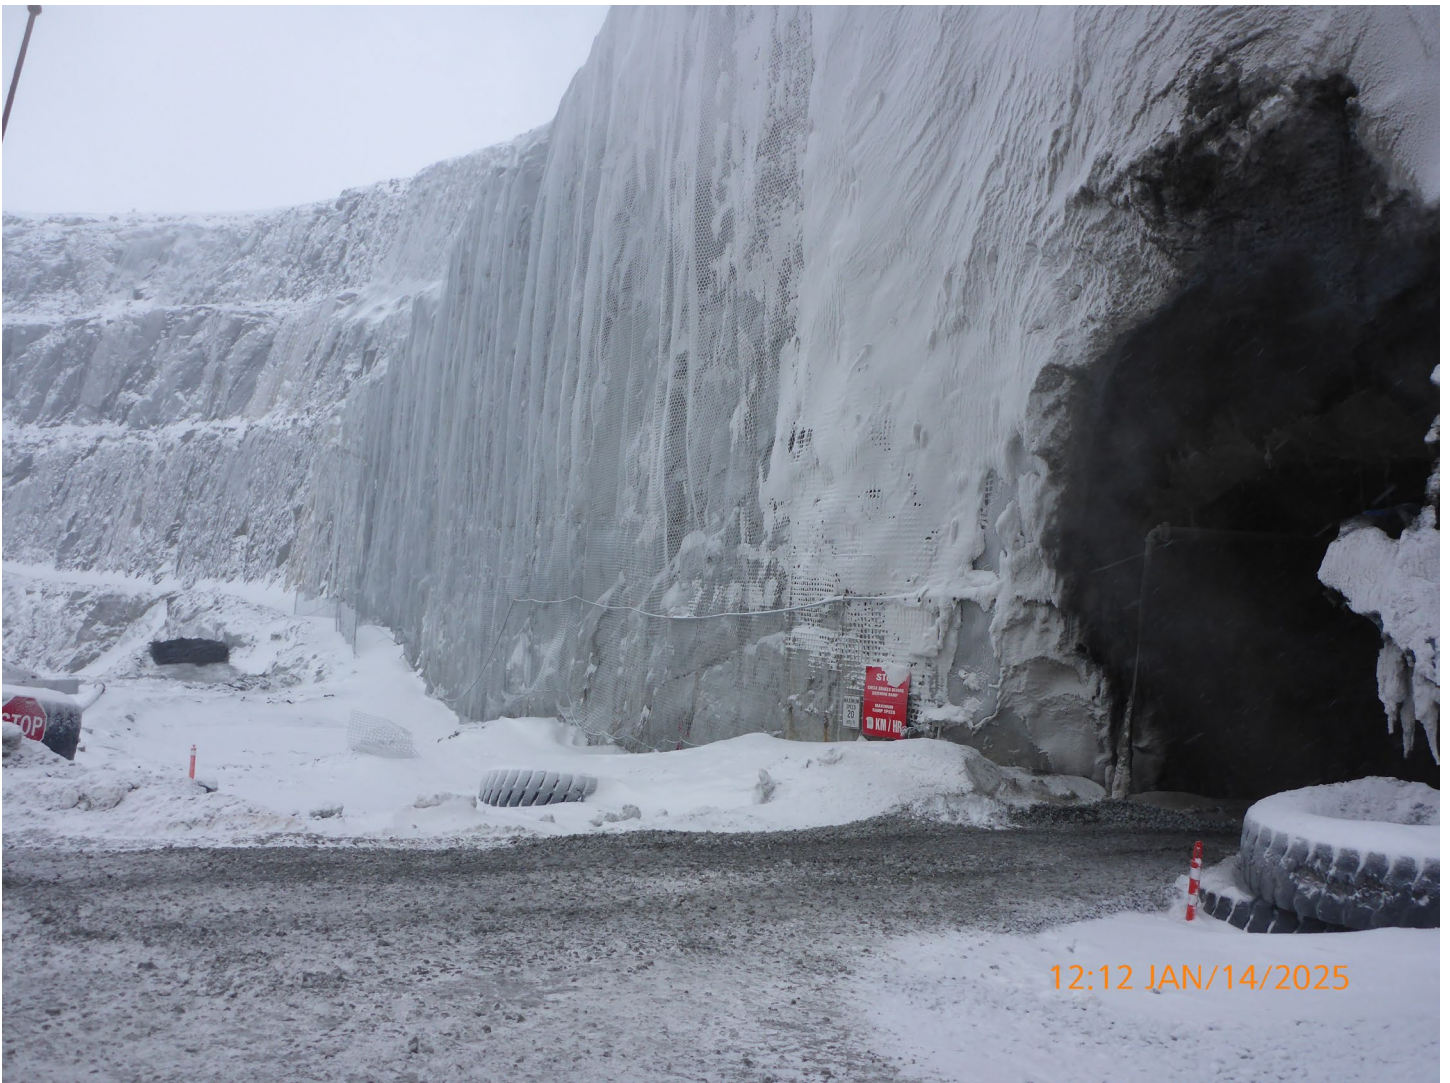
**Photo 15 – Misery Underground – The opening of the Misery Underground portal is on the ramp of the Misery Pit. Ore is transported out of the mine and placed outside the portal, then transported to the Process Plant.**

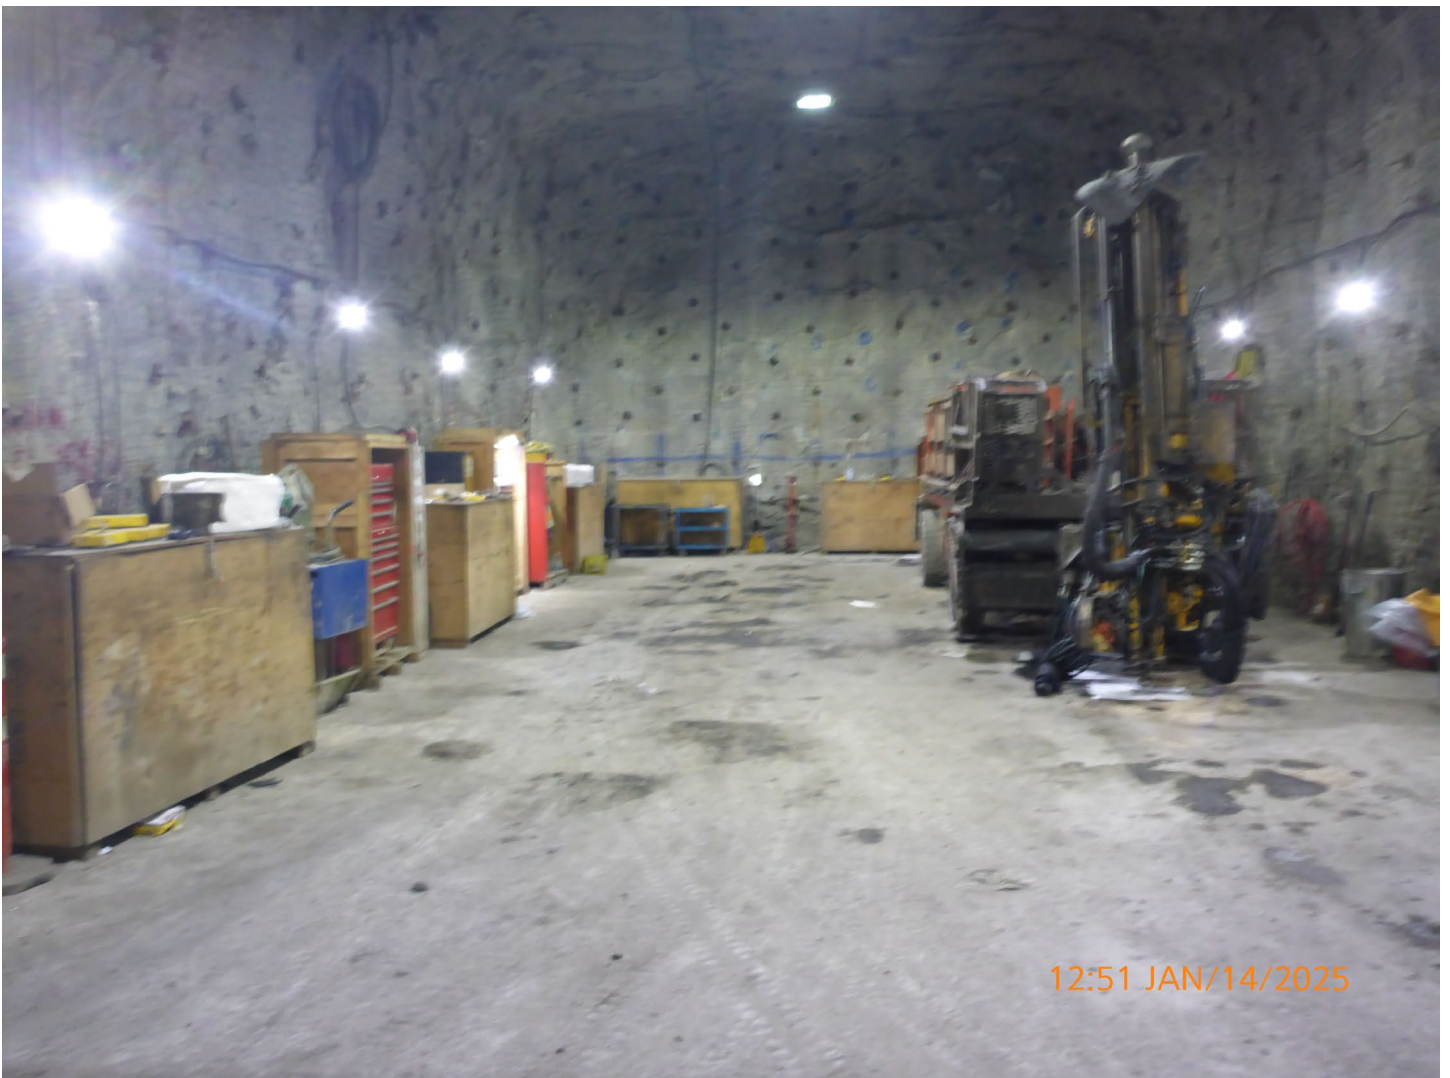
**Photo 16 – Misery Underground – The equipment Service Bay is located on the 1950 level of the mine. The shop was clean and well organized.**

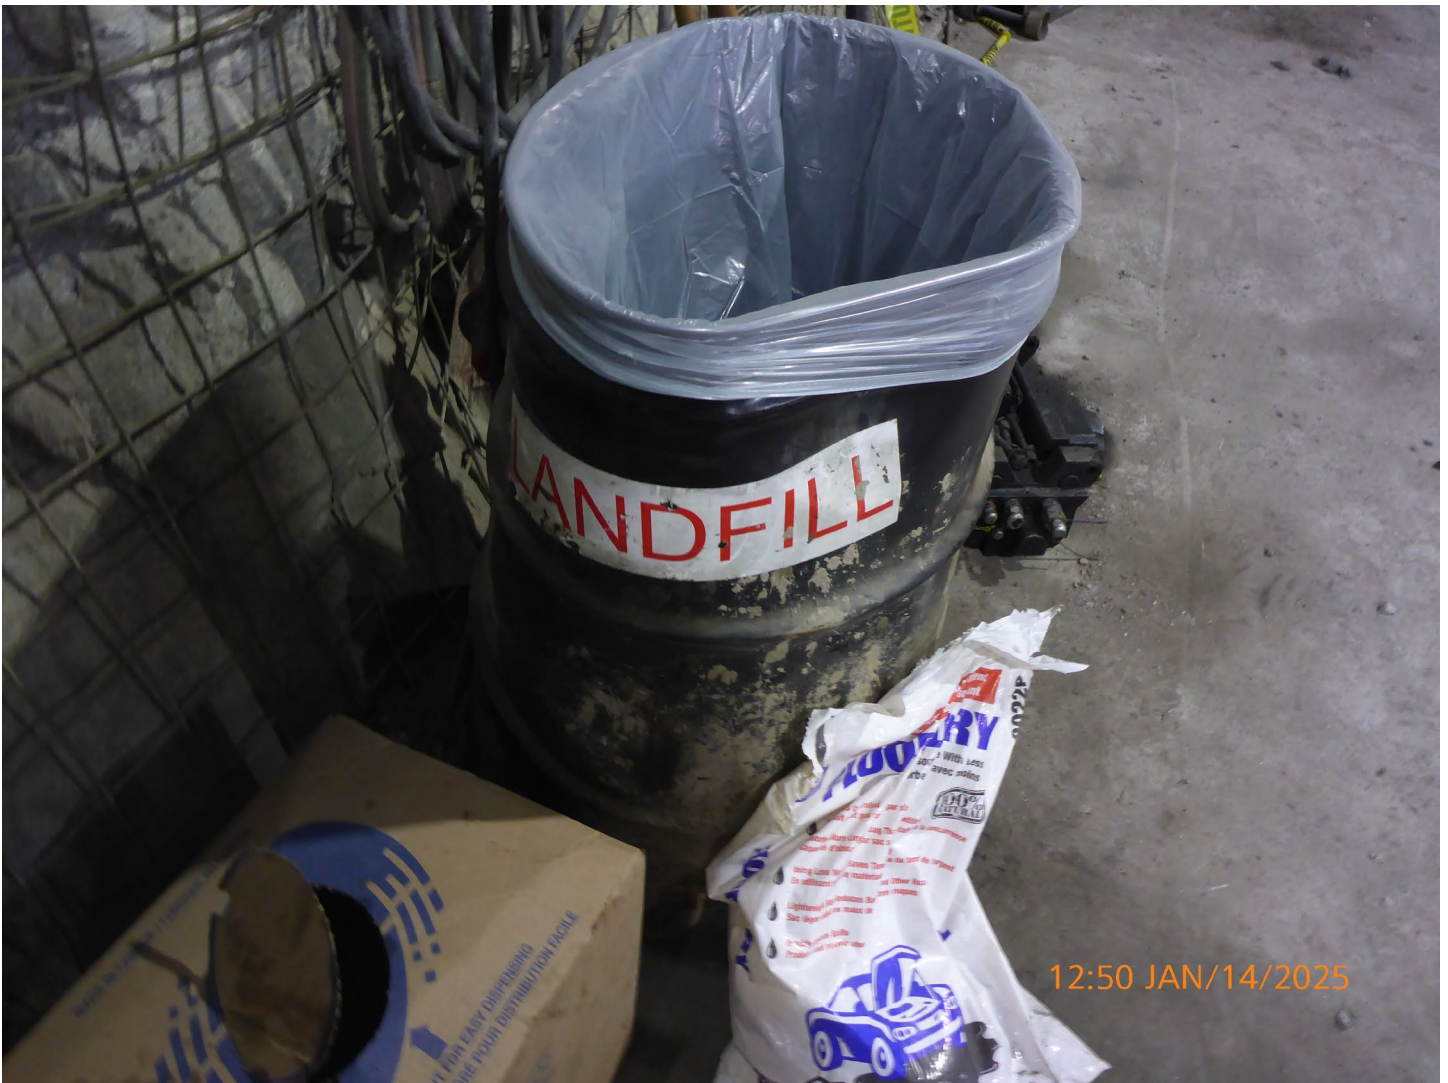
Photo 17 – Misery Underground – Labelled waste containers are located in the service bay. Waste is segregated and brought to surface for proper disposal. There were no indication so misdirected waste coming from the underground mine.

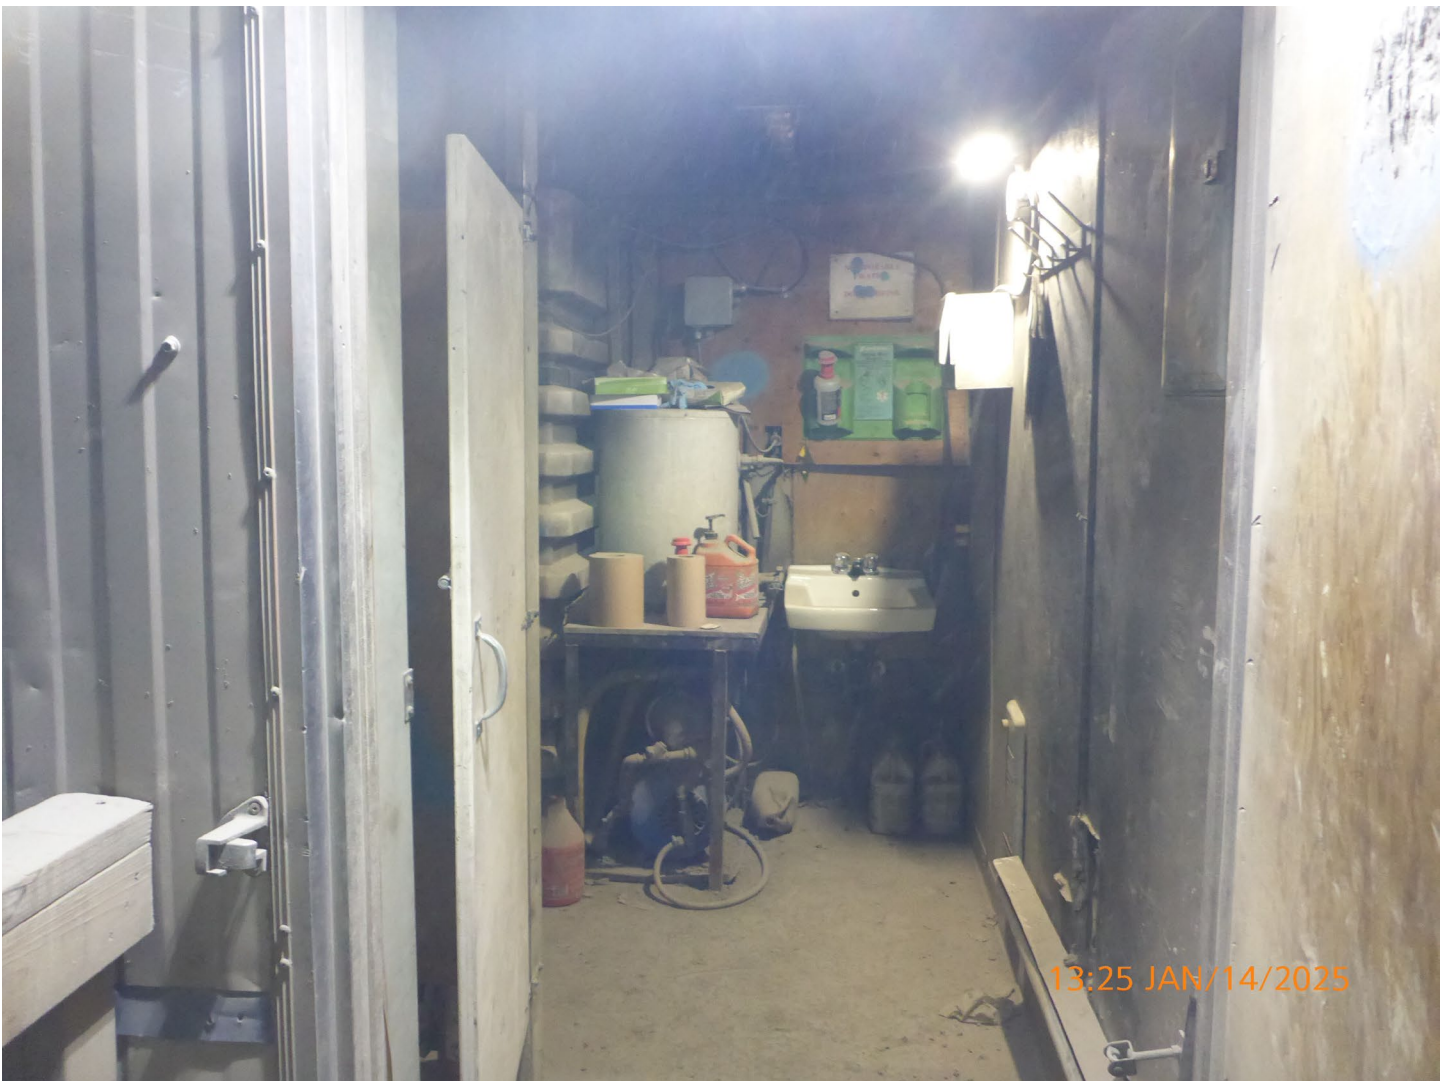
Photo 18 – Misery Underground – A washroom facility is located on the 2050 level of the mine. Waste is contained in a holding tank and transported to the Sewage Treatment Plant.

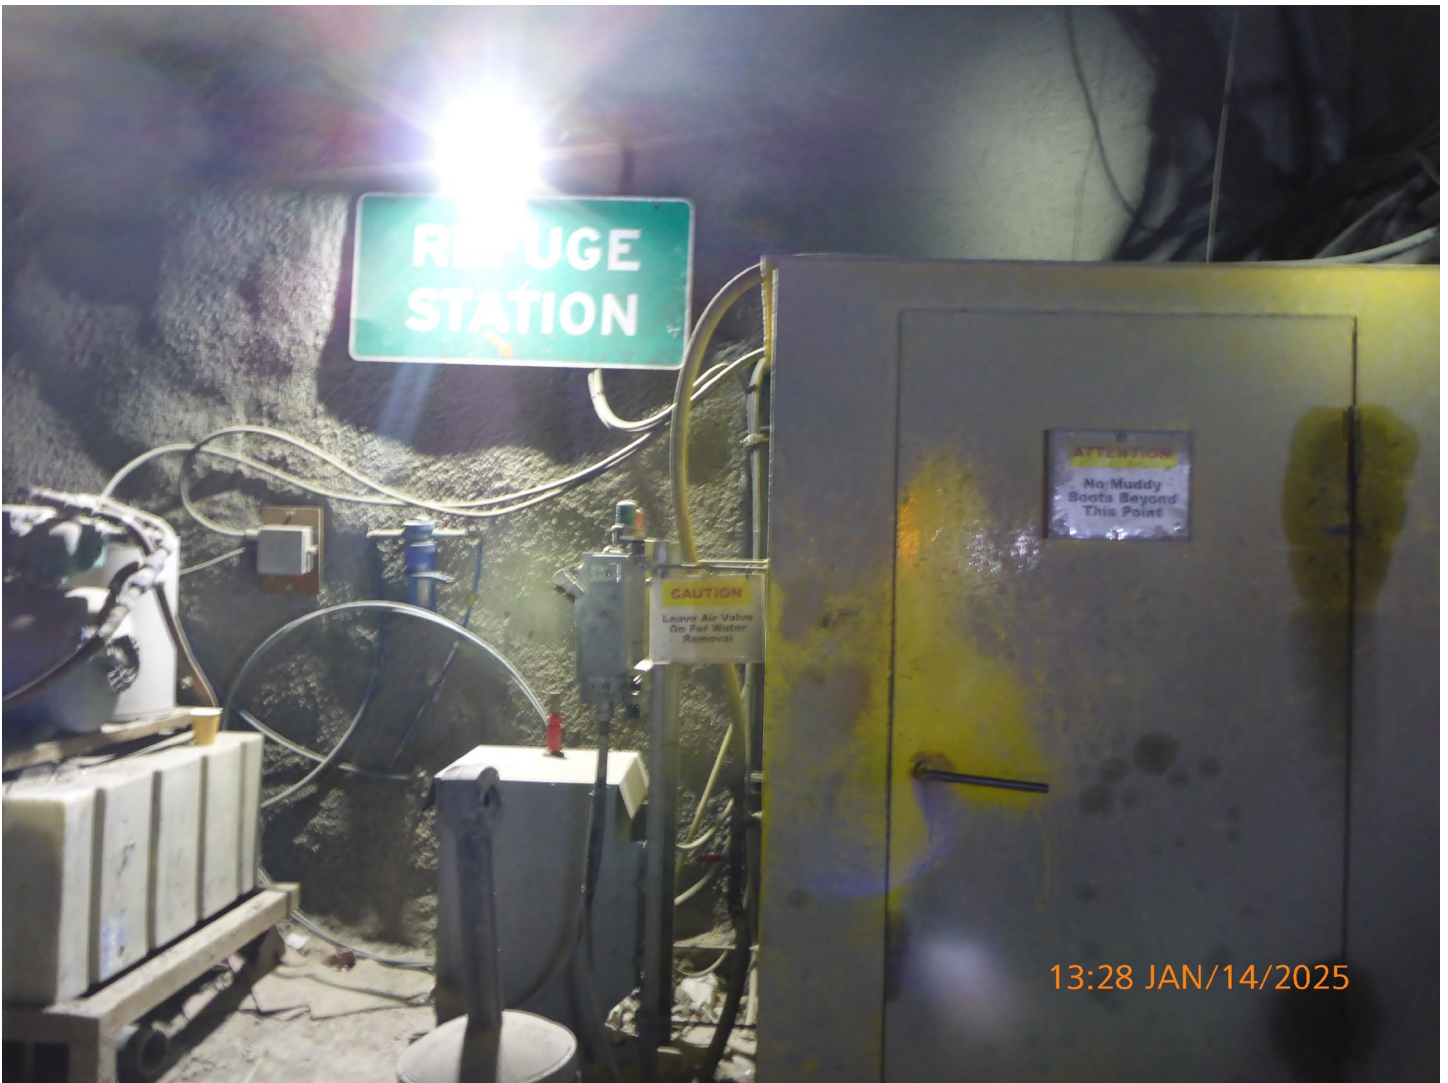
**Photo 19 – Misery Underground – Refuge stations are located on strategic levels in the mine. The primary refuge station is used as a lunchroom for workers. The refuge stations were clean and maintained. Food waste is collected and brought to surface for disposal.**

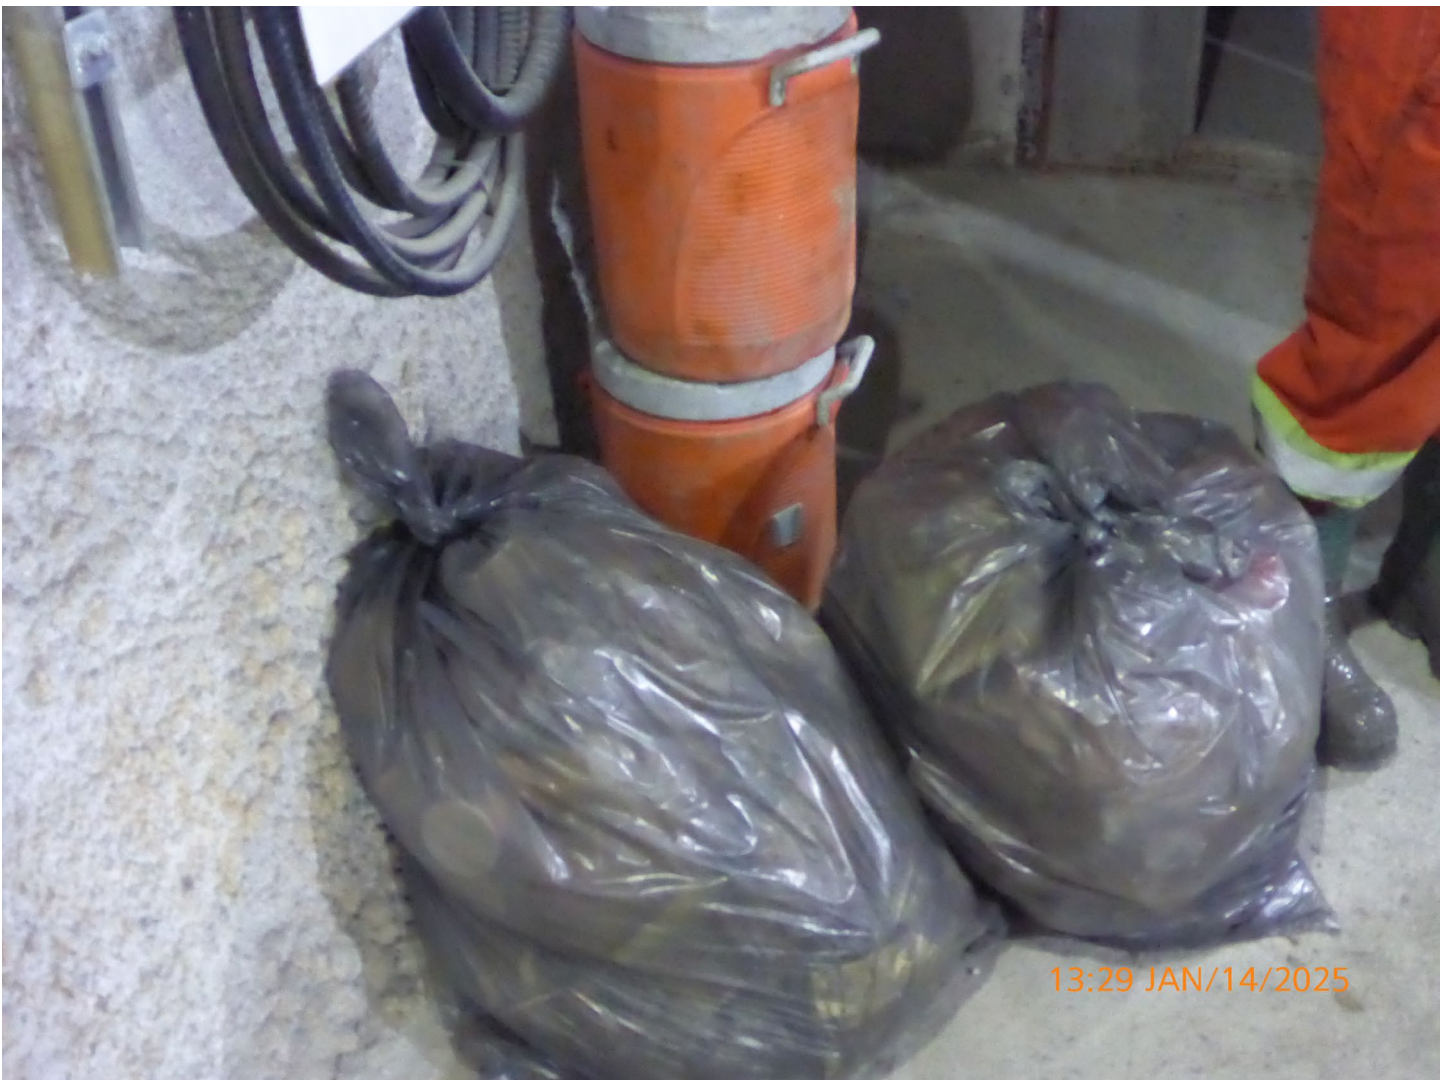
**Photo 20 – Misery Underground – Food waste is collected in the lunchrooms and brought to the surface for proper disposal at the incinerator building.**

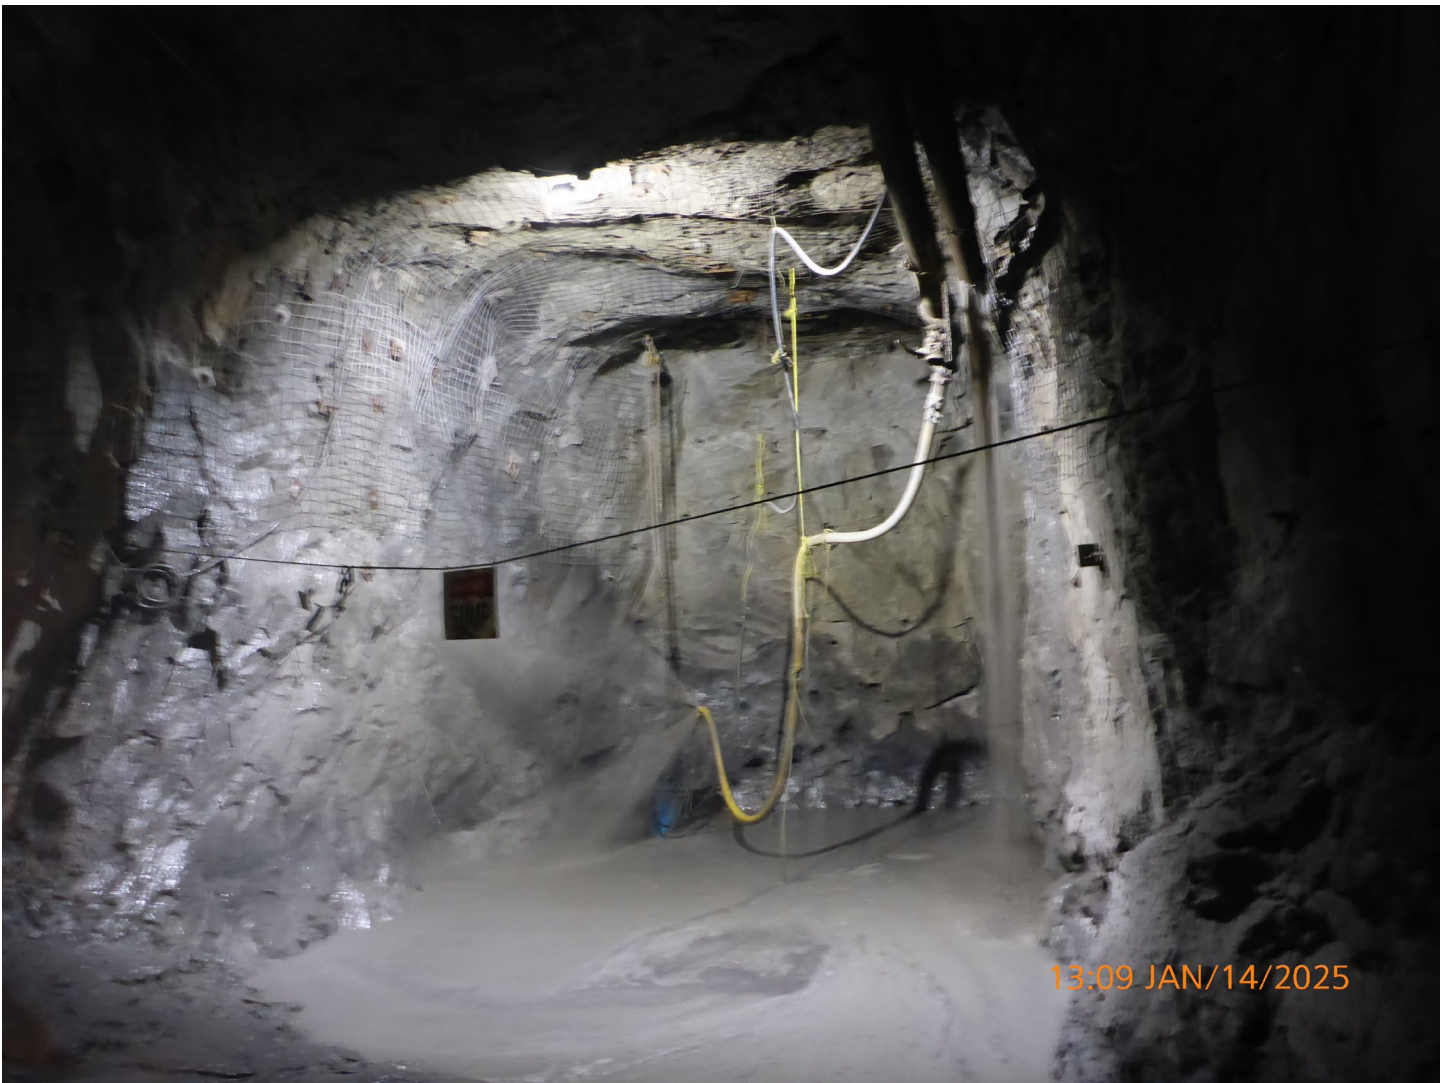
Photo 21 – Misery Underground – Water is collected in sumps on each level. Water is then pumped into the water collection system that reports to the Mud Wizard, and eventually to surface.

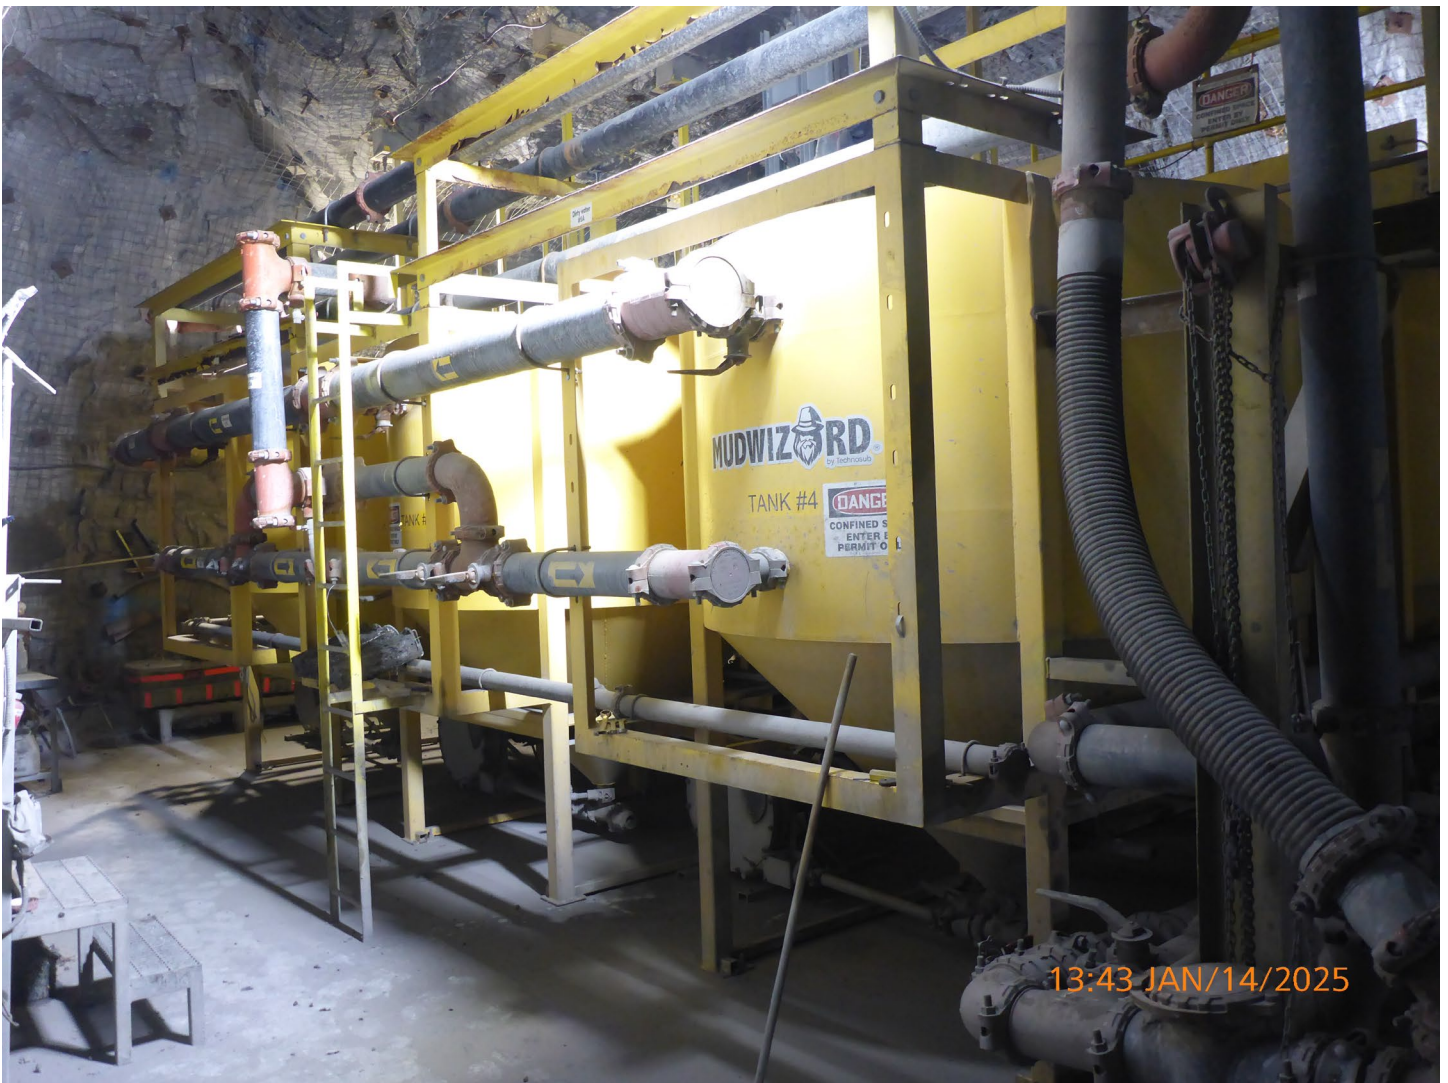
Photo 22 – Misery Underground – The Mud Wizard treats underground water to remove suspended solids. The water is then reused for mining equipment or sent to the surface for disposal in King Pond or Lynx Pit.

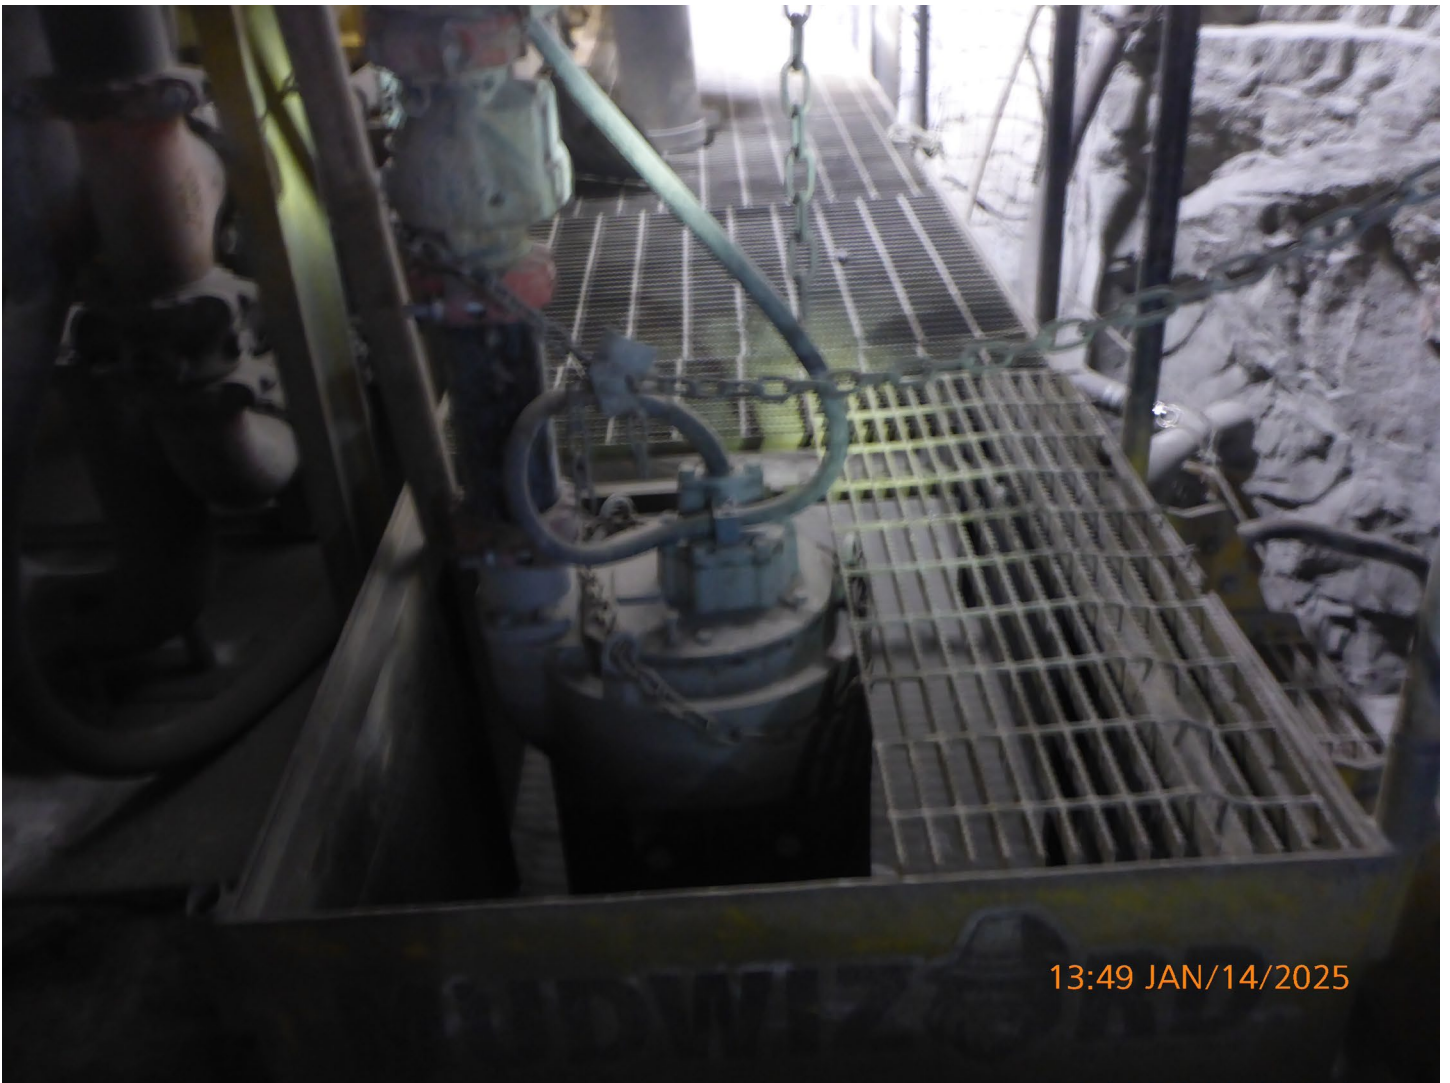
The Inspector toured through Misery Underground to inspect water and waste management throughout the mine. Overall waste was being managed very well with labelled waste containers placed in the lunchroom and strategic locations in the mine. All waste is collected and brought to surface regularly to be disposed of at the main camp facilities. The Inspector saw no indications of misdirected waste. Mine water is collected in sumps on each level and pumped into the water management system. The water management system reports to the Mud Wizard which is supposed to clarify the water before being reused for underground equipment, or pumped to surface for disposal in King Pond or Lynx Pit. SNP station 1616-46b is located underground at the Mud Wizard. There was no signage present indicating the sampling location. Arctic will need to install signage at the sampling location as per Part B Item 12 of the water licence (Photos 15 through 25).

Photo 23 – Misery Underground – SNP Station 1616-46b is located adjacent to the Mud Wizard. Proper signage indicating the sampling location needs to be installed as per Part B Item 12 of the Licence.

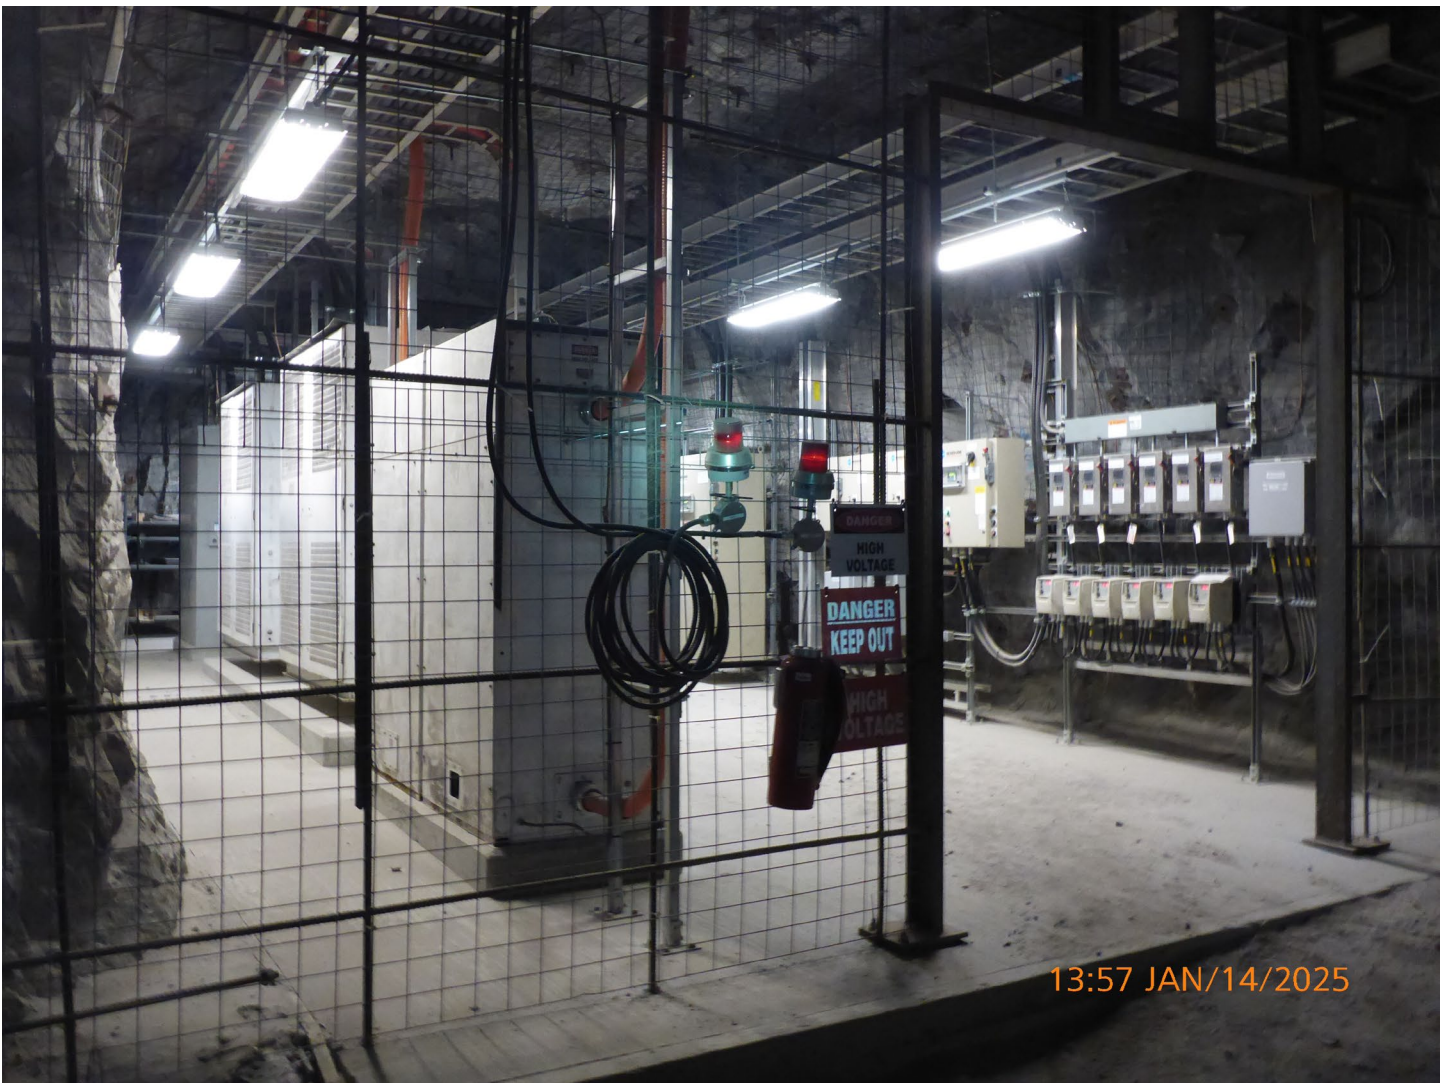
Photo 24 – Misery Underground – The underground electrical substation contains transformers and switch gear used to operate underground fans and pumps.

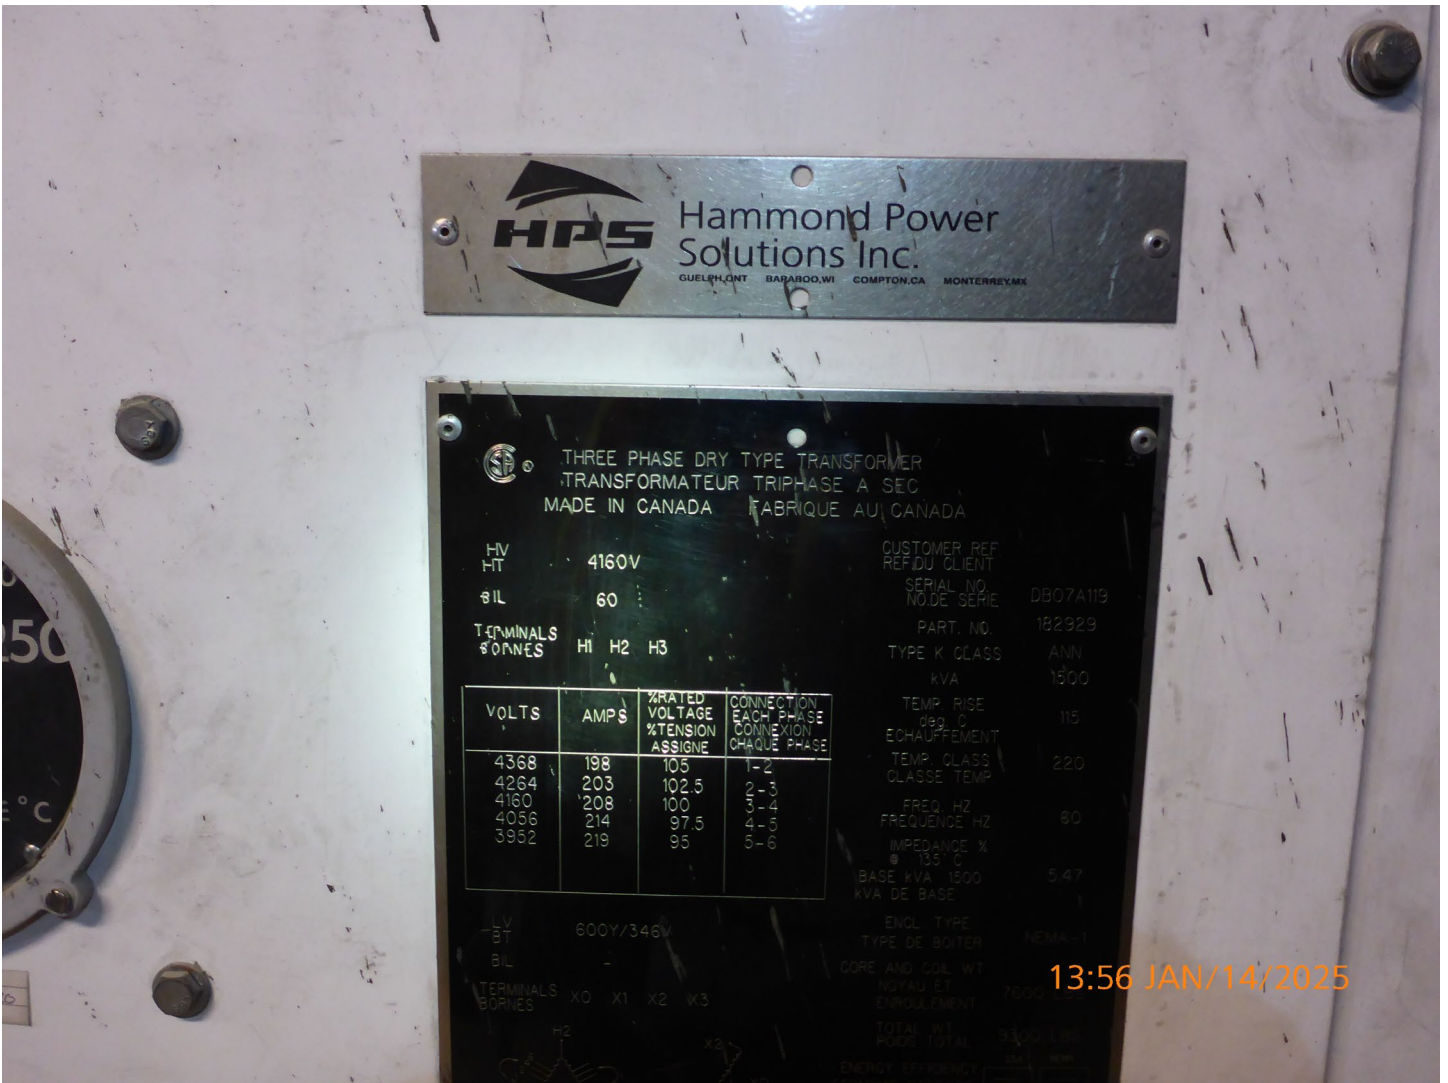
Photo 25 – Misery Underground – Transformers used underground are “Dry Type” and don’t use or contain any oils that can potentially contaminate water if flooded.

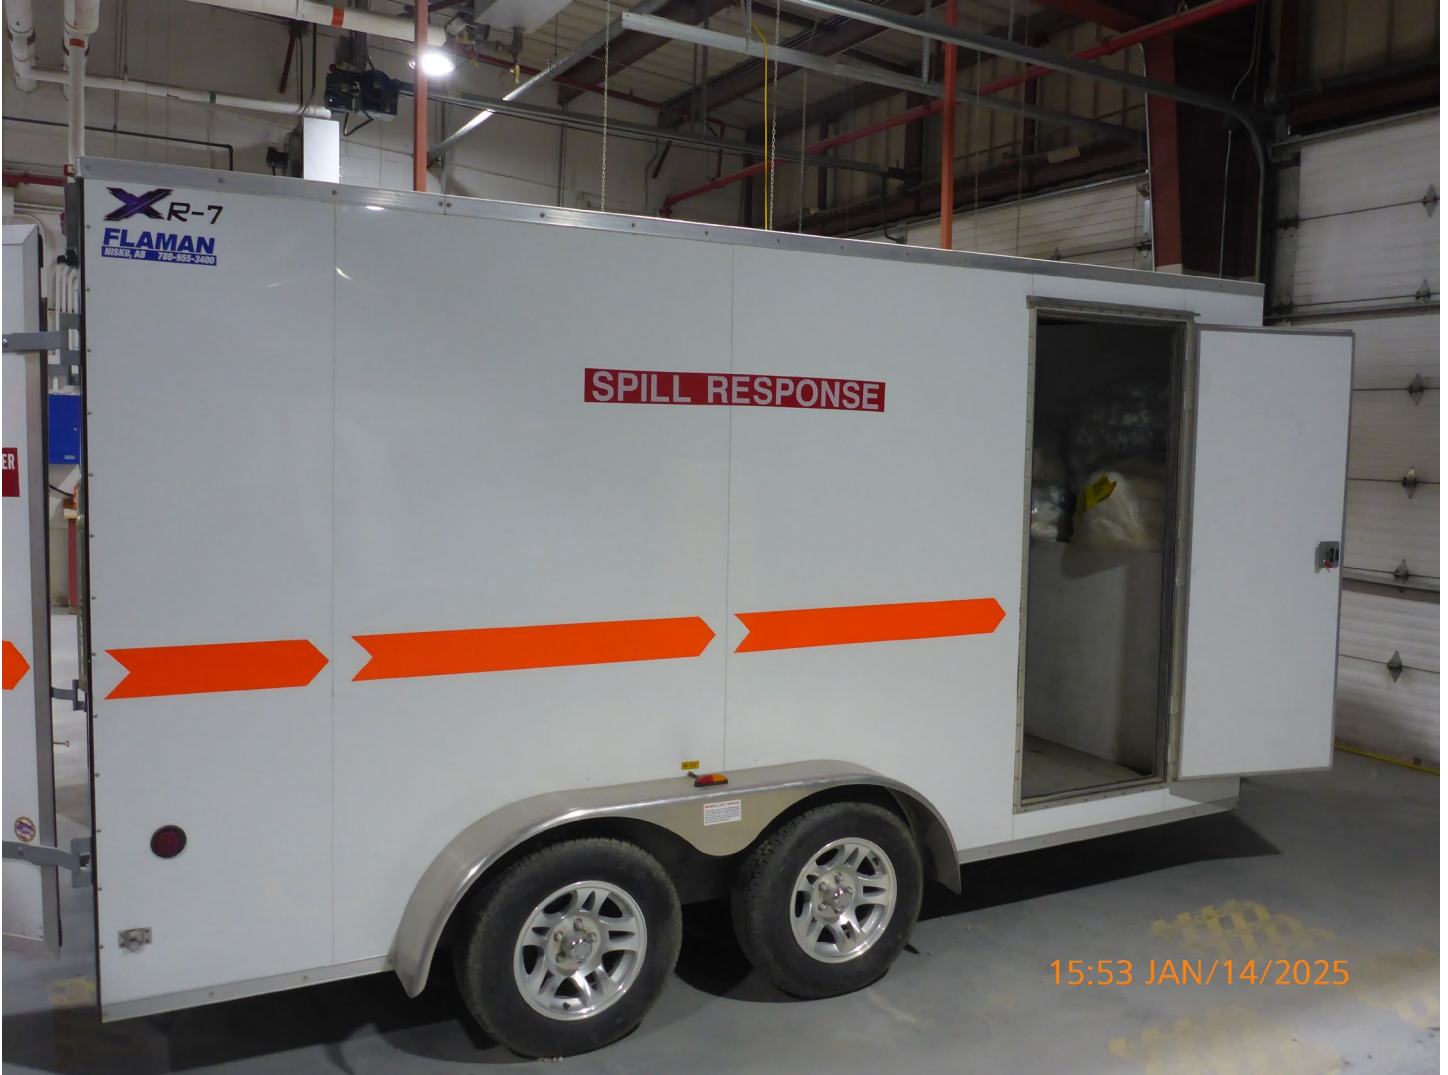
Photo 26 – Spill Response Trailer – The spill trailer is parked inside the fire hall at the main camp. Storing inside ensures that the equipment doesn’t freeze, and the trailer is always warm and accessible for quick deployment.

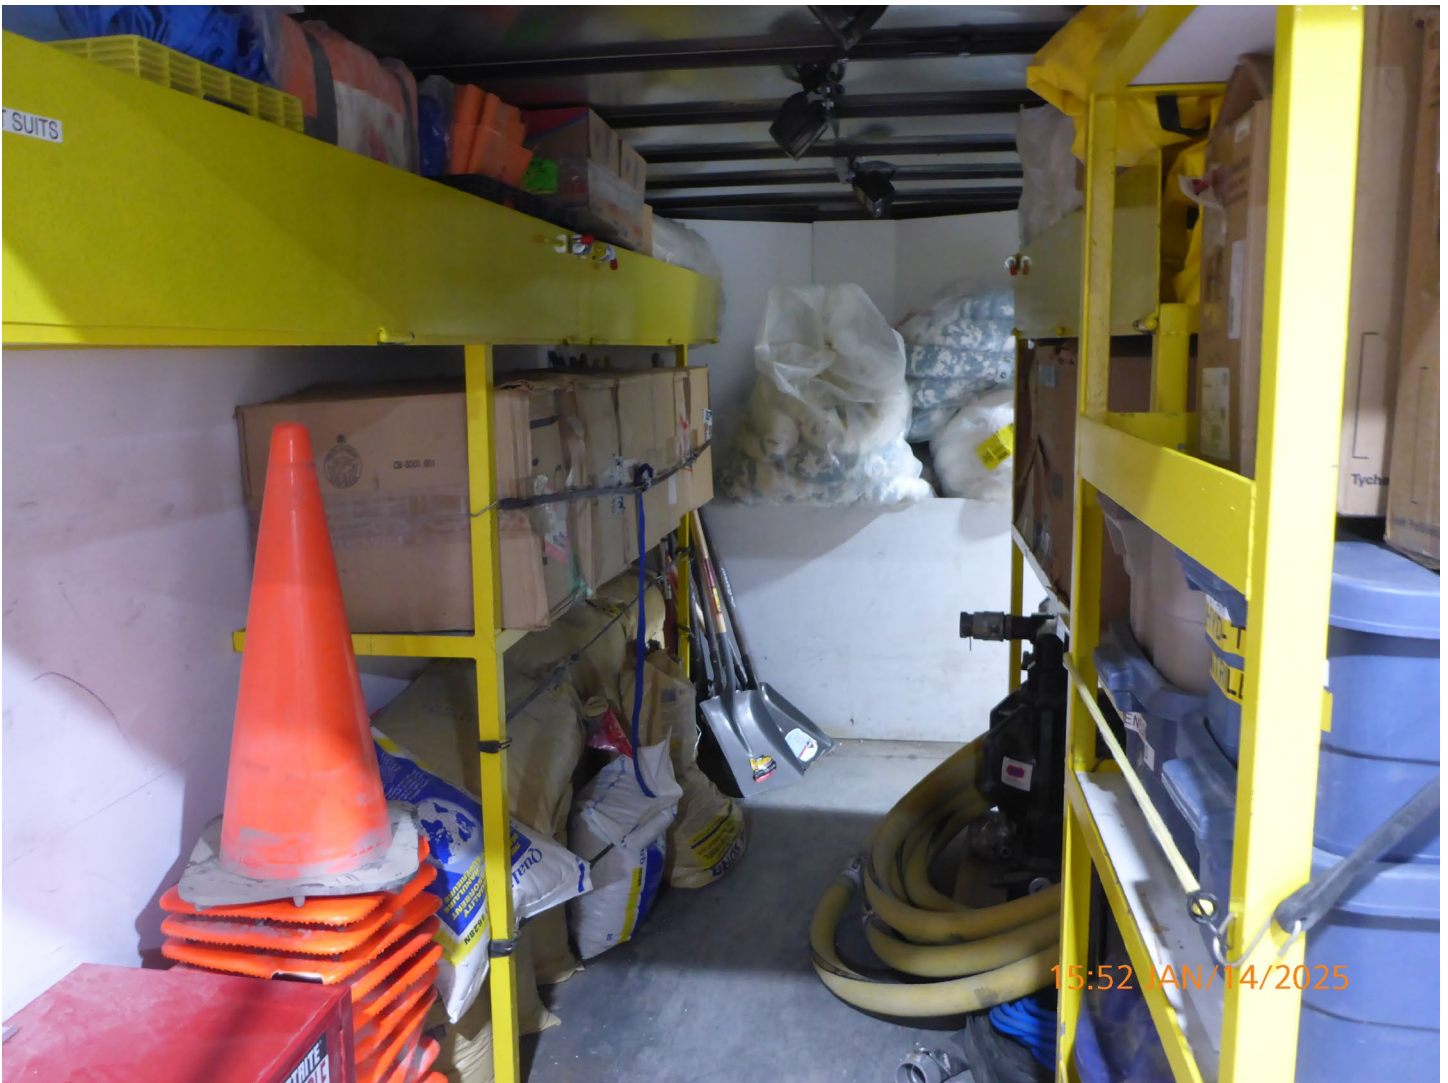
Photo 27 – Spill Response Trailer – The interior of the spill trailer was well organized with labelled containers for easy access and deployment.

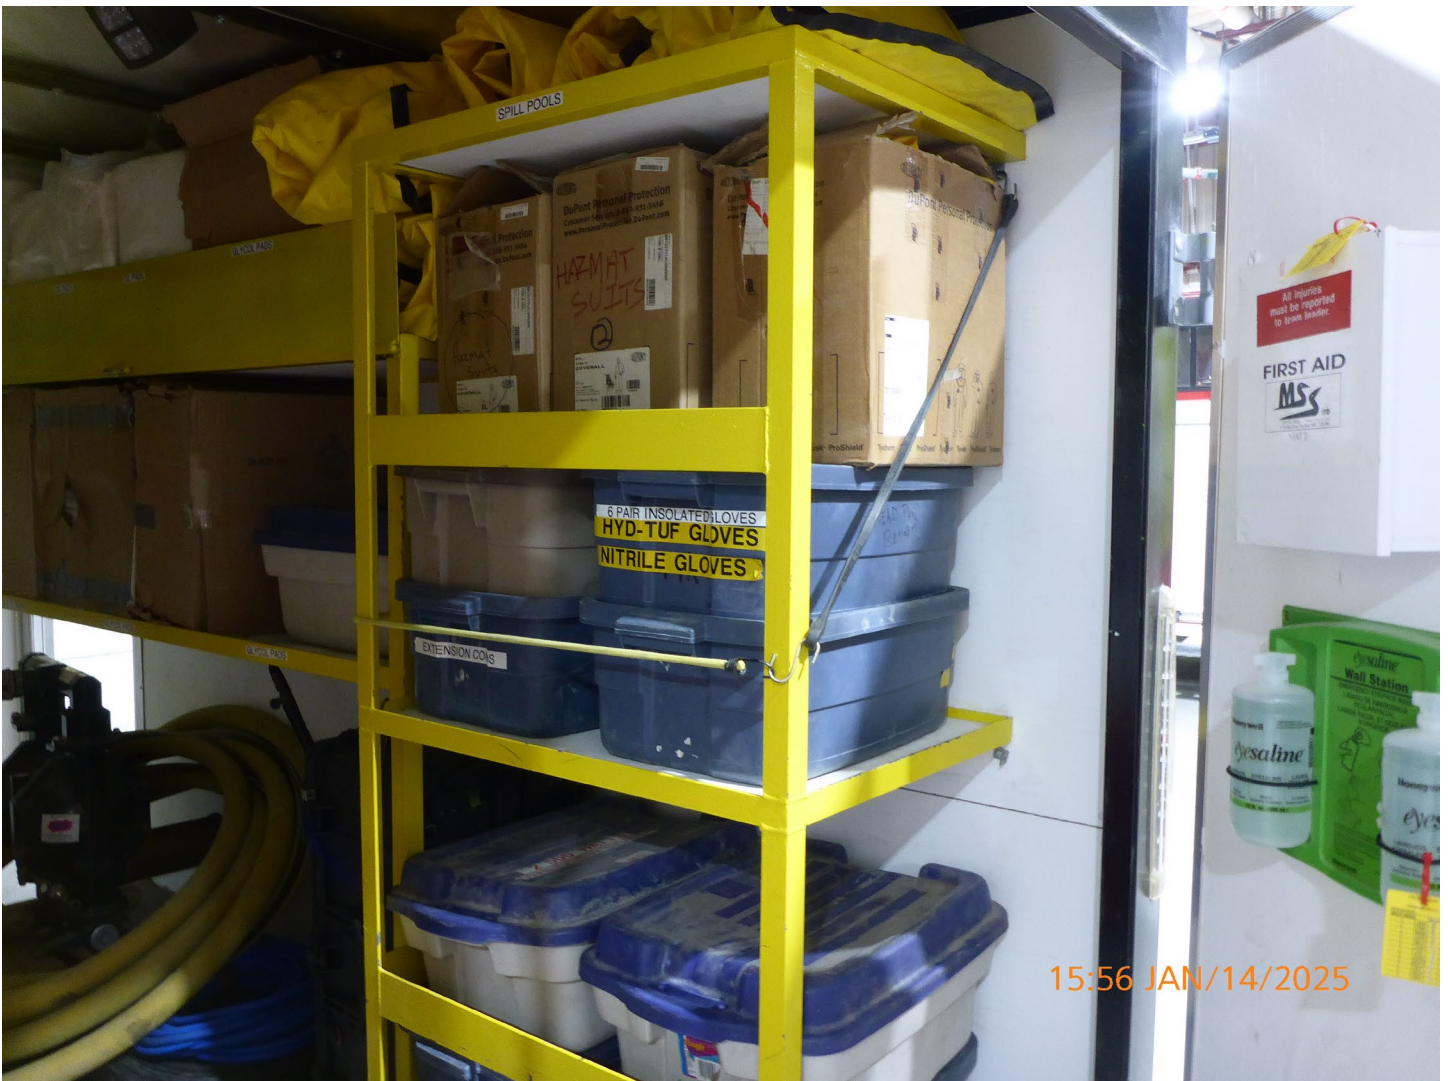
Photo 28 – Spill Response Trailer – The interior of the spill trailer was well organized with labelled containers for easy access and deployment.
