**GNWT ECC - North Slave Region**

**Water Licence W2022L2-0001**

**Re: July 29<sup>th</sup> 2026, Water Licence Inspection**

INDUSTRIAL WATER USE INSPECTION REPORT

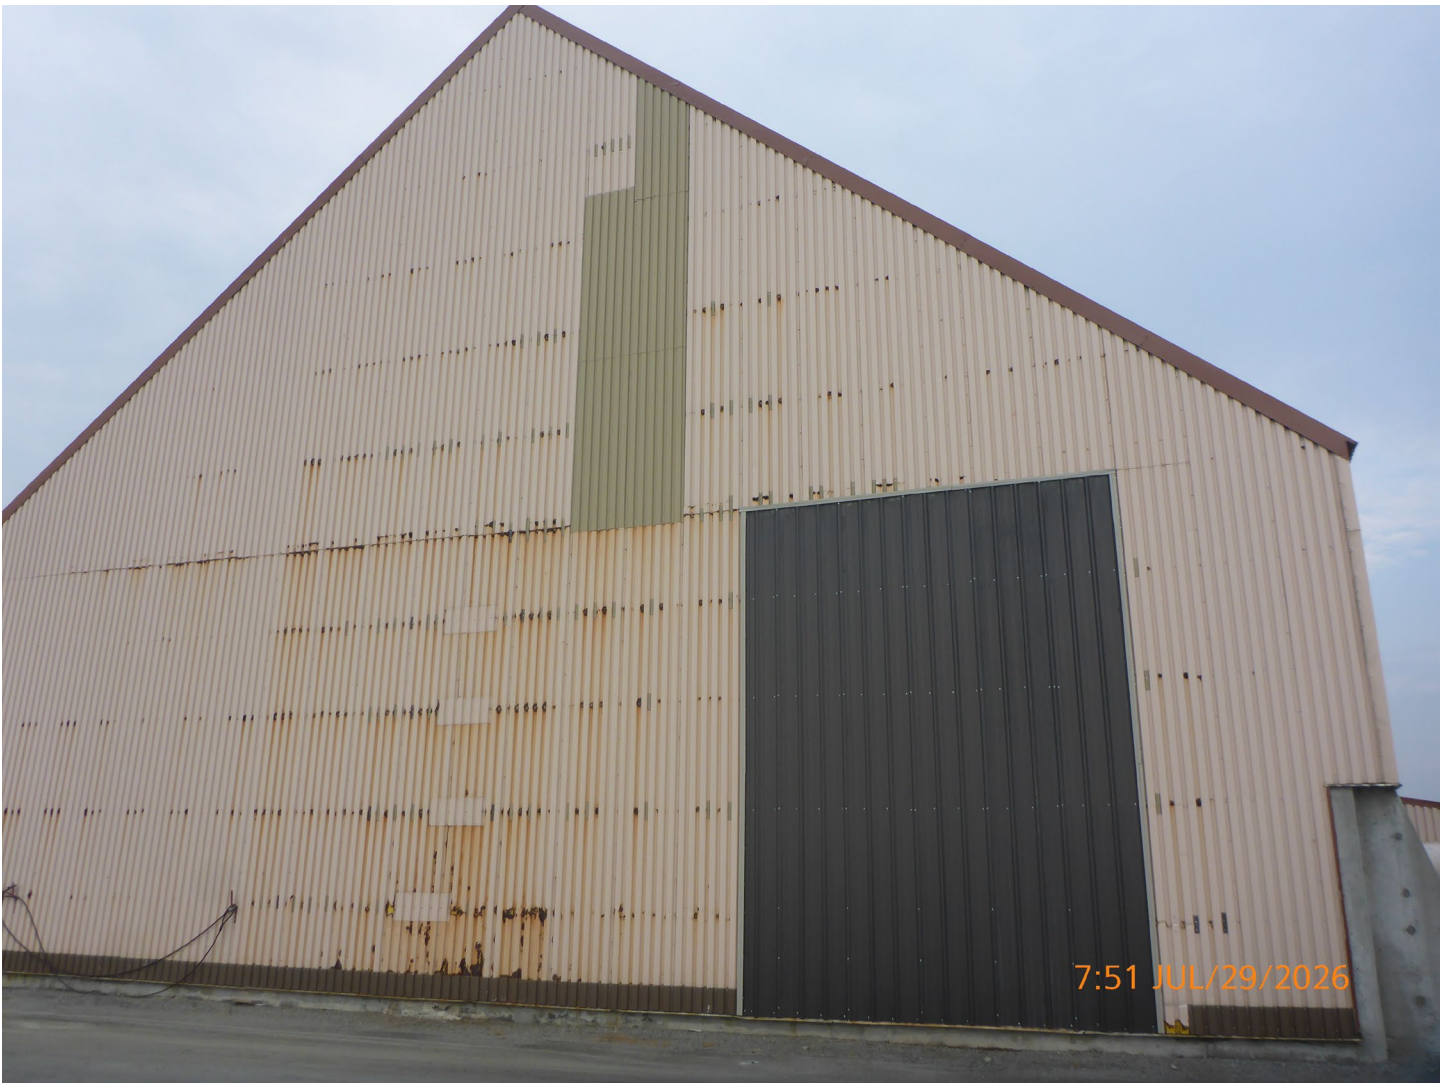
High winds over the winter had damaged the metal siding of the Ammonium Nitrate building. The Inspector has confirmed that the storm damage has been repaired and the exposed sections have been patched. The Inspector noted that Ammonium Nitrate is beginning to seep through cracks in the containment on the southern wall of the AN Building at section S8. A small amount of AN has accumulated at the base of the exterior wall.

**Photo 1 – Ammonium Nitrate Building – Repairs to the exterior siding of the AN Building are complete.**

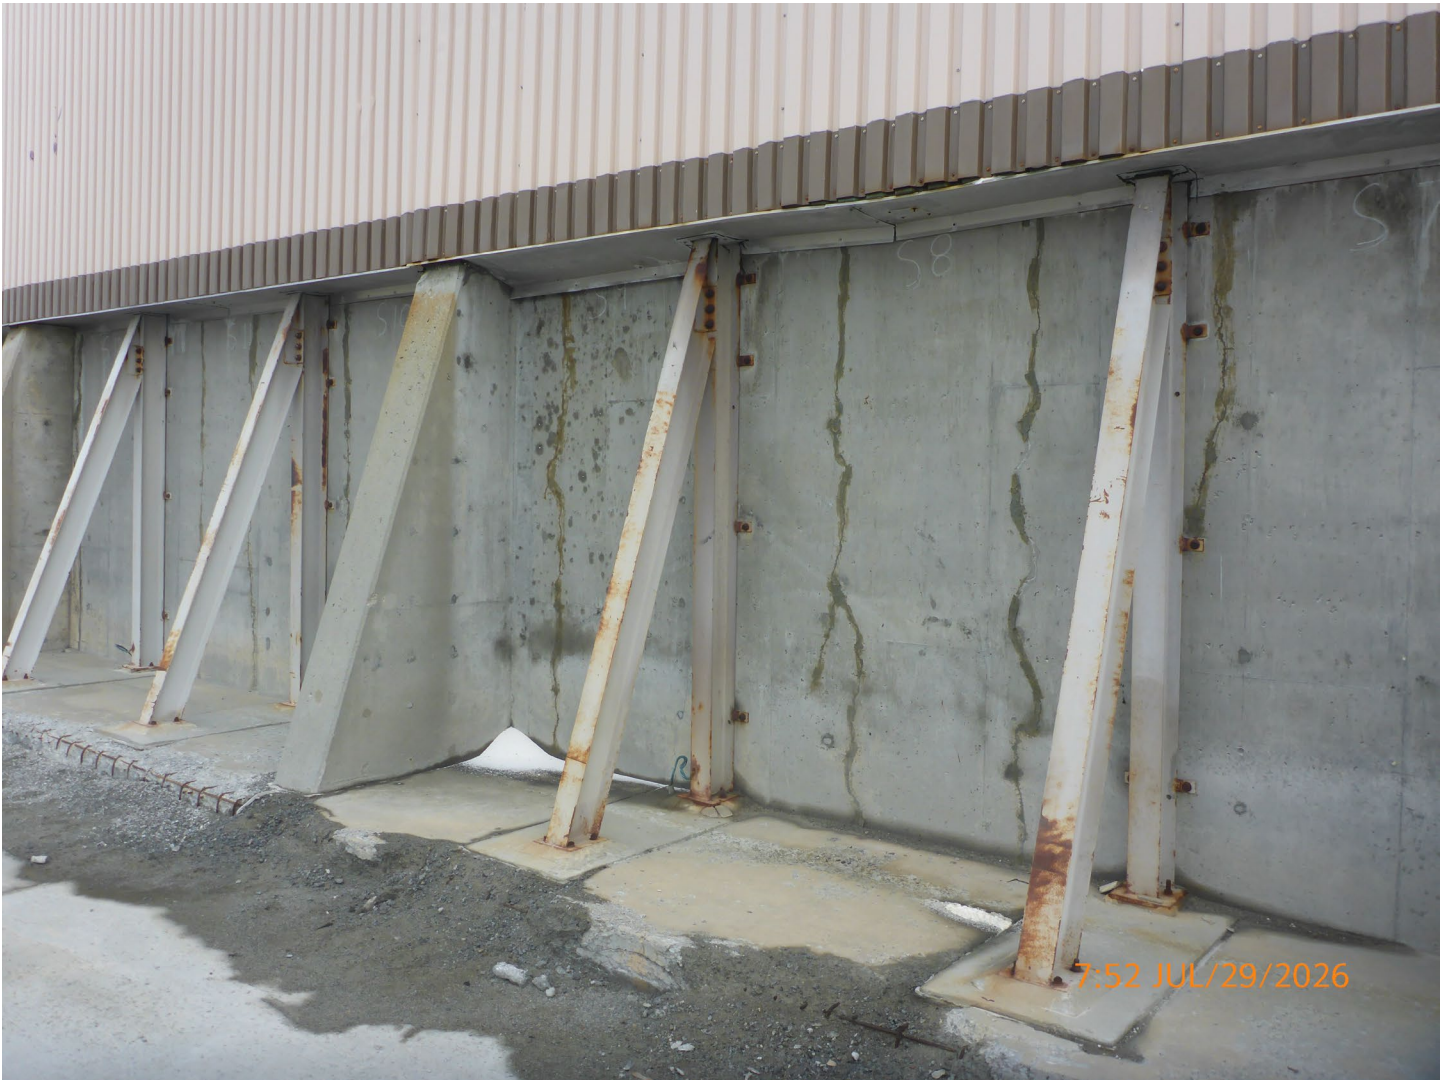
**Photo 2 – Ammonium Nitrate Building – A small amount of AN is seeping though openings in the siding above the concrete containment at Section S8 on the southern wall of the building.**

Additionally, the Inspector noted that Ammonium Nitrate Prill is escaping containment through gaps in the siding of the Ammonium Nitrate building. The Inspector recommends that any fugitive AN be recovered and returned to containment, and a plan be developed to facilitate repairs.

The Inspector recommends that any fugitive AN be collected and returned to containment, and a repair/decommissioning schedule be created and implemented to prevent future loss of containment.

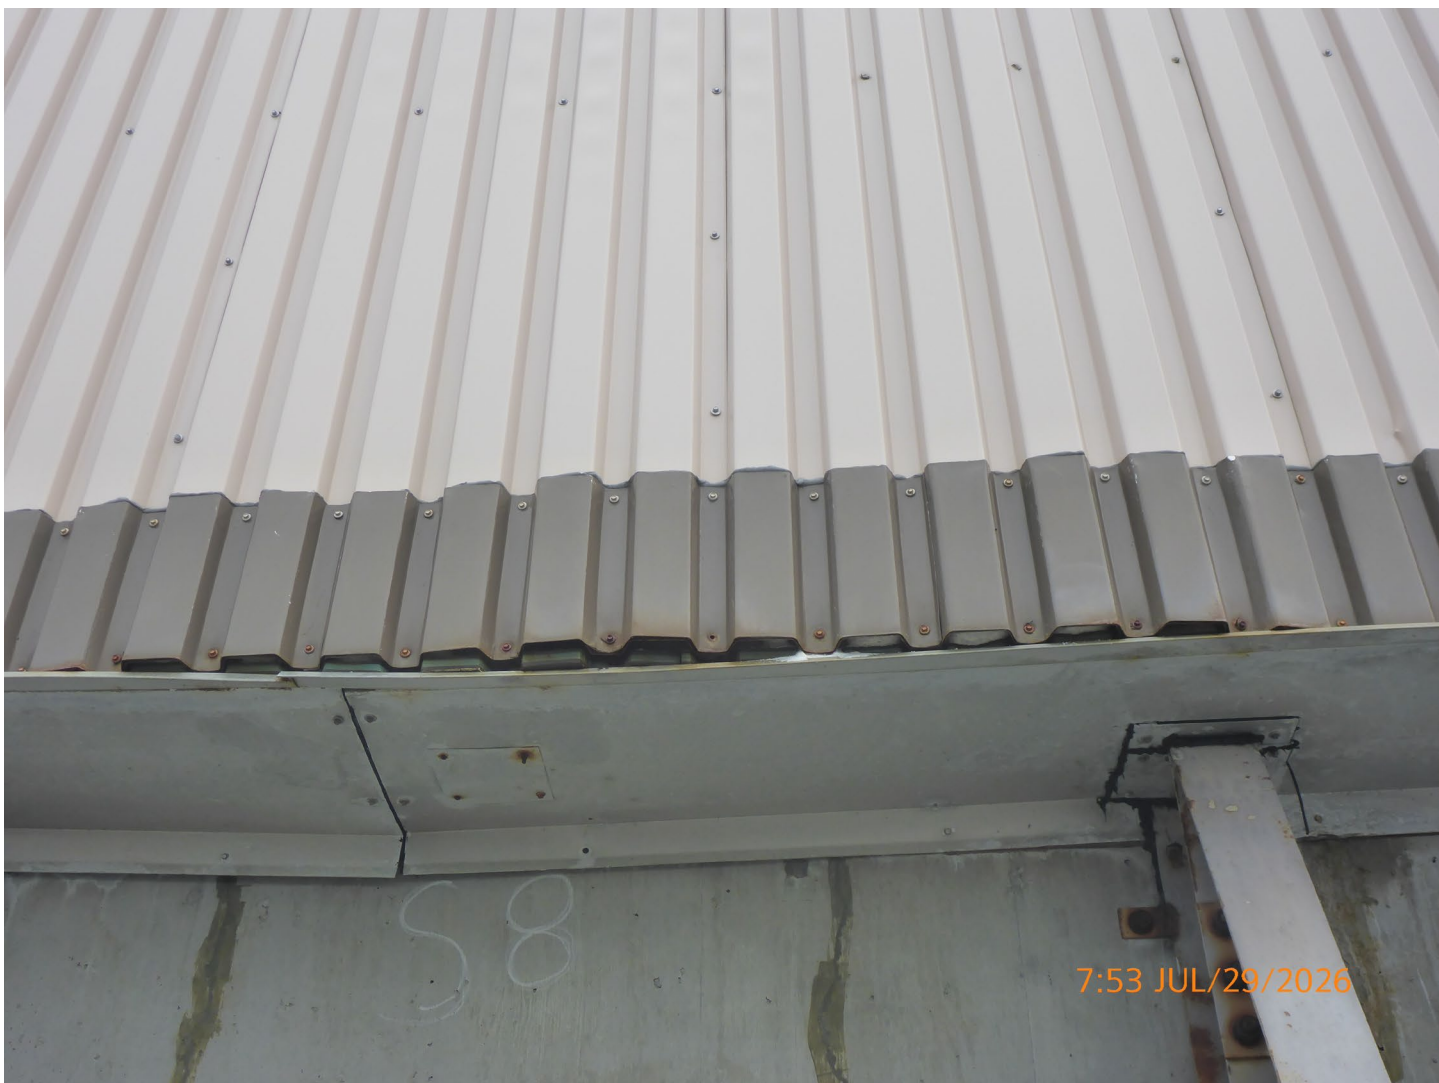
An inspection of the building interior revealed that AN dust has accumulated along the concrete containment barrier and is in contact with the metal sheeting. Corrosion of the metal has allowed the AN to escape containment and fall to the ground. The area around the AN building is graded toward containment sumps, and the sumps have plenty of capacity to contain any contaminated runoff. There is currently 4.6 Million kilograms of AN being stored inside the AN Building.

**Photo 3 – Ammonium Nitrate Building – AN dust along the concrete containment is causing corrosion of the metal siding allowing AN to seep through.**

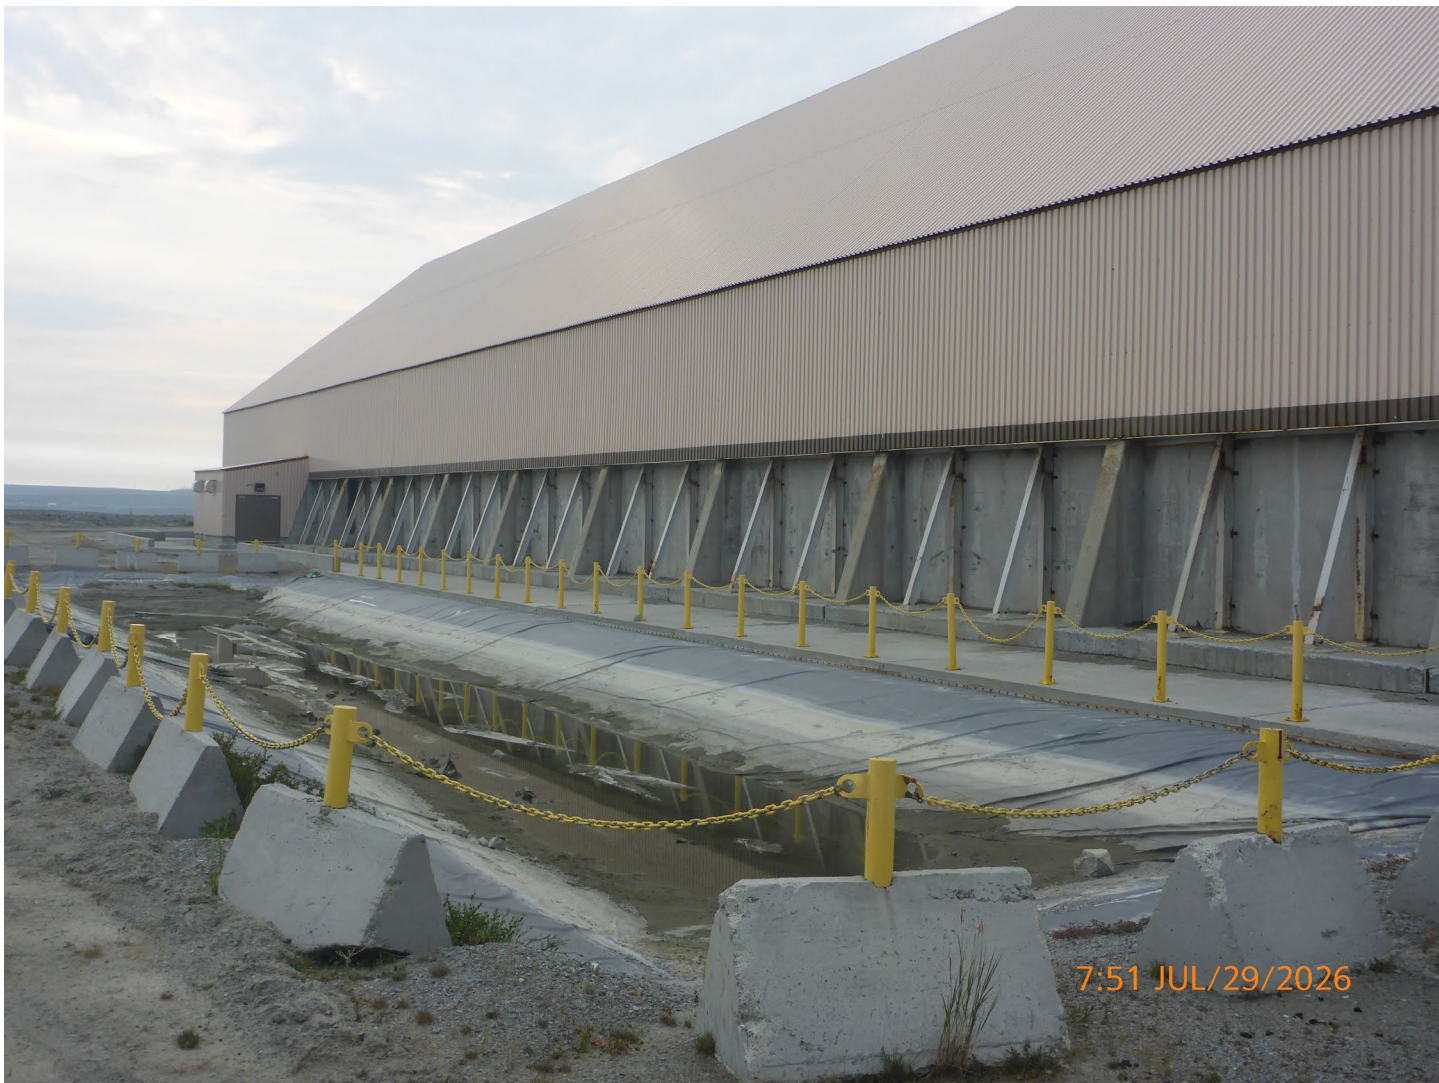
**Photo 4 – Ammonium Nitrate Building – The area around the AN Building is graded toward lined sumps that are designed to contain any contaminated runoff. The sumps were empty and have plenty of capacity.**

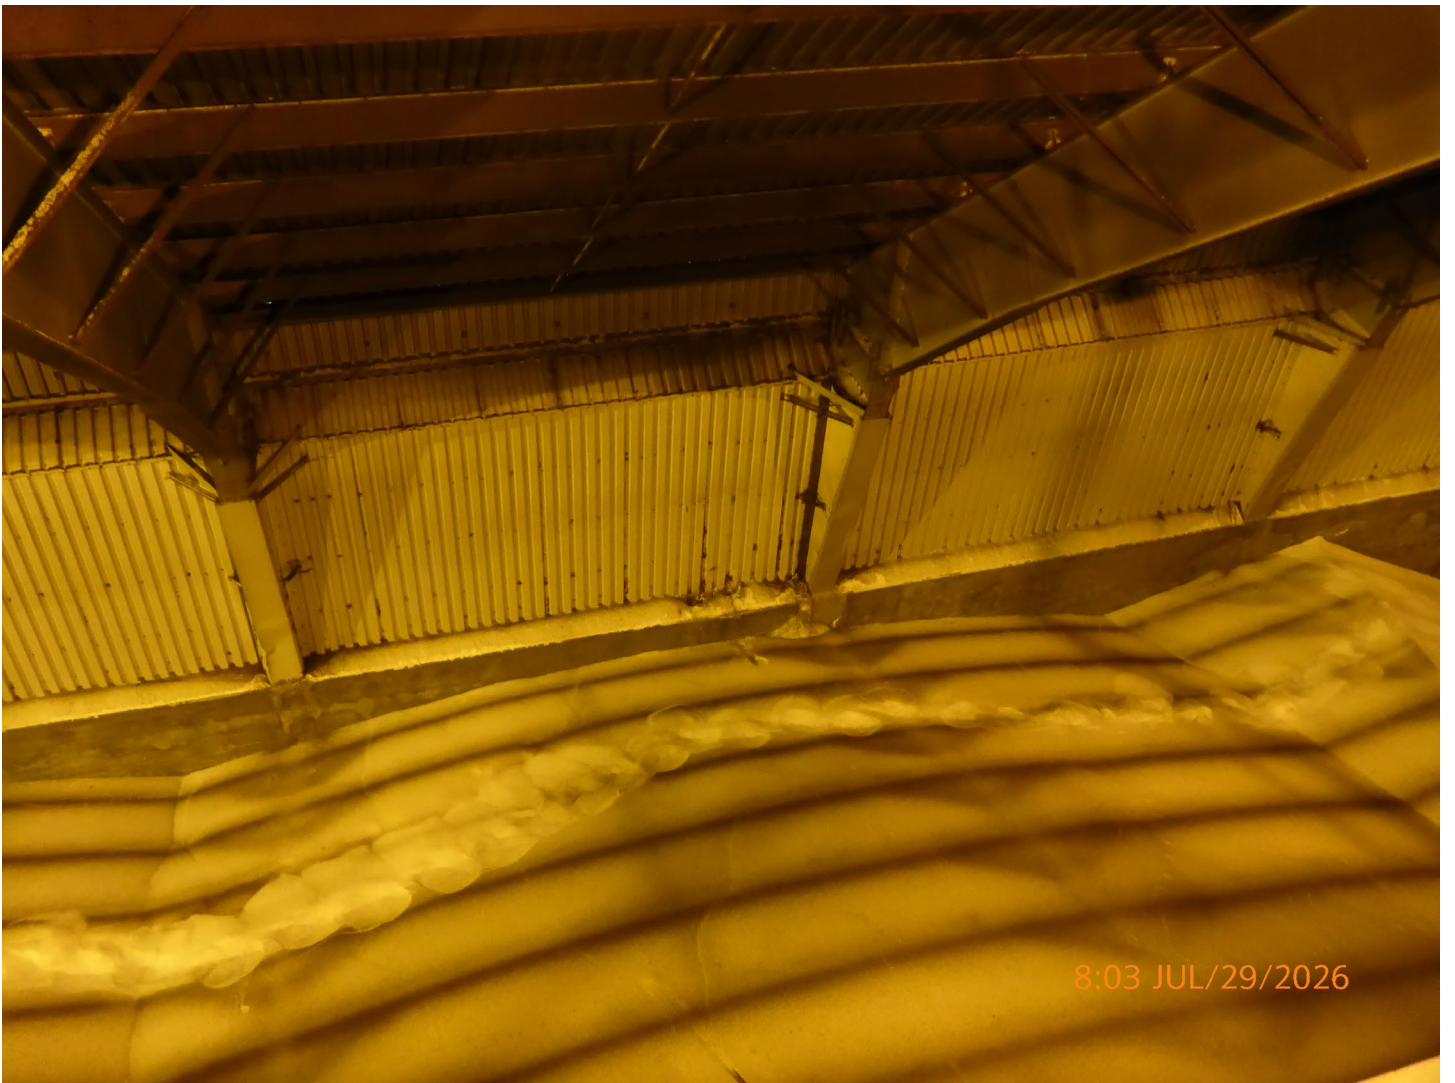
**Photo 5– Ammonium Nitrate Building – The Ammonium Nitrate storage levels are below the concrete containment, however, dust has accumulated along the top of the concrete containment and is in contact with the metal siding causing corrosion.**

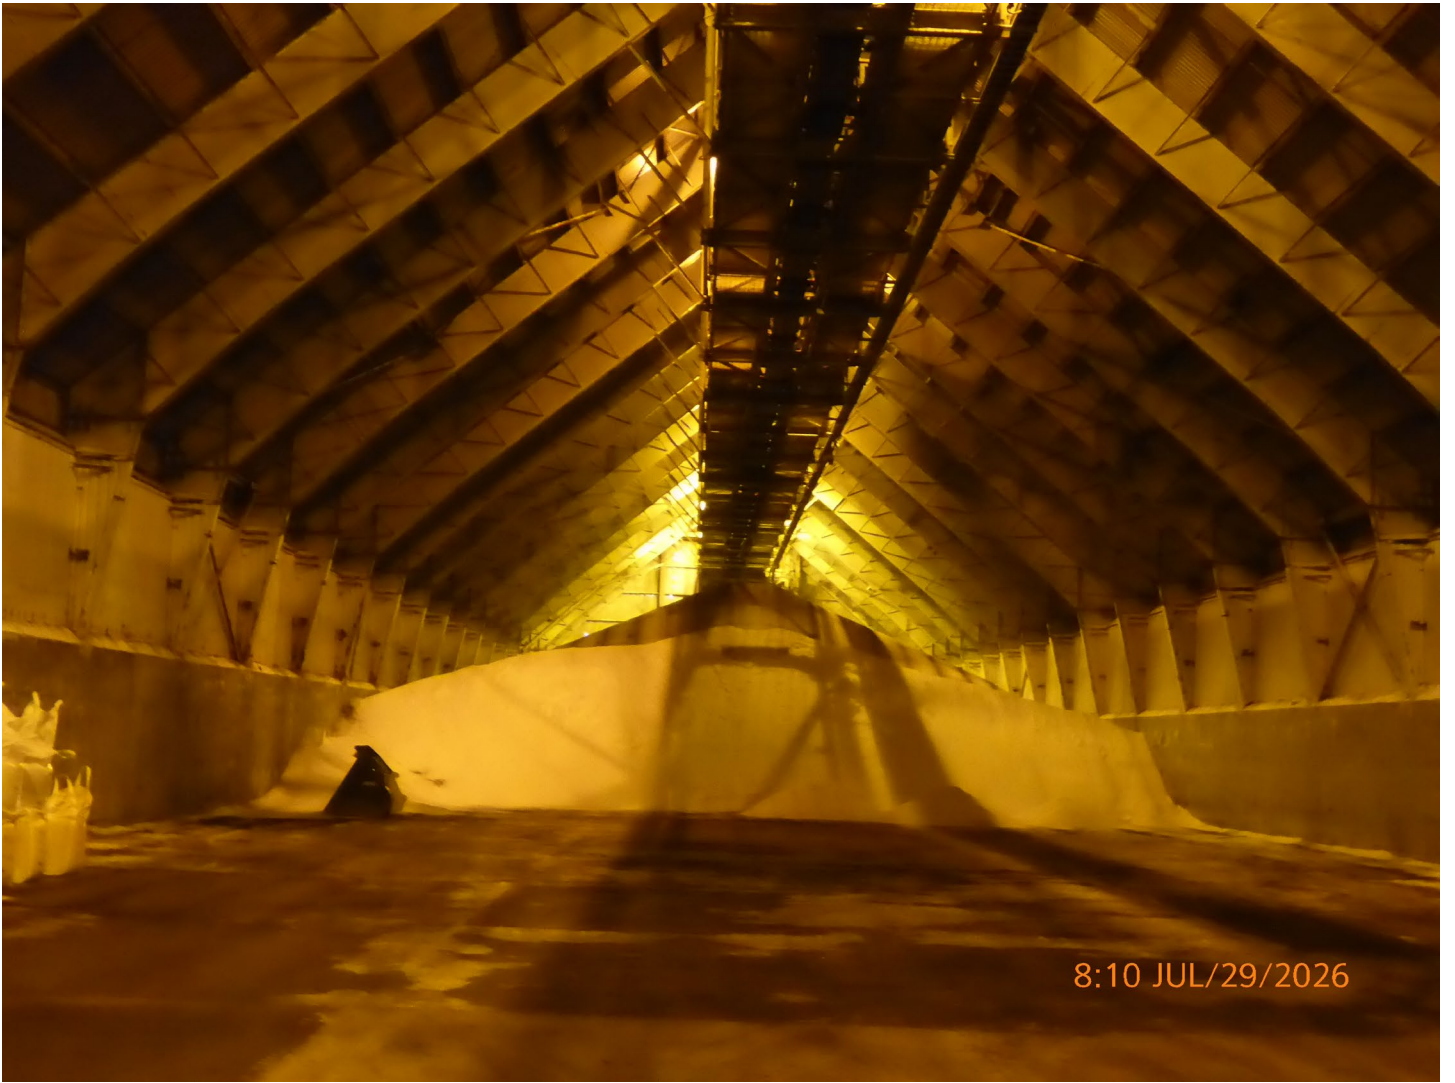
**Photo 6– Ammonium Nitrate Building – Approximately 4.6 million kilograms of Ammonium Nitrate is currently stored in the Building.**

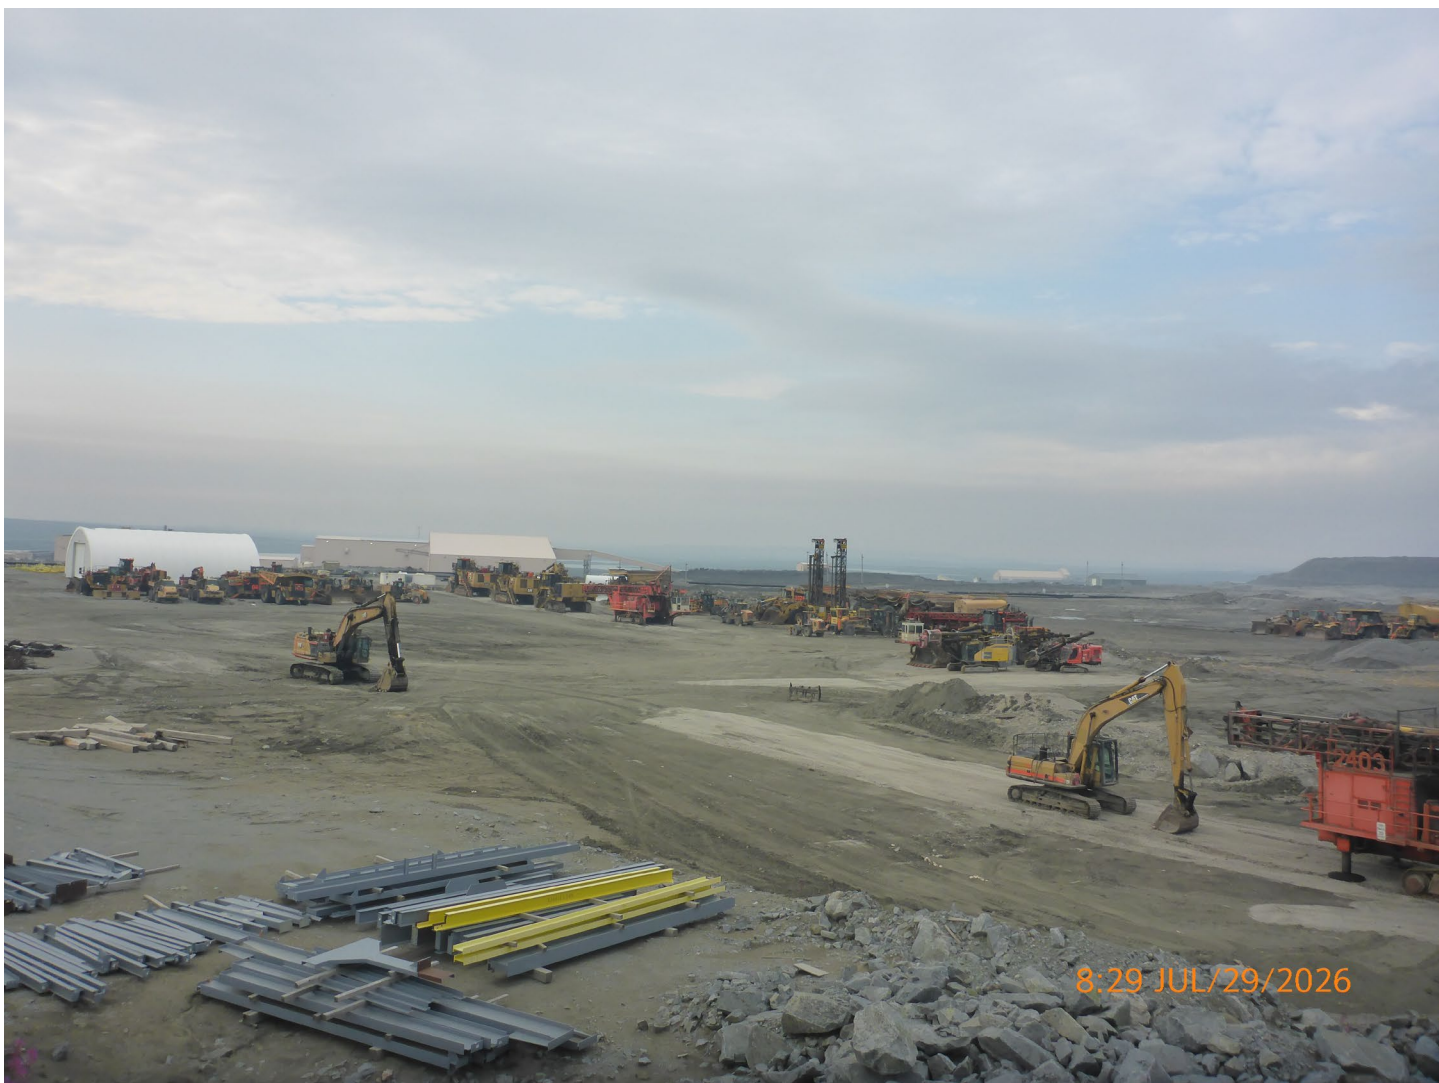
Zone 12 is a designated storage areas for mobile equipment during care and maintenance. Lined parking areas have been created to ensure containment of any hydrocarbon leaks or spills from parked equipment. The area was clean and well maintained. Spill kits are present and are fully stocked and easily accessible.

**Photo 7 – Zone 12 – Several units from the mobile equipment fleet are being stored in Zone 12 of the Panda/Koala Waste Rock Pile during care and maintenance.**

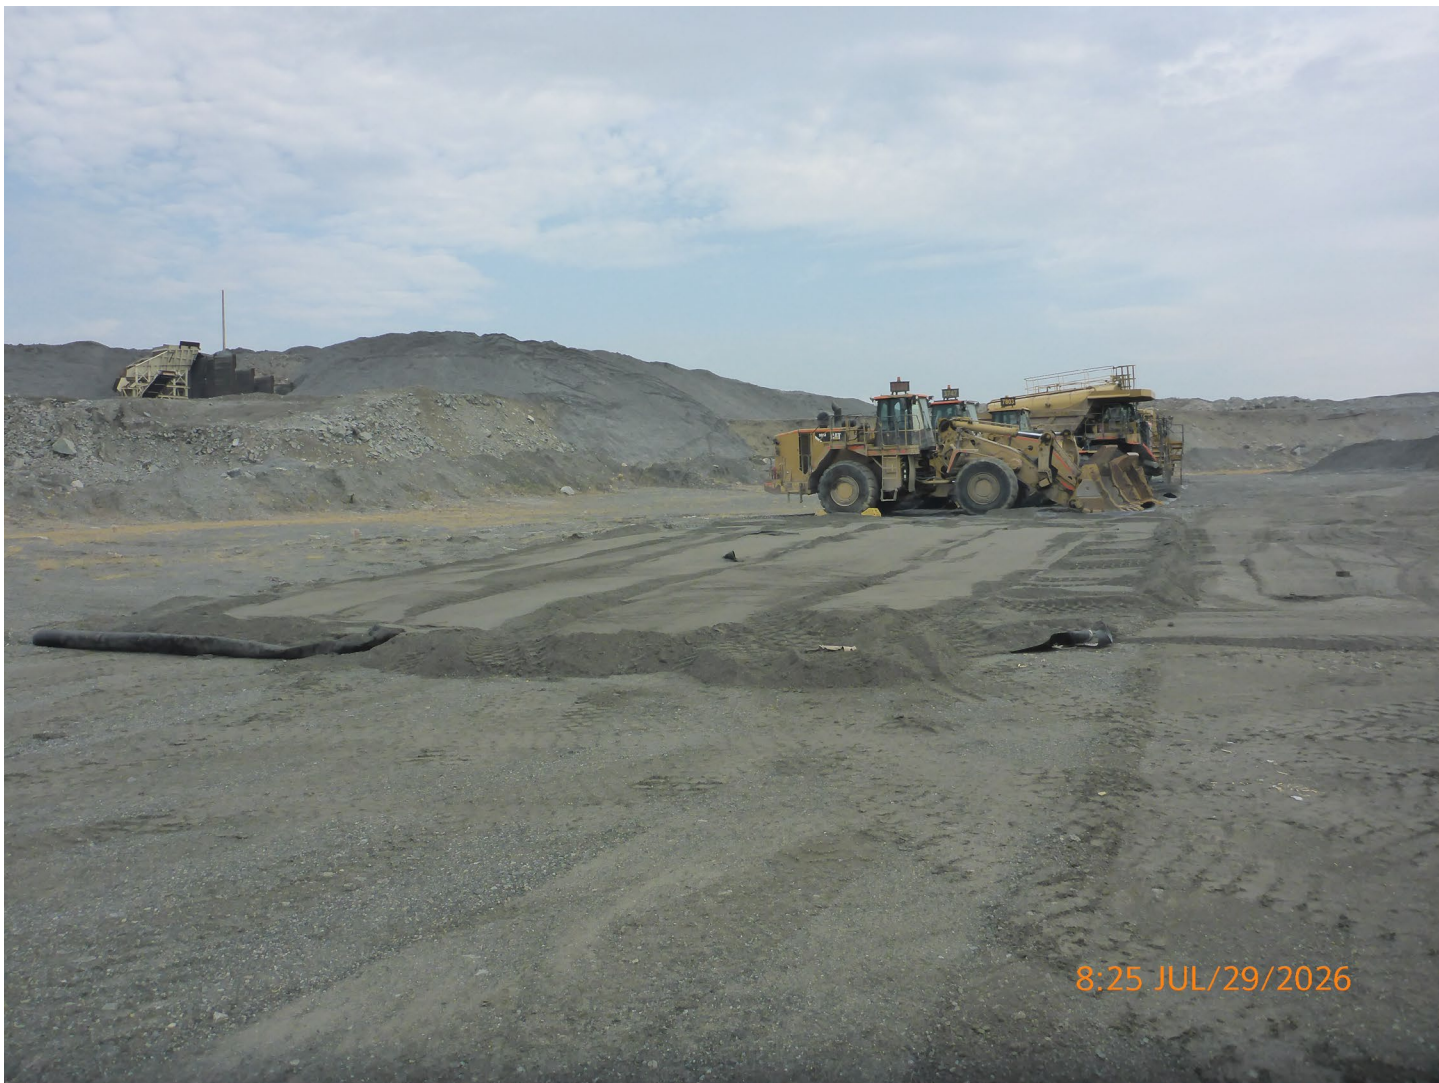
**Photo 8 – Zone 12 – Lined parking areas have been created to contain any potential hydrocarbon leaks or spills.**

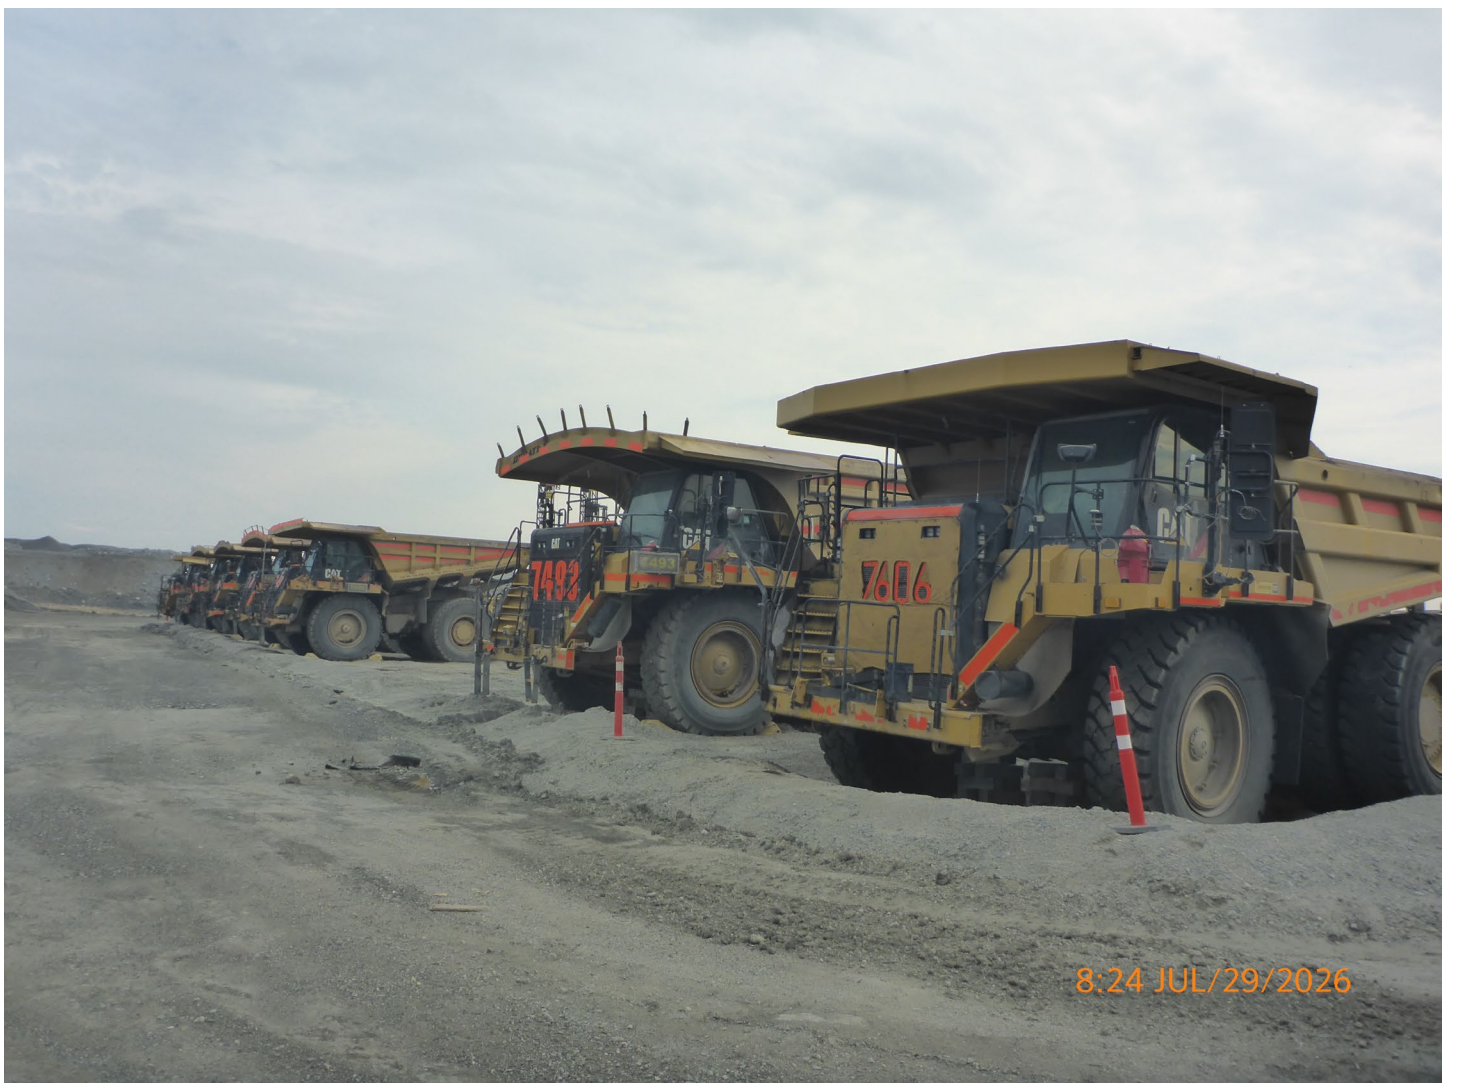
Photo 9– Zone 12 – Lined parking areas have been created to contain any potential hydrocarbon leaks or spills.

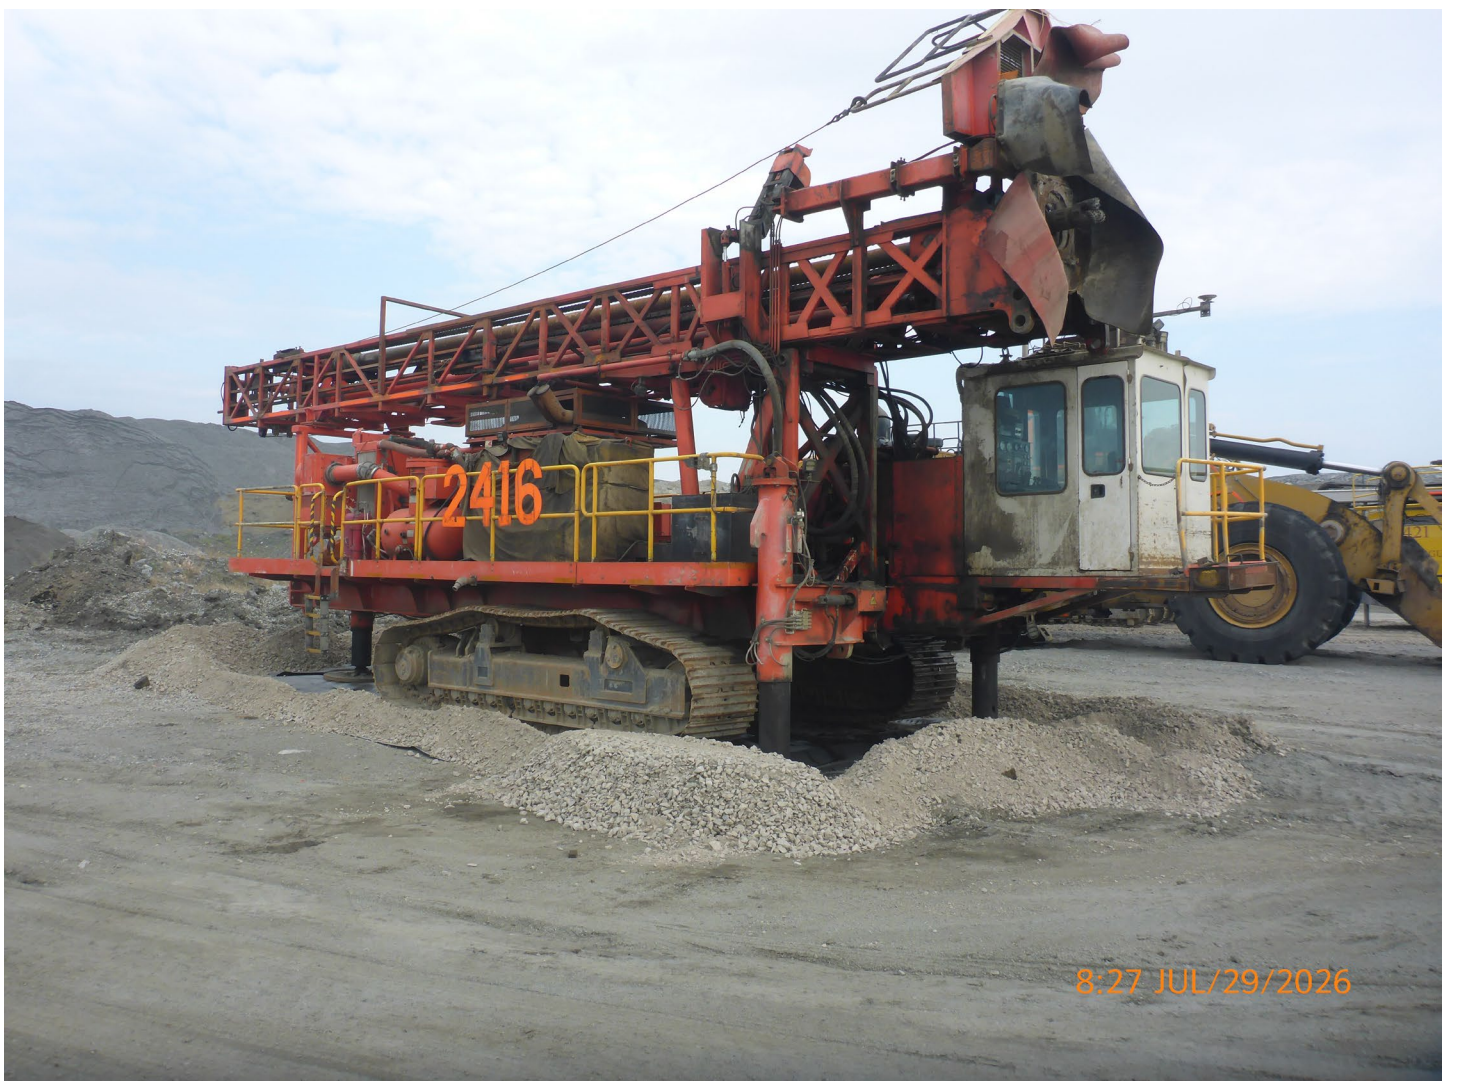
Photo 10– Zone 12 – Lined parking areas have been created to contain any potential hydrocarbon leaks or spills.

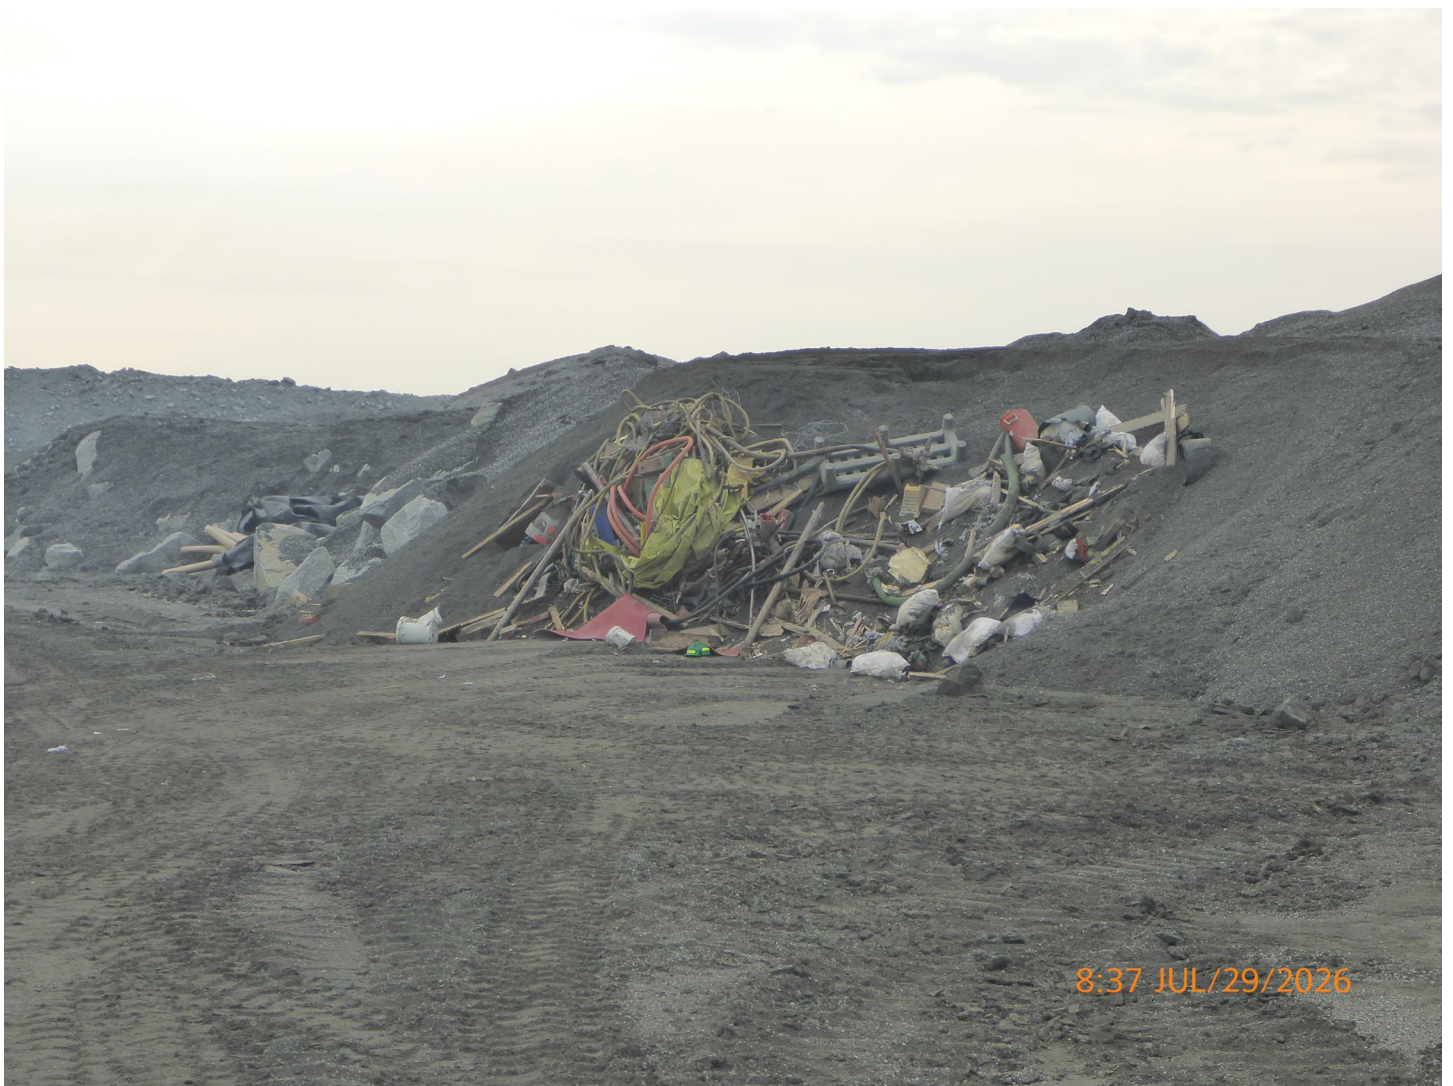
Photo 11 – Landfill – The Landfill has been recently covered with Coarse Kimberlite Rejects from the Process Plant.

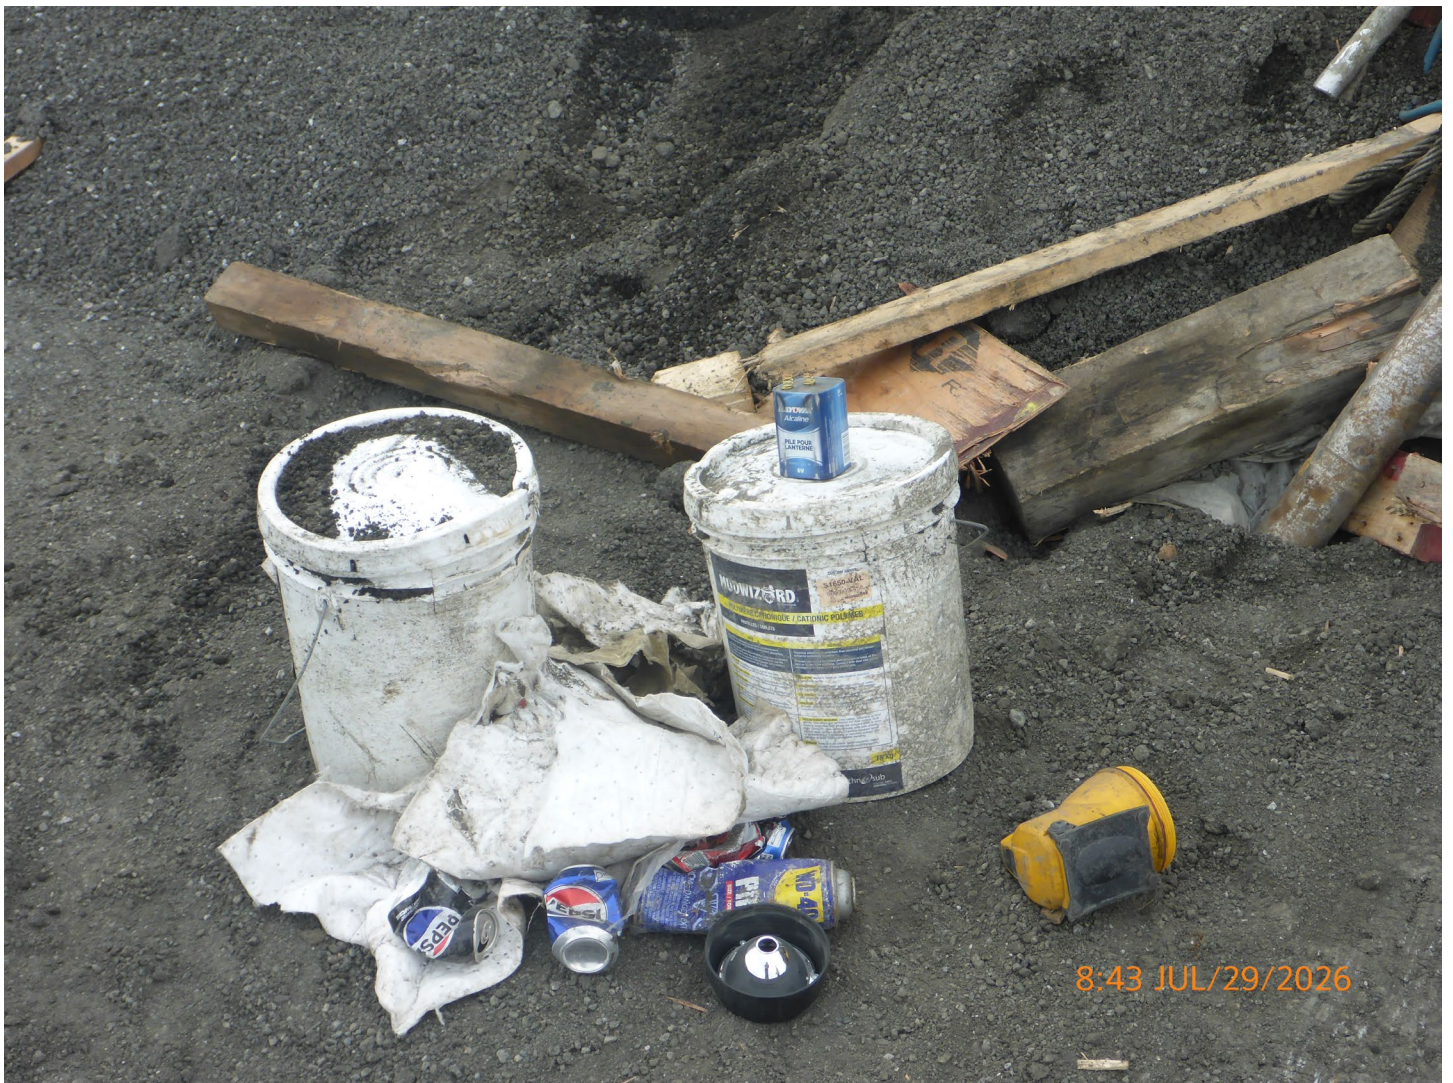
The Ekati Landfill is located on the Panda/Koala waste rock pile and is the disposal location for inert wastes such as wood, plastic and metal not suitable for recycling. The Landfill had been recently covered with Coarse Kimberlite reject material as per the landfill management plan. Several articles of noncompliant waste were identified and removed from the landfill during the inspection. Greater care is needed when segregating waste being sent to the Landfill.

Photo 12 – Landfill – Several articles of noncompliant waste were recovered from the landfill. Proper waste segregation is required

The Inspector noted that there was non-compliant waste in the landfill. The inspector recommends that landfill compliance and awareness of the Waste Management Plan be communicated to front line staff to ensure compliance.

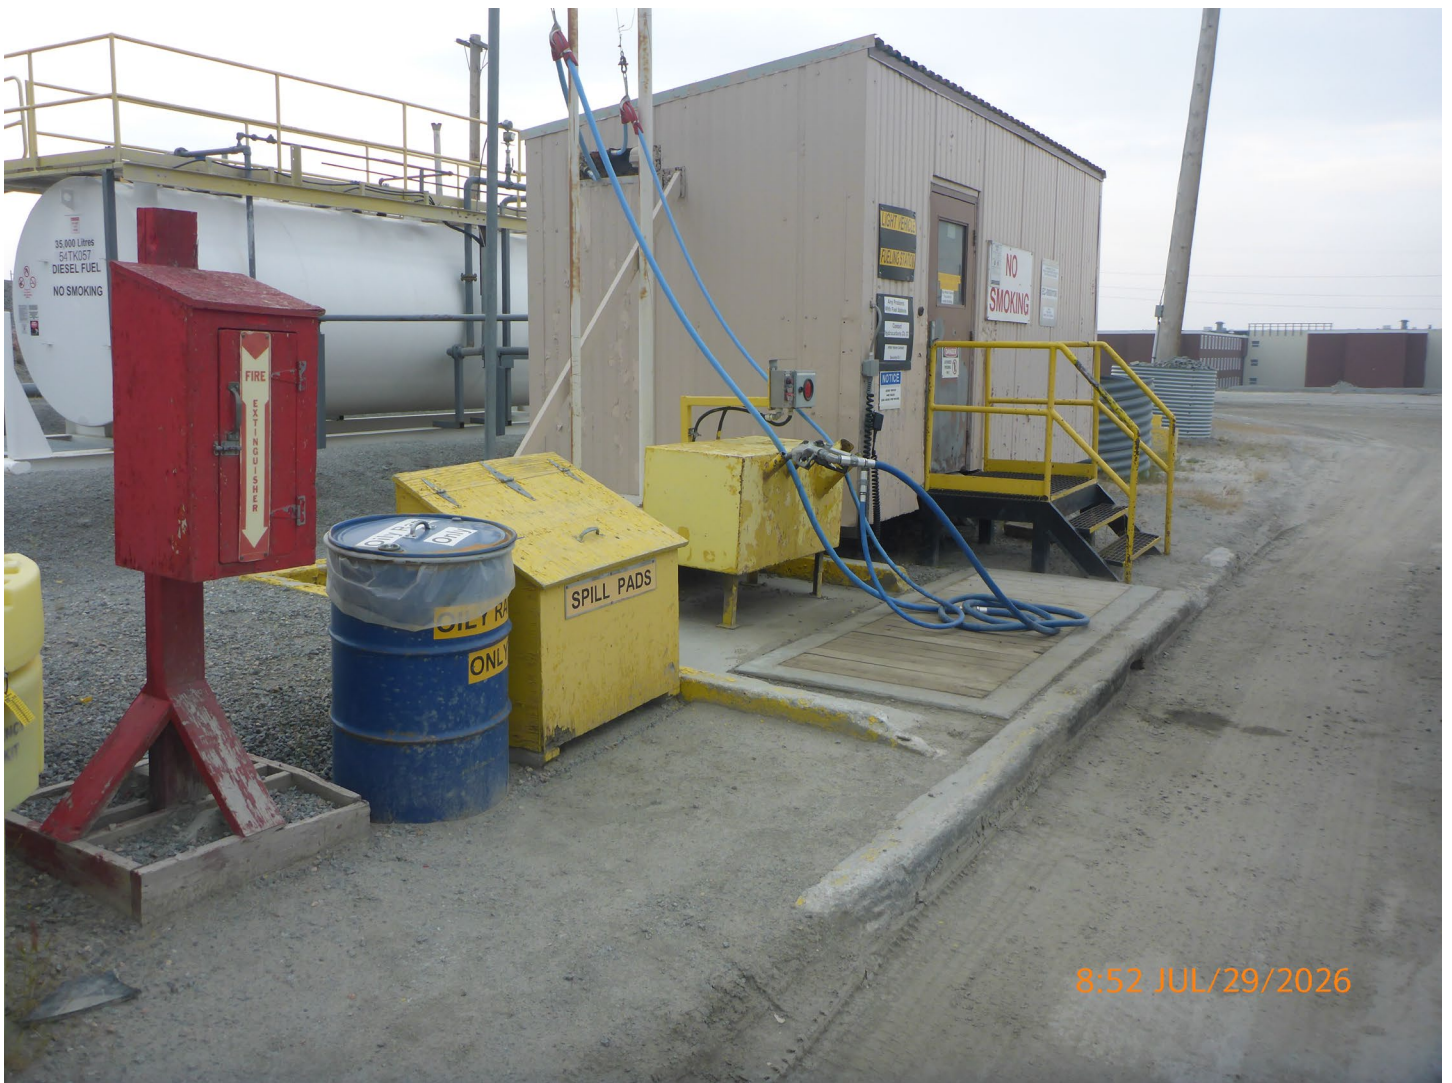
The Main Camp Refuelling, and bulk fuel transfer area were clean and well organized. Spill response equipment was fully stocked and easily accessible.

**Photo 13 – Main Camp Refuelling – The Main Camp Refuelling station was clean and well maintained. Spill response equipment was fully stocked and easily accessible.**

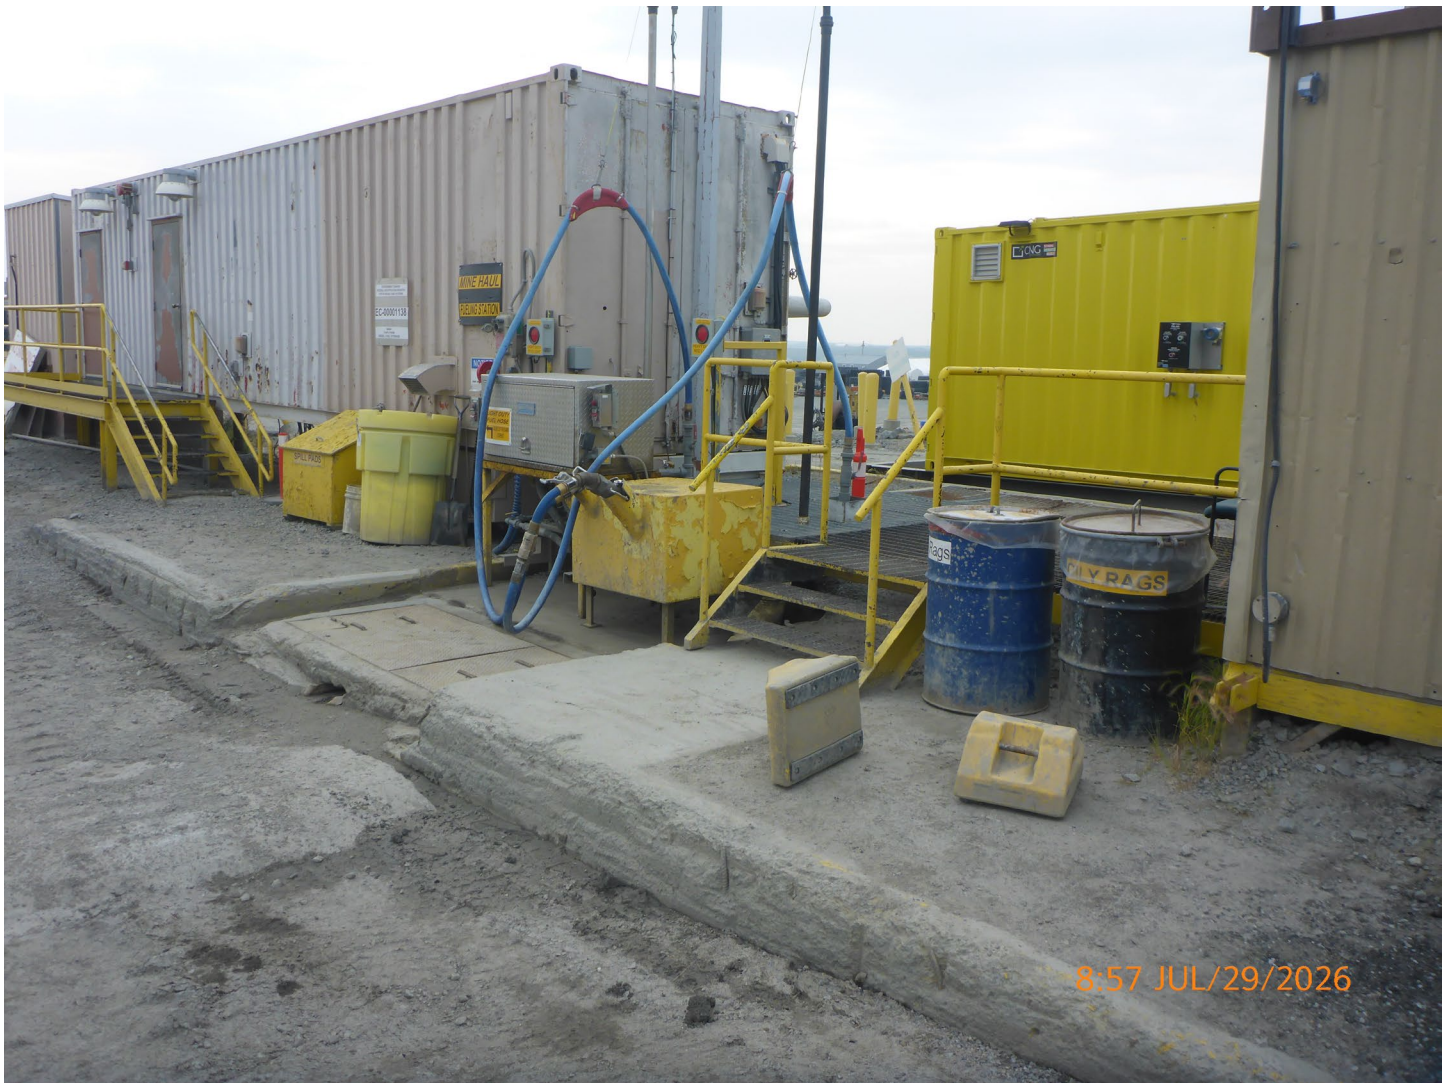
The Koala refuelling station was clean and well organized, and spill response equipment was fully stocked and easily accessible.

**Photo 14 – Koala Heavy Equipment Refuelling – The Koala Heavy Equipment Refuelling station was clean and well maintained. Spill response equipment was fully stocked and easily accessible.**
