GNWT ECC - North Slave Region

Water Licence W2022L2-0001

Re: October-November 2024 Water Licence Inspection

INDUSTRIAL WATER USE INSPECTION REPORT

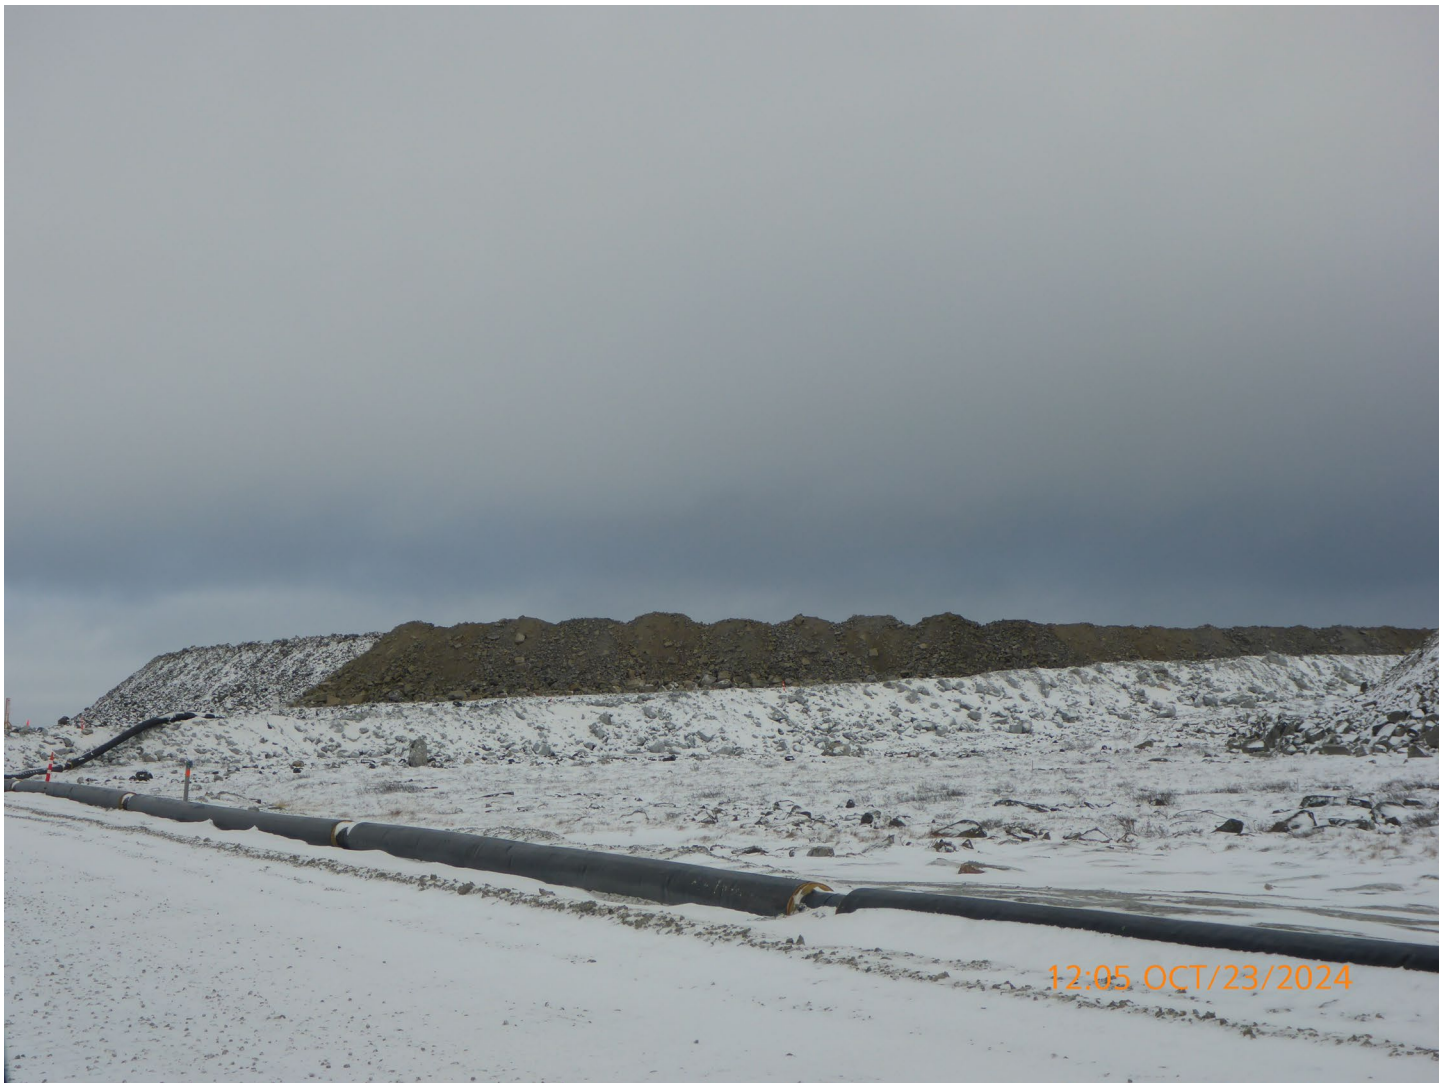
Point Lake construction is well underway. A perimeter ditch is being constructed around the waste rock pile to catch any problematic runoff that may occur. The ditch is lined to prevent seepage. Any runoff will be collected and pumped into the Lynx Pit, or the King Pond Settling Facility (Photos 1 through 4).

Photo 1 – Point Lake Project – Waste rock is being placed in the Point Lake WRSA

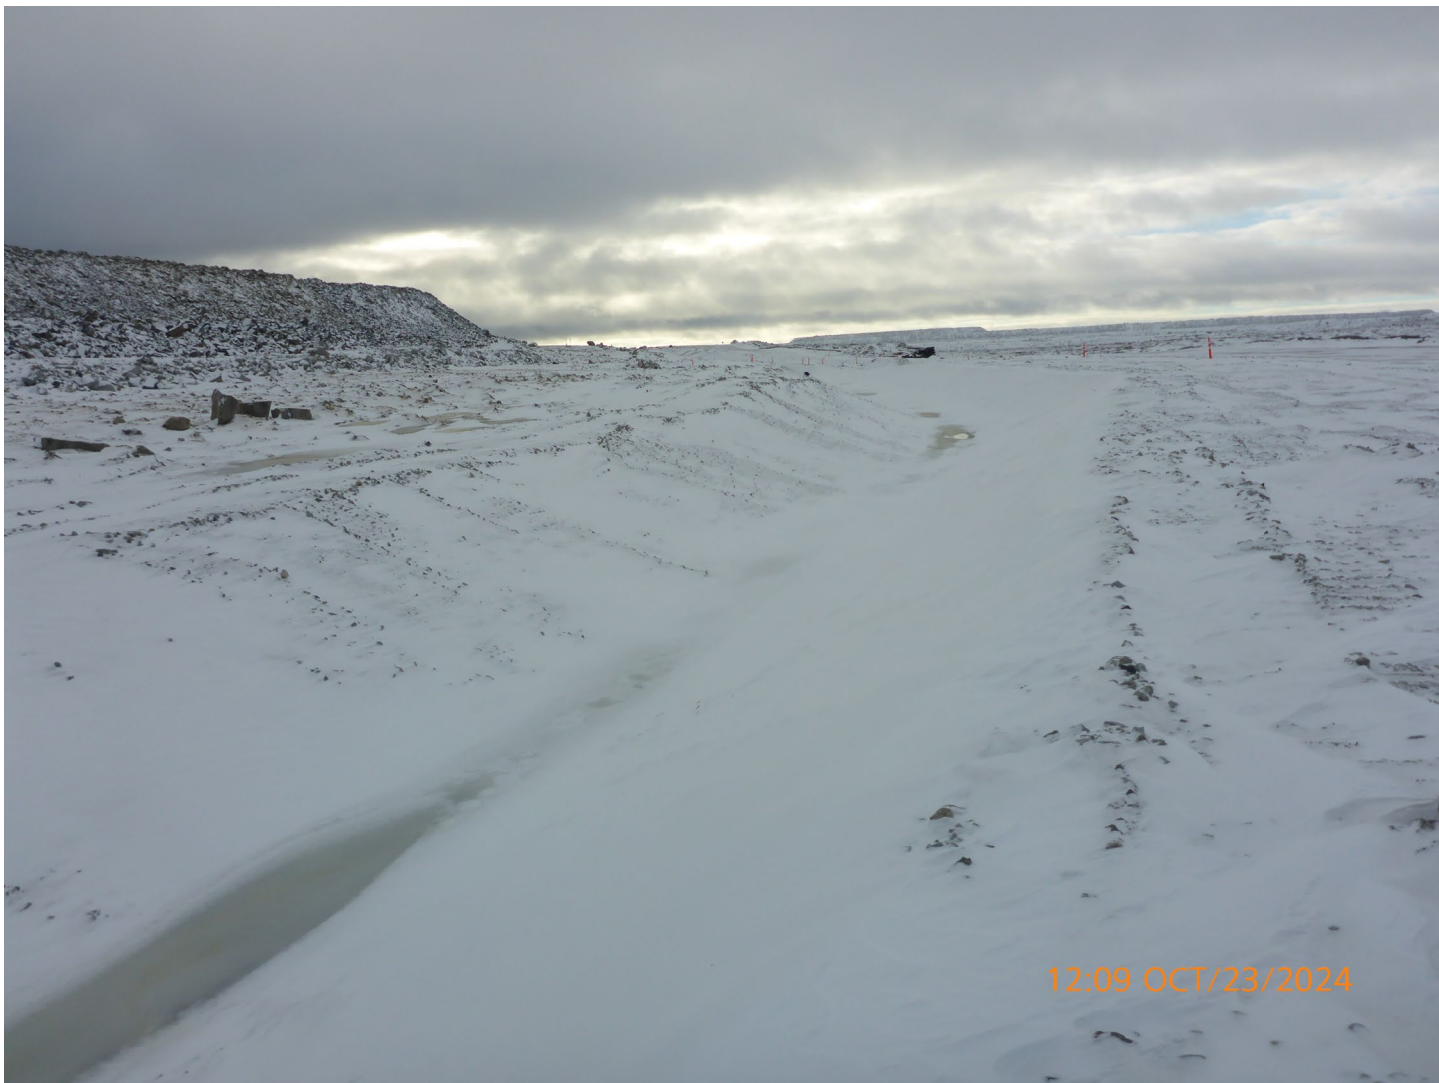
Photo 2 – Point Lake Project – WRSA Perimeter trench construction is continuing. The trench is lined and graded toward a collection sump.

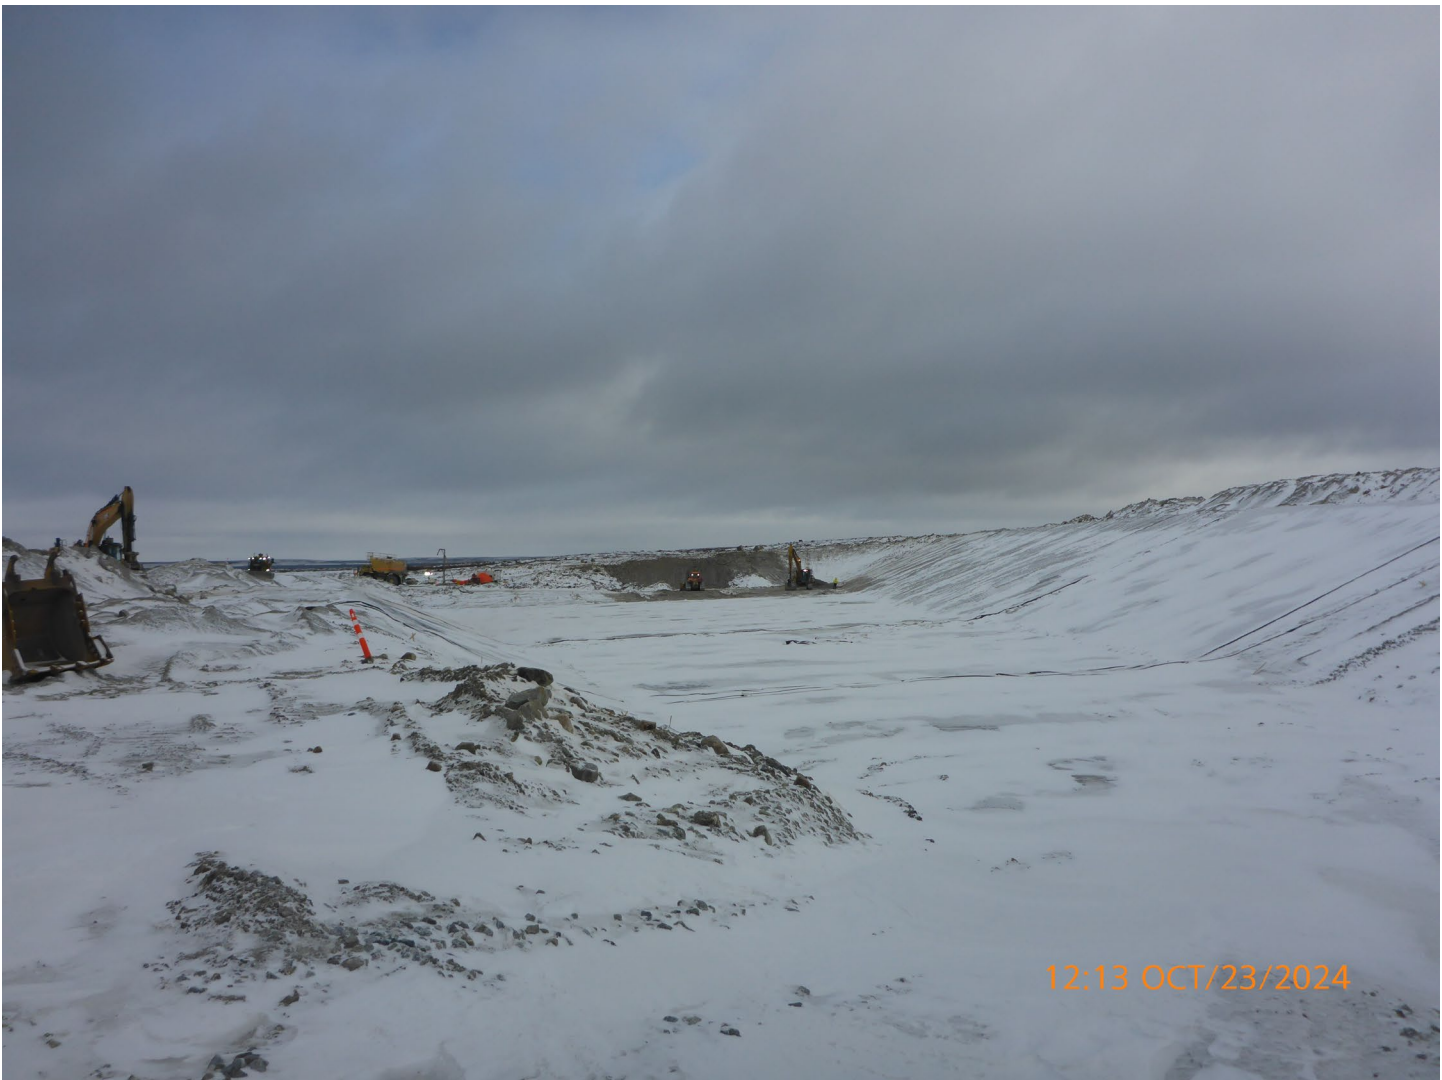
Photo 3 – Point Lake Project – Collection sump is designed to catch any runoff from the Point Lake WRSA. Water is then intended to be pumped into King Pond or the Lynx Pit.

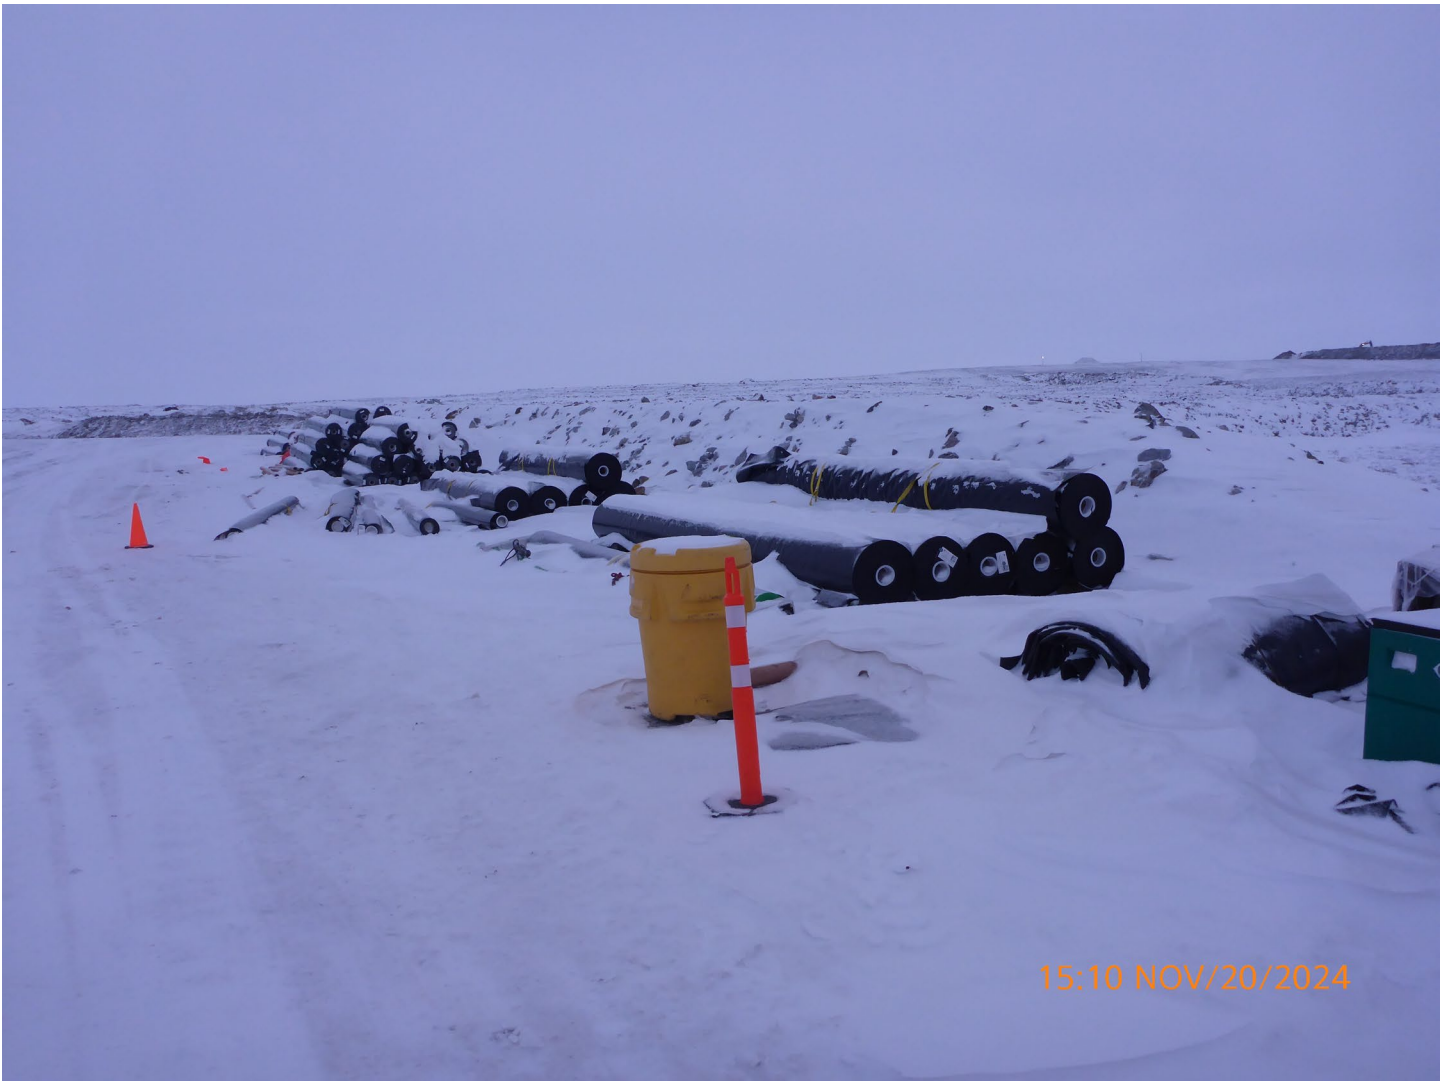
Photo 4 – Point Lake Project – Liner material is being staged along the Point Lake road.

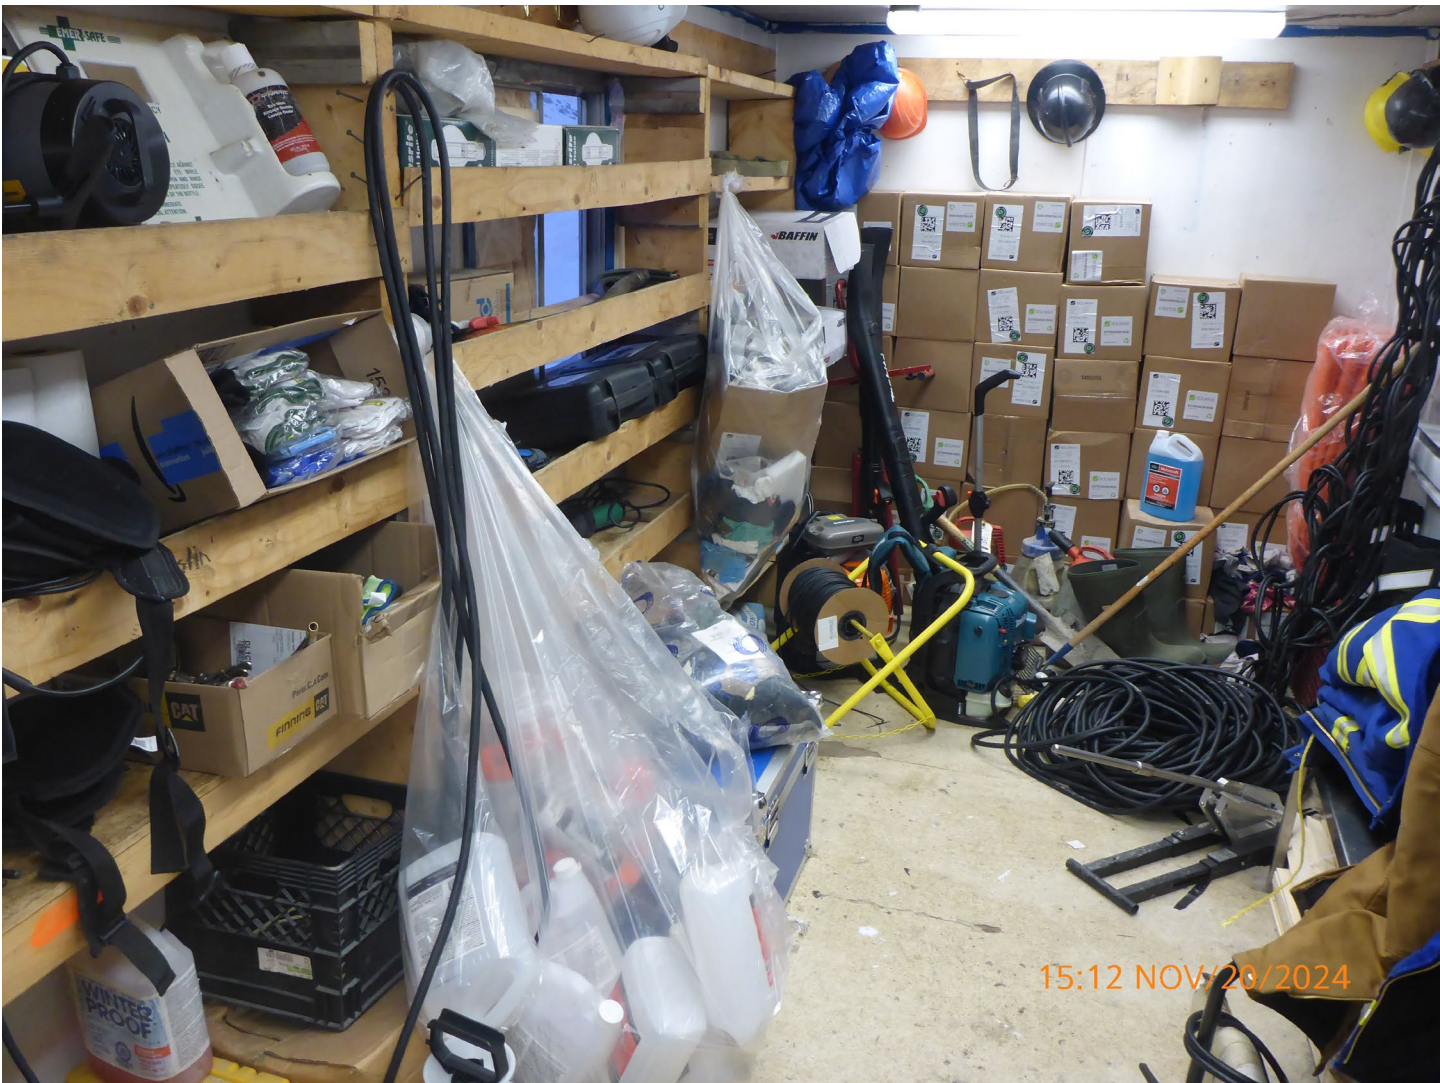
A heated tool shed is installed along the Point Lake Road. The building is being used for storage and emergency shelter. Garbage is being collected and segregated properly in the building; however, there are no labelled containers. The Inspector recommends using labelled containers as per the approved Waste Management Plan (Photo 5).

Photo 5 – Point Lake Project – A heated tool shed is placed along the Point Lake Road. Garbage is being collected and segregated properly; however, there are no labelled containers. The Inspector recommends using labelled containers as per the approved Waste Management Plan.

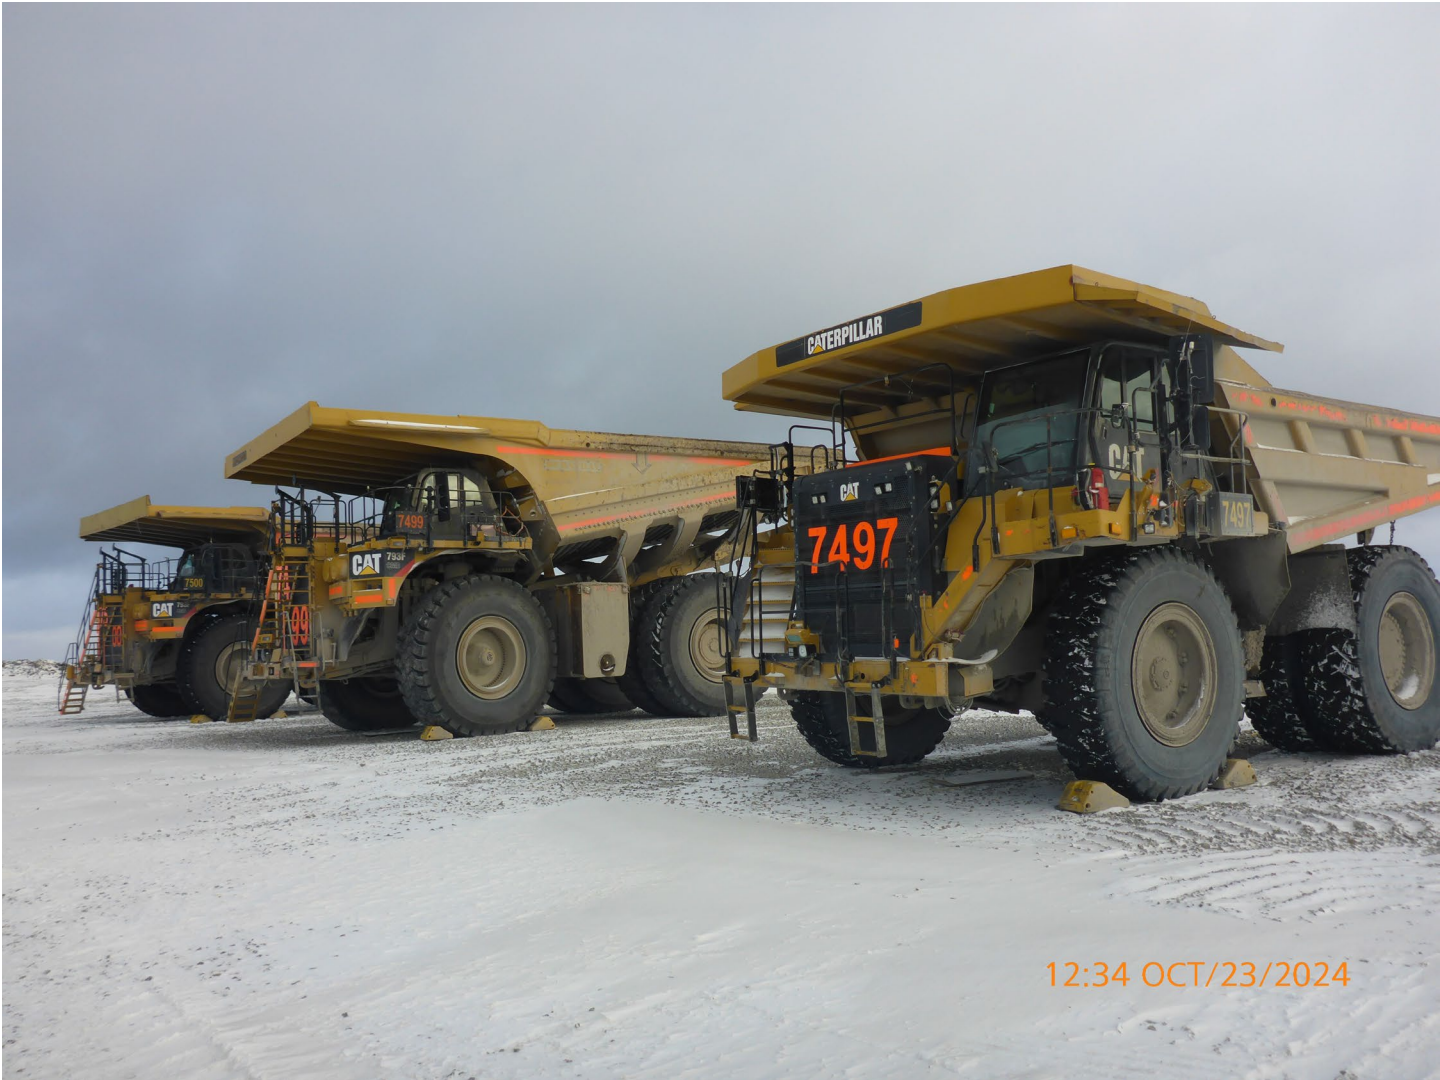
Equipment parked around the Misery Development area was utilizing drip trays to catch any potential leaks or drips. No leaks or spills were observed under any of the equipment inspected (Photo 6).

Photo 6 – Misery Equipment Parking – Drip trays are installed under parked equipment in the Misery area.

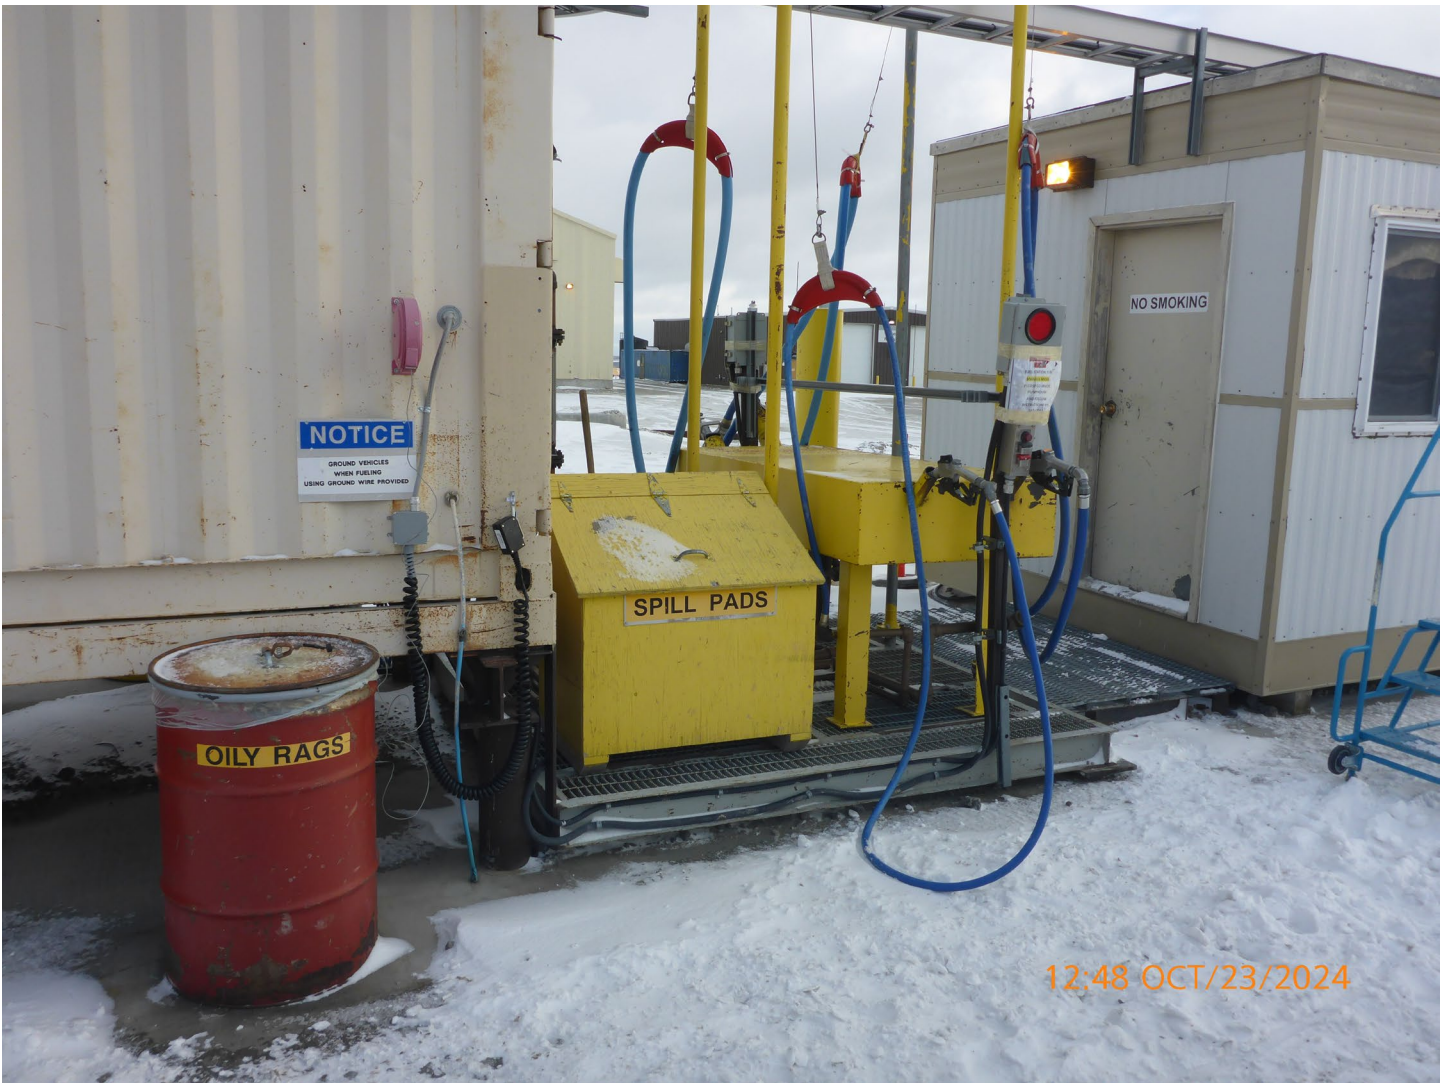
Photo 7 – Misery Refuelling Station – The refuelling station was clean and well organized with no indication of any leaks or spills. Spill response equipment was fully stocked and easily accessible.

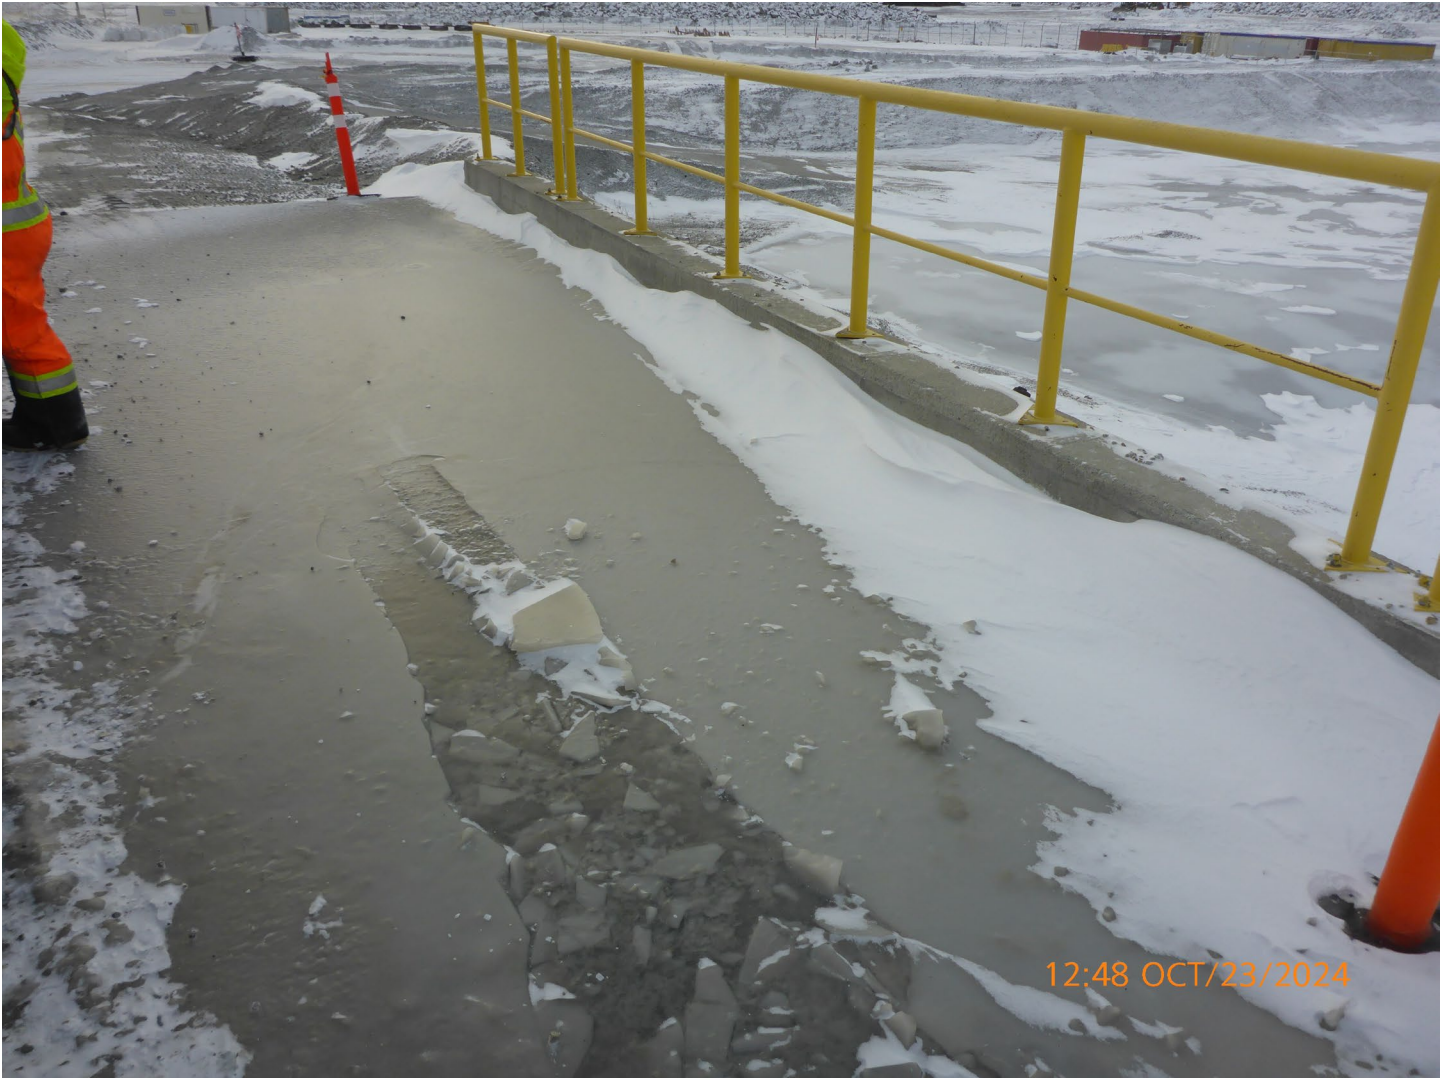
The Misery refuelling area was clean and well maintained with no indication of any hydrocarbon leaks or spills. Spill response equipment was fully stocked and easily accessible. The containment sump at the refuelling area was full of water/ice during the October inspection. A follow up inspection in November showed that the sump has been chipped out and the containment capacity restored (Photos 7 through 9).

Photo 8 – Misery Refuelling Station – The containment sump at the Misery refuelling station was iced over. This will need to be cleaned out in order to provide spill containment capacity.

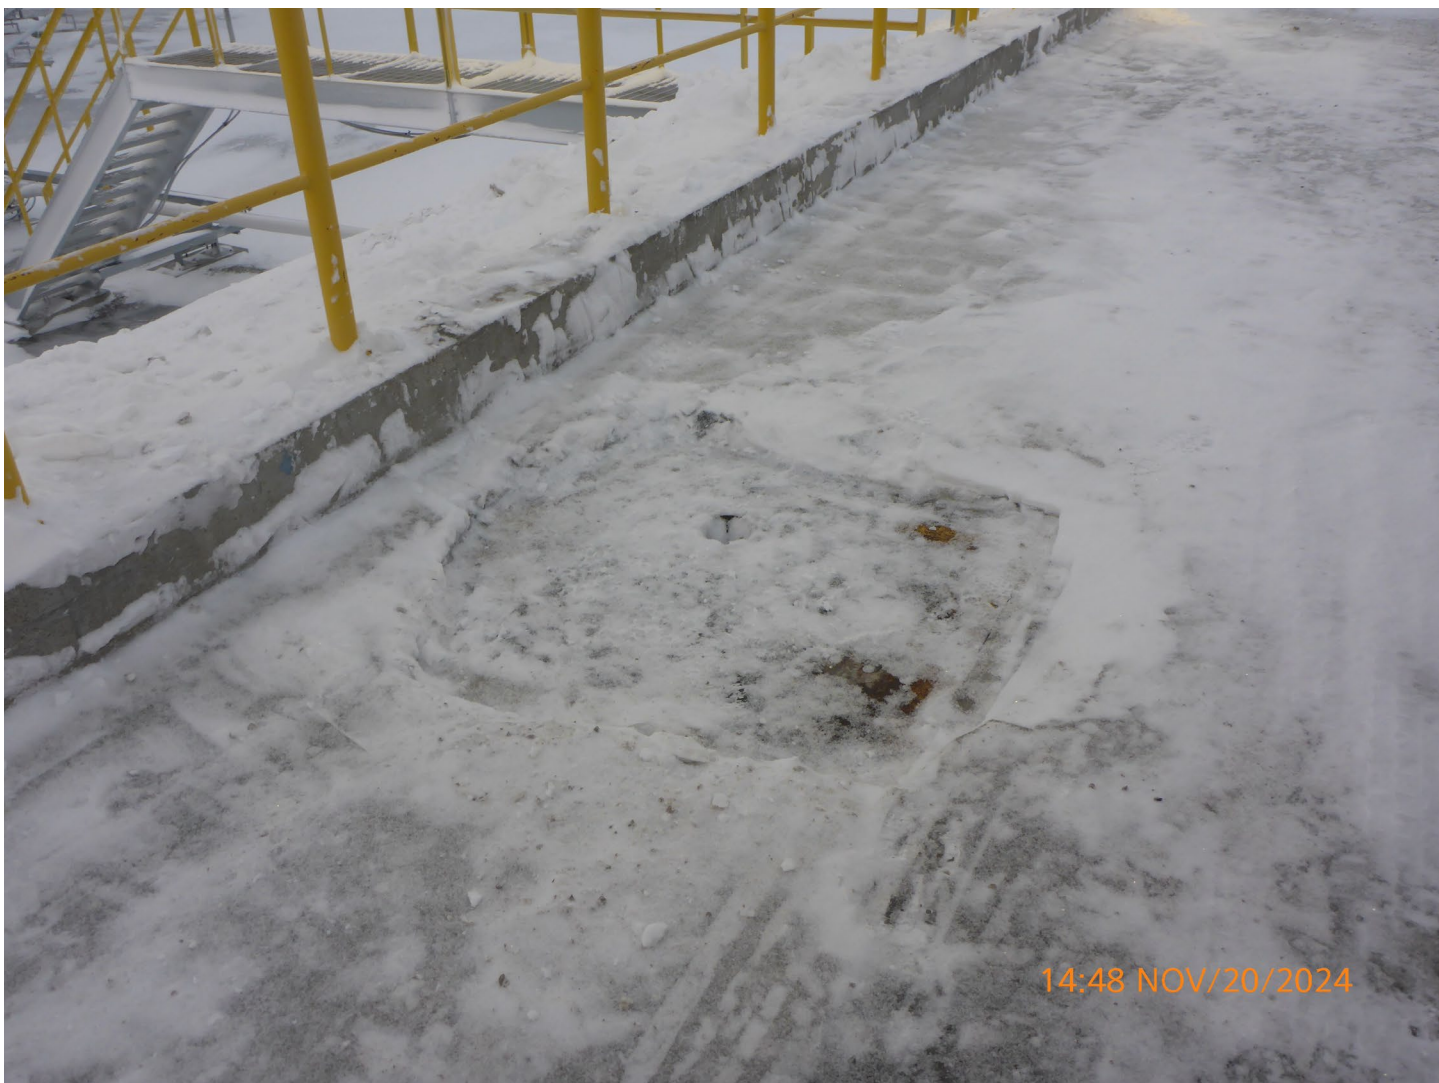
Photo 9 – Misery Refuelling Station – The containment sump at the Misery Refuelling station has been chipped out and is free of ice. The sump is functional and should contain any future spills.

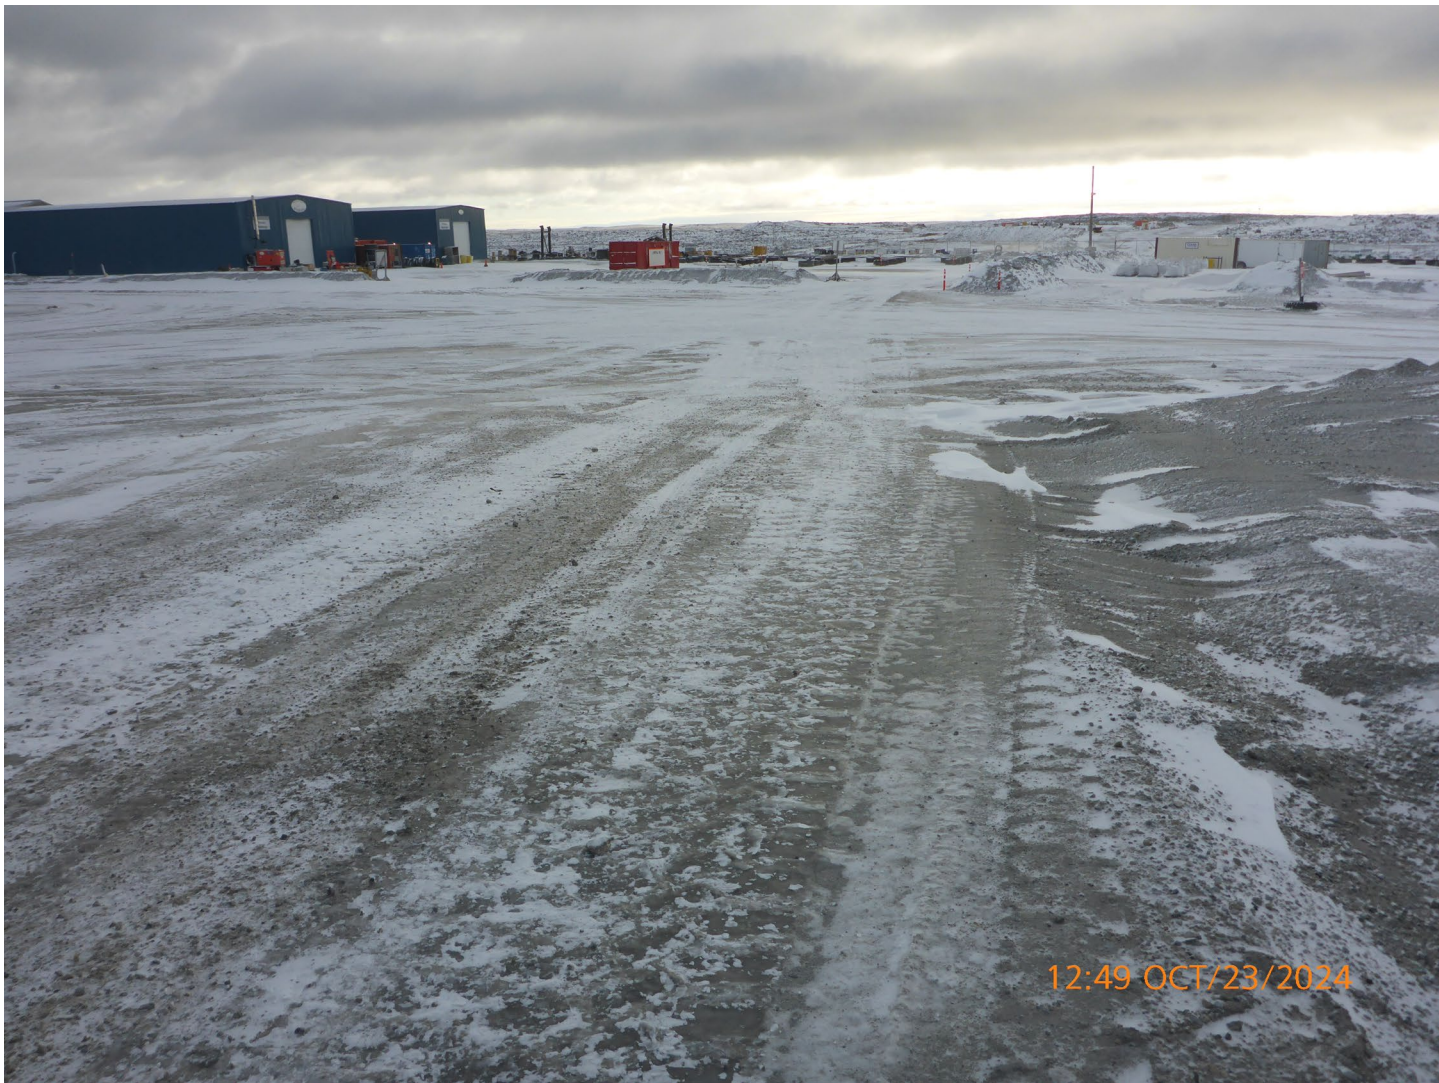
NT Spill #2024360 occurred on September 19 2024 when a lube truck was overfilled due to a failure of the max level sensor. The refuelling area containment sump was filled to capacity, and the remaining product flowed on the ground adjacent to the pad. The Inspector has verified that the area has been cleaned up and the spill report has been filed (Photo 10).

Photo 10 – Misery Refuelling Station – NT Spill #2024360 occurred on September 19 2024 when a lube truck was overfilled due to a failure of the max level sensor. The refuelling area containment sump was filled to capacity, and the remaining product flowed on the ground adjacent to the pad. The Inspector verified that the area has been cleaned up and the spill report has been filed.

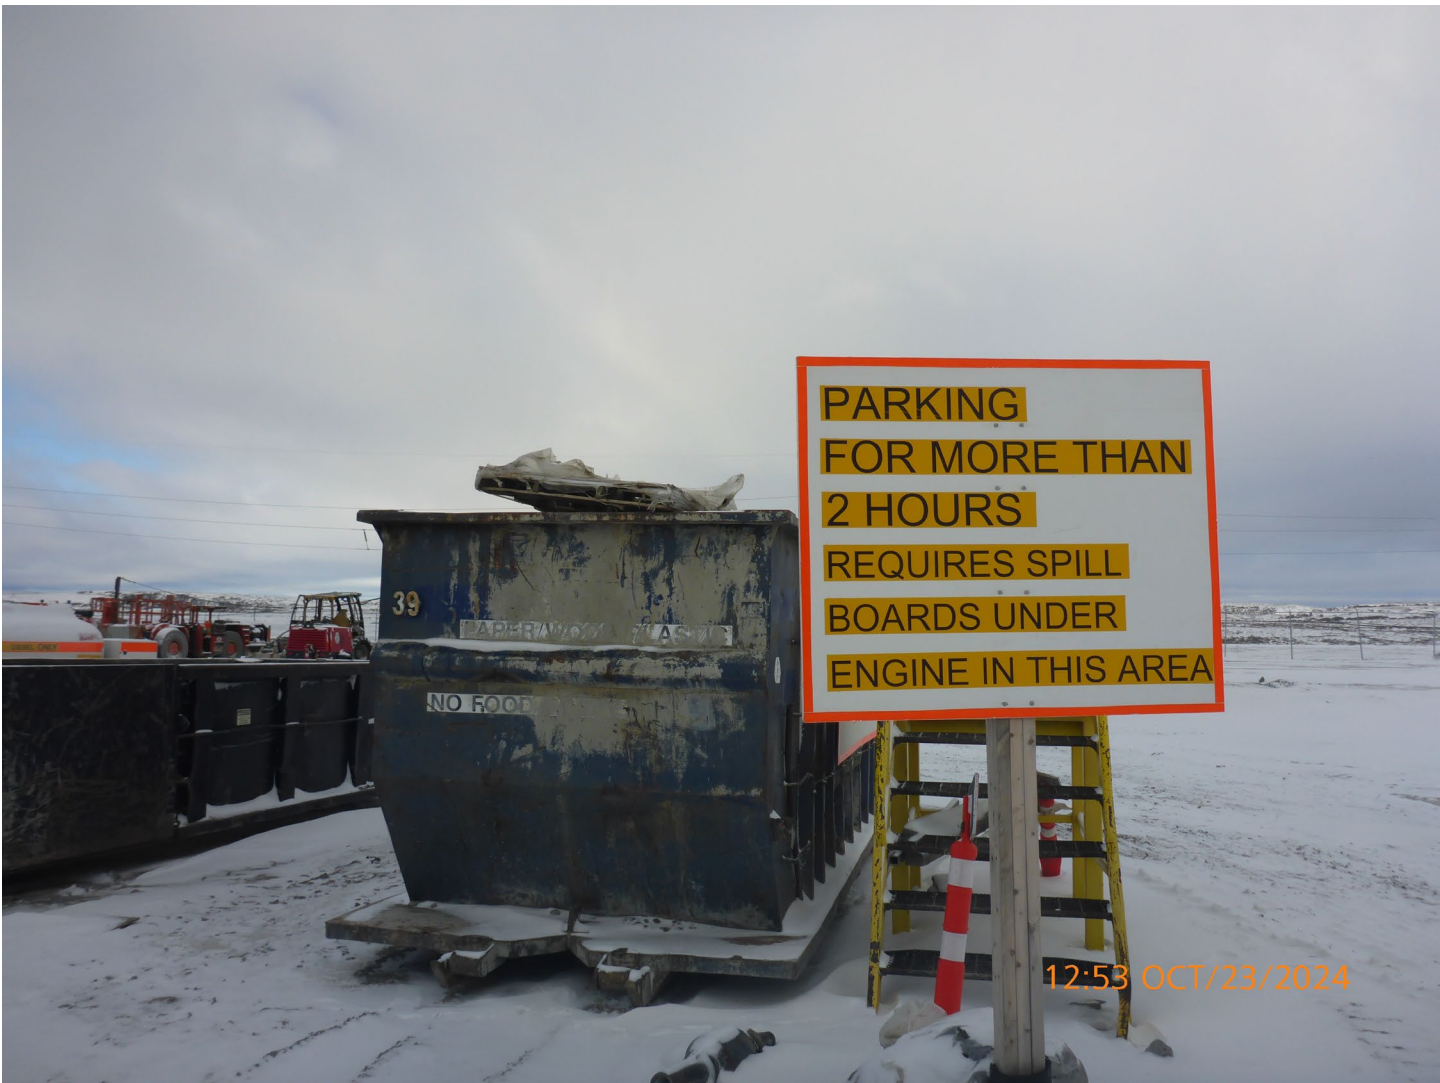
Photo 11 – Misery Waste Bins – Waste bins are placed in common areas around Misery. Bins were properly labeled and easily accessible.

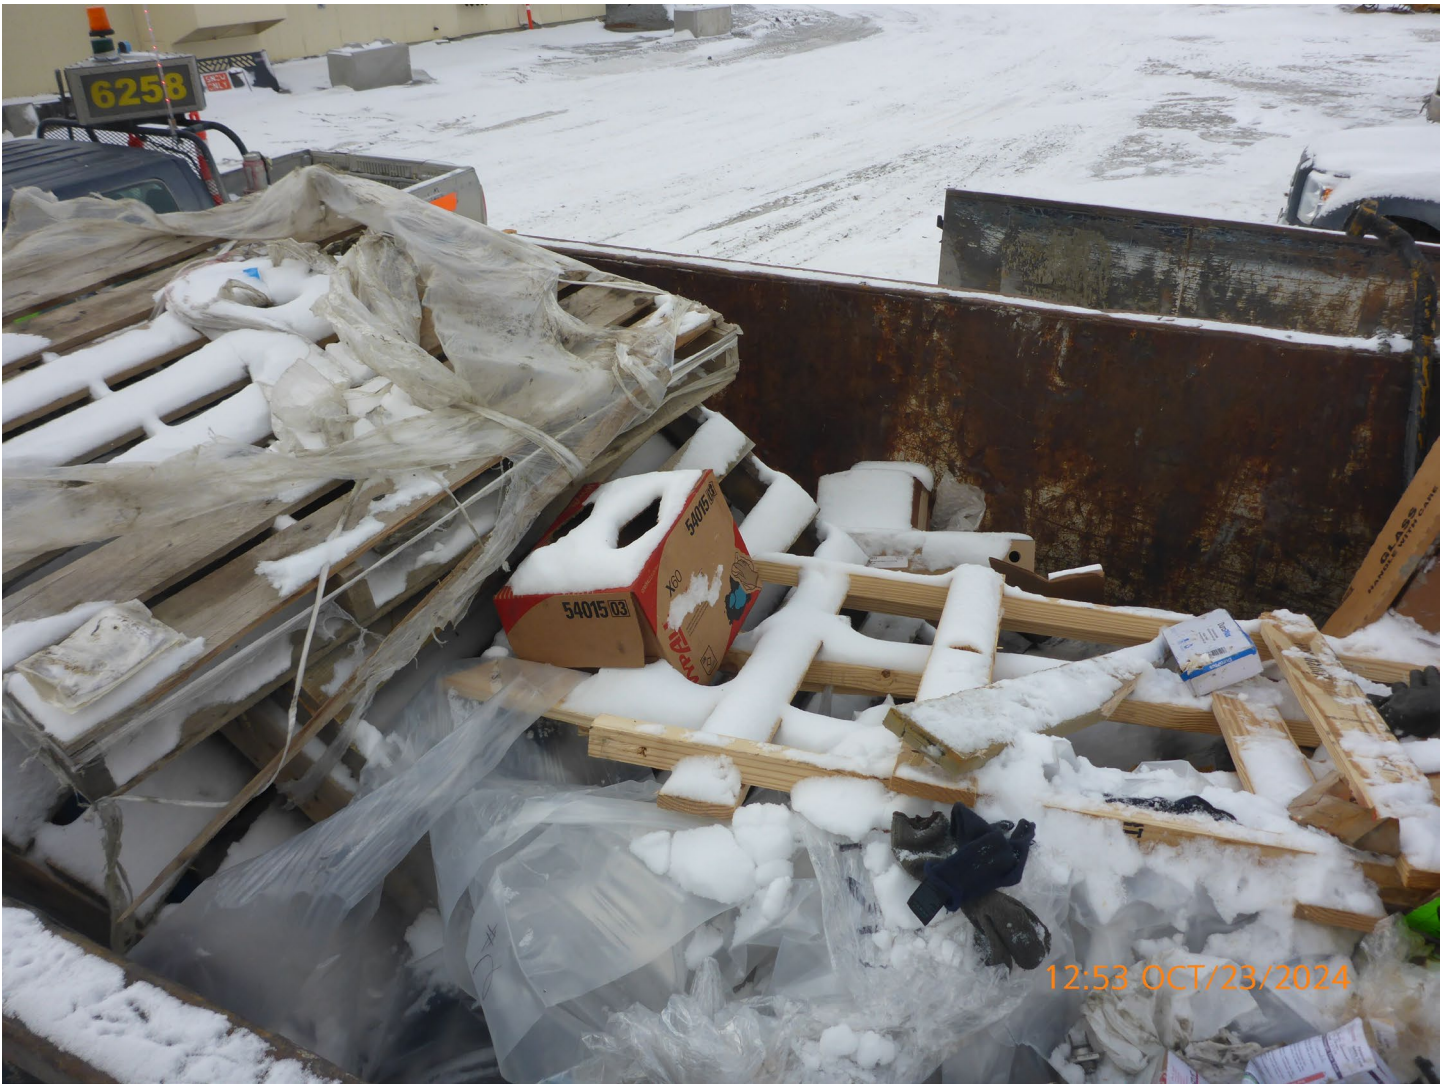
Photo 12 – Misery Waste Bins – Waste bins did not contain any misdirected waste.

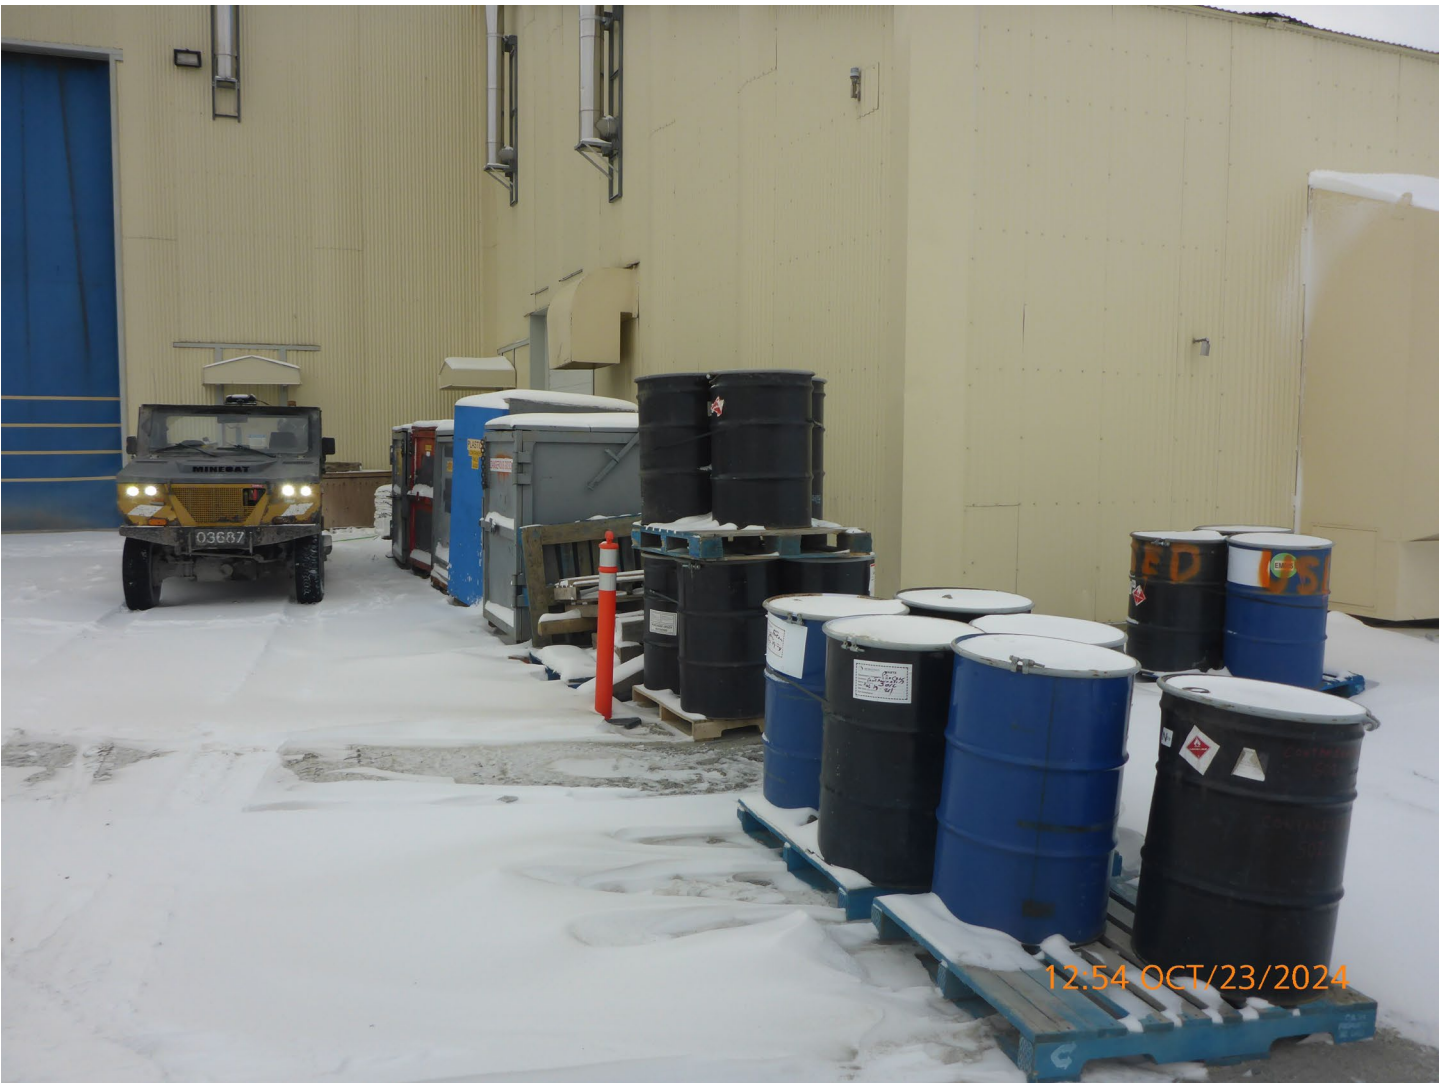
Photo 13 – Misery Waste Bins – Waste bins staged outside the Misery truck shop were labelled, organized and did not contain any misdirected waste.

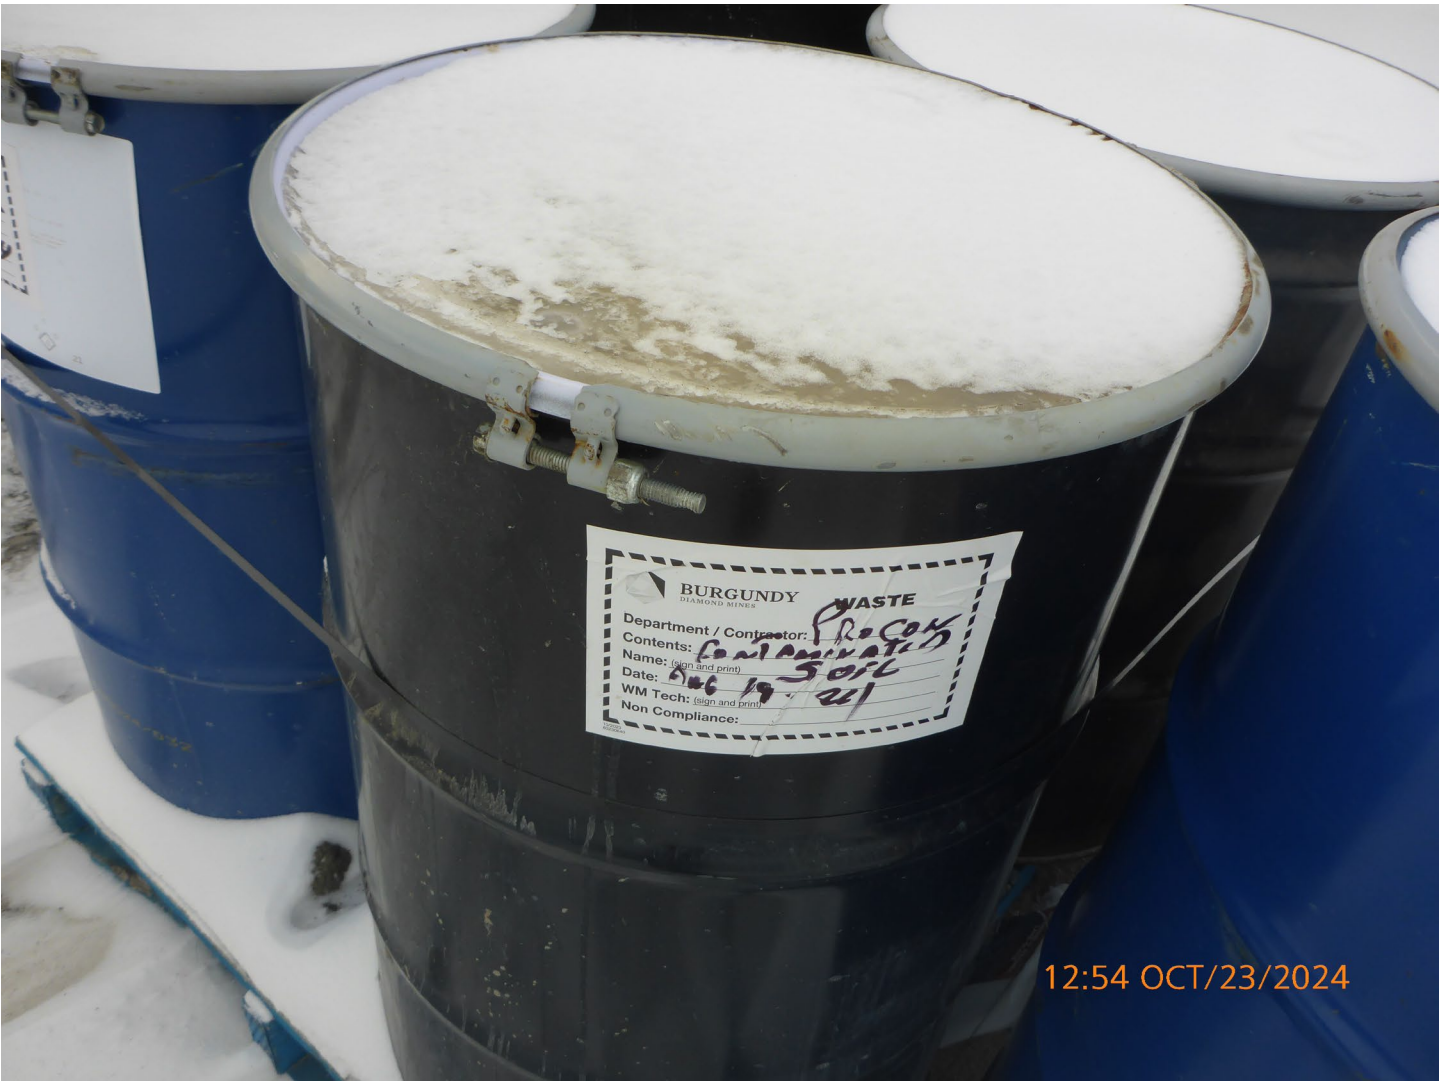
Photo 14 – Misery Waste Management – Waste bins were labelled with their contents as per the Waste Management Plan.
