GNWT ECC - North Slave Region

Water Licence W2022L2-0001

Re: October-November 2024 Water Licence Inspection

INDUSTRIAL WATER USE INSPECTION REPORT

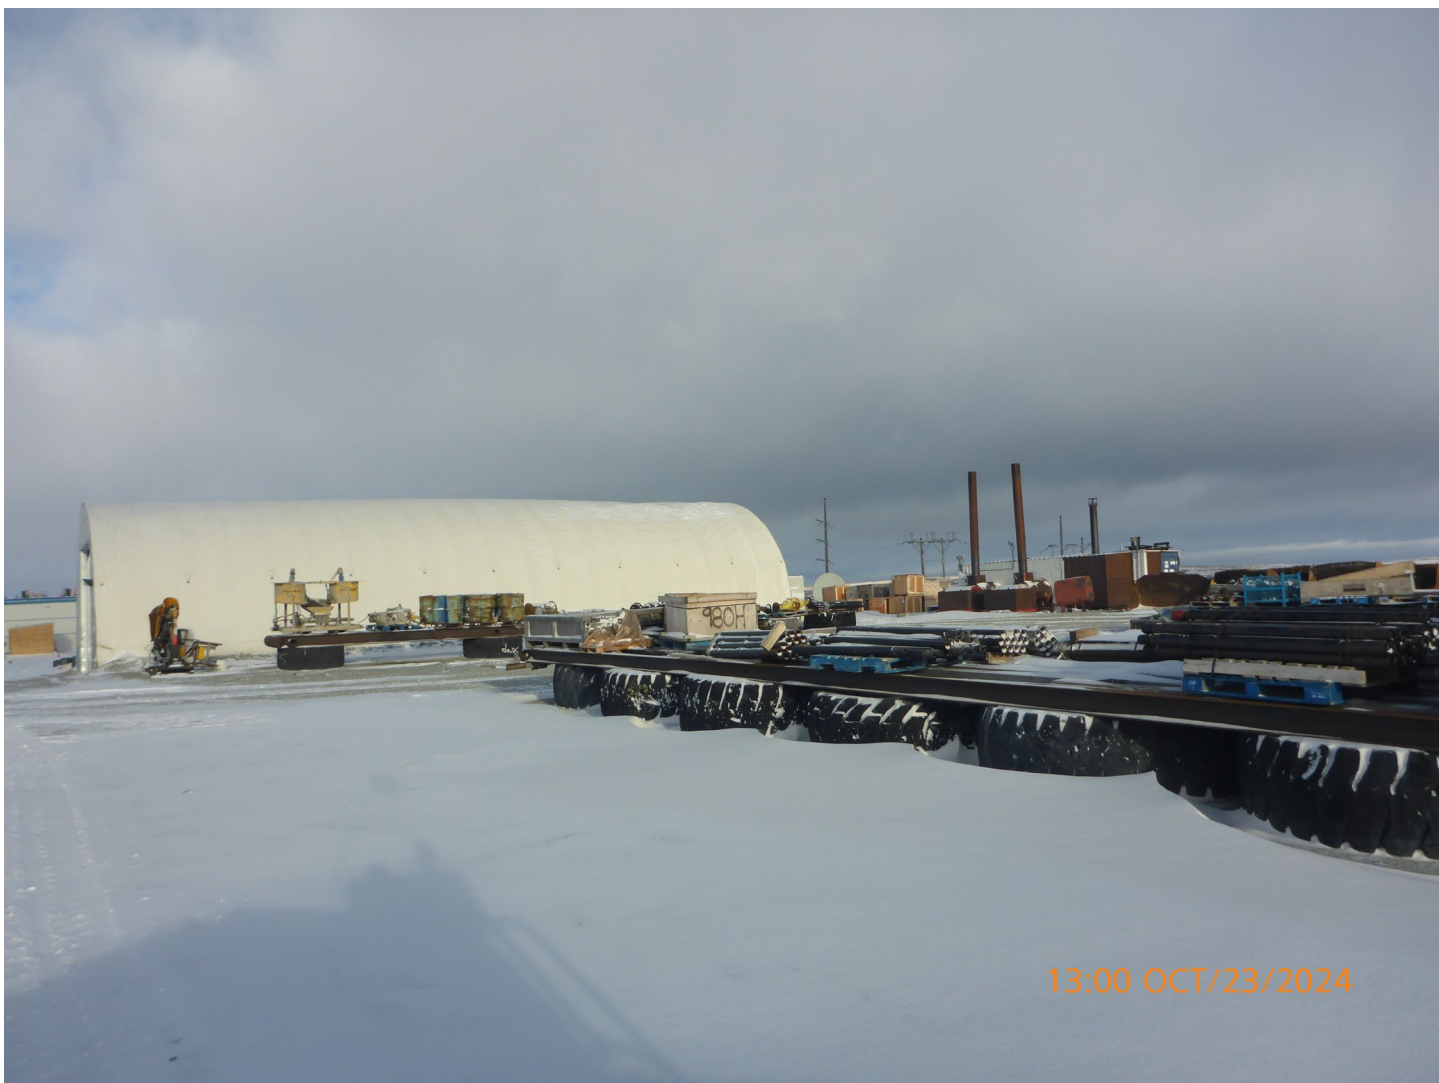
Laydowns were clean and well organized with no indication of hydrocarbon leaks or spills (Photo 15).

Photo 15 – Misery Laydown – Laydowns were clean and well organized with no indication of hydrocarbon leaks or spills.

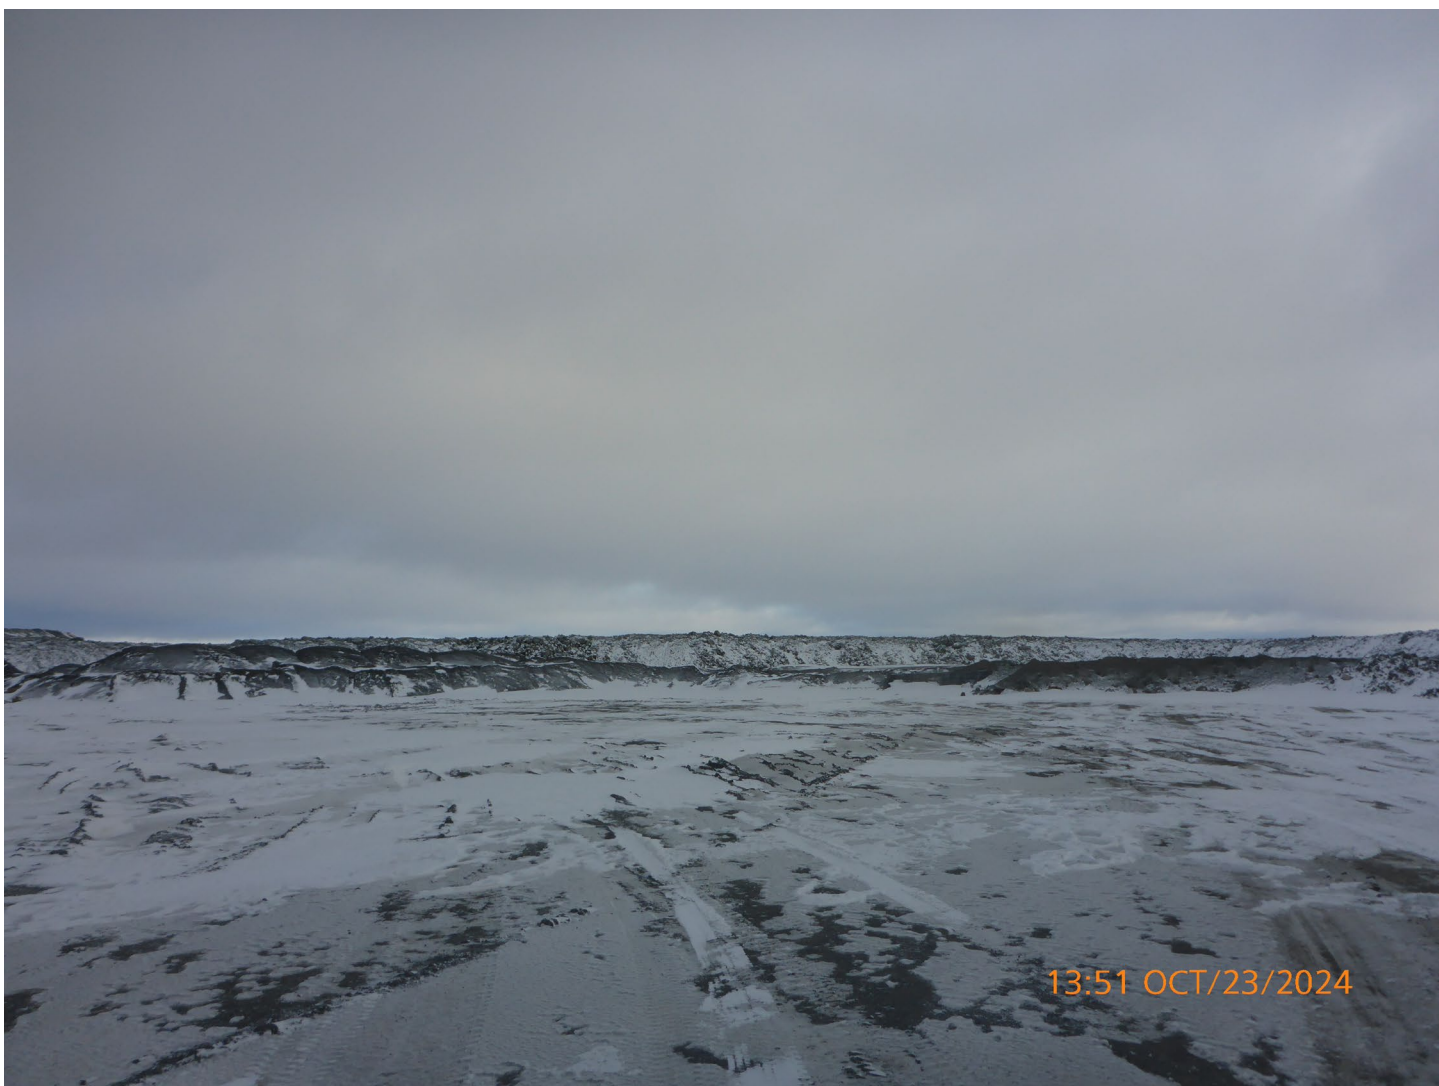
The Ekati Landfill is the designated disposal area for inert solid waste that is not incinerated or sent off site for recycling. The landfill receives wastes such as rubber, plastics, wood, and metal. A recent change in landfill operation has dumping restricted to approved operators only. This is an effort to reduce noncompliant waste being sent to the landfill. Operators now need to call in to the Environment Department to arrange for waste drop off. The landfill had been recently covered with coarse processed Kimberlite and appeared to be well maintained with no indication of any misdirected waste (Photo 16).

Photo 16 – Landfill – The Landfill has been recently covered by coarse processed kimberlite.

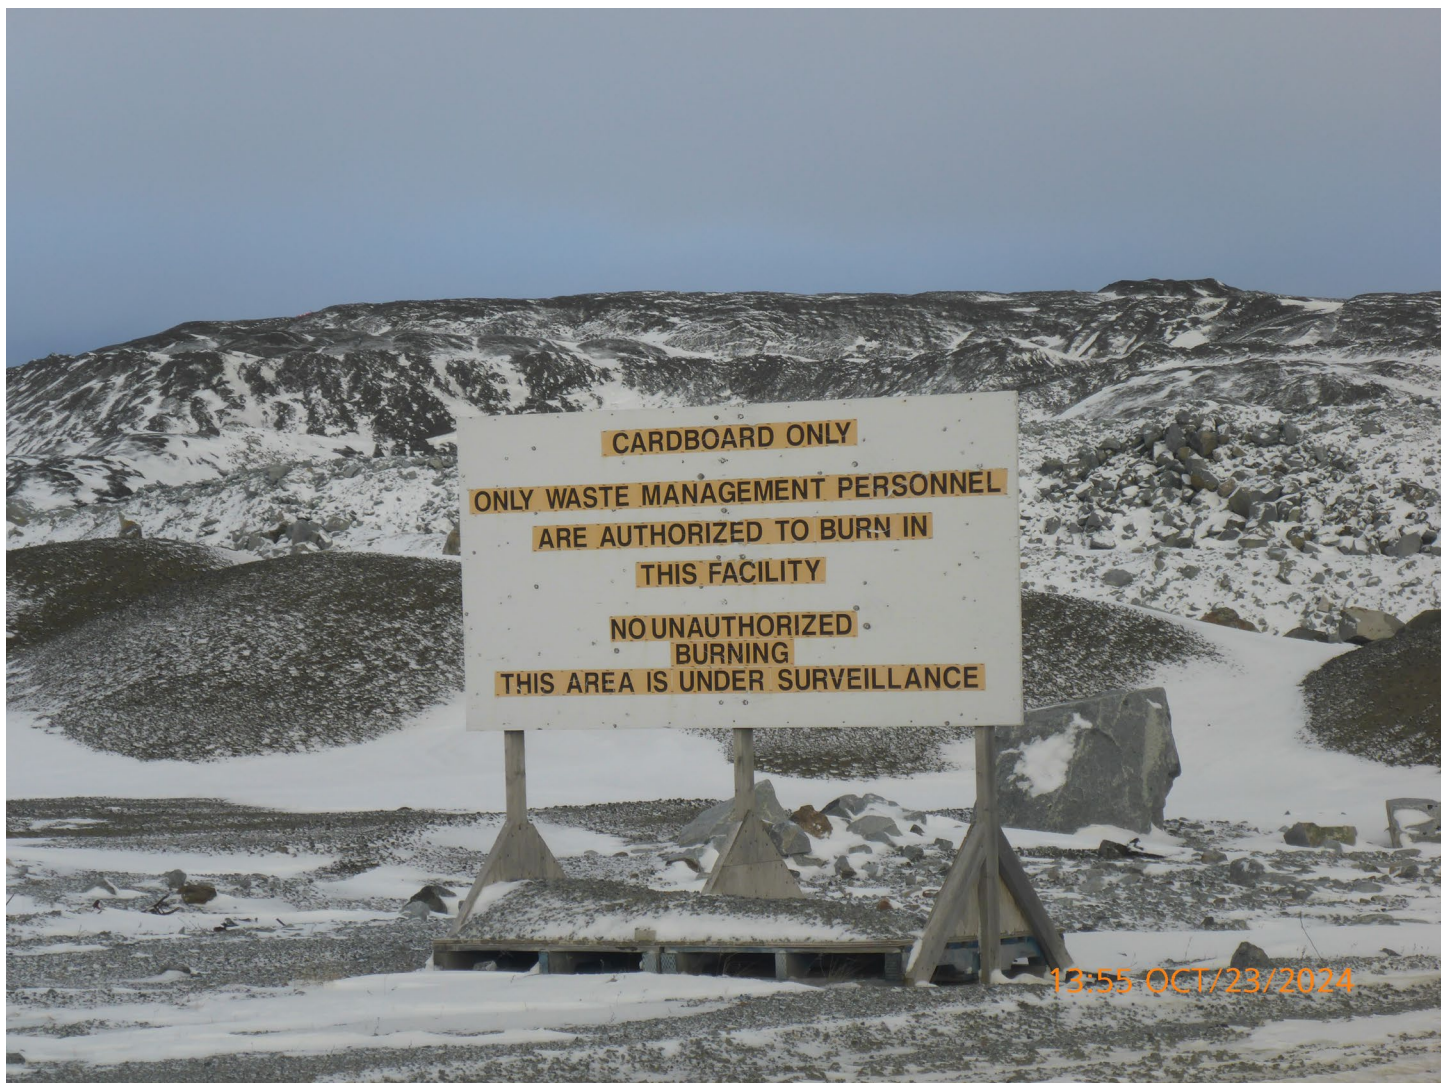
Photo 17 – Landfill – The landfill Burn Bin is the designated disposal area for some inert combustible waste such as explosives waste packaging.

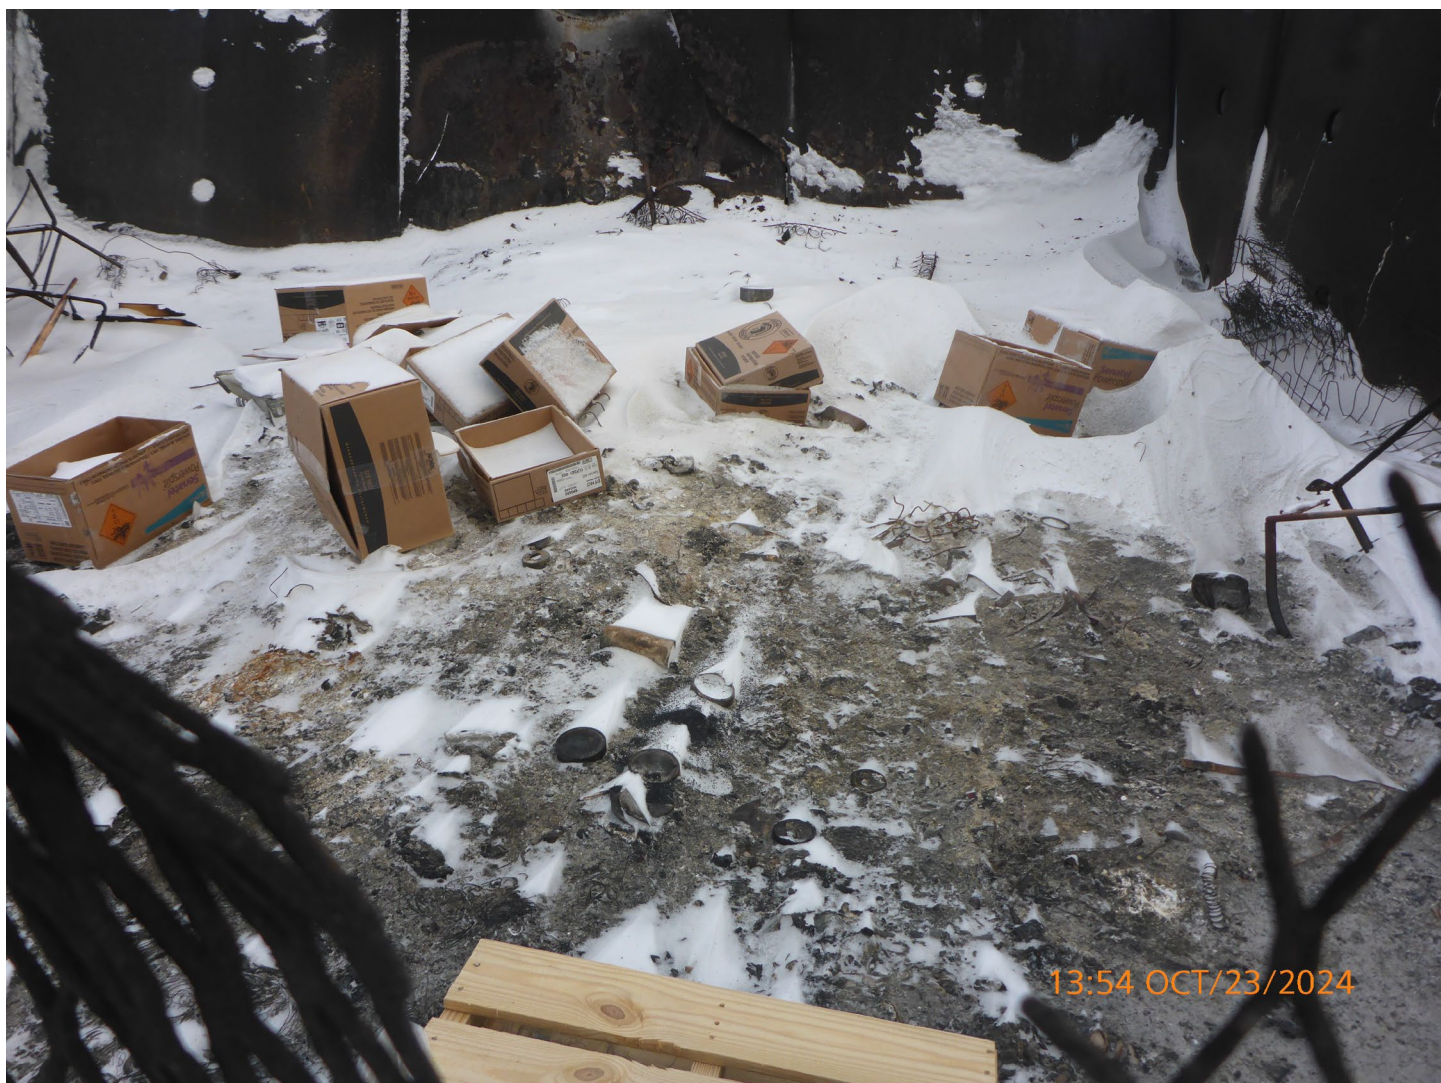
Photo 18 – Landfill – The Burn Bin is an enclosed truck box and is used as the disposal location for cardboard and explosive waste products. The bin is caged in and locked to prevent misuse and animals from entering. There was no indication of misdirected waste in the Burn Bin.

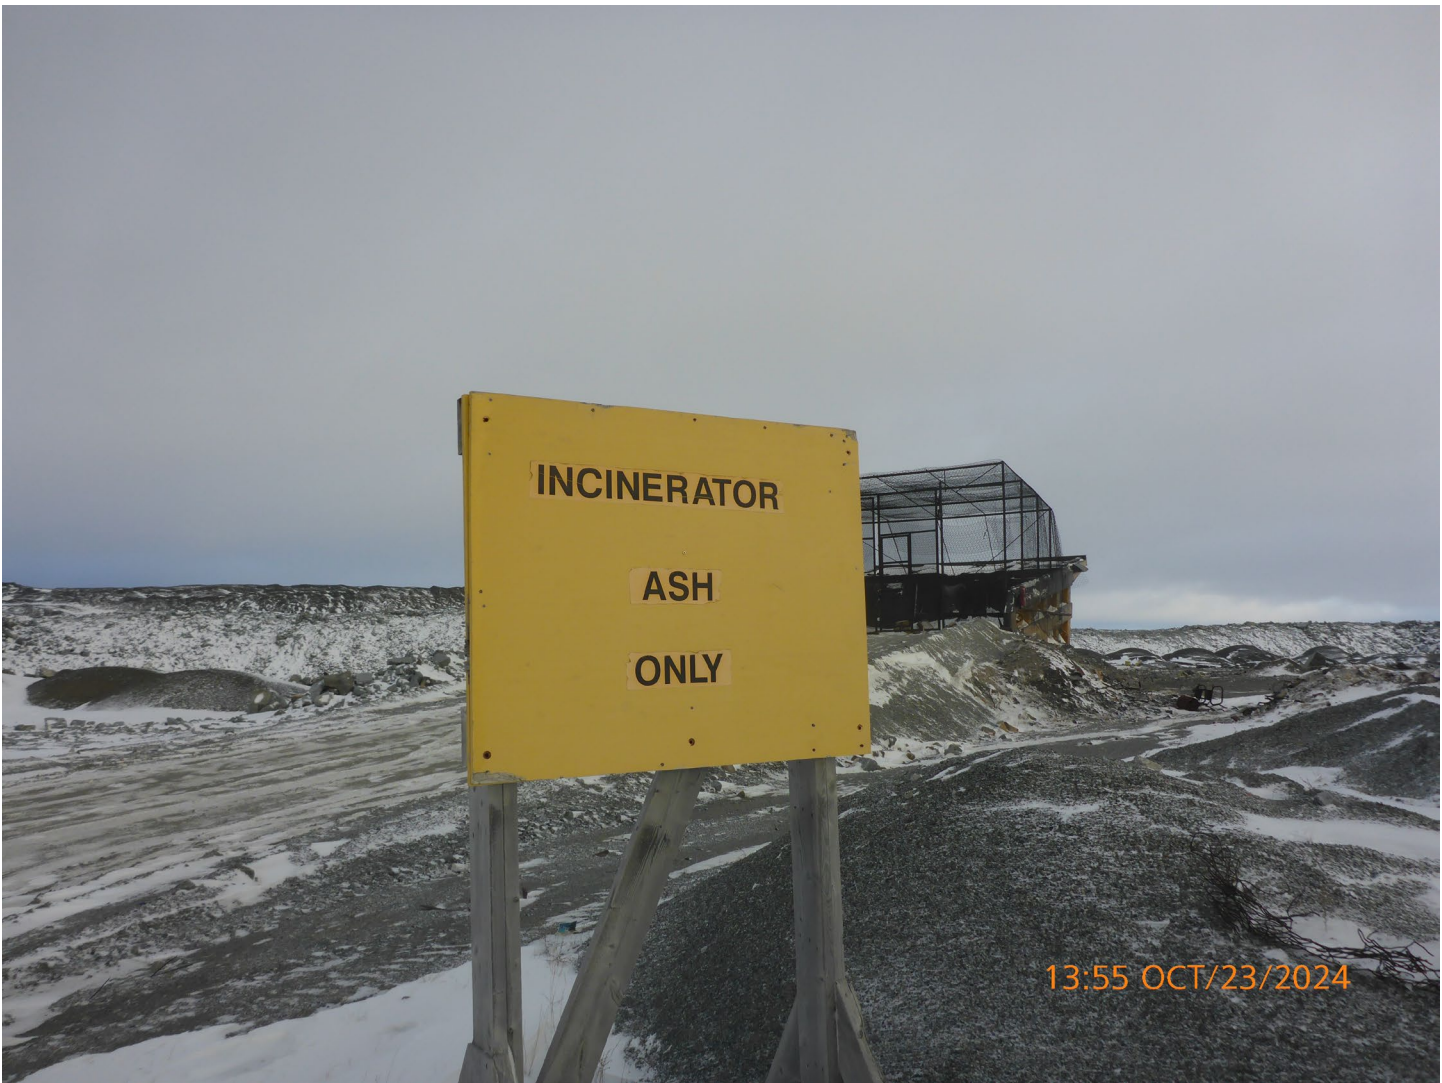
Photo 19 – Landfill – Incinerator Ash is disposed of in a designated area of the landfill near the burn bin.

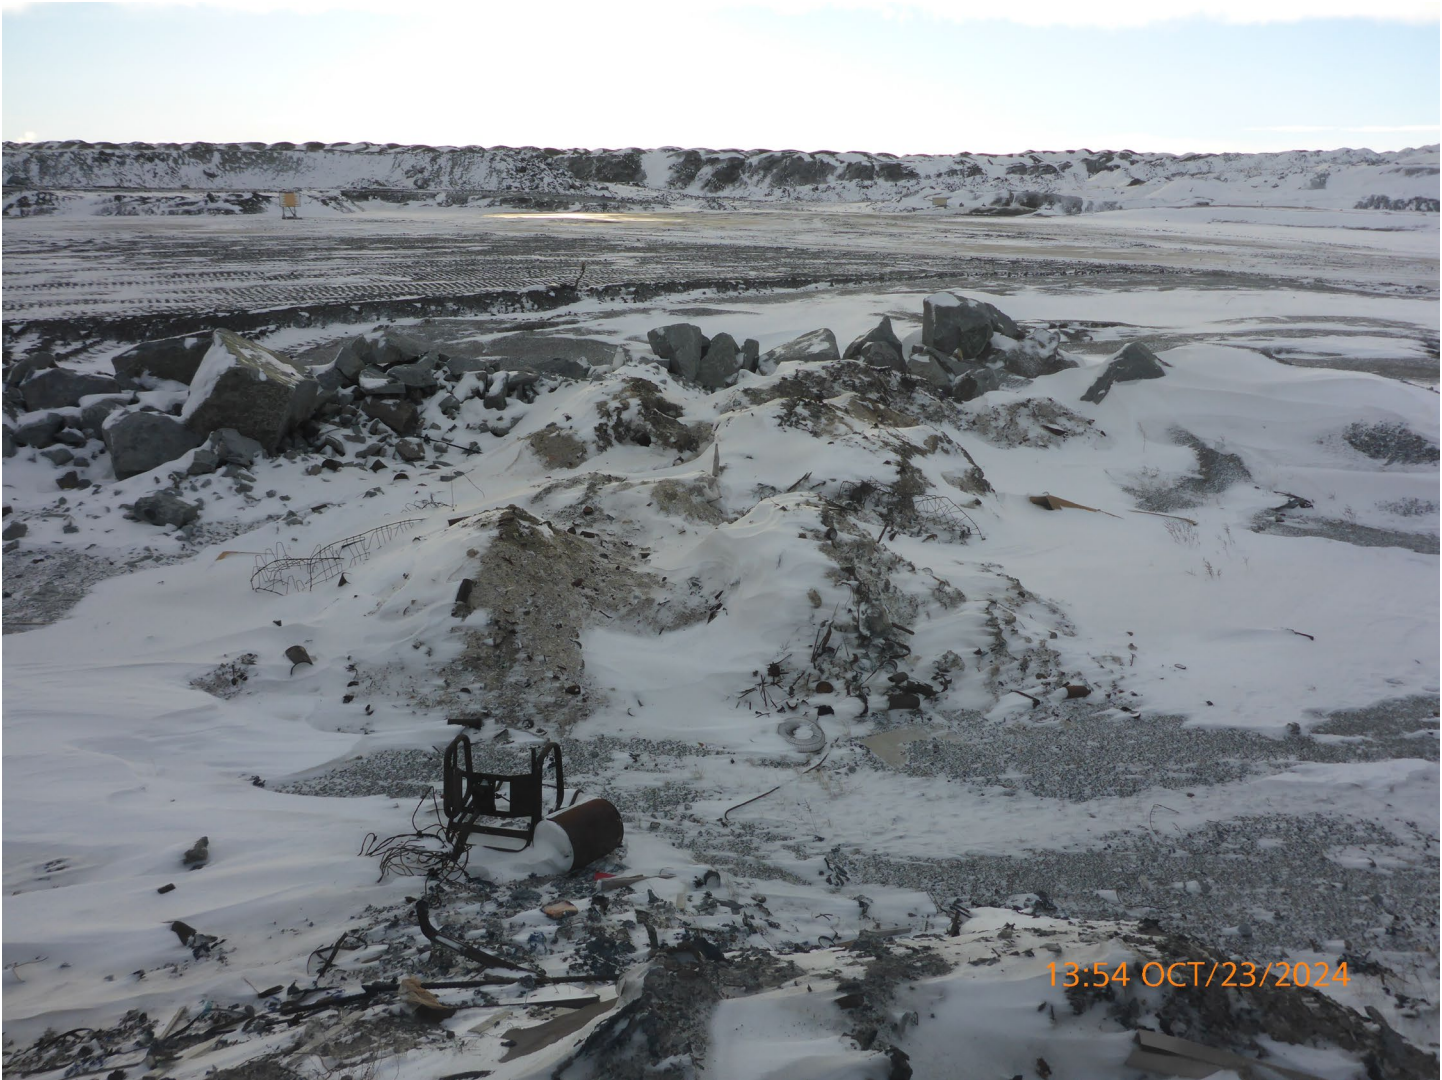
Photo 20 – Landfill – The ash disposal of the landfill shows no indication of misdirected waste.

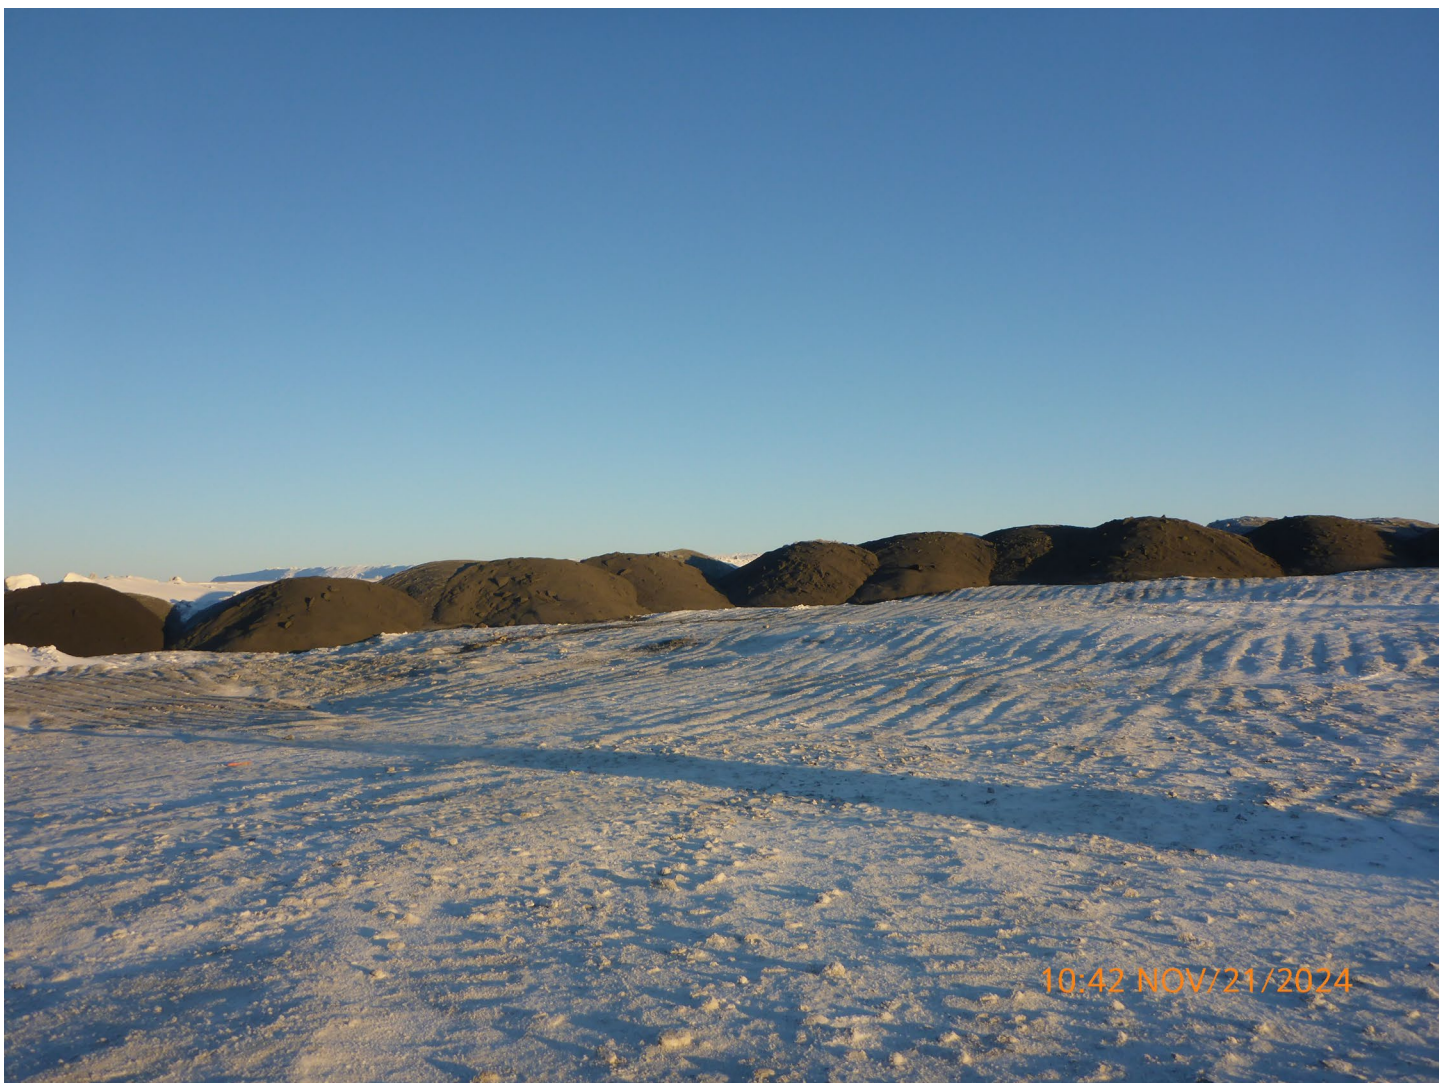
Coarse processed kimberlite is being disposed of on the Panda/Koala Waste Rock Pile as per the approved Wastewater Processed Kimberlite Management Plan. Coarse Kimberlite is also used to cover the landfill to contain the waste and prevent it from becoming wind blown (Photo 21). No issues were observed at the dumping location.

Photo 21 – Coarse Processed Kimberlite Dump – The coarse processed kimberlite disposal area is being placed as per the Wastewater Processed Kimberlite Management Plan. Coarse Kimberlite is also used to cap the landfill in between lifts.

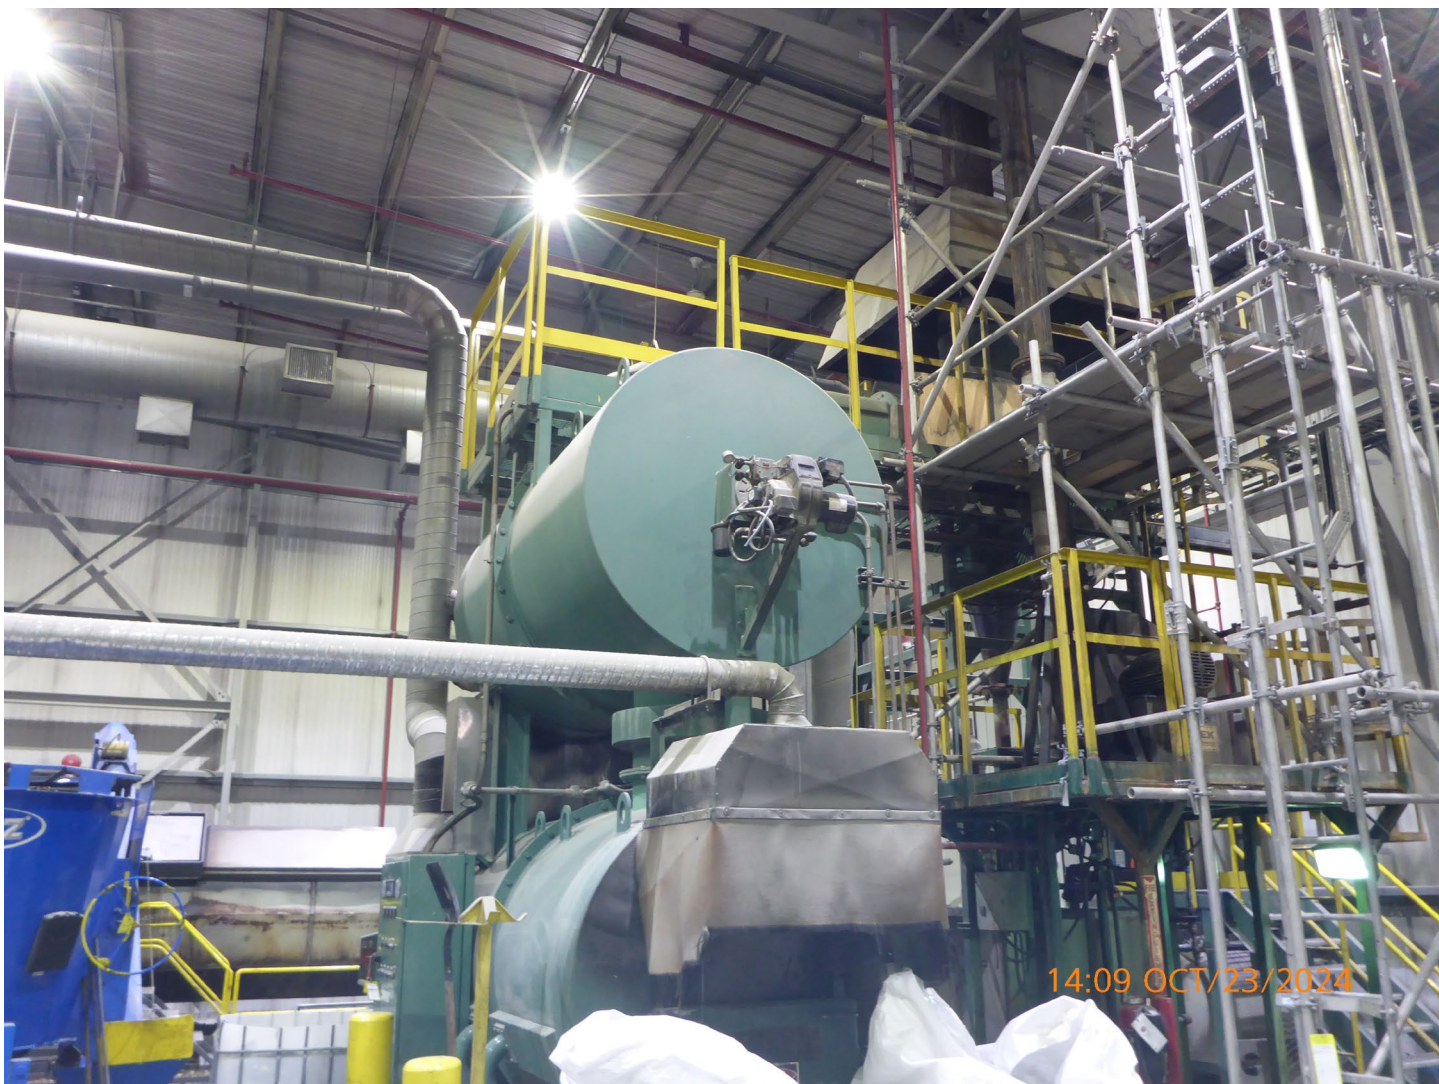
Burner tuning and stack testing was scheduled for the summer of 2024; however, the testing wasn't completed due to some maintenance issues. The testing will need to be rescheduled.

Photo 22 – Incinerator Building – Ekati is equipped with two dual chambered incinerators. The incinerators were scheduled for tuning and stack testing in the summer of 2024; however the testing was not able to proceed.

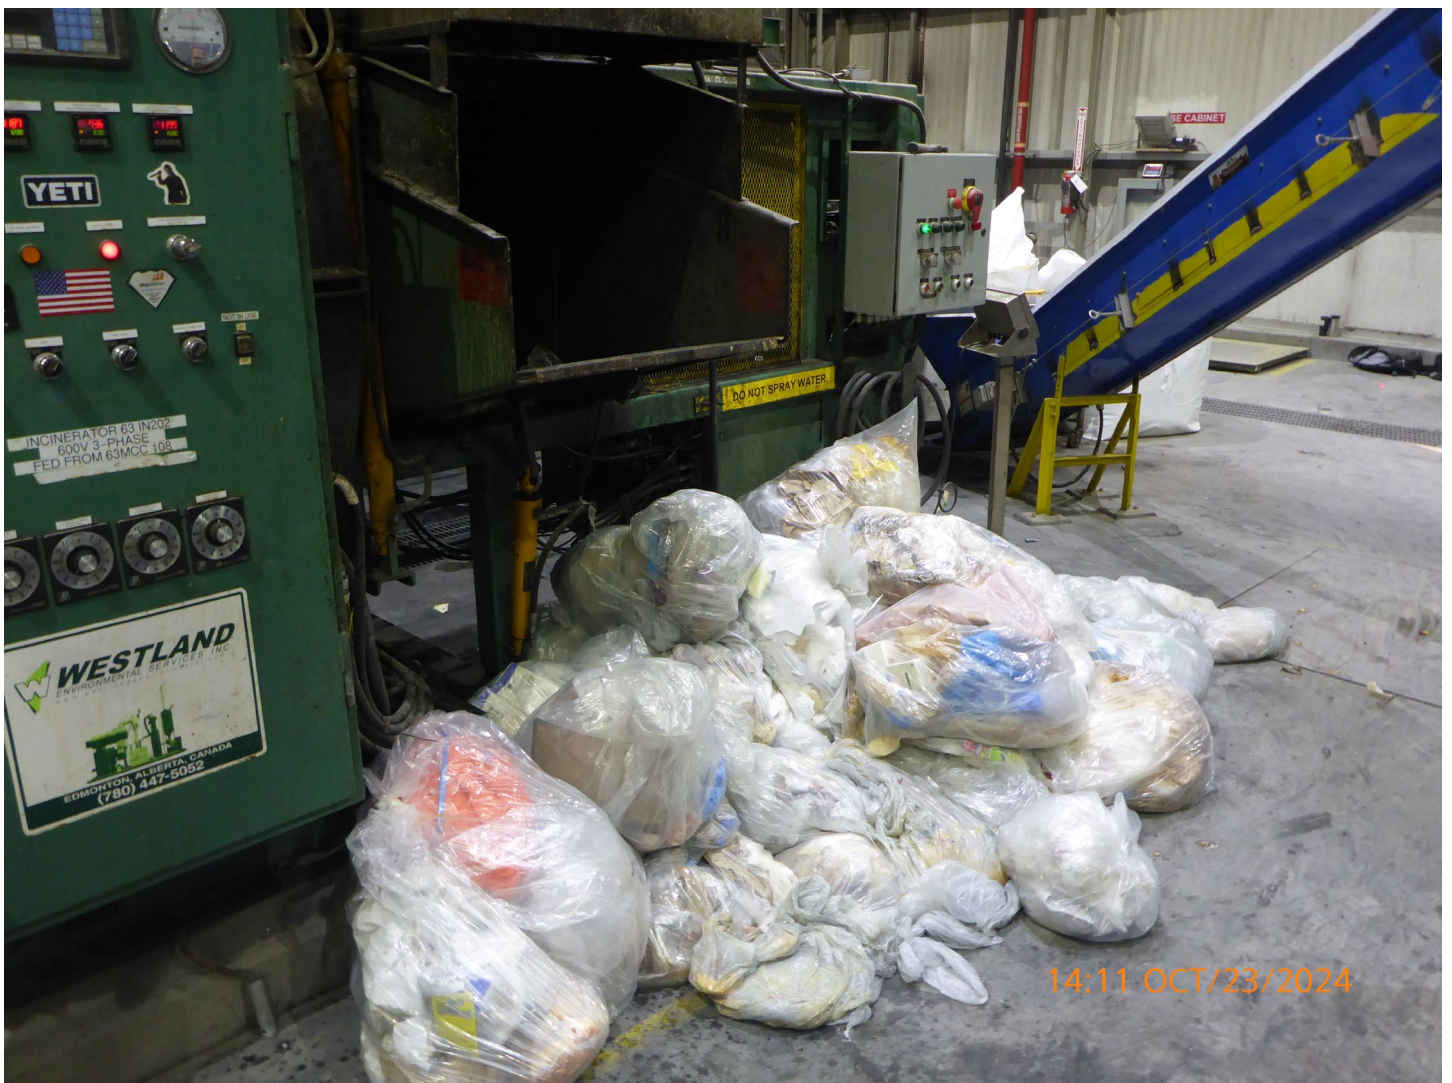
Photo 23 – Incinerator Building – Incinerator waste is segregated and batched. Much of the organics are sent to the composter, and the remaining waste is sent to the incinerators.

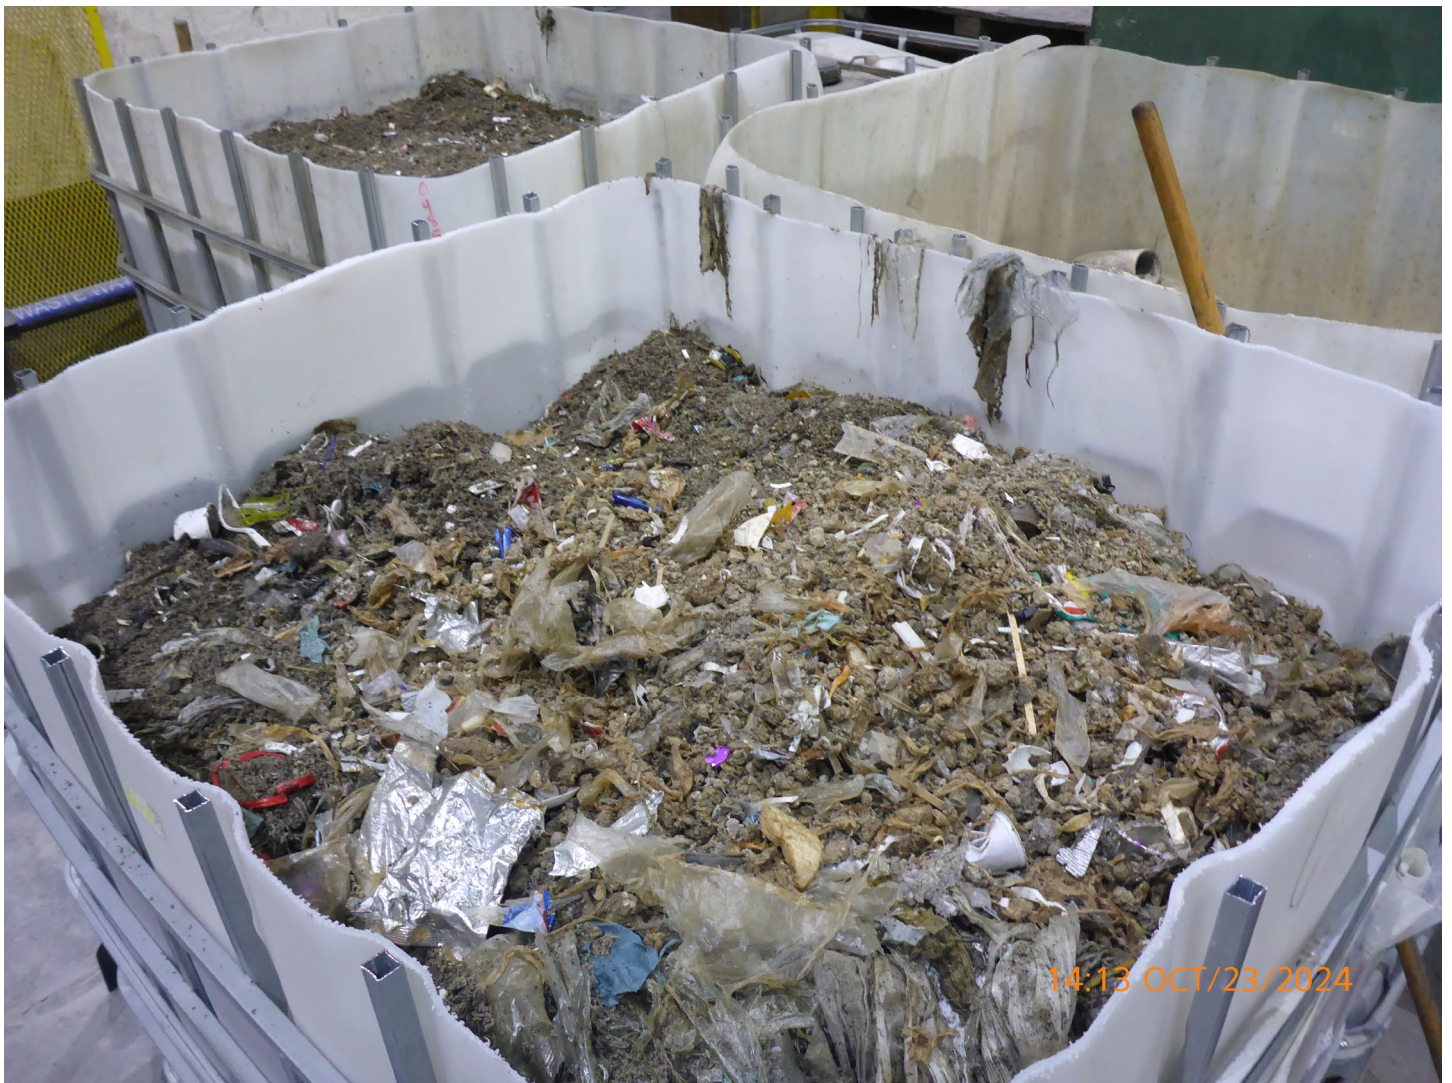
Photo 24 – Incinerator Building – Waste after it has been through the composter is dried out and rendered inert. It is then disposed of in the Landfill.

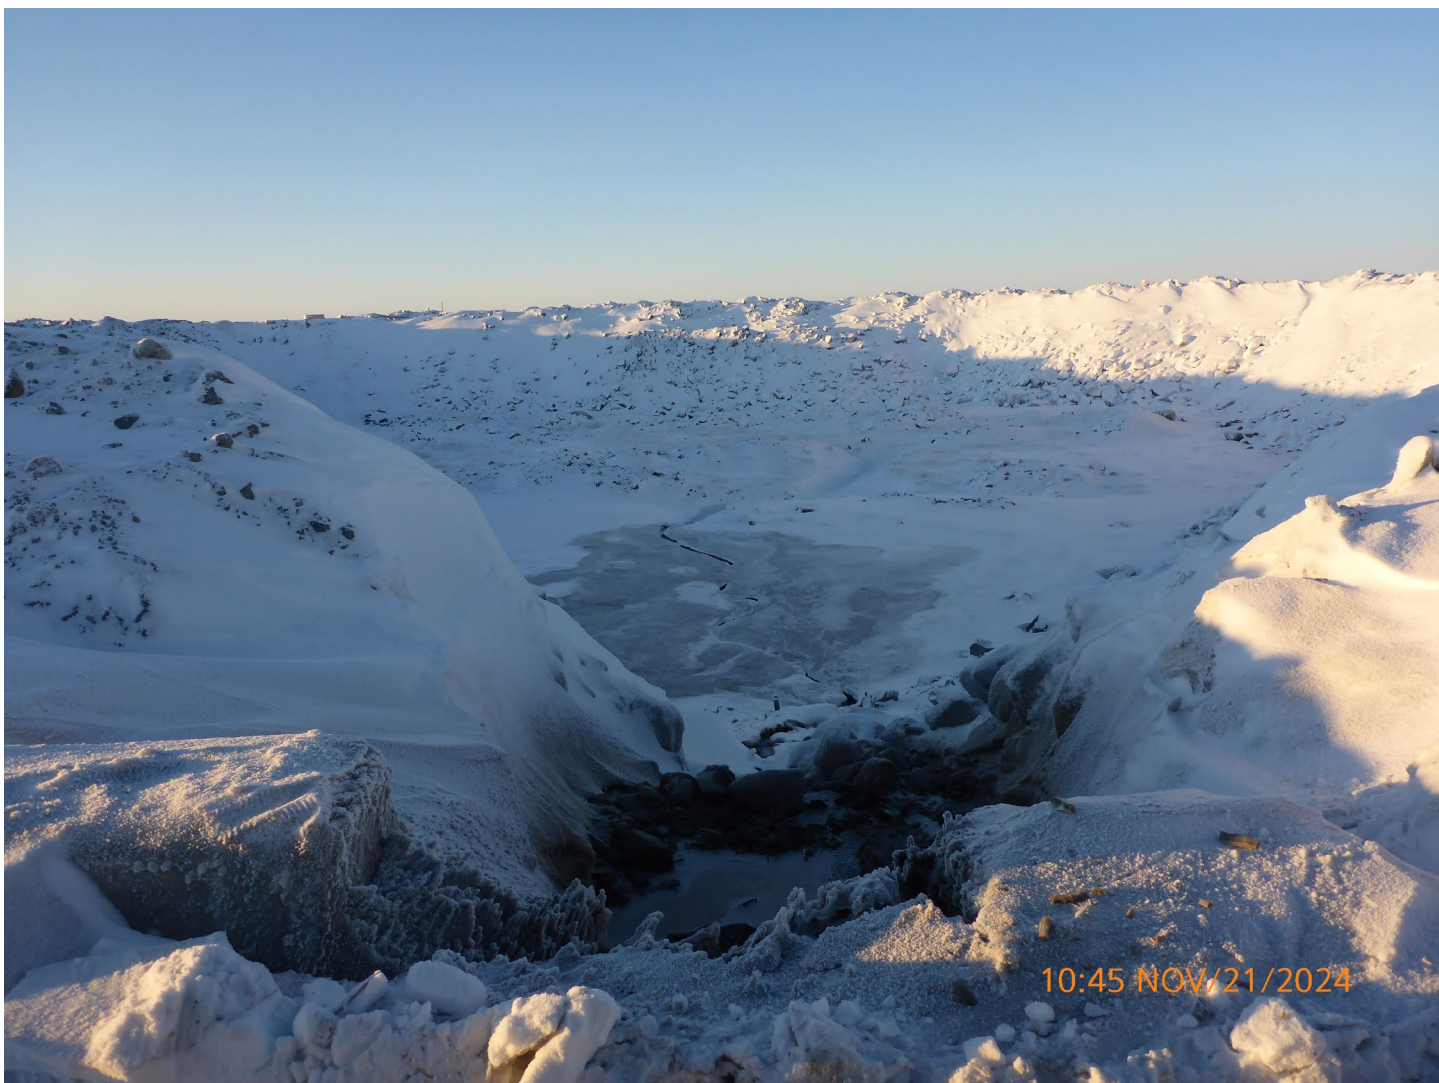
Zone S located on top of the Panda/Koala Waste Rock Pile is the designated disposal area for sewage sludge and hydrocarbon contaminated mine rock. Zone S has plenty of capacity and there is no indication of any non-compliant or misdirected waste (Photo 25).

Photo 25 – Zone S – Zone S is the designated disposal area for sewage sludge and hydrocarbon contaminated mine rock. Zone S has plenty of capacity and there is no indication of any non-compliant or misdirected waste.

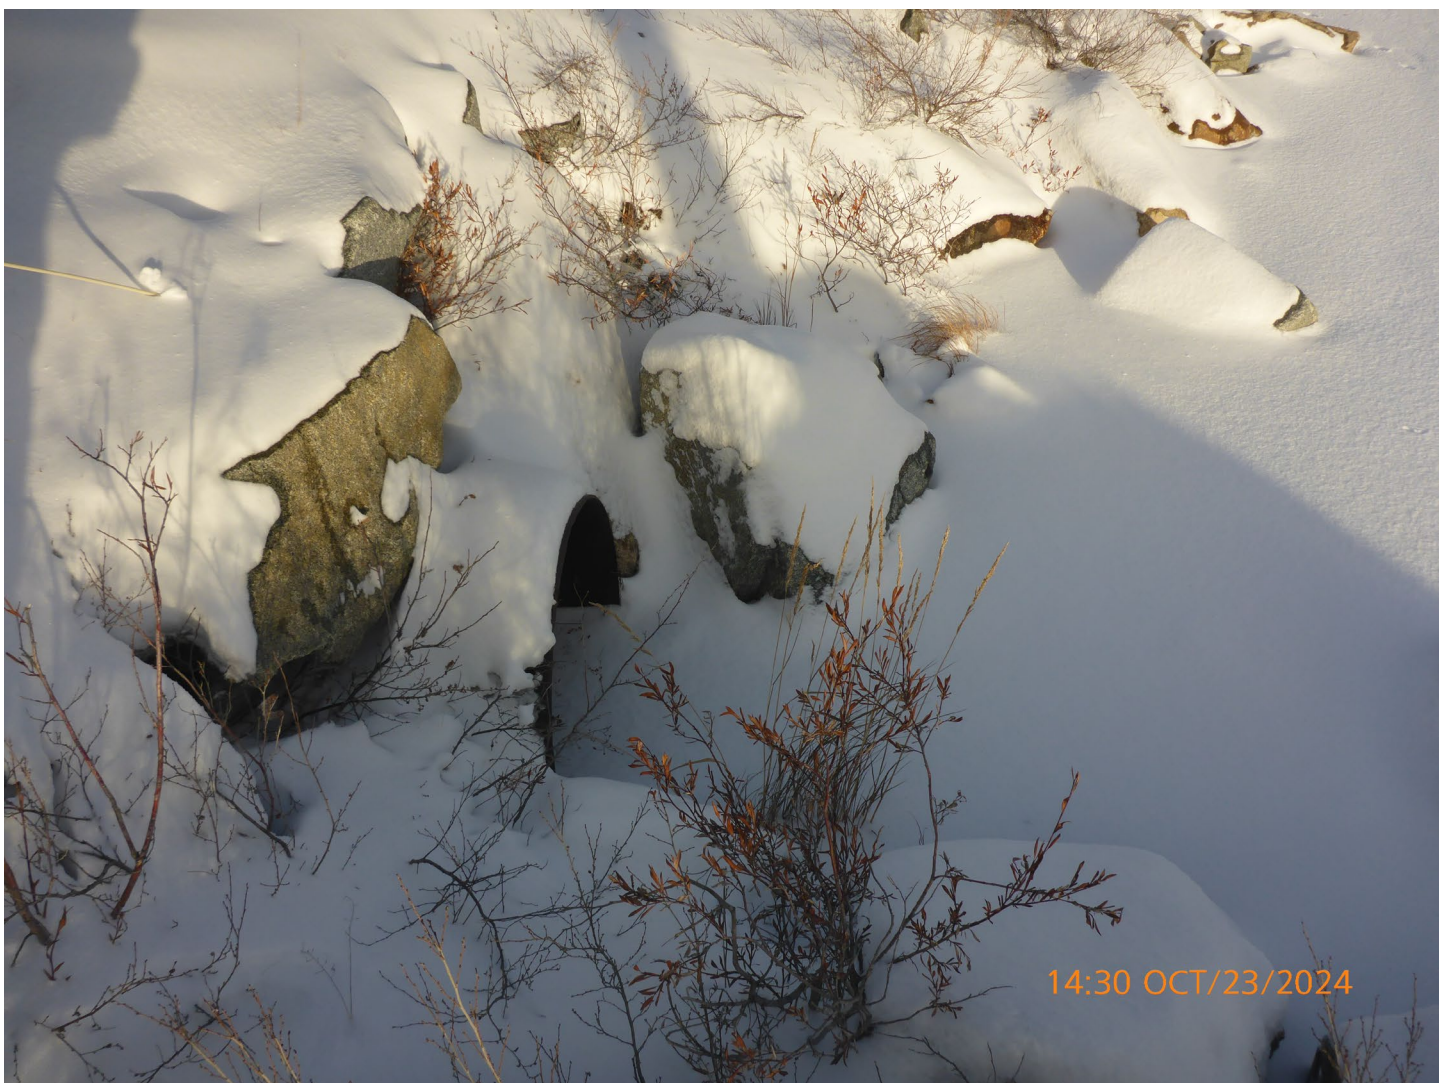
The culverts along the PDC are beginning to fill in with snow. Normally Ekati staff will cover these culverts to prevent them from becoming packed with snow. A packed culvert will potentially create a flooding situation in the spring. Culverts along the PDC and the Airstrip are of particular concern. Arctic should cover these culverts as soon as possible (Photo 26).

Photo 26 – PDC Culverts – The culverts along the PDC are beginning to fill in with snow. Normally Ekati staff will cover these culverts to prevent them from becoming packed with snow. A packed culvert will potentially create a flooding situation in the spring. Culverts along the PDC and the Airstrip are of particular concern. Arctic should cover these culverts as soon as possible.

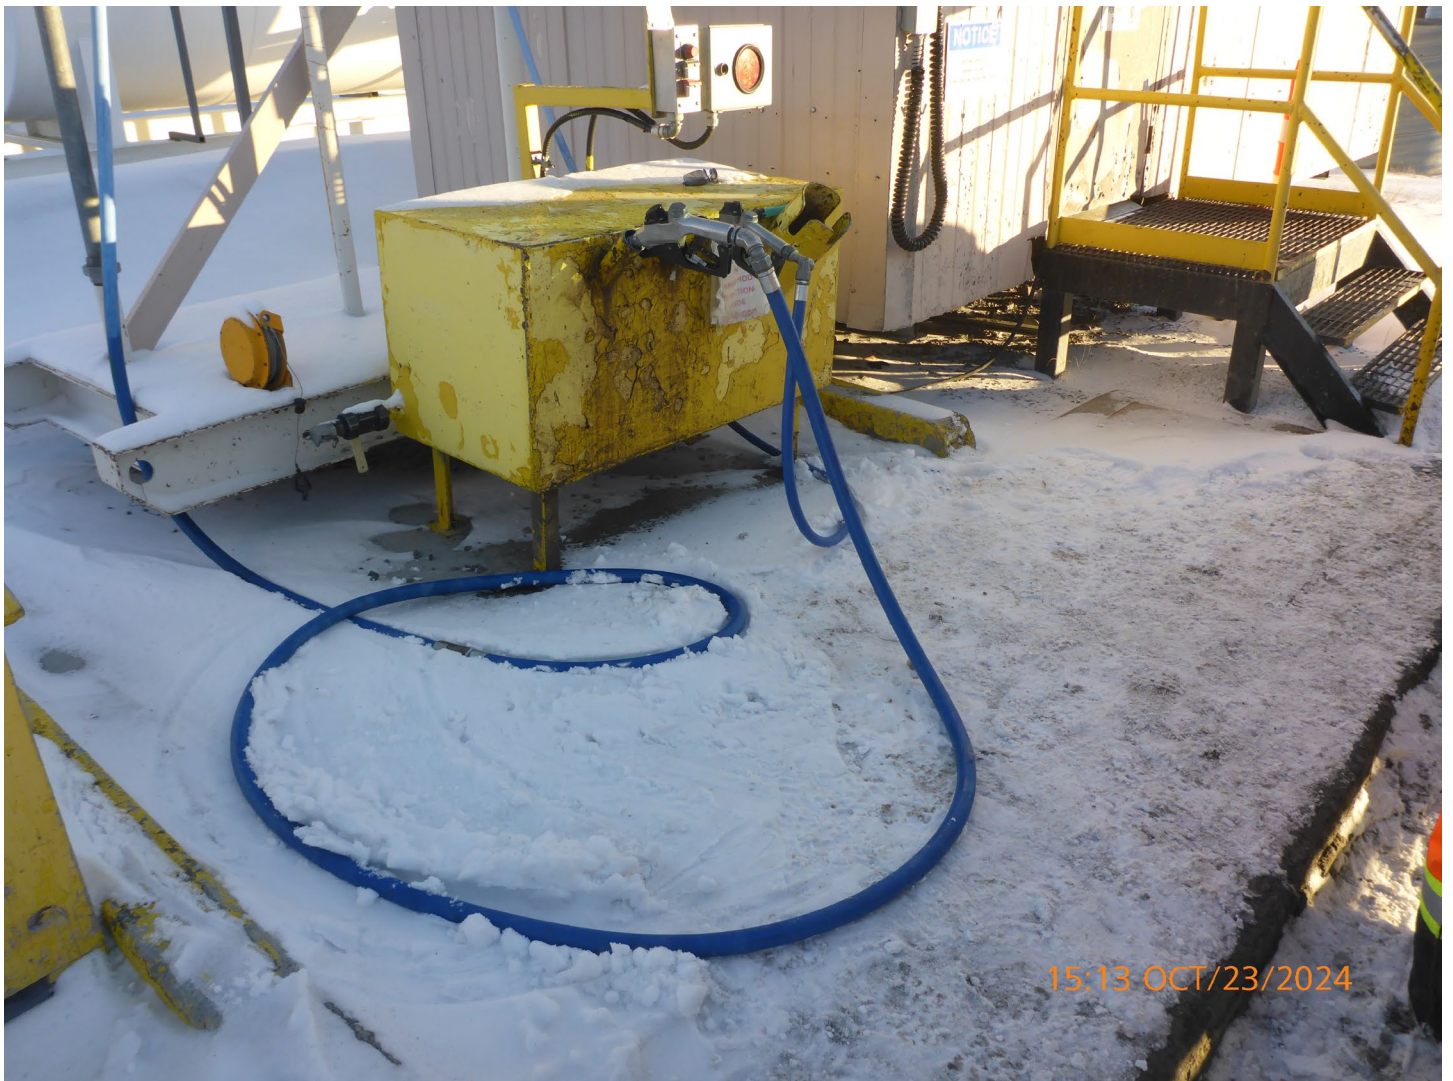
The Main Camp refuelling area was clean and well maintained with no indication of any hydrocarbon leaks or spills. Spill response equipment was fully stocked and easily accessible. Containment sumps were dry and had plenty of capacity to contain any potential spills (Photo 27).

Photo 27 – Main Camp Refuelling – The Main Camp Refuelling Station was clean and well organized with no indication of any leaks or spills. Spill response equipment is fully stocked and easily accessible.

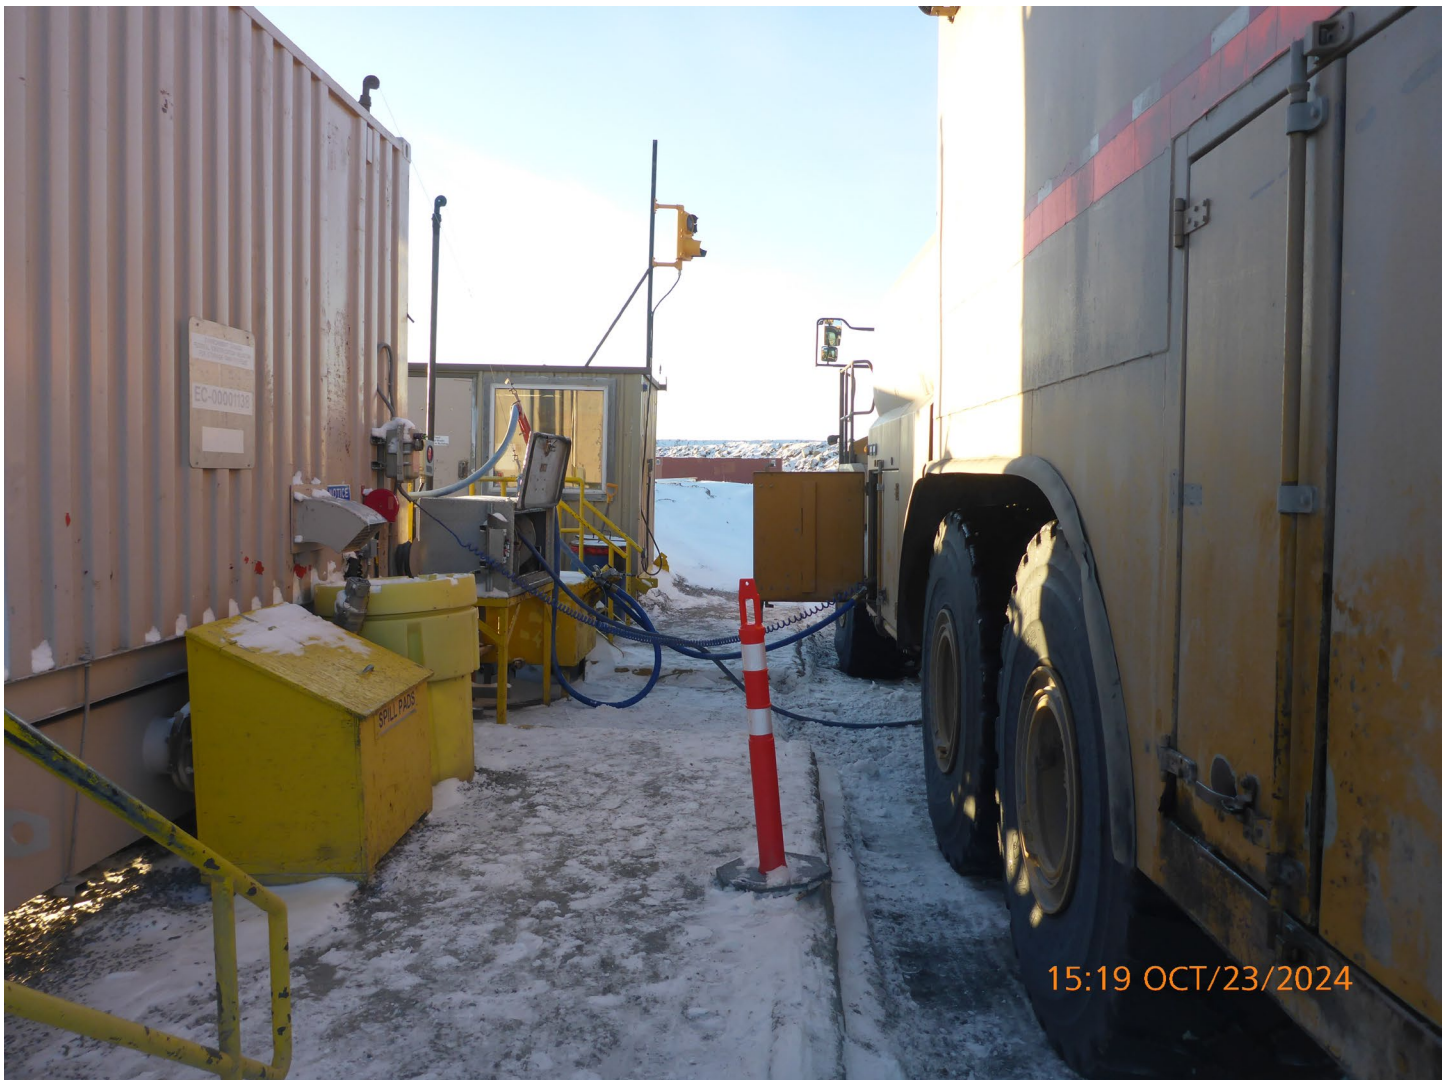
The Koala Refuelling Station was clean and well organized with no indication of any leaks or spills. Spill response equipment is fully stocked and easily accessible. Containment sumps were dry and had plenty of capacity to contain any potential spills (Photo 28).

Photo 28 – Koala Refuelling Station – The Koala Refuelling Station was clean and well organized with no indication of any leaks or spills. Spill response equipment is fully stocked and easily accessible.
