GNWT ECC - North Slave Region

Water Licence W2022L2-0001

Re: October-November 2024 Water Licence Inspection

INDUSTRIAL WATER USE INSPECTION REPORT

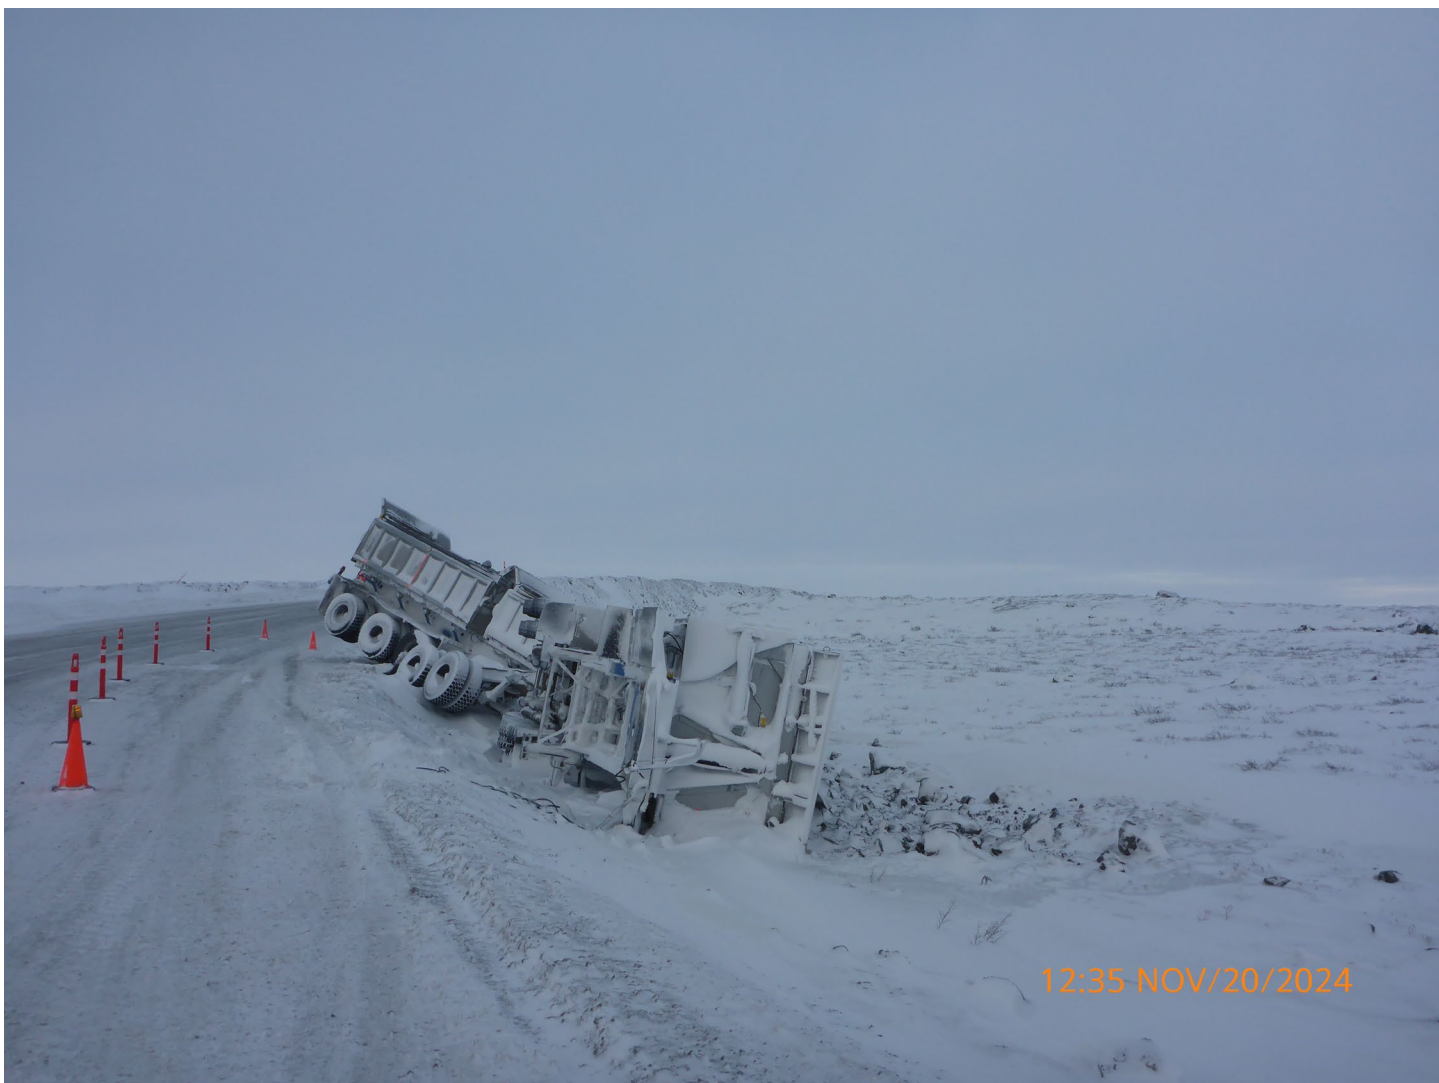
NT Spill #2024424 occurred on November 18, 2024. A Road Train hauling kimberlite ore went off the road and spilled some ore onto the ground. The Inspector attended the site, but the clean-up was still under way. The spill consisted of Kimberlite ore and some minor hydrocarbon staining in the snow from the hydraulic hoses disconnecting (Photo 29).

Photo 29 – Sable Haul Road – NT Spill #2024424 occurred on November 18 2024. A Road Train hauling kimberlite ore went off the road and spilled some ore onto the ground. The Inspector attended the site, but the clean-up was still under way. The spill consisted of Kimberlite ore and some minor hydrocarbon staining in the snow from the hydraulic hoses disconnecting.

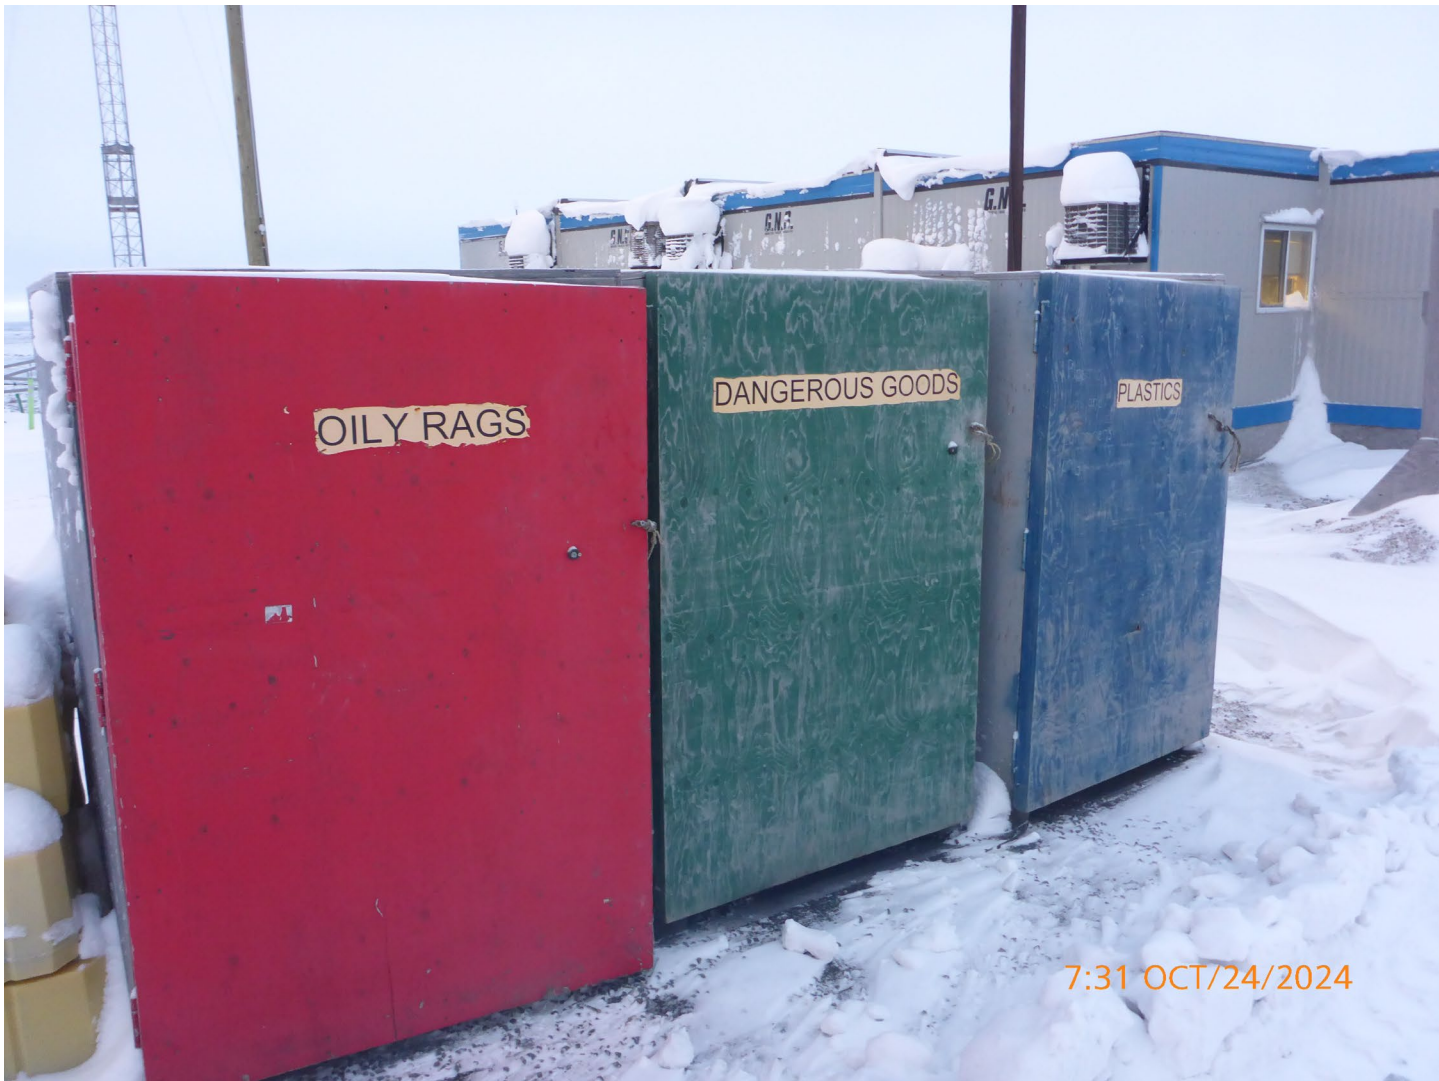
Waste at the Sable Development is segregated into labelled bins. The waste bins were well maintained with no indication of spills or misdirected waste (Photo 30).

Photo 30 – Sable Waste Bins – Waste at the Sable Development is segregated into labelled bins. The waste bins were clean and well maintained with no indication of spills or misdirected waste.

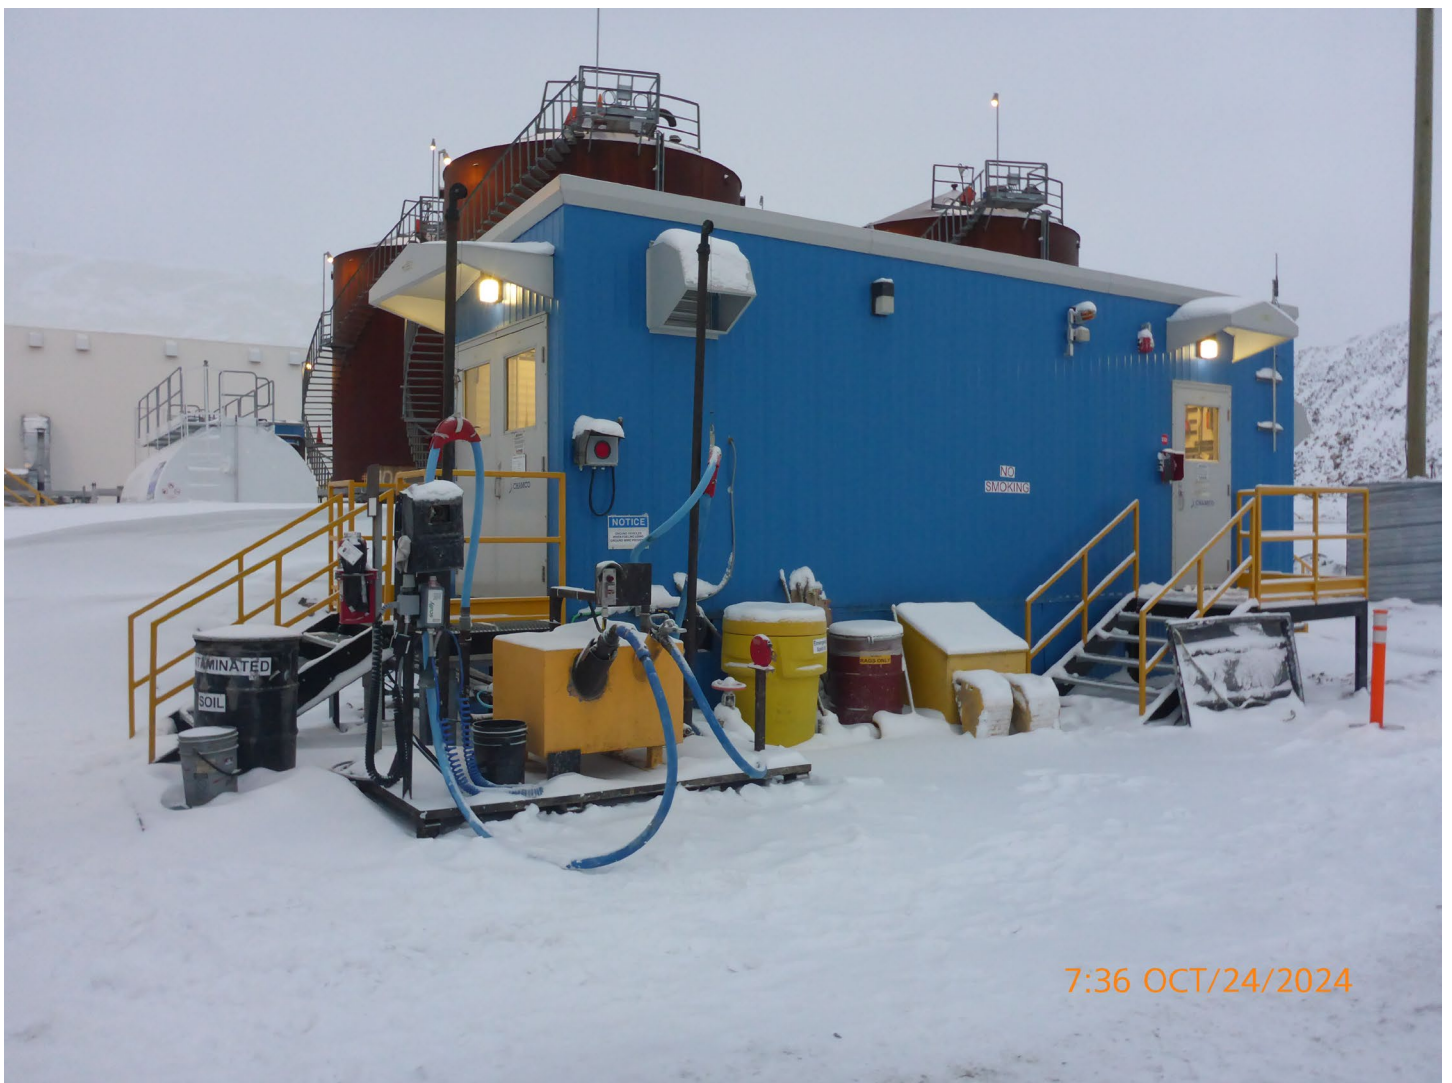
The Sable refuelling area was clean and well maintained with no indication of any hydrocarbon leaks or spills. Spill response equipment was fully stocked and easily accessible (Photo 31).

Photo 31 – Sable Refuelling Station – The Sable Refuelling Station is clean and well organized with no indication of any leaks or spills. Spill response equipment is stocked and easily accessible.

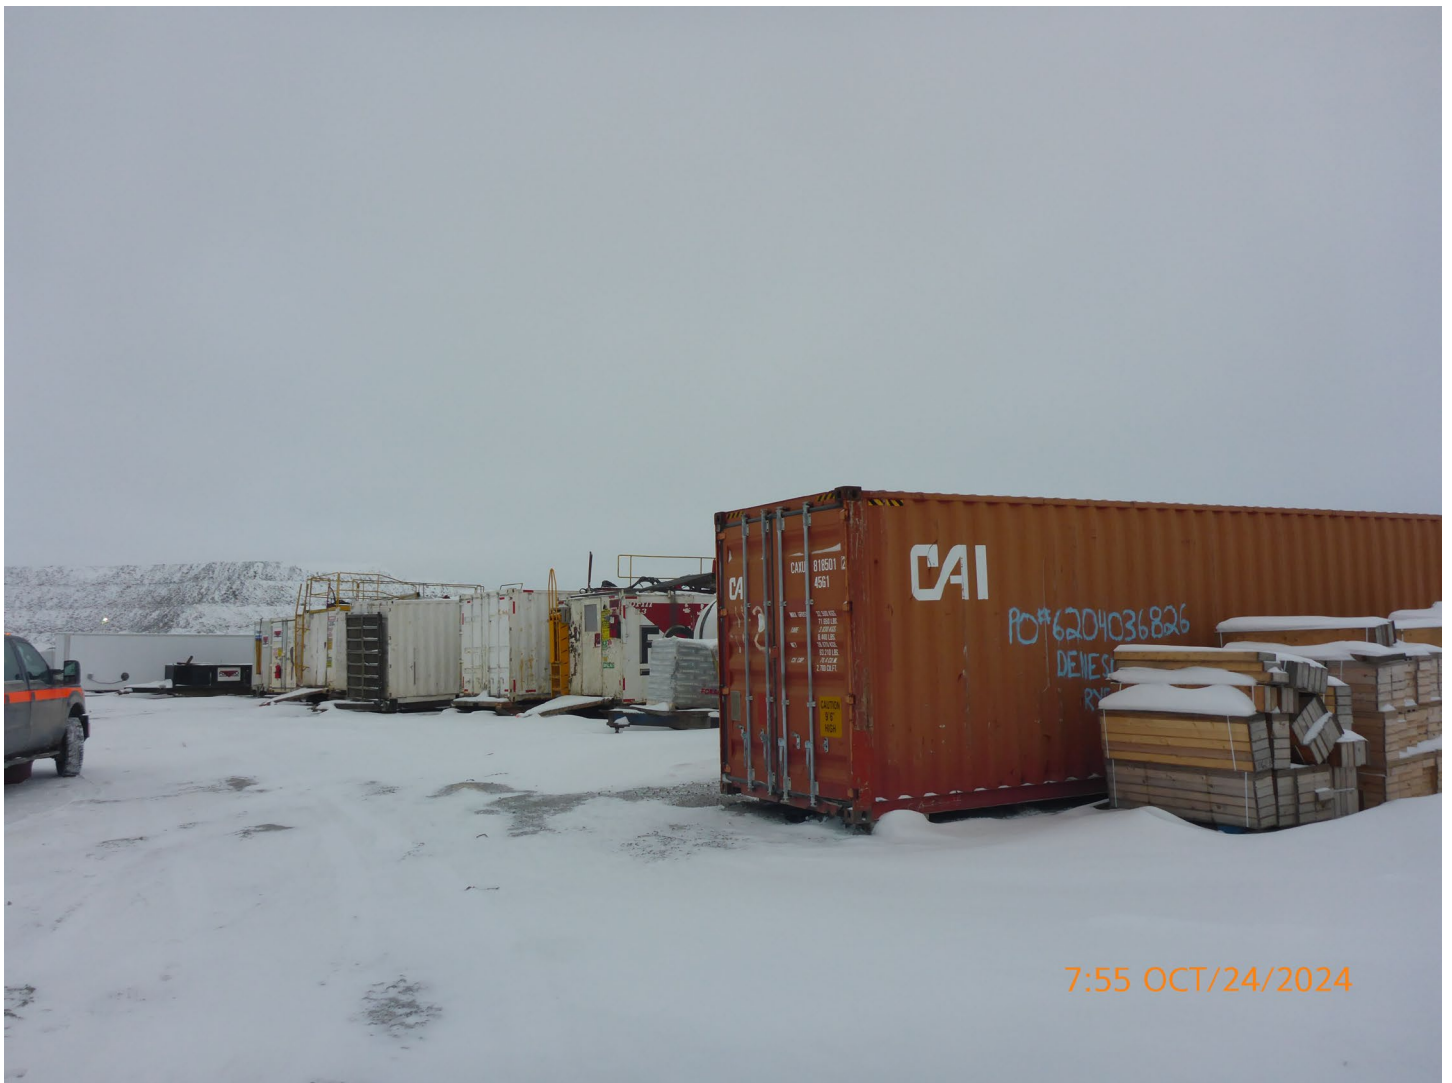
Drilling in the Sable Pit was ongoing throughout the summer in order to improve resource delineation. Drilling has been completed for the season, and the drills and equipment are stored in a laydown near the pit. Equipment storage is neat and well organized and there is no indication of any leaks or spills (Photos 32 and 33).

Photo 32 – Sable Drilling – Drilling in the Sable Pit has stopped for the season. The drills and equipment are stored in a laydown near the pit. Equipment storage is neat and well organized and there is no indication of any leaks or spills.

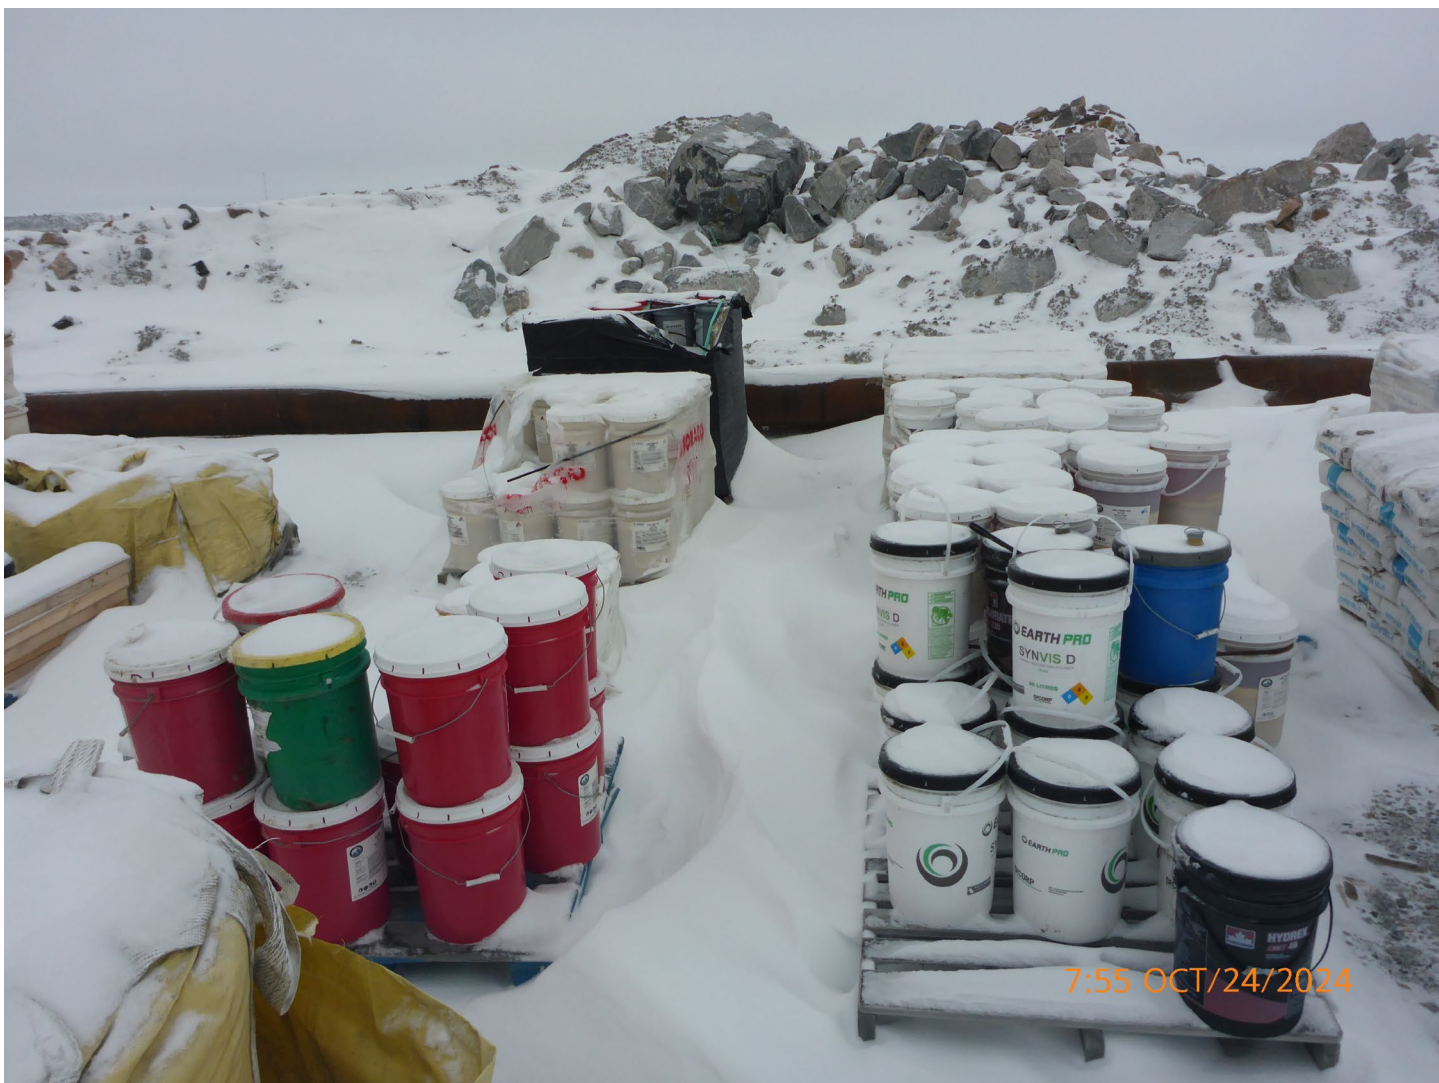
Photo 33 – Sable Drilling – Drilling additives are stored out of the way on pallets to prevent breakage and spills.

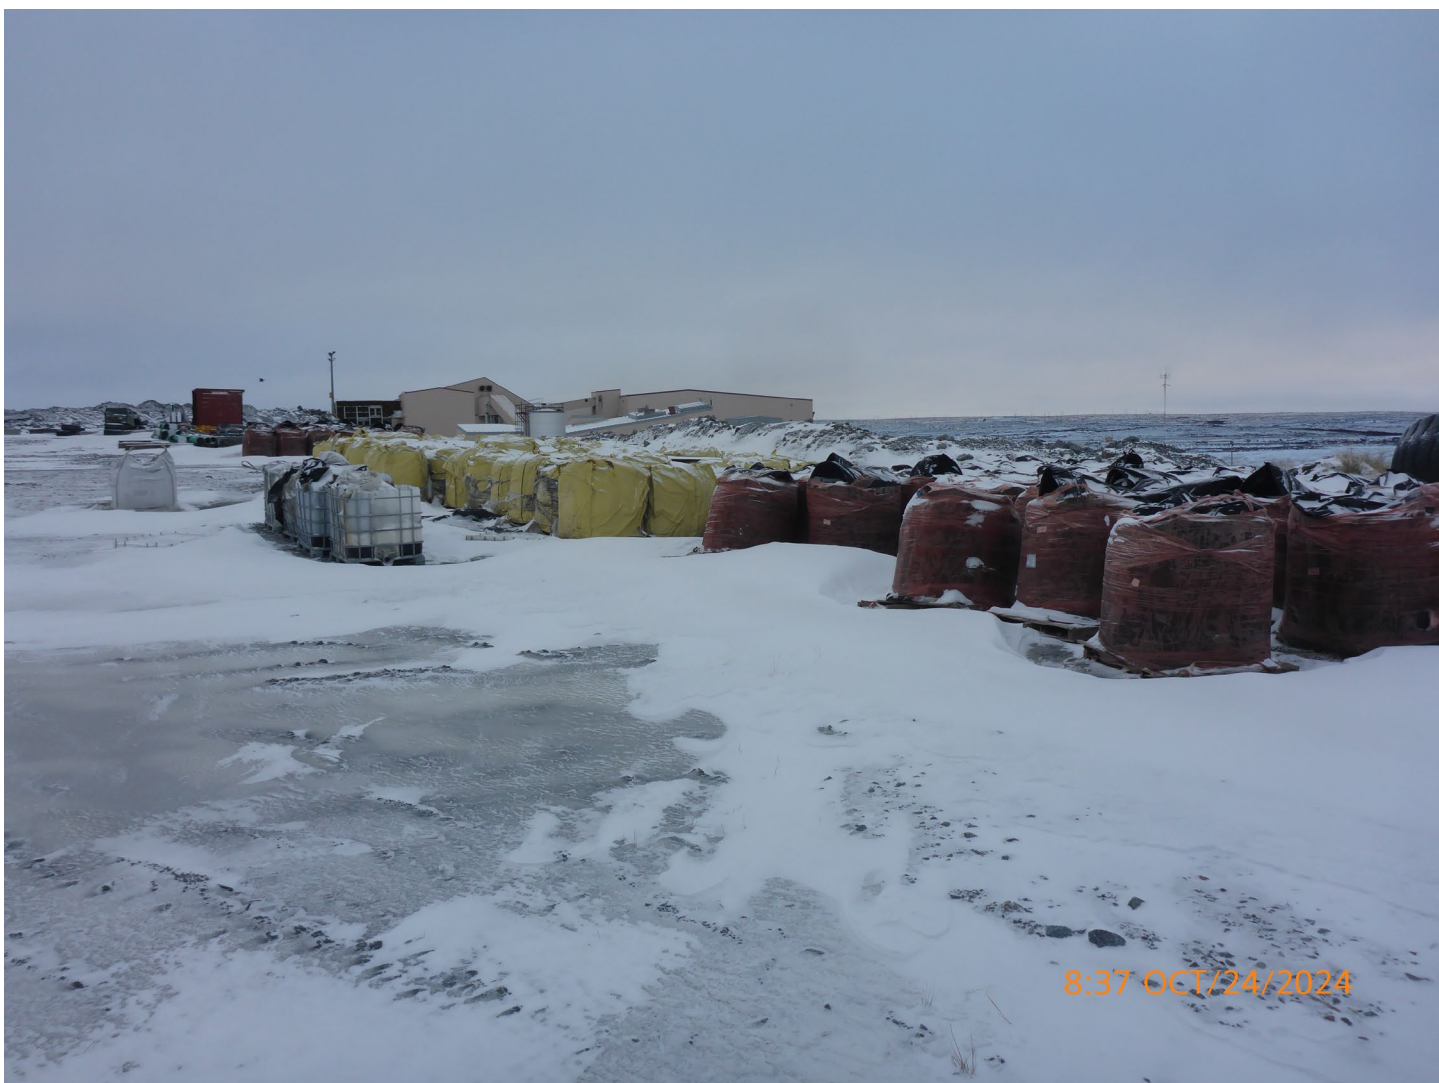
The Process Plant laydown has been cleaned up and the broken bags have been removed. The laydown is clean and well organized (Photo 34).

Photo 34 – Process Plant Laydown – The Process Plant laydown has been cleaned up and the broken bags have been removed. The laydown is clean and well organized.
