File Number	W2023L4-0001
Type of Operation	CLASS A - HYDRO
Location	Snare River, NT

An inspection of the above noted operation was conducted on August 13, 2024 by Water Resource Officers Meaghan MacIntyre-Newell and Nahum Lee. Enclosed is a copy of the Water Use Inspection Report.

WATER USE INSPECTION REPORT

LICENCE #:	W2023L4-0001	EXPIRY DATE:	May 17, 2063
LICENCEE:	Northwest Territories Power Corporation	PREVIOUS INSPECTION:	March 14, 2024
COMPANY REP:	Patrick Smith	INSPECTION DATE:	August 13, 2024

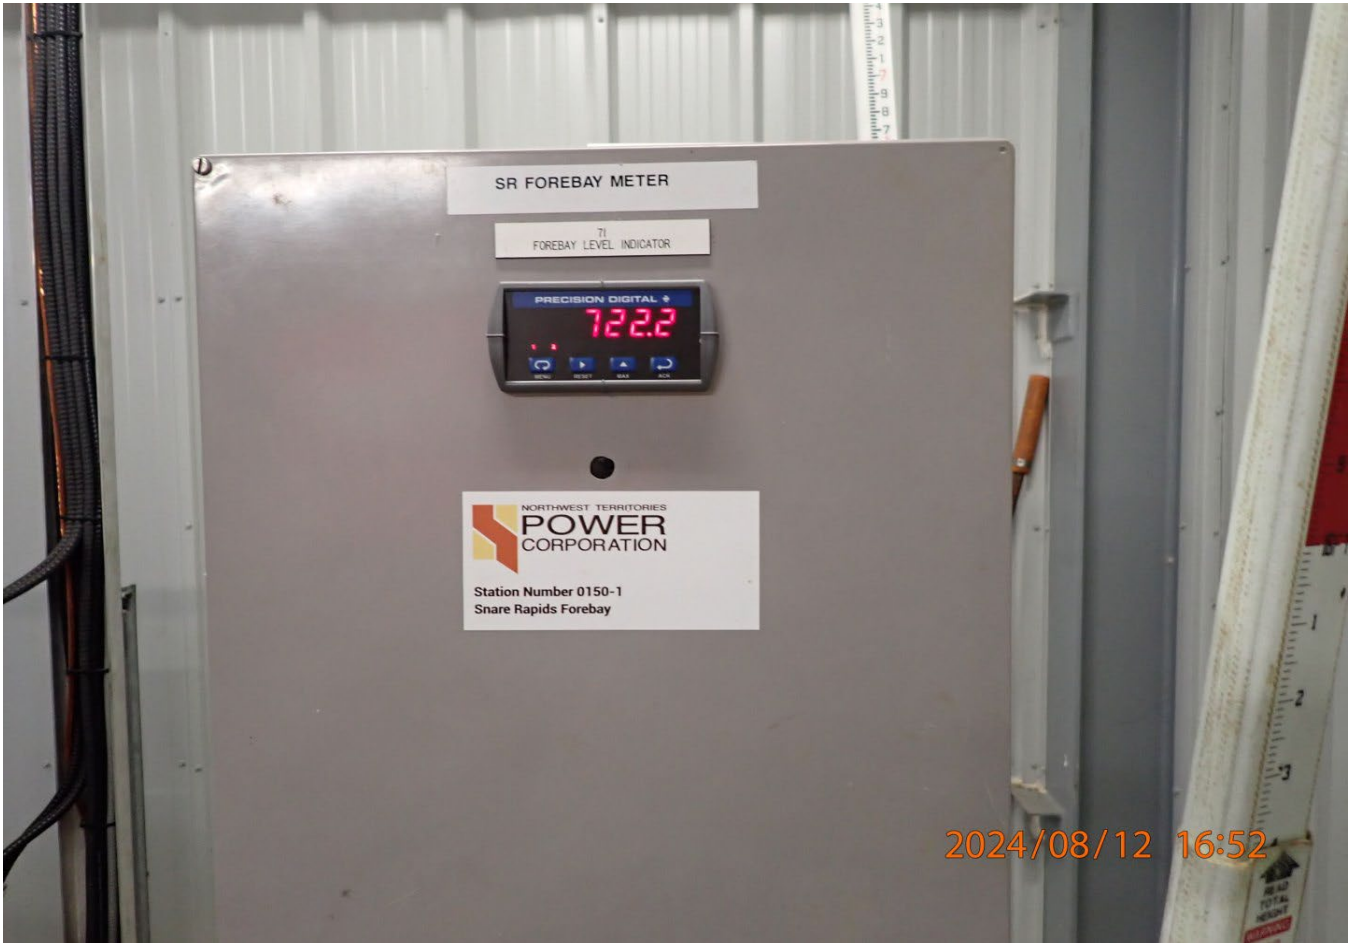
Figure 1. Snare Rapids Forebay

At the time of Inspection, the Snare Rapids Forebay was measured at 220.1 m (722.7 ft; Figure 1) which is within the requirements outlined in the Licence. In the headgate building, rags were being used to absorb a substance leaking from a box (Figure 2). When a leak is observed, the cause of the

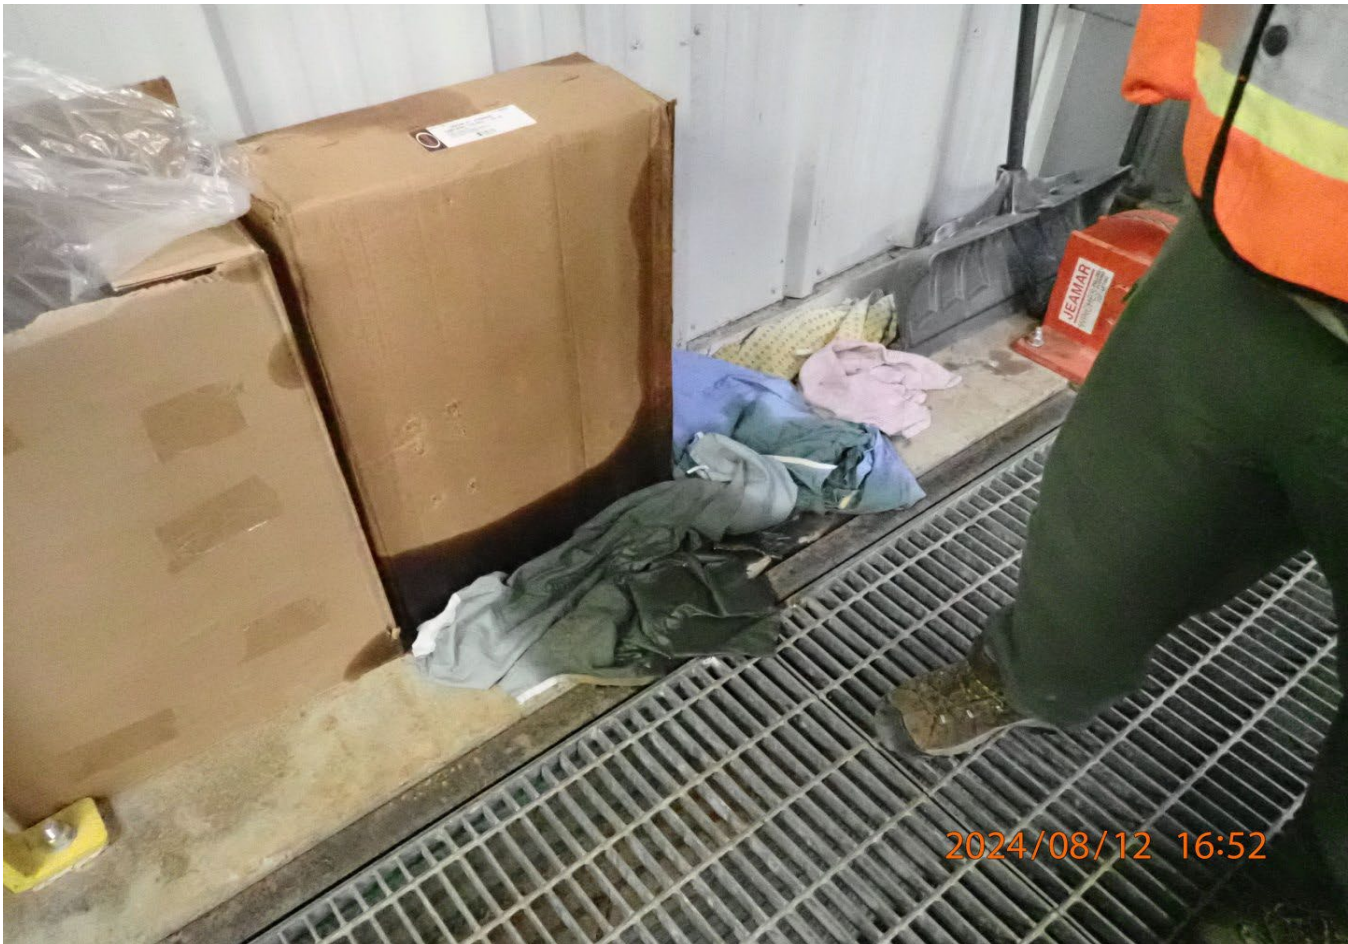
Figure 2. Leaking substance in Snare Rapids Headgate

1. **Part H, Condition 2:** The Licensee shall ensure that Unauthorized Releases associated with the Project do not enter any Water.
Explanatory Remarks: A box leaking an unknown substance was observed in the Snare Rapids Headgate Building during the Inspection. NTPC must provide the Inspector with evidence that the potential spill identified has been mitigated on or before 1300 hours MST on August 23, 2024.

spill should be addressed immediately, and secondary containment be used to prevent discharge into the receiving environment. Part H, Condition 2 of the Licence requires NTPC to prevent any Unauthorized Releases from entering Water. Given the location of the source of contamination, it is unclear how NTPC will prevent the substance from entering the water. NTPC must provide the Inspector with evidence that the potential spill identified in the Snare Rapids Headgate building has been mitigated on or before 1300 hours MST on August 23, 2024. The Inspector notes that if a spill has occurred, it must be reported according to Part H, Condition 4 of the Licence.

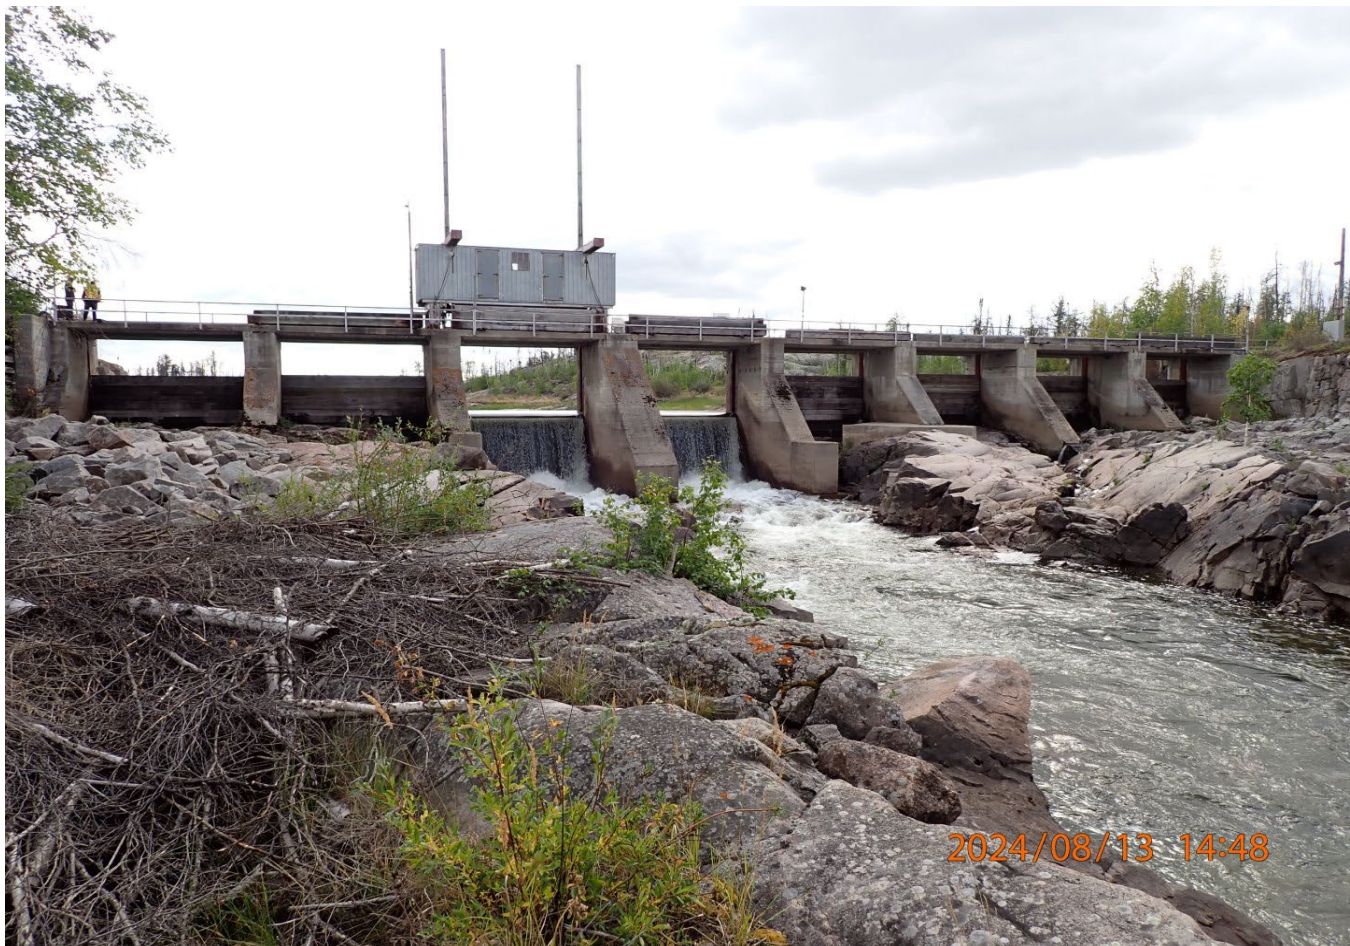
Figure 3. 5B Spillway

The 5B Spillway was inspected and no concerns were noted (Figure 3).

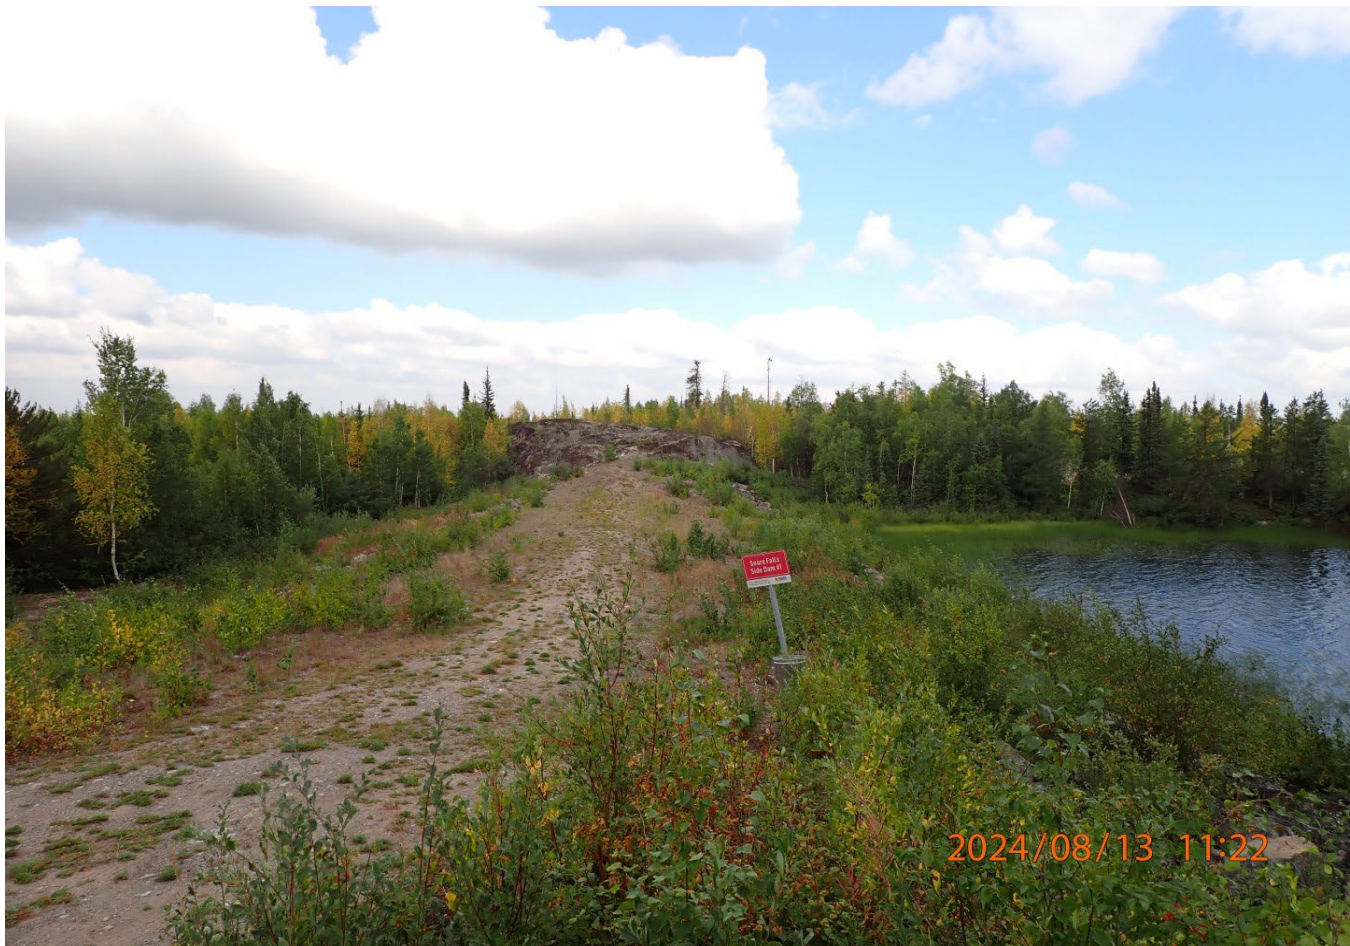
Figure 4. Snare Falls Side Dam 1

Brushing of the Snare Falls Side Dam #1 is required on the upstream face and downstream face (Figure 4). No other concerns were noted.

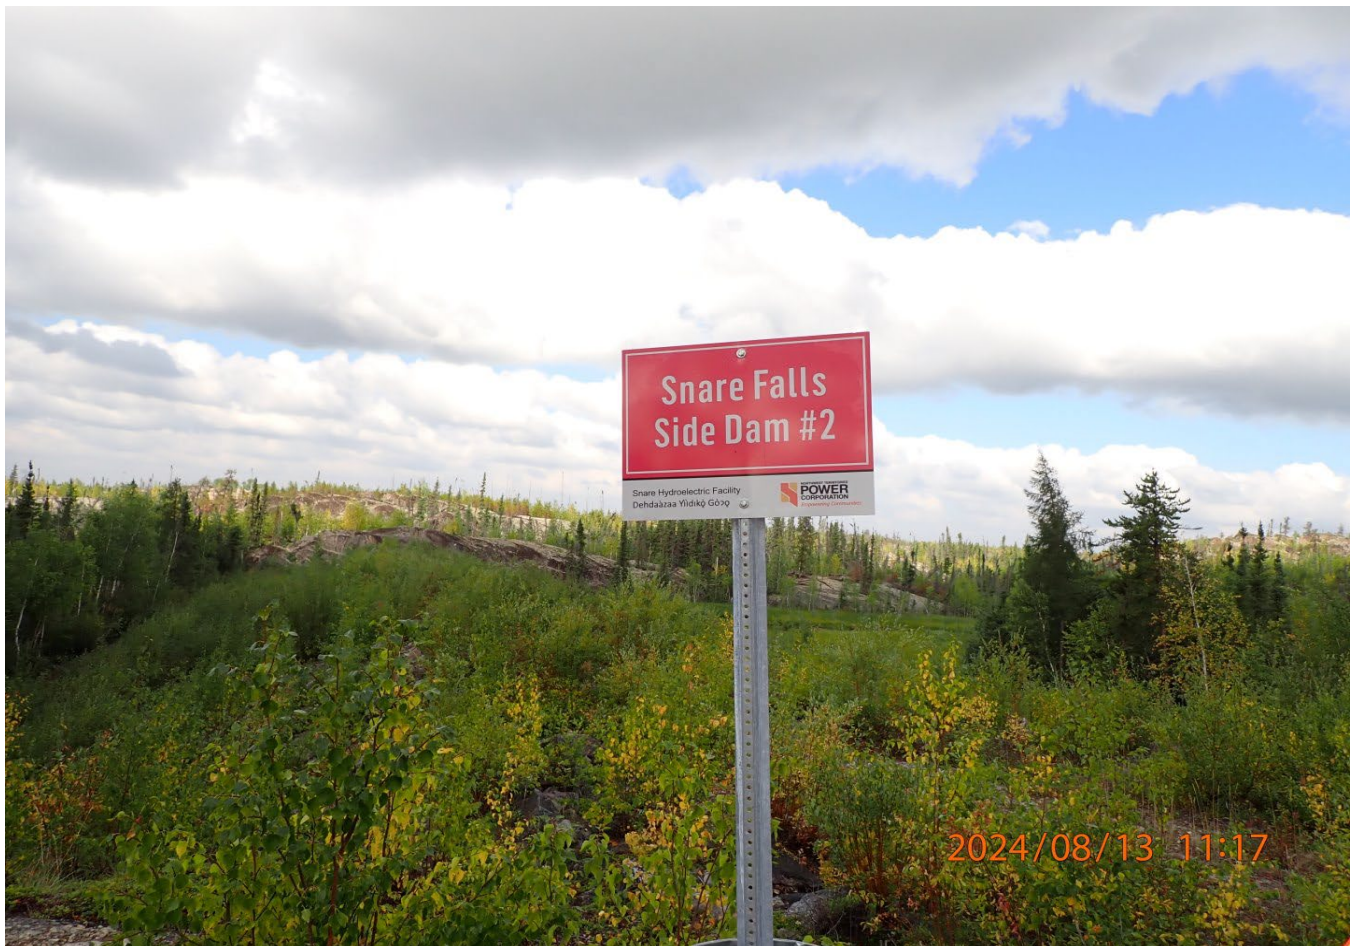
Figure 5. Snare Falls Side Dam 2

Brushing is required on the crest, upstream face, and downstream face of Snare Falls Side Dam #2 (Figure 5). No other concerns were noted.

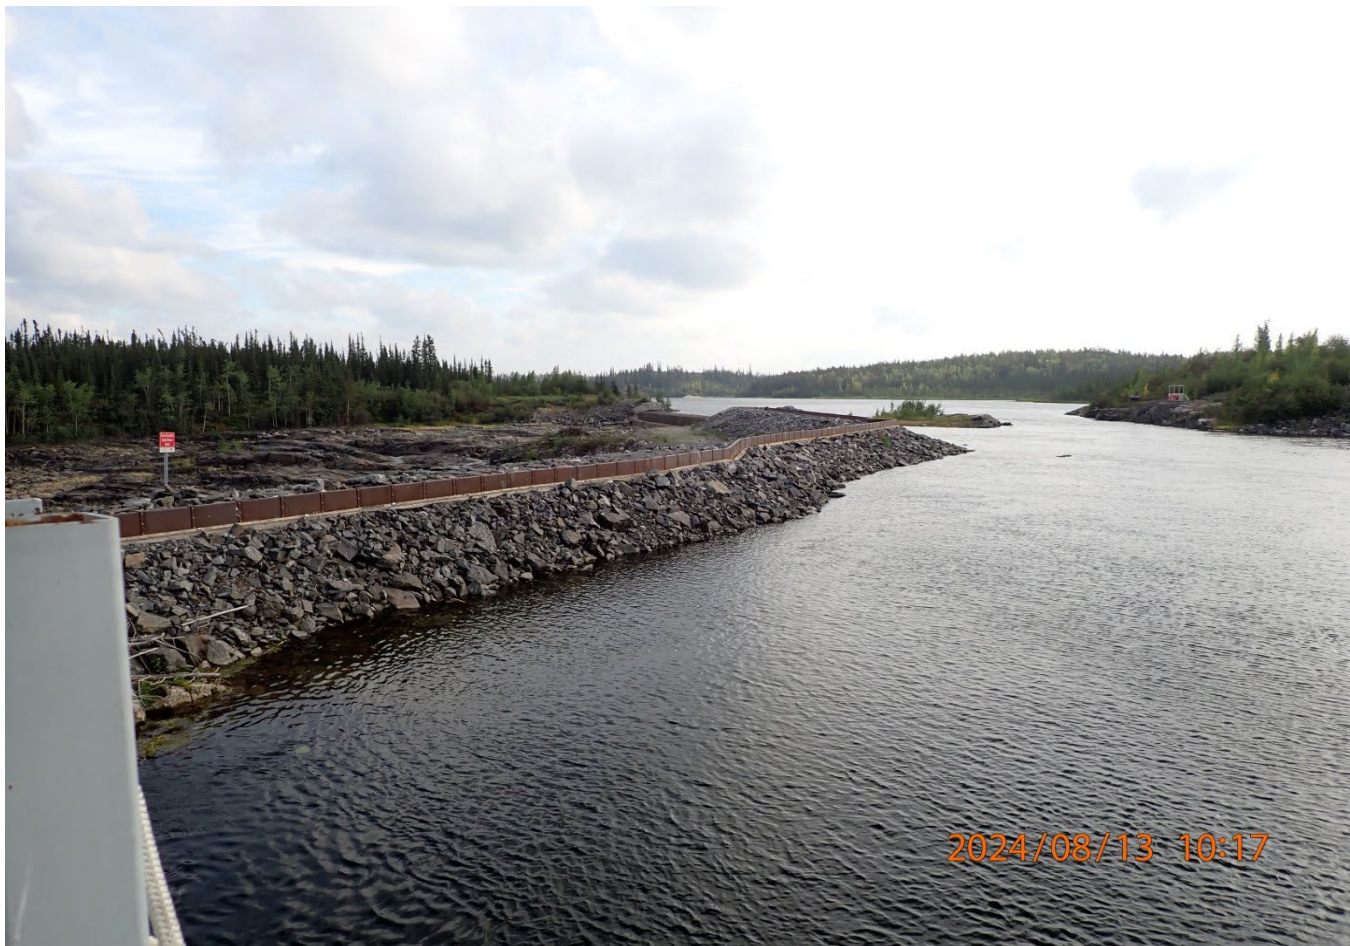
Figure 6. Snare Cascades Main Dam

The main dam at Snare Cascades was in good condition. The 2023 dam raise has been completed and no concerns were noted (Figure 6).

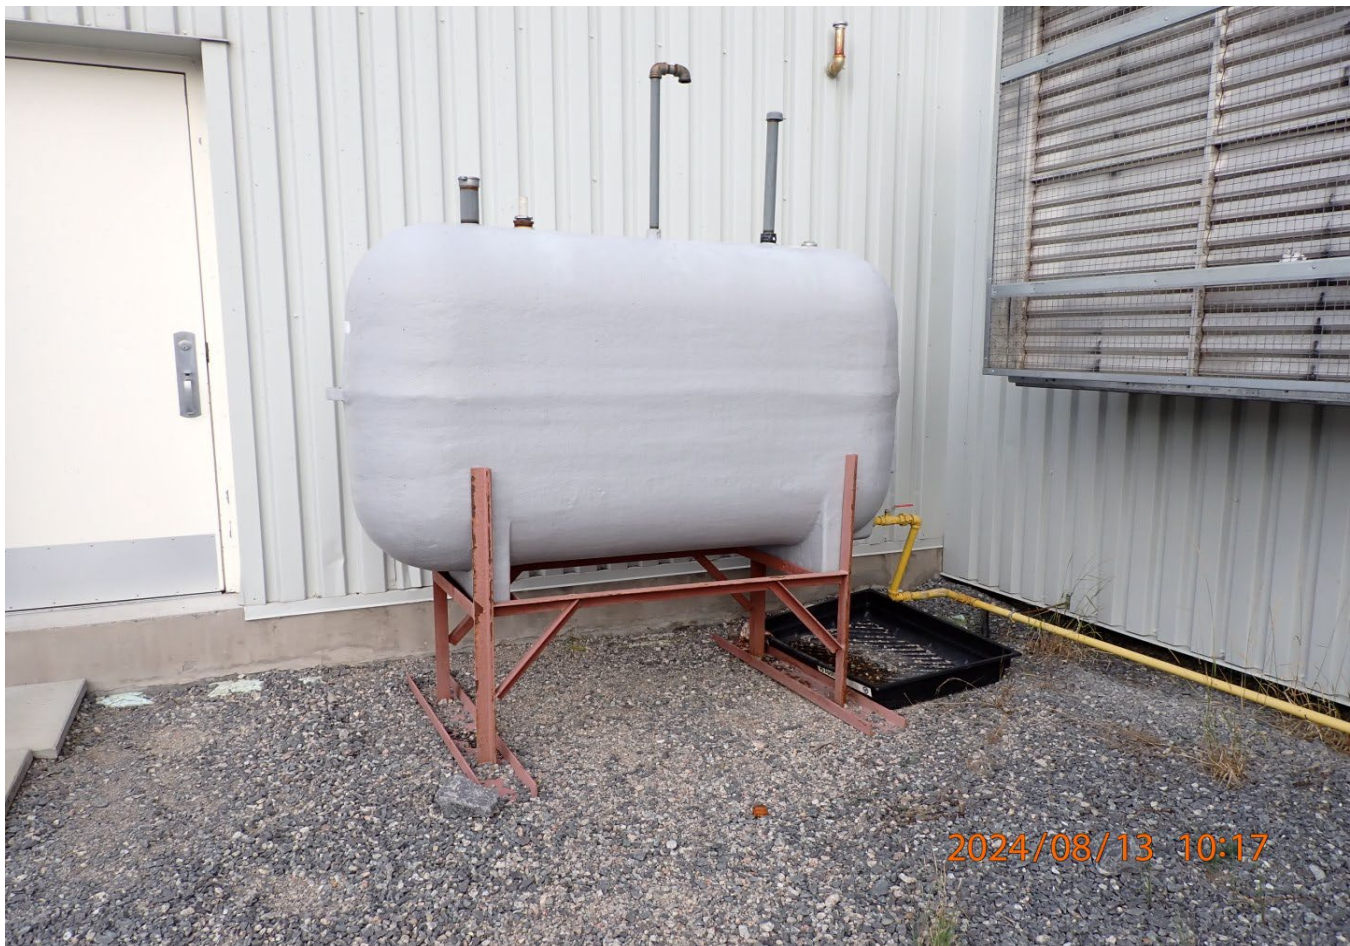
Figure 7. Snare Cascades fuel tank

There are two fuel tanks located at Snare Cascades. One fuel tank is used to supply the heating system within the building and has secondary containment at potential failure points (Figure 7). The second tank has a refueling pump with no secondary containment (Figure 8). The Inspector recommends adding a drip tray under the pump and refueling location to prevent small spills from occurring and having a spill kit located in close proximity to the fuel tanks.

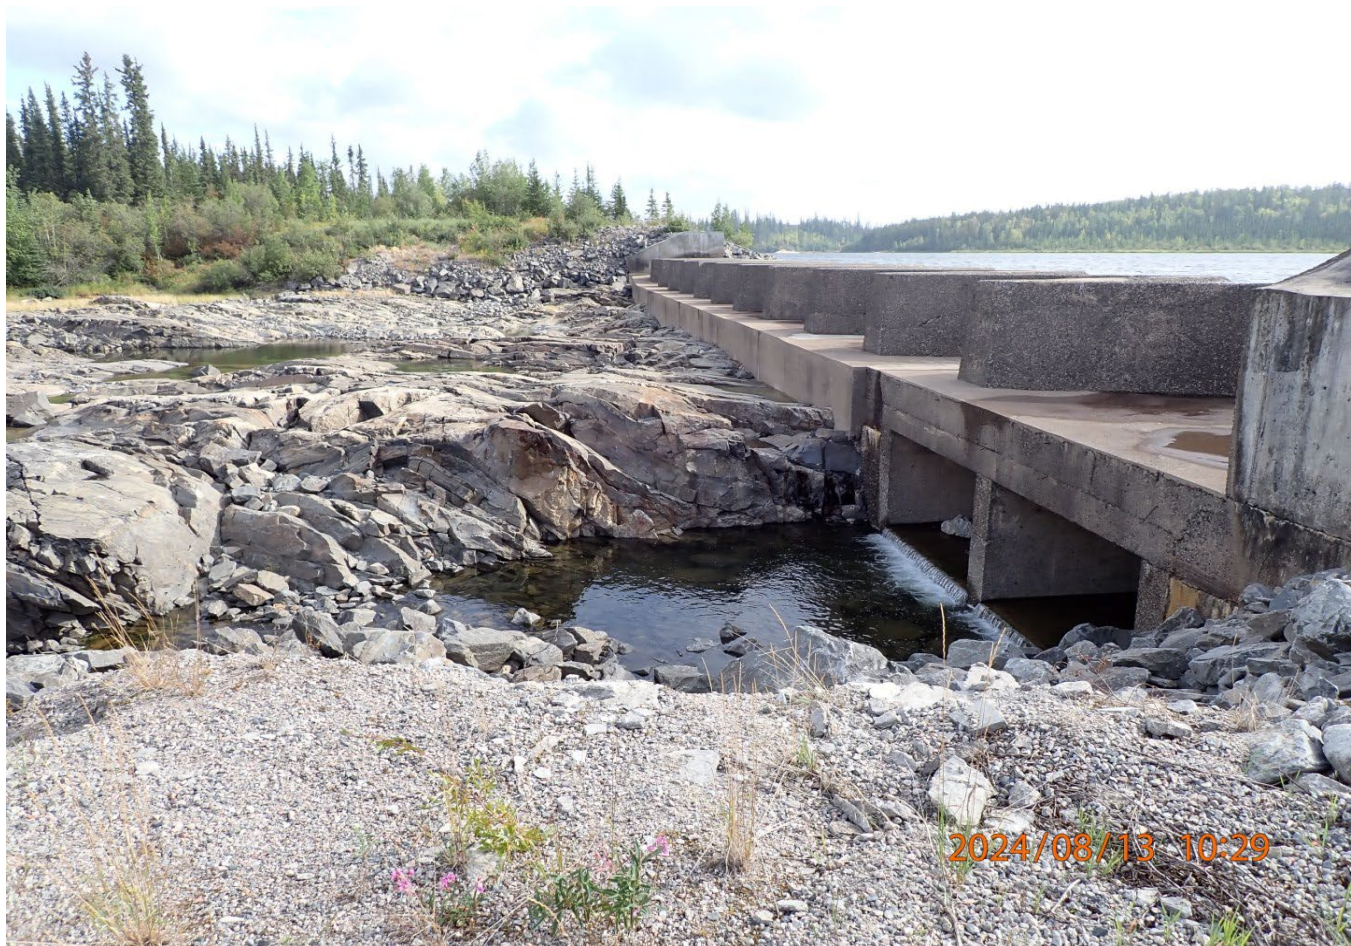
Figure 9. Snare Cascades Spillway

At the time of Inspection, the Snare Falls Forebay was recorded at 182.8 m and Tailrace was recorded at 174.3 m which is within the requirements outlined in the Licence. All facilities were clean and well-maintained. No concerns were noted. There was minimal flow through the Snare Cascades spillway (Figure 9).

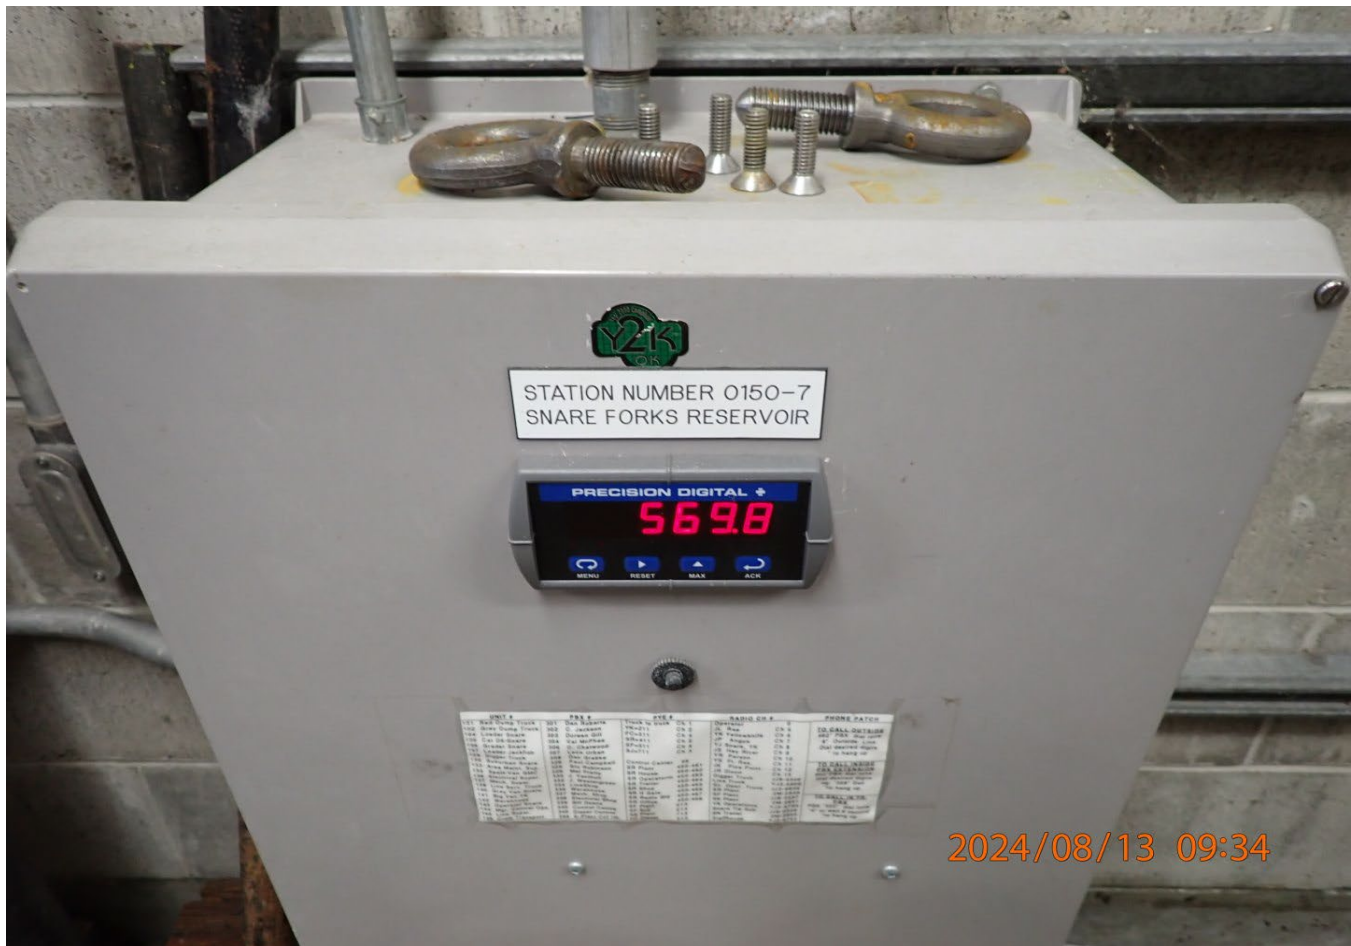
Figure 10. Snare Forks Forebay

At the time of Inspection, the Snare Forks Forebay was measured at 173.7 m (569.8 ft; Figure 10) which is within the requirements outlined in the Licence. All facilities were clean and well-maintained. No concerns were noted.

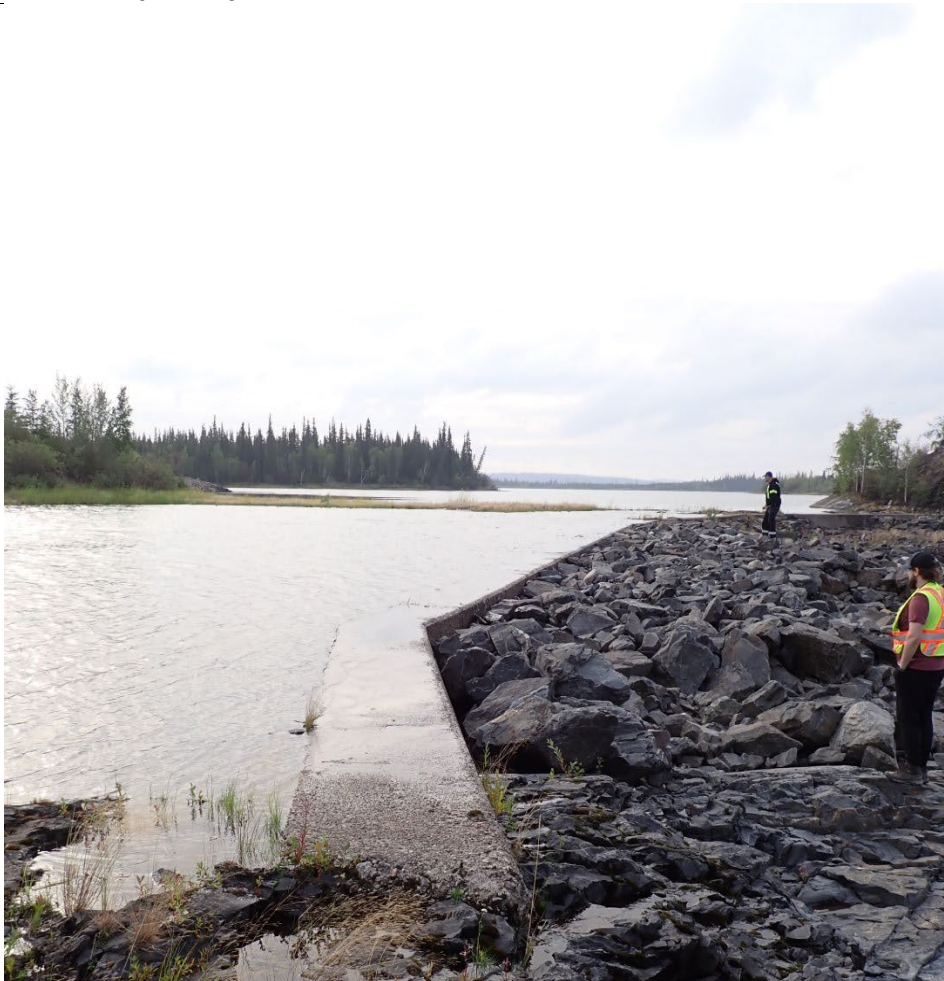
Figure 11. Snare Forks Spillway

The Snare Forks Spillway appeared to be in good condition (Figure 11). Minimal water was moving over the spillway and no erosion was evident.

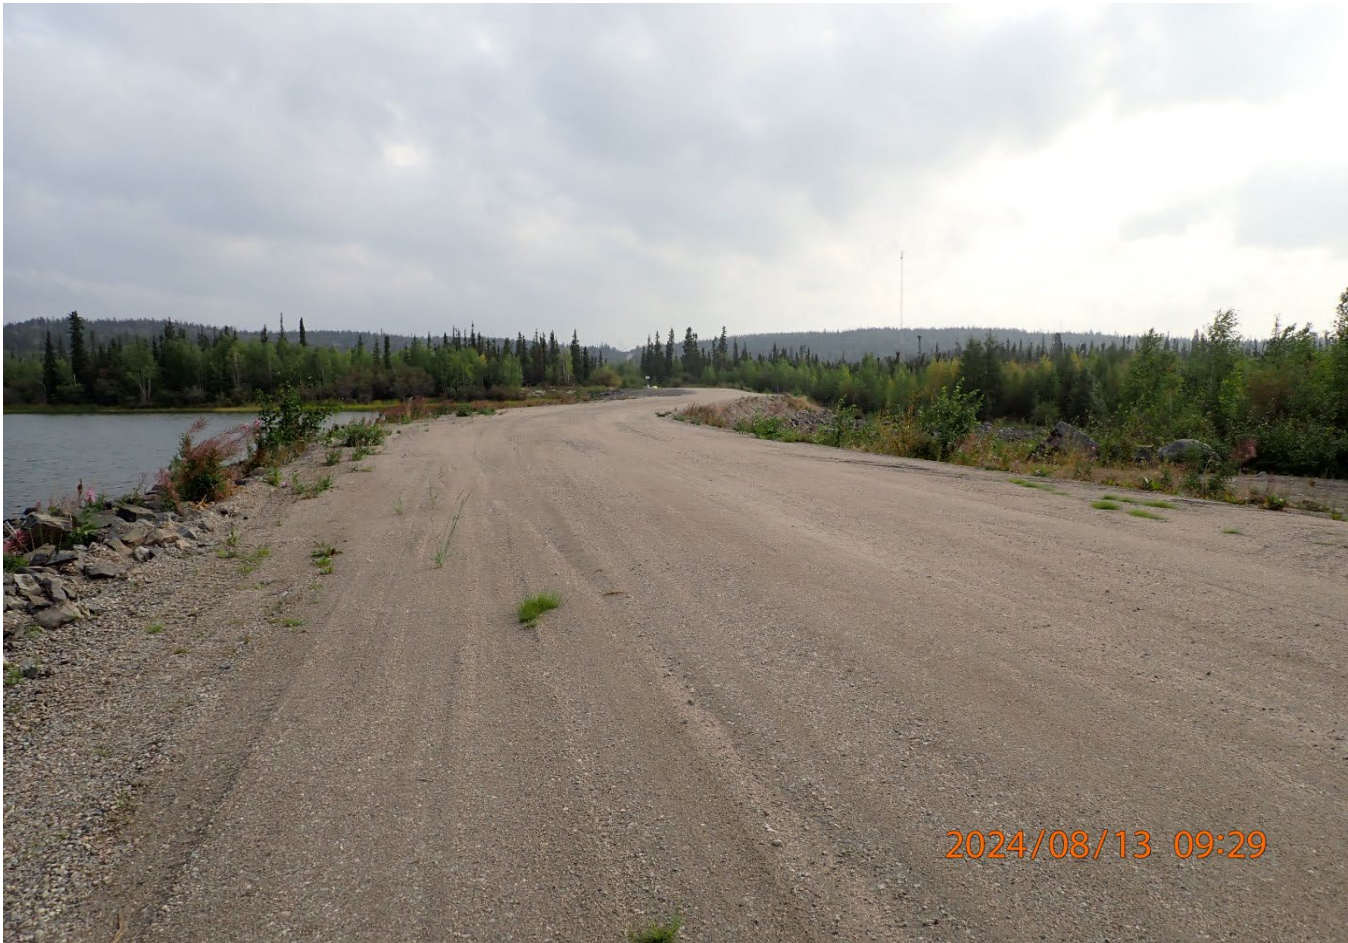
Figure 12. Snare Forks Dyke 1

Brushing is required on the upstream and downstream faces of Snare Forks Dyke #1. It was also noted that there is some subsidence in the crest (Figure 12). These issues should be addressed as soon as possible.
