CCI Project No. 2567

RE: Land Use Permit and Water License for Upgrades to Dempster Highway No. 8

Government of Northwest Territories Dempster Culvert Replacement Crossing Overview | KM 147

Structure Name	HWY008-KM00147.0

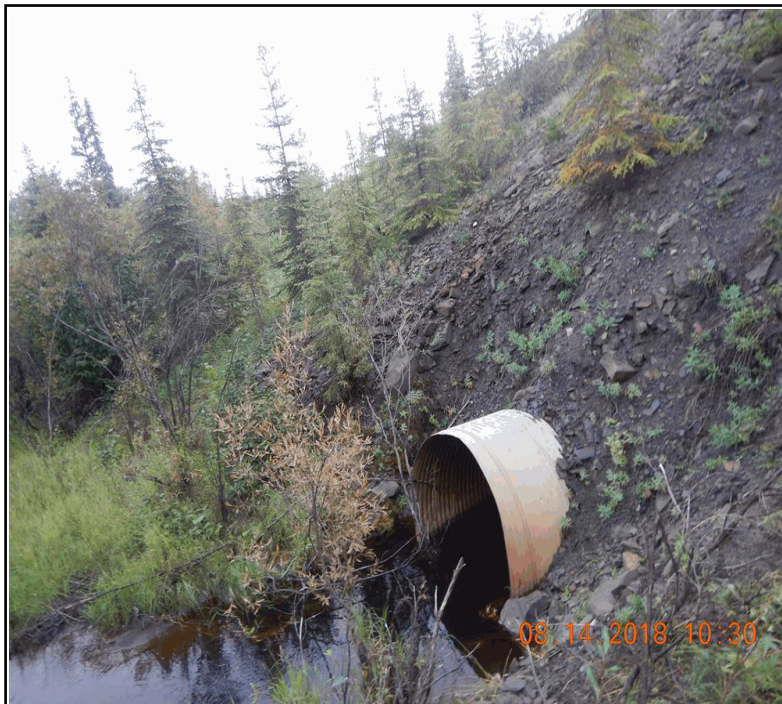
File Name 12 Downstream embankment.JPG

Good condition

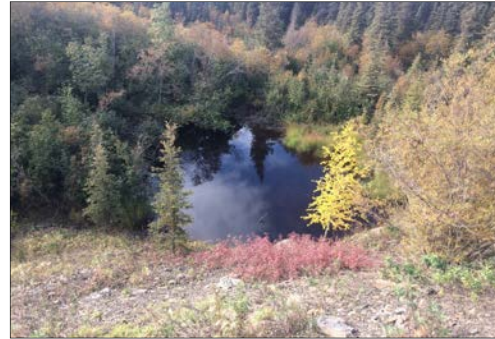
Photo 2: Facing downstream at centerline (↓CL); note culvert in red-coloured bushes
Fish Sampling Data

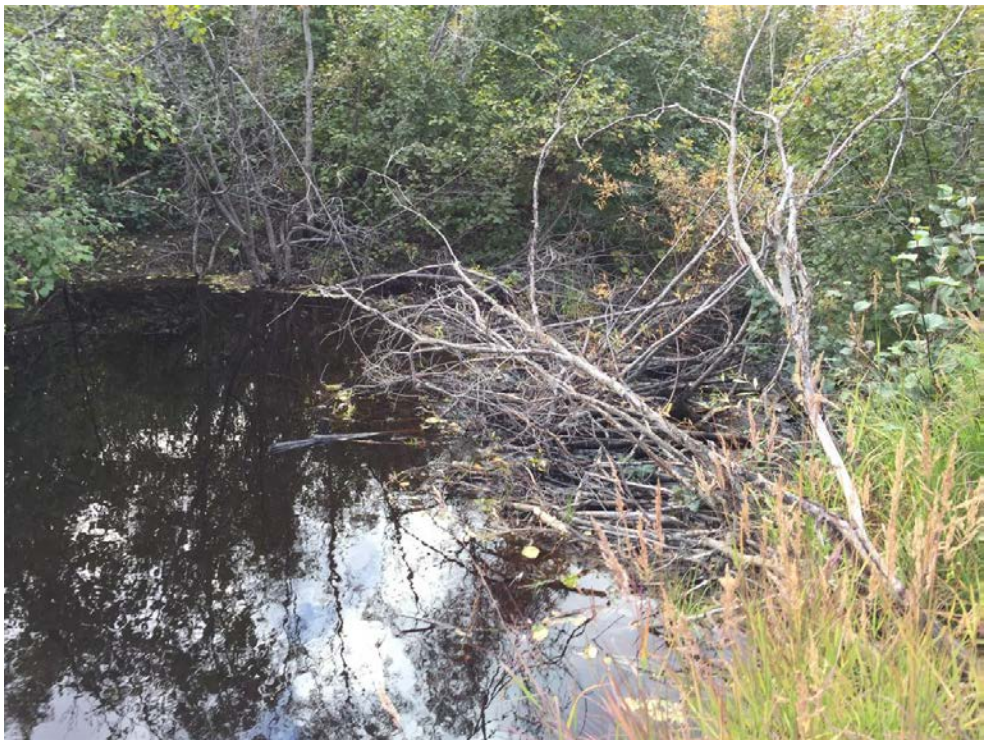
Photo Location: Beaver dam ~15 m downstream of existing culvert at KM 147.0 on unnamed stream (facing downstream)			
Direction: West			
Survey Date: 8/31/2018			
Comments:			
Photograph ID: 12
