File Number Type of Operation Location MV2010L1-0001 Type A – INDUSTRIAL WATER USE Strategic Oil & Gas Ltd. – Cameron Hills, NT.

An inspection of the above noted operation was conducted on September 17thand 18th, 2024 by Water Resource Officer Joshua Gauthier along with Resource Management Officer III, Norman McCowan. Enclosed is a copy of the Water License Inspection Report.

LICENCE #:	MV2010L1-0001	EXPIRY DATE:	December 9 th , 2025
LICENCEE:	Strategic Oil & Gas Ltd.	PREVIOUS INSPECTION:	February 16 th , 2023
COMPANY REP:	Duncan MacRae	INSPECTION DATE:	September 17/18th,2024

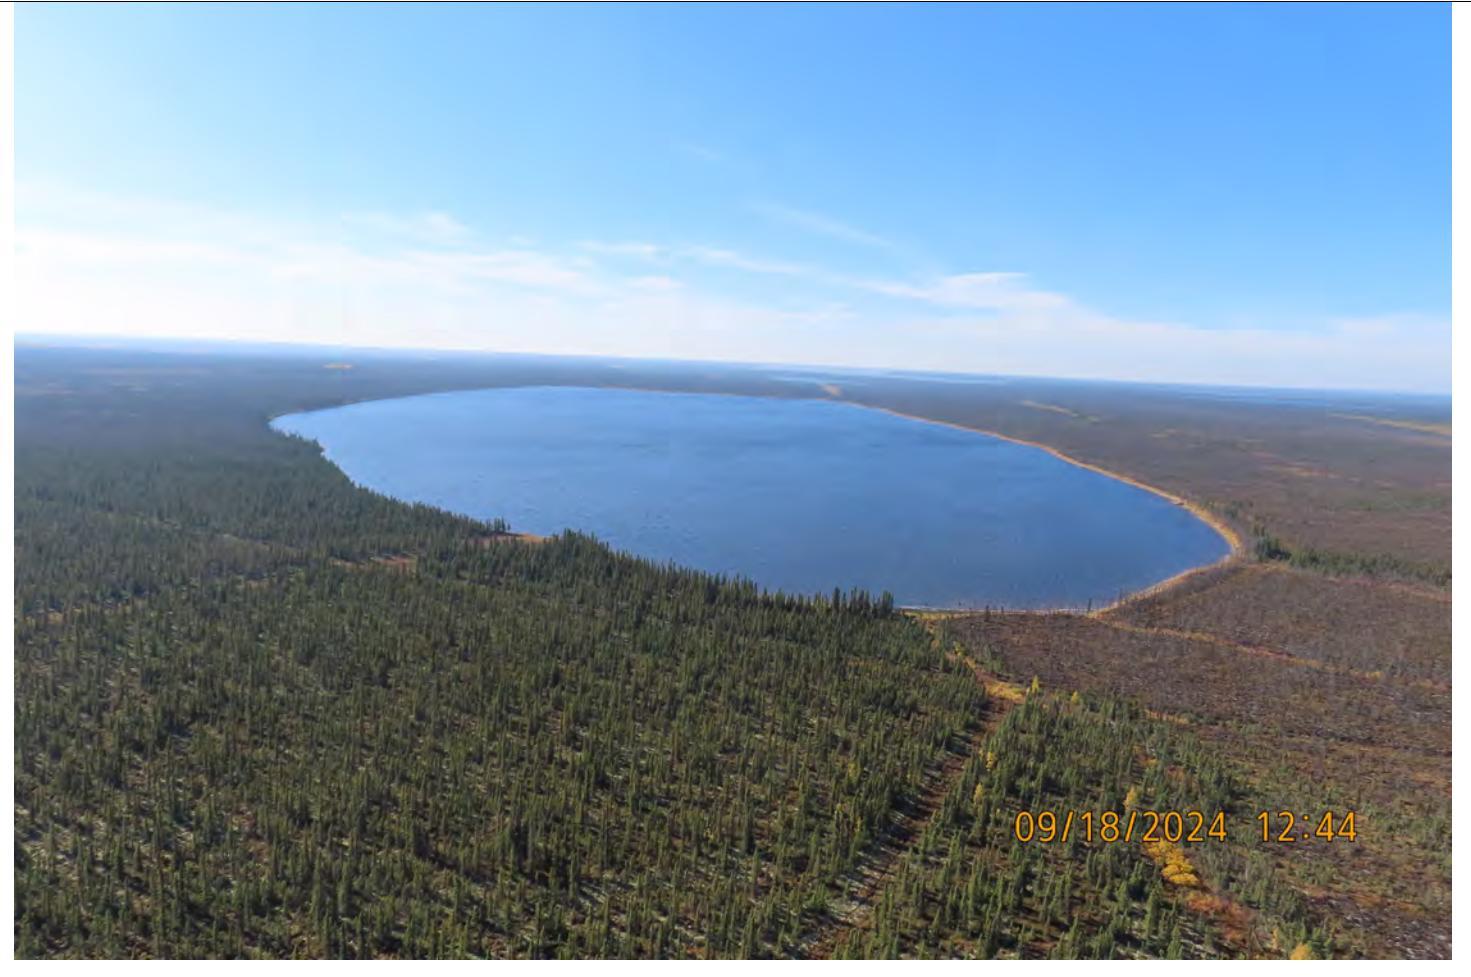
Figure 2 Water Source #3

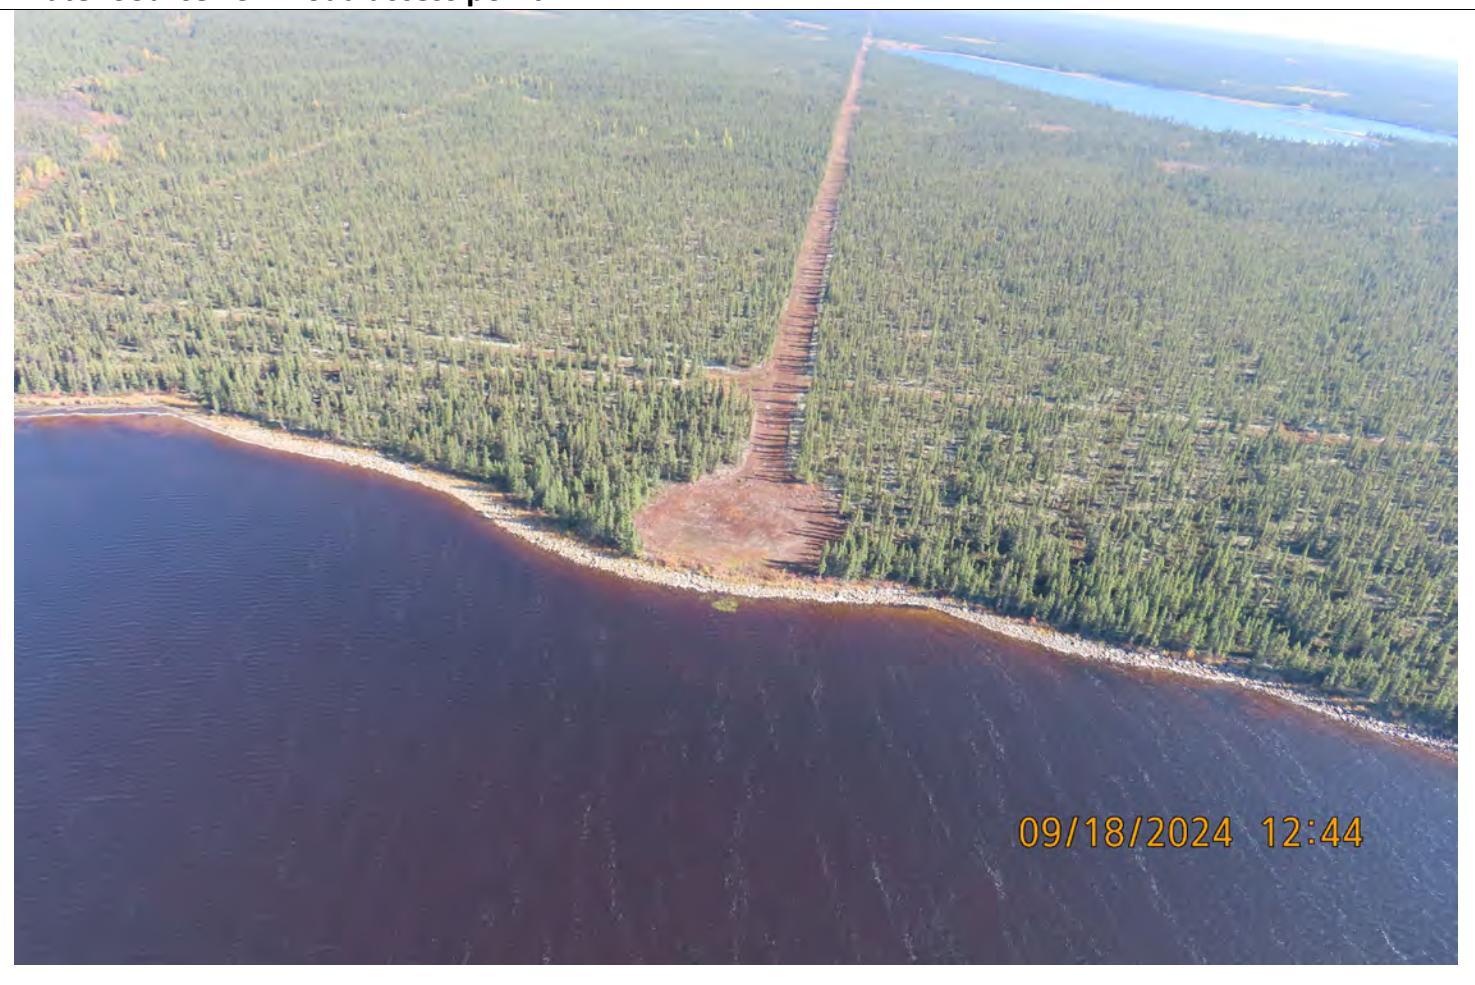
No equipment was staged for water use at any of the water sources during the Water License Inspection. Water Source #3 intake area was clean and no debris was noted (Figure 3). This area was used frequently for the well abandonment work that occurred in the winter of 2023, but no concerns were noted at this location during the inspection.

Figure 3 Water Source #3 – Road access point

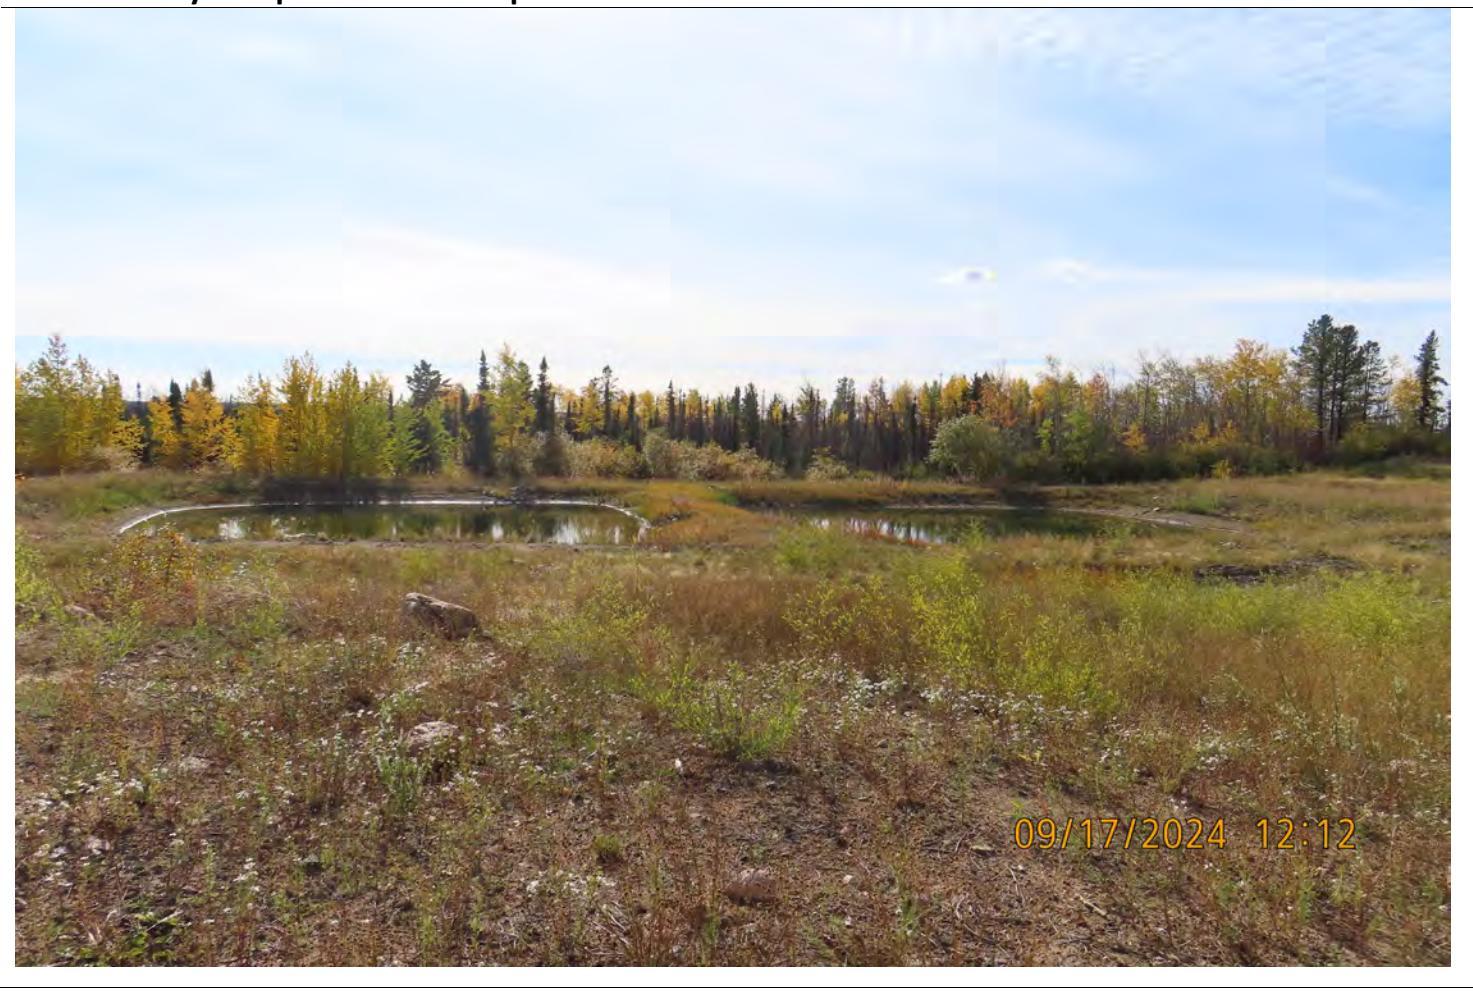
Both surface retention ponds (East & West) appeared to have inadequate free board. Ponds require a decant when feasible. It is recommended that the ponds be drawn down and monitored during spring freshet. There were no exceedances of any of the Effluent Quality Criteria limits outlined in Water License Condition D.16. During the inspection it was noted that the liner was visible in the east pond (Figure 16). Vegetation surrounding the retention ponds was acceptable and no clearing or maintenance is required.

Figure 14 Main Battery Camp – East & West ponds

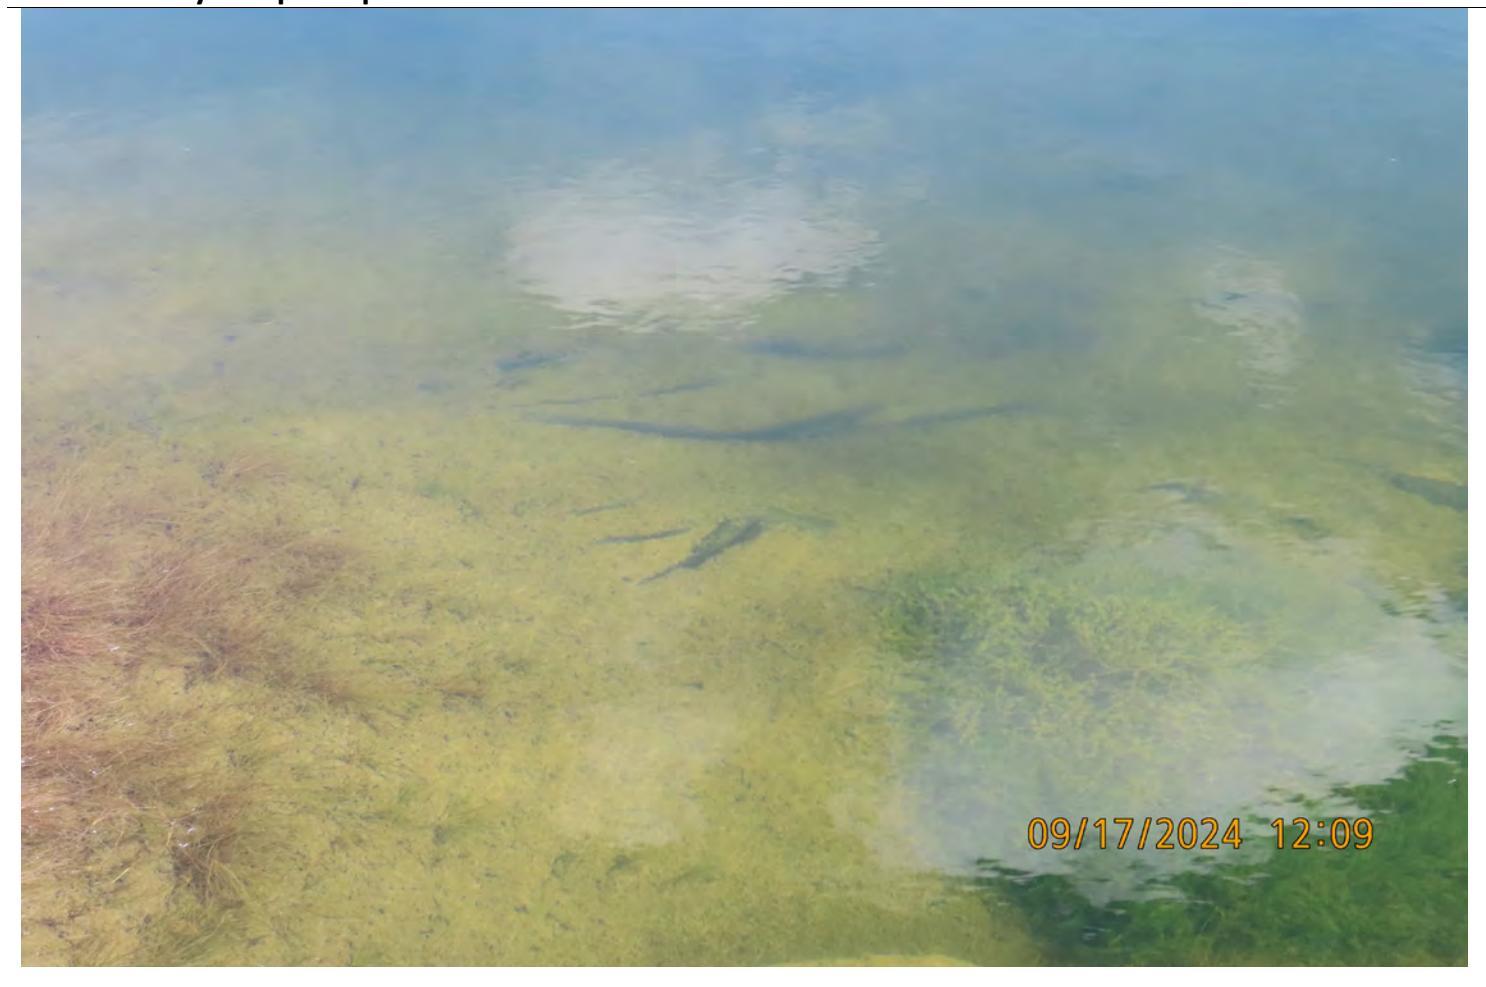
Figure 16 Main battery camp – Exposed liner noted

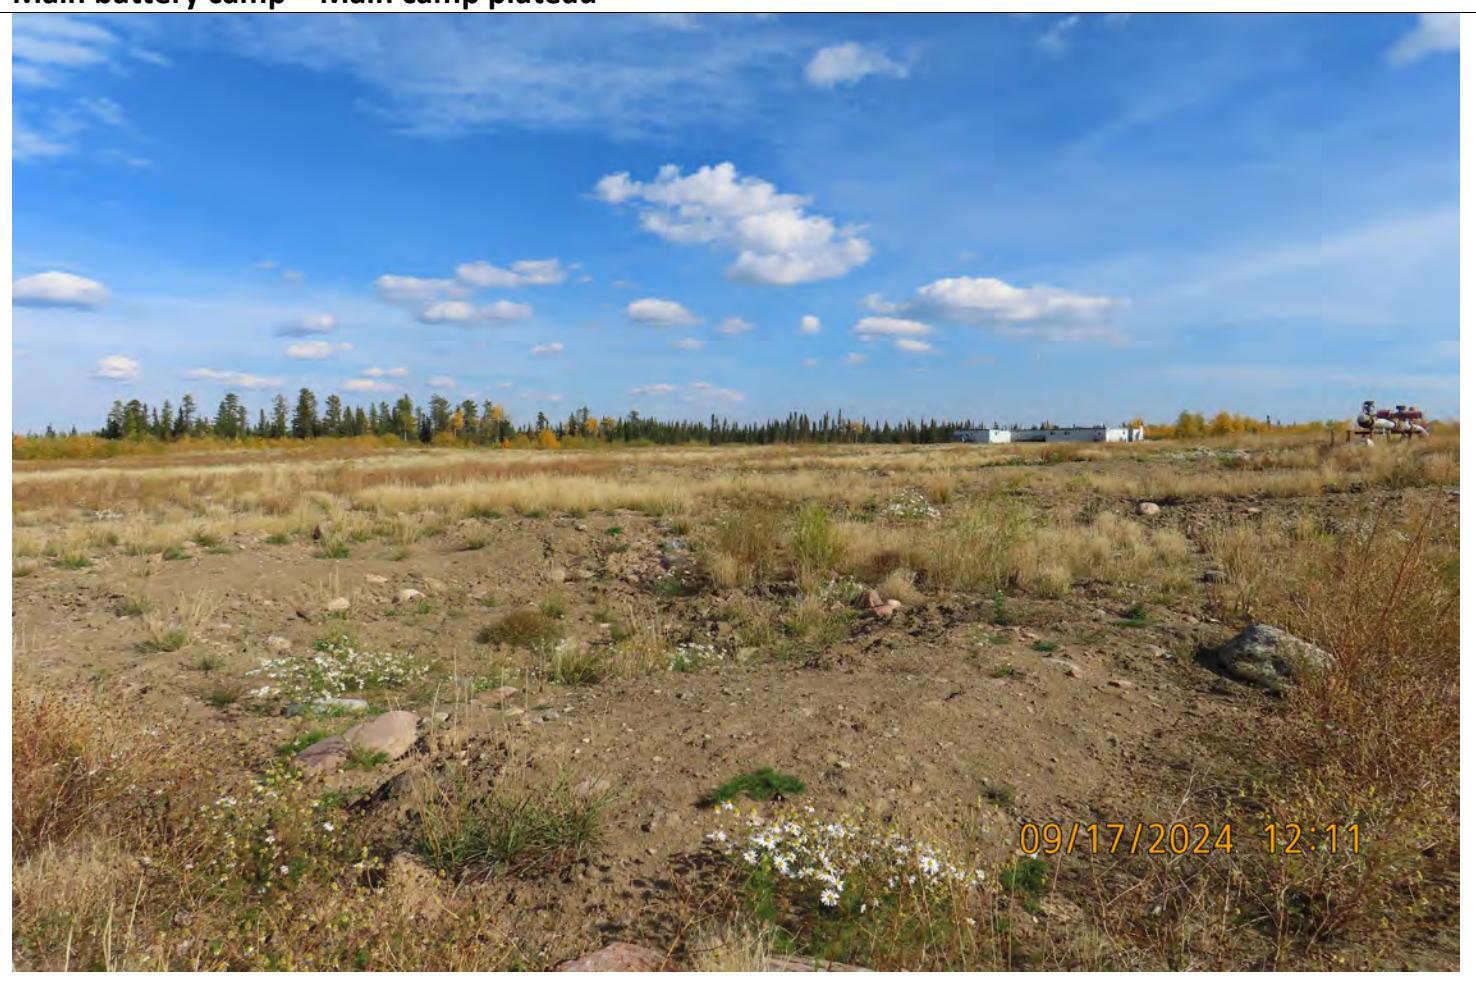
Over all the battery site camp was nearly demobilized and many of the structures have been removed during the well abandonment program that occurred in the winter of 2023. Many of the structures and equipment were removed by the winter road (Figure 18). However, many liabilities still remain on site such as the main camp building, pipeline riser, sewage lagoon, retention ponds (East & West), camp sump, and other miscellaneous solid waste items (tires, scrap metals, etc.). A complete list of outstanding liabilities can be found on <u>table 2</u> of Land Use <u>Inspection Report</u> for permit MV2022X0018 dated September 17, 18, 19, 2024.

Figure 18 Main battery camp – Main camp plateau

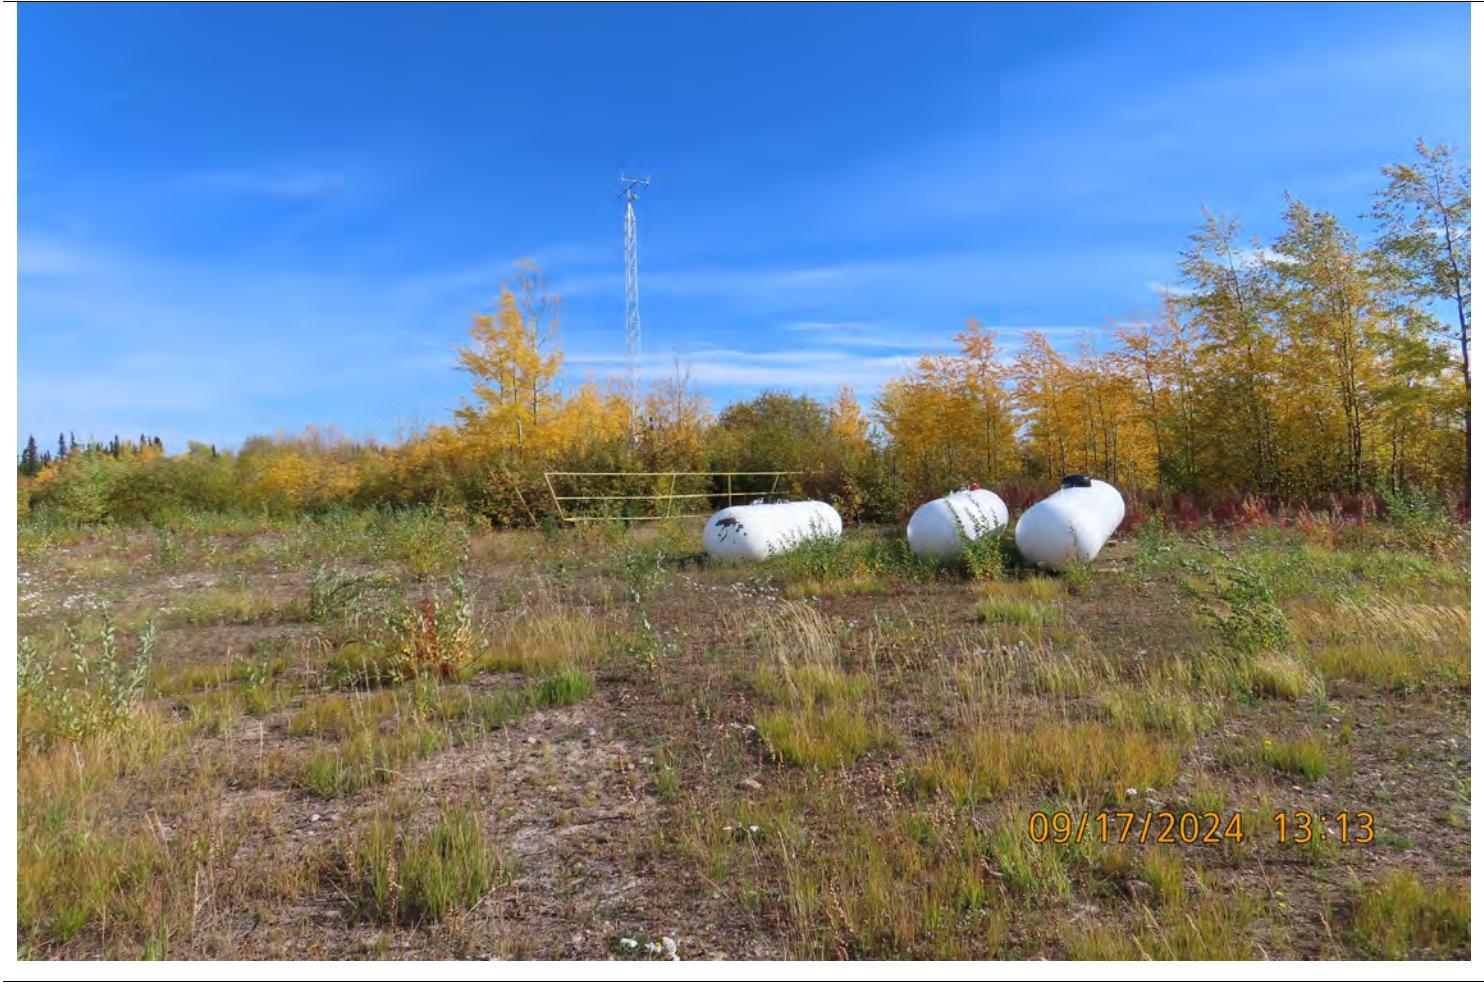
Some items at the main camp area still require off-site removal. Waste tires (Figure 23) and propane (Figure 21) tanks require removal.

Onsite, there were 3 drums of Jet A fuel that were staged prior to inspection. These will be removed upon inspection completion. There were also three large propane tanks still onsite (Figure 21). Each appeared to be in acceptable condition and no signs of concern were observed.

Figure 21 Battery camp – Fuel tanks behind camp building

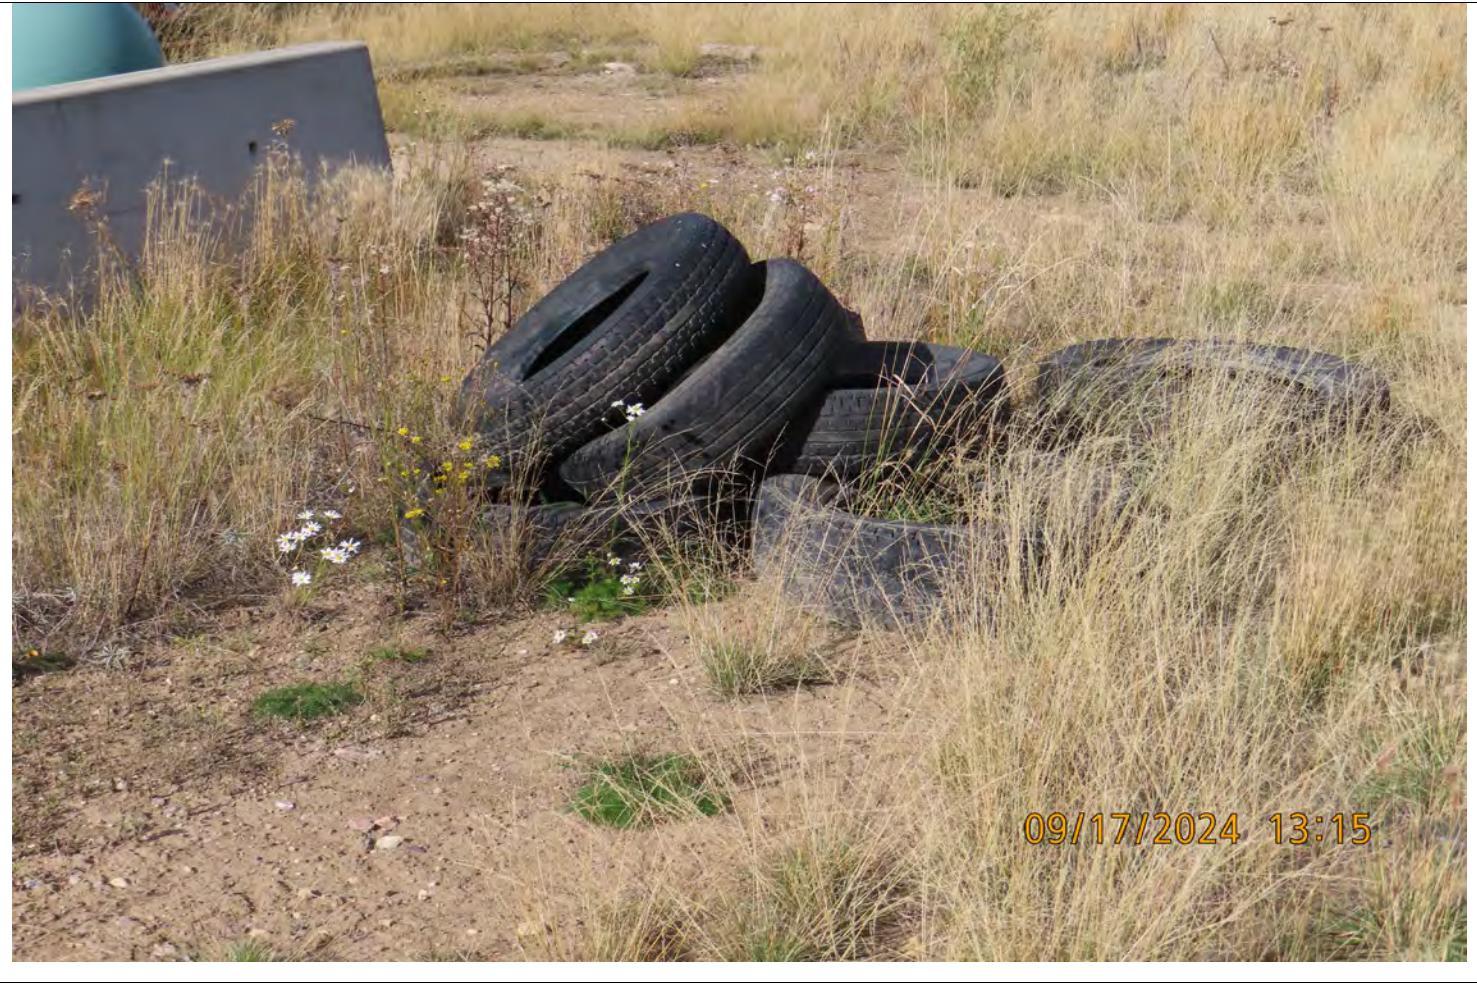
Figure 23 Battery Camp – Left over tires behind building

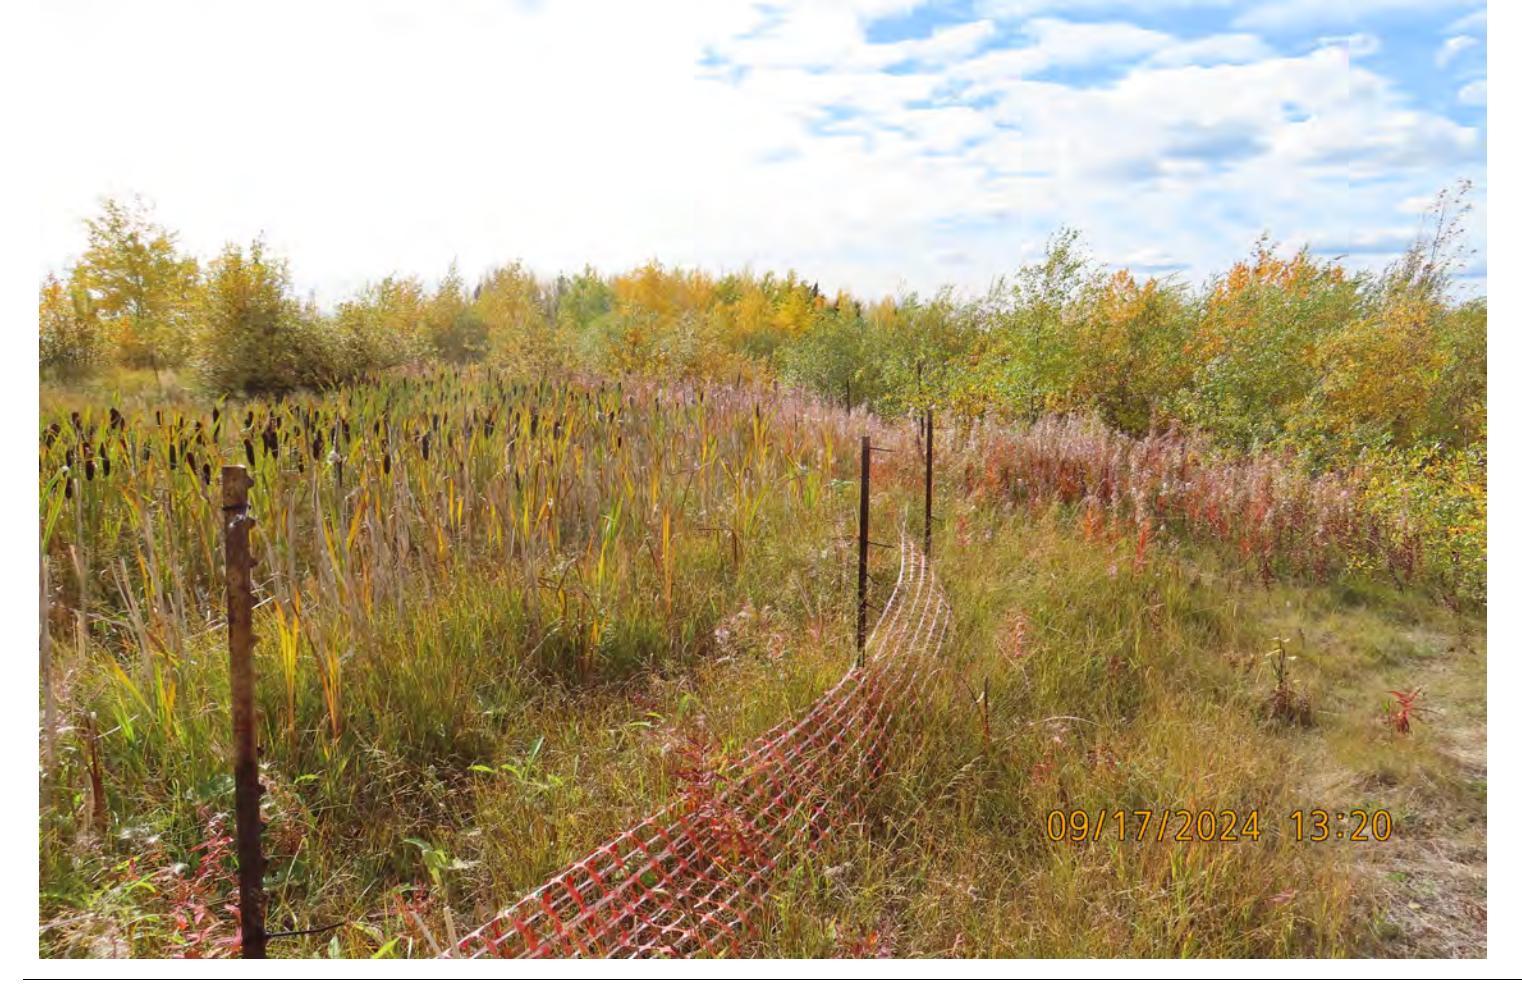
The snow fencing used as a perimeter guard around the lagoon to prevent access, was not repaired as requested at the last Water License inspection on February 16th, 2023. It is recommended that this fencing be repaired.

Battery camp – Sewage lagoon snow fencing not properly attached to posts

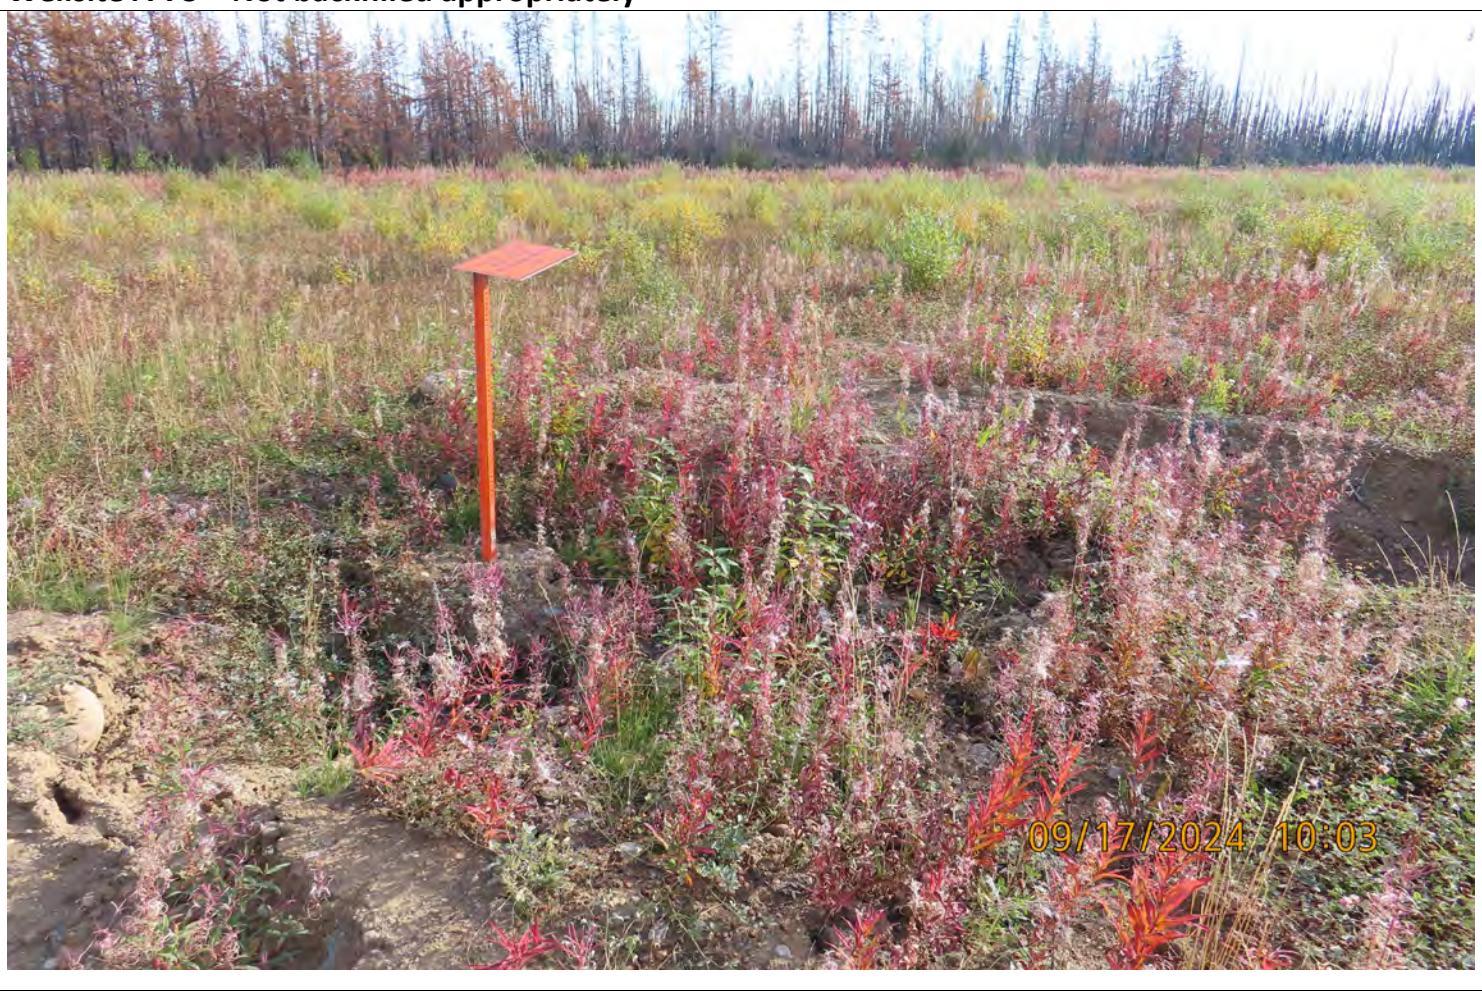
Figure 29 Wellsite A-73 – Not backfilled appropriately

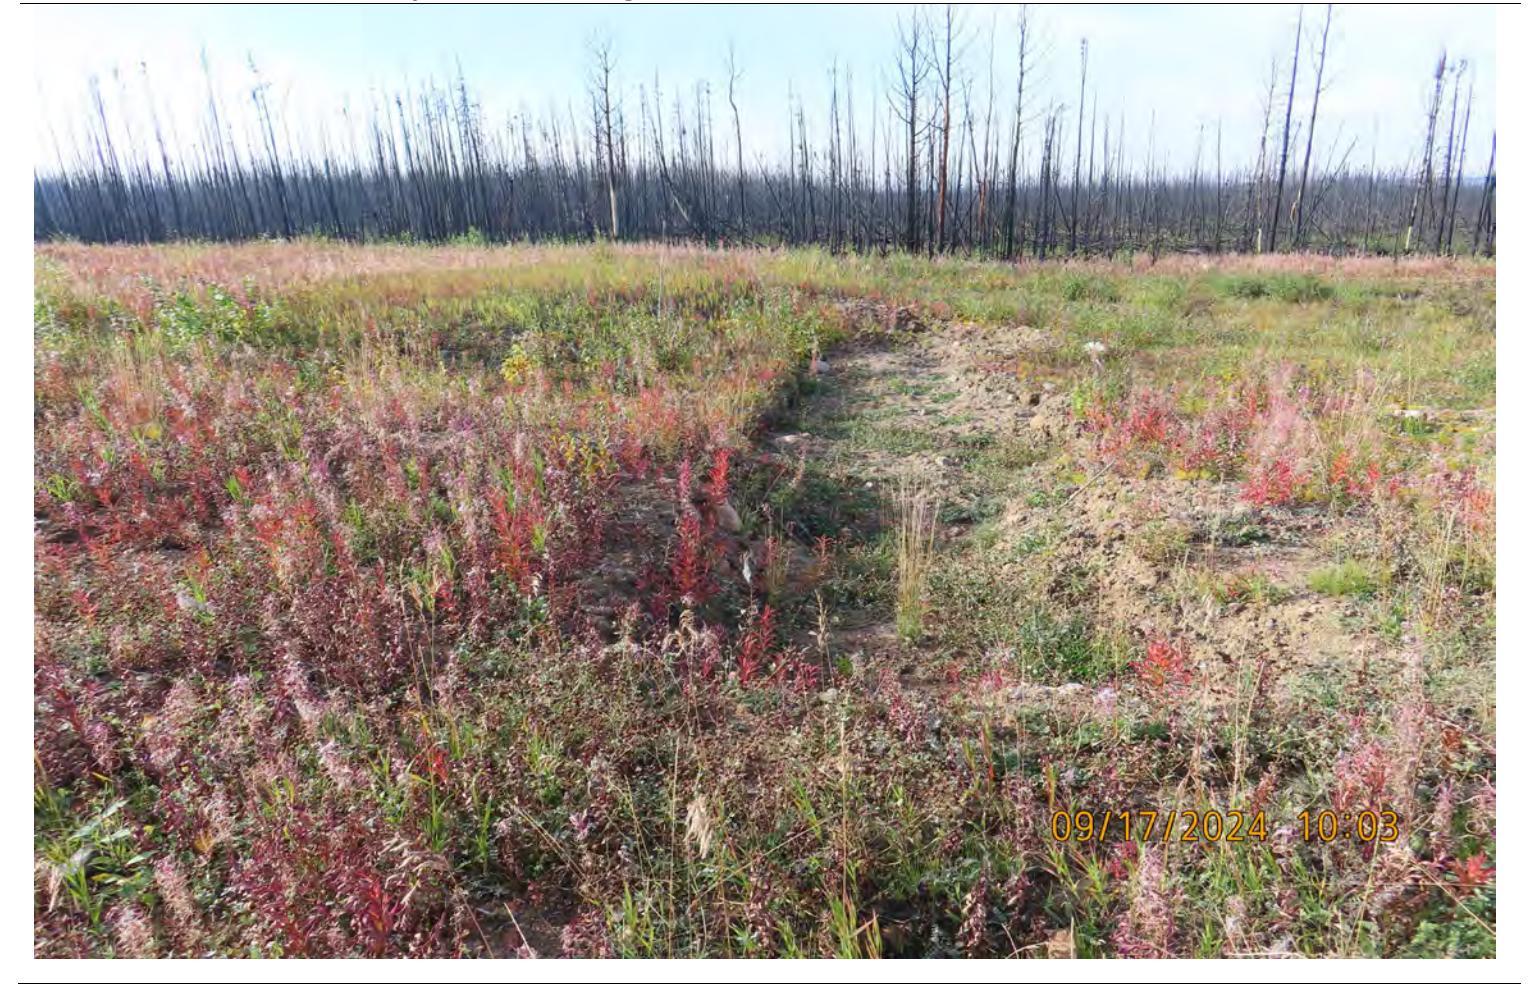
Figure 30 Wellsite A-73 – Backfill required following winter abandonment work

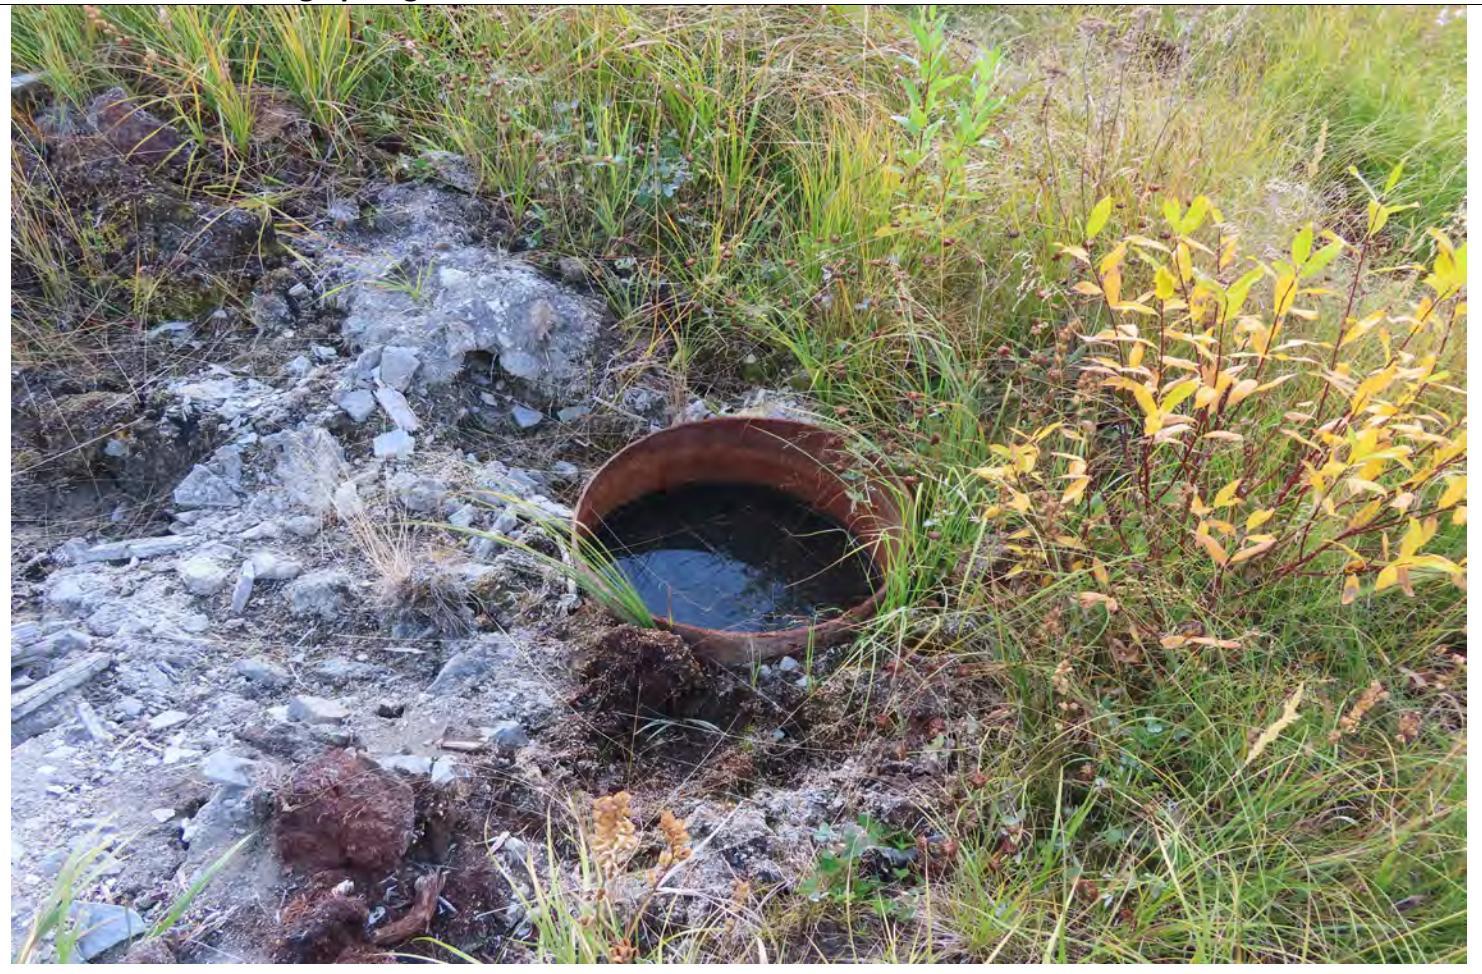
During the inspection it was noted that at drill site 2H-03 multiple large diameter pilings were left behind during the winter abandonment work. This poses a risk to people and particularly wildlife in the area. This will require removal as soon as possible.

Figure 32 Wellsite 2H-03 – Large pilings left behind
