AEC 43: Portal Fueling Station

Appendix A44 - Hazardous Materials Inventory

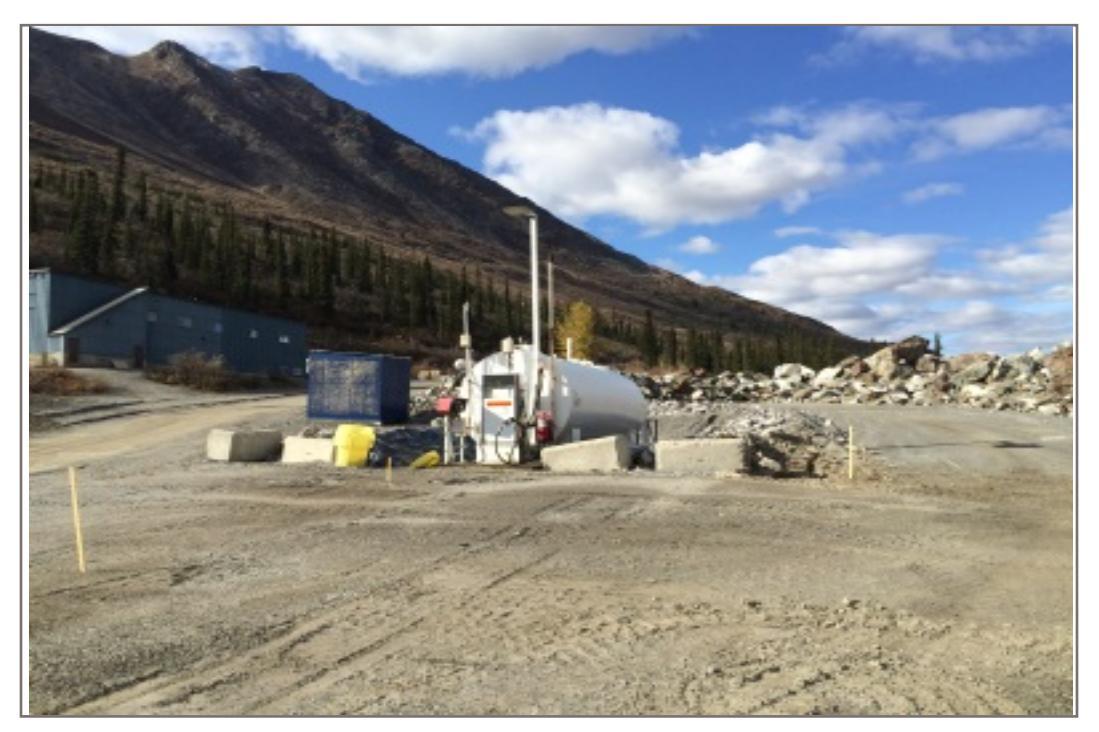
Photo 1: Facing northwest. Portal fueling station AST visible in centre of photo. Stakes indicate hand auger locations. (September 19, 2017)

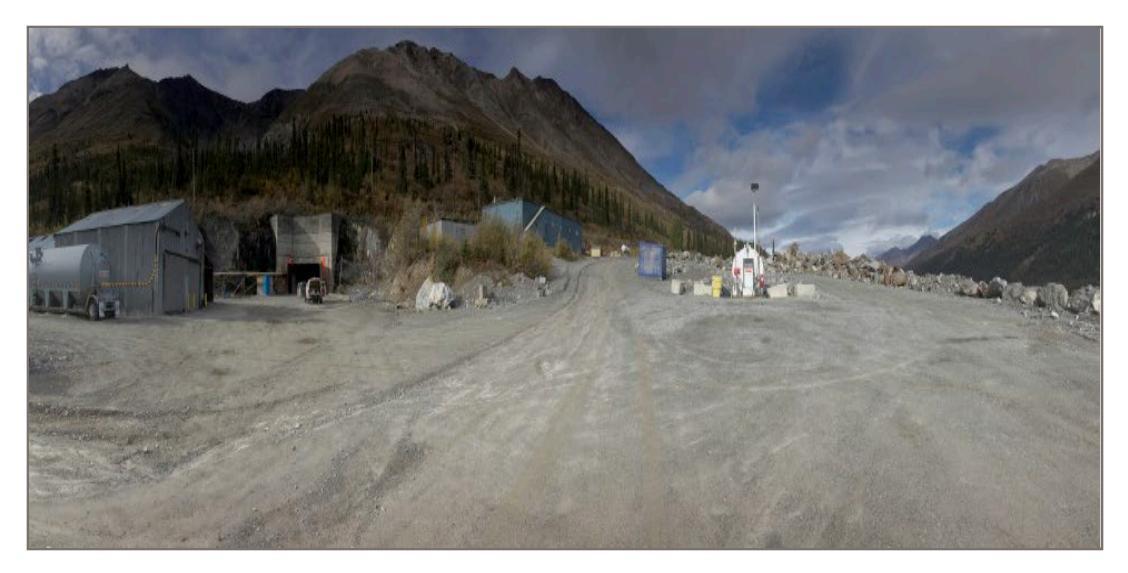
Photo 2: Facing northwest. Portal fuel station AST is seen on the right. Main portal visible to the left. (September 5, 2017)

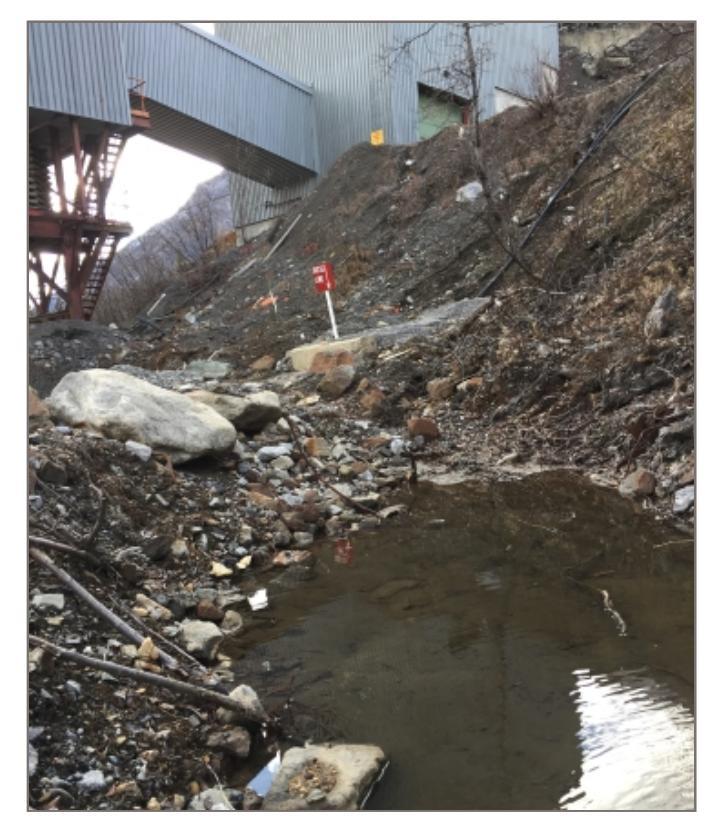
Photo 1: Facing southeast at crusher building. Scrap metal debris seen to the left of the photo with ditch in foreground. (October 5, 2017)

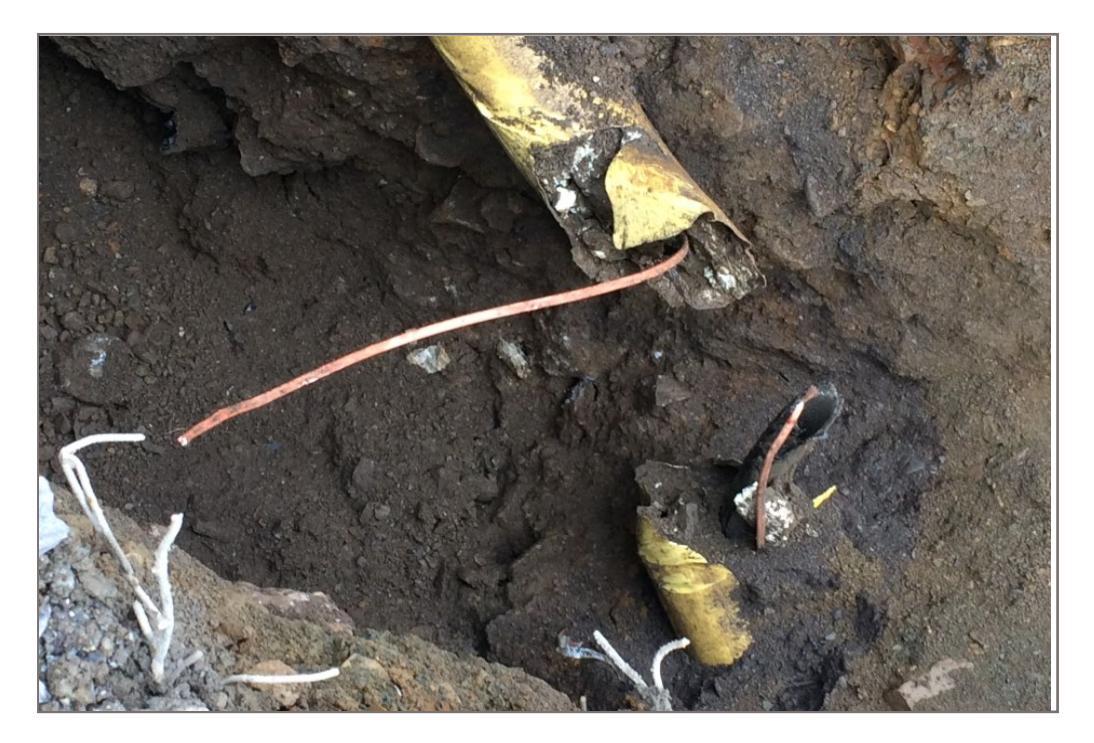
- A pile of scrap metal was observed at newly identified AEC.
- Buried debris including metal and wood was observed in several test pits advanced.
- PHC staining observed in test pit 17A49TP1 at depth of approximately 0.2 mbgs.
- No additional work was done in this area in 2018.

Photo 2: Metal and pipe debris in testpit 17A49TP1. (October 12, 2017)

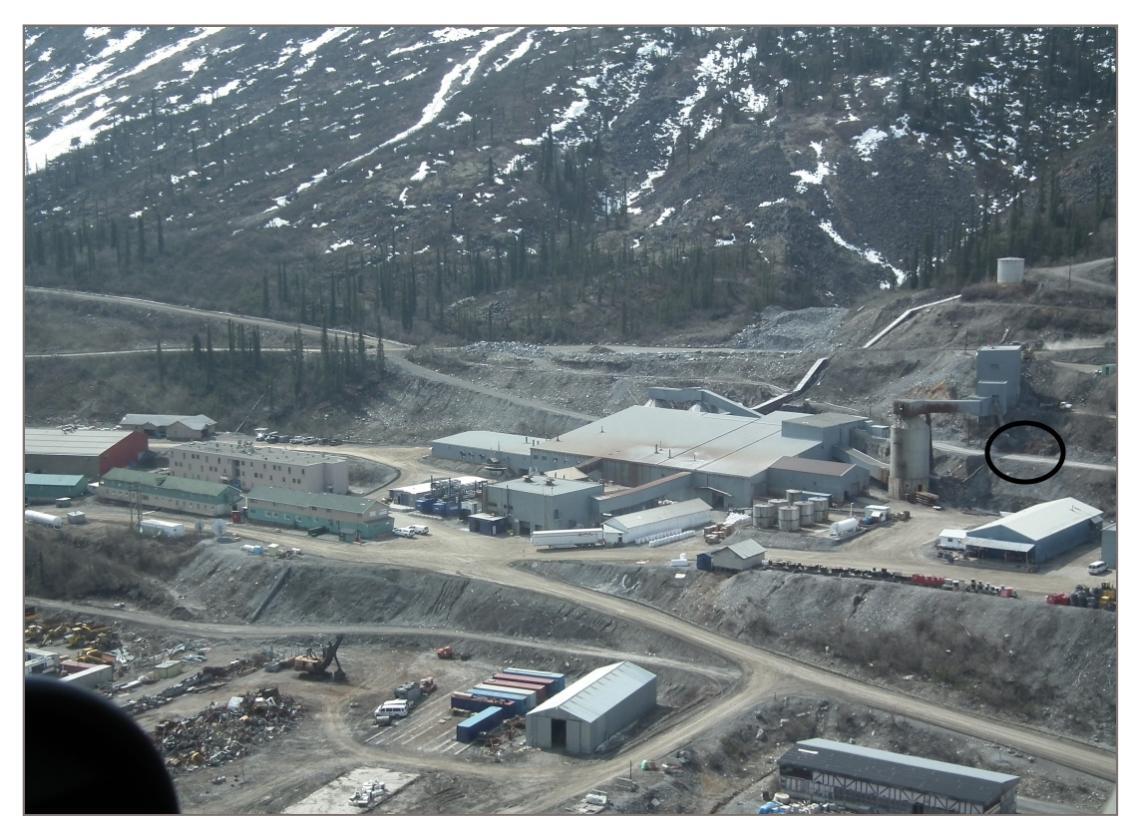
Photo 3: Metal and pipe debris area seen to the right of photo (circled). Photo provided by NATC. (May 29, 2014)

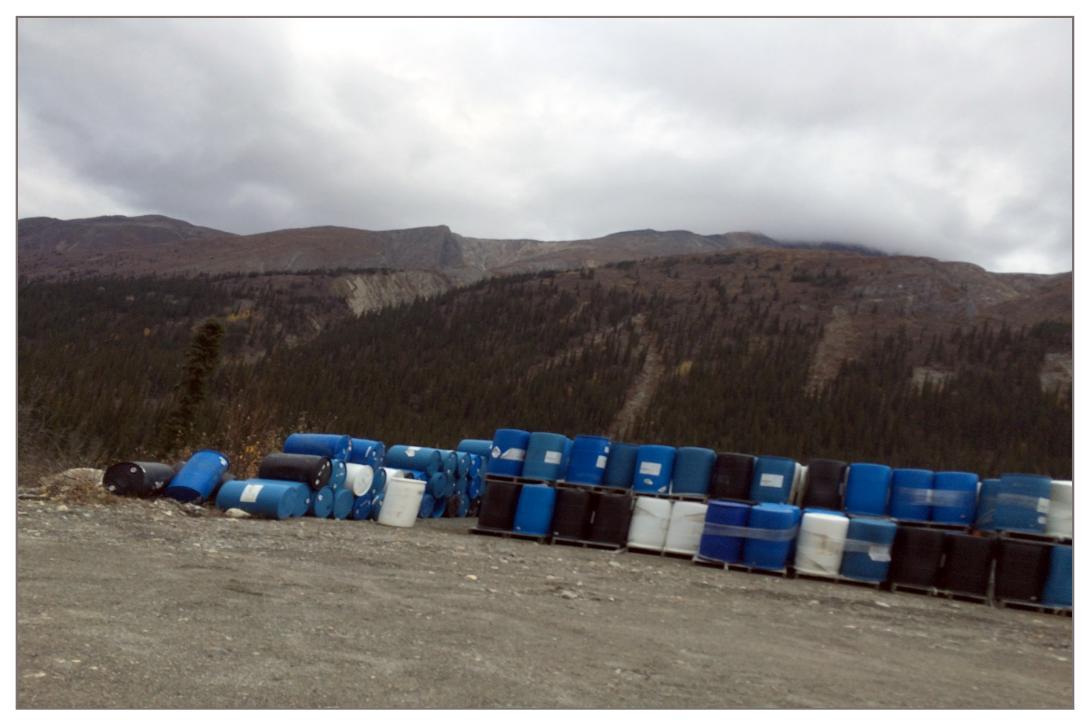
- More than half of the area of AEC 50 is currently covered with stockpiles of used drums, barrels and tires.
- Small surface-stained areas are visible beside some of the drums.

Photo 1: Facing northwest at drum storage. (September 21, 2017)

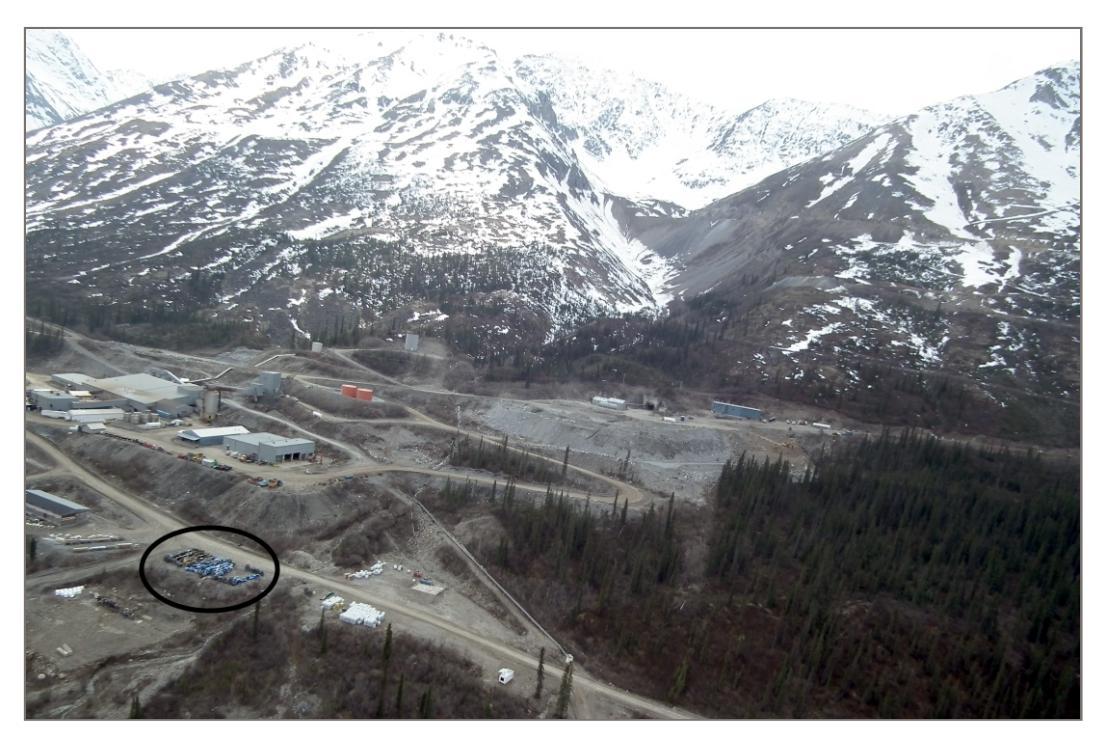
Photo 2: Facing southwest at drum storage area (circled). Photo provided by NATC. (May 29, 2014)

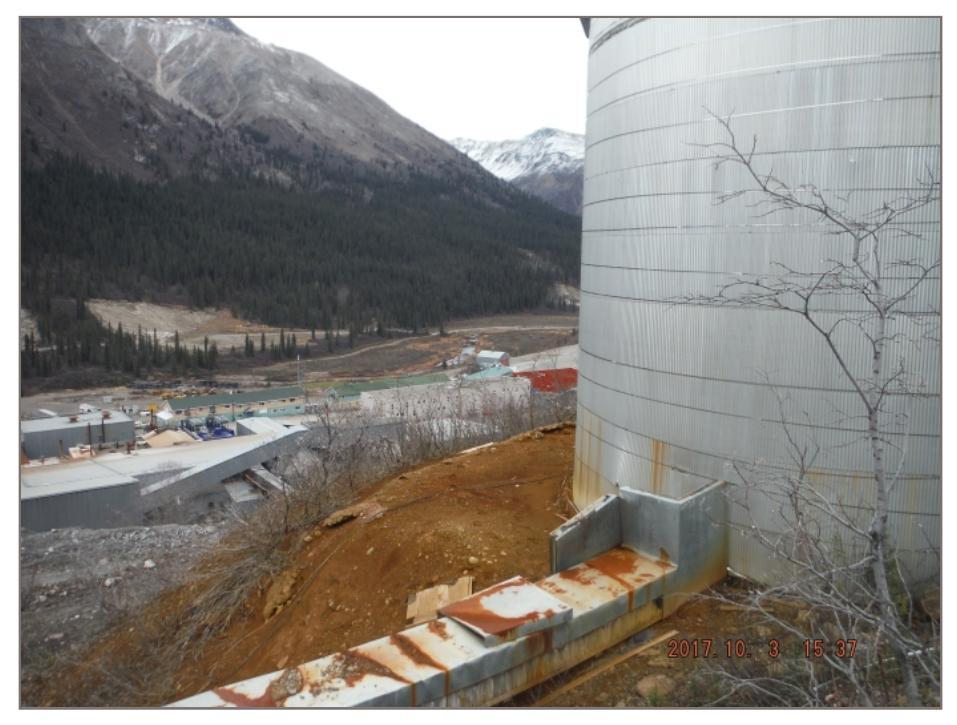
Photo 1: Oxidized tailings around the lower water tower (WT2). Sample 17WT-OX2. (October 3, 2017)

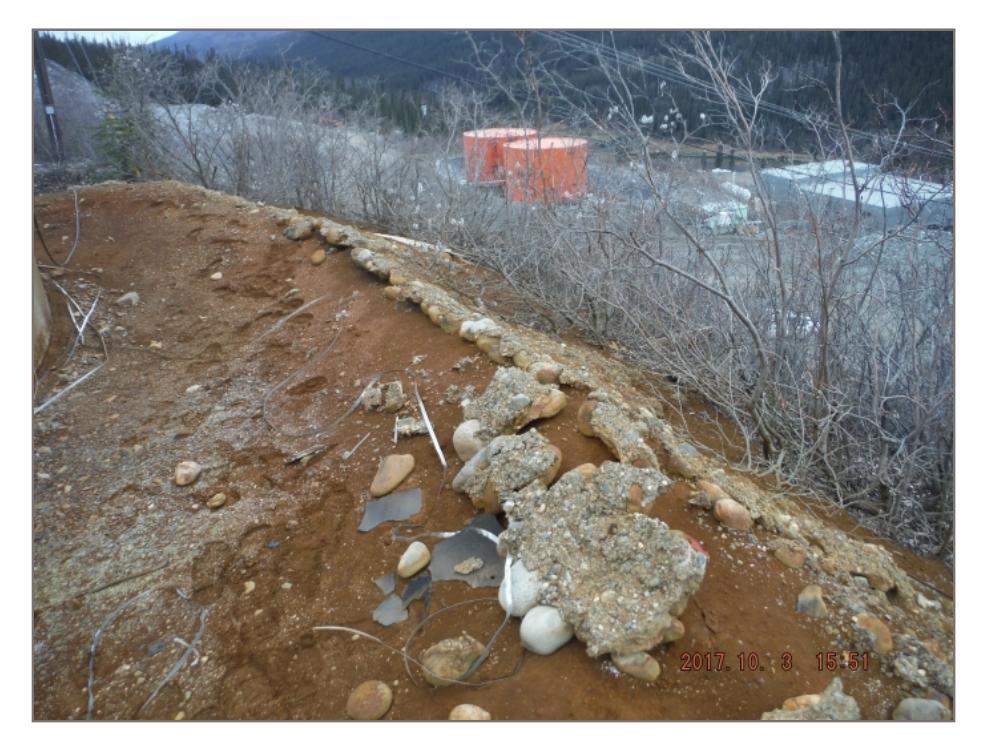
Photo 2: Detailed view of tailings around lower water tower. Scrap metal and debris. Cemented fill material within and surrounding tailings, possible from water tower foundation. (October 3, 2017)

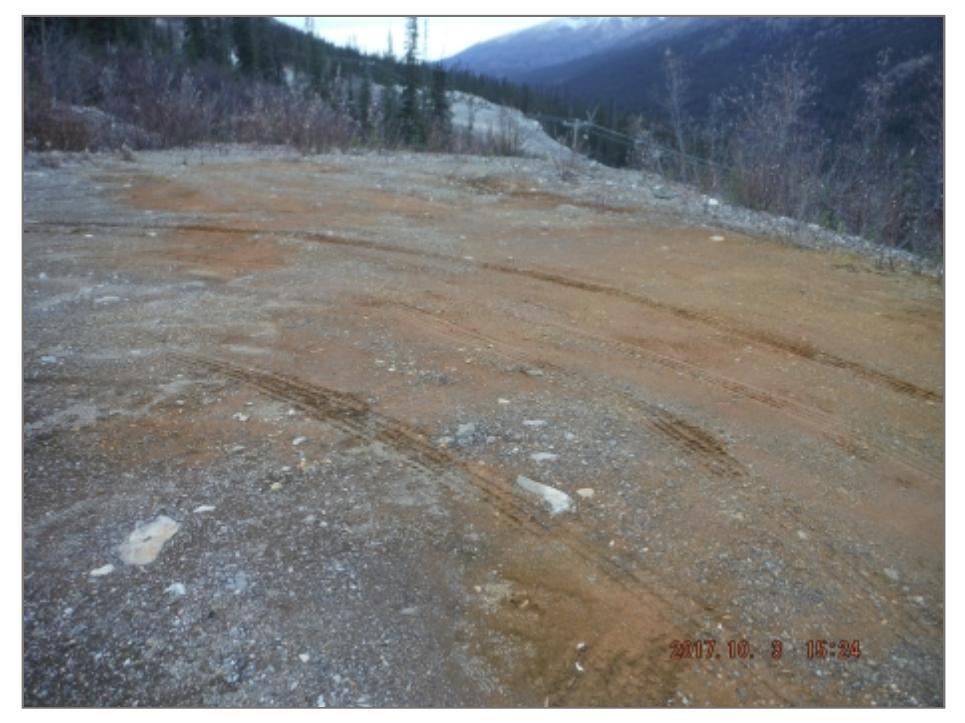
Photo 3: Oxidized tailings mixed in with soil material on construction pad adjacent to the upper water tower (WT1). Location of sample 17WT-0X1. (October 3, 2017)

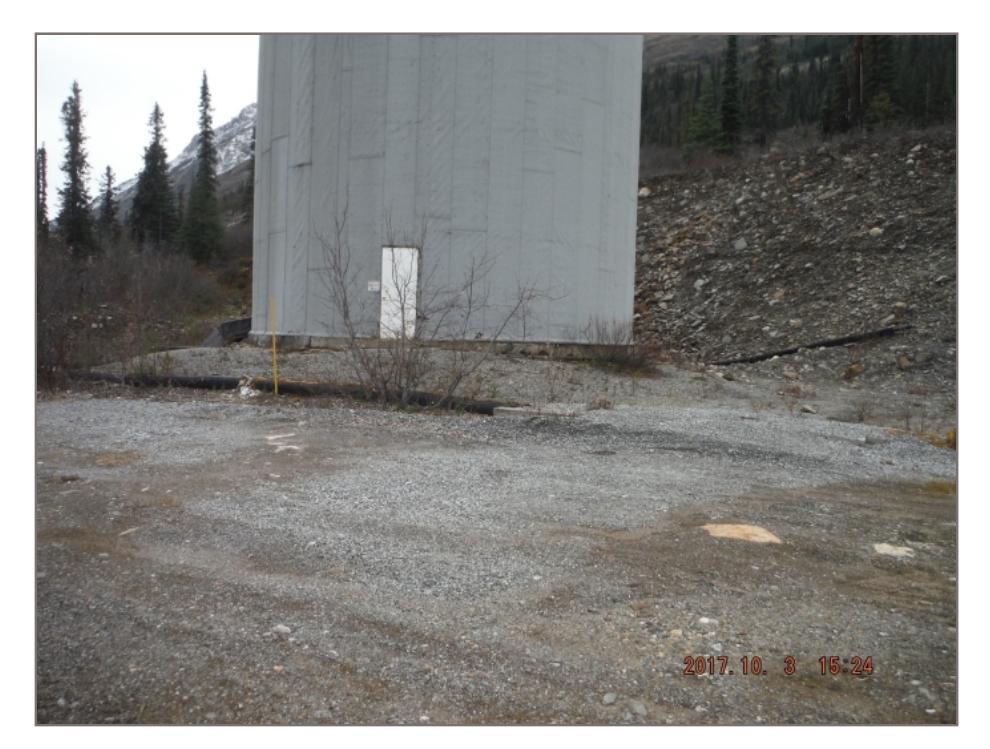
Diffuse and trace to mine 	or quantities of	tailings intermixed with fil	I material on road between Supply Tank #1 and #2.				
 Diffuse tailings observed 	d on satellite ima	agery in forested area do	wnslope (north) of Supply Tank #2.				
 A cracked and damaged the base of Supply Tank 	I PVC pipe with (#1.	exposed foam insulation	and minor amount of scrap metal and debris around				
 Steep drainage to the no 	orth; directed to	wards AEC23/33.					
No additional work was	done in this are	a in 2018.					
Soil: Petroleum Hydrocai	rbons, Metals,	Other PCOC's, Acid Ro	ck Drainage				
N/A Tailings: Potroloum Hydr	ocarbons Oth	or PCOC's					
N/A							
Tailings: Acid Rock Drain	nage (see Geog	hemistry Report. Tetra Te	ech 2019a)				
Tailings: Metals		······································					
N/A – not tested during this	s program; histo	rical data on tailings mate	erial from other areas is available.

Photo 4: Looking from sample station 17WT-OX1 towards the upper water tower. Cracked and broken PVC pipe with exposed foam insulation in the foreground. (October 3, 2017)

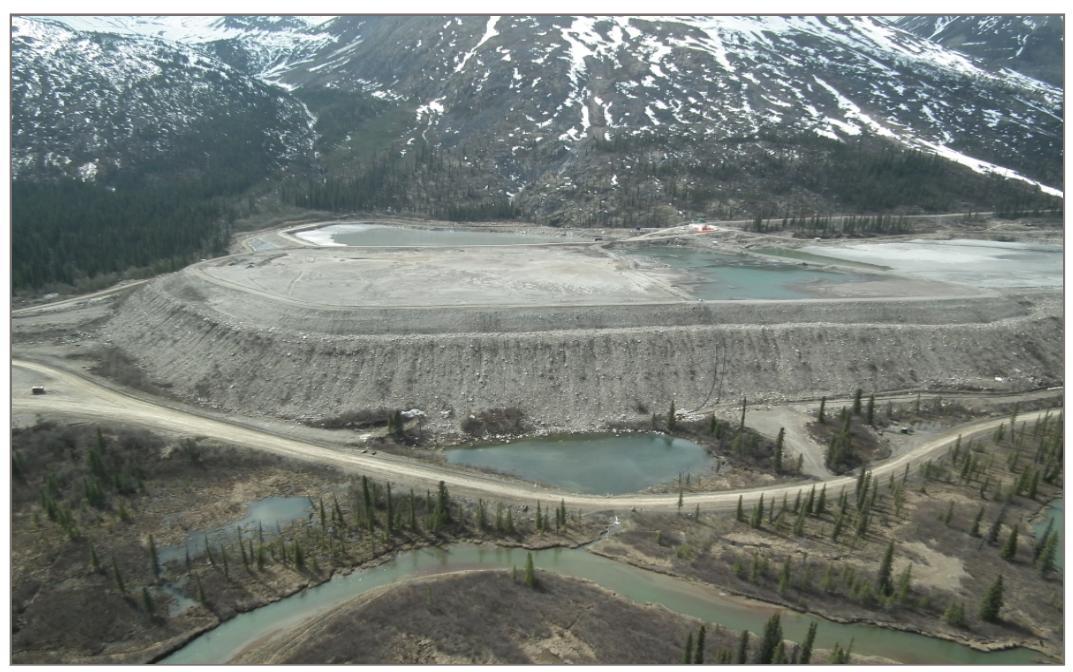
Photo 1: Facing west towards TP3. Stinky Pond visible in centre of photo. Photo provided by NATC. (May 29, 2014)
