Camlaren Mine Tailings Soil Containment Area Geotechnical Inspection

Gordon Lake Group Remediation Project

Project Number: 60710609

April 5, 2024

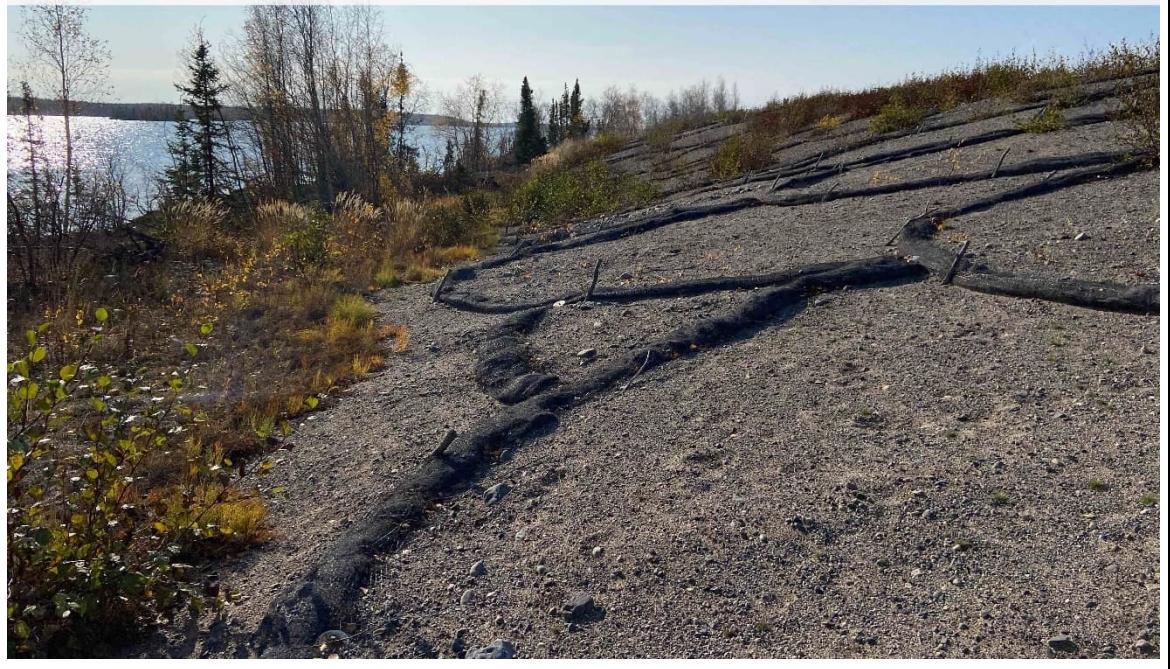
20

Southwest Description Erosion embankment and vegetation on the north end of the east

embankment.

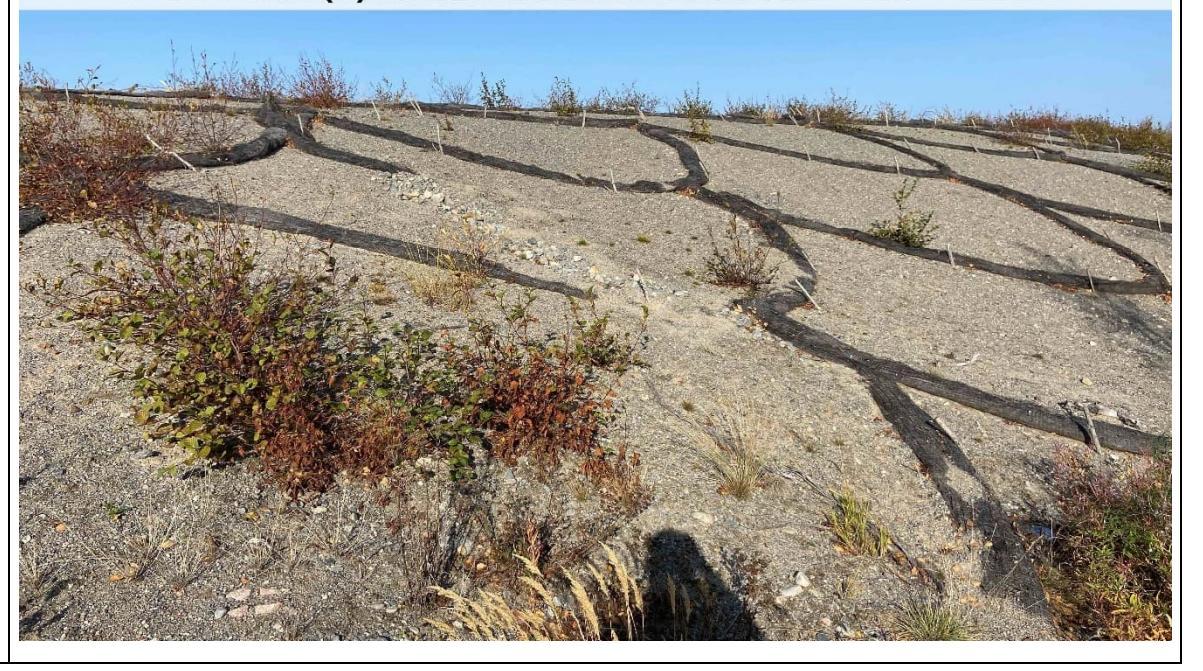
22

- East embankment has some vegetation growing along most of the embankment. (Photo 18, 19, and 20) Minor erosion is noted in several locations and washout sand is visible at some locations. (Photo 21). An erosion channel along the east embankment appears to have been stabilized with coarse aggregate (Photo 22).

Northwest Description An erosion channel appears to have been repaired using coarse aggregates placed within the channel.

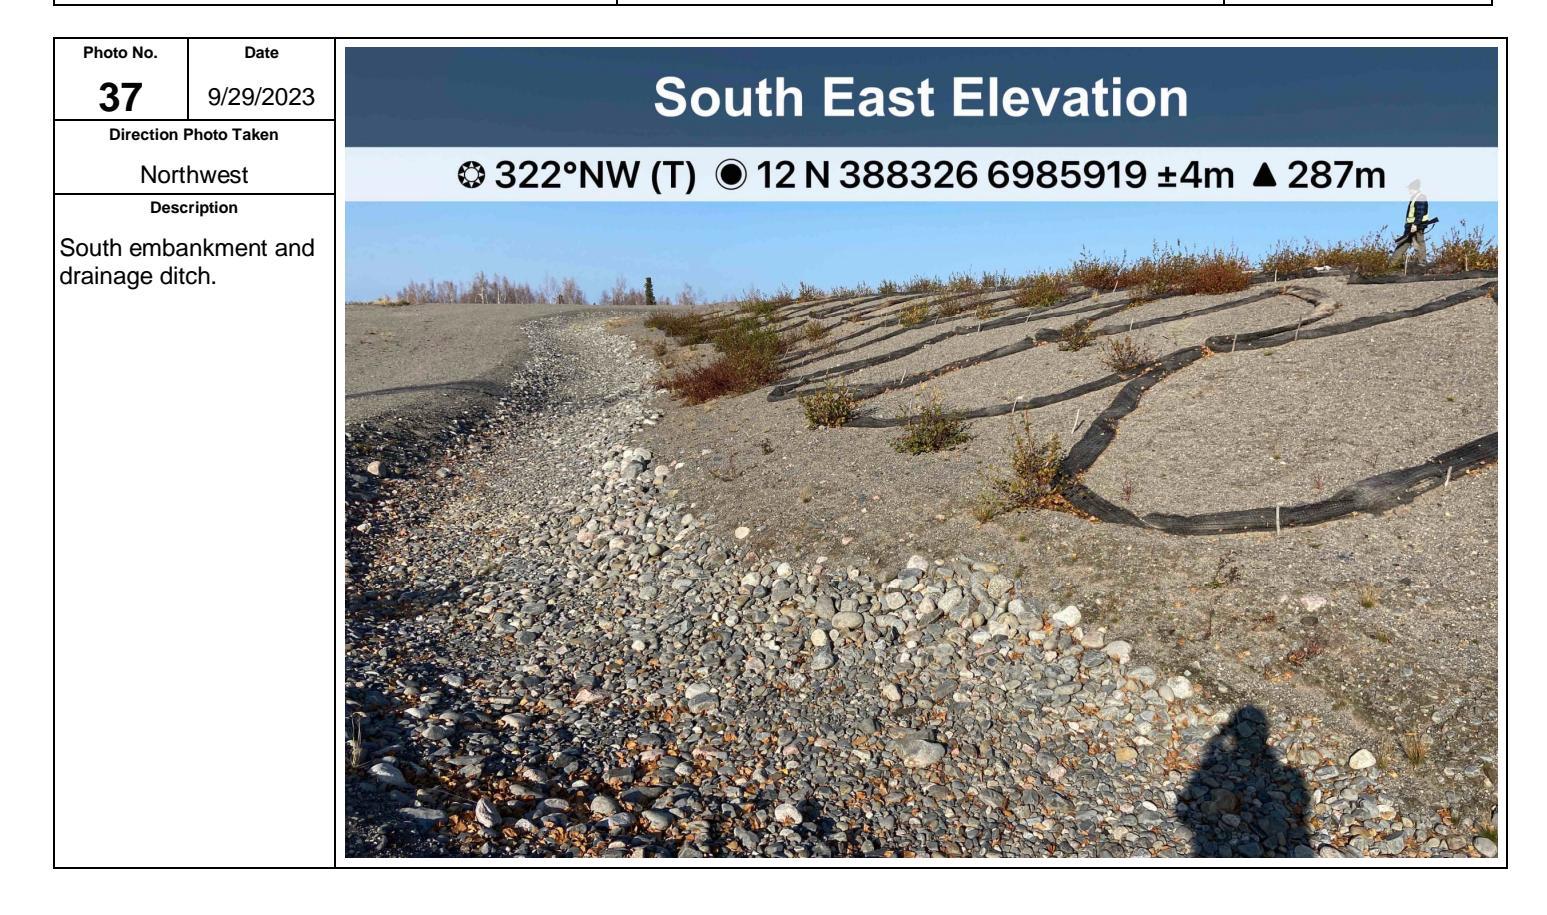
- South embankment has some vegetation and is generally stable (Photos 36 and 37).
- The erosion coir logs are in varying conditions. Some are pinned and in good condition, while others are loose or have degraded in condition (**Photos 38** and **39**). Along the south embankment, the coir logs have migrated up the slope. Along the east embankment, some of the coir logs have disappeared and migrated to different locations.

Photo No.	Date	
38	9/29/2023	
Direction F	Photo Taken	
Sc	South	
Desc	ription	
Erosion log embankmen and loose.	g on south t – degraded

The coir logs reduce erosion and aid in establishing vegetation. Some of the erosion coir logs on the east and south embankments have broken down, or torn, or have come loose and migrated elsewhere. Some of these logs should be replaced on the steeper slopes.

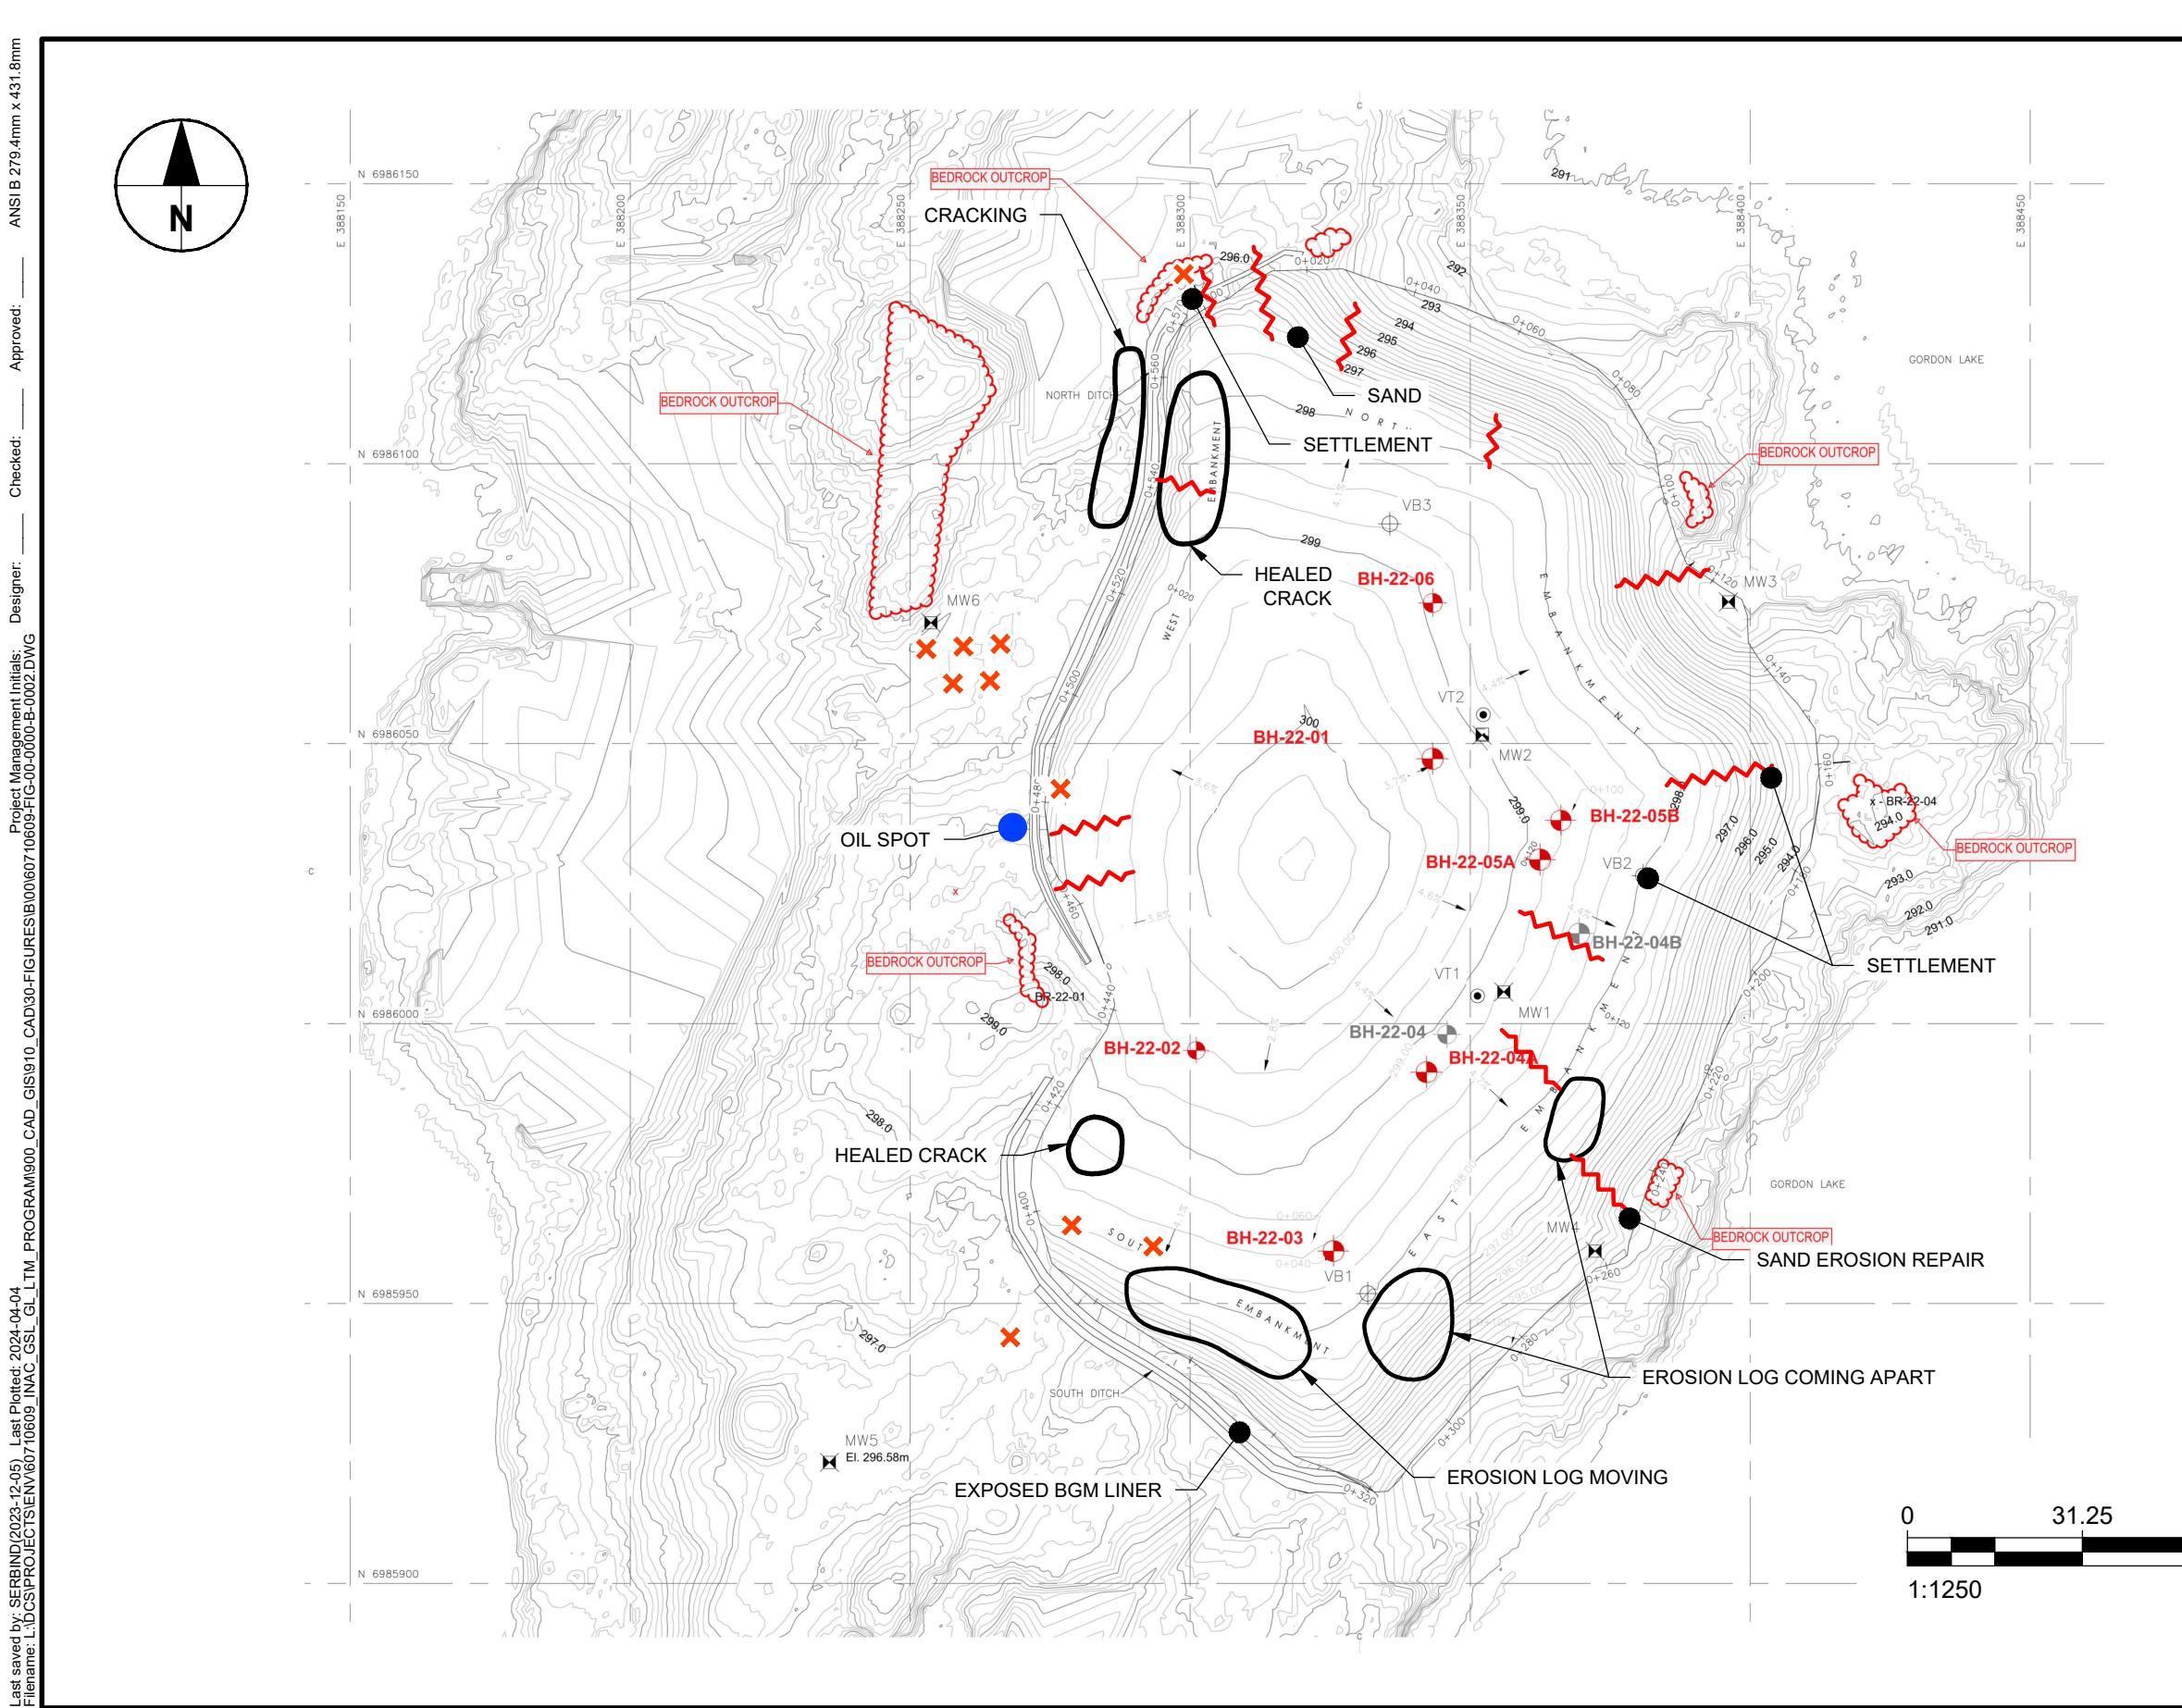
Figure 2

The TSCA is in generally good condition. Willow branches were placed across the top of the pile and the slopes appear to be generally stable. At the time of the inspection, the bottom of the embankments was dry and no water was observed in the ditches along the west and south sides of the TSCA. The following observations were noted and highlighted on **Figure 2** where applicable:
