# Memo

To:	MGM Energy	From:	James Hymers, Project Manager K'alo-Stantec Ltd.
	2800, 421 - 7 Avenue SW Calgary, AB T2P 4K9		Tulita, NT, Canada X0E 0T0
File:	123514551	Date:	January 22, 2024

#### Reference: 2023 Environmental Site Monitoring Report: Maunoir E-35 Sump Area

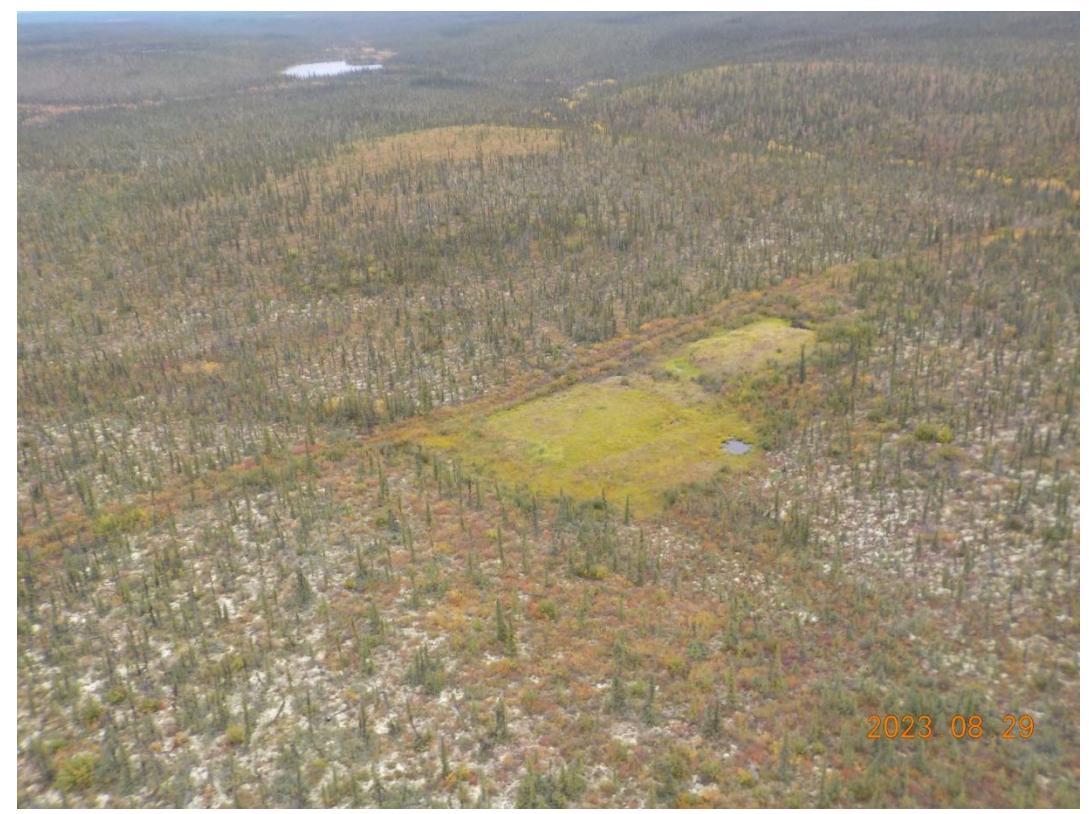
# Photo B.1 E-35 Sump Area: Overview

Note: Overview of the Sump Areas and surrounding area (facing northeast) showing overall terrain and vegetation conditions (August 29, 2023).

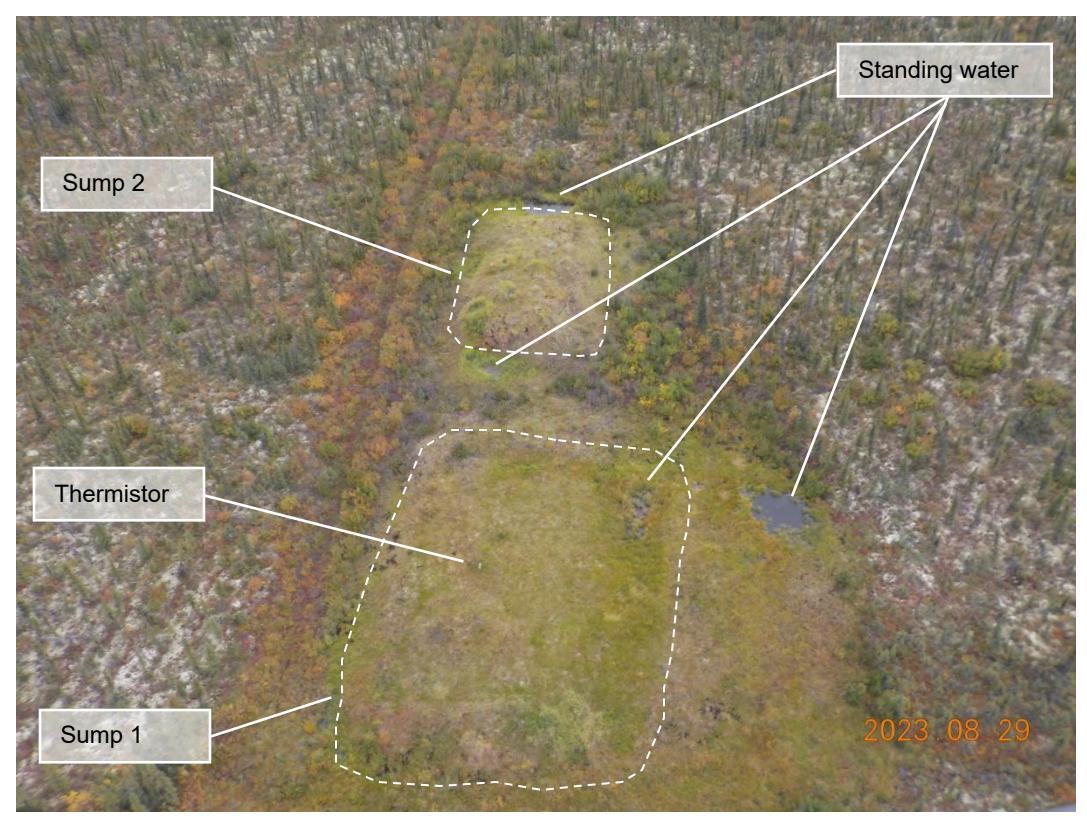
#### Photo B.2 E-35 Sump Area: Overview

Soil and Water Analytical Results	
Parameters	Qualitative Monitoring Observations and Results	(if exceedances)	Future Recommended Work
Standing Water	<ul> <li>Standing water was observed on the south side of Sump 1 and the east and west ends of Sump 2 (Attachment B: Photo B.2, Photo B.5, and Photo B.6).</li> <li>Water samples were not collected from standing water at the sumps or surrounding areas during the 2023 site visit.</li> </ul>	<ul> <li>Not applicable, no water samples were collected during 2023.</li> </ul>	• Three additional water samples from upgradient standing water should be collected to update 2015 and 2016 reference chemistry <sup>4</sup> . Samples should be collected and analyzed for routine chemistry and total metals parameters.
			<ul> <li>Collect up to three standing water samples from the Sump Areas during 2024 to monitor water chemistry within areas identified during previous EM survey<sup>5</sup> with anomalous apparent conductivity.</li> </ul>

Note: Overview of the Sump Areas facing northeast showing locations of Sump 1 and Sump 2, standing water locations, and thermistor location (August 29, 2023).

<ul> <li>Samples of standing water at the Sump Areas, if observed, should be collected, and analyzed for routine chemistry and total metal parameters to monitor trends in water quality.</li> </ul>
Soils	<ul> <li>Soil samples were not collected during the site visit.</li> <li>No evidence of visible surface soil contaminants such as petrogenic sheen, surface staining, or surface crusts were observed within the Sump Area.</li> </ul>	<ul> <li>Not applicable, soil samples were not collected during the 2023 site visit.</li> </ul>	Collect soil samples from the Sump Areas to monitor soil acidity and salinity parameters in areas with reported elevated EC identified
	<ul> <li>Historical soil sample analysis conducted from 2012 to 2017 reported elevated soluble conductivity values in the bare areas on Sump 2 due to elevated inorganics (calcium, magnesium, and sulfate) when compared with reference data. Revegetation treatments were completed in 2019 to improve the soil conditions and support vegetation establishment<sup>6</sup>.</li> </ul>		previous soil sampling programs and electromagnetic surveys conducted during 2018 and 2022 <sup>5,4</sup> .

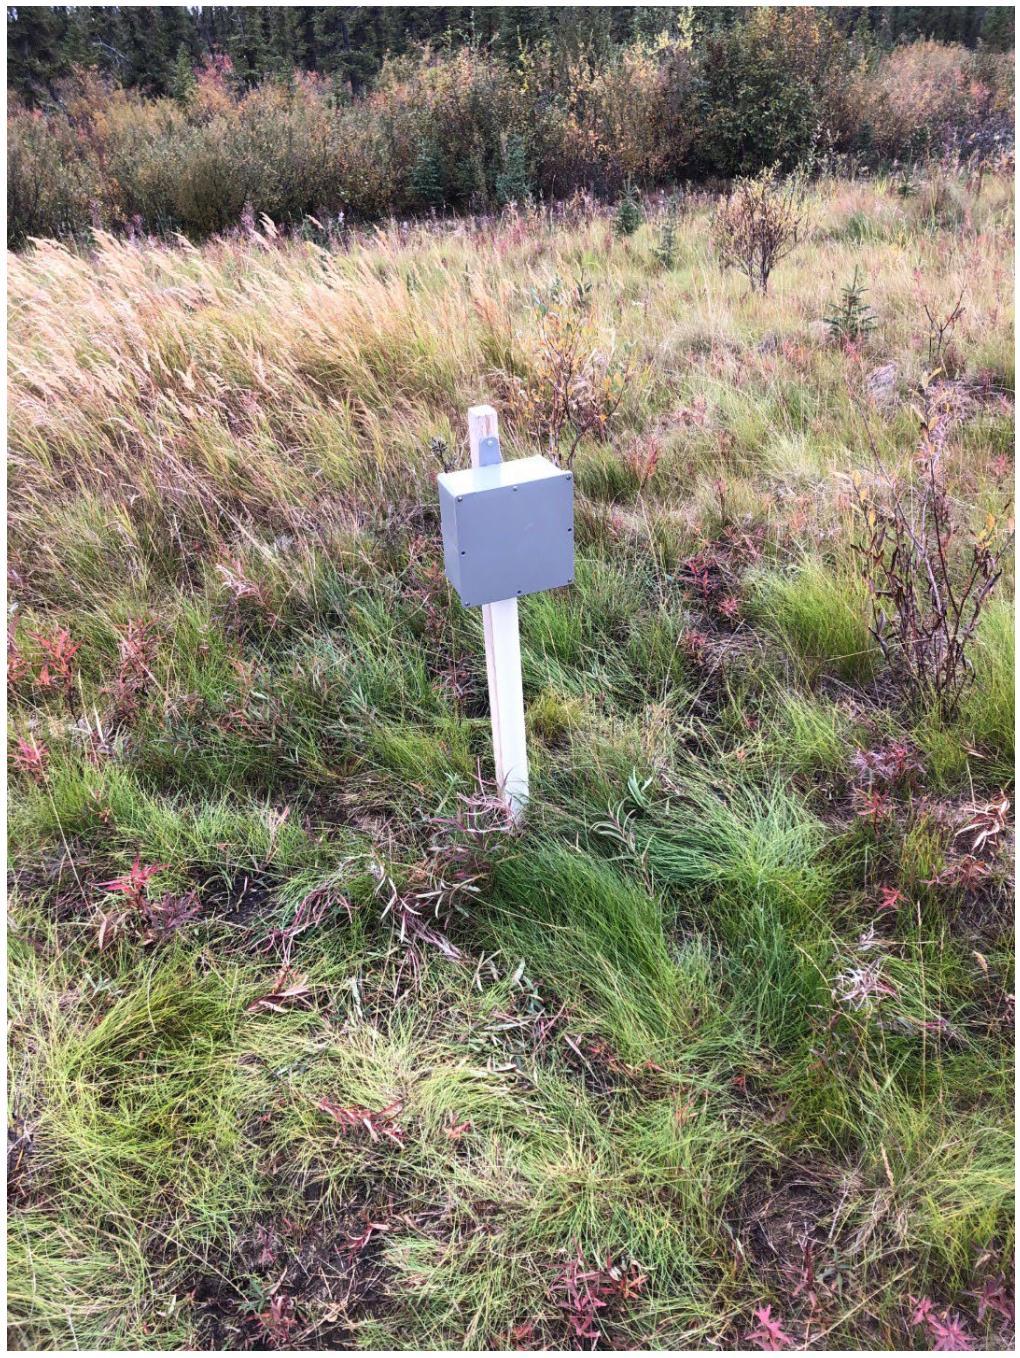
Photo B.3 E-35 Sump Area: On-Site Materials

Note: Northwest facing view of on-site materials showing thermistor located on the north side of Sump 1 (August 29, 2023).

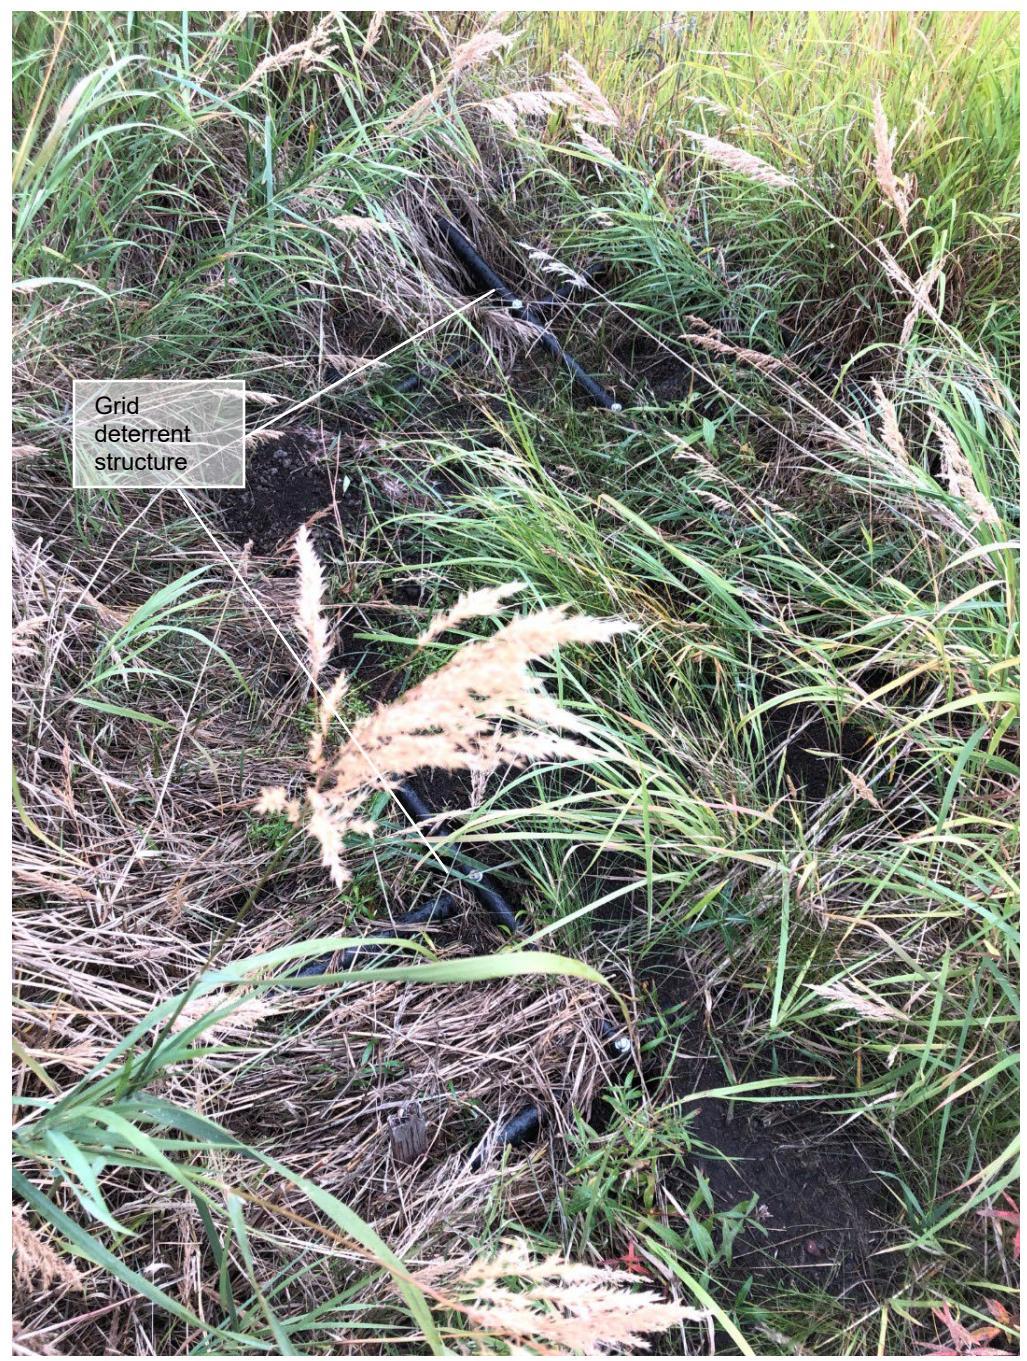
## Photo B.4 E-35 Sump Area: On-Site Materials

• Four polyvinyl chloride grid deterrent structures were present on Bare Areas 2, 3 and 4 on Sump 2. The grids were covered and overgrown by seeded native grasses (Attachment B: Photo B.4). They were installed as part of reclamation treatments conducted during the 2019 site visit and left in place for long-term protection of the bare areas.		<ul> <li>3 and 4 and carry out maintenance or repair tasks, if required.</li> <li>No other actions related to on-site materials are recommended at this time.</li> </ul>
	<ul> <li>No other surface structures, materials or wastes were observed at the Site during the 2023 site visit.</li> </ul>		
Terrain	<ul> <li>Sump Area:</li> <li>Visual observations and site photographs indicated that Sump 1 was stable, with no signs of stress, erosion, or subsidence (Attachment B: Photo B.5).</li> <li>Localized depressions were observed along the south side of Sump 1 (Attachment B: Photo B.5), as well as the east and the west sides of Sump 2 (Attachment B: Photo B.6). These depressions appeared similar to the last observation</li> </ul>	Not applicable for this parameter.	<ul> <li>Continue visual monitoring for potential signs of stress and/or ground movement during a future site visit.</li> <li>Backfilled and/or recontour tension cracks.</li> </ul>

Note: On-site materials showing grid deterrent structure located in Bare Area 3. Grid has become overgrown and covered by seeded native grasses (August 29, 2023).

Parameters	Qualitative Monitoring Observations and Results	Soil and Water Analytical Results (if exceedances)	Future Recommended Work
	Sumn Area:	Not applicable for this parameter	Sump Area:
Materials	<ul> <li>As part of the 2022 site visit<sup>4</sup>, a thermistor cable, protective casing, and associated data logger were installed at Sump 1 (Attachment A: Figure A.3, Attachment B: Photo B.2 and Photo B.3).</li> </ul>		<ul> <li>Conduct a maintenance check on the thermistor equipment, replace batteries and download temperature data.</li> </ul>
	<ul> <li>The thermistor was intact and operational at the time of the 2023 site visit.</li> </ul>		• Check on the condition of the grid deterrent structures on Bare Areas 2,

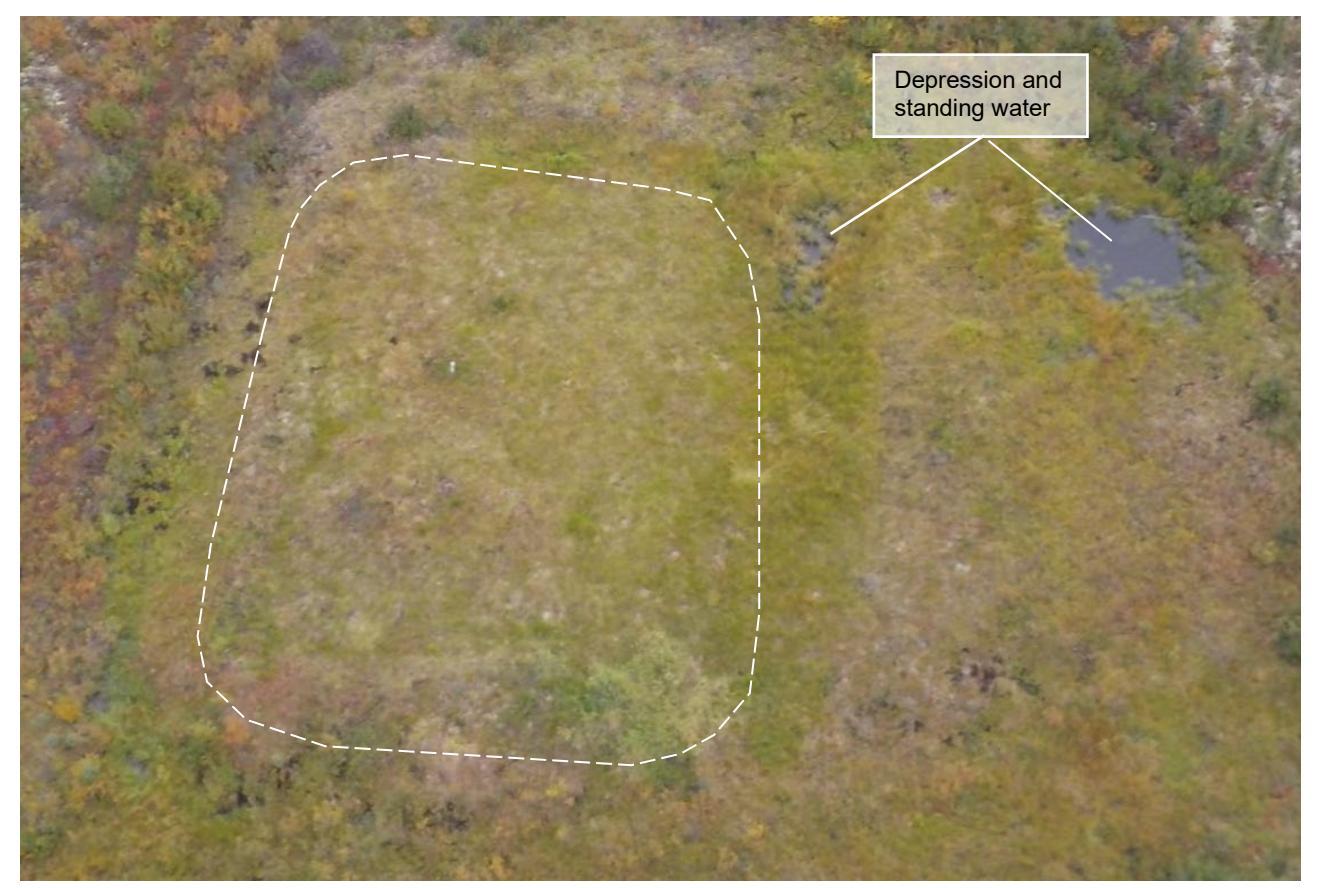
## Photo B.5 E-35 Sump Area: Overview of Sump 1

Note: Overview of Sump 1 facing northeast showing terrain, standing water, and vegetation conditions. (August 29, 2023). Approximate sump footprint denoted with white dashed line.

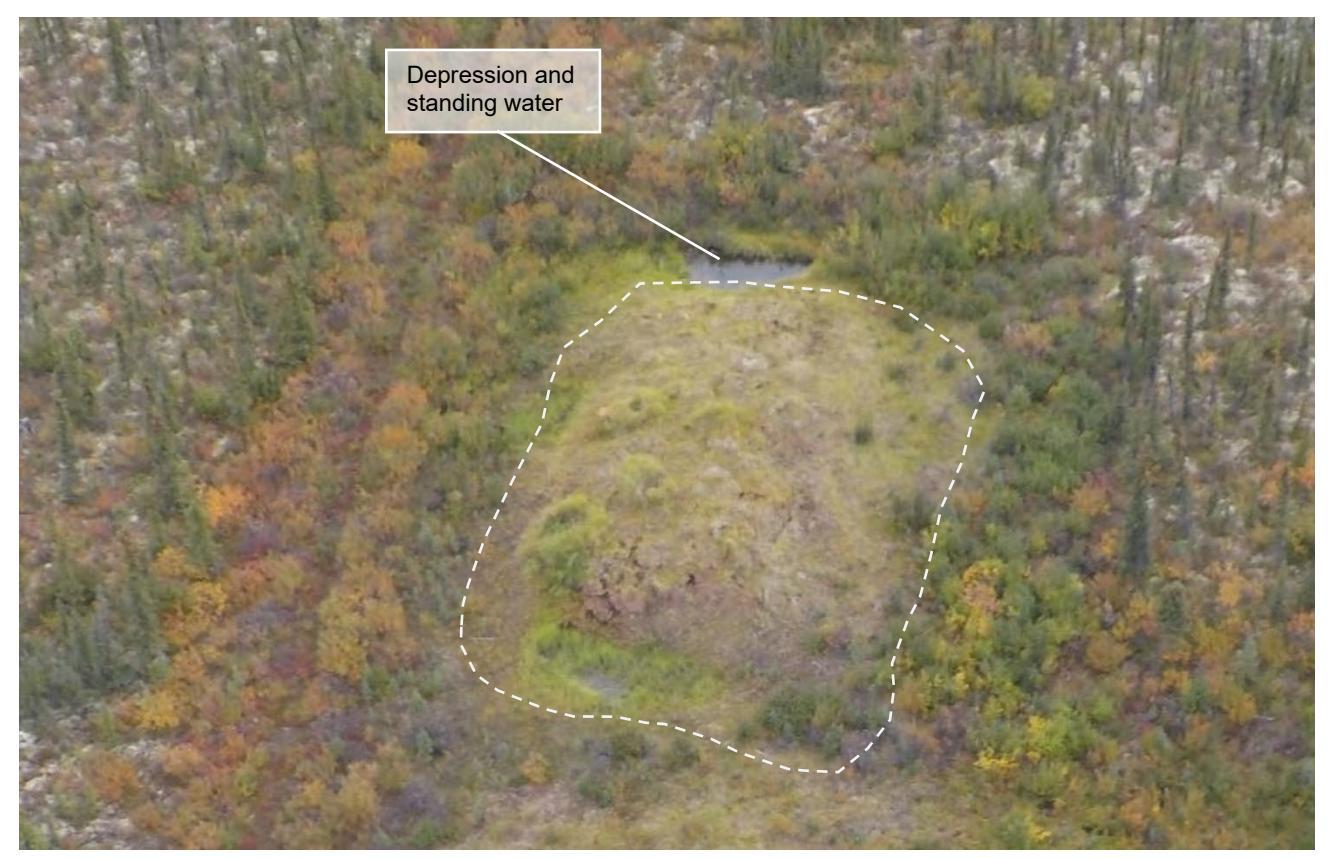
## Photo B.6 E-35 Sump Area: Overview of Sump 2

Note: Overview of Sump 2 facing northeast showing terrain, standing water, and vegetation conditions. Approximate sump footprint displayed with white dashed line (August 29, 2023).

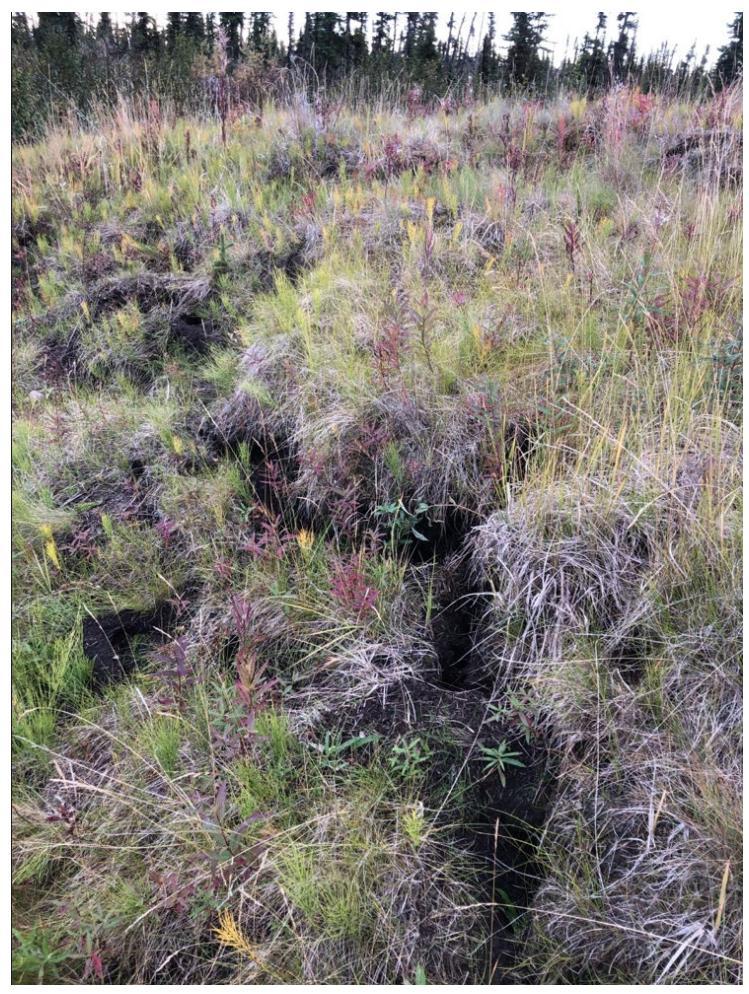
# Photo B.7 E-35 Sump Area: Tension cracks at the surface of Sump 2

Parameters	Qualitative Monitoring Observations and Results	Soil and Water Analytical Results (if exceedances)	Future Recommended Work
Terrain (cont'd)	• Tension cracks were visible at the surface of Sump 2 (Attachment B: Photo B.7). Cracks were first observed at the surface of Sump 2 during the 2016 visit, then backfilled as part of the 2019 site visit. No cracks were observed during the 2020 site visit (although cracks were potentially obscured by vegetation). The observation of tension cracks during the 2023 site visit suggests that some settlement occurred after the cracks were backfilled.	See above	See above

Note: View of a tension crack observed on the surface of Sump 2 (facing southeast) (August 29, 2023). Cracks were first observed at the surface of Sump 2 during the 2016 site visit then backfilled during the 2019 site visit. No cracks were observed during the 2020 site visit (although cracks were potentially obscured by vegetation). The observation of tension cracks as part of the 2022 and 2023 site visits suggests that some additional settlement has occurred after the cracks were backfilled.

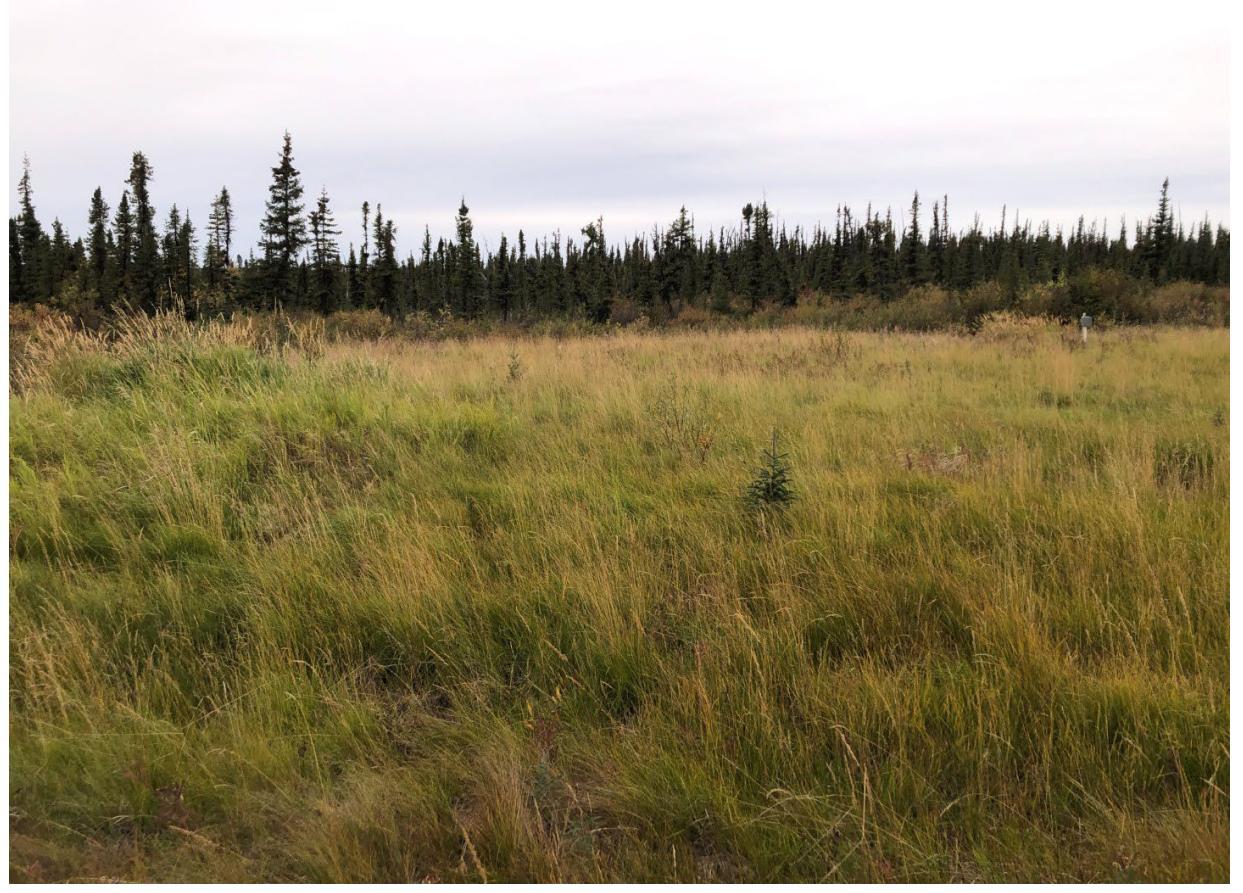
Photo B.8 E-35 Sump Area: Vegetation Cover - Sump 1

Note: View facing northwest looking at the ground and vegetation conditions on Sump 1. Sump 1 revegetated with agronomic and native grasses and naturally established shrubs and forbs. Vegetation cover met the permit requirements (i.e., >70% cover and healthy condition) (August 29, 2023).

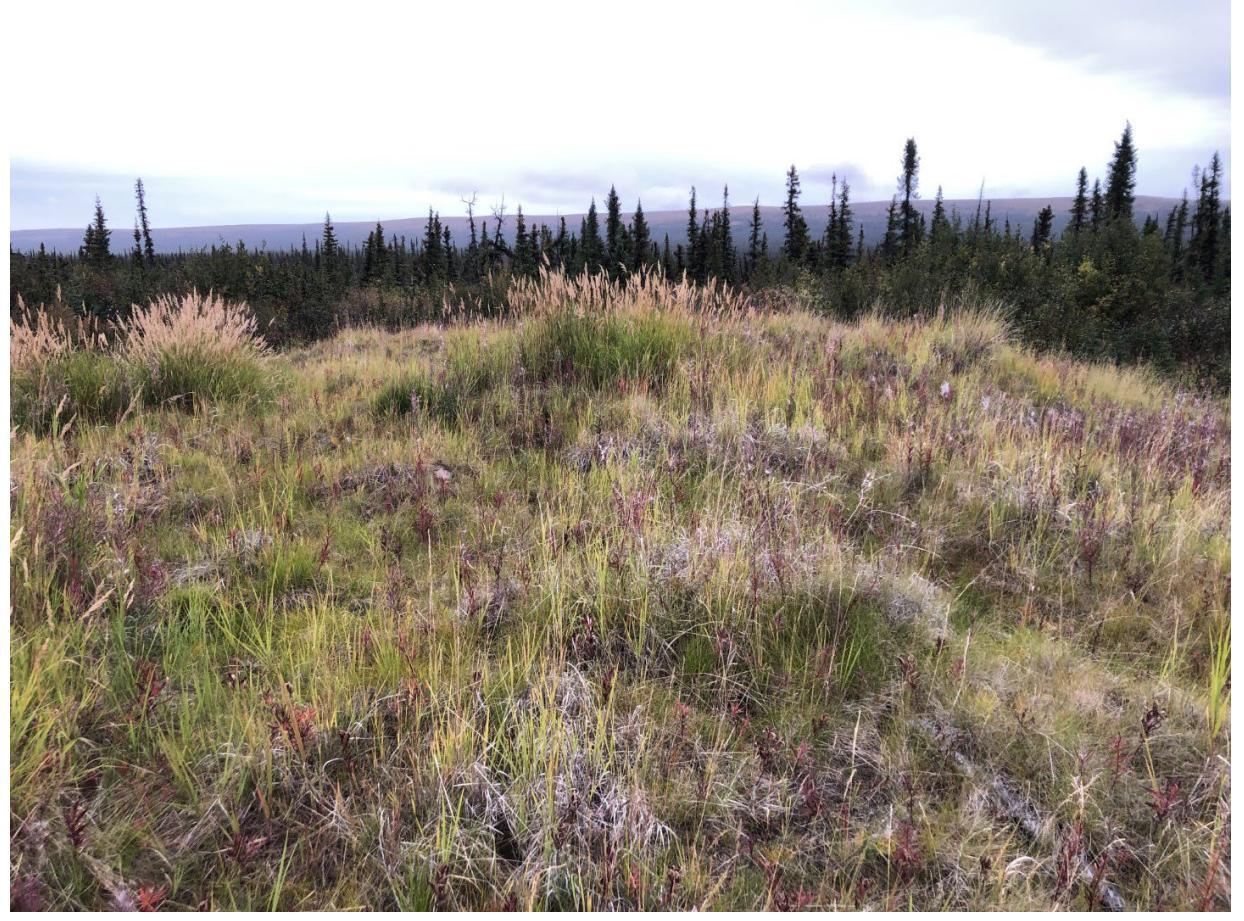
Photo B.9 E-35 Sump Area: Vegetation Cover - Sump 2

Note: View facing northeast looking at the ground and vegetation conditions on Sump 2. Sump 2 revegetated with agronomic and native grasses and naturally established shrubs and forbs. Vegetation cover met the permit requirements (i.e., >70% cover and healthy condition) (August 29, 2023).

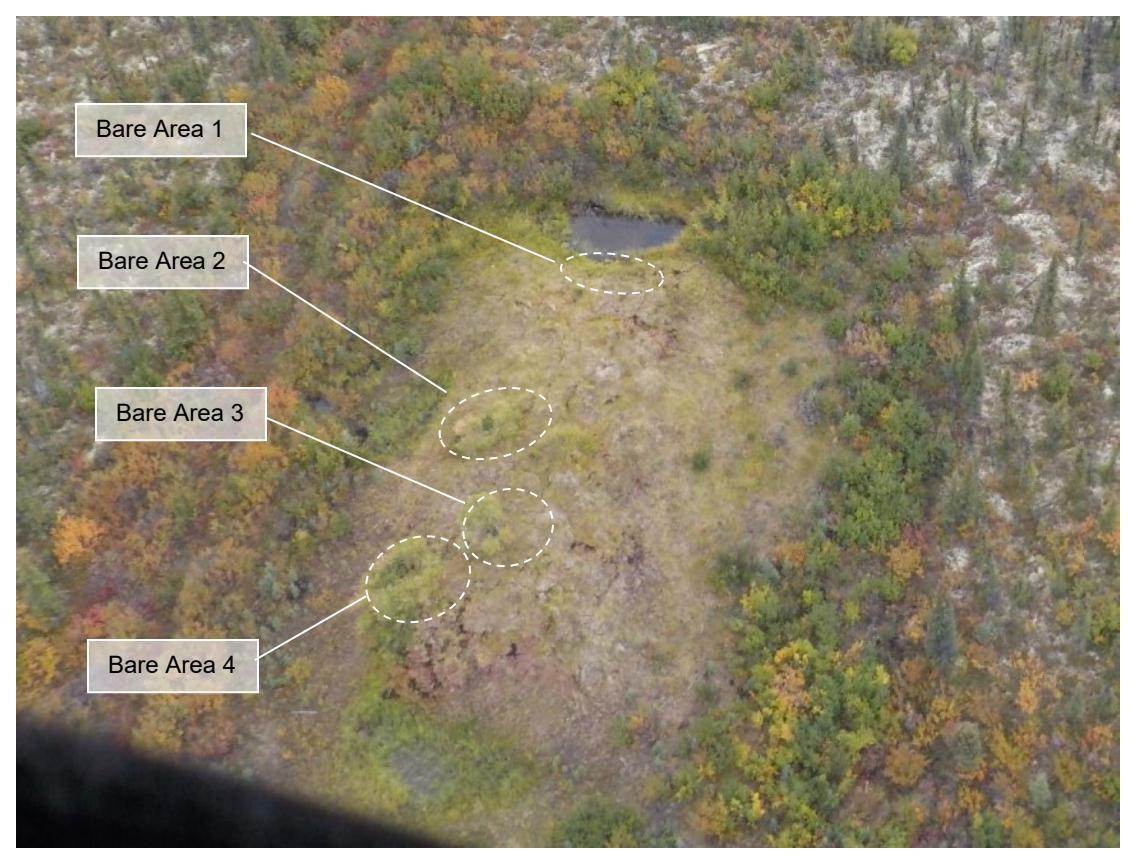
Photo B.10 E-35 Sump Area: Vegetation Cover - Sump 2 - Bare Areas 1, 2, 3, and 4

Note: View facing northeast at the Bare Areas 1 to 4 on Sump 2. Revegetation/phytoremediation treatments were carried out in bare areas in July 2019 (organic mulch pellet application, ground tilling, native grass seed and fertilizer application, grid deterrent structures installation). Vegetation has become well established and appeared healthy. Vegetation cover in the bare areas ranged from 65% to 100% cover (August 29, 2023).

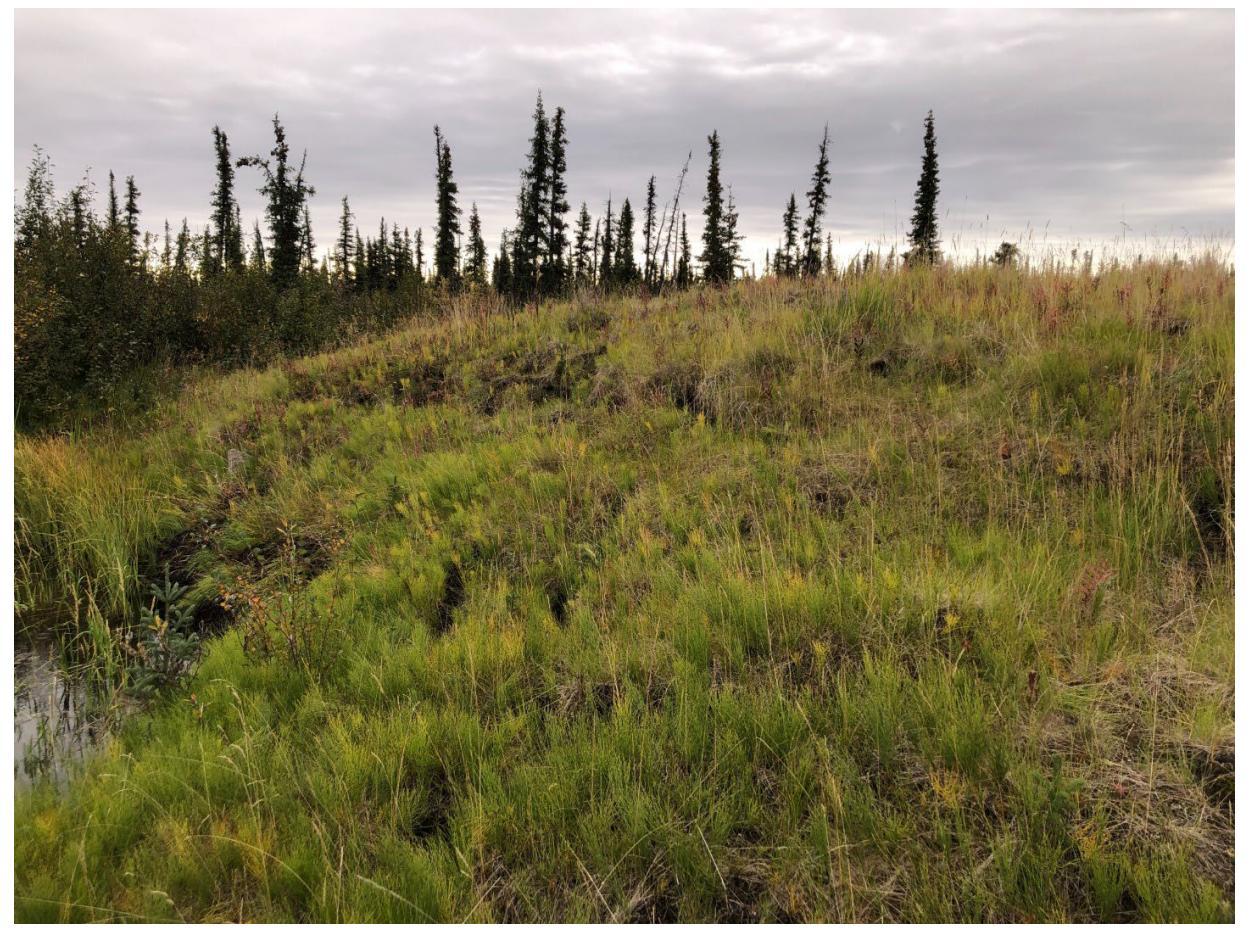
Photo B.11 E-35 Sump Area: Vegetation Cover - Sump 2 (Bare Area 1)

Note: View facing south toward Bare Area 1 showing ground and vegetation conditions. Vegetation cover was approximately 70% to 75% cover. Vegetation appeared healthy and met the permit requirements (i.e., >70% cover and healthy condition) (August 29, 2023).

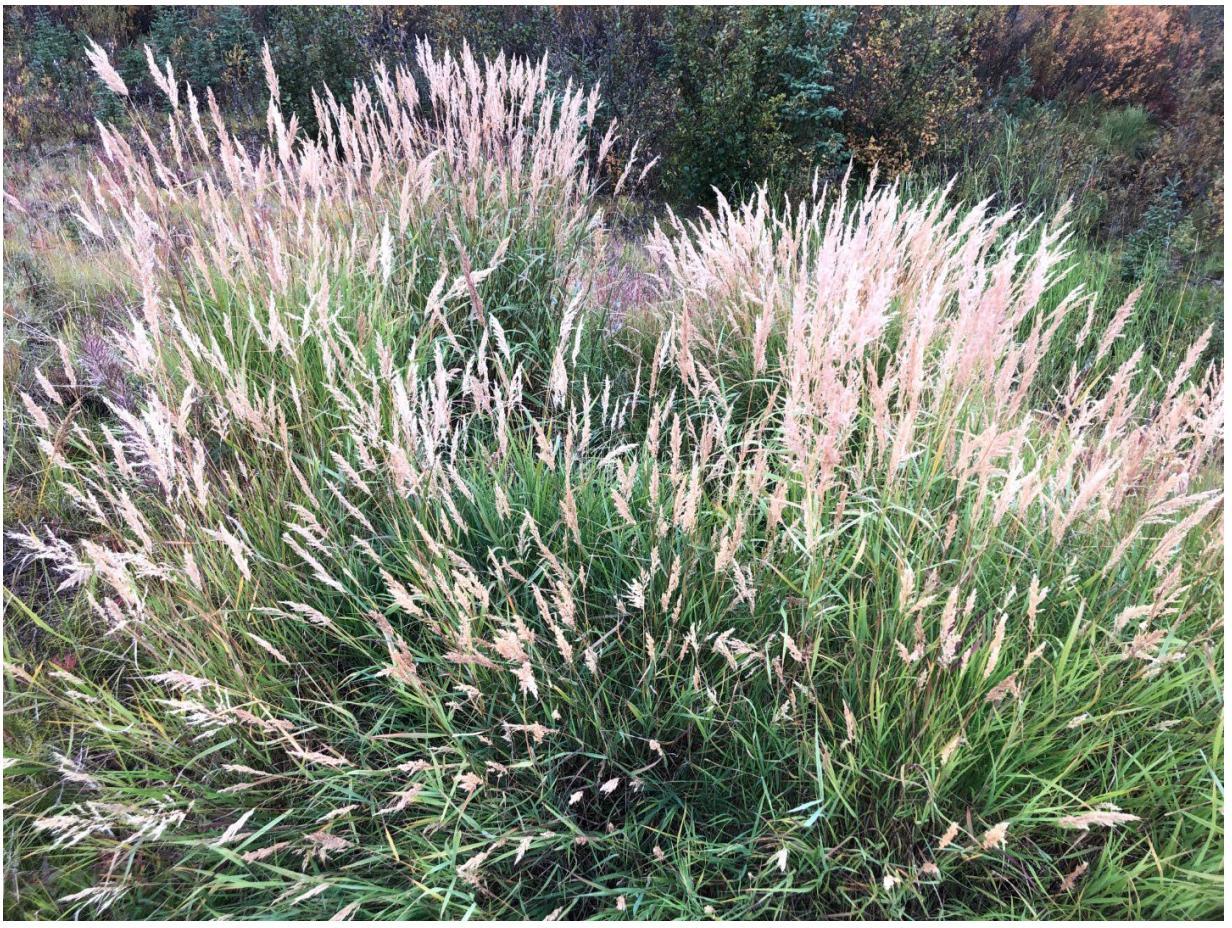
Photo B.12 E-35 Sump Area: Vegetation Cover - Sump 2 (Bare Area 2)

Note: View facing west toward Bare Area 2 showing ground and vegetation conditions. Vegetation cover was approximately 90% to 95% cover, appeared healthy and met the permit requirements (i.e., >70% cover and healthy condition) (August 29, 2023).

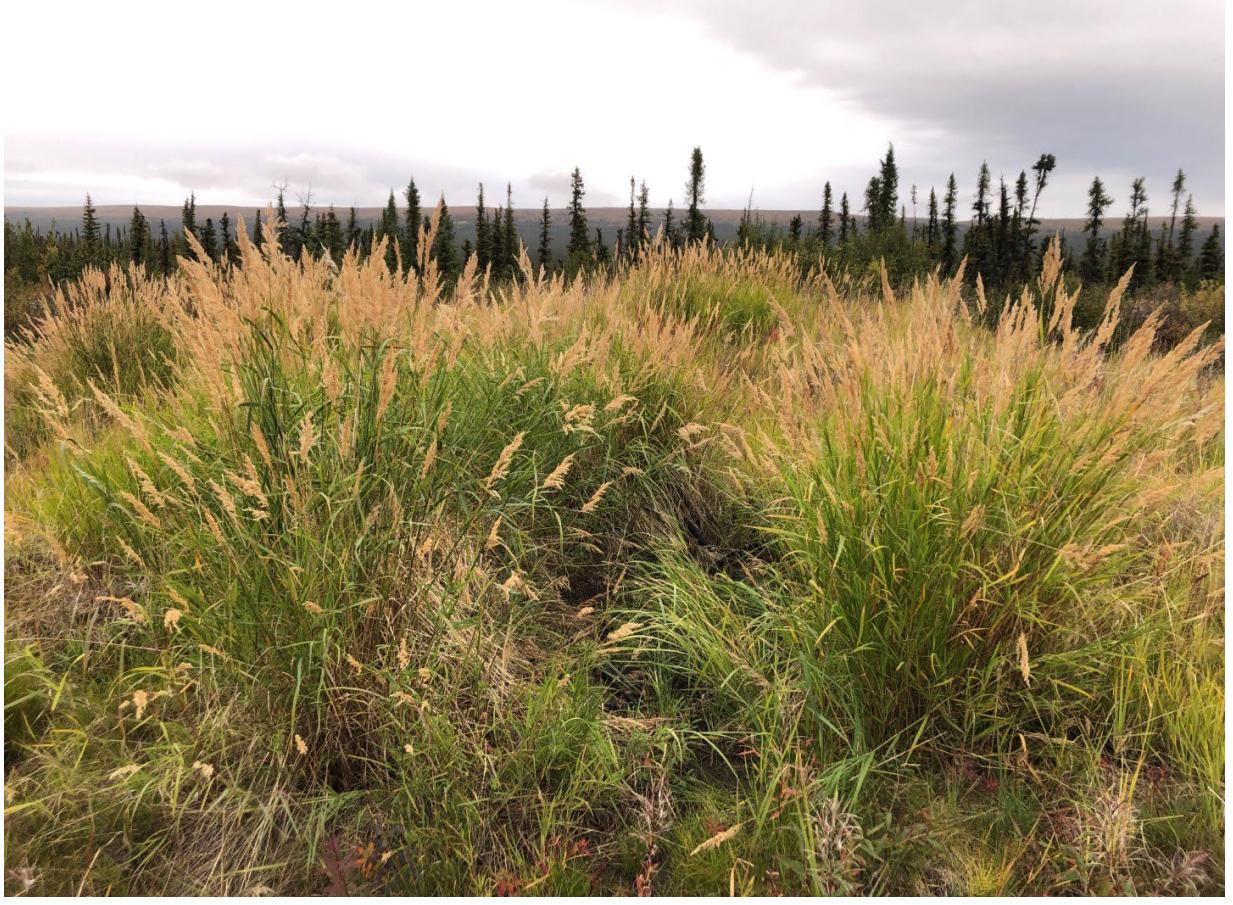
Photo B.13 E-35 Sump Area: Vegetation Cover - Sump 2 (Bare Area 3)

Note: View facing northeast toward Bare Area 3 showing ground and vegetation conditions. Vegetation cover was approximately 90% to 95% cover. Vegetation appeared healthy and met the permit requirements (i.e., >70% cover and healthy condition) (August 29, 2023).

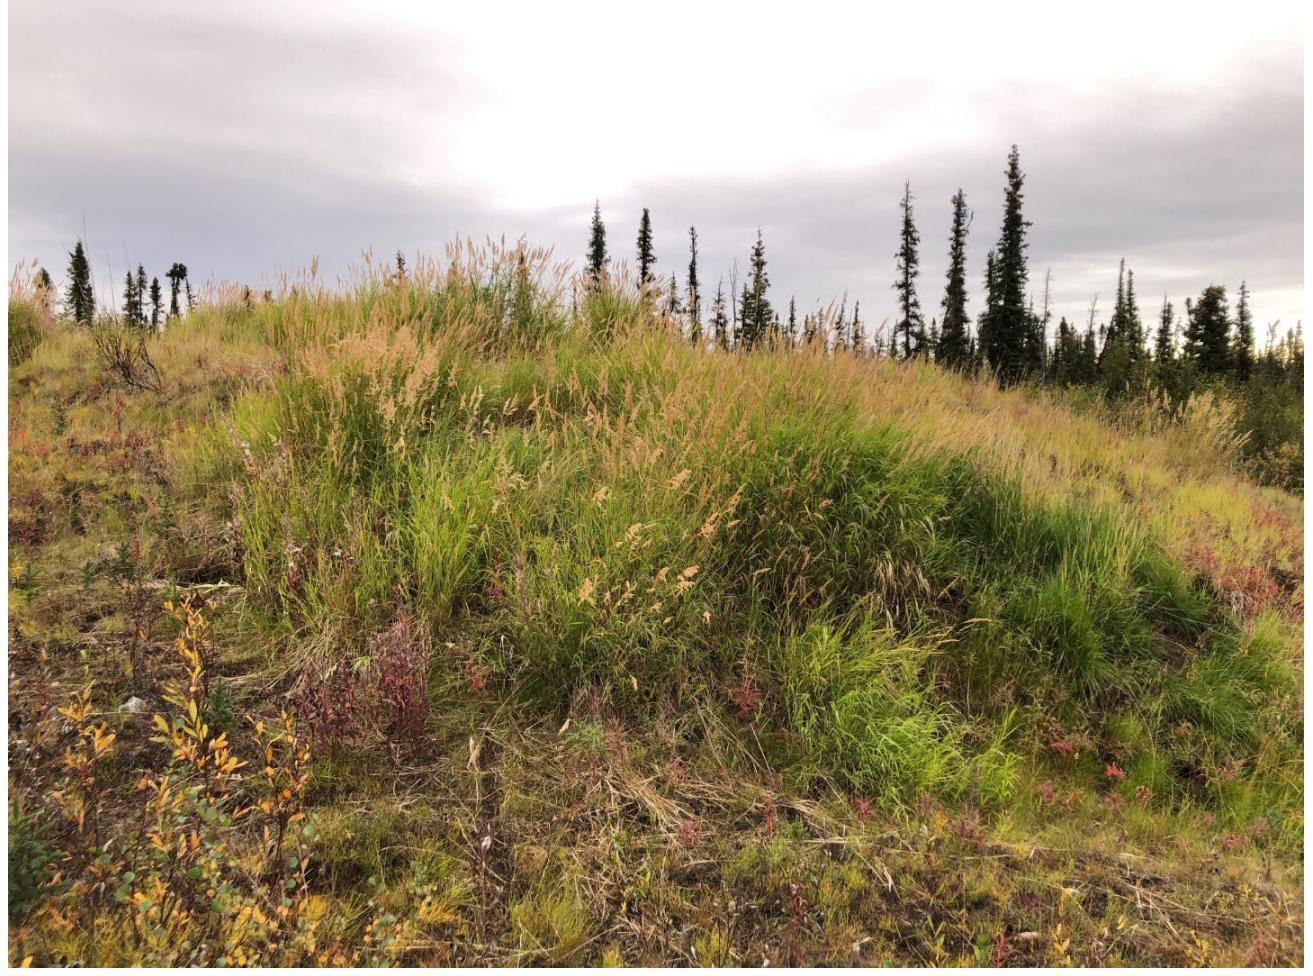
Photo B.14 E-35 Sump Area: Vegetation Cover - Sump 2 (Bare Area 4)

Note: View facing southeast toward Bare Area 4 showing ground and vegetation conditions. Vegetation cover was approximately 95% to 100% cover. Vegetation appeared healthy and met the permit requirements (i.e., >70% cover and healthy condition) (August 29, 2023).

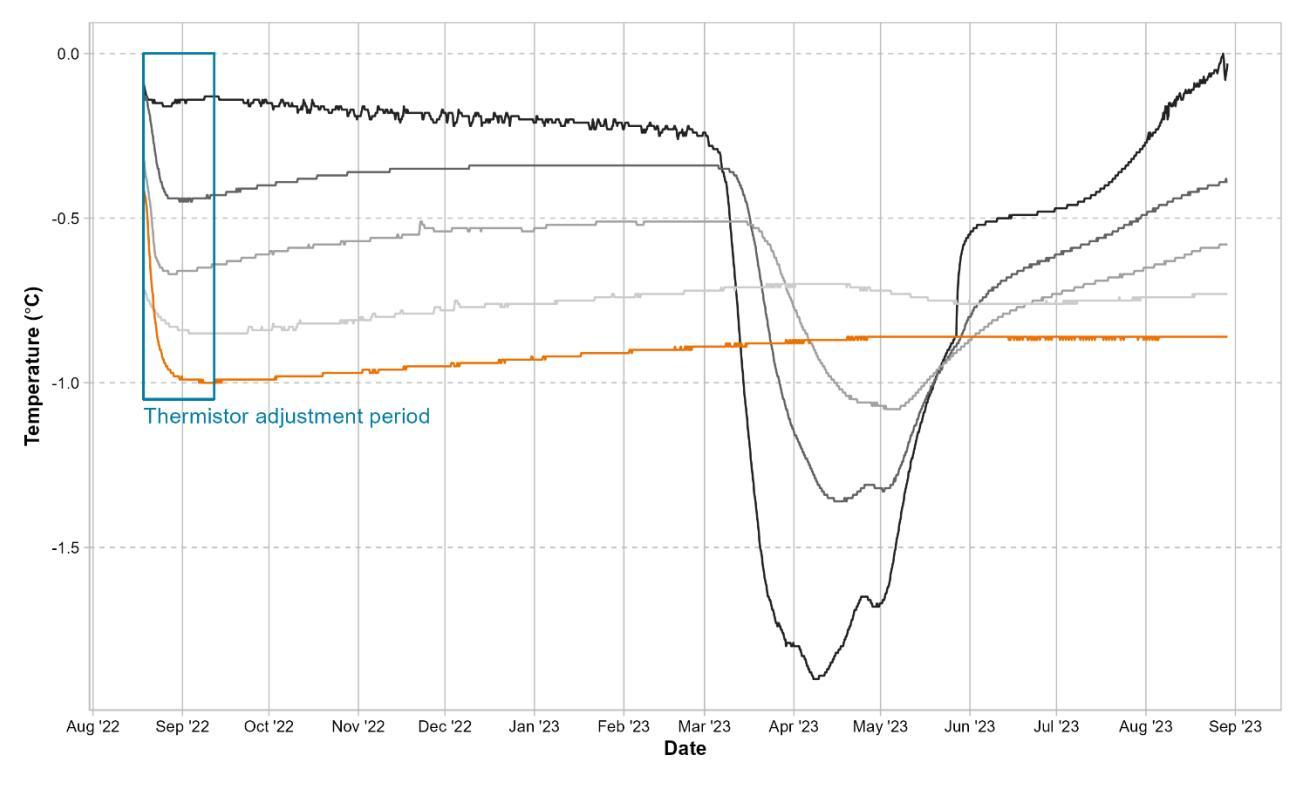
Graph C.1 Summary of Thermistor Data

• Ground temperature readings were collected from a thermistor installed in Sump 1. The data recorded during the August 2022 to August 2023 period is indicative of the presence of frozen ground within the sump. This includes buried drilling mud where depth is expected to range from 1.5 m to 3 m below ground surface. Refer to the temperature graphs (Attachment C: Graph C.1 and Graph C.2) for an overview of the ground temperatures recorded at Sump 1.
