# Memo

. sTo:	MGM Energy	From:	James Hymers, Project Manager K'alo-Stantec Ltd.
	2800, 421-7 Avenue SW Calgary, AB T2P 4K9		Tulita, NT, Canada X0E 0T0
File:	123514551	Date:	January 22, 2024

#### Reference: 2023 Environmental Site Monitoring Report: Nogha M-17 Wellsite Area

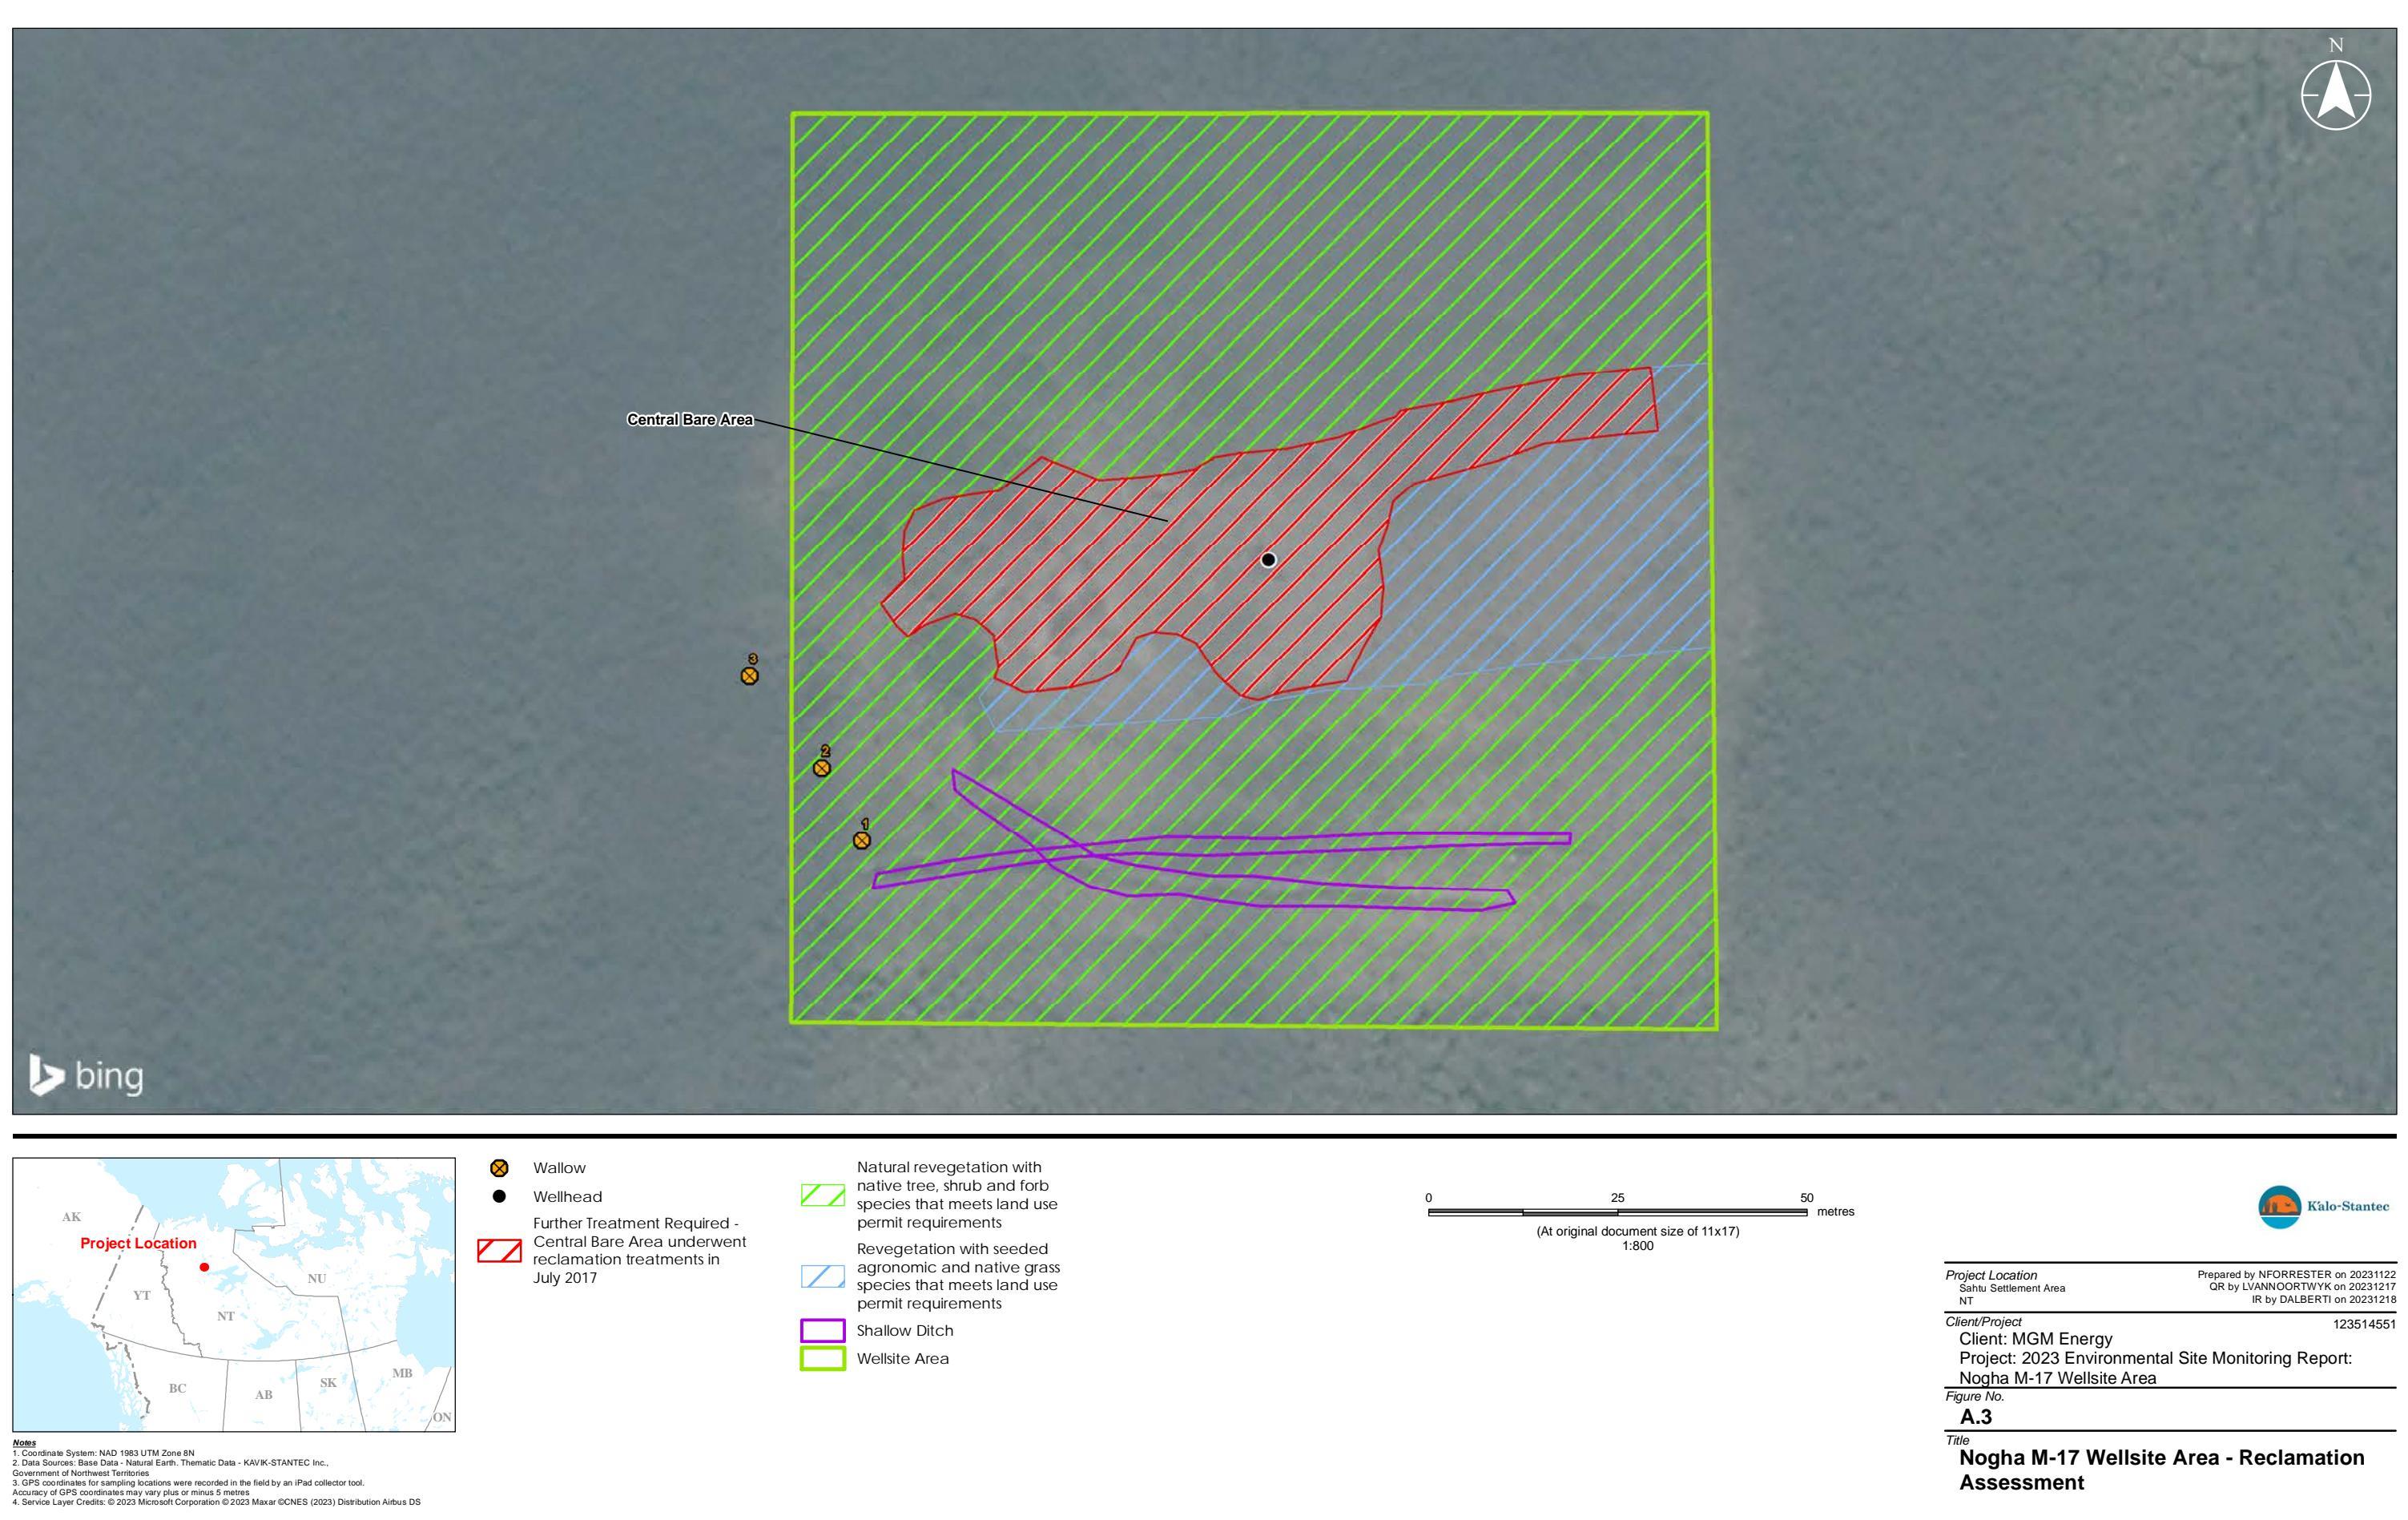
Parameters	Monitoring Observations and Results	Soil and Water Analytical Results (if exceedances)	Future Recommended Work
Vegetation (cont'd)	<ul> <li>Wallow 1 (Attachment A: Figure A.3):</li> <li>Wallow contained standing water at the time of the site visit and no vegetation was visible. Ground surface</li> </ul>	See above	<ul> <li>Reconnaissance level monitoring for invasive plants when a site visit is carried out.</li> </ul>
	around flooded wallow did not appear trampled or compacted by ungulate hoof traffic (Attachment B: Photo B.2 and Photo B.8)		<ul> <li>Carry out invasive plant/weed control treatments if infestations reach a density that prohibits vegetation establishment and growth, including pulling plants, storing in garbage bags, and disposing off-site at an approved facility.</li> </ul>
	<ul> <li>Vegetation in this area was not meeting the permit requirements for percent cover and health condition (i.e., had &lt;70% cover and in unhealthy condition).</li> </ul>

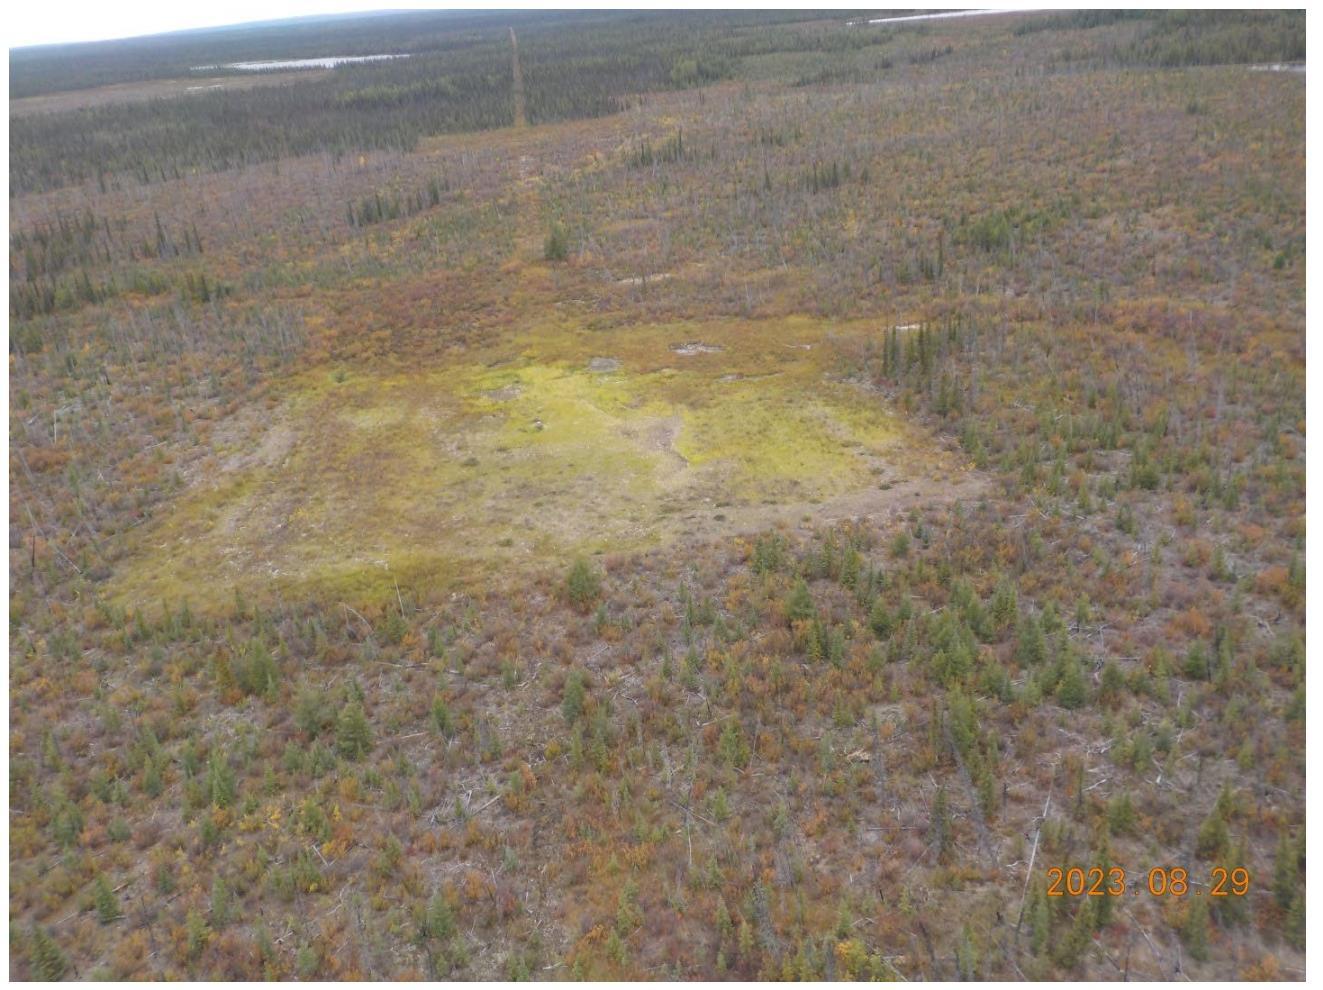
## Photo B.1 M-17 Wellsite Area: Overview

Note: West facing overview of the Wellsite Area and surrounding area showing overall terrain, water, and vegetation conditions (August 29, 2023).

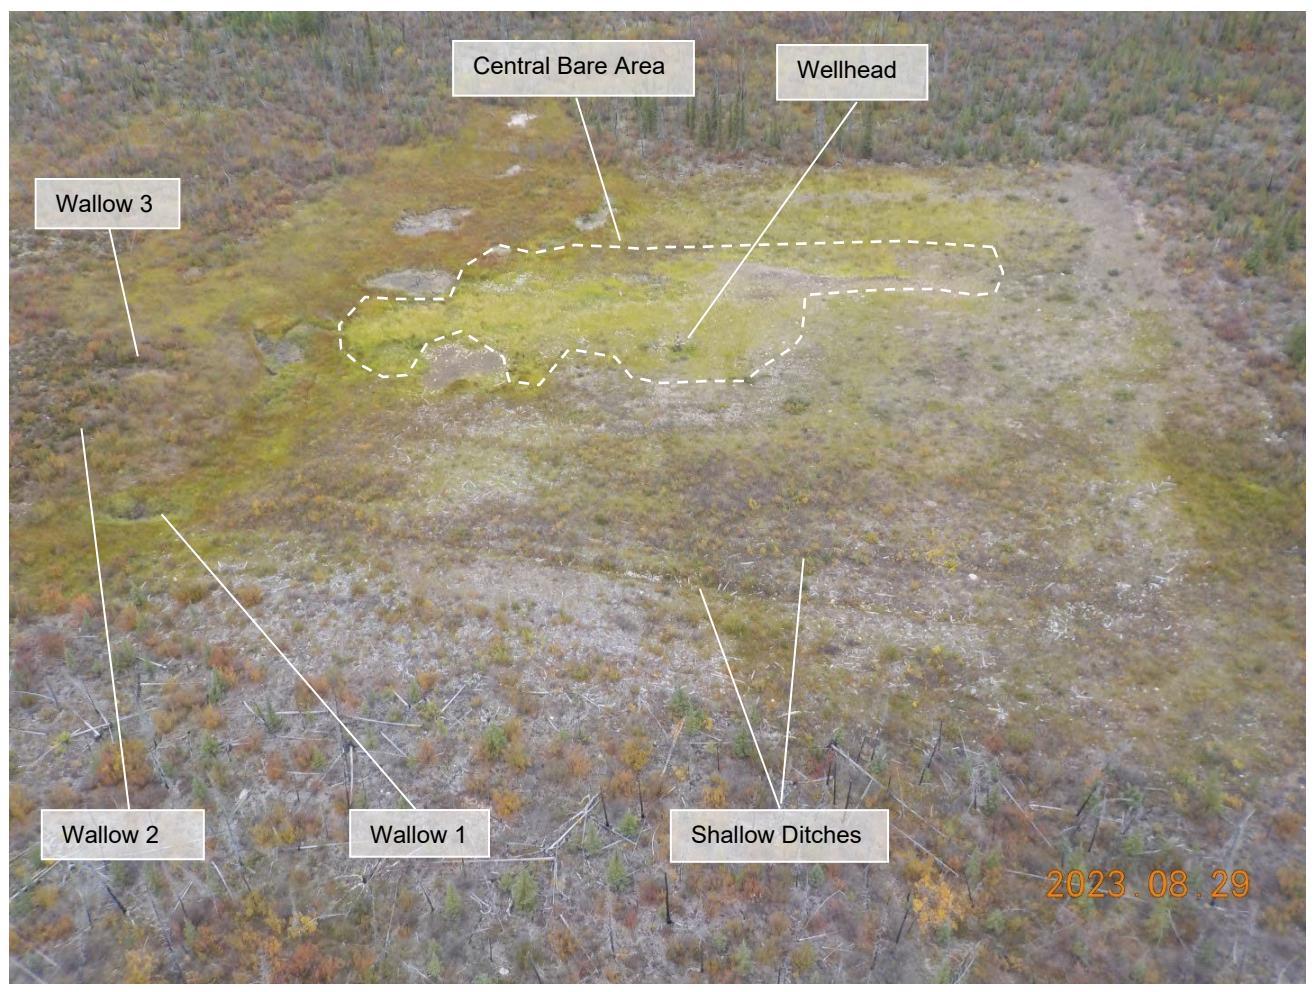
## Photo B.2 M-17 Wellsite Area: Overview

Wallow 2 (Attachment A, Figure A.3):		
	• Vegetation cover ranged from approximately 0% to 5% cover. Ground material consisted of soft peat and organic material which appeared trampled or compacted by ungulate hoof traffic or wallowing (Attachment B: Photo B.2 and Photo B.8).		
	<ul> <li>Vegetation in this area was not meeting the permit requirements for percent cover and health condition (i.e., had &lt;70% cover and in unhealthy condition).</li> </ul>		
	Wallow 3 (Attachment A, Figure A.3):		
	<ul> <li>Vegetation cover was approximately 35% cover. Ground material consisted of soft peat and organic material which appeared trampled or compacted by ungulate hoof traffic or wallowing (Attachment B: Photo B.2 and Photo B.8).</li> </ul>		
	<ul> <li>Vegetation in this area was not meeting the permit requirements for percent cover and health condition (i.e., had &lt;70% cover and in unhealthy condition).</li> </ul>

Note: North facing view showing the Wellsite Area, Wellhead, Central Bare Area, Wallow 1, Wallow 2, Wallow 3, and Shallow Ditches (August 29, 2023).

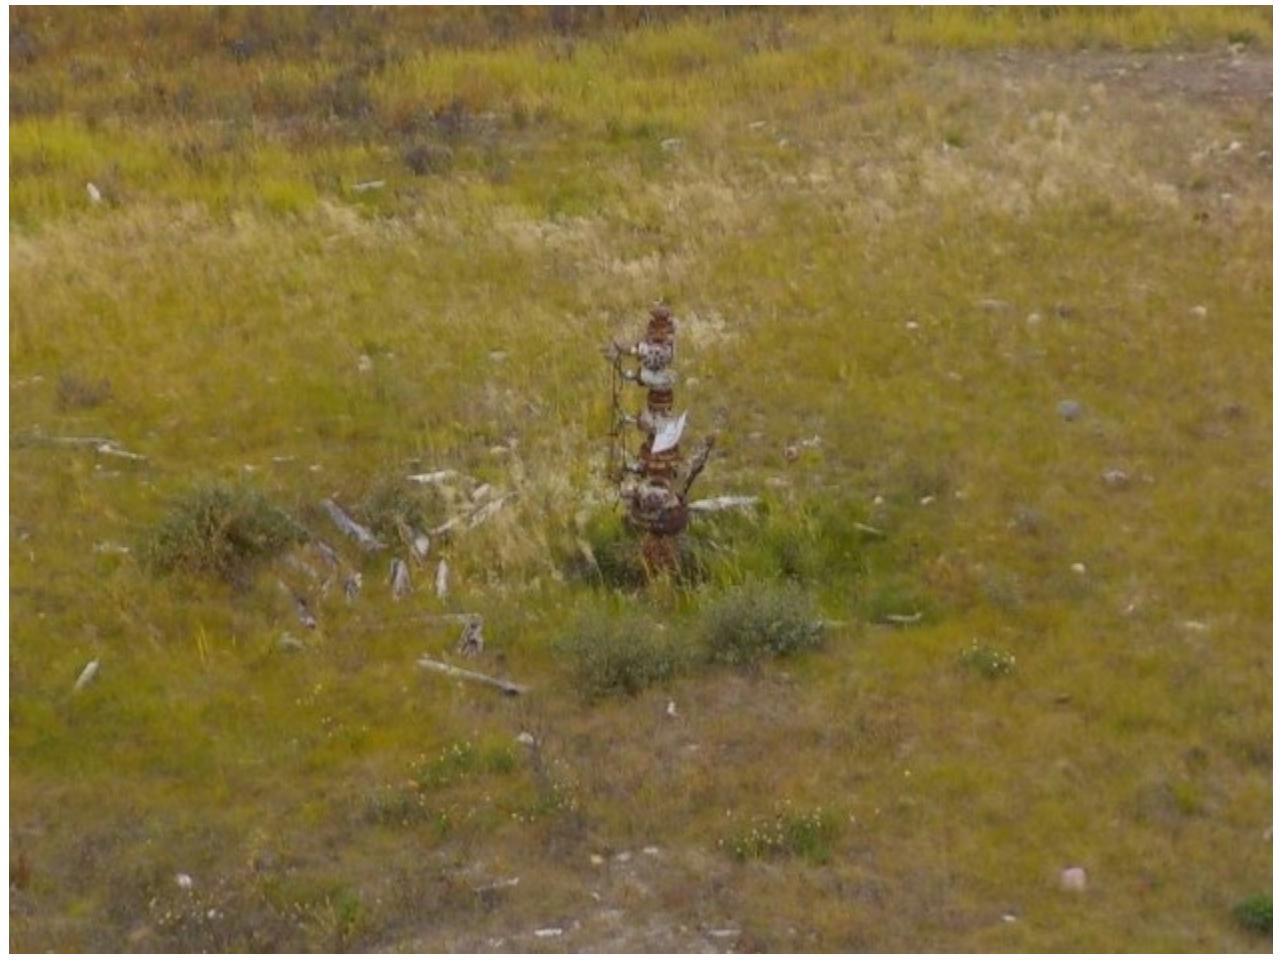
## Photo B.3 M-17 Wellsite Area: On-Site Materials

Soil and Water Analytical Results	
Parameters	Monitoring Observations and Results	(if exceedances)	Future Recommended Work
On-Site Materials	<ul> <li>Wellhead and protective culvert were the only structures observed at the time of the site visit (Attachment B: Photo B.3).</li> <li>No other surface structures, materials, or waste were observed within the remainder of the Site during the site visit.</li> </ul>	Not applicable for this parameter.	<ul> <li>No further work related to on-site materials is recommended until the wellhead is cut, capped, and abandoned.</li> </ul>
Terrain	<ul> <li>No erosion issues were observed at the Site during the site visit.</li> <li>No terrain stability concerns were observed at the Site during the site visit. Terrain conditions were observed to be stable.</li> </ul>	Not applicable for this parameter.	<ul> <li>Continue visual monitoring for potential signs of stress and/or ground movement.</li> </ul>

Note: North facing view of on-site materials showing wellhead, sign, and protective culvert (August 29, 2023).

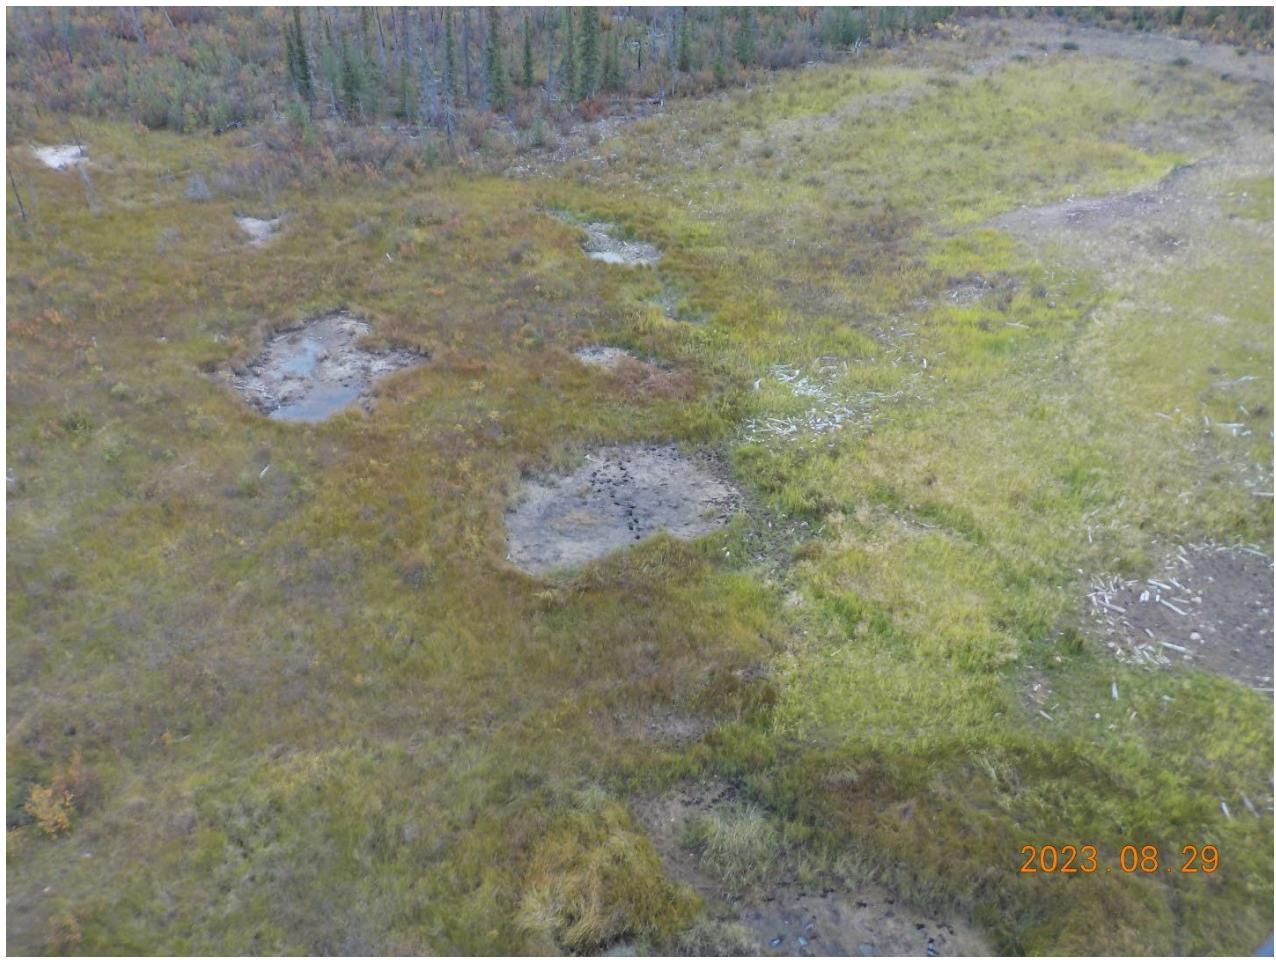
## Photo B.4 M-17 Wellsite Area: Standing Water - west end of lease area

Standing Water	<ul> <li>No standing water was sampled during the site visit.</li> <li>Standing water was observed in the west end of the Site along the lease boundary (Attachment B: Photo B.4). Unlike previous site visits, most of the pond areas at the west end of the Site were dry at the time of the 2023 site visit.</li> </ul>	• Water samples were not collected in this area during the 2023 site visit.	<ul> <li>Standing water sample collection at the wellhead and Central Bare Area, if present, to determine if there are any potential salinity exceedances originating from the wellhead to correlate with the soil data (M17-SS19-01<sup>4</sup>).</li> </ul>
Soils	<ul> <li>Soil was not sampled during the 2023 site visit.</li> <li>Previous samples collected in 2019 from Wallows 1, 2 and 3 reported petroleum hydrocarbon (PHC) exceedances. However, the exceedances were reported to be attributed to high organic matter (peat) interference based on the F3a/b fractionation and field observations of high organic matter and lack of petrogenic observations (i.e., odour and/or staining). As a result, further investigation pertaining to the PHC exceedances was not recommended <sup>5</sup>.</li> </ul>	• Soil samples were not collected in this area during the 2023 site visit.	• Soil sample collection to support vegetation reclamation may be required where vegetation is affected by elevated EC and SAR. Sampling to be completed after amendment application once well is abandoned. Samples should be submitted for detailed salinity.

Note: Northeast facing view of standing water areas on the west end of the Wellsite Area (August 29, 2023). Unlike previous site visits, most of the areas did not contain water at the time of the 2023 site visit.

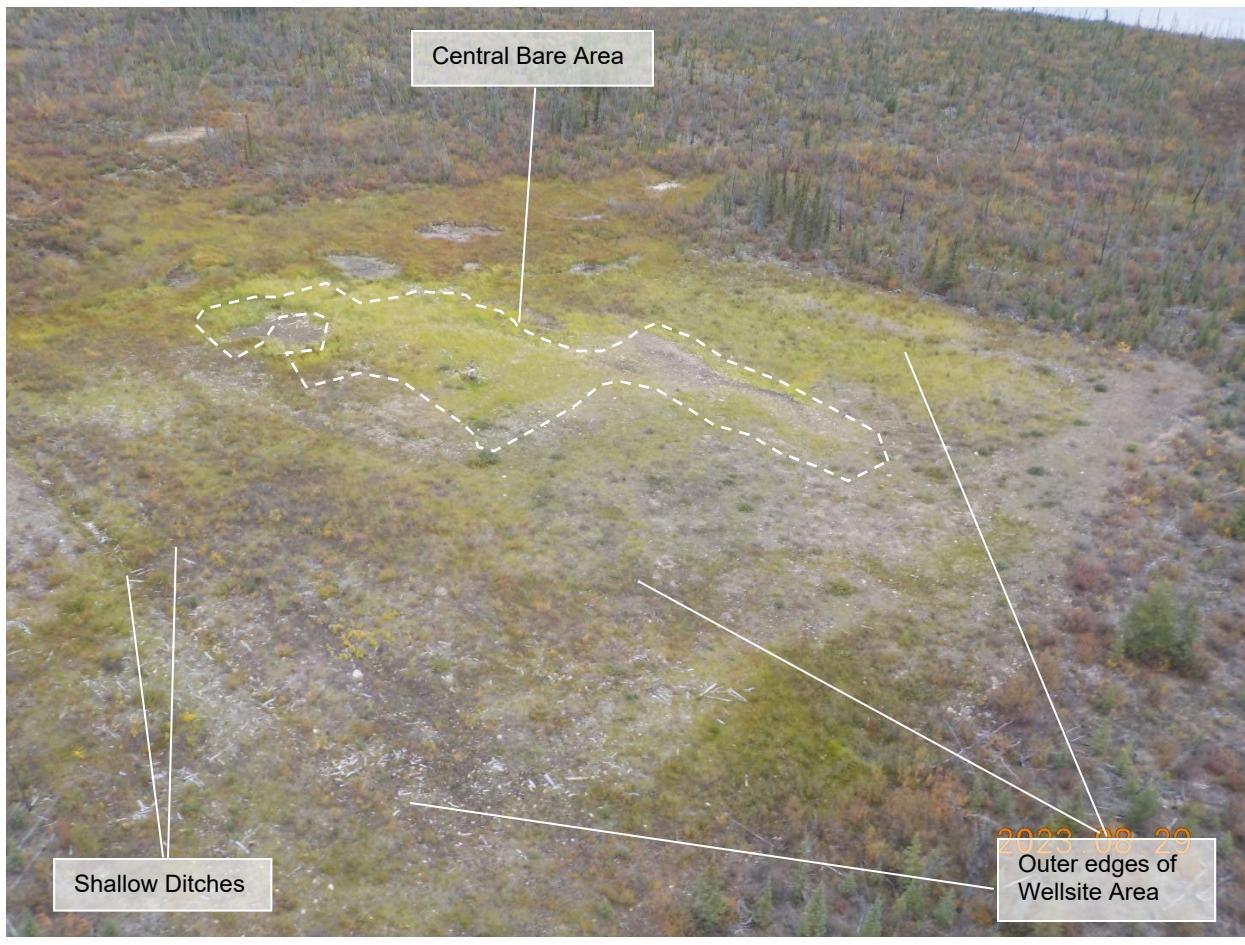
### Photo B.5 M-17 Wellsite Area: Vegetation Cover - Wellsite Area

Note: Northwest facing view of ground and vegetation conditions in the Wellsite Area. Outer edges of the Wellsite Area had revegetated with seeded grasses and naturally established tree, shrub, and forb species and continued to meet permit conditions (i.e., >70% cover and healthy condition) (August 29, 2023).

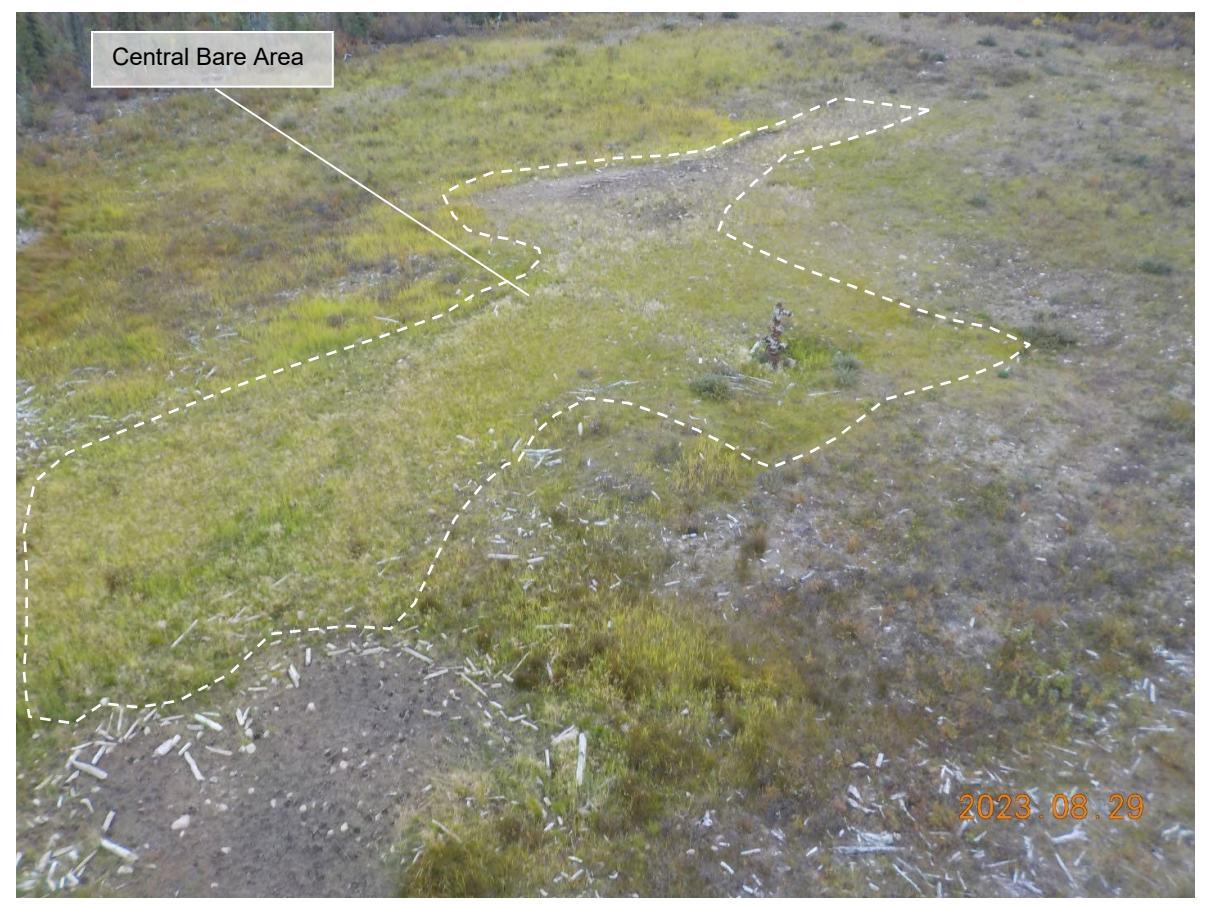
#### Photo B.6 M-17 Wellsite Area: Vegetation Cover - Central Bare Area

Note: Northeast facing view of Central Bare Area (August 29, 2023). Area underwent reclamation treatments in July 2017. Vegetation cover ranged from approximately 40% to 75% cover. In some sections, vegetation was heavily grazed by ungulates (most likely muskox) (66% to 80% of plants grazed) and ground was heavily trampled and compacted by hoof traffic. Note ungulate hoof prints in the muddy ground. Overall, vegetation cover was not meeting permit requirements (i.e., had <70% cover and in unhealthy condition).

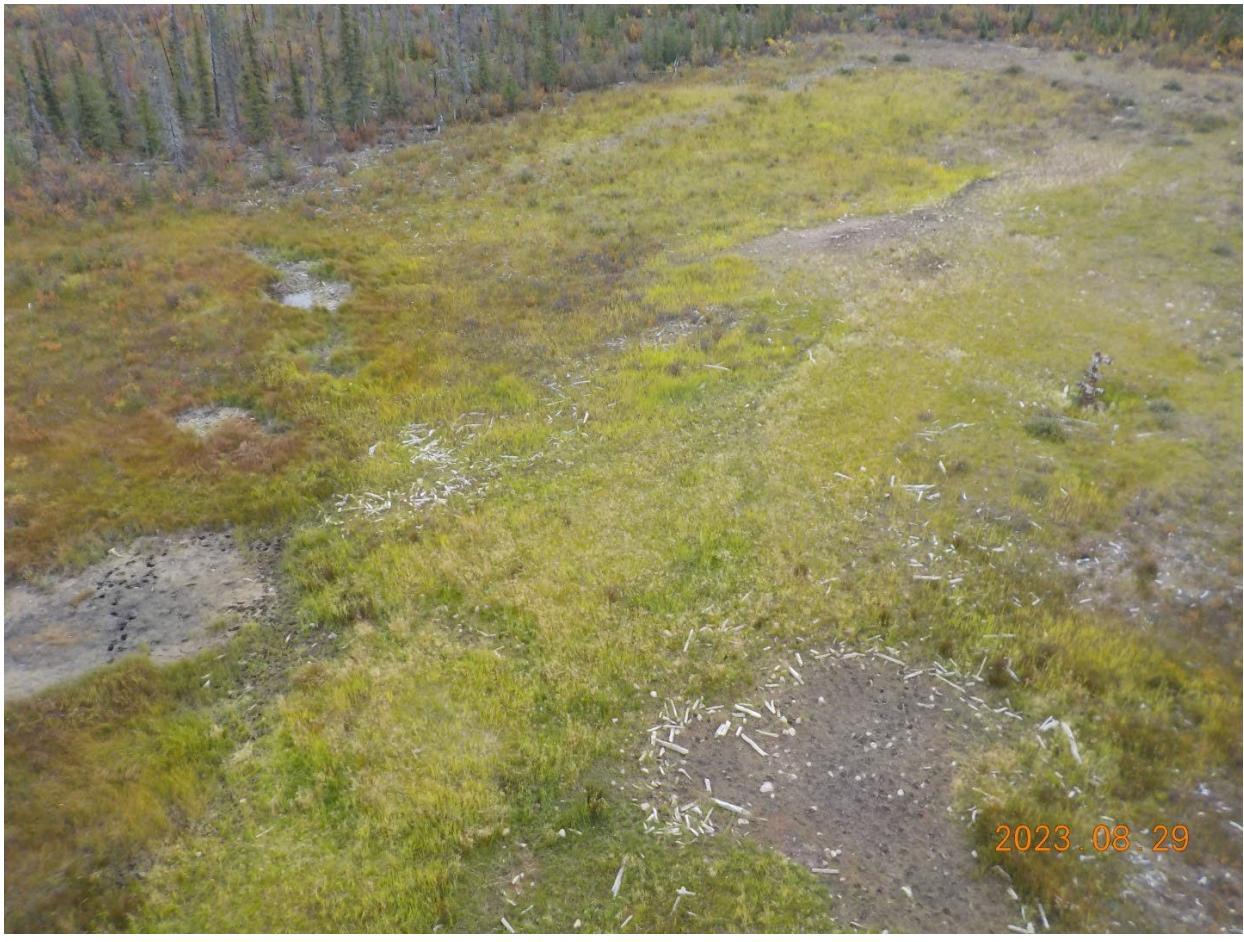
Photo B.7 M-17 Wellsite Area: Wildlife Signs - standing water areas

Parameters	Monitoring Observations and Results	Soil and Water Analytical Results (if exceedances)	Future Recommended Work
Wildlife Signs	• Muskox, or other ungulates, had heavily used standing water at the west end of the Site as evidenced by numerous hoof prints observed in the muddy soil adjacent to the water (Attachment B: Photo B.7).	<ul> <li>Not applicable for this parameter.</li> </ul>	• Due to heavy muskox use on the Site, no further reclamation treatments recommended on the Central Bare Area unless fencing, or deterrent structures/coarse woody debris can be installed to effectively protect treated areas from muskox damage.
	<ul> <li>Wallows 1 to 3 were still present at the time of the site visit and continued to be used by ungulates (most likely muskox) (Attachment B: Photo B.8).</li> </ul>		
	<ul> <li>No other wildlife signs of use observed within the Site during the site visit.</li> </ul>		<ul> <li>Continue monitoring for wildlife use at the Site.</li> </ul>

Note: Northeast facing view of standing water areas located on the west end of the Wellsite Area. Muskox heavily used standing water at the west end of the Site as evidenced by numerous hoof prints in muddy soil (August 29, 2023).

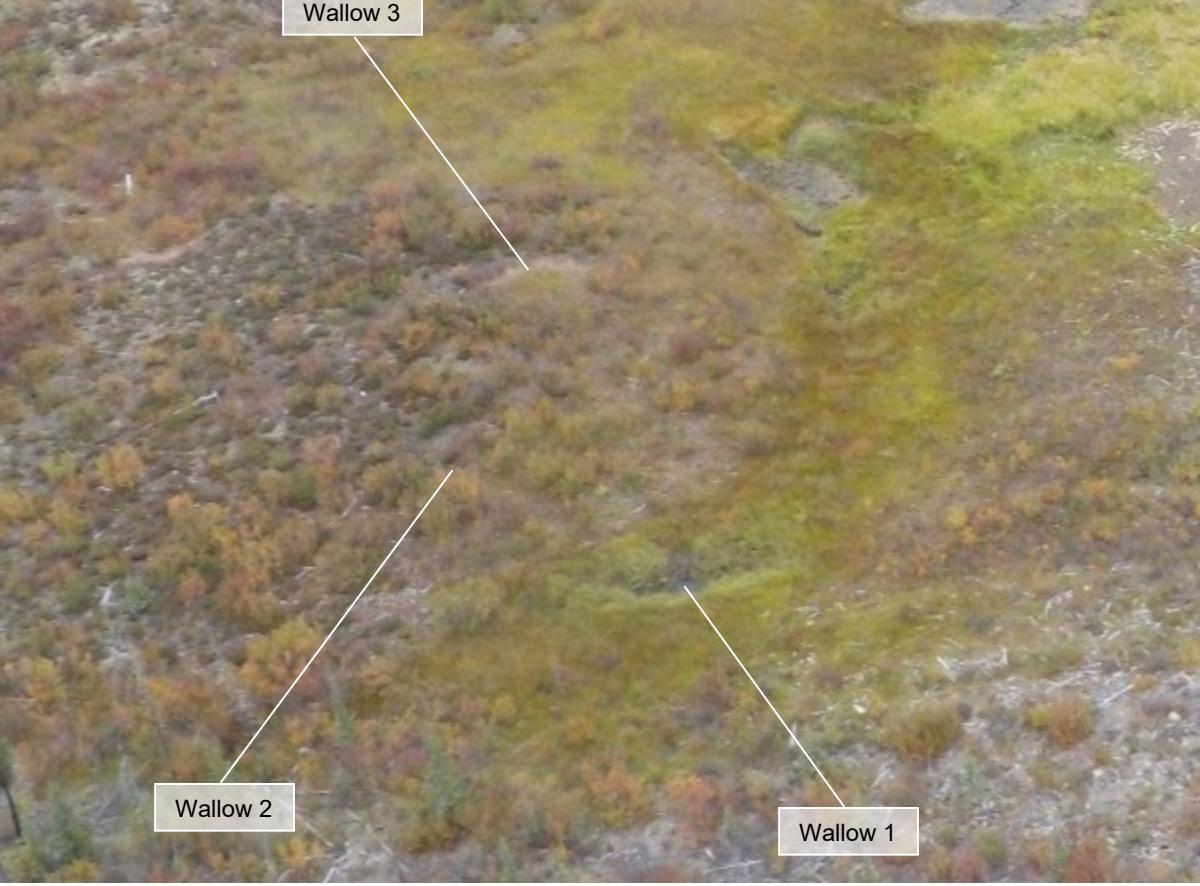
#### Photo B.8 M-17 Wellsite Area: Wildlife Signs - Wallows

Note: North facing view of Wallows 1, 2, and 3 located on the west end of the Wellsite Area. Wallows were still present and continued to be used by ungulates (most likely muskox) (August 29, 2023).
