Closure and Reclamation Plan East MacKay, Northwest Territories

September 2022
Suite 2800
421, 7th Avenue SW
Calgary, AB T2P 4K9
Phone: (403) 290-3600

APPENDIX A

Site Photos

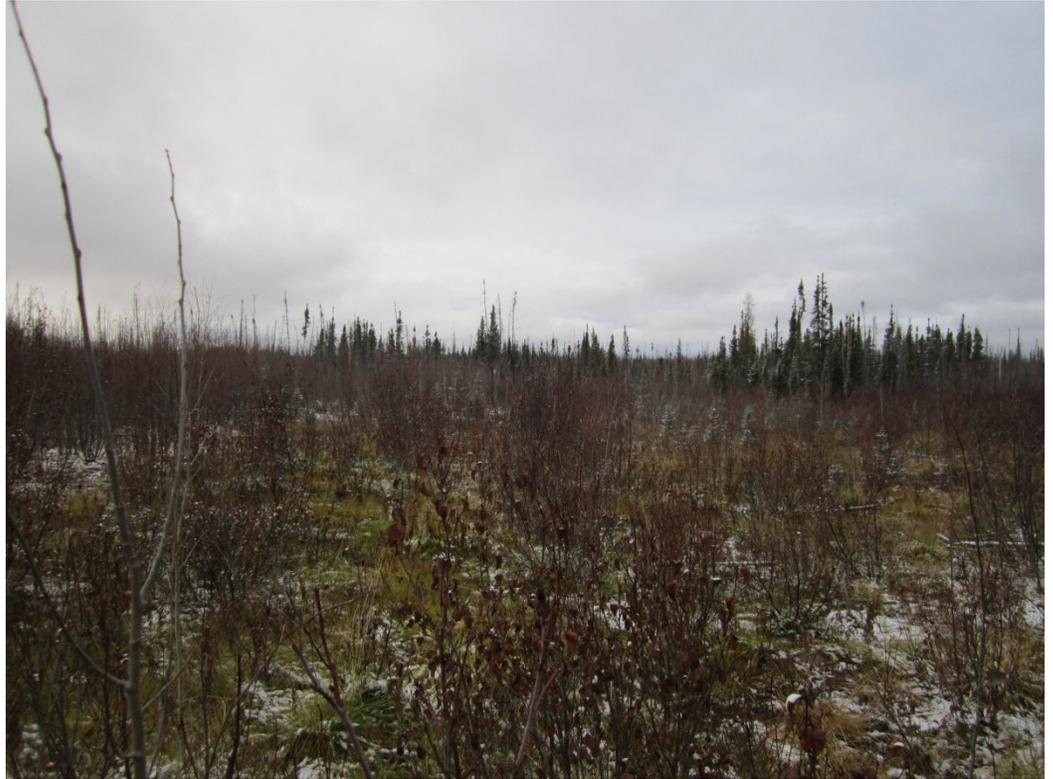
Photo No.
5

Old burn area with new re-
growth Area of Interest -
North

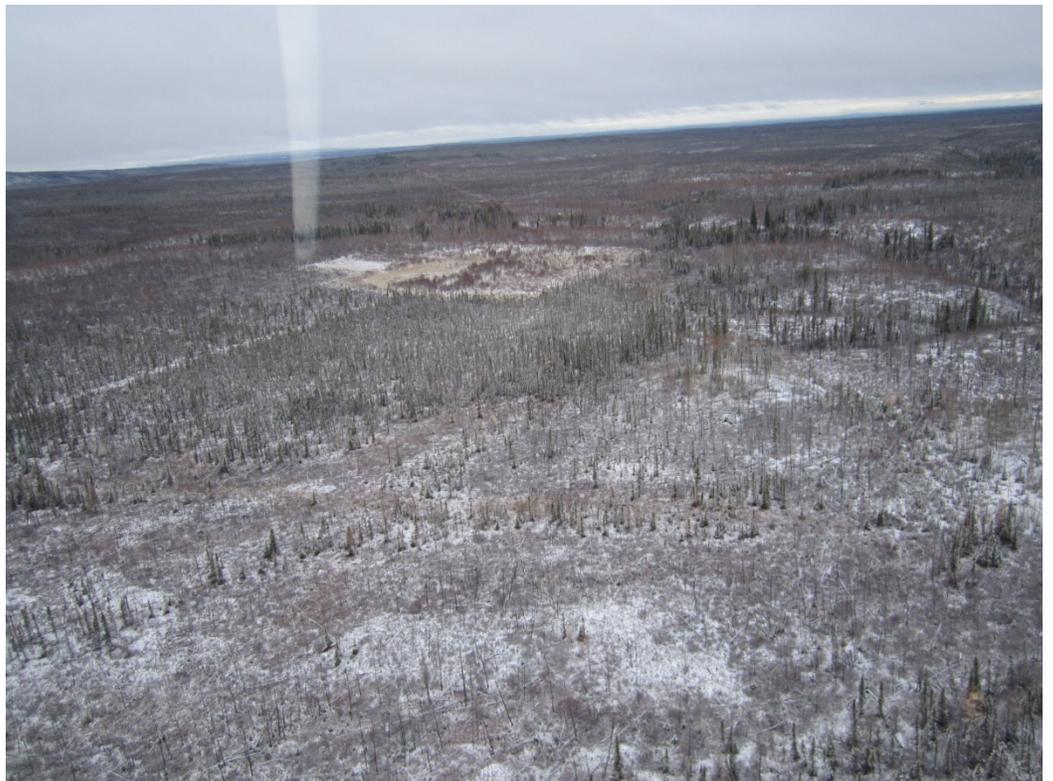
Photo No.
6

Area of Interest - North
from helicopter.

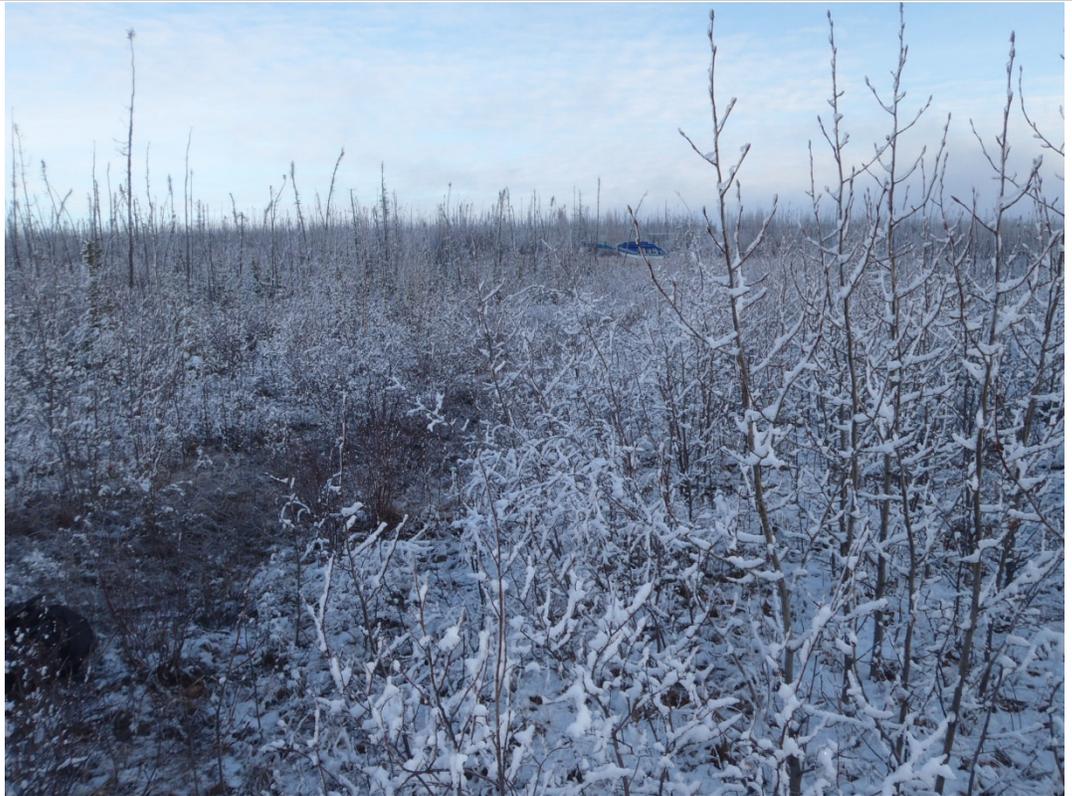
Photo No.
3

Campsite #2, next to seismic line with road in the distance.

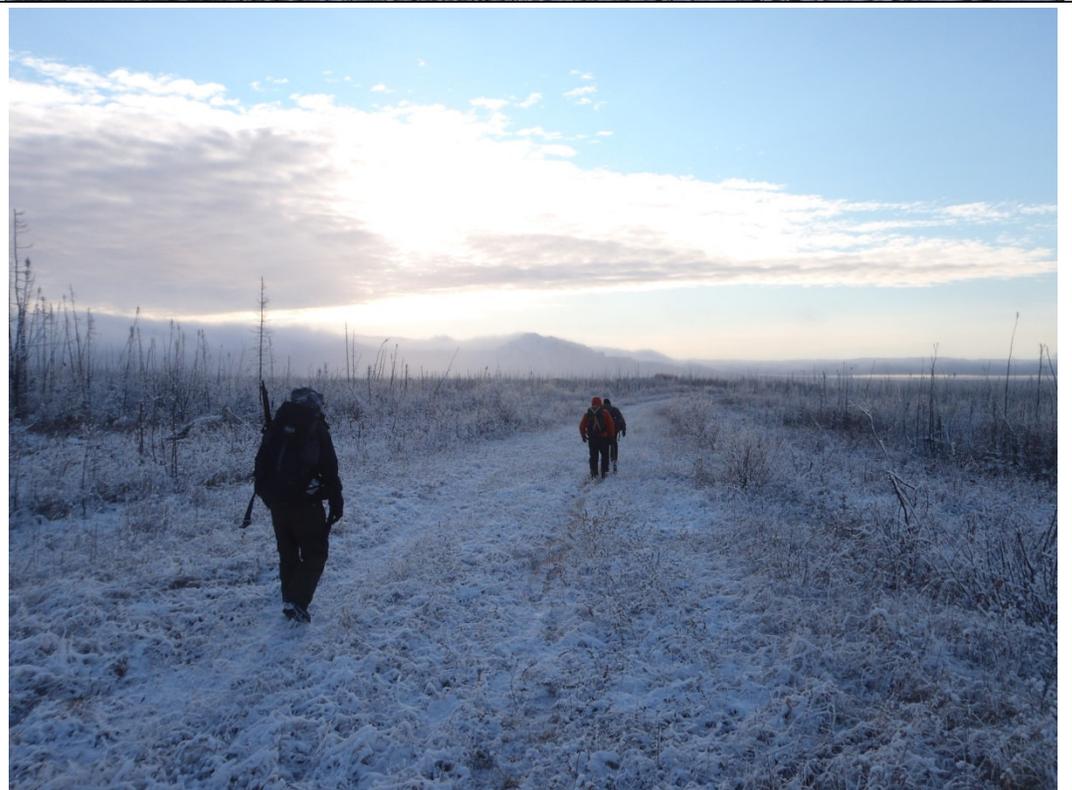
Photo No.
4

Road Northeast of
campsite #2.

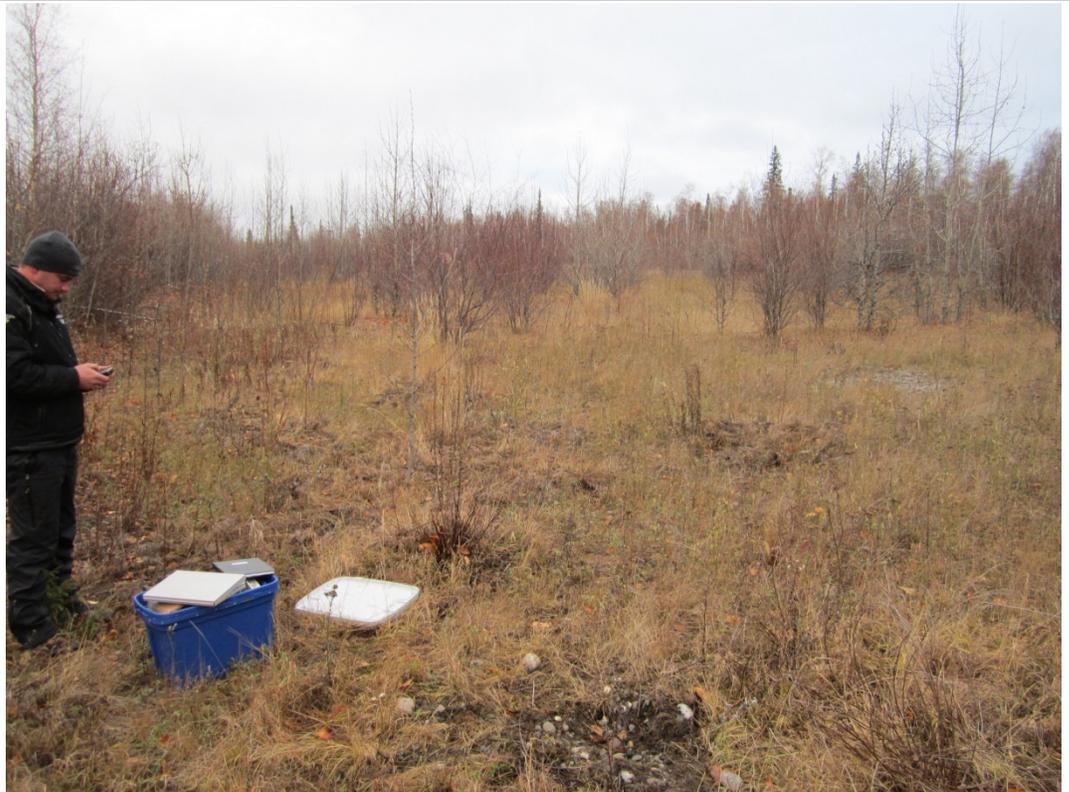
Photo No.
3

Northwest of Staging
area.

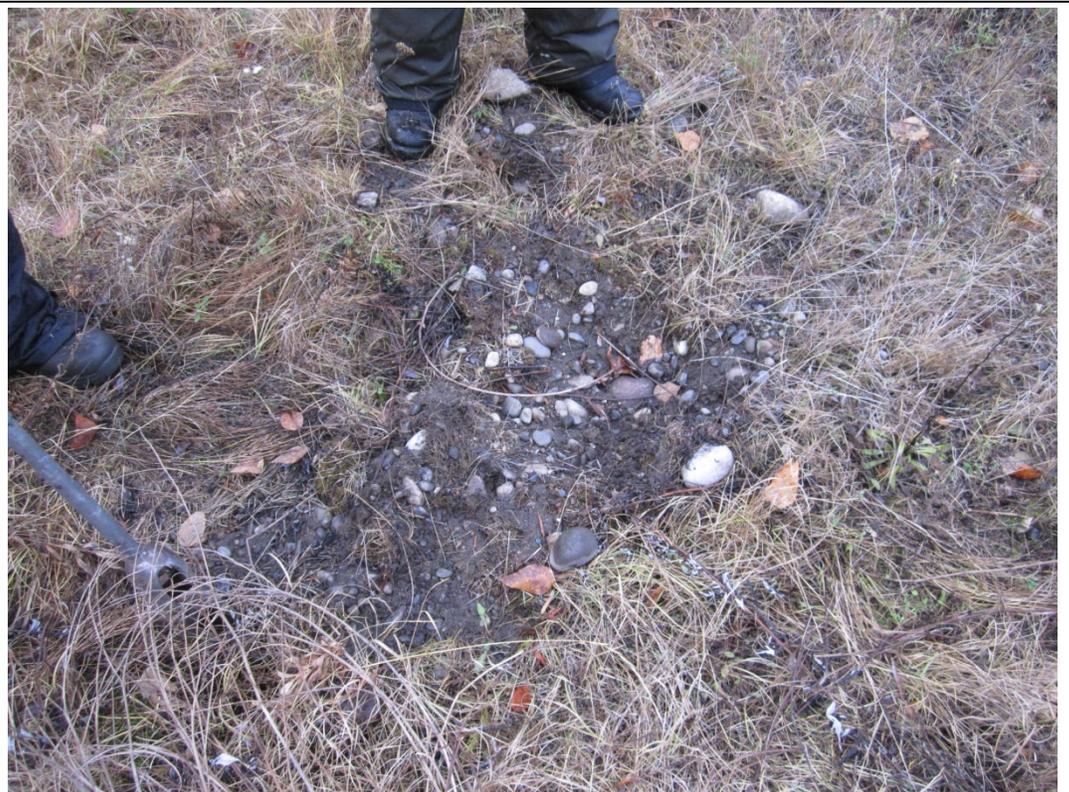
Photo No.
4

Dense gravelly, cobbly
sand encountered at
Staging area.

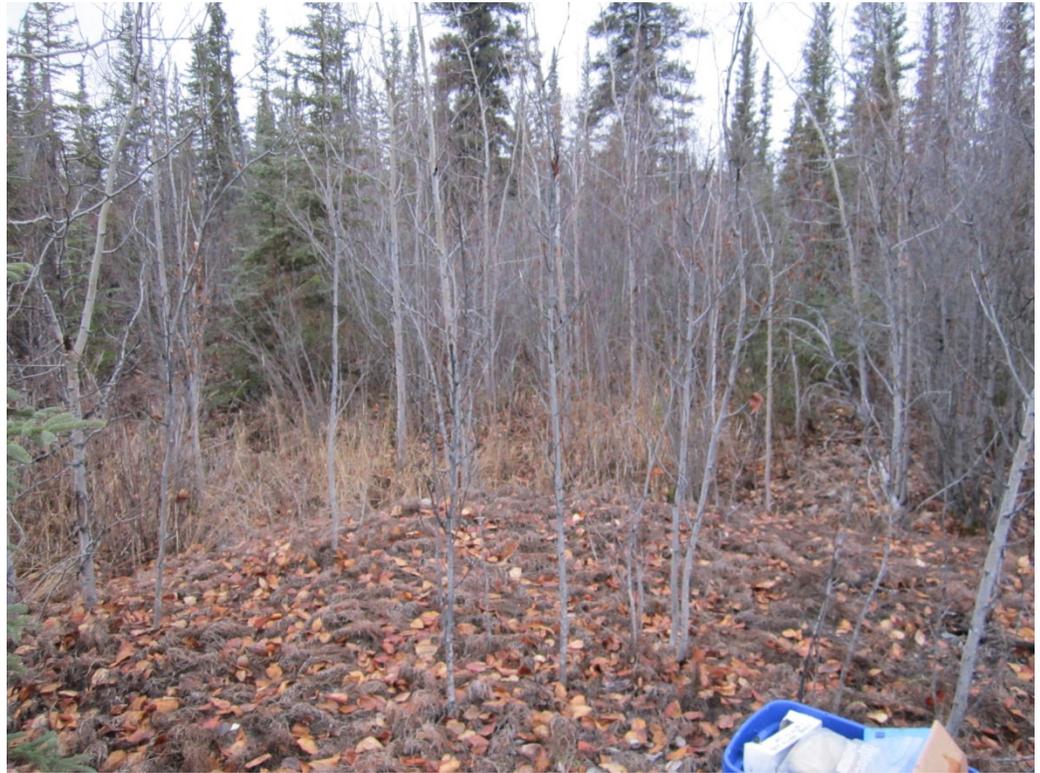
Photo No.
5

Southwest of Staging
Area.

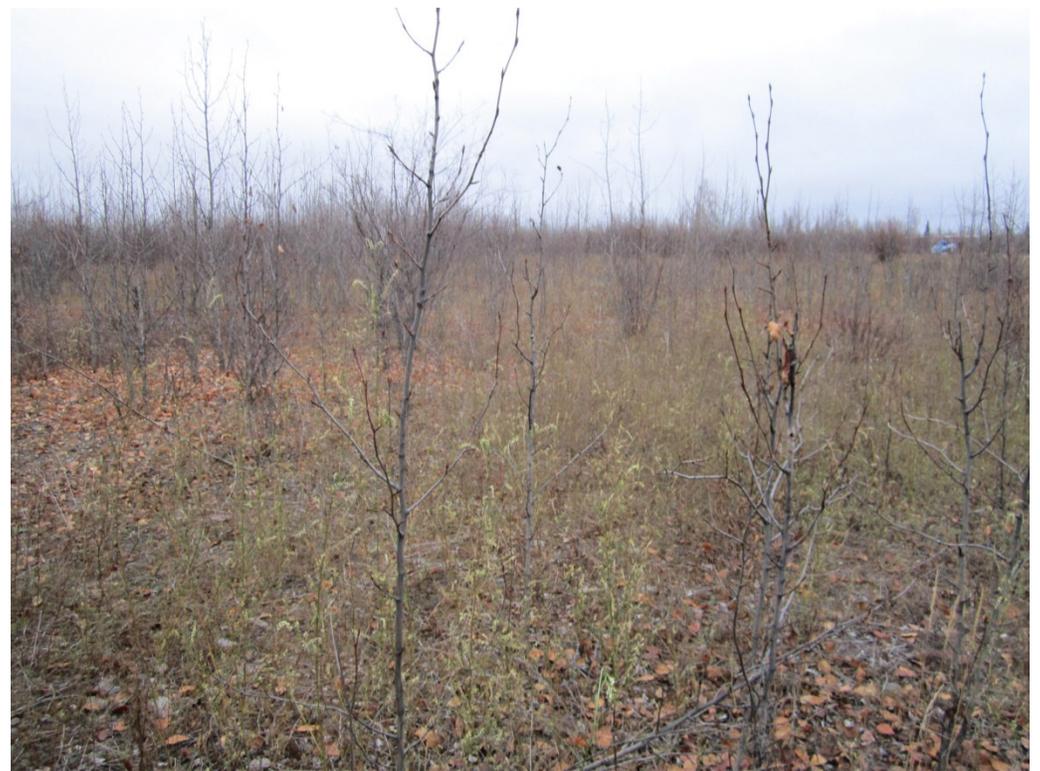
Photo No.
6

Southwest of Staging area
toward centre of site.

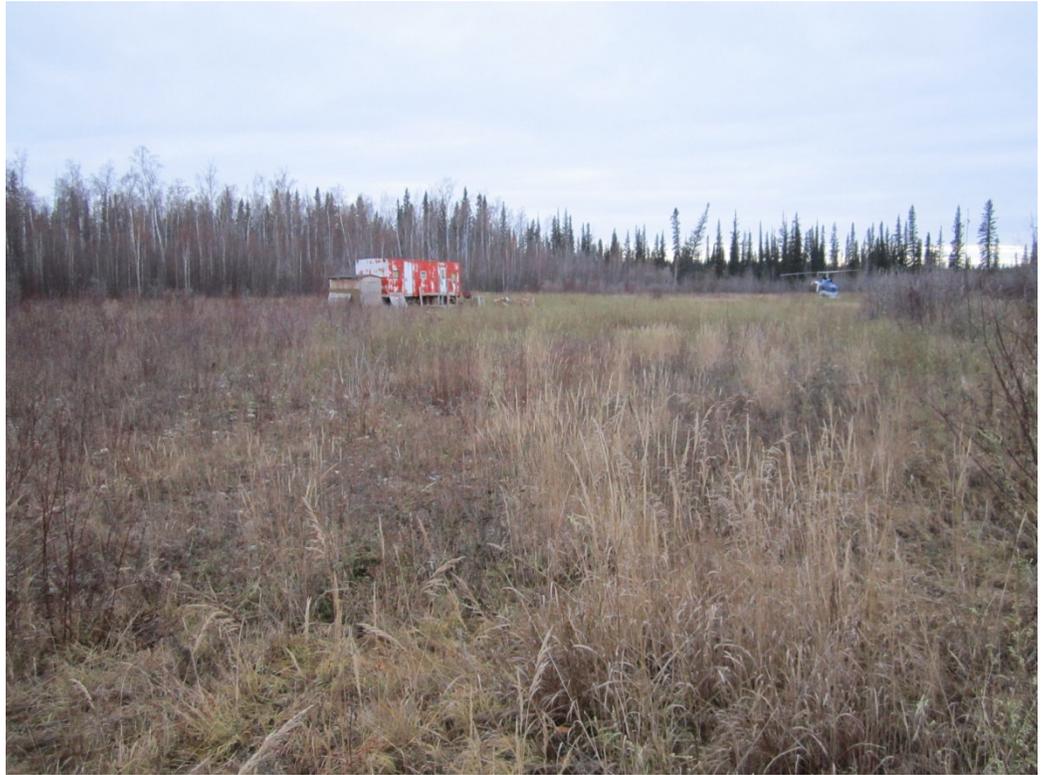
Photo No.
7

Northeast of Staging area
toward centre of site.

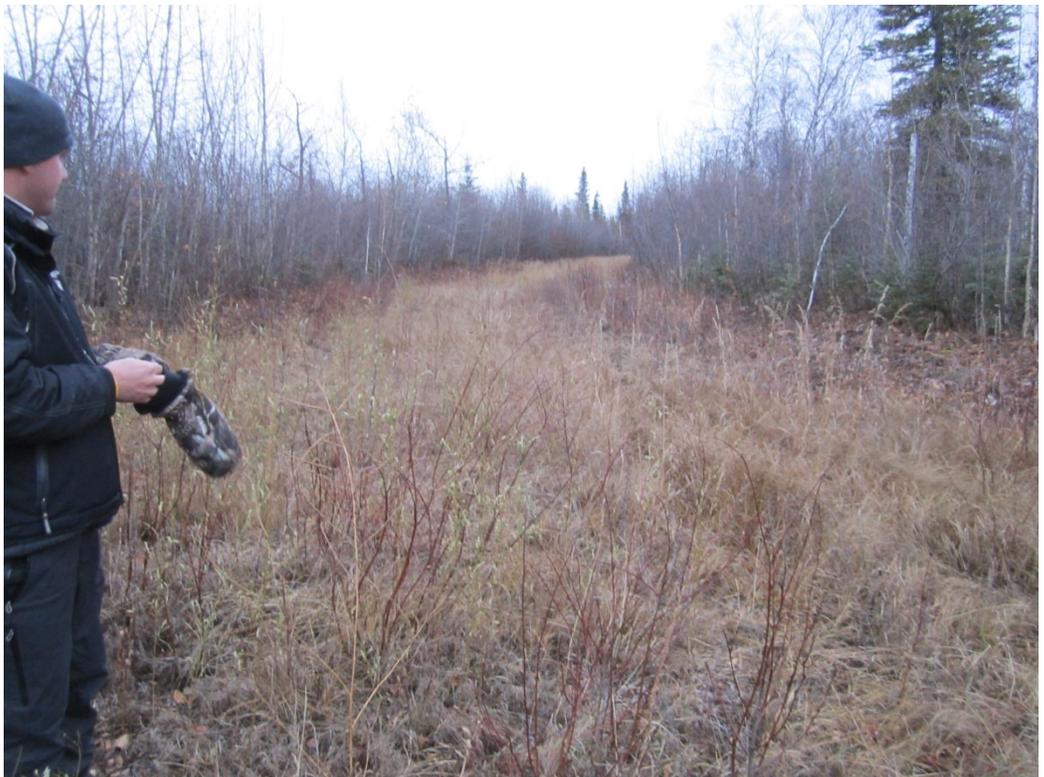
Photo No.
8

Access road West of
Staging area from Staging
area.

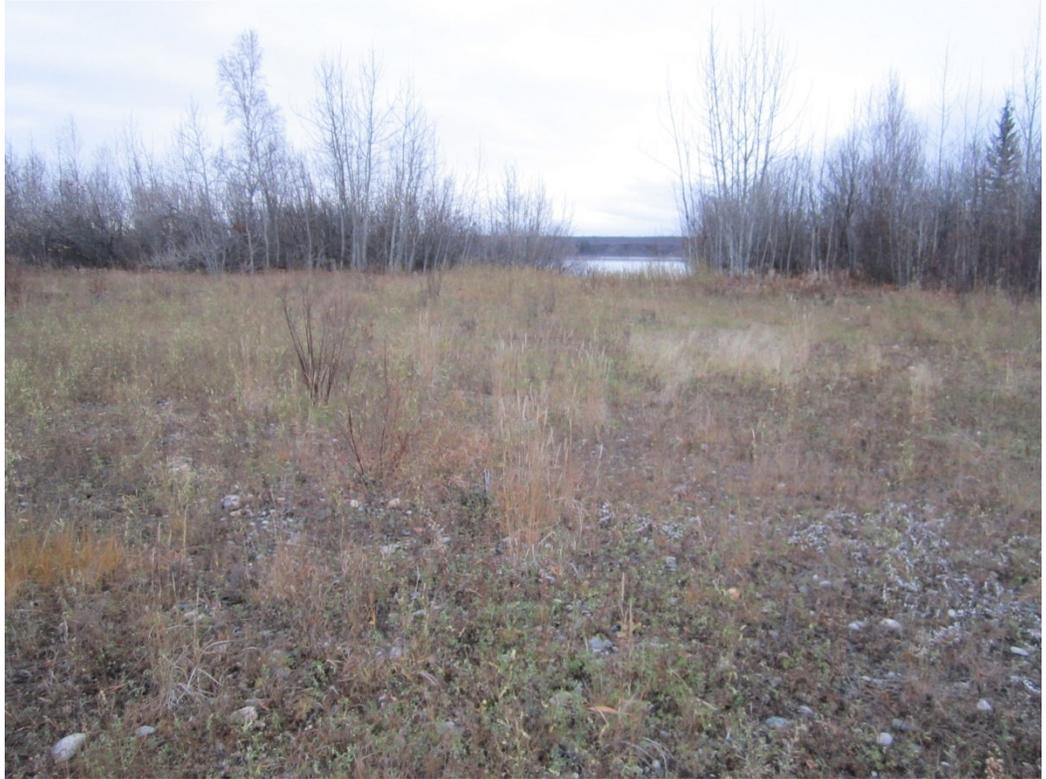
Photo No.
8

Staging area toward
MacKenzie River; view
from next to trailer at site.

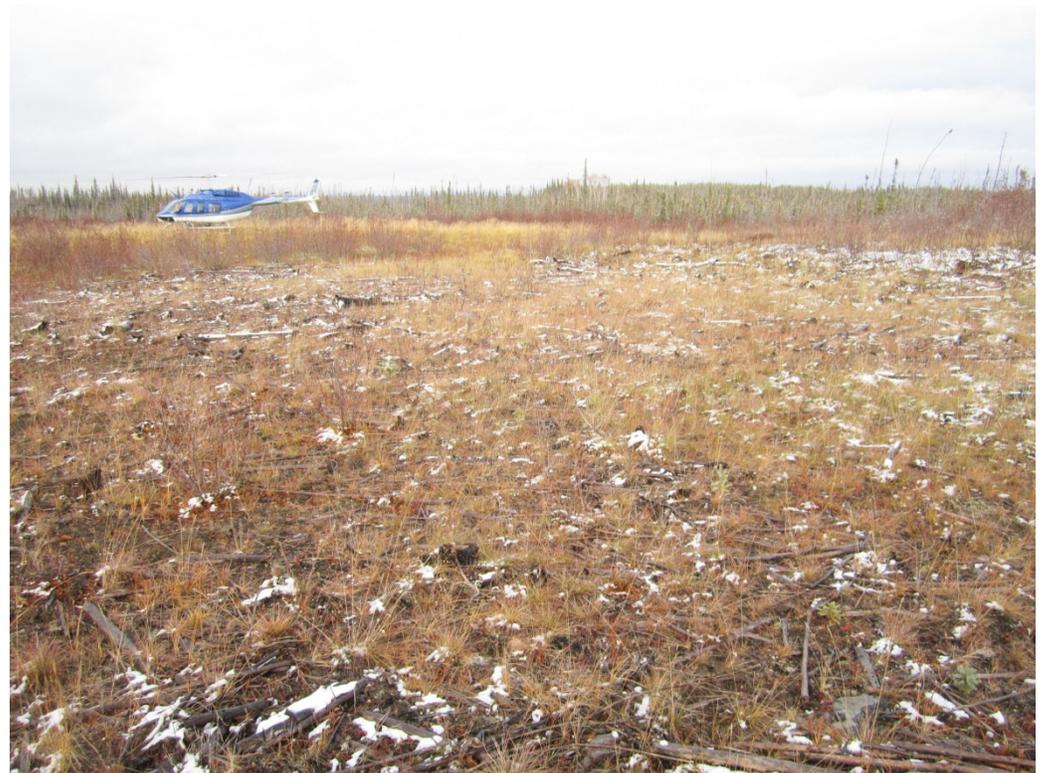
Photo No.
10

Staging Area.

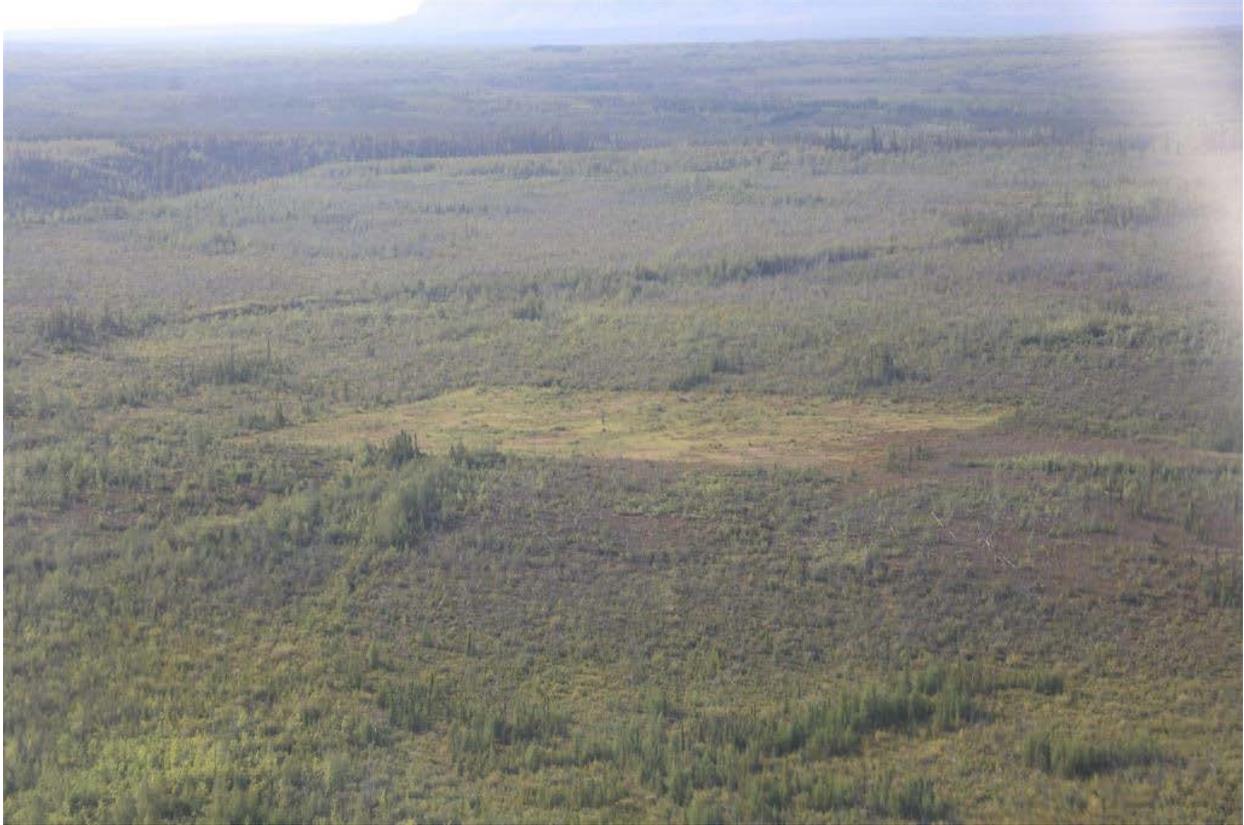
NOTE: Overview of the Wellsite Area and surrounding area showing overall terrain and vegetation conditions (August 20, 2020).

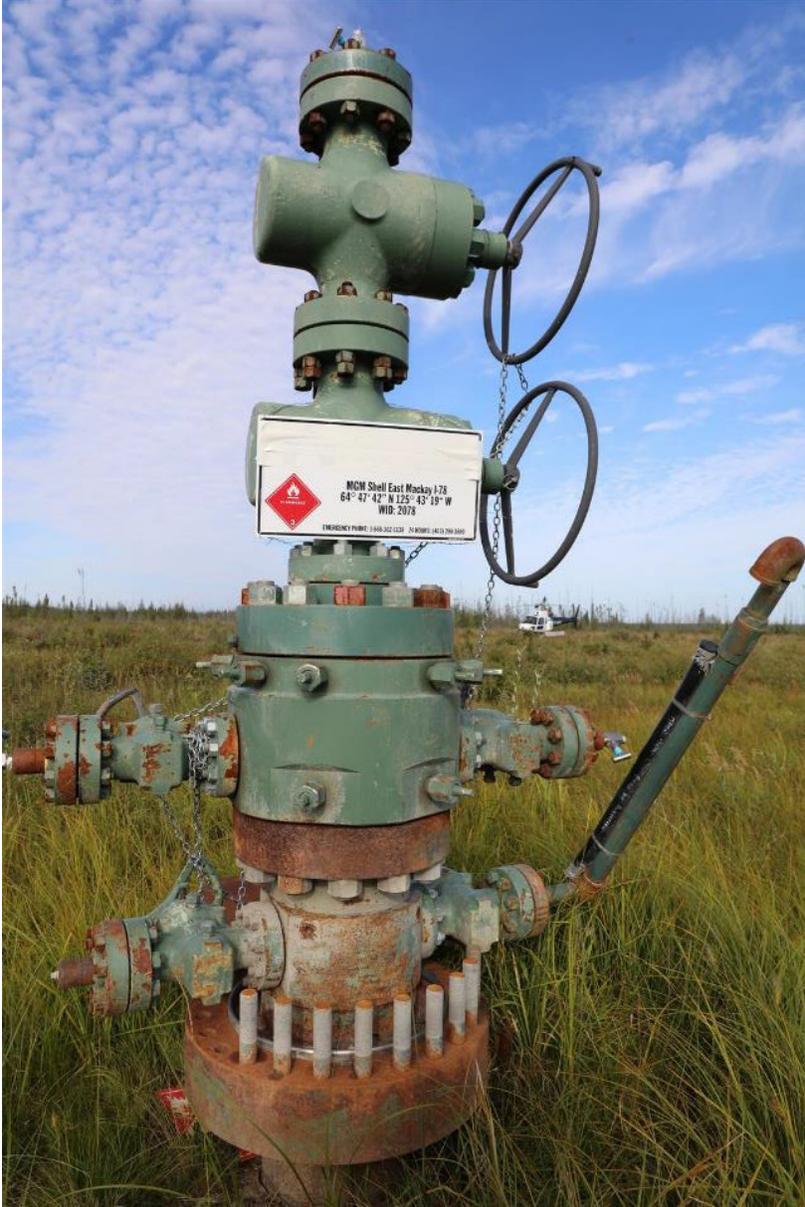
Minor slumping around the wellhead was noted by the Land Use Inspector in 2021, this will be addressed after the abandonment after the wellhead has been removed.

NOTE: On-site materials showing wellhead and sign (August 20, 2020).

Soil and standing water exceedances were noted at the well center in 2019. The well center (wellhead) area exceedances were delineated in the summer of 2022. Results will be submitted as part of the 2022 Annual Report and will be used to inform the amount of reclamation/remediation for the site. After cut and cap of the wellhead soils will be sampled, any remaining soil exceedances will be removed. MGM expects to remove the impacted soils, if any, from the site as per the project Waste Management Plan. MGM will source clean fill and backfill the excavation, this operation will also address the noted slumping at the wellhead.

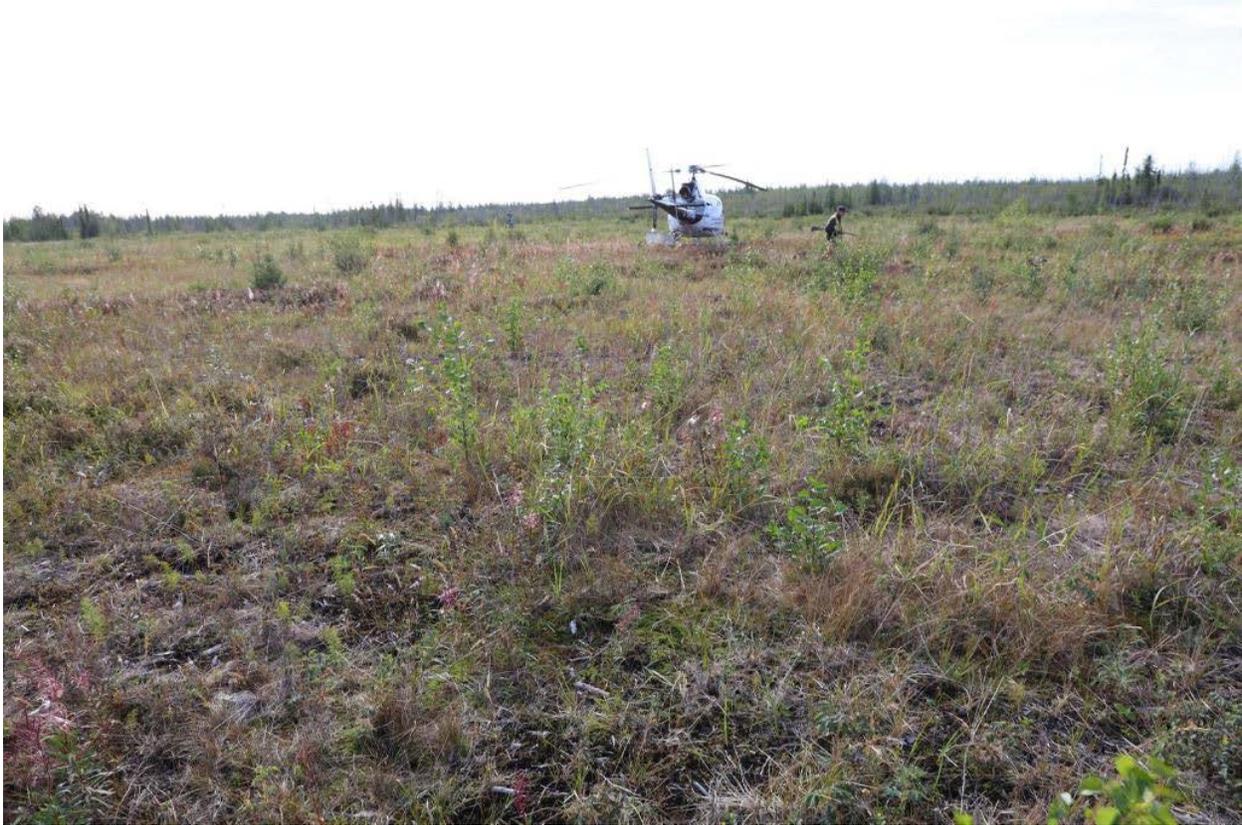
NOTE: View of ground and vegetation conditions in the Wellsite Area looking southeast. Wellsite Area was undisturbed and has revegetated with naturally established native trees, shrubs, and forbs. Vegetation cover, was meeting permit requirements (>70% cover, healthy conditions) (August 20, 2020).

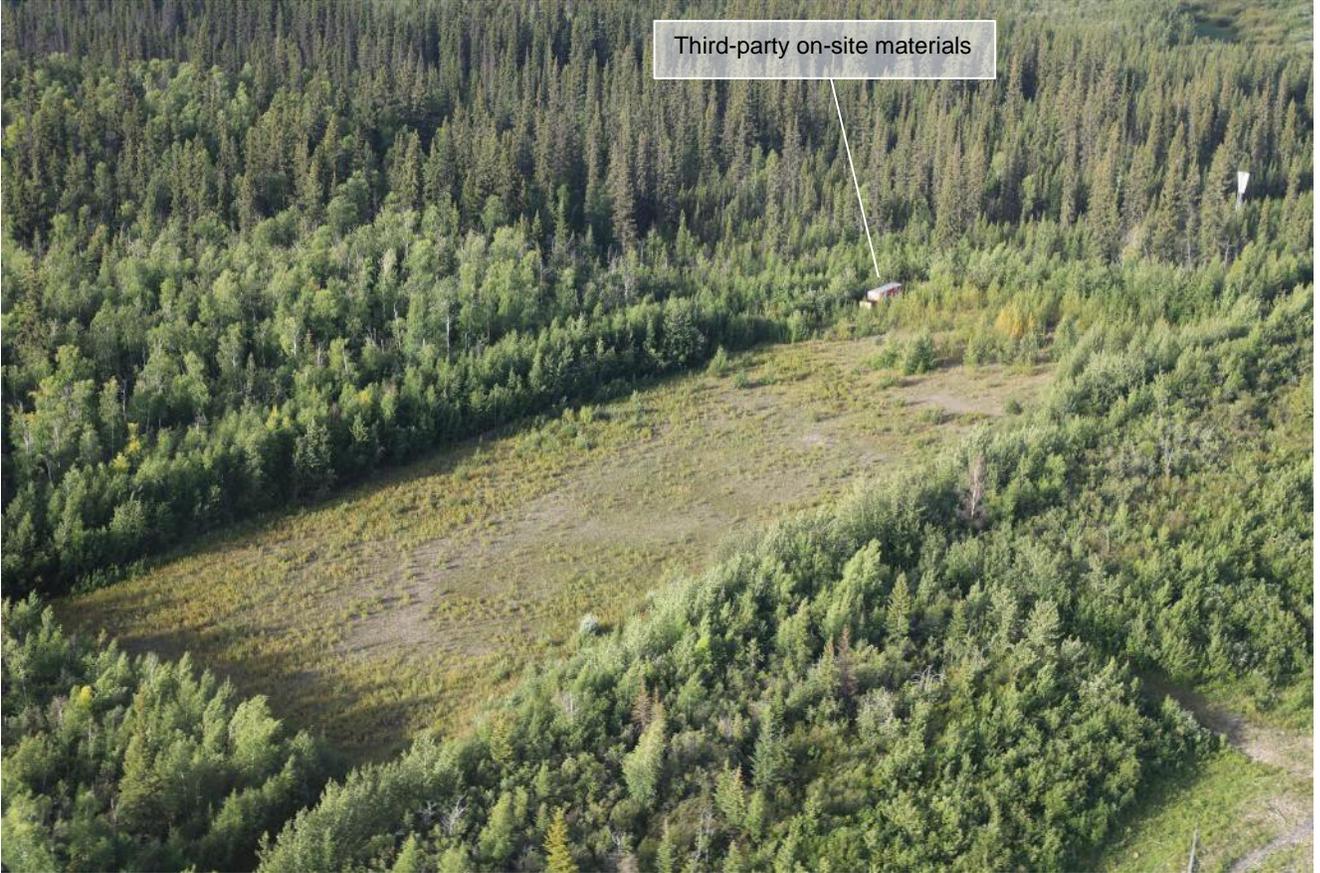
NOTE: Overview showing the overall ground and vegetation conditions and location of the third-party on-site materials (August 20, 2020).

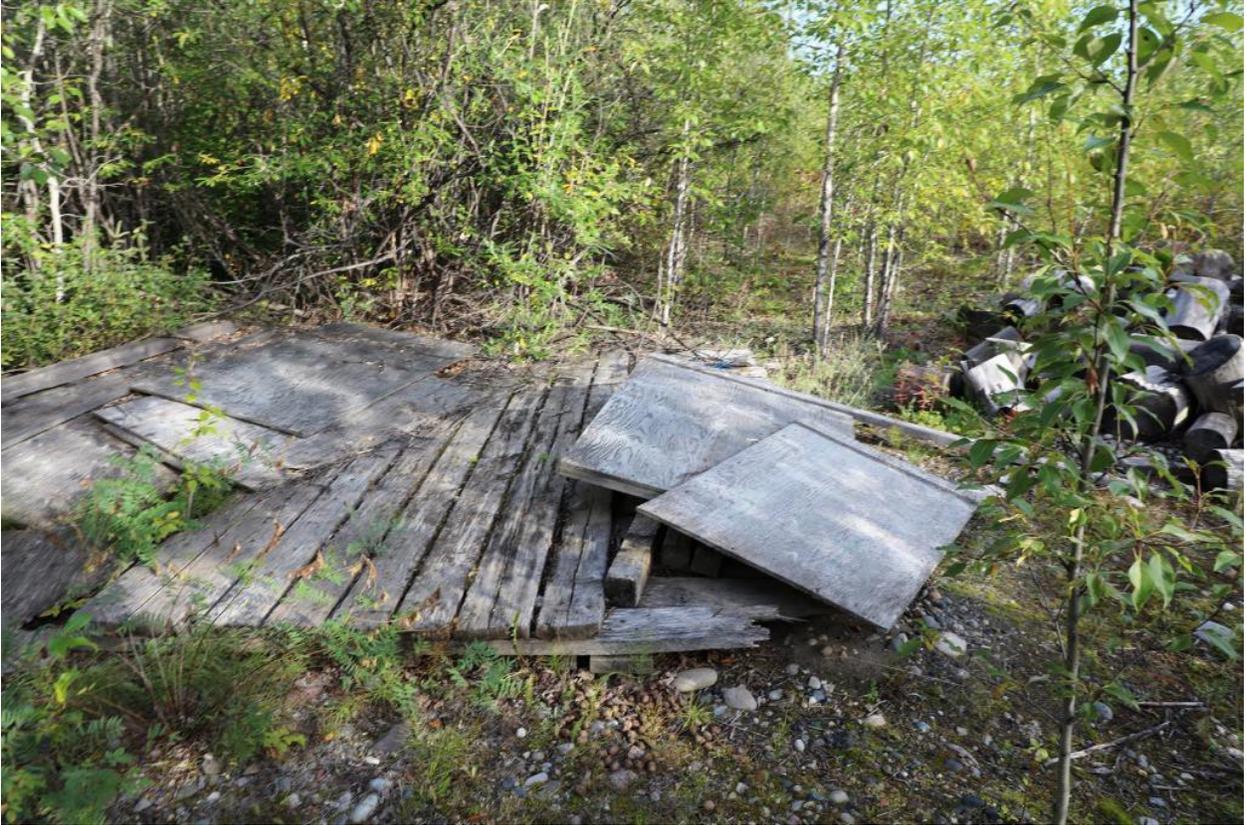
NOTE: Third-party debris located in the southwest corner of the Staging Area.

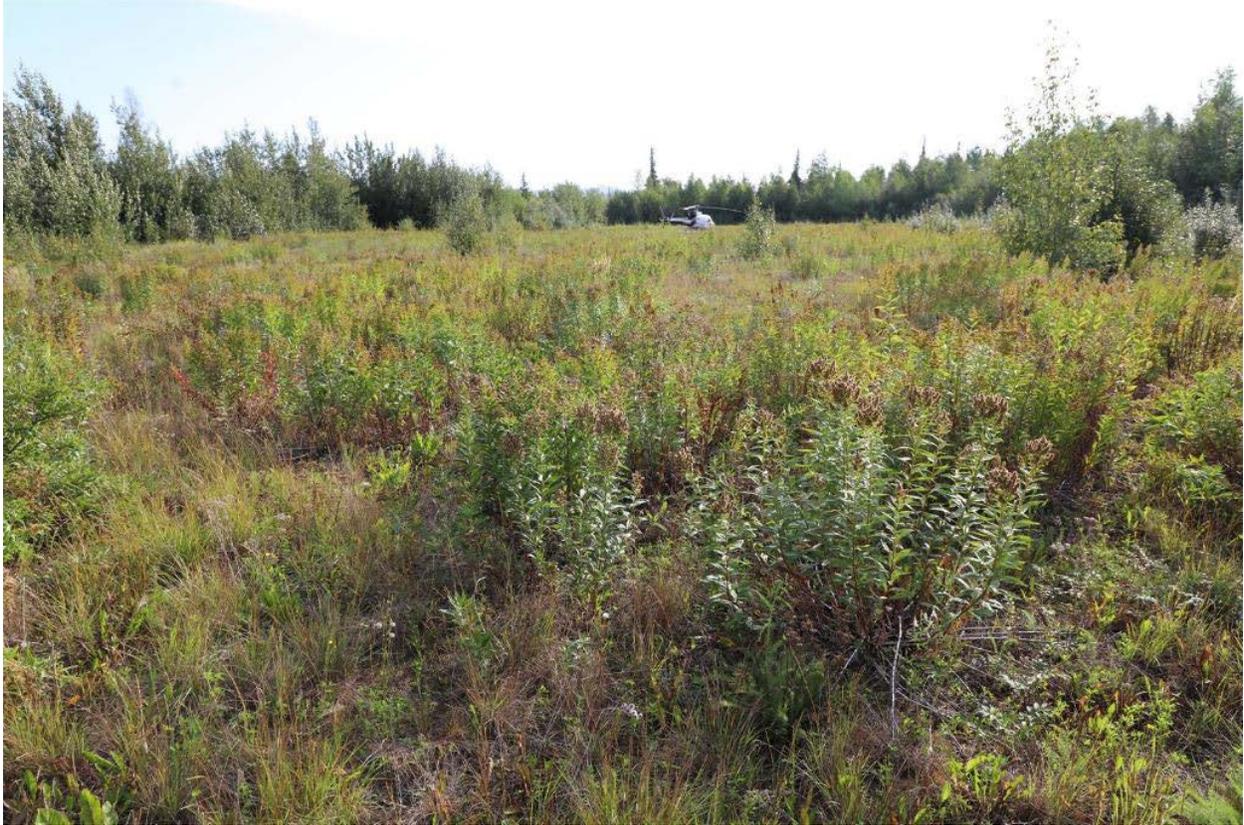
NOTE: View of ground and vegetation conditions in the east portion of the Staging Area looking east. East portion has revegetated with seeded agronomic legumes and grasses and naturally established native trees, shrubs, and forbs. Vegetation cover in the east portion was approximately 55% to 70% cover and appeared healthy (August 20, 2020).
