Subject: 2024 Annual Dam Safety Inspection – Processed Kimberlite Containment Facility and Water Management Pond System

Attachments: Report on PKCF and Water Management Ponds – 2024 Annual Dam Safety Inspection for Diavik Diamond Mines (2012) Inc. by WSP Canada Inc. – November 2024

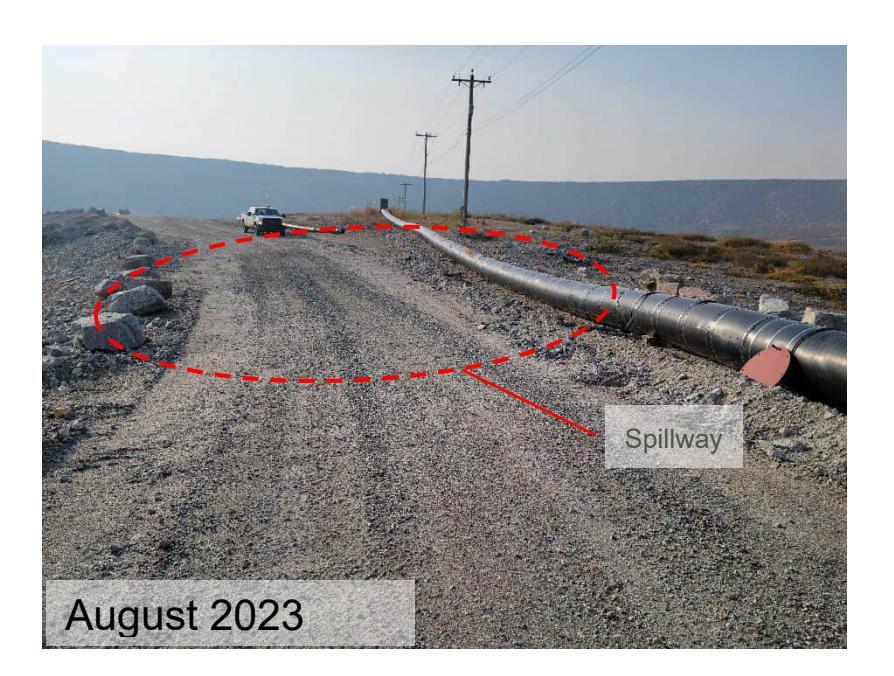
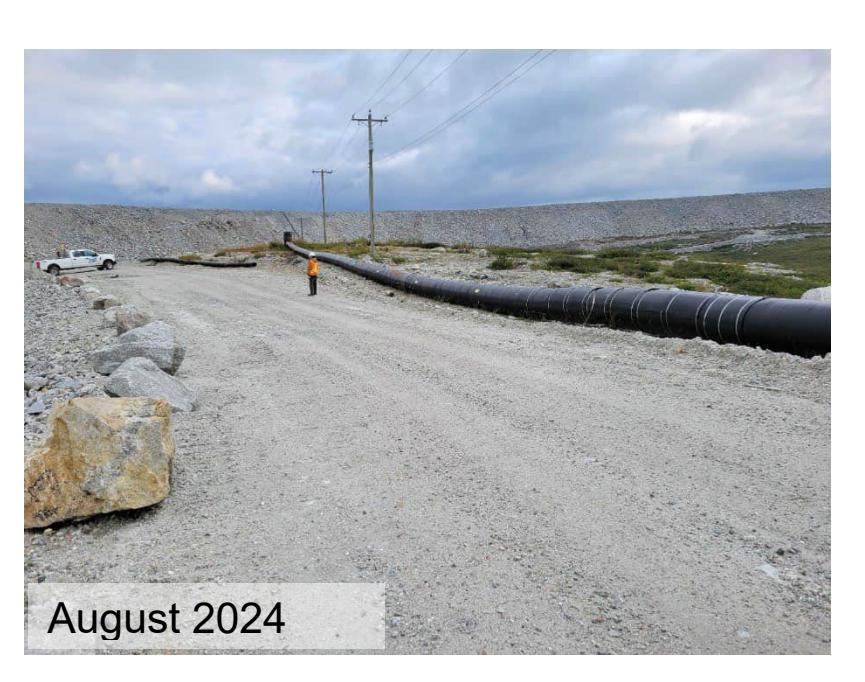
Photograph Pond 3 – 1: View to the southeast along the crest of Pond 3 Dam. The A21 pipeline along the downstream crest of Pond 3 Dam and runs through the spillway. The pipeline was raised on blocks in October 2020 but blocks had shifted in 2023, obstructing the spillway. A small berm from crest/road maintenance also obstructs the spillway.

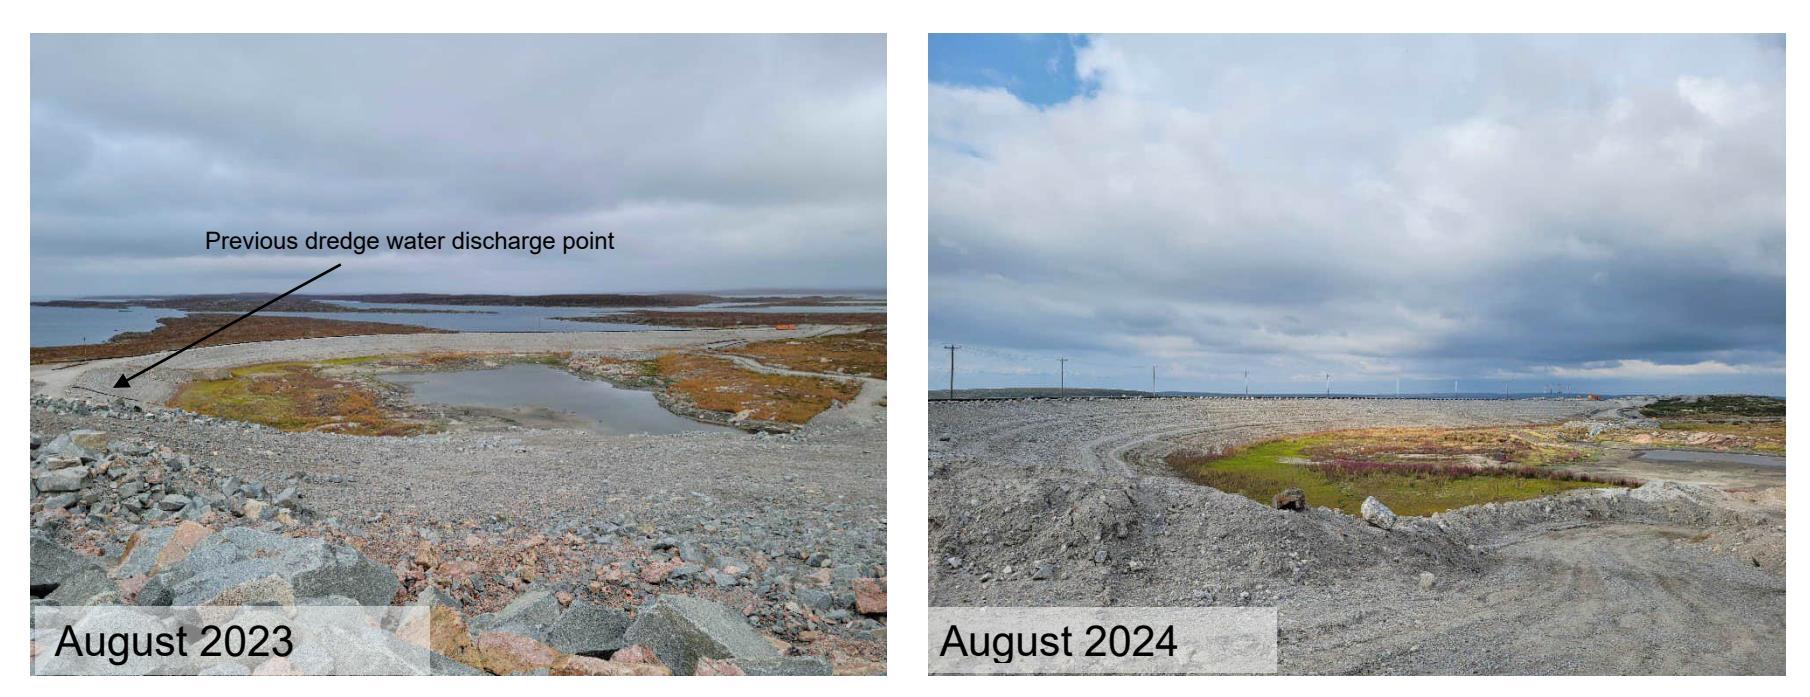
Photograph Pond 3 – 2: View to the northwest across Pond 3 from southern abutment.

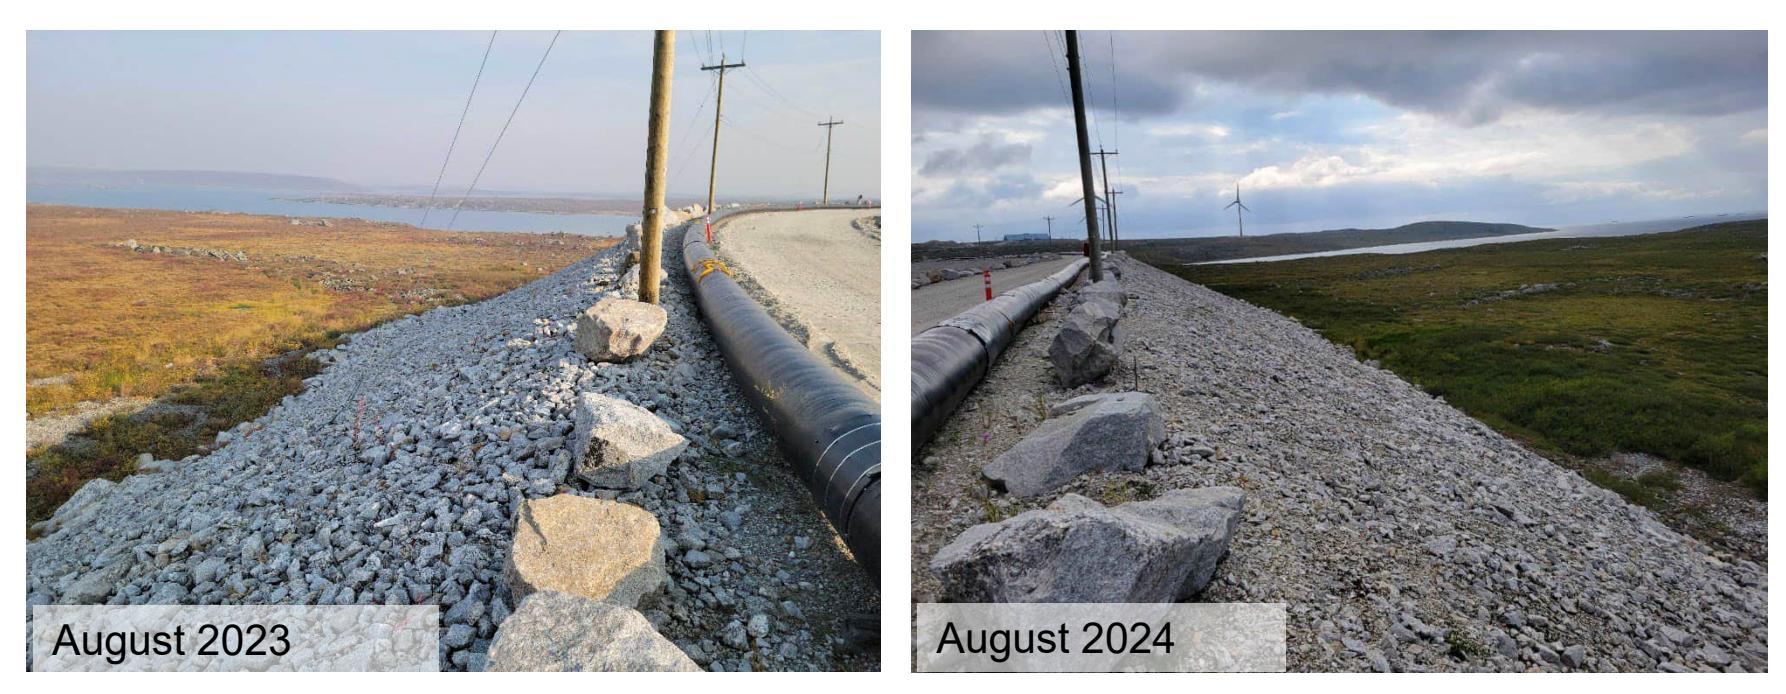
Photograph Pond 3 – 3: View along the downstream slope of Pond 3. 2023 photo looking to the north and 2024 photo looking to the southwest.

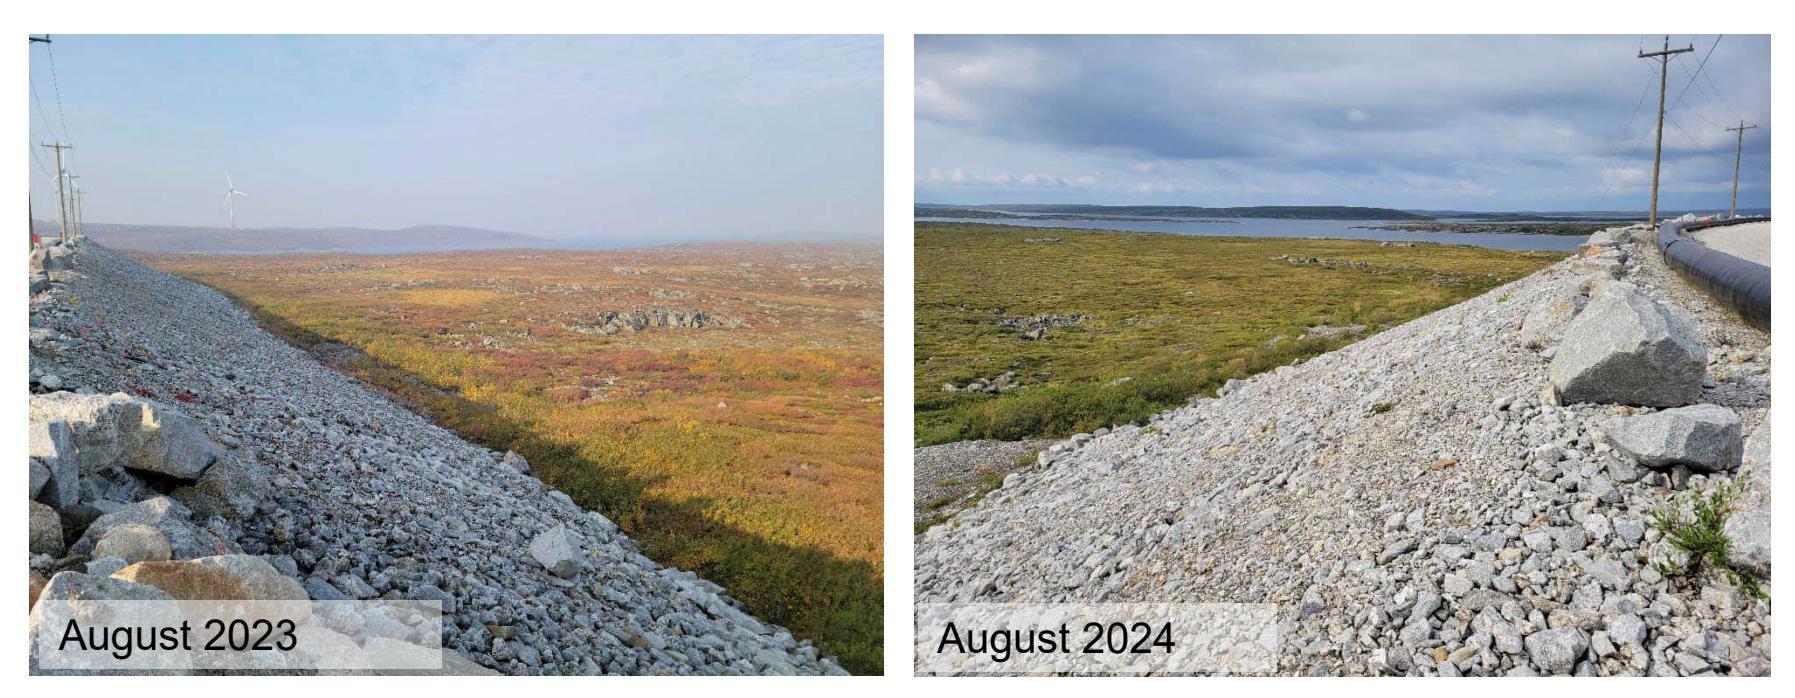
Photograph Pond 3 – 4: View along the downstream slope of Pond 3 Dam. 2023 photo looking to the southwest and 2024 photo looking to the northwest.

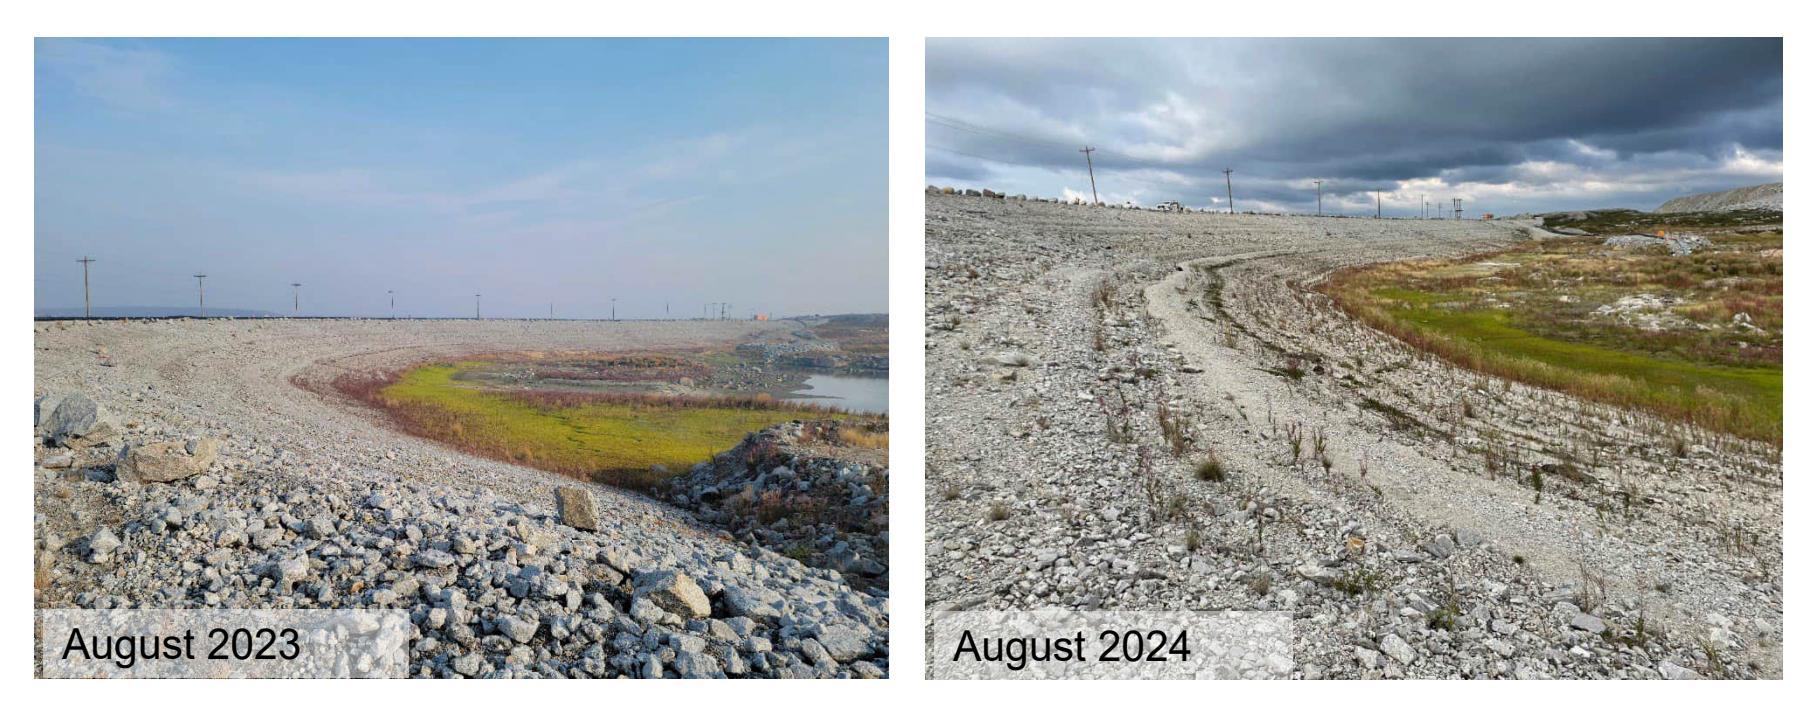
Photograph Pond 3 – 5: View of upstream slope and toe of northern half of Pond 3 Dam. Pond level lower in 2024 than 2023.

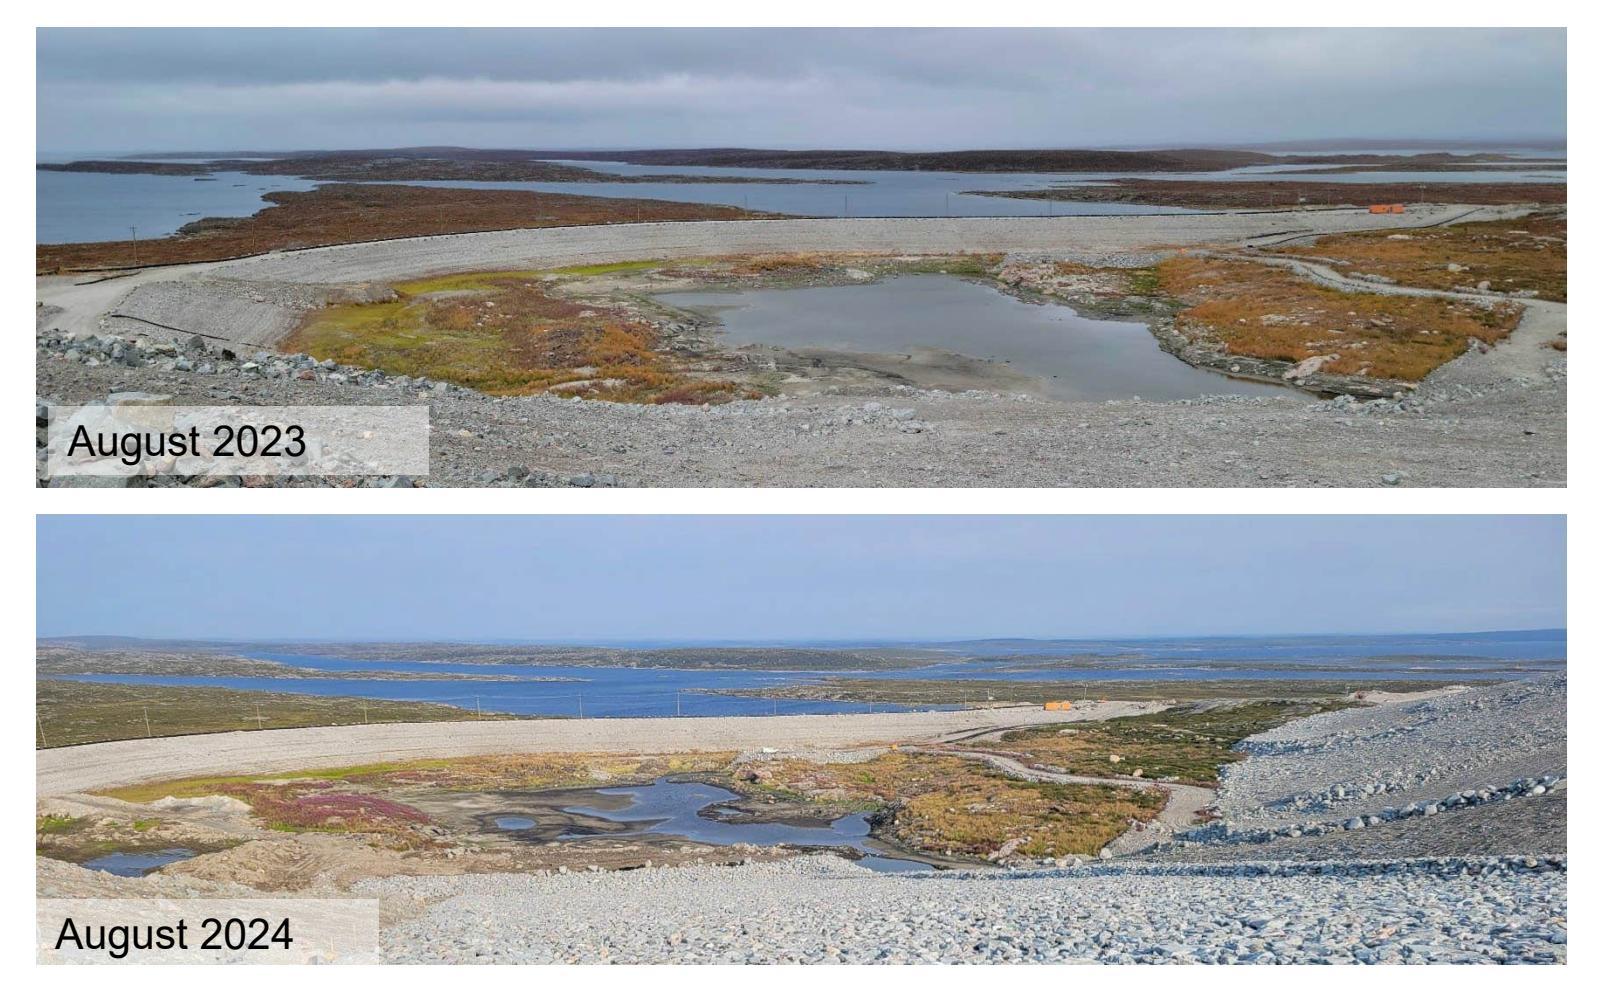
Photograph Pond 3 – 6: View of Pond 3, from crest of PKC Phase 7 spillway looking west.

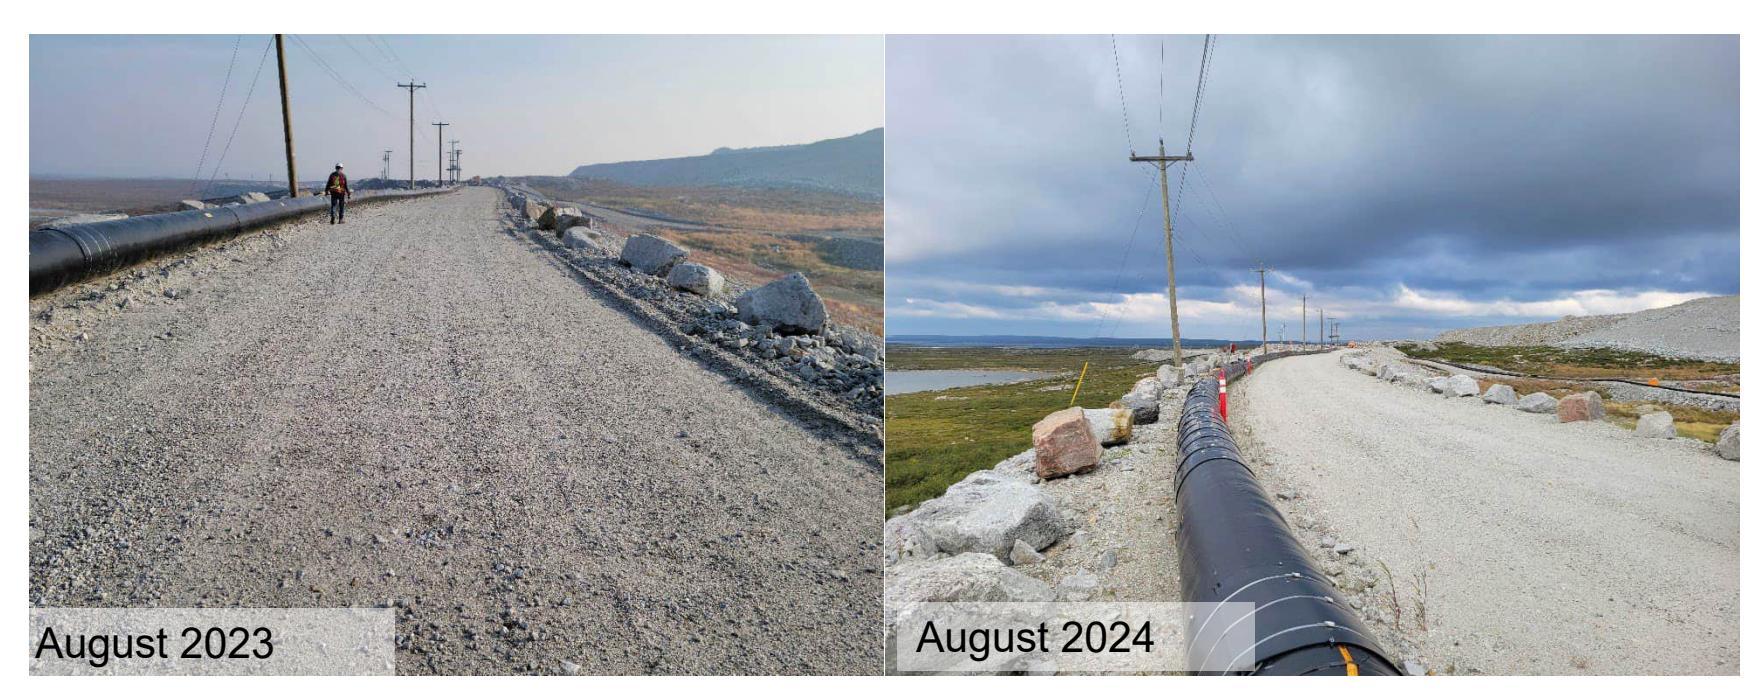
Photograph Pond 3 – 7: Crest of Pond 3 Dam, looking north.

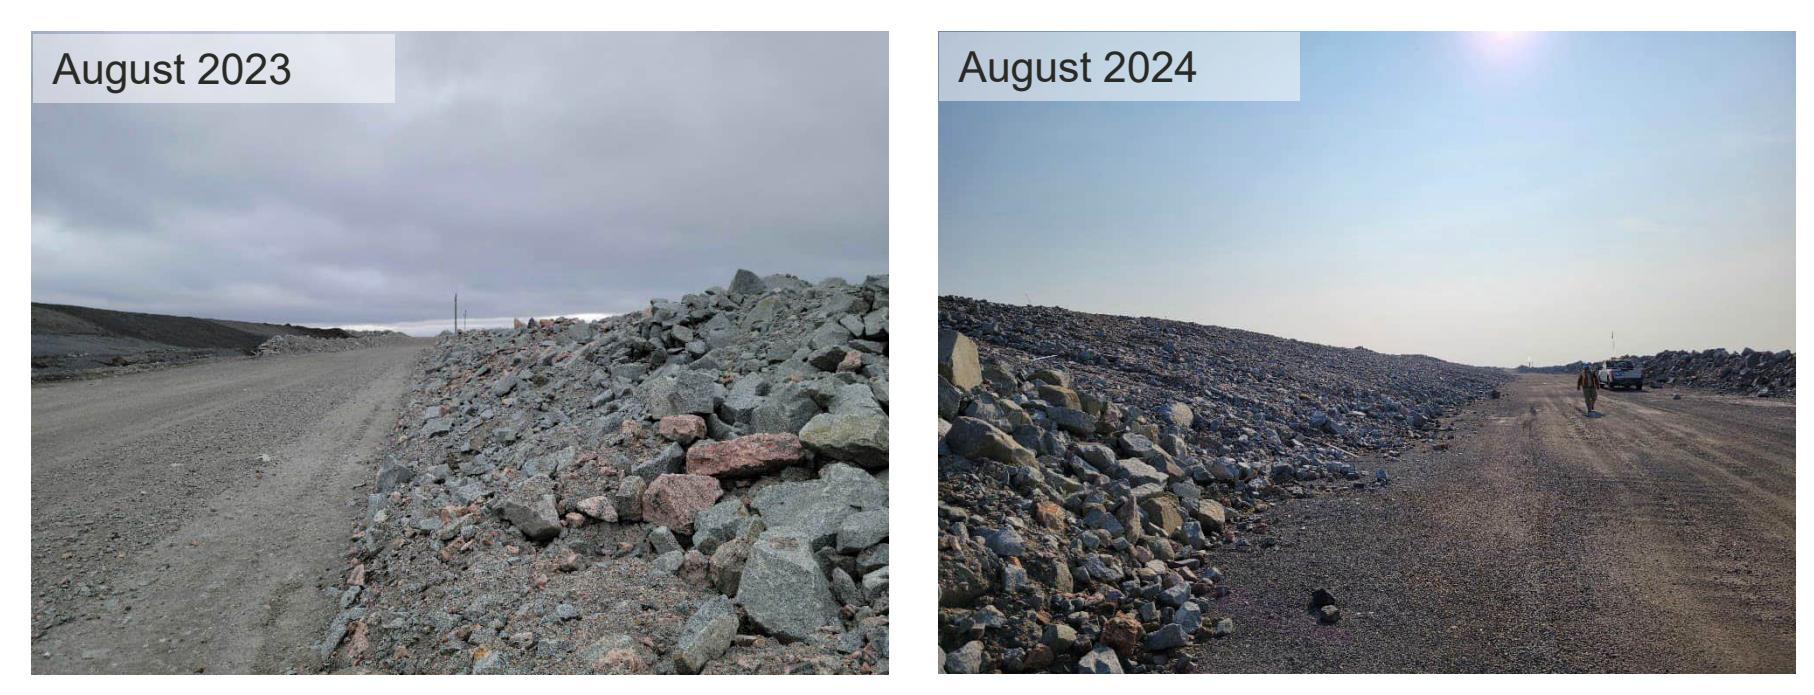
Photograph South PKC Dam – 1: Phase 7 elev. 469 m crest of the South PKC Dam looking southeast near 70+900 (2023 photo) and looking northwest near 70+500 (2024 photo). Upstream CPK berm on left side of both photos; covered with closure rockfill cover in 2024 photo.

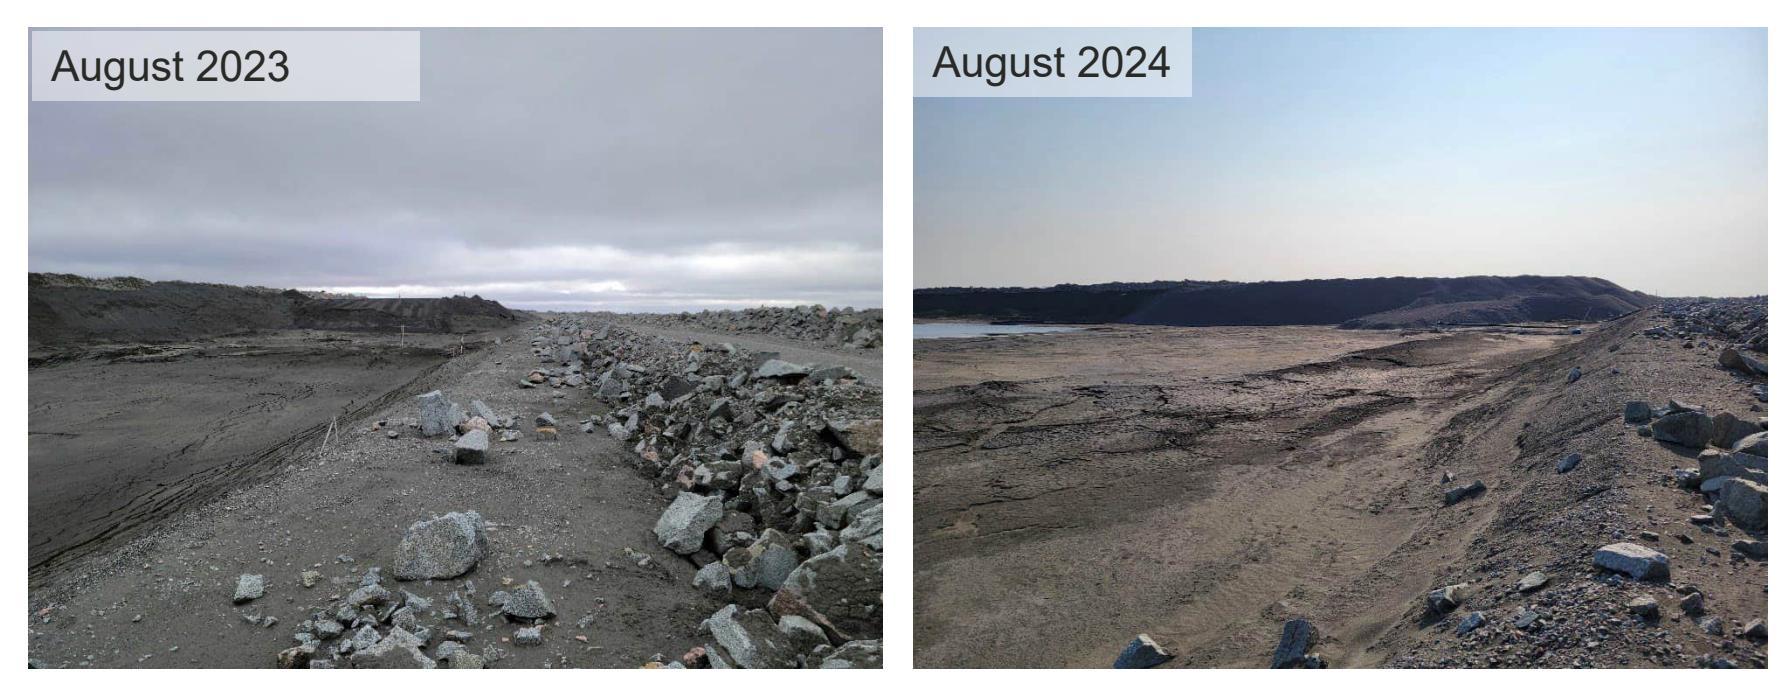
Photograph South PKC Dam – 2: Phase 7 elevation 469 m crest looking southeast over the West Cell. Settlement resulting from consolidation of FPK evident in cracking/slumping of FPK along the upstream slope in 2023 now appears to have slowed or ceased.

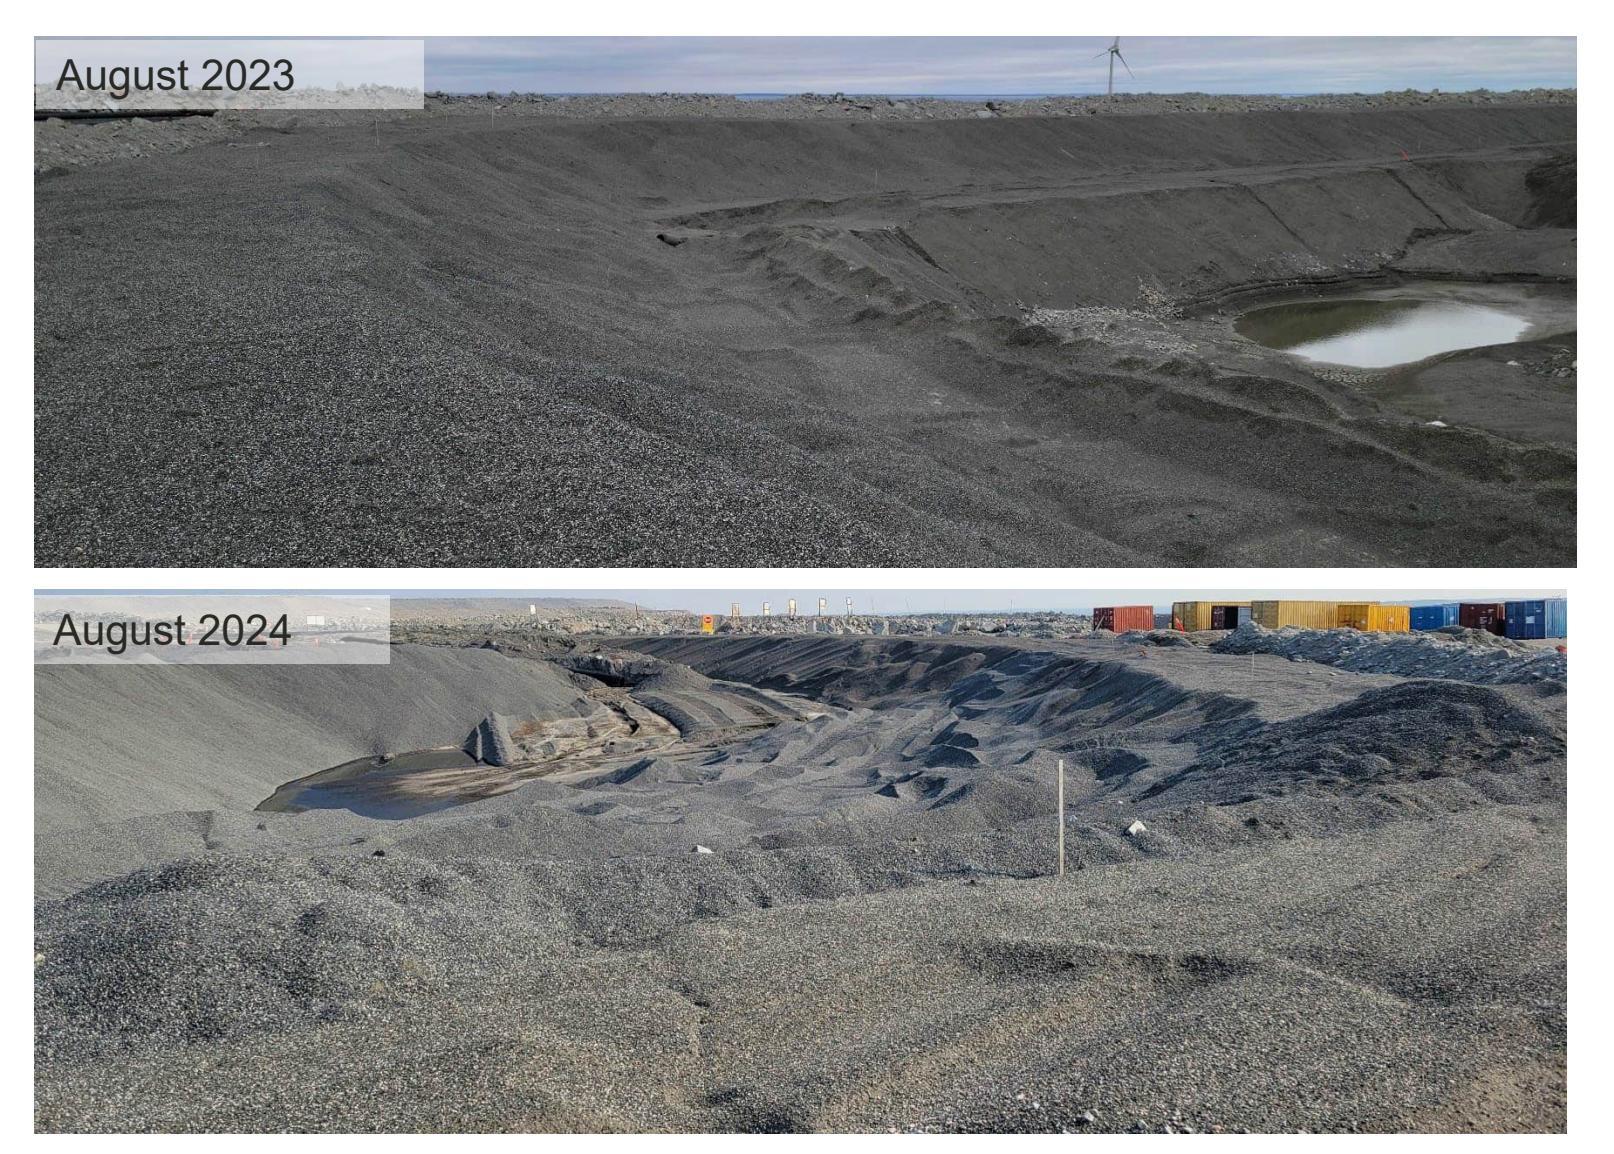
Photograph South PKC Dam – 3: View of the upstream slope of the South PKC Dam at elevation 469 m and Southeast Cell area. CPK is being stored in the Southeast Cell and in similar condition to 2023. A small isolated pond retained in the cell.

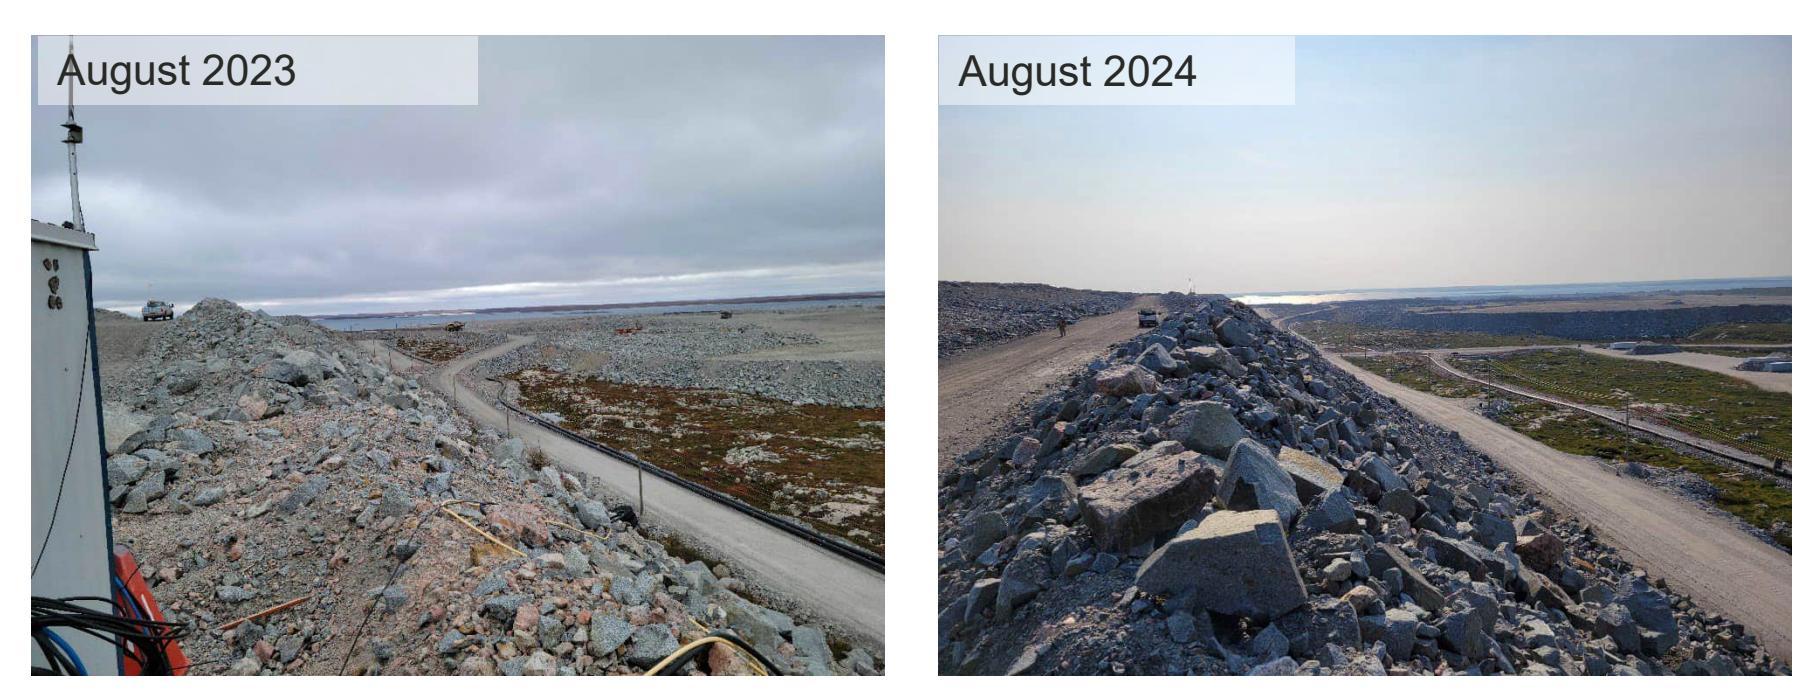
Photograph South PKC Dam – 4: View from the elevation 469 m crest to the southeast along the downstream slope and toe of the South PKC Dam near Sta. 71+100 (2023) and Sta. 70+700 (2024), looking towards the South Country-Rock Pile.

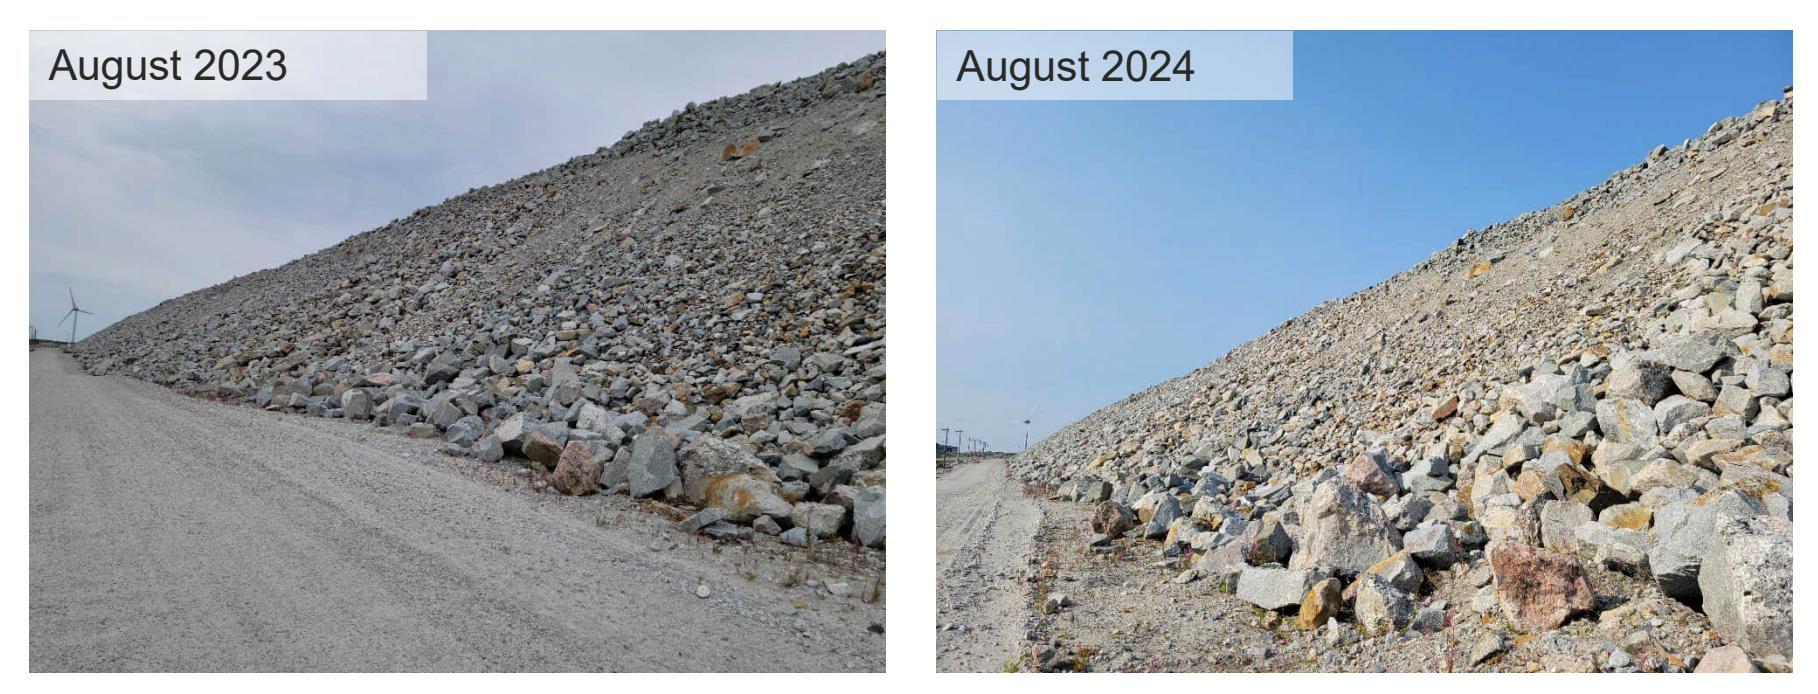
Photograph South PKC Dam – 5: View to the northwest along the South PKC Dam downstream slope and toe near Sta. 70+800. Toe and downstream slope are in good condition similar to previous years.

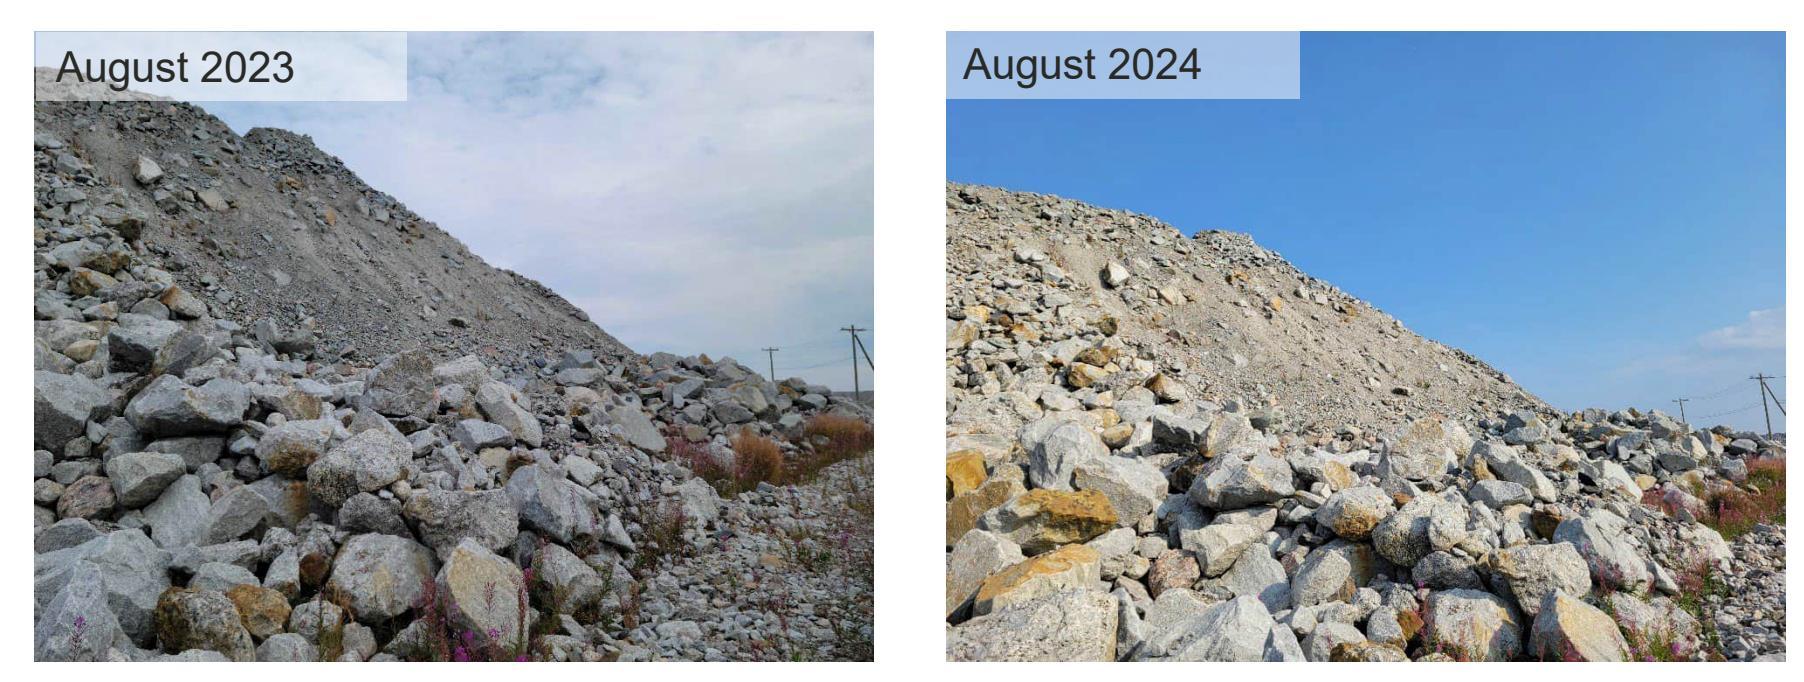
Photograph South PKC Dam – 8: View of downstream slope of the South Dam rockfill shell at approximately 70+300. Fine grained granular fill material visible on slope as in previous years.

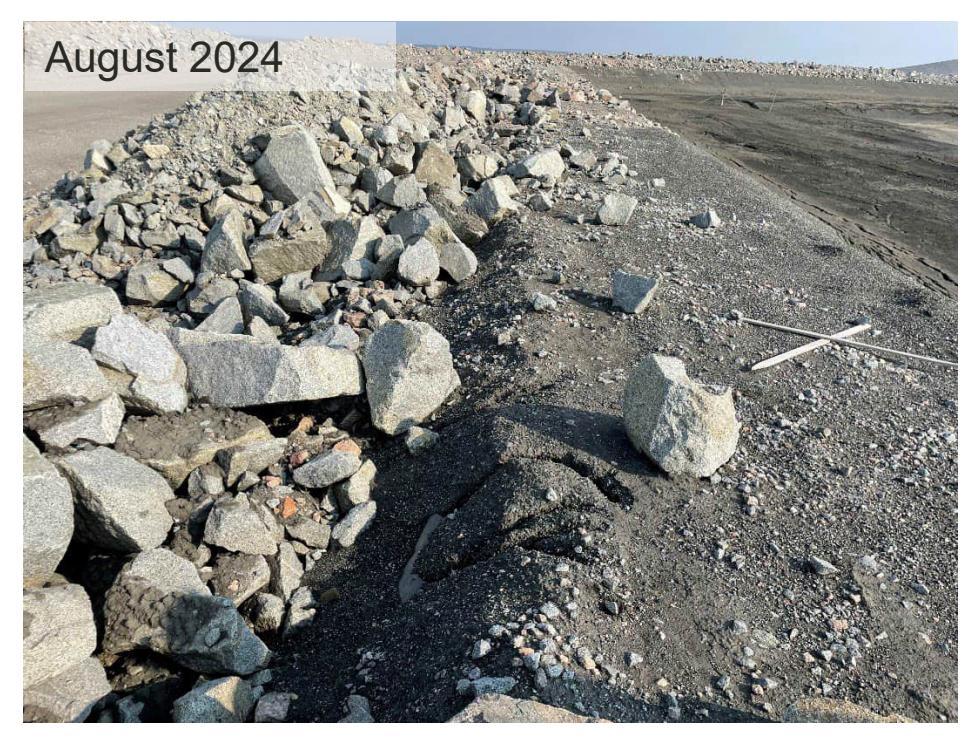
Photograph South PKC Dam – 9: Liner exposed through the CPK cover of the anchor trench at approximately Station. 70+150.

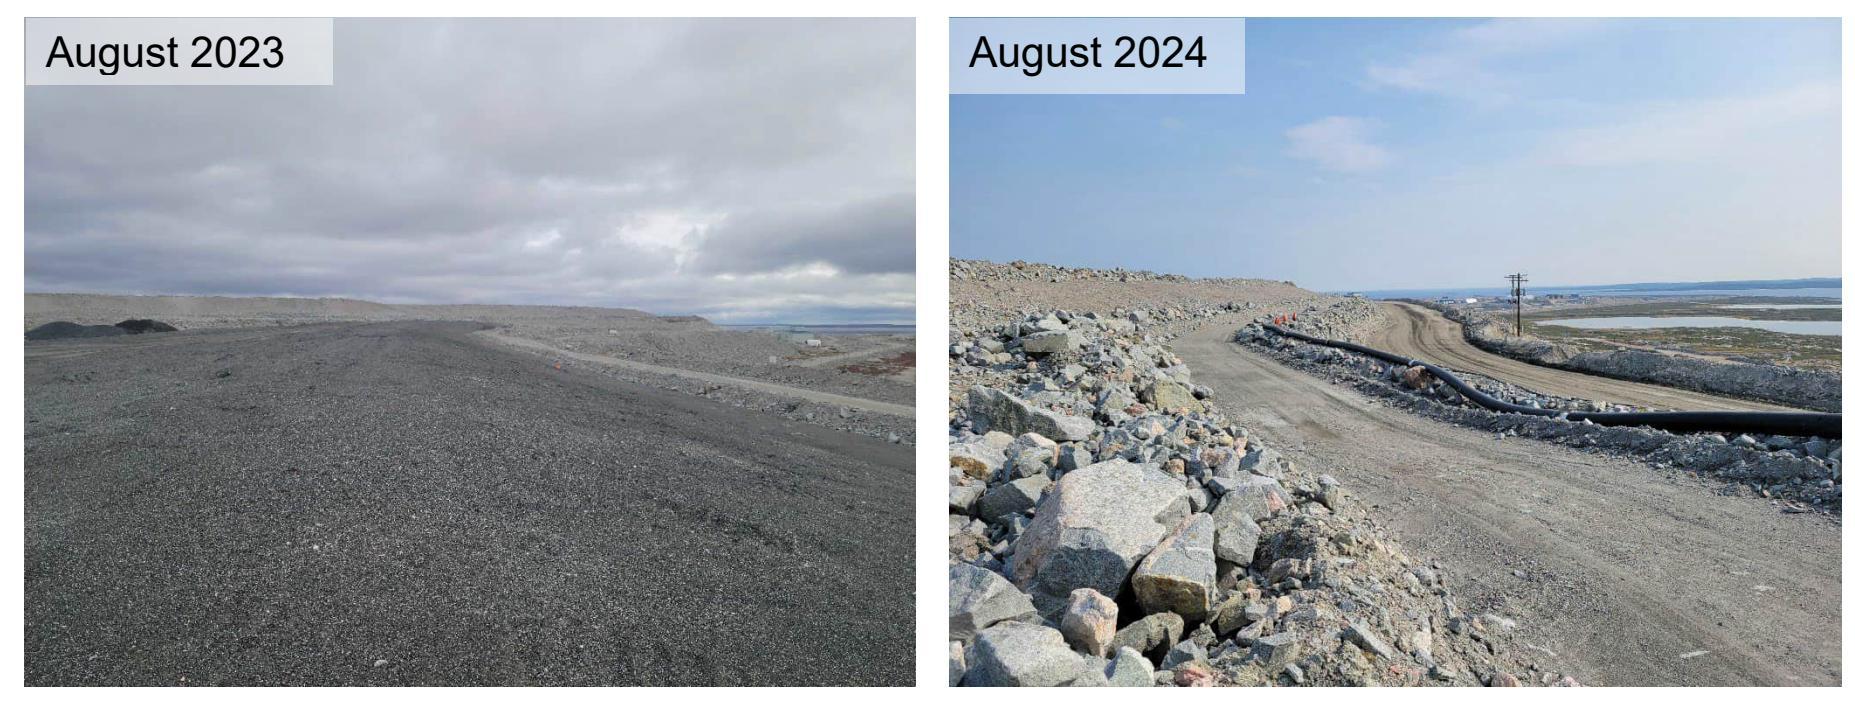
Photograph East PKC Dam – 1: Upstream crest and CPK zone near Sta. 72+500 (2023 photo taken from elevation 474 m) and closure cover completed in 2024 (photo taken from elevation 469 m crest).

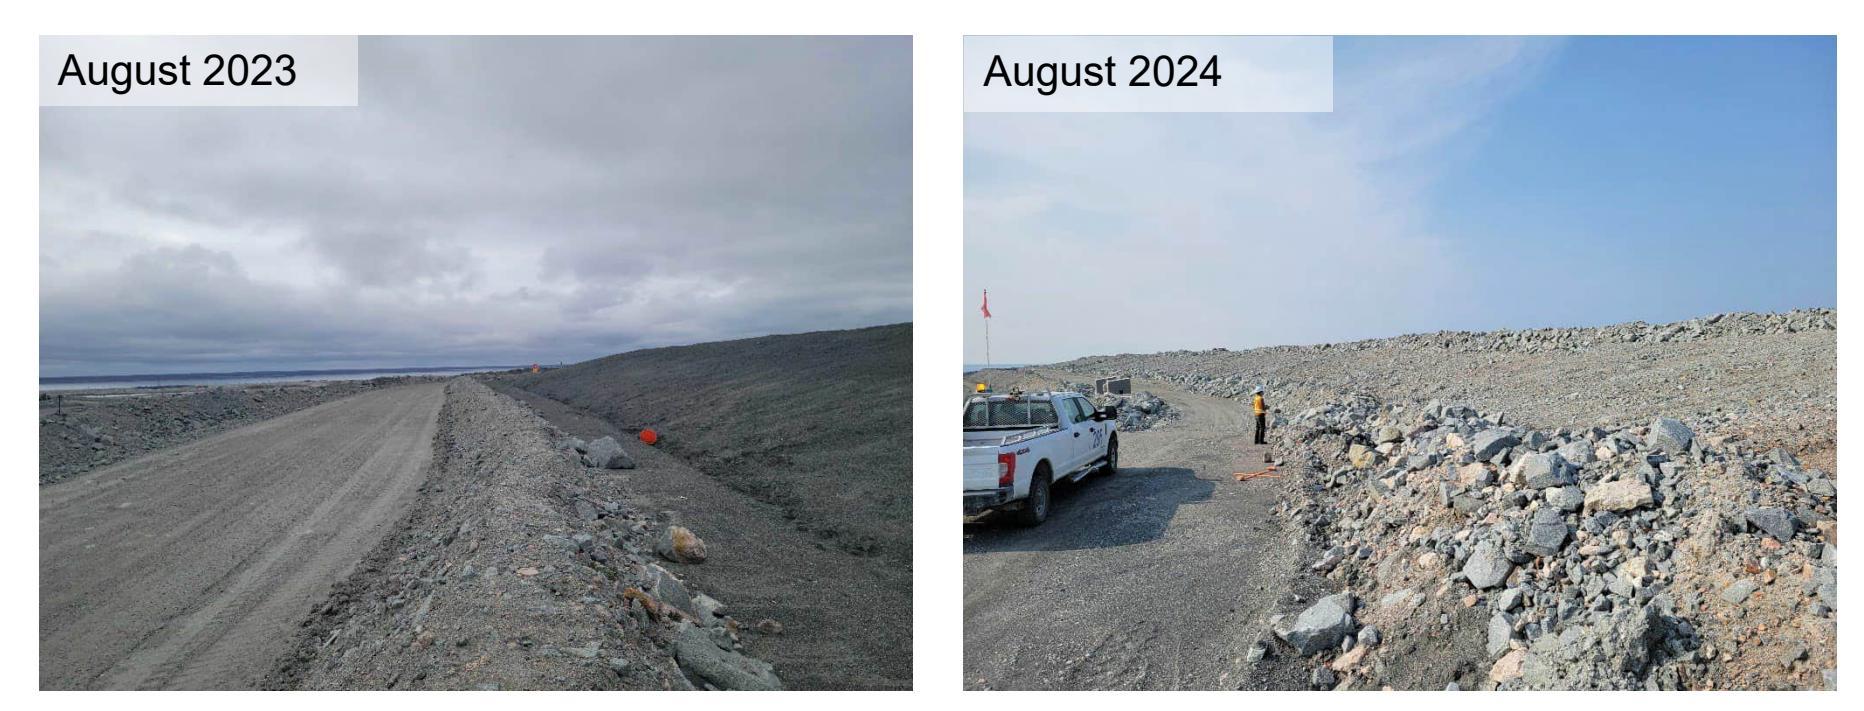
Photograph East PKC Dam – 2: Upstream crest and CPK zone looking south. CPK placement and 3:1 re-slope complete in 2023. Rockfill closure cover along 3:1 CPK Phase 7 slope completed in 2024.

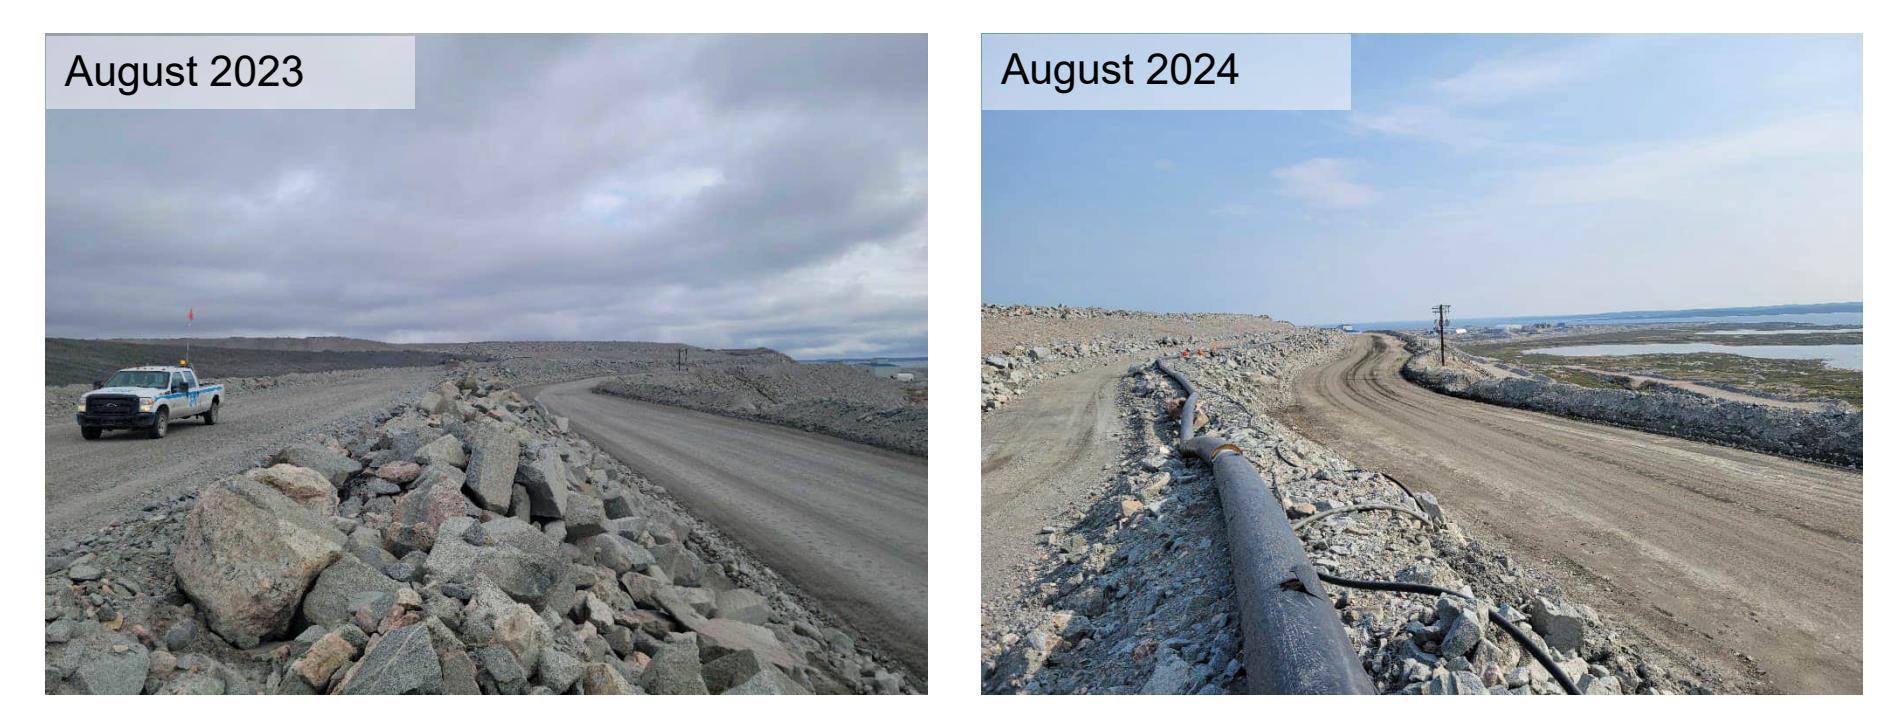
Photograph East PKC Dam – 3: Haul road on elev. 465 m crest of the East PKC Dam looking north from near Sta. 72+500 towards NCRP. 465 m crest in good condition during 2023 DSI visit. Rockfill closure cover along 3:1 CPK Phase 7 slope completed in 2024.
