Subject: 2024 Annual Dam Safety Inspection – Processed Kimberlite Containment Facility and Water Management Pond System

Attachments: Report on PKCF and Water Management Ponds – 2024 Annual Dam Safety Inspection for Diavik Diamond Mines (2012) Inc. by WSP Canada Inc. – November 2024

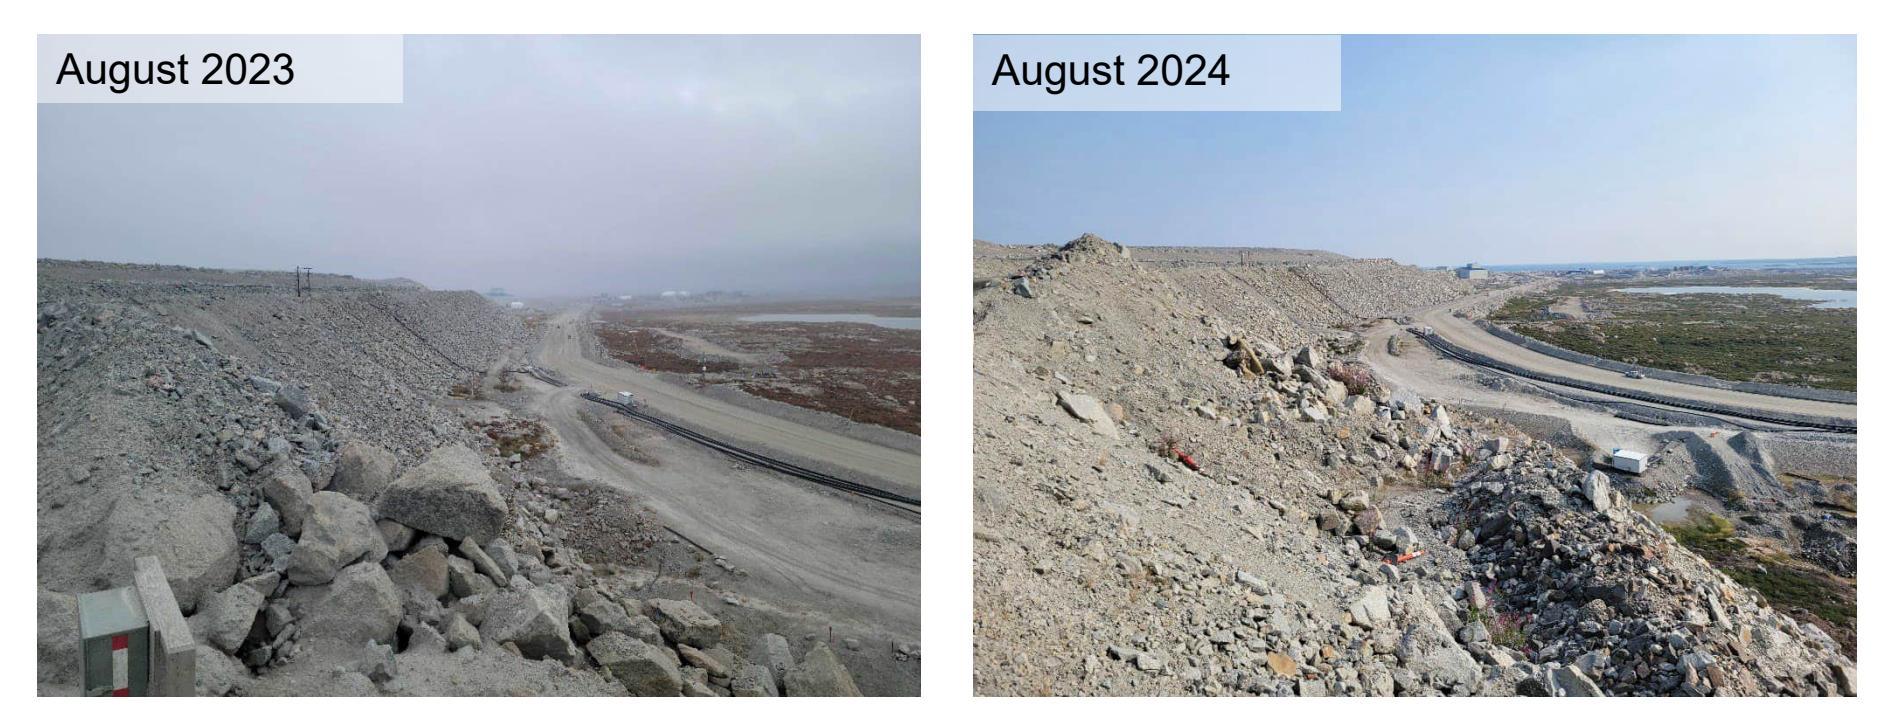
Photograph East PKC Dam – 4: Downstream slope looking north from approx. Sta. 72+400 above Pond 5.

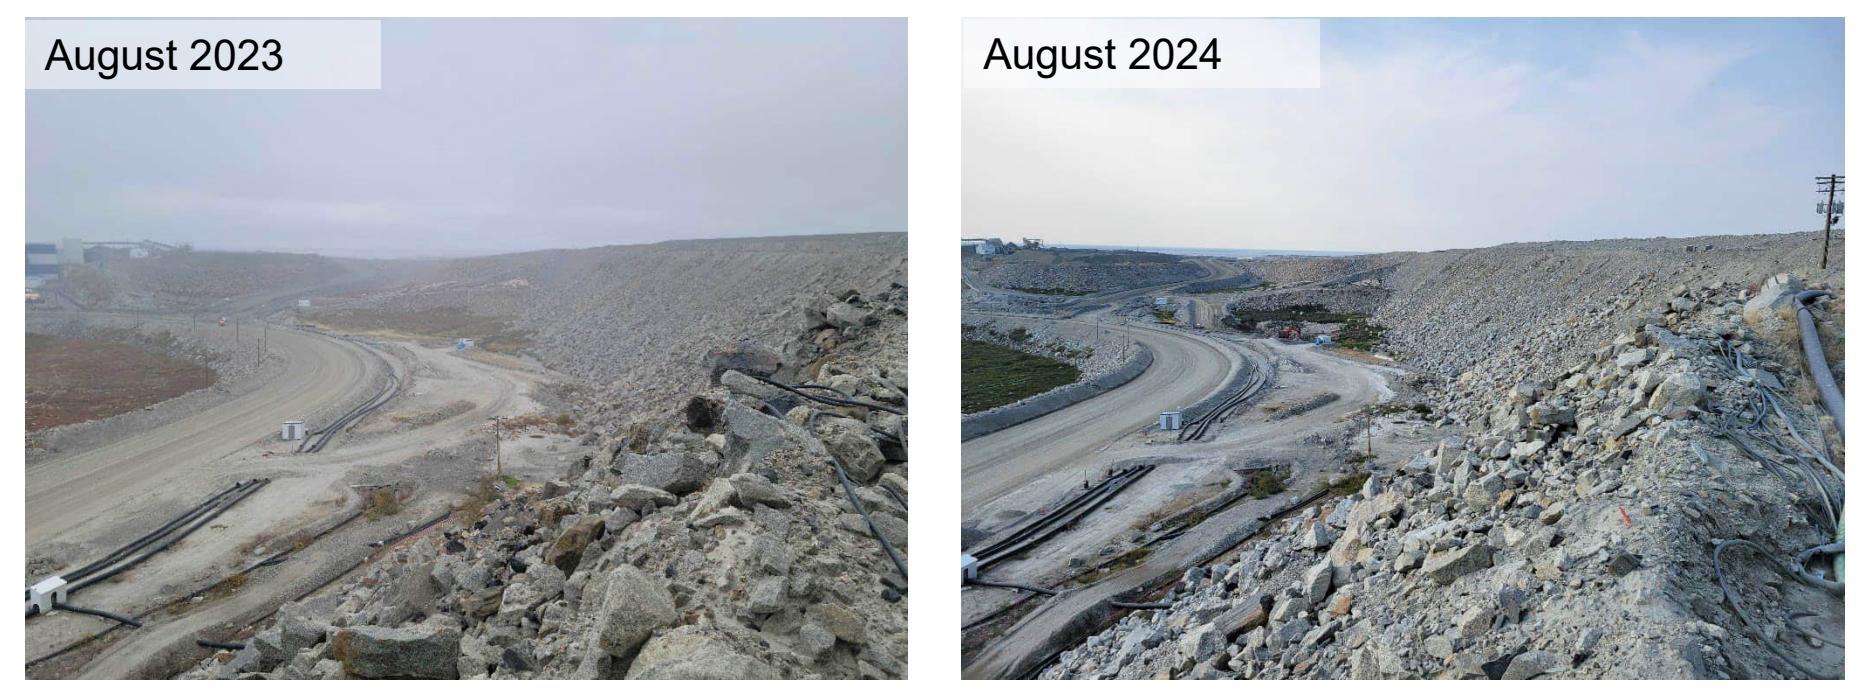
Photograph East PKC Dam - 5: View of area downstream of the East Dam from near Sta. 72+950.

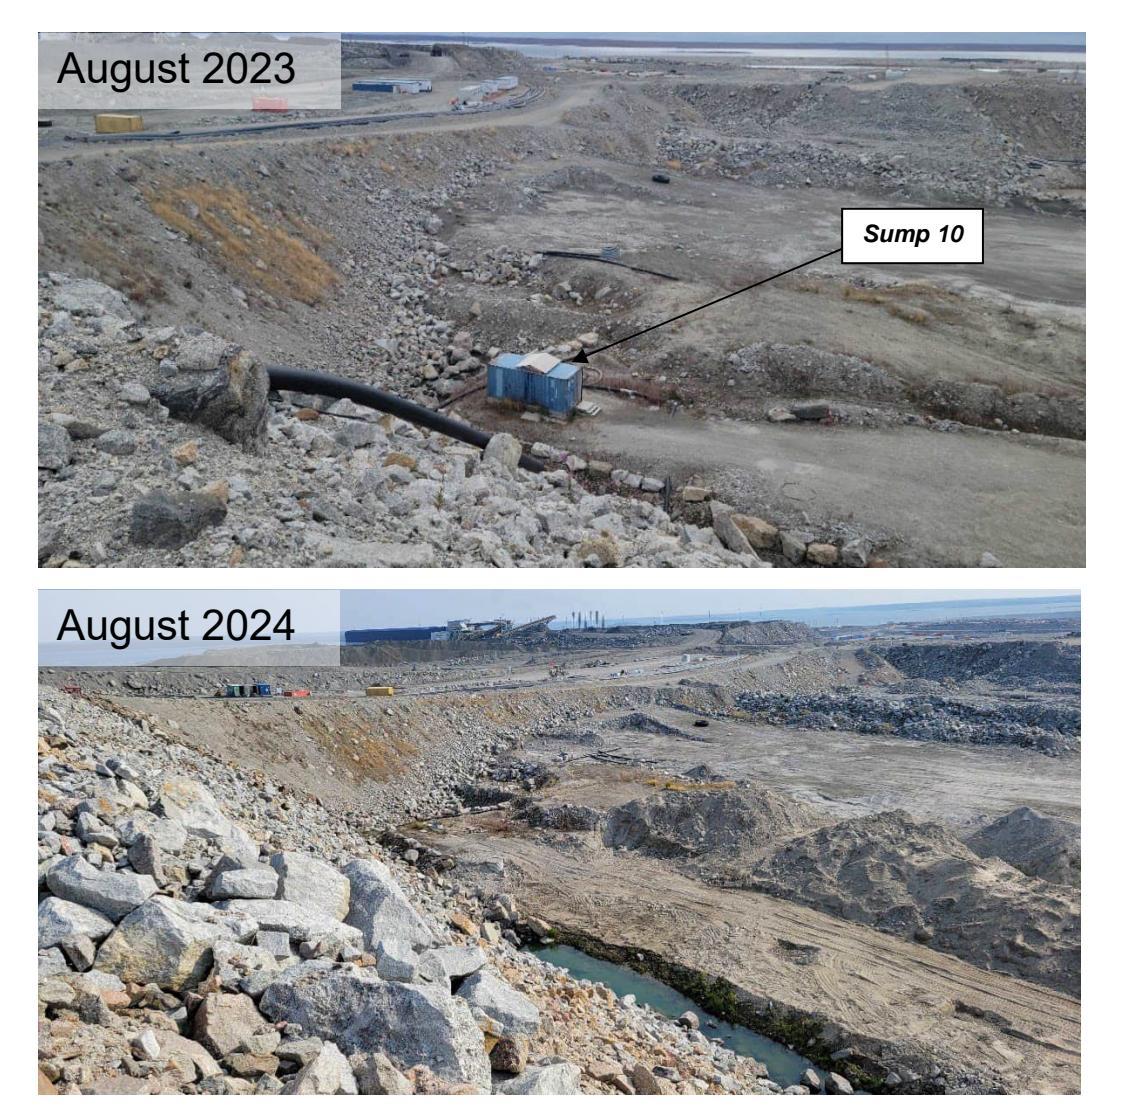
Photograph East PKC Dam – 6: Downstream slope of East Dam downstream of Zone 7 seepage zone Sump 10 removed in 2024 during closure resloping works.

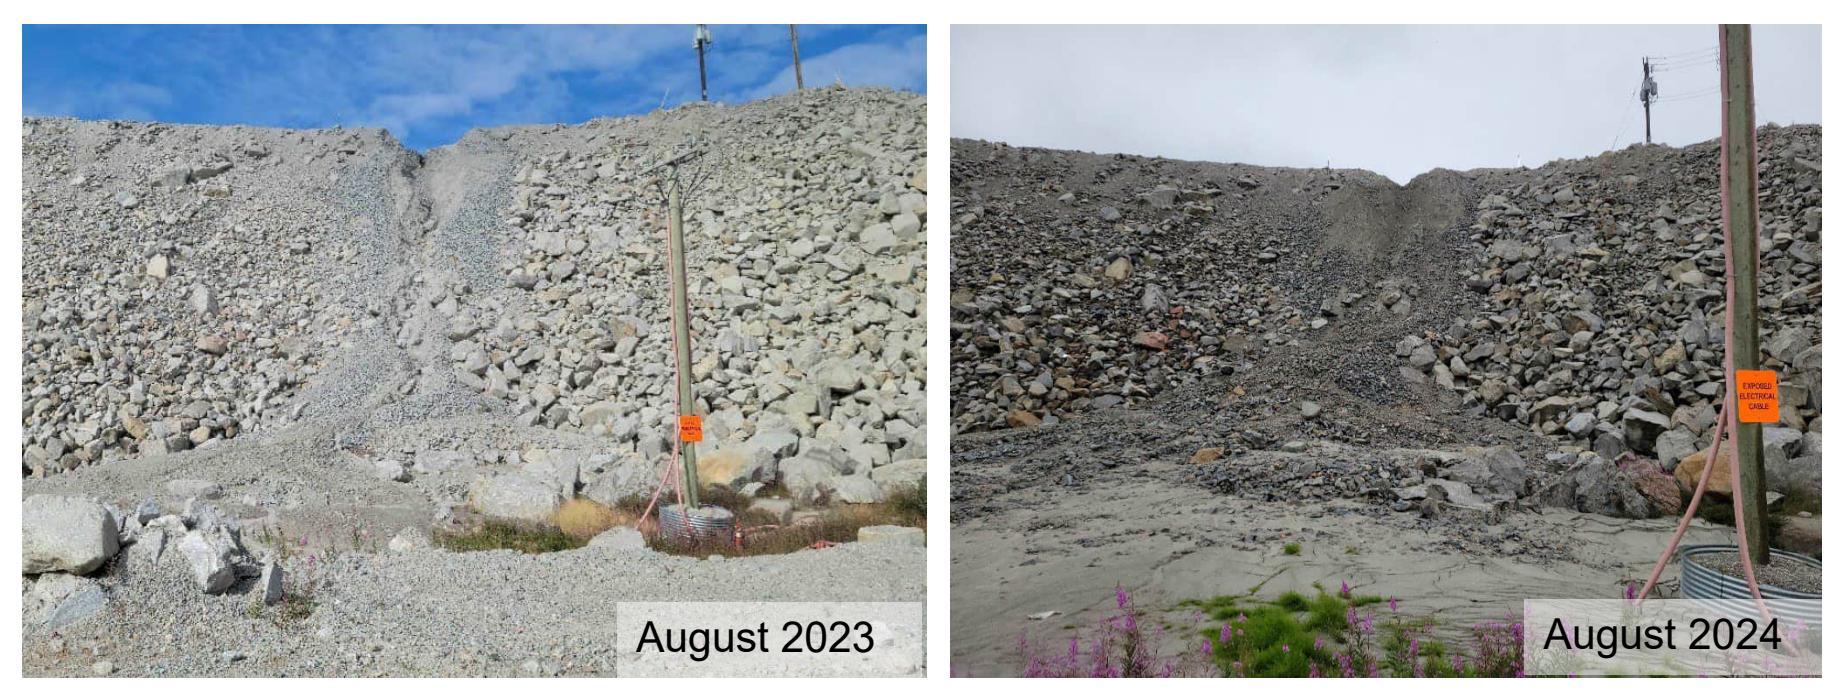
Photograph East PKC Dam – 7: View of localized shallow erosion gullies in the downstream slope of the East Dam near 72+600 (right). DDMI placed jaw run rockfill to repair gully in 2022, but some additional erosion has since occurred. Channel continues to incise into dam and fines accumulating at the dam toe. Incision appears siimilar to 2023 with an increase accumulation of material at the toe.

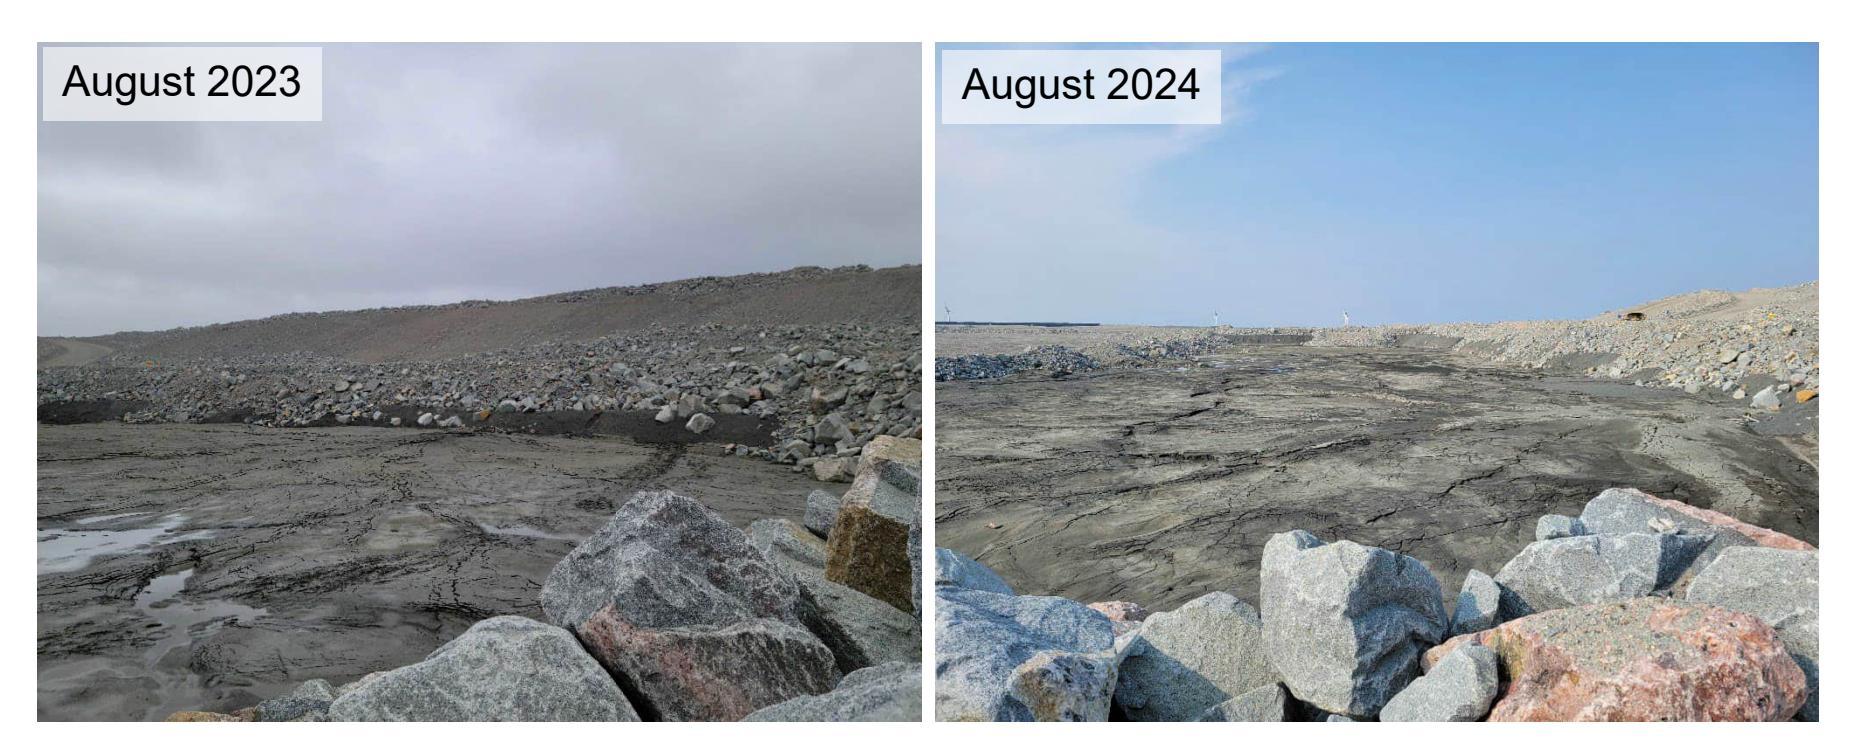
Photograph North PKC Dam – 2: PKC area of FPK beach upstream of the North Dam where PKC closure cover rockfill does not yet extend from Sta. 73+900 to 74+200.

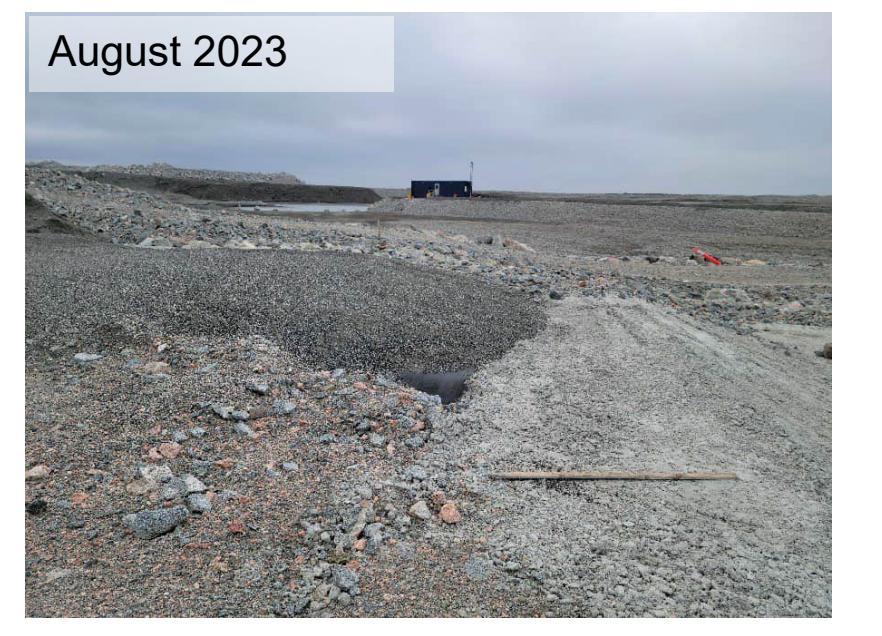
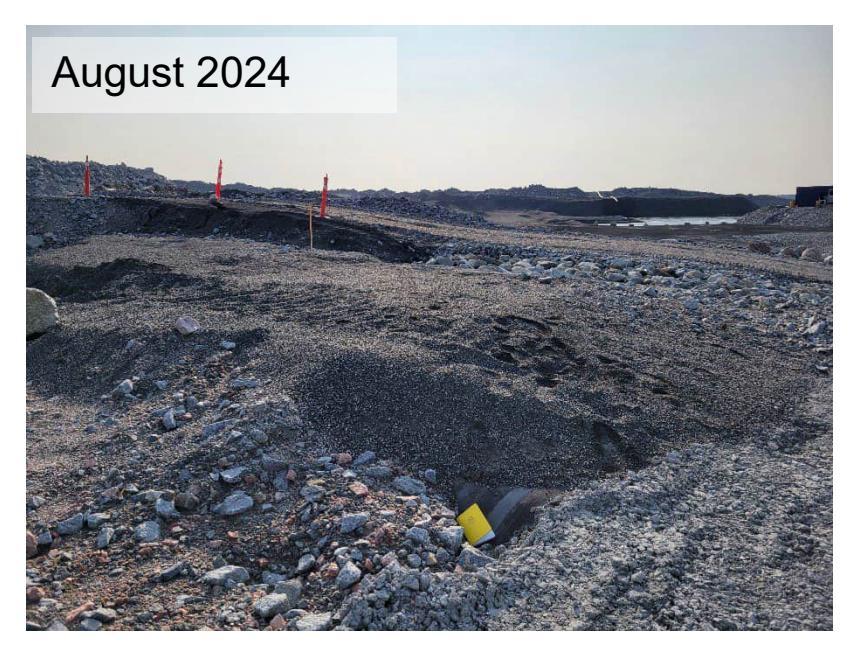
Photograph North PKC Dam – 3: Exposed liner at downstream edge of anchor trench at North Dam / spillway CRF tie-in at 74+700. Exposed liner observed at the time of 2023 inspection and remains in similar condition in 2024.

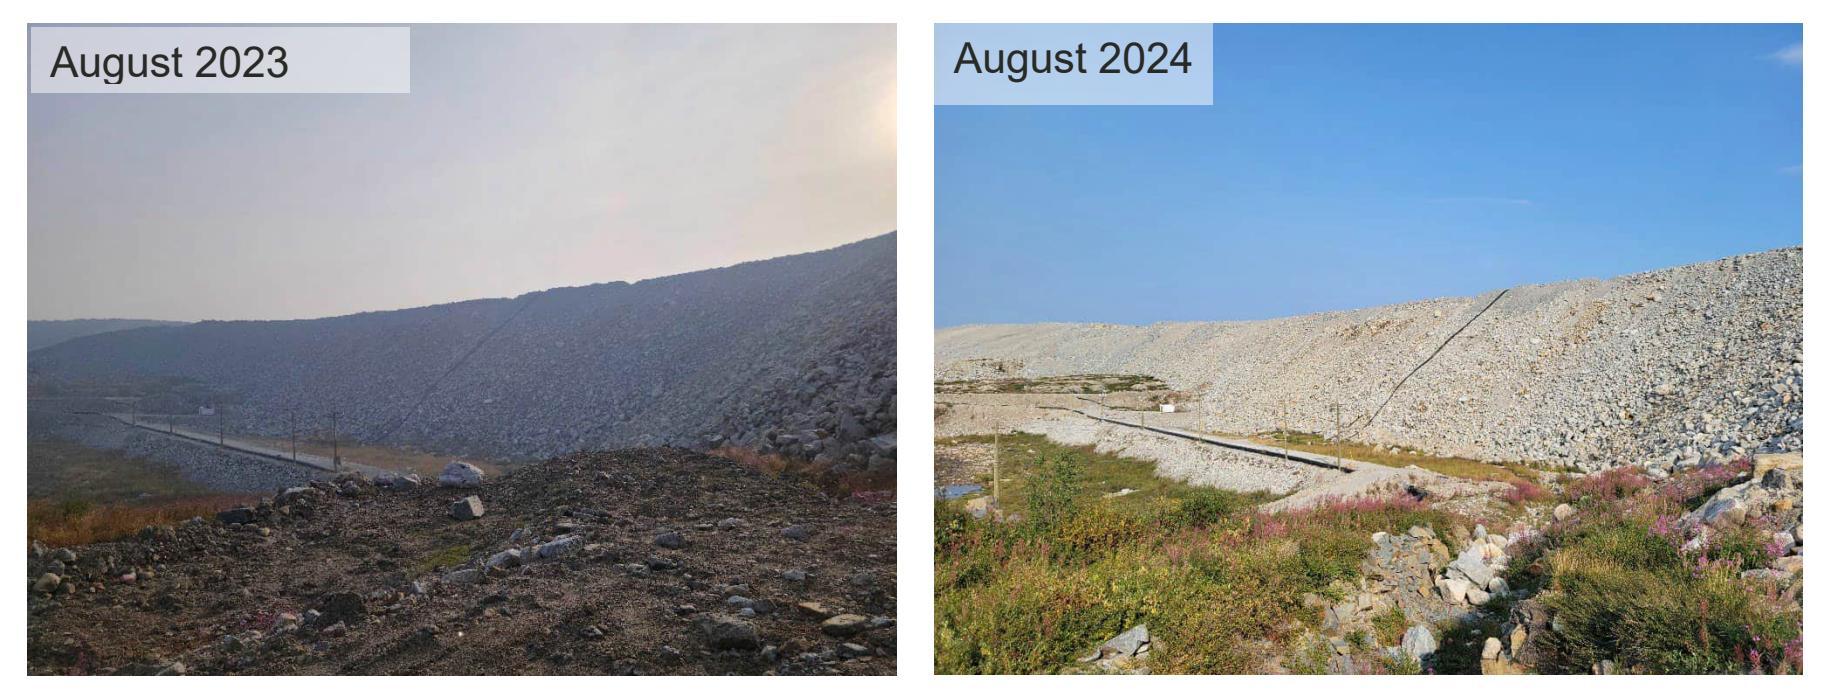
Photograph West PKC Dam – 1: View of the downstream slope of West PKC Dam from about Sta. 75+450 looking north. Downstream slope is in good condition.

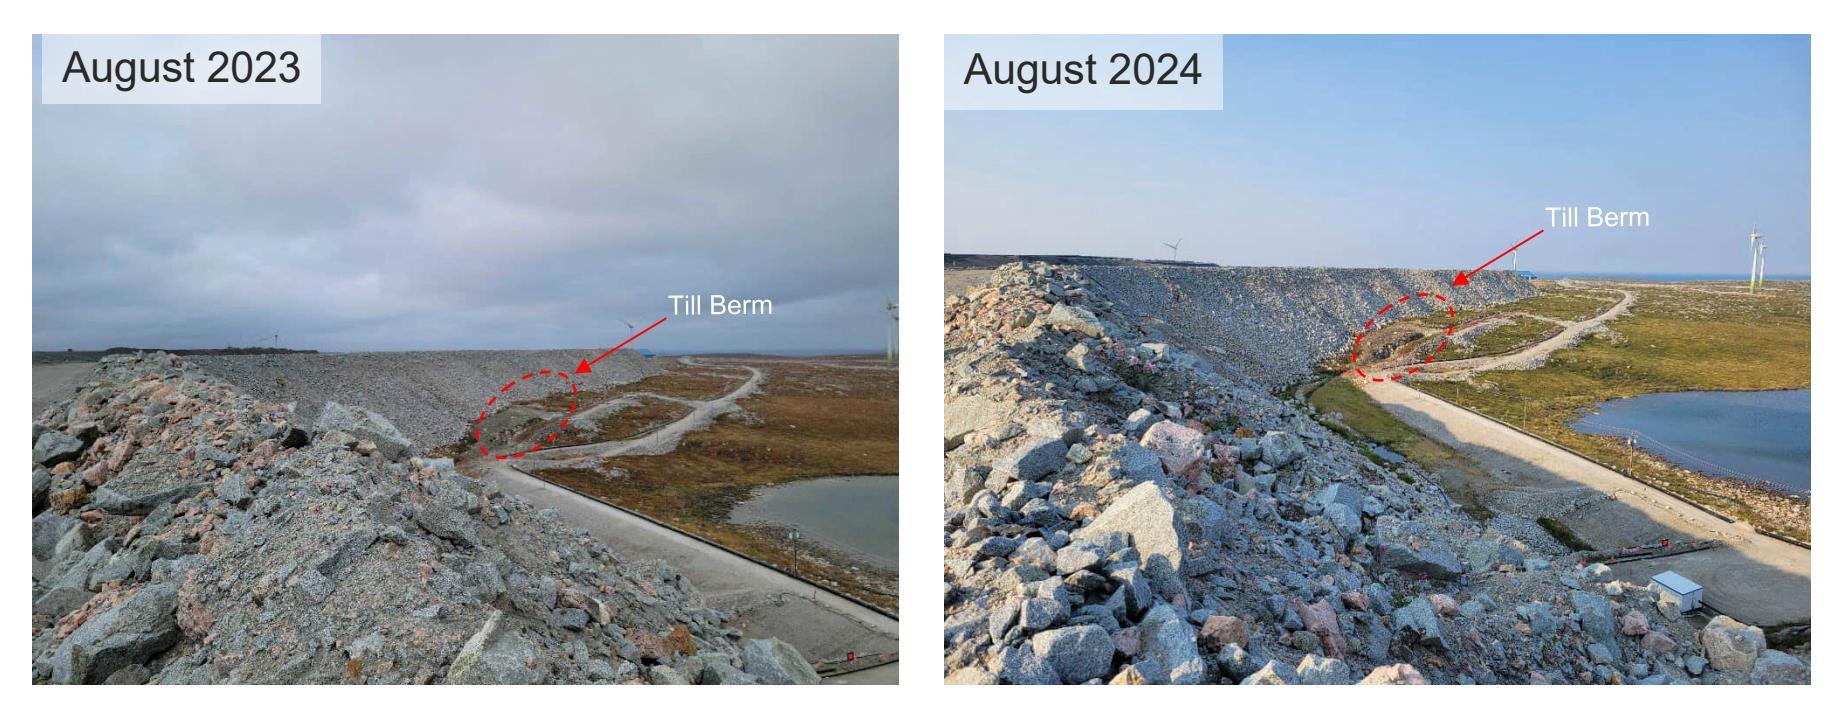
Photograph West PKC Dam – 2: View of the downstream slope from about Sta. 75+100 looking southwest. Seepage collection channel downstream of dam toe. Till berm constructed to direct seepage observed from November 2021 to February 2022 to Pond 4. No seepage in this area has been noted since 2022.

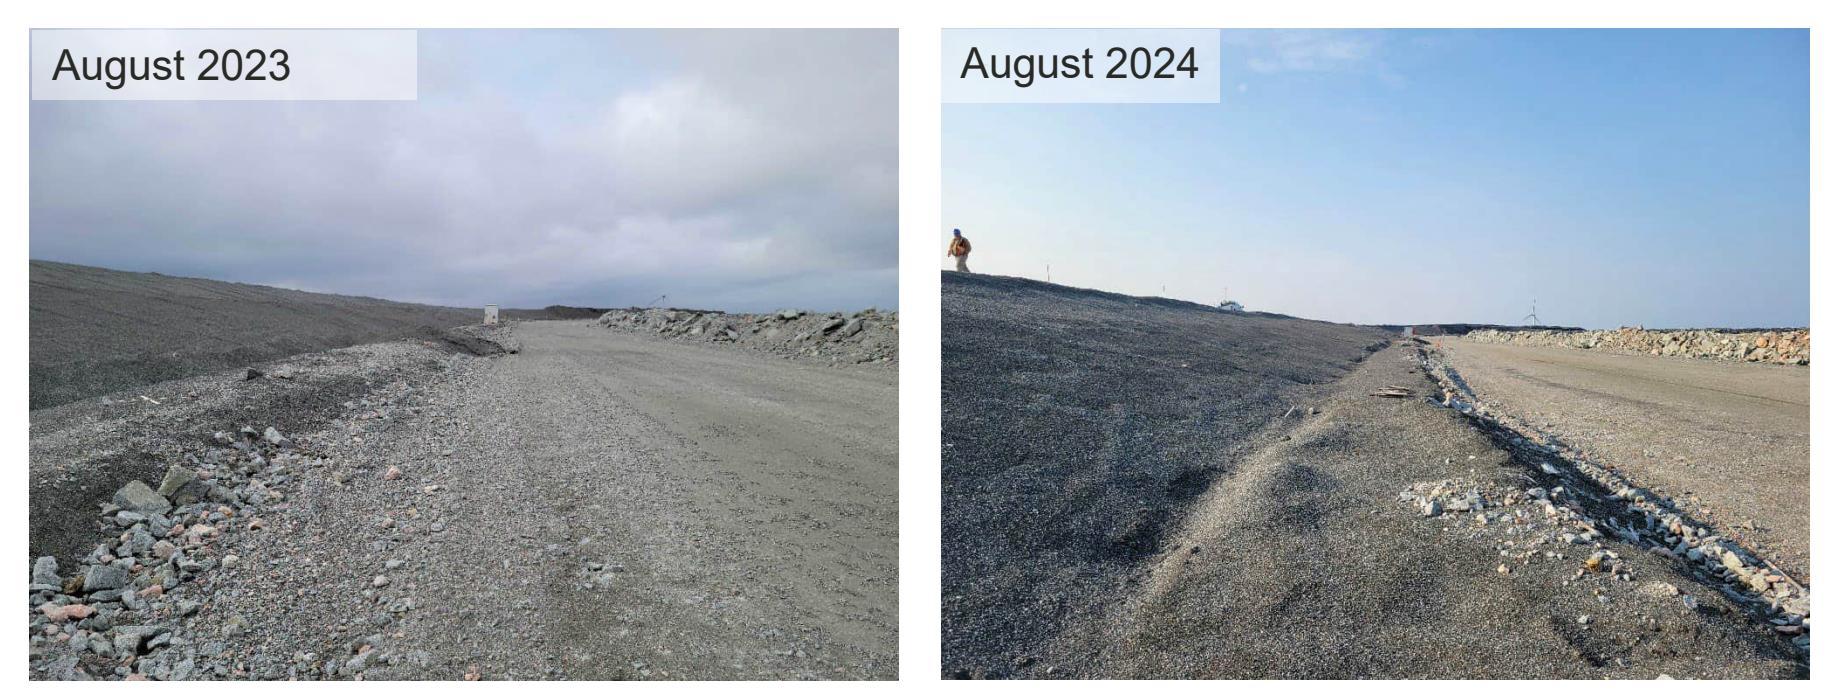
Photograph West PKC Dam – 3: View from Sta. 74+900 to the south looking along the upstream crest. Upstream CPK raised to elev. 473 m between 2022 and 2023. Closure clover is yet to be placed on the 3:1 slope.

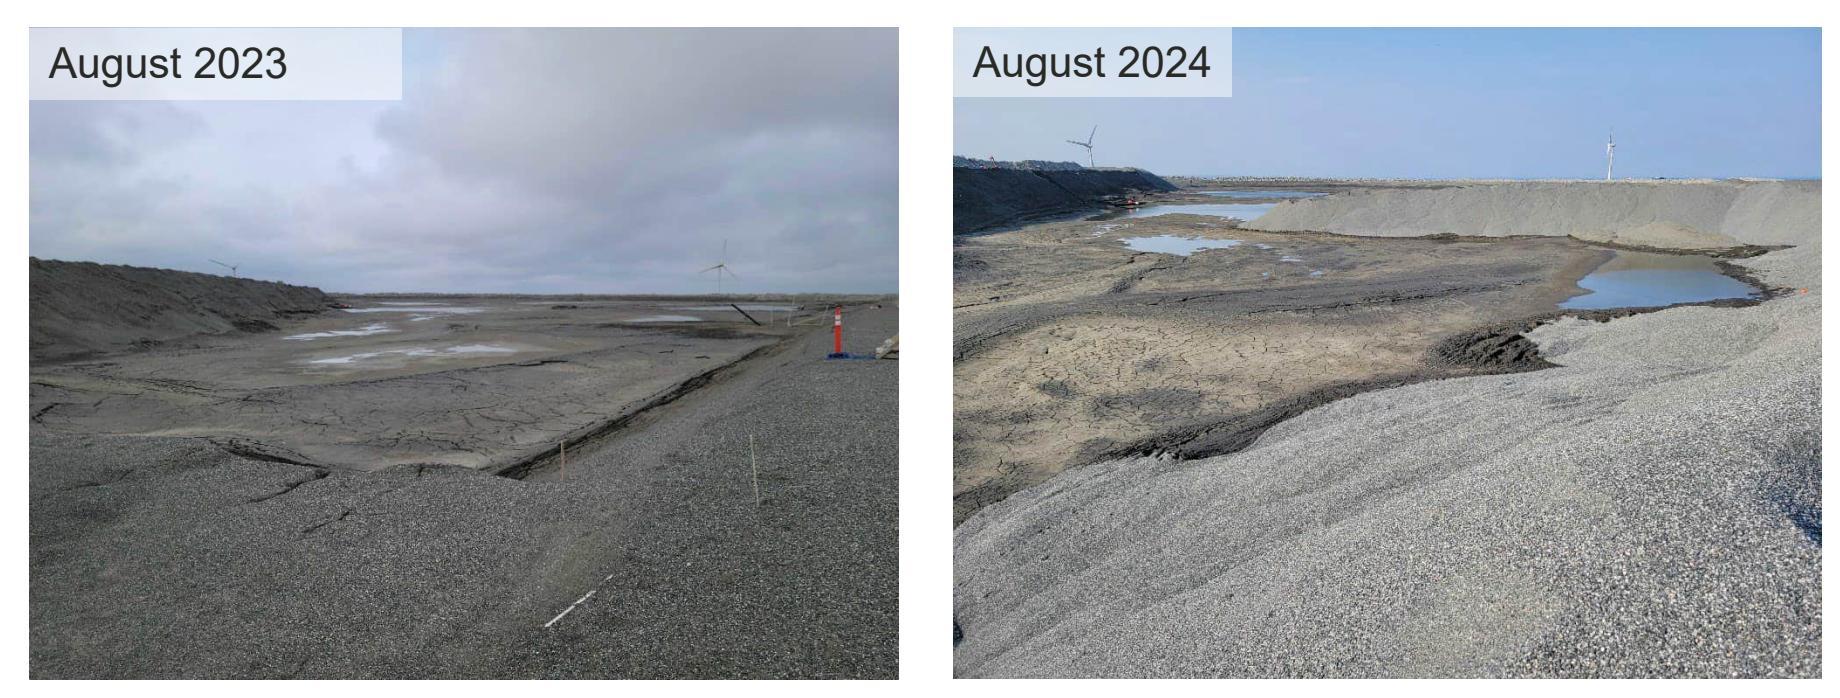
Photograph West PKC Dam – 4: West Cell area near Sta. 75+300 looking south. FPK was last deposited into West Cell in 2021. West Cell causeway at left of photo raised in 2022 to elev. 473 m. CPK road under construction in 2024 to create a containment cell for EFPK planned to be excavated from the closure spillway inlet channel.

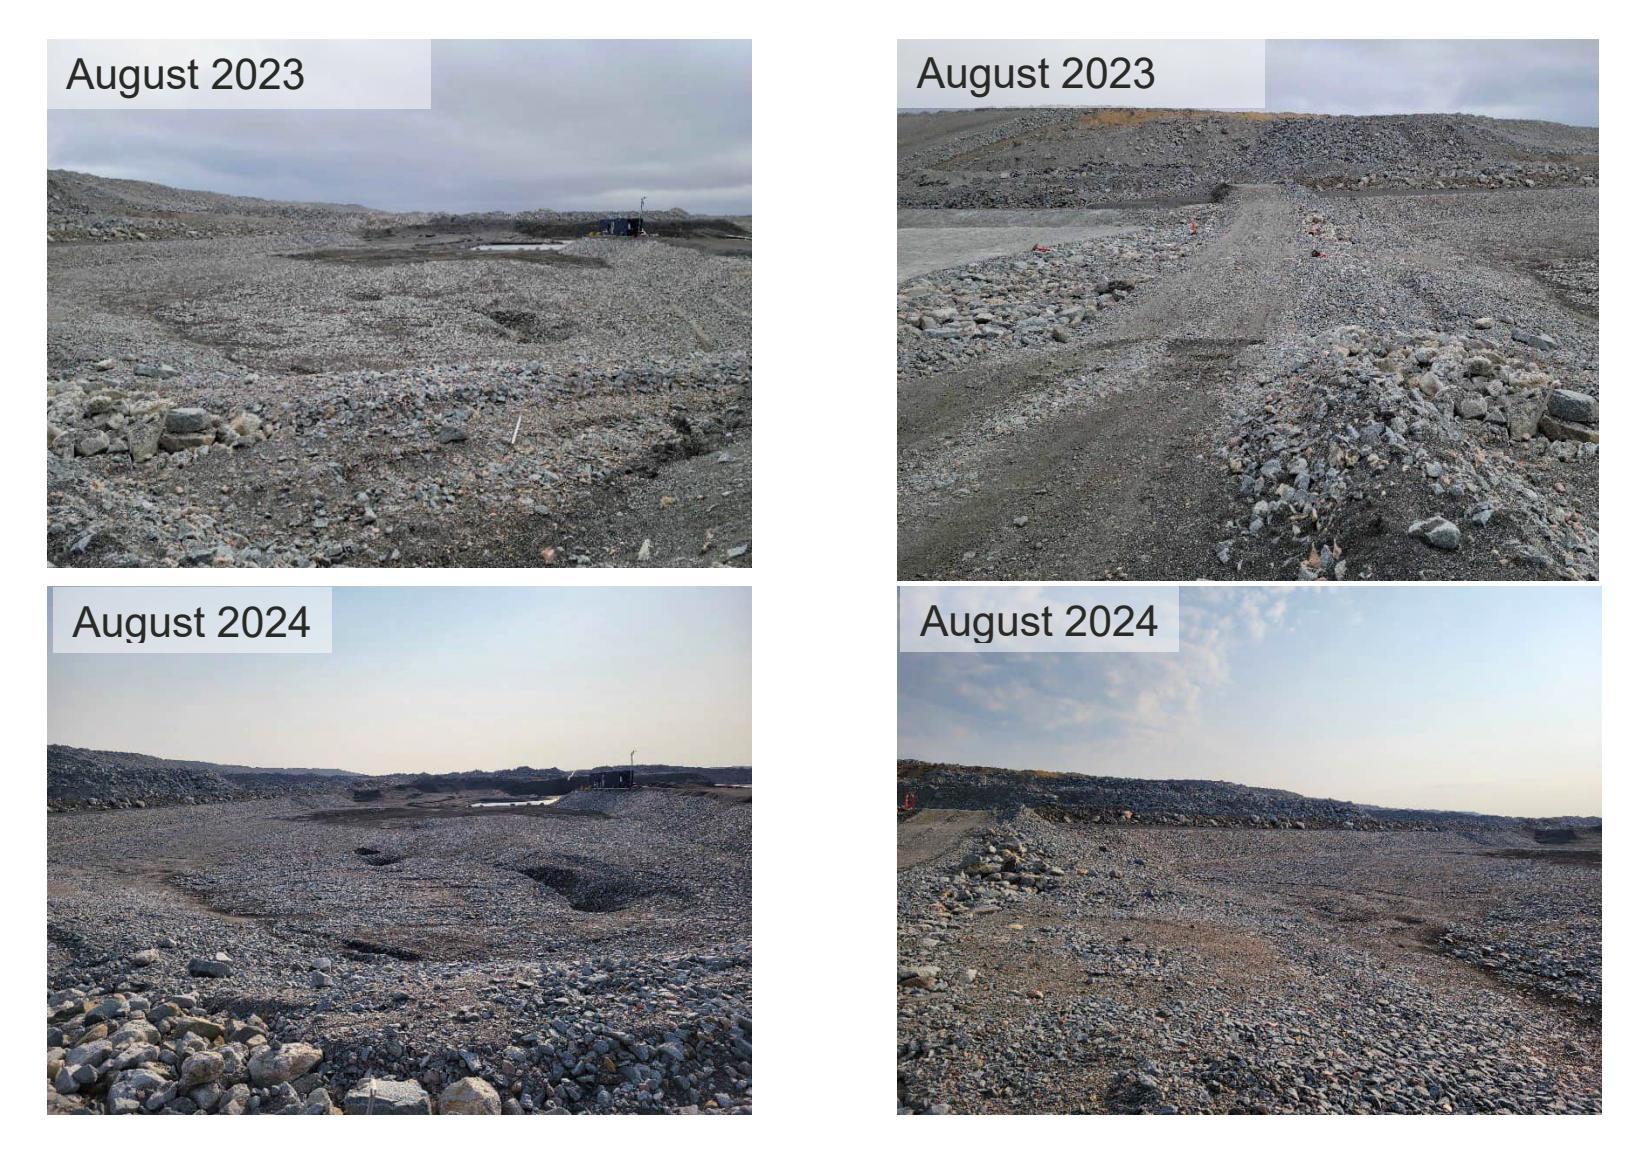
Photograph West PKC Dam – 5: Spillway channel across the West Dam crest looking upstream in left photos, looking parallel to crest in right photo. Sinkholes were observed by DDMI upstream of the PKC spillway in August 2022 and were backfilled during September 2022. Some further development has occurred in the sinkholes since the 2023 DSI.

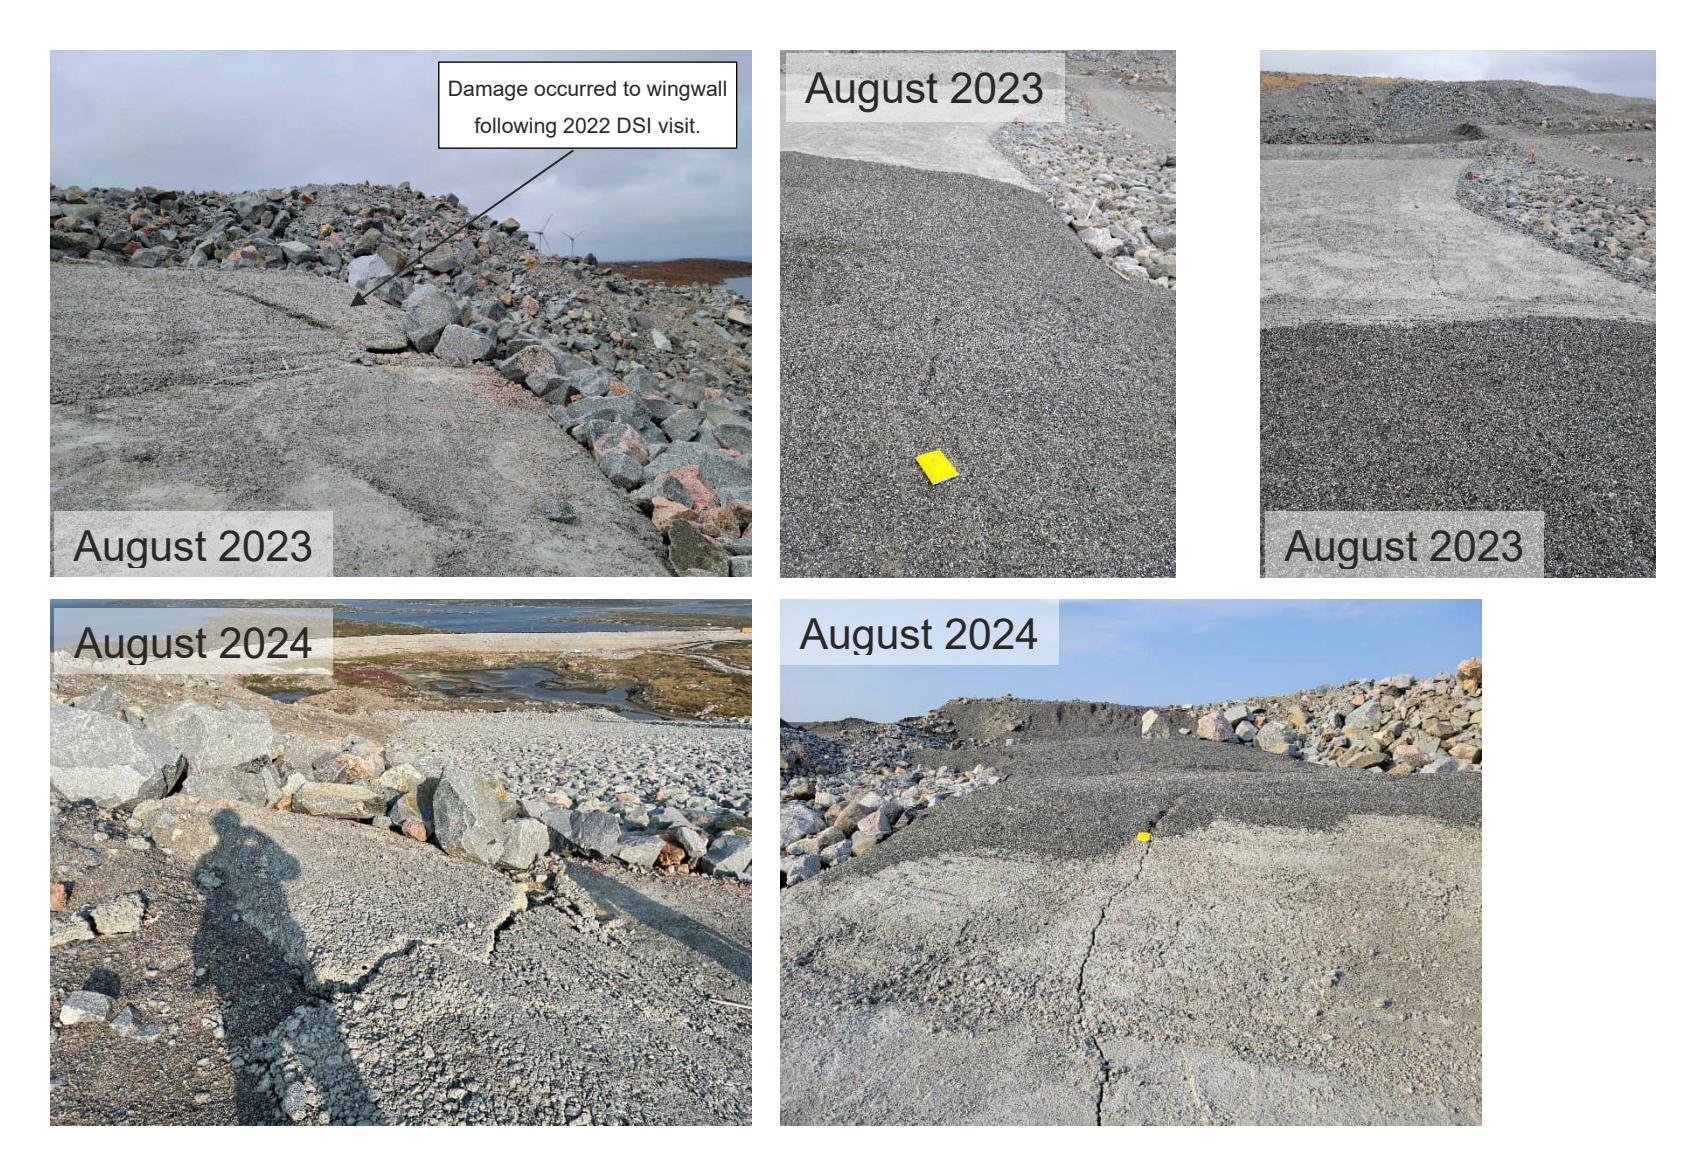
Photograph West PKC Dam – 6: Cracking observed in CRF in south side slope at downstream end of CRF (left), closeup of cracked CRF (centre and right). Condition of cracking in CRF at spillway invert has developed since 2023 in aperture width and appears upstream of the liner anchor trench.

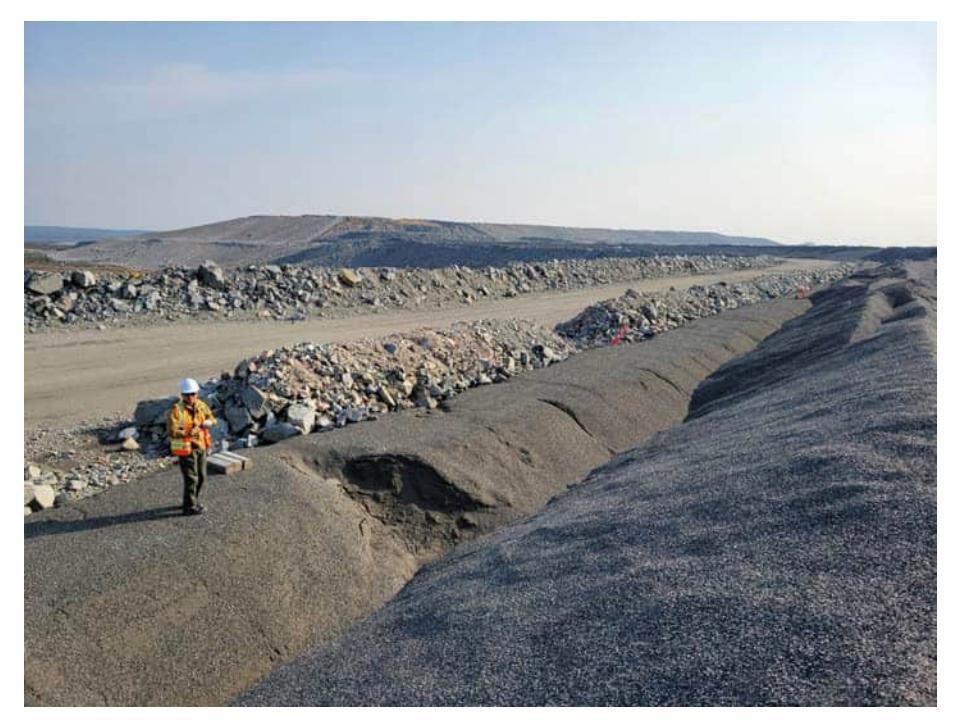
Photograph West PKC Dam – 7: Erosion has occurred of the CPK liner cover in the anchor trench adjacent to the West Cell at approximately Station 75+550, likely caused for past spigotting or FPK pipe break.

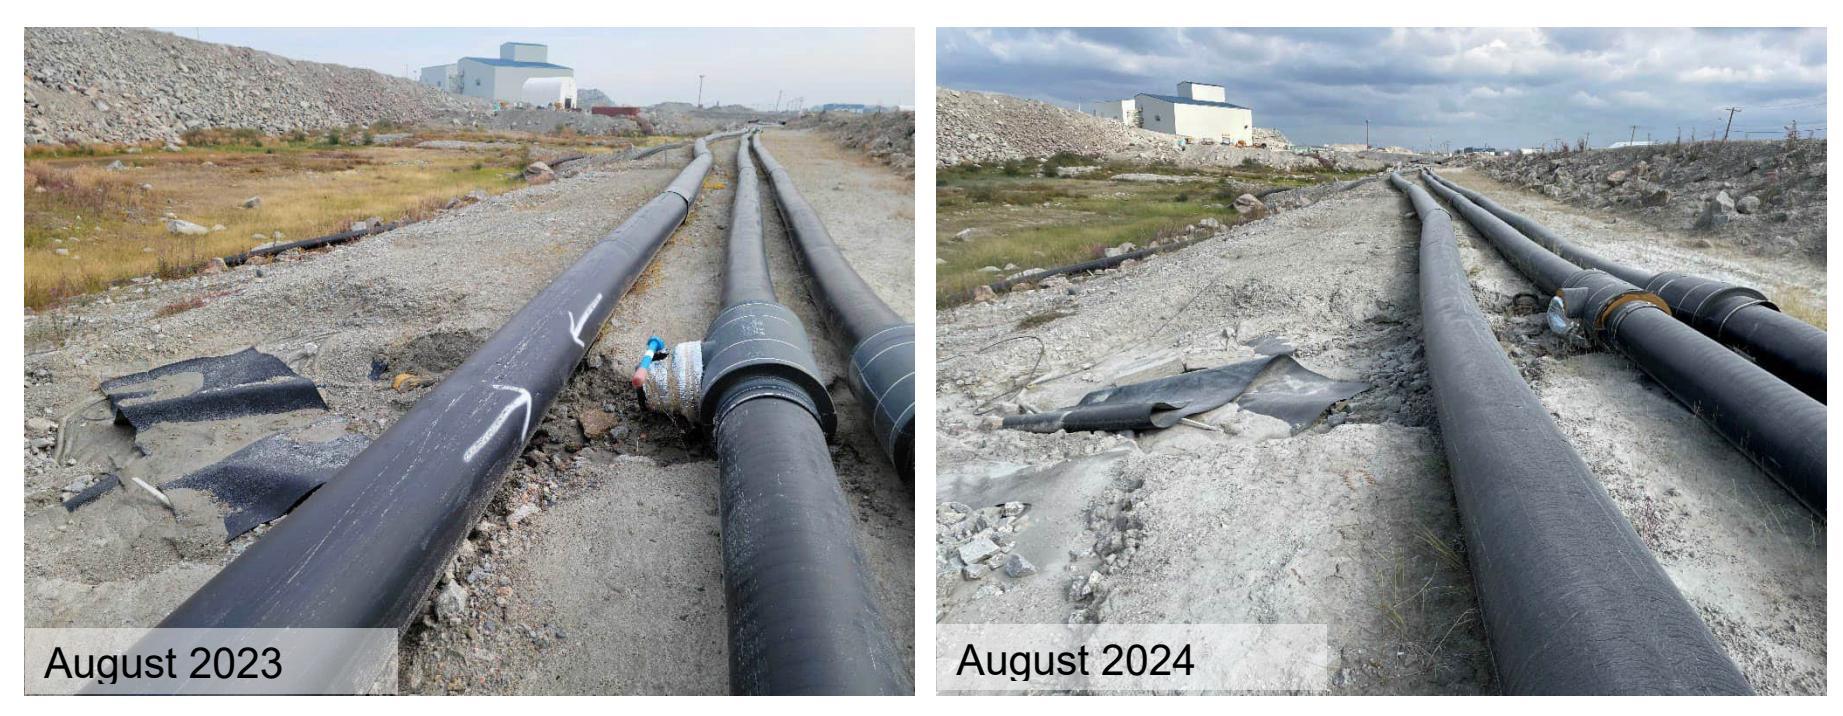
Photograph Pond 1 – 1: View of upstream slope of Pond 1 near access ramp to Pond 1 pump. Surface erosion continues over an area of exposed high density polyethylene liner. Erosion of cover and liner bedding is similar to previous years' inspections.

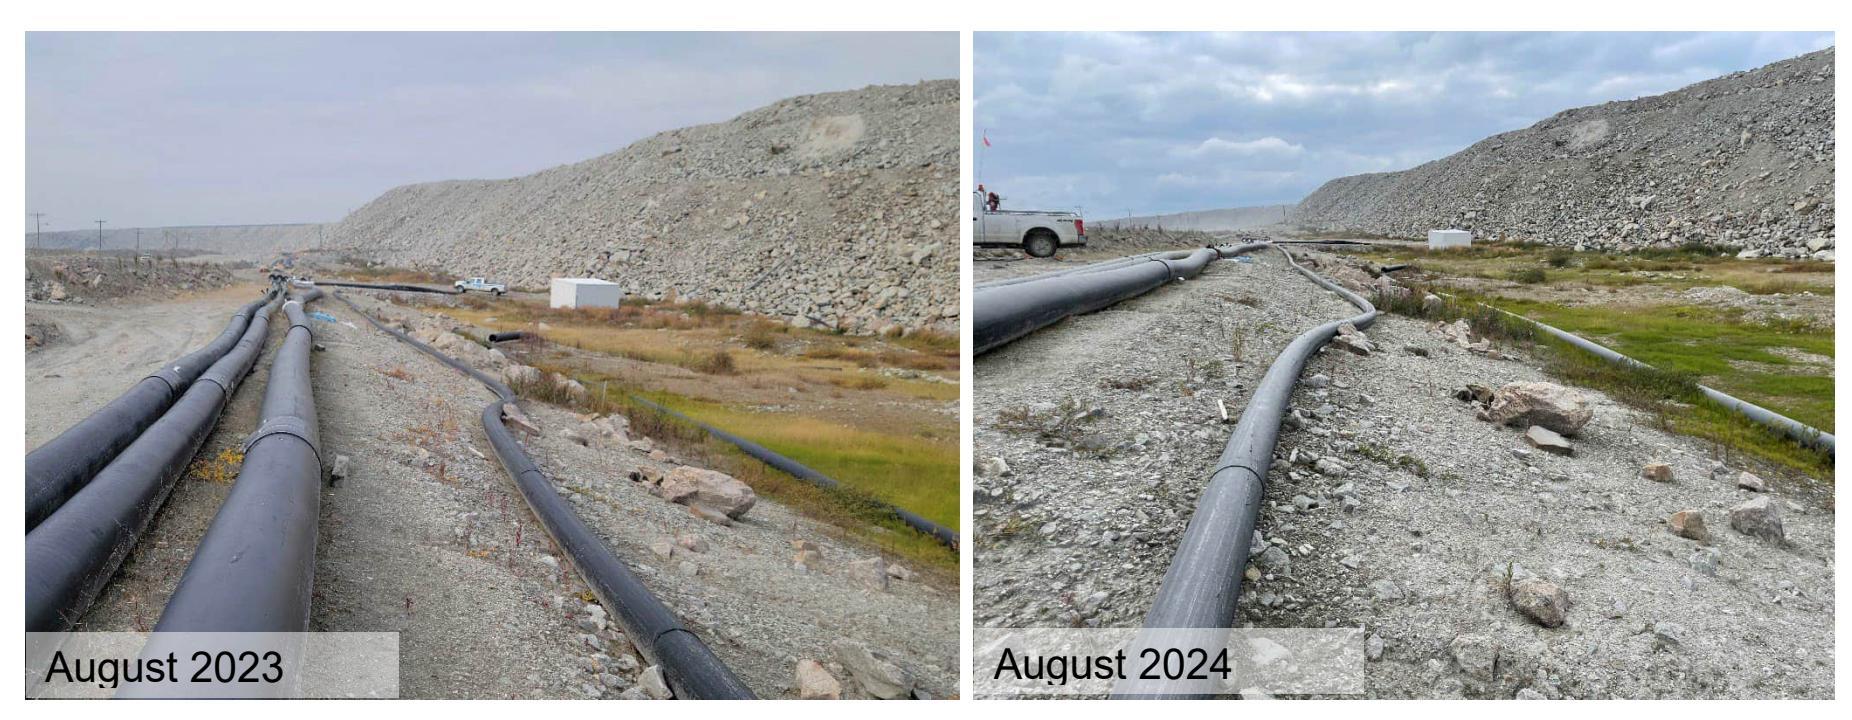
Photograph Pond 1 – 2: Possible bulging of area upstream of dam toe at south end of Pond 1 first observed in September 2020 just north of erosion shown in Photo 1. No further movement observed in 2024.

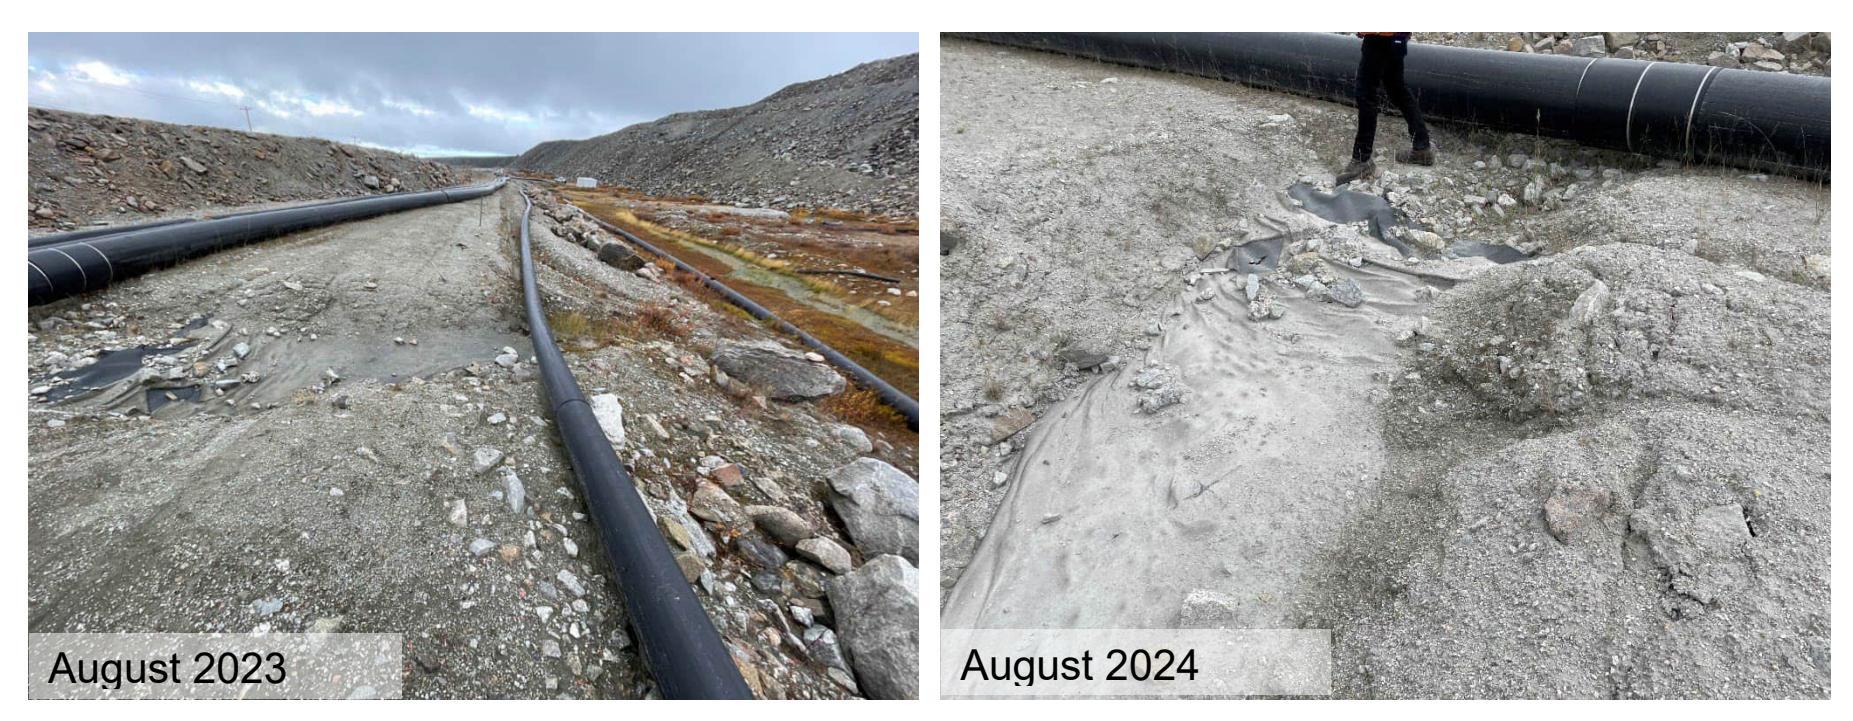
Photograph Pond 1 – 3: View of the Pond 1 dam crest and upstream slope. Erosion of the liner cover crest and upstream slope due to temporary discharge of water on the downstream side of the liner crest in 2014. Conditions observed in 2024 is similar to previous years.
