Subject: 2024 Annual Dam Safety Inspection – Processed Kimberlite Containment Facility and Water Management Pond System

Attachments: Report on PKCF and Water Management Ponds – 2024 Annual Dam Safety Inspection for Diavik Diamond Mines (2012) Inc. by WSP Canada Inc. – November 2024

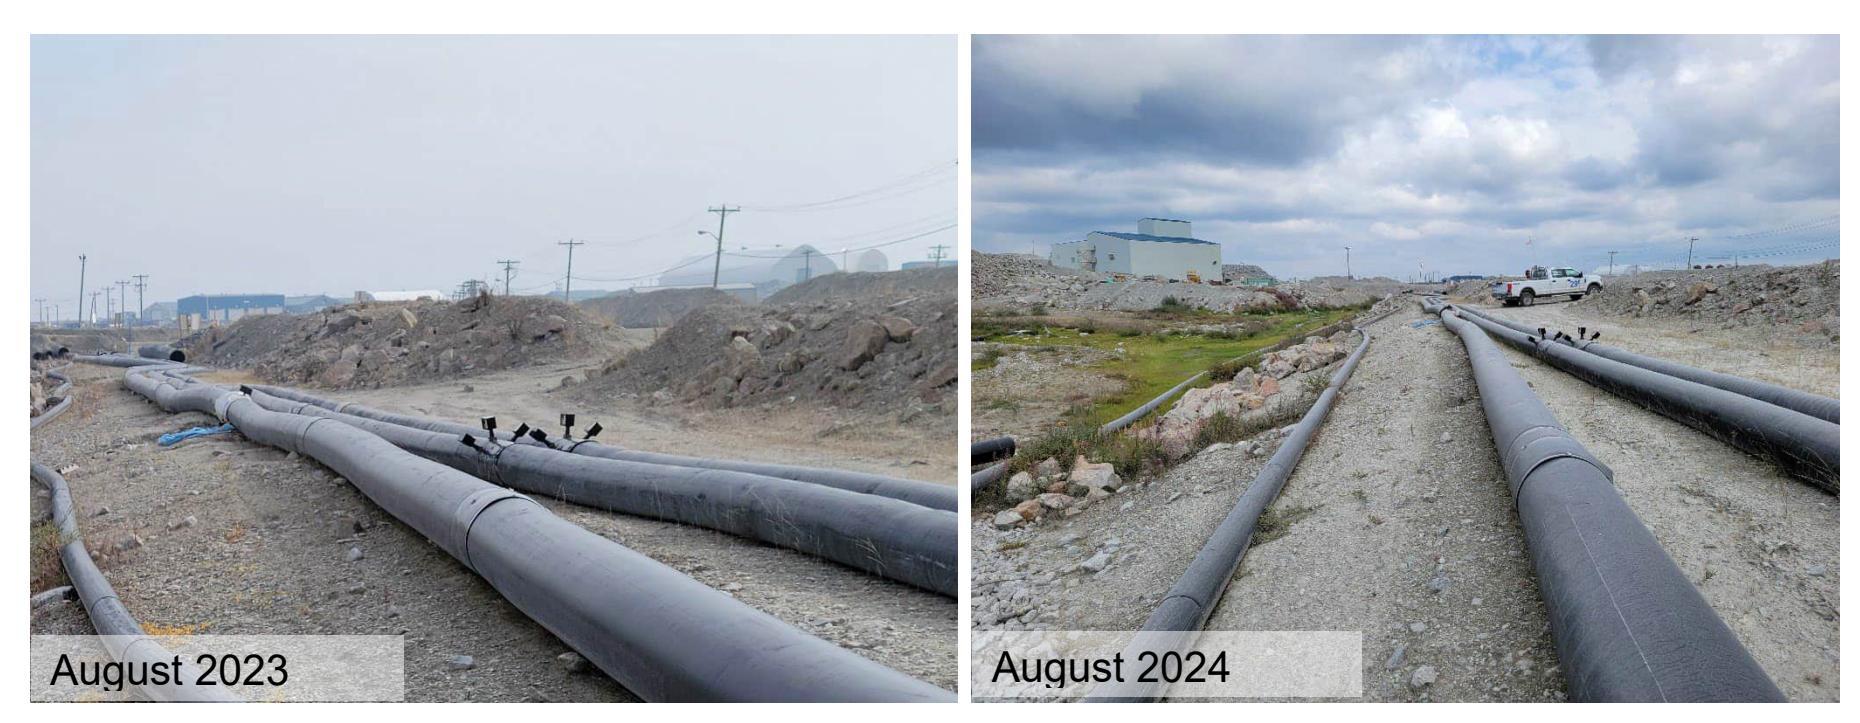
Photograph Pond 1 – 4: View of crest and upstream slope of Pond 1 where the haul road berm was excavated in 2017 to allow for a new access to the Pond 1 dam crest area. Erosion of crest and upstream slope similar to observations in previous years.

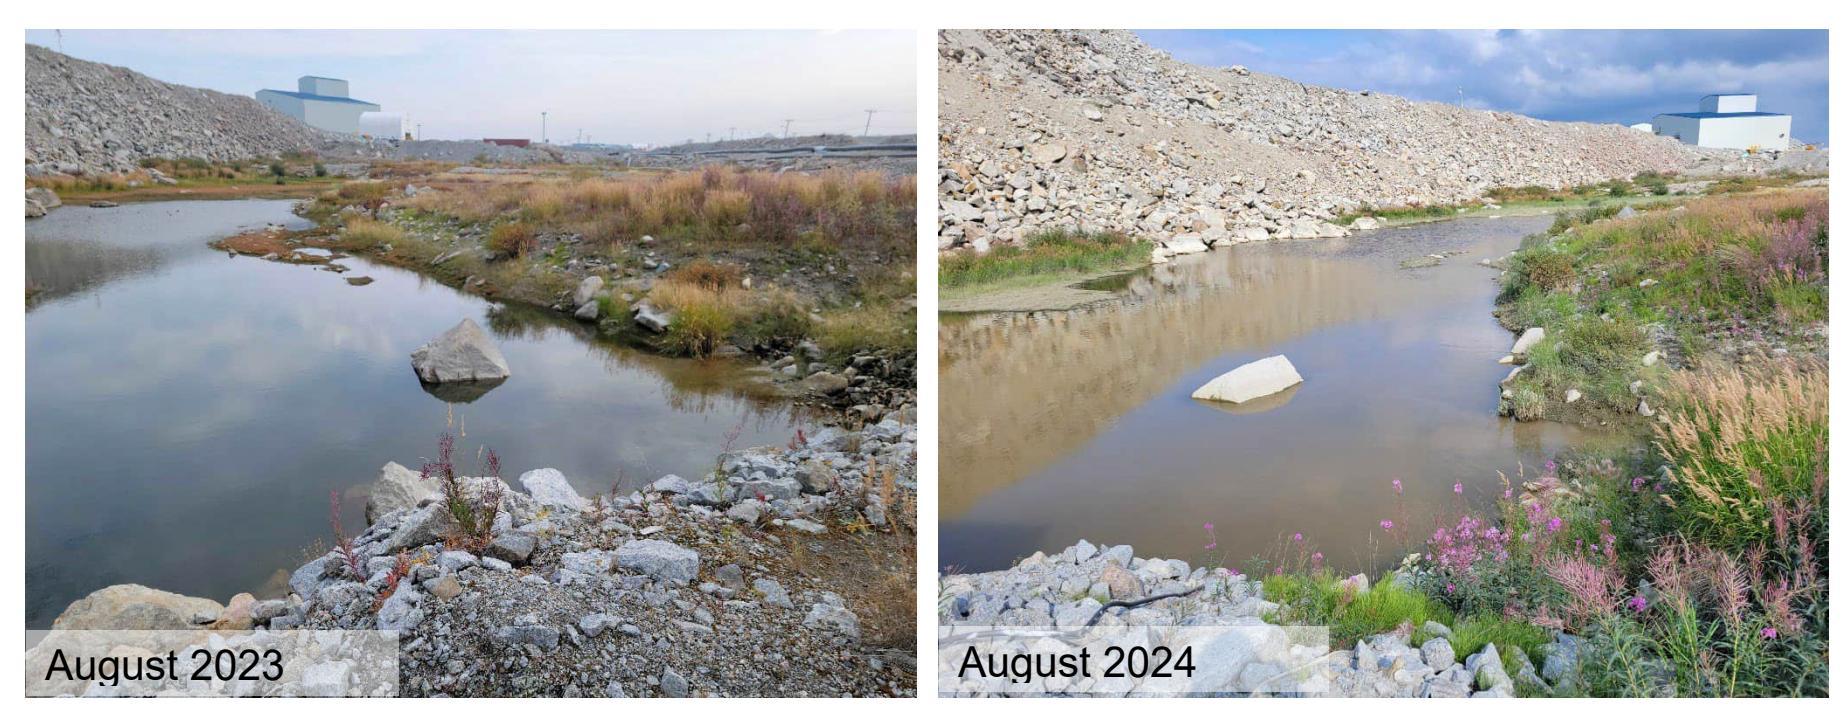
Photograph Pond 1 – 5: Pond 1 water level kept low by pumping. Water level observed in 2024 was similar to 2023.

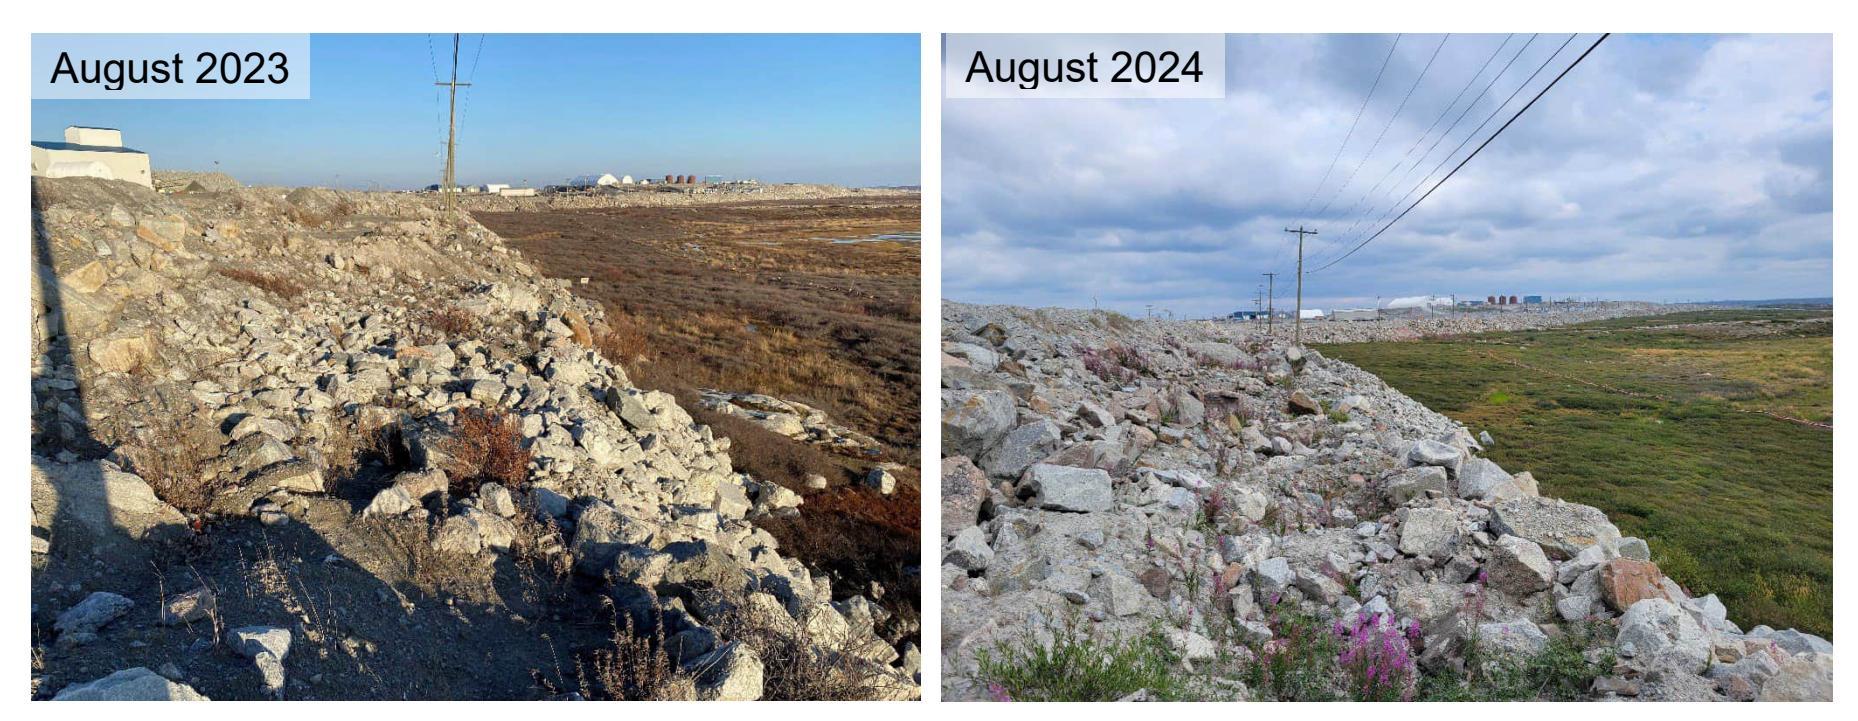
Photograph Pond 1 – 6: View to the north along the toe of the south haul road downstream of Pond 1. No signs of seepage observed from crest; lower lake level downstream than observed in pervious years.
Pond 2

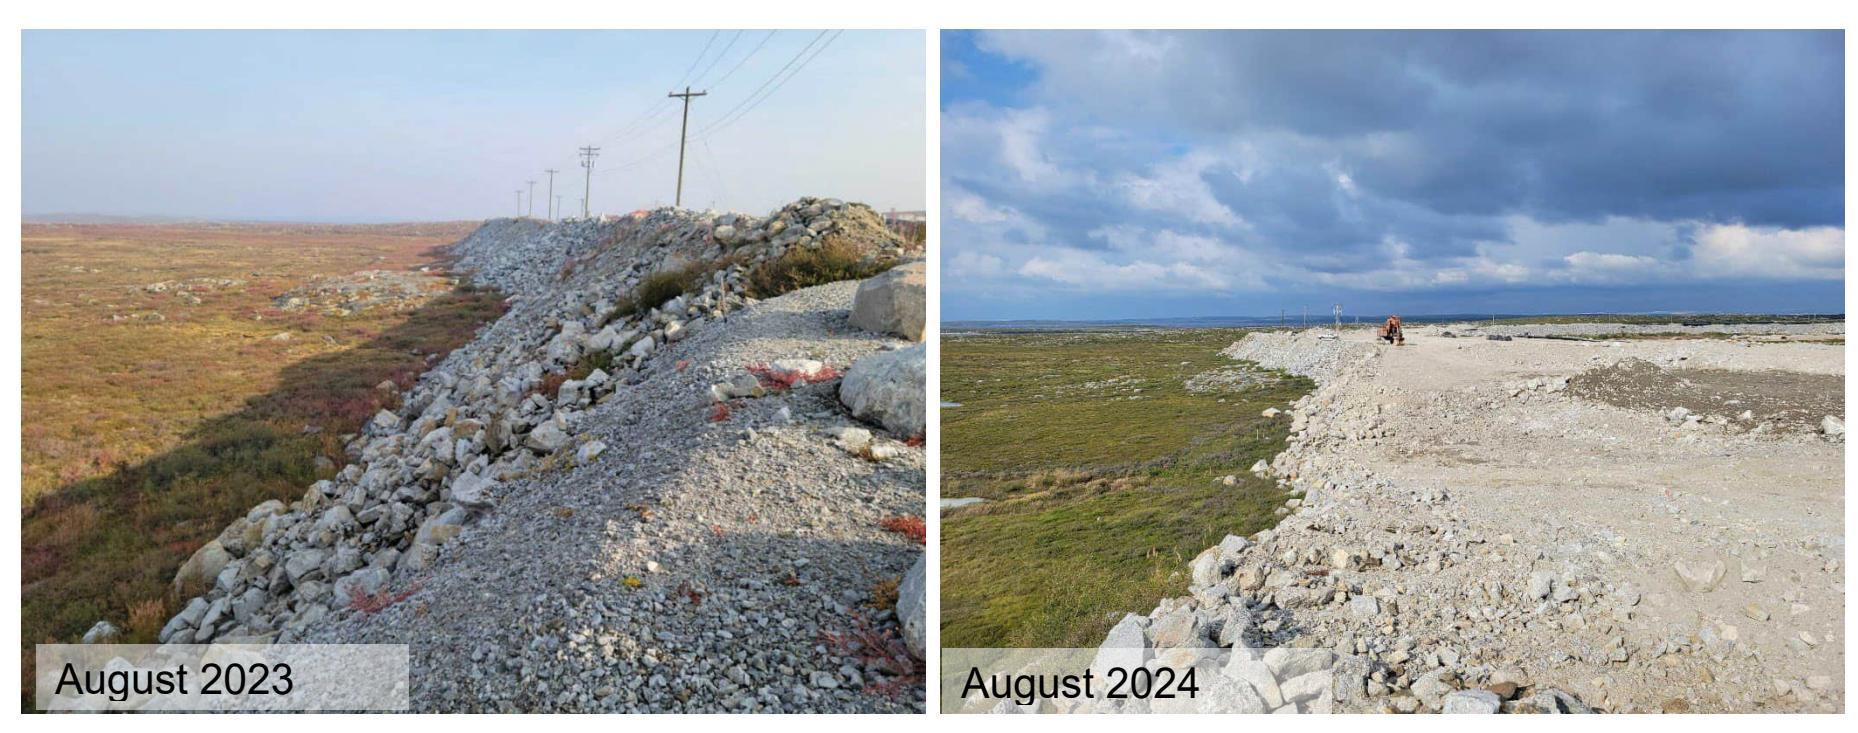
Photograph Pond 2 – 1: View to the north along the western downstream toe of Pond 2 dam. Breaching underway in 2024. 2024 photo shows breach 2B rockfill excavation.

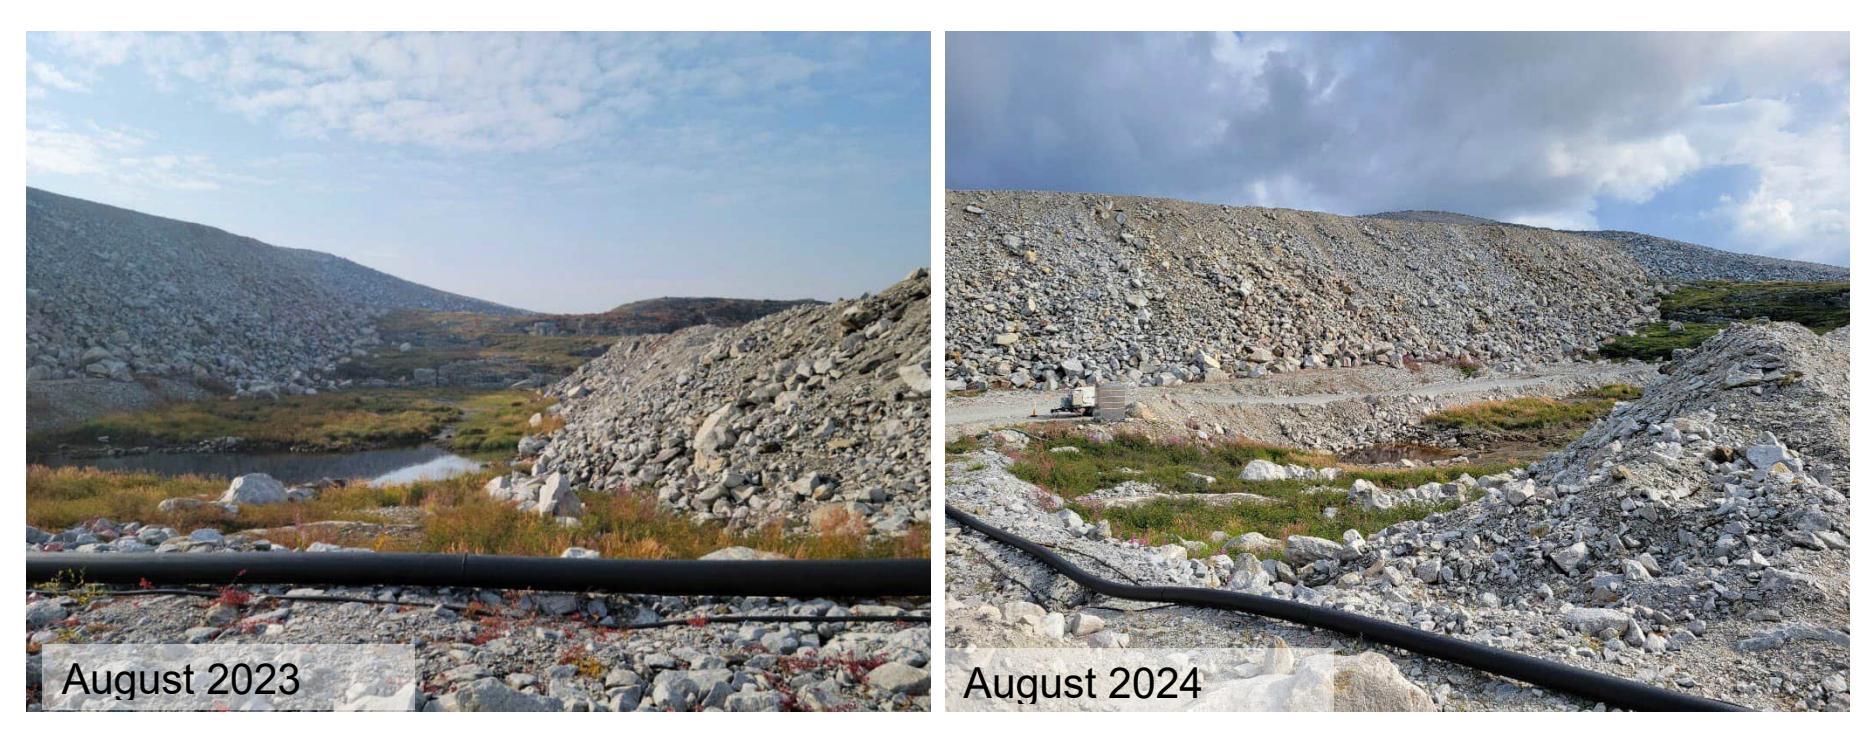
Photograph Pond 2 – 2: View to the south along the upstream toe of Pond 2 dam. Some water ponded near upstream toe in 2023 has since been drawn down during dam breach closure works in 2024.

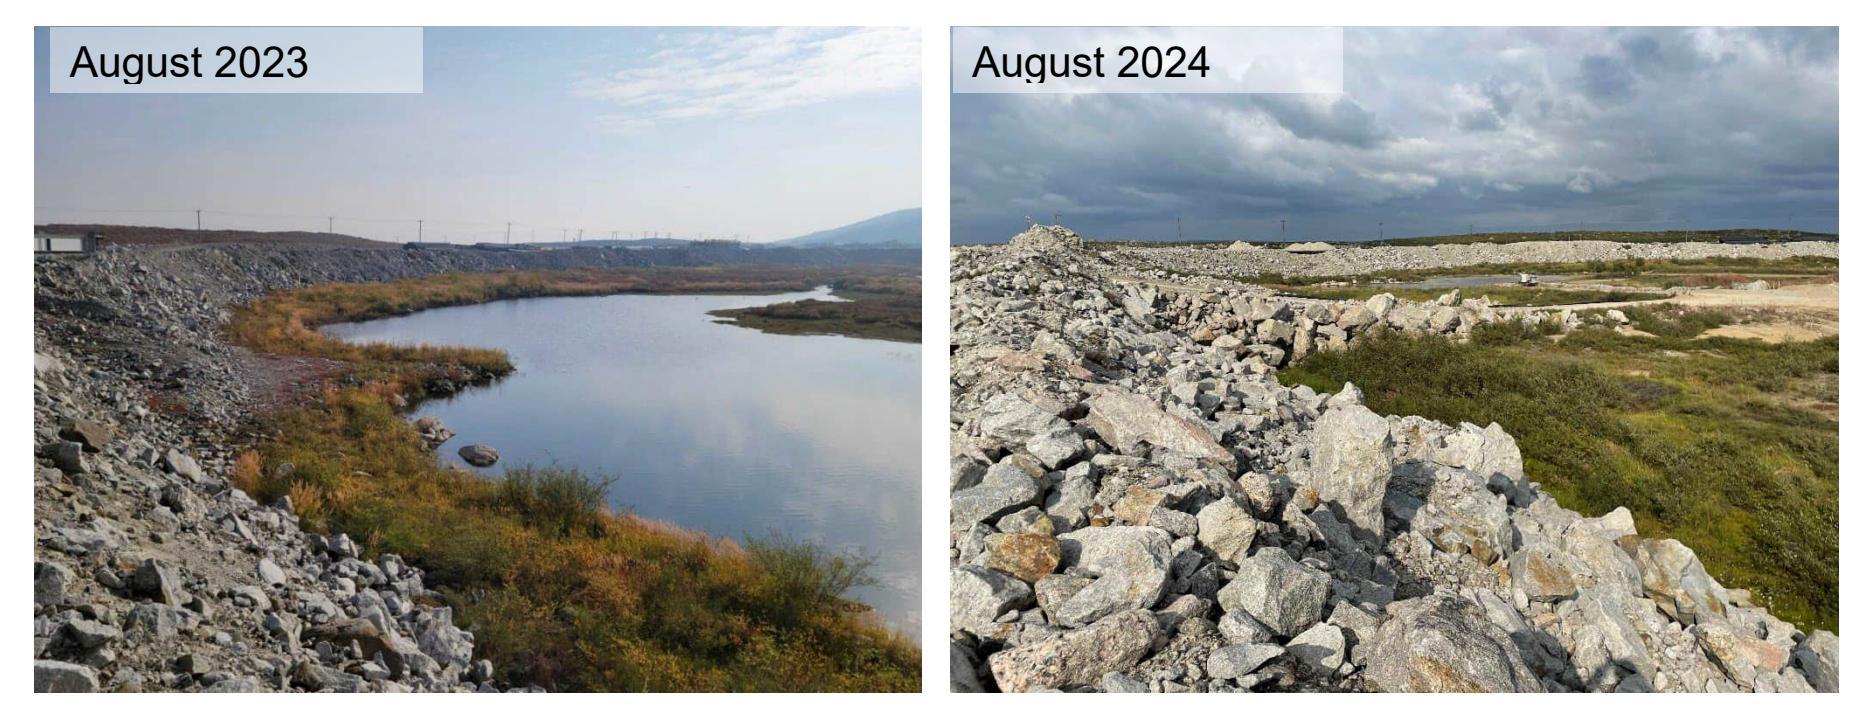
Photograph Pond 2 – 3: View of upstream toe of Pond 2 dam. The water level has been drawn down during the Pond 2 breaching works. The upstream pond area was being backfilled and graded at the time of the 2024 DSI.

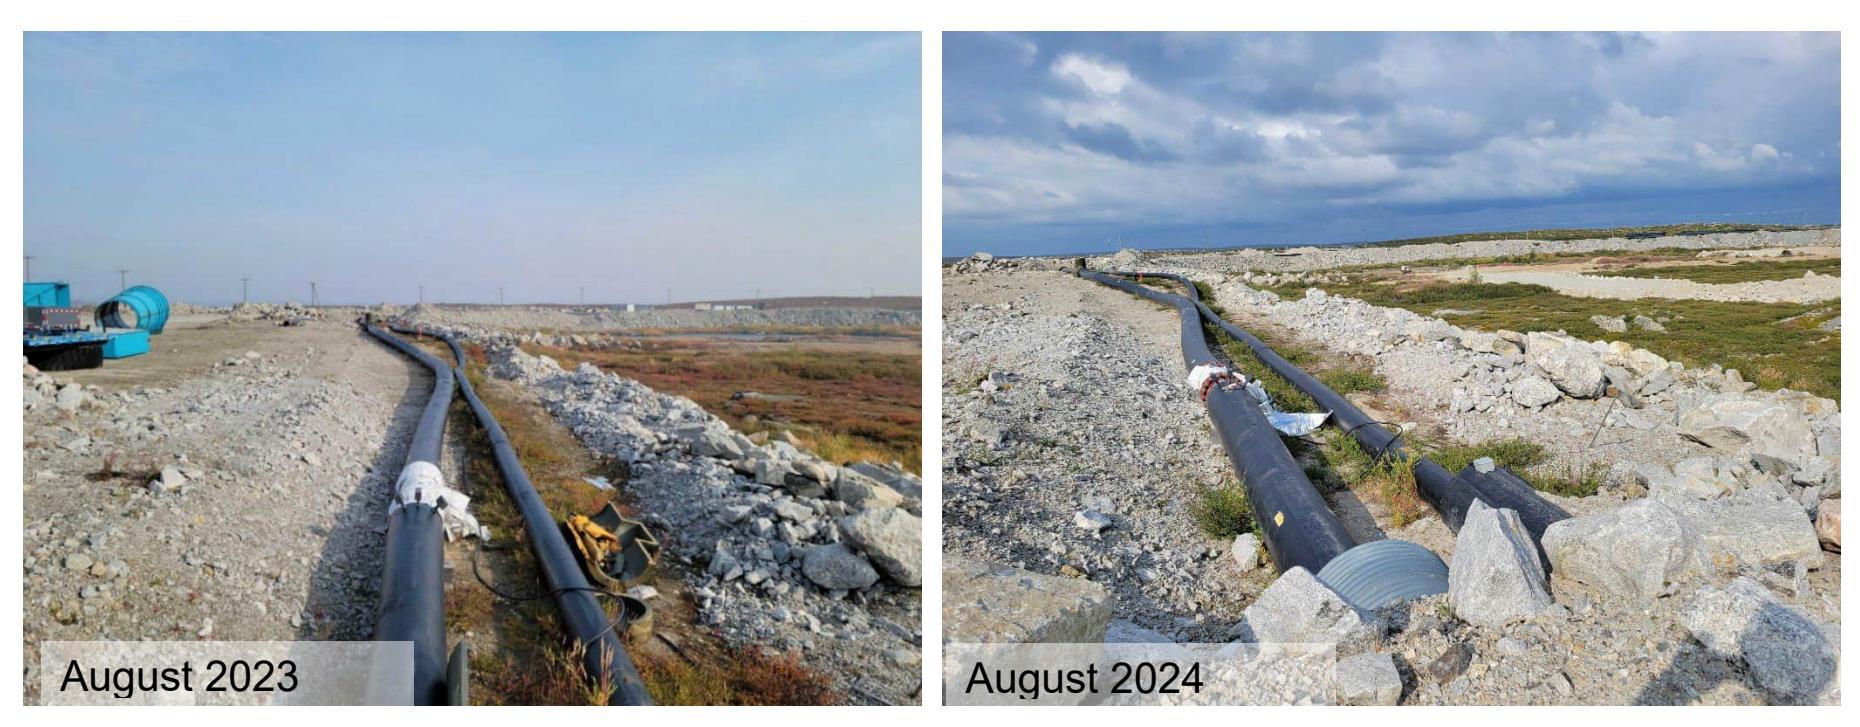
Photograph Pond 2 – 4: Upstream crest and pipeline along the Pond 2 dam, looking north, settled with creep of the upstream slope north of the pump access ramp. Settlement and creeping of the upstream slope appears to be similar to previous years.

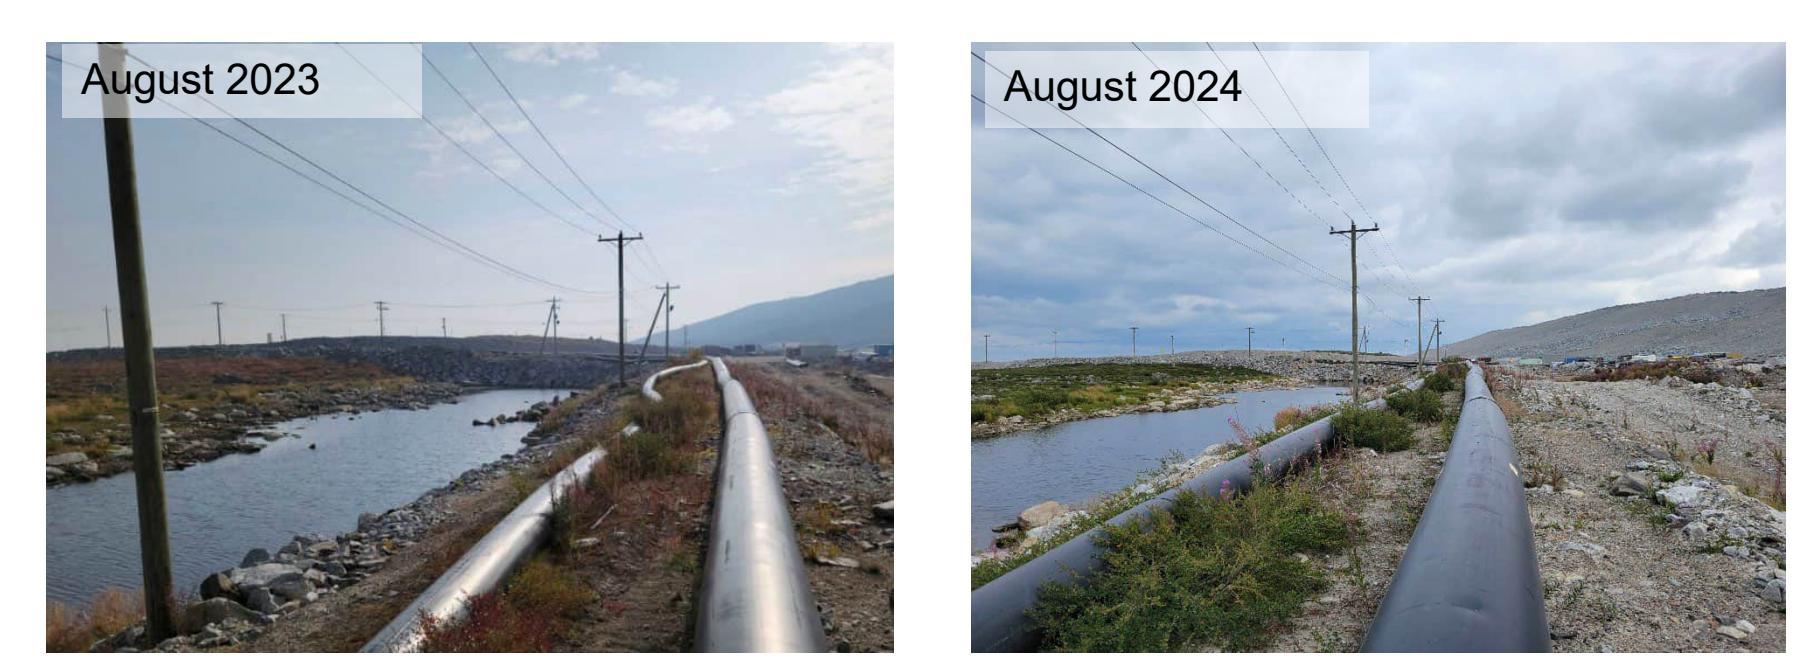
Photograph Pond 2 – 5: Local pond downstream of Pond 2 dam near northeast abutment; similar conditions to those observed in previous years.

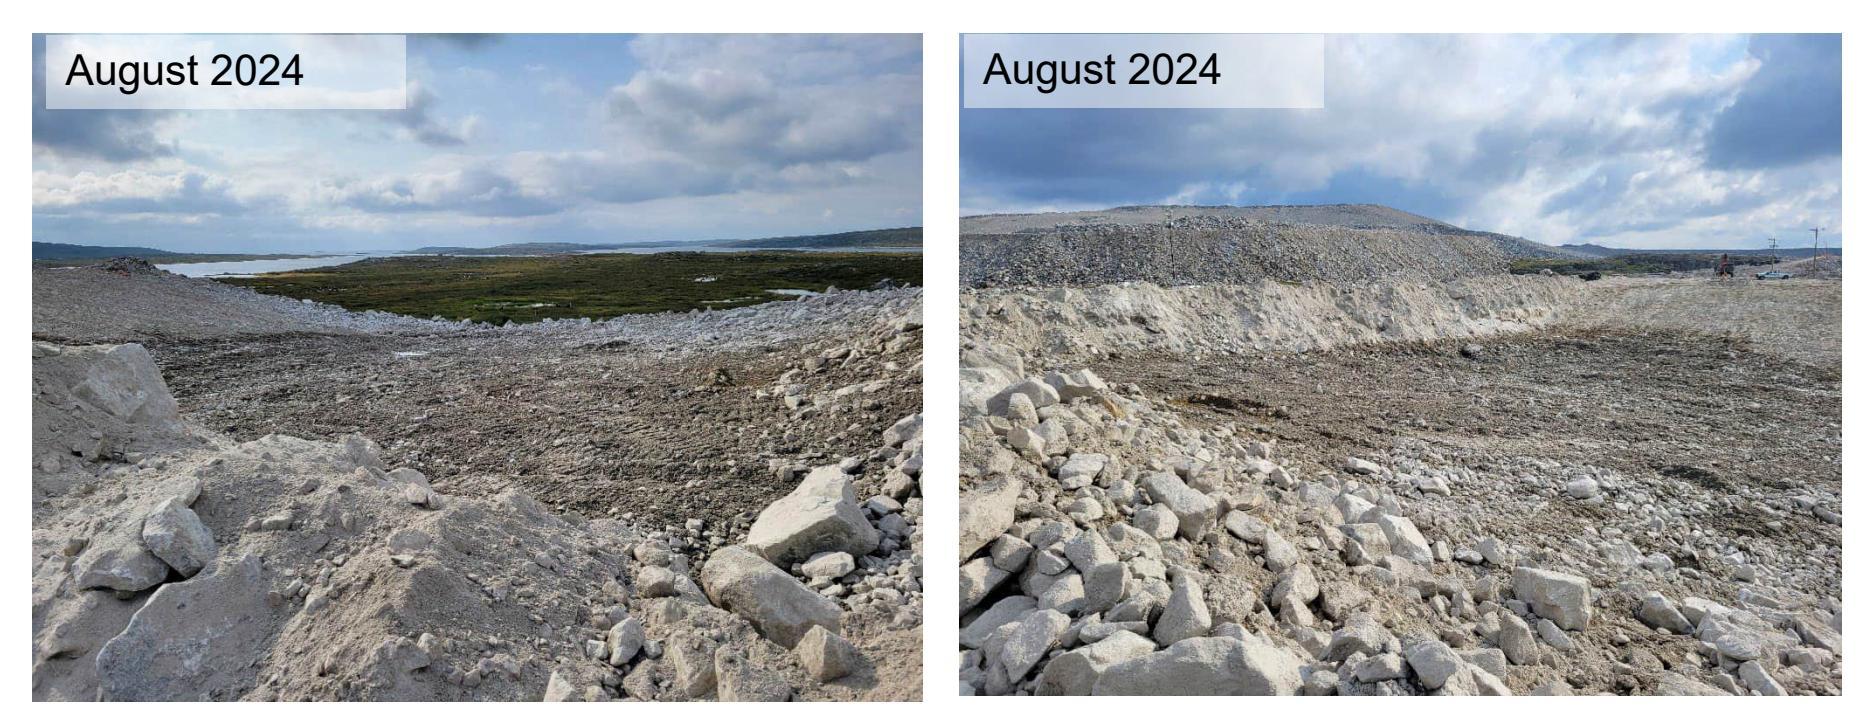
Photograph Pond 2 – 6: Pond 2B breach. Bulk rockfill excavation underway at the time of the 2024 DSI including breach of the pond liner, looking east and west, left and right photograph, respectively.

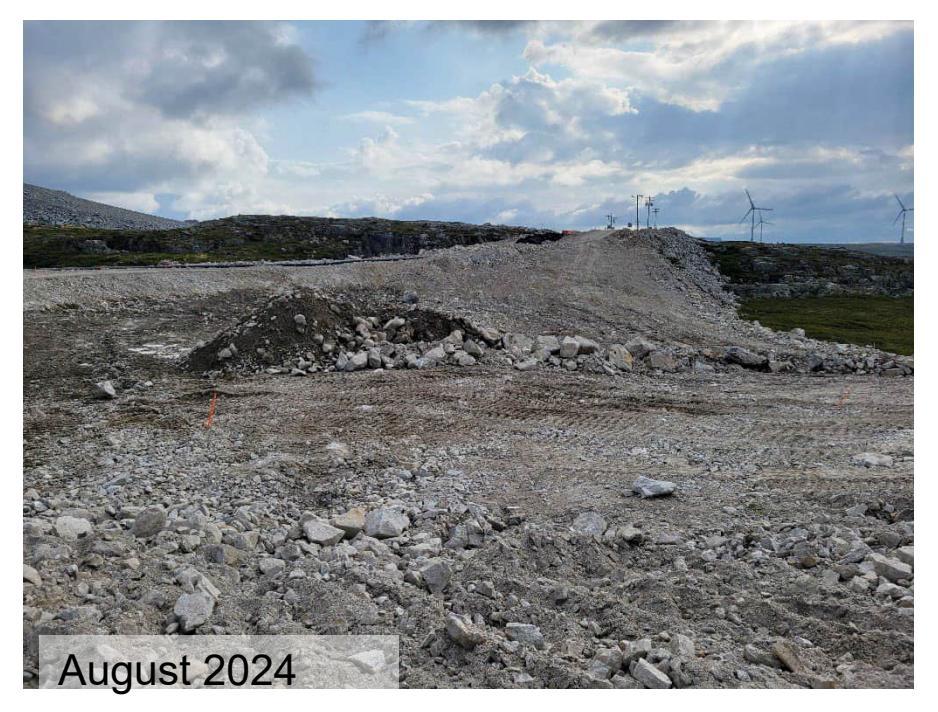
Photograph Pond 2 – 7: Pond 2A breach. Bulk rockfill excavation underway at the time of the 2024 DSI including breach of the pond liner.

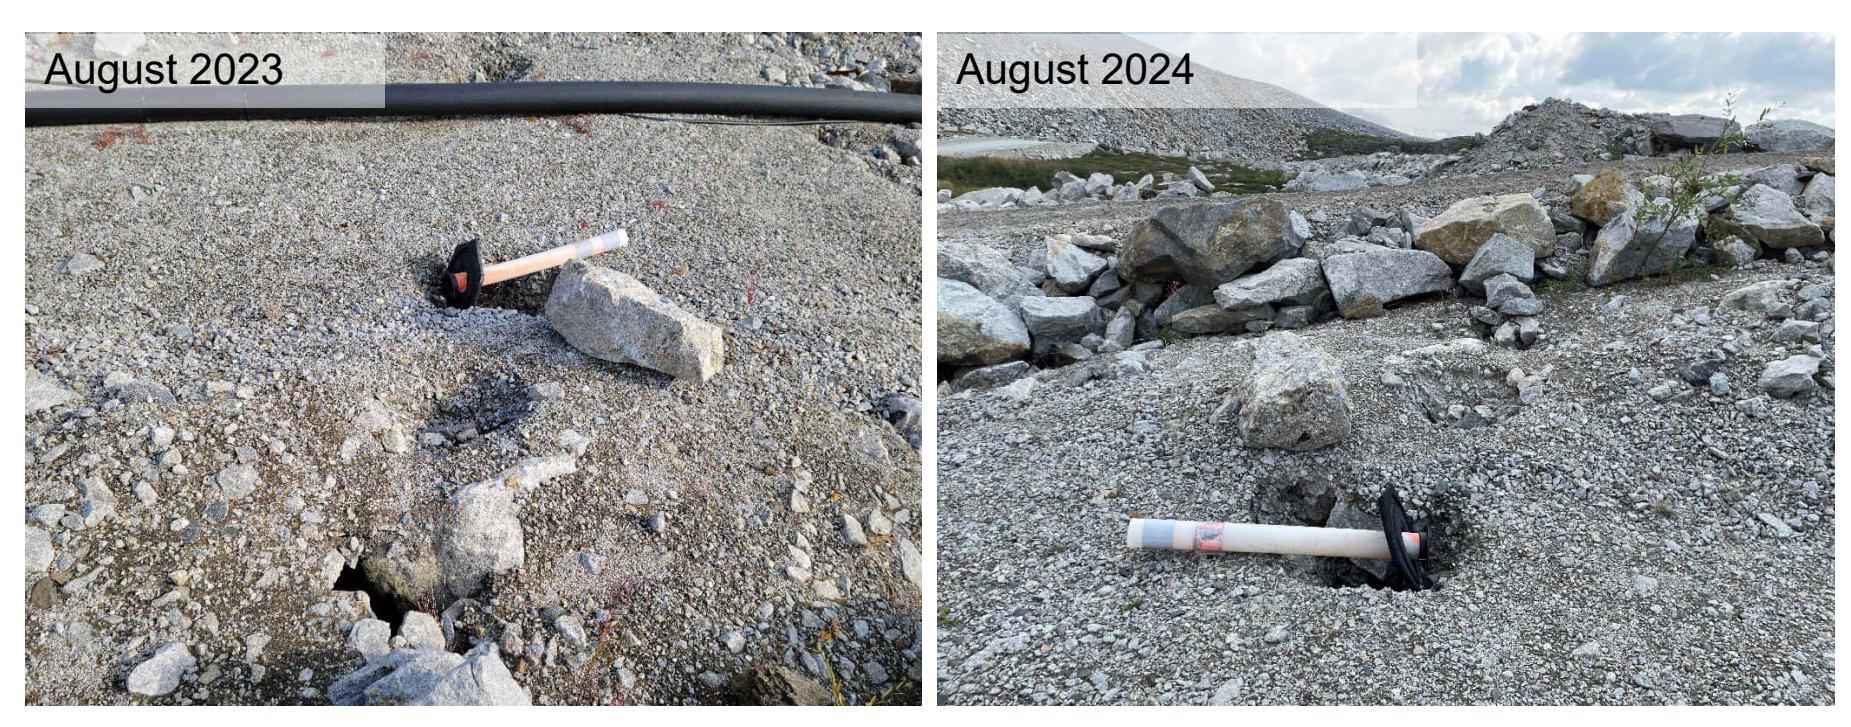
Photograph Pond 2 – 8: Sinkholes in fill upstream of liner near access ramp to pump, looking north. Photographs show sinkholes in material placed for pipe access. Some continued development of sinkholes appears to have occurred in 2024.

Drainage C	ontrol and C	collect	ion Systen	
Pond 2	Include monitoring, review, and recommendations for filling of sinkholes in geotechnical inspection reports. Survey cracking and sinkholes to confirm distance from	2019 DSI	ε	Closed	Closed – Superseded by ongoing operations recommendations.

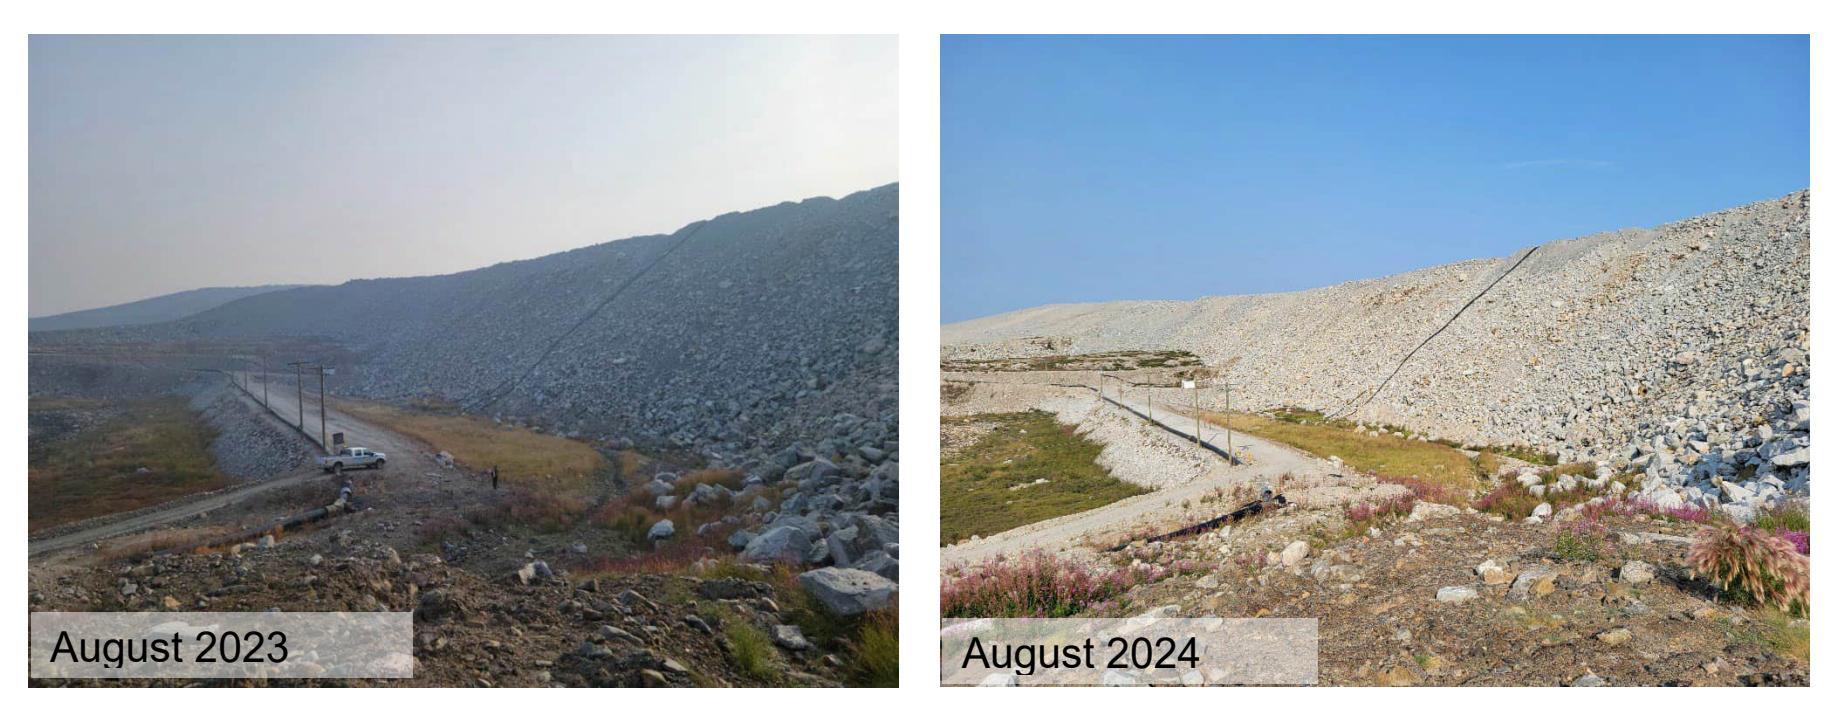
Photograph Pond 4 – 1: Overview of Pond 4 from the south abutment looking north. Low water level is maintained in Pond 4. Water is discharged from the West Dam seepage collection well directly into Pond 4. The rock-lined collection channel along the West PKC Dam toe and is conveyed to the Pond 4 sump.

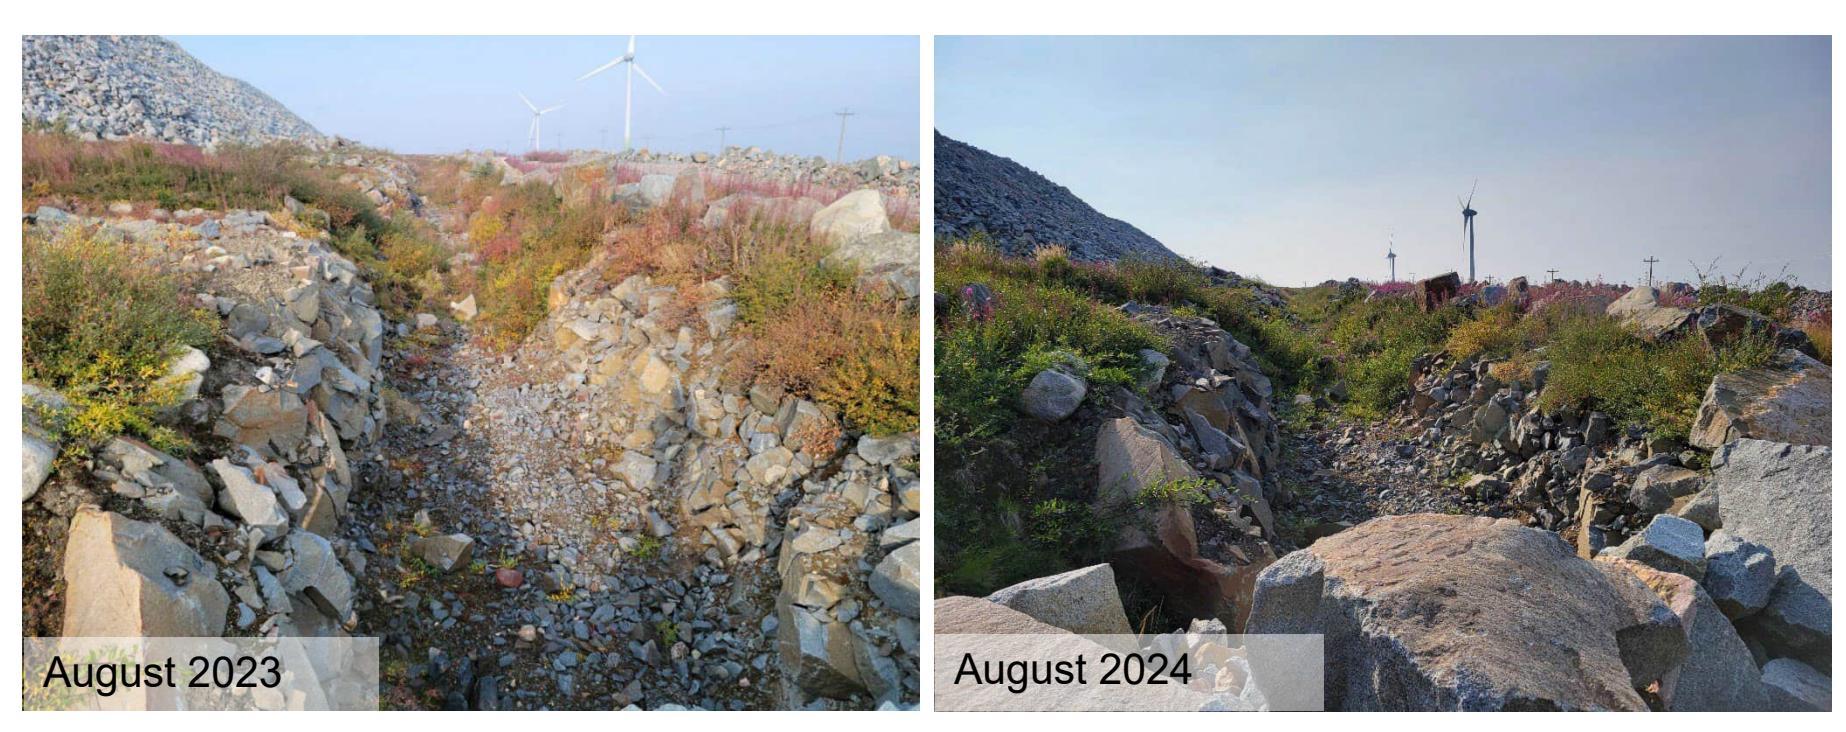
Photograph Pond 4 – 2: View of the collection channel along the toe of the West PKC Dam which drains into Pond 4. Channel appeared dry at time of inspection.

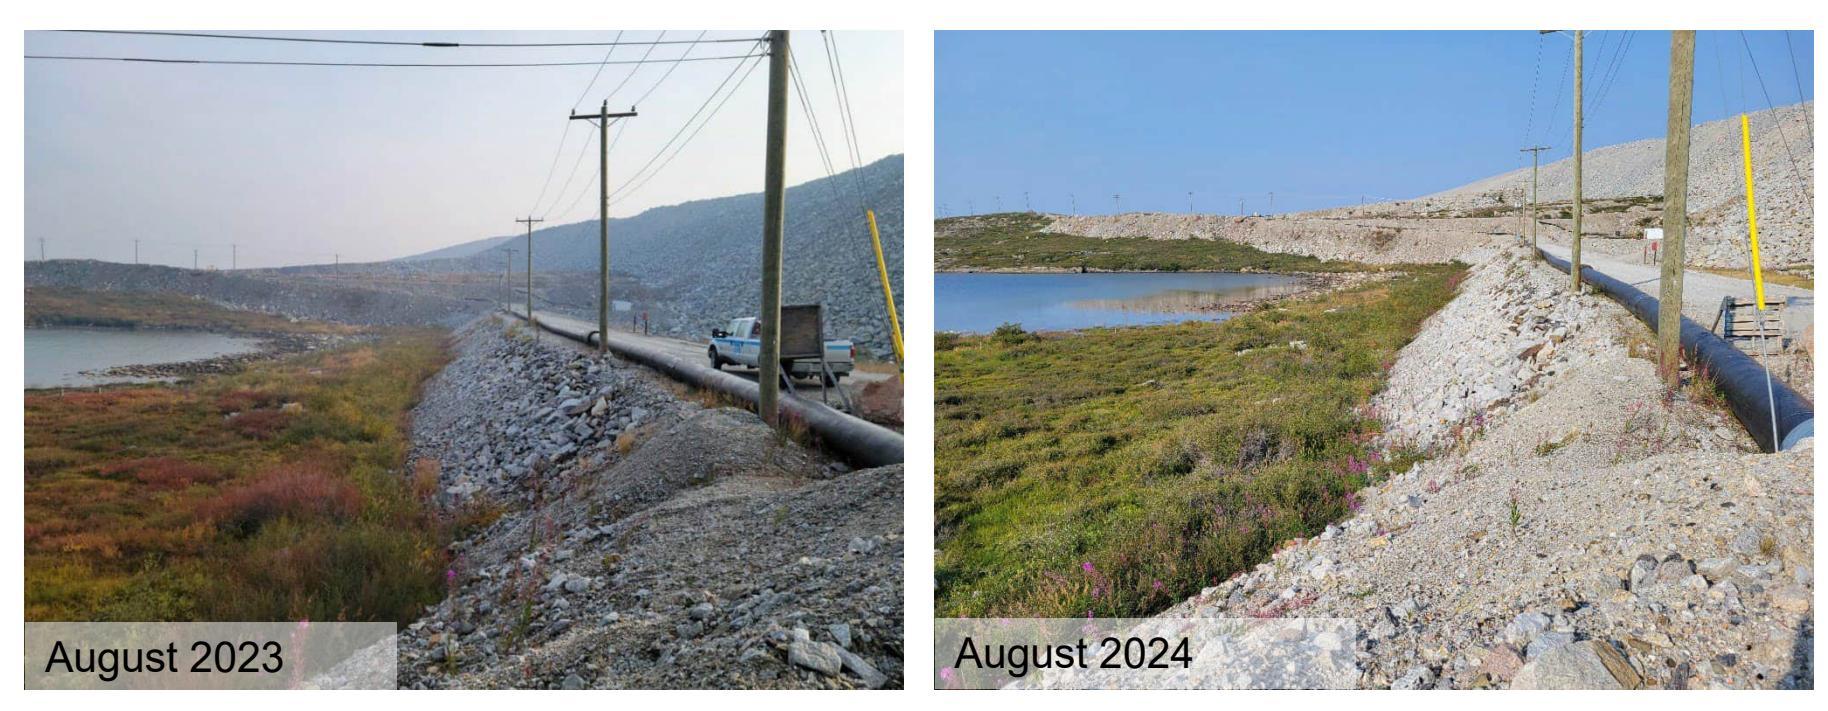
Photograph Pond 4 – 3: View to the north along the downstream slope of Pond 4 dam. Downstream slope is in good condition. Lac de Gras encroaches on downstream toe area at north end.

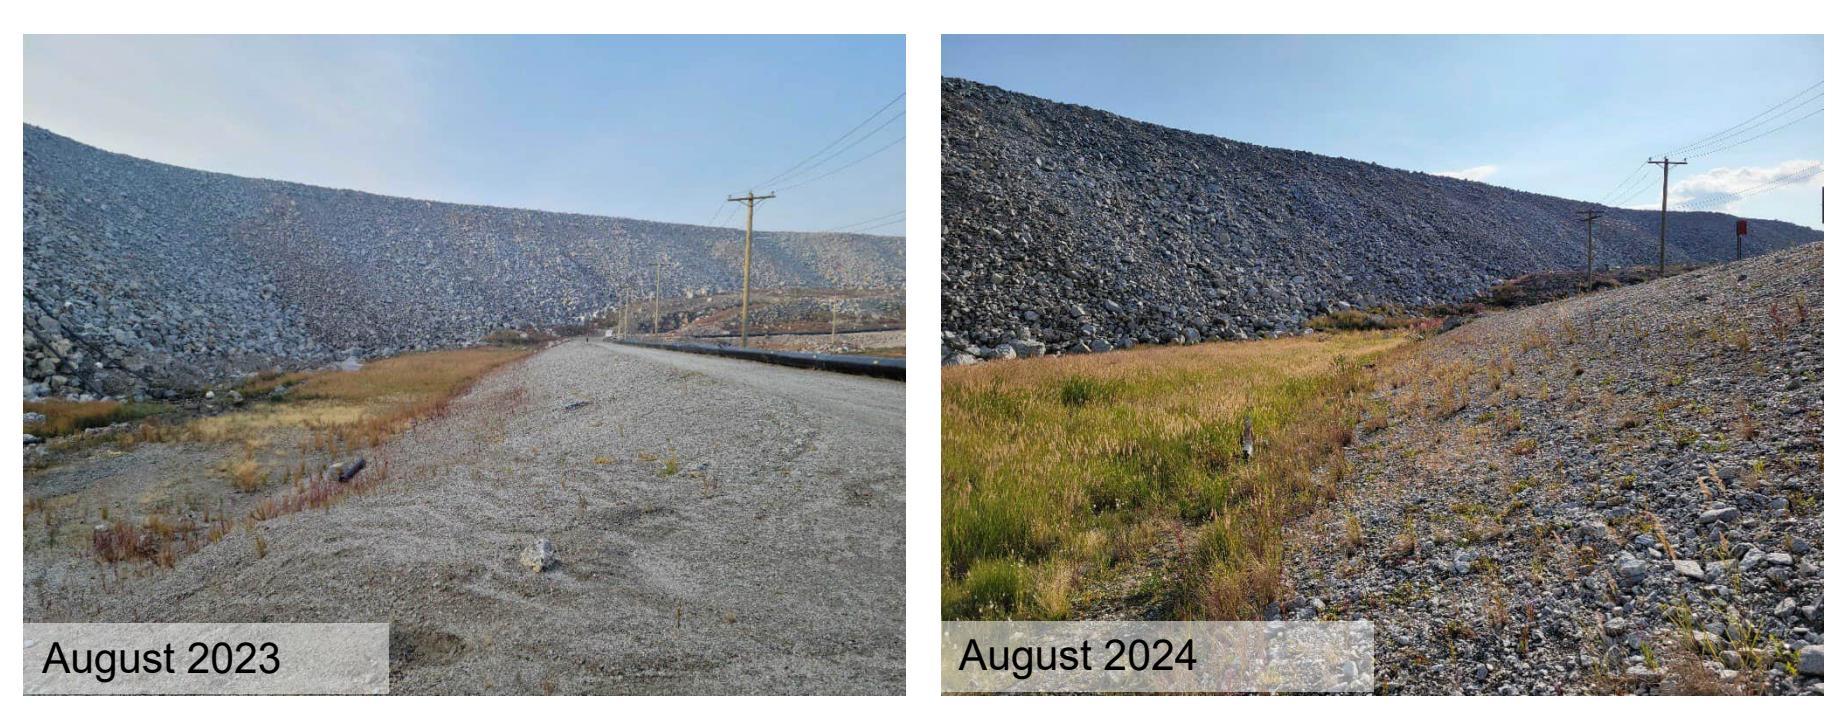
Photograph Pond 4 – 4: View to the south along the upstream slope of Pond 4 dam. Similar condition to 2023.
