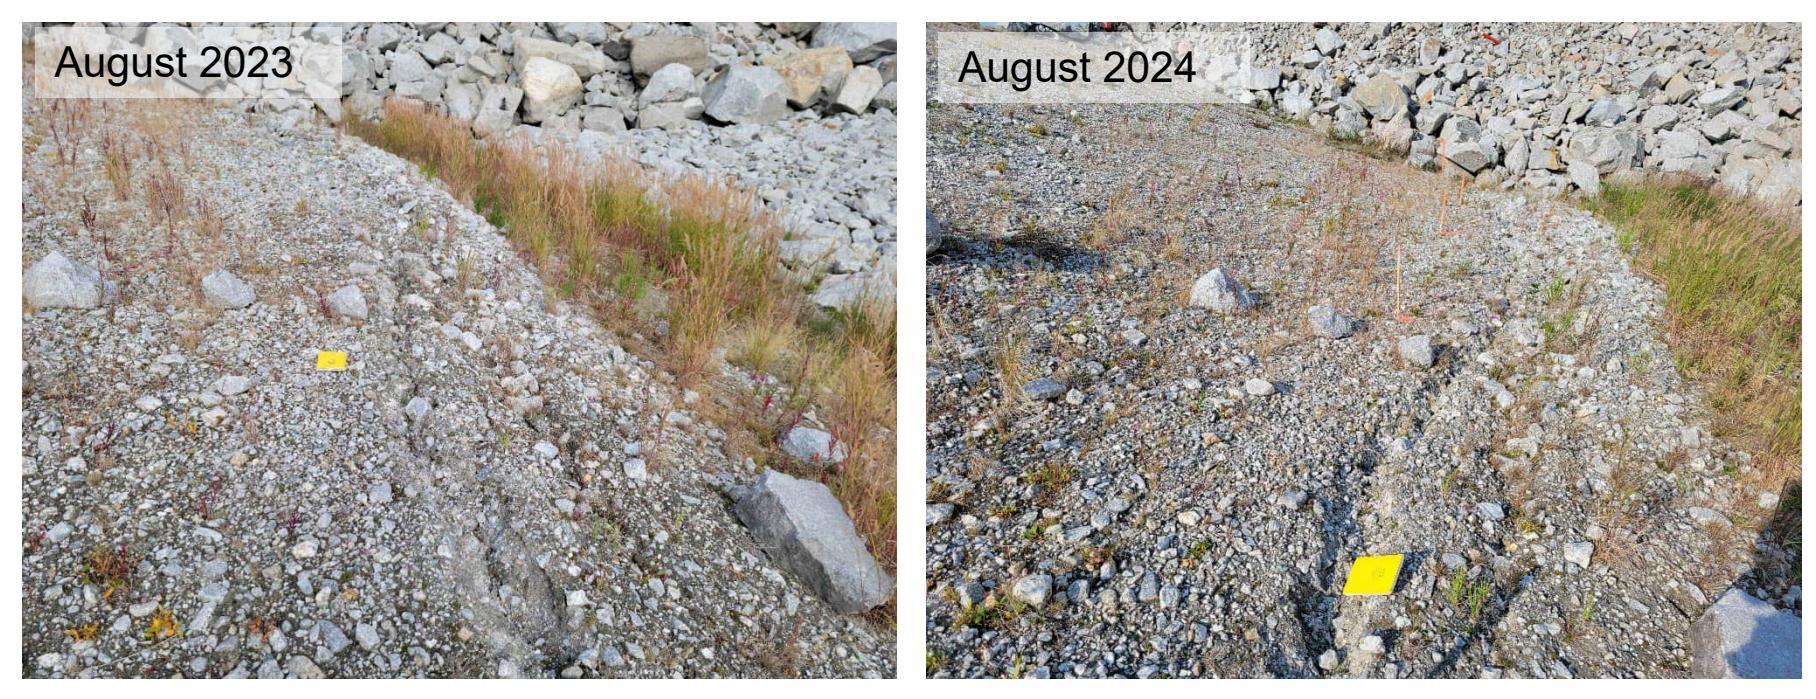
Photograph Pond 4 – 5: Displacement of the upstream toe adjacent to the northern abutment observed first in-2023. DDMI to continue to monitor to assess movement. No new observed displacement in 2024.

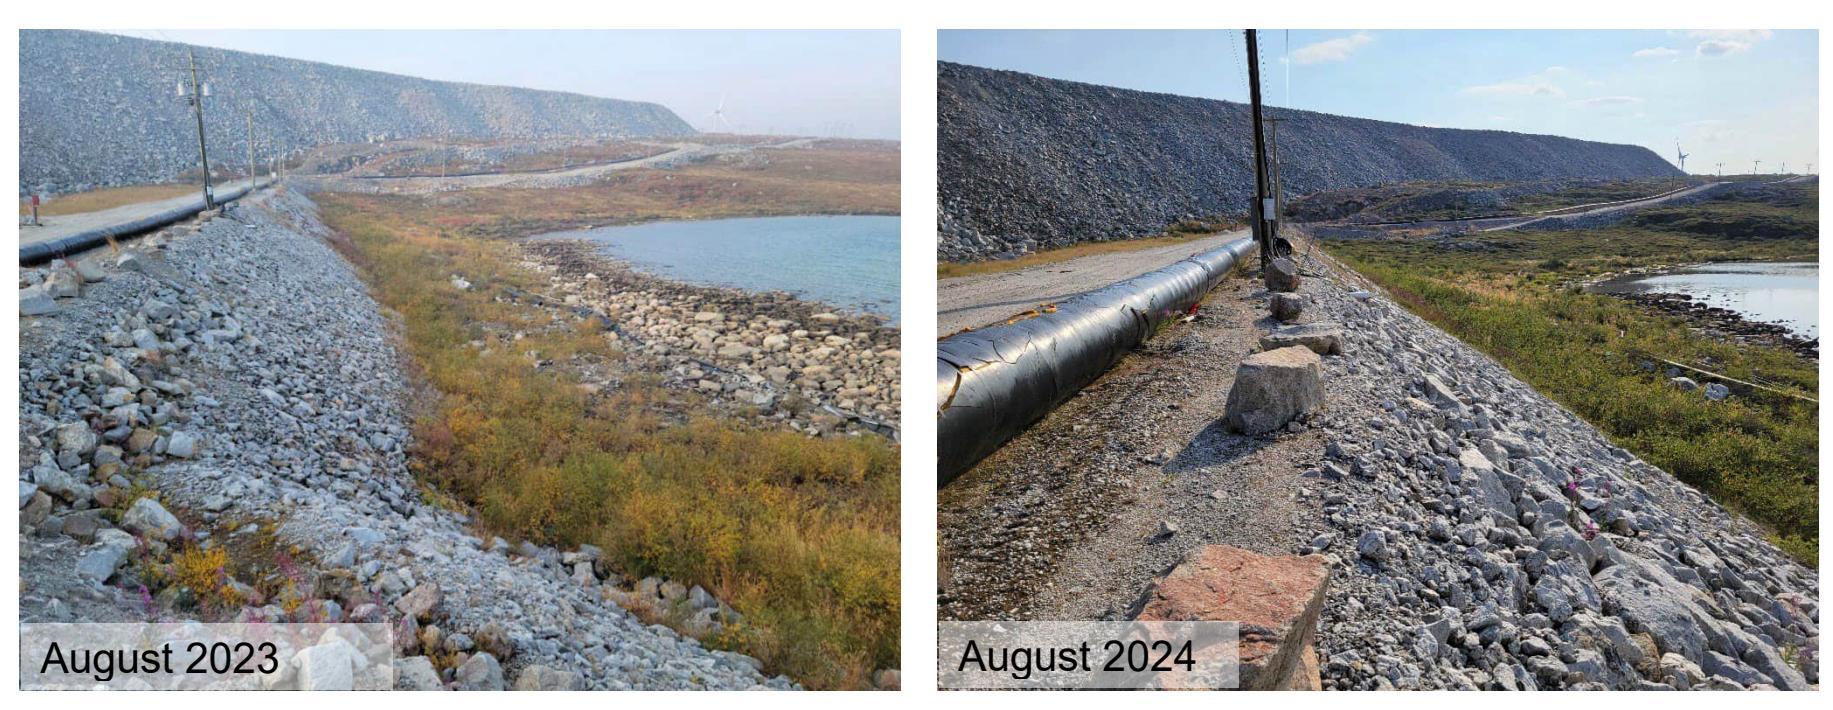
Photograph Pond 4 – 6: View along the north end of the downstream slope of Pond 4 Dam. Slope appears in good condition.

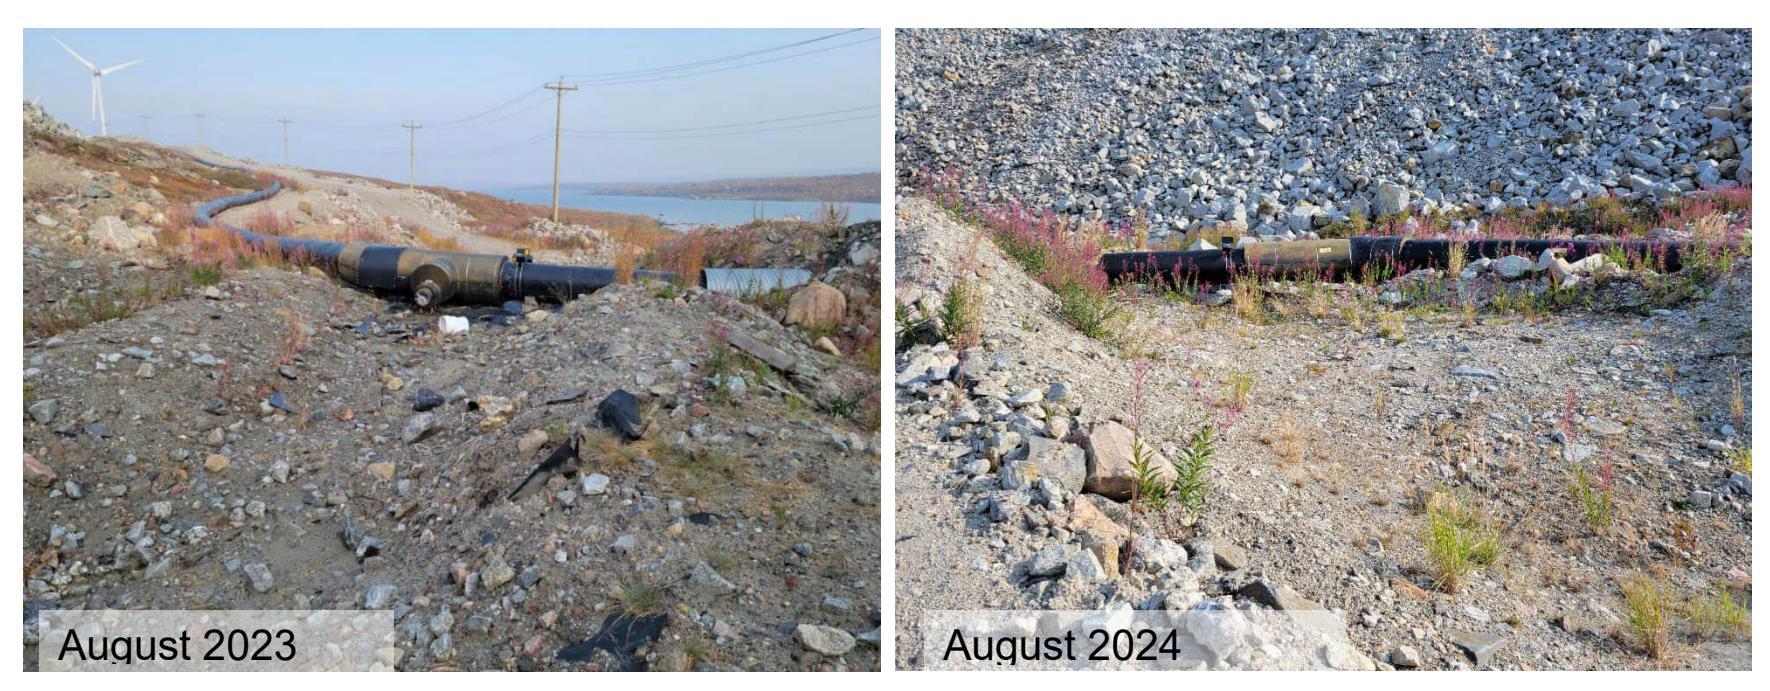
Photograph Pond 4 – 7: A21 pipeline blocking the Pond 4 spillway, similar to previous years.

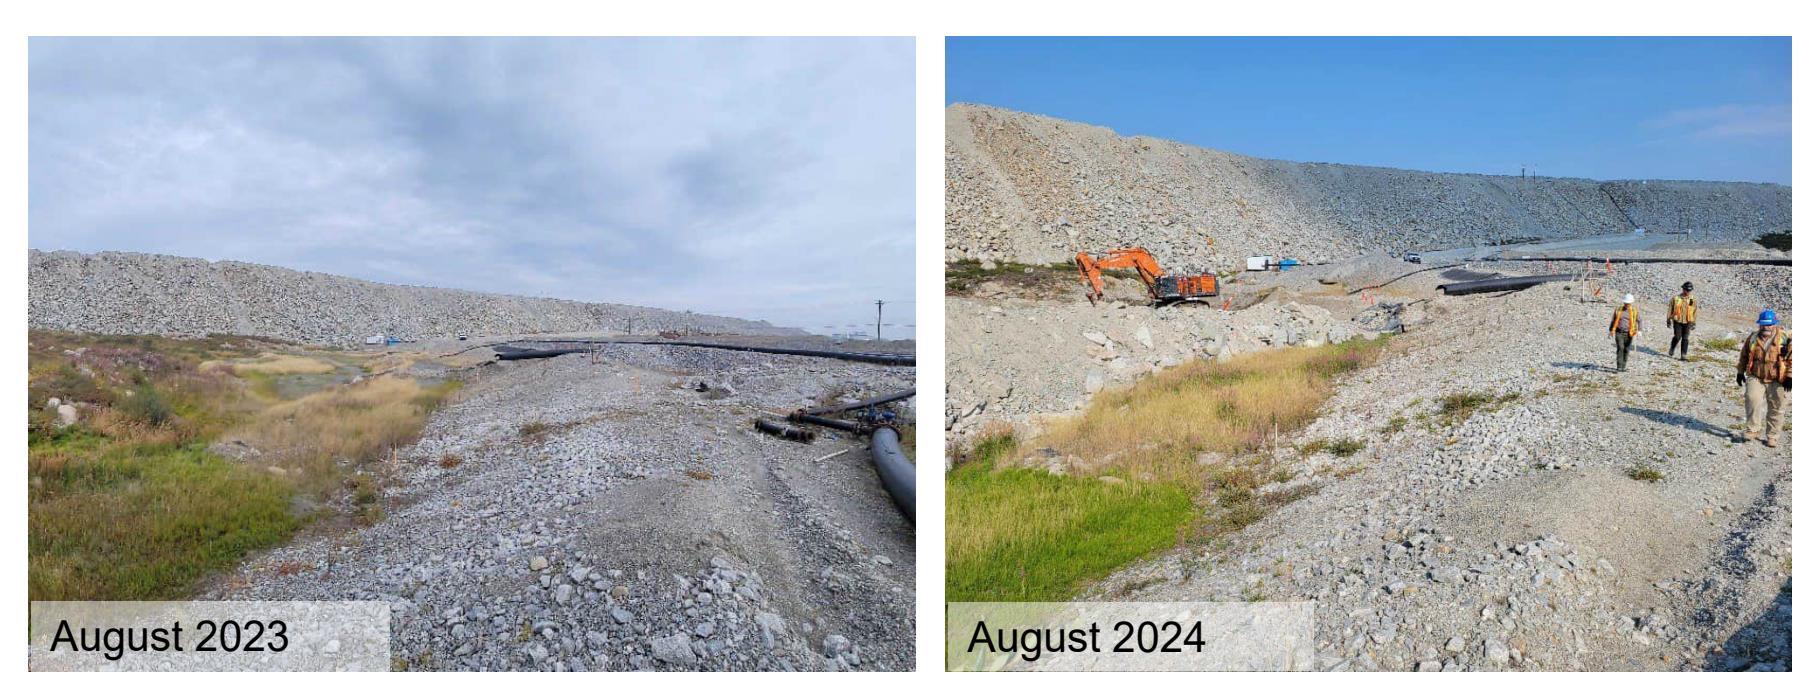
Photograph Pond 5 – 1: View to the north along the upstream face of Pond 5 dam. Additional pumping deployed to draw down reservoir and ground water for ground improvement construction for the East Dam closure buttress.

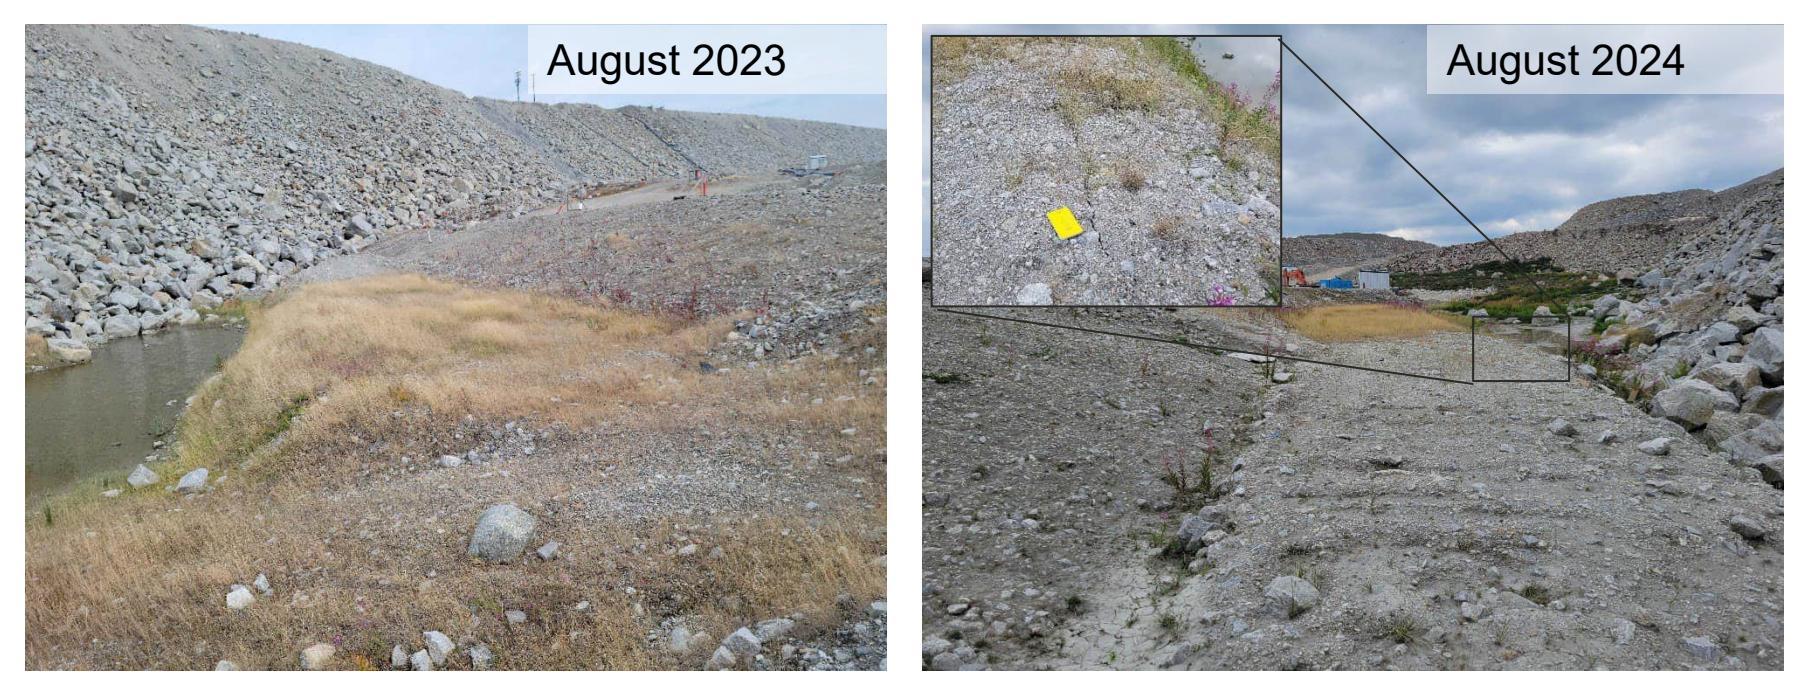
Photograph Pond 5 – 2: Toe berm at North abutment of Pond 5 dam. The liner and liner cover were repaired in this area in 2016/2017. Some isolated minor cracking noted in 2024.

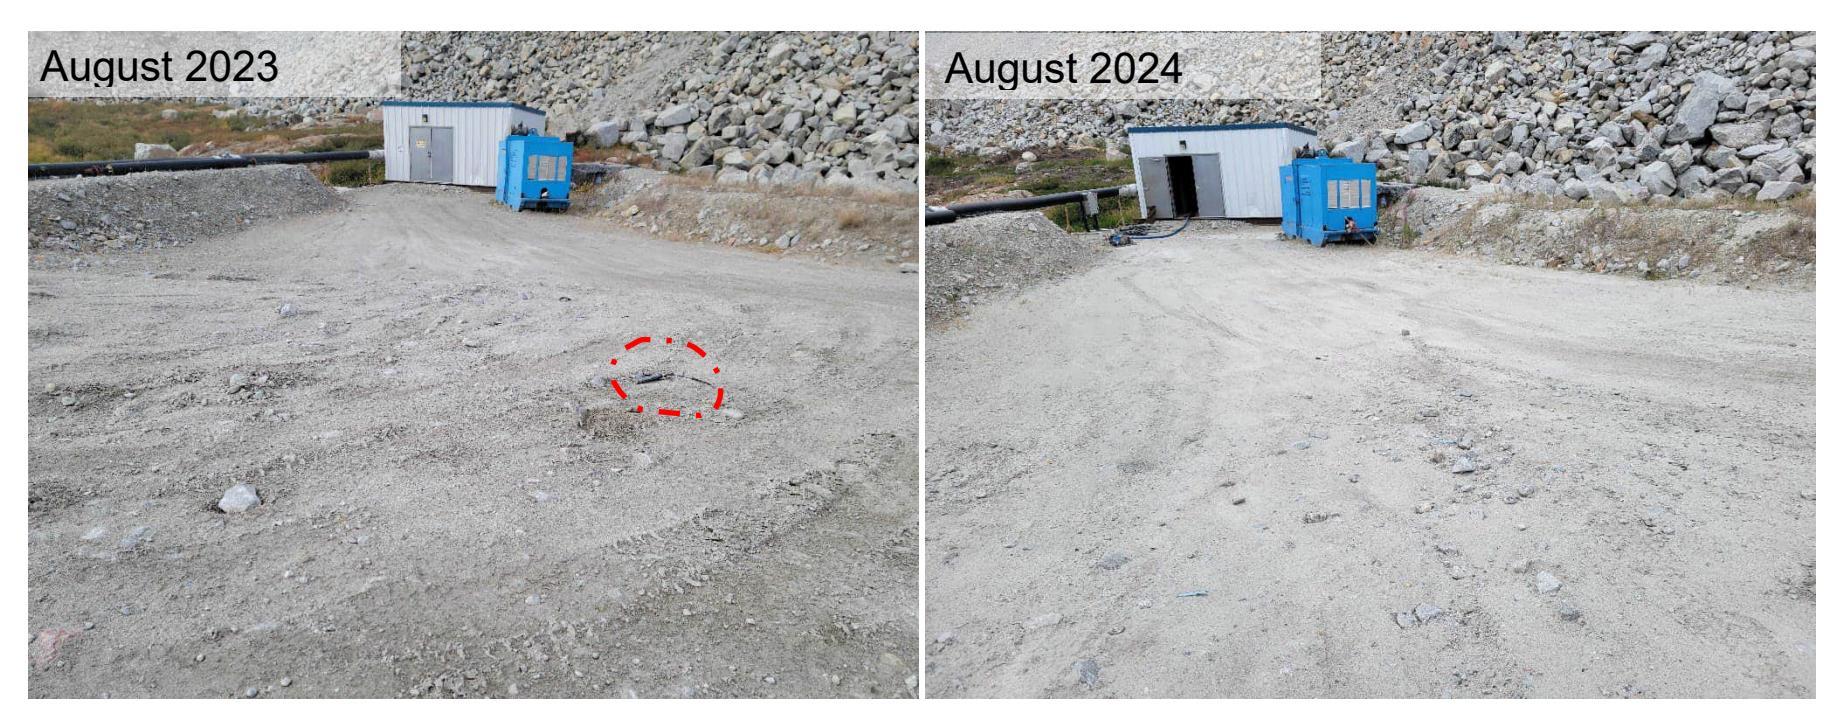
Photograph Pond 5 - 3: Torn or exposed liner observed in 2020 along approximate crest of Pond 5 dam, where ramp to pump house has been graded and cleared of snow in winter for access. Liner not observed in 2024.

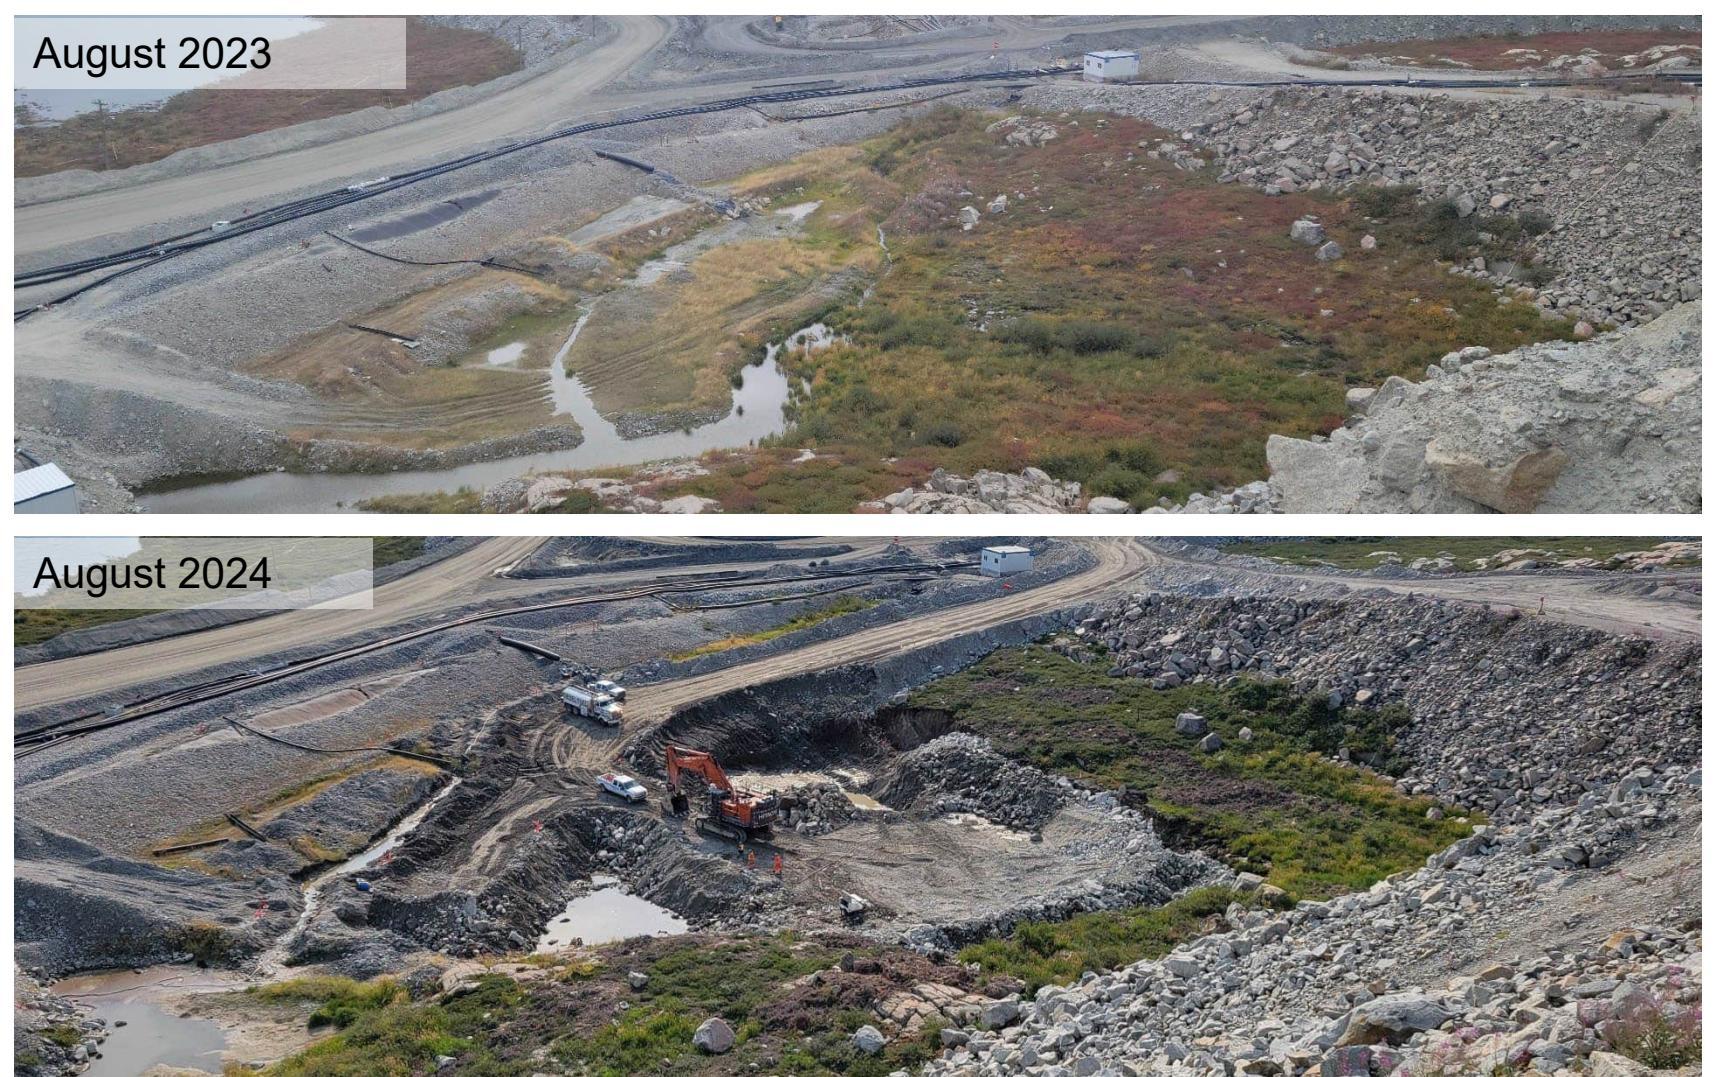
Photograph Pond 5 – 4: Overview of Pond 5 dam. Ground improvement works underway to remove ice-rich till from the East Dam closure buttress footprint. Sumps constructed to manage water ingress to excavation.

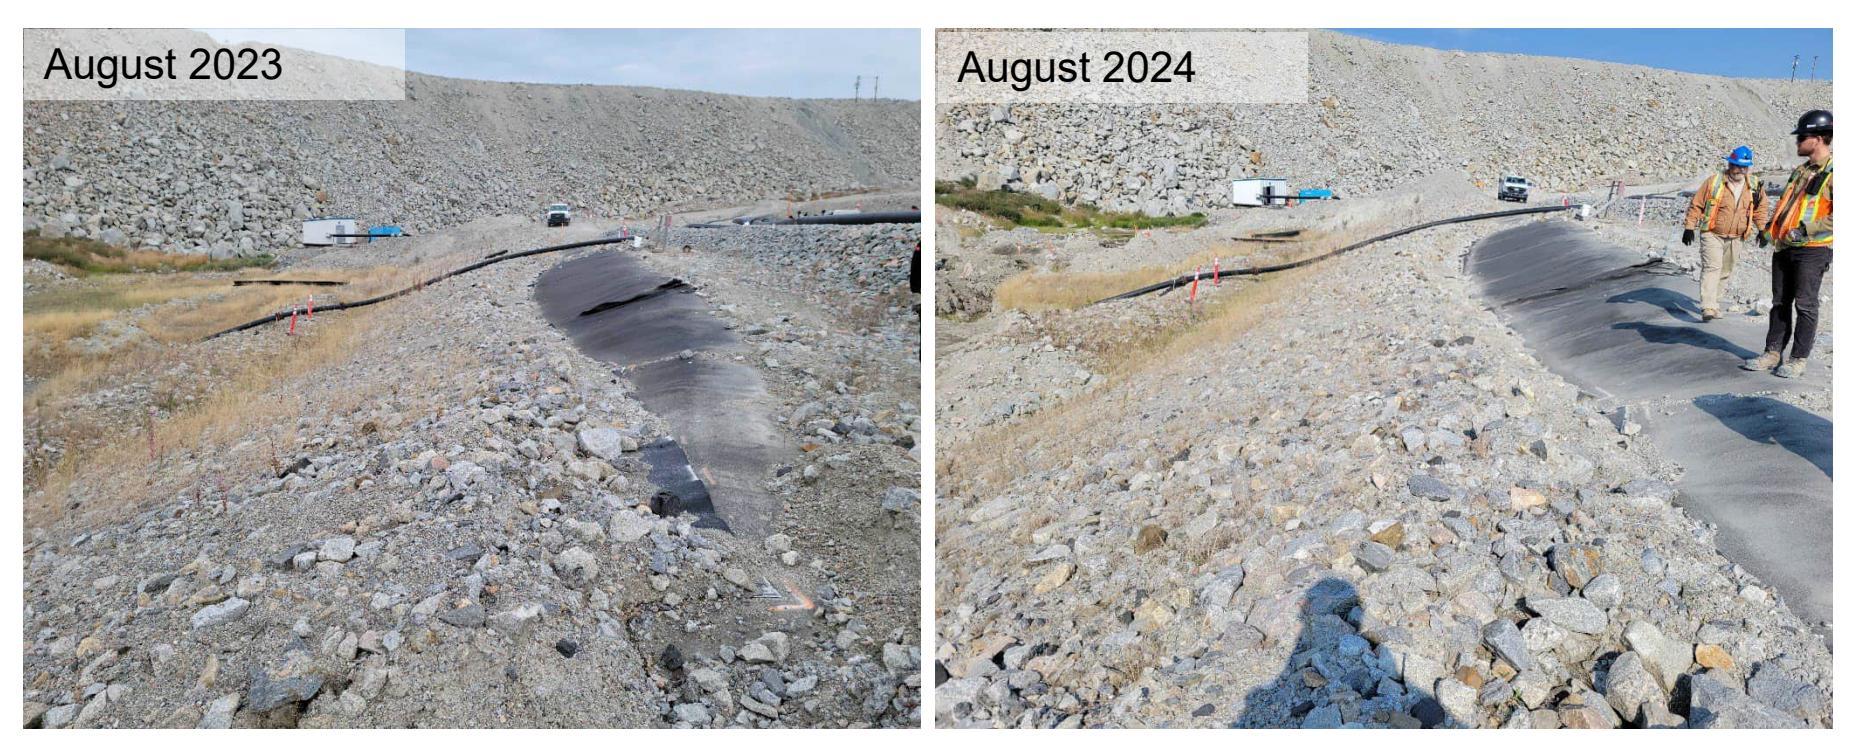
Pond 5 liner had slumped in 2020 and again in 2023 due to high precipitation (2020) and inferred ingress into the downstream fill from a leaking pipe (2023). The liner movement ceased in both cases when pressure behind the liner was released by DDMI making a small cut into the liner. Additionally, DDMI ceased routing water through the inferred leaking pipe after the 2023 movement. No further movement of the liner or the liner cover material was observed during the 2024 inspection.

Photograph Pond 5 – 5: View of upstream slope of Pond 5 Dam where liner slid down slope in 2020 exposing geotextile. Similar condition to 2023 observed in 2024.

- Develop a mitigation plan or a water management plan for Pond 5 to manage water below damaged liner and meet the design intent.
- Prevent South Haul Road culvert from discharging directly on the Pond 5 toe berm cause saturation of the berm.

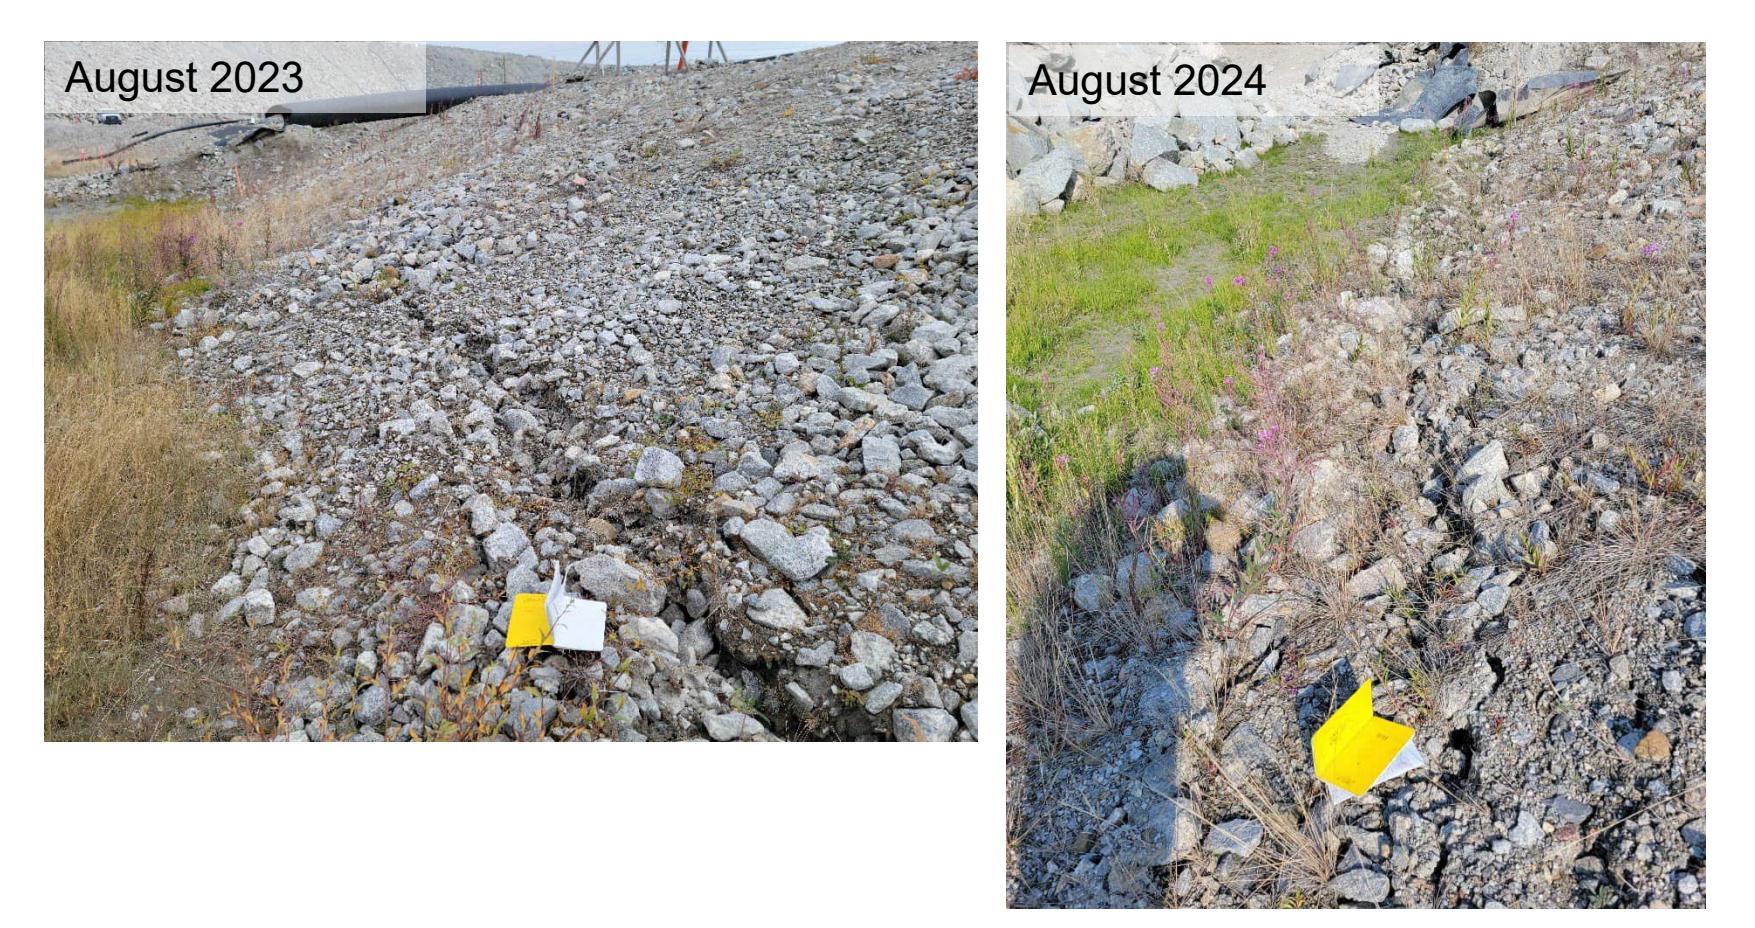
Photograph Pond 5 – 6: View of southern end of Pond 5 Dam upstream slope toe berm, where cracking developed during 2023 freshet was observed during the 2023 inspection. No new displacement noted in 2024.

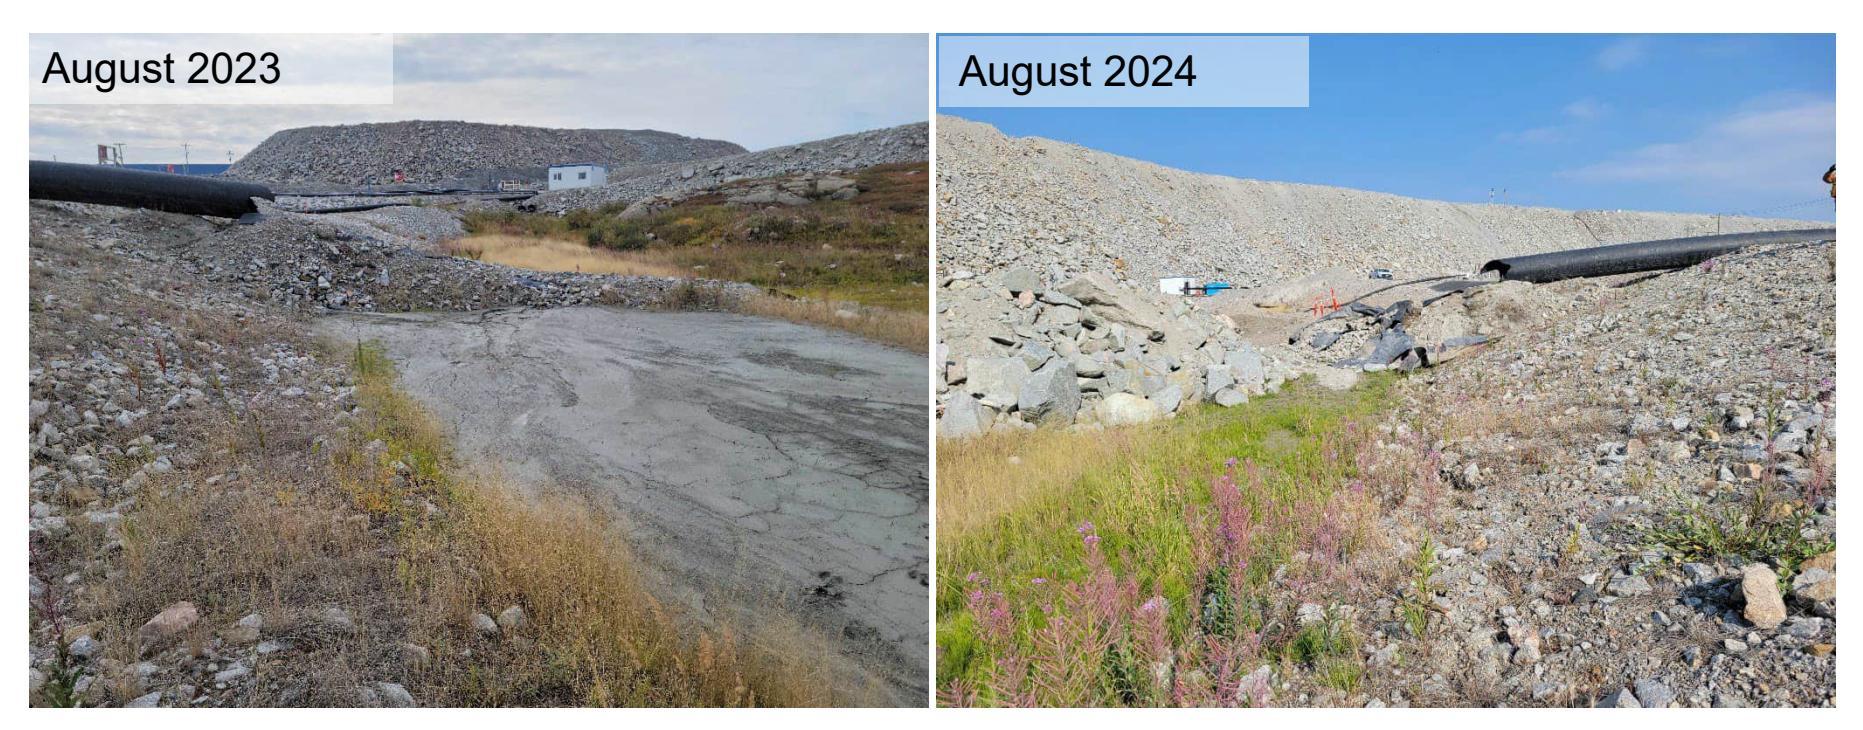
Photograph Pond 5 – 7: South Haul Road runoff outflow pipe discharges onto the Pond 5 toe berm where sediment has been deposited and water is ponding on the toe berm. Outflow has improved since 2022 but sediment continues to build up on the toe berm. Area is impacted by the East Dam closure buttress ground improvement works.

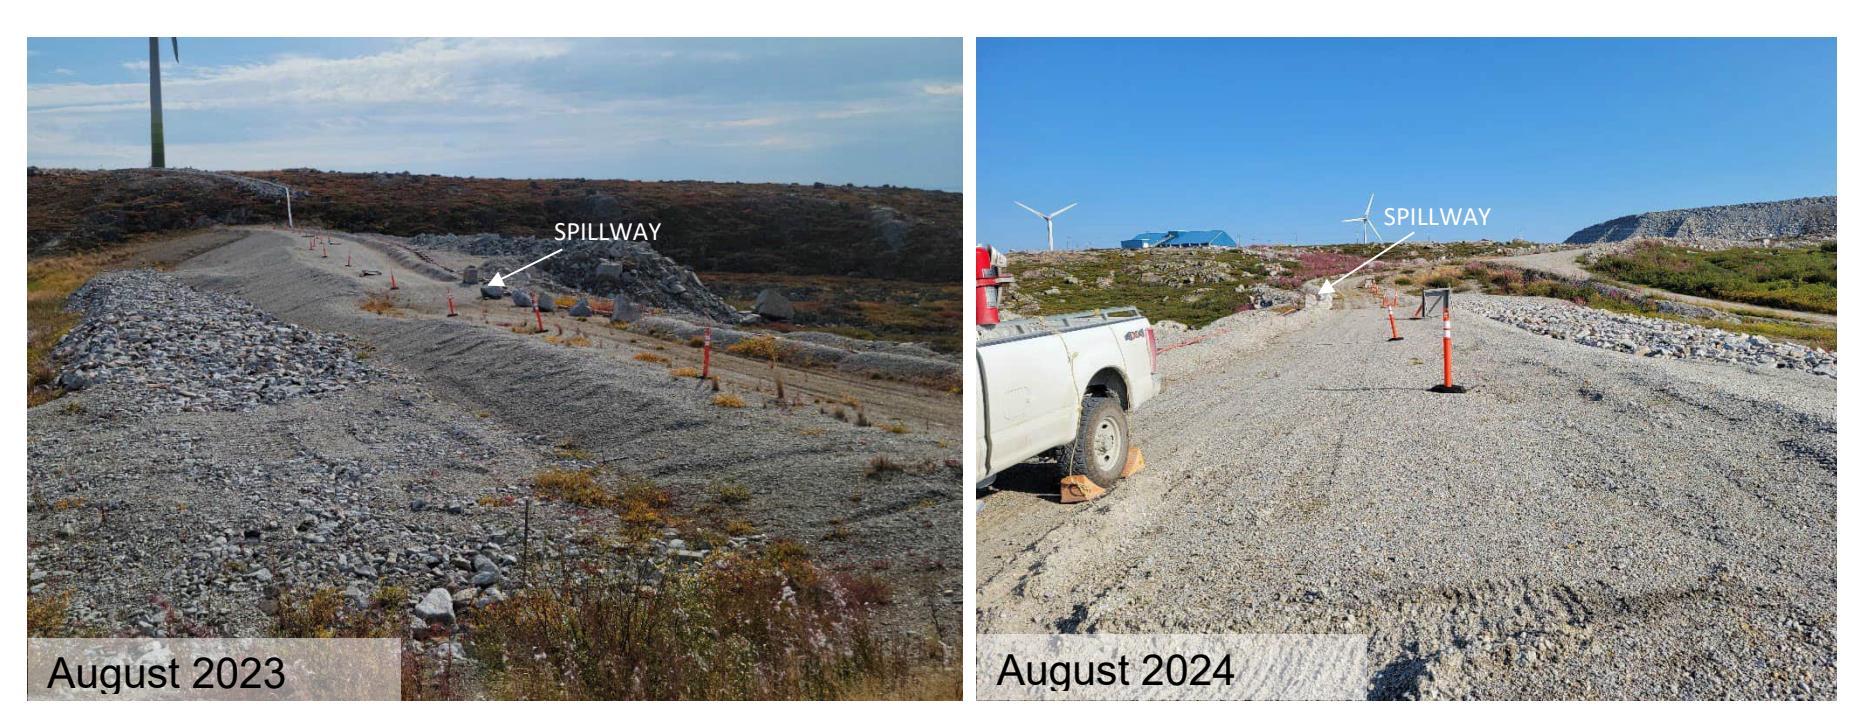
Photograph Pond 7 – 1: View along Pond 7 crest looking south. Boulders placed as berm across spillway. Berm is in place to protect cribbing for high voltage cable and optic-fibre to wind tower along downstream crest. Cones were placed along edge of liner crest to prevent vehicles from driving over the liner. Crest was drilled to facilitate thaw to improve excavation conditions for the planned breach of Pond 7.

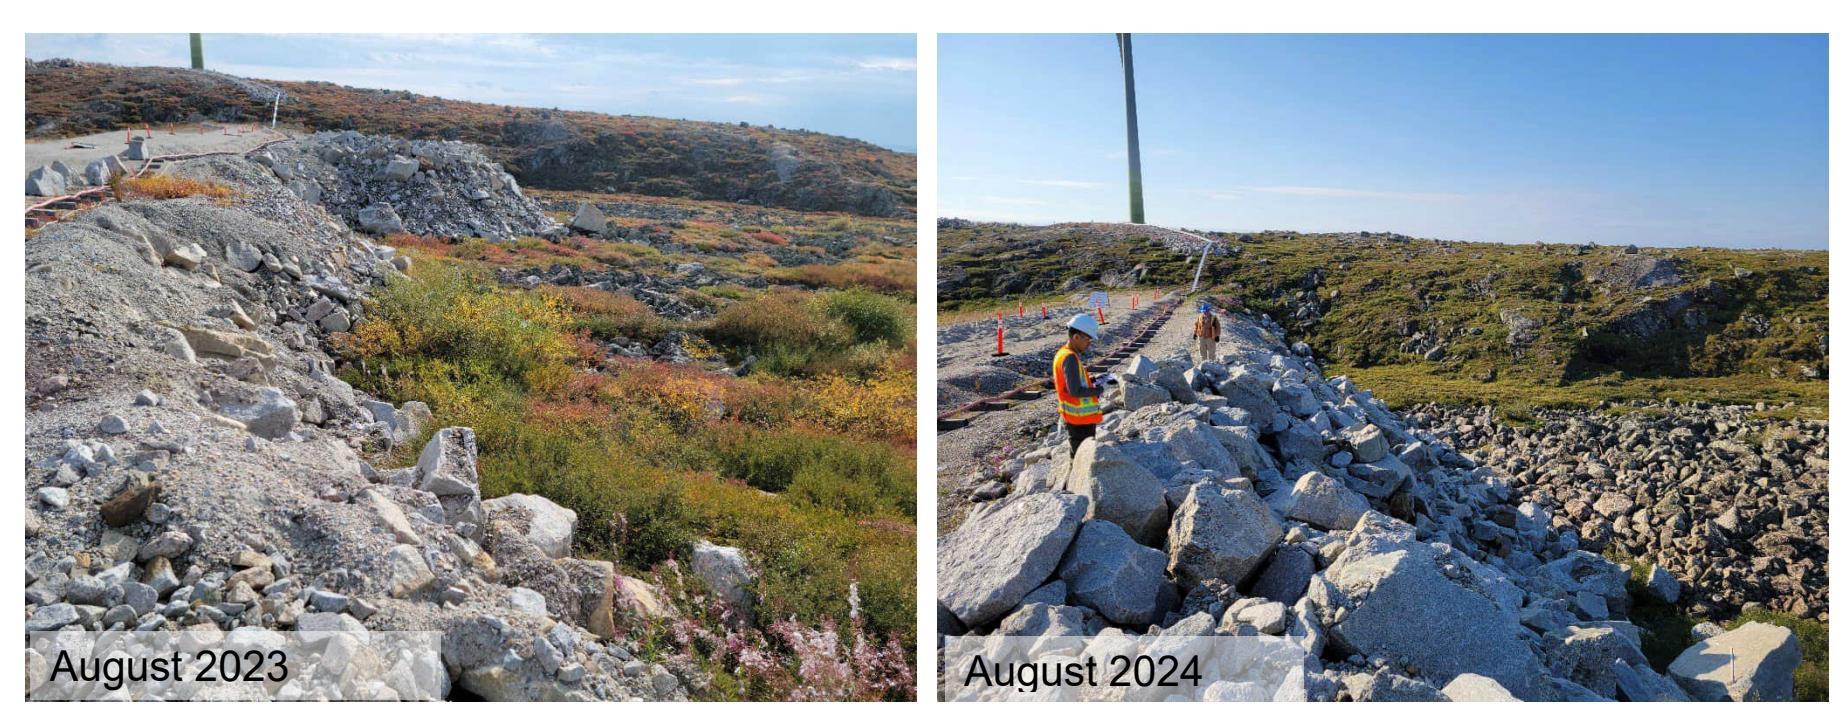
Photograph Pond 7 – 2: View of the downstream slope and south abutment of Pond 7 dam. Condition is similar to previous years and appears in good condition.

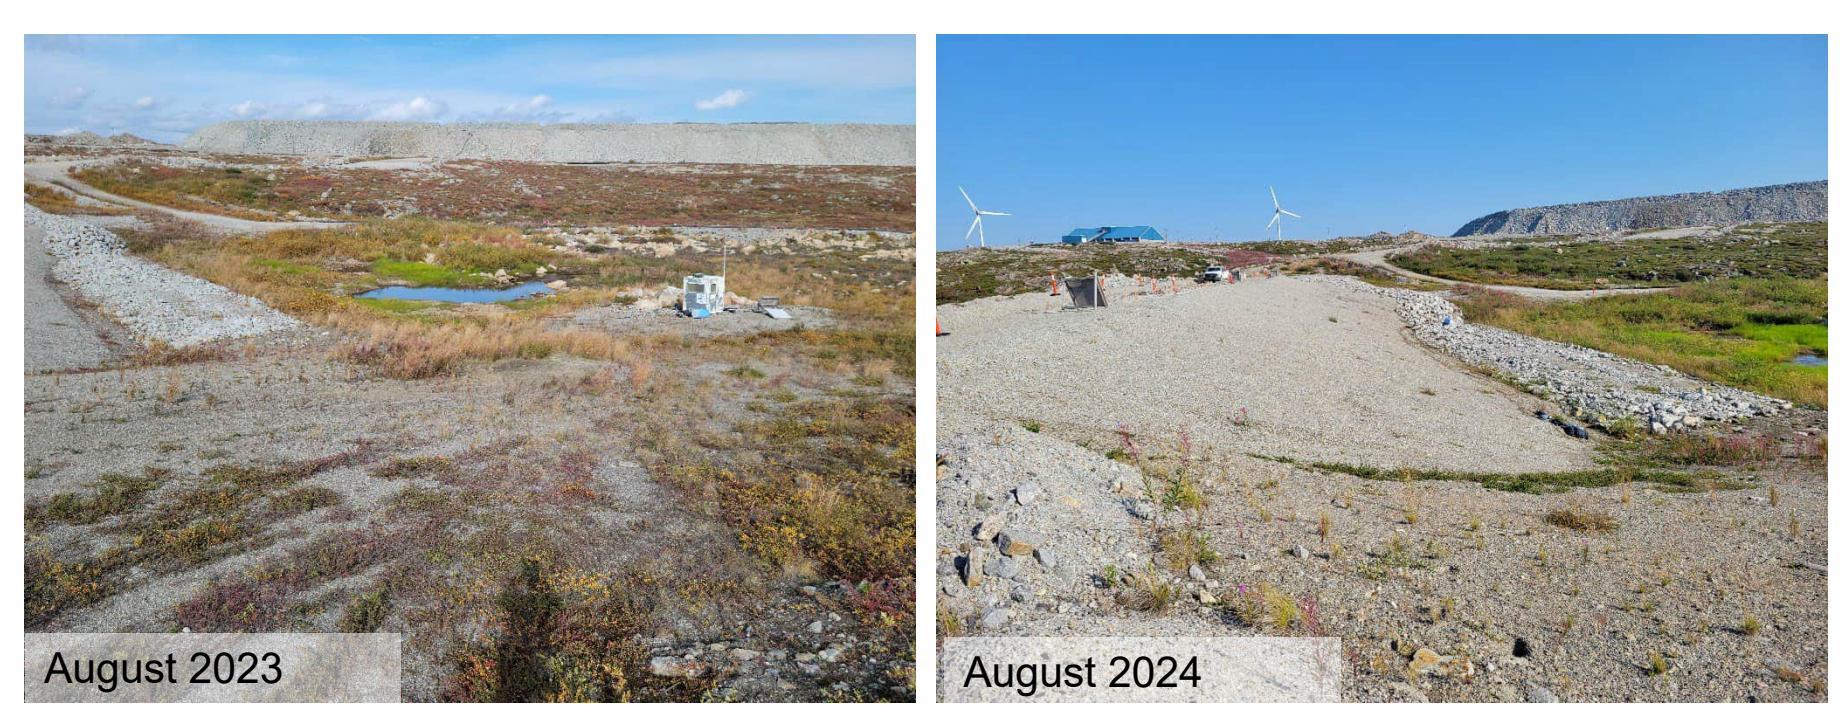
Till blanket at the south abutment was in good condition, similar to previous years. A berm is in place at crest to restrict vehicles travelling over the till blanket.

Photograph Pond 7 – 3: View of the south abutment till blanket on upstream slope of Pond 7 dam. Pond volume is minimal and similar to observations in 2023.

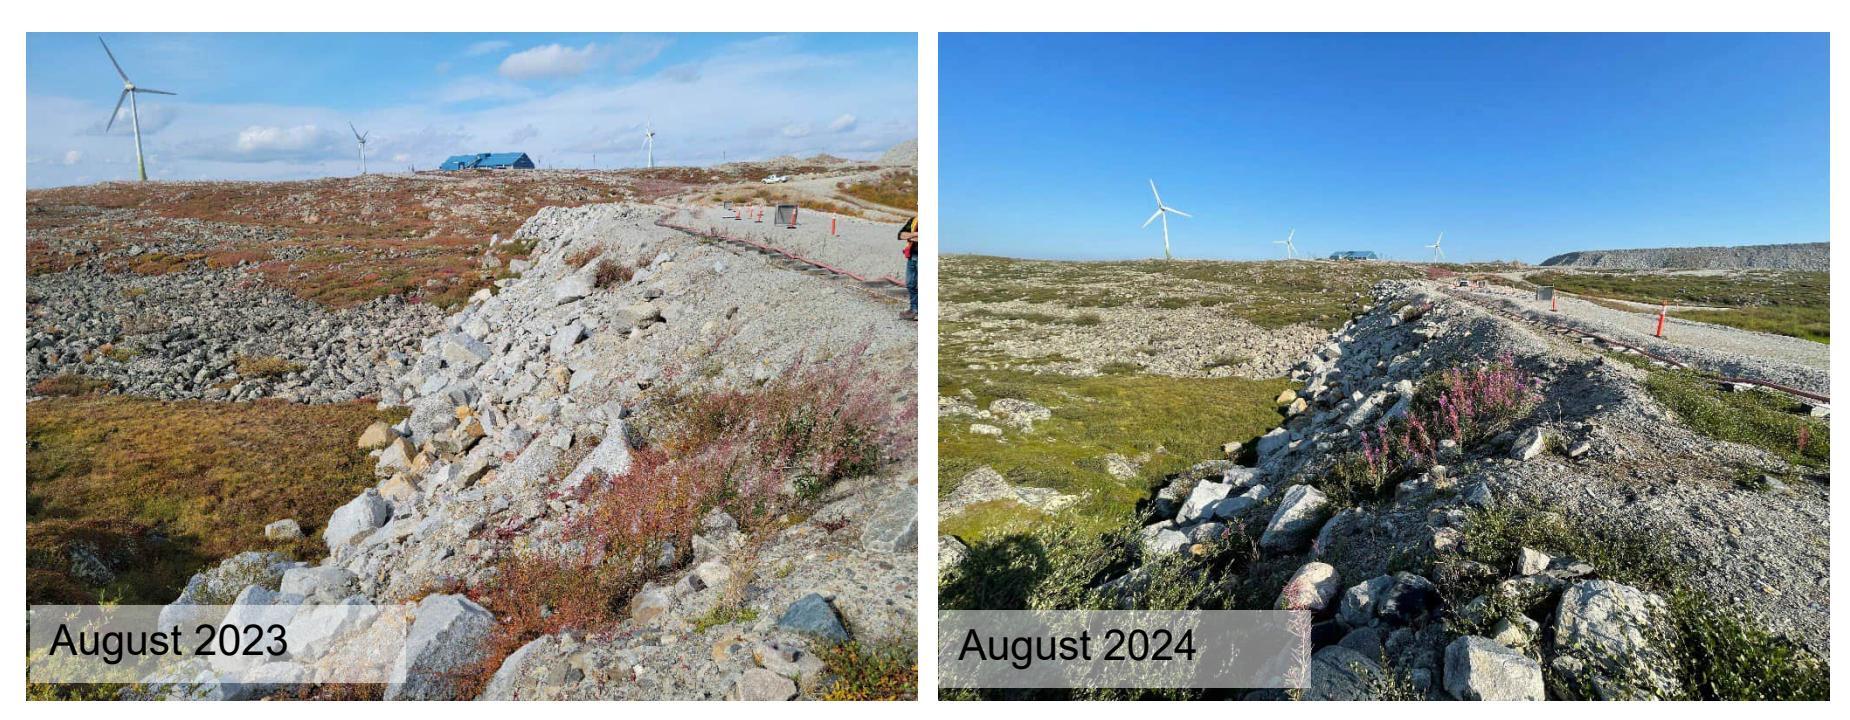
Photograph Pond 7 – 4: View of the downstream slope of Pond 7 Dam; looking north from the south abutment.

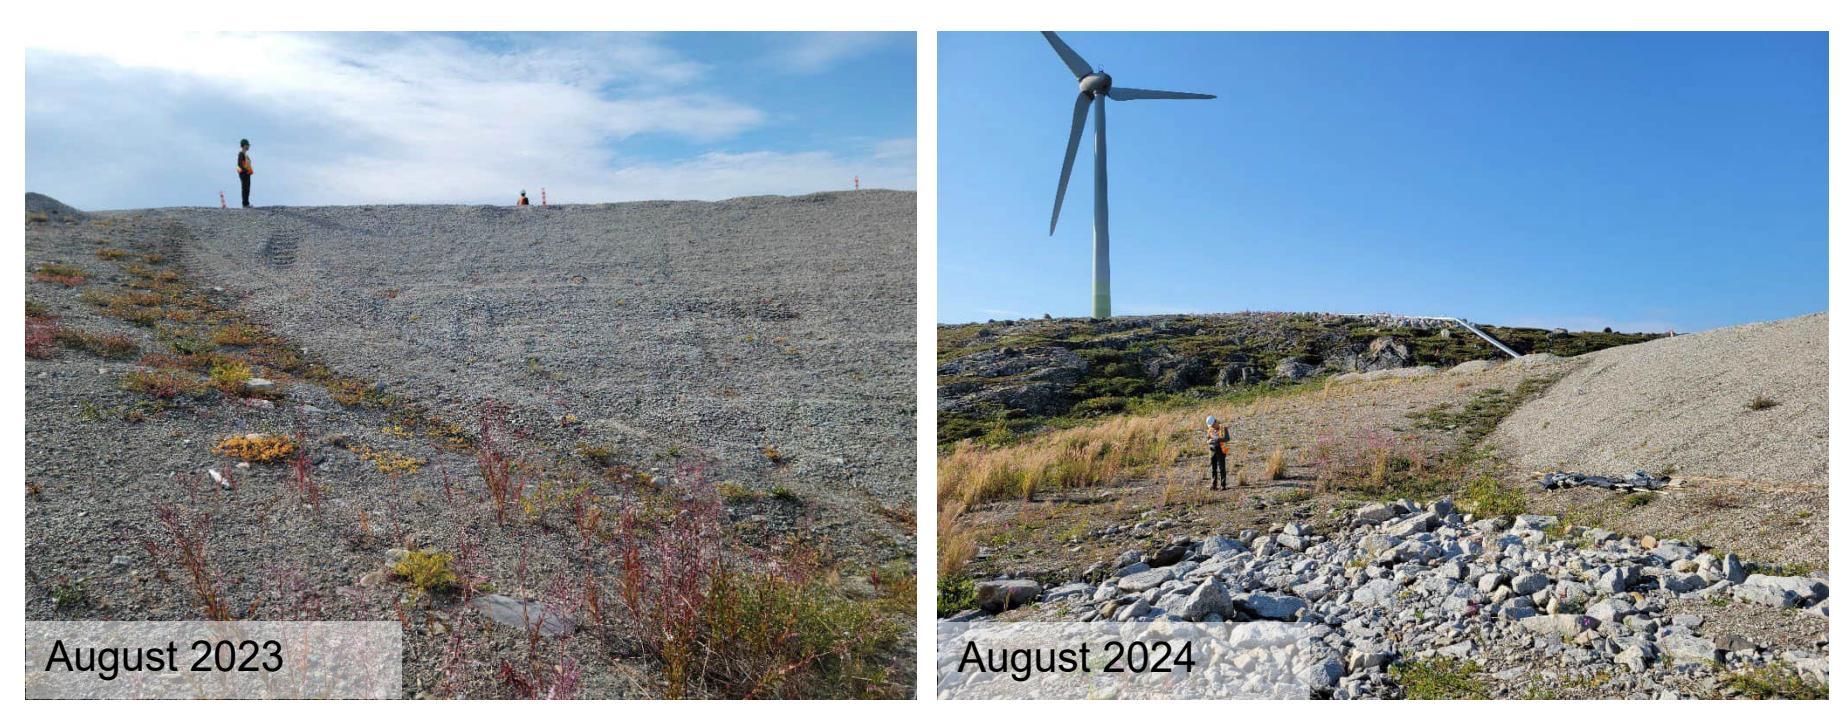
Photograph Pond 7 – 5: Rutting at upstream crest and on slope. Appears to be historic vehicles/equipment tracks and possibly some erosion and remains consistent to previous years. Debris noted on upstream slope in 2024 indicates recent high water level.

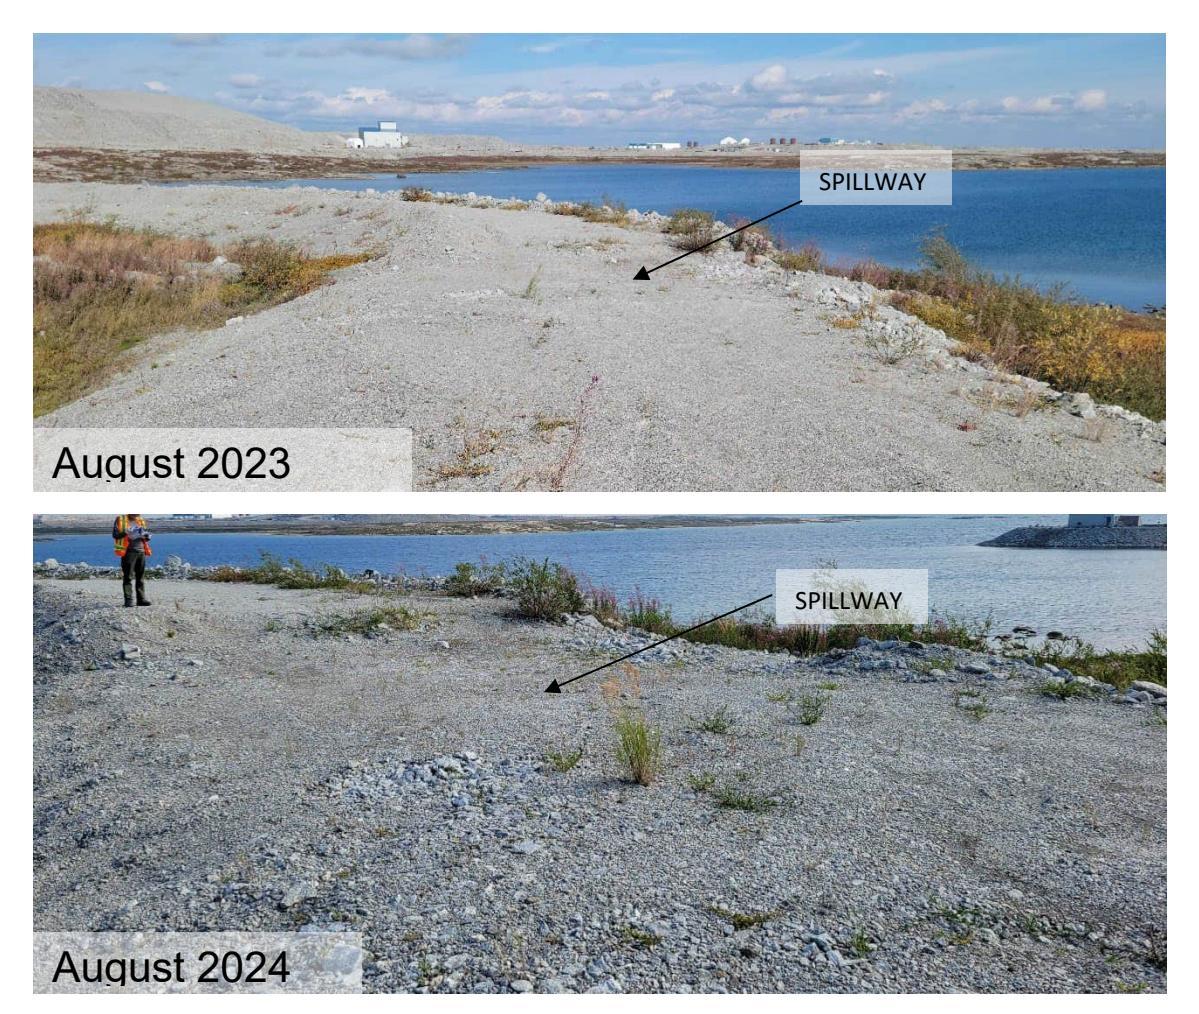
Photograph Pond 10 – 1: View to the north along the crest of Pond 10 showing spillway. Dam crest and slope are in good condition, minor vegetation.
