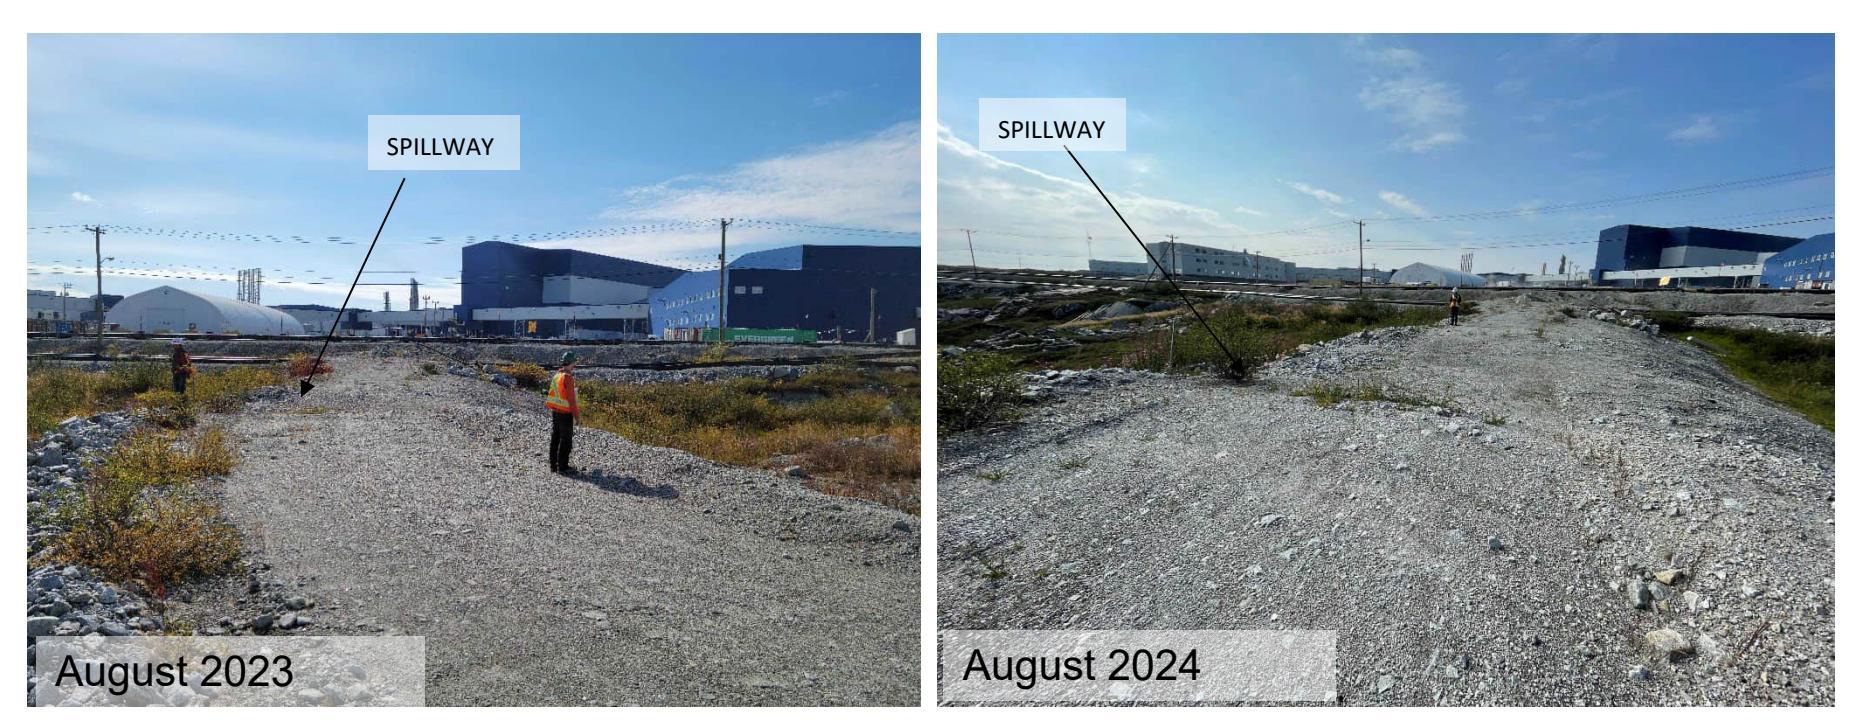
Photograph Pond 10 – 2: View of Pond 10 spillway looking south. Spillway surveyed in 2023 to assess if current geometry aligns with design.

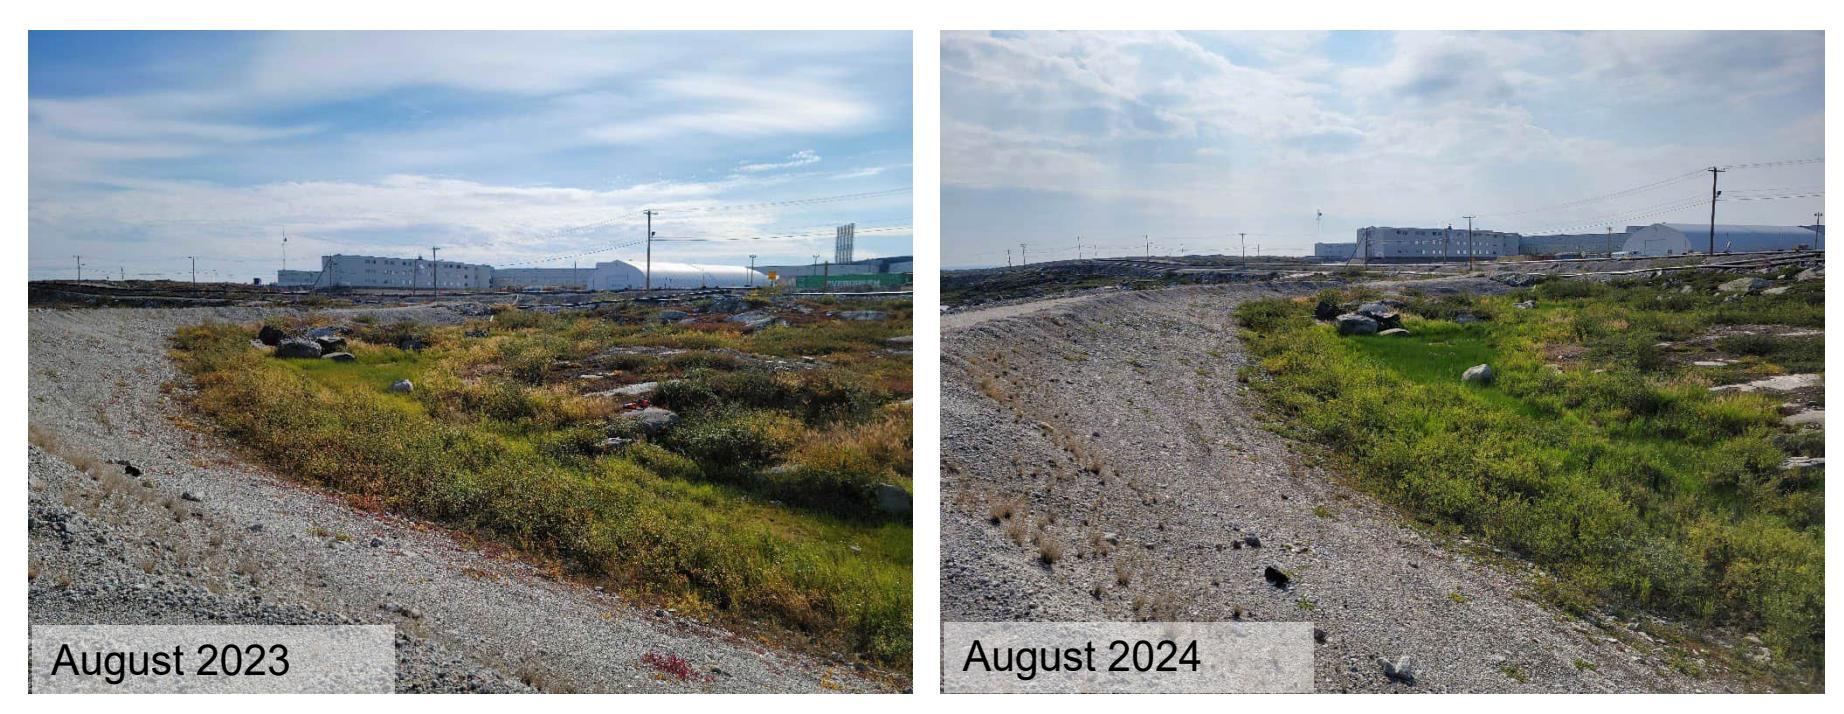
Photograph Pond 10 – 3: View along the crest and upstream slope of Pond 10 Dam, looking southeast. Crest and slope in good condition. Pond level is kept low and but appeared higher than in 2023.

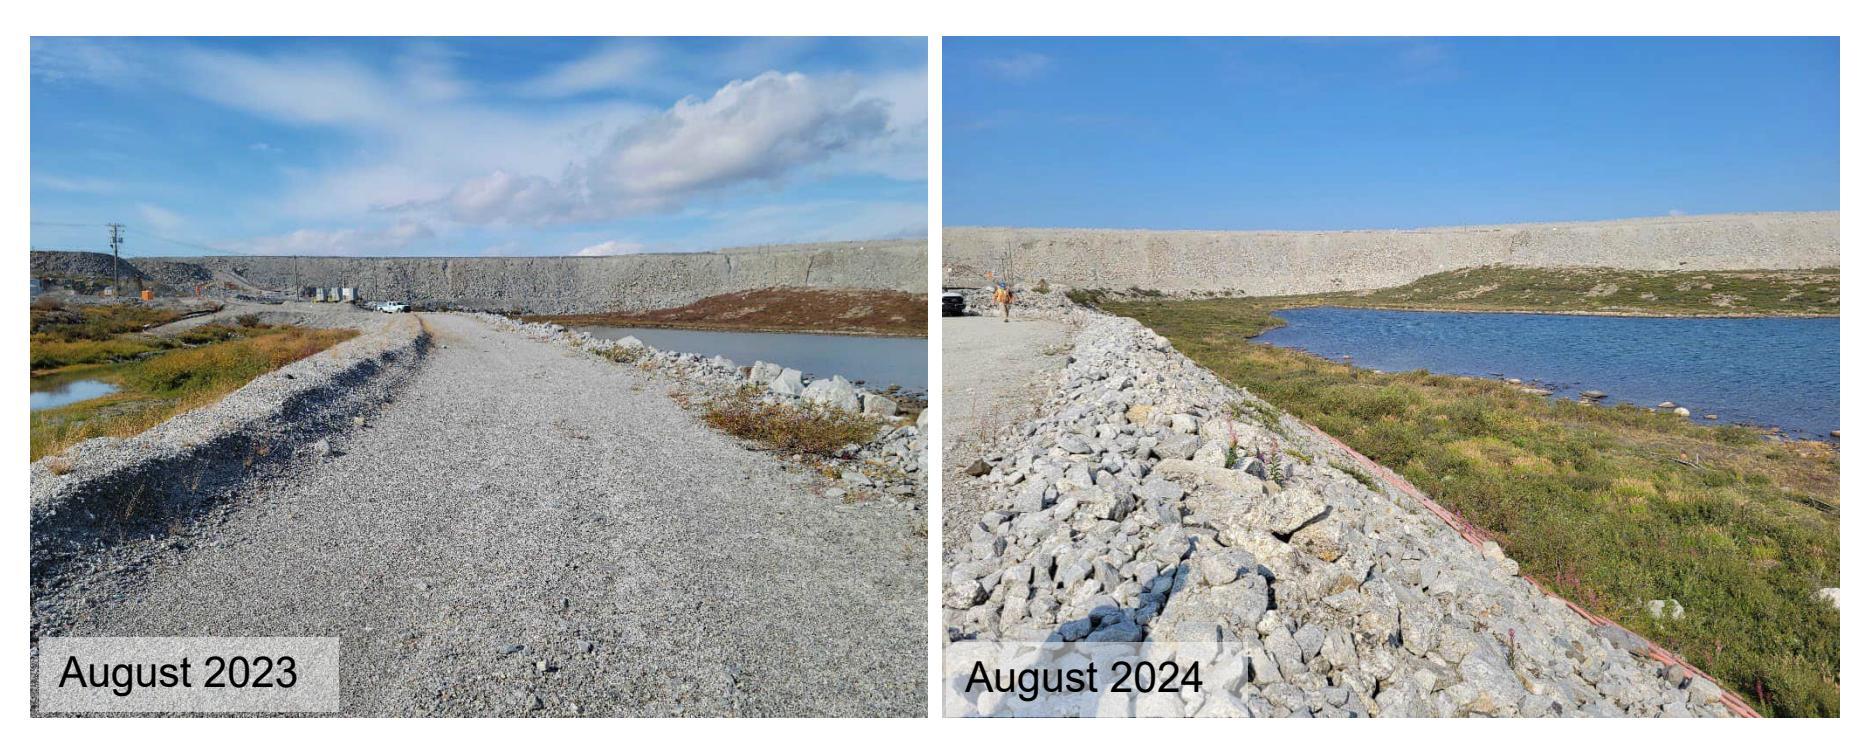
Photograph Pond 10 – 4: View to the northwest along the crest and downstream slope of Pond 10 dam. Downstream slope in good condition. Downstream toe could not be inspected due to high-voltage electrical cables on the tundra.

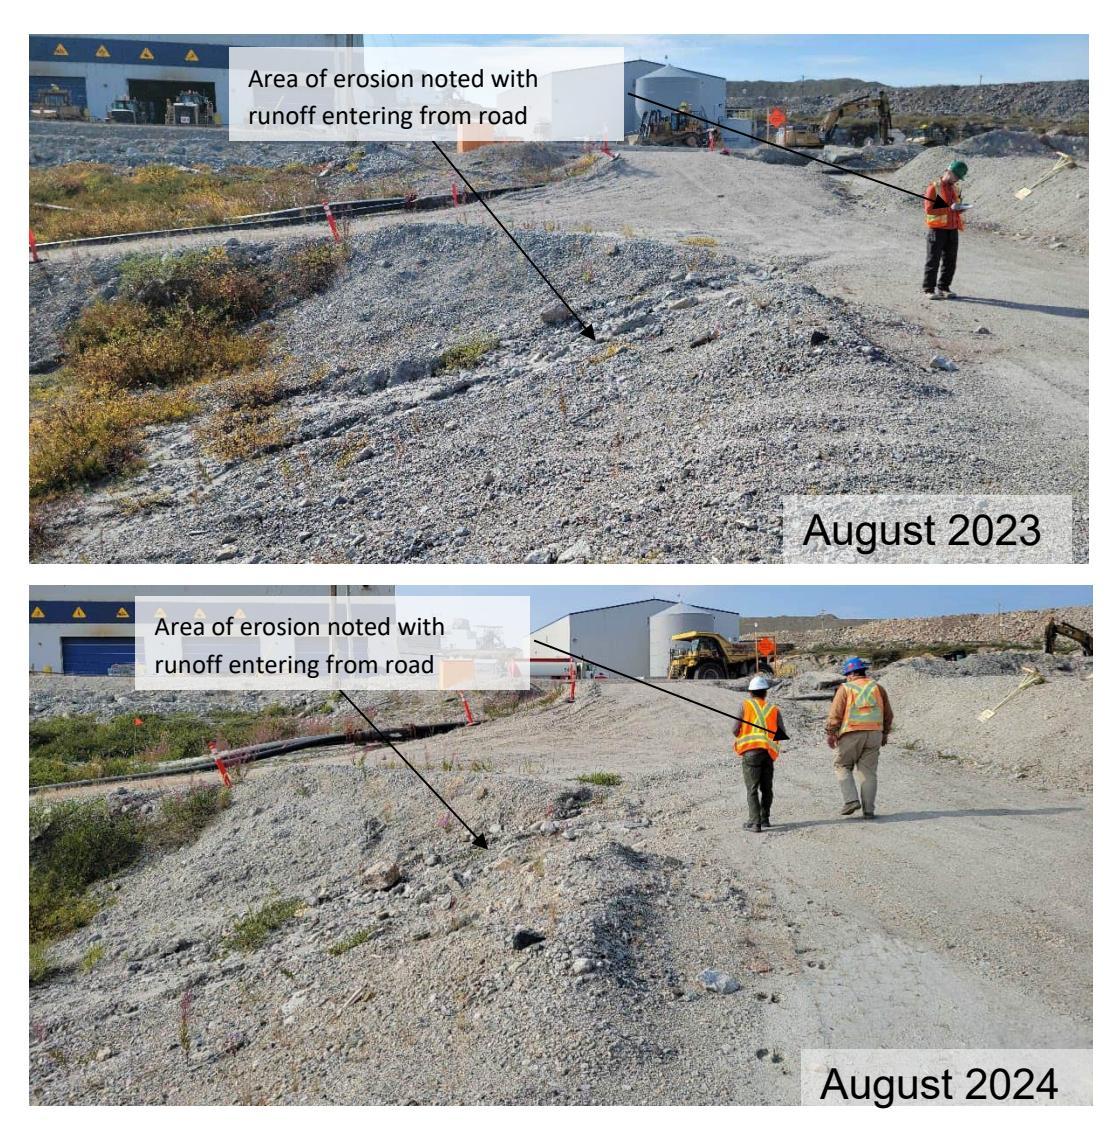
Erosion has developed in the northwest corner of the facility where runoff from the truck-shop area routes into the pond/sump. Condition appears similar to 2023.

Photograph Pond 10 – 5: View of upstream slope and crest of Pond 10 dam at north abutment area. Minor rutting and erosion were noted on the upstream slope in 2019. Extent of erosion was similar to conditions observed in 2023.

Area in northwest corner to be re-graded to maintain design crest and the eroded liner cover material on the upstream slope replaced and /or rip rap armoured to reduce future erosion in this area.

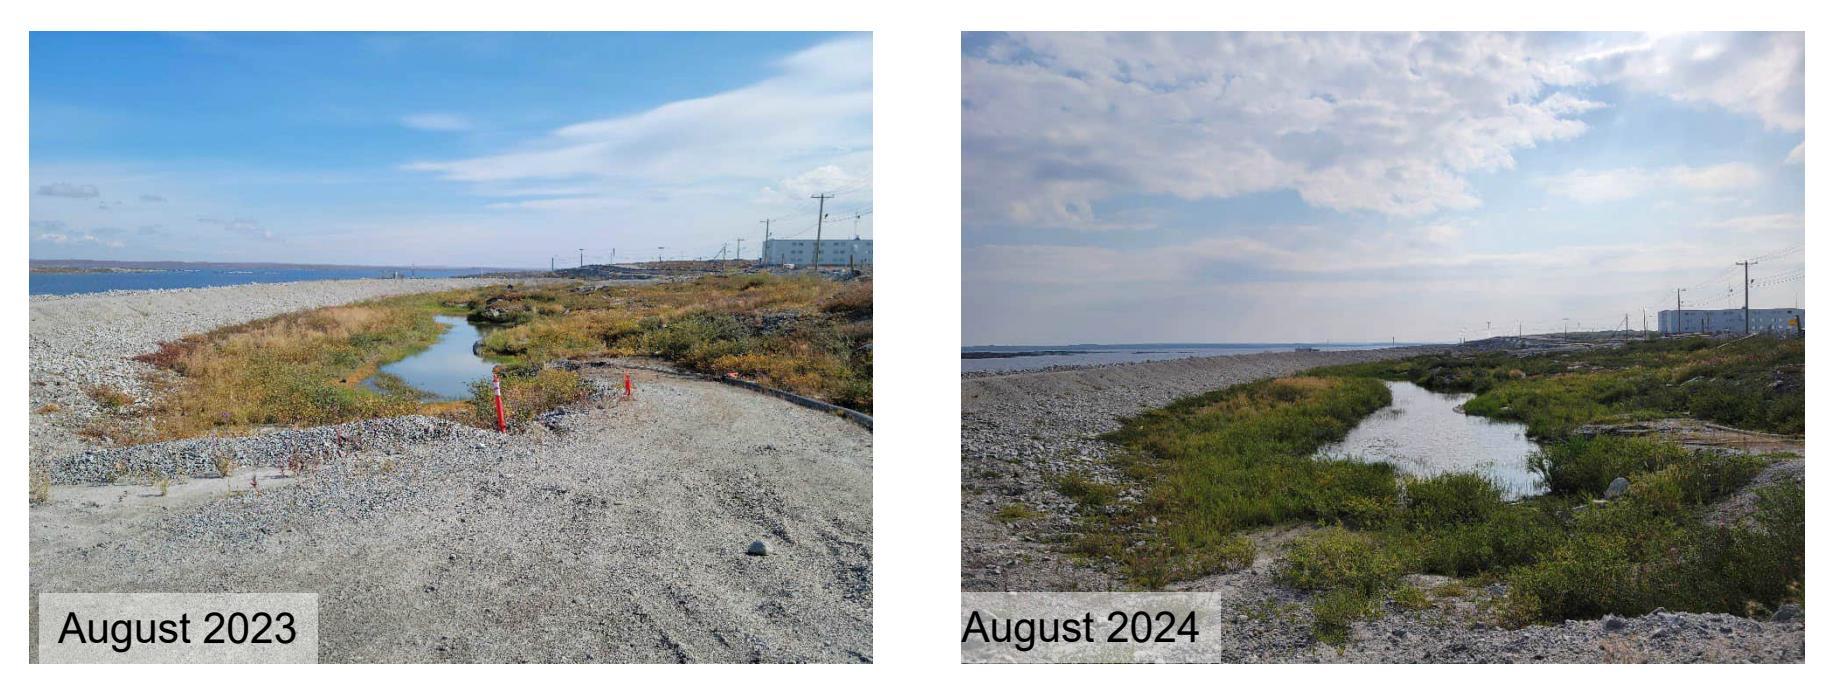
Photograph Pond 10 – 6: View of upstream slope of Pond 10 dam from pump access near south abutment, pond level is kept low and back from upstream toe. Pond level observed higher in 2024.

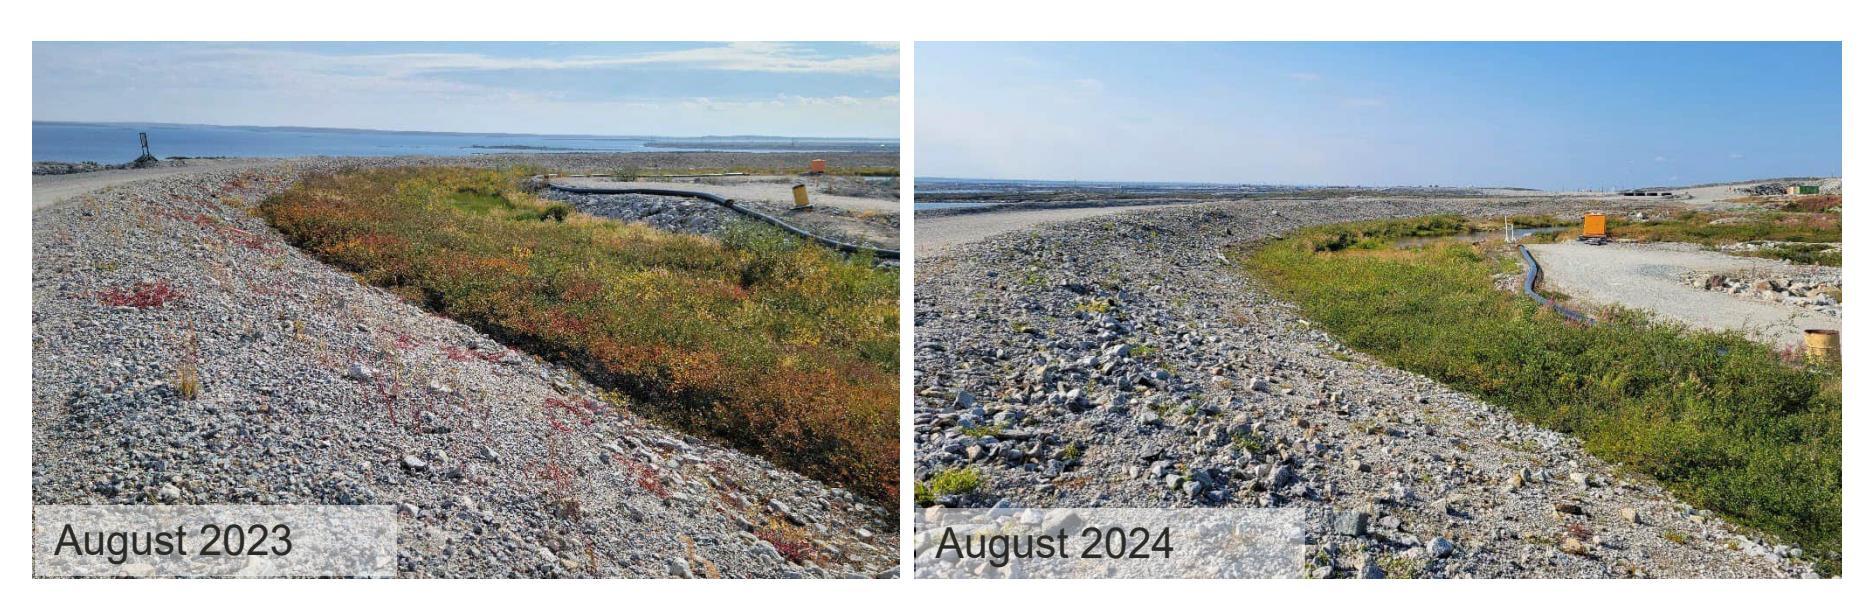
Photograph Pond 11 – 1: View of Pond 11 upstream slope. Water level kept low by the pumping system as observed in previous years. Upstream slope is in good condition. Vegetation encroaching on toe.

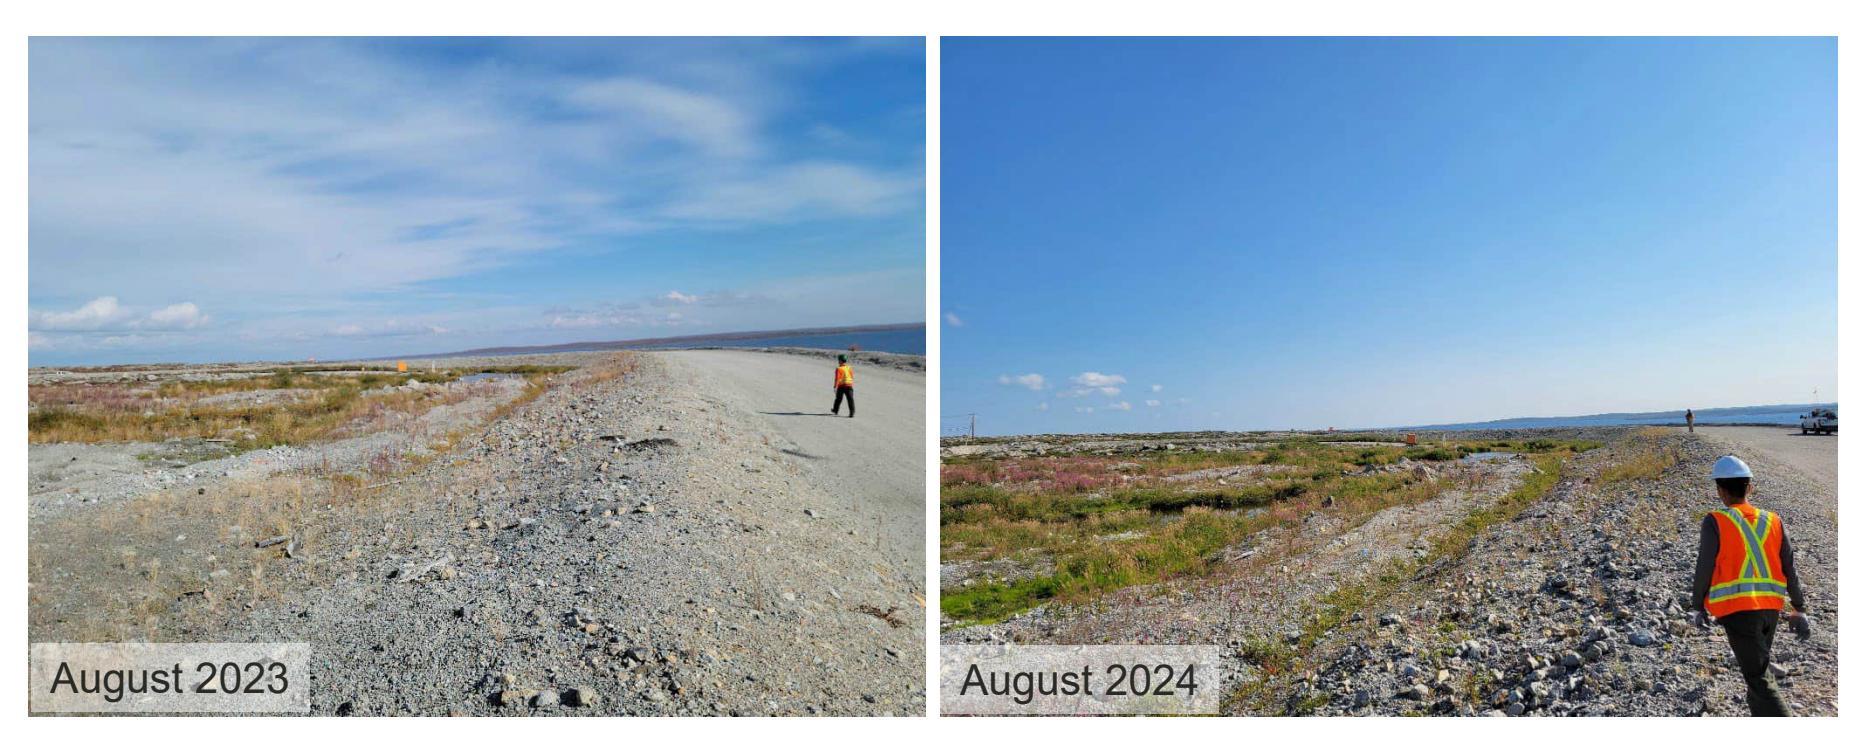
Photograph Pond 11 – 2: View along the upstream slope of Pond 11 dam. Slope is in good condition. Some debris material visible on upstream, likely use of Pond 11 for snow clearing storage, similar to previous years.

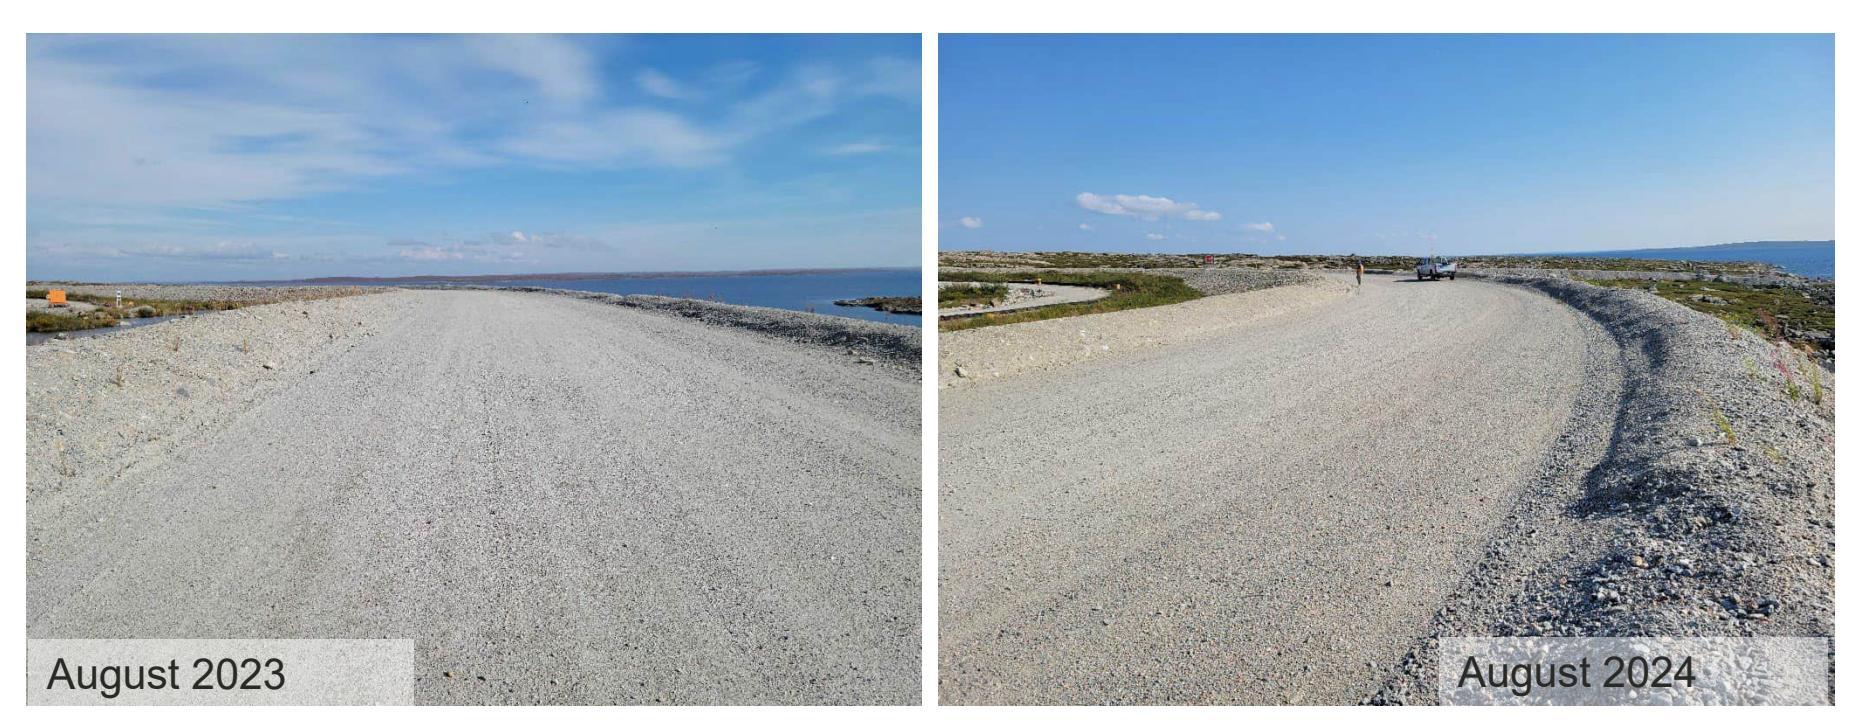
Photograph Pond 11 – 3: View looking east (2023 photo) and north (2024 photo) along the crest of Pond 11 dam. Crest is in good condition.

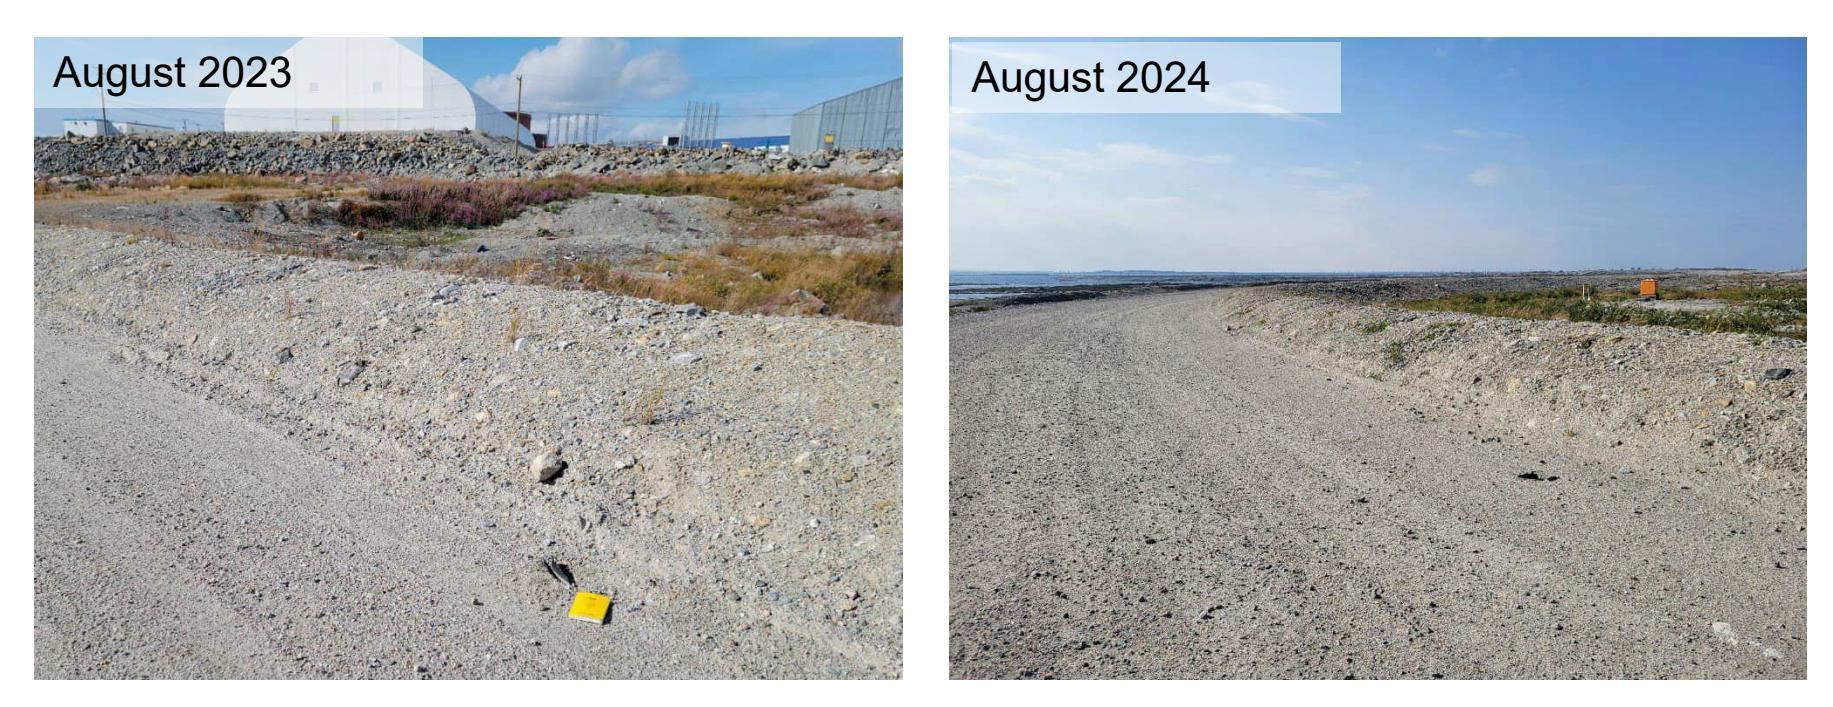
Small aeras of liner have been exposed in the running surface of the road. Liner has been observed previously, prior to 2022. If they areas of liner continue to be uncovered, additional road base may be required to be placed.

Photograph Pond 11 – 4: View looking south along the crest of Pond 11 dam. Three areas observed of small pieces of exposed liner at crest on the road's running surface; similar to those observed previously.

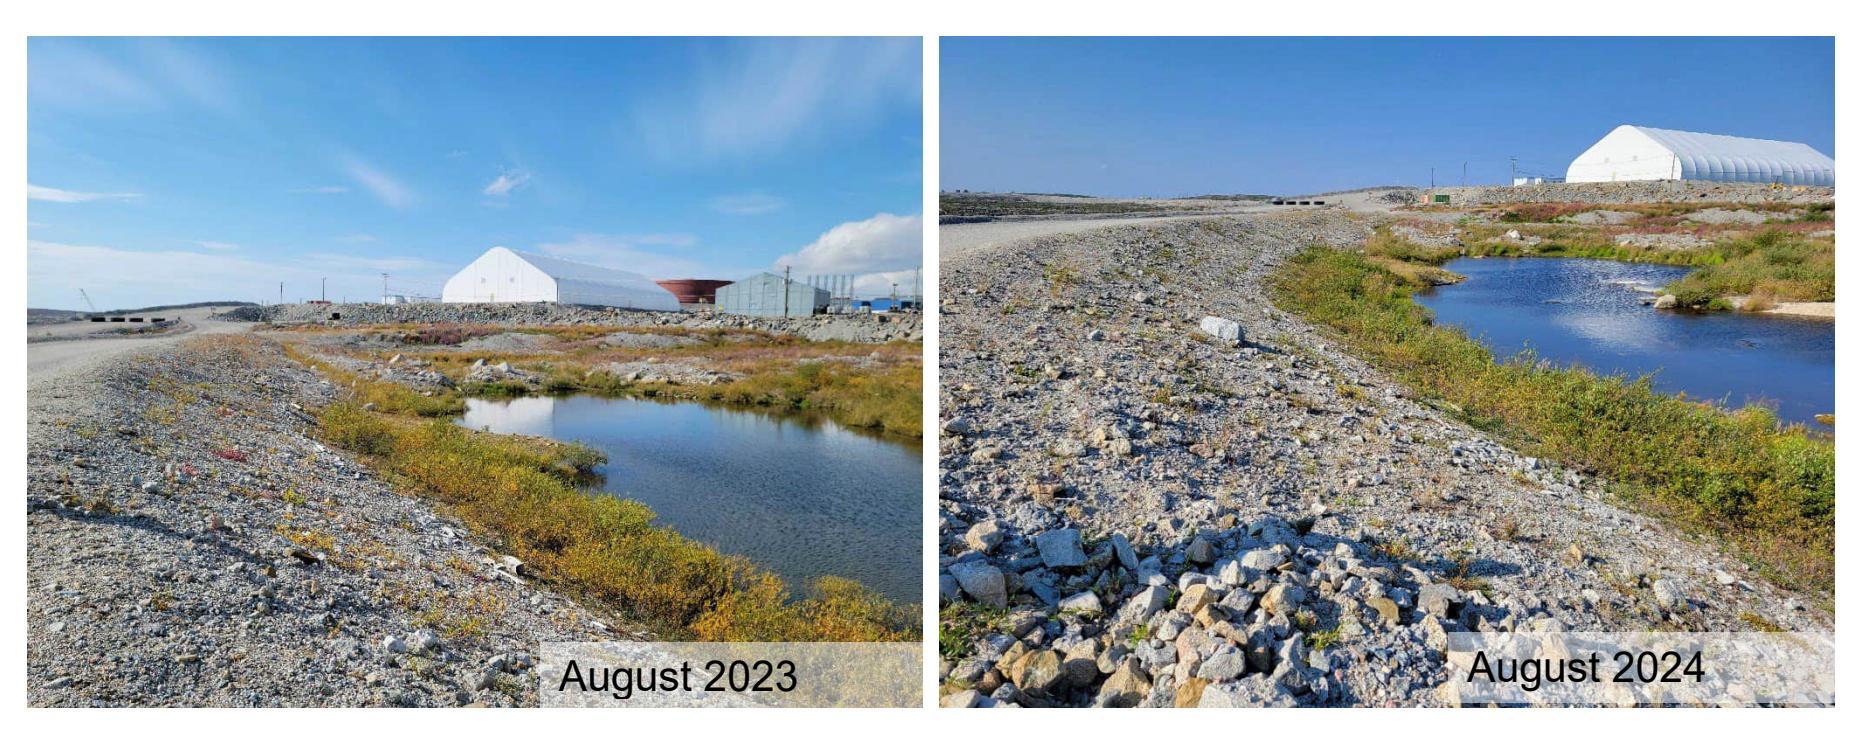
Photograph Pond 11 – 5: View of Pond 11 upstream slope and toe near the south abutment. Slope is in good condition and pond observed at a similar level in 2024 to previous years.

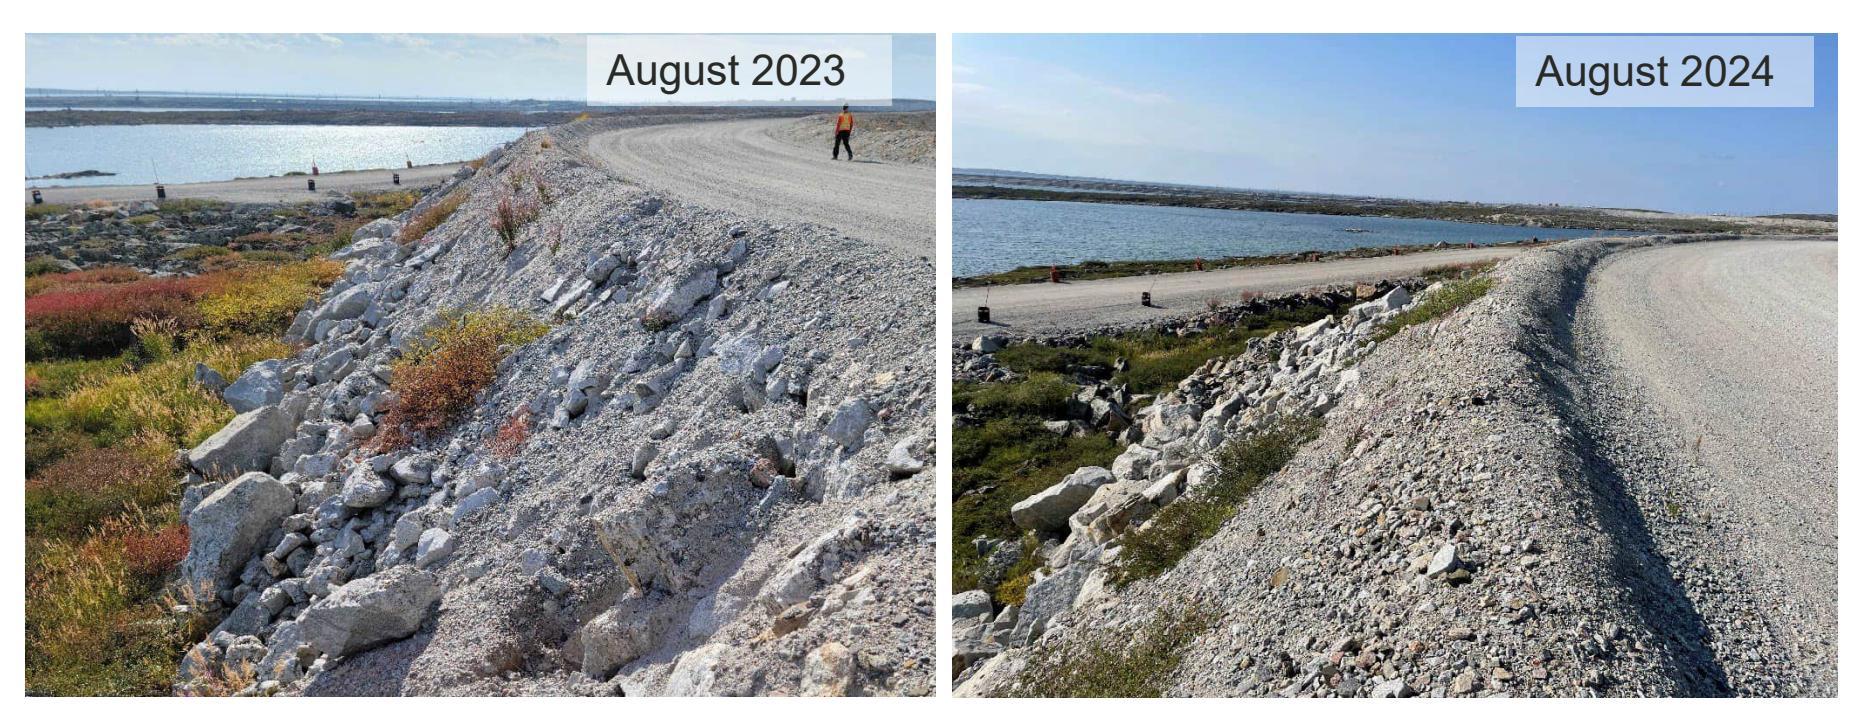
Photograph Pond 11 – 6: View of Pond 11 downstream slope and toe. Slope is in good condition. Very minor ponding at downstream toe; less than previous years.

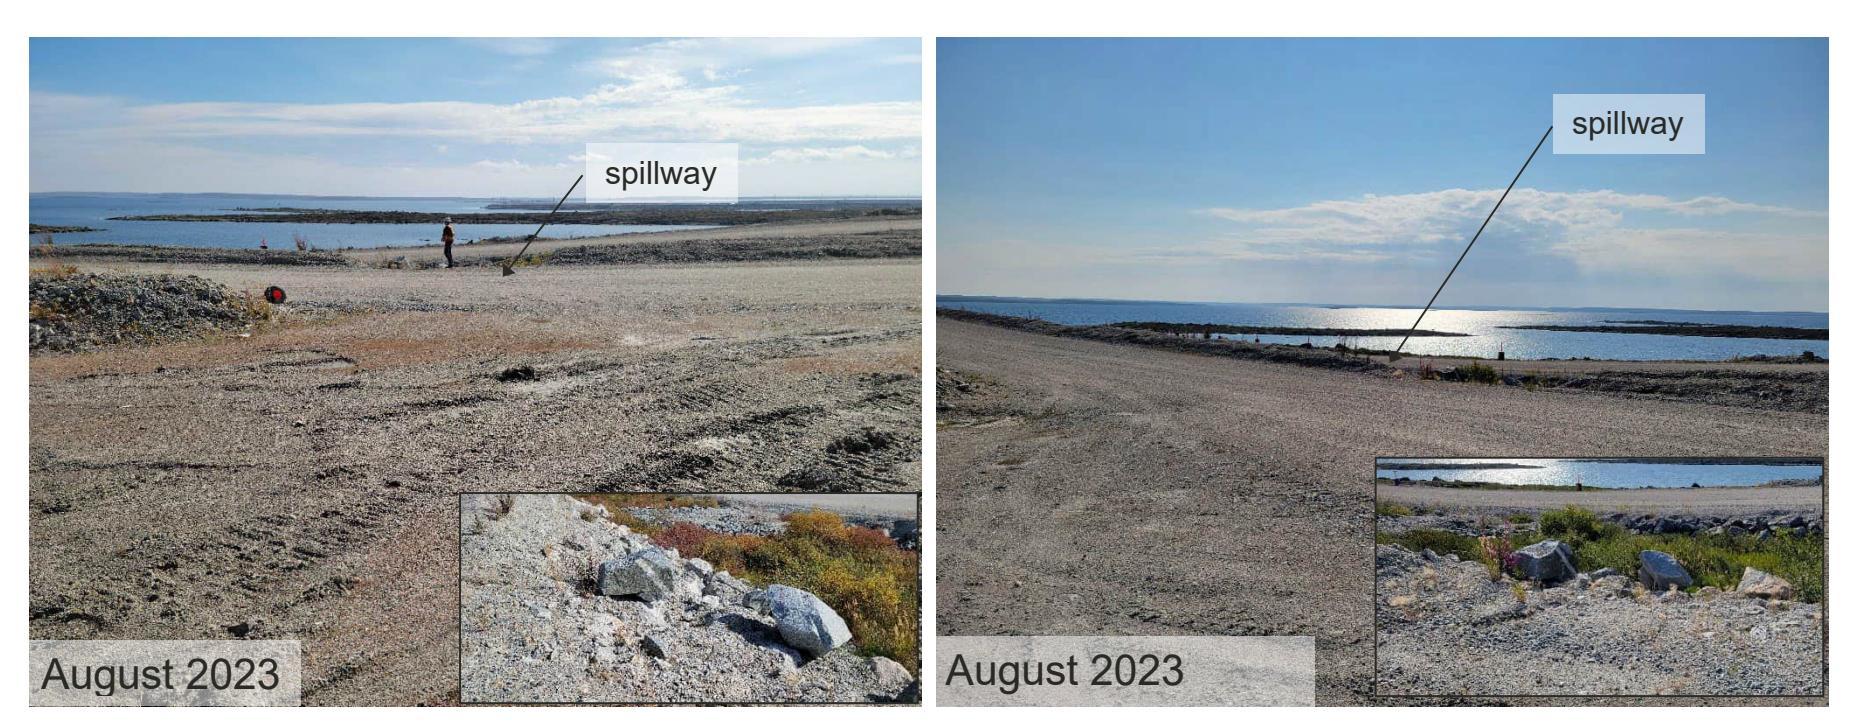
Photograph Pond 11 – 7: Slot cut in downstream safety berm for spillway. Boulders placed as safety berm across spillway. Some minor erosion observed on downstream crest of spillway in 2024 similar to 2023 (inset).

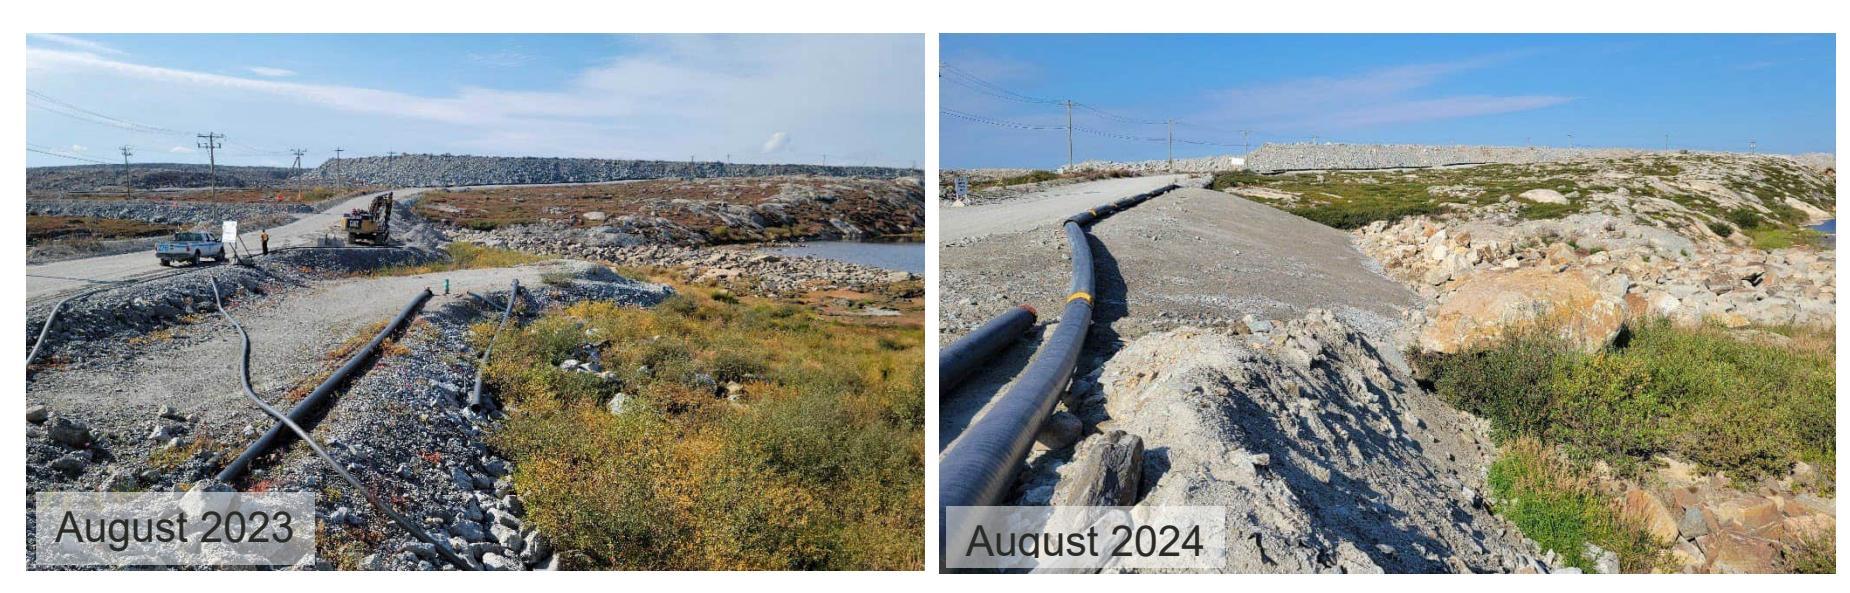
The upstream slope and pond liner was damaged in 2022 and repaired after the 2023 annual inspection. The upstream slope of Pond 12 now appears in good condition.

Photograph Pond 12 – 1: View to the west along the upstream slope of Pond 12. Repairs to upstream slope were underway during 2023 inspection and completed by the 2024 inspection. Water level in pond is maintained low.

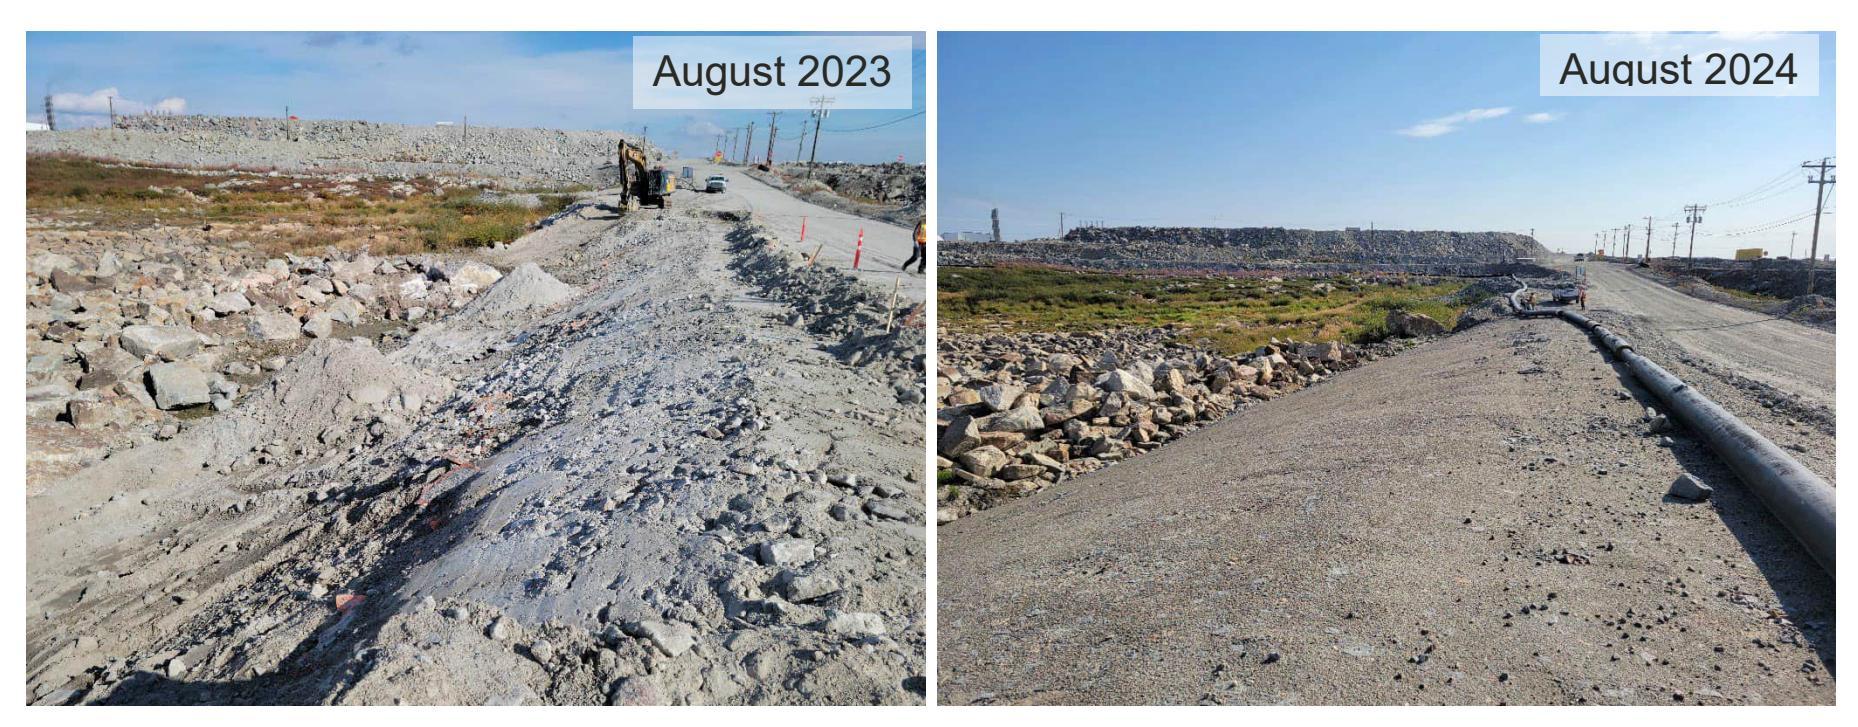
Photograph Pond 12 – 2: View to the east along the upstream slope of Pond 12. Repairs underway during the 2023 inspection and completed by the 2024 inspection.

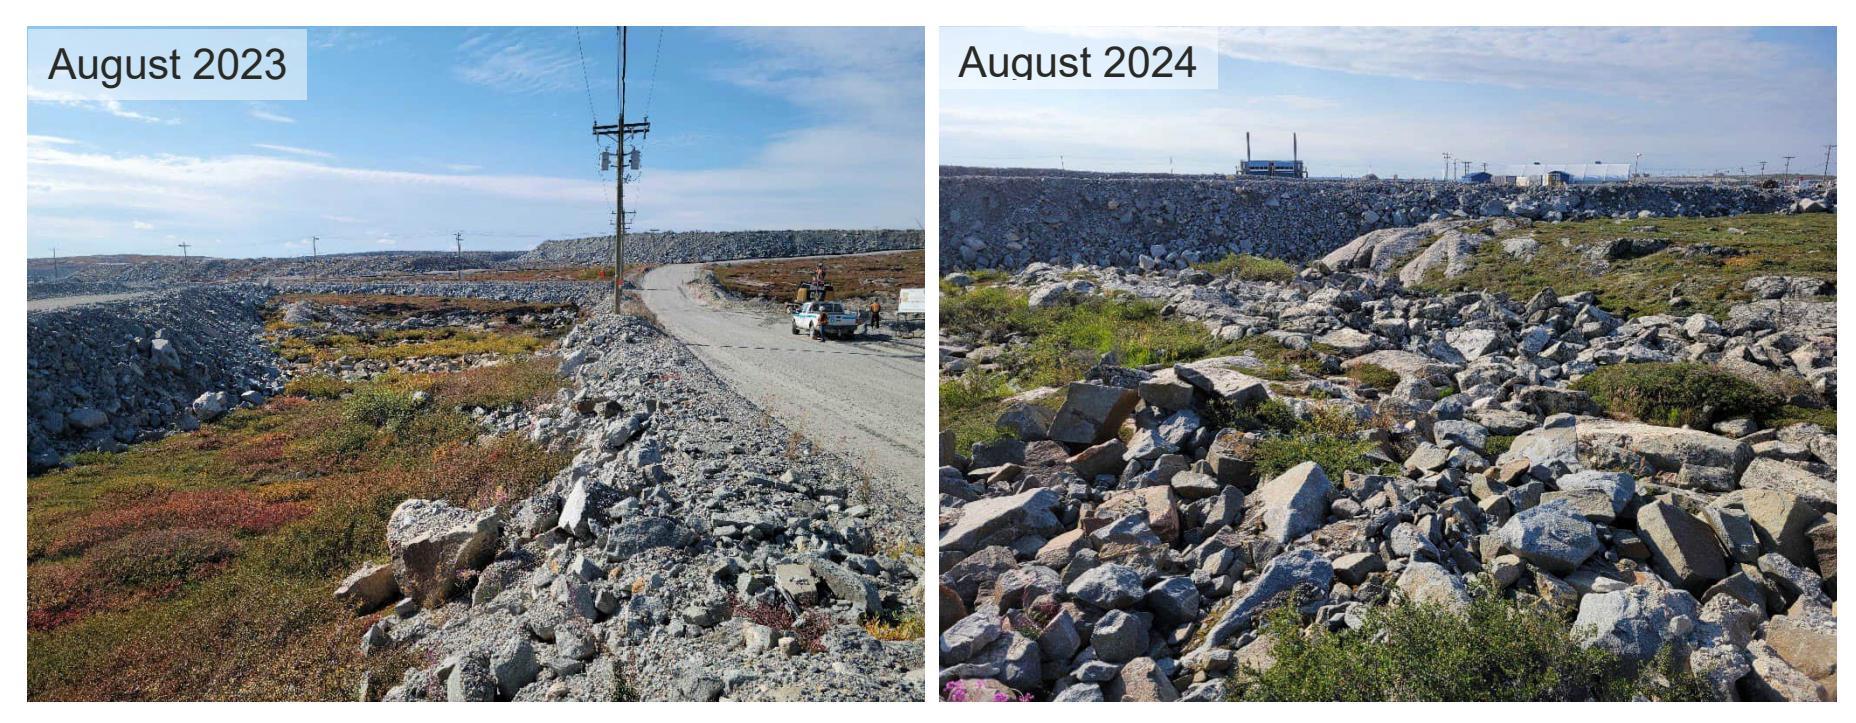
Photograph Pond 12 – 3: View to the west along the crest of Pond 12 dam and downstream area (AN access road) (2023 photo) and to the southeast (2024 photo). Crest and downstream slope in good condition.

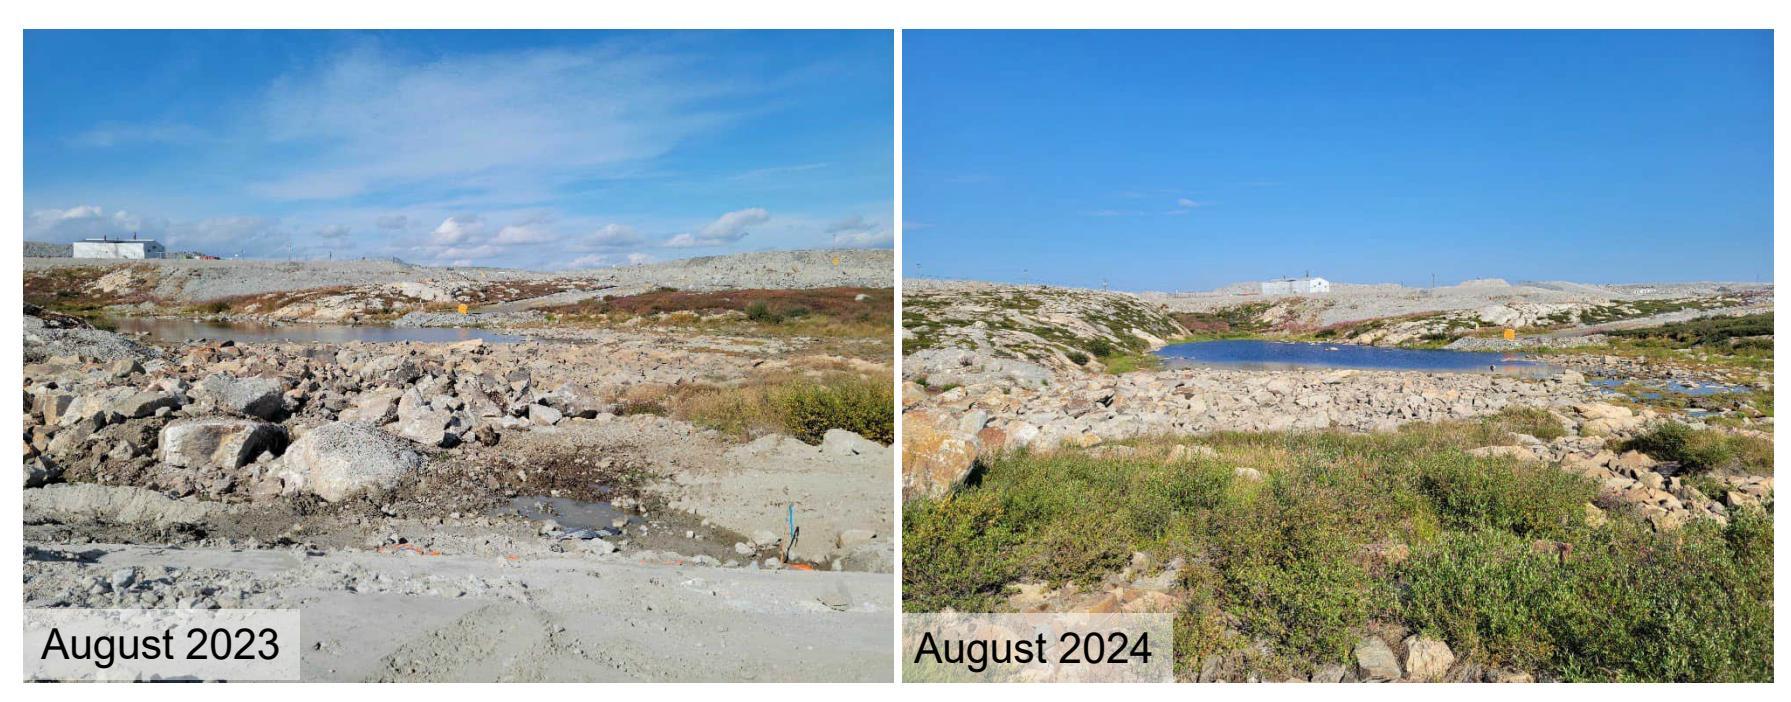
Photograph Pond 12 – 4: View to the north from Pond 12 dam crest looking upstream to pump shack. Pond level is low. Water does not encroach on the dam.
