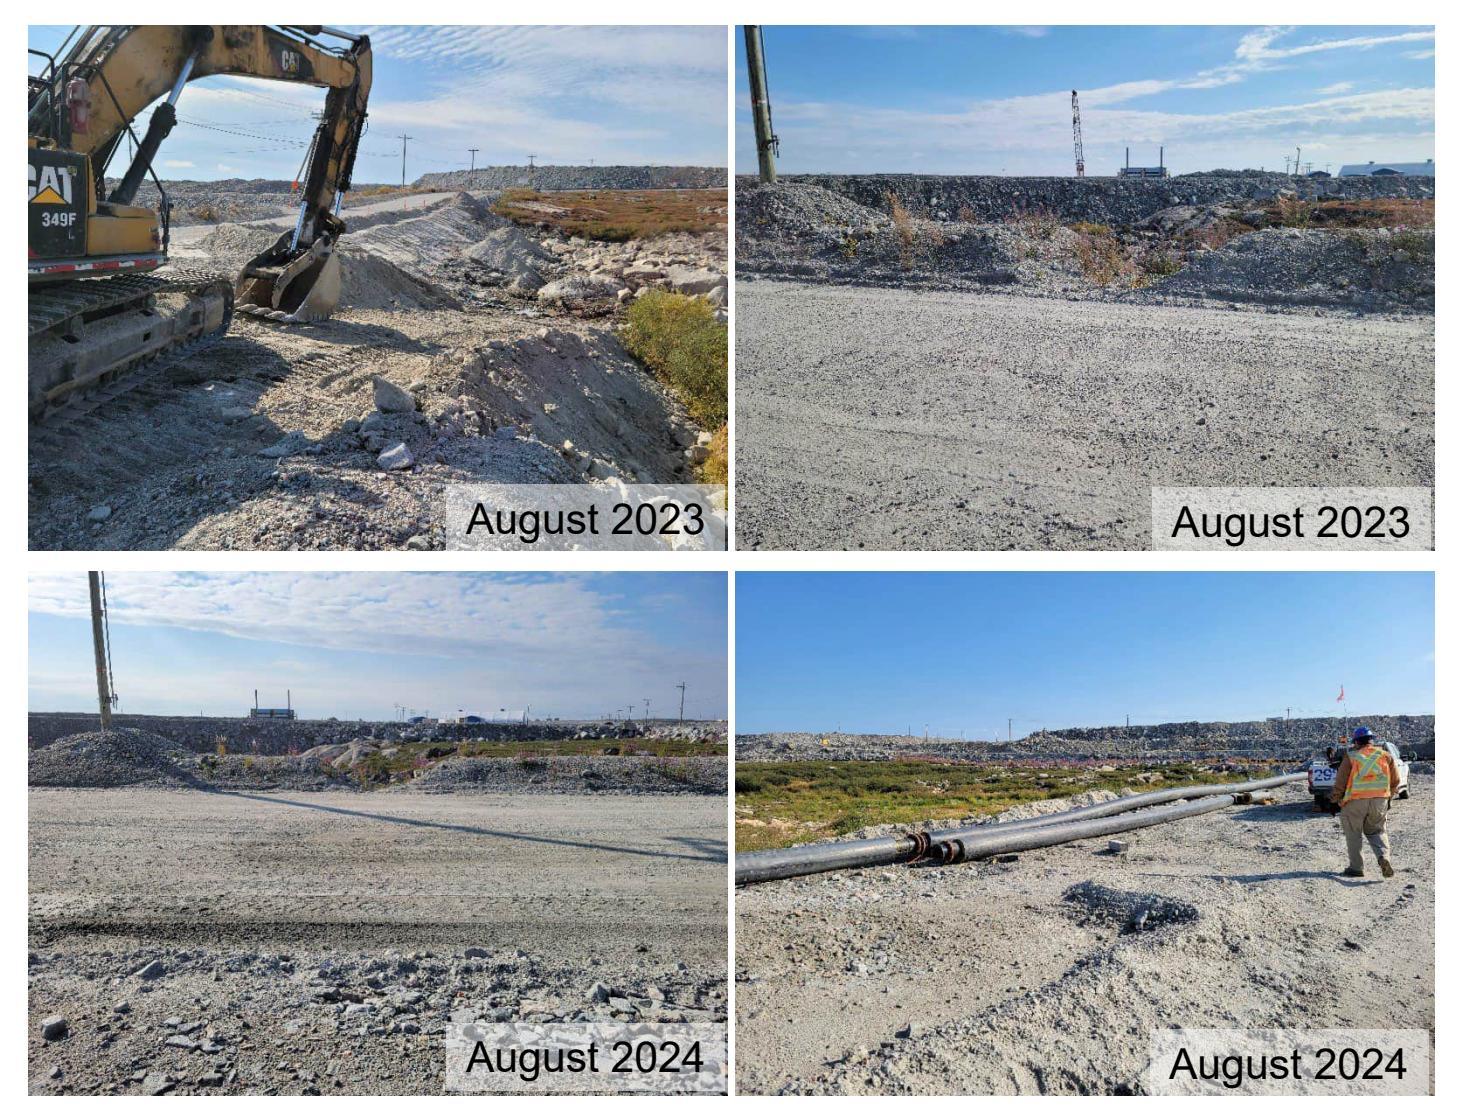
The crest was observed to be in good condition, with no settlement or cracks, however, the emergency spillway is partially obstructed by a water pump pipeline placed along the upstream extent of the dam crest and disused pipe.

Photograph Pond 12 – 6: Notches cut in downstream berm (Pond 12 dam crest) to form spillway. Spillway reinstated after repair works, however, redundant and pipe line partially obstructs spillway alignment.

Place pipe on blocks or cribbing to allow flow under the pipe through the emergency spillway, and/or remove pipe, prior to freshet.

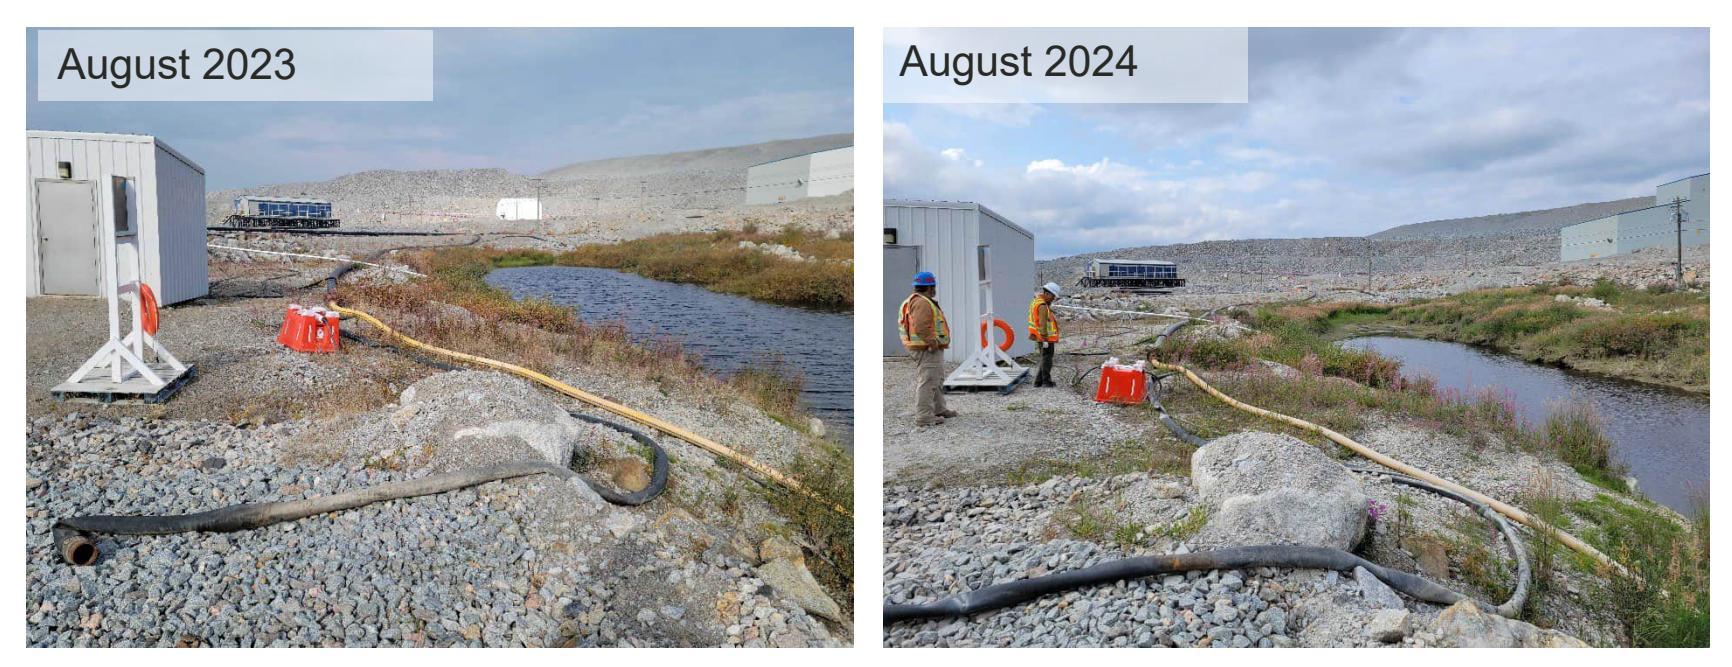
Photograph Pond 13 – 1: View to the west along the upstream face of Pond 13. Dam is in good condition. Water level is kept low in the pond by pumping.

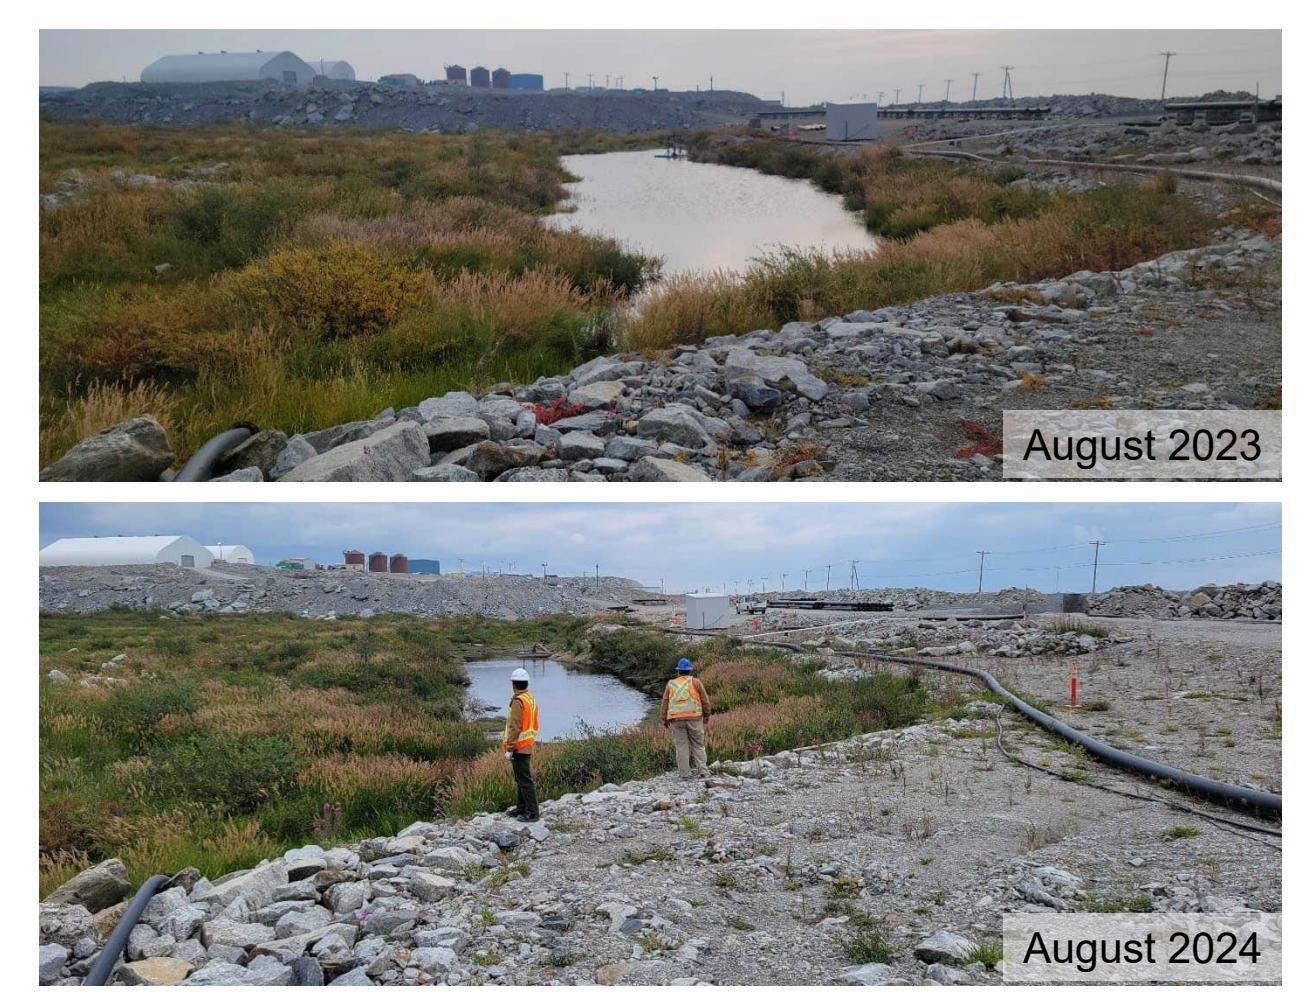
Photograph Pond 13 – 2: View across Pond 13 to the southeast. Upstream slope of dam is in good condition and pond volume appears similar to 2023.

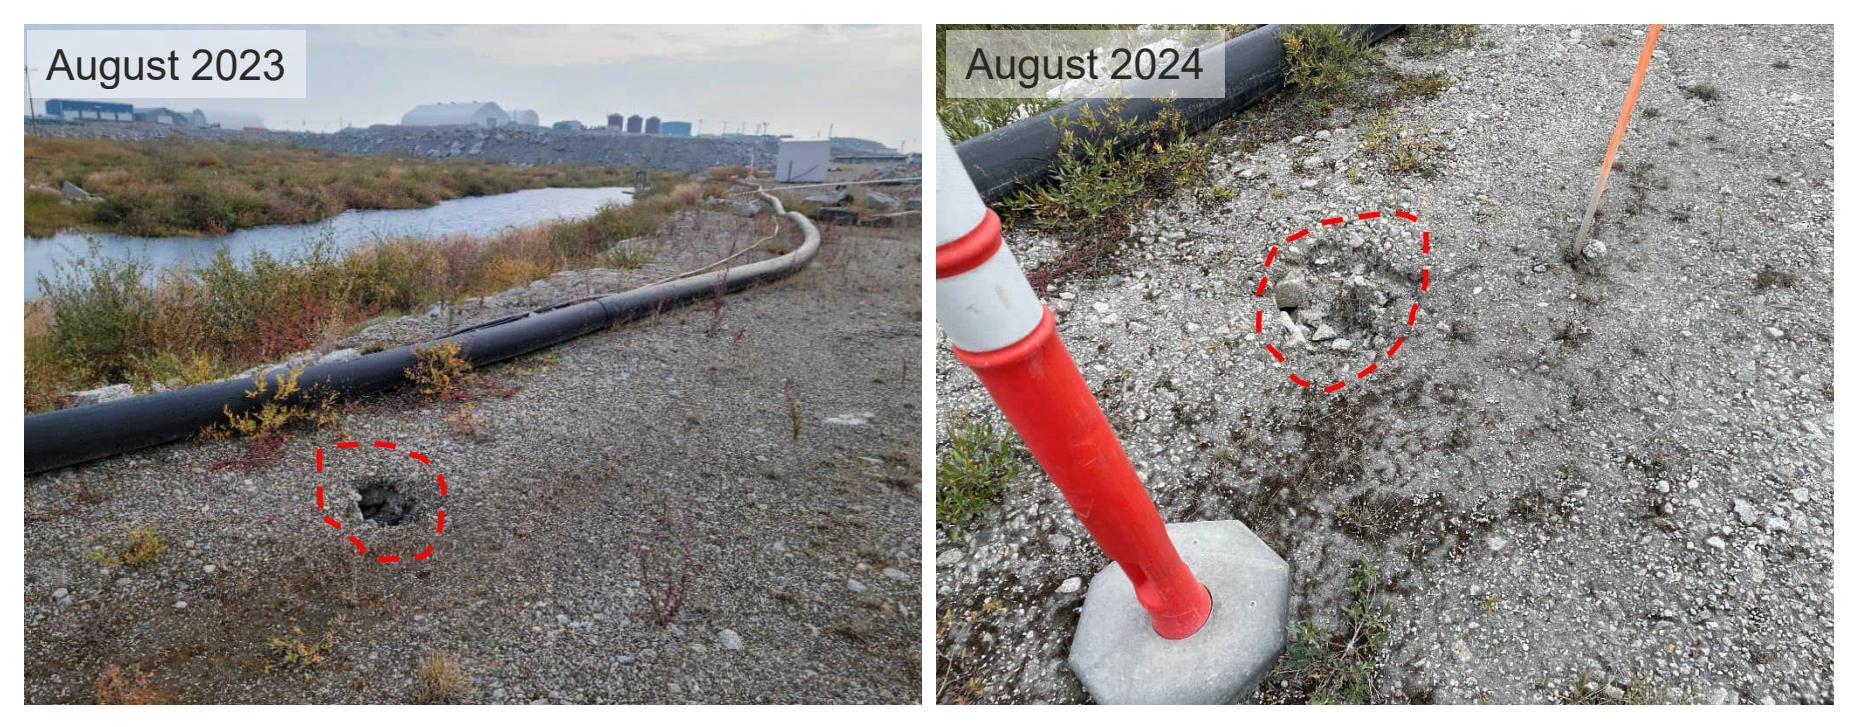
A series of small sink holes that were identified in the 2023 annual inspection at approximately at stn. 0+60 and between 1+80 and 2+00 appear to be in similar condition in 2024. Sinkholes appear to be upstream of the liner.

Photograph Pond 13 – 3: Small sink holes have developed at the crest and do not appear to be developing.

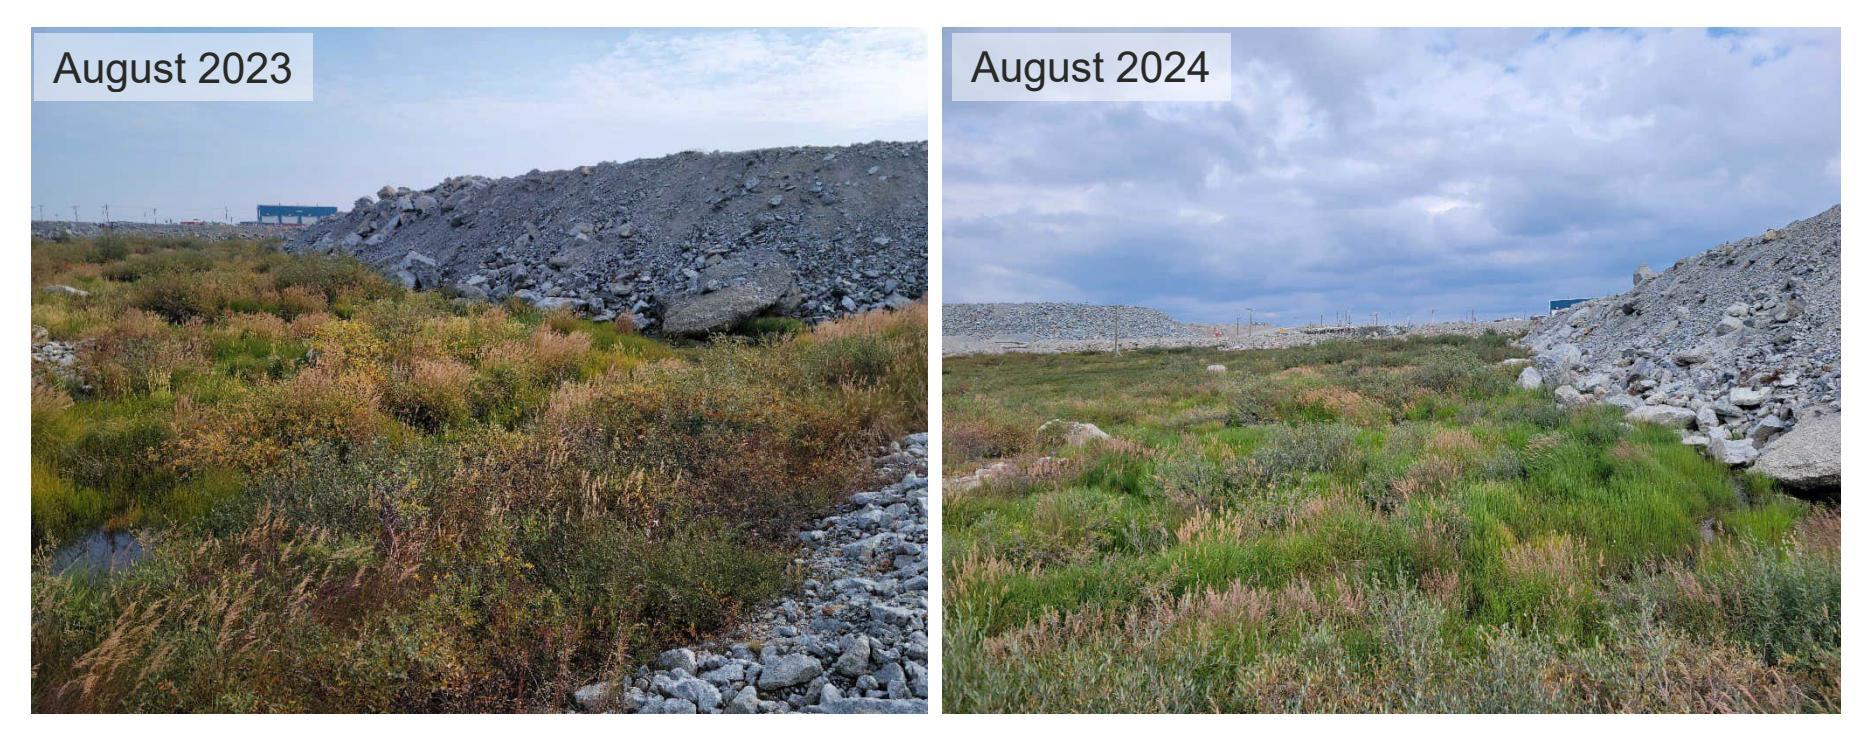
Photograph Pond 13 – 4: View to the north along the eastern section of Pond 13 dam. Underground rockfill pad has been pushed into Pond 13 over the eastern section of the Pond 13 dam; similar conditions to those observed in previous years.

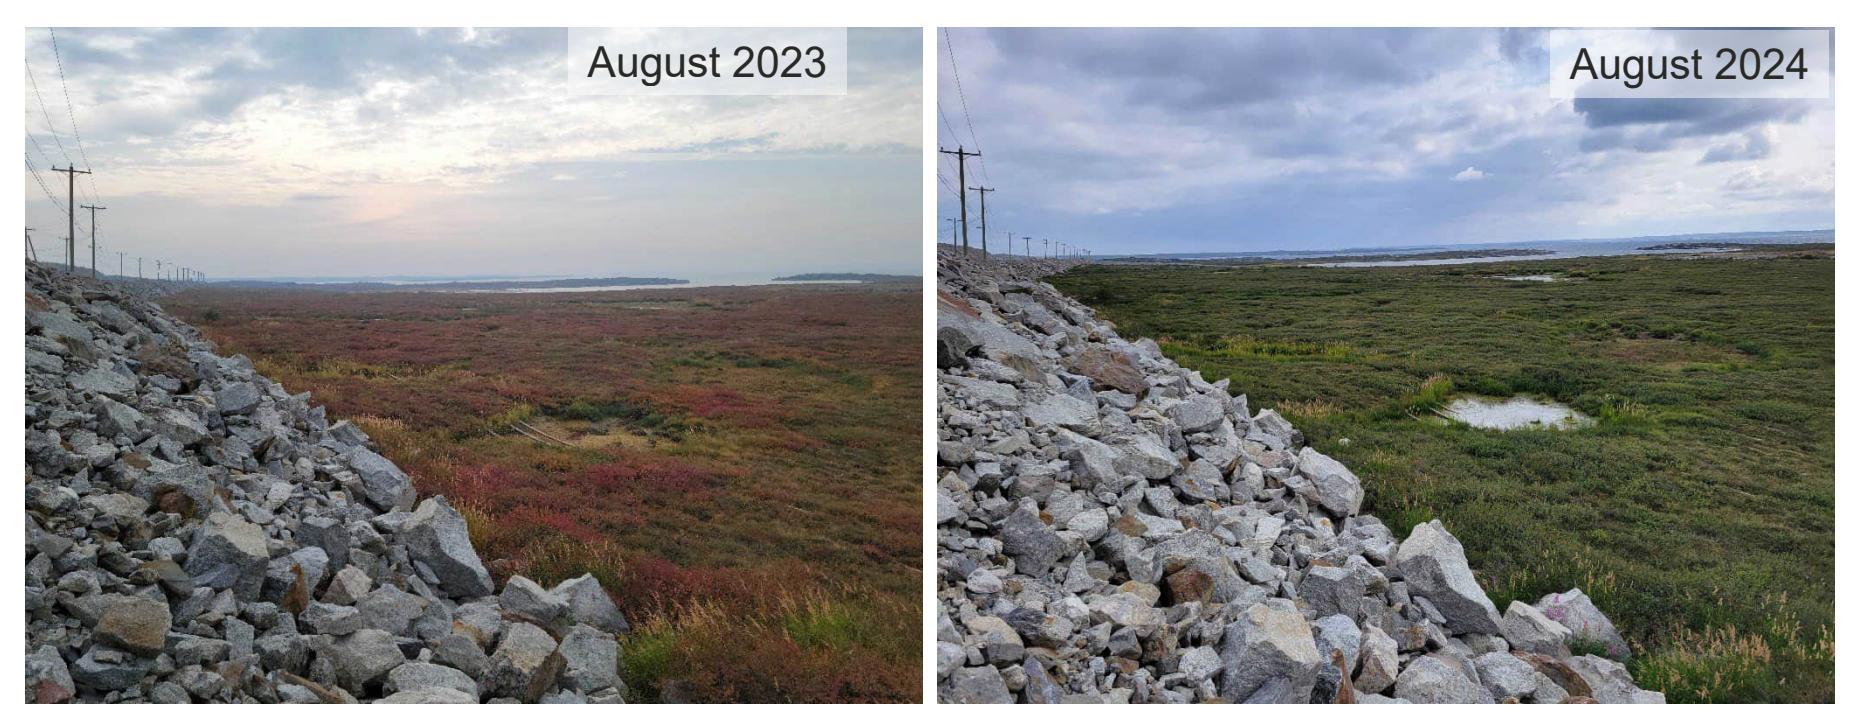
Photograph Pond 13 – 5: View to the east along the downstream toe of the haul road fill south of Pond 13. A small static pond that typically exists over tundra in the low area downstream of Sta. 0+120 was observed wet during the 2024 inspection. No signs of seepage were observed.

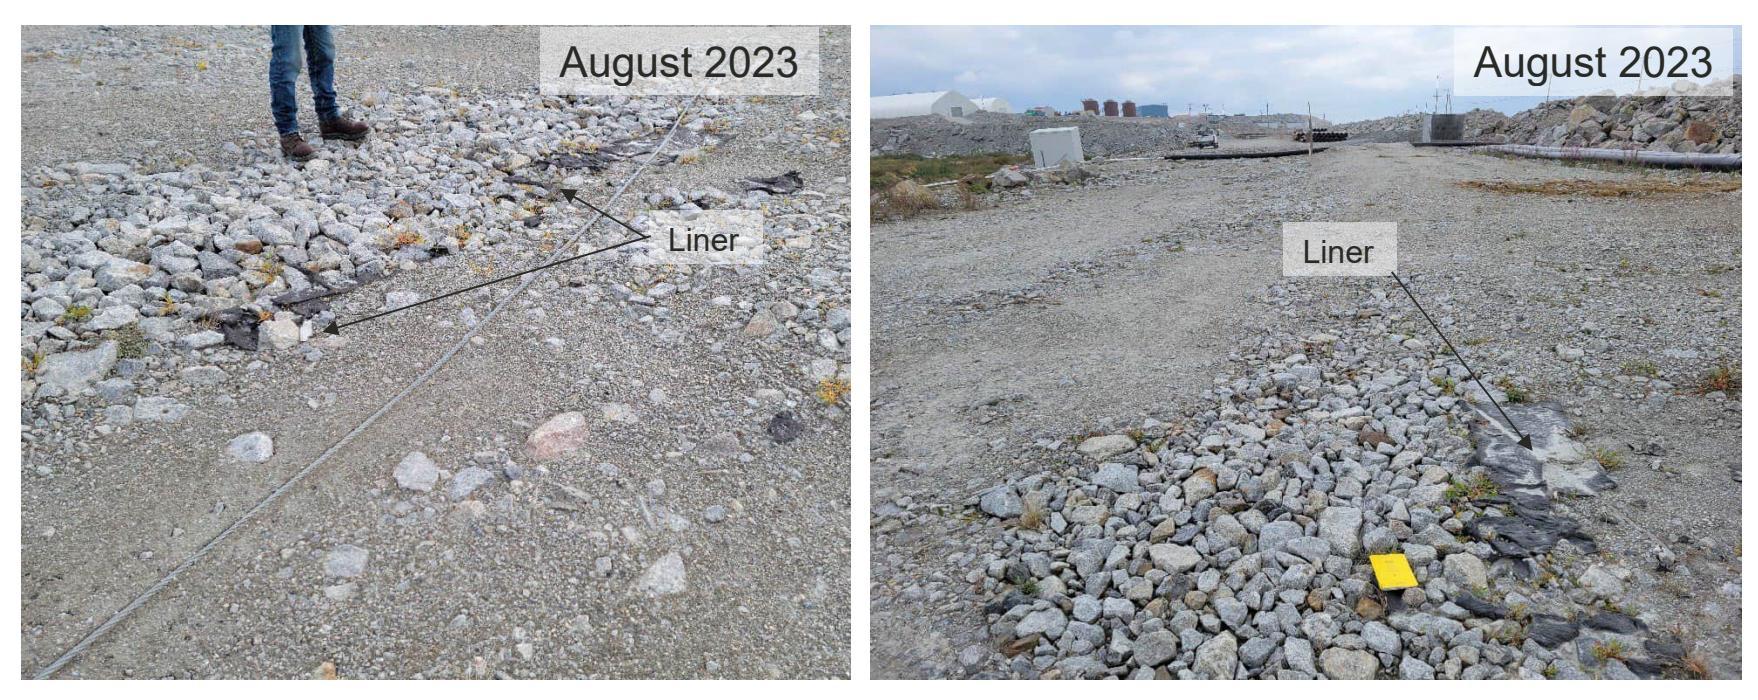
Photograph Pond 13 – 6: View to the east along the crest of Pond 13 dam. Crest is in good condition. Two areas of exposed liner observed downstream of anchor trench, similar condition to previous years.

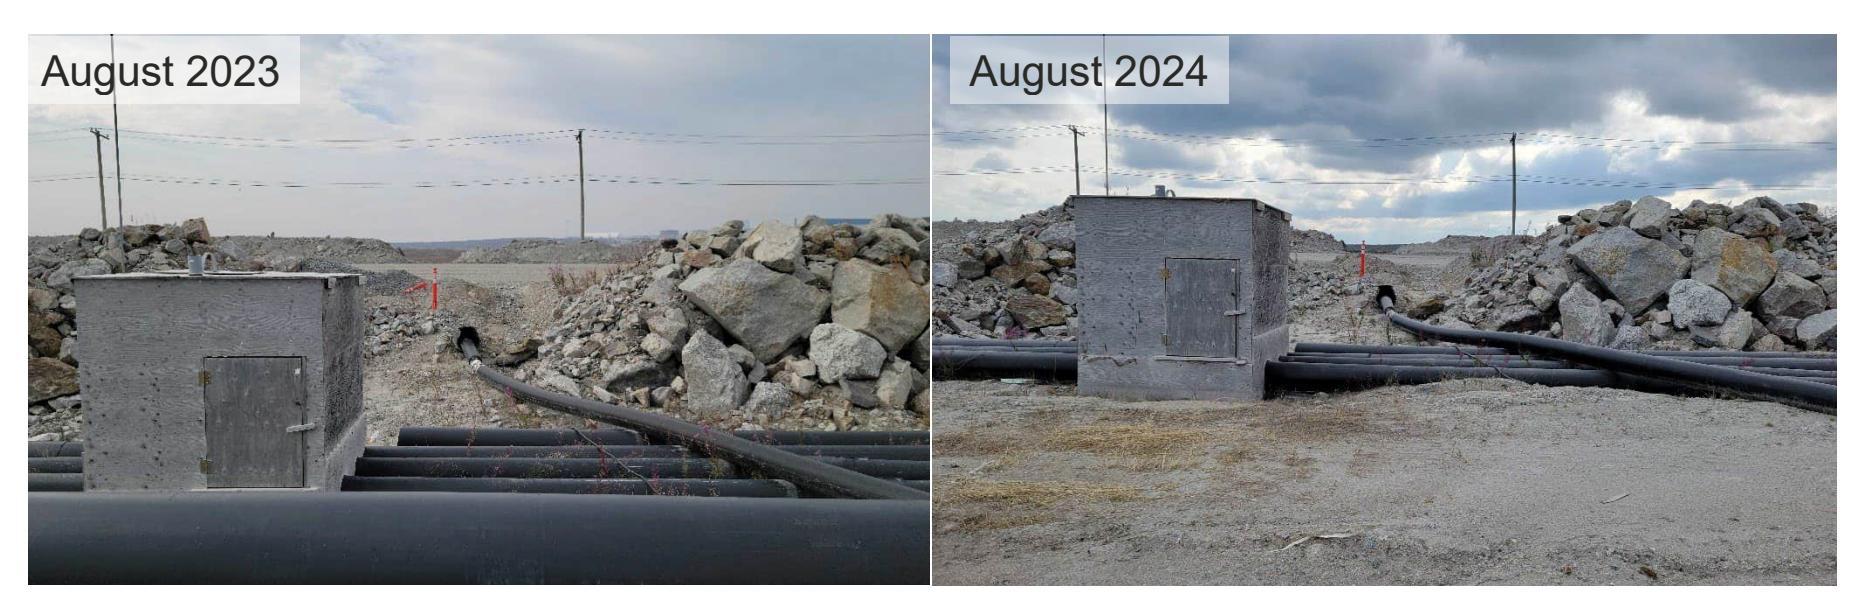
Photograph Pond 13 – 7: View looking downstream. Pipelines raised on cribbing. Pump shack and gravel pile partially blocks opening.
