CIRNAC-CARD Rayrock Remediation Project

RE: Land Use Permit W2020X005, Water License W2020L8-0003 – Rayrock Remediation Project

INSPECTION DATE –October 18th, 2024

ENVIRONMENTAL INSPECTION REPORT (W2020X0005 & W2020L8-0003)

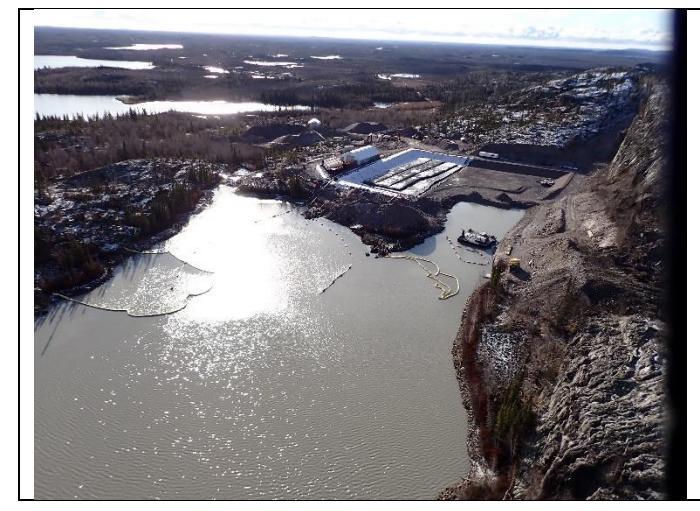
A fly-over of Mill Lake when departing site displayed the significant construction progress undertaken this past season (Photo #13). The Inspectors extend their gratitude to Nicolas Robichaud at Sanexen for facilitating the end of season site visit and implementing corrective actions prior to closing down the camp. The Inspectors look forward to the upcoming 2025 winter road season.

Photo #13: Overview of Mill Lake, the CDF, and the Mill Lake water treatment facility.
