GNWT ECC - North Slave Region

Re: August and September 2024 Water Licence Inspection

INDUSTRIAL WATER USE INSPECTION REPORT

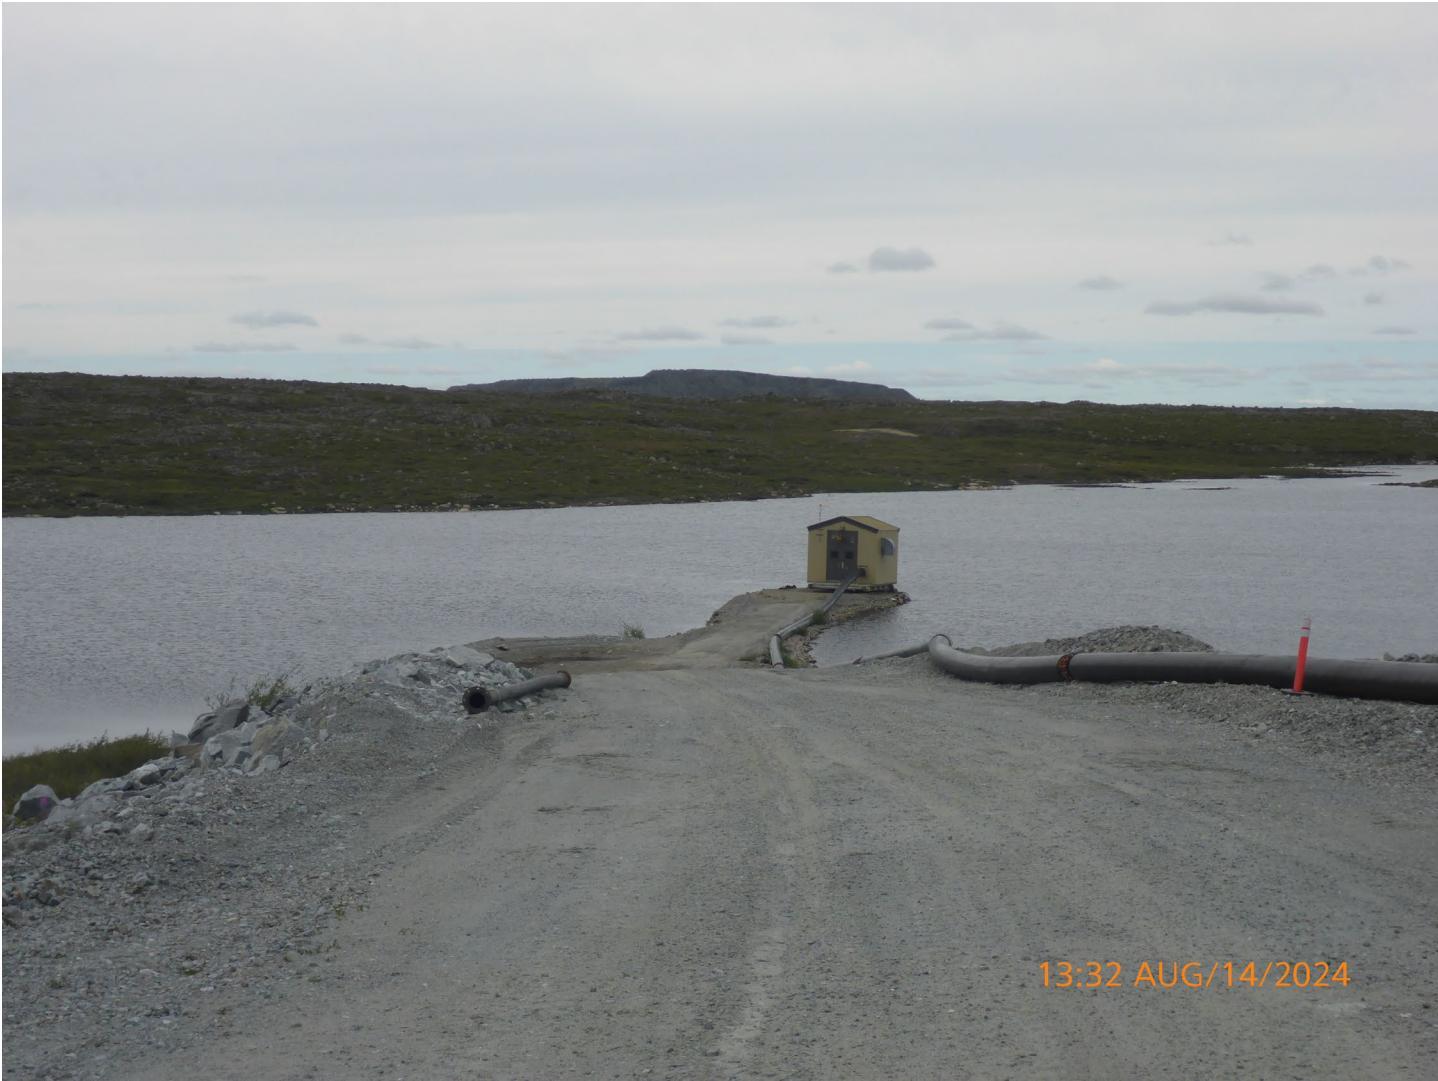
Water levels in Bearclaw Lake have been drawn down to target elevation for the season. The Bearclaw Lake pumphouse is now accessible and the pumps will be inspected and serviced to facilitate pumping next year. Flowmeters have been removed and are scheduled for recalibration (Photo 1).

Photo 1 – Bearclaw Lake – Bearclaw Lake has been drawn down enough to provide access to the pump facility. The facility will require some repairs before next pumping season.

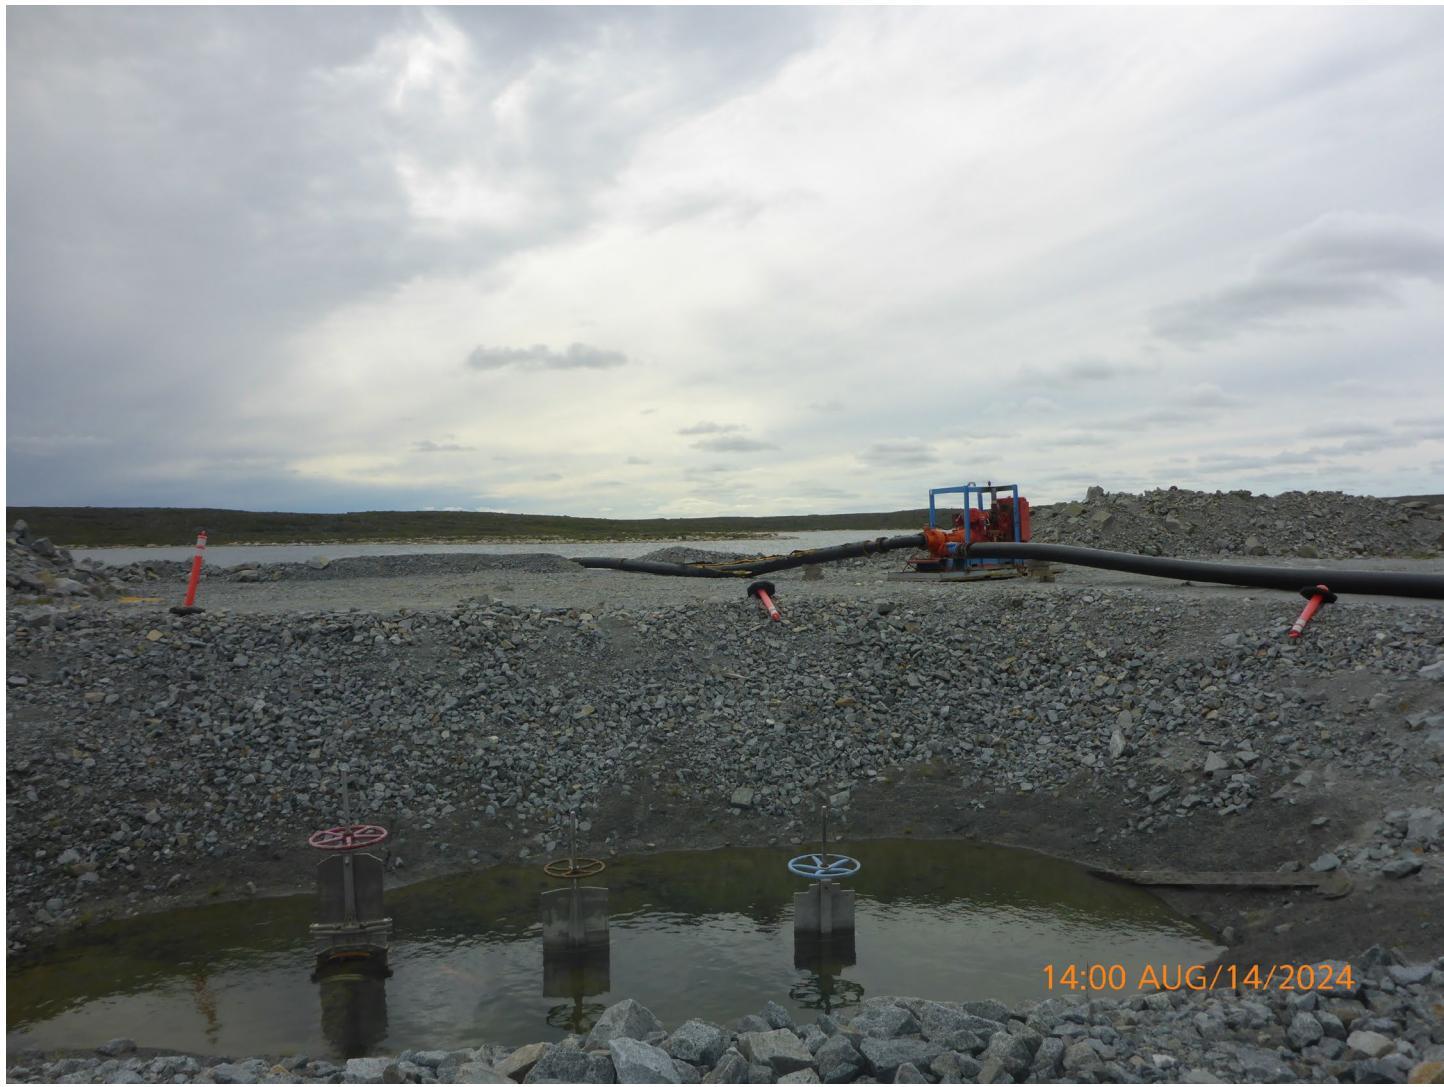
There was no discharge from Cell E to Leslie Lake this year. Water is being pumped back from Cell E to Cell D in order to maintain Cell D water levels. Water levels need to be maintained at a minimum elevation to accommodate the reclaim barge that draws recycled water from Cell D for the Process Plant (Photos 2 and 3).

Photo 2 – Long Lake Containment Facility – Water levels in Cell D of the LLCF need to be maintained above minimum target elevation to ensure there is enough water for the Process Plant Reclaim Barge. The Process Plant gets nearly all of its water from Long Lake for processing diamonds.

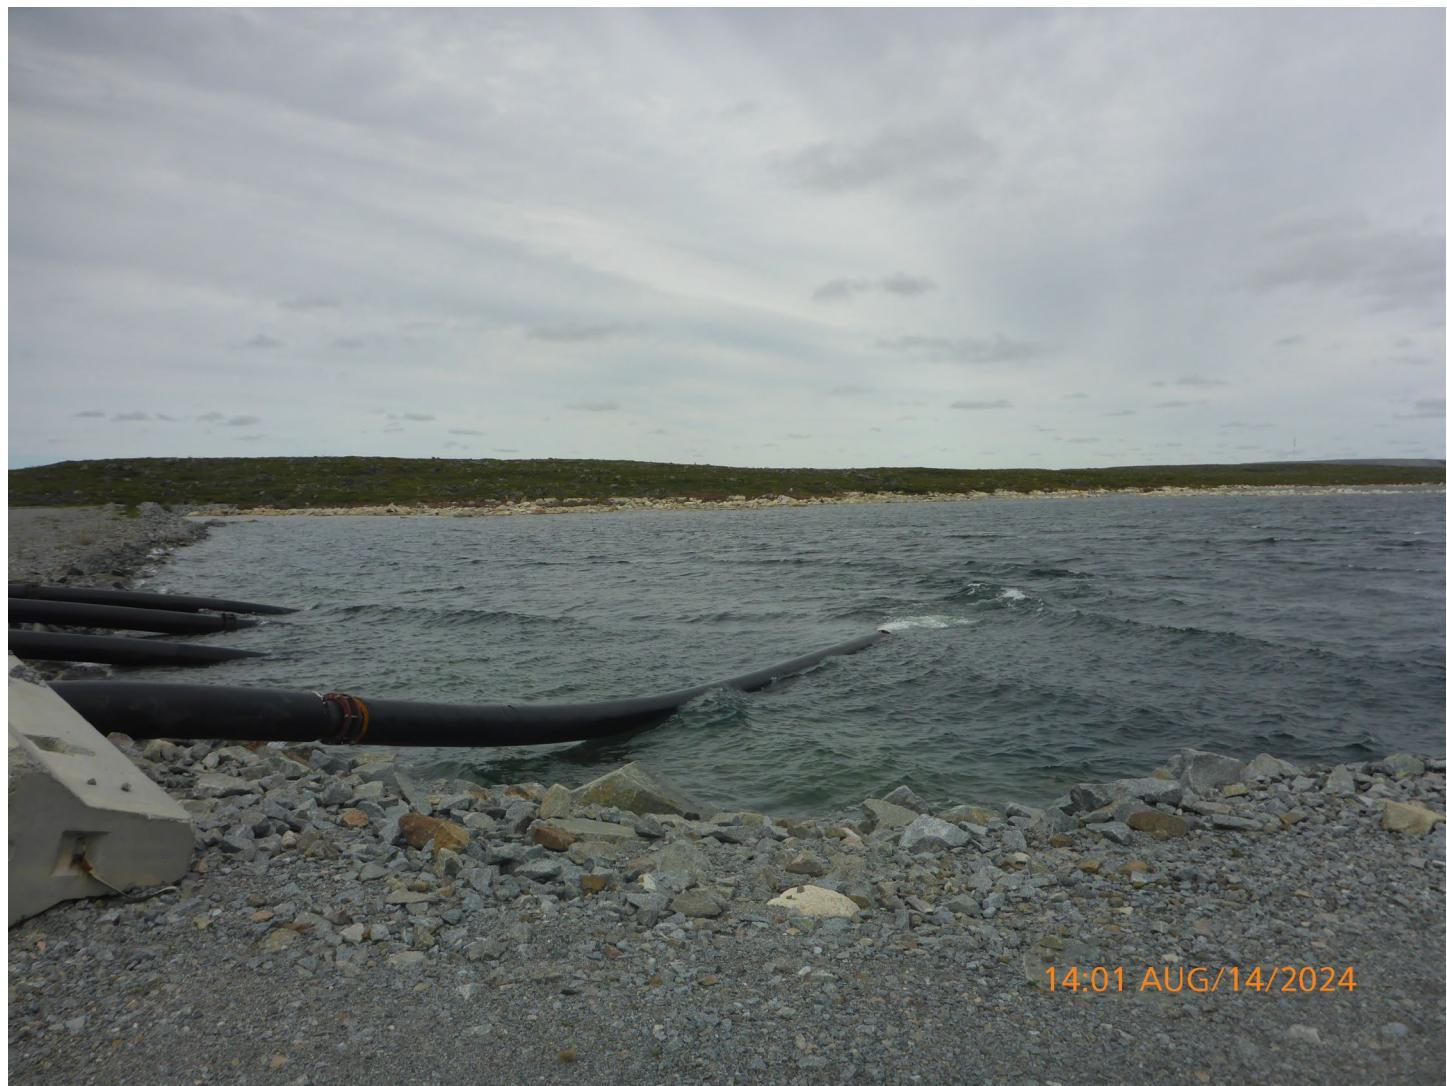
Photo 3 – Long Lake Containment Facility – Discharge point from Cell E to Cell D of the LLCF.

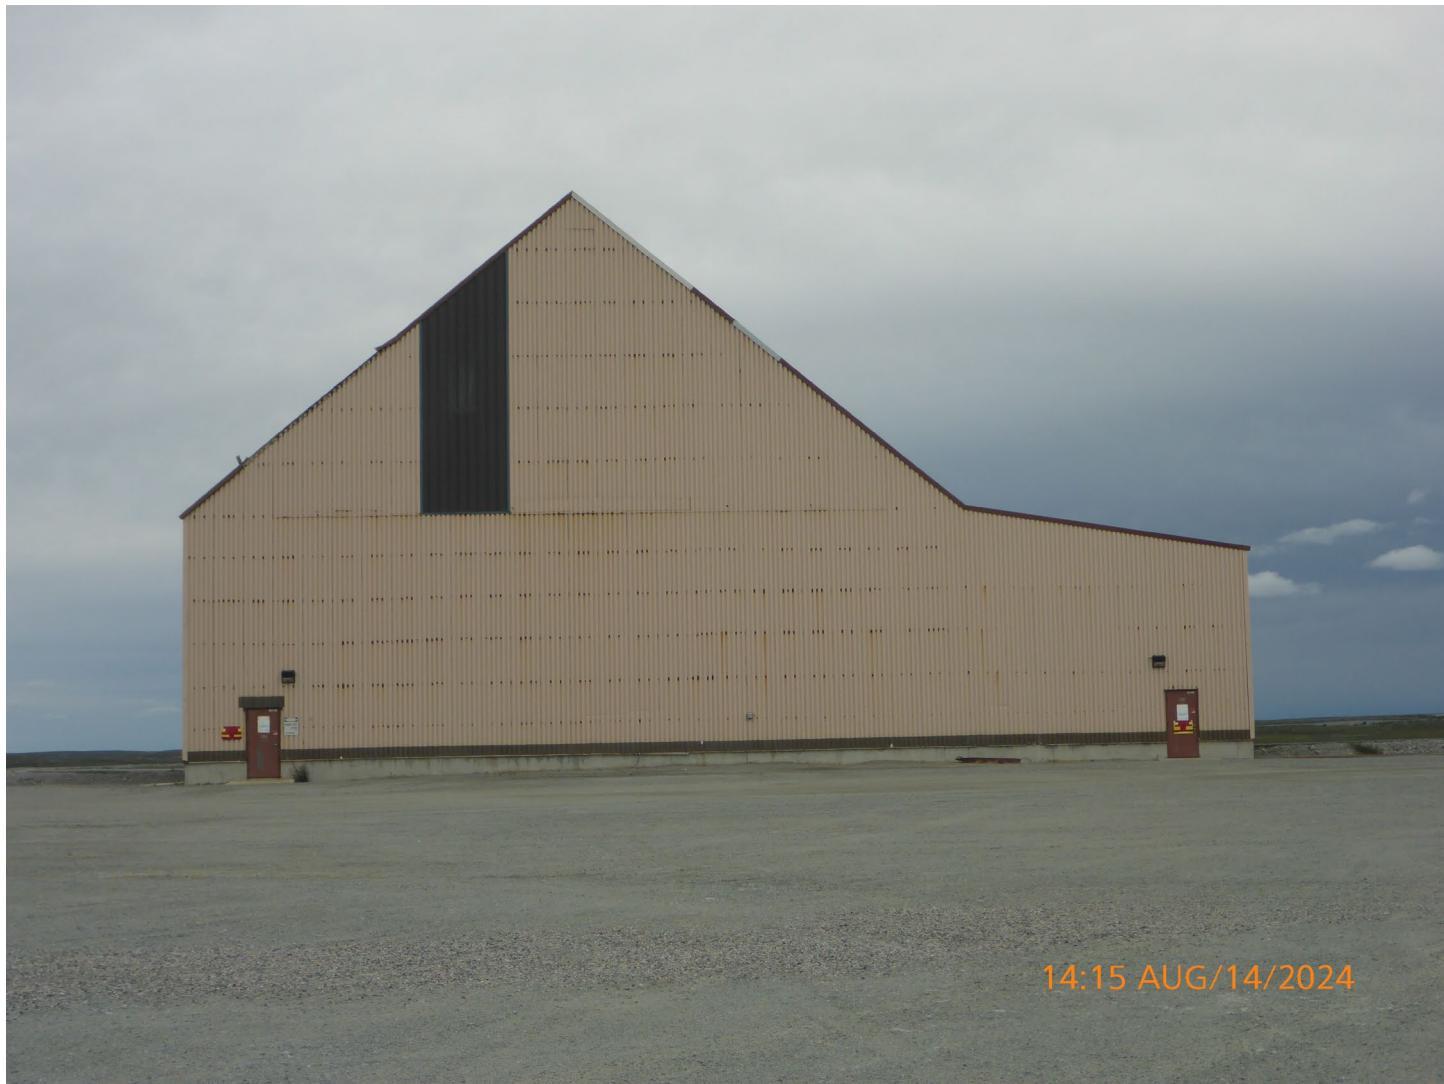
The area around the AN building was clean and well maintained. There was no evidence of any spills or loss of containment. Perimeter sumps around the building are designed to catch any contaminated runoff from the location. The sumps were relatively dry and there was plenty of capacity to contain any runoff if necessary (Photos 4 and 5).

Photo 4 – Ammonium Nitrate Storage – The area around the Ammonium Nitrate storage building was clean and well maintained with no indication of spills or loss of containment.

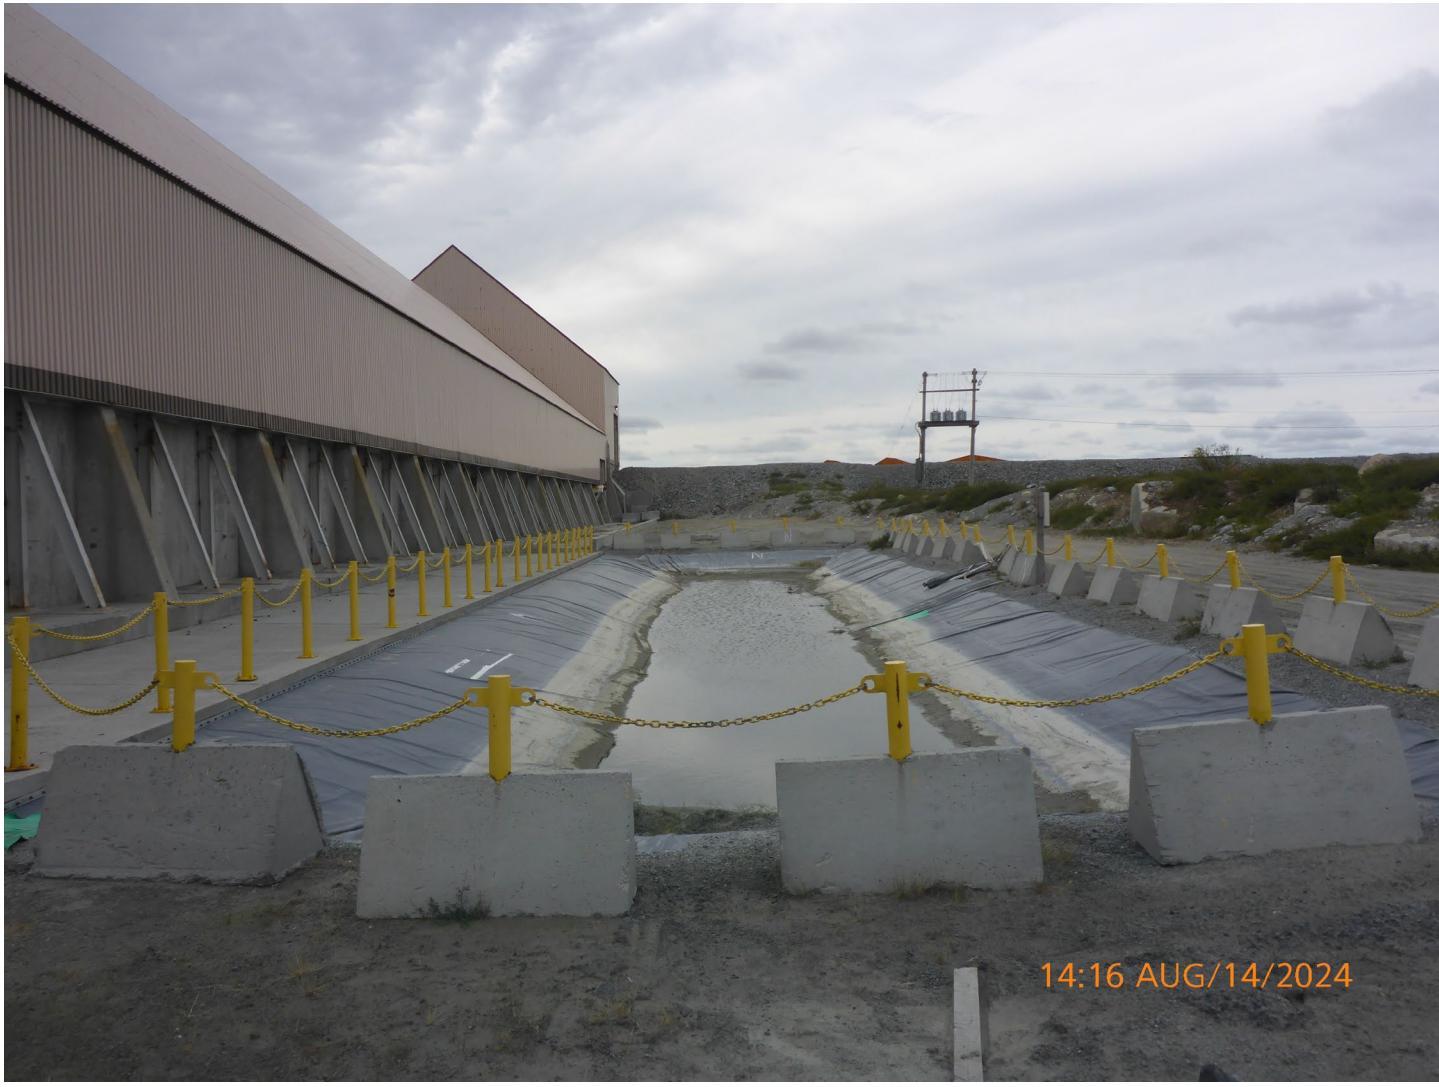
Photo 5 – Ammonium Nitrate Storage – The perimeter sumps around the AN building are designed to contain any seepage from the building. The sumps were well maintained with plenty of holding capacity.

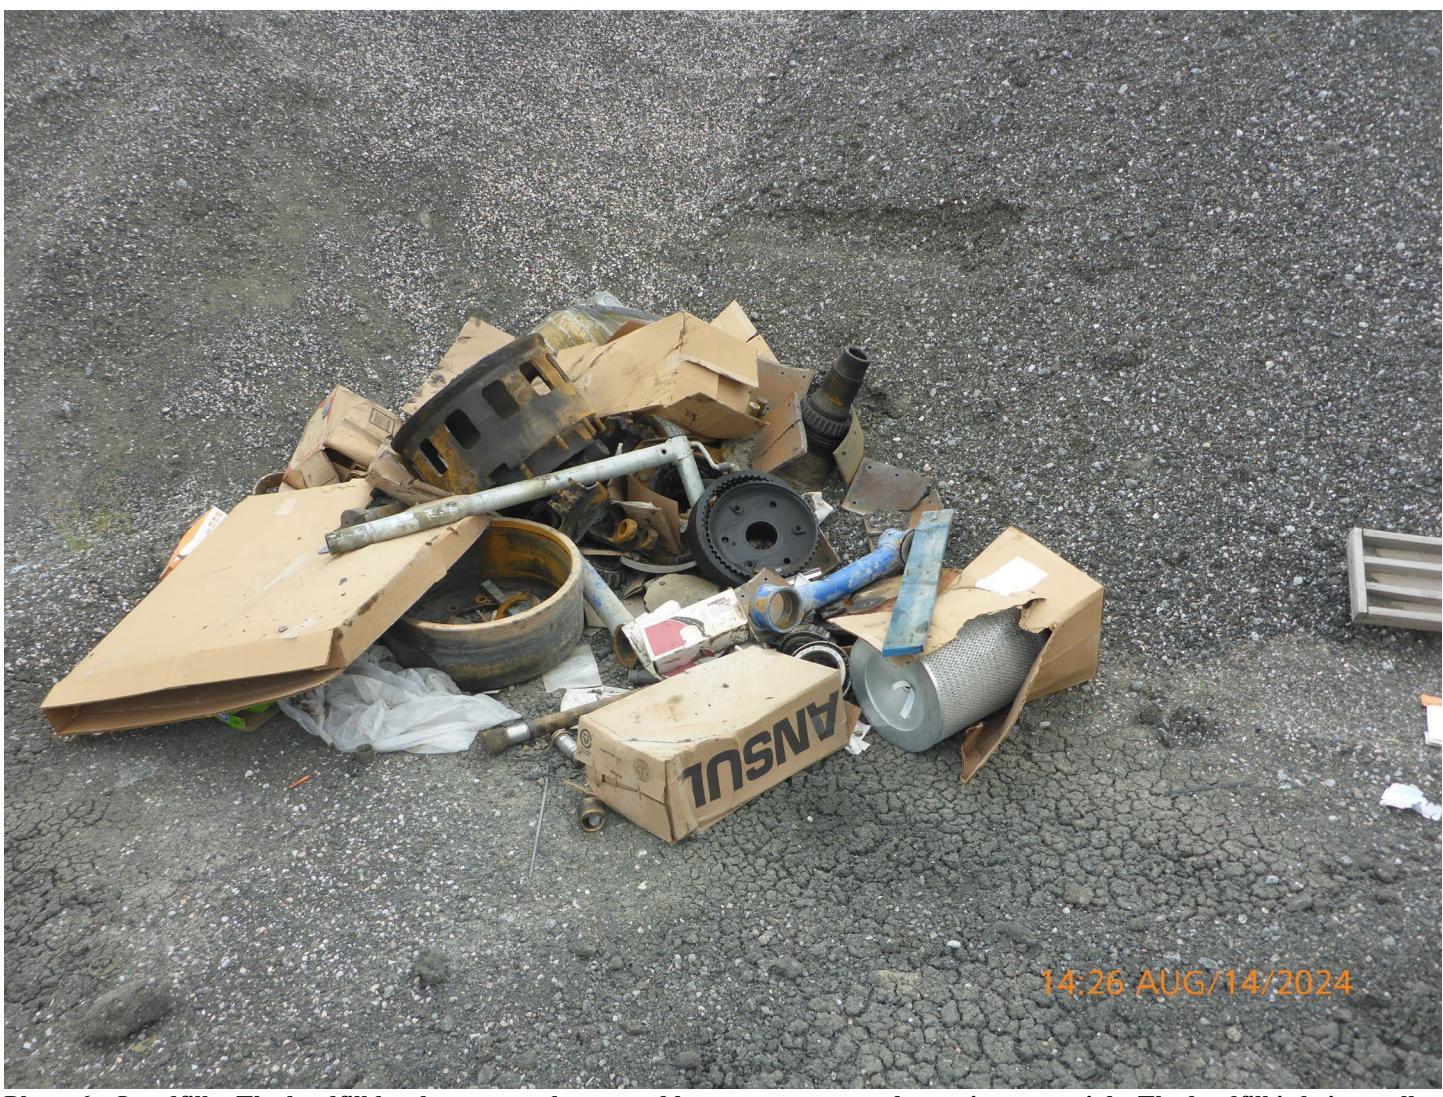
The Ekati Landfill is the designated disposal area for inert solid waste that is not incinerated or sent off site for recycling. The landfill receives wastes such as rubber, plastics, wood, and metal. The landfill had been recently covered with coarse processed Kimberlite and appeared to be well maintained with no indication of any misdirected waste (Photo 6). The burn bin was actively burning at the time and could not be inspected properly (Photo 7).

Photo 6 – Landfill – The landfill has been recently covered by coarse process plant reject materials. The landfill is being well maintained with no indication of misdirected waste.

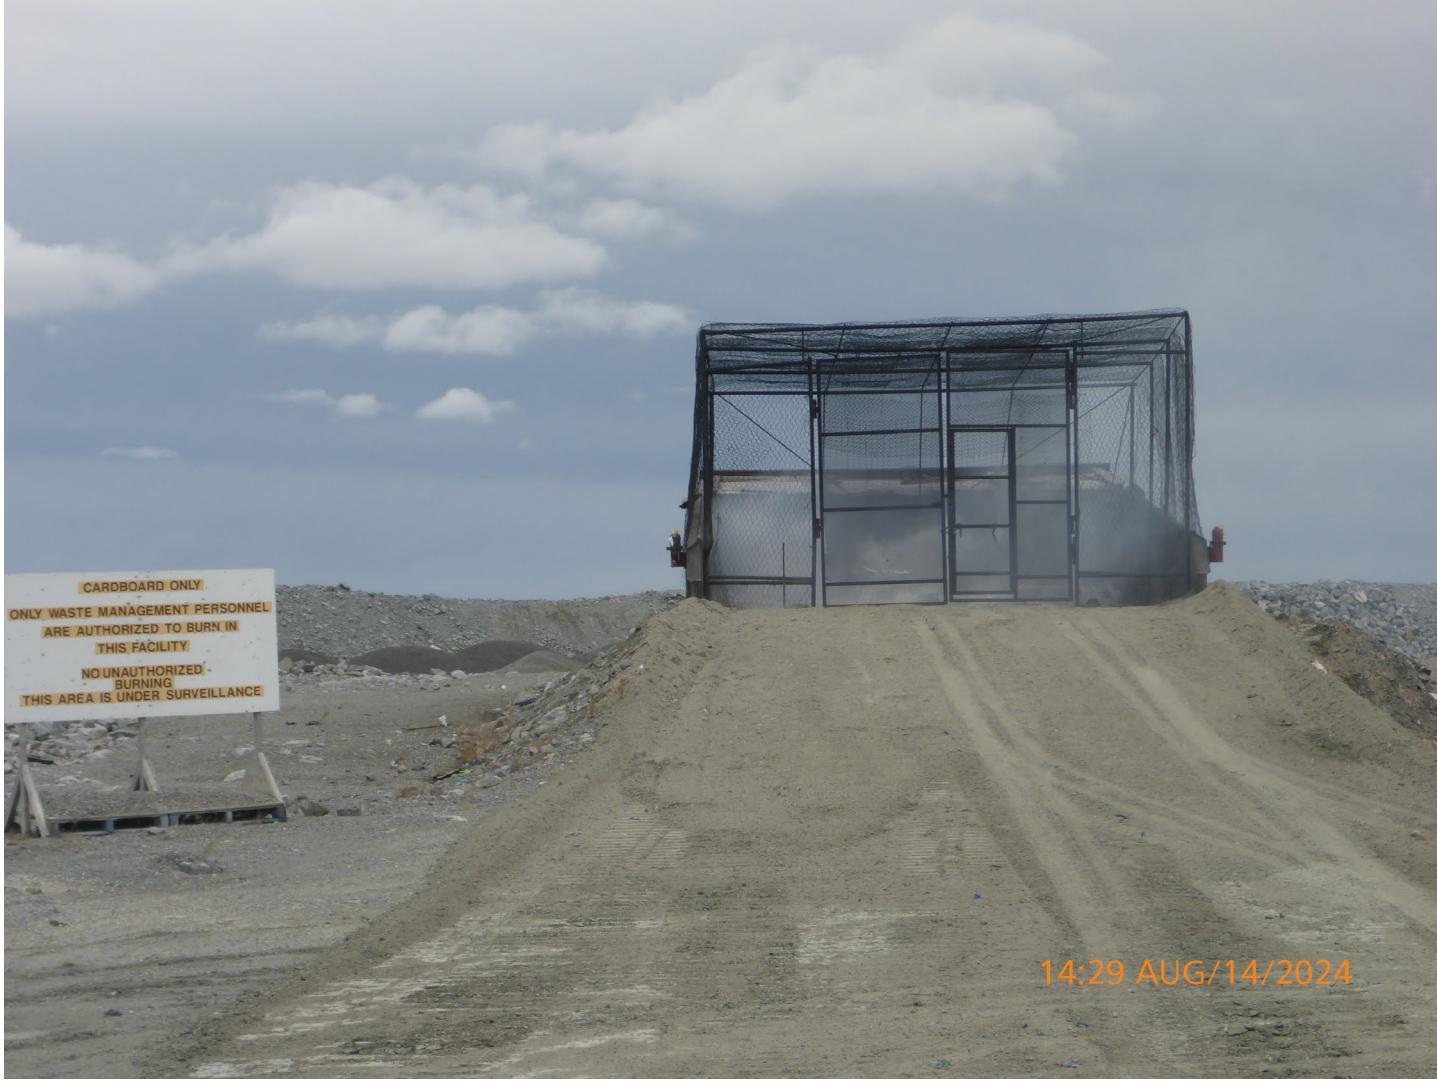
Photo 7 – Burn Bin – Combustible waste was being burned in the burn bin located at the landfill.

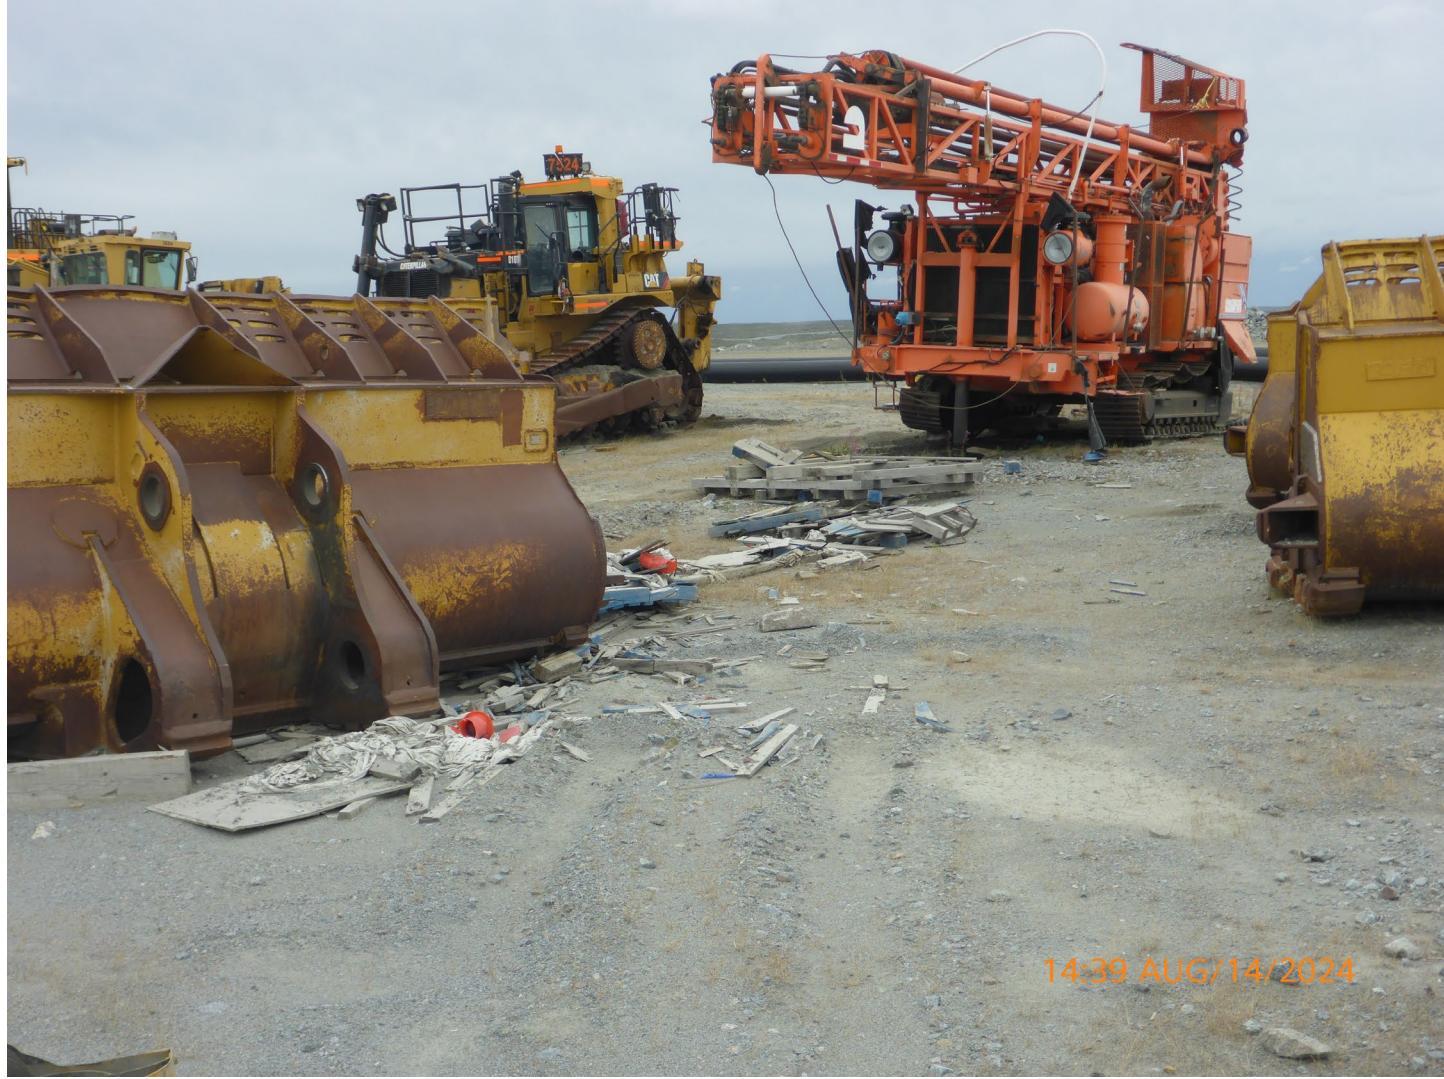
The "Boneyard" is the designated storage area for broken down equipment used for salvage parts. Some of the downed equipment has been removed and some significant clean-up has happened in this area; however, regular maintenance is required in this area as equipment continues to leave hydrocarbon staining on the ground. Much of the equipment has drip drays installed to contain leaks and drips. These drip trays should be checked and changed out as required (Photos 8 and 9).

Photo 8 – Heavy Equipment "Boneyard" – Broken pallets and debris are present in the boneyard. This is a housekeeping issue that needs to be addressed.

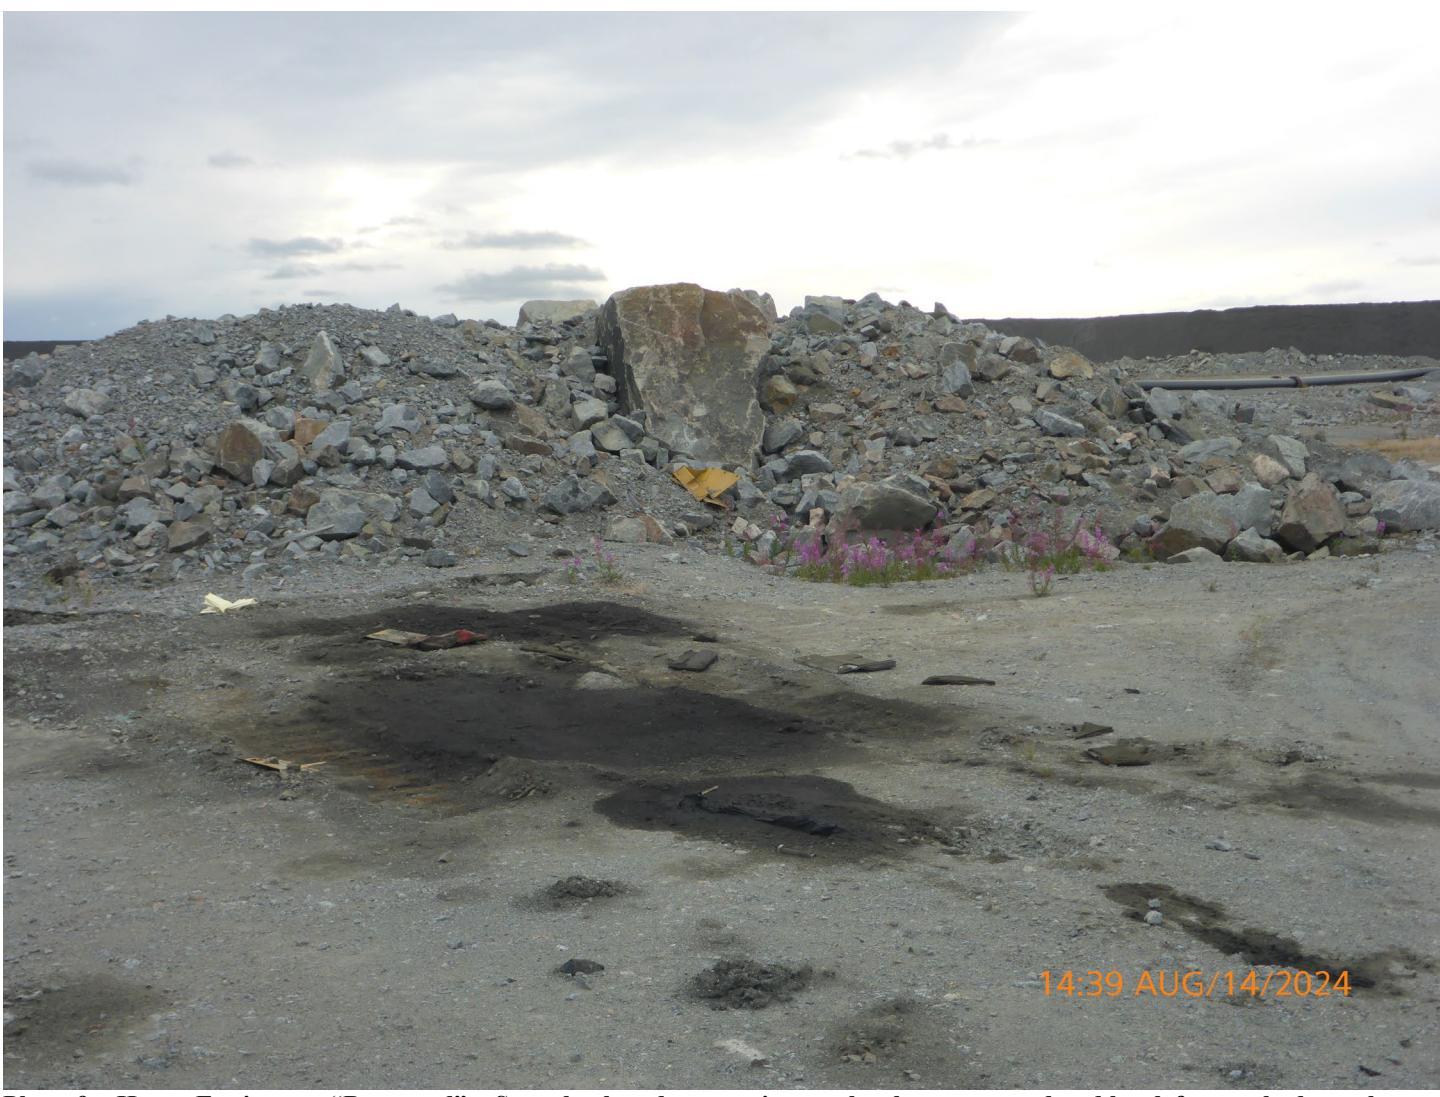
Photo 9 – Heavy Equipment "Boneyard" – Some broken down equipment has been removed and has left some hydrocarbon staining. This contaminated material needs to be cleaned up and disposed of as per the approved Waste Management Plan.

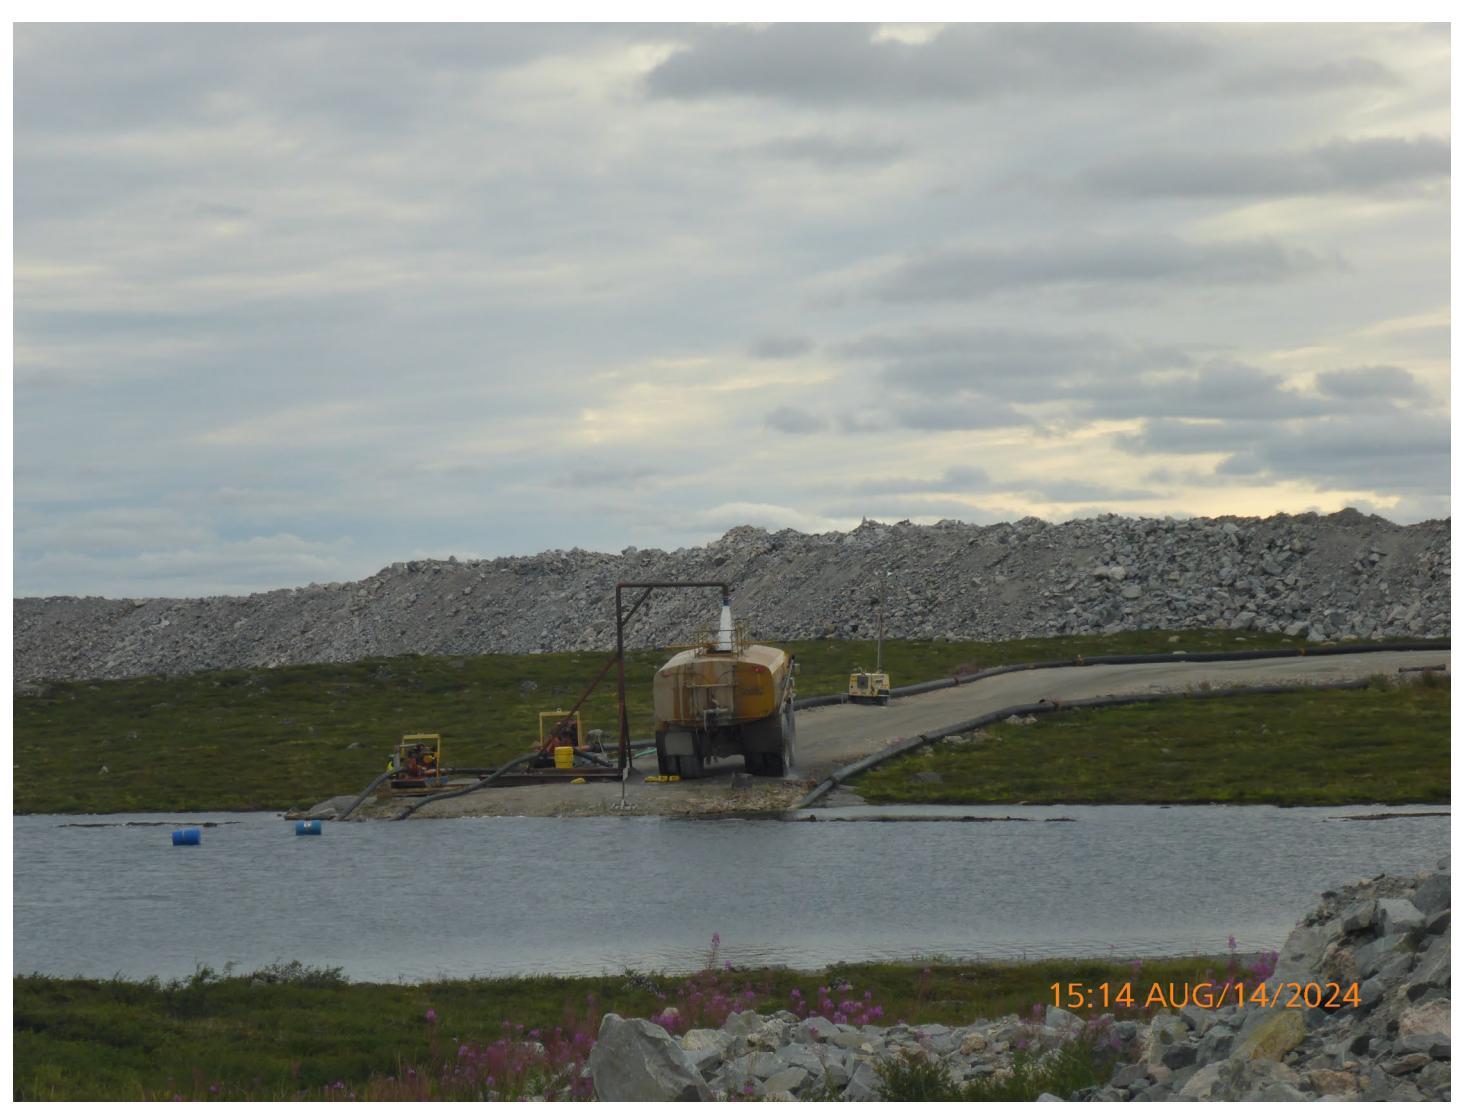
The Two Rock Sedimentation Pond has been pumped to target elevation for the season. Flowmeters have been pulled and are scheduled for calibration. Water from Two Rock was still being used for road watering dust suppression (Photo 10).

Photo 10 – Two Rock Settling Facility – Two Rock has been drawn down to target elevation. Photo shows a water truck being filled for road watering dust suppression.

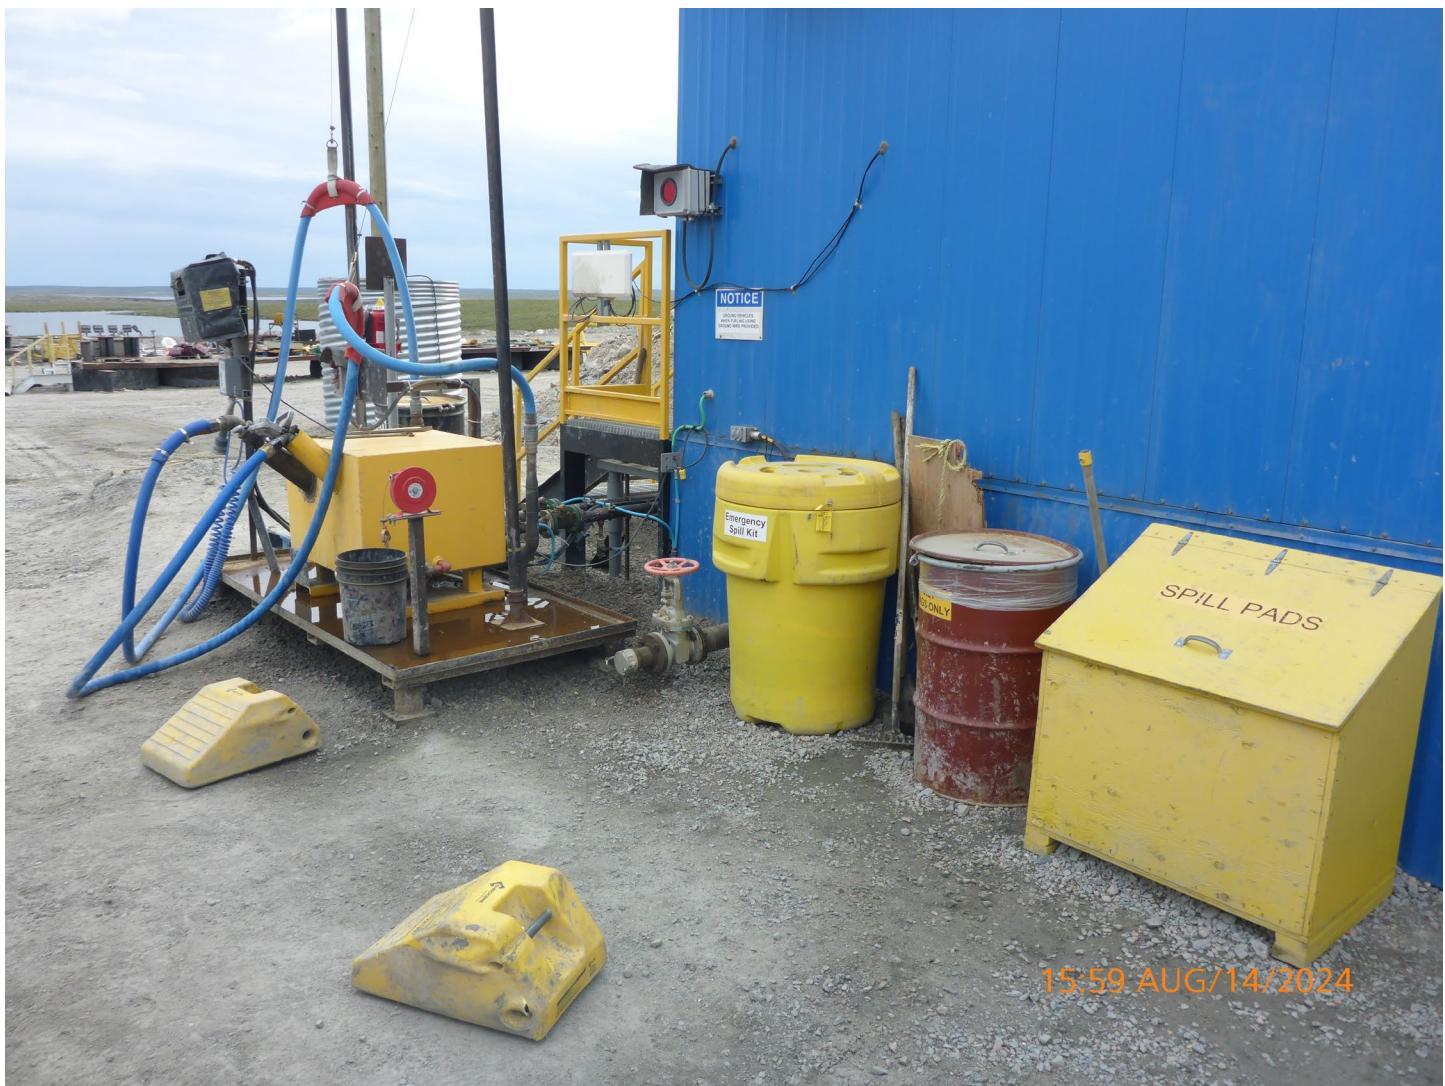
The Sable refuelling area was clean and well maintained with no indication of any hydrocarbon leaks or spills. Spill response equipment was fully stocked and easily accessible (Photo 11).

Photo 11 – Sable Refuelling Station – The Sable Refuelling Station was clean and well maintained with no indication of any leaks or spills.

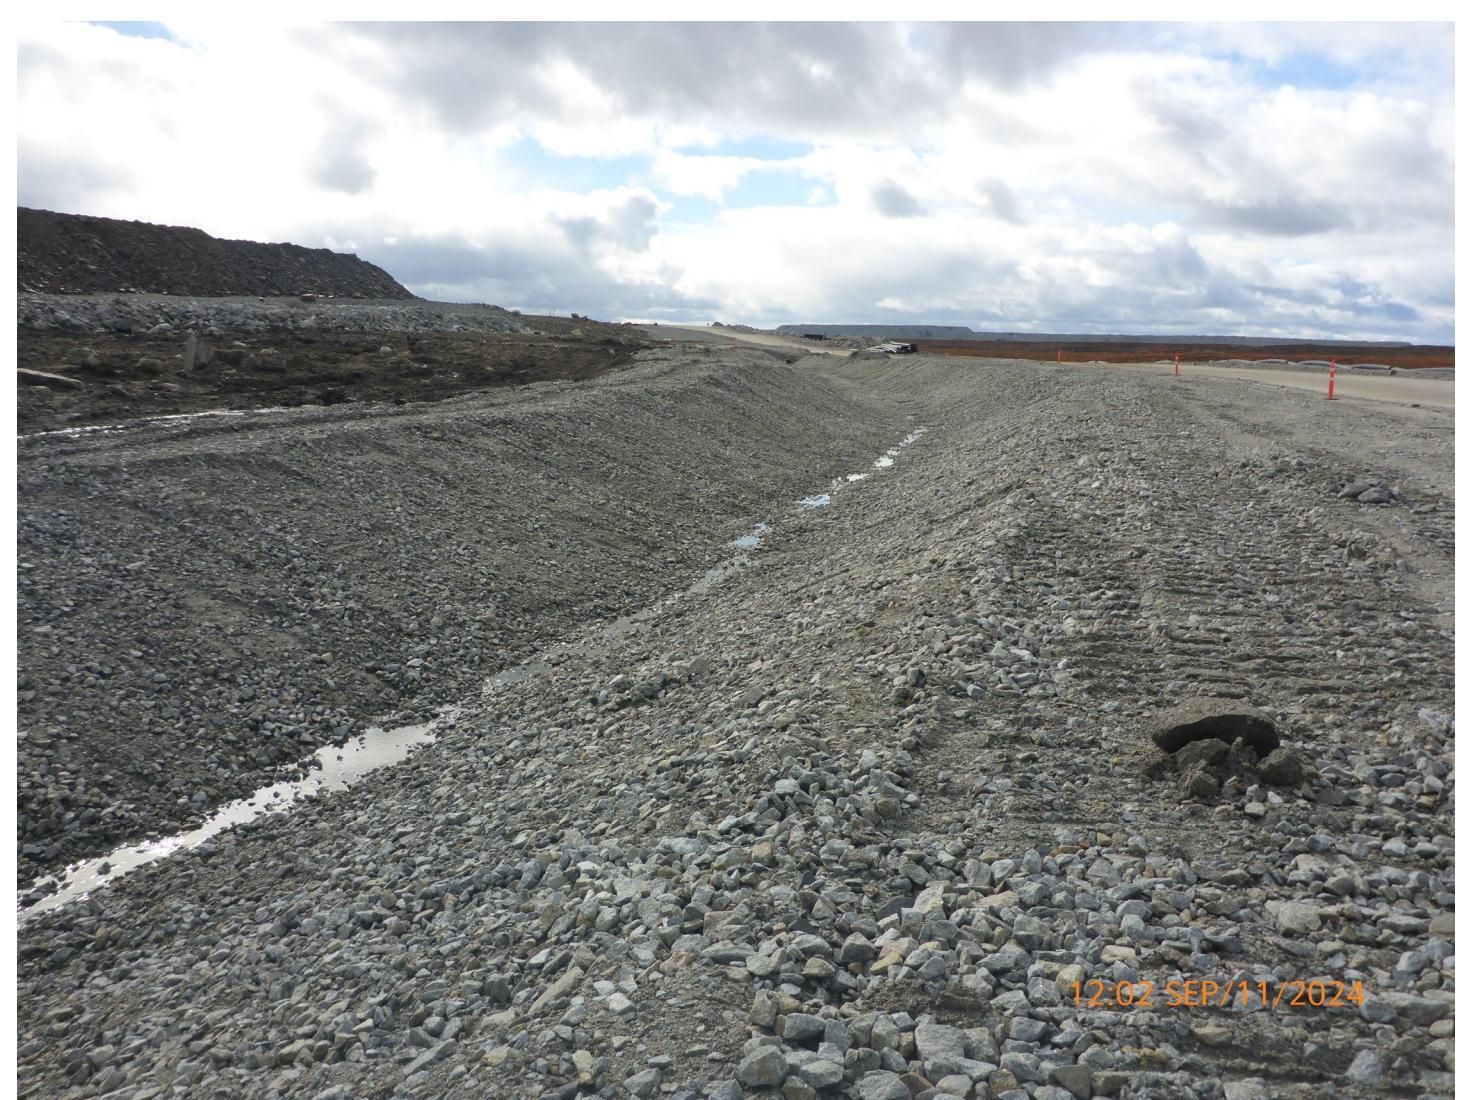
Point Lake construction is well underway. A perimeter ditch is being constructed around the waste rock pile to catch any problematic runoff that may occur. The ditch is lined to prevent seepage. Any runoff will be collected and pumped into the King Pond Settling Facility. Waste bins were properly labelled and had no misdirected waste. Parked equipment had drip trays deployed to catch any potential leaks or drips (Photos 12 through 16).

Photo 12 – Point Lake Waste Rock – A perimeter ditch is being constructed to catch any runoff that may cause water quality concerns.

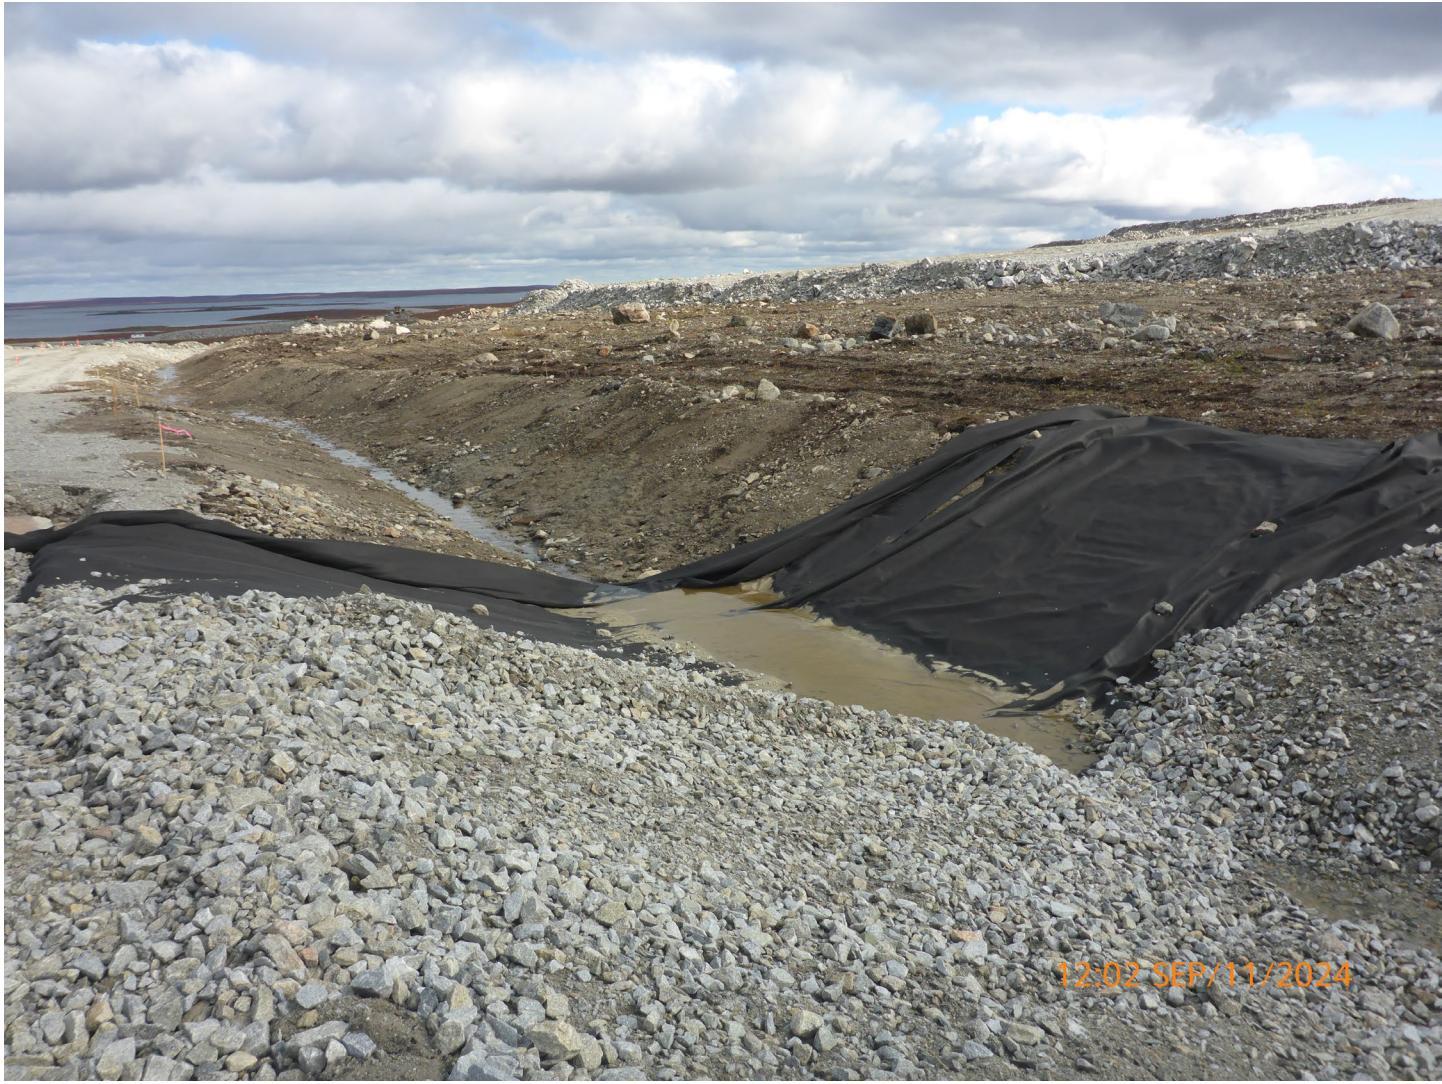
Photo 13 – Point Lake Construction – The perimeter ditch is lined and graded to catch runoff.
