GNWT ECC - North Slave Region

Re: August and September 2024 Water Licence Inspection

INDUSTRIAL WATER USE INSPECTION REPORT

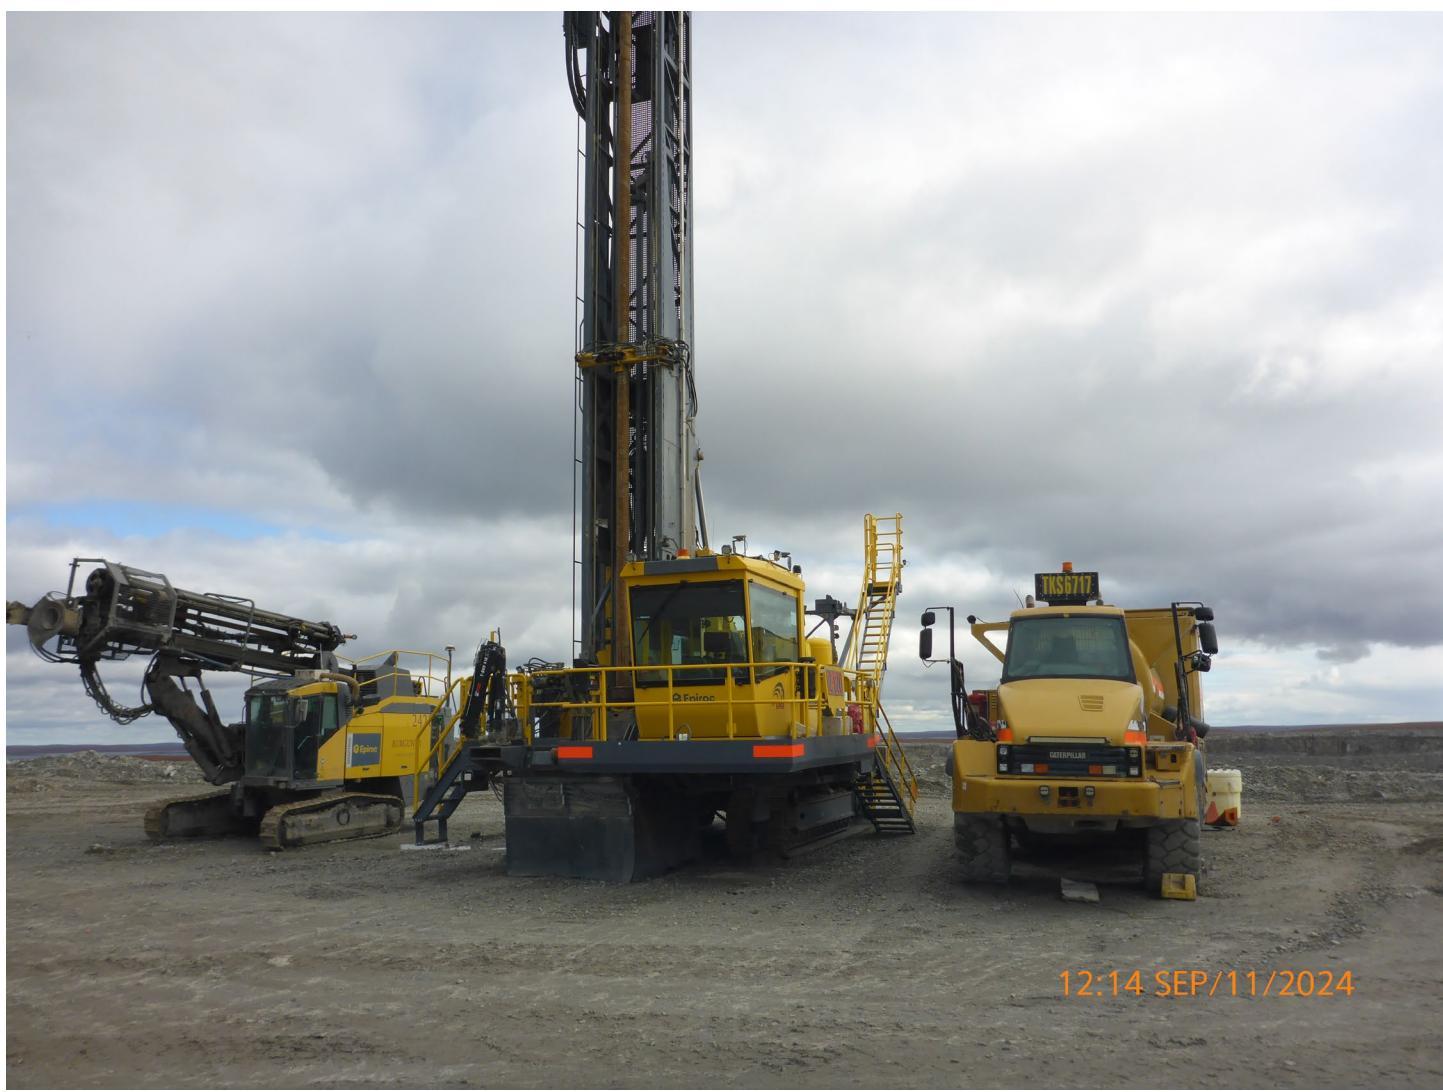
Photo 14 – Point Lake Construction – Equipment parked over spill pads to catch any leaks or drips.

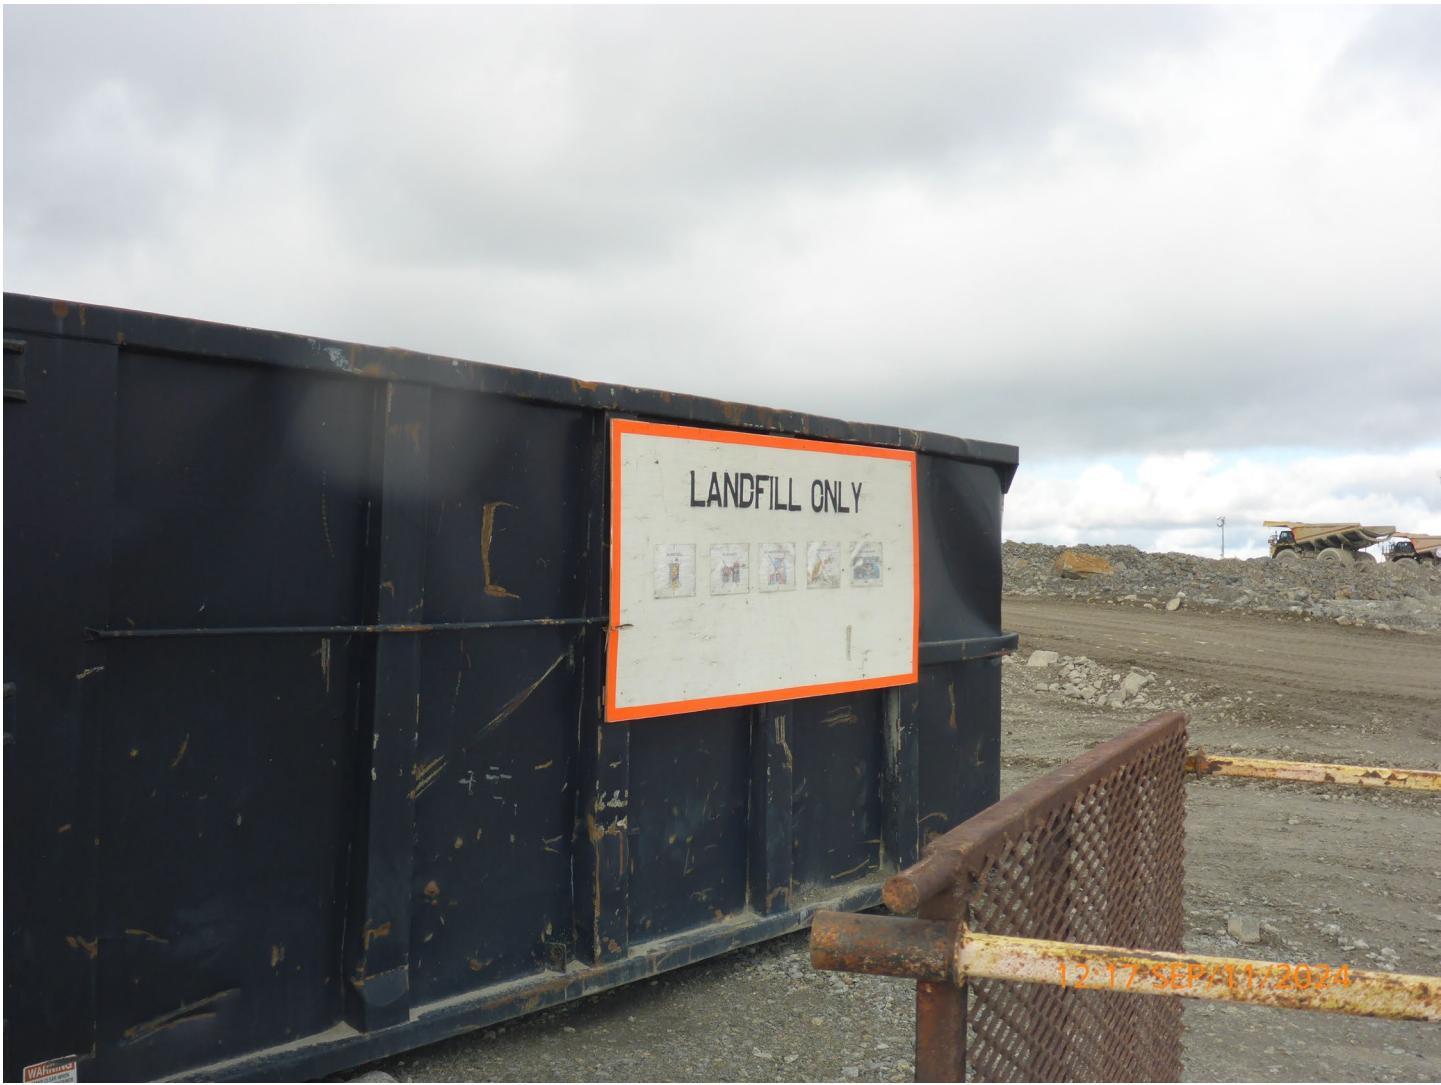
Photo 15 – Point Lake Construction – Waste bins are placed at the work site and are properly labelled.

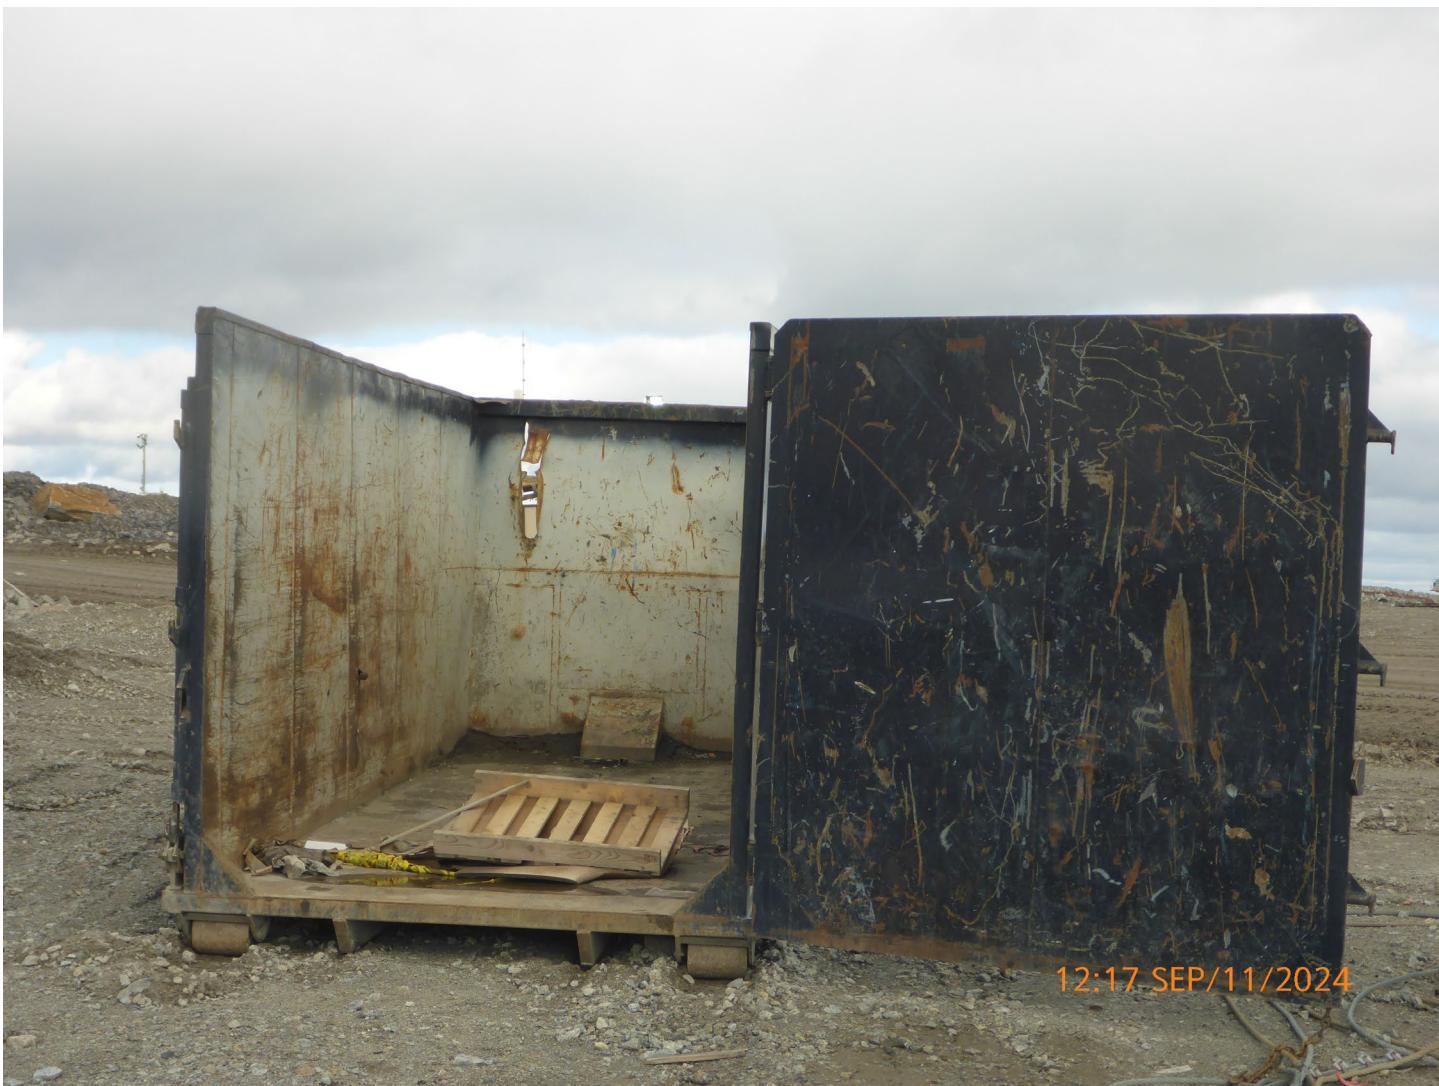
Photo 16 – Point Lake Construction – Waste Bins are well maintained and show no indication of misdirected waste.

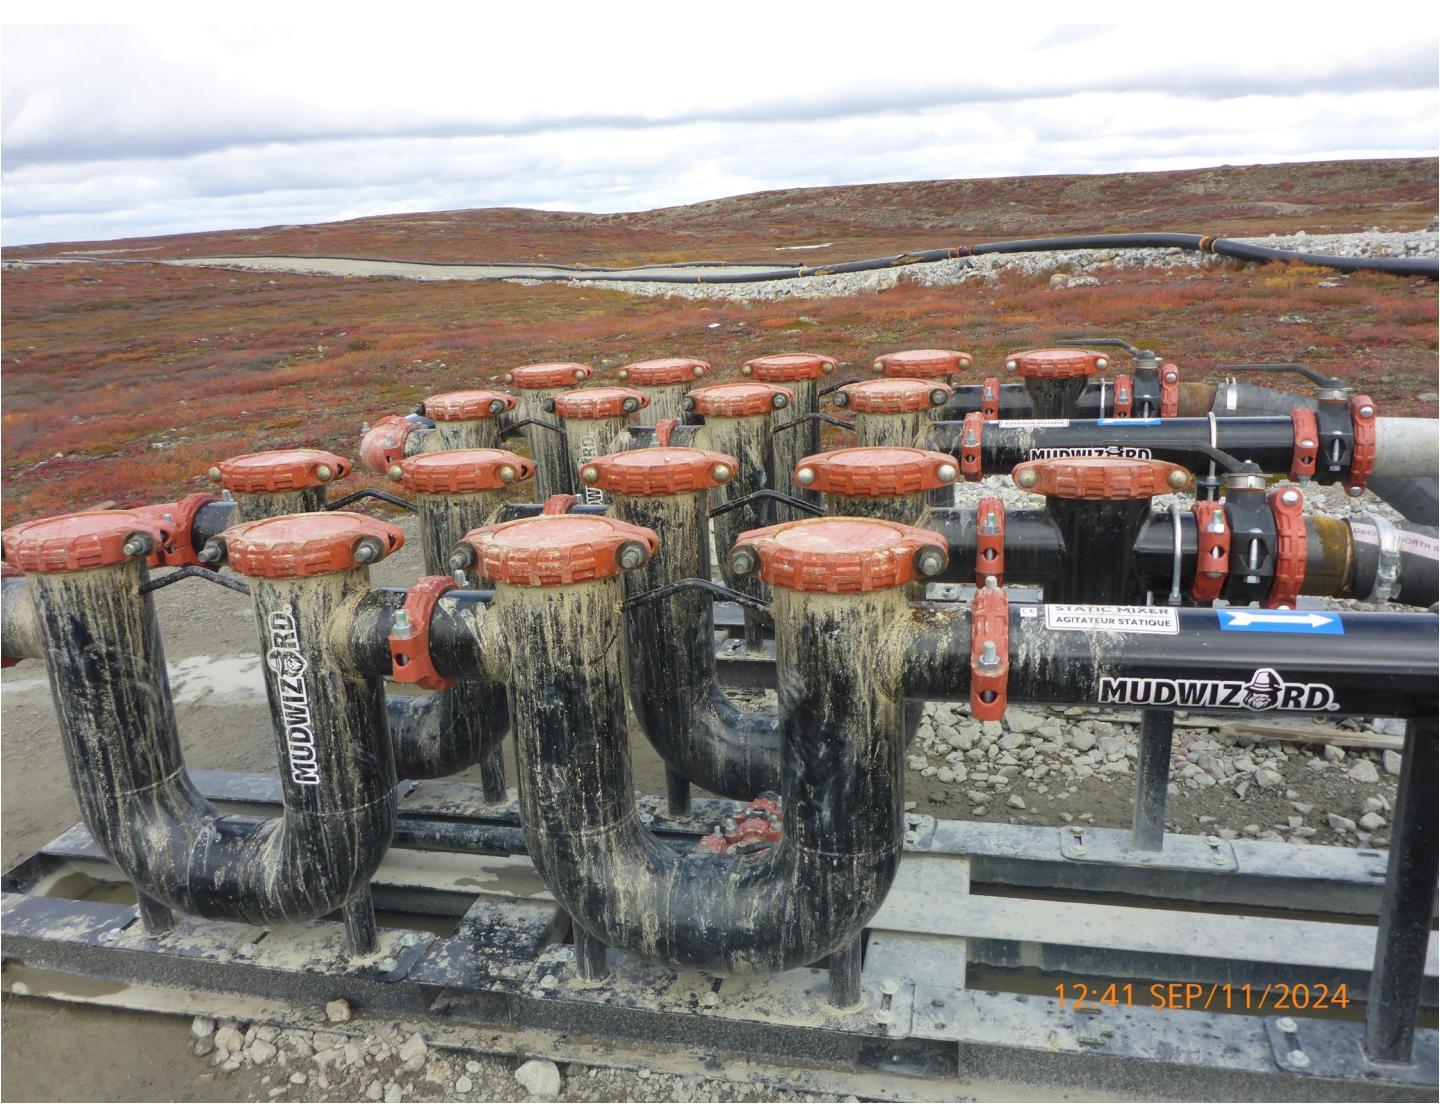
The KPSF has been pumped to the target elevation for the year. The Inspector verified that the pipe insulation and debris has been cleaned up, and the area is clean and well maintained. Arctic has installed a Mud Wizard to help reduce TSS within King Pond resulting from sediments being disturbed from Point Lake dewatering (Photos 17 and 18).

Photo 17 – King Pont Settling Facility – A mud wizard is used to settle out TSS within King Pond that has been disturbed from the addition of water from Point Lake dewatering.

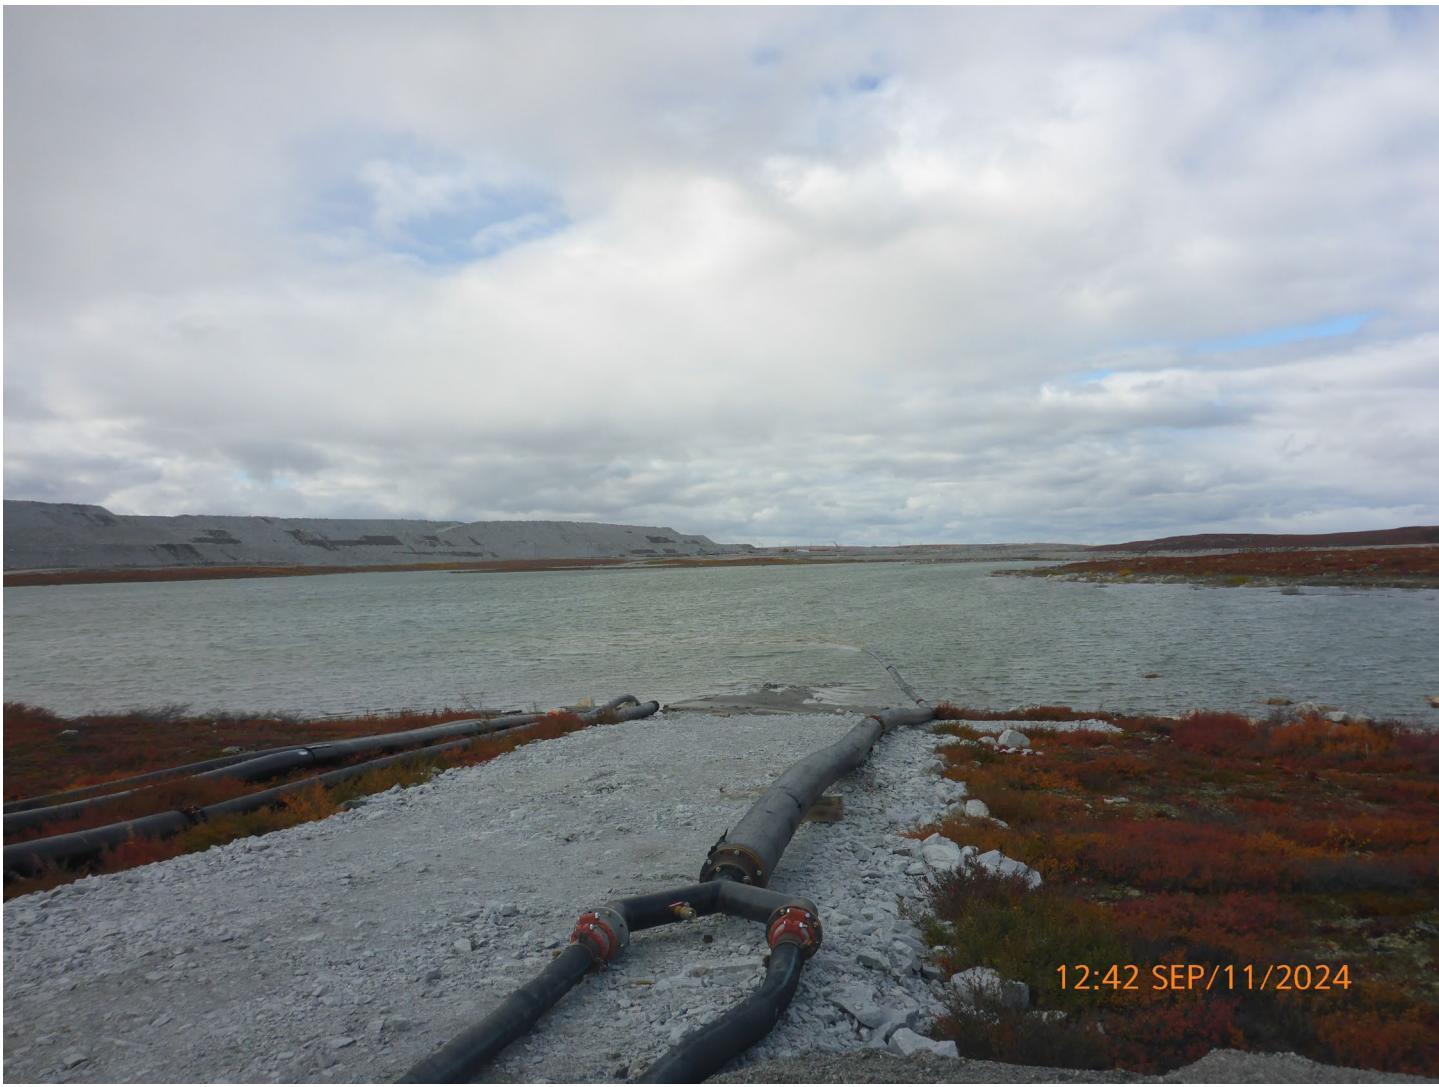
Photo 18 – King Pond Settling Facility – Kind Pond has been drawn down to the target elevation. Photo shows the outlet from Point Lake to King Pond.

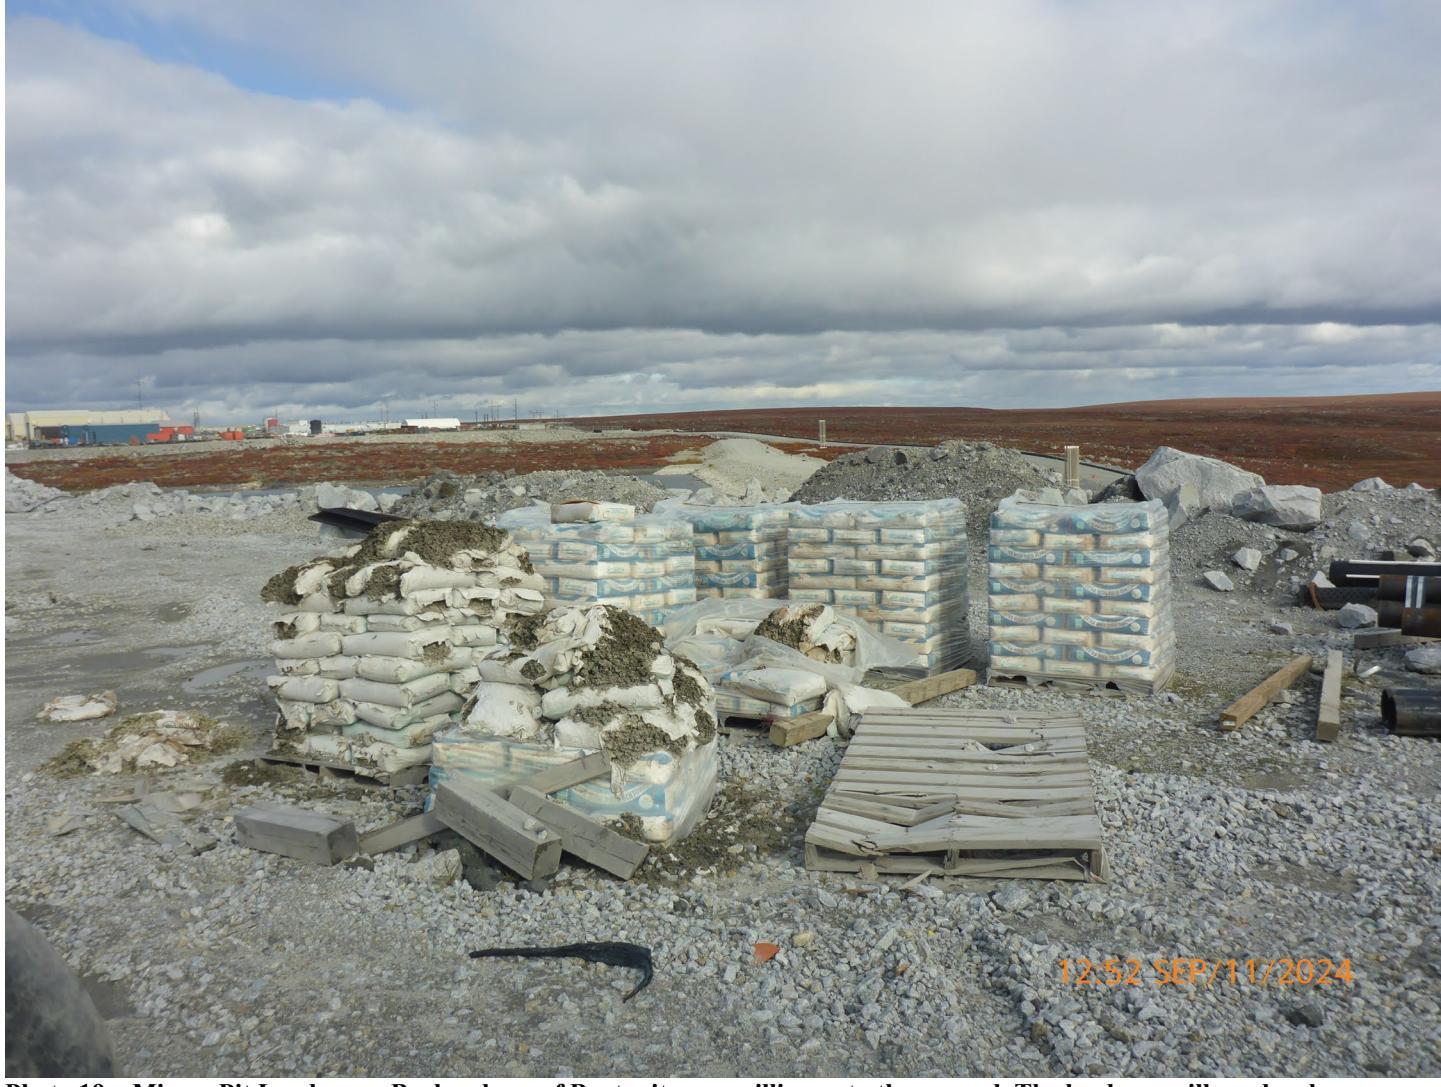
The Misery laydown requires a general clean-up as there are broken pallets and bags of bentonite spilling onto the ground. The inspection did not note any hydrocarbons or hazardous materials being stored in the laydown (Photo 19).

Photo 19 – Misery Pit Laydown – Broken bags of Bentonite are spilling onto the ground. The laydown will need a clean-up.

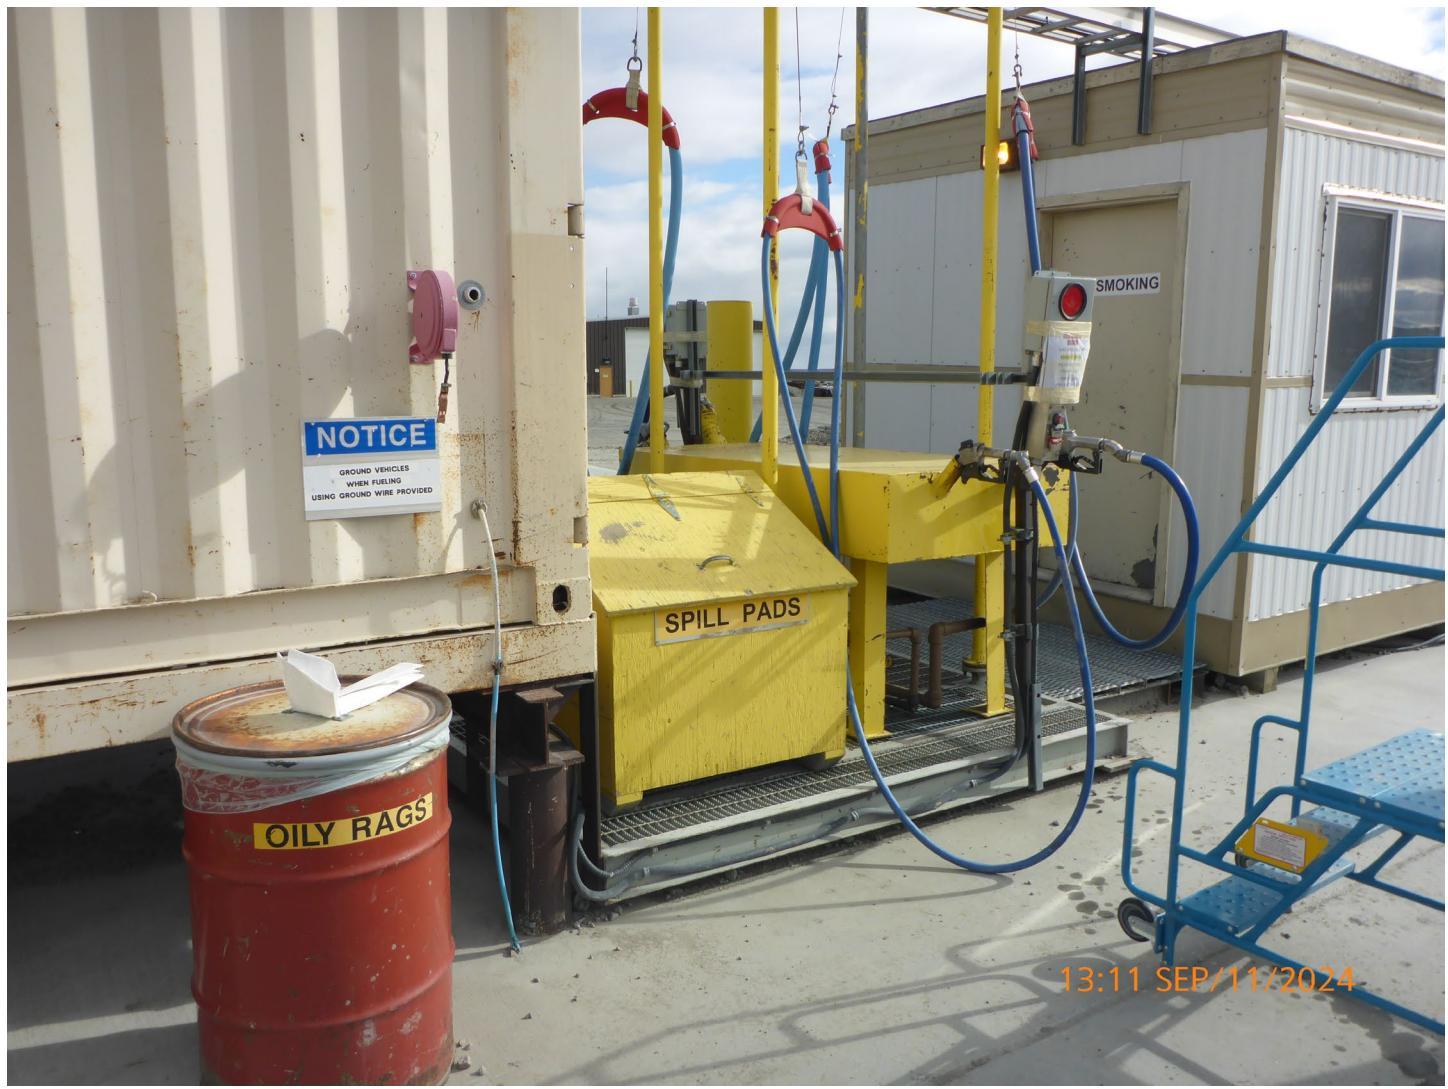
The Misery refuelling area was clean and well maintained with no indication of any hydrocarbon leaks or spills. Spill response equipment was fully stocked and easily accessible. The containment sump at the refuelling area was full of water. This needs to be pumped out to ensure spill containment capacity. The tank farm itself had a small amount of water accumulated inside but still has plenty of capacity. Accumulated water is an indicator that the liner is still competent and capable of containing a major spill (Photos 20 through 22).

Photo 20 – Misery Refuelling Station – The Misery Refuelling Station was clean and well maintained with no indication of any leaks or spills.

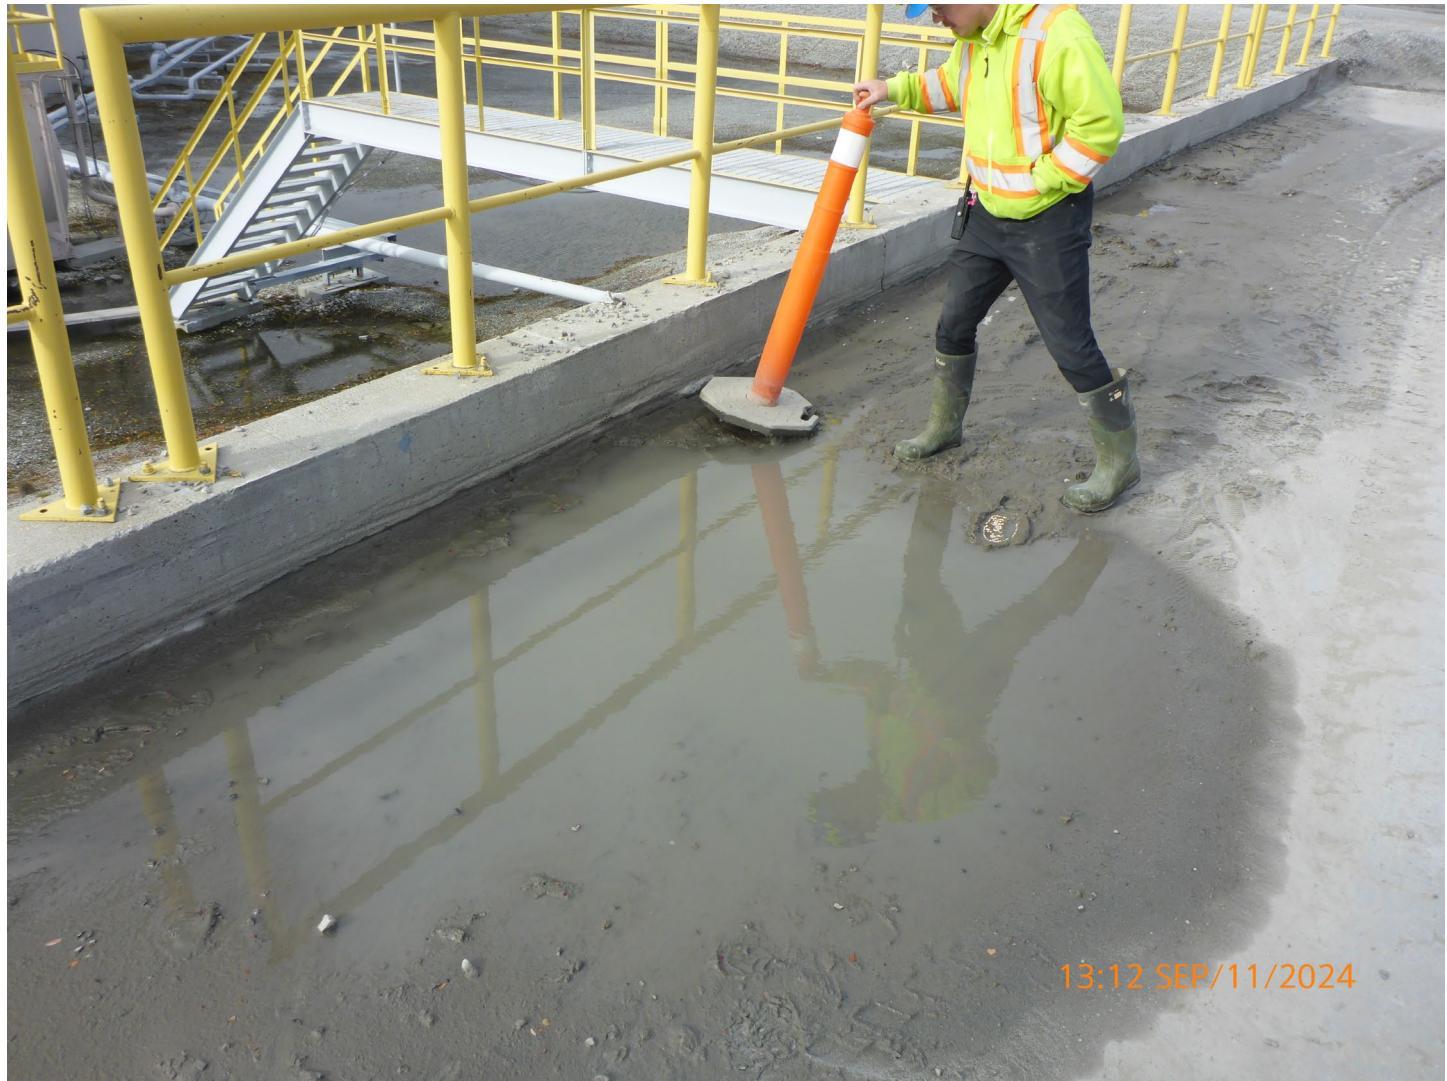
Photo 21 – Misery Refuelling Station – The containment sump at the Misery Refuelling Station was full of water. This containment will need to be pumped out to ensure emergency spill containment.

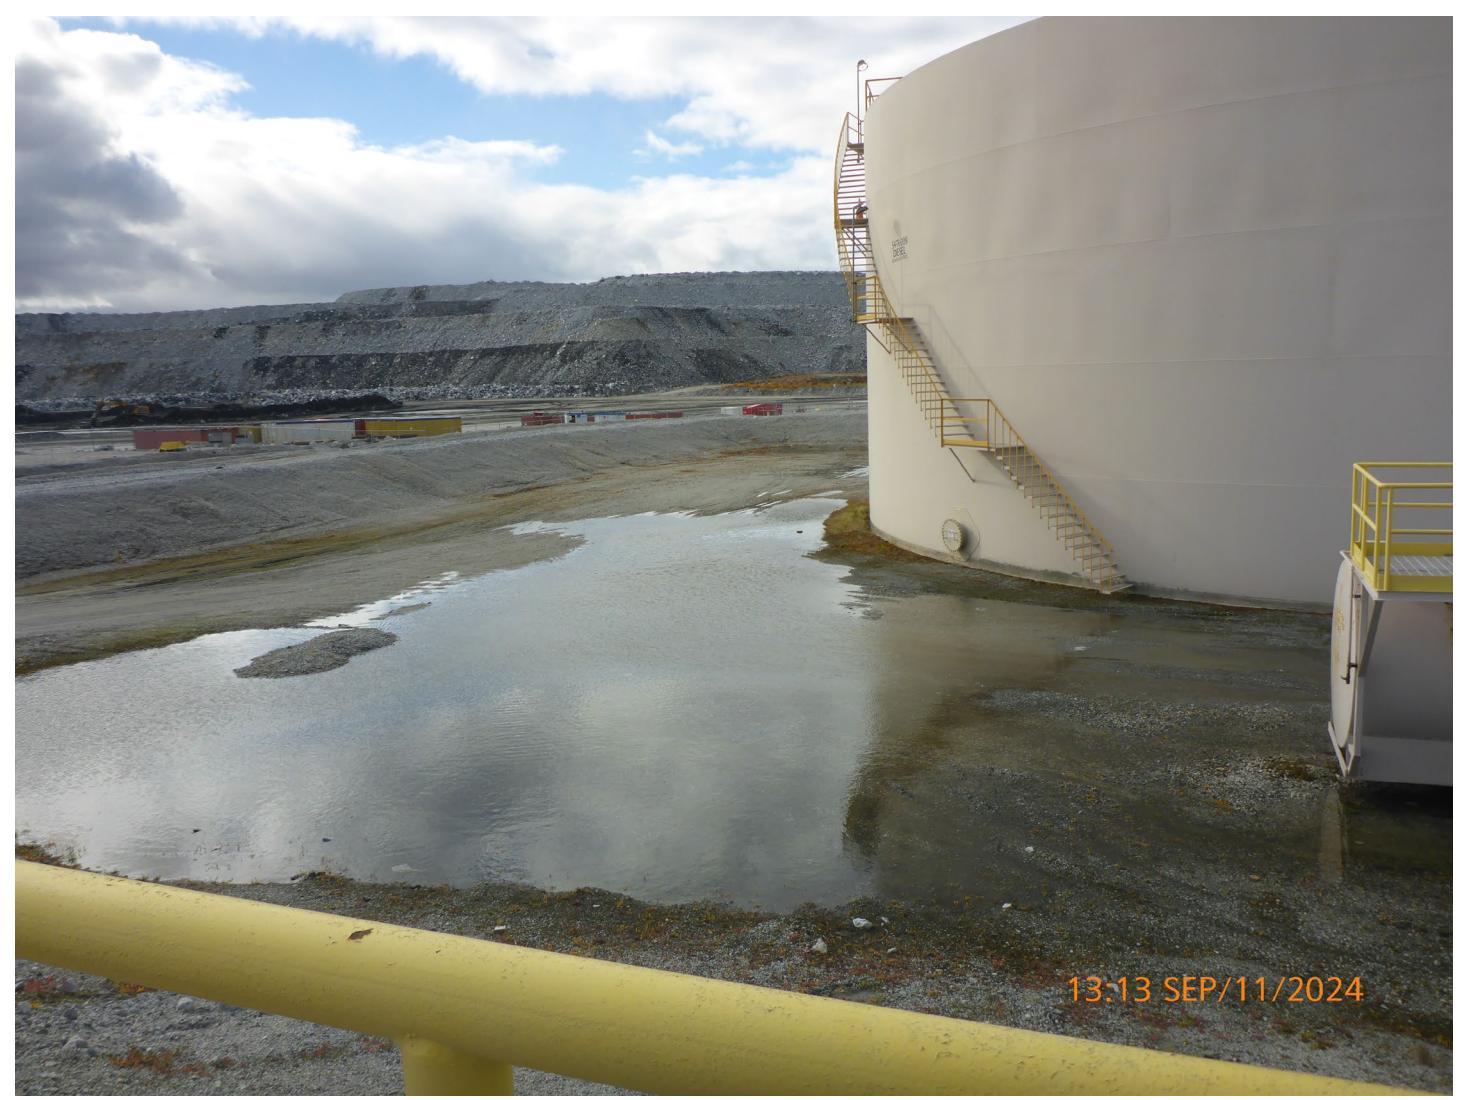
Photo 22 – Misery Tank Farm – Misery Tank Farm has a small amount water accumulated from a recent rainfall. The accumulated water shows the lined containment is competent and will contain a spill.

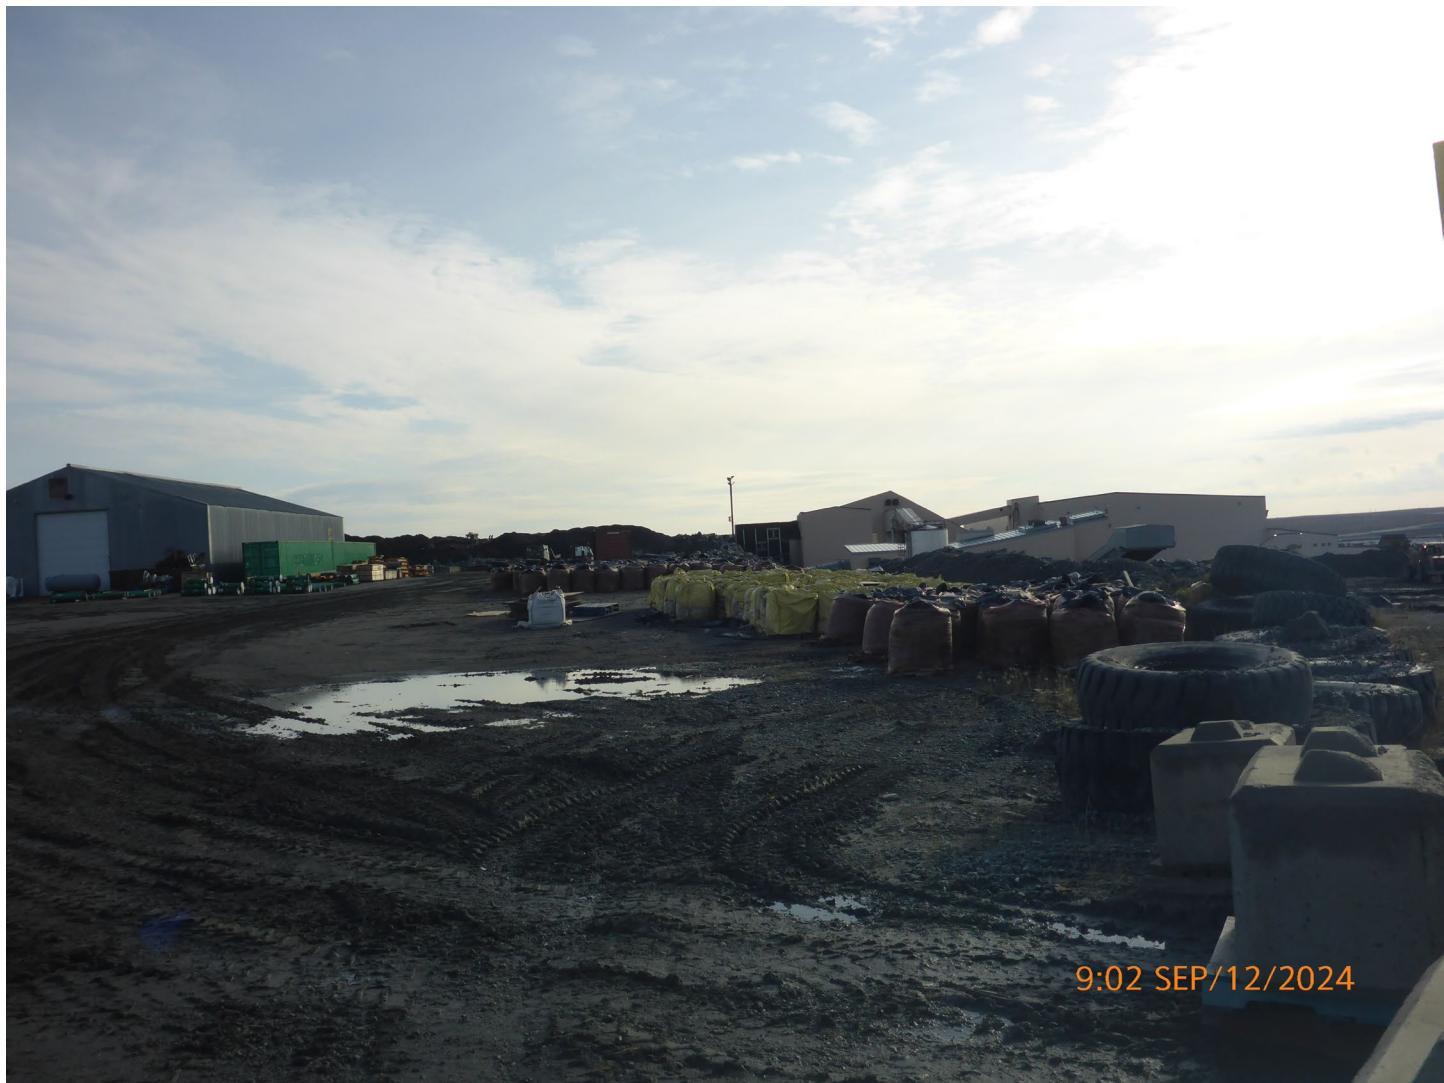
The Process Plant laydown requires a general clean-up as there are broken pallets and bags of floc and other reagents spilling onto the ground. The inspection did not note any hydrocarbons or hazardous materials being stored in the laydown (Photos 23 and 24).

Photo 23 – Process Plant Laydown – Process plant laydown is used to store process plant reagents used in diamond processing. The laydown had several broken bags and small spills. The area will need a clean-up.

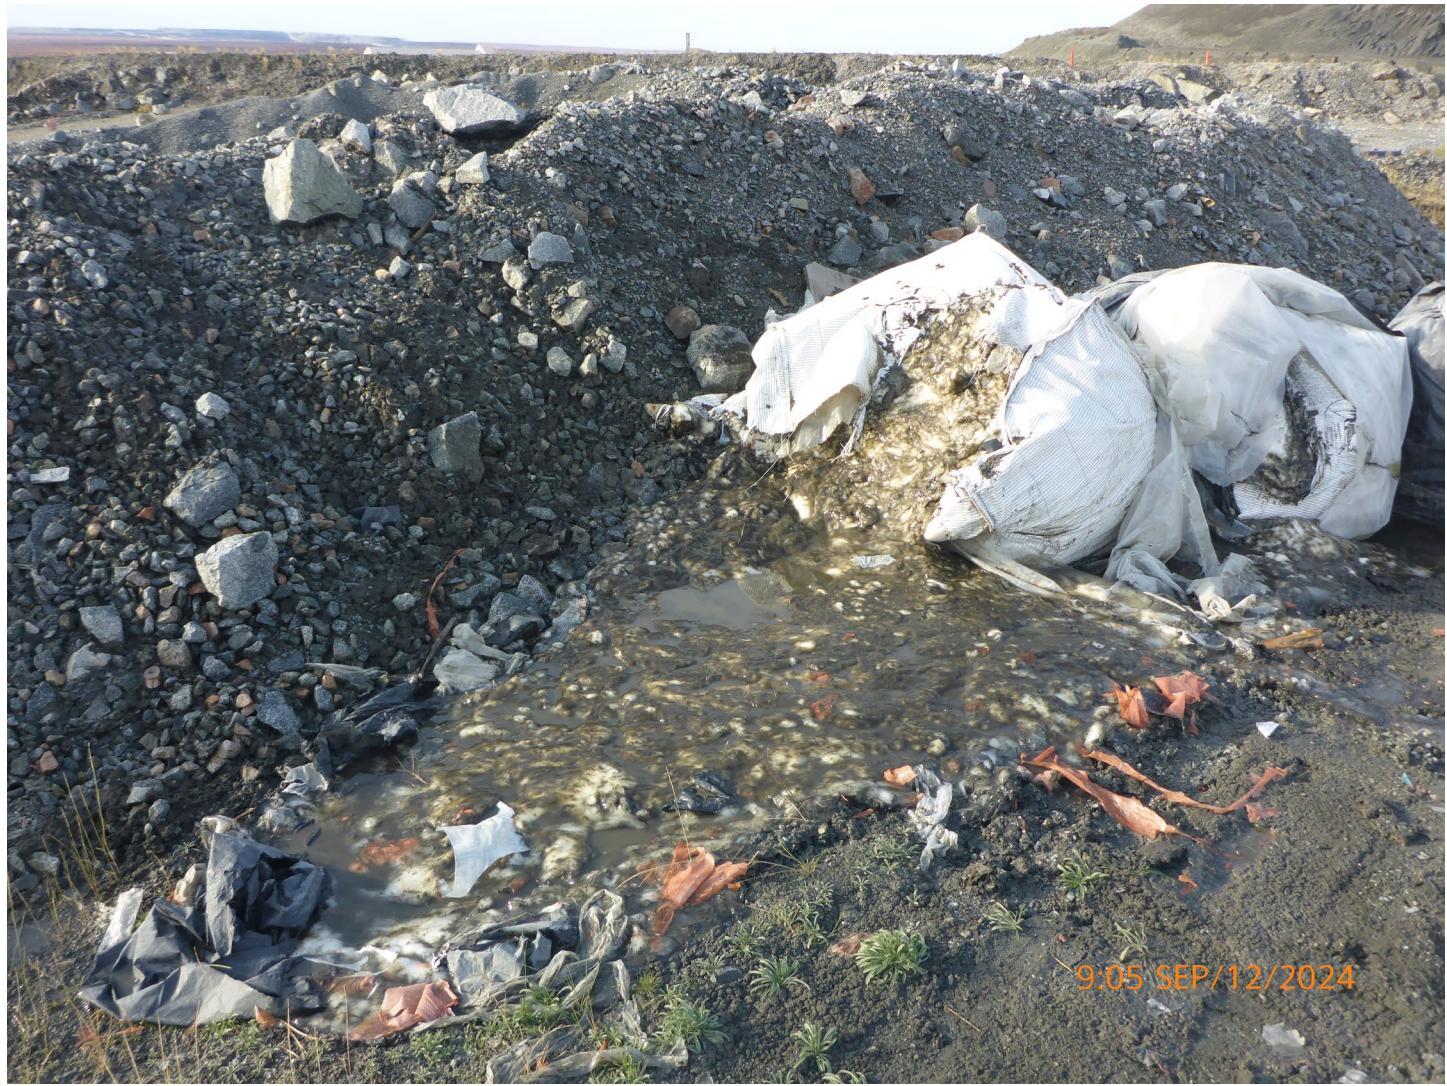
Photo 24 – Process Plant Laydown – Broken bags of flocculant on the ground require clean-up.

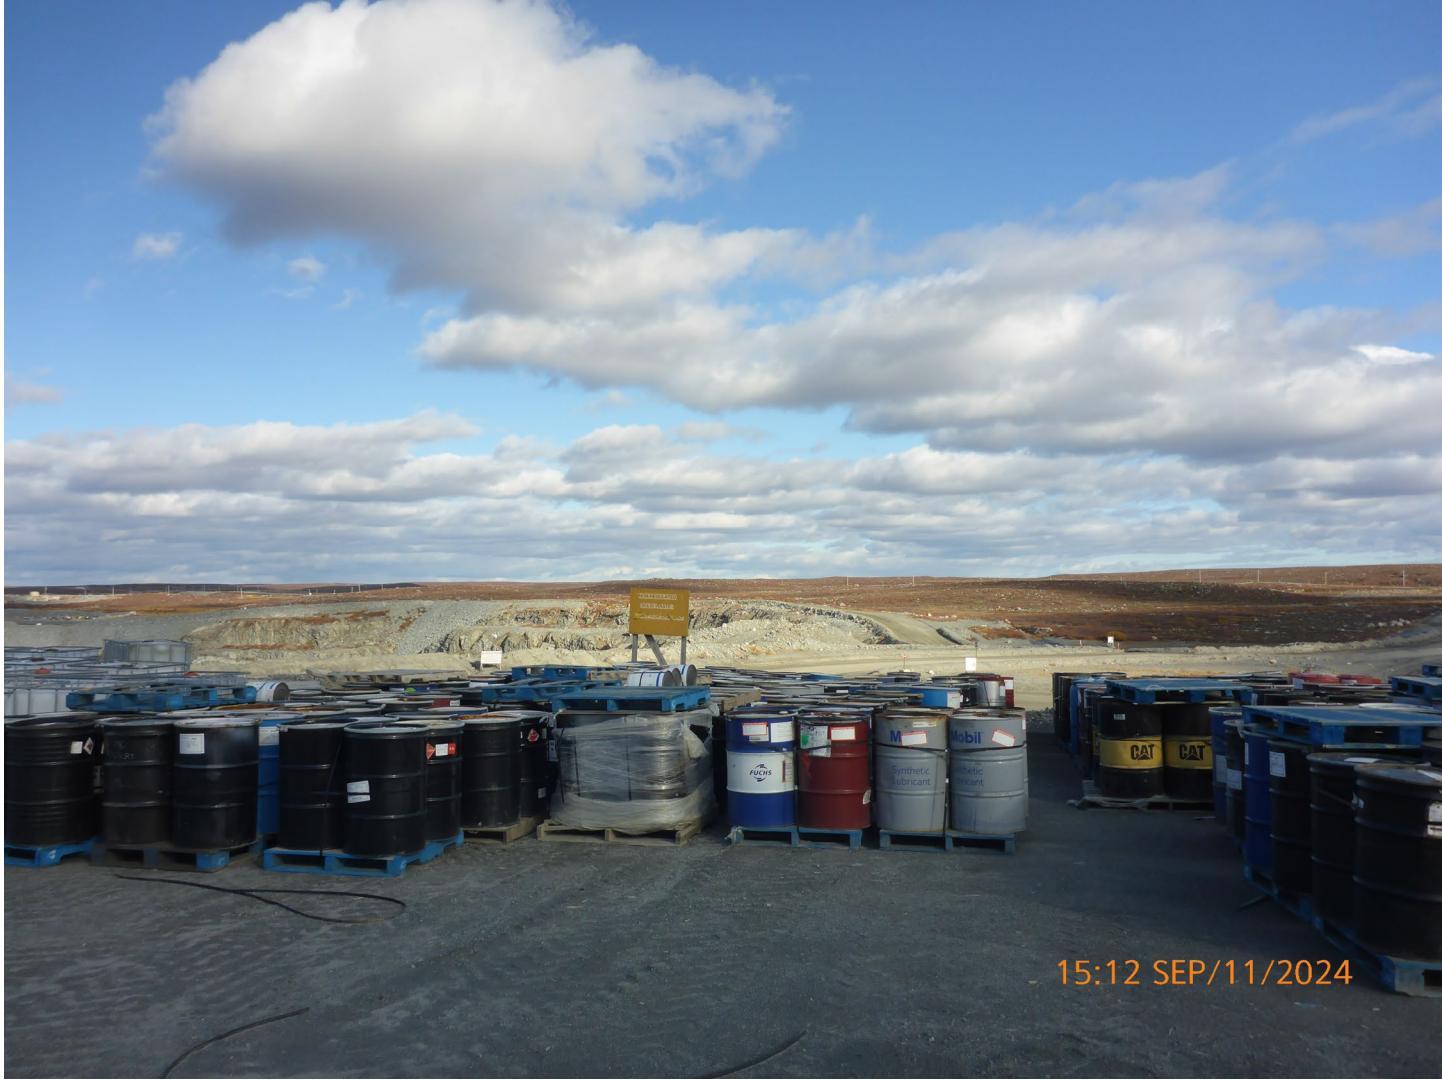
The Waste Management Yard was clean and well organized. Waste materials are staged in labelled containers for eventual shipment off site to and approved facility for final disposal. The Waste management Building was clean and well maintained. The building is used to collect and sort waste materials in preparation for shipment off site. Waste products such as plastic and drums are crushed or shredded to reduce landfill volume and to make shipment off site more cost effective (Photos 25 through 28).

Photo 25 – Waste Management Yard – The Waste Management Yard was clean and well organized with no indication of leaks, spills, or misdirected waste.

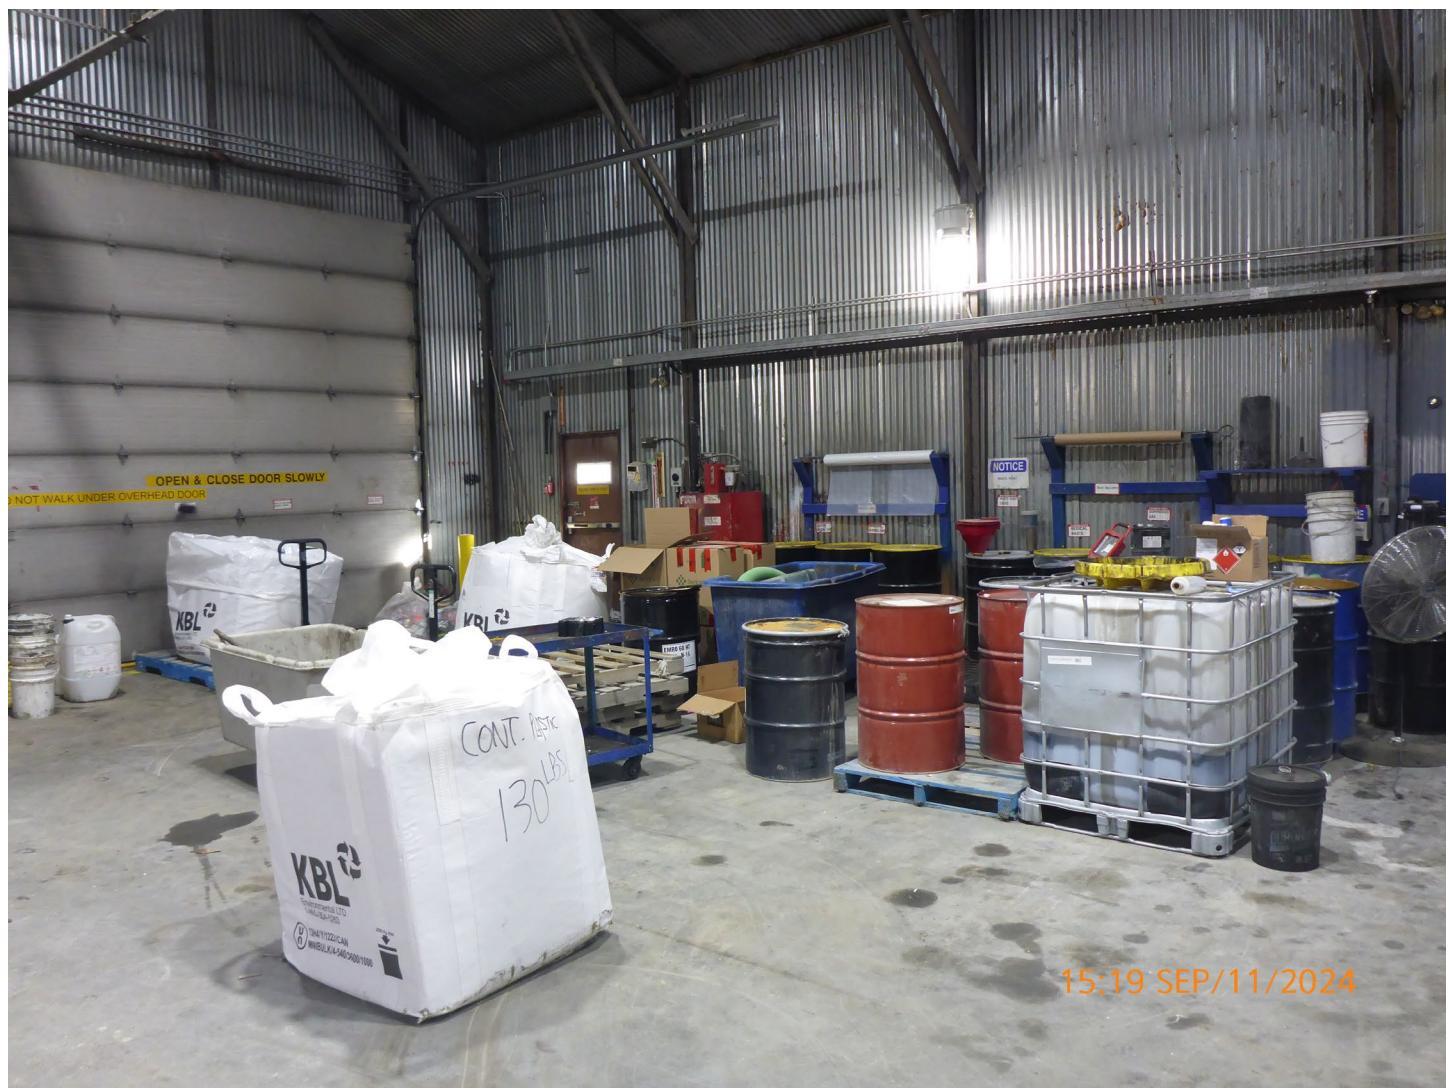
Photo 26 – Waste Management Building – The Waste Management Building was clean and well organized. Waste products not suitable for disposal on site are sent off site for final disposal or recycling at an approved facility.

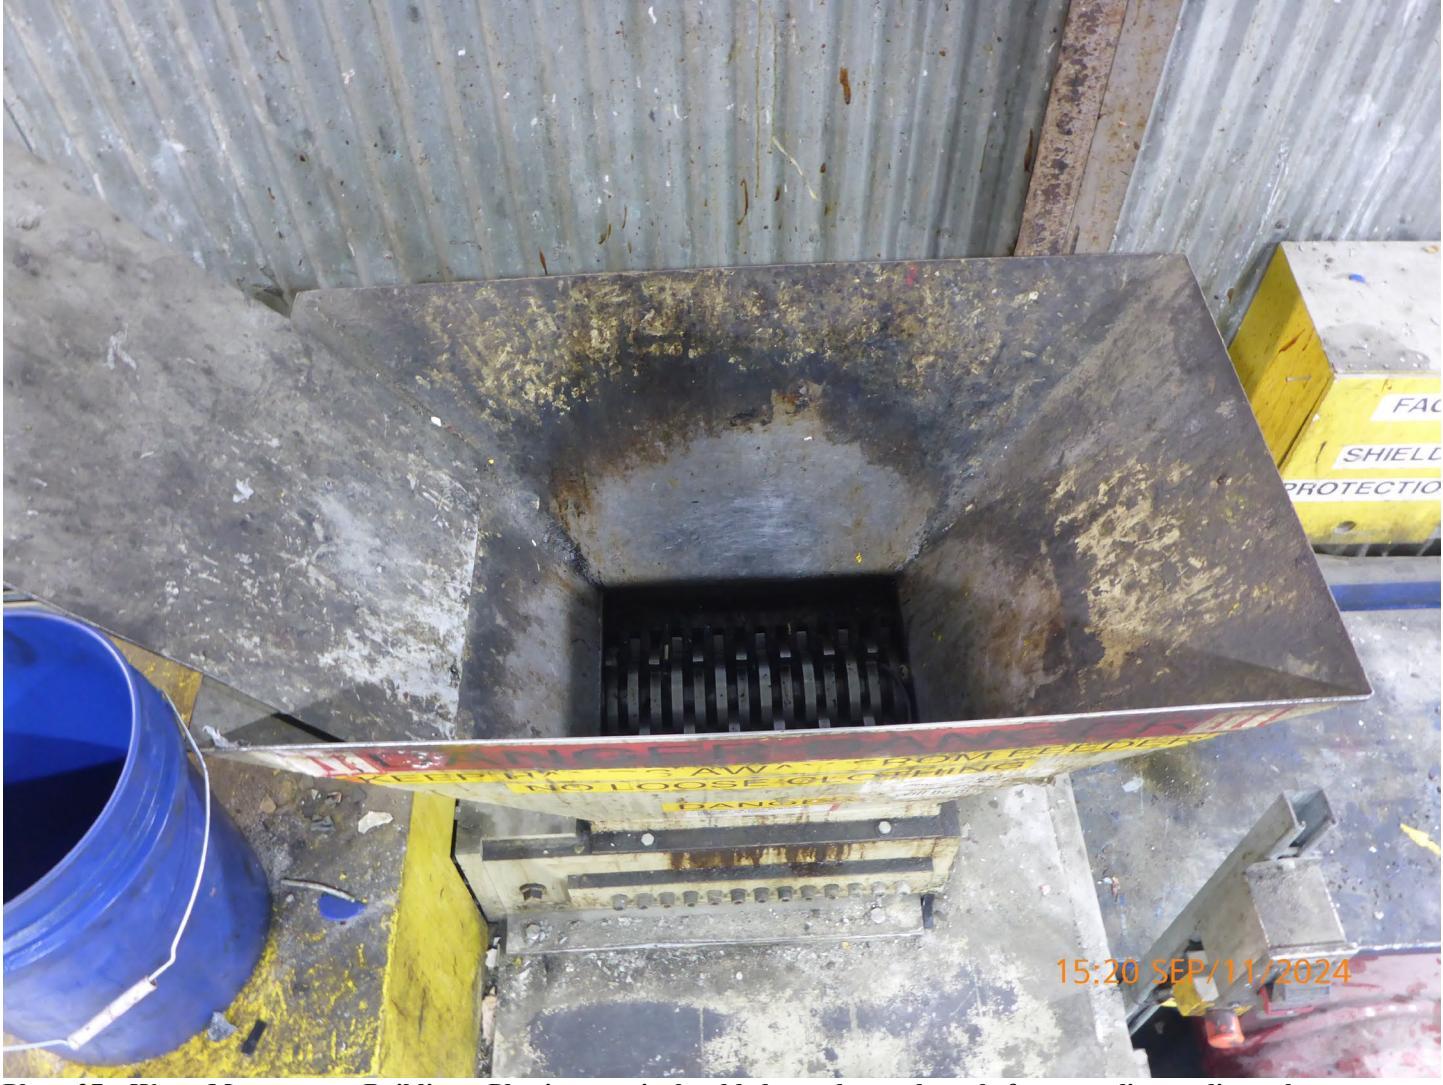
Photo 27 – Waste Management Building – Plastic waste is shredded to reduce volume before recycling or disposal.
