GNWT ECC - North Slave Region

Re: August and September 2024 Water Licence Inspection

INDUSTRIAL WATER USE INSPECTION REPORT

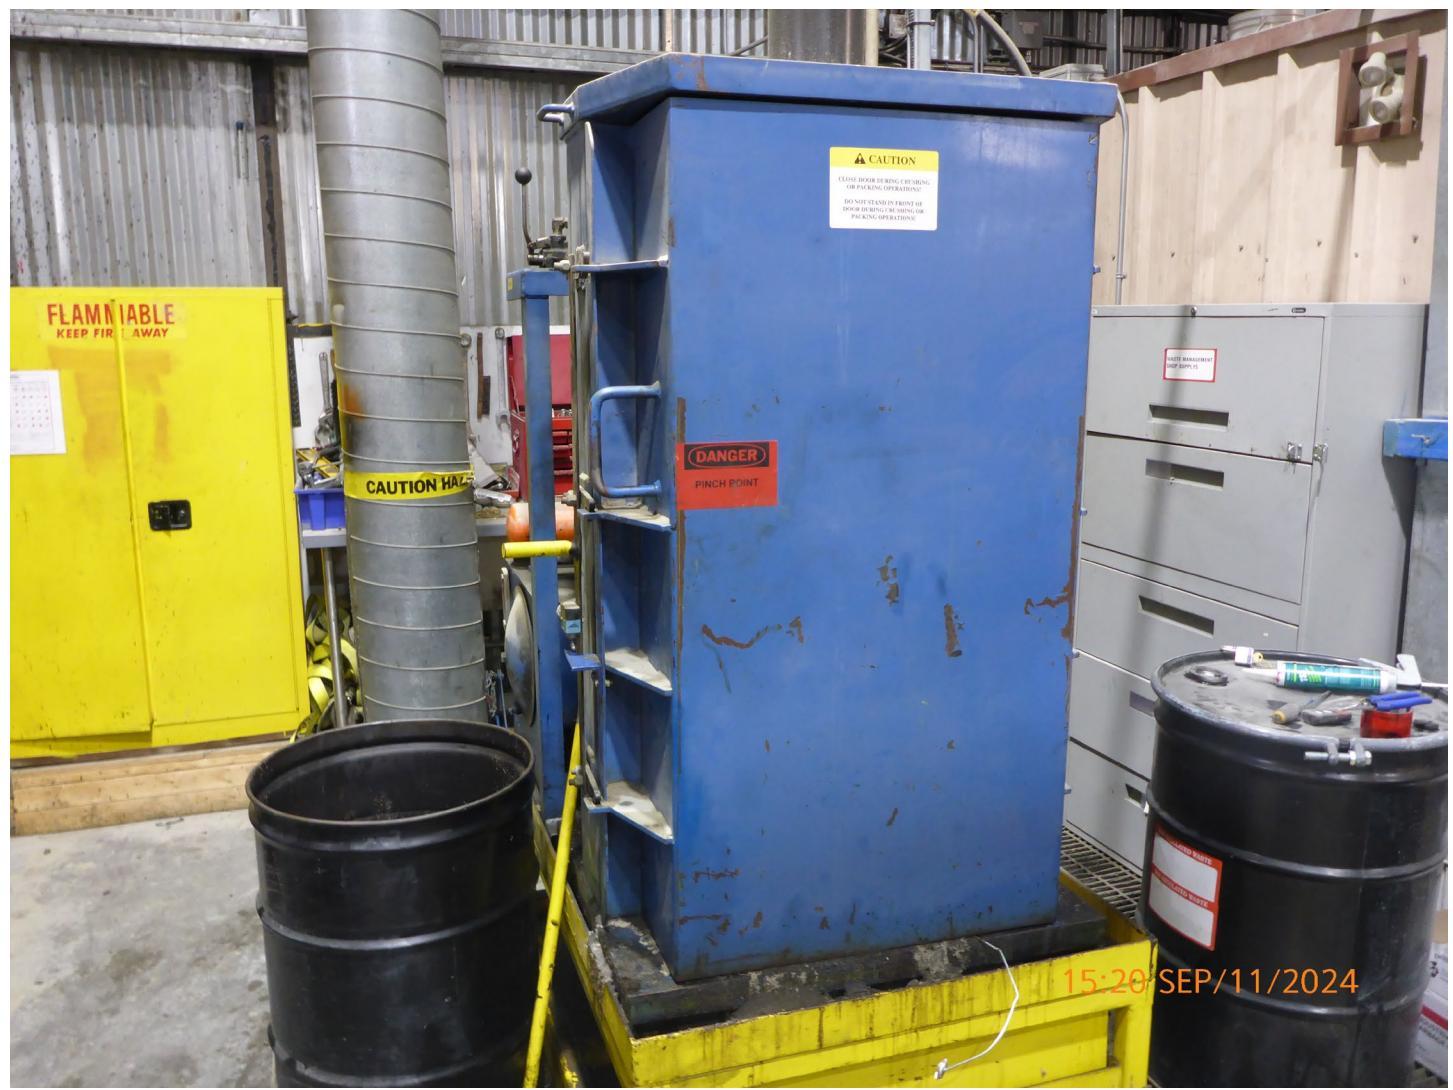
Photo 28 – Waste Management Building – Waste oil Drums are drained and crushed in a drum crusher to reduce waste volume being disposed of in the landfill.

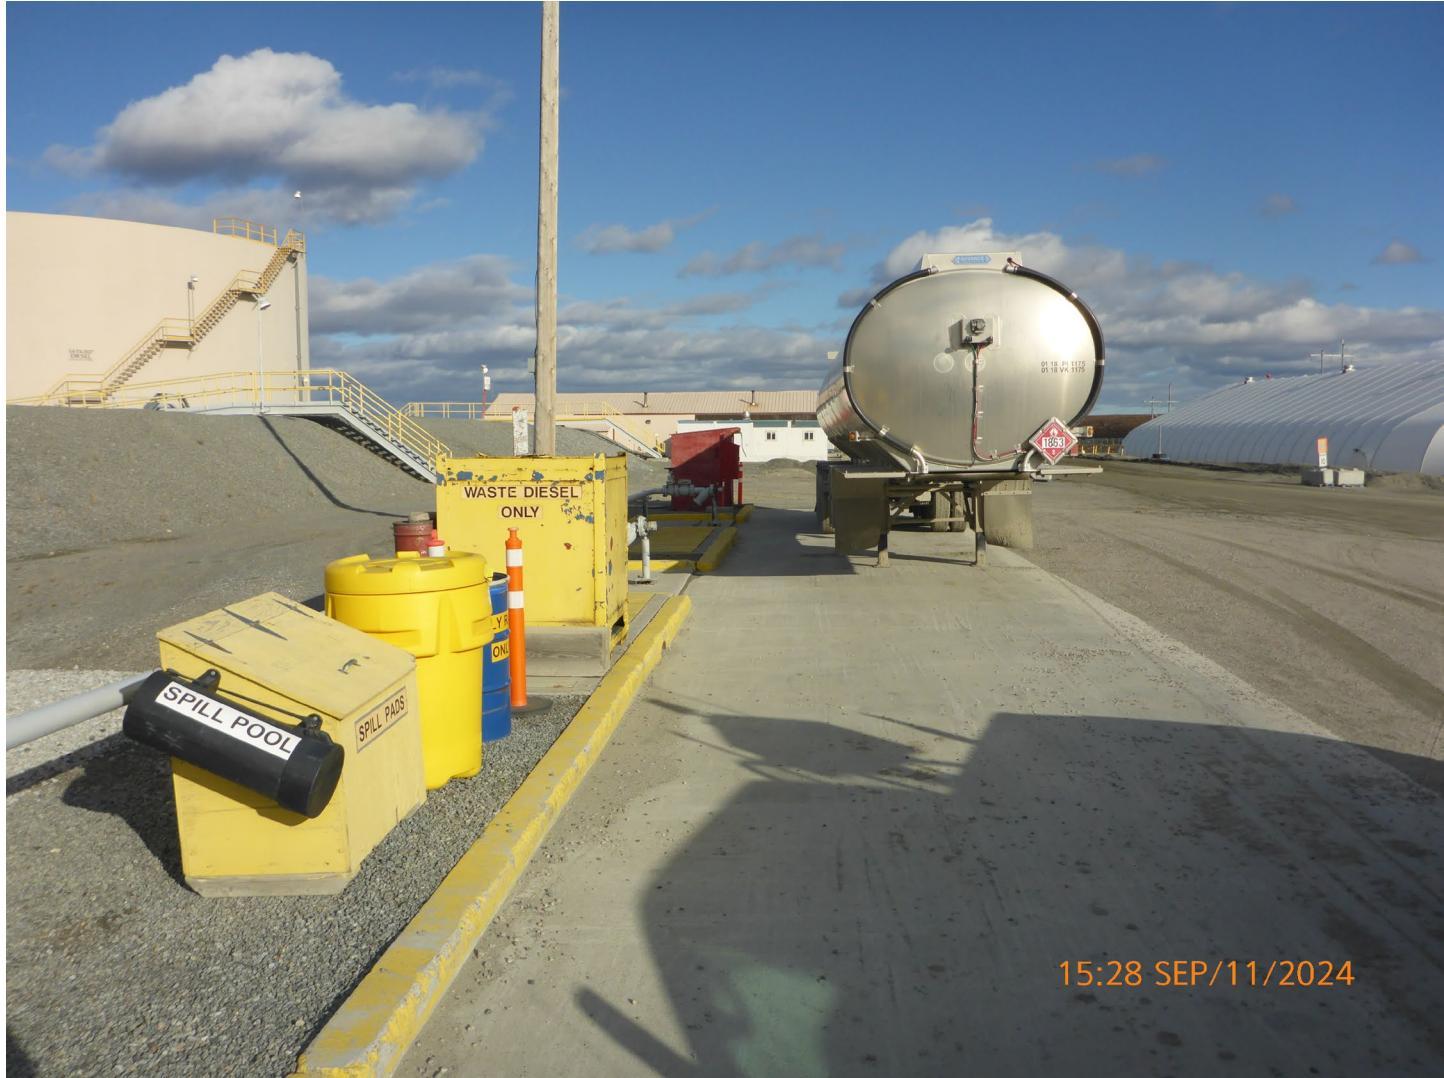
The Main Camp refuelling area was clean and well maintained with no indication of any hydrocarbon leaks or spills. Spill response equipment was fully stocked and easily accessible. Containment sumps were dry and had plenty of capacity to contain any potential spills (Photos 29 through 31).

Photo 29 – Main Camp Tank Farm Transfer Area – The Main Camp Tank Farm Transfer Area us used to fill and draw down the main tank farm on site. The area was clean and well maintained with no indication of any leaks or spills.

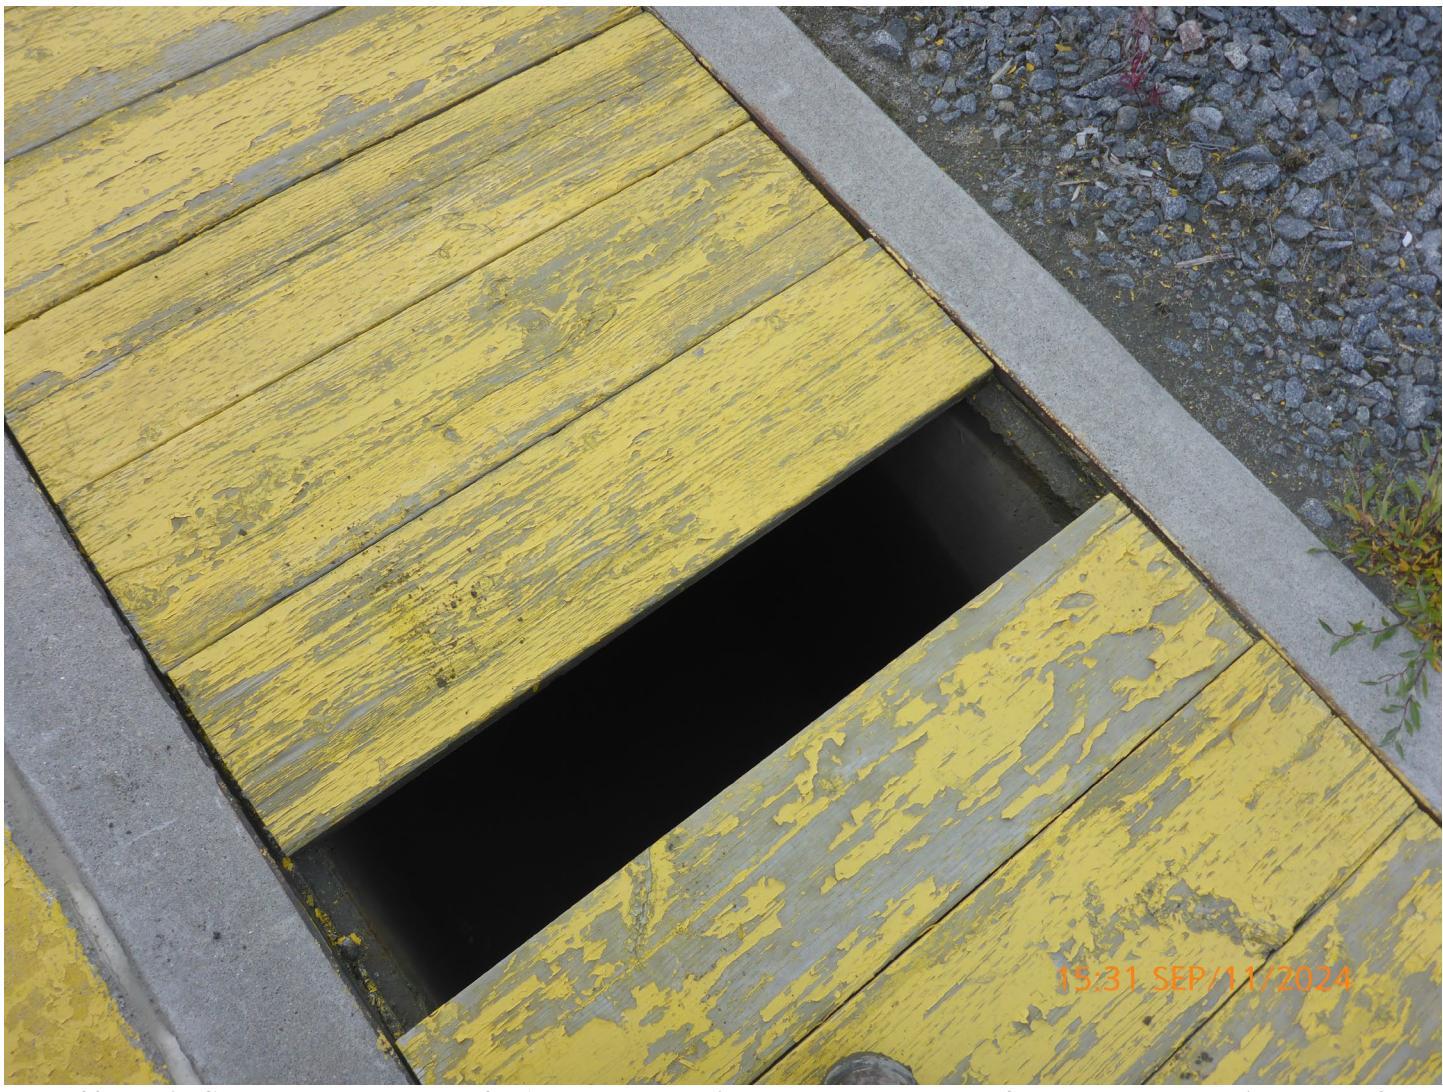
Photo 30 – Main Camp Tank Farm Transfer Area – The containment sump at the transfer area was empty with plenty of capacity to contain any spills during fuel transfer.

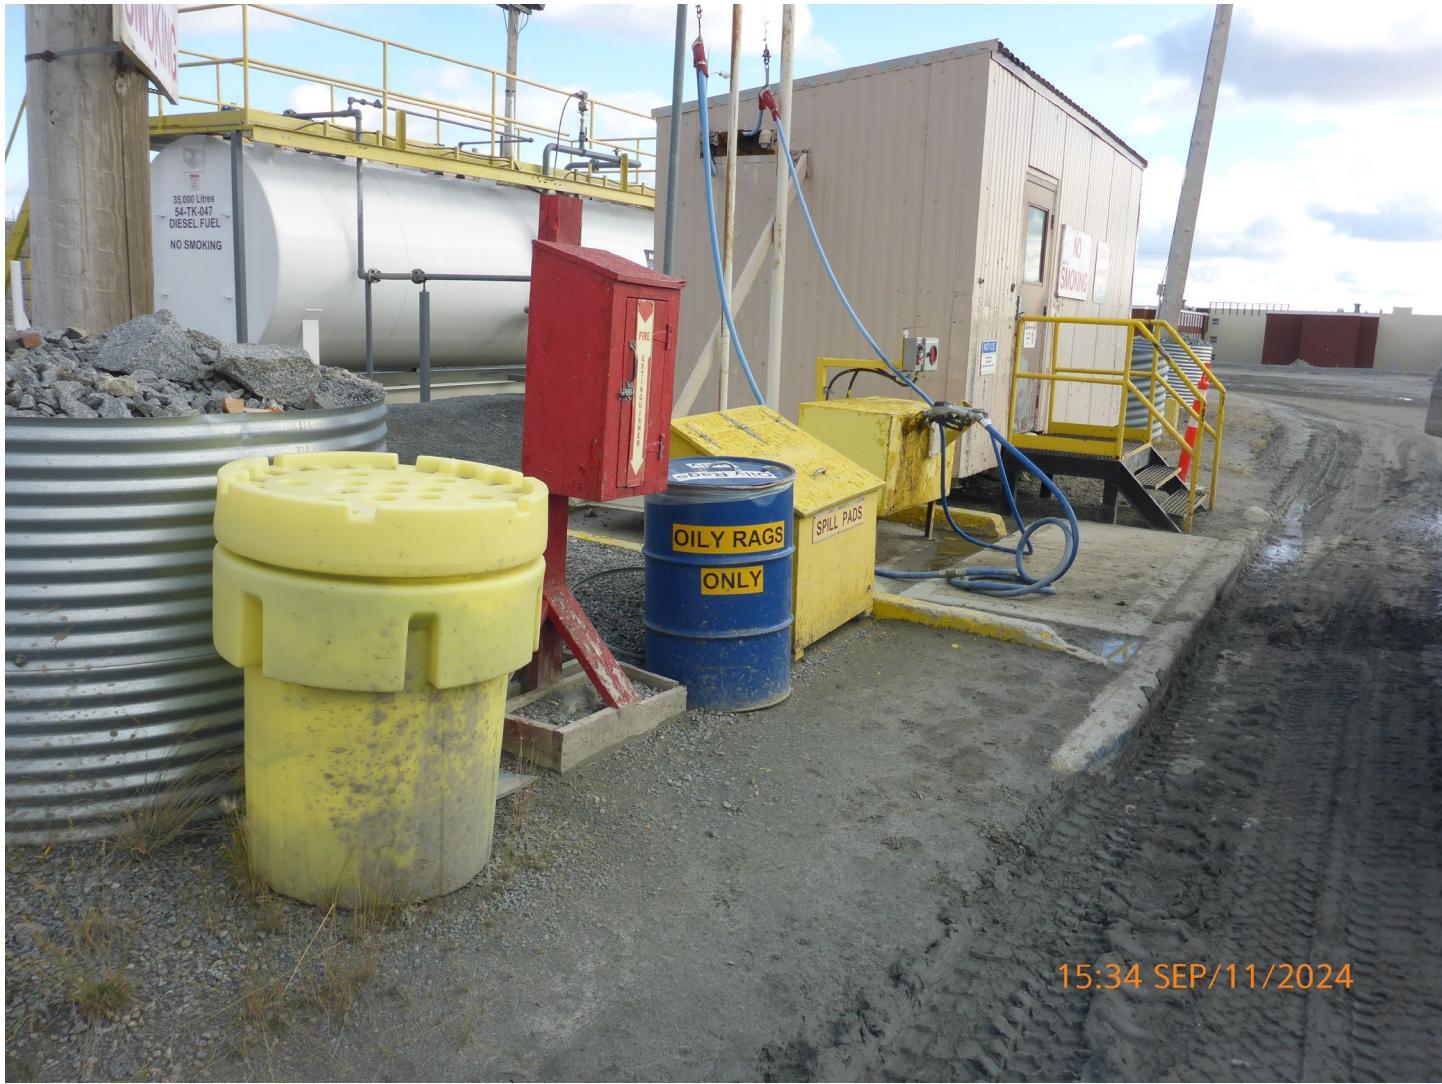
Photo 31 – Main Camp Refuelling Station – The Main Camp Refuelling Station was clean and well maintained with no indication of any leaks or spills.

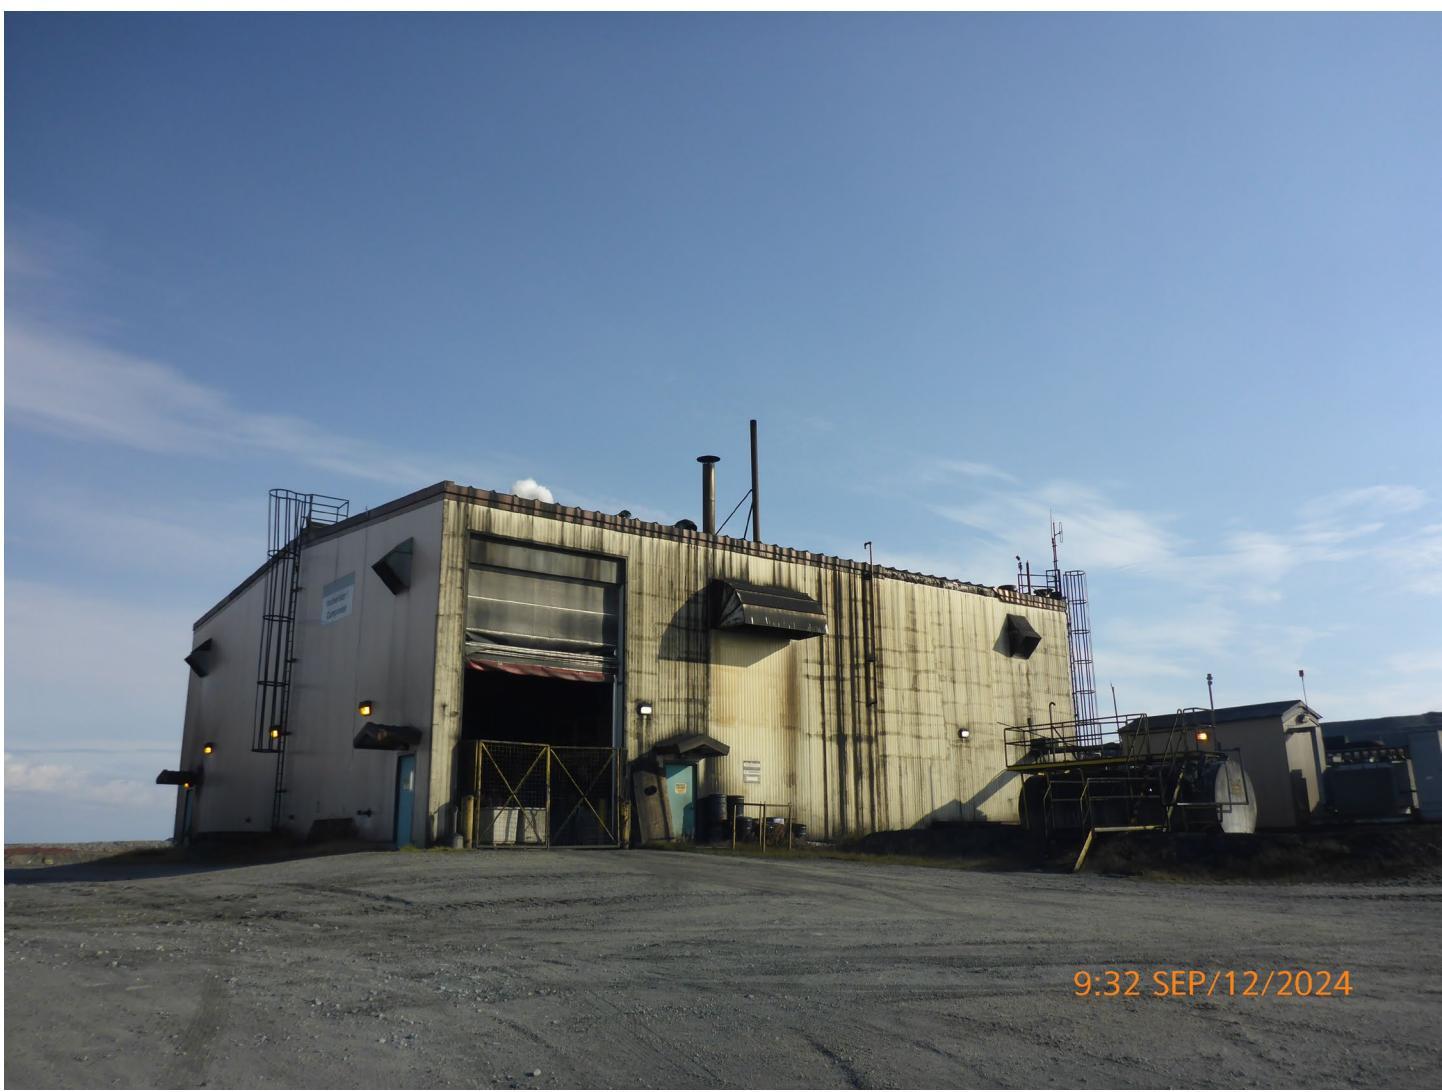
Food waste and other combustible waste collected around camp is directed to the incinerators and the composter for final disposal. Waste is sorted inside the building by Ekati staff and suitable organic material is sent to the composter, the remaining waste is incinerated. The incinerators have wet scrubbers to clean incinerator stack gas before venting to the atmosphere. Scrubber water is collected in a storage tank and disposed of in the Long Lake Containment Facility. Incinerator ash is collected in bins and disposed of in the landfill. The ash bin was inspected and showed some incomplete incineration. This issue should be rectified when the burners are tuned for optimal performance. Burner tuning and stack testing is scheduled later in 2024 (Photos 32 through 36).

Photo 32 – Incinerator Building – All food waste generated at the site is sent to the incinerator building for final disposal. This facility accepts food, paper and other combustible waste that is not sent out for recycling.

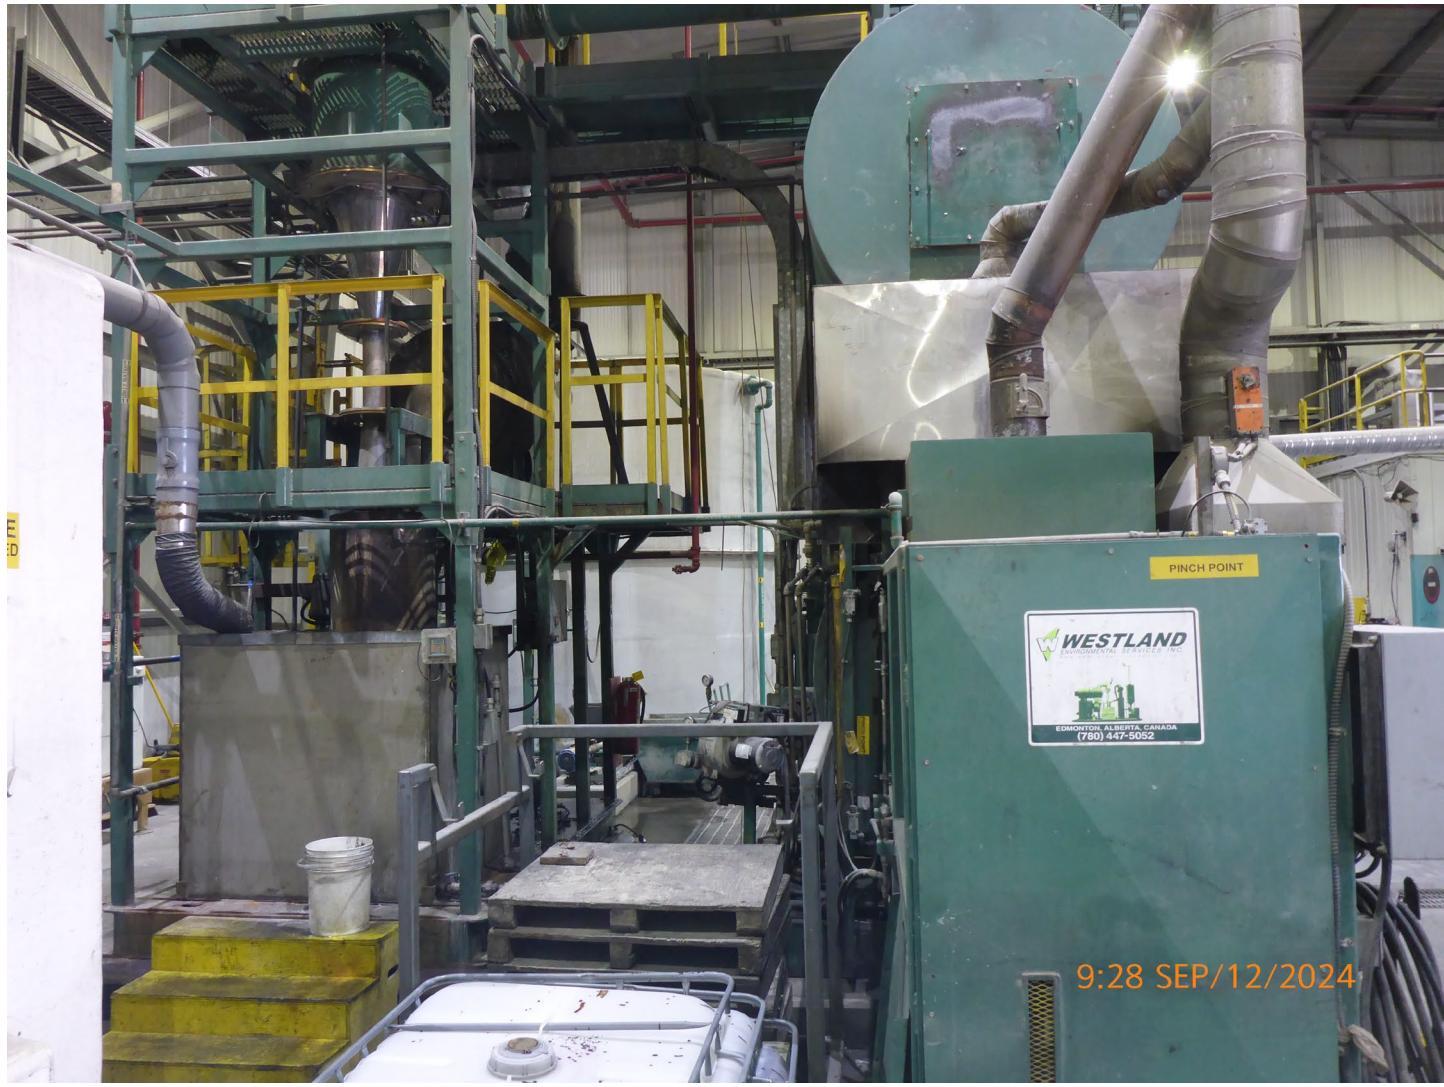
Photo 33 – Incinerator Building – The building contains two dual chambered incinerators. Both incinerators are functional at the time of inspection.

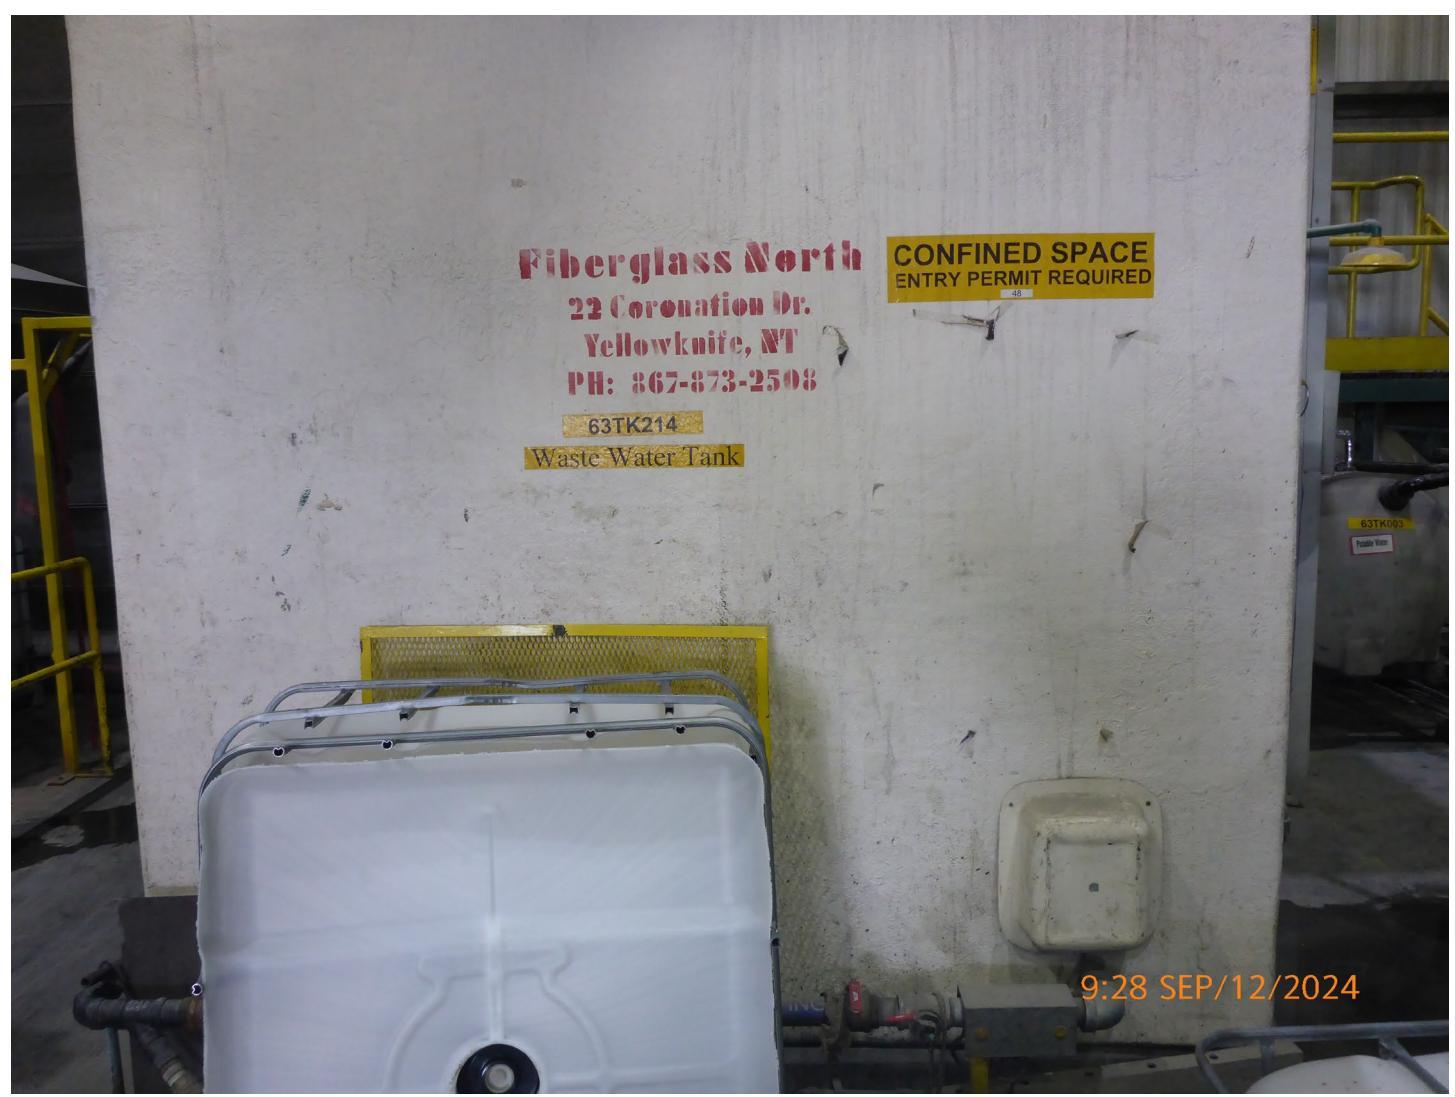
Photo 34 – Incinerator Building – Incinerators use wet scrubbers for pollution control. The scrubbers wash out any ash and particulate before exhausting out the stacks. Scrubber water is disposed of in the long lake containment facility.

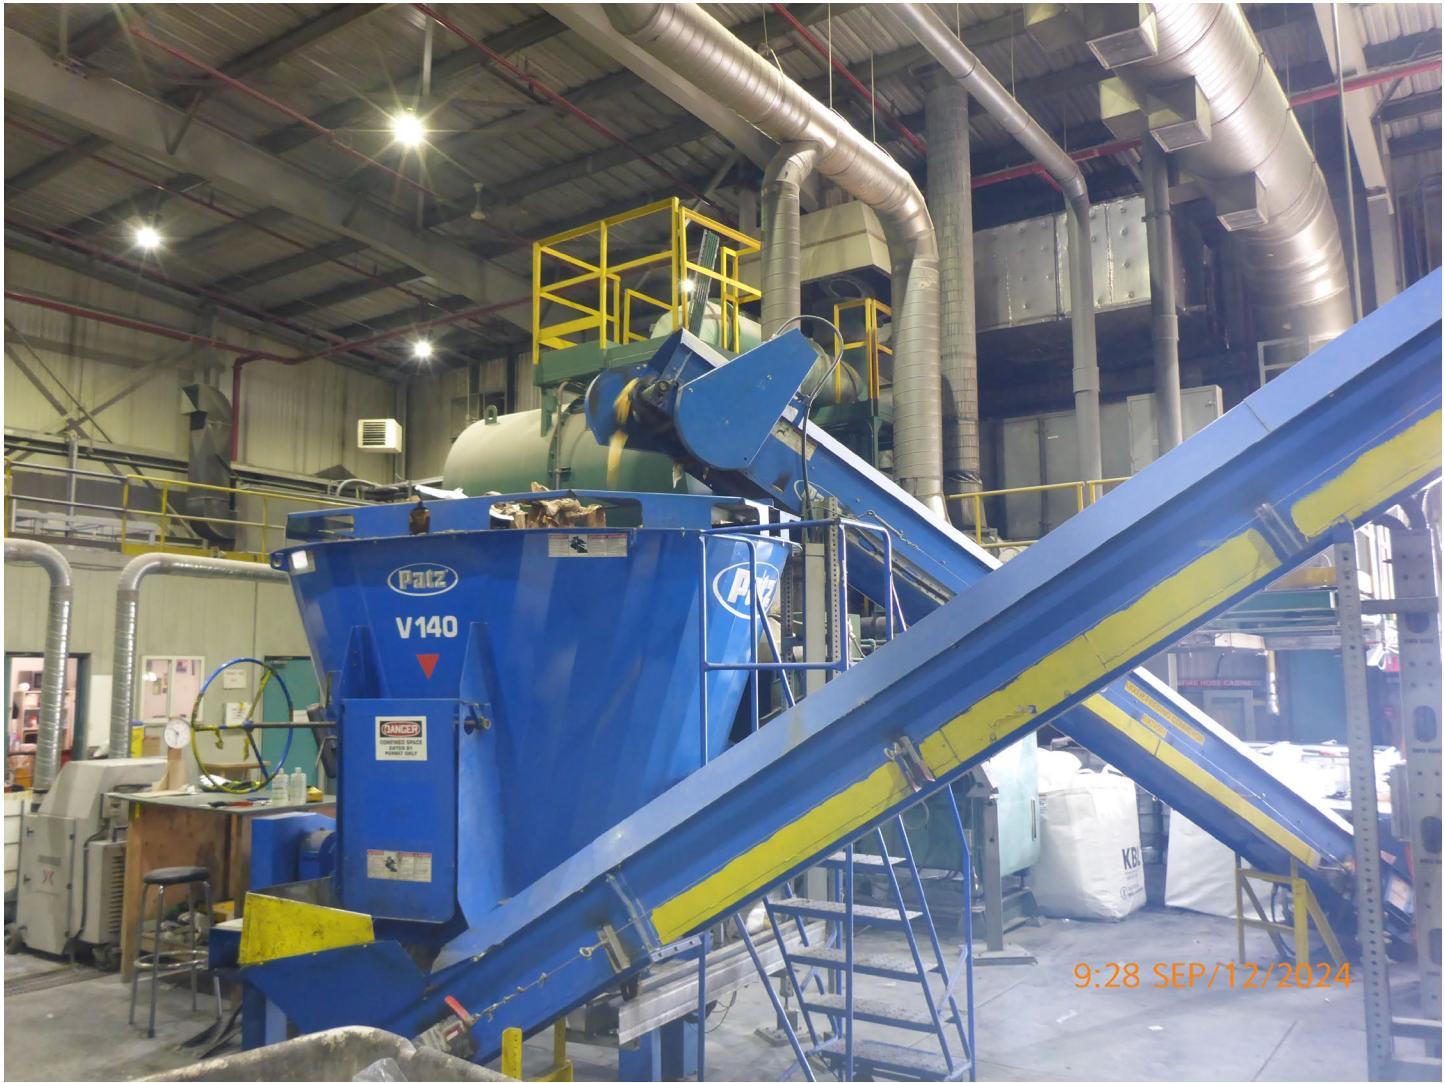
Photo 35 – Incinerator Building – Much of the food waste is separated into the composting waste stream. The waste is sent through the composter then disposed of in the landfill as inert waste.

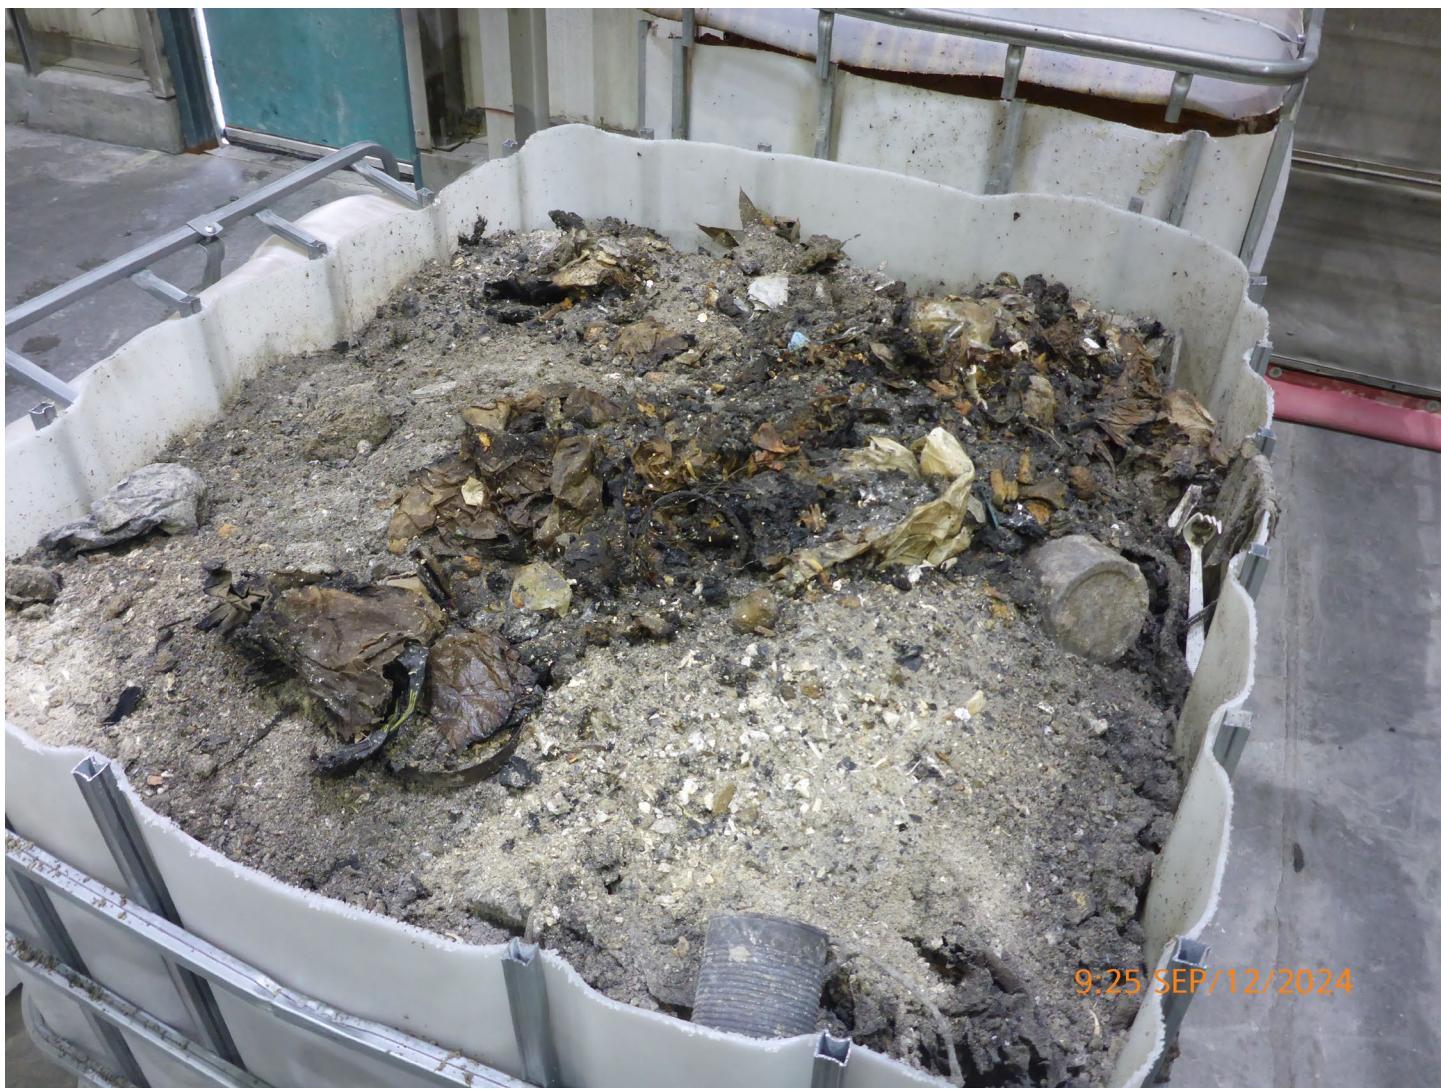
Photo 36 – Incinerator Building – Incinerator ash is collected in bins and disposed of in the landfill. This batch of ash shows that some of the waste isn't being incinerated completely. This issue should be rectified after the burners have been tuned for optimal performance. Stack testing and burner tuning is scheduled for later in 2024.
