# Closure and Reclamation Plan

Inuvik Hydrocarbon Contaminated  
Soil Treatment Facility  
Gwich'in Land and Water Board  
G17L1-002 Type "B" Licence

KBL Environmental Ltd.  
Version 1.1

May 2022

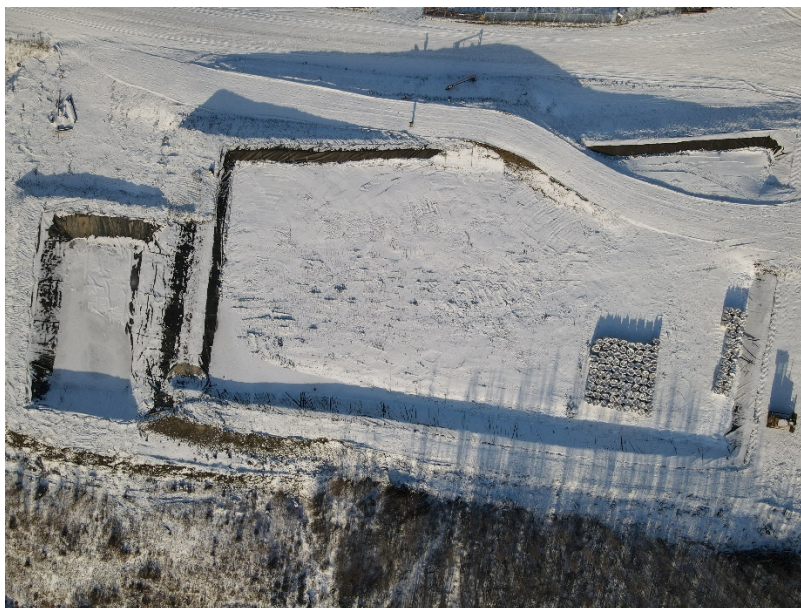
**Photo 1:** Constructed Facility, October 12, 2021

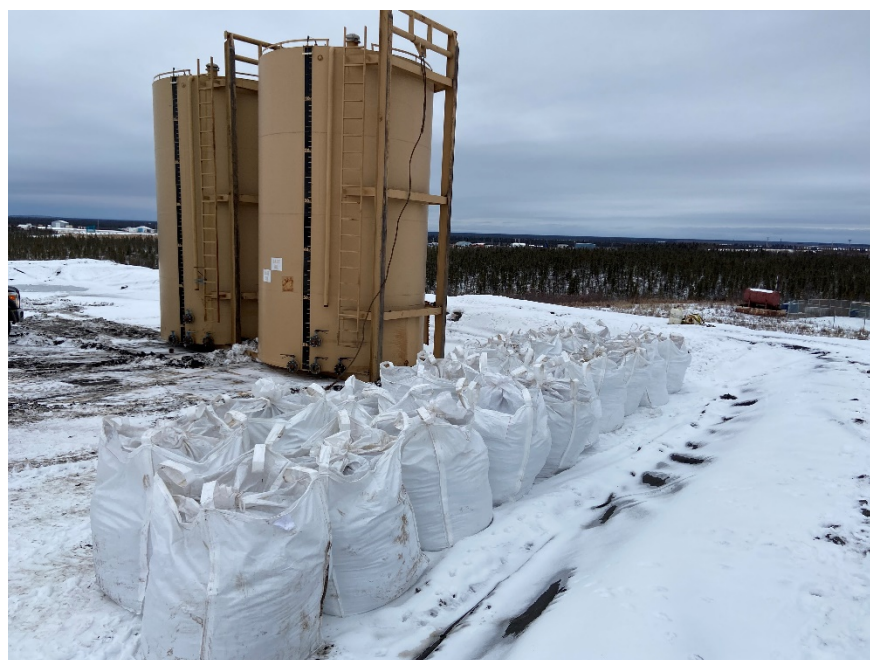
**Photo 2:** Facility ASTs, October 12, 2021
