Town of Fort Smith

# **Water Licence Renewal Background Report Volume 1**

60164818

January, 2011

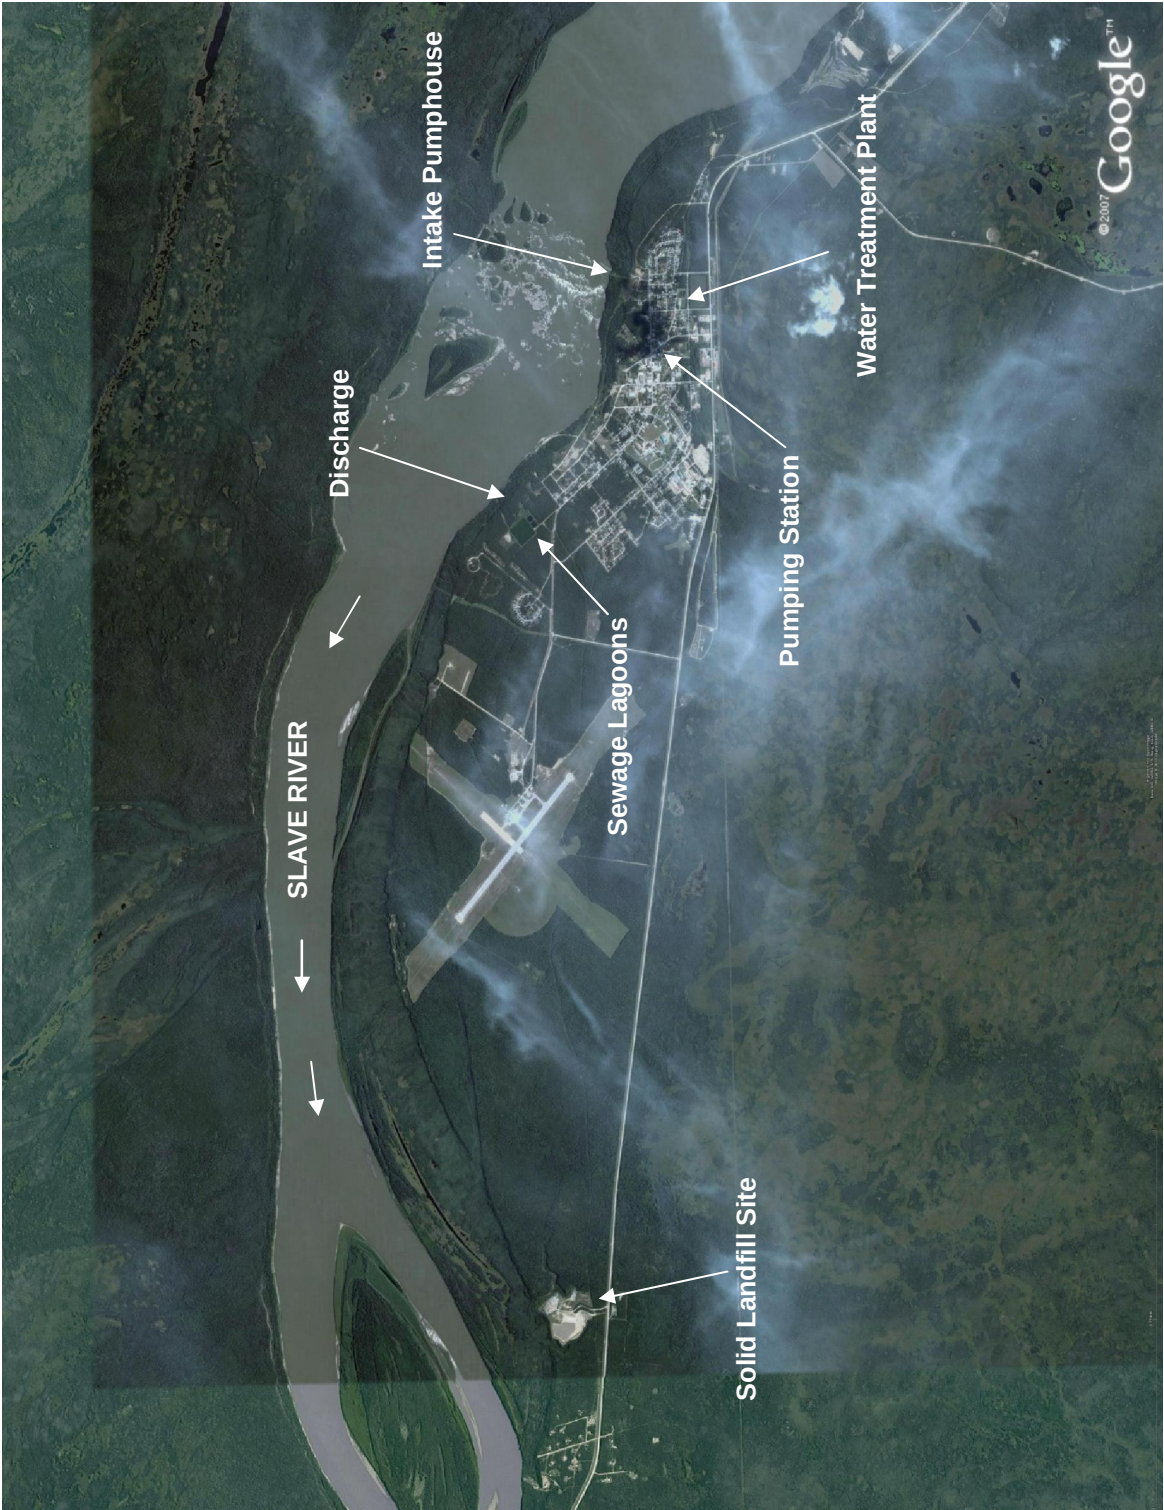
Figure 1 Fort Smith, Wastewater and Solid Waste Disposal Facilities

The municipal infrastructure under the water licence includes potable water, wastewater and solid waste. The location of the infrastructure is indicated on the site plan, Figure 1.

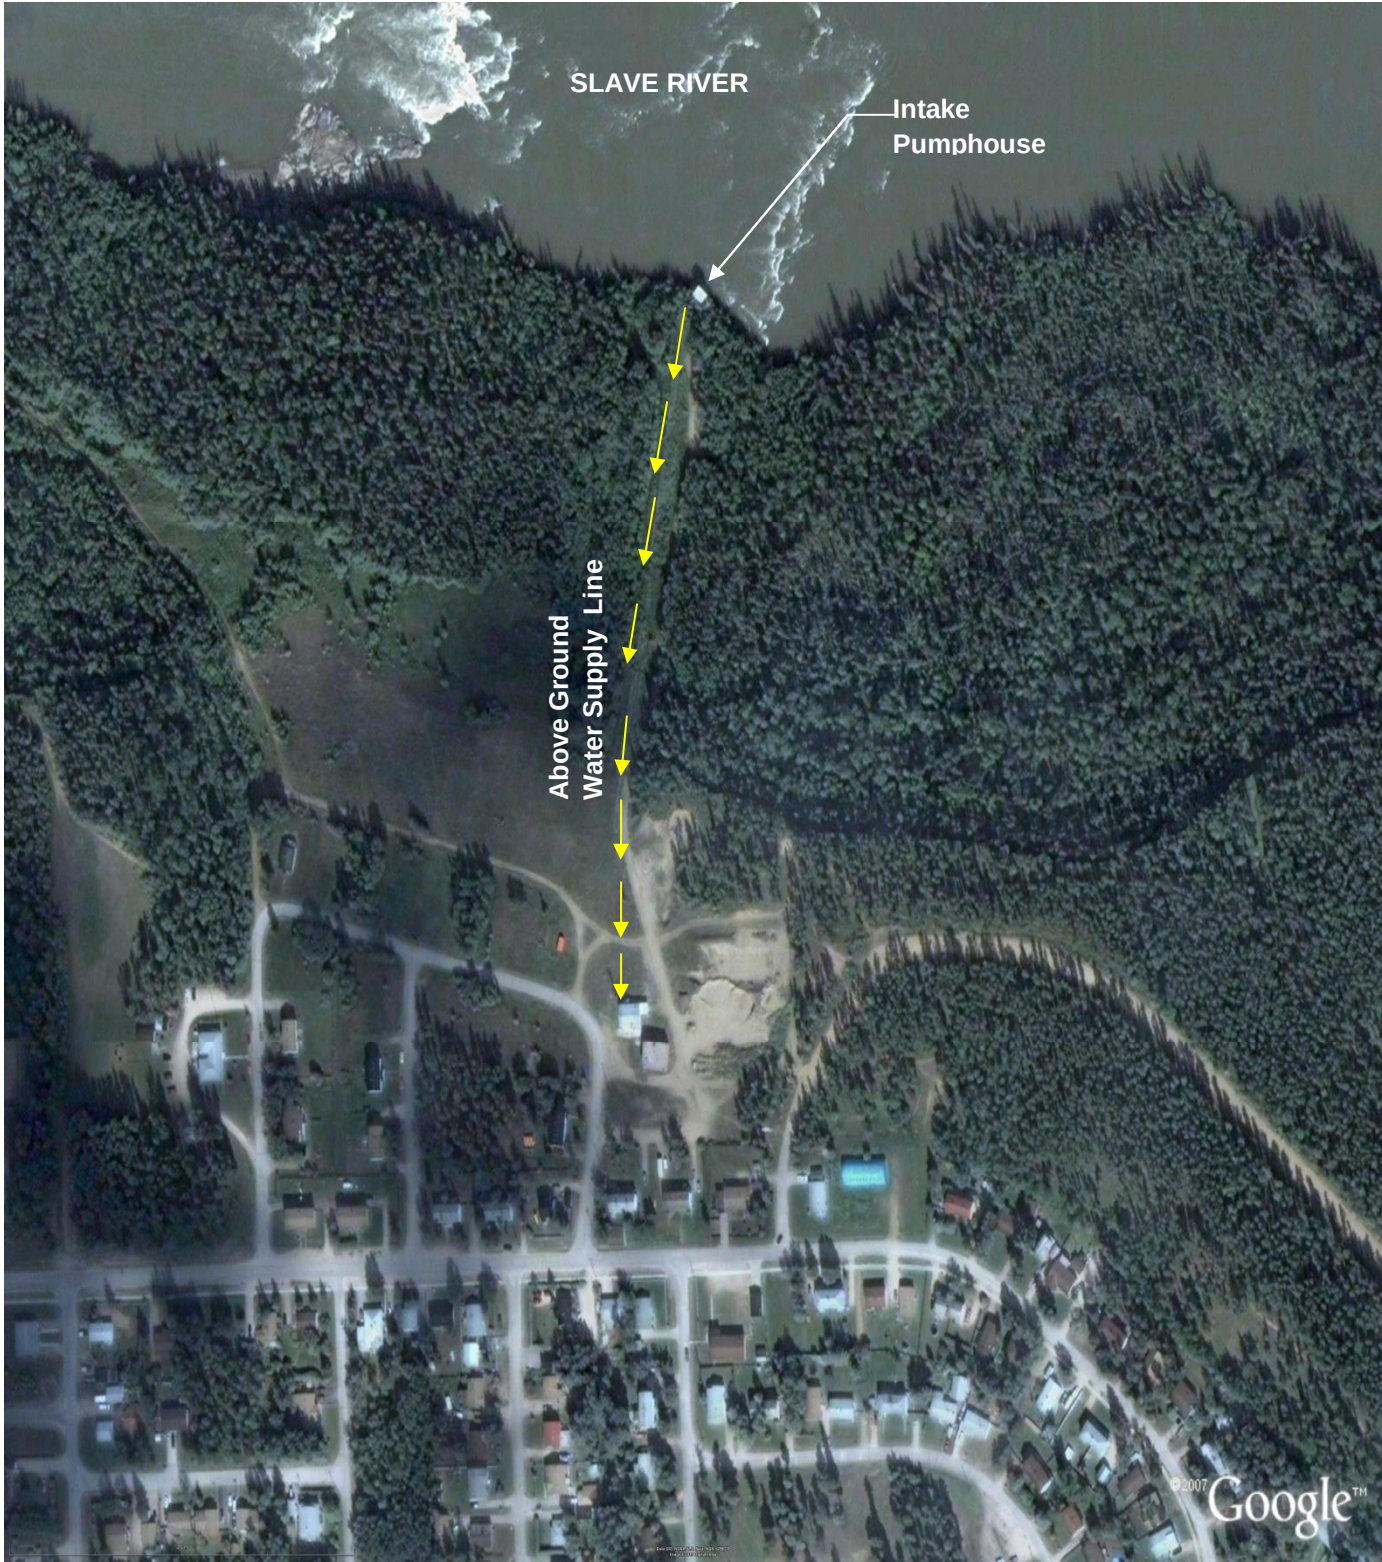
Figure 3 Site Plan Showing Intake Pumphouse

The pipeline from the intake pumphouse to the top of the riverbank consists of an above ground insulated steel pipe (See Figure 3), and from the top of the riverbank to the water treatment plant the pipeline consists of a buried, high density polyethylene pipe.

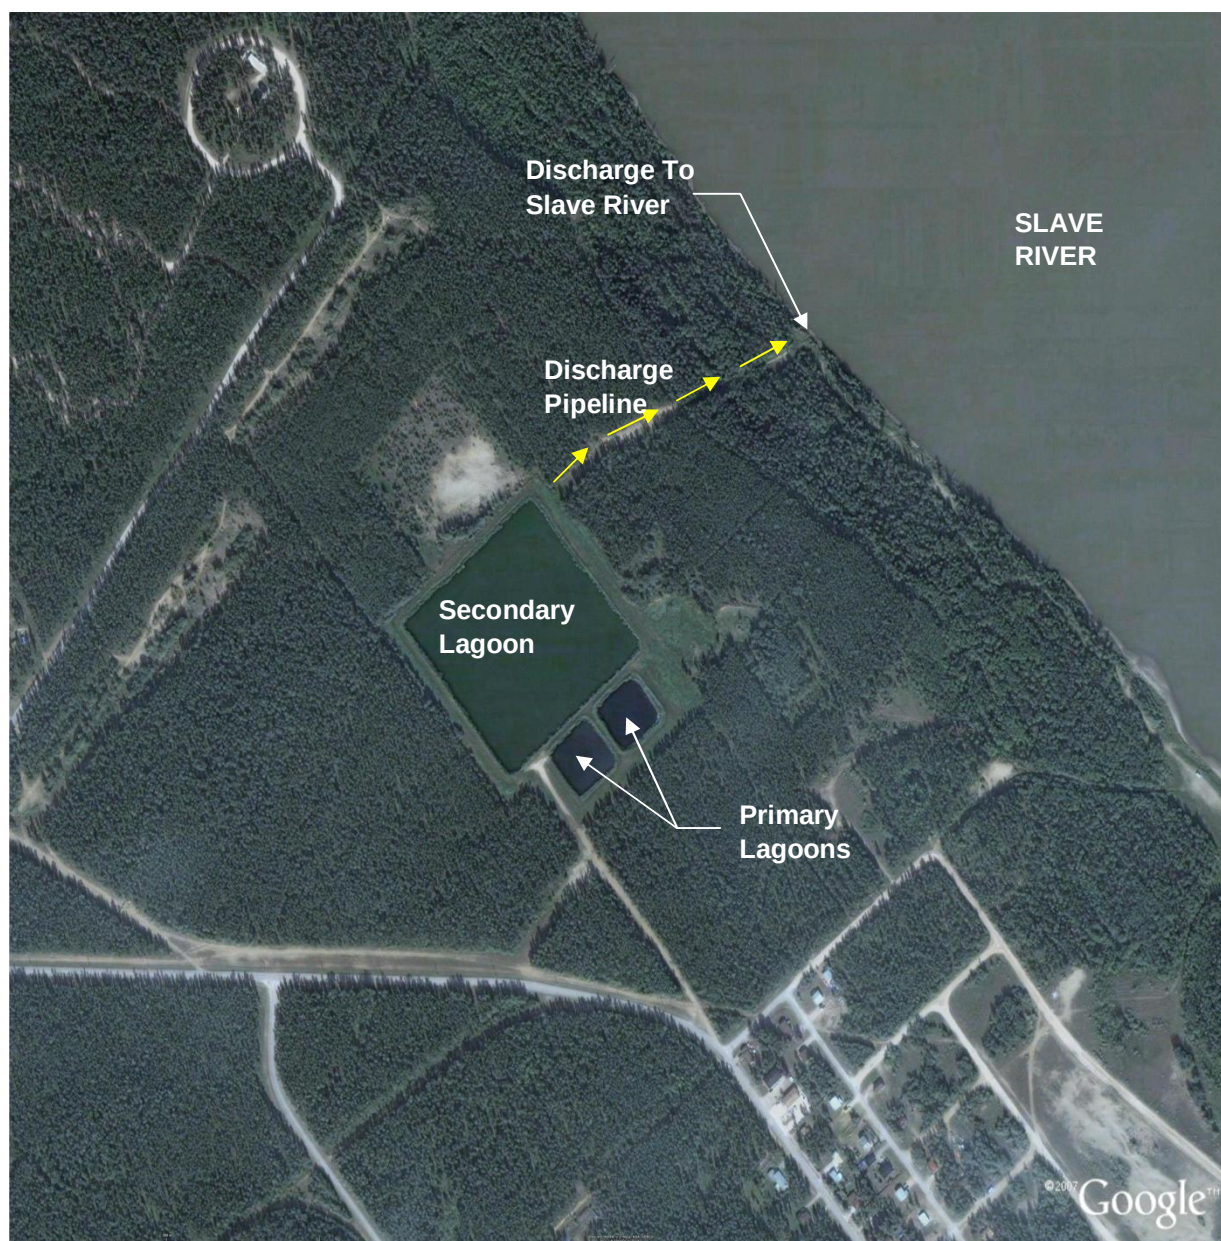
**Figure 6 Site Plan Showing Sewage Lagoons and Discharge Pipeline**

Sewage from the lagoon discharges continuously into the Slave River via a 250m long above ground pipeline, at the location shown on Figure 6. The pipeline consists of a 250mm diameter high density polyethylene (HDPE) pipe, insulated with polyurethane foam and protected by a metal jacket.

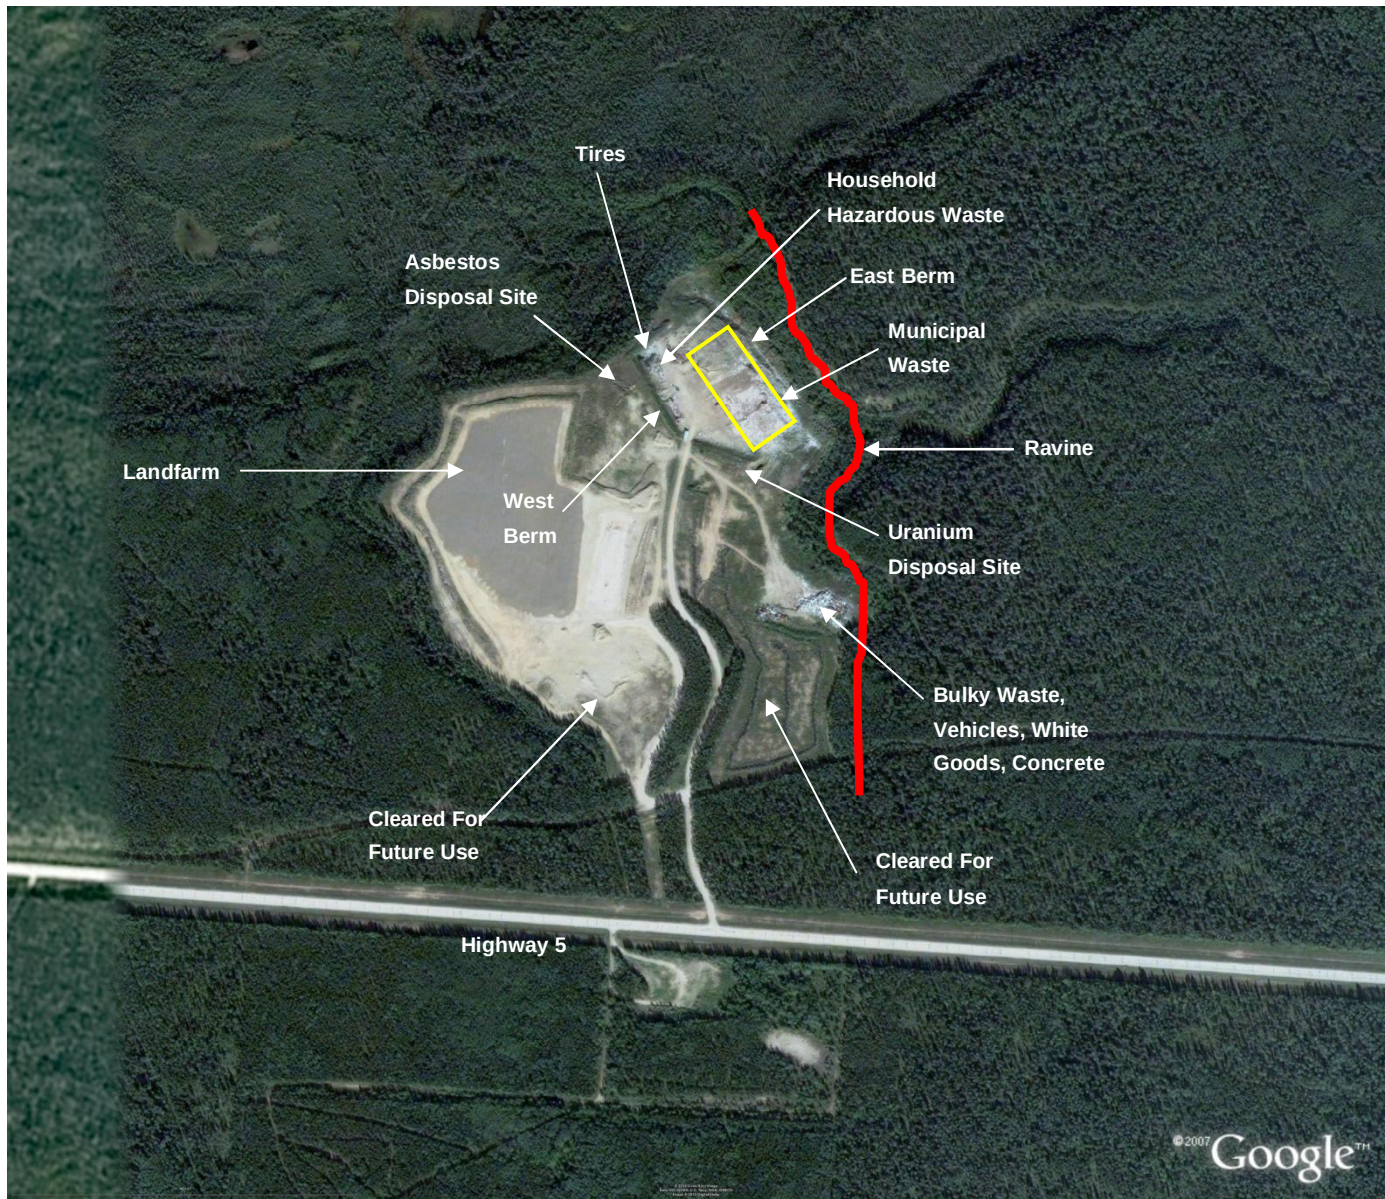
Figure 7 Plan Showing Solid Waste Facility

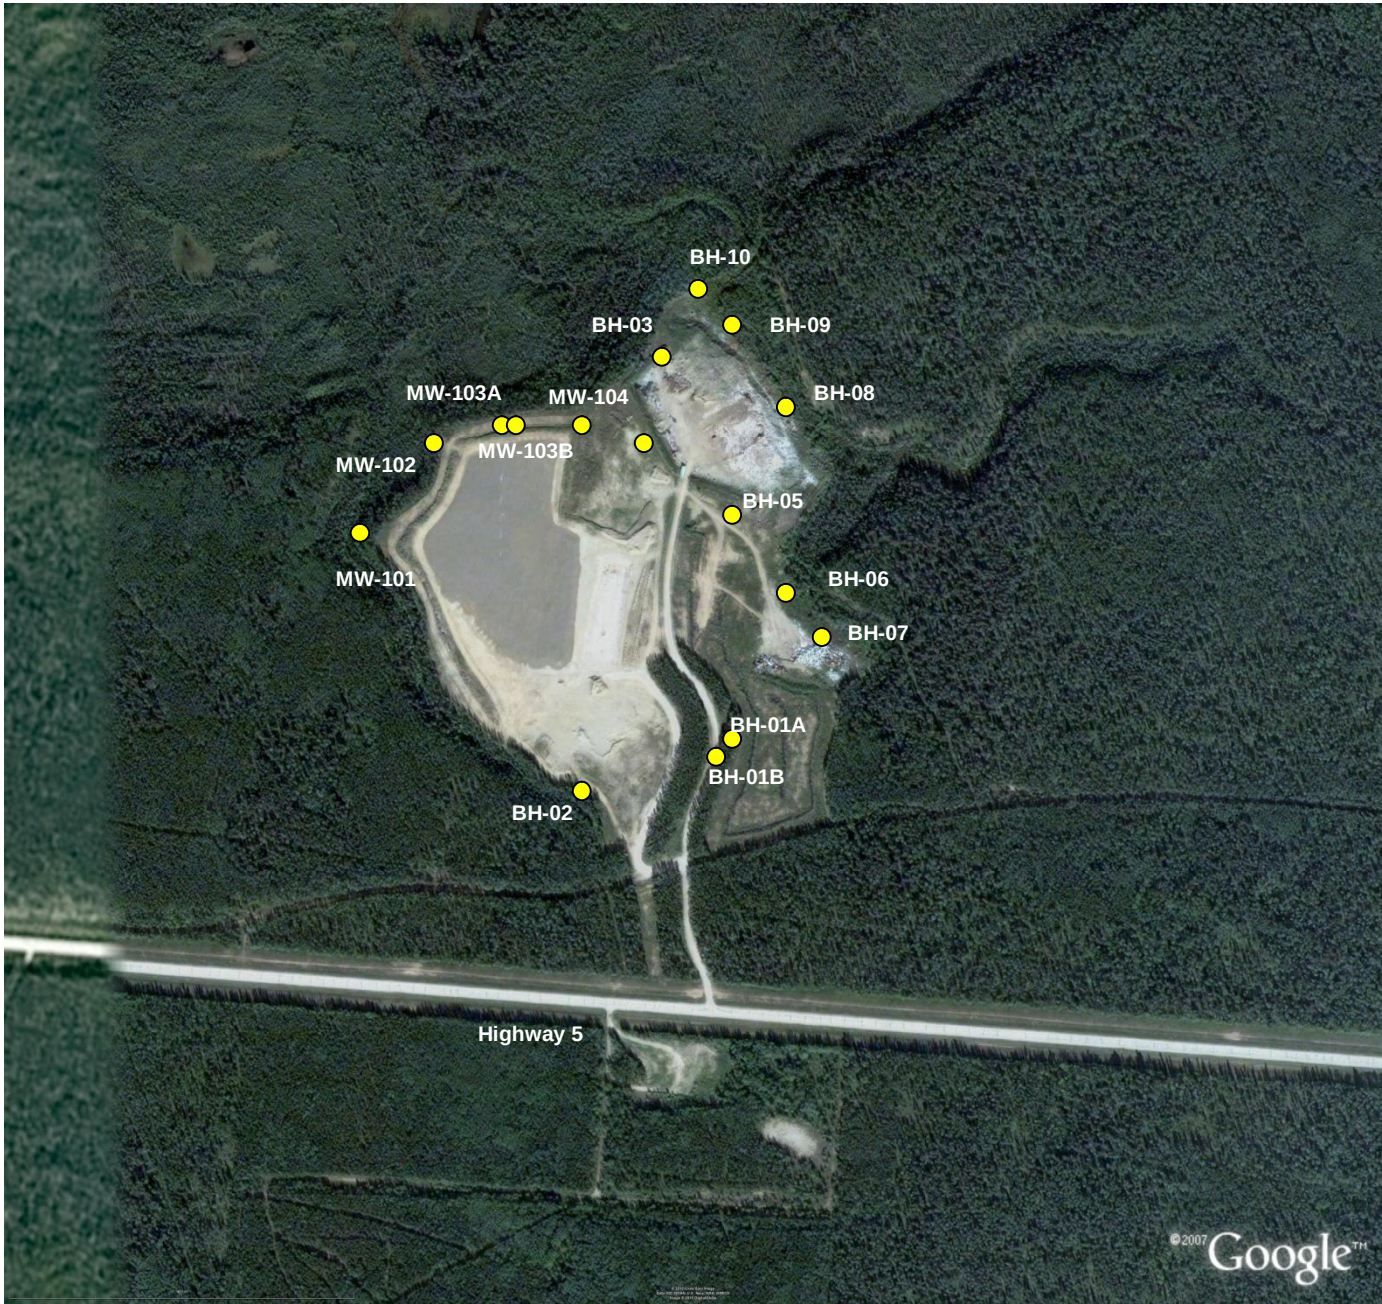
Figure 8 Plan Showing Groundwater Monitoring Wells

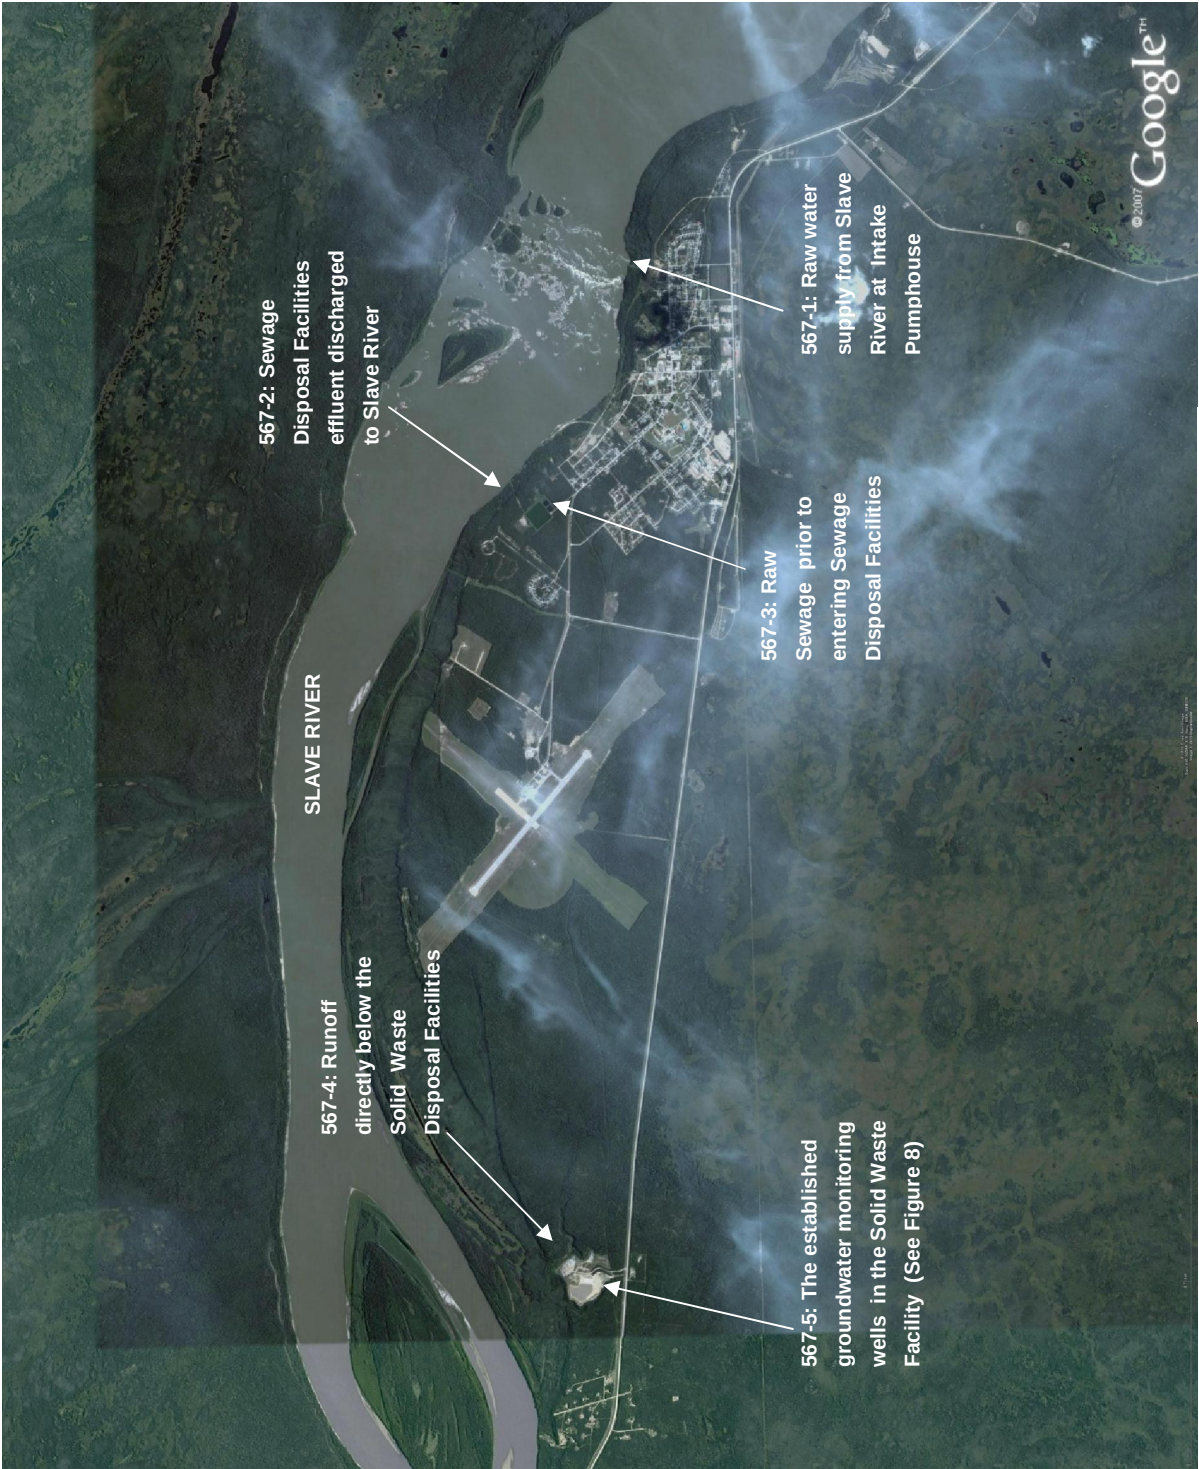
Figure 9 Location of SNP Stations
