NORTHWEST TERRITORIES  
**POWER  
CORPORATION**

## EXECUTIVE SUMMARY

**NTPC TALTSO AQUATIC EFFECTS MONITORING PROGRAM**  
**Fish, Sediment Quality, and Water Quality Sample Sites in Nonacho Lake**

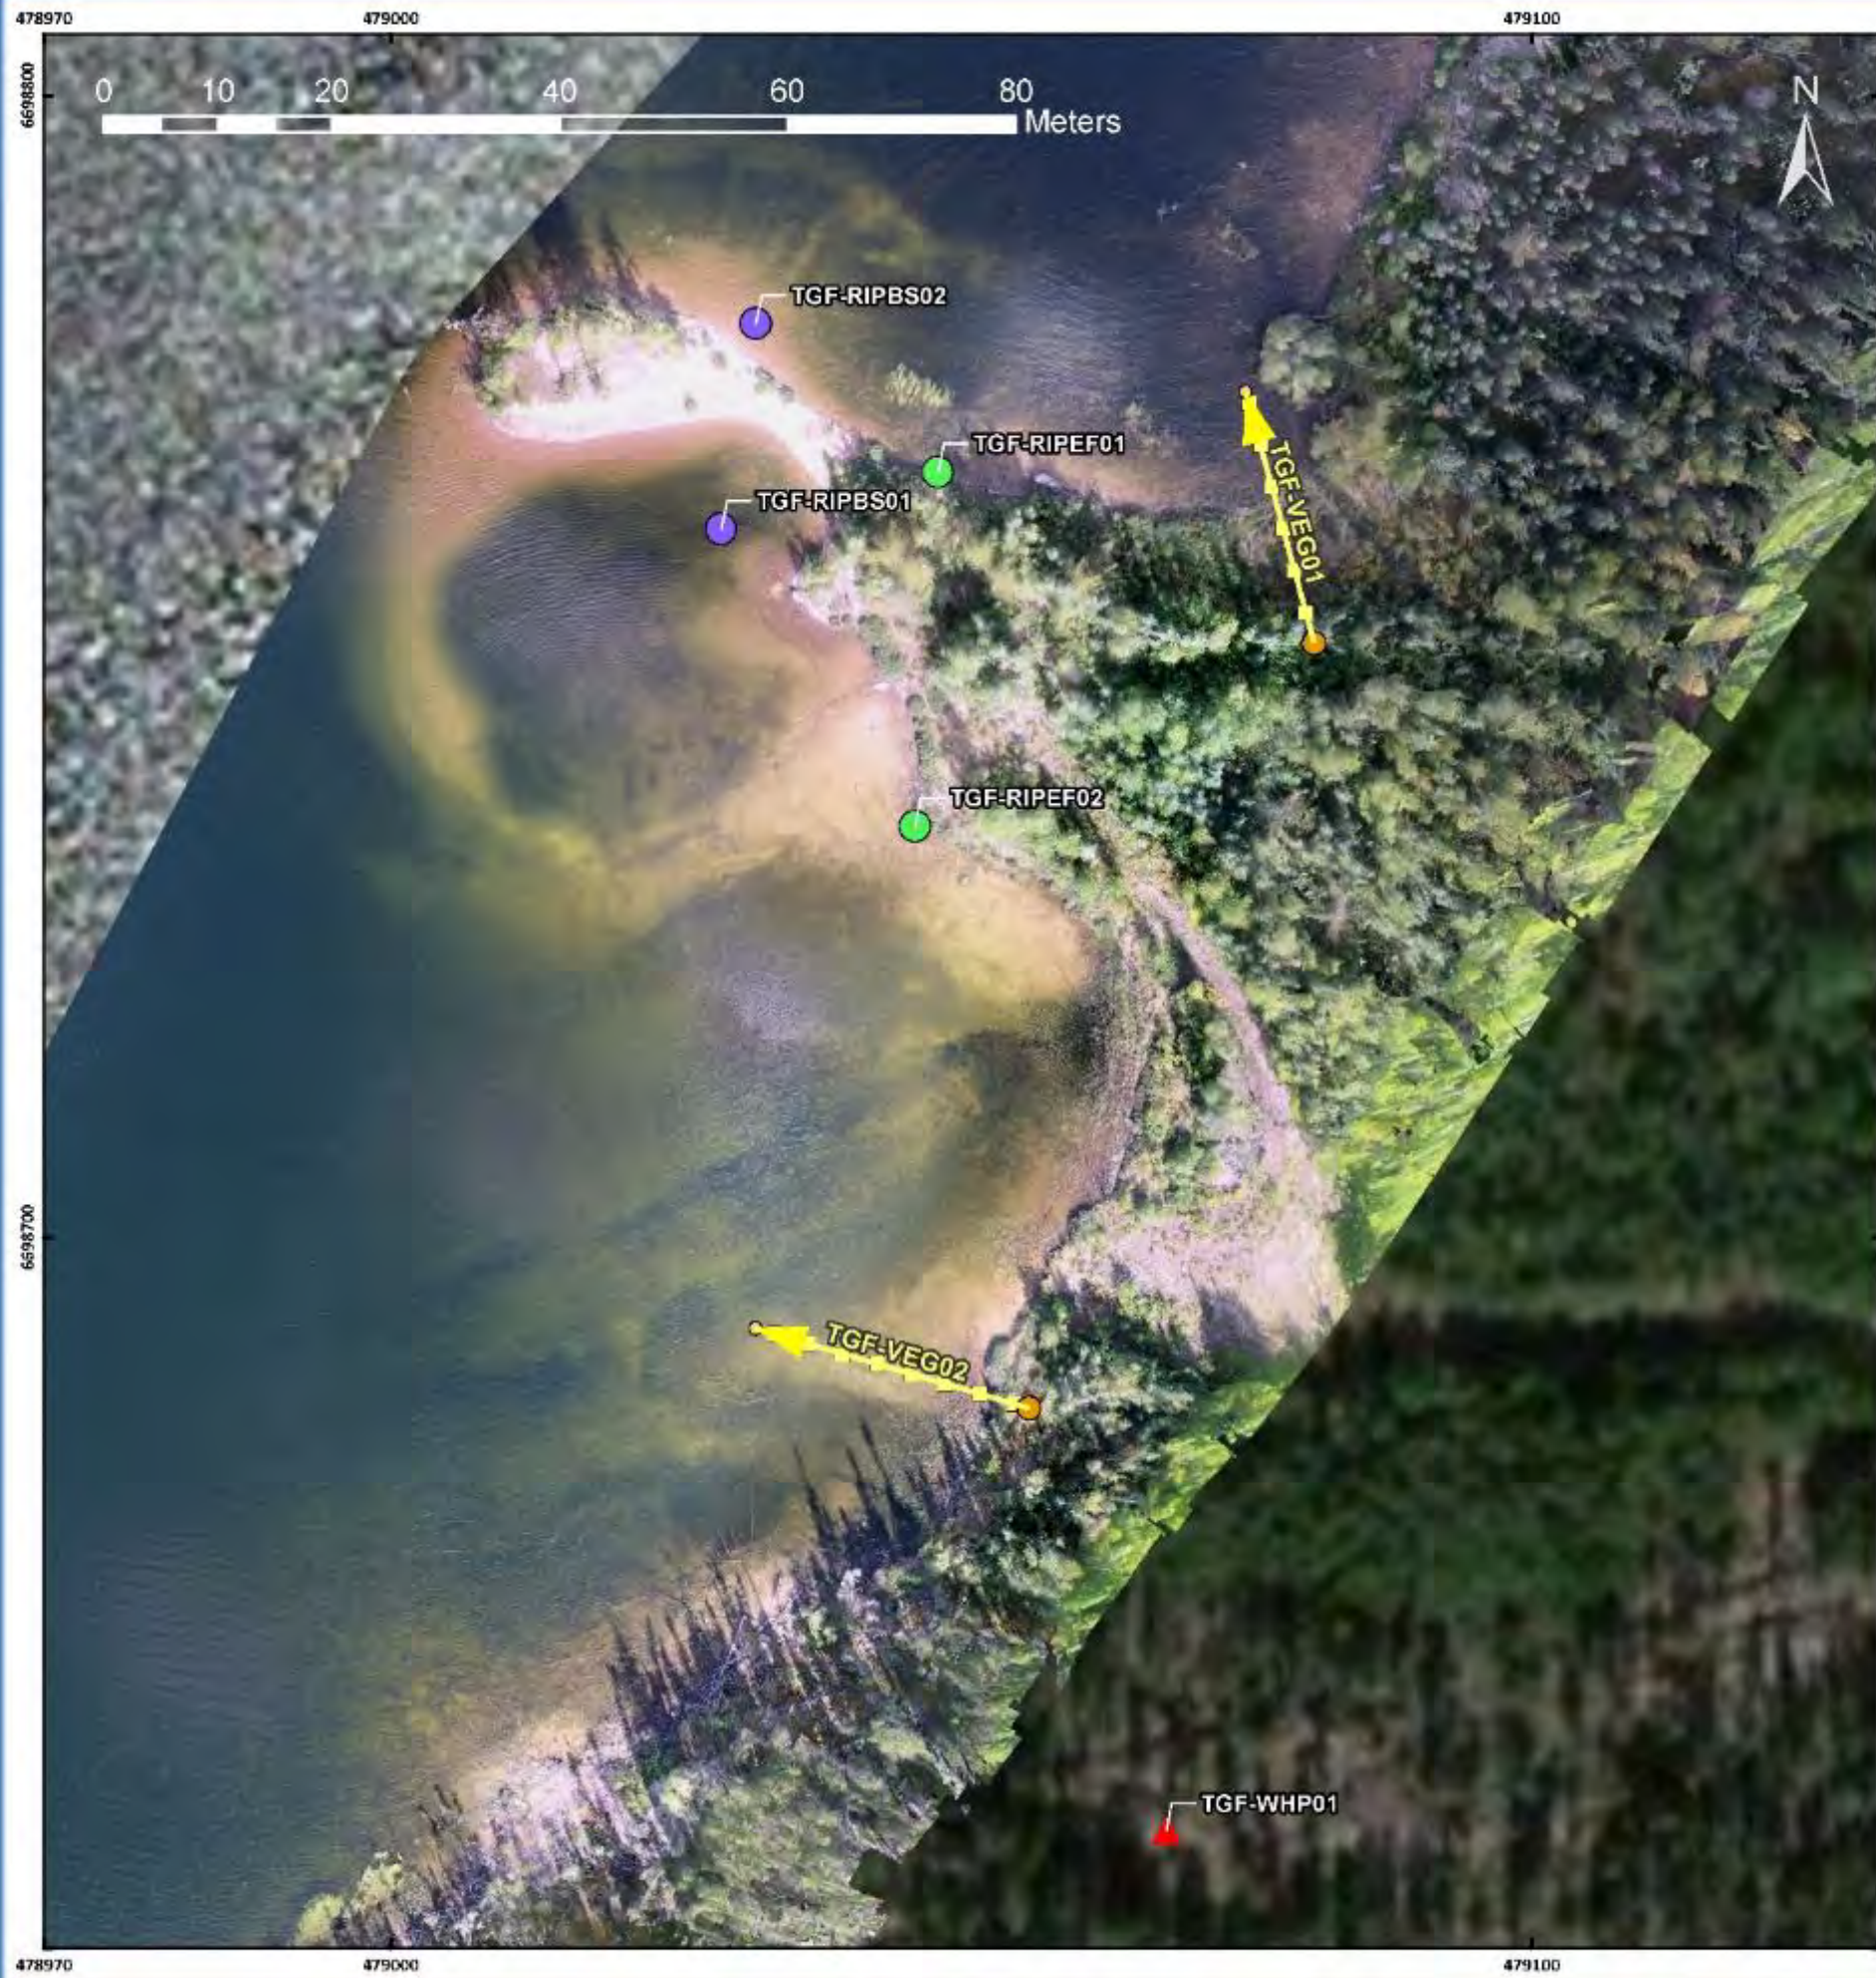
## Twin Gorges Forebay

### NTPC TALTSO Twin Gorge Mitigation Taltson Riparian Habitat and Fish Use Assessment Sites (2019)

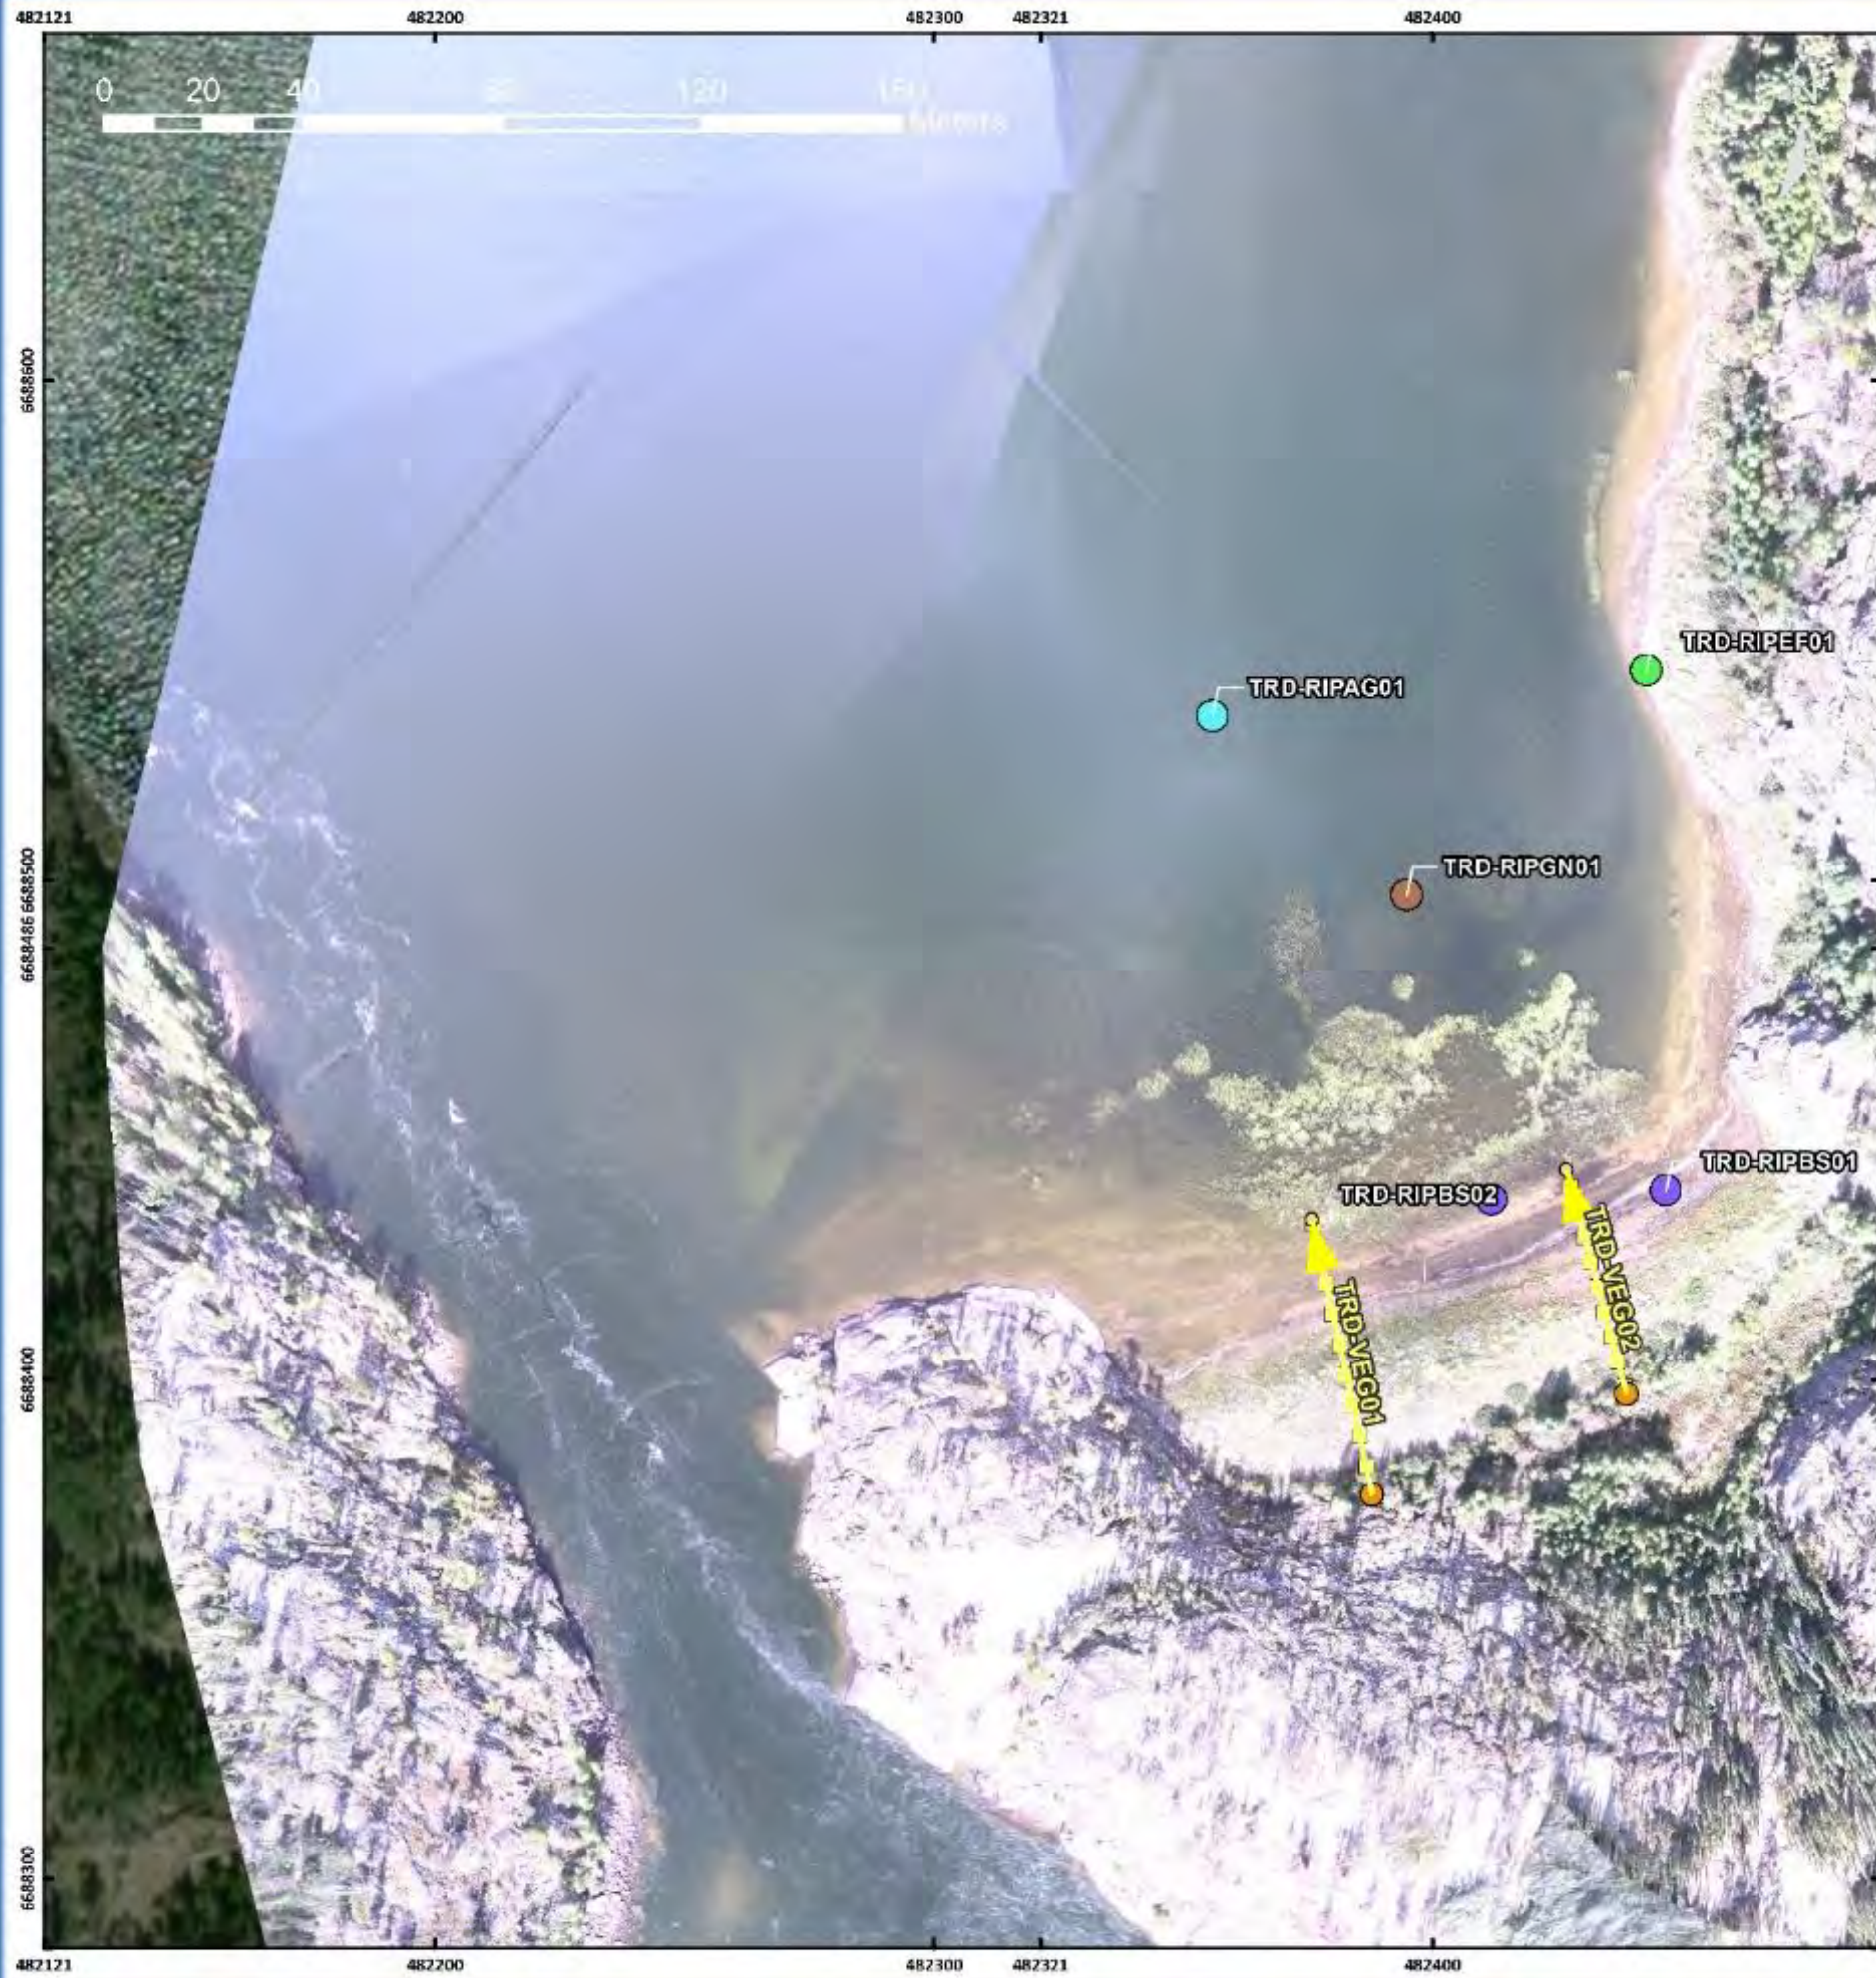
## Trudel Lake

### NTPC TALTSON Twin Gorge Mitigation Taltson Riparian Habitat and Fish Use Assessment Sites (2019)

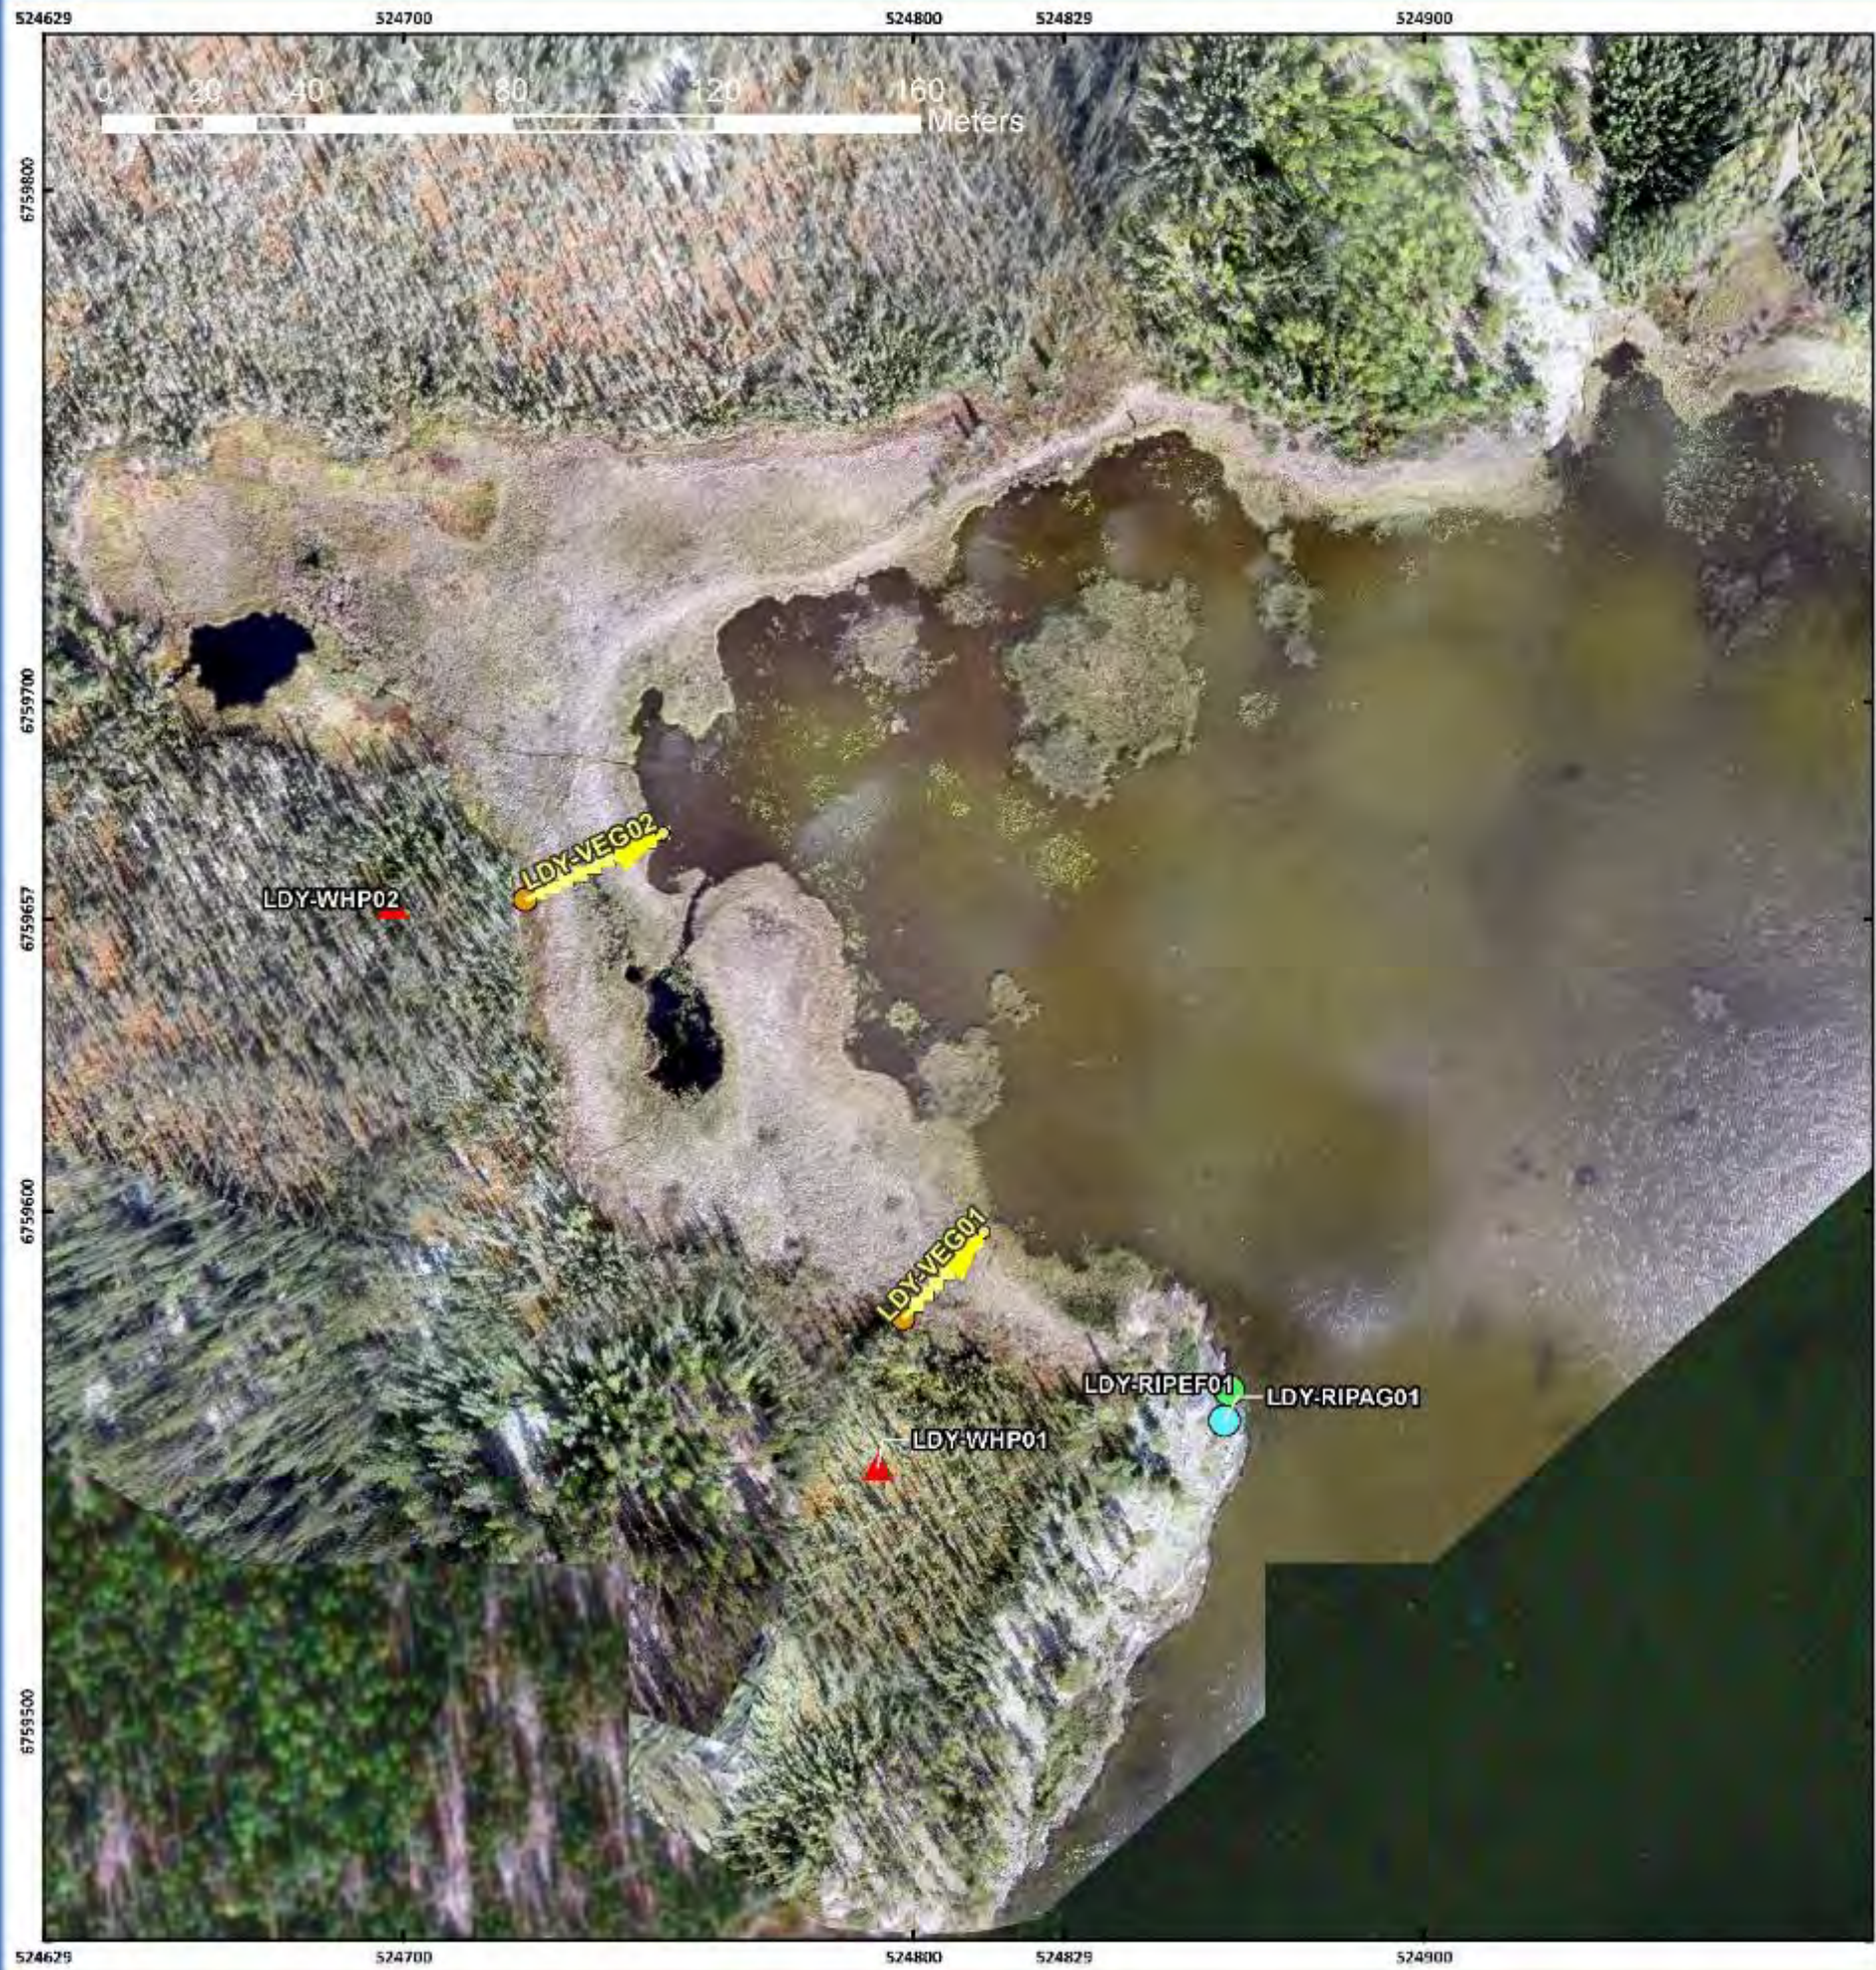
## Lady Gray Lake

### NTPC TALTSON Twin Gorge Mitigation Taltson Riparian Habitat and Fish Use Assessment Sites (2019)

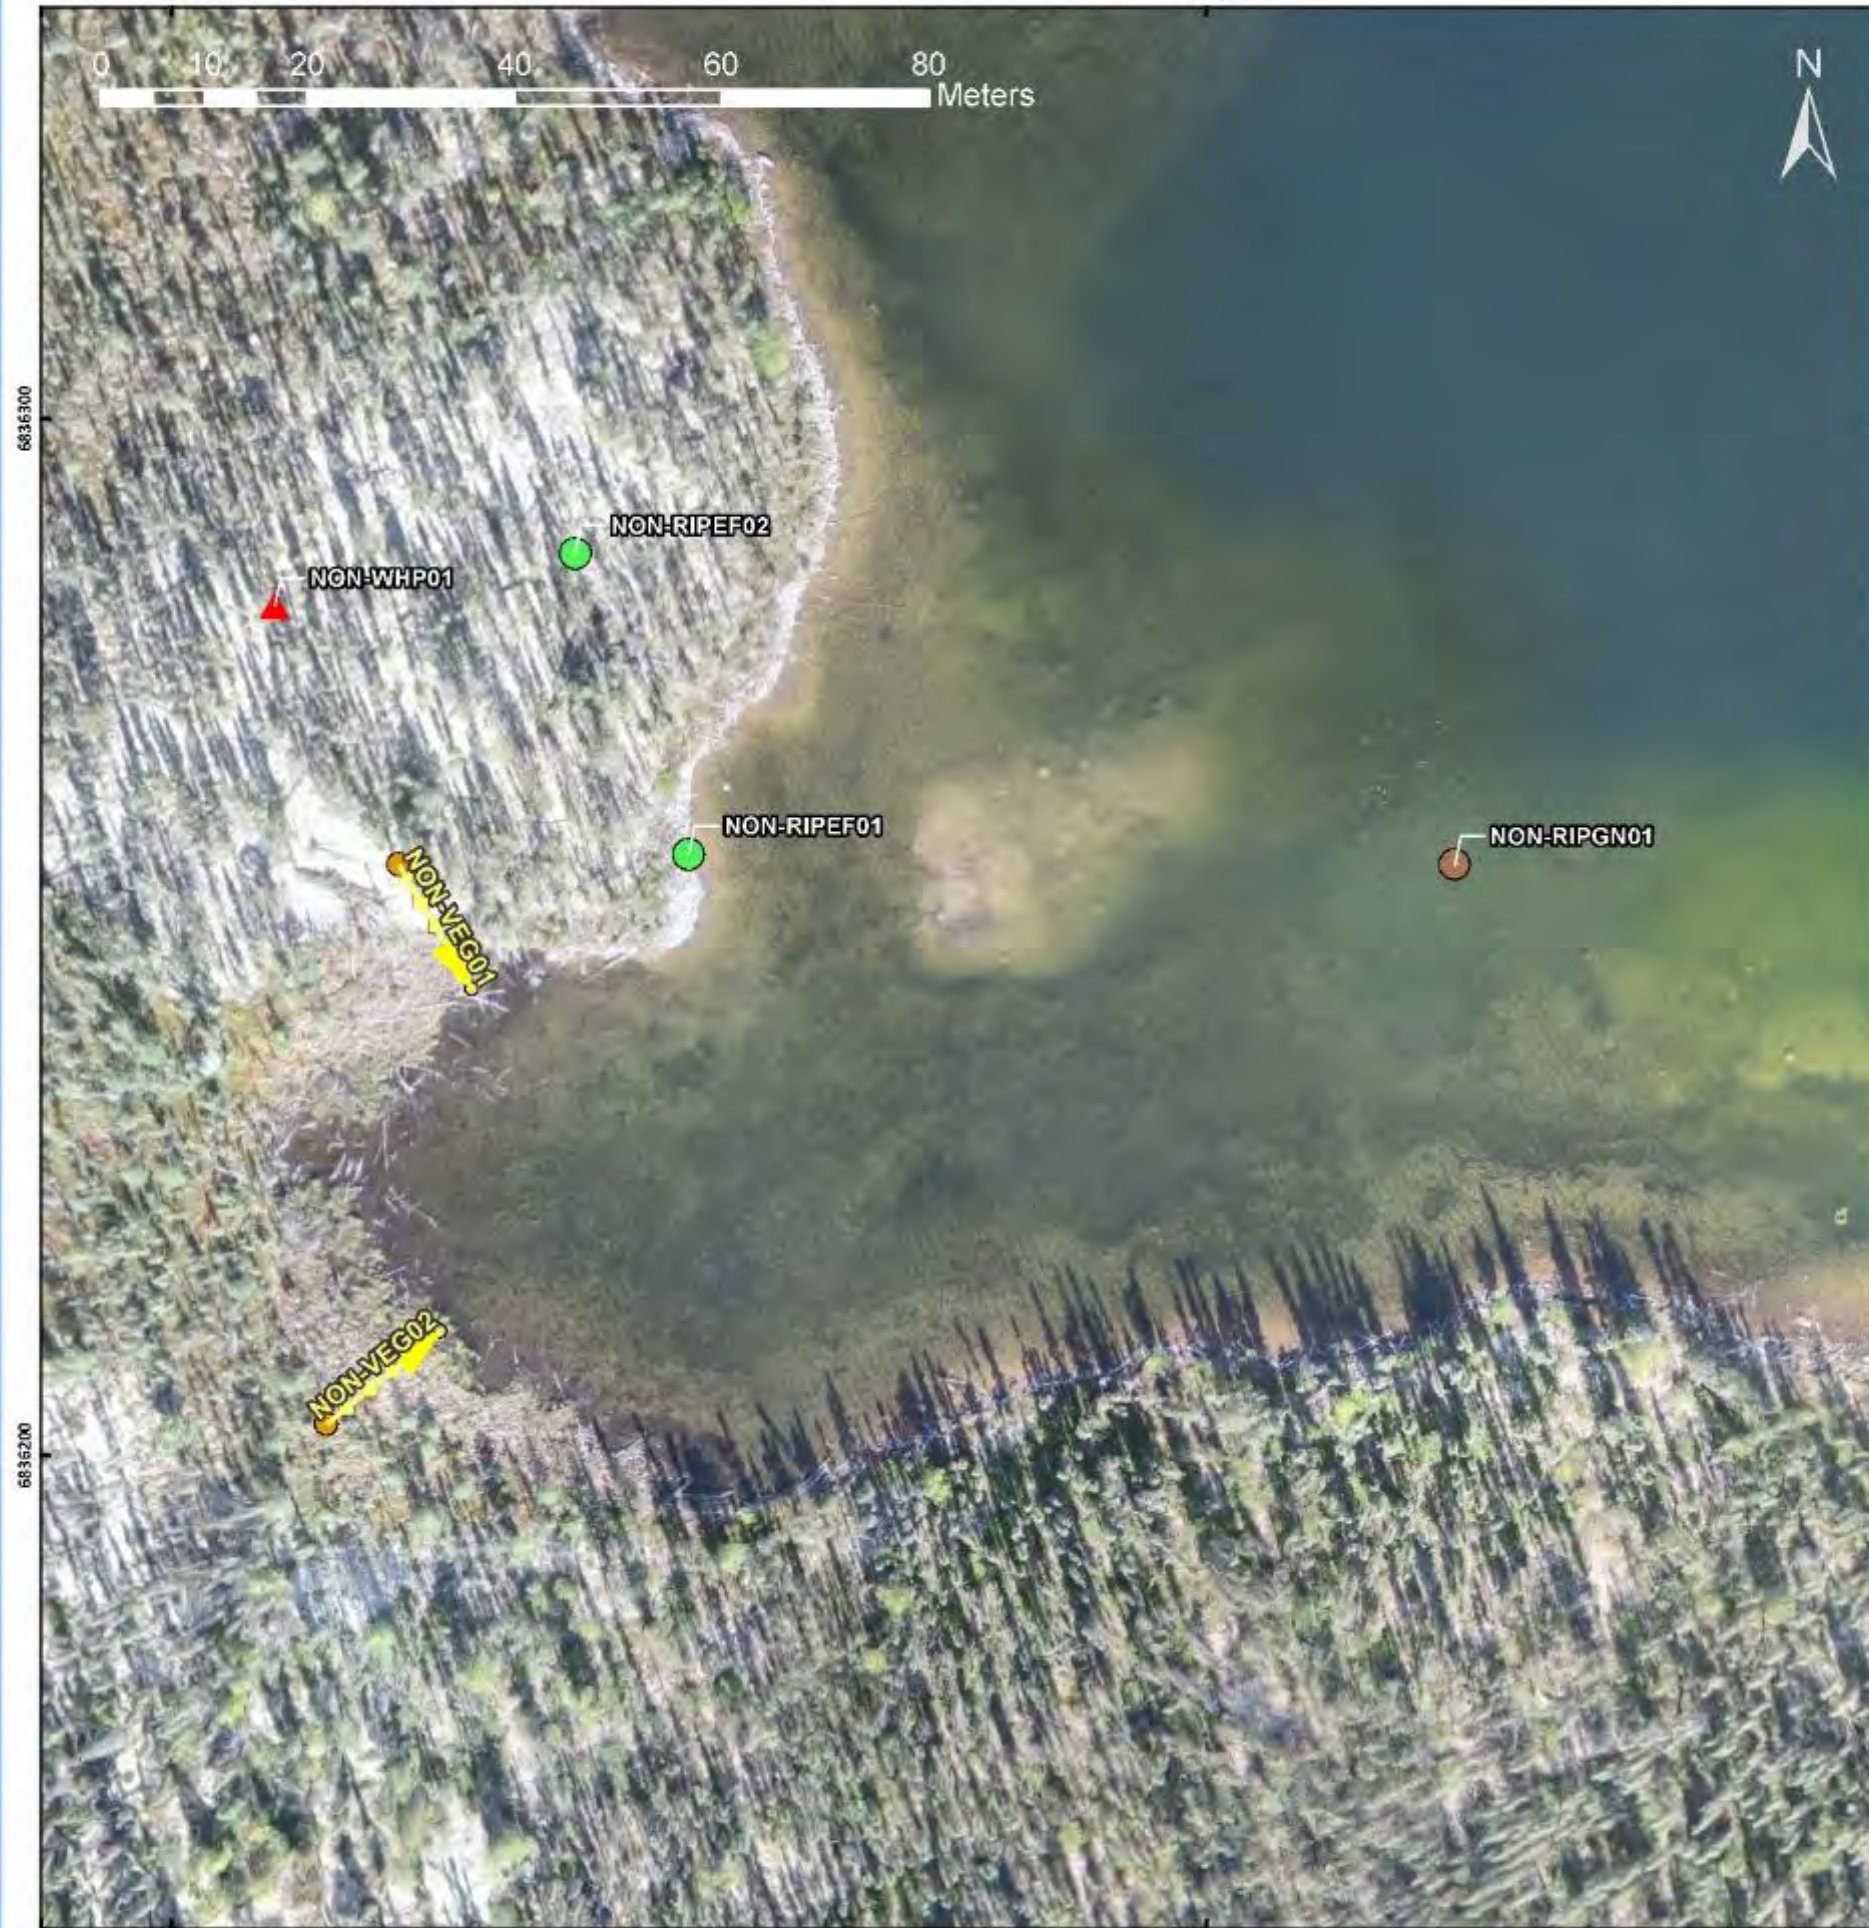
### Nonacho Lake

### NTPC TALTSON Twin Gorge Mitigation Taltson Riparian Habitat and Fish Use Assessment Sites (2019)

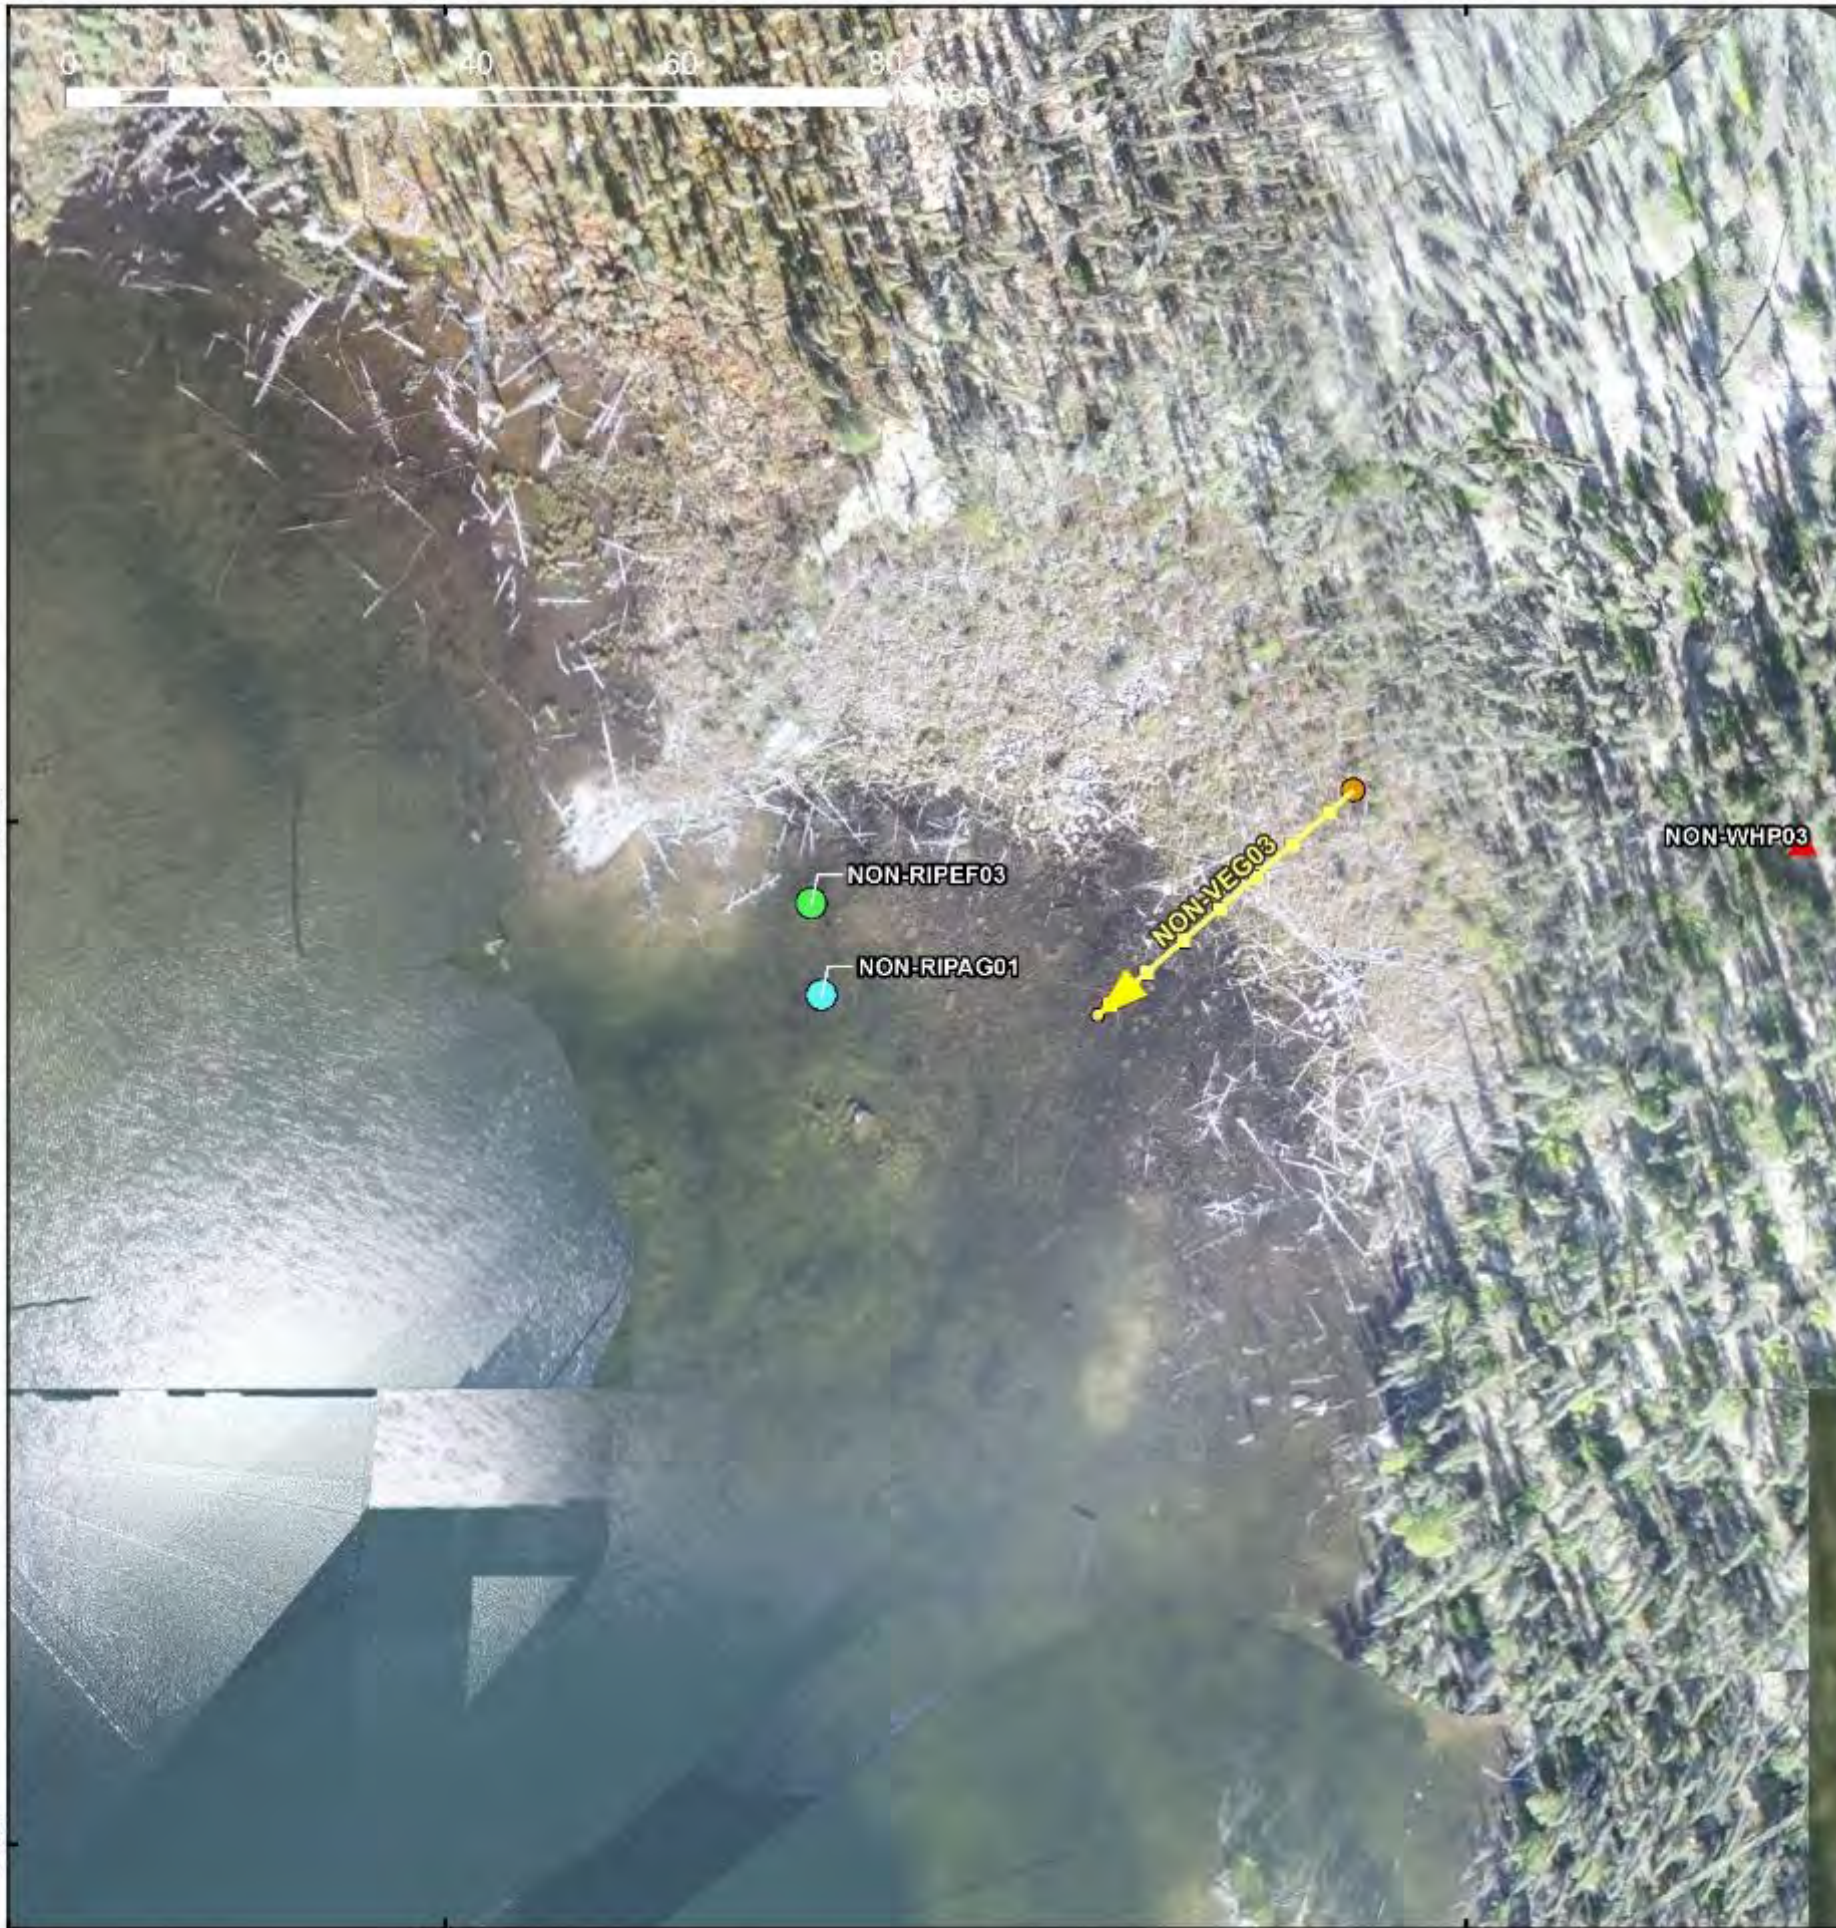
## Nonacho Lake

### NTPC TALTSON Twin Gorge Mitigation Taltson Riparian Habitat and Fish Use Assessment Sites (2019)

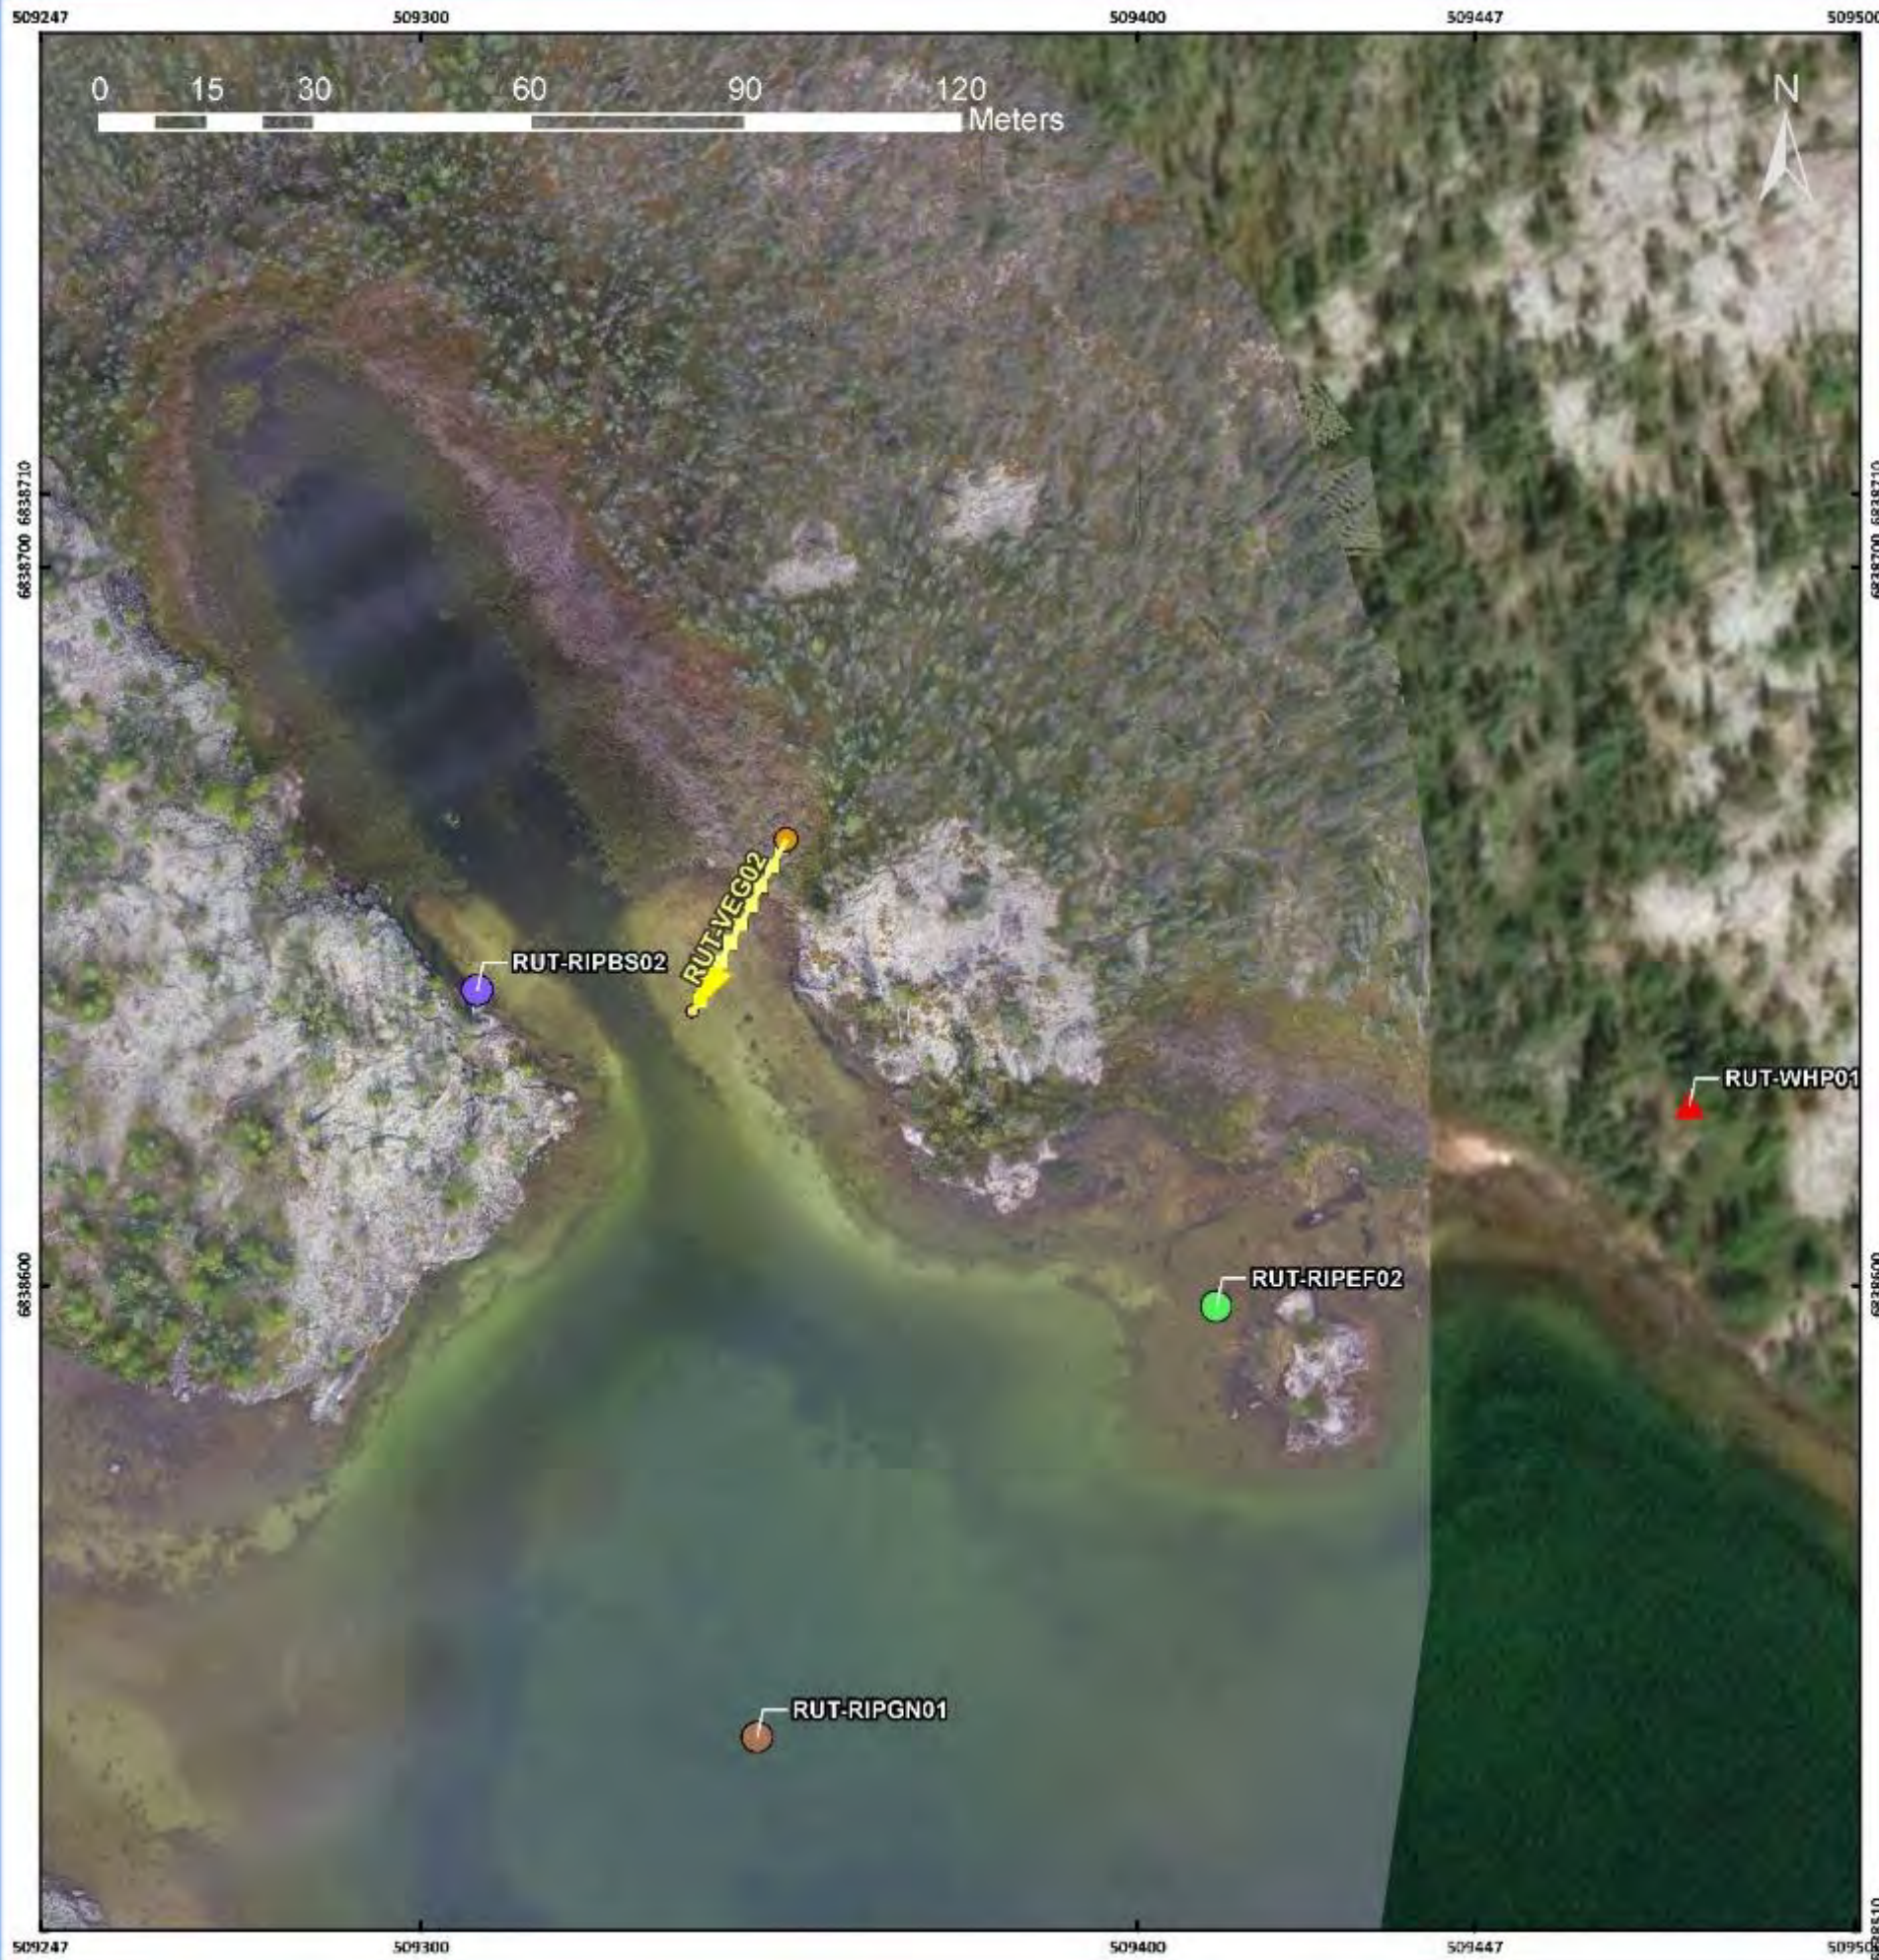
### Rutledge Lake

### NTPC TALTSON Twin Gorge Mitigation Taltson Riparian Habitat and Fish Use Assessment Sites (2019)
