NORTHWEST TERRITORIES  
**POWER  
CORPORATION**

## EXECUTIVE SUMMARY

**NTPC TALTSO AQUATIC EFFECTS MONITORING PROGRAM**  
**Fish, Sediment Quality, and Water Quality Sample Sites in Nonacho Lake**

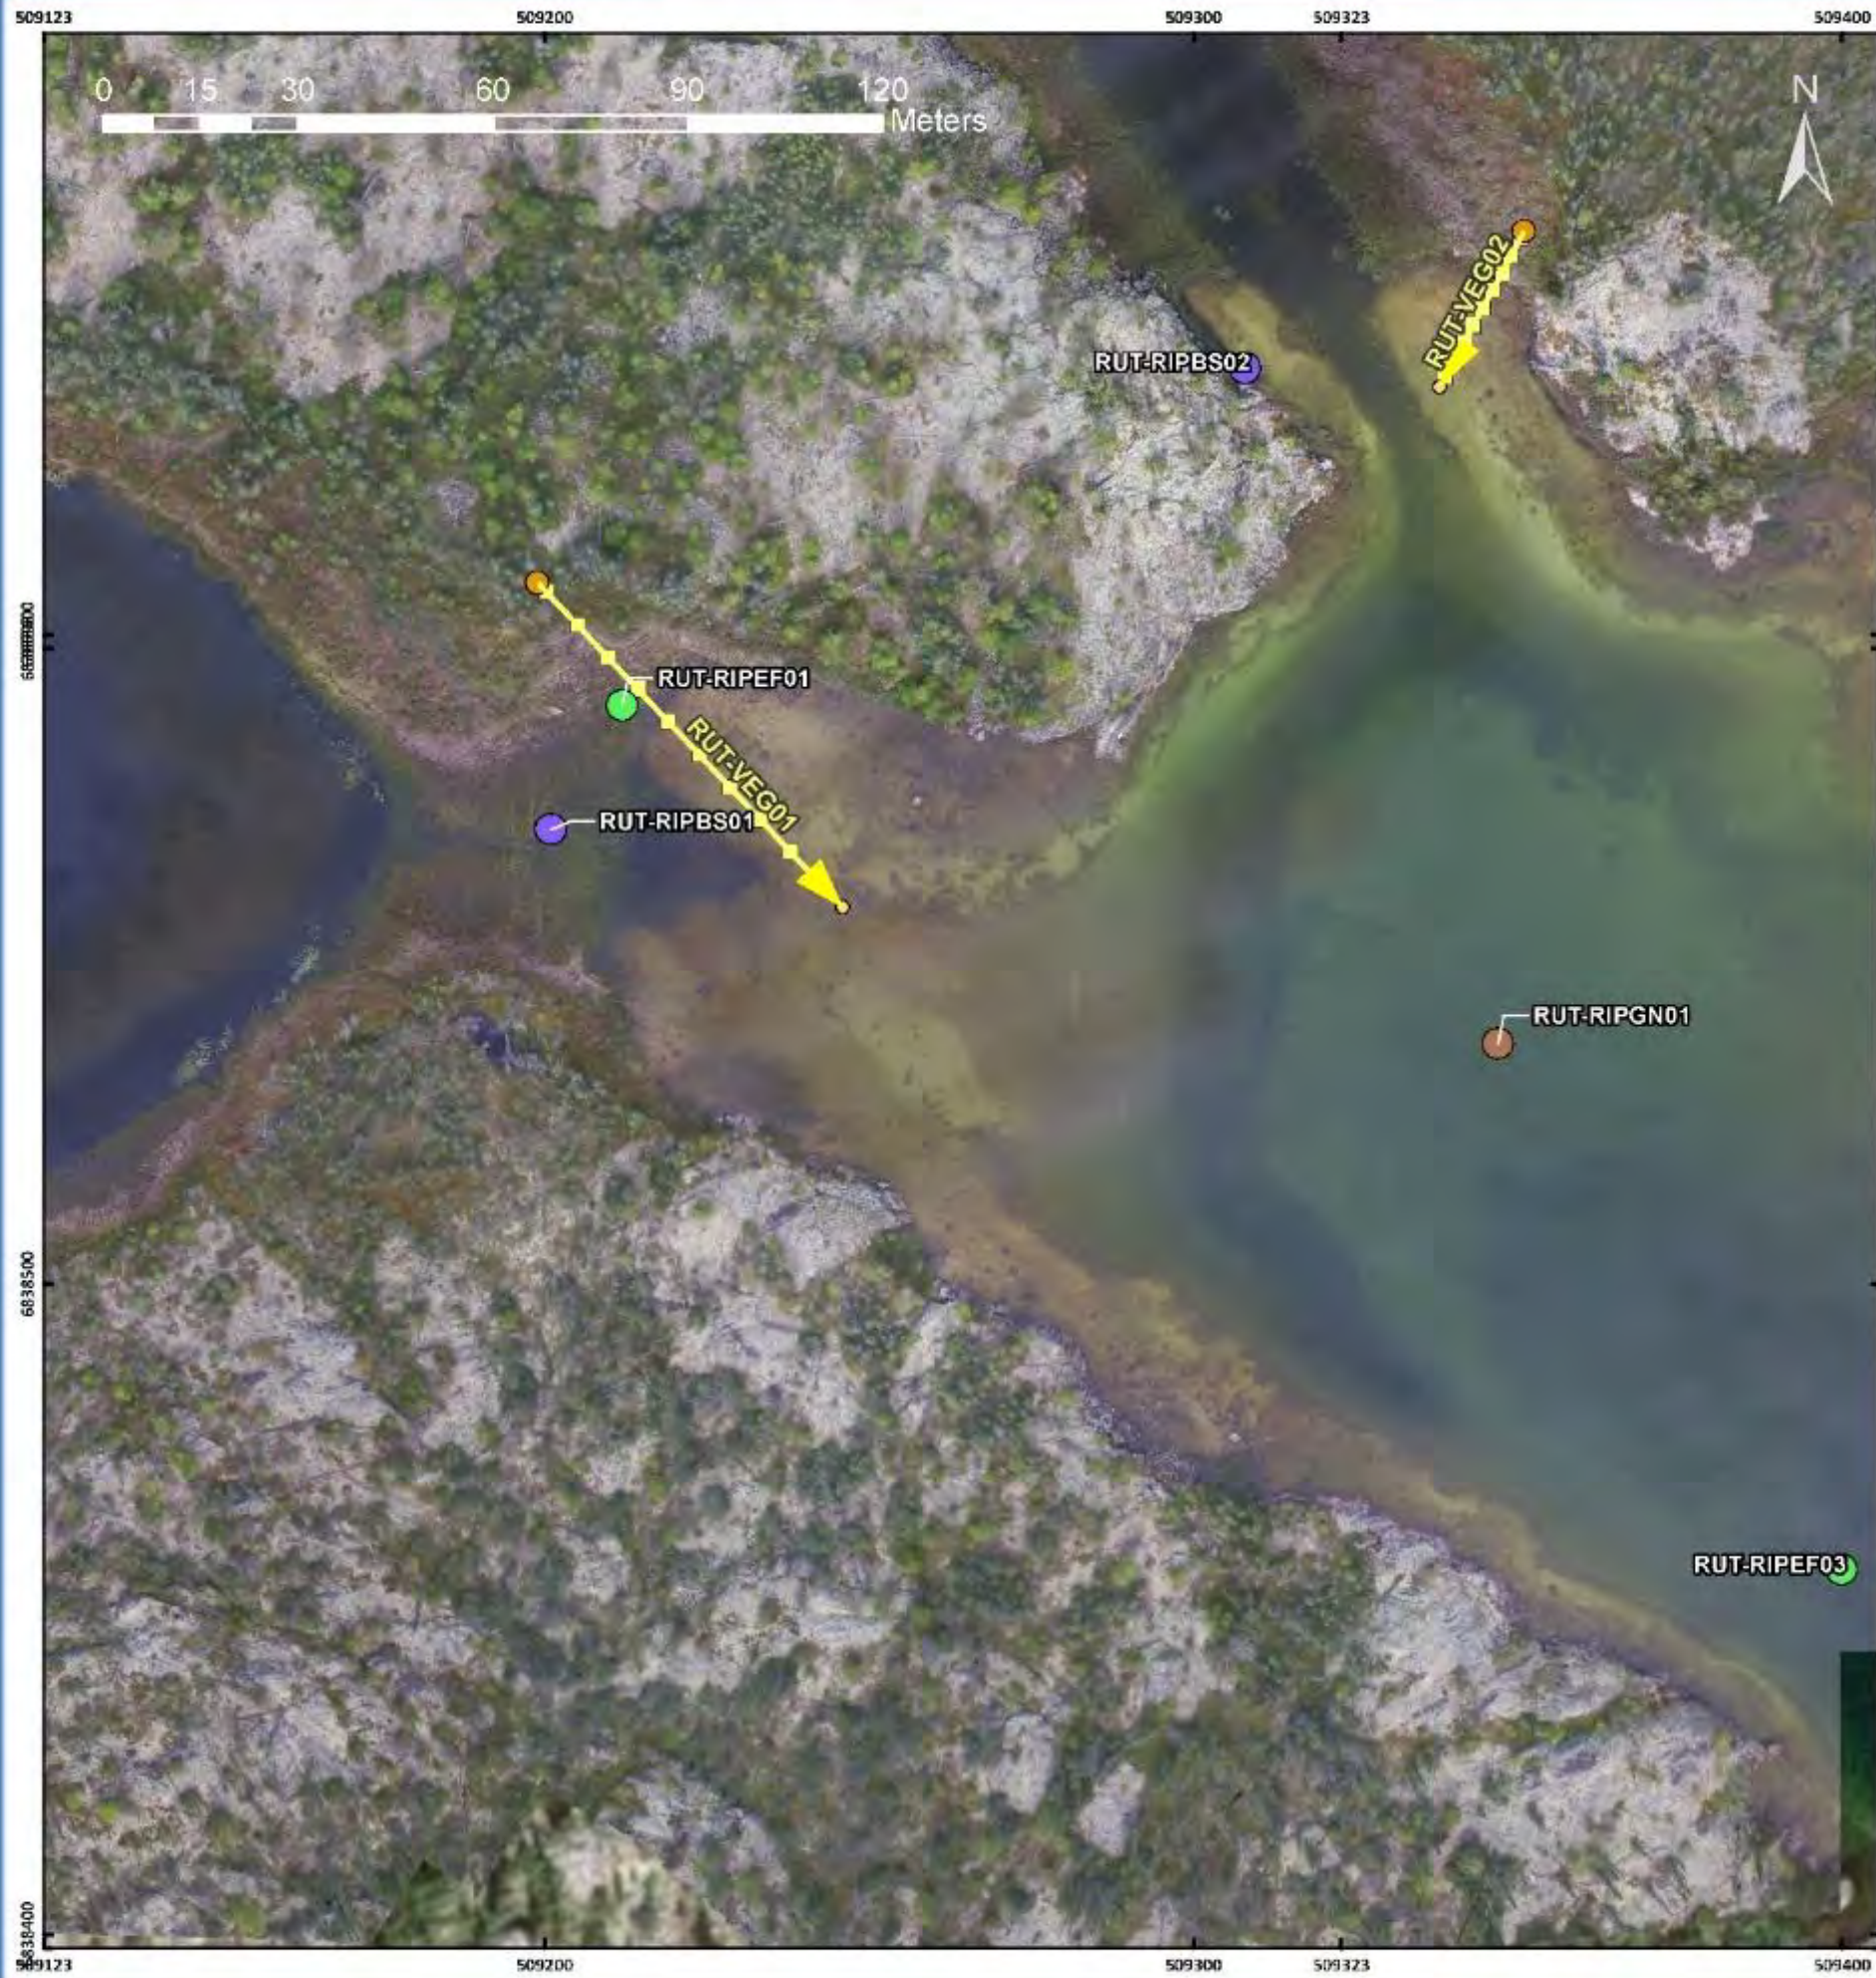
### Rutledge Lake

### NTPC TALTSON Twin Gorge Mitigation Taltson Riparian Habitat and Fish Use Assessment Sites (2019)

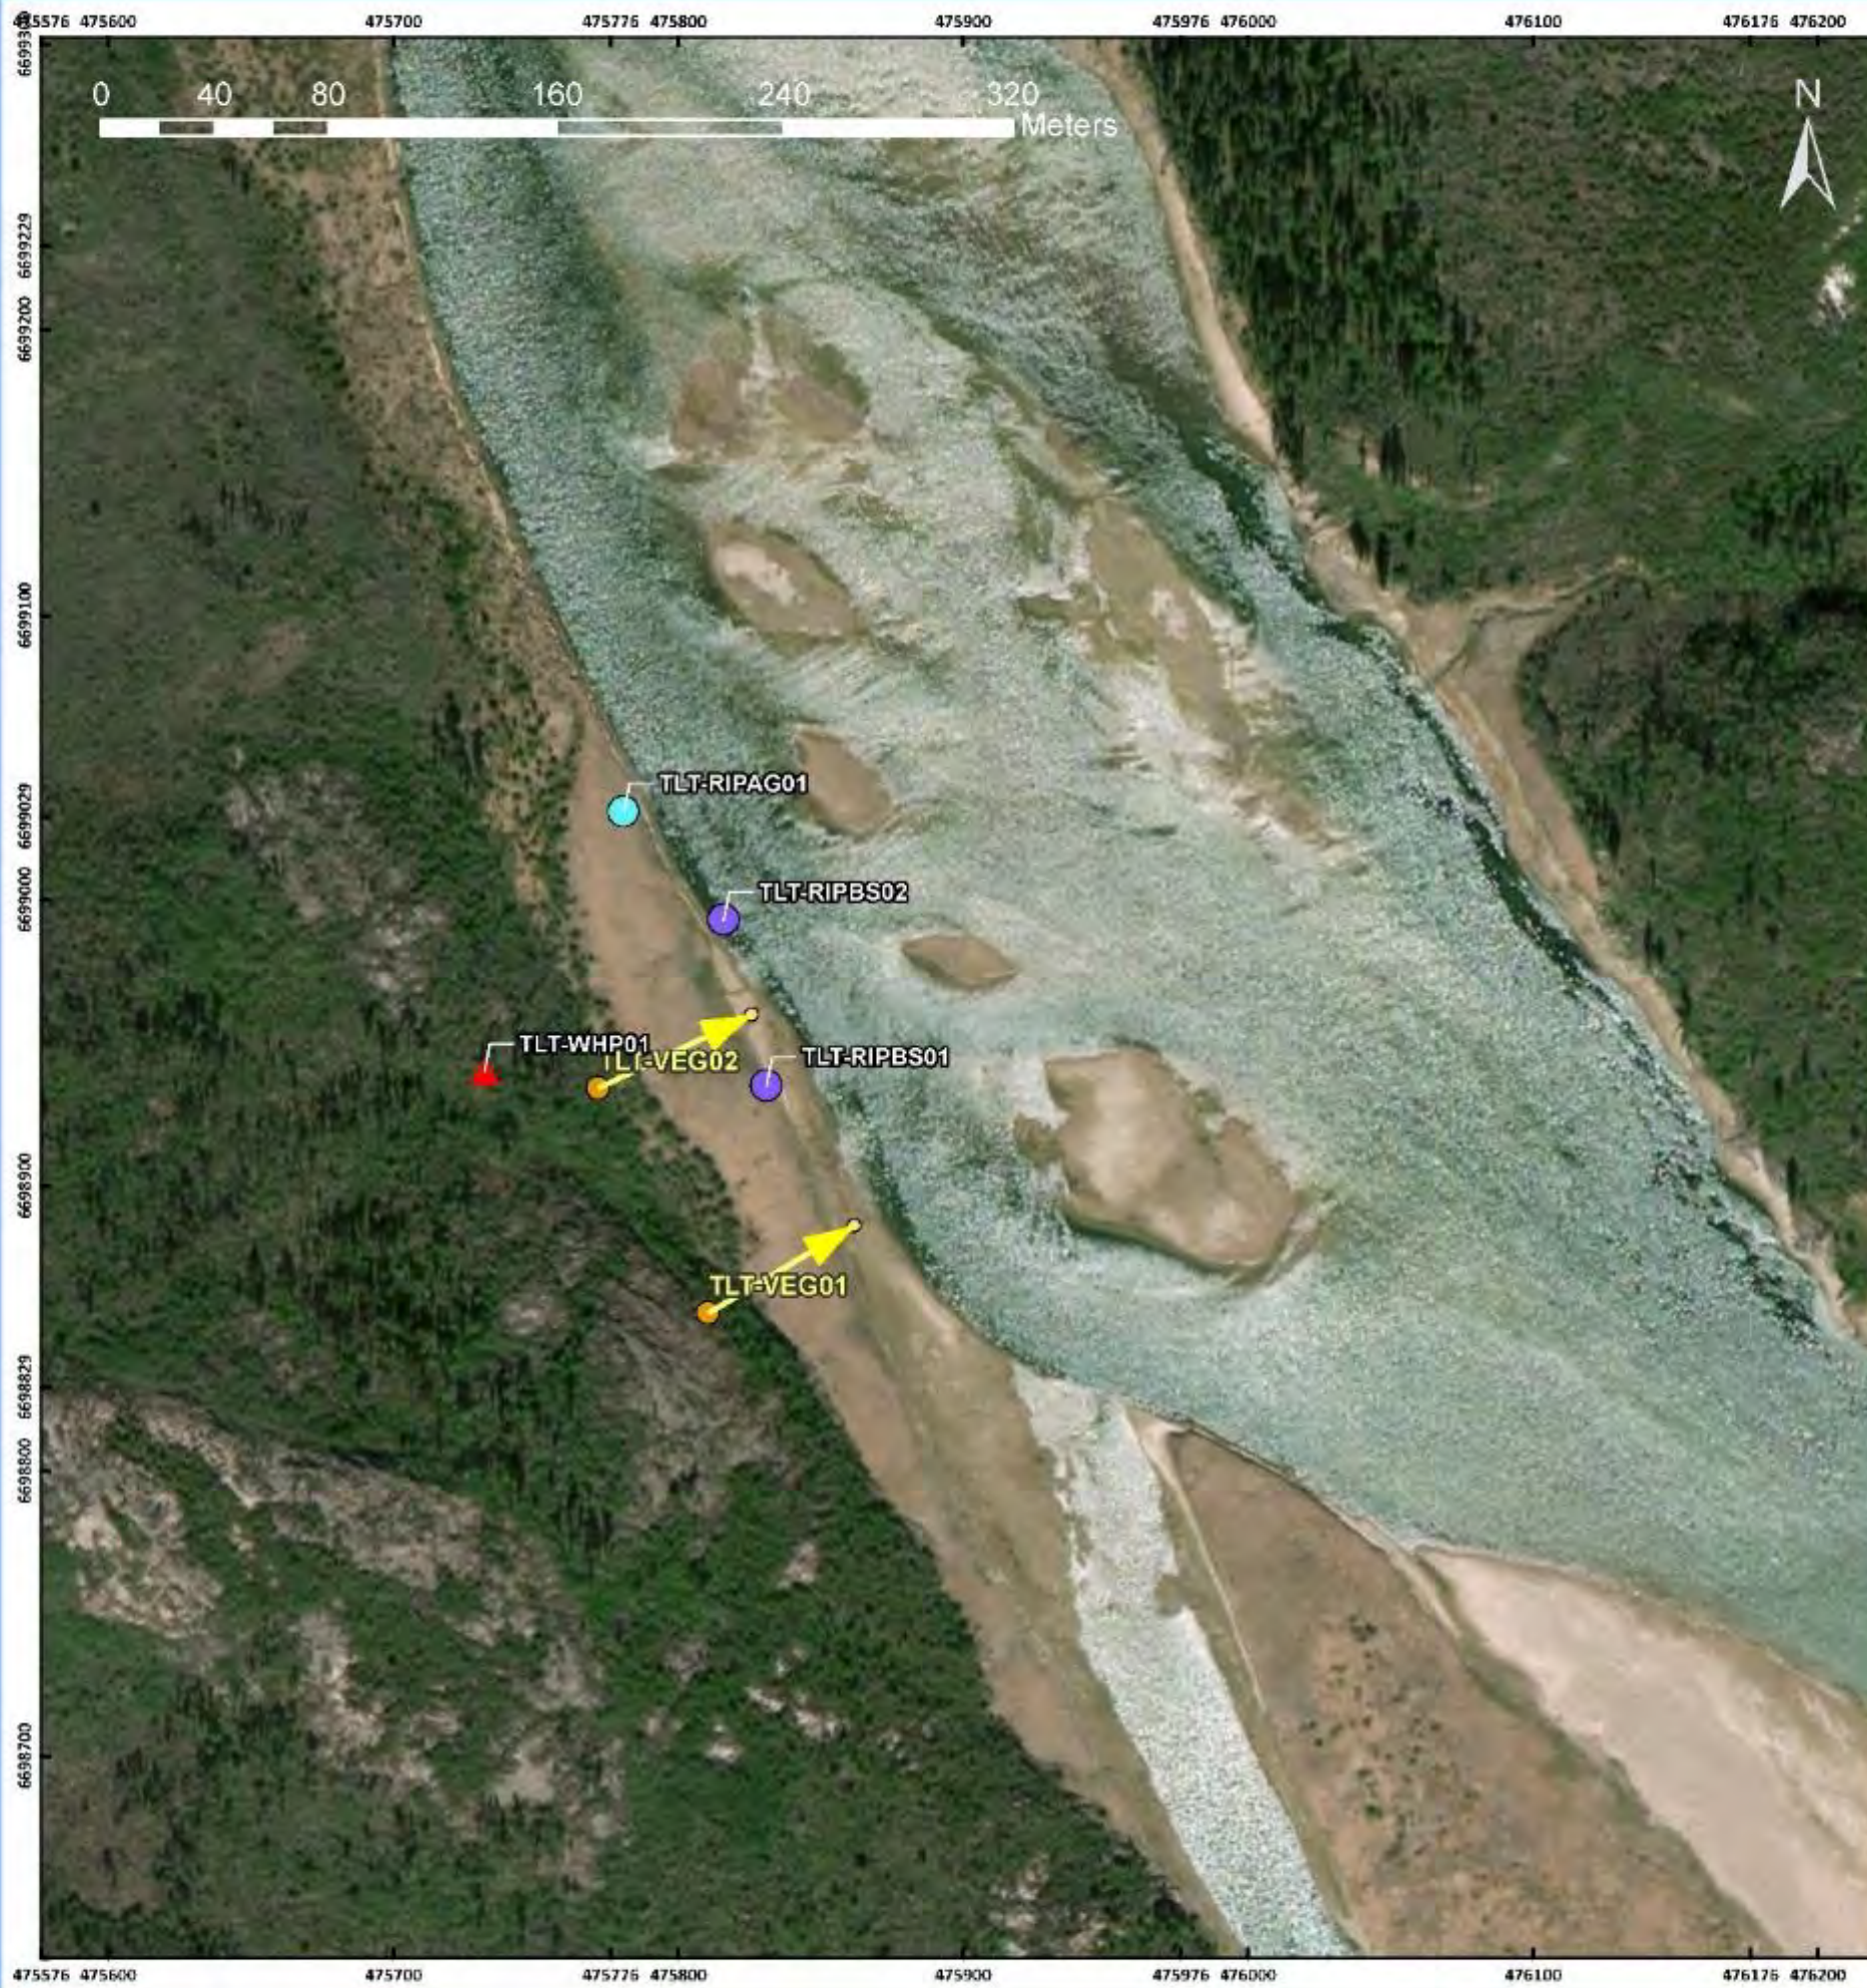
## Talston River

### NTPC TALTSON Twin Gorge Mitigation Taltson Riparian Habitat and Fish Use Assessment Sites (2019)

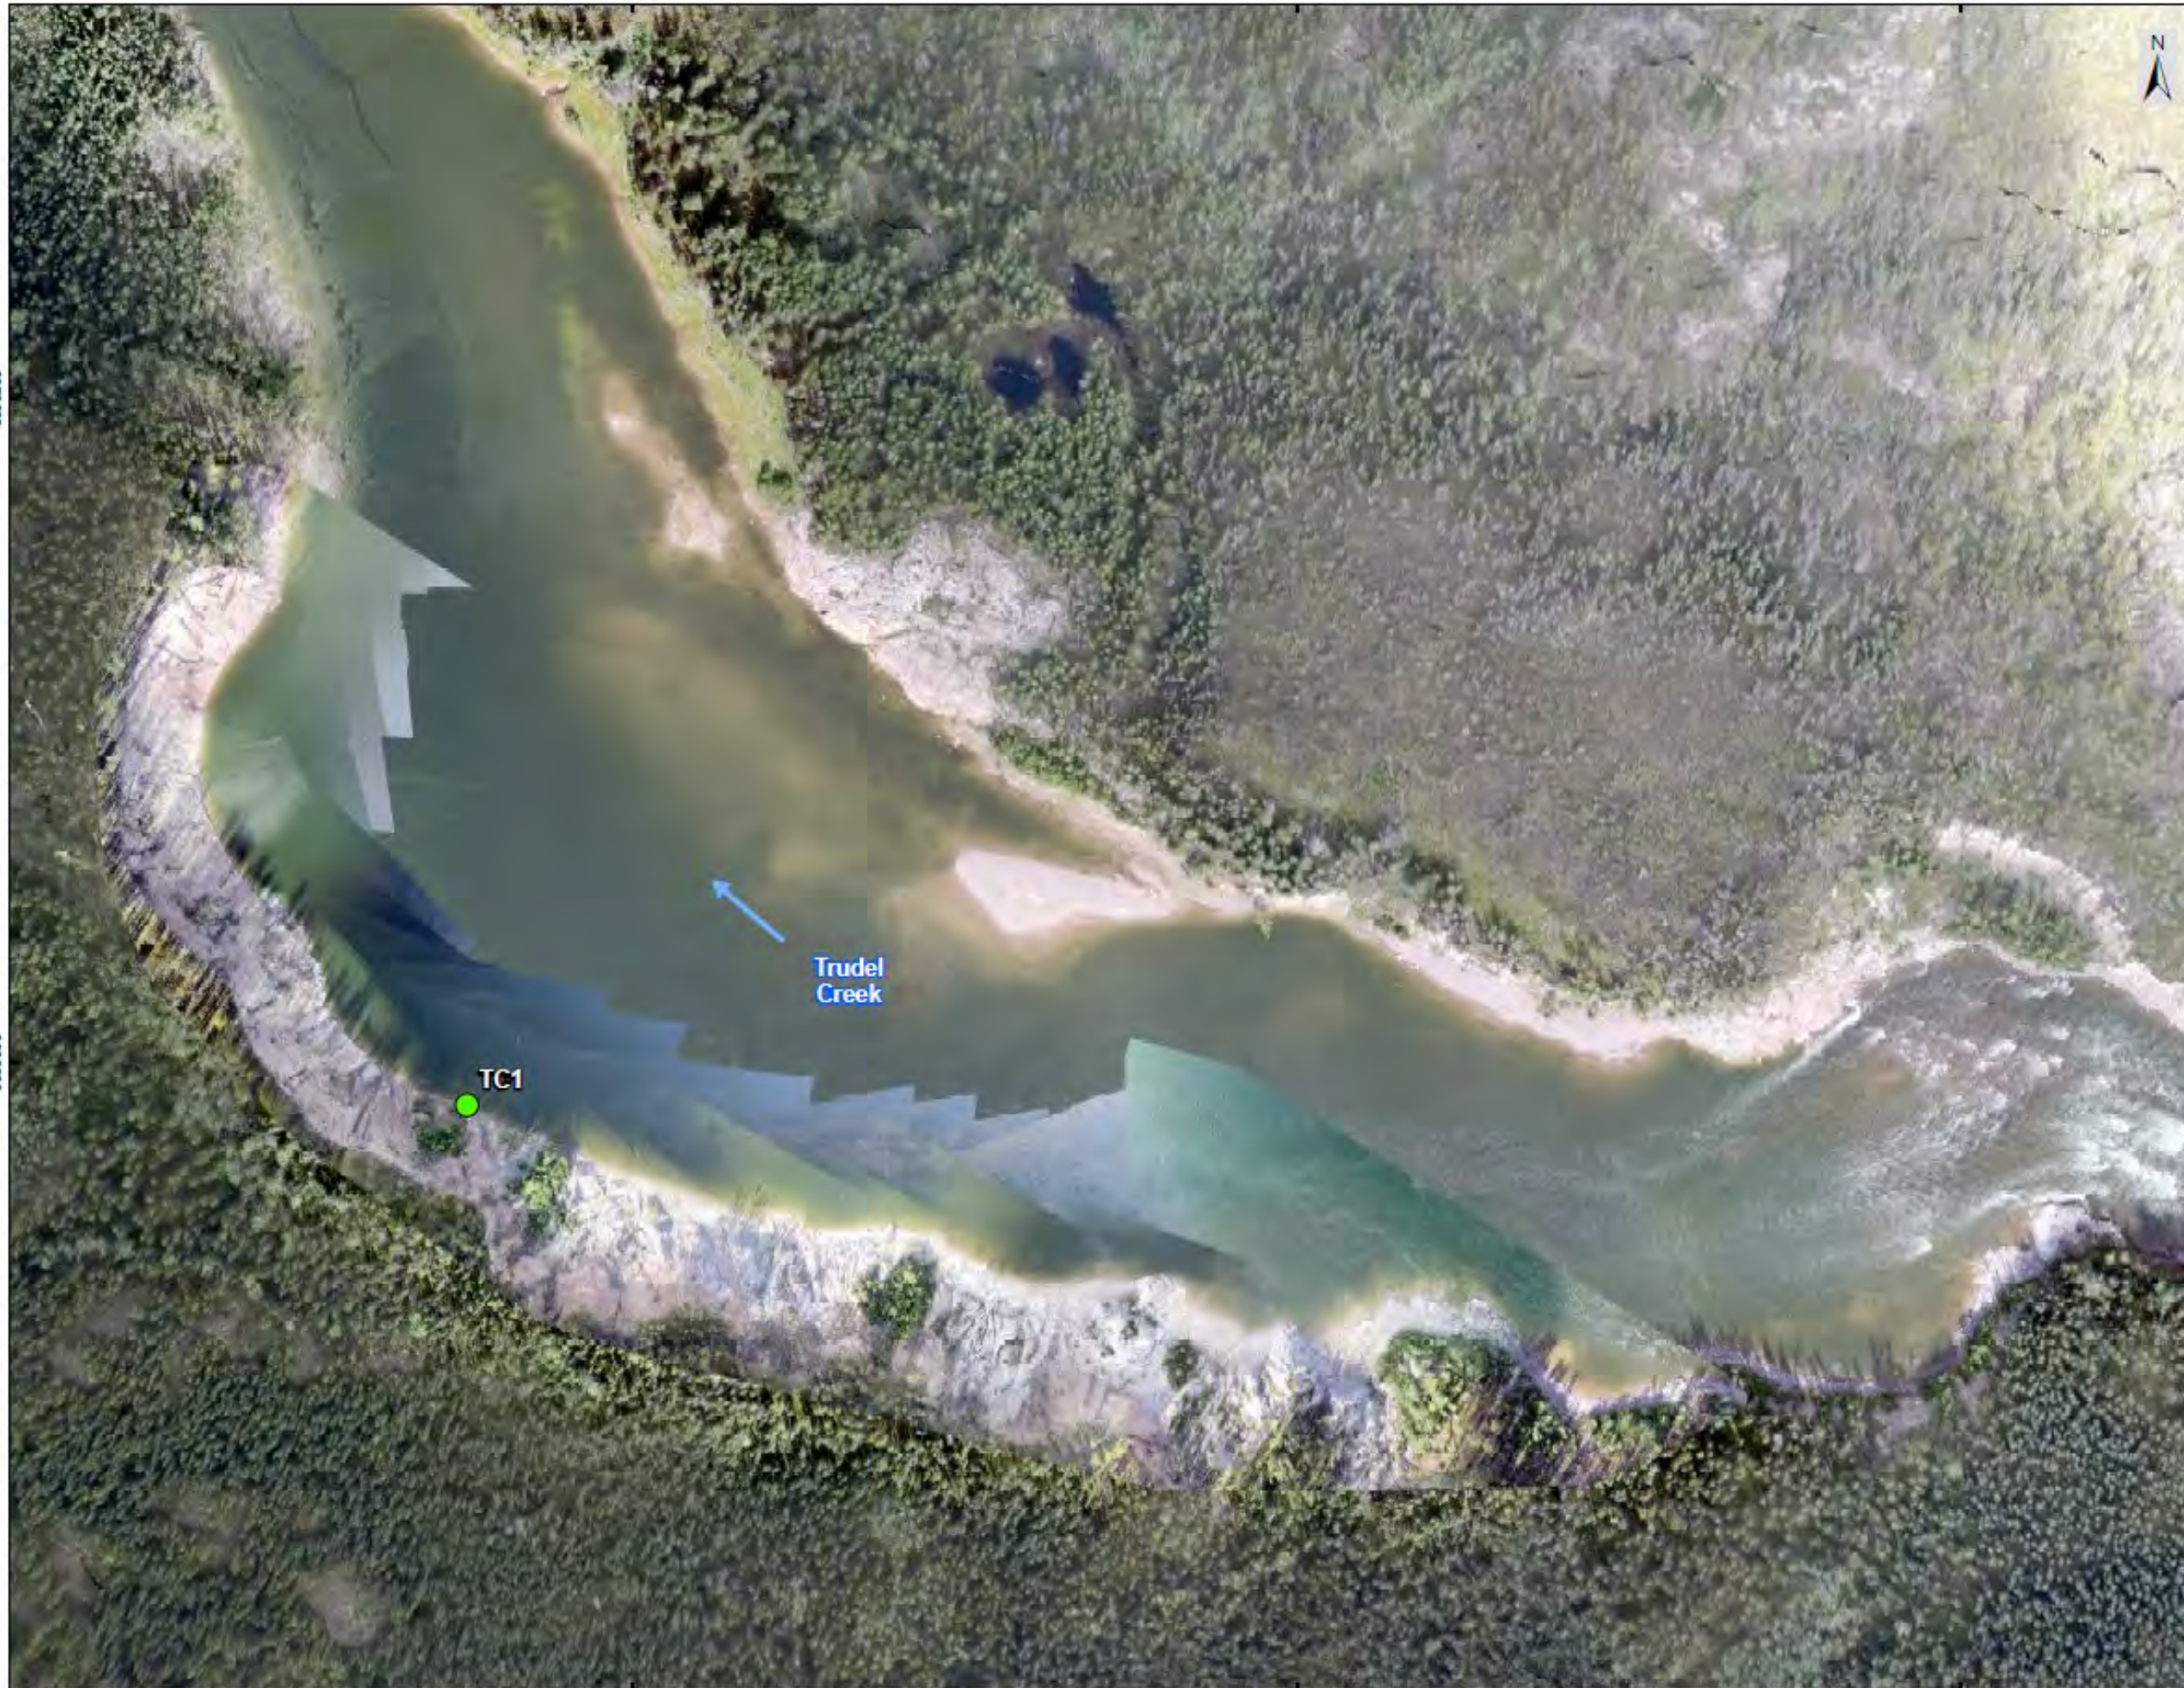
**Trudel TC1**

TALTSON HYDROELECTRIC PROJECT  
SEDIMENT AND EROSION MONITORING PROGRAM
