Overview of Taltson Hydroelectric Facility and Nonacho Lake Operations

MV2011L4-0002

NTPC Compensation Claim Re-Hearing Presentation

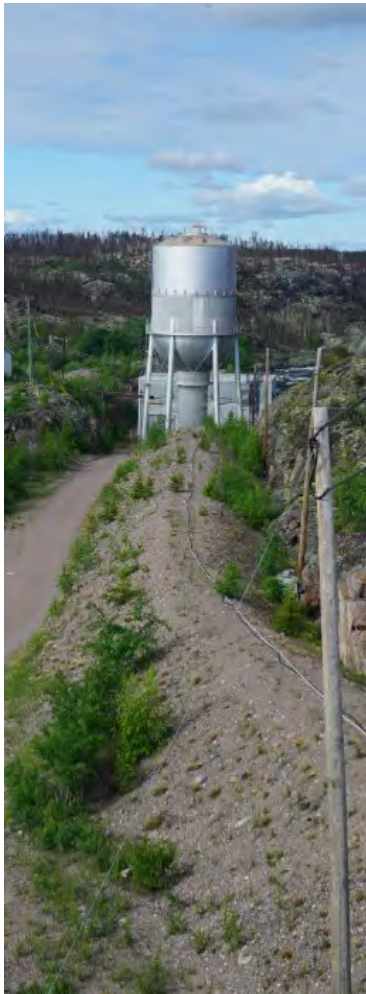
Twin Gorges Generating Station

- Installed in 1965
- 18 MW power generation capacity
- Since the closure of Pine Point Mine has run under capacity at 8-12 MW
- Operates similar to a run-of-river power generation facility

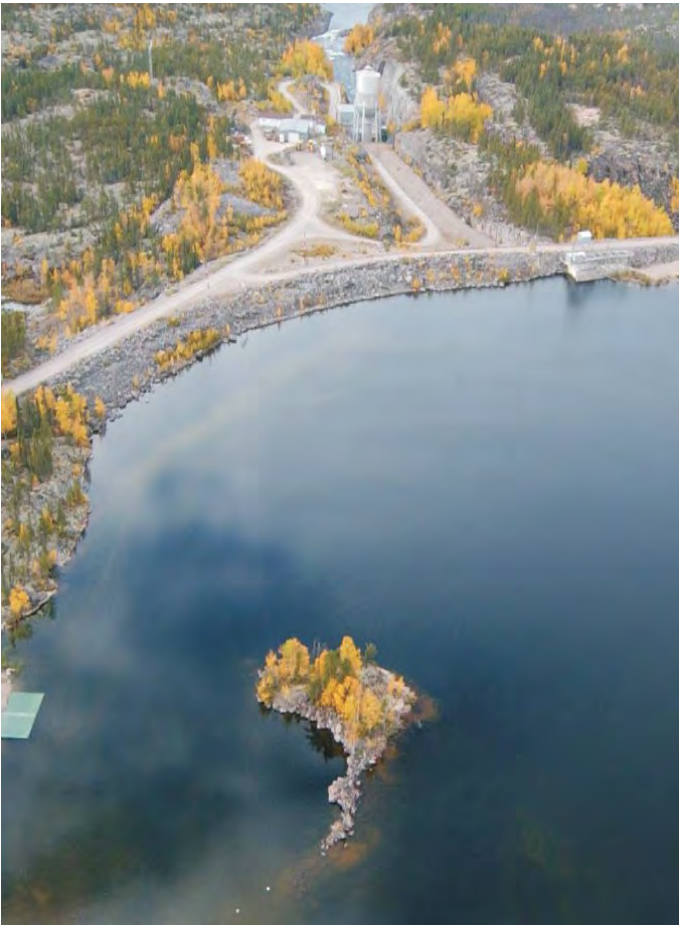
Twin Gorges Reservoir

- Provides storage for Twin Gorges Generating Station
- Excess water spills through the South Valley Spillway located 6 km upstream of the main dam
- Power generation has minimal impact on flows in the basin as much more water flows through spillway than through the plant

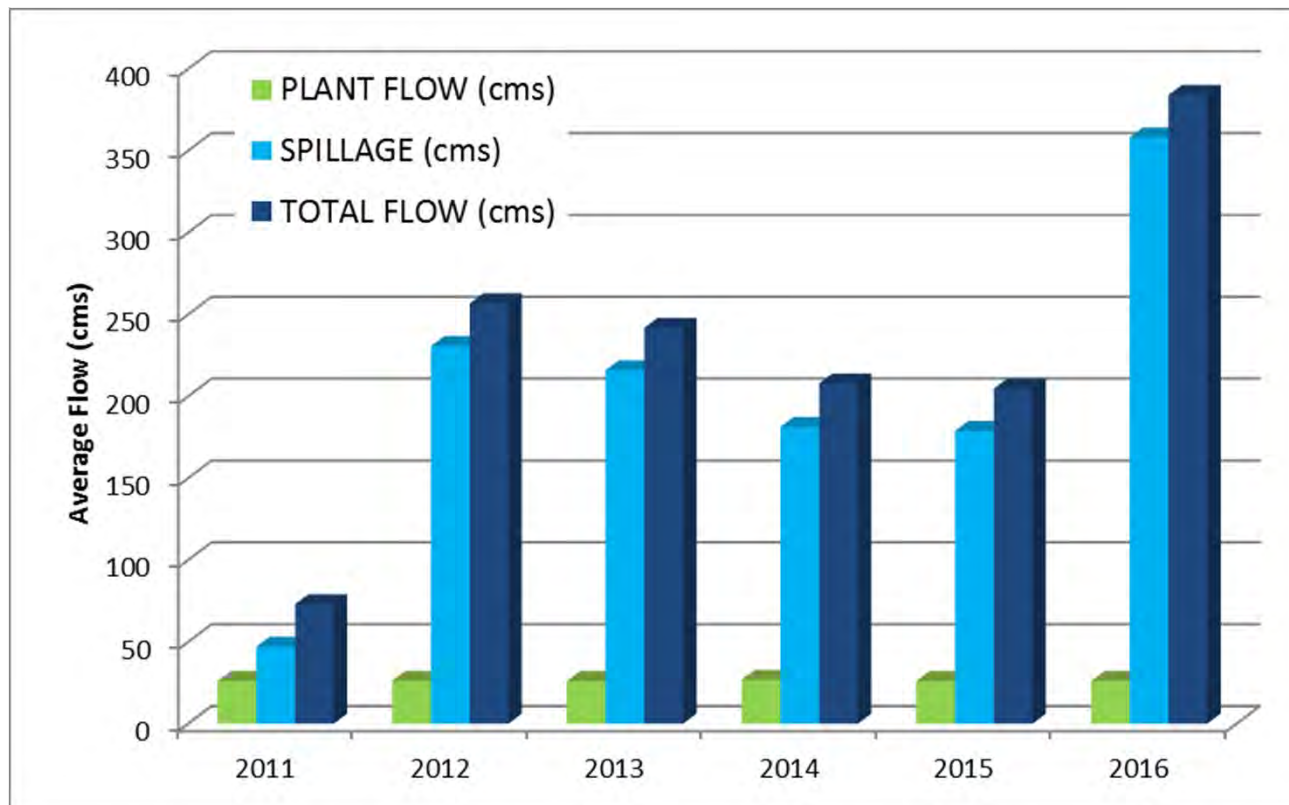
- Average outflow from Twin Gorges Reservoir 2011-2016

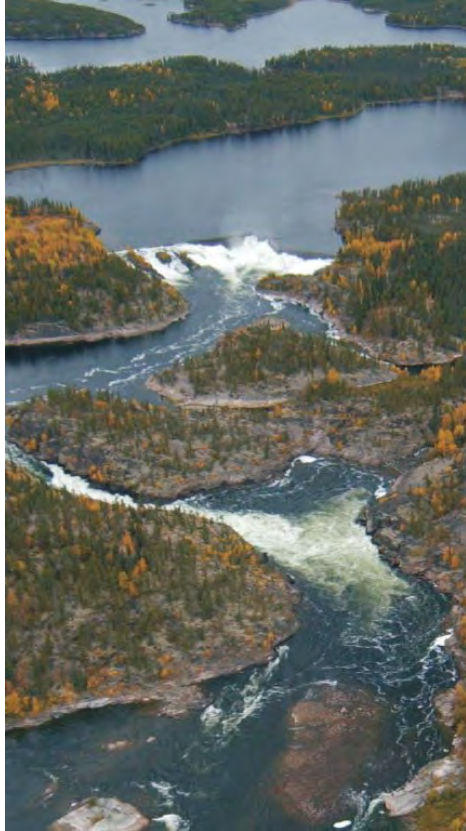
South Valley Spillway

- Uncontrolled spillway from Twin Gorges Reservoir into Trudel Creek
- Amount of spill is determined by elevation of water in Reservoir
- Main spillway is a 100m long concrete structure
- Trudel Creek flows in a loop that rejoins the Taltson River downstream of Twin Gorges Dam

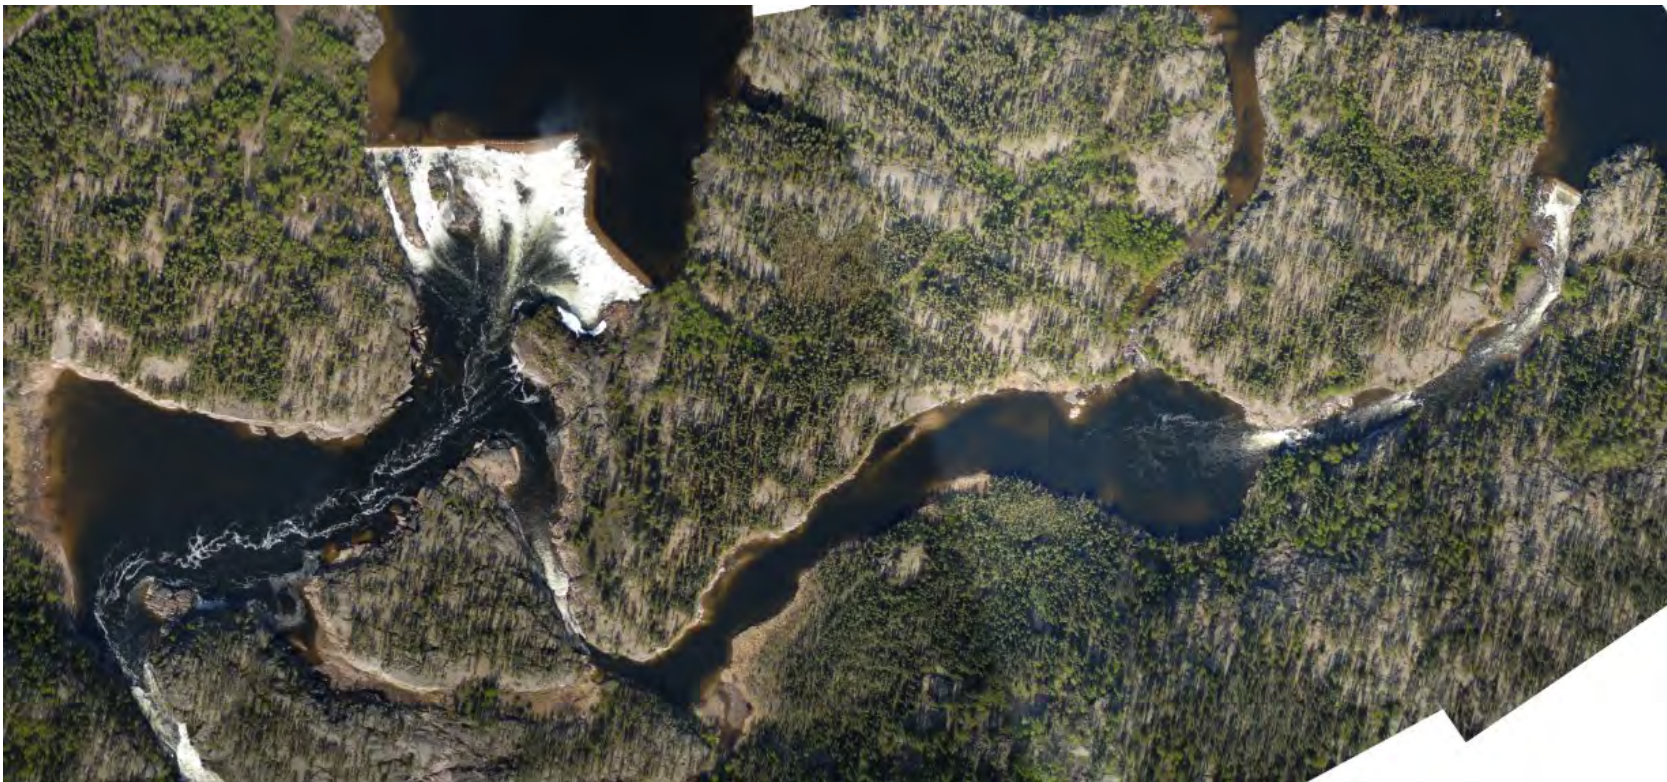
South Valley Spillway

- Has been continuously spilling since mine closure in 1986

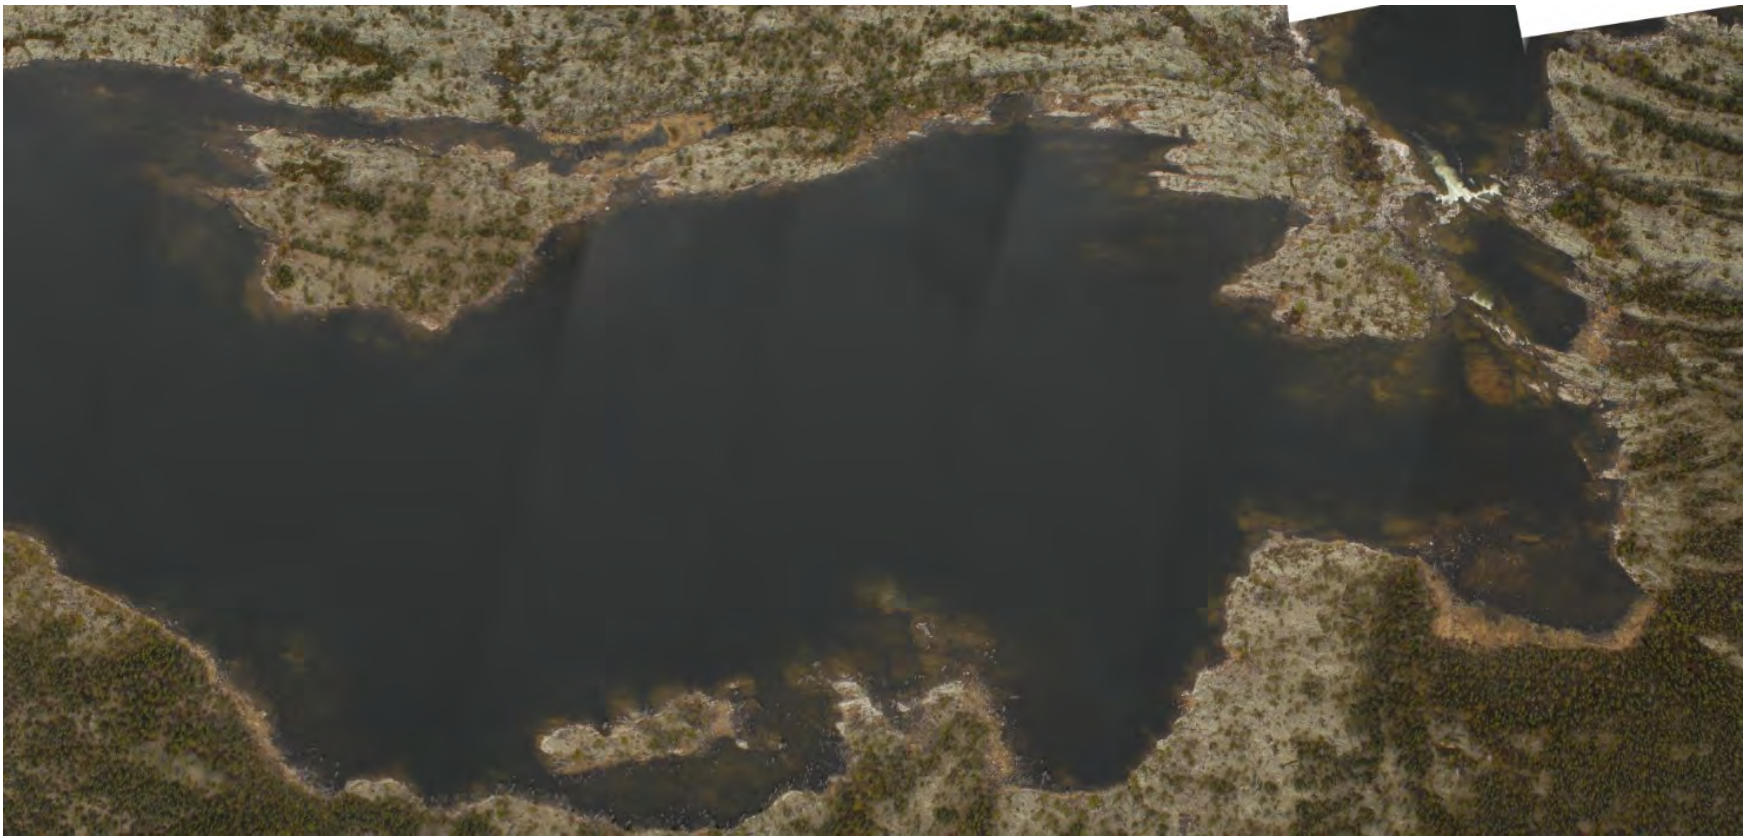
Tronka Chua Gap

- Secondary outlet out of Nonacho Lake
- Controlled by water level only

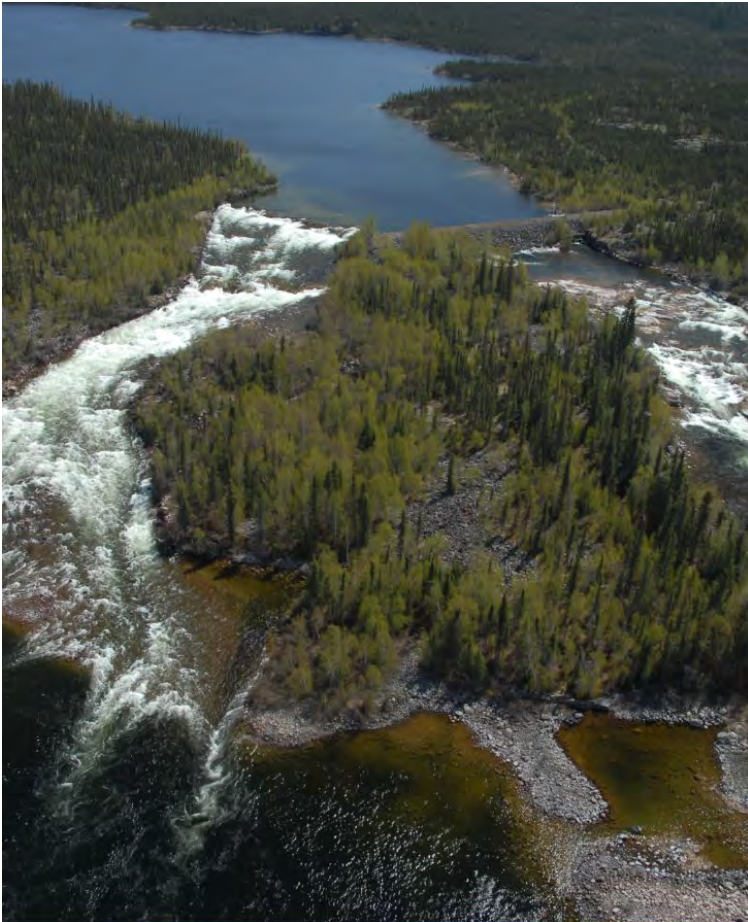
Nonacho Lake Dam

- Constructed in 1968 at the outlet of Nonacho Lake
- 160km upstream of Twin Gorges
- Installed for additional storage for the Taltson Twin Gorges generating station
- Consists of:
 - Natural overflow spillway adjacent to the dam
 - Impermeable rock fill dam
 - Control structure

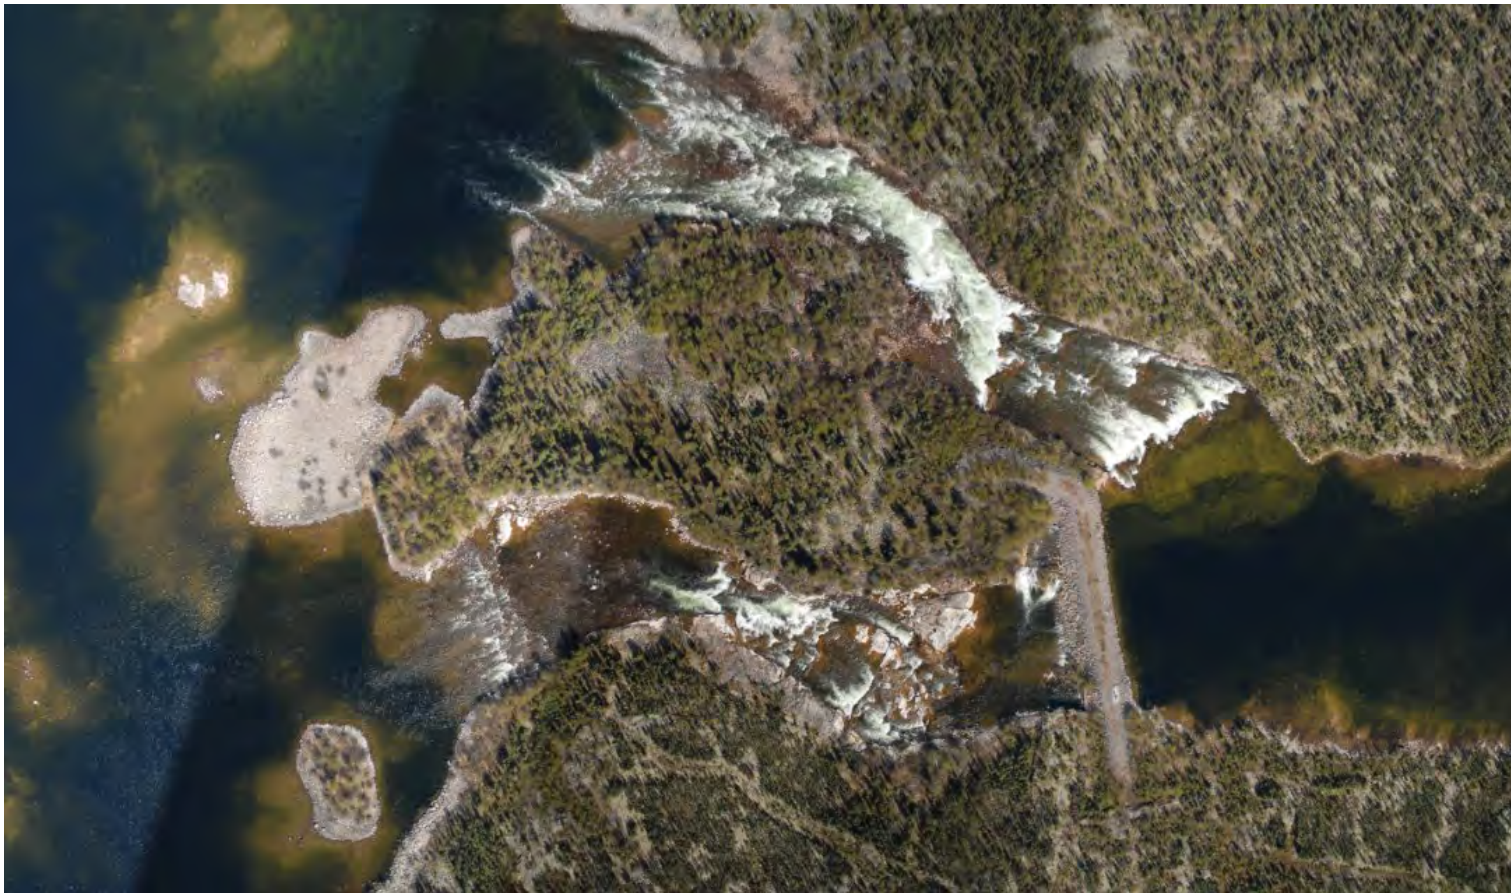
Natural Overflow Spillway

- Natural spillway over a rock barrier adjacent to the dam
- Width of 67m and a crest elevation of about 320.0m

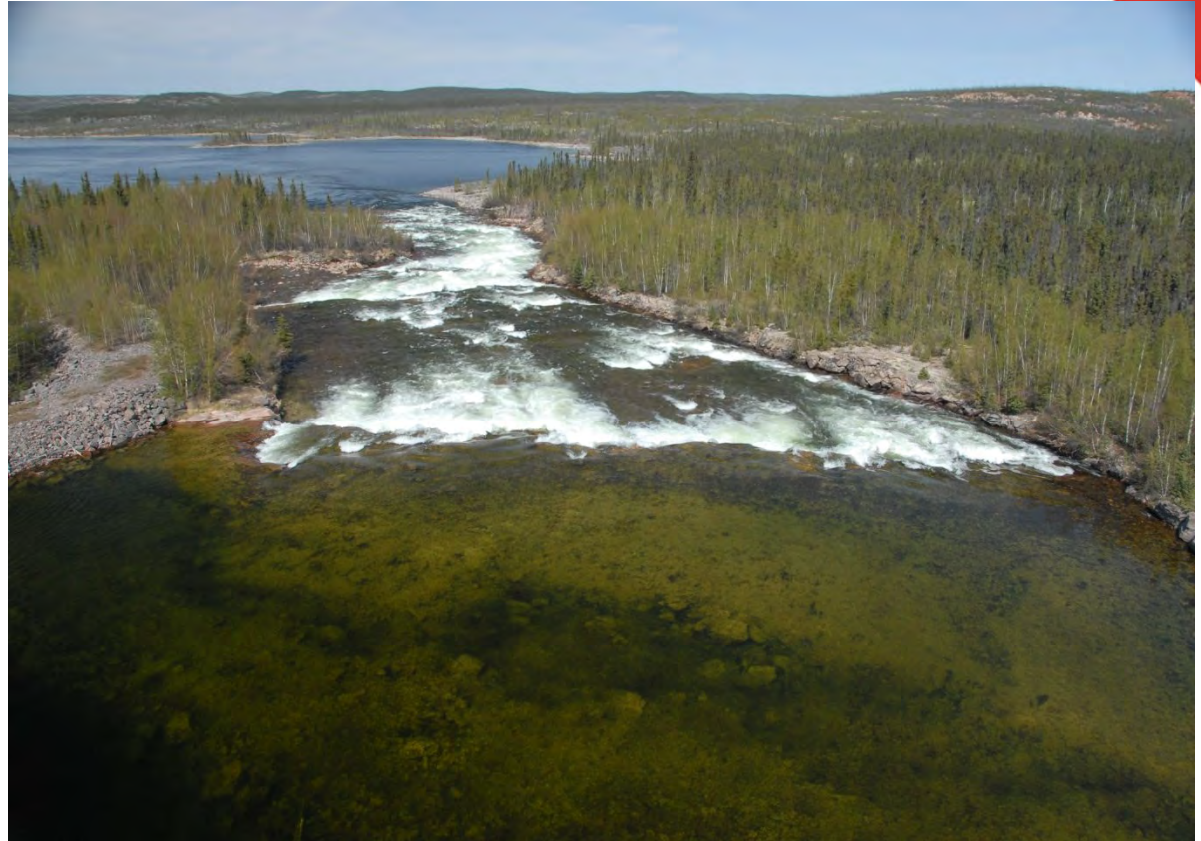
Impermeable Rock Fill Dam

- Leakage of approximately $8.5 - 10 \text{ m}^3/\text{s}$
- Helicopter access only
- Width of approximately 100m

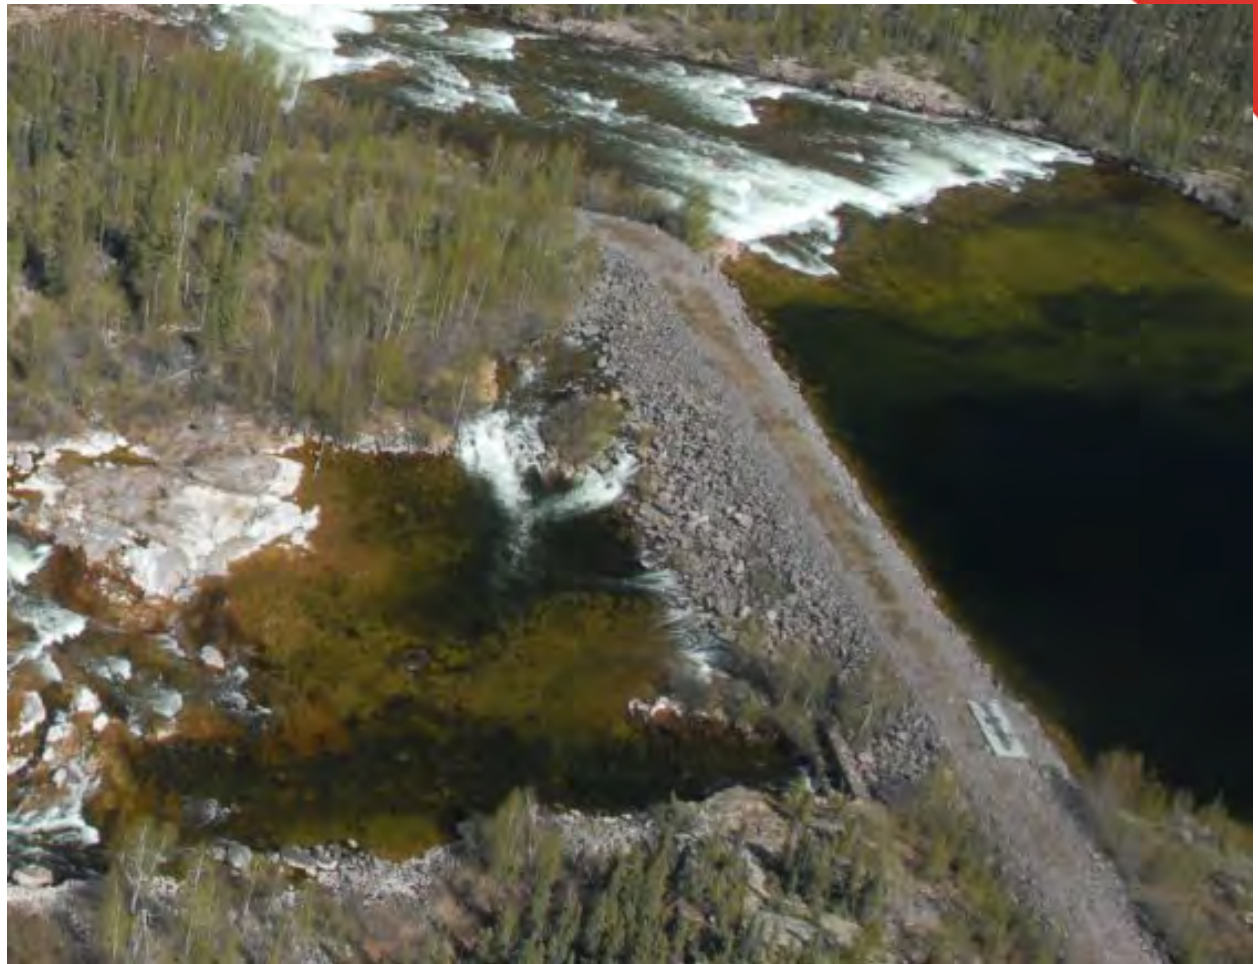
Control Structure

- Three 1.8m x 1.8m passages through the dam
- Three gates within the dam control passages
- One gate conveys 14.5-16.5 m³/s
- Minimal control of flow compared with spillway

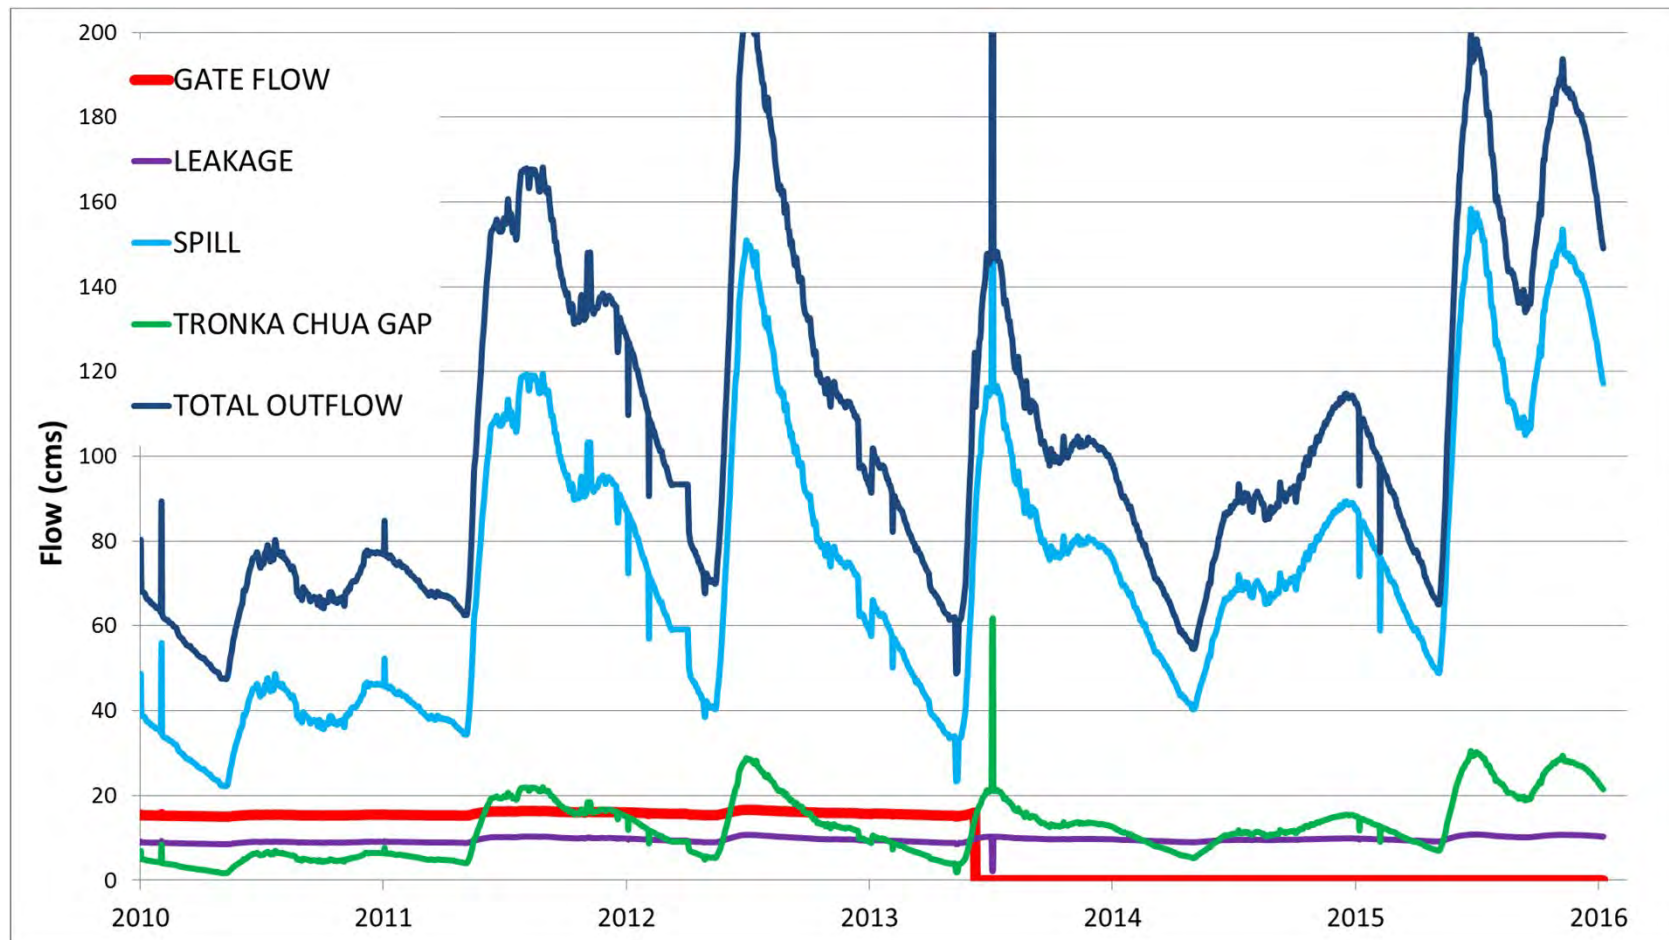
Outflows from Nonacho Lake

- Only gate flow controlled by NTPC

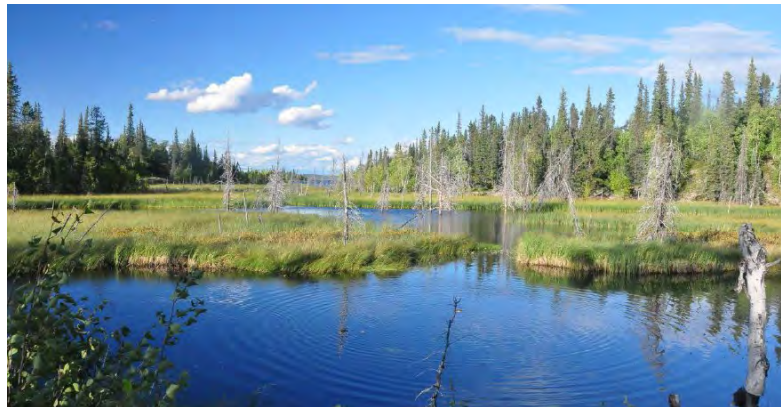
Figure 2-10. Trudel Creek banklines 2014-1955 with cross-section measurement locations.
