ENVIRONMENTAL INSPECTION REPORT

Well Site A-3:

On July 13, 2016 inspectors with the Department of Lands inspected well site A-3 which falls under Land Use Permit MV2014X0011. The permit is held by Apache Canada Ltd. for their interests in the former Pointed Mountain Gas Field near Fort Liard.

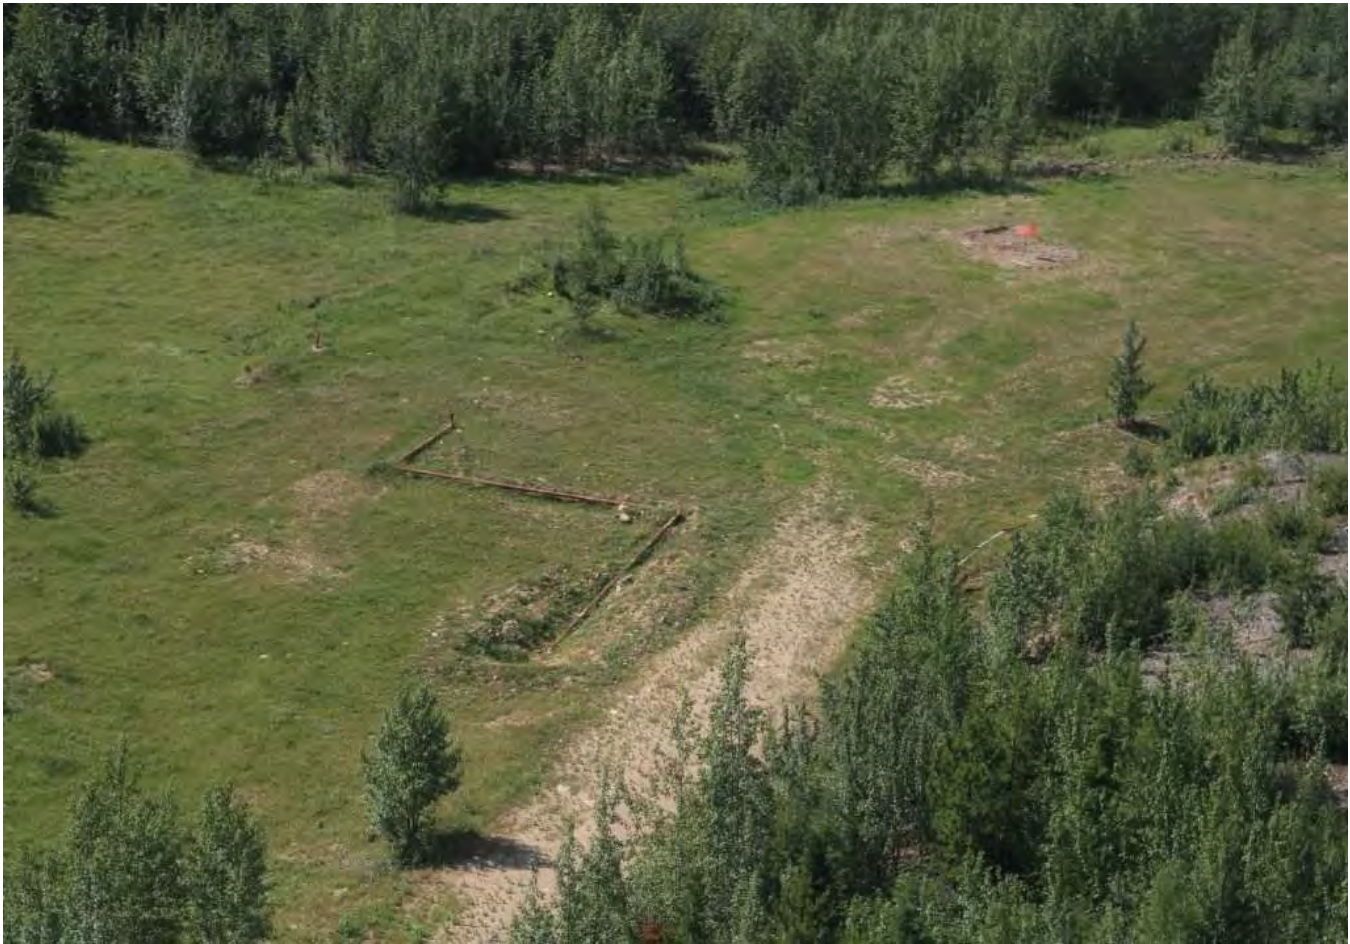
Figure 3

Exposed piping on the left of the access road. Photo: July 13, 2016

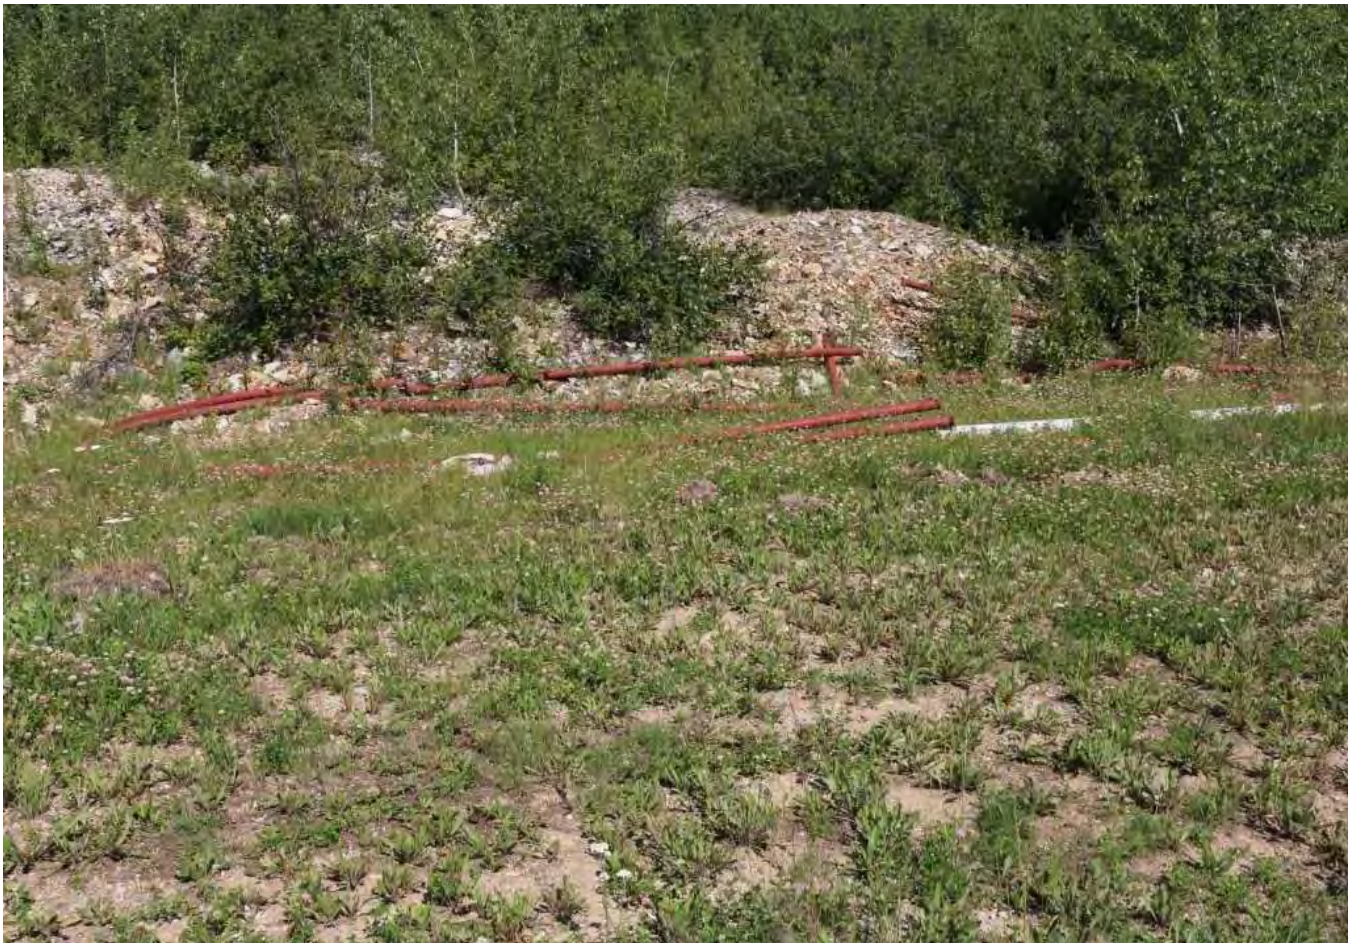
Figure 4

The well head was removed earlier in the year during the winter season. Signage for the well site was installed where the well head was removed. The soil has settled where the well head removed in the winter season. Inspectors found some old pipes lying along the edge of the lease which should be removed off site prior to expiry of the land use permit. Exposed piping was also found next to the access road during the inspection. Inspectors also noted that ground water monitoring wells were on site. Vegetation has established on site, however bare soil was visible throughout the site.

Old pipes and debris found on site. Photo: July 13, 2016.
